SEISMIC ASSESSMENT OF A TRADITIONAL RESIDENTIAL BUILDING IN  
ANTAKYA AFTER 2023 TÜRKİYE EARTHQUAKE SEQUENCE

A THESIS SUBMITTED TO  
THE GRADUATE SCHOOL OF NATURAL AND APPLIED SCIENCES  
OF  
MIDDLE EAST TECHNICAL UNIVERSITY

BY  
HASİP ATICI

DECEMBER 2024

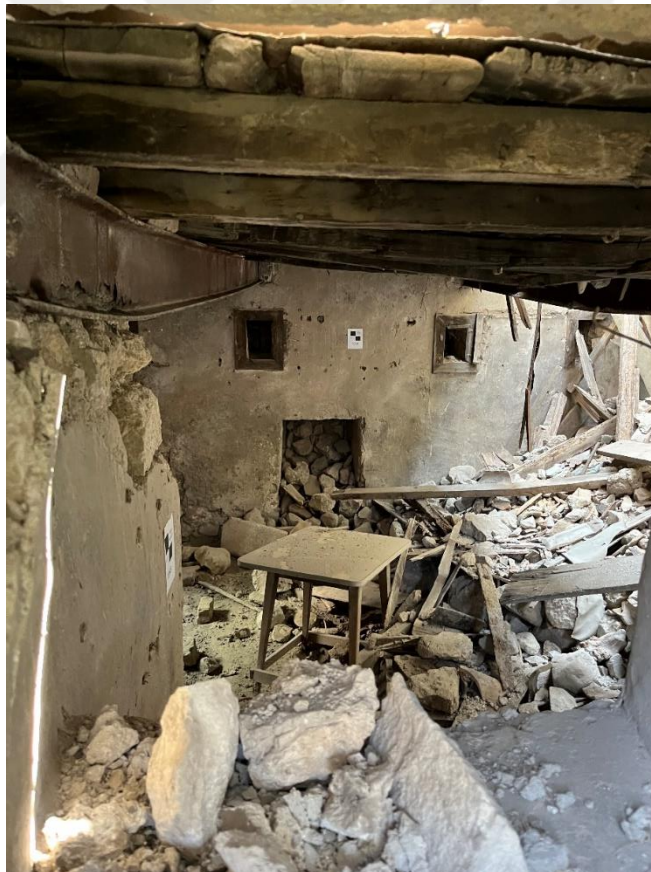
Figure 2.50 Damage in the B01 room (METU TAÇDAM, 2023)

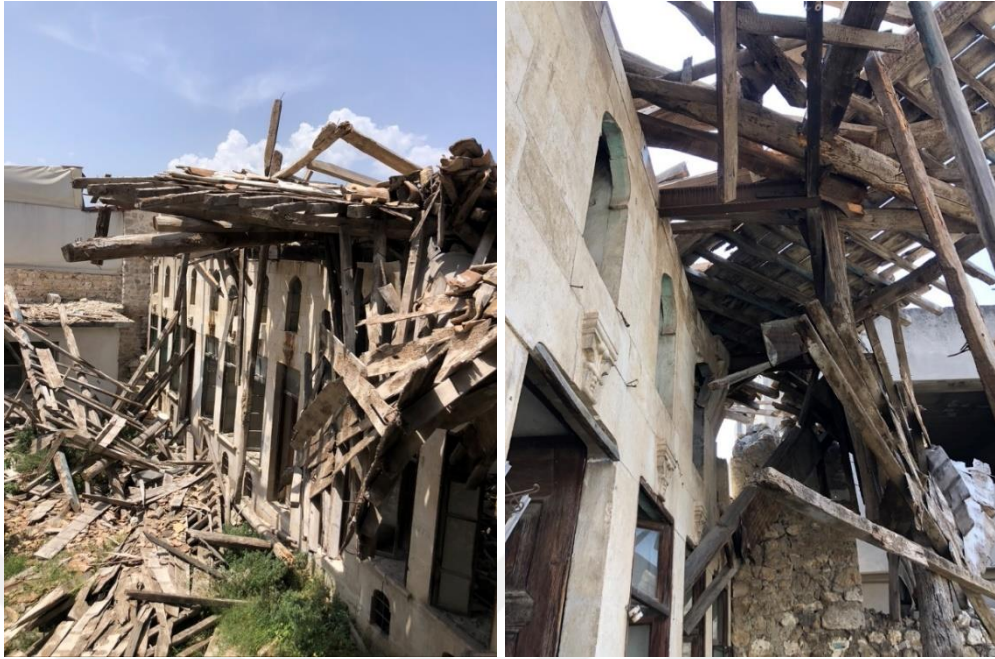
Figure 2.51 First floor failure (METU TAÇDAM, 2023)

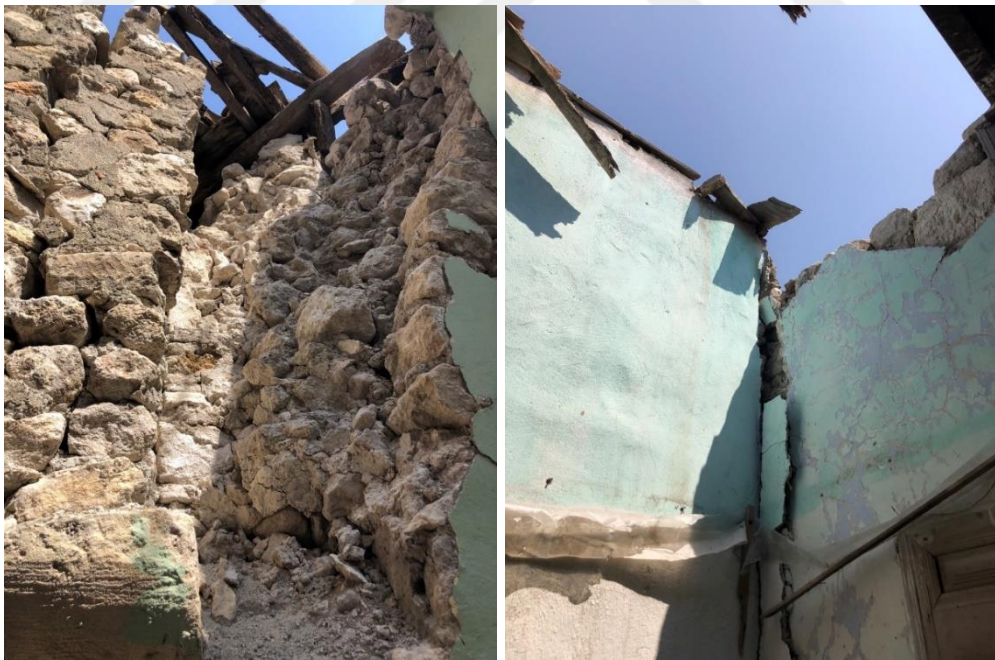
Figure 2.52 Wall coursing with weak mortar (left) and wall intersections (right) (METU TAÇDAM, 2023)

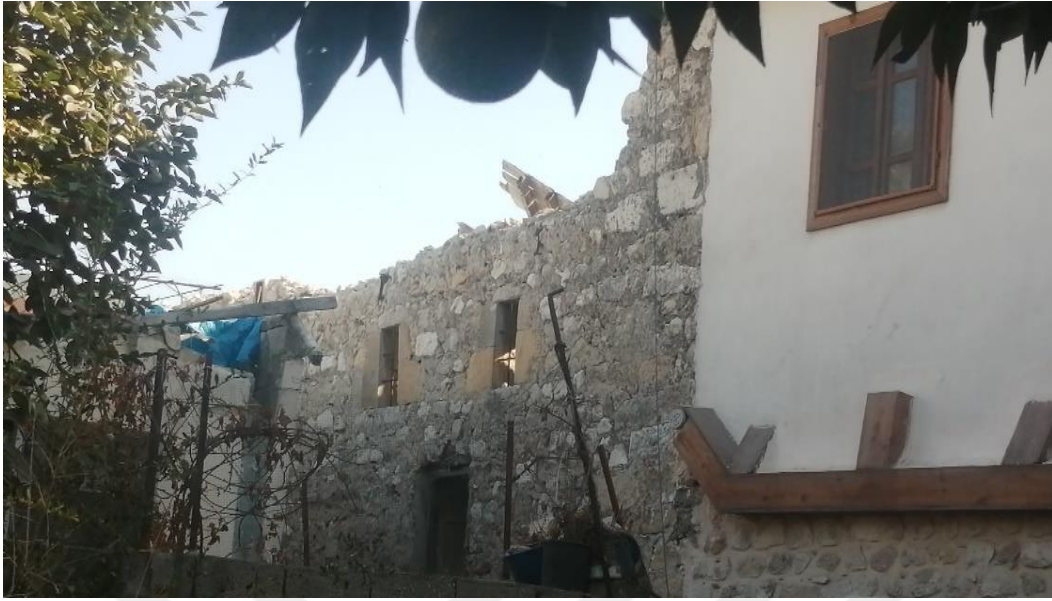
Figure 4.1 Out-of-plane collapse of the north wall on the first floor

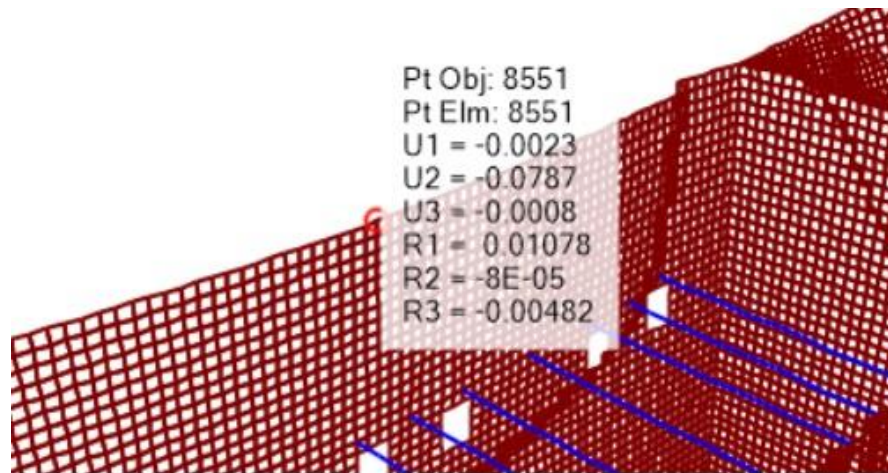
Figure 4.3 Drift in the north wall of the first floor according to the analysis results (U2=7.9 cm)

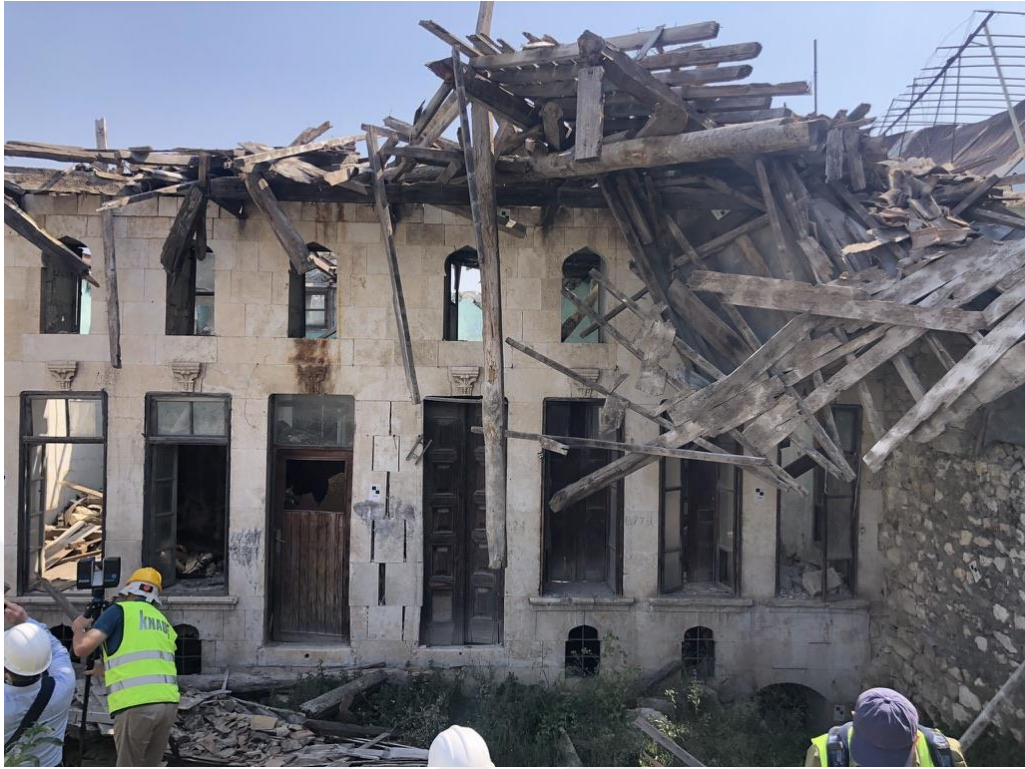
Figure 4.6 Observed earthquake damage for the south wall (METU TAÇDAM, 2023)

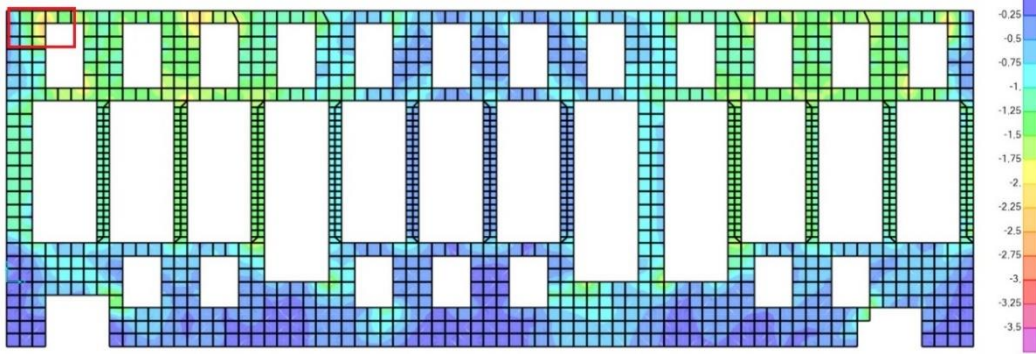
Figure 4.7 Expected shear failure in the upper corner of the openings in the south wall of the ground floor

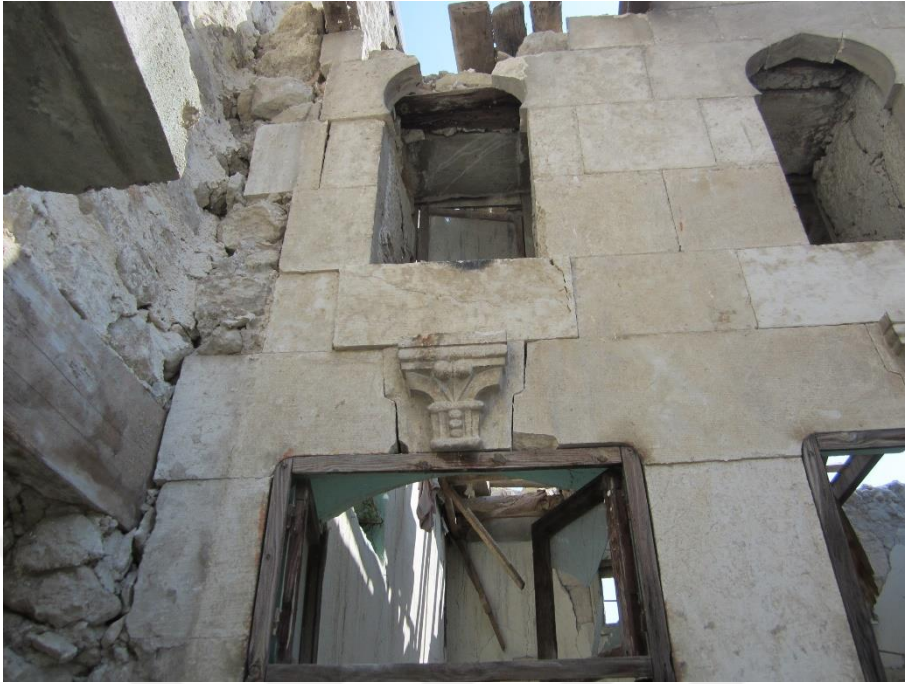
Figure 4.8 Observed damage in the upper corner of the openings in the south wall of the ground floor (METU TAÇDAM, 2023)
