**ARCHIVING OF THE CONSERVATION DATA OF  
IMMOVABLE CULTURAL ASSETS DATING TO  
1300-1600 IN URLA CENTER USING GIS**

**A Thesis Submitted to  
the Graduate School of Engineering and Sciences of  
İzmir Institute of Technology  
in Partial Fulfillment of the Requirements for the Degree of  
MASTER OF SCIENCE  
in Architectural Restoration**

**by  
Veli Mustafa YÖNDER**

**July 2019  
İZMİR**

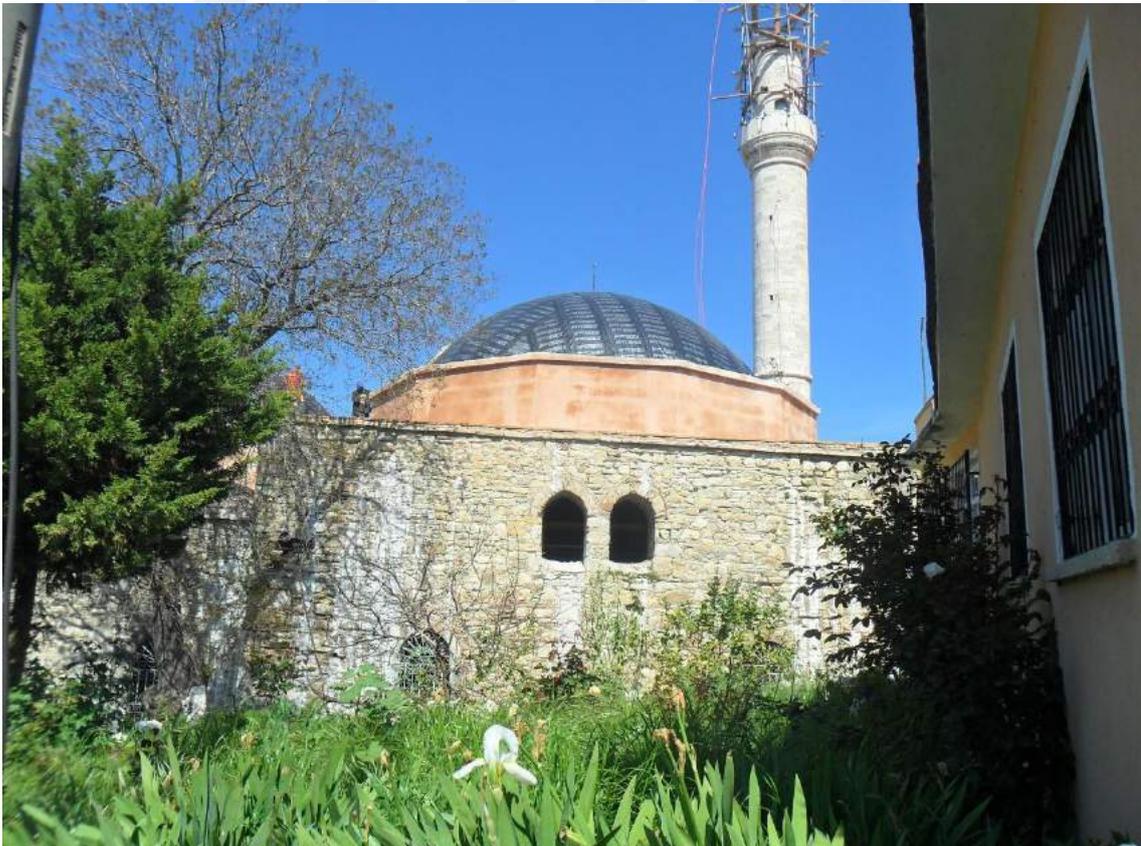
Also, some minor changes such as partial painting, door and window repairs, and cleaning of the graveyard were realised, but there is no clear information in the records. The restoration has been continuing (Figure 3.9).

Figure 3.9. The graveyard and the south facade of the mosque as viewed from the south

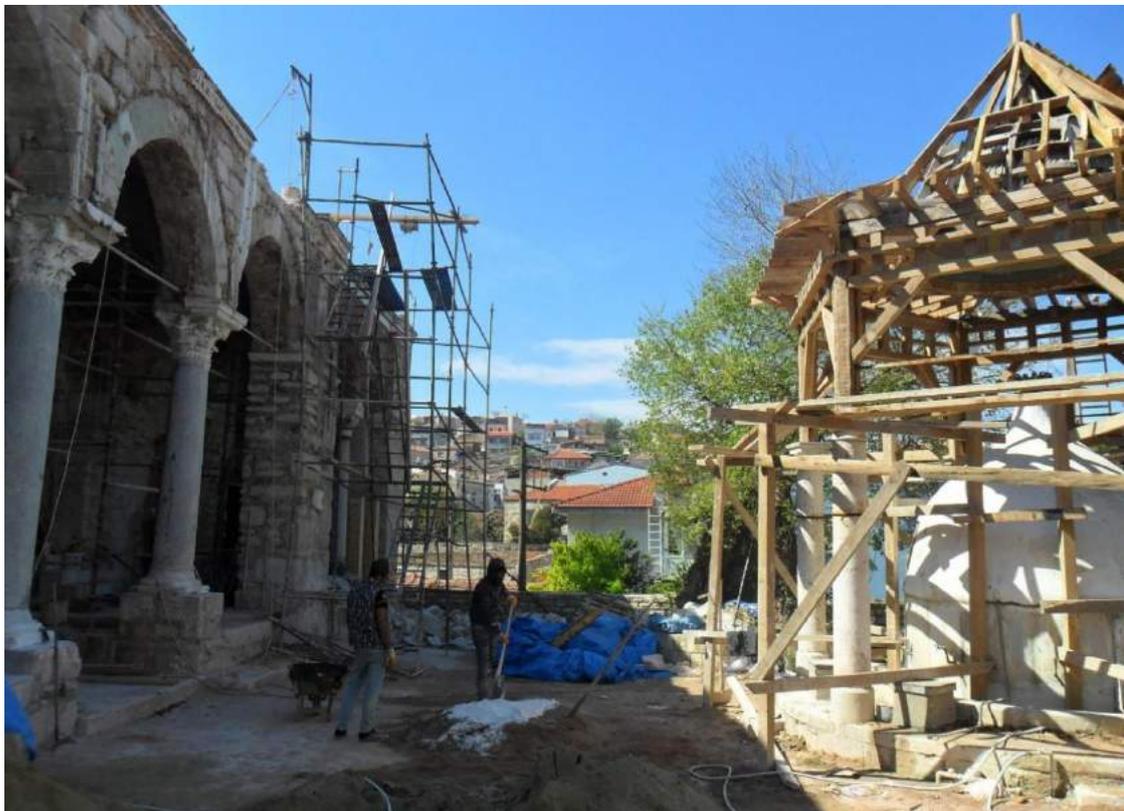
The water storage is also domed, and the ablution fountains underneath surrounded by stone seats which all rest on a stone platform slightly elevated from the courtyard (Figure 3.13). The dome is in timber lath technique, plastered and painted (25 square meters). Registration history of the *Şadırvan* is the same with the mosque because they are in the same lot. The restoration has been continuing (Figure 3.14).

Figure 3.14. The courtyard as viewed from the northeast

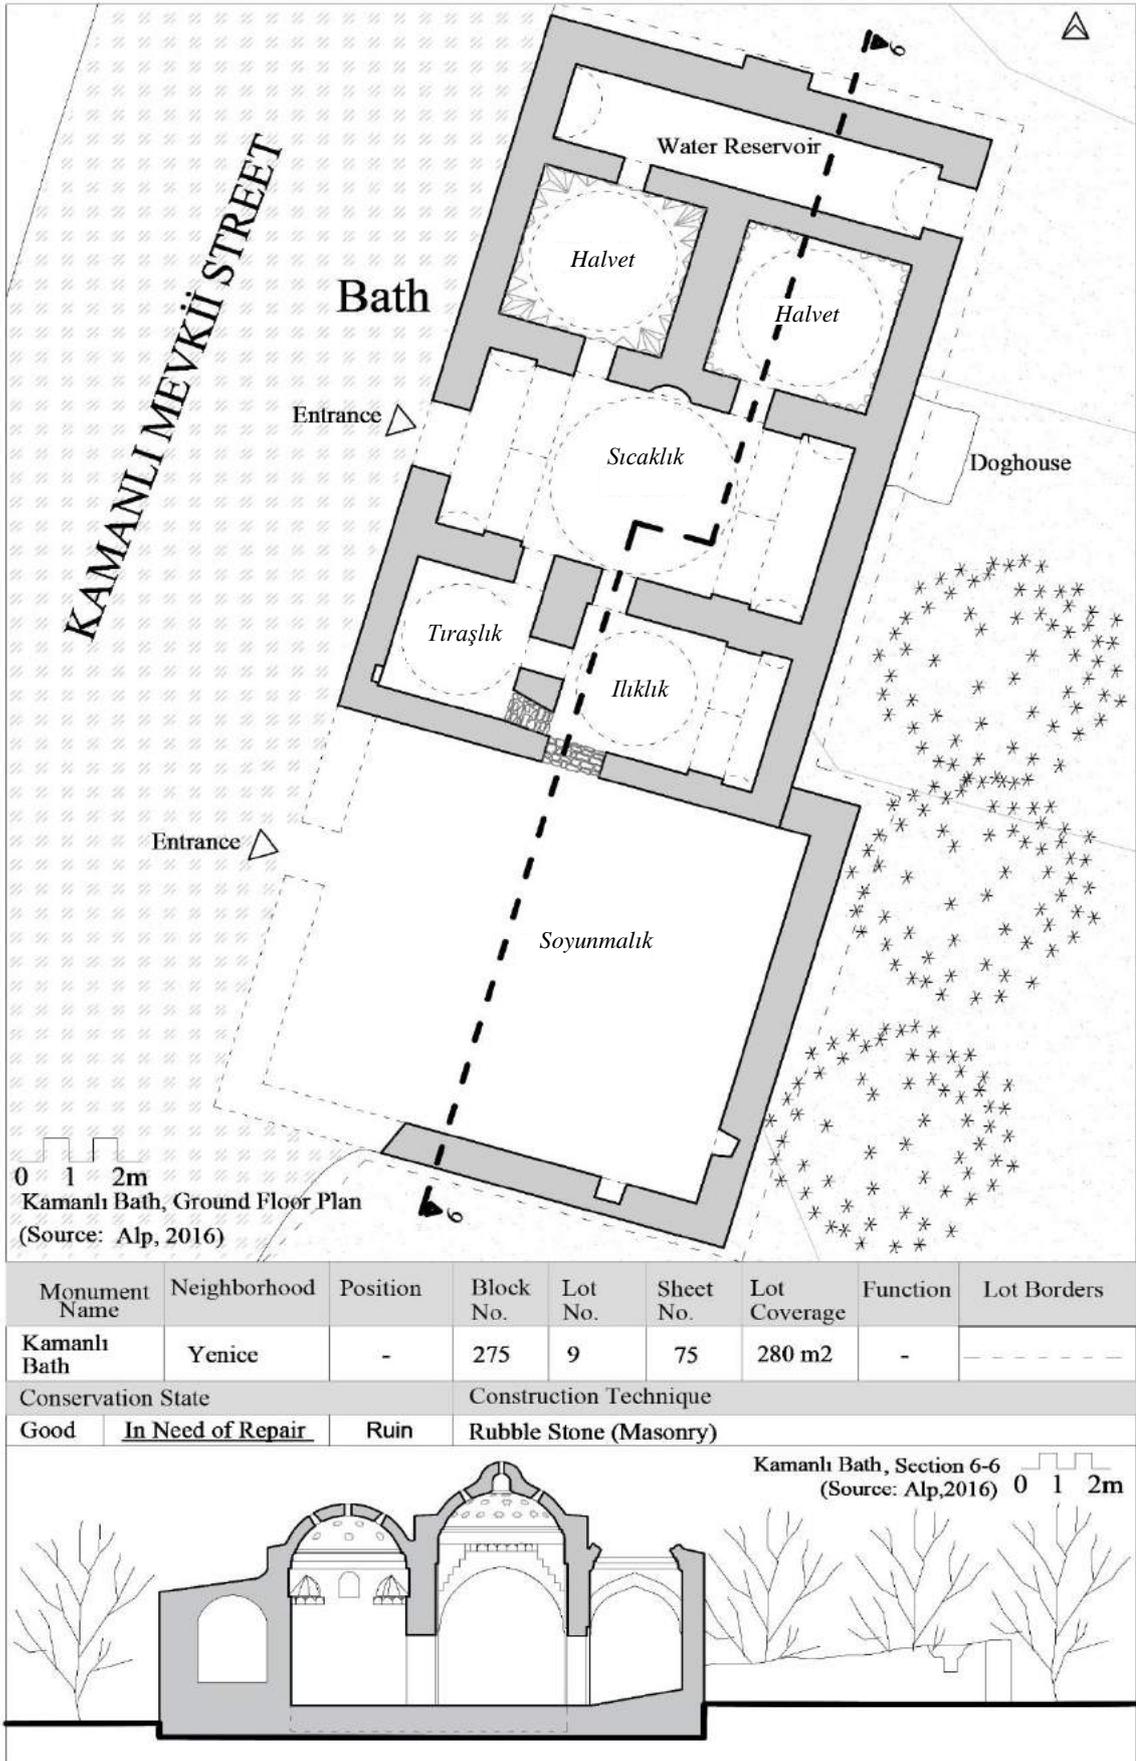
An entrance door exists in northwest facade, but the original location of the entrance is unpresent. Bayrakal (2009) and Alp (2016) state that the main entrance should be from the south of the northwest facade, which is now in ruins. Also, construction material is a rubble stone. The bath has a rectangular plan in the north-south direction. The entrance of the *soyunmalık*, which is thought to be a southern direction, is uncertain. This rectangular space (10 x 11m) is surrounding with demolished walls (Figure 3.33). This space is in open air completely at present. This space's function was *Soyunmalık* (*Camekan*). The east wall projected outward. Moreover, there are niches on south and east of this space. There was an opening at the north of the *soyunmalık* but it is closed at present. Its brick arch is still perceivable.

Figure 3.33. Ground floor plan and section, Kamanlı Bath

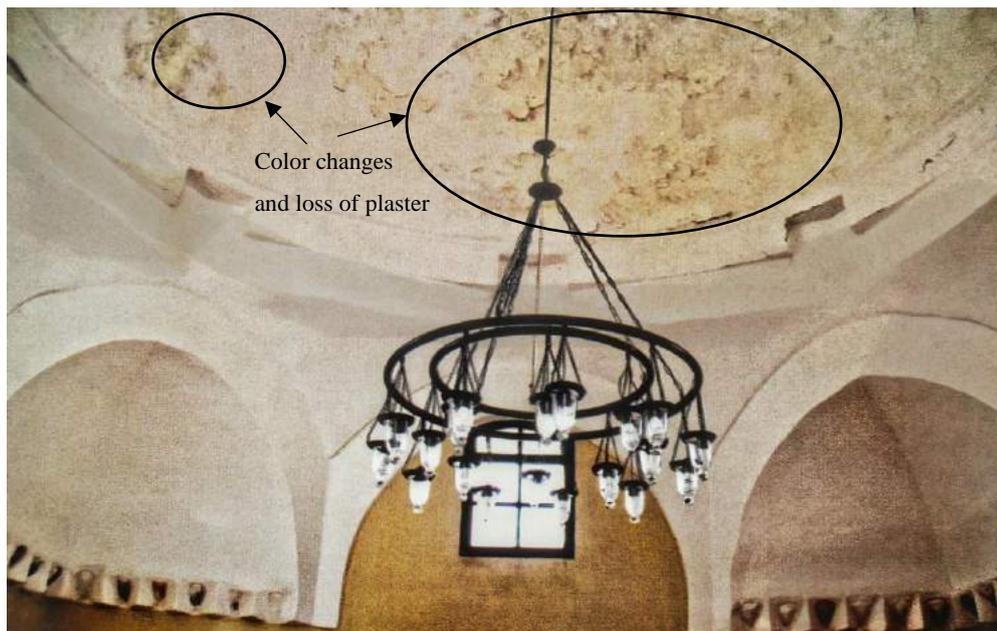
The main praying hall has a square plan (7.6 x 7.6 m) and spanned by a dome, which rests on an octagonal profile and then squinches (Figure 3.50, 3.51). There are three niches at the southeast wall. The middle niche is the mihrab and the other two serve as bookshelves. There are two openings and one bookshelf niche at the northwest wall. White and yellow plasters were used in walls. Color change was observed on the inner surface of the dome. The mosque dates to the 15<sup>th</sup> century first listed in 1965 (Table 3.10) (RDPF Archive, 1965) (Appendix A, Figure A.8). According to the inventory sheet, domes of the original semi-open last comers' hall had collapsed (RDPF Archive, 1965). In 1978 and 1982, the mosque was re-listed (RDPF Archive, 1978). In 1991, permission was given to clean the garden and paint the interior (Conservation Board Archive, 1991). However, it has been decided that restoration was necessary (Conservation Board Archive, 1991). In 2000, the roof and minaret were affected from a storm. So, the mukhtar asked for permission of maintenance work (Conservation Board Archive, 2000). In 2005, the restoration project of the mosque, which was designed by Umut Genç, was approved and restoration started in 2006 (Conservation Board Archive, 2006). During the restoration, the graveyard was cleaned, and an ablution unit was added (Conservation Board Archive, 2008). After the restoration was completed, the semi-open last comers' hall was re-closed with glass screens once (Figure 3.52, 3.53). Unfortunately, at the roof of the praying hall, material problems have started to be seen ten years after the restoration.

Figure 3.50. Inner surface of the dome

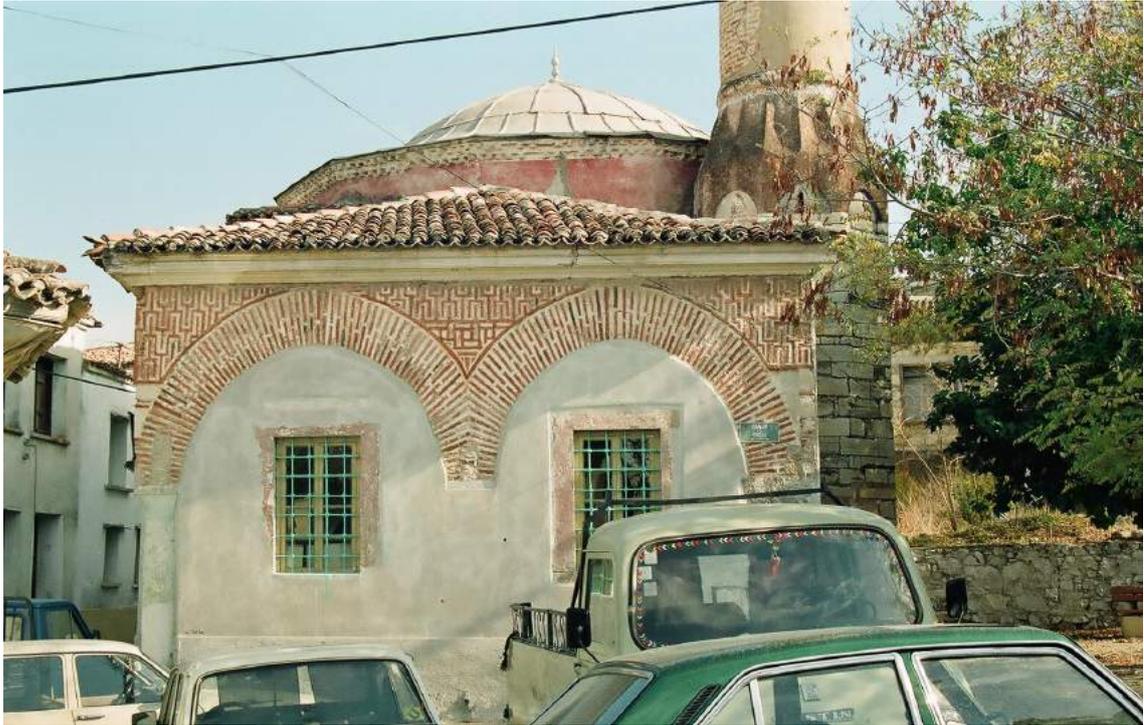
Figure 3.64. Before restoration implementation as viewed from the west  
(Source: RDPF Archive, 1990)

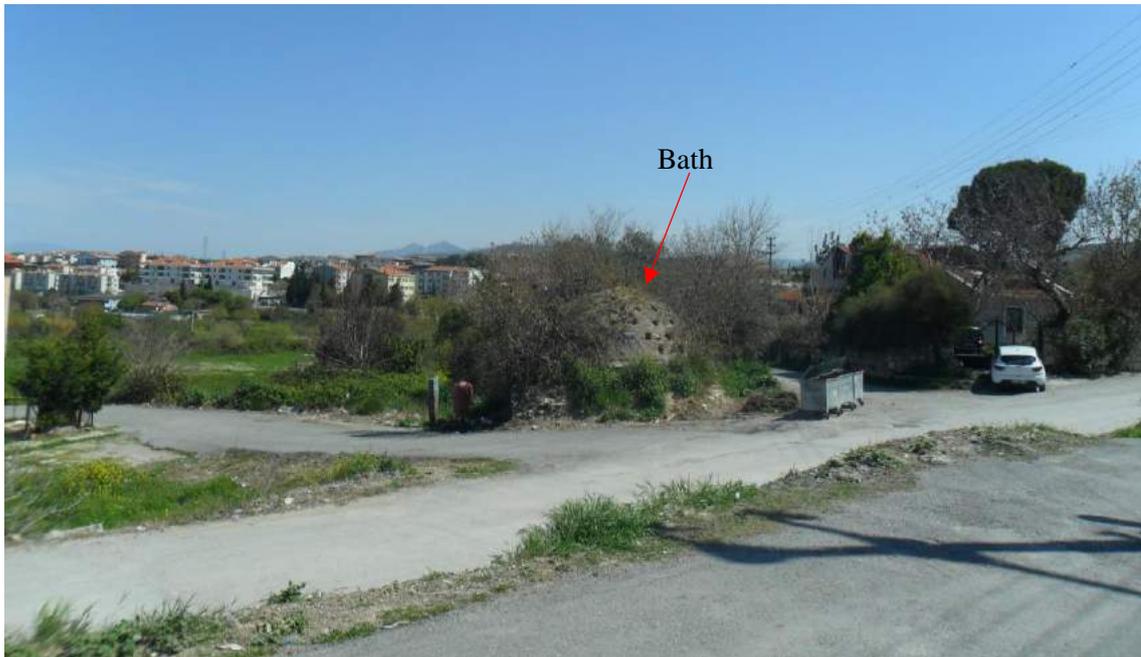
Figure 3.92. Rüstem Paşa Bath current situation as viewed from the northwest

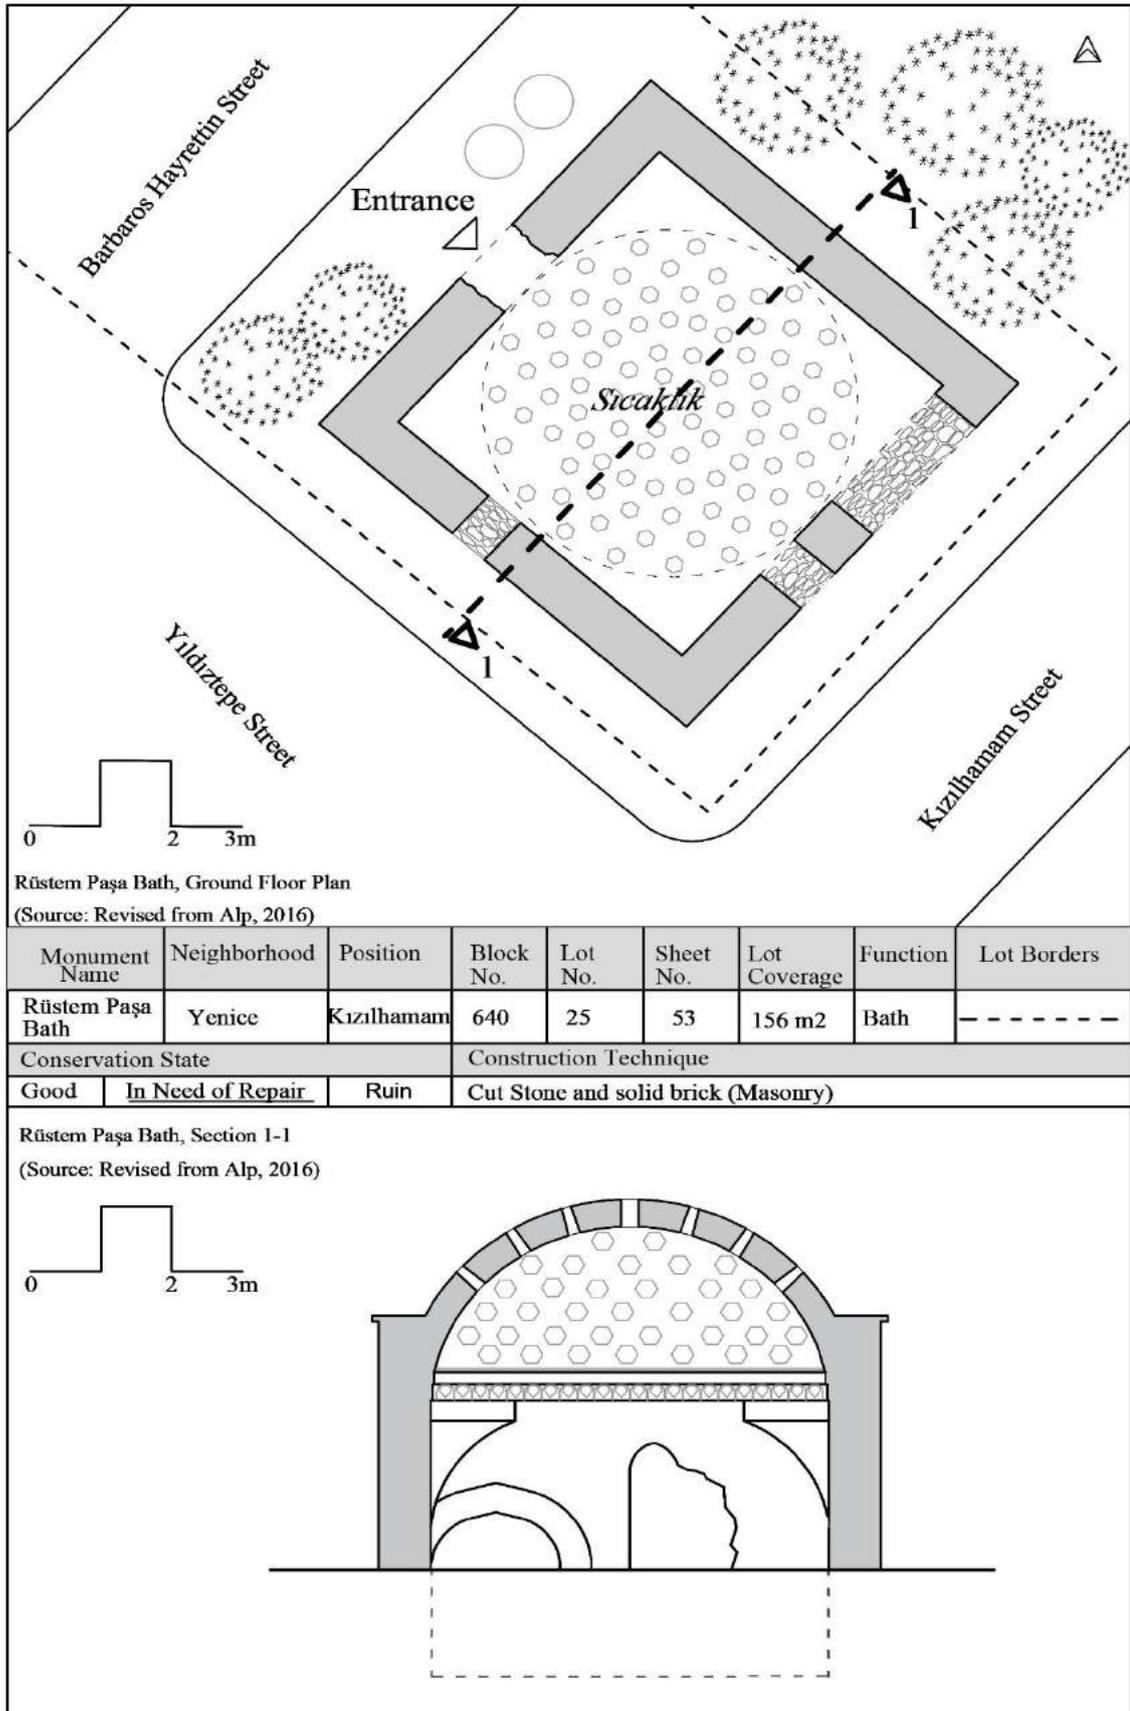
It is square planned (5.50 x 5.50 m) (Figure 3.93, 3.94). The cubic mass may be the largest space comprehending *sıcaklık* (Alp, 2016: 45). Due to the earth, other parts cannot be observed. At the northwest facade, there is an entrance opening. Hexagonal shaped oculi on the dome of the space is used for lighting elements. Squinches and cornice provide transition to the dome. There are traces of an arched openings on the southeast and southwest walls, but these openings were filled later. Cut stone and rubble stone were used in walls and also solid brick was used in superstructure and transition elements. Consequently, the loss of the spaces affects architectural character. For this reason, the bath has lost its entirety.

Figure 3.93. Ground floor plan and section, Rüstem Paşa Bath
