**EVALUATION OF HOLE FILLING REPAIR OF CARBON**  
**FIBER REINFORCED POLYMER COMPOSITE**  
**LAMINATES**

**M.Sc. Thesis by**

**Department of Mechanical Engineering**

**May, 2022**

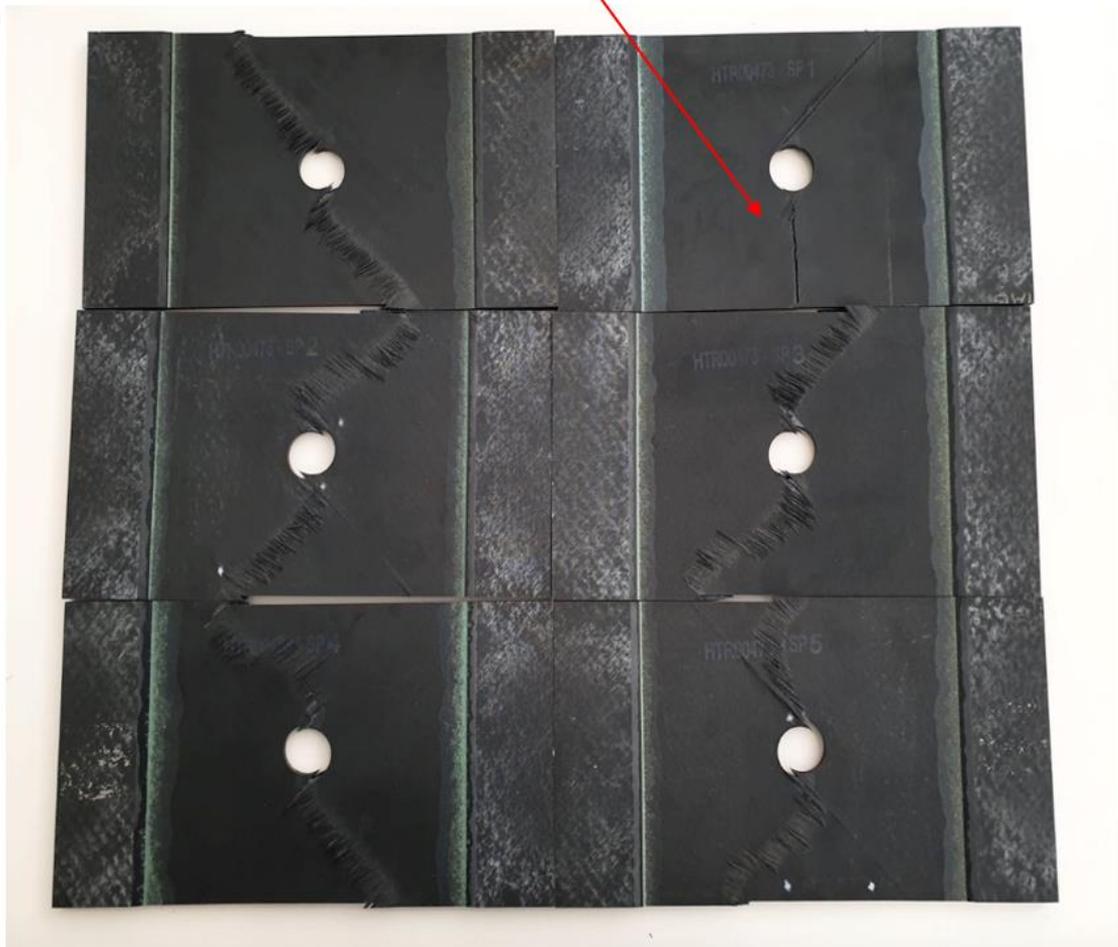
Figure 4.1 illustrates the follow-up tensile test of unrepaired specimens. Firstly, tensile test was applied to the six unrepaired specimens. Figure 4.1 shows the failure behavior of these six specimens. As can be seen here, the failure behavior of the second specimen which is shown in Figure 4.2, is different from the others.

**Figure 4.1** Failure mechanism of unrepaired specimens

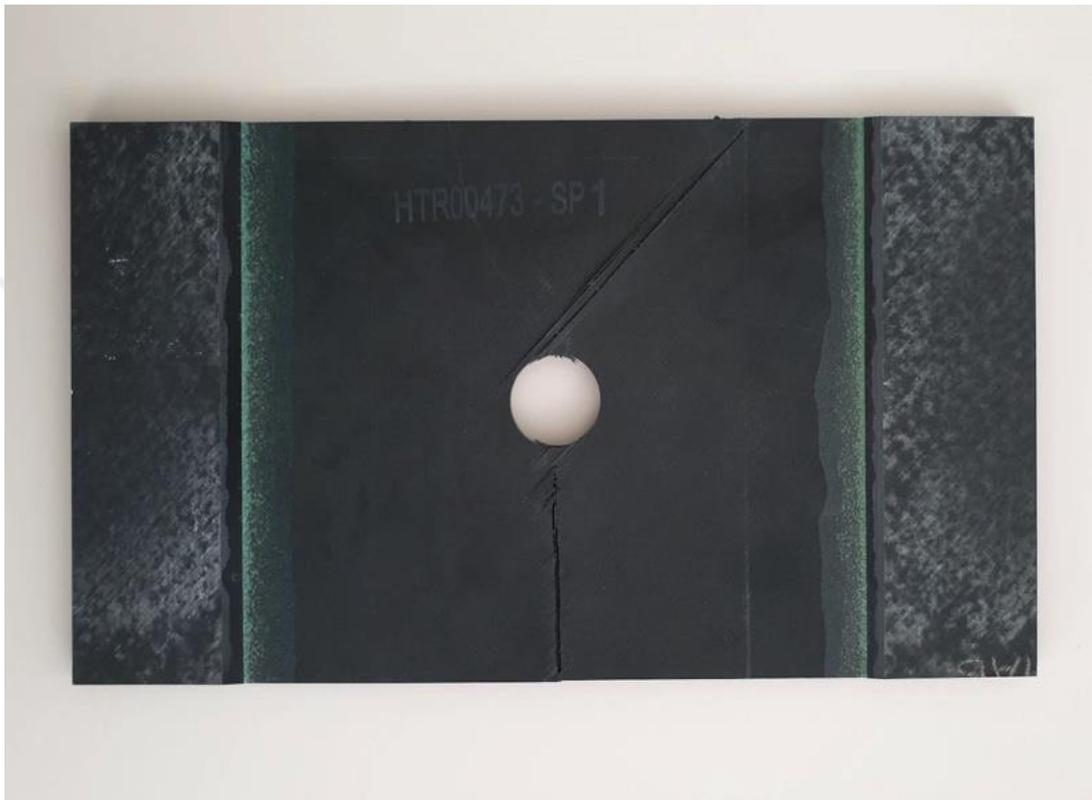
**Figure 4.2** Failure behavior of the unrepaired specimen 2

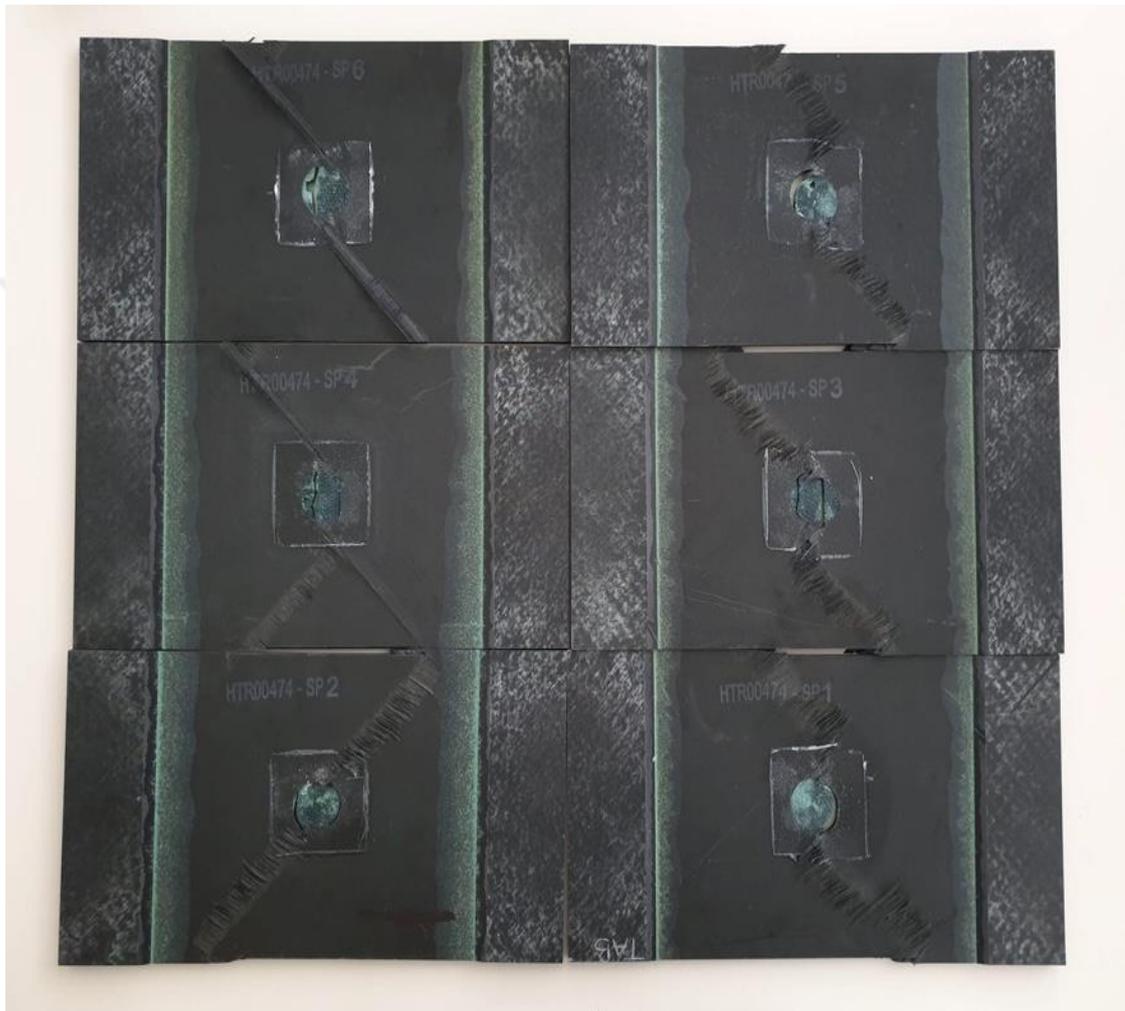
Figure 4.4 illustrates the tensile test of the repaired with Loctite 9396 adhesive specimens. The test was applied to the six repaired specimens. Figure 4.4 shows the failure behavior of these six specimens. No different failure behavior is observed in this type of repair.

**Figure 4.4** Failure mechanism of repaired with Loctite 9396 adhesive

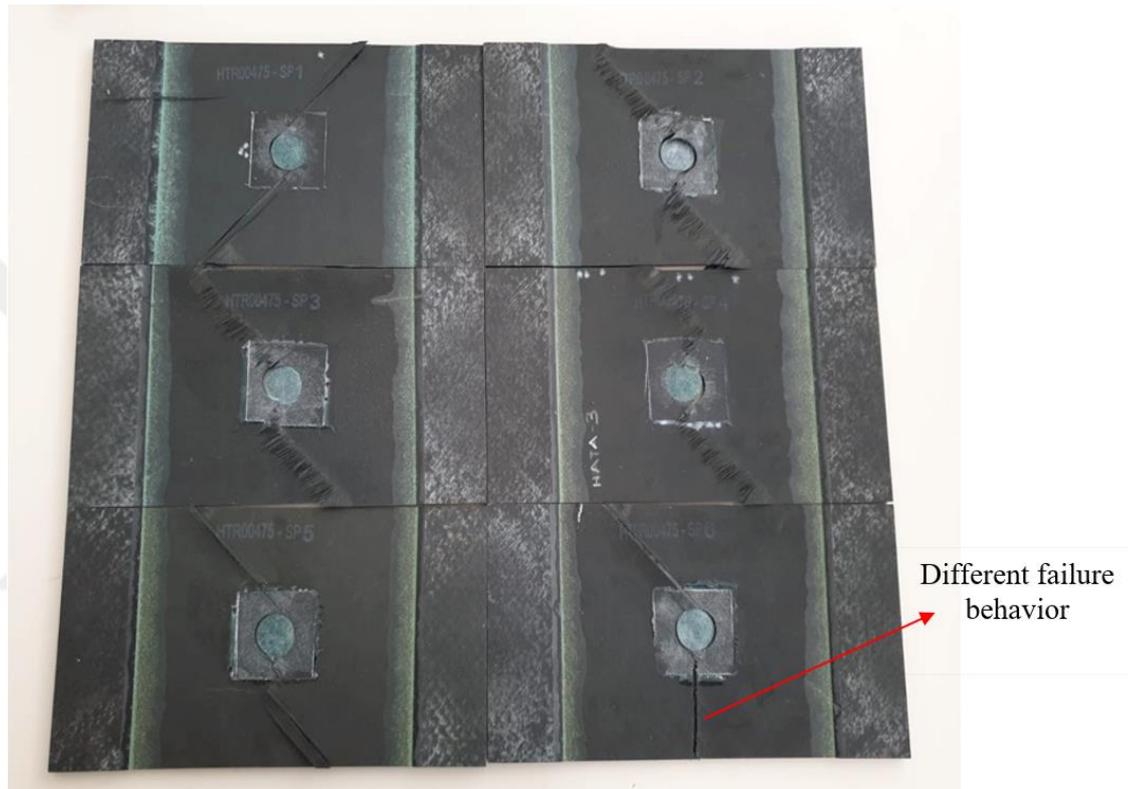
Figure 4.6 illustrates the situation after the tensile test of the repaired with 30% chopped glass fiber and Loctite 9396 adhesive specimens. The test was applied to the six specimens as usual and Figure 4.6 shows the failure behavior of these six specimens. As can be seen in Figure 4.7, the failure behavior of the last specimen is different from the others.

**Figure 4.6** Failure mechanism of the repaired with %30 chopped glass fiber and Loctite 9396 adhesive

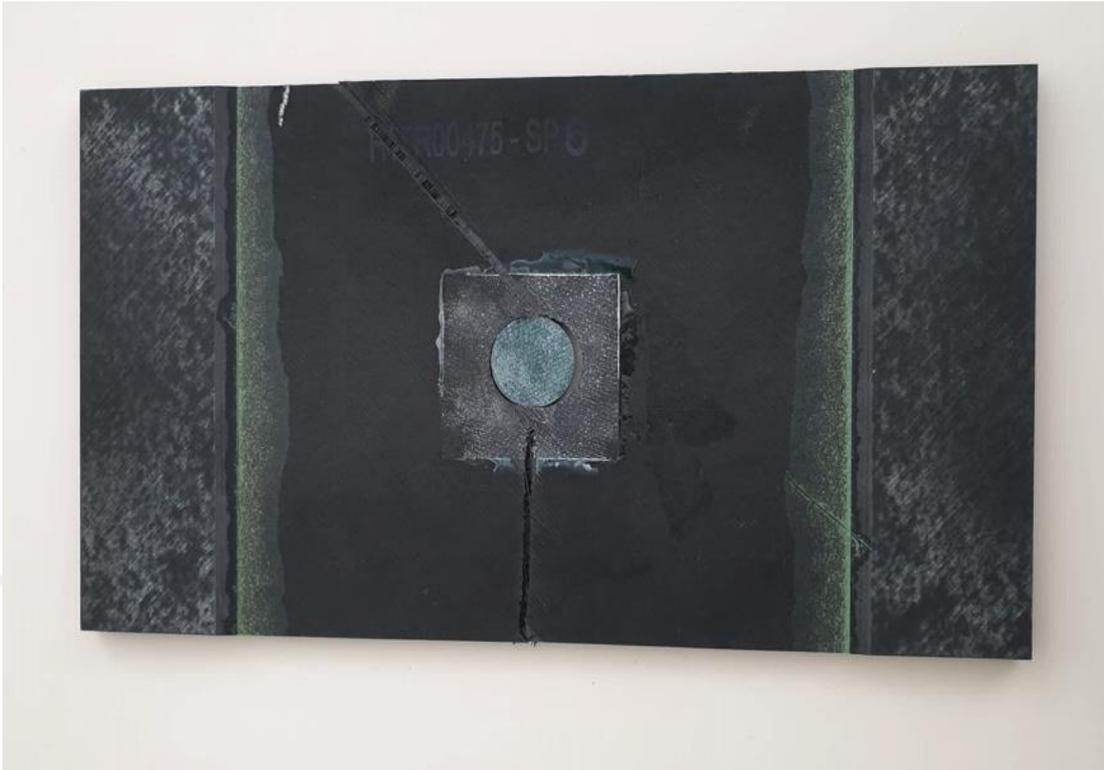
**Figure 4.7** Failure behavior of the specimen 6 repaired with 30% chopped glass fiber and Loctite 9396 adhesive

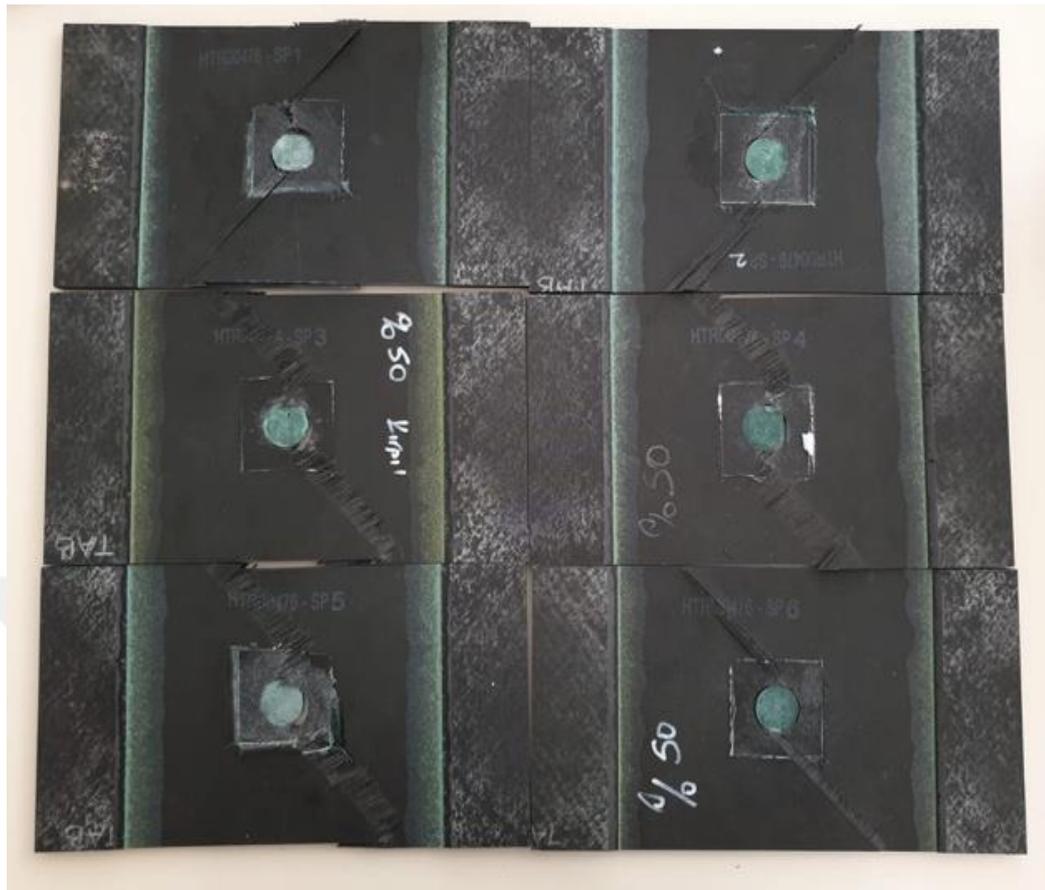
Figure 4.9 illustrates the condition after the tensile test of the repaired with 50% chopped glass fiber and Loctite 9396 adhesive specimens. The test was conducted for the six specimens again and Figure 4.9 shows the failure behavior of these six specimens. No different failure behavior was observed for the specimens.

**Figure 4.9** Failure mechanism of the specimens repaired with 50% chopped glass fiber and Loctite 9396 adhesive

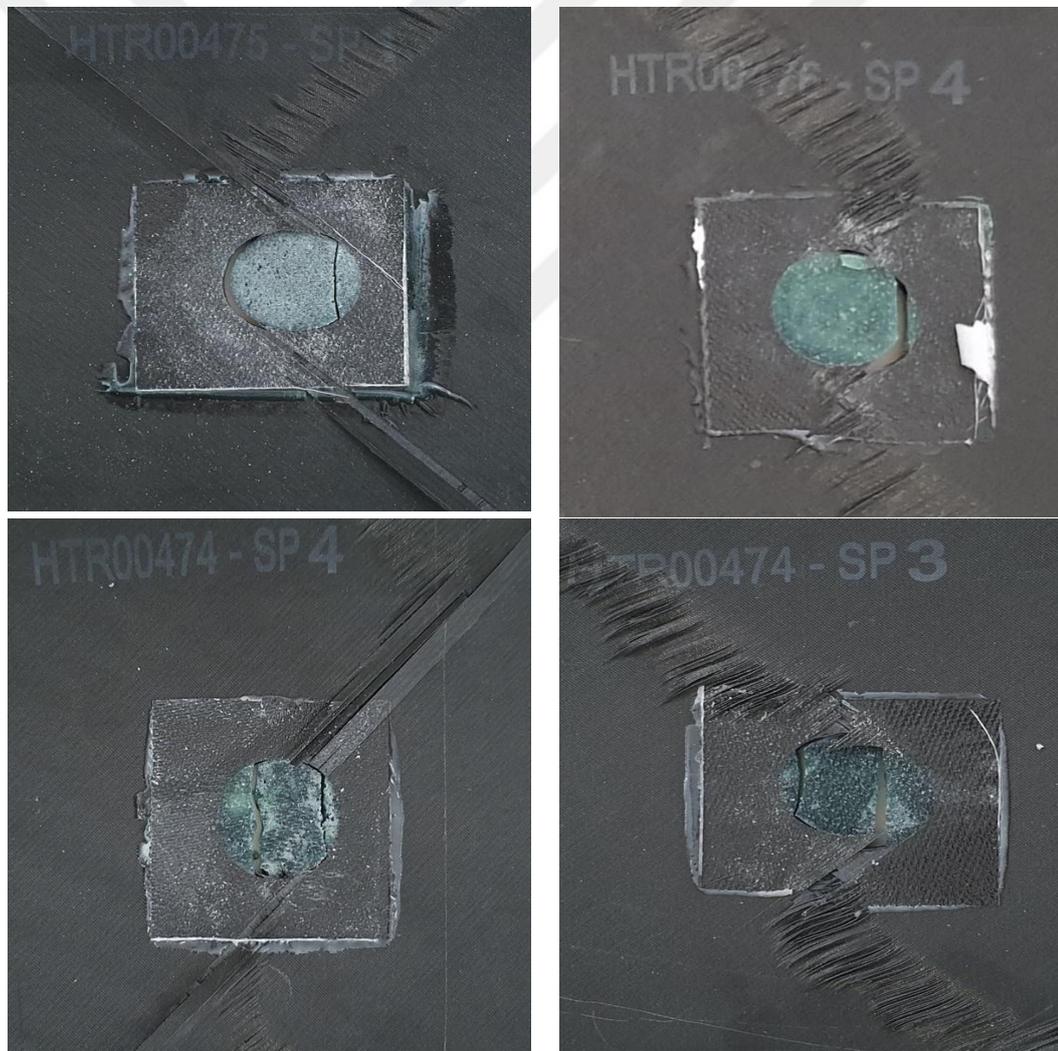
In this thesis, holes made on 18 specimens were repaired with the plug repair method. Based on the experimental observation, some specimens had brittle defects. (Figure 4.11)

**Figure 4.11** Brittle failures of the repaired specimens

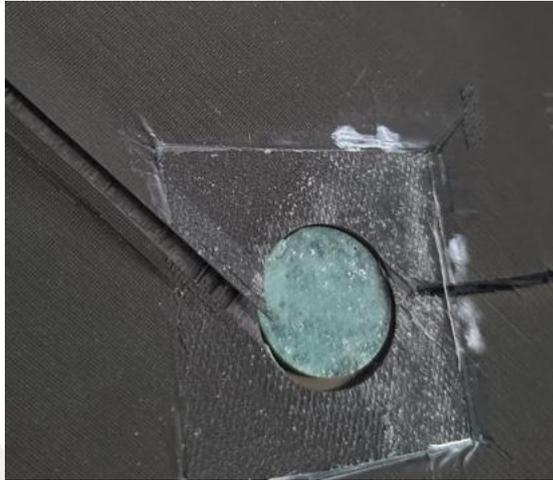
It was observed that some of the filled hole regions remained almost the same as the original state. Figure 4.12, for example illustrates the situation of a specimen repaired with the 30% chopped glass fiber and Loctite 9396 adhesive.

**Figure 4.12** The specimen on which no brittle failure was observed

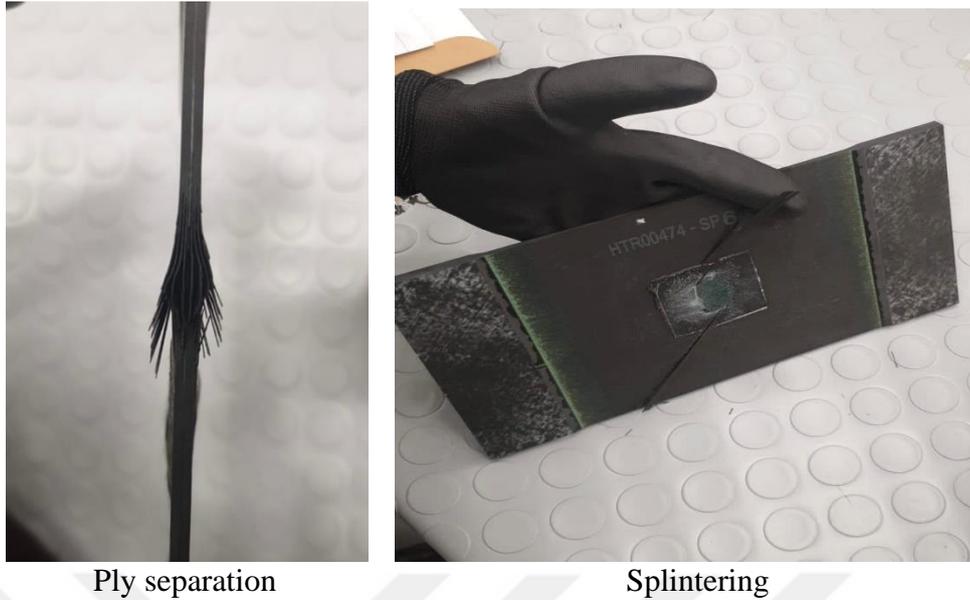
In composite laminates, different types of failures can be observed. Strength and stiffness of the composite may sometimes decrease due to this failure behaviors [39]. Similarly, different failure types were observed after the tensile test. Ply separation and splintering, which are illustrated in Figure 4.13, were observed in the specimens.

Ply separation

Splintering

**Figure 4.13** Failure mechanism of specimens after tensile test

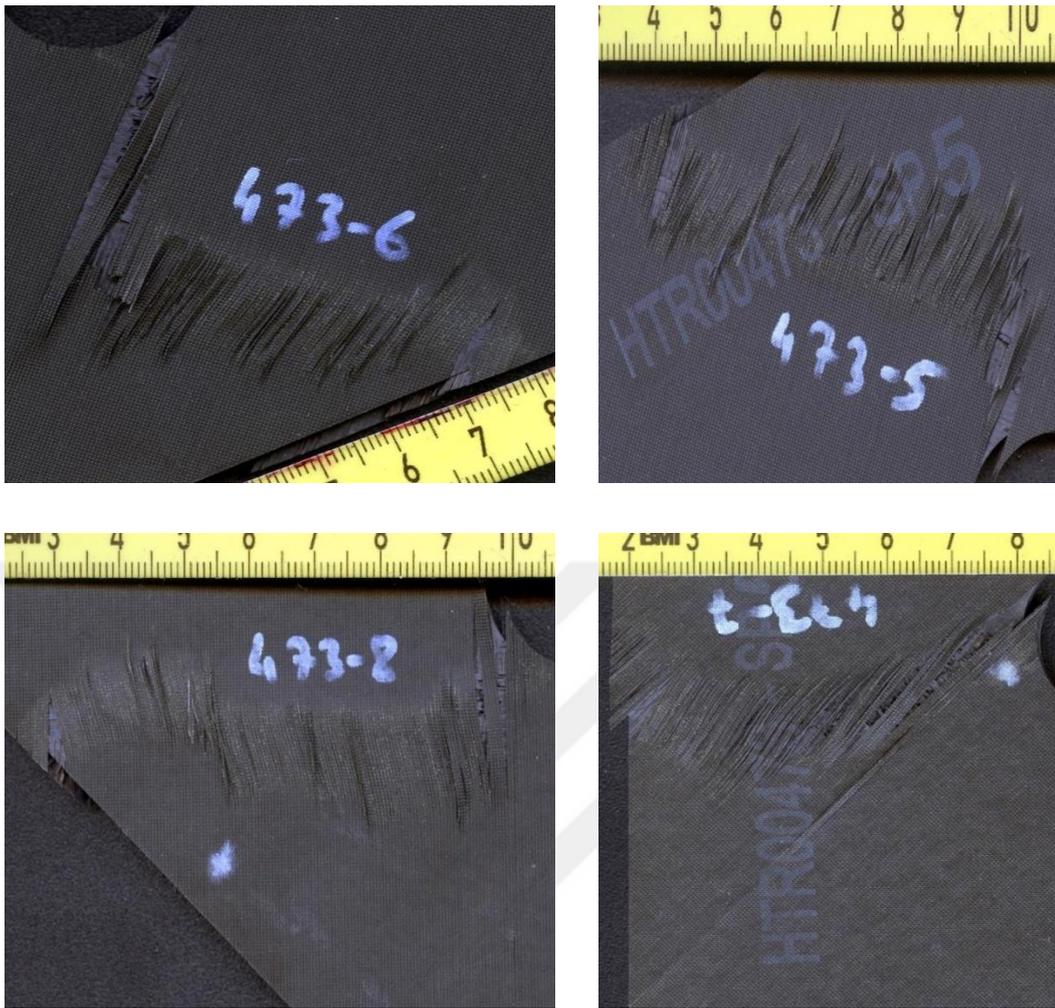
The failure behavior of the second unrepaired specimen and failure behavior of the sixth specimen repaired with 30% chopped glass fiber and Loctite 9396 adhesive were different from the others. These specimens were scanned with Epson Perfection V700 Photo scan device, and different failure behaviors were examined. The scan results are shown in the Figure 4.14 and 4.15.

**Figure 4.14** Scan photos of the second unrepaired specimen

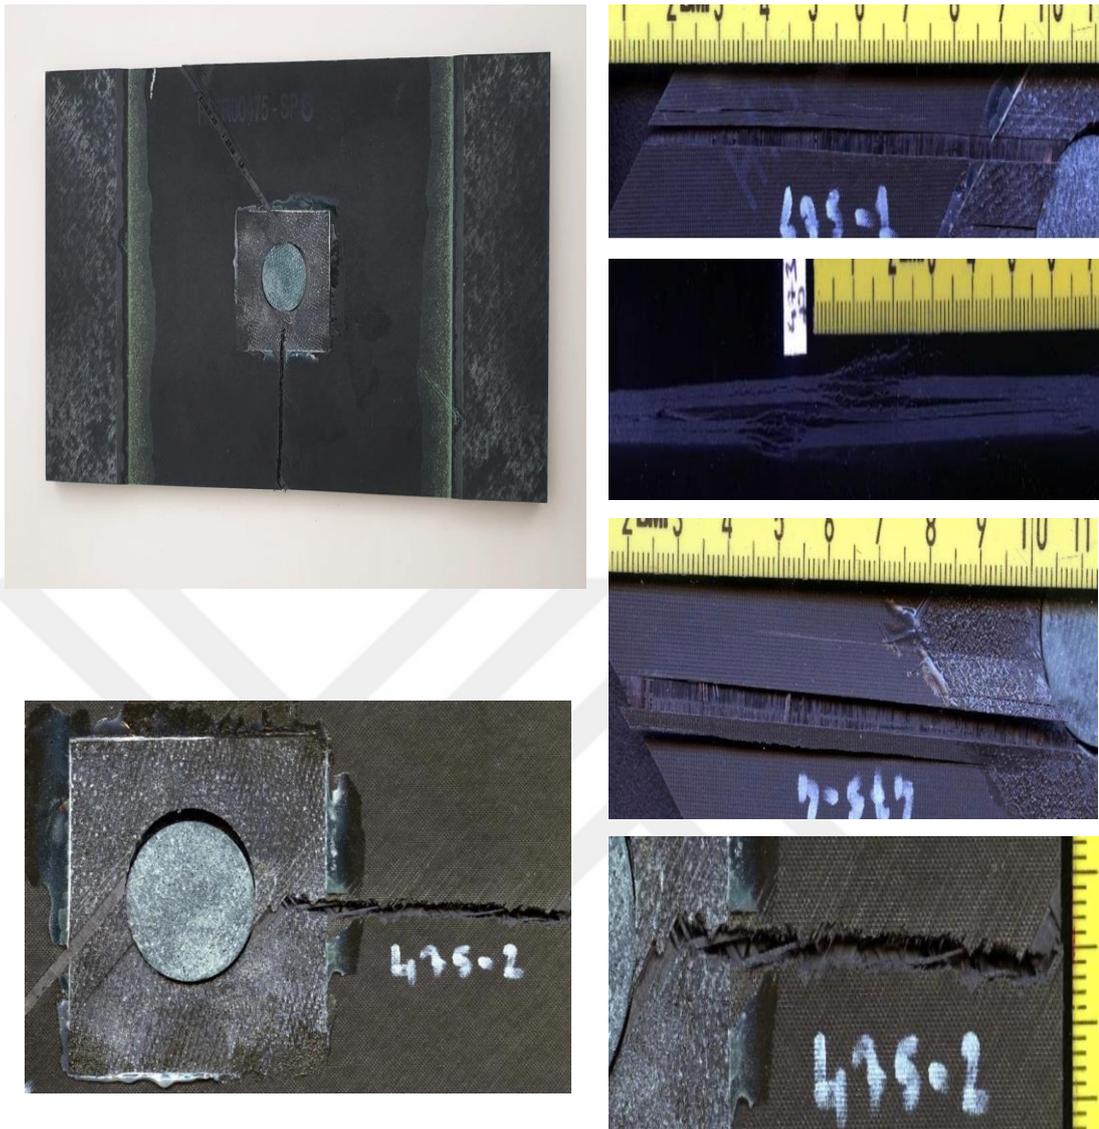
**Figure 4.15** Scan photos of the sixth specimen repaired with the 30% chopped glass fiber and Loctite 9396 adhesive
