NON-DESTRUCTIVE EXAMINATION OF STONE MASONRY HISTORIC
STRUCTURES – QUANTITATIVE IR THERMOGRAPHY AND
ULTRASONIC TESTING

A THESIS SUBMITTED TO
THE GRADUATE SCHOOL OF NATURAL AND APPLIED SCIENCES
OF
MIDDLE EAST TECHNICAL UNIVERSITY

FEBRUARY 2010

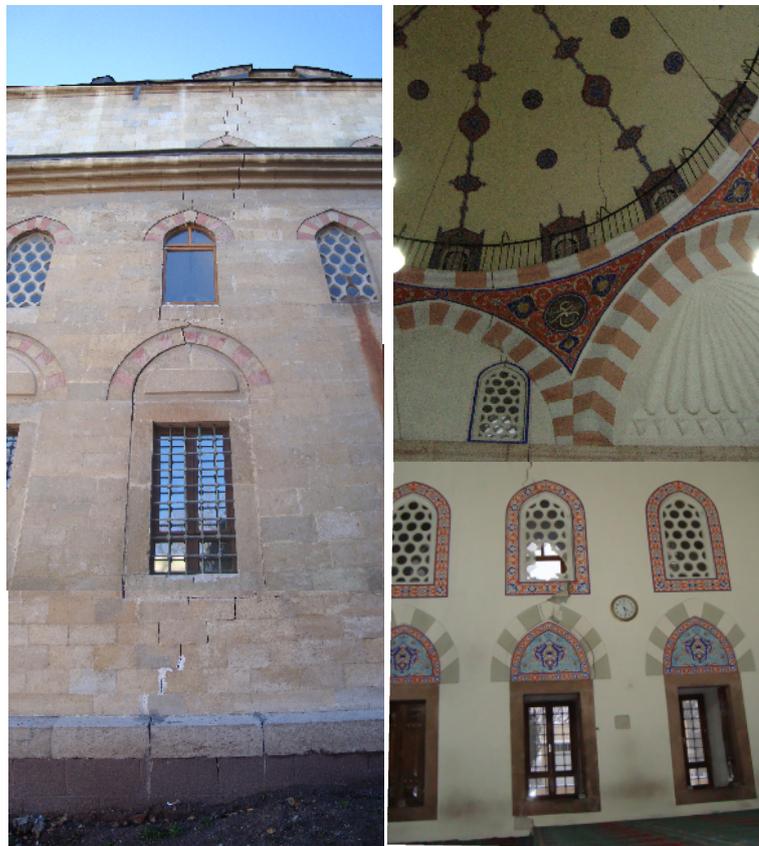
Figure 3.2 The exterior (at the left) and interior views (at the right) of crack on the east wall of structure.

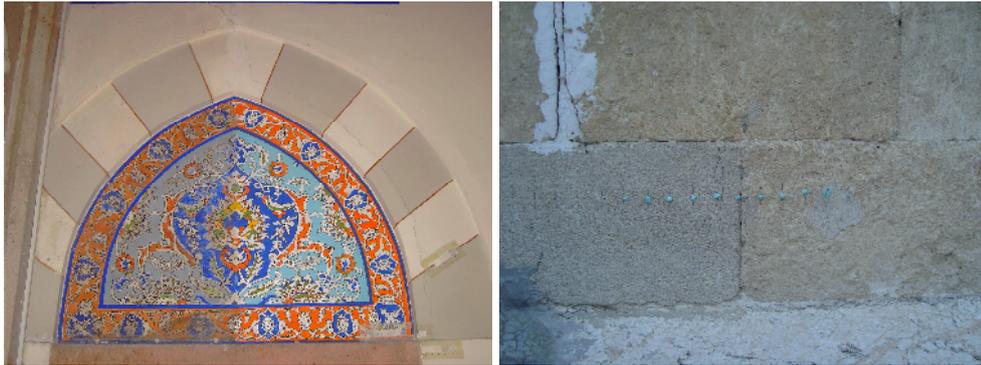
Figure 3.3 Interventions on wall paintings (at the left) and on exterior wall surfaces (at the right)

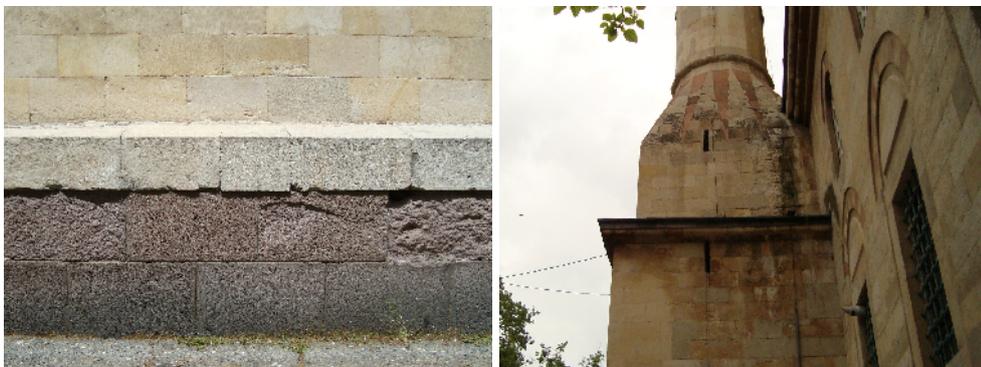
Figure 3.4 Partial view of deteriorations; material loss (at the left) and dampness problem (at the right)

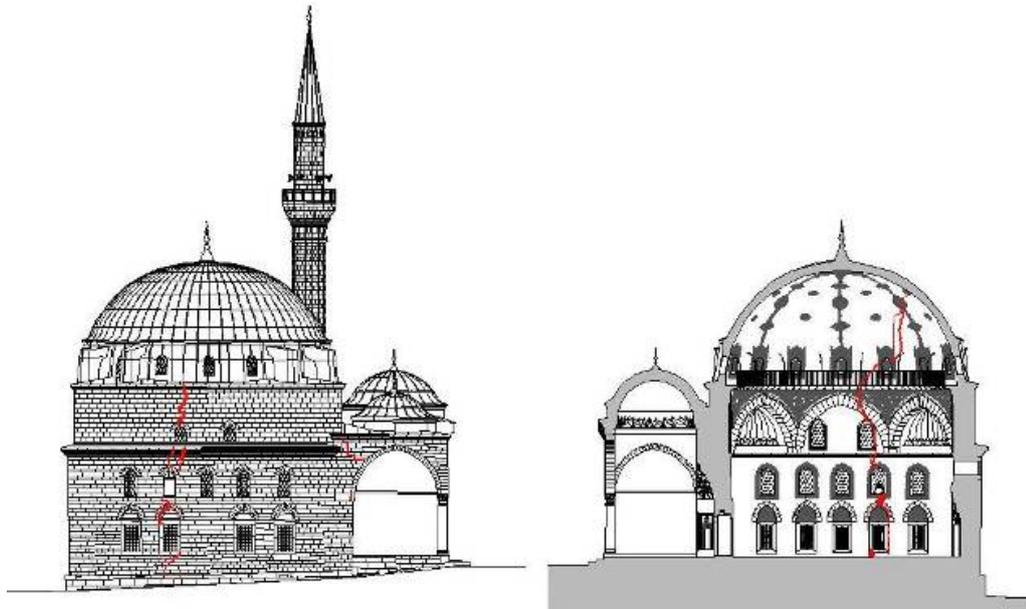
Figure 4.1 The exterior and interior elevations of the east façade, showing the route of the structural crack (in red) due to the differential settlement of the clayey ground.

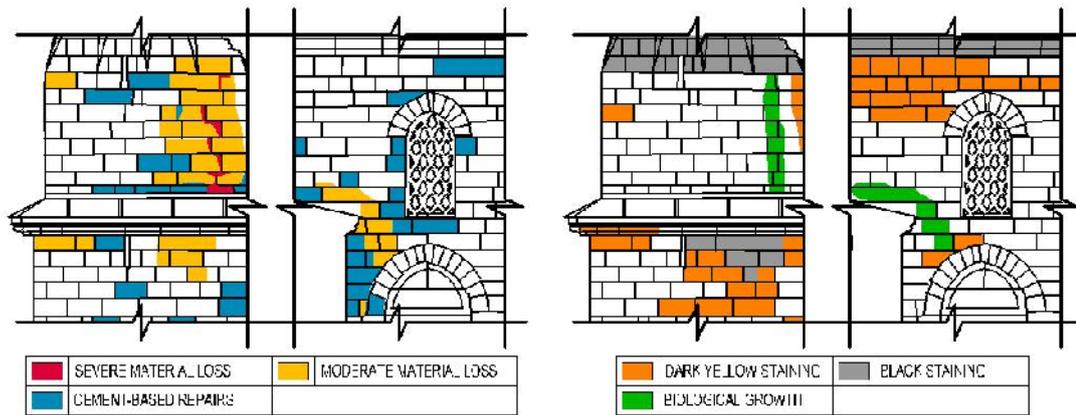
Figure 4.3 Partial elevation drawings for the exterior wall surfaces defined in Figure 4.2 showing the mappings of material loss and cement based repairs (at the left) and discoloration and deposits (at the right).

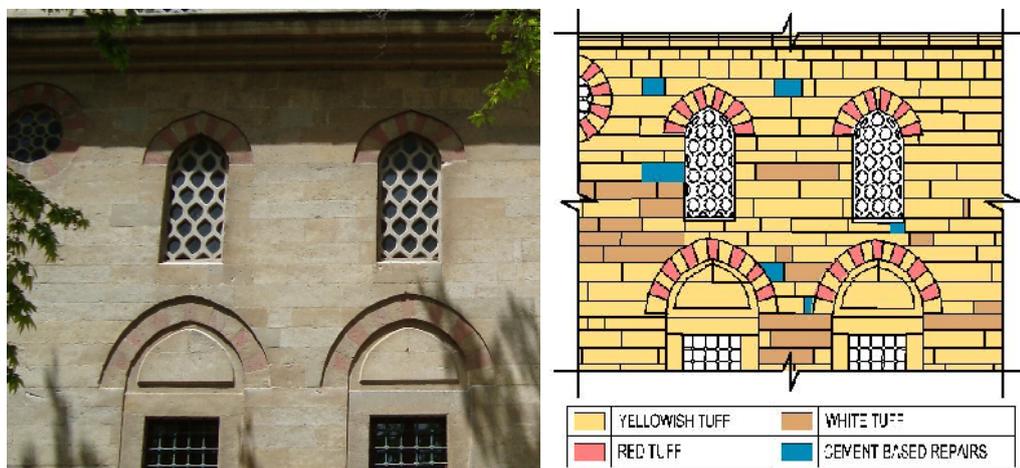
Figure 4.4 Partial view of exterior wall surface on south elevation (at the left) and mapping of selected region (at the right) showing the distribution of yellowish tuff, white tuff and red tuff on exterior wall surface together with the cement-based repairs.

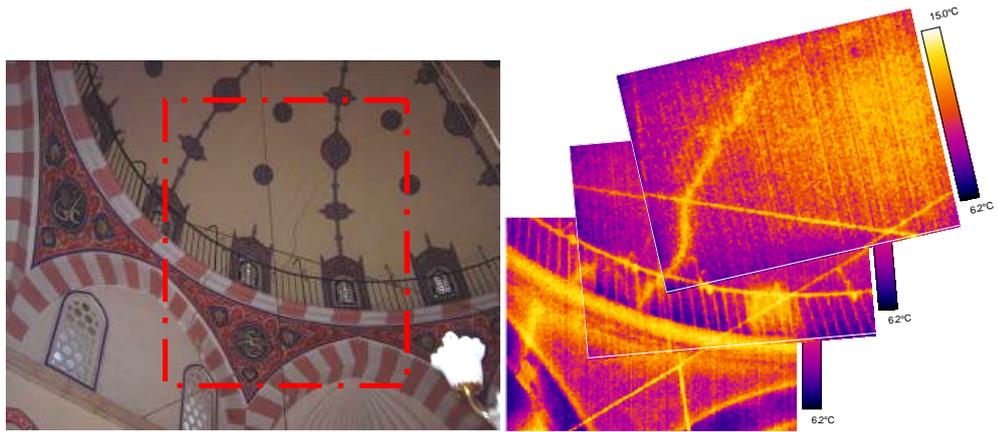
Figure 4.5 View of the structural crack passing through the transition elements and dome (at the left) and IR image of the selected region: The route of crack in IR images as a warmer wide path while it could not be followed clearly by eye.

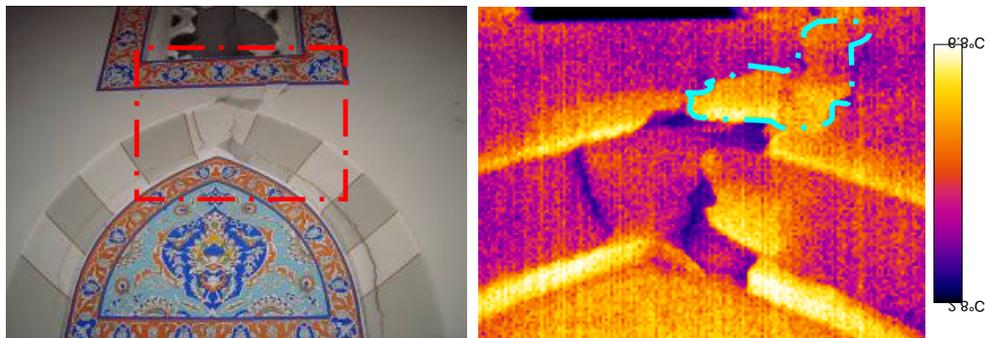
Figure 4.6 Partial view of the structural crack on the east wall (at the left) and the IR image of the selected region (at the right): The detached surfaces as warmer patches with heterogeneous temperature distribution while the deepest cracks were the coldest path in IR image.

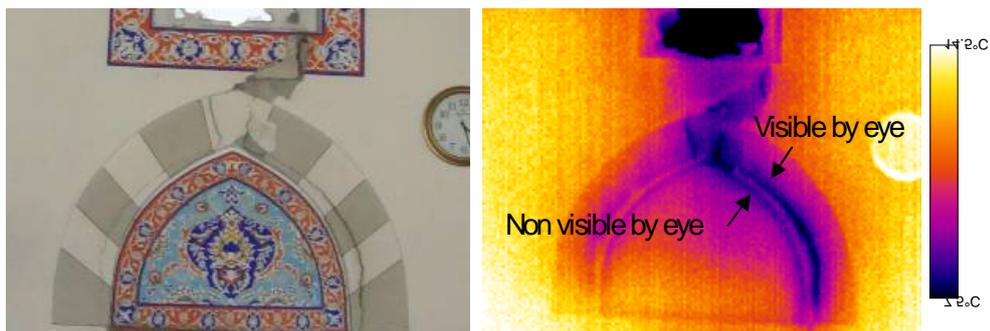
Figure 4.7 Partial view of the same region shown in Figure 4.6 taken eleven months later (at the left) and its IR image (at the right): The detached surfaces were lost (follow the blue circled area in Figure 4.6). The deepest crack following the arch was observed to have the coldest path. The non-visible deepest crack hidden behind the plaster layer was also detected in the IR image as the next colder path.

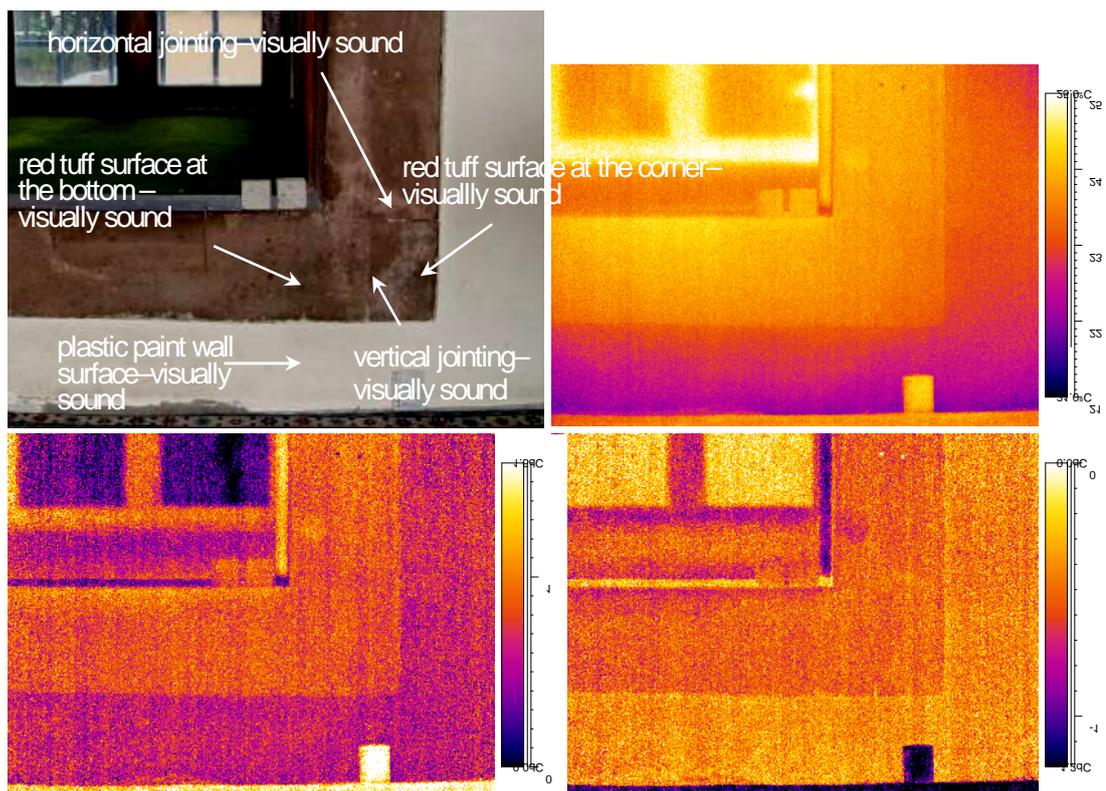
Figure 4.8 Partial view from the right bottom of window opening at the east side of the structure (at the top left), its IR image (at the top right); and the differential IR images of the heating period (at the left bottom) and the cooling period (at the right bottom).

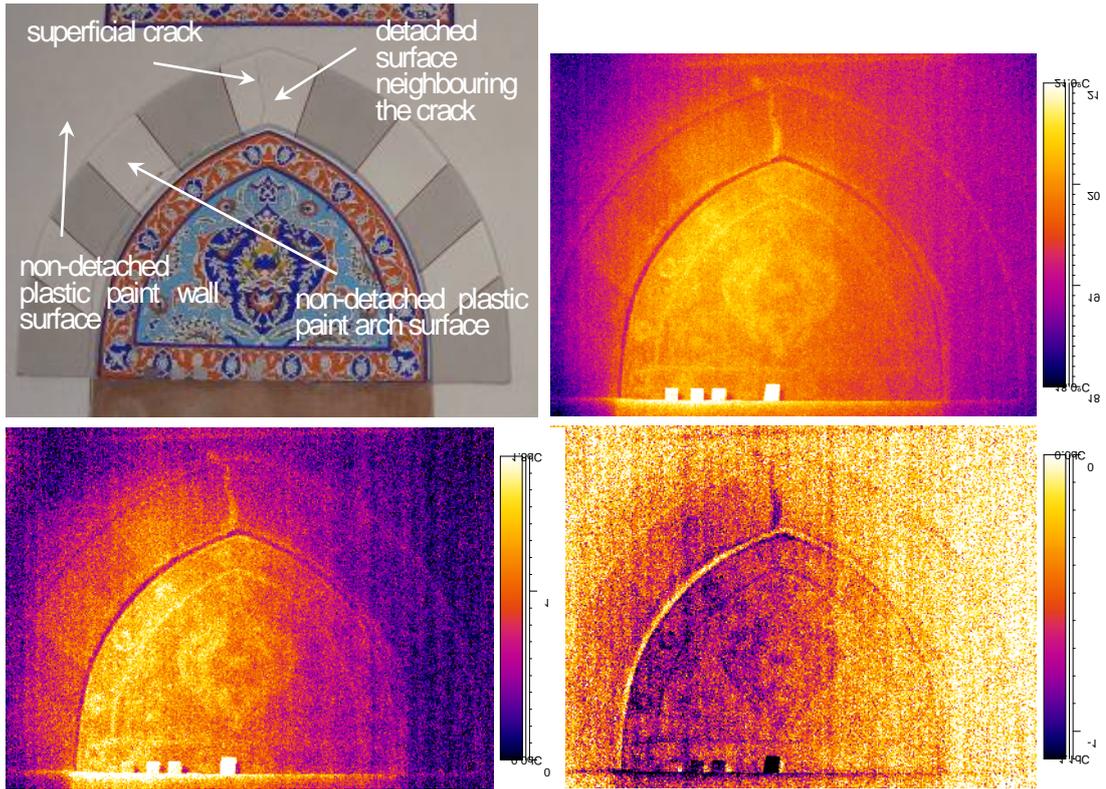
Figure 4.11 Partial view from a window arch located at the south of the structure (at the top left), its IR image (at the top right); and the differential IR images of the heating period (at the left bottom) and the cooling period (at the right bottom).

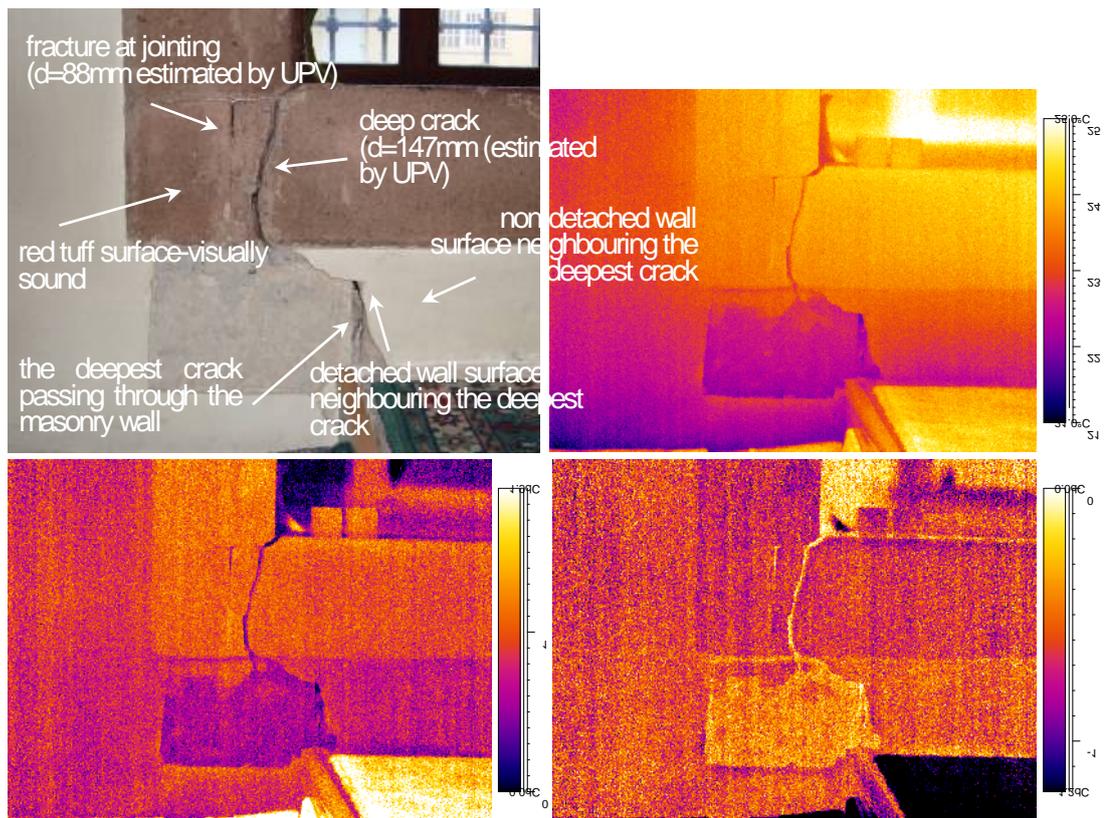
Figure 4.14 Partial view from the left bottom of window opening at the east side of the structure (at the top left); its IR image (at the top right); and the differential IR images of the heating period (at the left bottom) and the cooling period (at the right bottom).

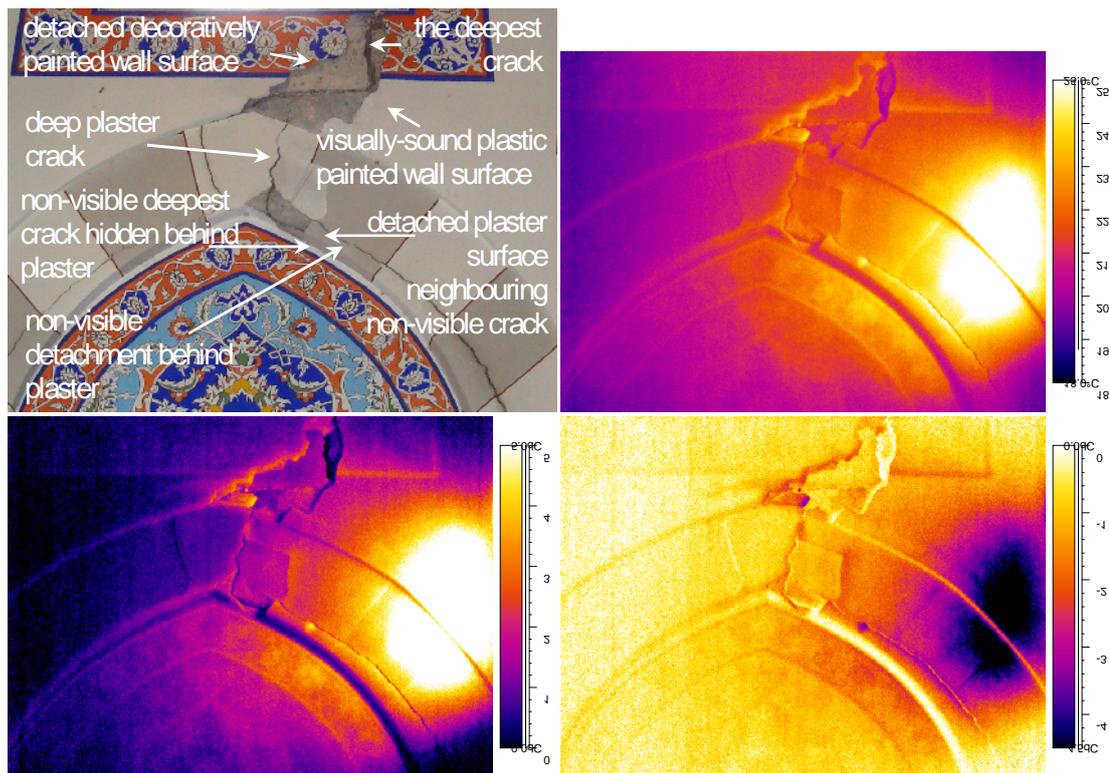
Figure 4.19 Partial view from a window arch located at the east of the structure (at the top left), its IR image (at the top right); and the differential IR images of the heating period (at the left bottom) and the cooling period (at the right bottom).

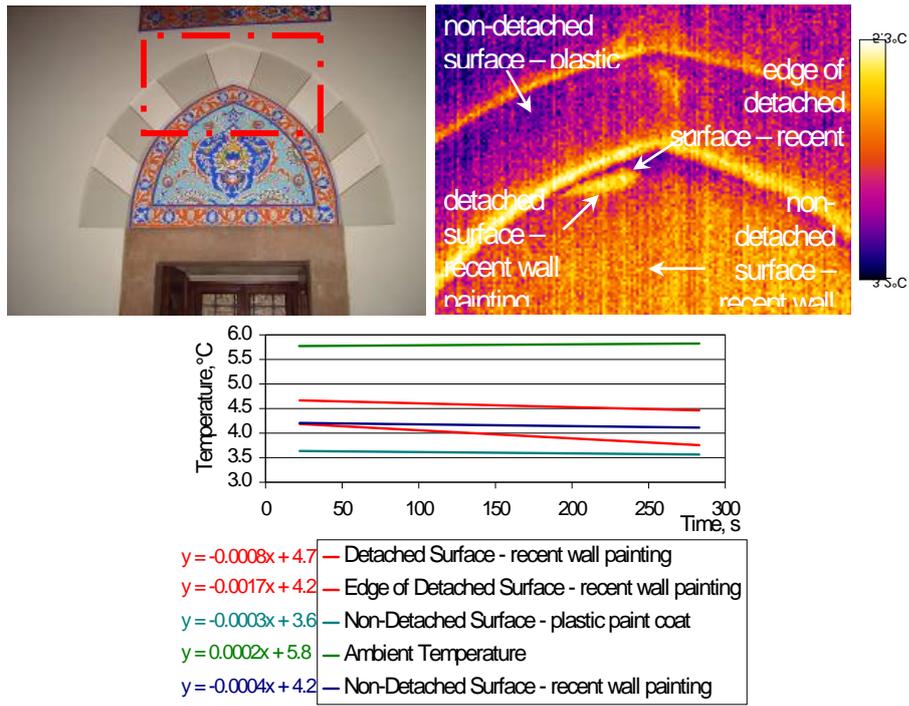
Figure 4.26 Partial view from a window at the west side of the structure (at the top left), the IR image of selected region (at the top right), and the surface temperature curves versus time during the cooling period (at the bottom): Non-visible detached surface, which was detected in the IR image as a warmer patch, cooled down faster than the non-detached surfaces while the fastest cooling was observed at the edge of the detachment. The wall surfaces were colder than the ambient temperature while the plastic paint coated surfaces were the coldest.

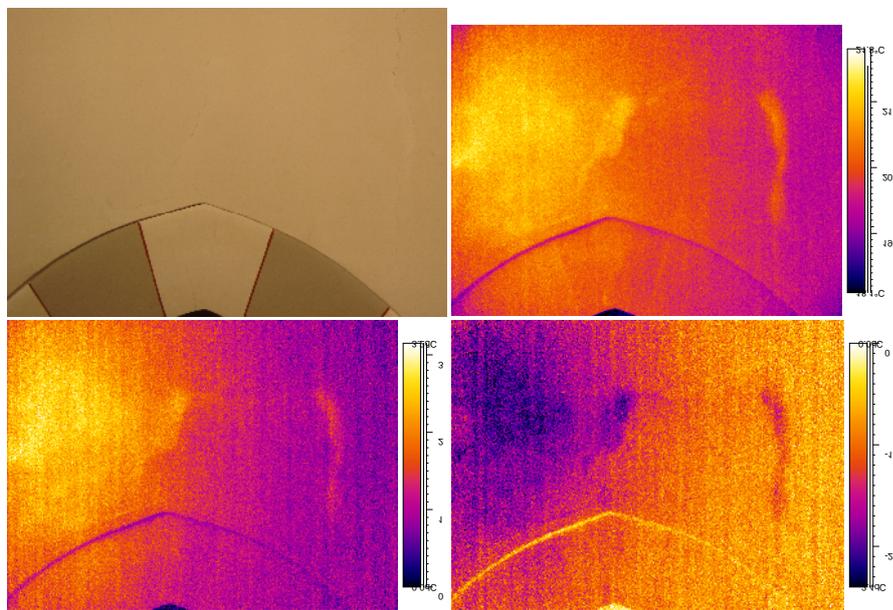
Figure 4.27 Partial view from the wall surface of second floor at the north side of the structure (at the top left), its IR image (at the top right); and the differential IR images of the heating period (at the left bottom) and the cooling period (at the right bottom).

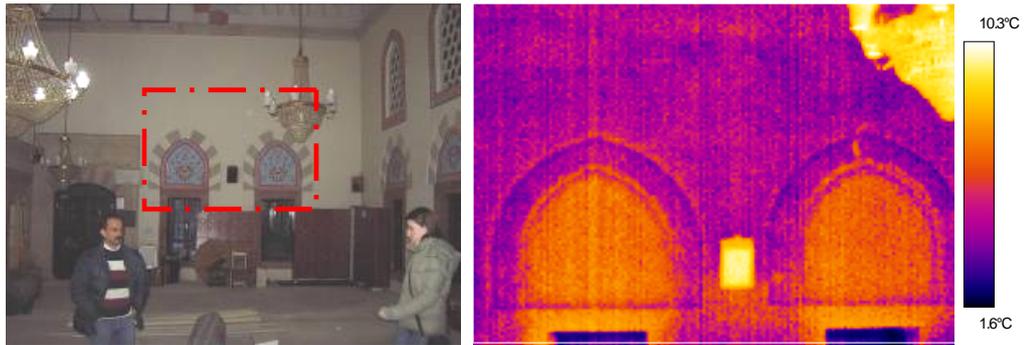
Figure 4.29 Partial view from the north wall of the structure (at the left) and the IR image of the selected region: The decoratively-painted wall surfaces were slightly warmer than the plastered wall surfaces coated with white plastic paint

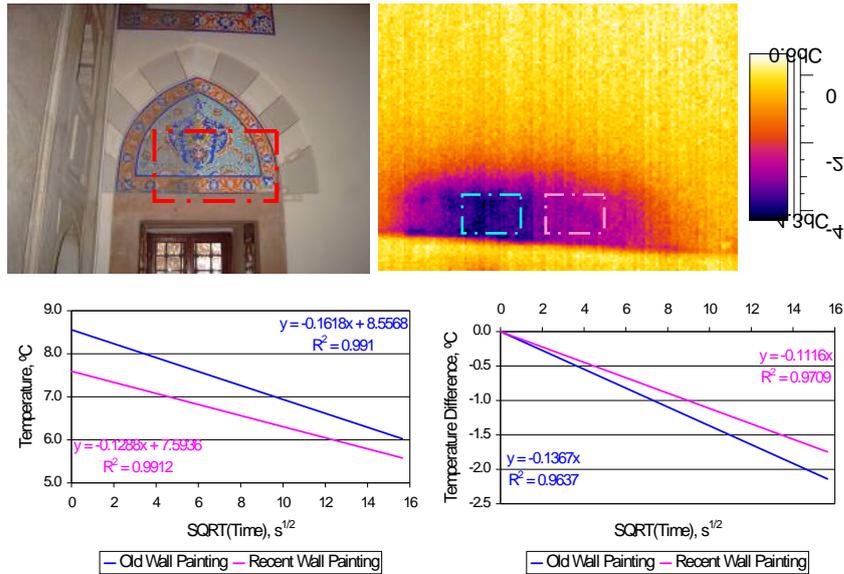
Figure 4.31 Partial view of old and recent wall paintings on the south wall (at the top left), the differential IR image of the selected region during the cooling period (at the top right), the linear fitting of surface temperatures and temperature difference versus square root of time during the cooling period (at the bottom): the old wall painting surfaces cooled down faster than the recent wall painting surfaces.

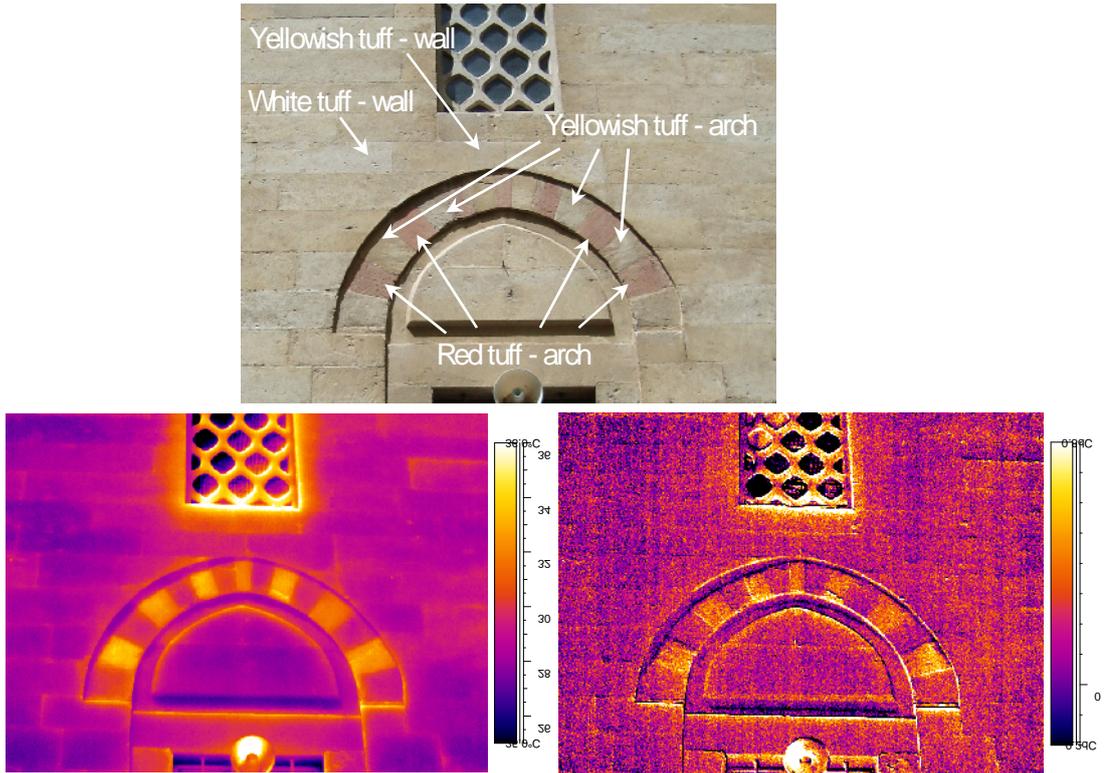
Figure 4.32 Partial view of exterior wall surfaces at south side (at the top), its IR image (at the left bottom); and the differential IR image of the heating period (at the right bottom).

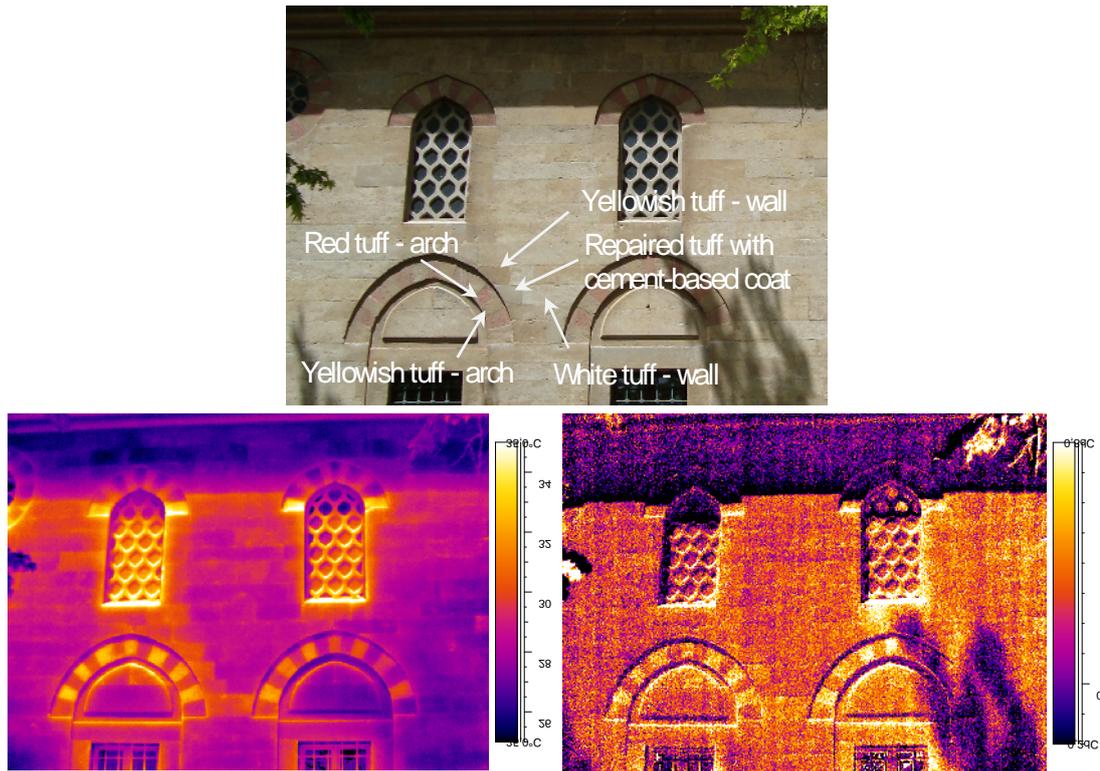
Figure 4.34 Partial view of exterior wall surfaces at south side (at the top), its IR image (at the left bottom); and the differential IR image of the heating period (at the right bottom).
