ASSESSMENT OF SLOPE STABILITY FOR A SEGMENT
(Km: 25+600-26+000) OF ANTALYA-KORKUTELİ HIGHWAY

A THESIS SUBMITTED TO
THE GRADUATE SCHOOL OF NATURAL AND APPLIED SCIENCES
OF
MIDDLE EAST TECHNICAL UNIVERSITY

JUNE 2010

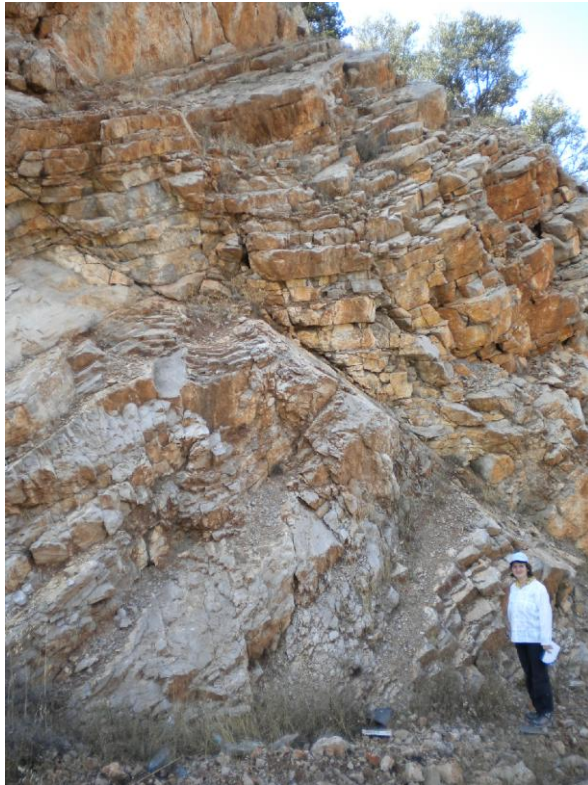
Figure 4.1. Photograph showing main discontinuities developed in the limestone at Km: 25+600.

At this location, two joint sets and a bedding plane form the main discontinuities (Figure 4.1). The kinematic analysis for planar failure performed at Km: 25+600 shows that except one joint set, no plane failure is expected. Nevertheless, the poles of this problematic joint set partly fall within the daylight envelope. Since the difference of the strikes between the slope (64/240) and the discontinuity (35/191) is more than 20° , no planar failure is expected at this location (Figure 4.2). According to the kinematic analysis for wedge and toppling failures (Figures 4.3 and 4.4), the cut slope is stable for both cases.

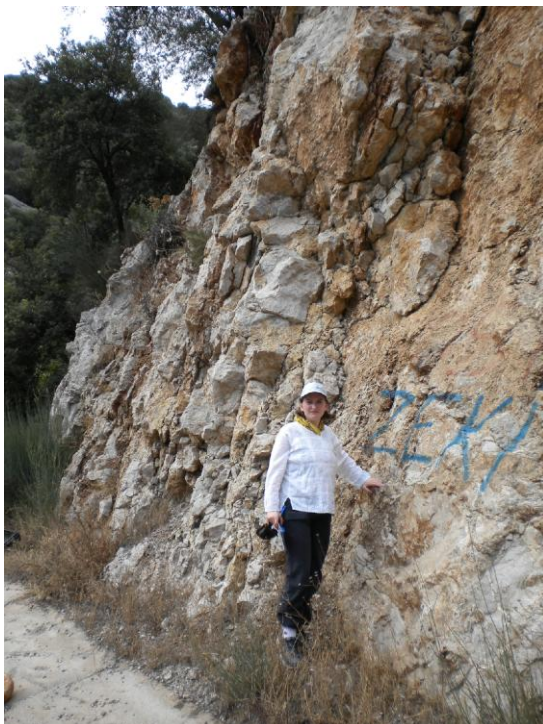
Figure 4.5. Photograph showing main discontinuities developed in the limestone at Km: 25+900.

Two joint sets and a bedding plane also form the main discontinuities at Km: 25+900 (Figure 4.5). The slope amount and its direction for the cut slope at this location is 64/250. The kinematic analysis for plane failure performed at Km: 25+900 shows that the poles of one joint set (57/256) falls within the daylight envelope. Therefore, planar failure controlled by the joint is likely to occur at this location (Figure 4.6). In order to eliminate this problem, a slope flattening of 10° may be recommended (Figure 4.7).

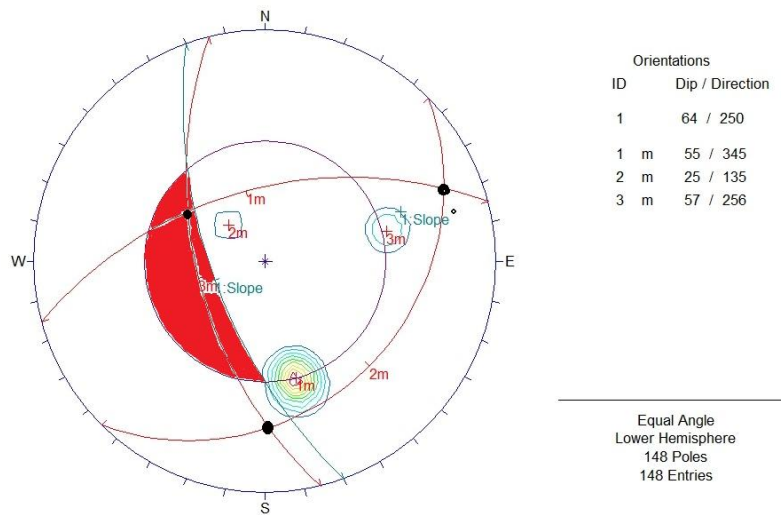
Figure 4.8. Kinematic analysis of the cut slope for wedge failure at Km: 25+900.

The kinematic analysis for wedge failure performed at Km: 25+900 shows that the intersection of the bedding plane (55/345) and joint set 2 (25/135) falls within the danger zone. Therefore, wedge failure is likely to occur at this location (Figure 4.8). In order to eliminate this problem, a slope flattening of 8° is suggested (Figure 4.9). The kinematic analysis for toppling failure reveals that no toppling failure is likely at this cut slope (Figure 4.10).

As a summary, according to the kinematic analysis carried out at Km:25+900, the cut slope does not have any toppling failures, but the planar and wedge failures are likely to occur. 10° of slope flattening will eliminate both risks. Therefore, only kinematic analysis is performed for this part of the study area.

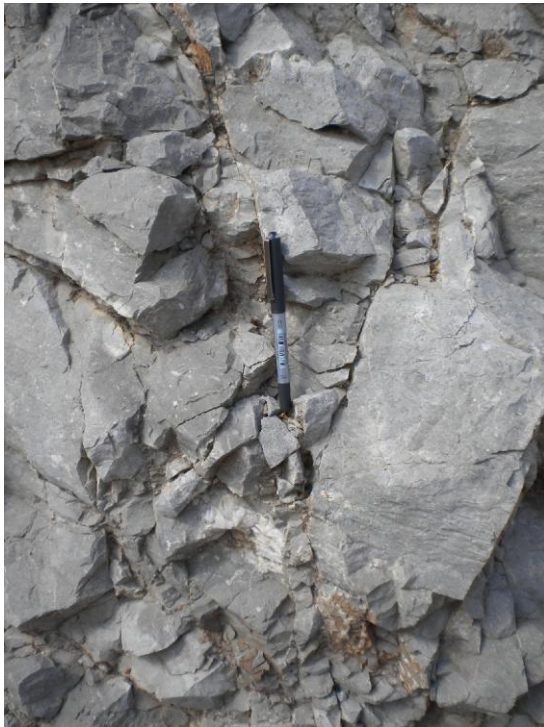
Figure 4.11. Photograph showing main discontinuities developed in the limestone at Km: 26+000.

Similar to the other two cut slopes, two joint sets and a bedding plane also form the main discontinuities at Km: 25+900 (Figure 4.11). The kinematic analysis for plane failure performed at Km: 26+000 shows that although poles of the joint (J2) partly fall within the daylight envelope, its dip amount is steeper than the slope angle (Figure 4.12). Thus, this discontinuity is not daylighting. So, no planar failure is expected at this location.

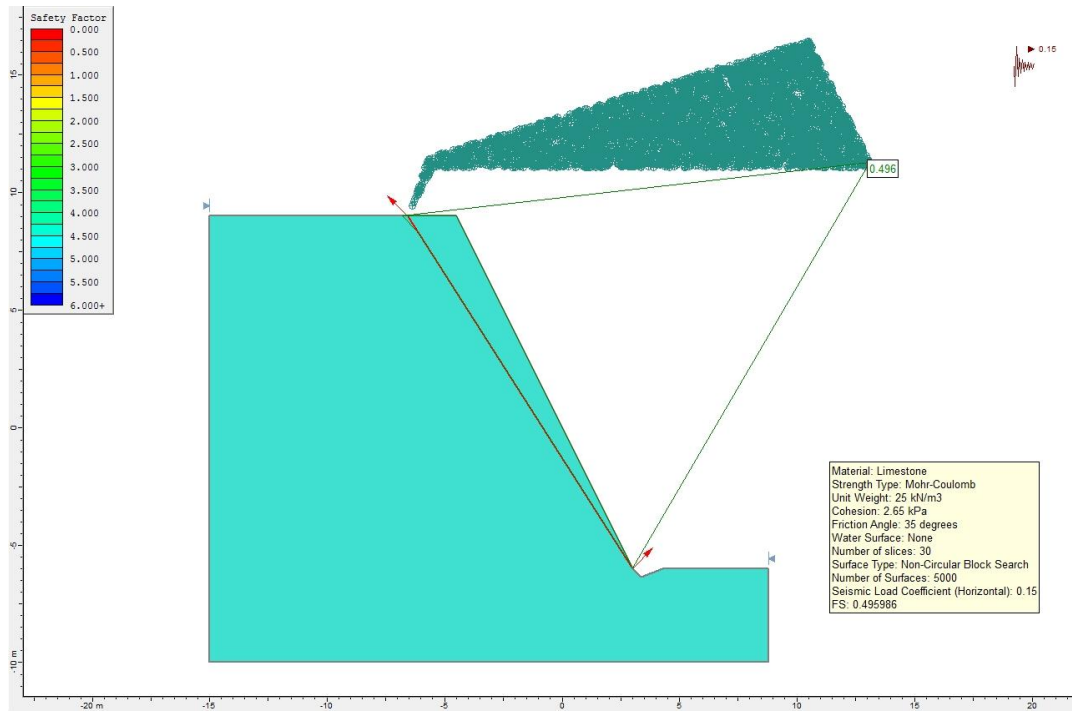
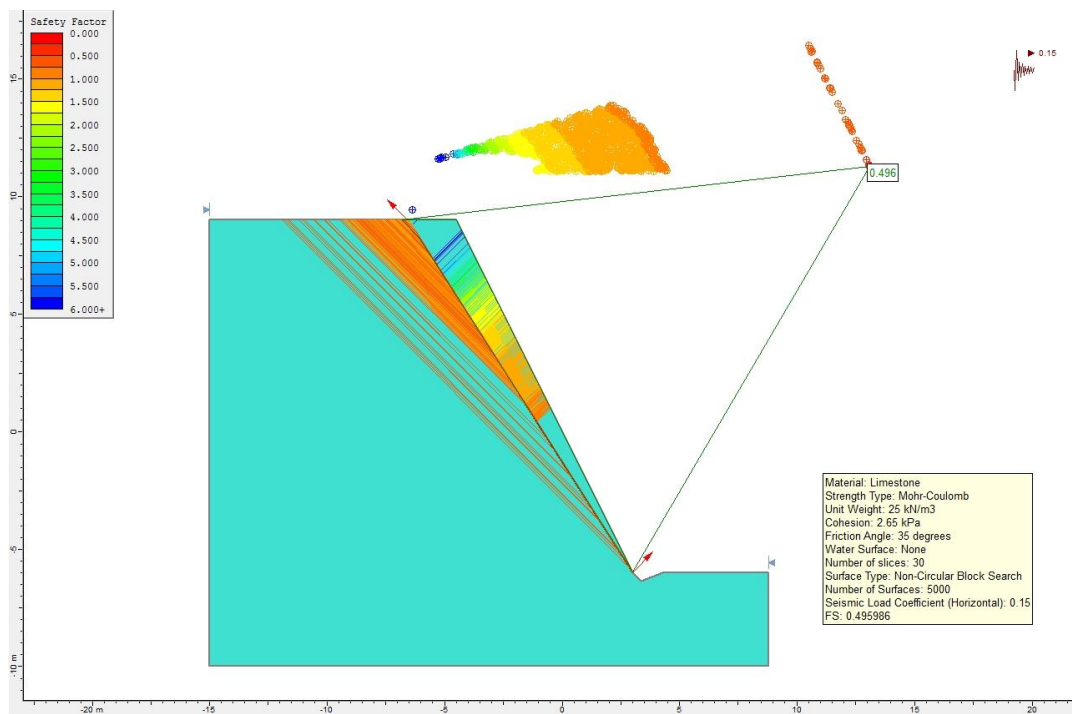
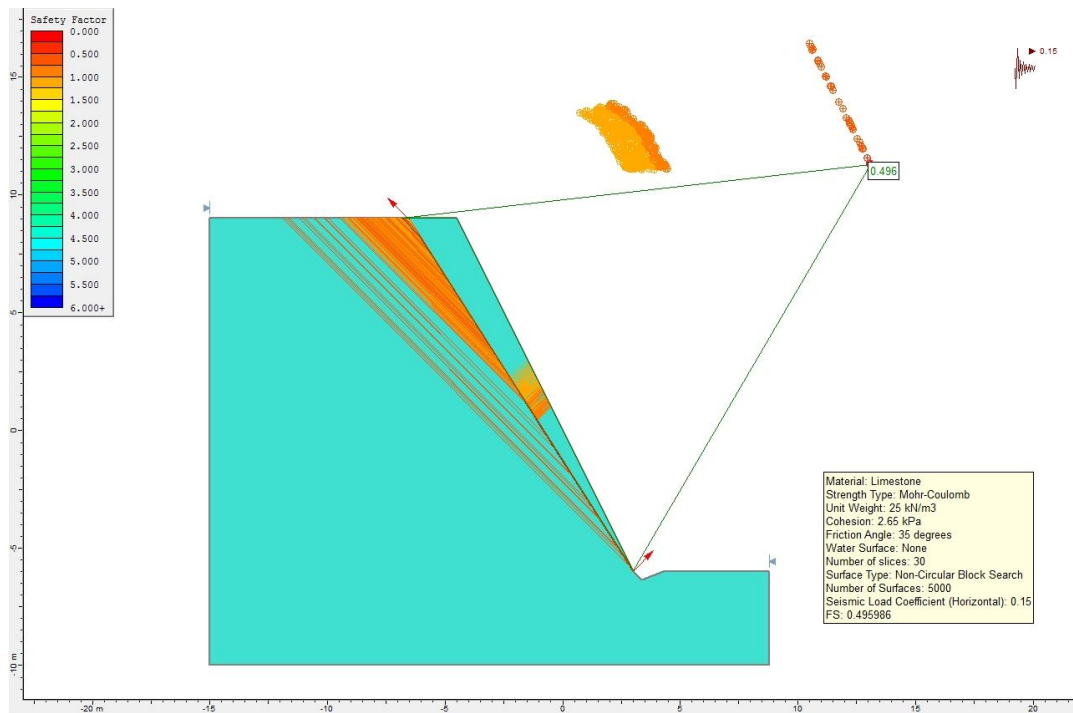
According to the analysis carried out, this part is found to be the most problematic part of the highway. It is not safe in the current situation due to a very low factor of safety of 0.50 with seismic coefficient (Figures 5.1-5.3).

Figure 5.1. Limit equilibrium analysis of the cut slope with discontinuity controlled failure surface using current highway slope geometry.

Figure 5.2. Limit equilibrium analysis of the cut slope with all surfaces analysed.

Figure 5.3. Limit equilibrium analysis of cut slope with surfaces showing factor of safety only less than 1.1.

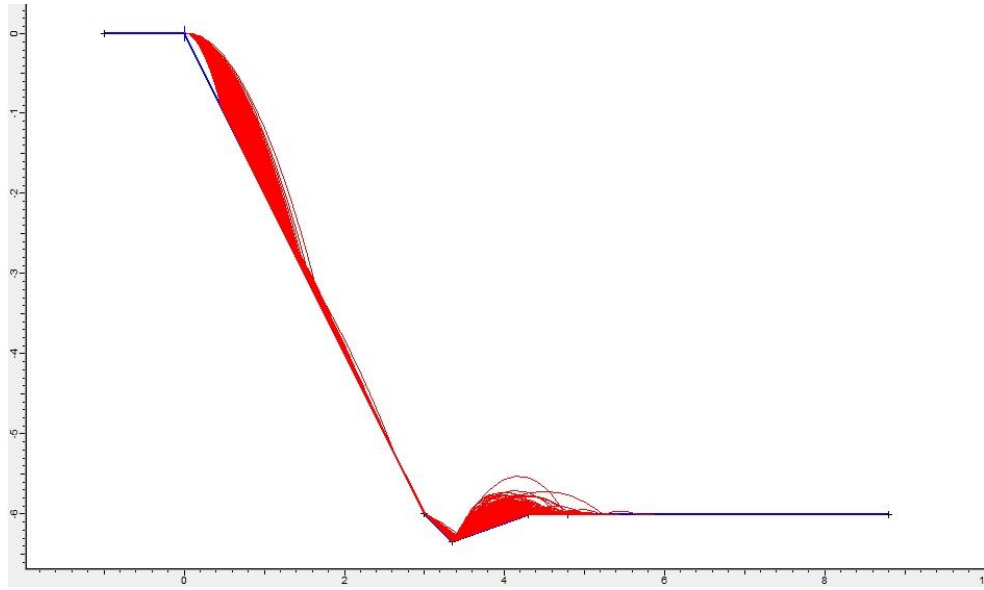
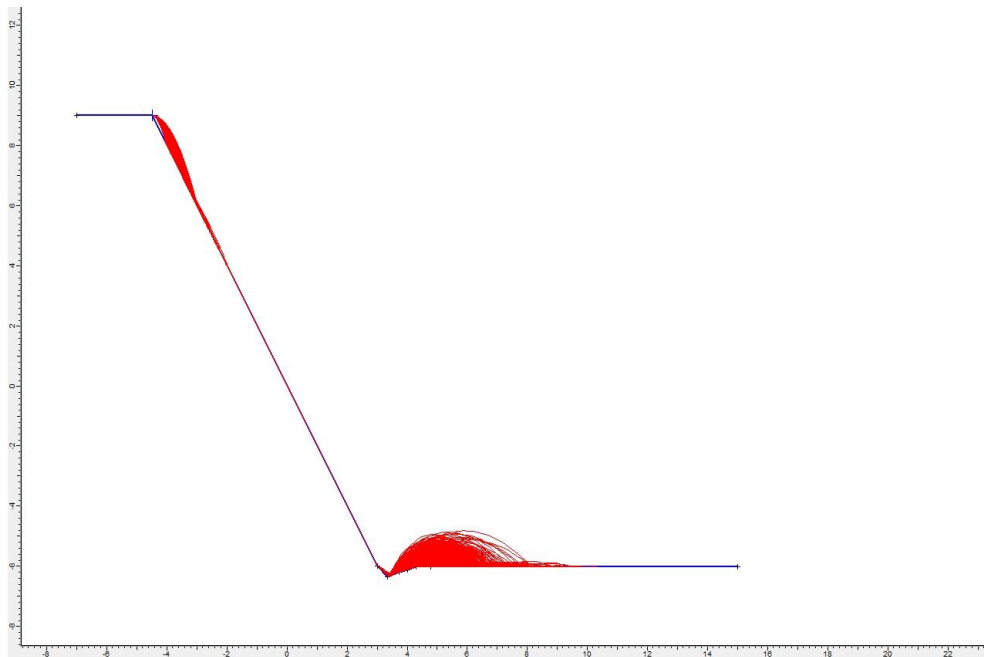
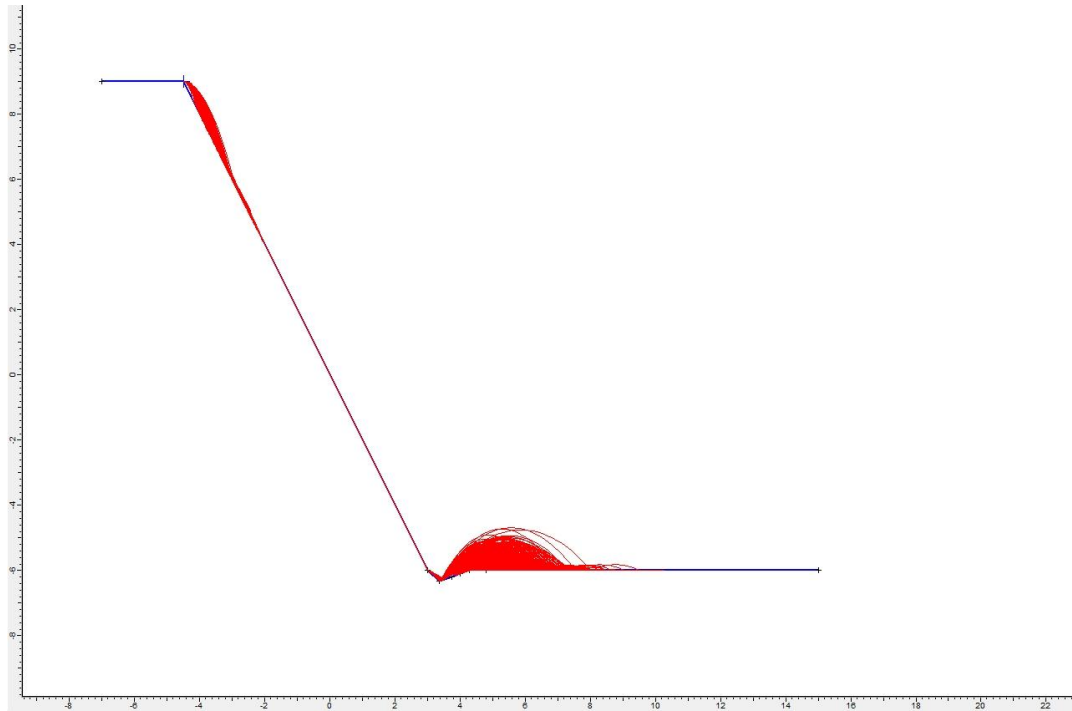
The rockfall analyses using the parameters given in Table 5.1 for the current cut slopes are performed for 10 kg, 60 kg and 150 kg blocks. The results indicate that the rocks are likely to reach the highway (Figures 5.16-5.18) and this is not an acceptable condition for the driver's safety.

Figure 5.16. Rockfall analysis with 10 kg block for current slope condition.

Figure 5.17. Rockfall analysis with 60 kg block for current slope condition.

Figure 5.18. Rockfall analysis with 150 kg block for current slope condition.
