STRUCTURAL ANALYSIS, EVALUATION AND RECOMMENDATIONS  
FOR CONSERVATION OF THE LAHORE MUSEUM

A THESIS SUBMITTED TO  
THE GRADUATE SCHOOL OF NATURAL AND APPLIED SCIENCES  
OF  
THE MIDDLE EAST TECHNICAL UNIVERSITY

JULY 2018

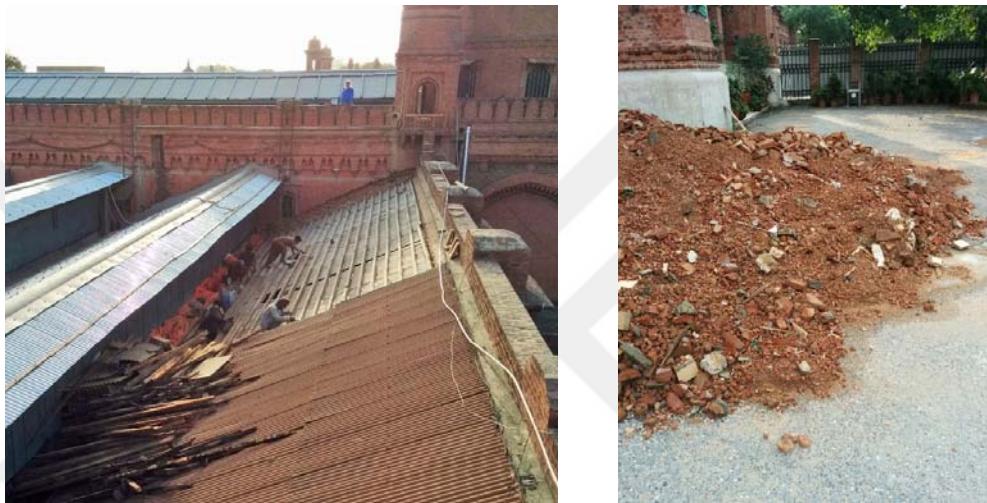
Figure 2.49: Gnd-E/01 – Islamic Arts Gallery – Roof Repairs (2015)  
 Looking West over the roof (left)  
 Pile of Lime Concrete and brick tiles removed from the roof of Gnd-E/01 during repairs (right)

The same roof detail has been used for the roof modification of space Gnd- E/01 in 2015 (Figure 2.49). The trusses and the roofs above are supported in the middle by two compound girders running along the length of each space in the E-W axis. The compound girder consists of two steel channel sections 305 mm x 102 mm (12 in. x 4 in.) welded together both at top and bottom with 102 mm (4 in.) wide steel plates. The girders rest on the CI columns and masonry walls which help transfer the load of the truss and the roof to the ground.

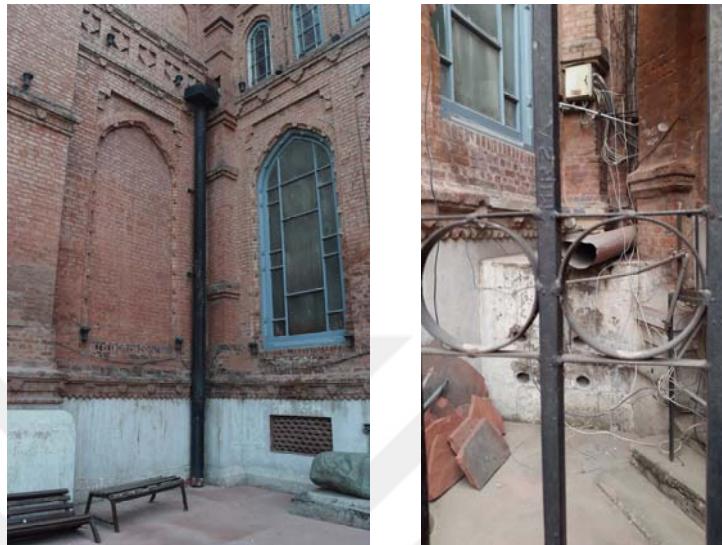
Figure 2.74: Two downspouts one at the eastern end (left) and the other at the western end (right) of the wall Gnd-E/01-N-W.

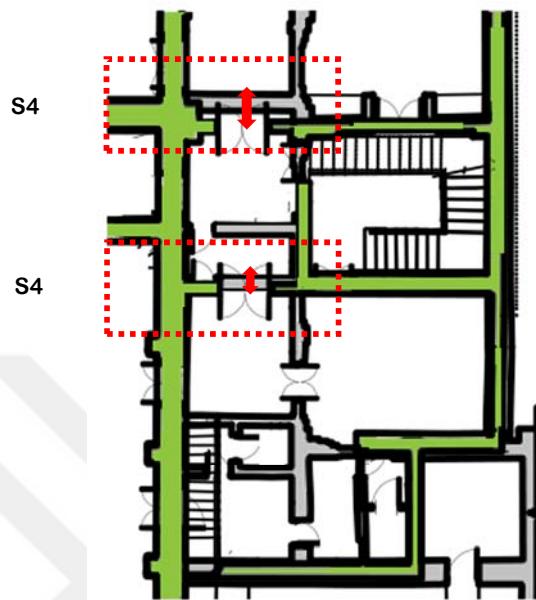
Figure 2.75: Structural Discontinuities in Zone 03 seen by overlapping of Plans  
 Plan at +2.5m Plan at +6.45m

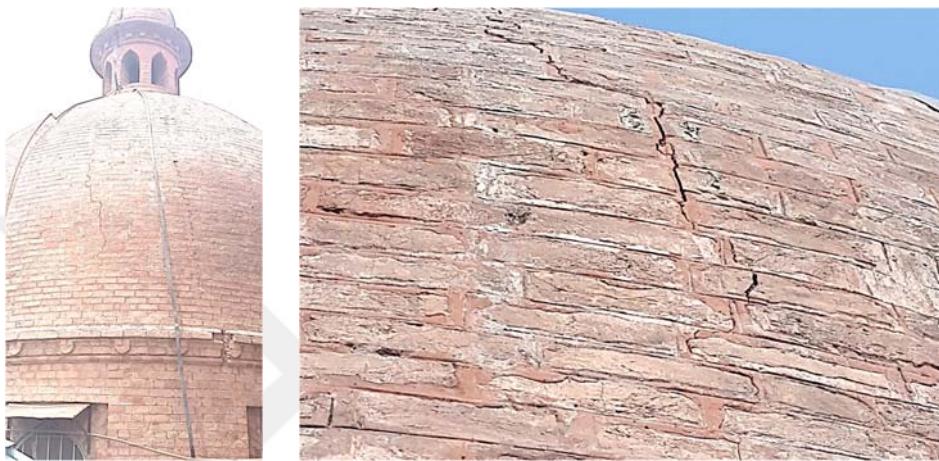
Figure 2.77: The meridional cracks observed on the Main Dome (left) Close-up showing the crack breaking brick unit (right)

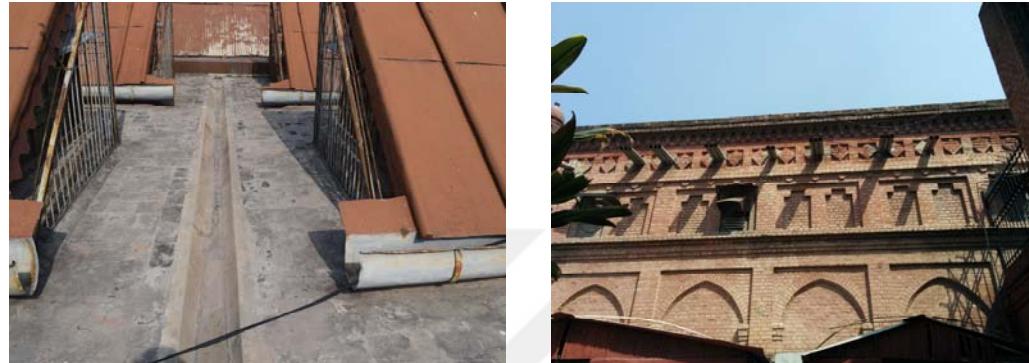
Figure 2.79: Sloping roofs draining into gutter which discharge onto flat roof (left)  
Roof draining directly onto Southern Façade through scuppers (right)

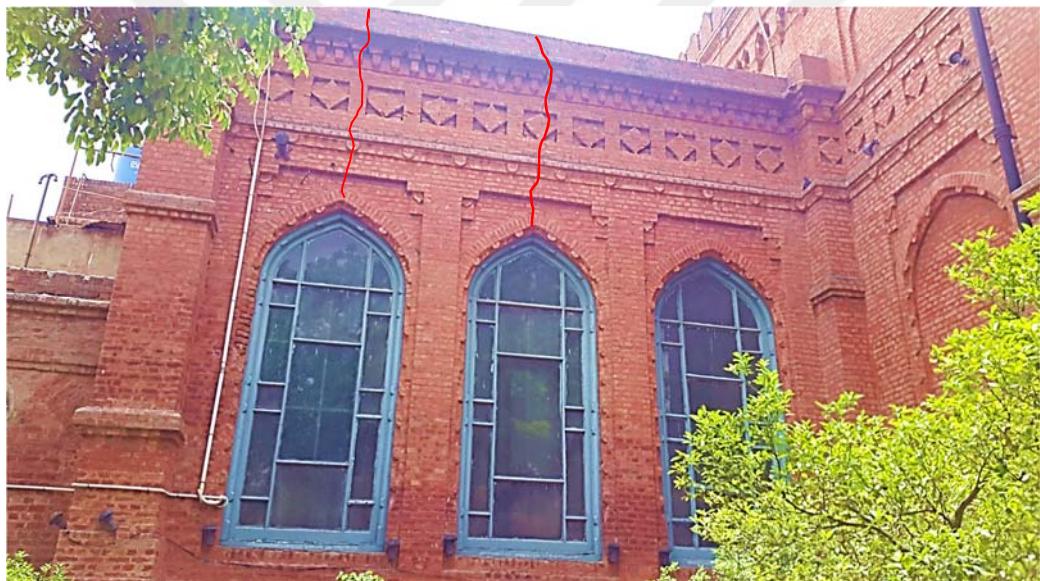
Figure 3.32: Vertical Cracks (S1)  
Through the Central and Eastern Arch of Gnd-E/04-N-W (2017)

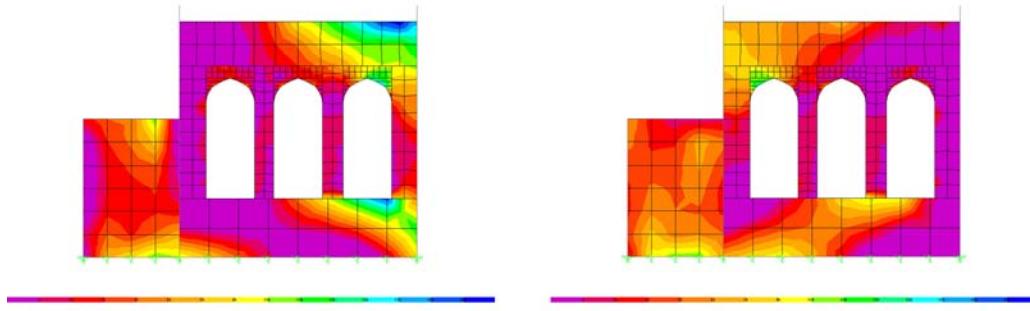
Figure 3.34: Maximum Principal Stresses (kPa) for wall Gnd-E/04-N-W  
 Left: North (exterior) Face; Right: South (interior) Face

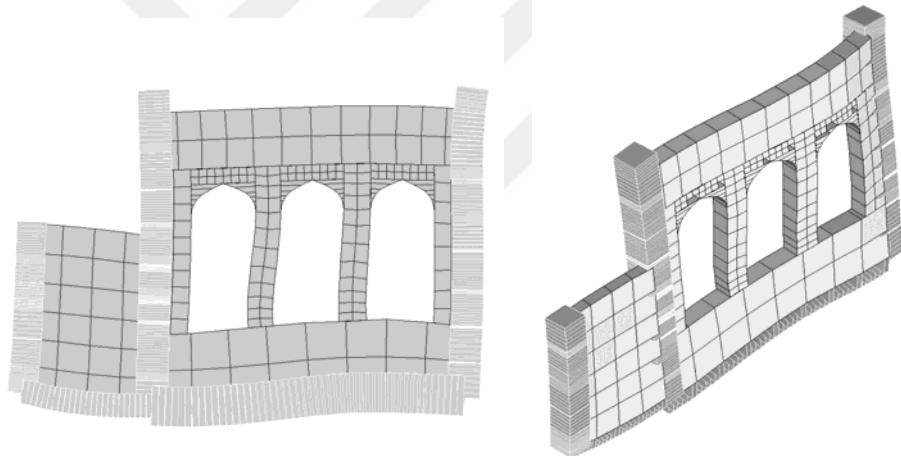
Figure 3.35: Deformed shape of wall Gnd-E/04-N-W  
 Left: North (exterior) face elevation showing differential settlement  
 Right: North (exterior) face 3D showing lateral buckling

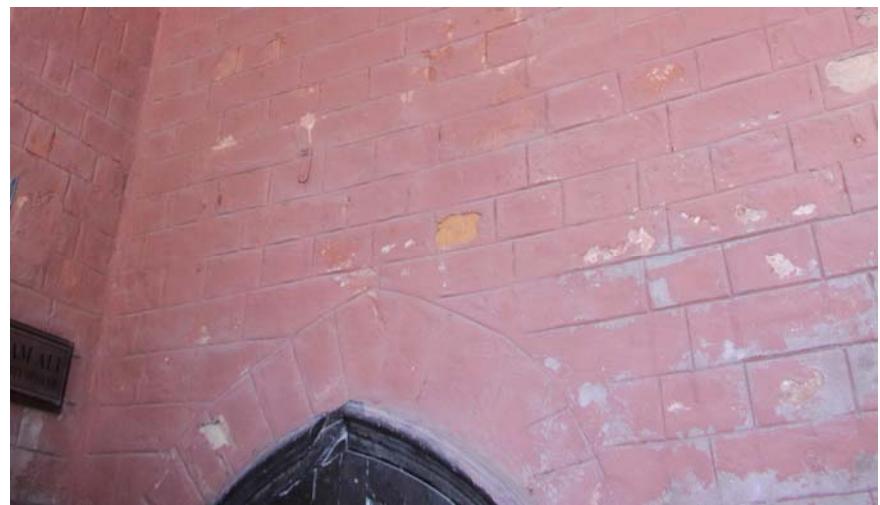
Figure B.2: Gnd-N/01 – Entrance Portico (2017)  
Flaking of red tinted cement layer and powdering of brick

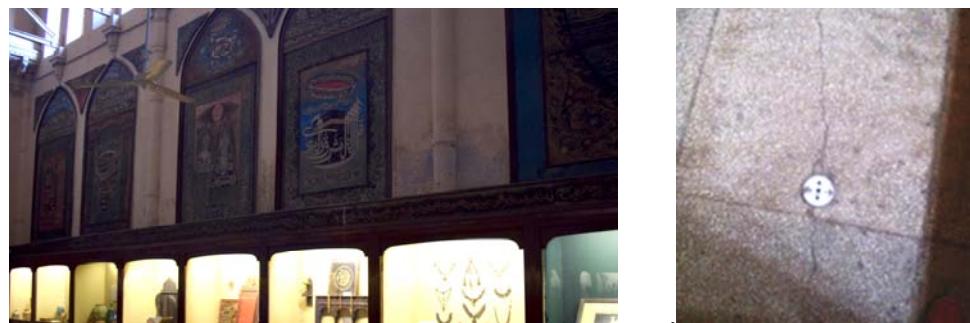
Figure B.10: Gnd-E/01 – Islamic Arts Gallery – Deterioration (2015)  
Discoloration of paint due to dampness on the Northern wall (left) Crack observed on the floor (right)

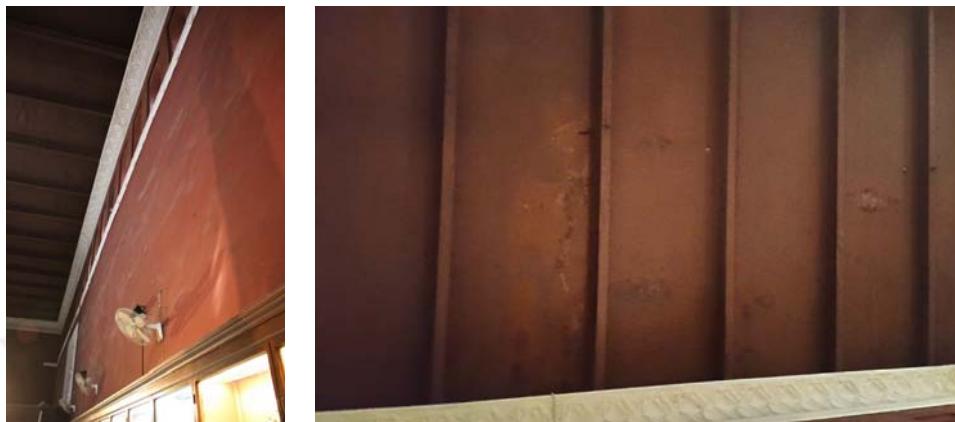
Figure B.14: Gnd-E/03 – Hindu and Buddhist Gallery (2017)  
Plaster swelling on Eastern wall (left) Discoloration due to dampness on roof (right)

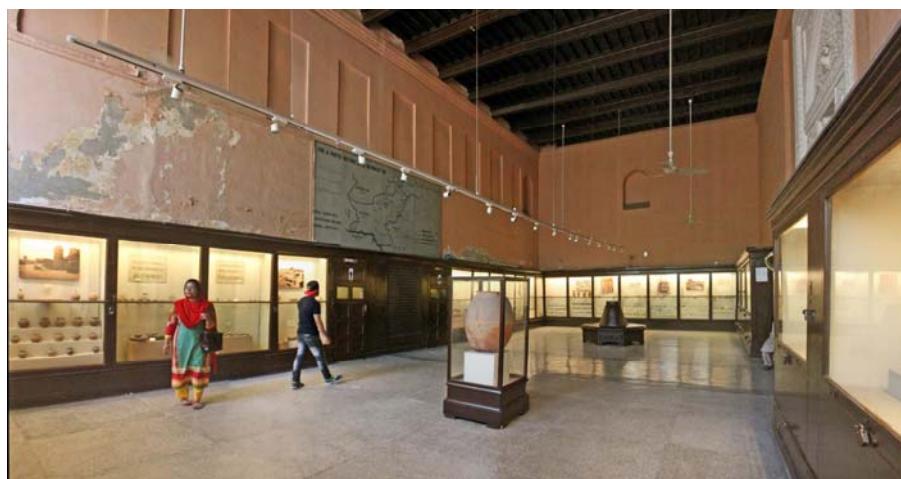
Figure B.15: Gnd-E/04 – Pre and Proto Historic Gallery (2016)  
Looking South East; Discoloration and flaking of paint can be observed on the eastern wall

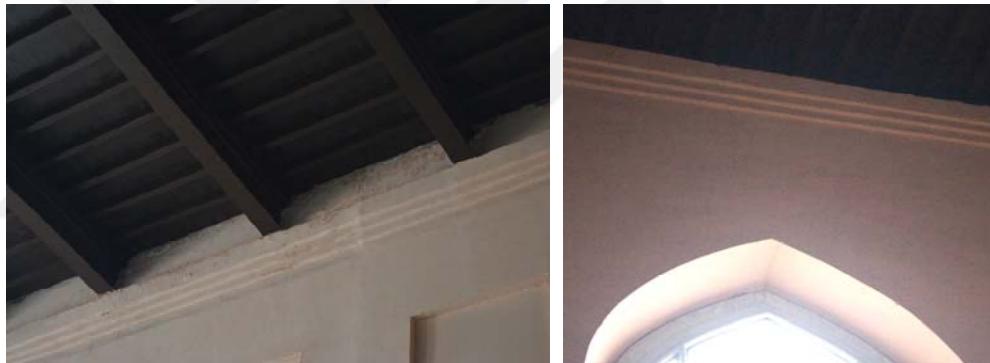
Figure B.16: Gnd-E/04 – Pre and Proto Historic Gallery – Deterioration (2016)  
Discoloration and flaking of paint near the ceiling on the Eastern wall (left) Vertical crack passing through the central window on the Northern wall (right)

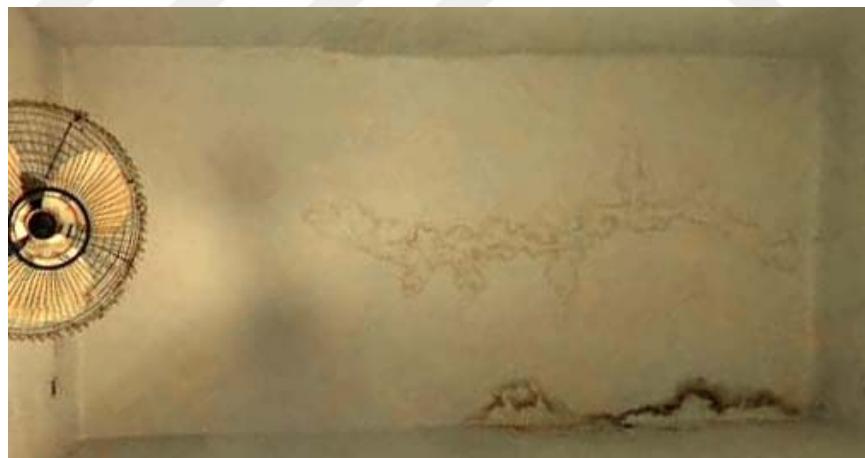
Figure B.18: Gnd-E/05 – Men's Toilet – Deterioration (2015)  
Discoloration of paint due to dampness on the ceiling

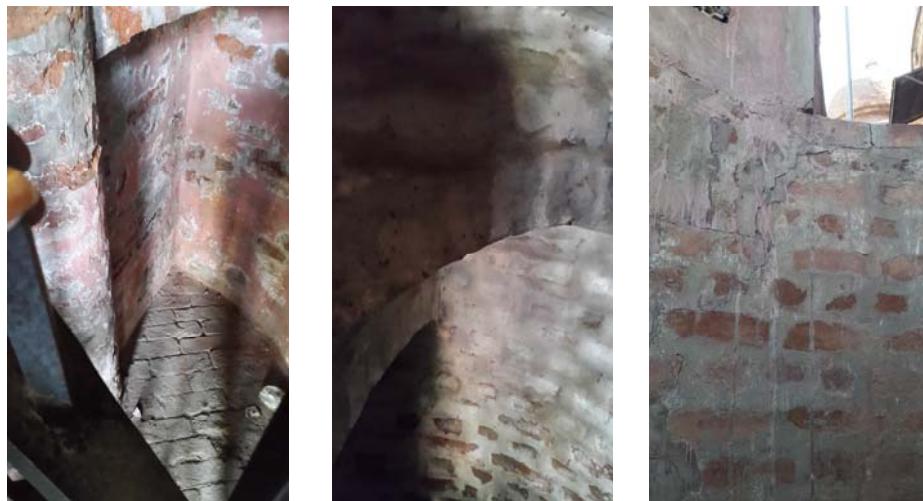
Figure B.42: Gnd-N/11 – North Western Stairwell (2016)  
Powdering of brick and mortar on the central column and the periphery wall (left) Steps supported on brickwork arches (center) Crack towards the North, halfway to the first floor (right)

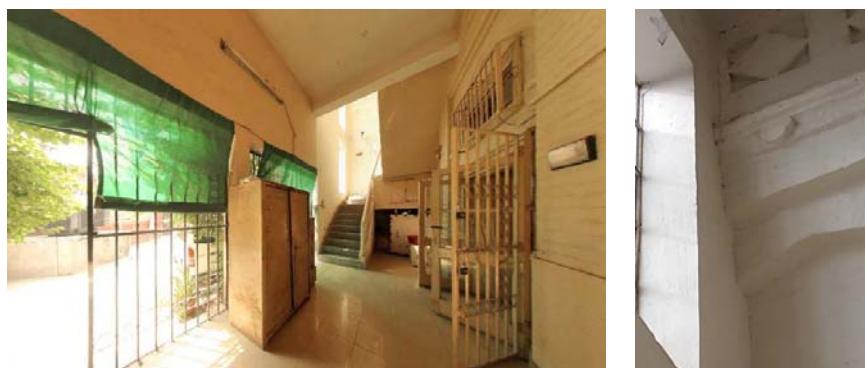
Figure B.49: Gnd-E/12 – Verandah/ Stair hall for Conservation Laboratory (2015)  
Looking West (left) Separation Crack (right)

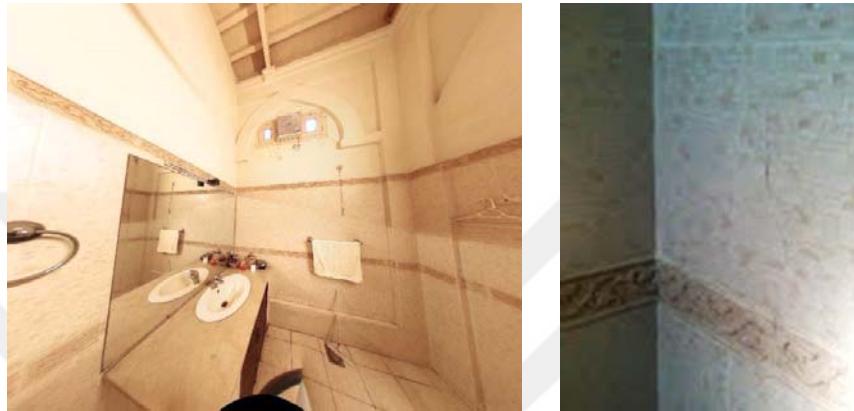
Figure B.58: Gnd-S/03 – Toilet for Director's Office (2015)  
Looking South (left) Diagonal crack on the Northern wall (right)

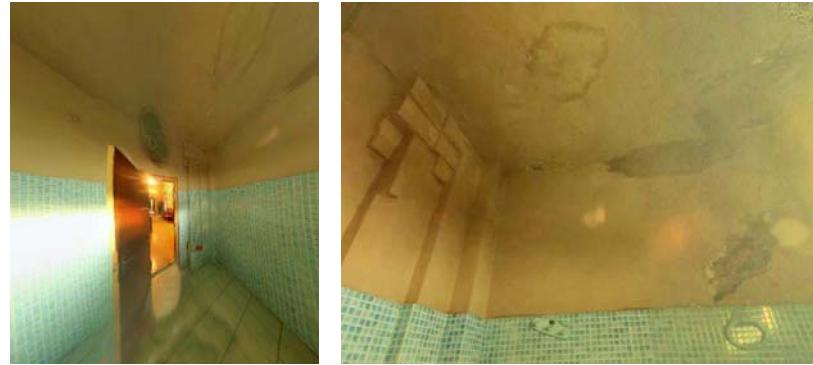
Figure B.75: Gnd-W/11 – Toilet for the Conference Room (2015)  
 Looking North-East (left) Flaking of paint and efflorescence on eastern wall as well as discolouration on the ceiling due to dampness (right)

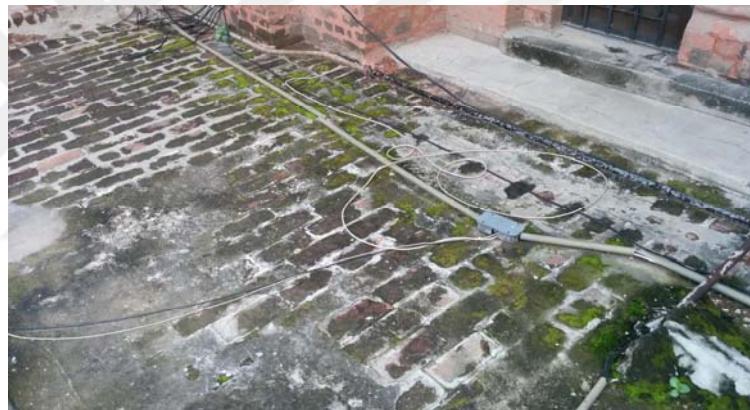
Figure B.86: Fst-N/03 – Terrace – Deterioration (2015)  
Microbiological growth on the floor
