RESTORATION OF A HISTORIC OLIVE OIL MILL IN DİKİLİ

**A Thesis Submitted to the Graduate School of Engineering and Science
of İzmir Institute of Technology in Partial Fulfillment of the
Requirements for Degree of**

in Architectural Restoration

December 2014

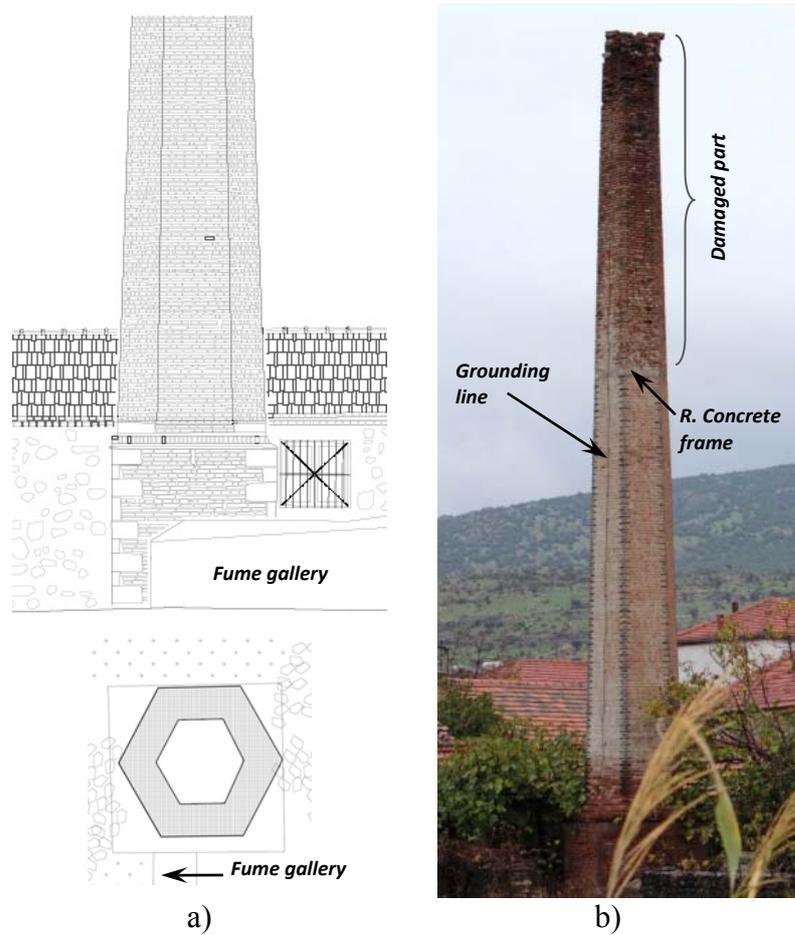
Figure 4.27. a) Plan and eastern façade of chimney, b) the view from the same direction

Chimney: Chimney is the symbol of the mill which is visible, even from farthest points around the village. The shaft of the chimney, total height of which is around 18.60 m (including the base-height – 2.40 m) from the ground (Appendix B.5) and hexagonal in plan (Appendix B.1), is built of solid brick units and tapers off upwards. Upper half of the chimney is slightly damaged and some brick losses are observed at the uppermost part besides a slight bend towards south east (Figure 4.27 a, b, Appendix E.6).

It is said that upper half of the chimney faced some damages (the reason is not known, but likely by the stroke of lightning as the inhabitants implied) and repaired by the placement of a reinforced concrete frame and completed to the original height. Some mortar losses and irregularities in brick courses visible at present indicate that workmanship was not good as in the lower parts. A grounding line visible on the northern part of the chimney is thought to be fixed during the time of repair (Figure 4.27 b, Appendix B.6).

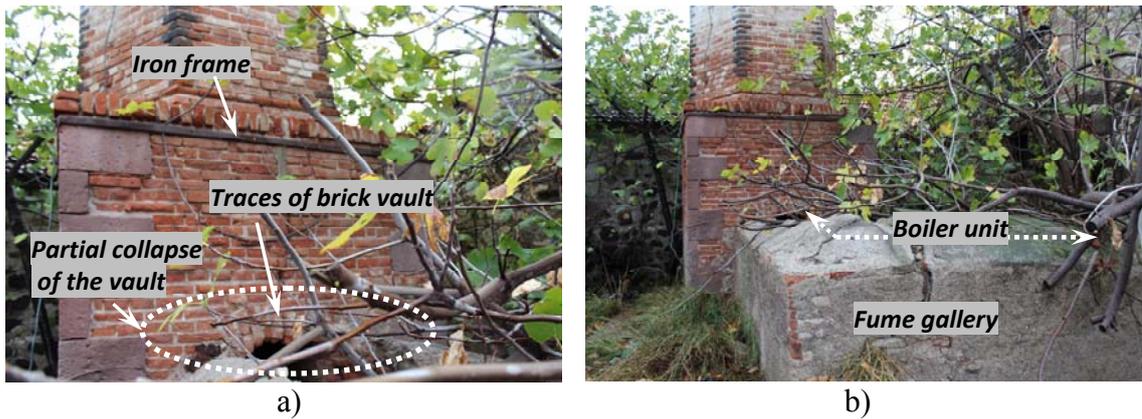
Figure 4.28. a) The base of the chimney and fume gallery, b) view of cut stone-quoin of the base and view of damaged vault of fume gallery with semicircular profile

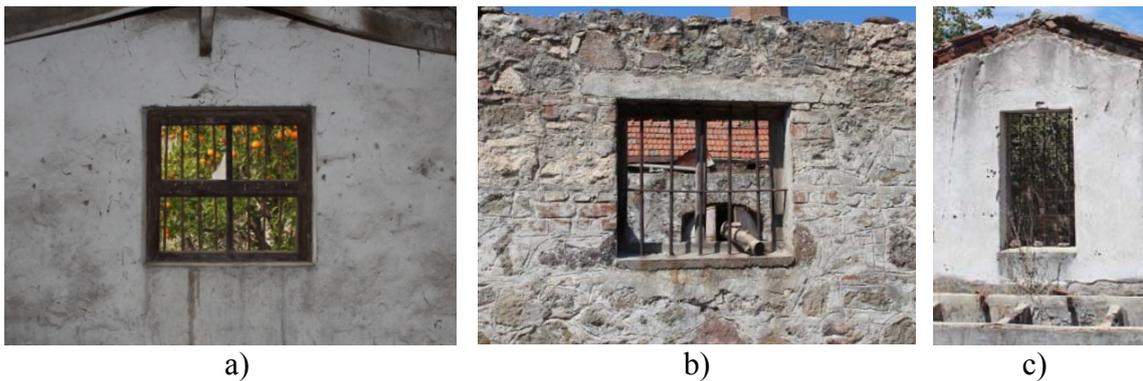
Figure 4.37. a) A single-hung sash window of an administration office (G-03), b) double-wing wooden window in the eastern wall of decantation unit (G-02), c) a window opening in the northern wall of decantation area (G-02) with iron grilles (wings are missing)

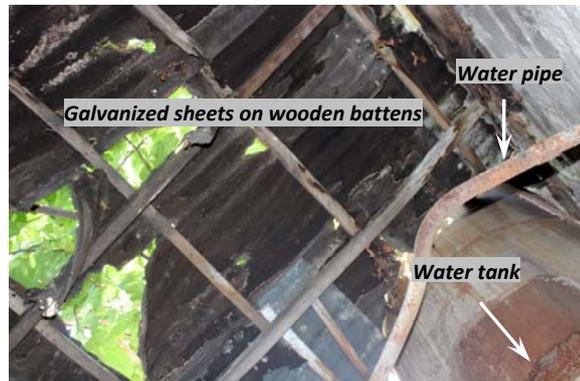
The half of the roof of water-tank unit G-06 is covered with sheets of galvanized steel. The other half is almost open and water tank extends over the walls. A considerable portion of the galvanized sheets that are nailed on wooden battens simply fixed to the walls is missing (Figure 4.51).

Figure 4.51. The roof of water tank unit G-06

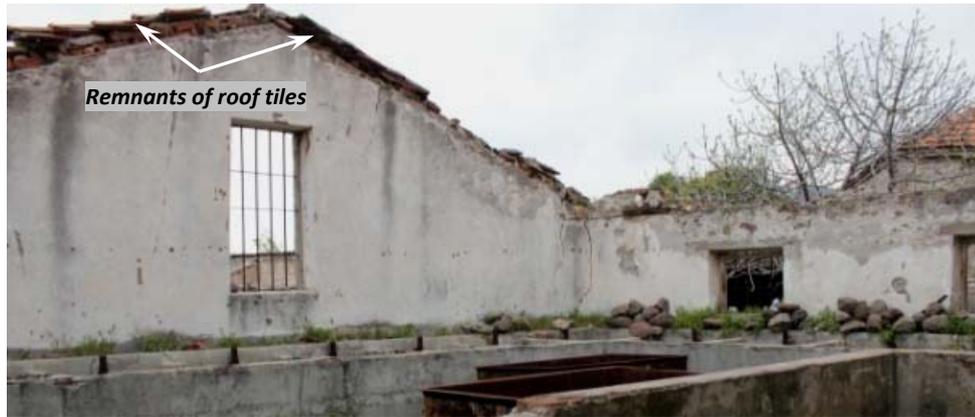
The roof of decantation ponds unit (G-02) is the most prominent constructional loss in the mill building (Appendixes D.4 and D.7.). Wooden windows in the northern wall of the production unit (G01) (Appendix D.3), the wooden door of the office (G05) in the administrative unit, and glasses of some window panes can be considered as other elemental losses. Although not constructional, but production equipment, such as; steam engine, grinder, boiler, hydraulic pump and hydraulic presses are considered as missing elements which have importance in terms of industrial hardware of the mill.

Figure 4.52. Gable and side walls of decantation unit remained standing after roof-collapse

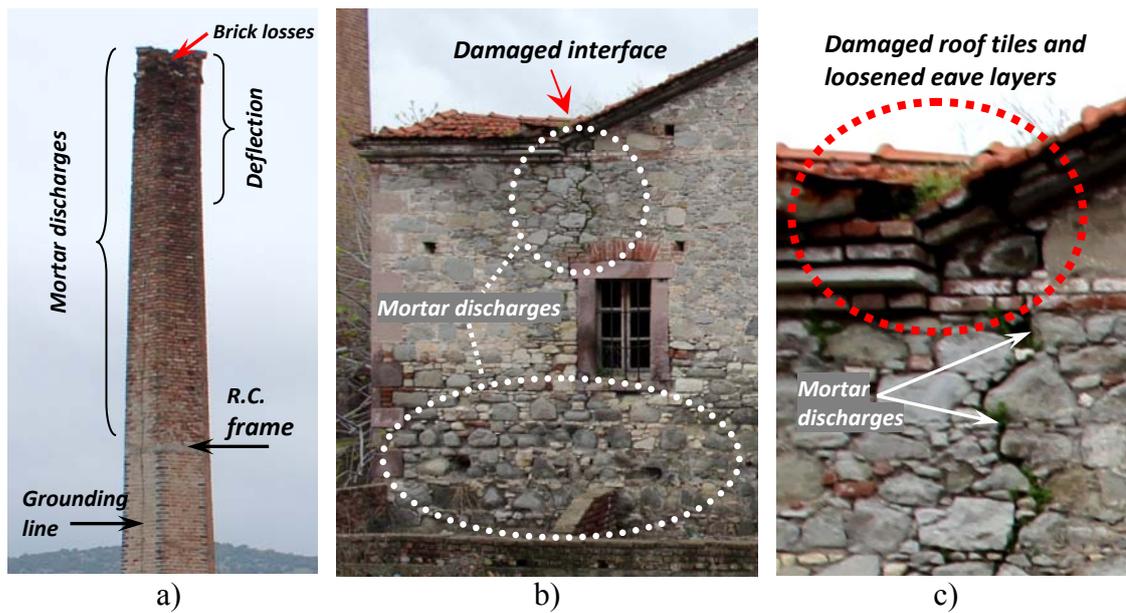
Figure 4.53. a) Mortar discharges and deflection in the upper parts of the chimney, b) mortar discharges in the upper and lower parts of the northern part of the western façade, and c) a view from the loosened interface of the roof edge and inclined eave of the gable roof (Figure 4.50. a)

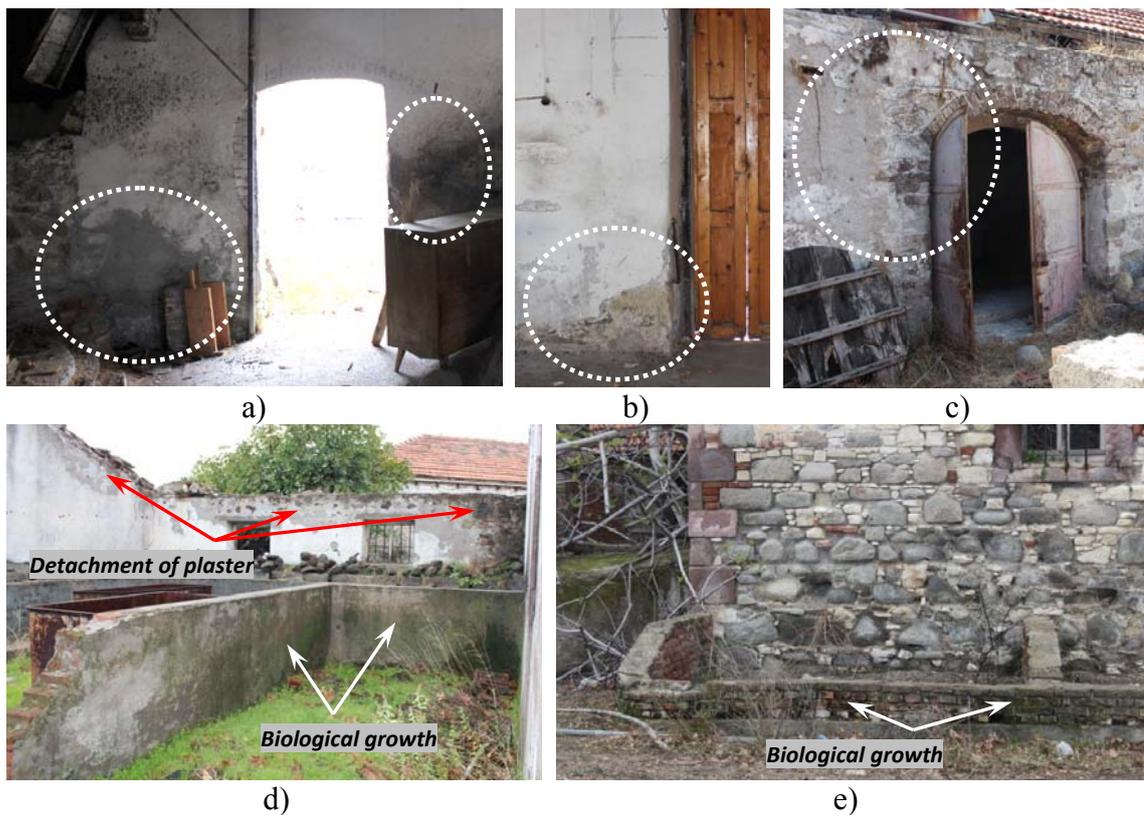
Figure 4.54. a, b, c) Plaster detachments in production and decantation units,
d) biological growth on the damped-surfaces of decantation ponds,
e) mortar discharges and biologic growth on the damped-stone walls of
boiler unit and brick bonds of storage bays (*dökeks*)
