**CONSERVATION PROBLEMS OF HISTORICAL CHURCHES IN
ELAZIĞ: SURP SIMON CHURCH**

**IN PARTIAL FULFILLMENT OF THE REQUIREMENTS
FOR THE DEGREE OF MASTER OF SCIENCE
IN ARCHITECTURE DEPARTMENT**

**GAZİ UNIVERSITY
GRADUATE SCHOOL OF NATURAL AND APPLIED SCIENCES**

DECEMBER 2023

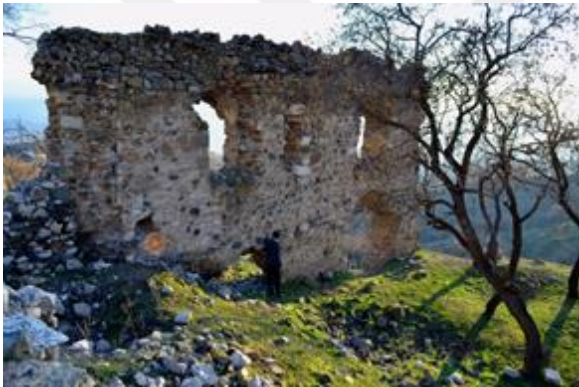
The remaining part of the church, much of which has collapsed, is vulnerable to human and natural destruction (Figure 3.11-3.12). Since the north and south walls are not connected to each other, their structural balance is fragile and there is a risk of complete collapse.

Figure 3.11. Current Status of Surp Hagop Church (Source: <https://harput.web.tr/harputun-tarihi-eserleri/harputdaki-kiliseler/surp-hagop-kilisesi/>, Access Date: 10.09.2023)

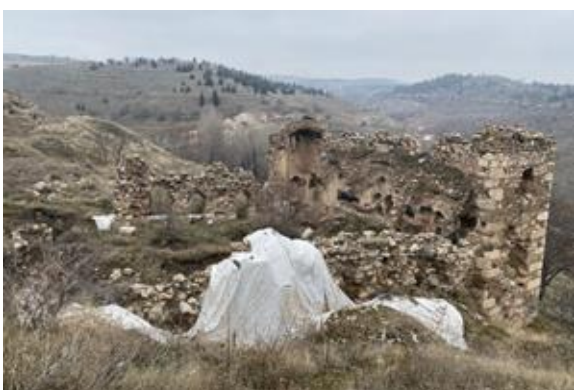
The smooth cut stone and rubble stone were used in the construction of the building, and the east, north, and south walls are still partially standing (Figure 3.15). However, the west wall has been demolished. Information about the ends and upper floors of the north and south walls is not available. The upper cover of the dome was entirely demolished, except for the beginning stone rows. It is not possible to read the plan scheme clearly. Material loss and deterioration in almost all parts of the church are quite extensive. Although the eastern wall and side cells remain standing as a whole, there is serious deterioration in the masonry stone walls. The north and south walls have suffered greater material loss than the east wall. Since the building has been largely demolished and no conservation measures have been taken around it, it is completely open to human and natural destruction and is at high risk. The walls are more deteriorated due to material loss than serious structural problems. The ground is covered with overgrown weeds. The church has been vandalized in the last few years.

Figure 3.15. Kızıl Church (Source: Author's Archive, 01.02.2023)

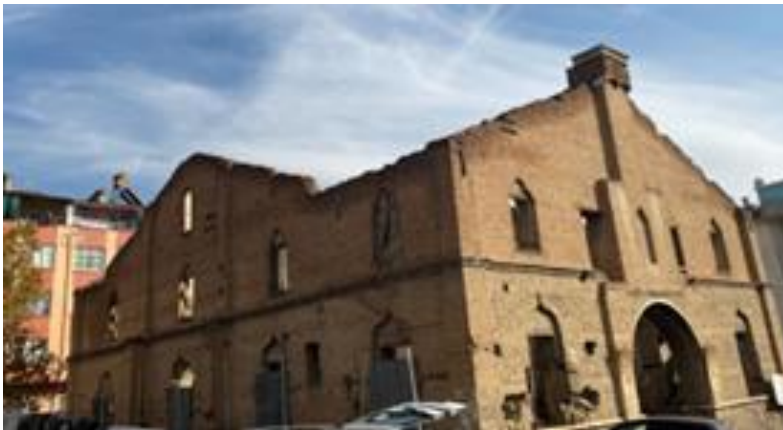
The church located in the center of Elazığ province is under the threat of extinction due to various reasons. At present, there are only the body walls of the building and the structural elements such as the bell tower, roof, floors, etc. have completely disappeared (Figure 3.19).

Figure 3.19. Current Situation of the Armenian Protestant Church (Author's Archive, 2023)

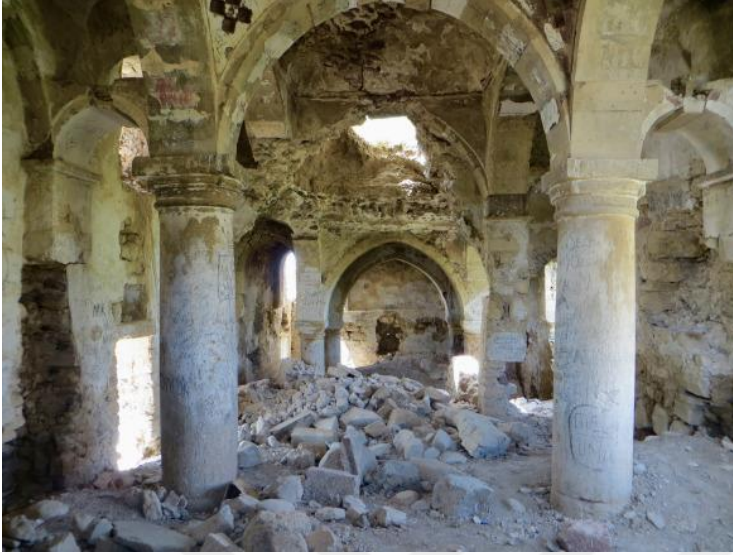
The church, in its current structural condition, is highly vulnerable to damage in natural disasters such as earthquakes and floods due to the weakened state of its walls and roof. Furthermore, it remains susceptible to potential human-inflicted harm.

Figure 3.25. Deterioration of the Surp Hulvenk Monastery due to vandalism (Source: <https://arkeofili.com/elazigdaki-1000-yillik-hulvenk-kilisesi-10-yildir-tahrip-ediliyor/>, Access Date: 02/11/2023)

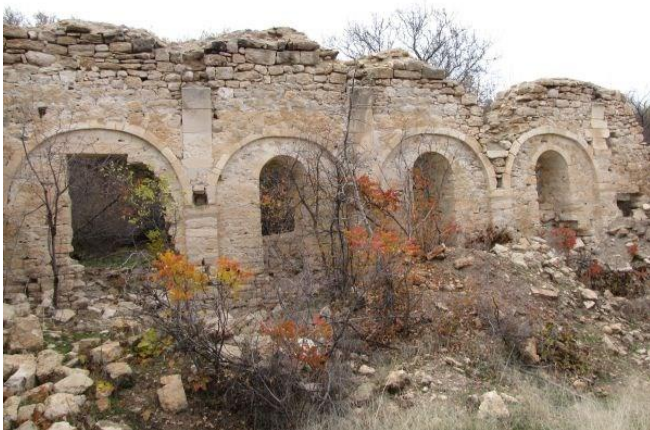
Only the northern wall, extending up to the beginning of the vault, has been preserved. The western wall and the apses are partially preserved. The remnants of the south wall can be found below ground level. The building is exposed to external elements that could lead to deterioration (Figure 3.27).

Figure 3.27. Current Situation of Küşne Church (Source: <http://www.agin.gov.tr/kusne-kilisesi>, Access Date: 05.11.2023)

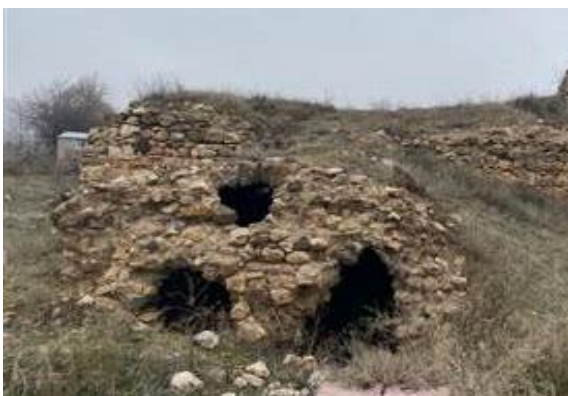
Figure 4.8. Library Section Material Losses (Source: Author's Archive, February 2023)

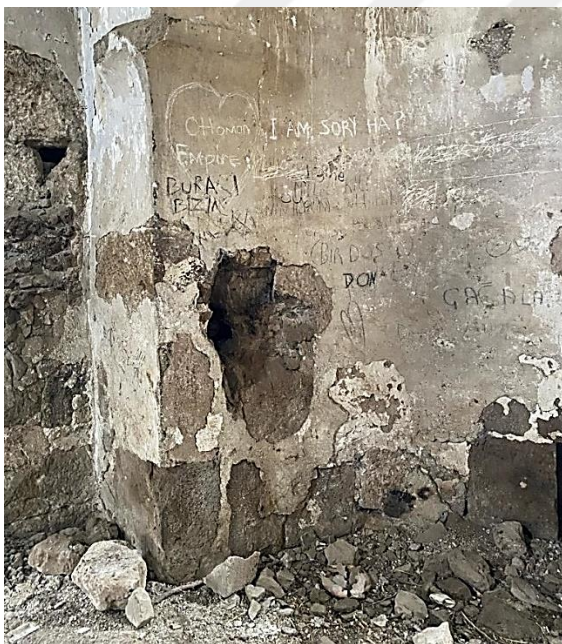
Figure 4.20. Damages observed on walls due to vandalism (Author's Archive, 2023)

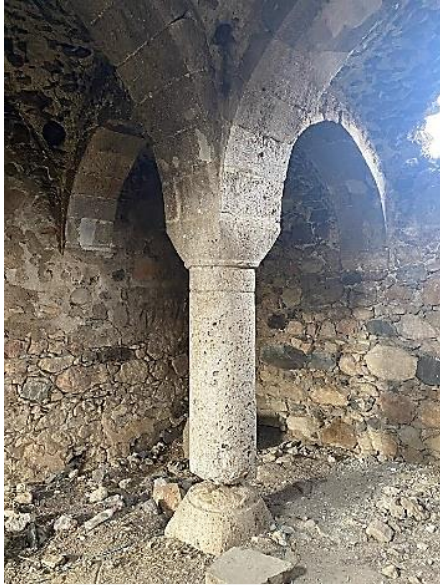
Figure 4.21. Sectional weakenings observed on the columns (Author's Archive, 2023)

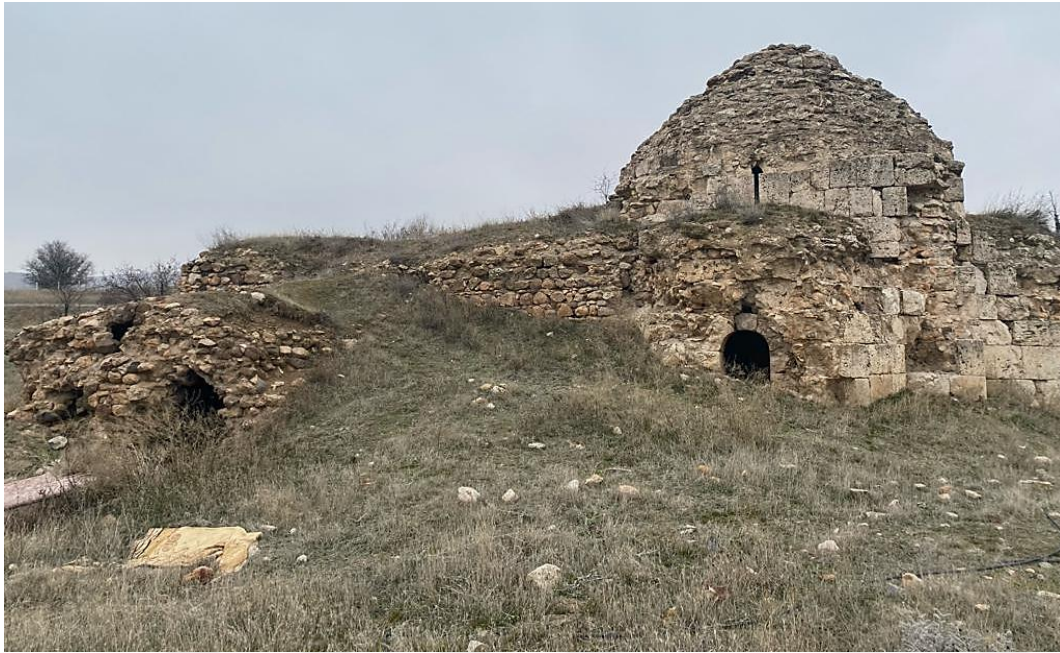
Figure 4.23. Burials observed in ground level in the area (Author's Archive, 2023)
