**SEISMIC BEHAVIOR OF RC COLUMNS WITH CORRODED
PLAIN AND DEFORMED REINFORCING BARS**

Ph.D. THESIS
Çağlar GÖKSU

Department of Civil Engineering
Structure Engineering Programme

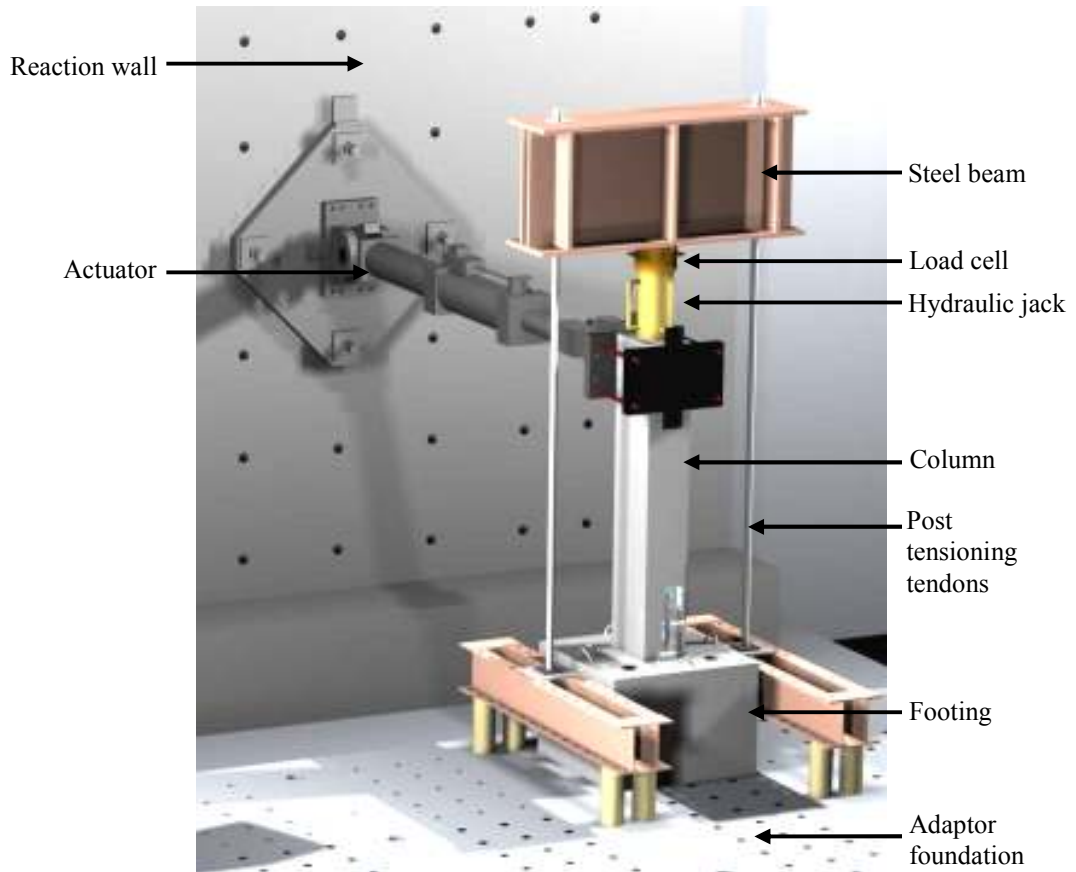
Figure 4.5 : Test setup (Demirtaş, 2008).

Following the anchorage of the specimen on the adaptor footing, vertical lines were drawn every 50 mm on the surface of the specimens to observe the crack pattern. The cracks formed due to corrosion and/or shrinkage was marked on the surface of the specimens. Ten mm diameter holes were drilled at 20 mm, 150 mm and 300 mm above the footing for mounting the LVDTs which were used to measure the displacement and calculate the moment-curvature relationships. The steps for the preparation of the specimen for the test can be seen in Figure 4.6

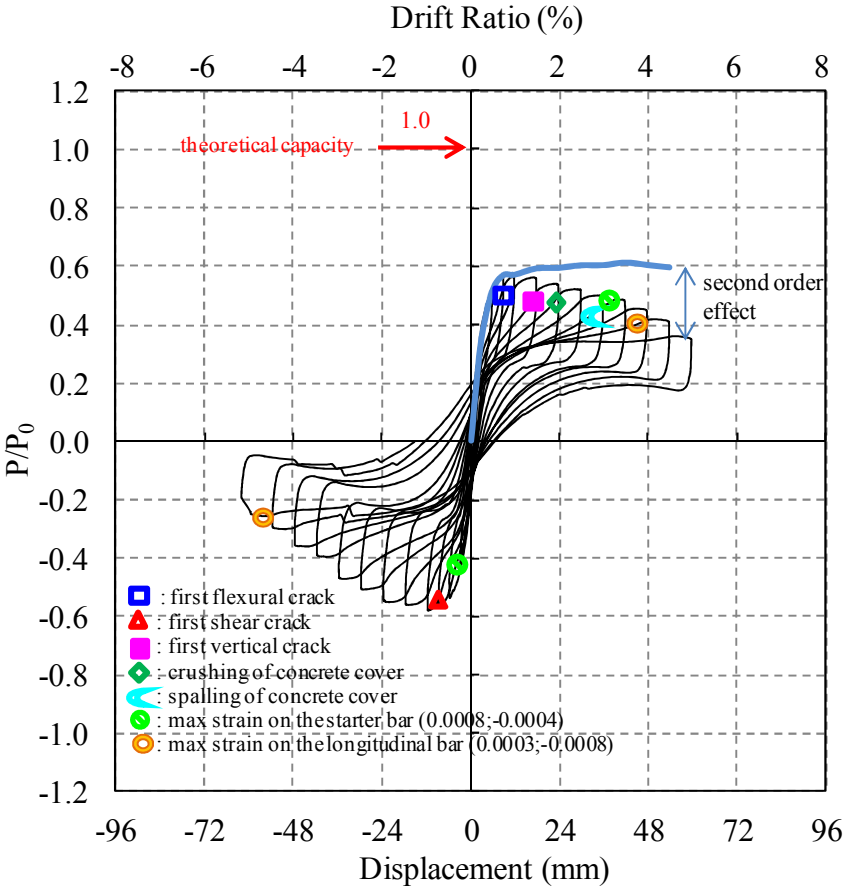
Figure 6.10 : Lateral load/Theoretical load capacity capacity versus displacement for LS-X0.

Force-displacement relationship of the specimen LS-X0 is presented in Figure 6.10. In this figure, P is applied lateral load and P_0 is the theoretical lateral load capacity of the specimen determined without considering the effect of corrosion. First flexural crack, first shear crack, first vertical crack, crushing of concrete cover, spalling of concrete cover, maximum strain on the starter bar and maximum strain on the longitudinal bar are marked on the figure. As seen from Figure 6.10, no strength loss was observed. The decline is due to the horizontal component of the axial load. As the line of action of the axial load does not pass through the column base during the tests of all column specimens, to account P- Δ effects, the effect of axial load resolved to its horizontal and vertical components. Then, the horizontal components of the axial load subtracted from the force applied by the actuator and the net horizontal force obtained. This correction was done due to PEER (2004) Case 4.

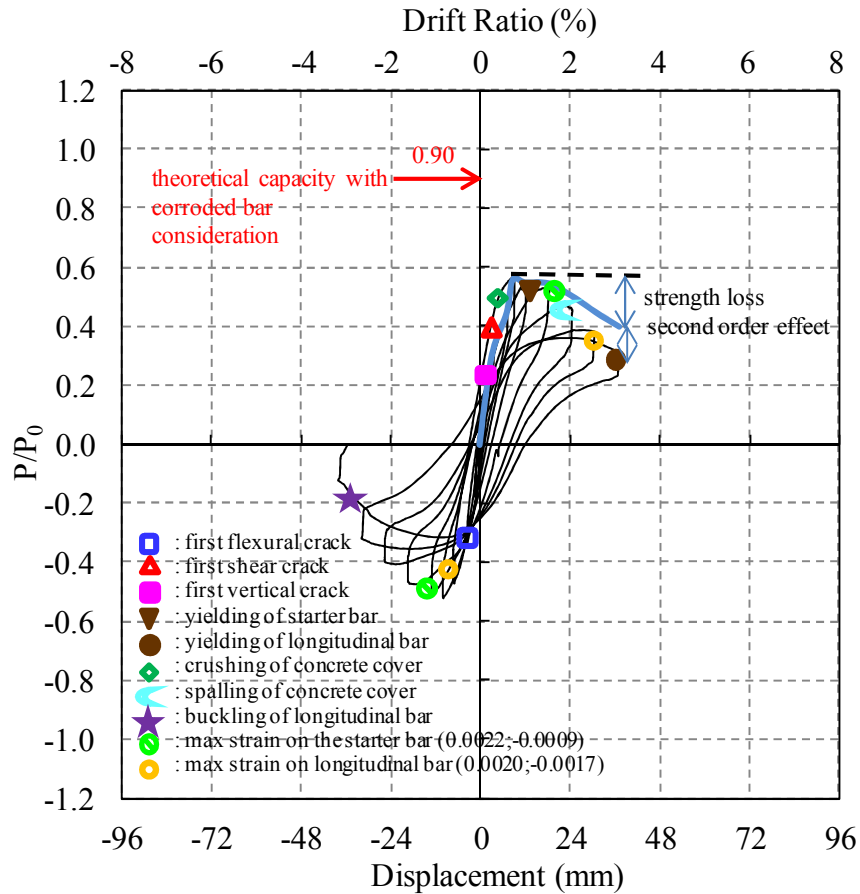
Figure 6.39 : Lateral load/Theoretical load capacity versus displacement for LS-X12.

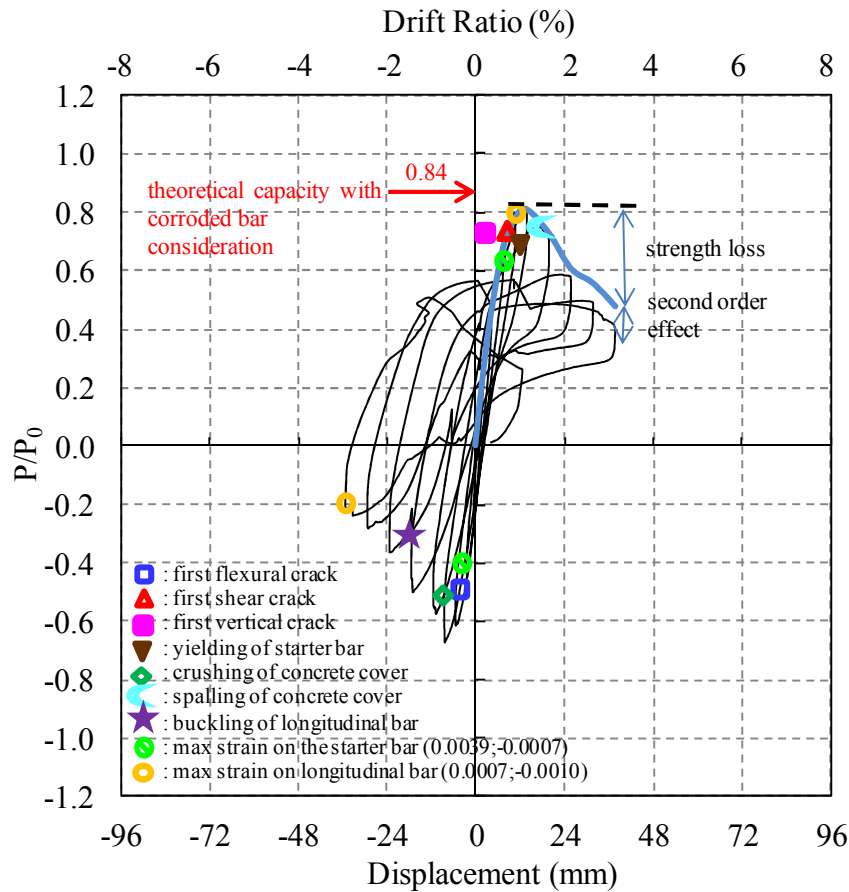
Figure 6.48 : Lateral load/Theoretical load capacity versus displacement for LS-X21.

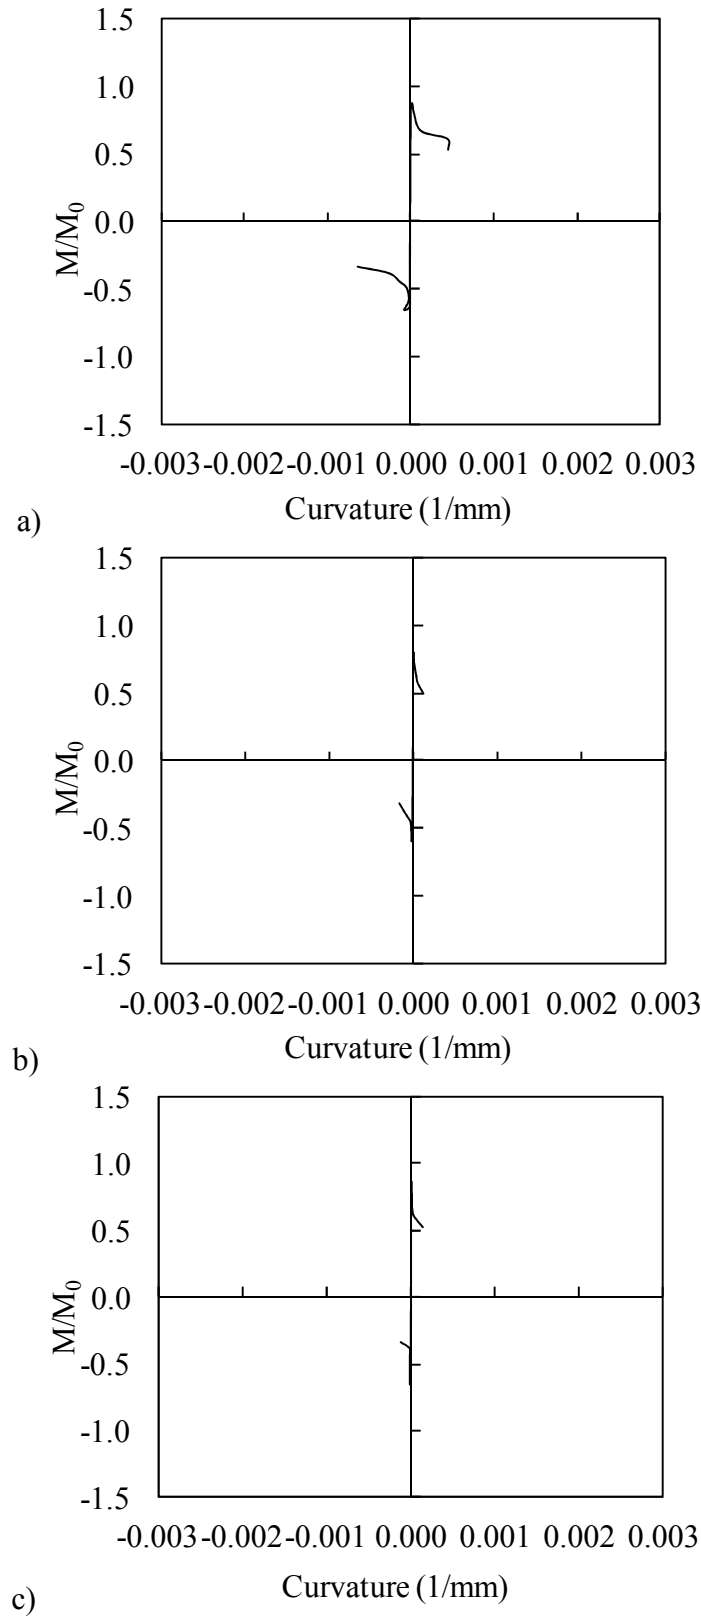
Figure 6.49 : Moment-curvature relationships obtained for a) 0-20 mm, b) 20-150 mm, c) 150-300 mm gauge lengths.

Average experimental moment-curvature relationships obtained for critical sections of LS-X21 are presented in Figure 6.49. For the calculation of moment-curvature relationships, the average curvature values obtained for the ranges of 0-20 mm, 20-150 mm and 150-300 mm heights above the footing are taken into account. As seen from Figure 6.12, the curvature values of the member measured in 20-150 mm and 150-300 mm height above the support are in the order of $5 \cdot 10^{-5}$ (1/mm), while the curvatures measured in 0-20 mm height are in the order of $3 \cdot 10^{-3}$ (1/mm). According to the figure, it is of interest to note that the damage is accumulated especially in 20 mm height of the member from top of the base according to the moment-curvature relationships.

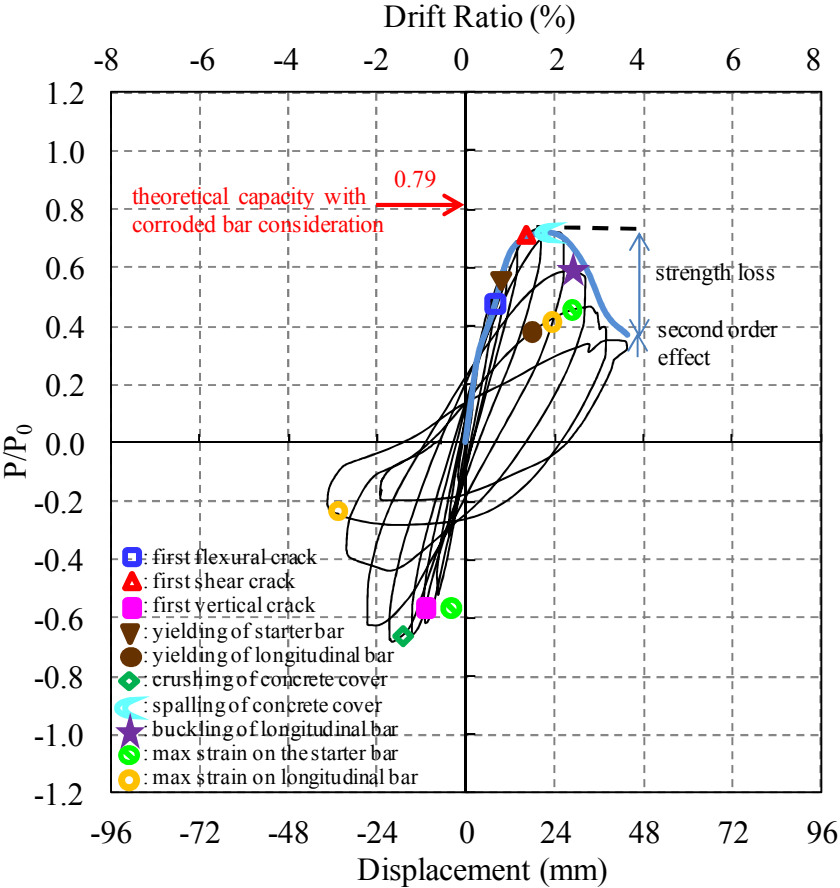
Figure 6.58 : Lateral load/Theoretical load capacity versus displacement for LS-X28.

Force-displacement relationship of LS-X28 is presented in Figure 6.58. In this figure, P is applied lateral load and P_0 is the theoretical lateral load capacity of the specimen determined without considering the effect of corrosion. First flexural crack, first shear crack, first vertical crack, yielding of starter bar, yielding of longitudinal bar, crushing of concrete cover, spalling of concrete cover, buckling of longitudinal bar, maximum strain on the starter bar and maximum strain on the longitudinal bar are marked on the figure. As seen from the figure, strength loss was observed.

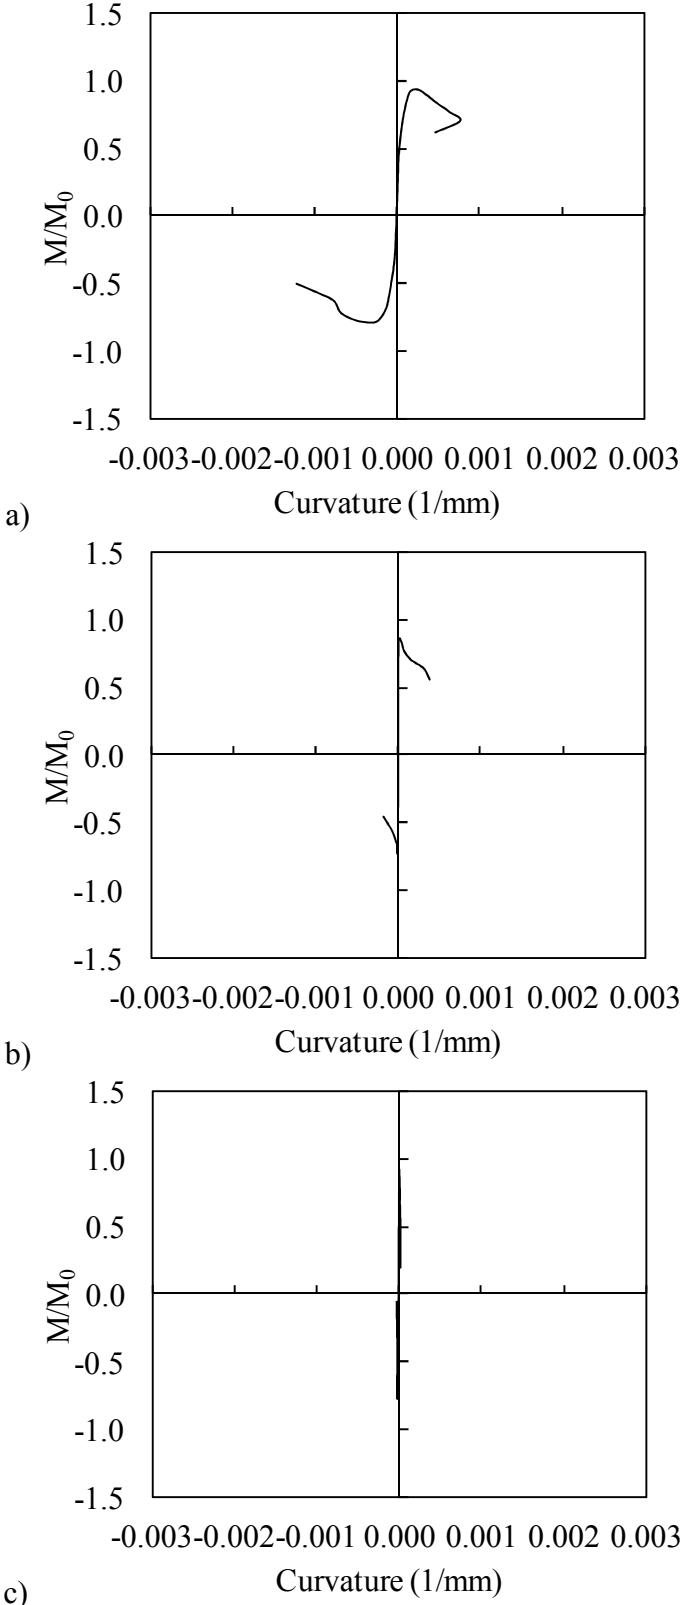
Figure 6.67 : Moment-curvature relationships obtained for a) 0-20 mm, b) 20-150 mm, c) 150-300 mm gauge lengths.

Average experimental moment-curvature relationships obtained for critical sections of NS-X0 are presented in Figure 6.67.

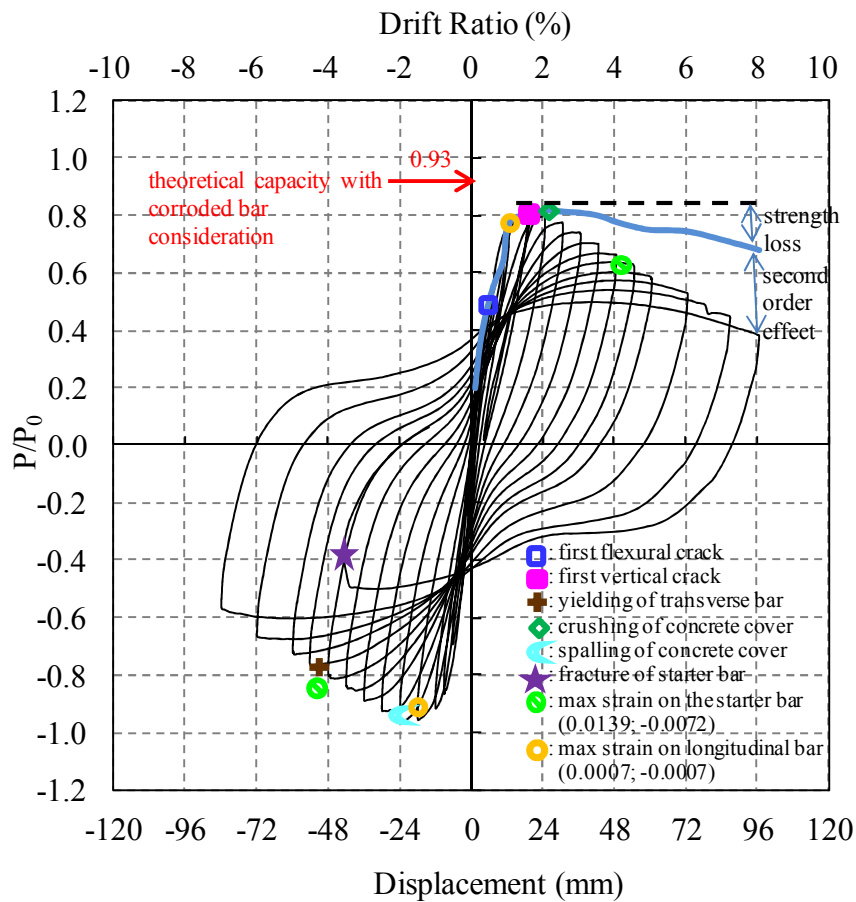
Figure 6.75 : Lateral load/Theoretical load capacity versus displacement for NS-X9.

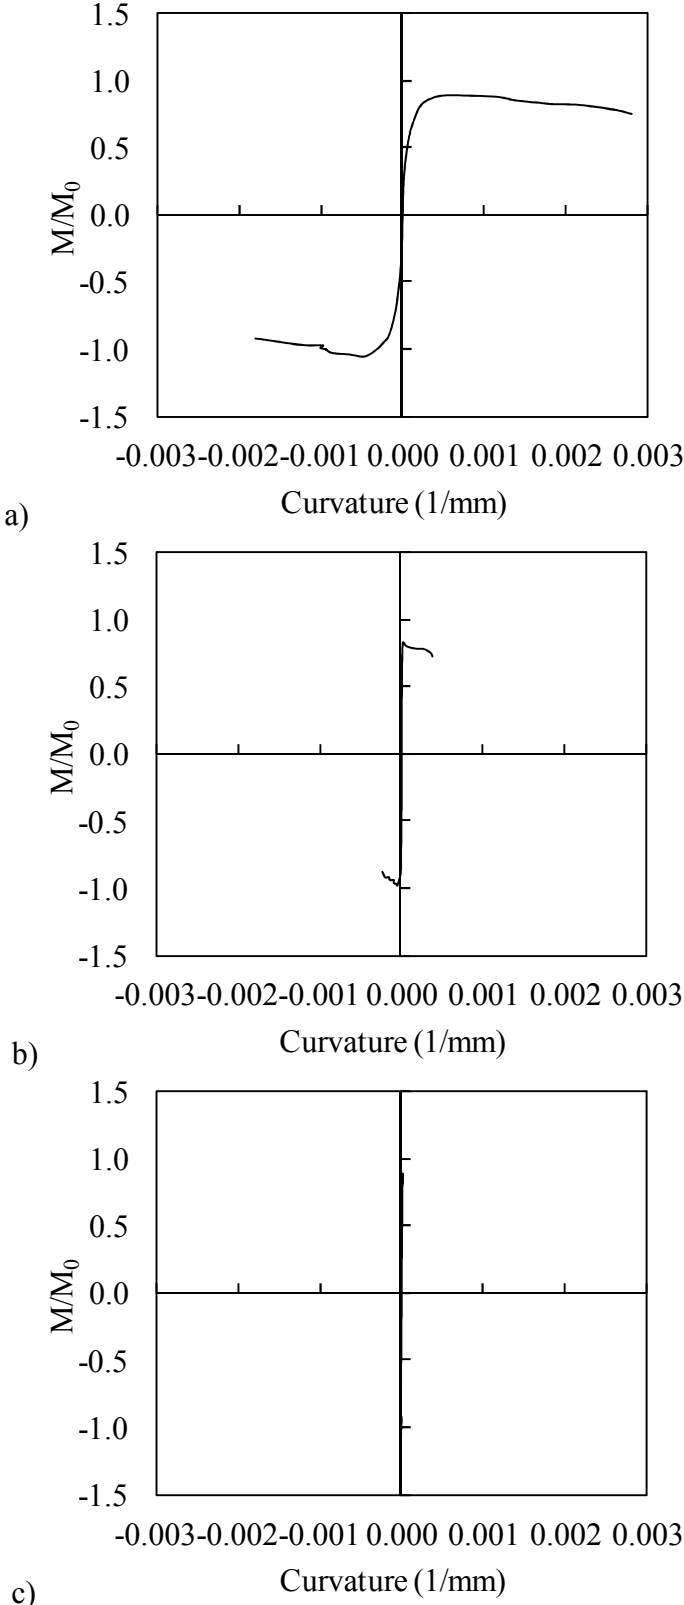
Figure 6.76 : Moment-curvature relationships obtained for a) 0-20 mm, b) 20-150 mm, c) 150-300 mm gauge lengths.

Average experimental moment-curvature relationships obtained for critical sections of NS-X9 are presented in Figure 6.76.

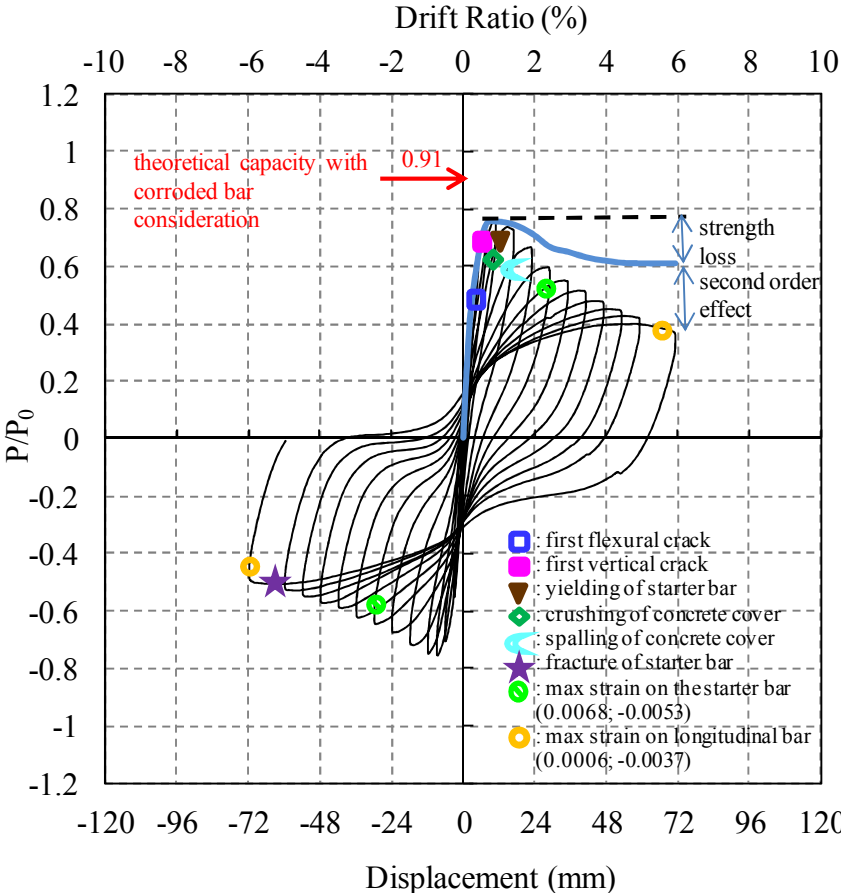
Figure 6.84 : Lateral load/Theoretical load capacity versus displacement for NS-X13.

Force-displacement relationship of NS-X13 is presented in Figure 6.84. In this figure, P is applied lateral load and P_0 is the theoretical lateral load capacity of the specimen determined without considering the effect of corrosion. First flexural crack, first vertical crack, yielding of starter bar, crushing of concrete cover, spalling of concrete cover, fracture of starter bar, maximum strain on the starter bar and maximum strain on the longitudinal bar are marked on the figure. As seen from Figure 6.84, strength loss was observed. Average experimental moment-curvature relationships obtained for critical sections of NS-X13 are presented in Figure 6.85. For the calculation of moment-curvature relationships, the average curvature values which were obtained for the ranges of 0-20 mm, 20-150 mm and 150-300 mm heights above the footing were taken into account. As seen from the figure, the curvature values of the member measured in 20-150 mm and 150-300 mm height above the support are in the order of 5.10^{-5} (1/mm), while the curvatures measured in 0-20 mm height are in the order of 3.10^{-3} (1/mm). According to the figure, it is of interest to note that the damage is accumulated especially in 20 mm height of the member from top of the base according to the moment-curvature relationships.

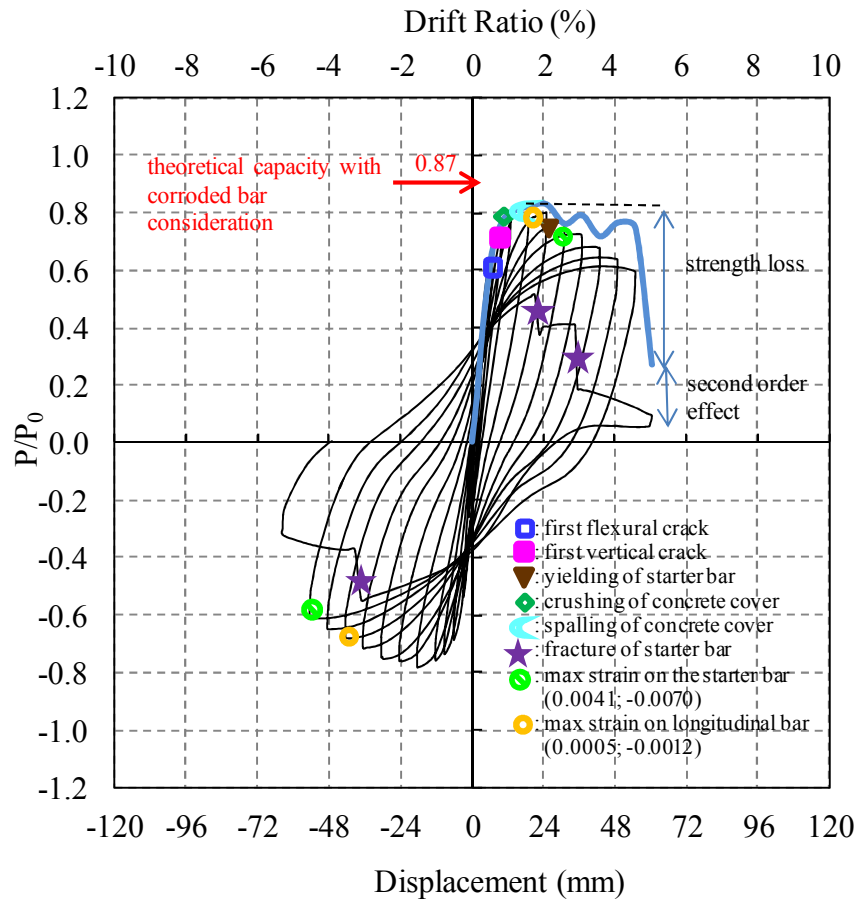
Figure 6.94 : Lateral load/Theoretical load capacity versus displacement for NS-X16.

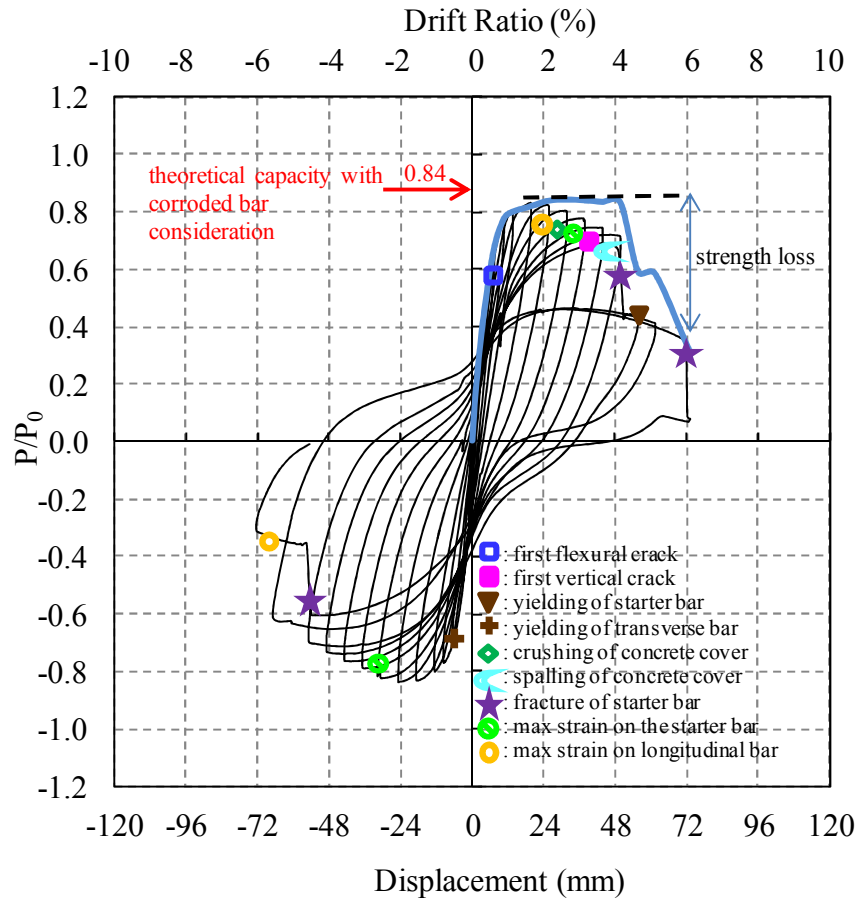
Figure 6.104 : Lateral load/Theoretical load capacity versus displacement for NS-X22.

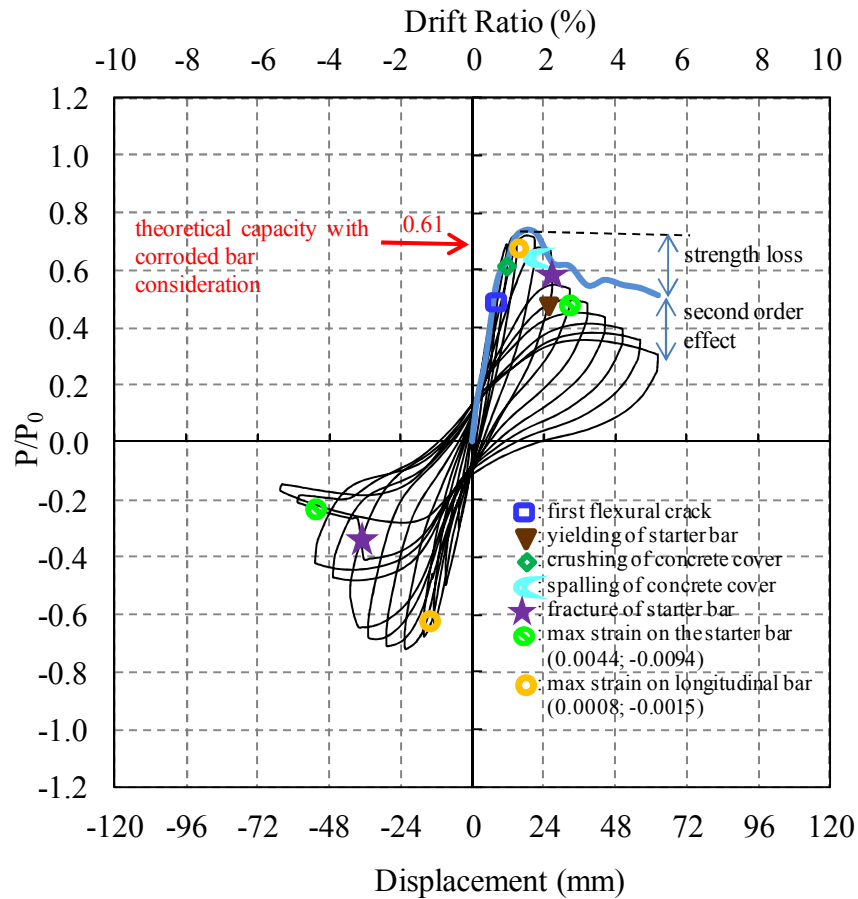
Figure 6.112 : Lateral load/Theoretical load capacity versus displacement for NS-X54.

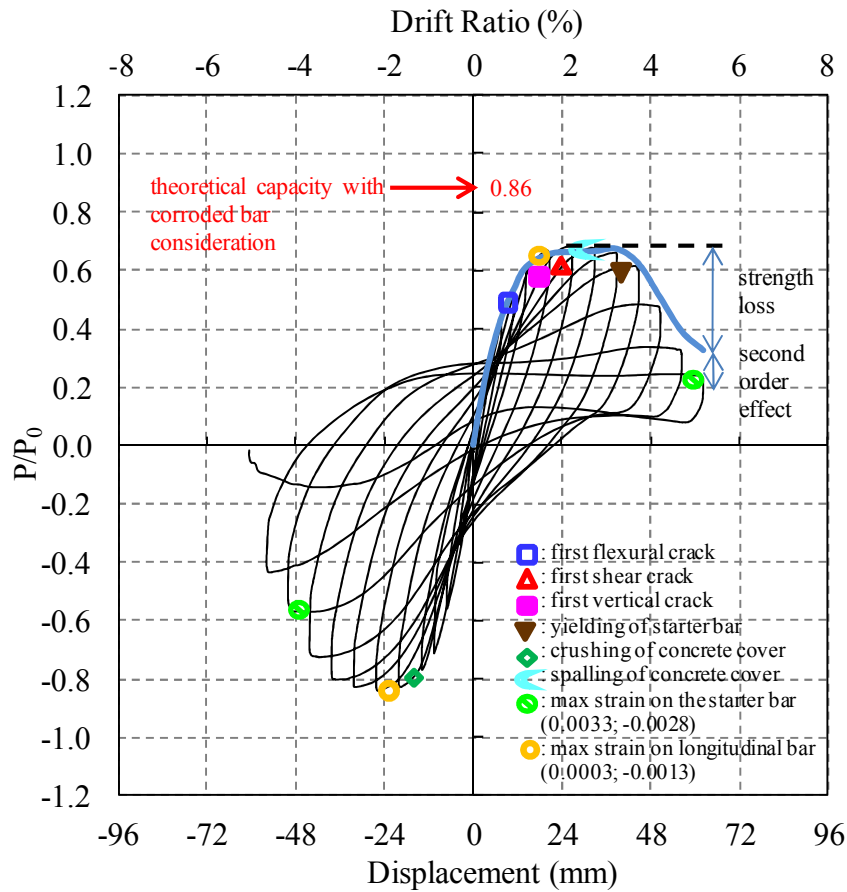
Figure 6.122 : Lateral load/Theoretical load capacity versus displacement for LS-X19-H.

Force-displacement relationship of LS-X19-H is presented in Figure 6.122. In this figure, P is applied lateral load and P_0 is the theoretical lateral load capacity of the specimen determined without considering the effect of corrosion. First flexural crack, first shear crack, first vertical crack, yielding of starter bar, crushing of concrete cover, spalling of concrete cover, fracture of starter bar, maximum strain on the starter bar and maximum strain on the longitudinal bar are marked on the figure. As seen from Figure 6.122, strength loss was observed.

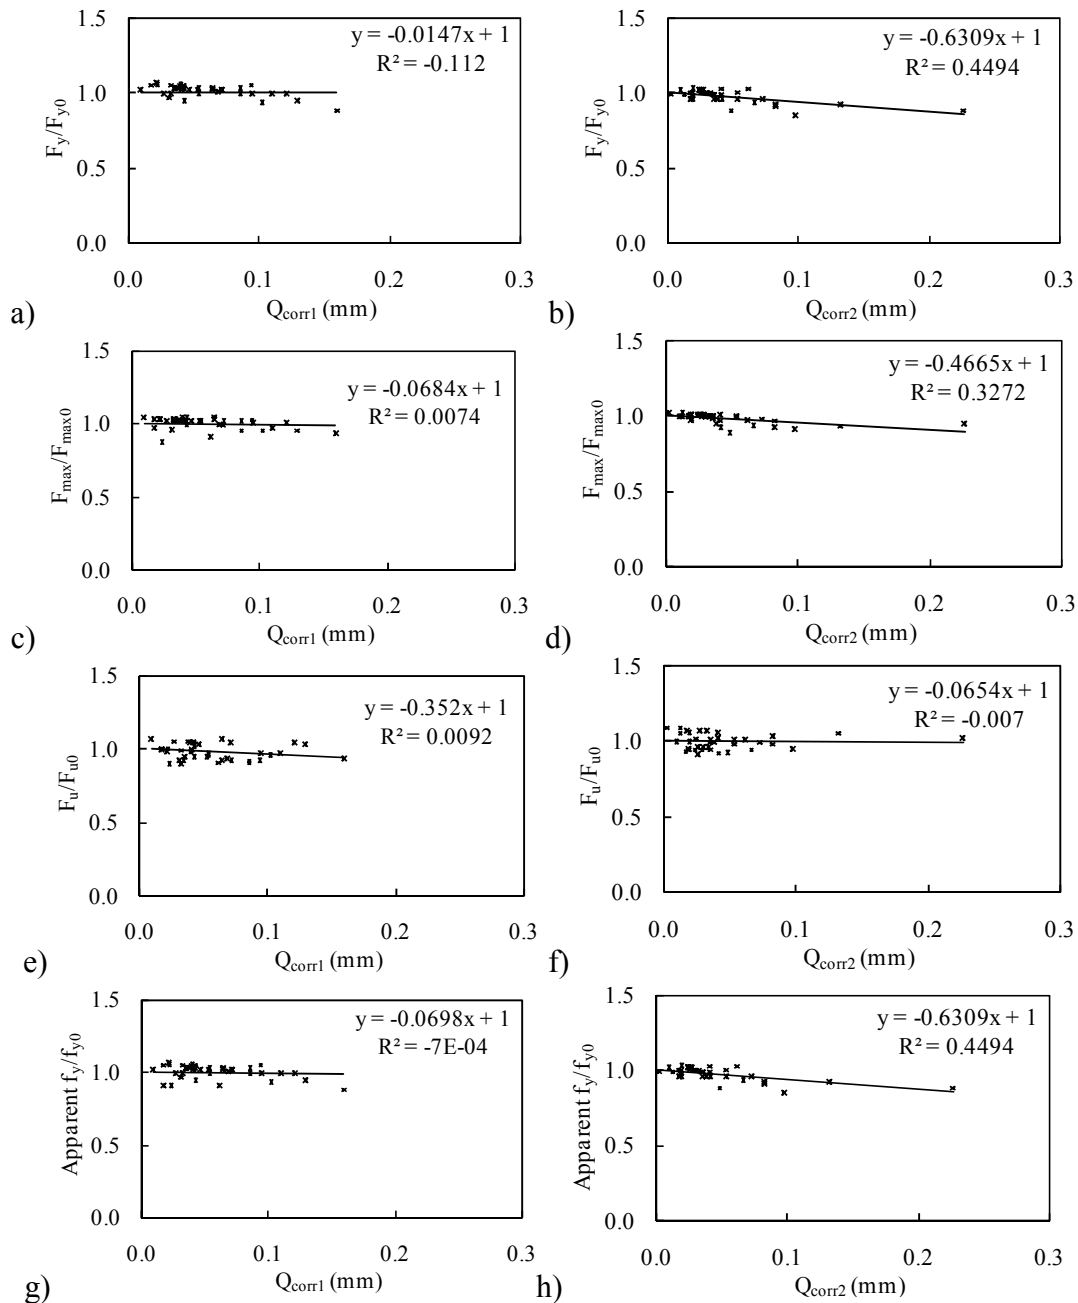
Figure 6.129 : Variation of a,b) Yield strength, c,d) Maximum strength, e,f) Ultimate strength g,h) Apparent yield stress, i,j) Apparent maximum stress, k,l) Apparent ultimate stress, m,n) Effective yield stress, o,p) Effective maximum stress, r,s) Effective ultimate stress t,u) Ultimate strain with respect to maximum and average cross-section losses

The variation of strength and deformability characteristics of corroded reinforcing bars with respect to variation of Q_{corr1} and Q_{corr2} are presented in Figure 6.129. In these figures, F_y , F_{max} and F_u are the yield, maximum and ultimate strengths of corroded bars, respectively. In these figures, F_{y0} , F_{max0} and F_{u0} are used for the yield, maximum and ultimate strengths of uncorroded reinforcing bars, respectively. It should be noted that the strengths in these figures are tensile forces resisted by the corroded bars, not the tensile stresses, which can not be calculated reliably. The apparent and effective stresses are calculated as given in Apostolopoulos and Papadakis (2008). The apparent stress is calculated as the quotient of the load capacity, divided by the uncorroded cross-section of reinforcing bars while the effective stress is calculated as the quotient of the load capacity divided by the corroded cross-sections (considering both maximum local loss and average losses of cross-sections).

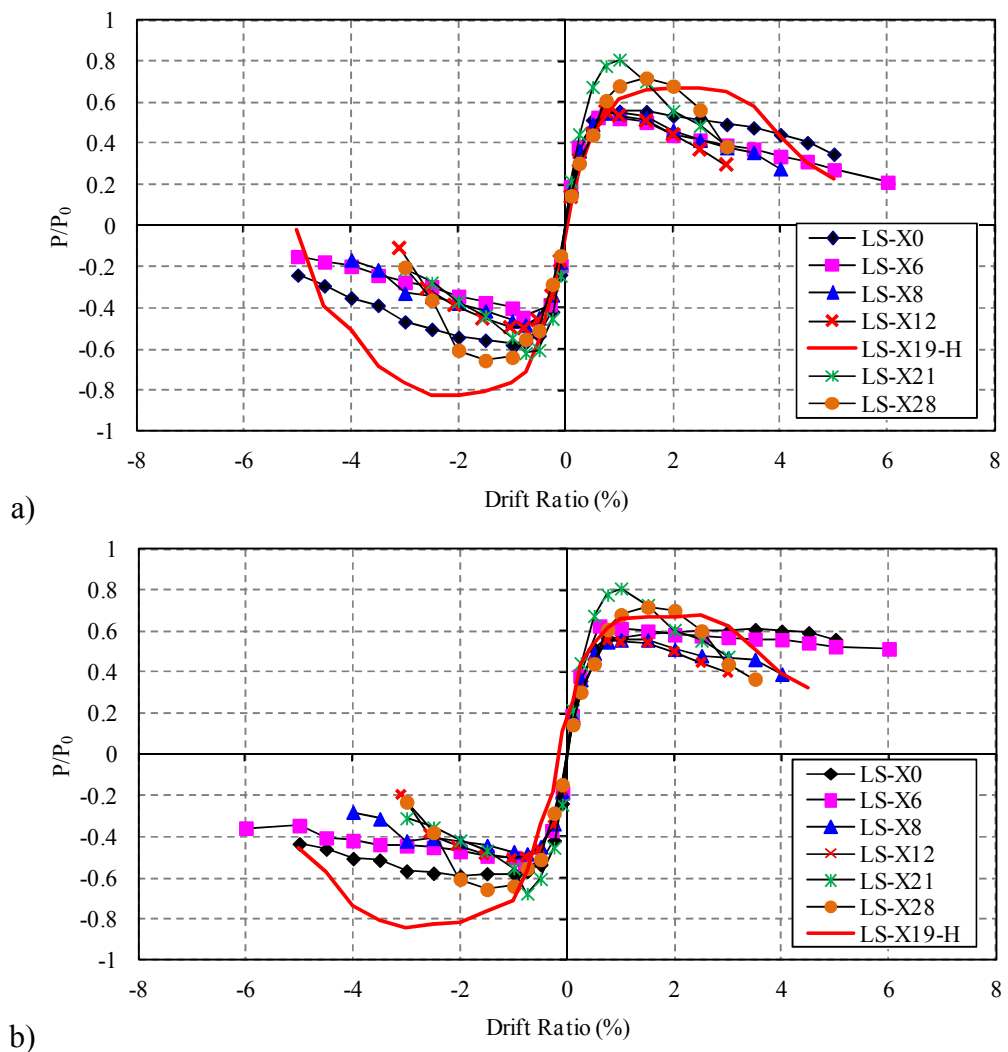
Figure 7.1 : Envelopes of the load-displacement curves for the first and the third type specimens a) without considering $P-\Delta$ effects, b) considering $P-\Delta$ effects.

The envelopes of load-displacement curves for the first and the third type specimens are shown in Figure 7.1.

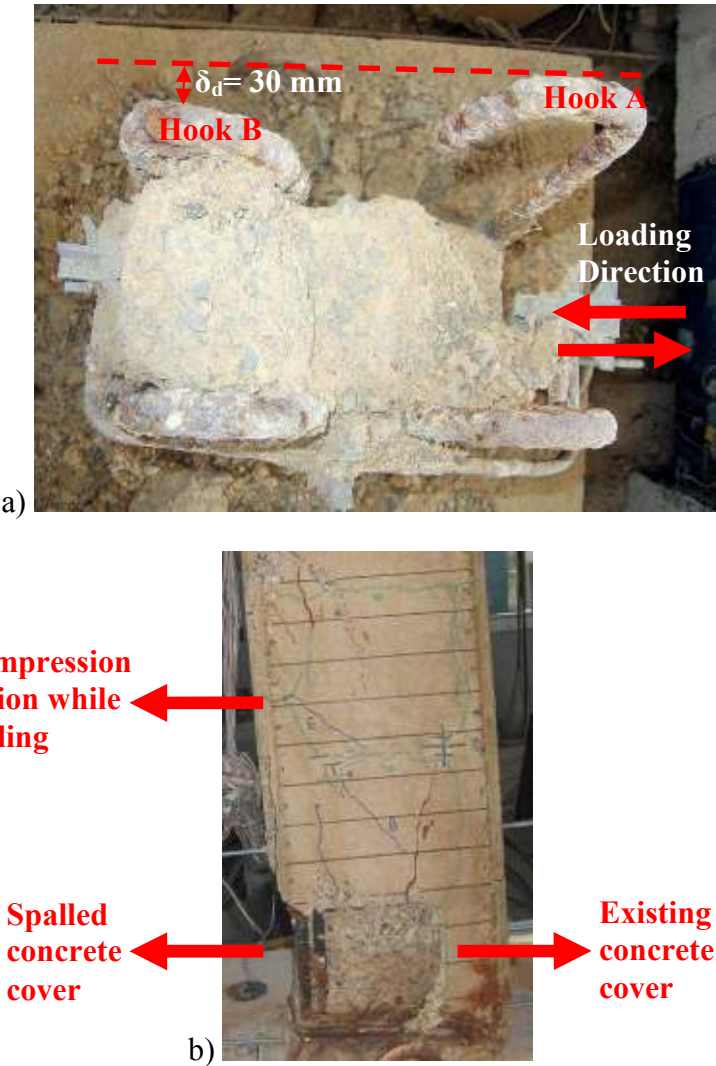
Figure 7.2 : Views from a) Reinforcing cage of LS-X19-H, b) Damages of concrete of LS-X21 (after the test).

The behavior of LS-X21 in the pushing direction and the behavior of LS-X19-H in the pulling direction is selected in evaluating these specimens.

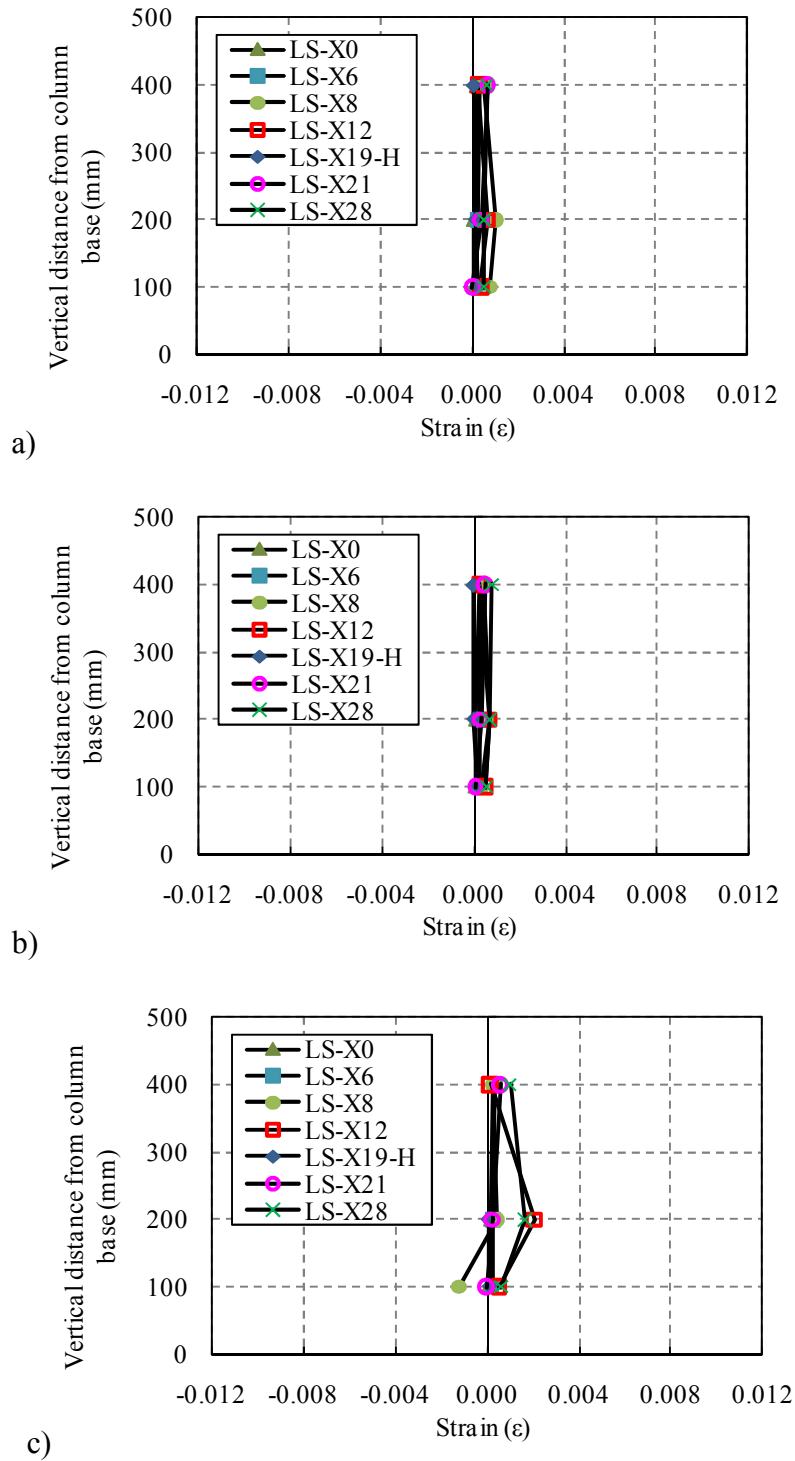
Figure 7.4 : Strain distribution of longitudinal reinforcement at a) 1%, b) 2%, c) 3% drift ratios.

The variation of axial strains of longitudinal bars and starter bars at different locations are presented in Figure 7.4 and Figure 7.5.

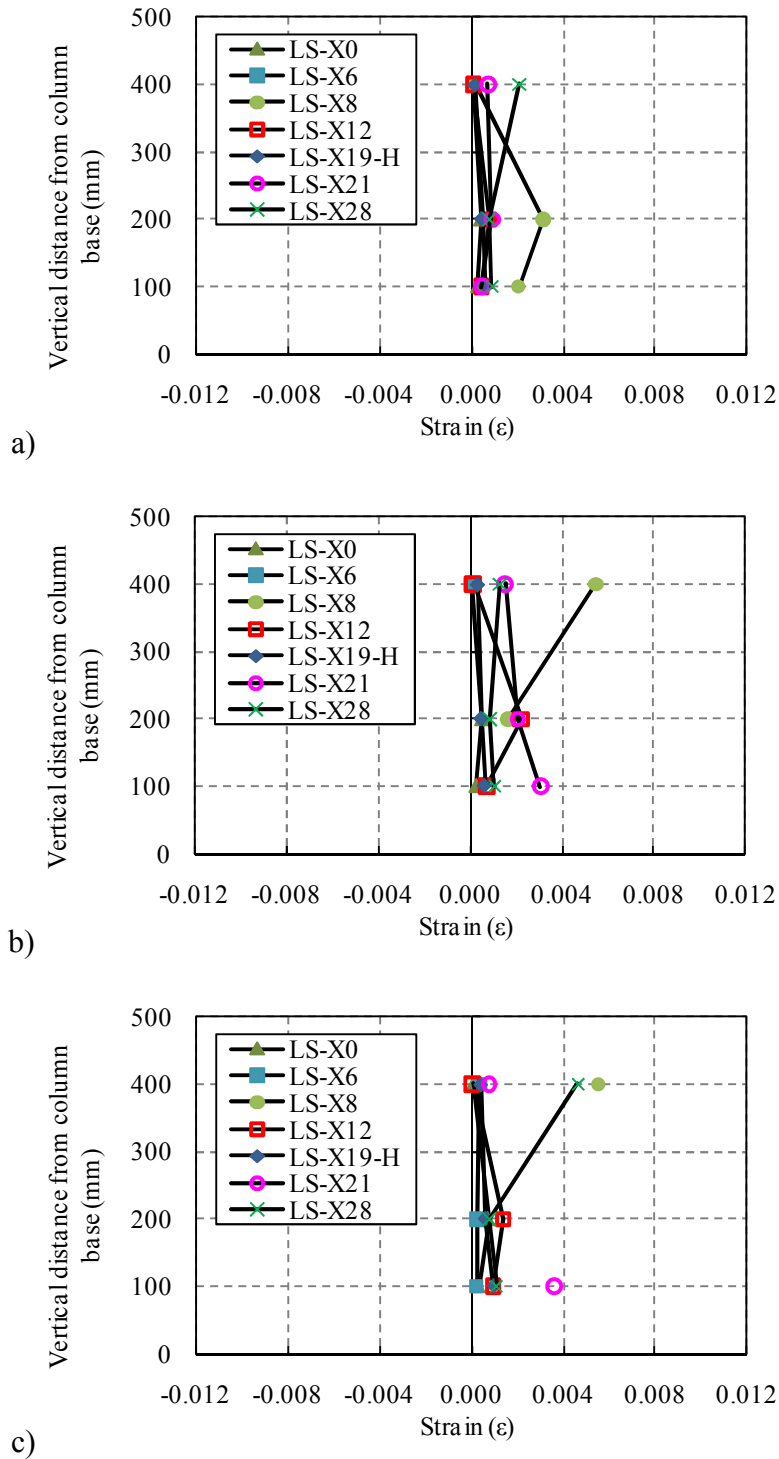
Figure 7.5 : Strain distribution of the starter bars at a) 1%, b) 2%, c) 3% drift ratios.

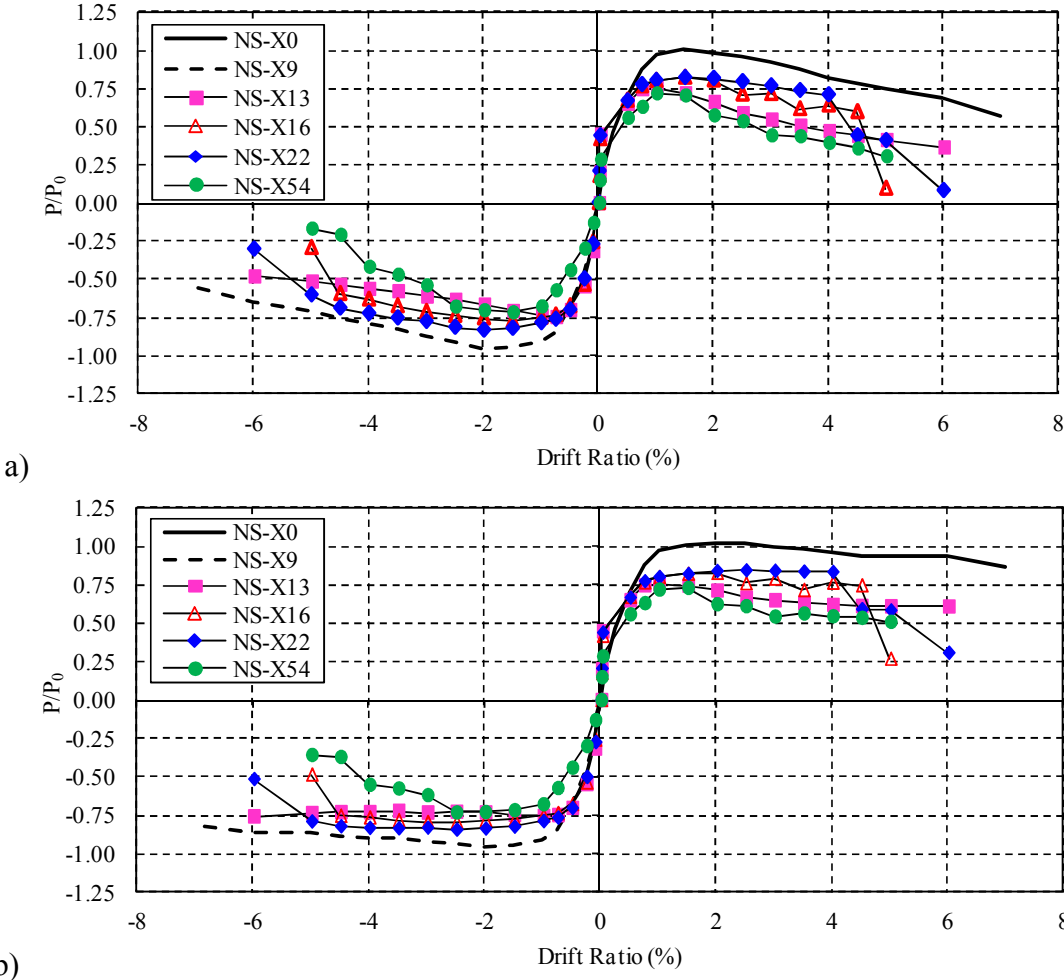
Figure 7.9 : Envelopes of the load-displacement curves for the second type specimens a) without considering $P-\Delta$ effects, b) considering $P-\Delta$ effects.

The envelopes of load-displacement curves for the second type specimens are shown in Figure 7.9.

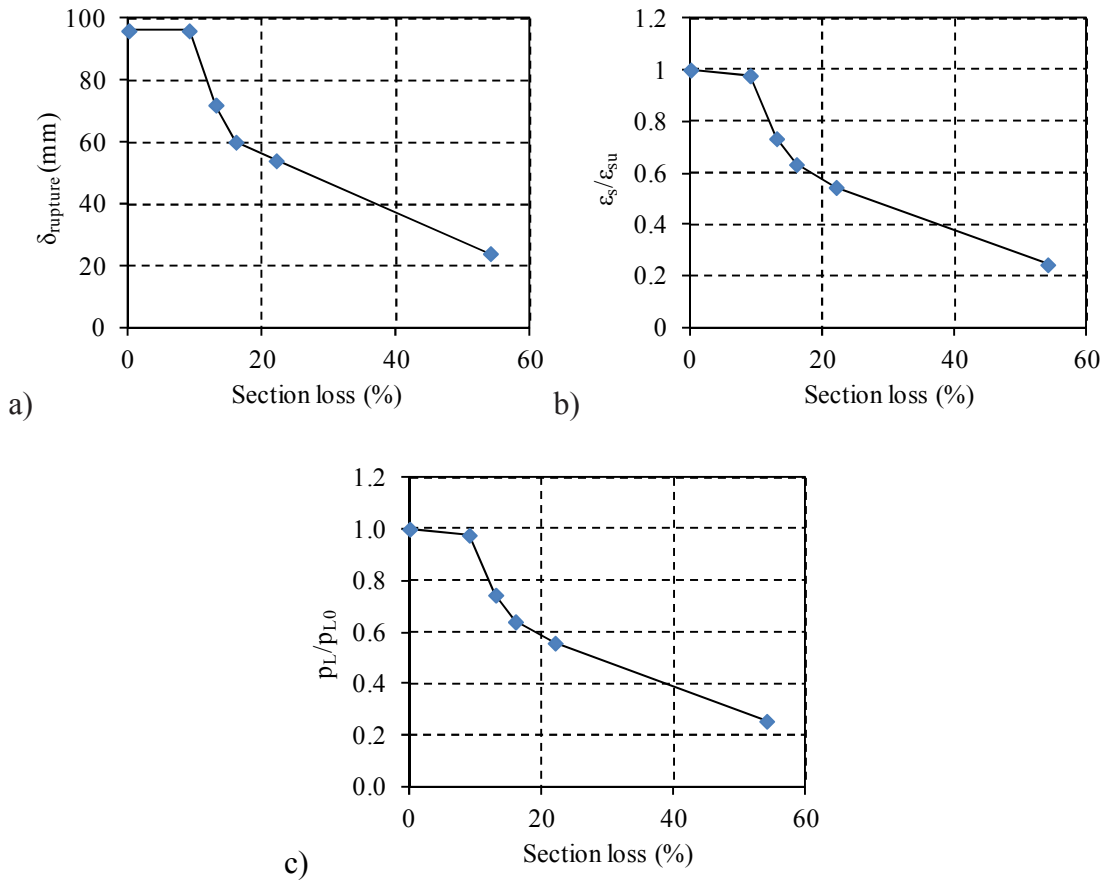
Figure 7.10 : Relationship of a) $\delta_{rupture}$, b) $\varepsilon_s/\varepsilon_{su}$, and c) p_L/p_{L0} with section loss.

The relationship of $\delta_{rupture}$, $\varepsilon_s/\varepsilon_{su}$, and p_L/p_{L0} with section loss is presented in Figure 7.10. In this figure $\delta_{rupture}$ is the displacement where the bar ruptures, ε_s is the strain of the reinforcing bar, ε_{su} is the ultimate strain of the reinforcing bar without corrosion, and p_L is the plastic hinge length, p_{L0} is the plastic hinge length of the column without corroded reinforcing bars.
