**SEISMIC BEHAVIOR OF RC COLUMNS WITH CORRODED
PLAIN AND DEFORMED REINFORCING BARS**

Ph.D. THESIS
Çağlar GÖKSU

Department of Civil Engineering
Structure Engineering Programme

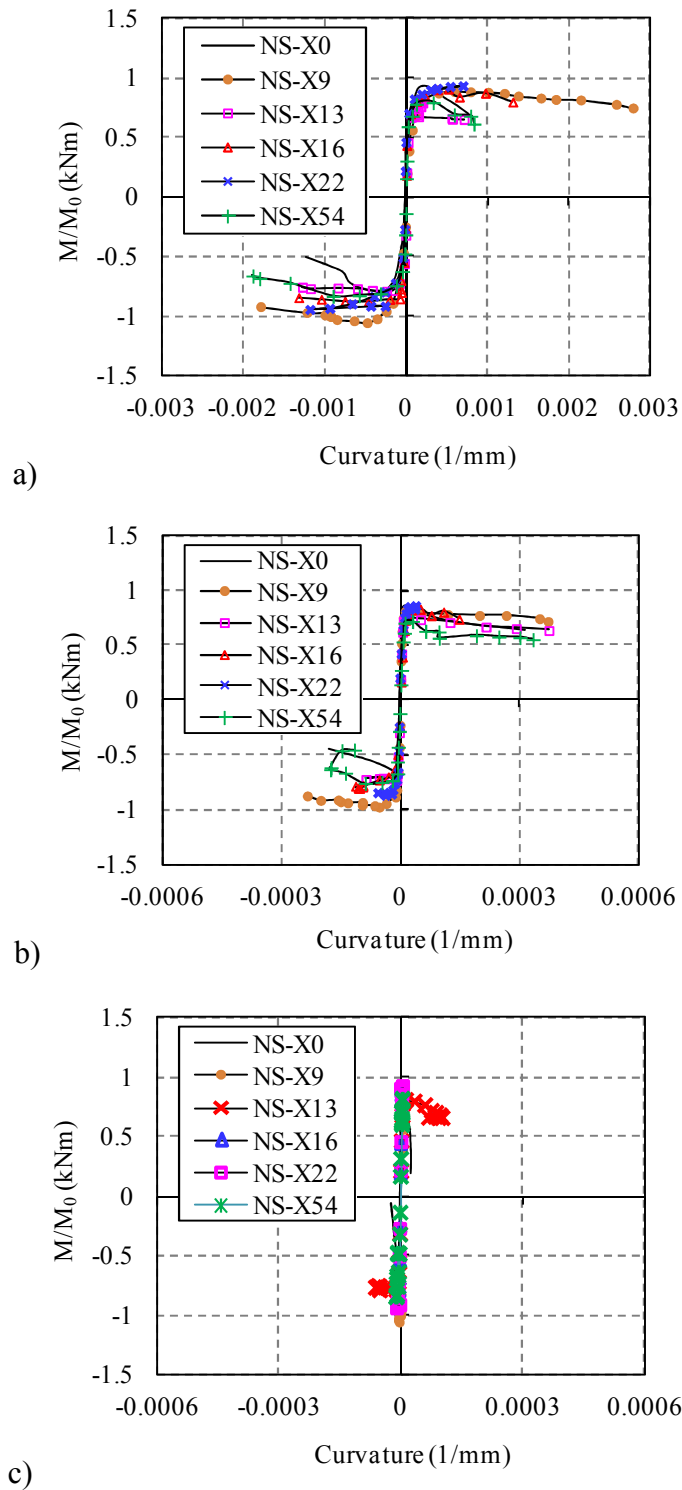
Figure 7.15 : Moment-curvature relationships obtained for different gauge lengths
 (a) Gauge length between 0-20 mm, (b) Gauge length between 20-150 mm, (c) Gauge length between 150-300 mm.

While the damage was distributed in reference specimen NS-X0 and specimen with minimal corrosion (NS-X9), the damage was localized to the interface of column and footing in the case of other highly corroded specimens. No shear crack and vertical cracks initiated at the tips of the lap spliced bars were observed.

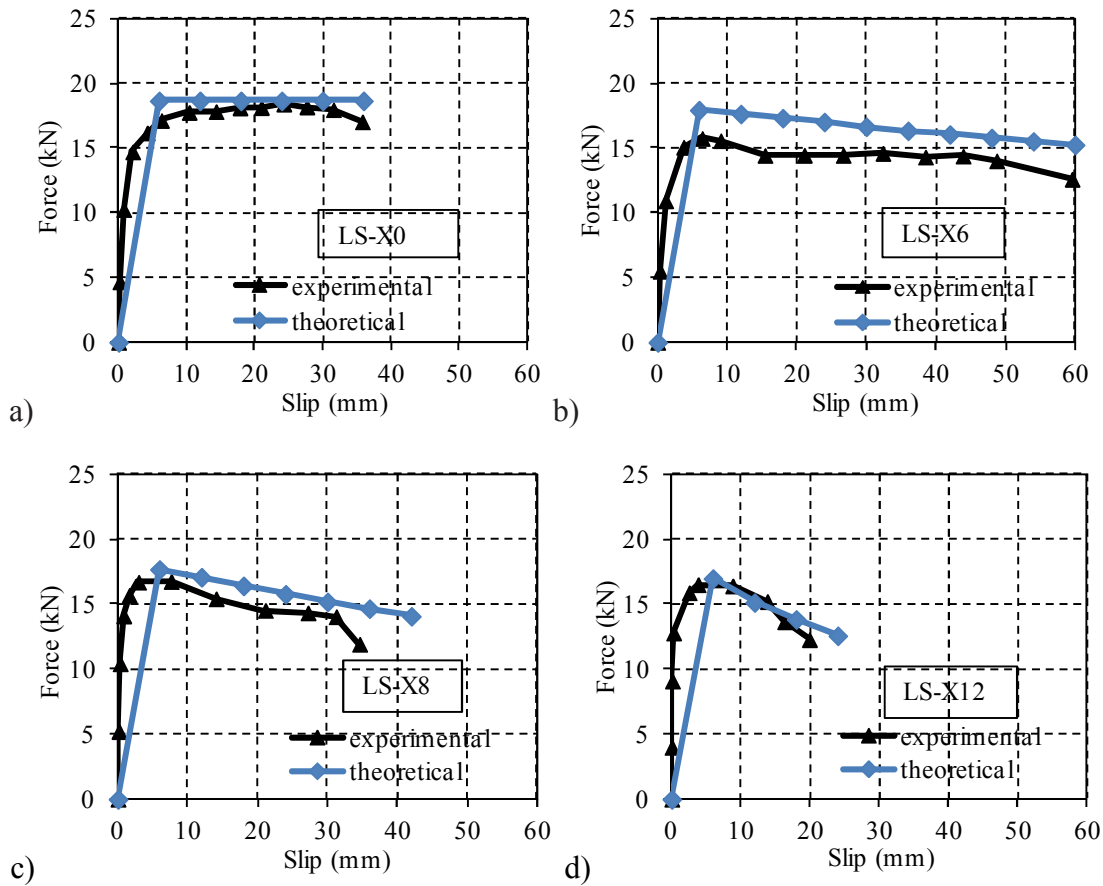
Figure 8.4 : Experimental and analytical considerations of slip dominated specimens.

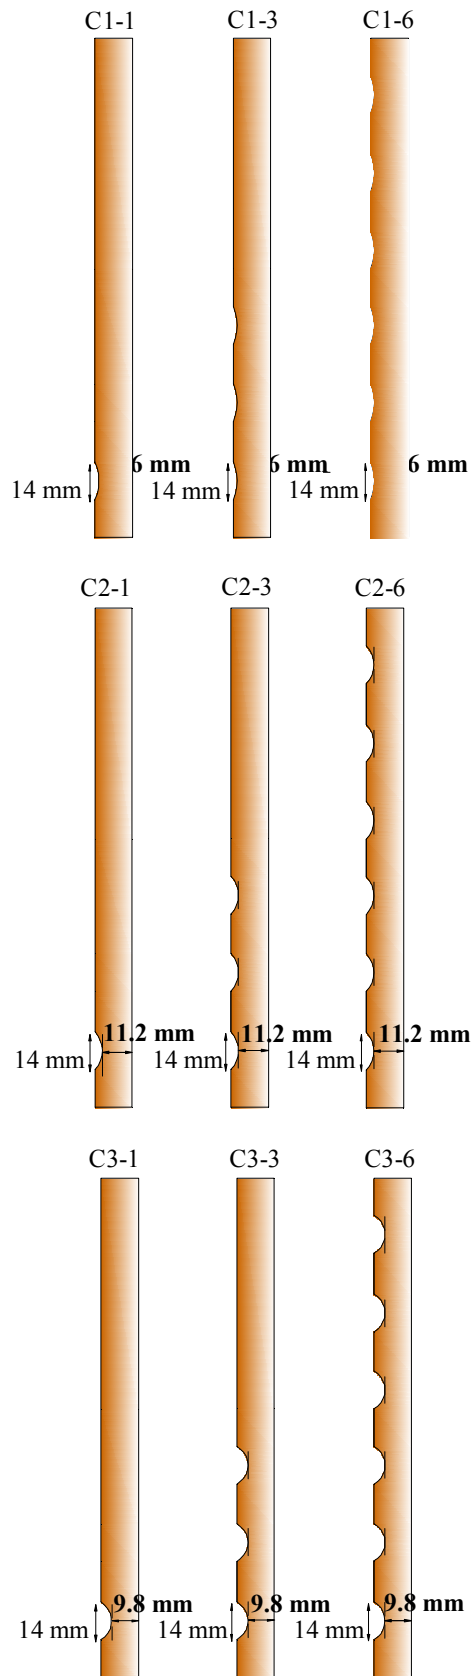
Figure 8.8 : Idealized corrosion patterns of the columns.

The concrete strength is assumed to be 25.5 MPa, while the yield strengths of longitudinal and transverse bars are assumed to be 460 and 420 MPa, respectively. The diameters of longitudinal and transverse deformed bars are 14 and 8 mm, respectively. Clear cover is 20 mm from transverse bar. The transverse load is assumed to be acting at the free end of cantilever column at the height of 1200 mm from the column base. Axial load on the columns is 282 kN, which corresponds to 20% of the gross axial capacity of the column. C0 is the reference column, while the C1, C2 and C3 columns have maximum loss of cross-section of 10%, 20% and 30%, respectively. Columns are named with the first and second letters symbolizing the level of corrosion (C0, C1, C2, C3) and the third character symbolizing the number of the pits: such as 1, 3 and 6. The length of each corrosion pit is assumed to be 14 mm, which is equal to the diameter of deformed bars. The assumed corrosion patterns of the reinforcing bars are presented in Figure 8.8. It should be noted that all the pits are assumed to occur within the plastic hinge length of columns.

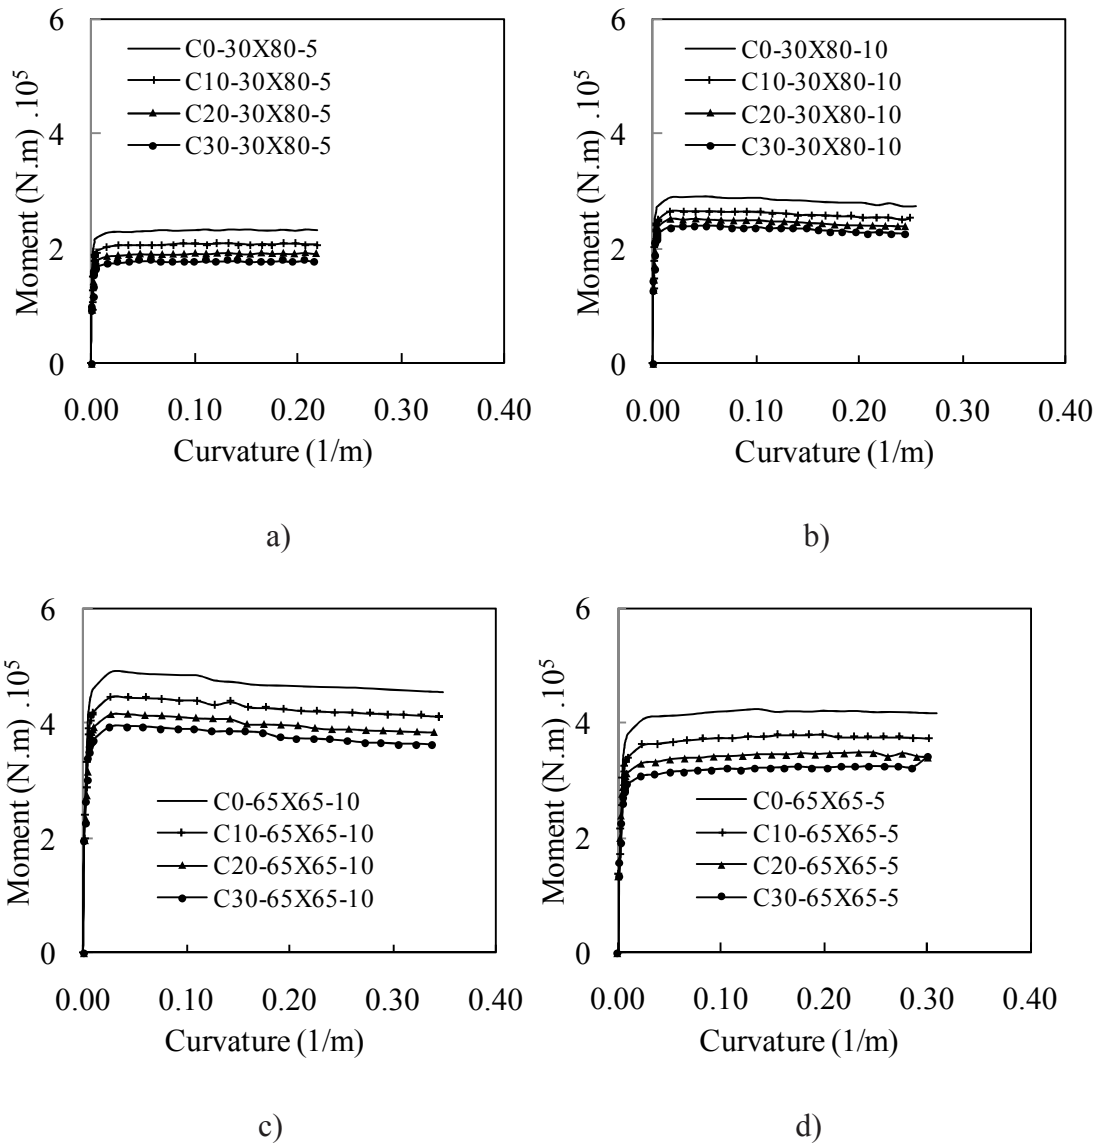
Figure 8.15 : Moment-curvature relationships of cross sections of (a) 30x80 cm for 10% axial load level, (b) 30x80 cm for 5% axial load level, (c) 65x65 cm for 10% axial load level, (d) 65x65 cm for 5% axial load level with different cross-section losses.

According to the results of the program, the failure of the columns is dominated by tensile fracture. Moment at first yield and ultimate moment significantly decreased due to the cross-sectional loss (Figure 8.15).

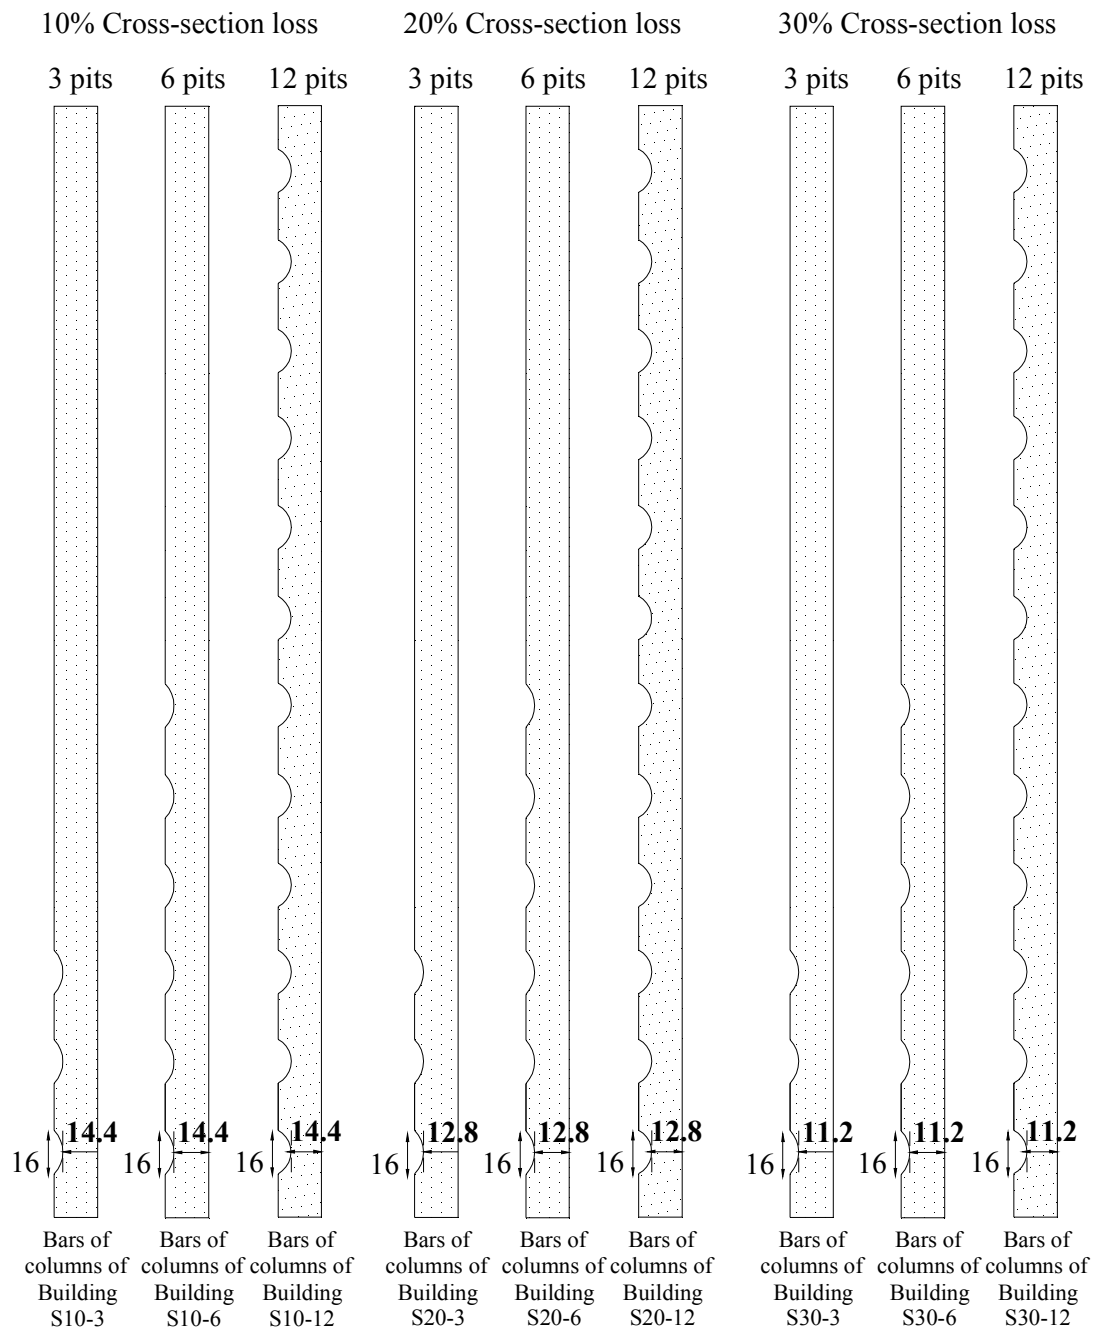
Figure 8.16 : The assumed dimensions of the pits on a typical reinforcing bar of column (Dimension units in mm).

Rotations were obtained by multiplying curvatures with plastic hinge length of the columns to carry out an incremental analysis approach for nonlinear load-displacement relationship of the column. For uncorroded columns, plastic hinge length is assumed to be $h/2$ as proposed by TSDC (2007), where h represents effective depth of cross-section of column in bending. For corroded columns, as all plastic deformations are concentrated at the pits, the plastic hinge length is taken as the total of the lengths of the pits. The assumed dimensions of the pits are shown in Figure 8.16.

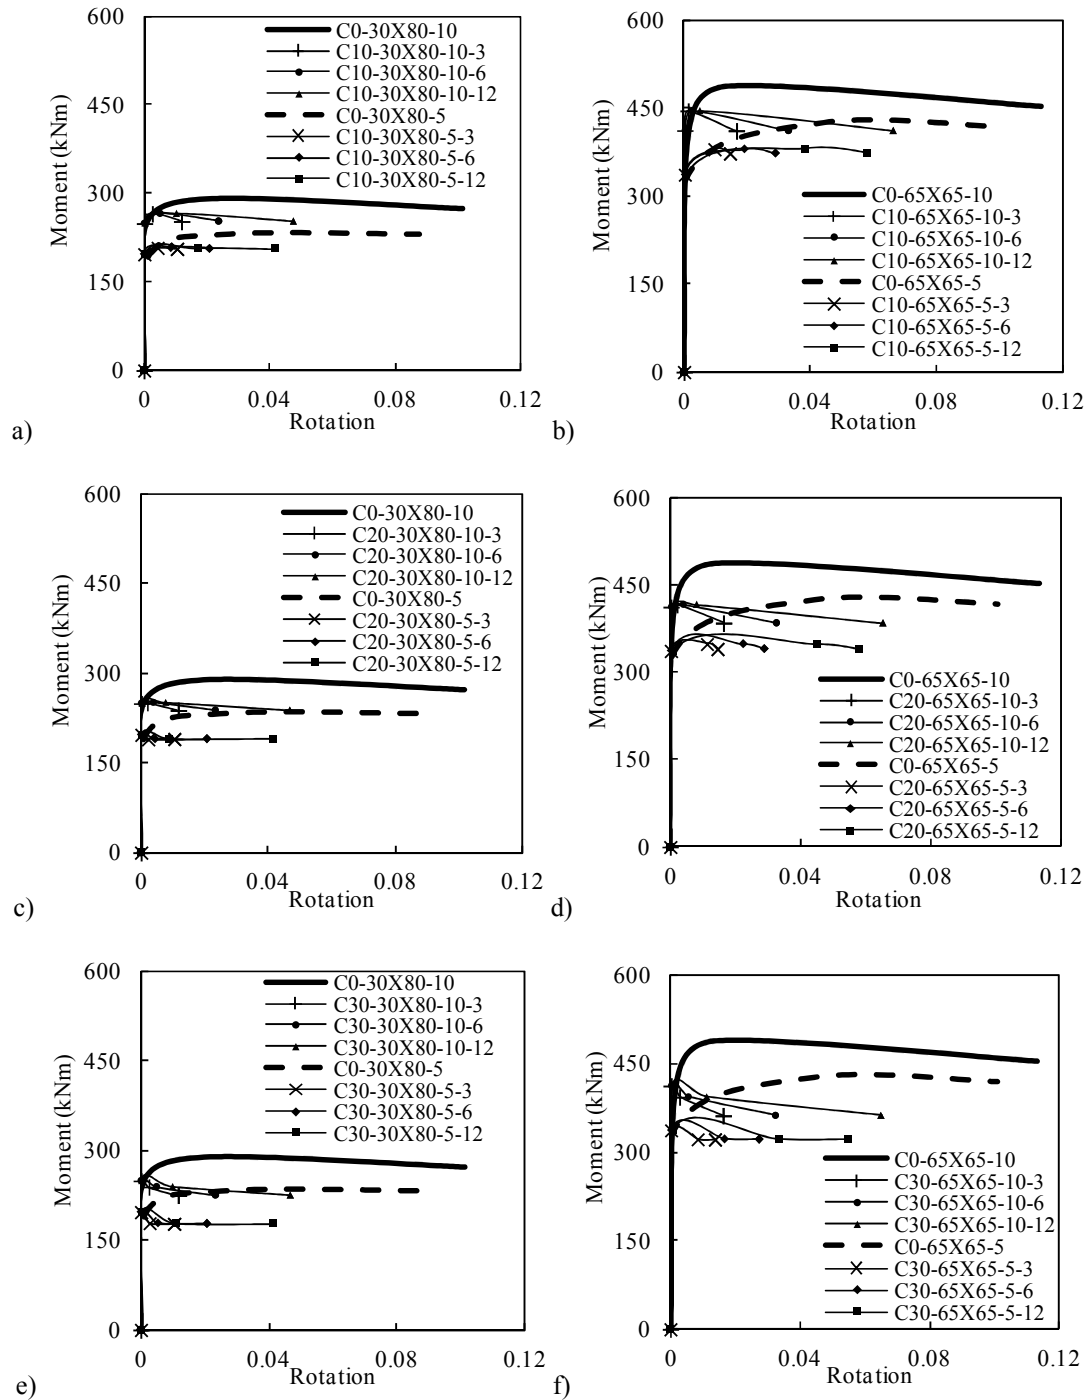
Figure 8.17 : Moment-rotation relationships for the plastic hinges of the columns.

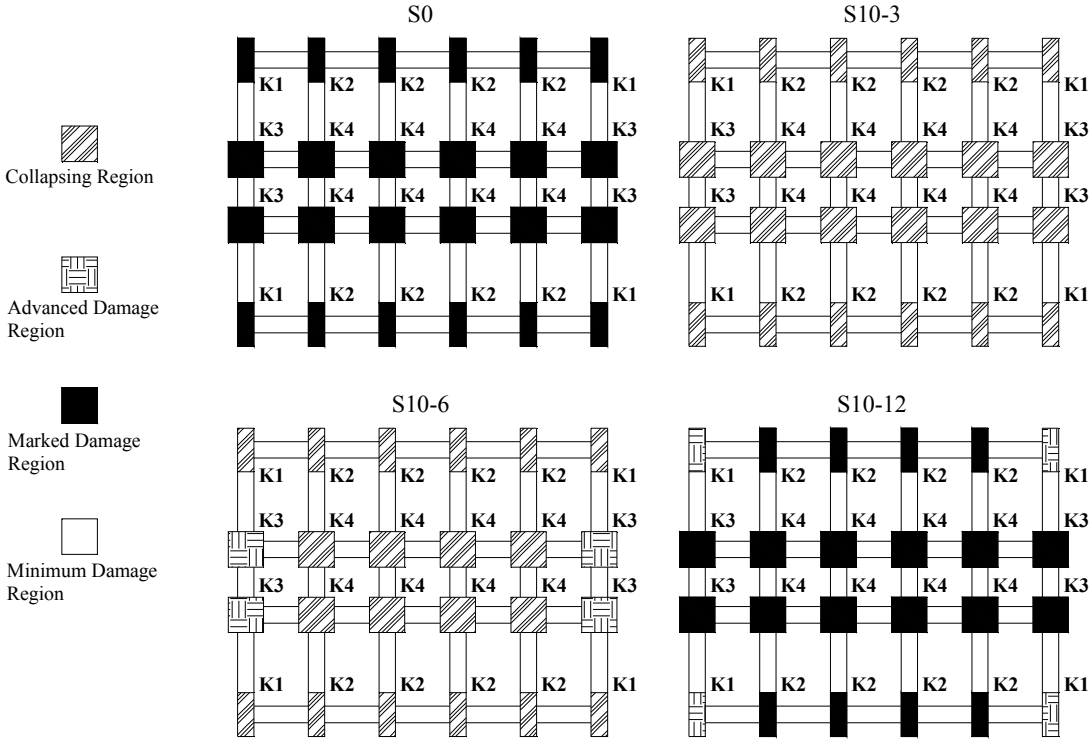
Figure 8.32 : Damage levels of base columns of S0, S10-3, S10-6 and S10-12 buildings.

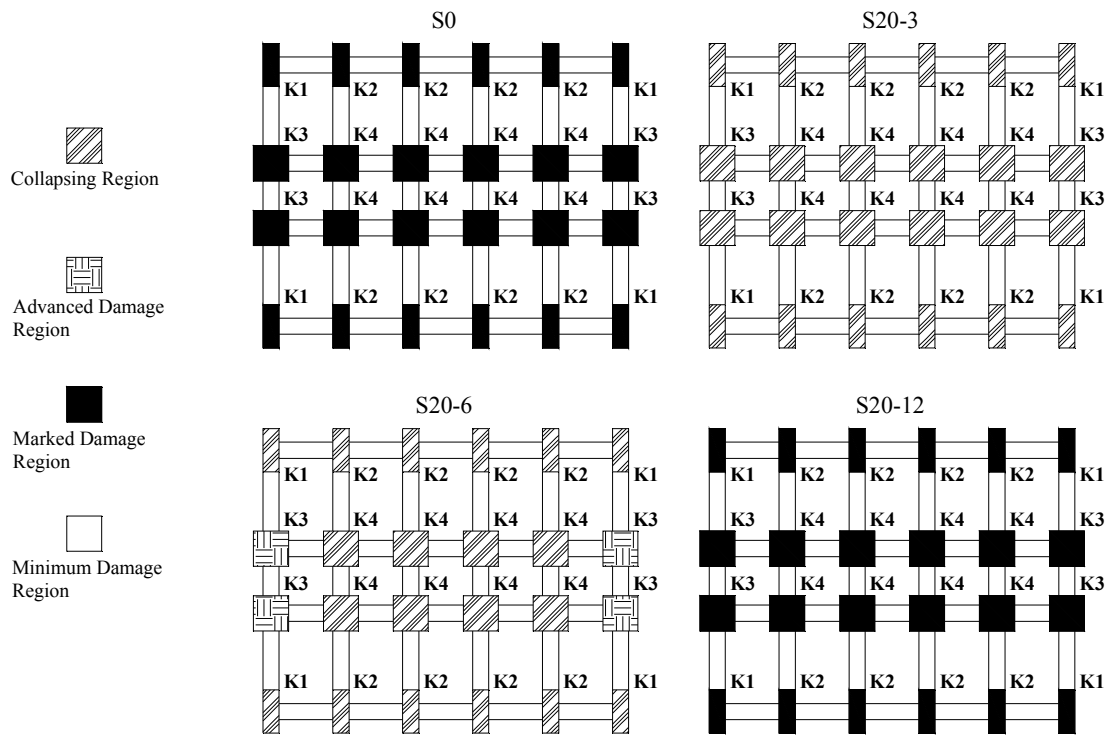
Figure 8.33 : Damage levels of base columns of S0, S20-3, S20-6 and S20-12 buildings.

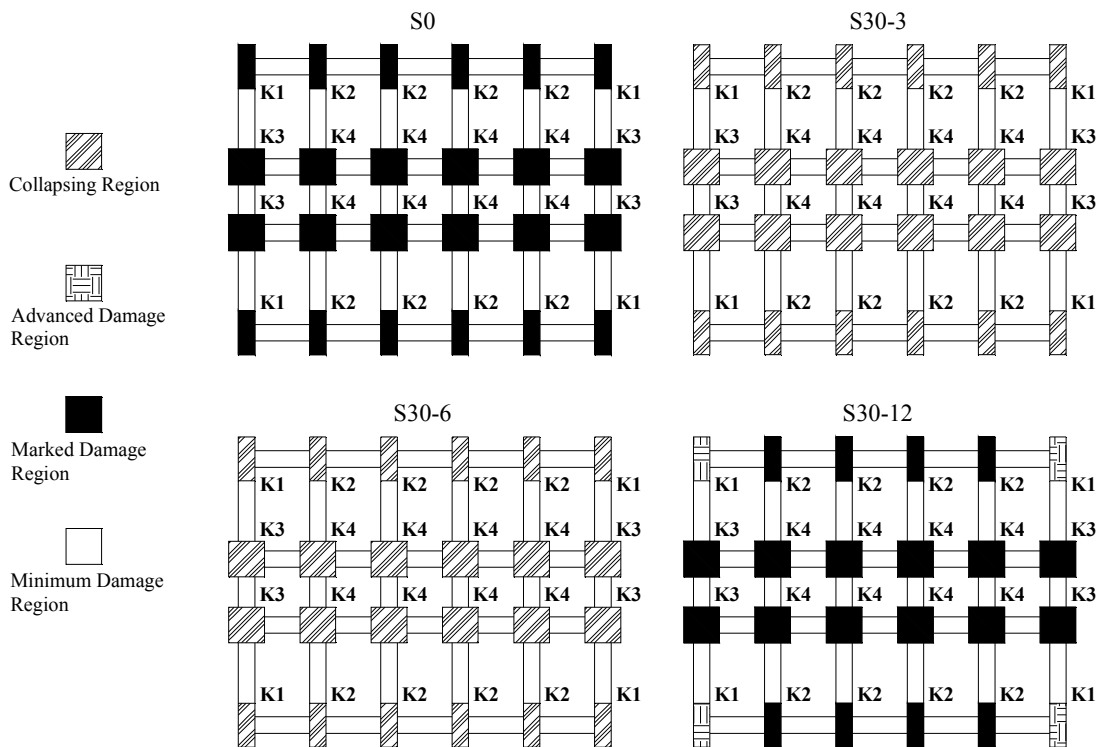
Figure 8.34 : Damage levels of base columns of S0, S30-3, S30-6 and S30-12 buildings.

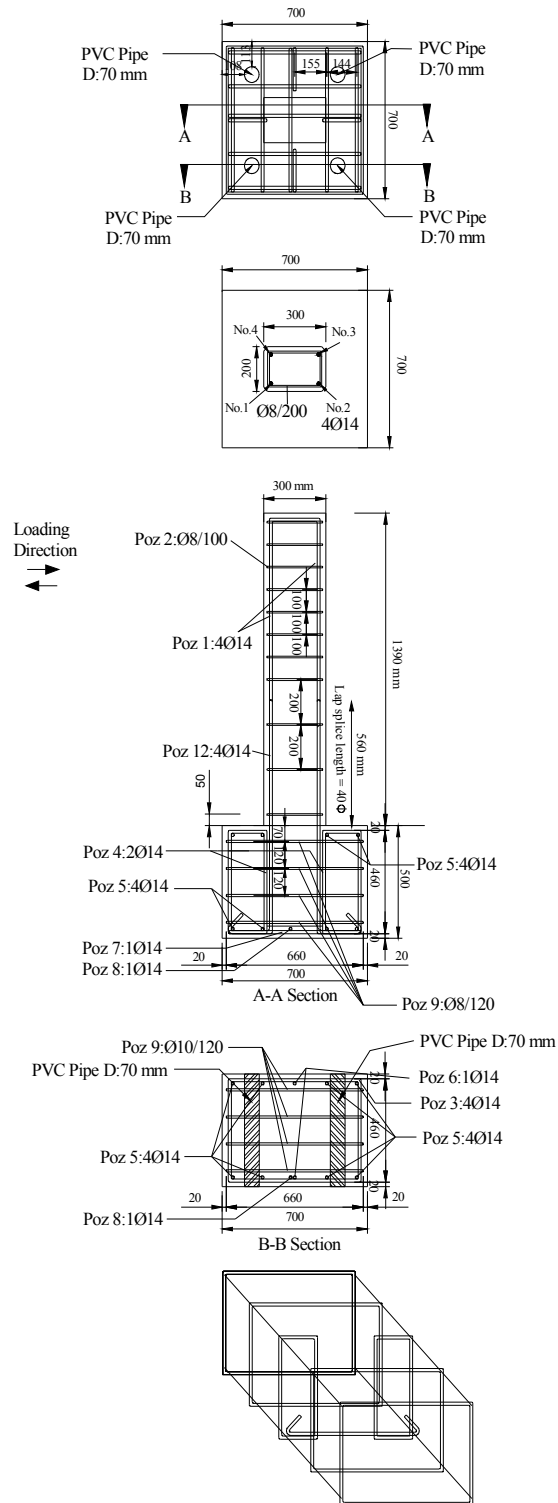
Figure A.1 : Reinforcing cage of the first type specimens (south side).

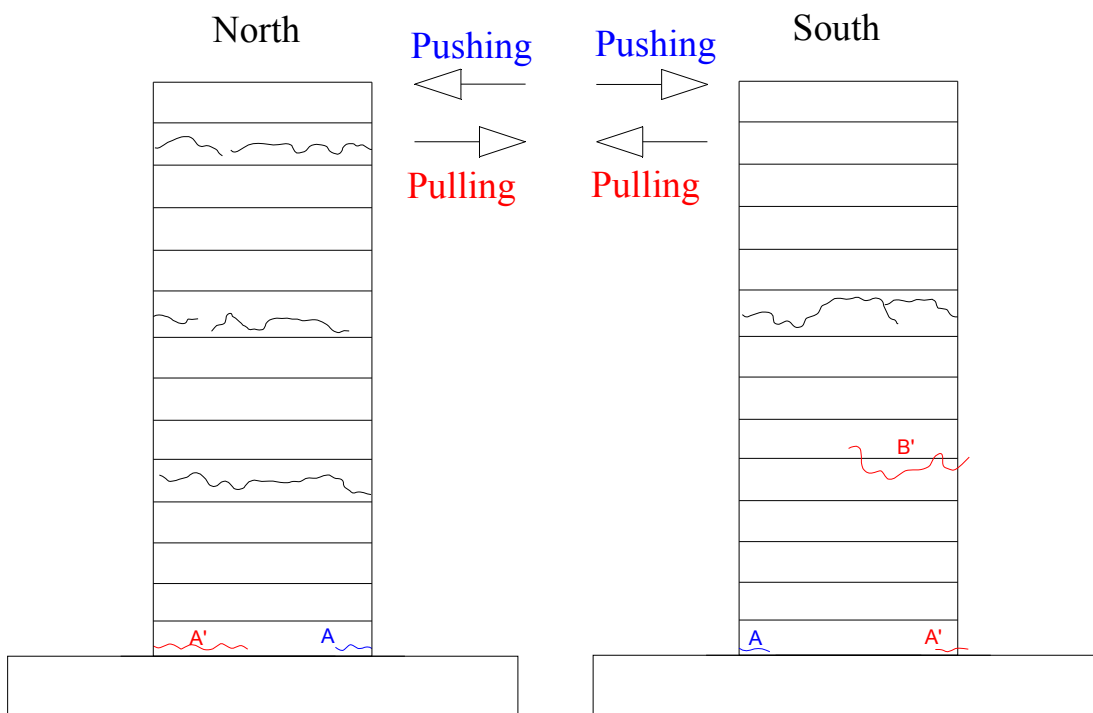
Figure E.2: Crack pattern of LS-X0 after -0.5% drift ratio.

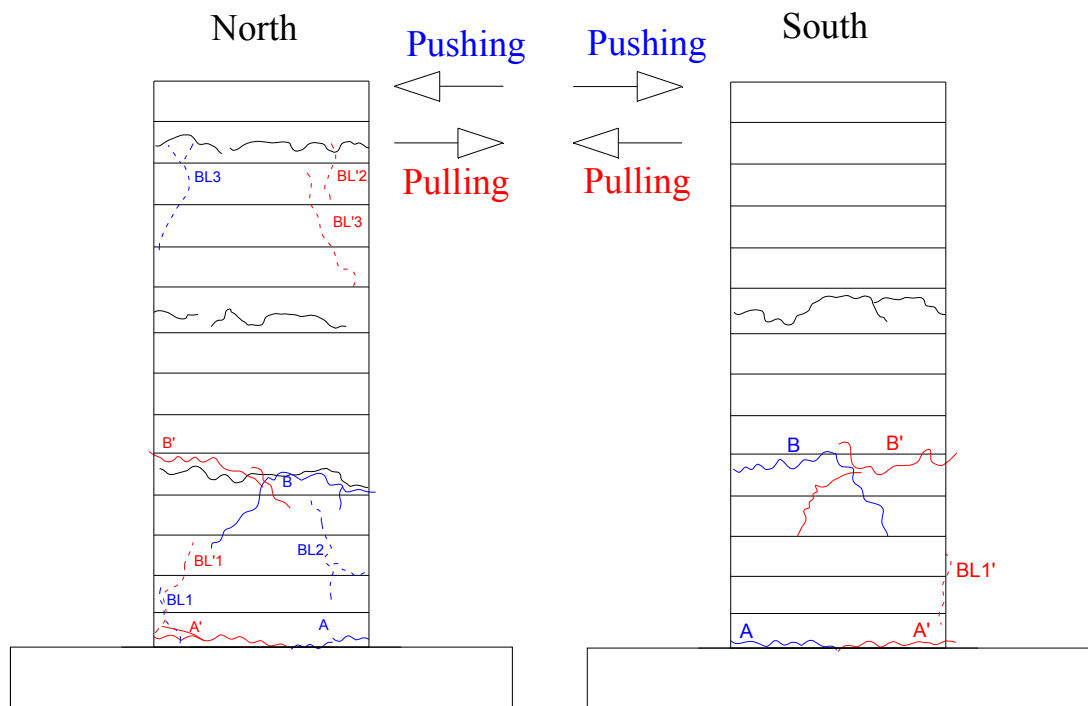
Figure E.12: Crack pattern of LS-X0 after -2.5% drift ratio.

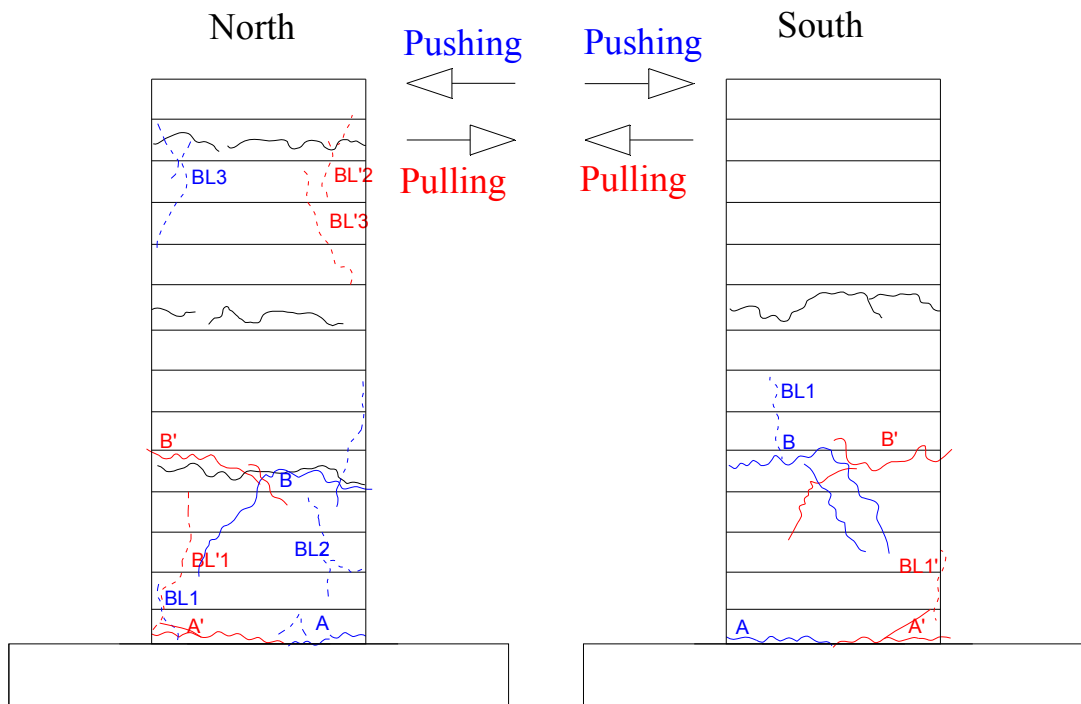
Figure E.16: Crack pattern of LS-X0 after 3.5% drift ratio.

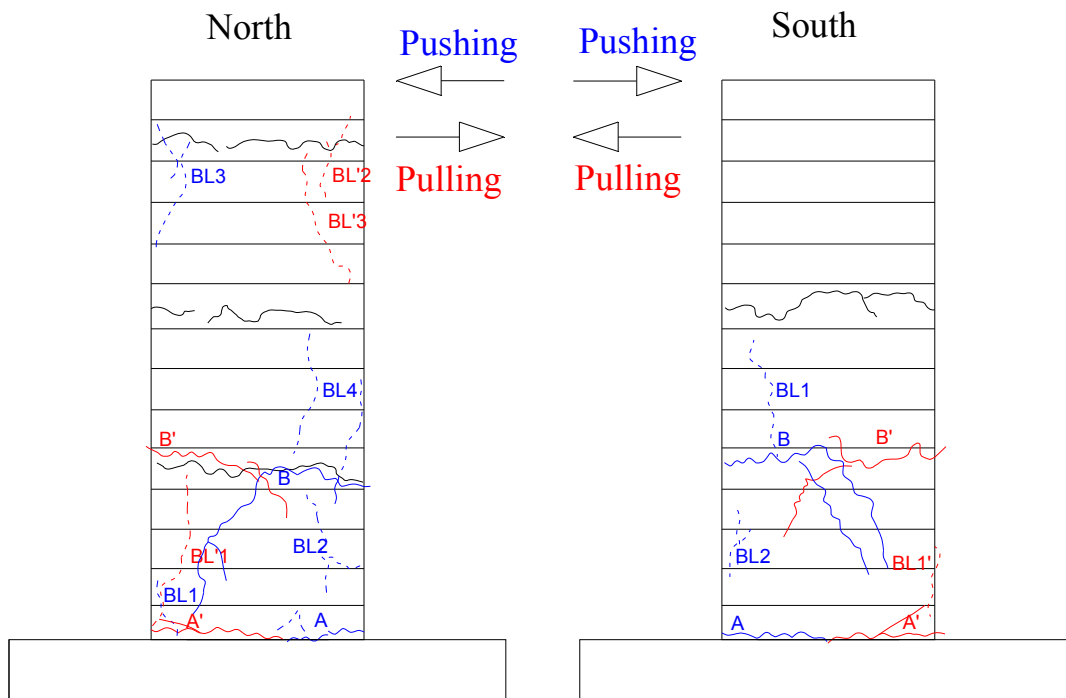
Figure E.18: Crack pattern of LS-X0 after -4% drift ratio.

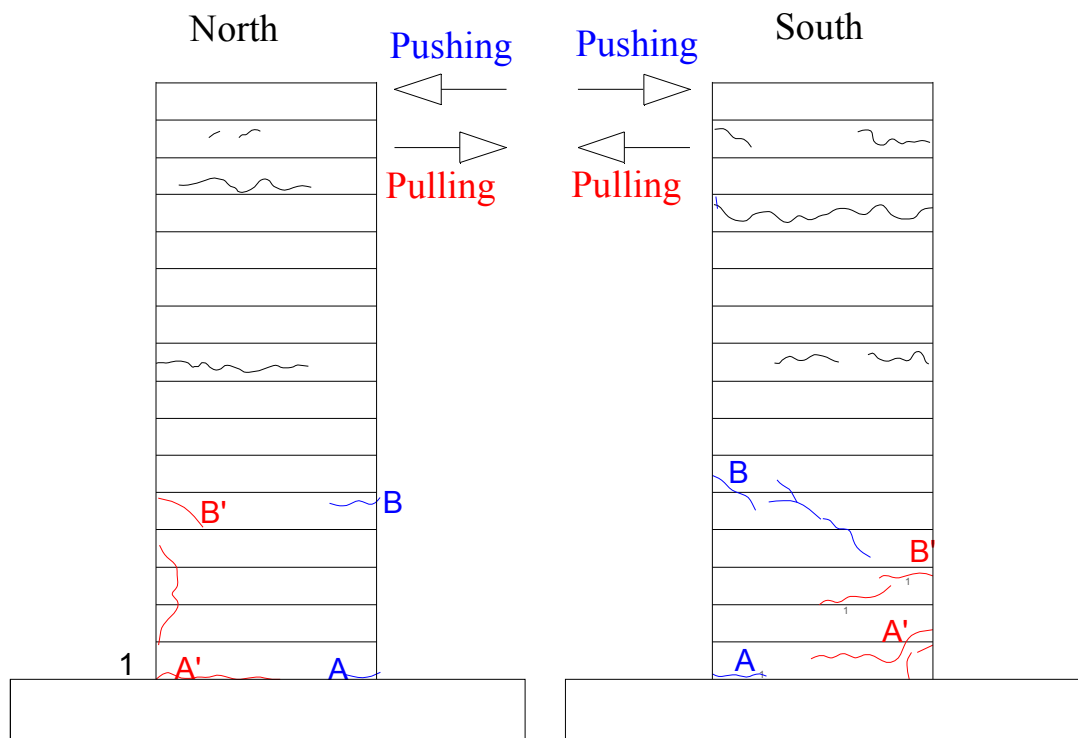
Figure E.24: Crack pattern of LS-X6 after -0.5% drift ratio.

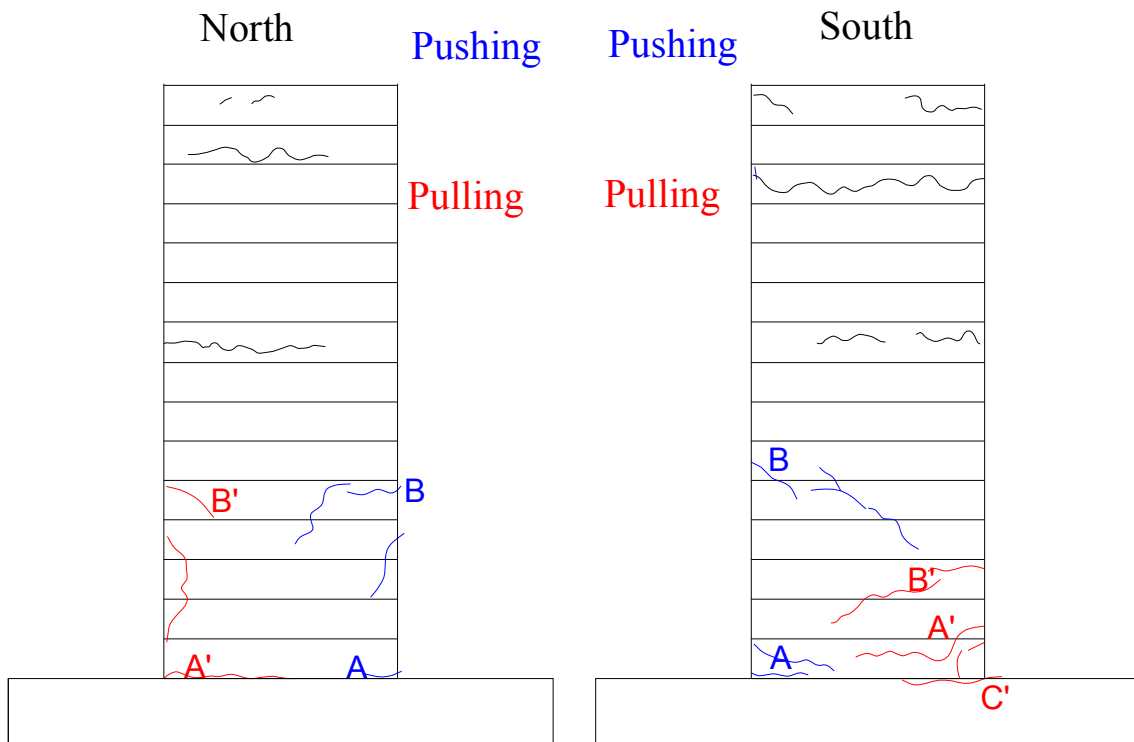
Figure E.26: Crack pattern of LS-X6 after -1% drift ratio.

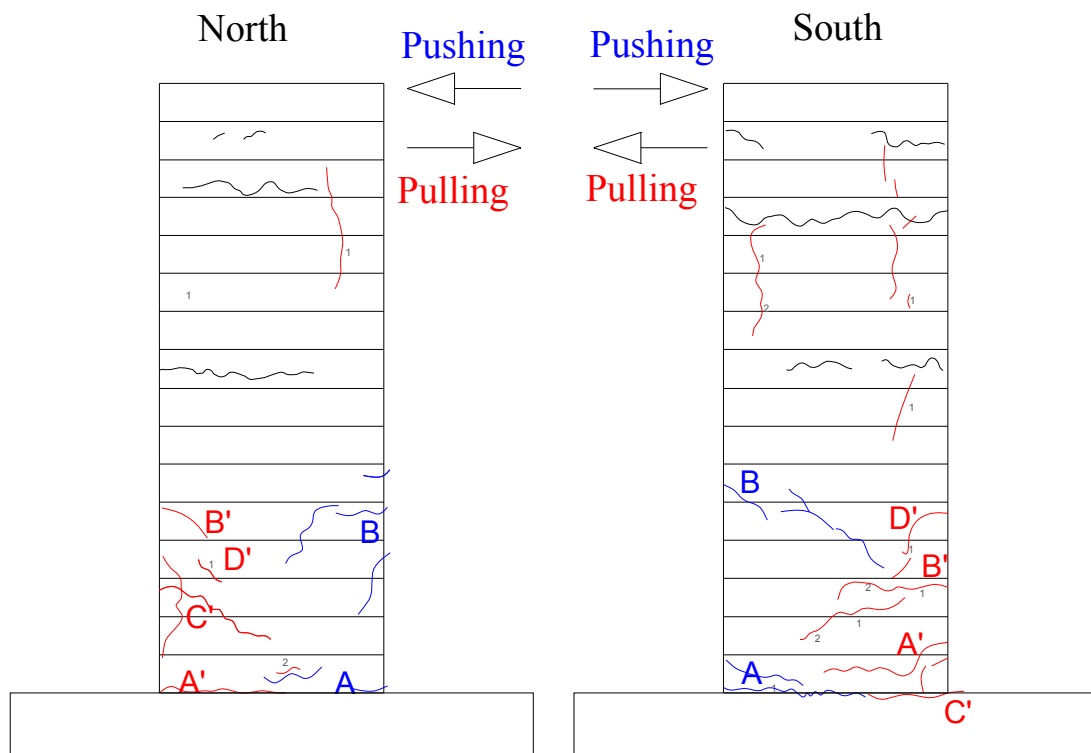
Figure E.28: Crack pattern of LS-X6 after -1.5% drift ratio.

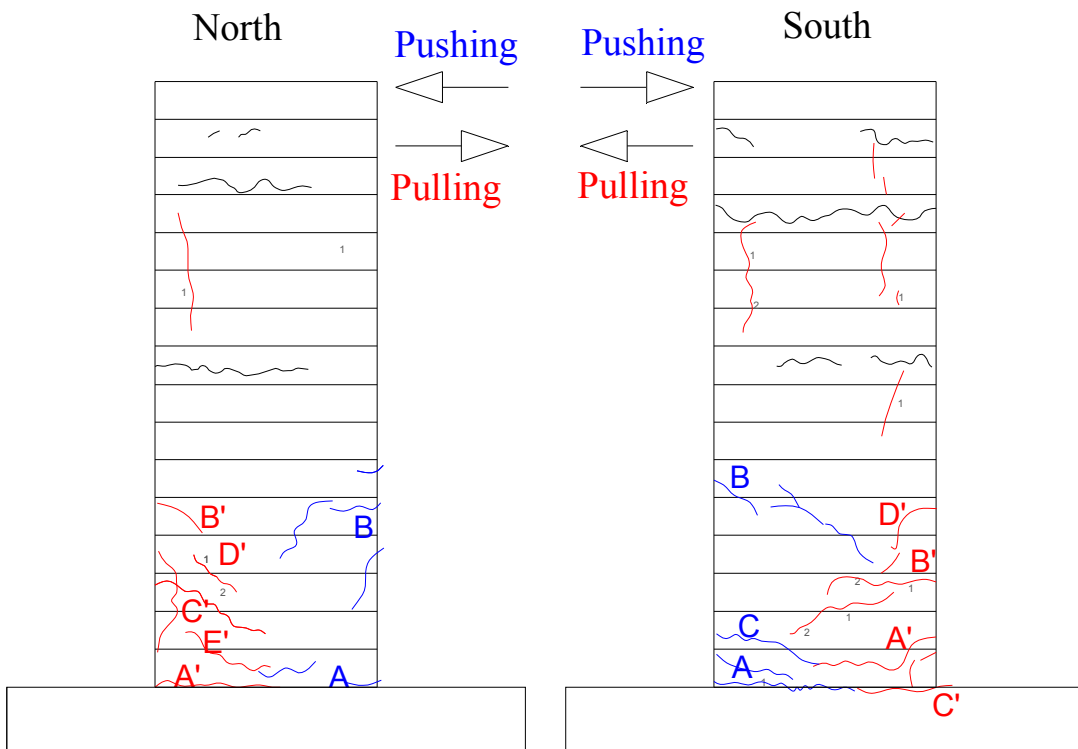
Figure E.30: Crack pattern of LS-X6 after -2% drift ratio.

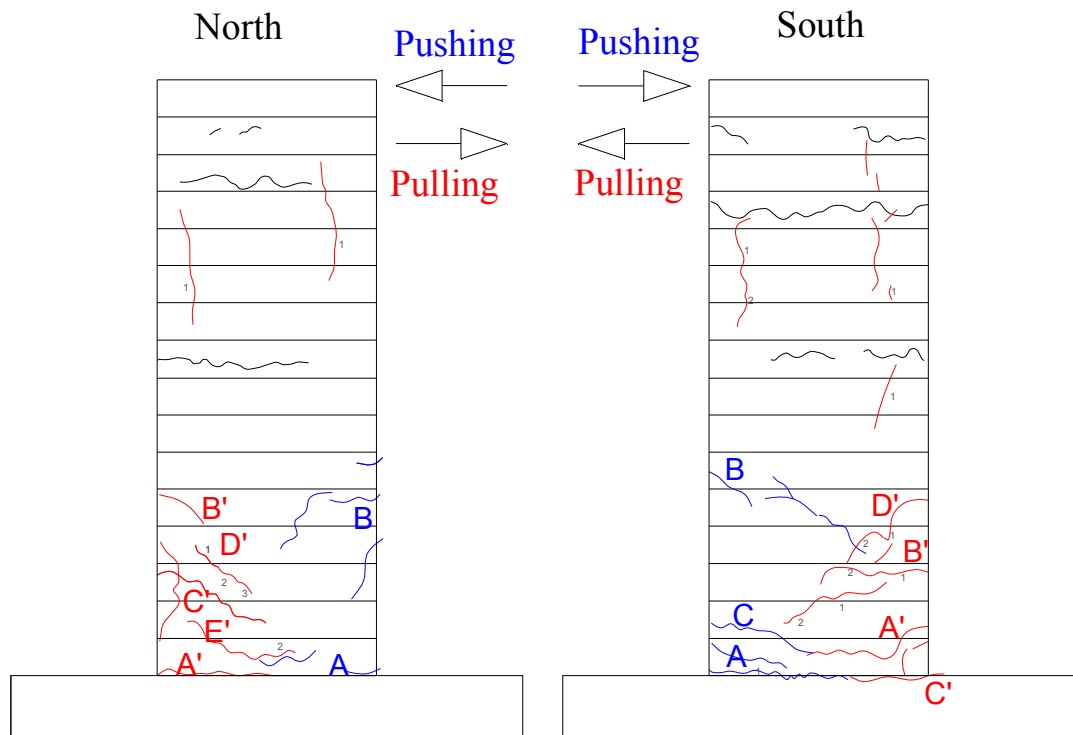
Figure E.32: Crack pattern of LS-X6 after -2.5% drift ratio.

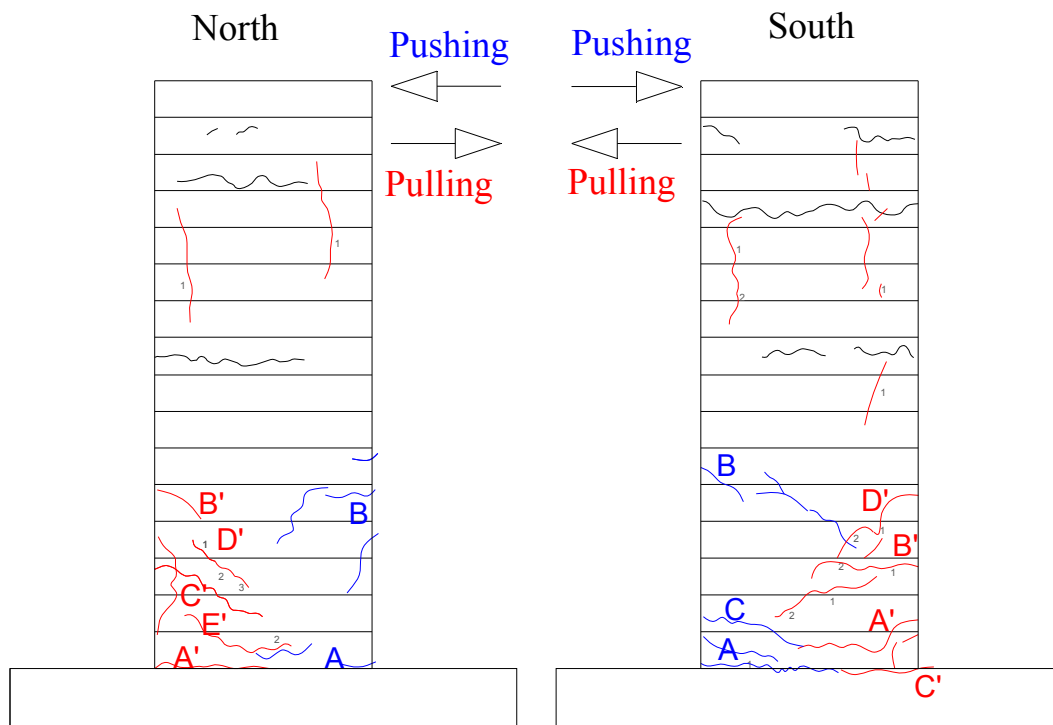
Figure E.34: Crack pattern of LS-X6 after -3% drift ratio.

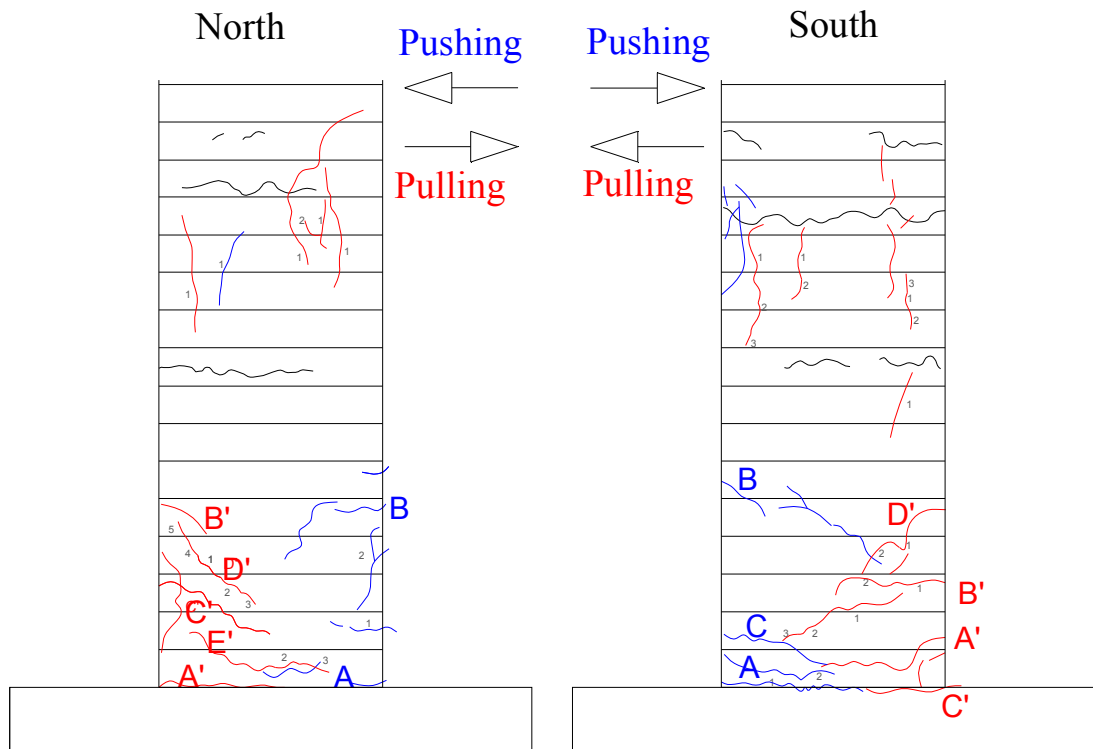
Figure E.36: Crack pattern of LS-X6 after -3.5% drift ratio.

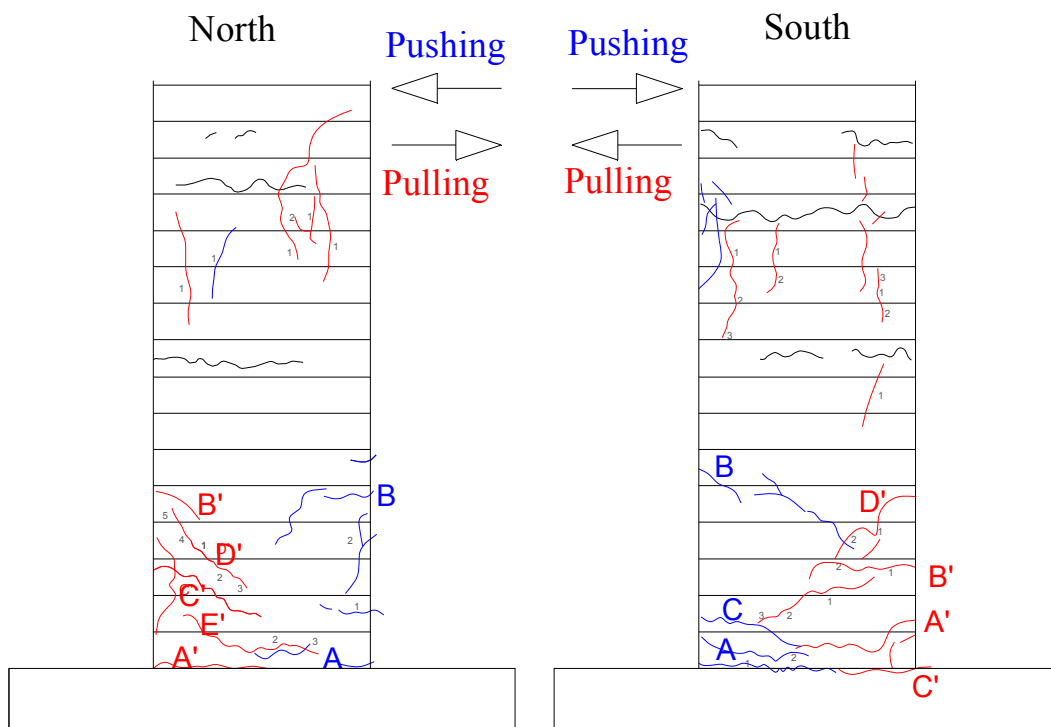
Figure E.38: Crack pattern of LS-X6 after -4% drift ratio.

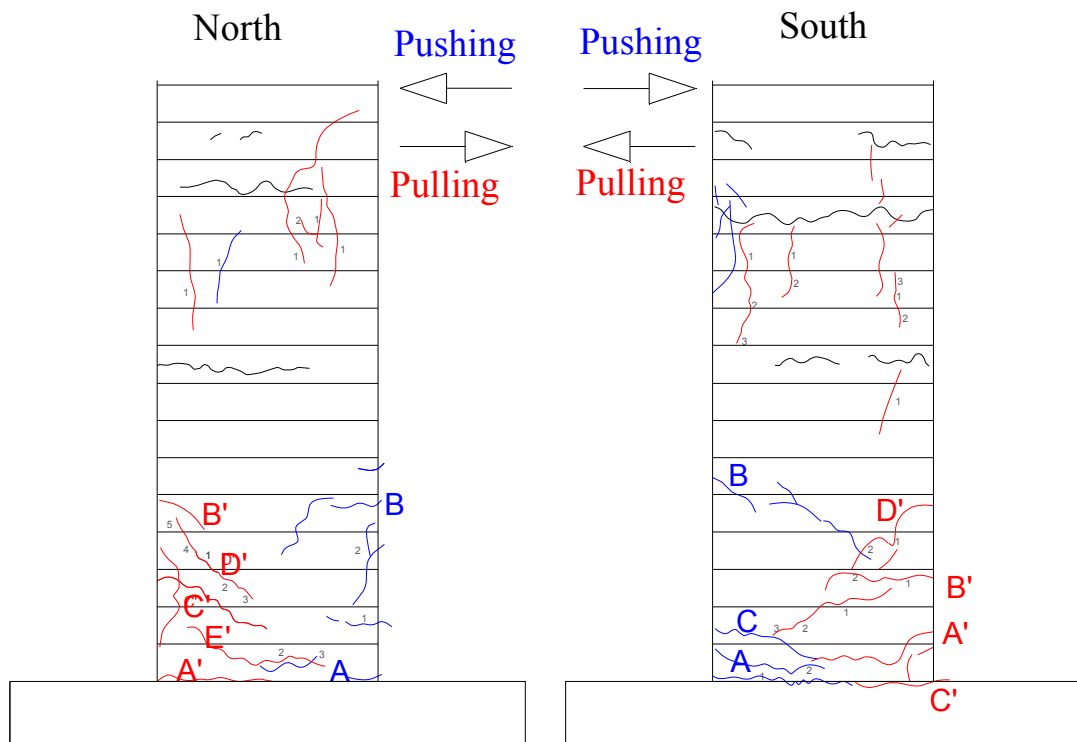
Figure E.40: Crack pattern of LS-X6 after -4.5% drift ratio.

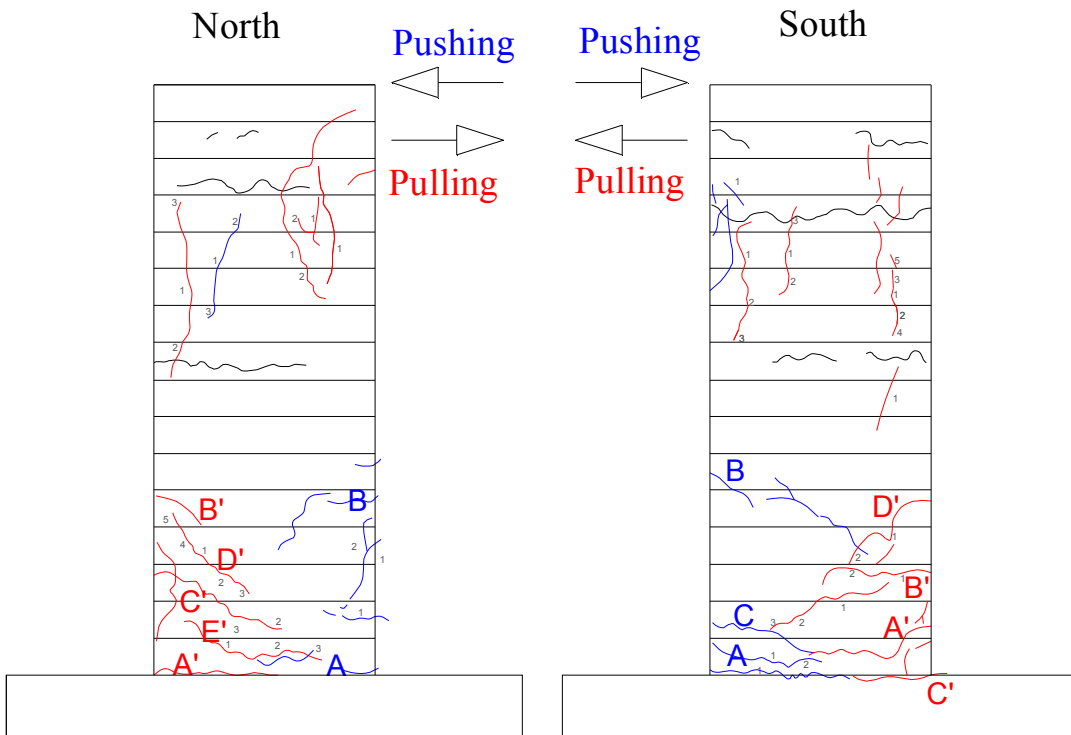
Figure E.42: Crack pattern of LS-X6 after -5% drift ratio.

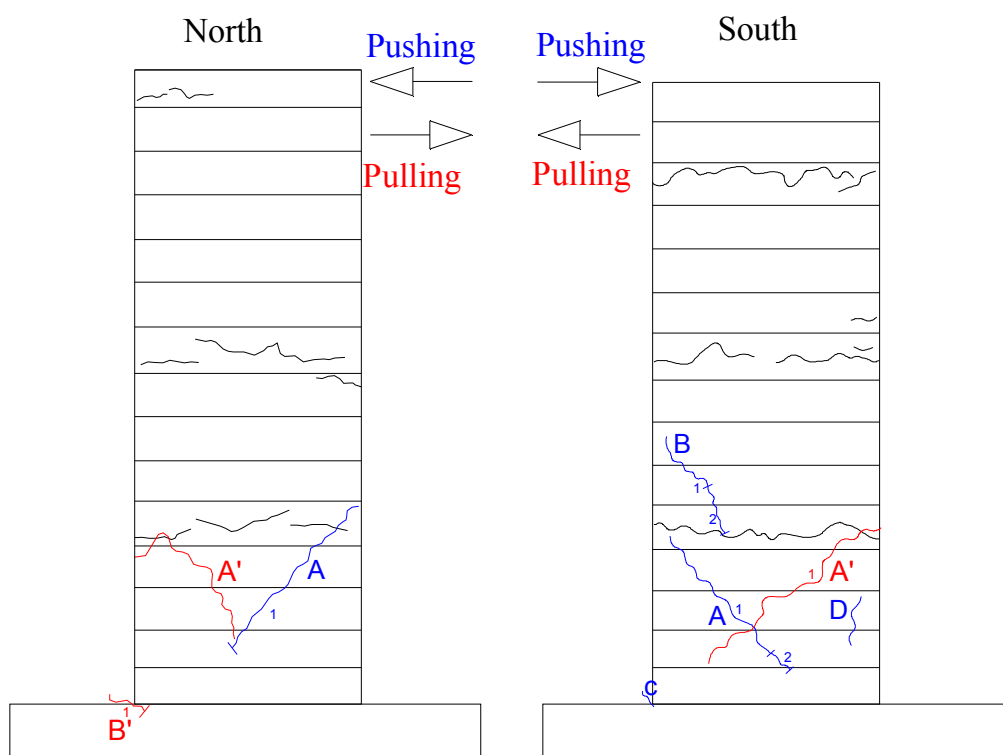
Figure E.48: Crack pattern of LS-X8 after -0.75% drift ratio.
