**SEISMIC BEHAVIOR OF RC COLUMNS WITH CORRODED
PLAIN AND DEFORMED REINFORCING BARS**

Ph.D. THESIS
Çağlar GÖKSU

Department of Civil Engineering
Structure Engineering Programme

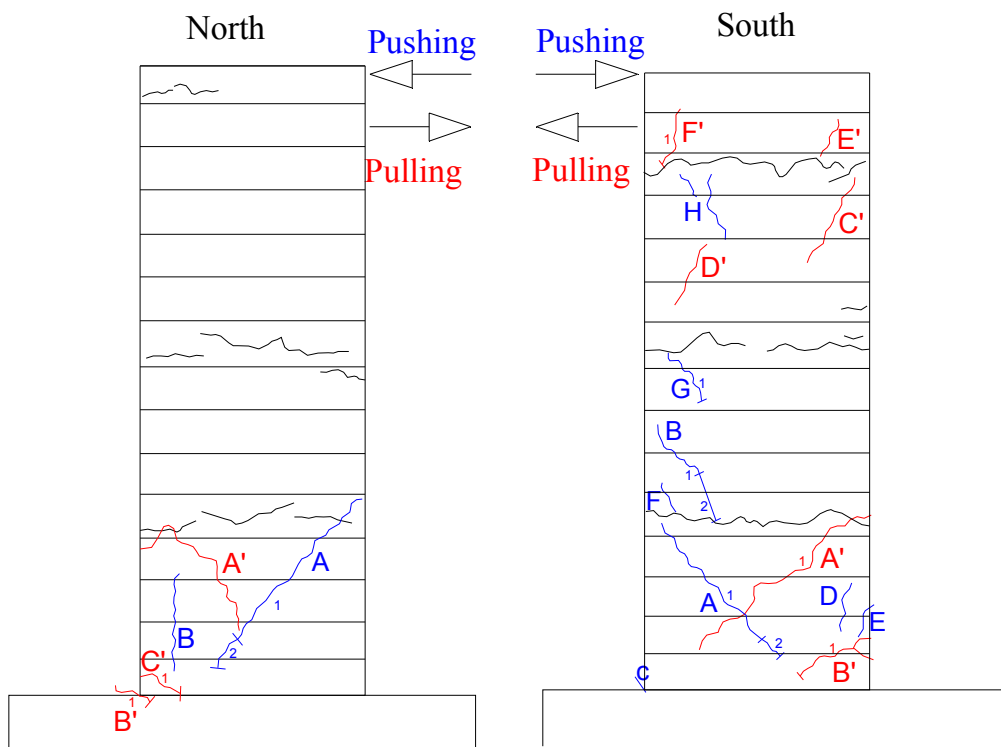
Figure E.50: Crack pattern of LS-X8 after -1% drift ratio.

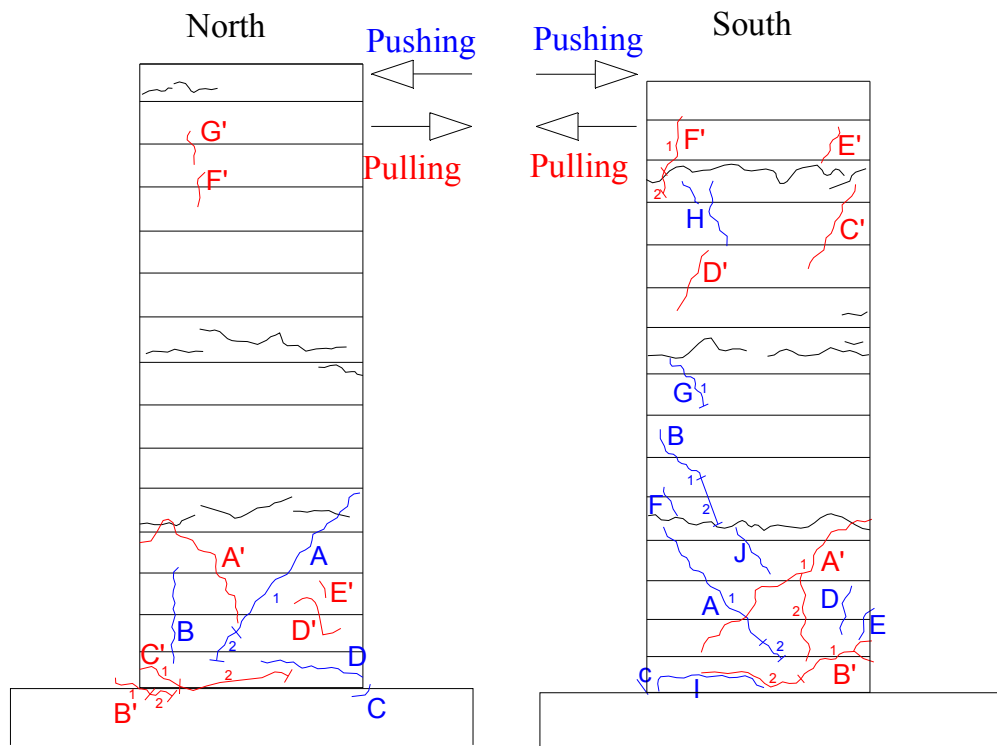
Figure E.52: Crack pattern of LS-X8 after -1.5% drift ratio.

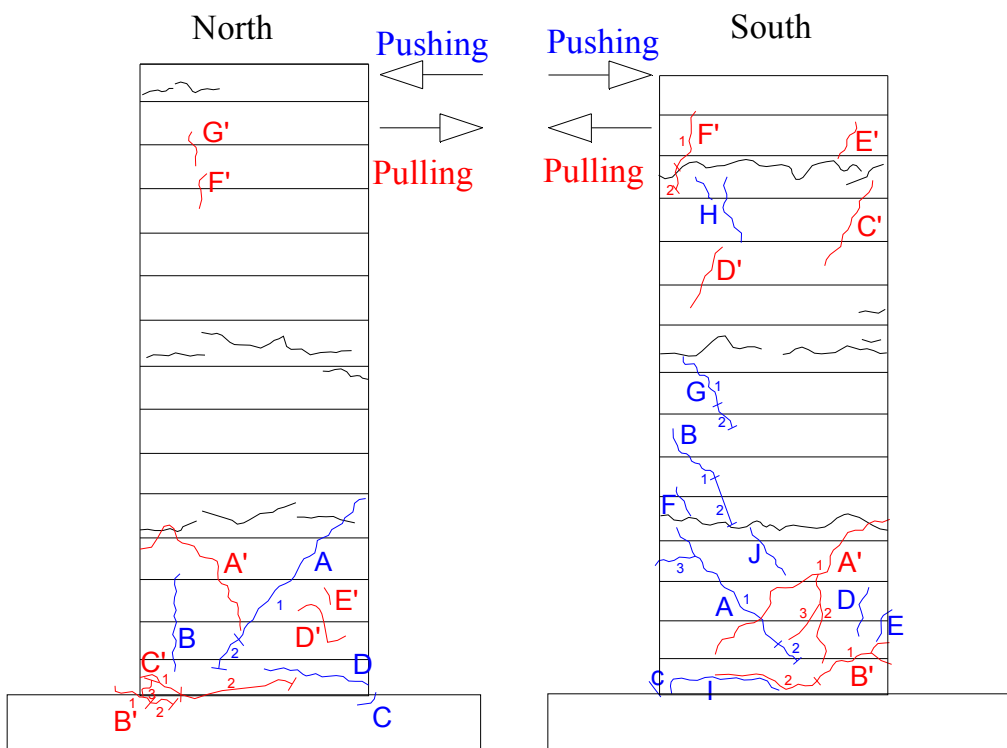
Figure E.54: Crack pattern of LS-X8 after -2% drift ratio.

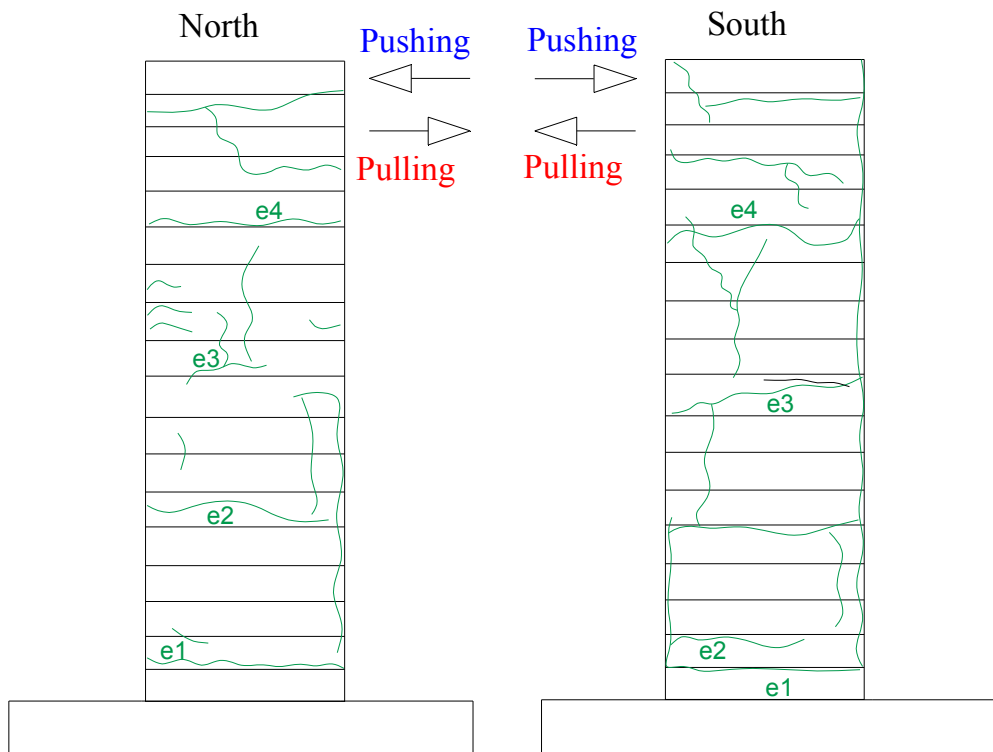
Figure E.118: Crack pattern of LS-X19-H after -0.1% drift ratio.

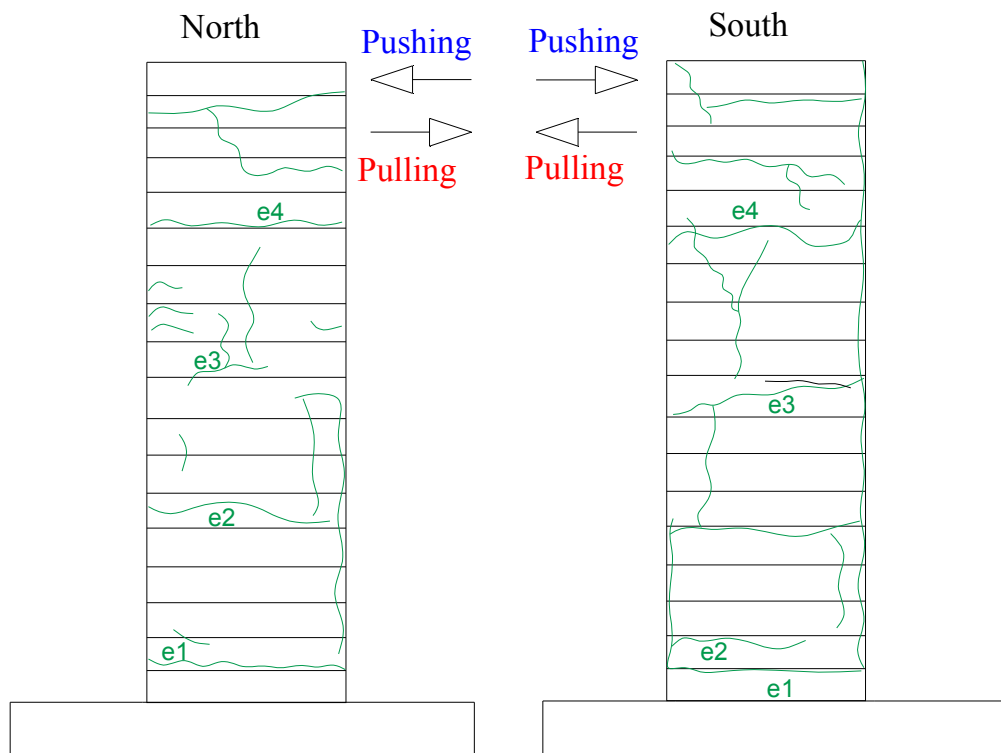
Figure E.120: Crack pattern of LS-X19-H after -0.25% drift ratio.

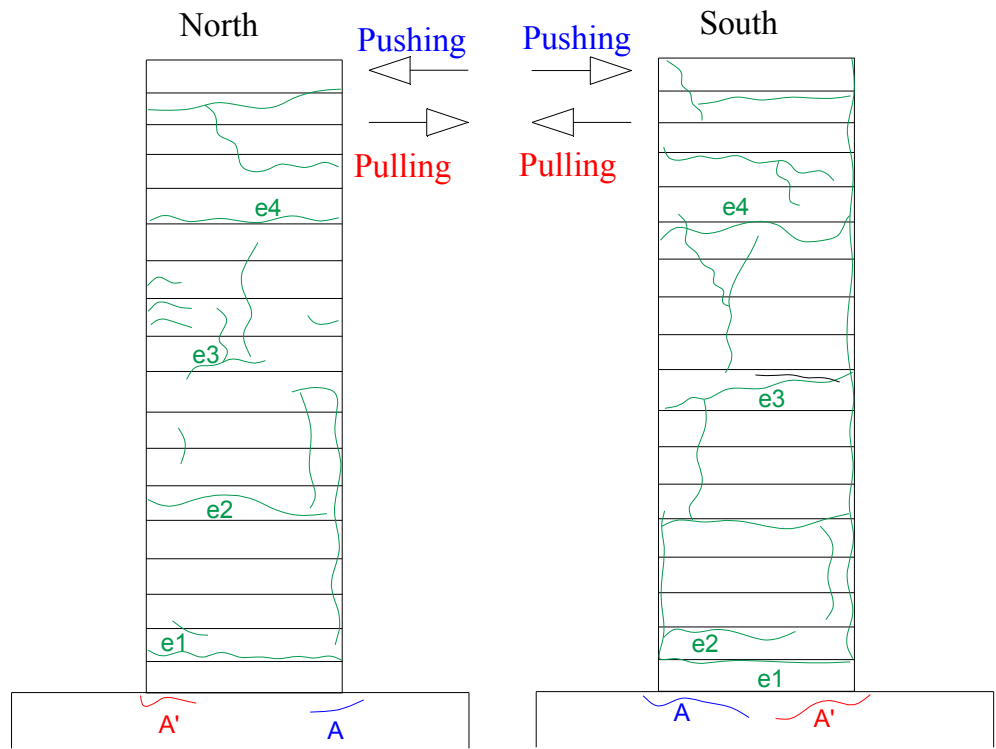
Figure E.126: Crack pattern of LS-X19-H after -1% drift ratio.

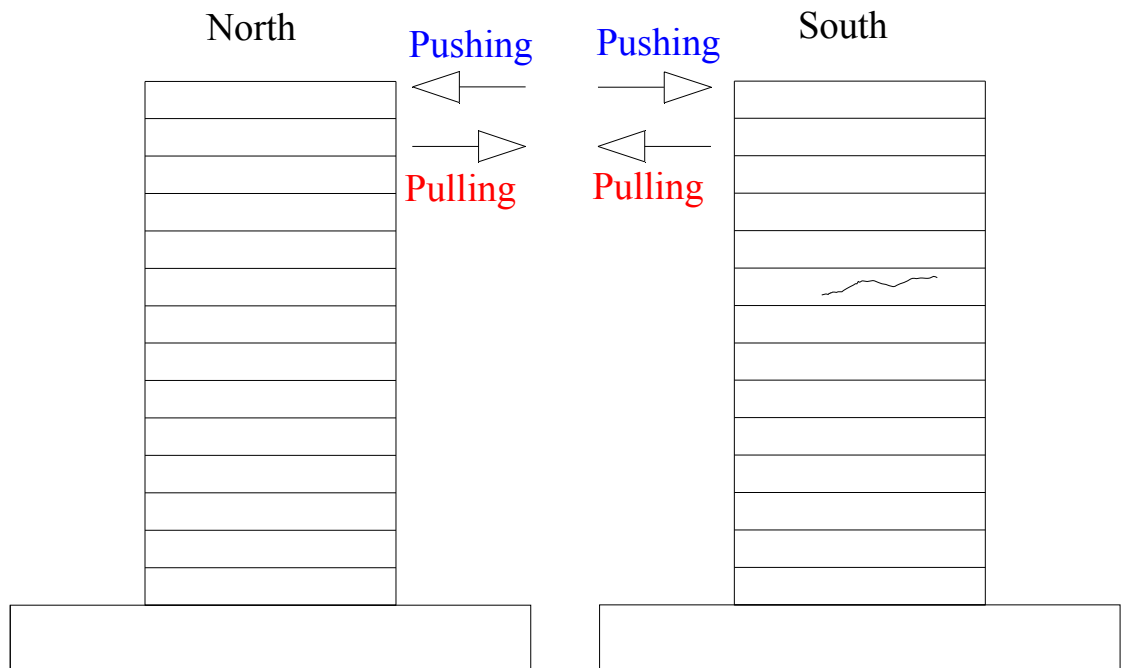
Figure E.196: Crack pattern of NS-X13 after -0.1% drift ratio.

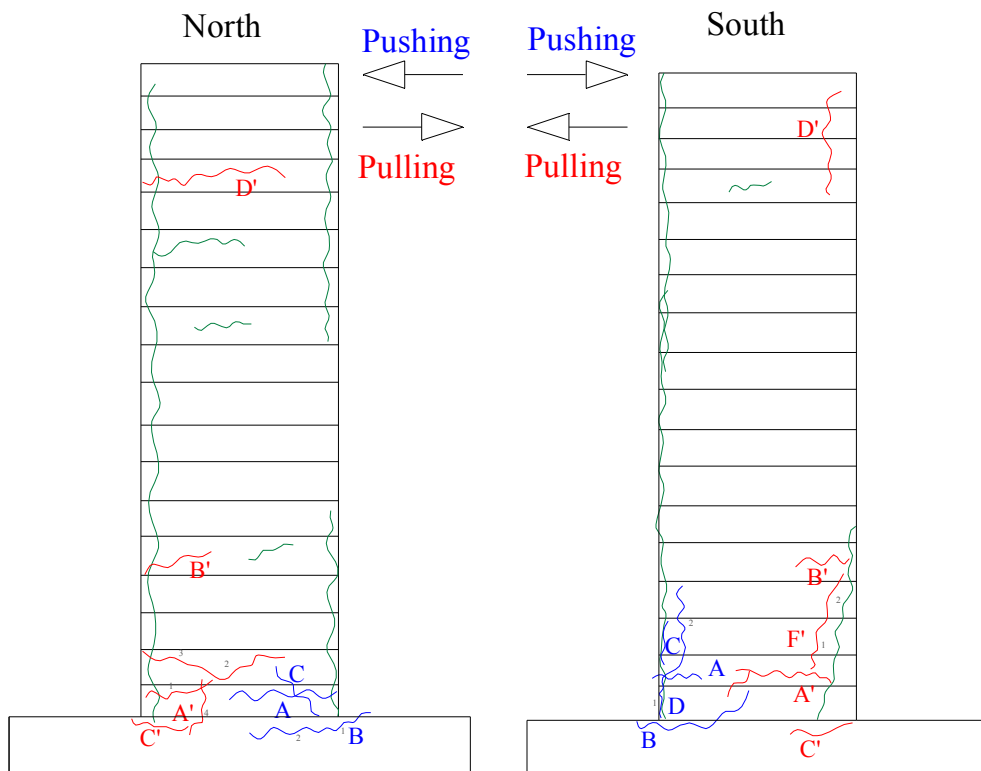
Figure E.234: Crack pattern of NS-X16 after -1.5% drift ratio.

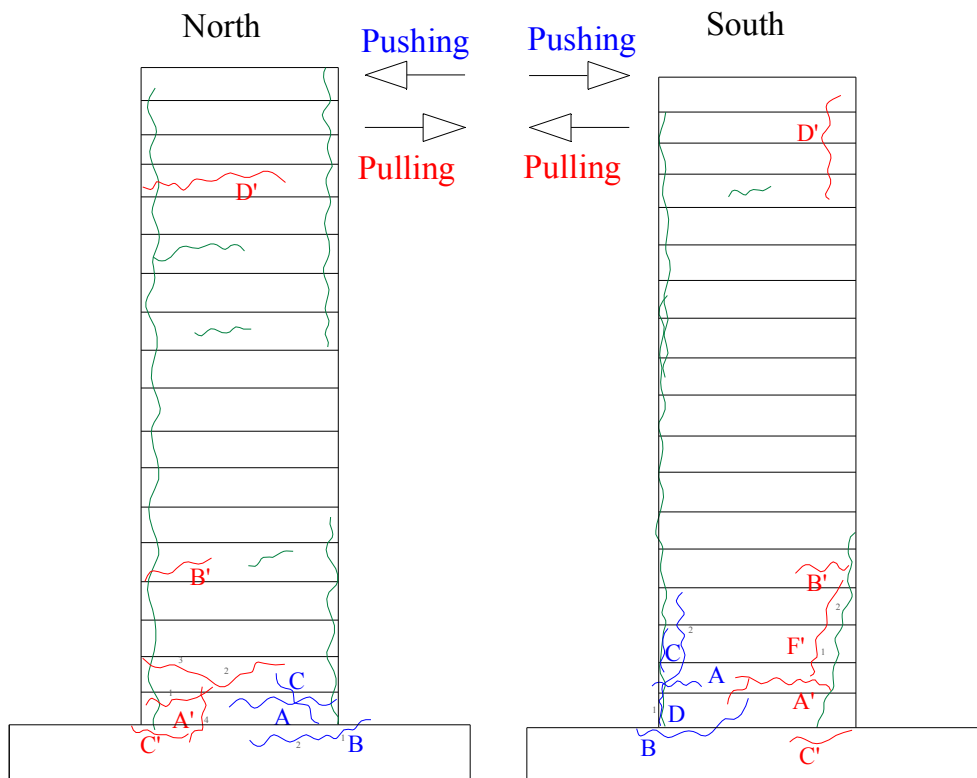
Figure E.236: Crack pattern of NS-X16 after -2% drift ratio.

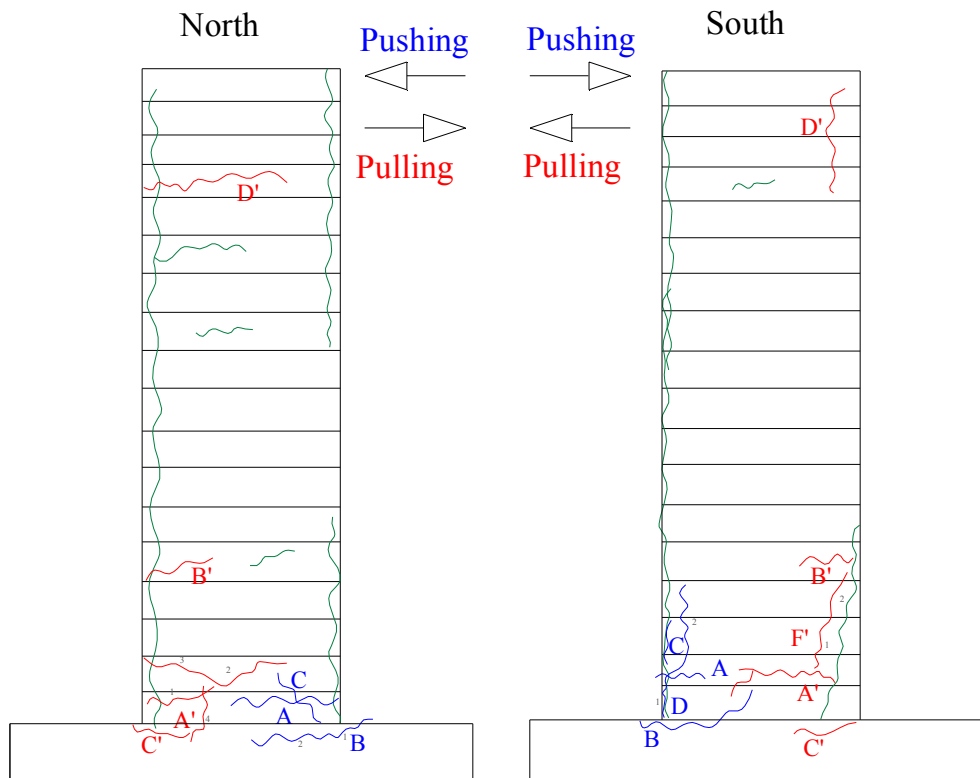
Figure E.238: Crack pattern of NS-X16 after -2.5% drift ratio.

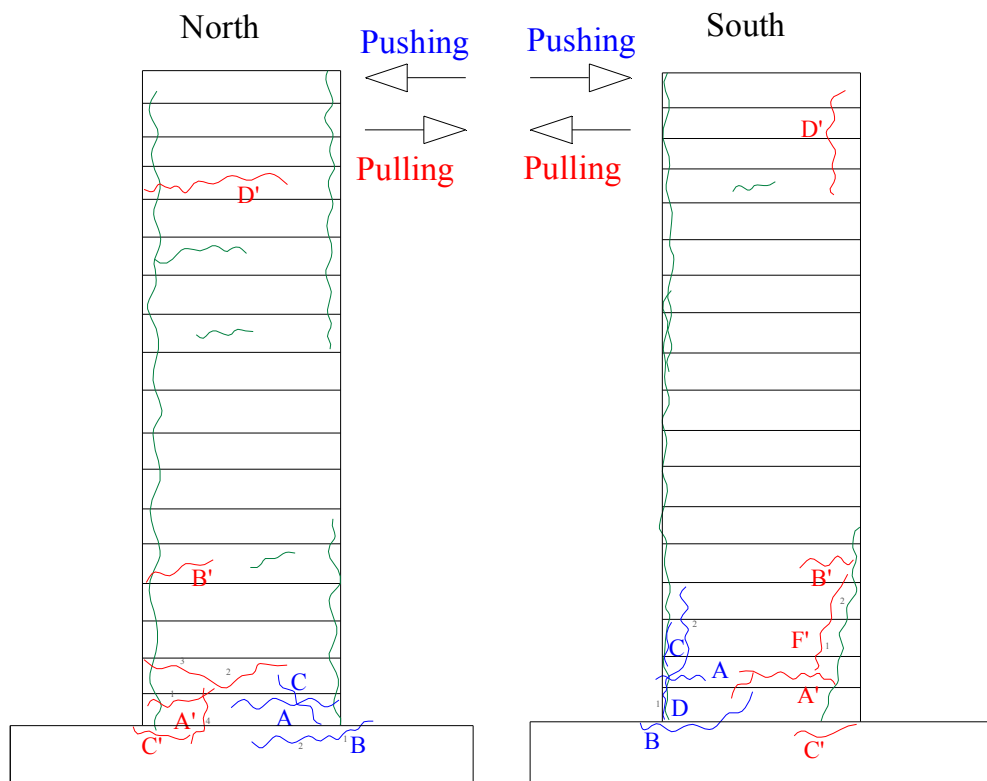
Figure E.240: Crack pattern of NS-X16 after -3% drift ratio.

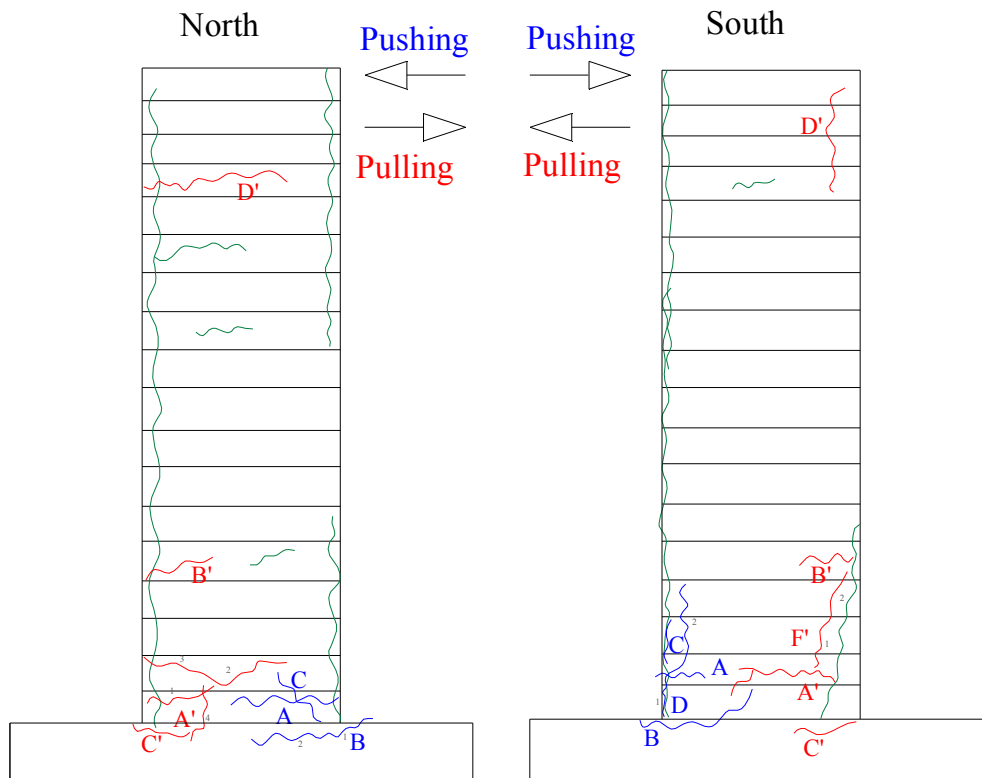
Figure E.242: Crack pattern of NS-X16 after -3.5% drift ratio.

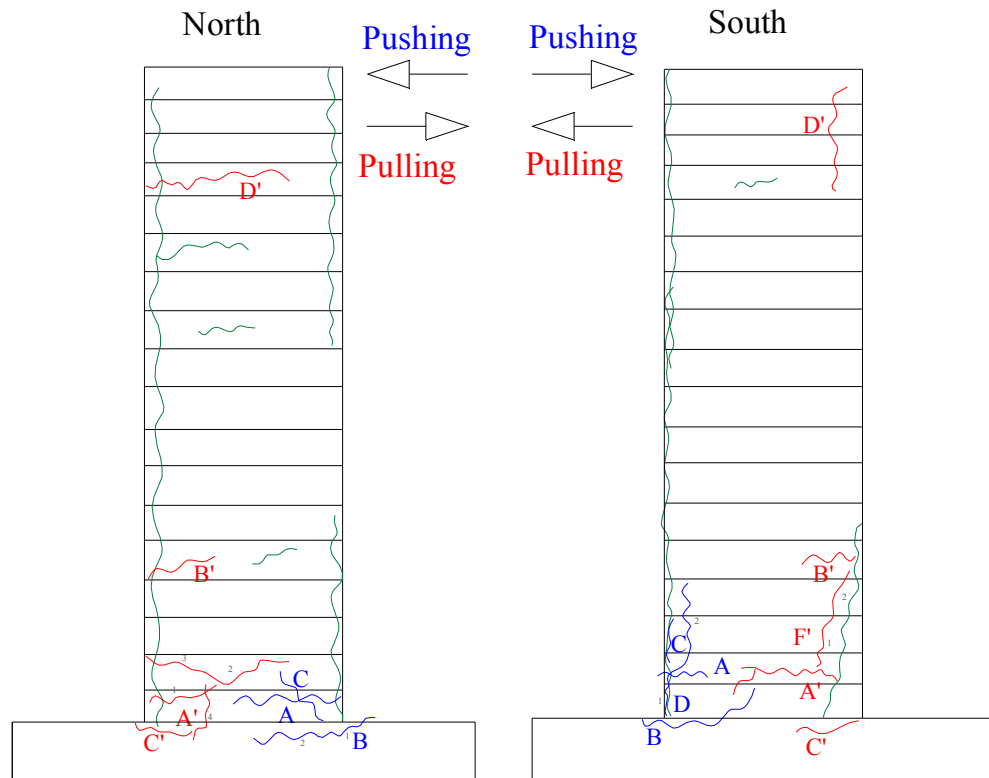
Figure E.244: Crack pattern of NS-X16 after -4% drift ratio.

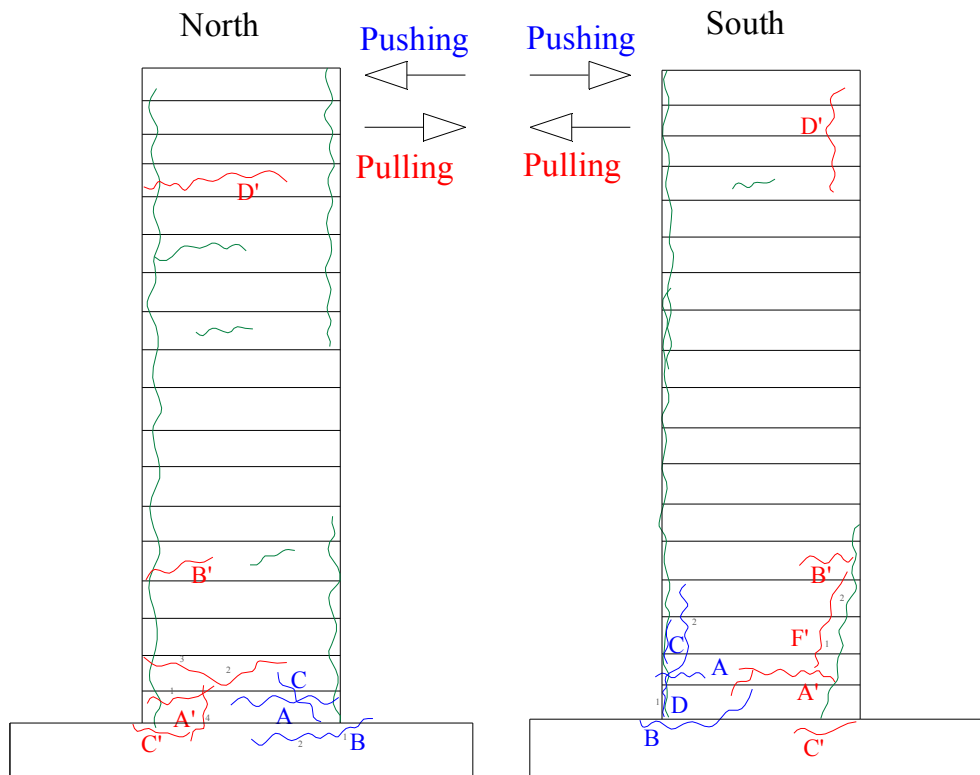
Figure E.246: Crack pattern of NS-X16 after -4.5% drift ratio.

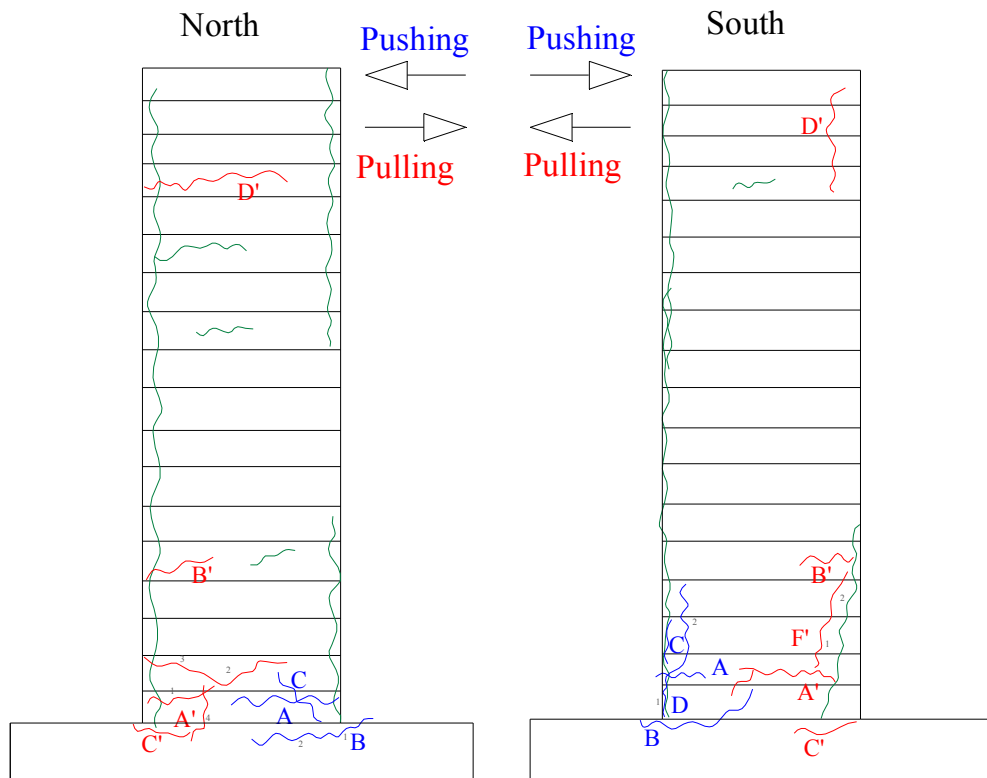
Figure E.248: Crack pattern of NS-X16 after -5% drift ratio.

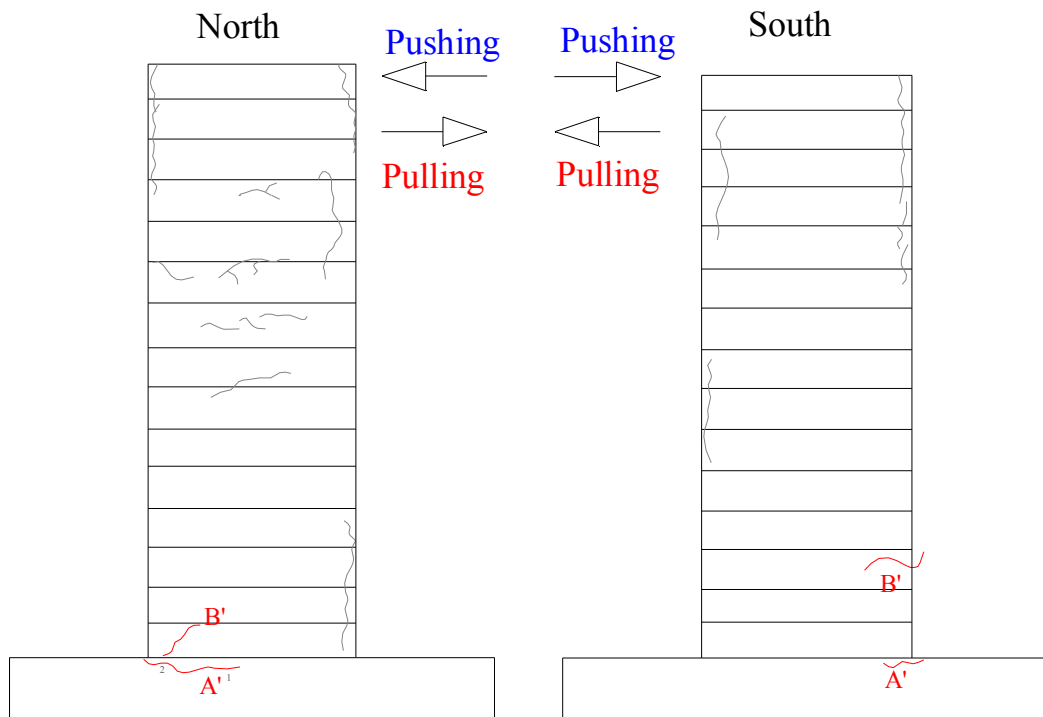
Figure E.256: Crack pattern of NS-X22 after -0.75% drift ratio.

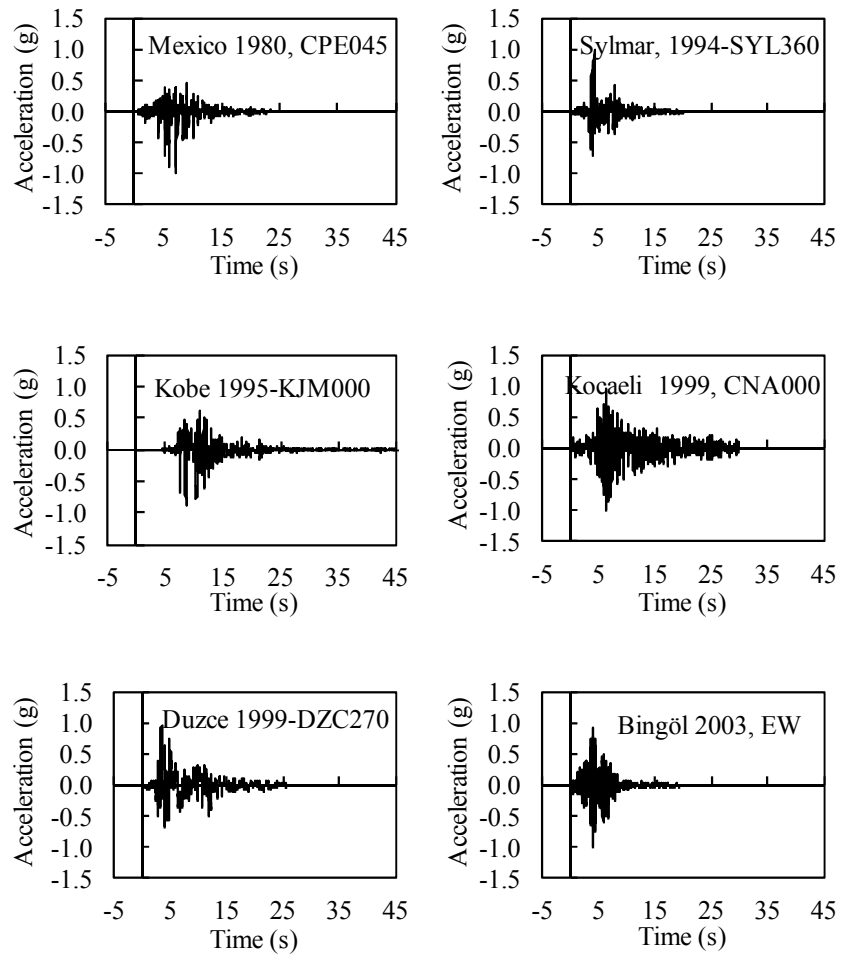
Figure G.1 : Earthquake records scaled to 0.95g.

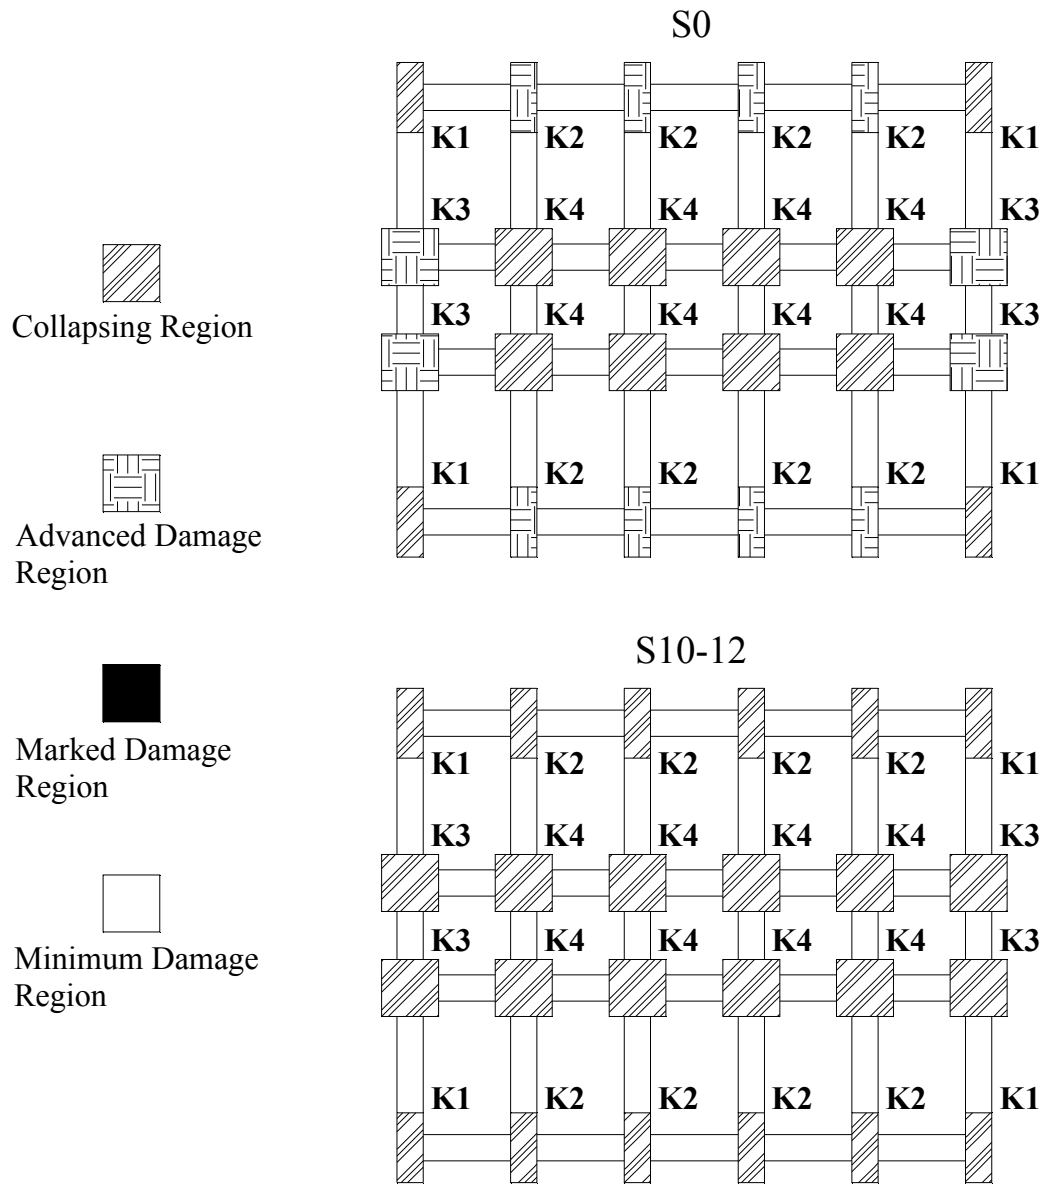
Figure J.1 : The view of damage levels of base columns of S0 ve S10-12 buildings on plan for SYLMAR, 1994.

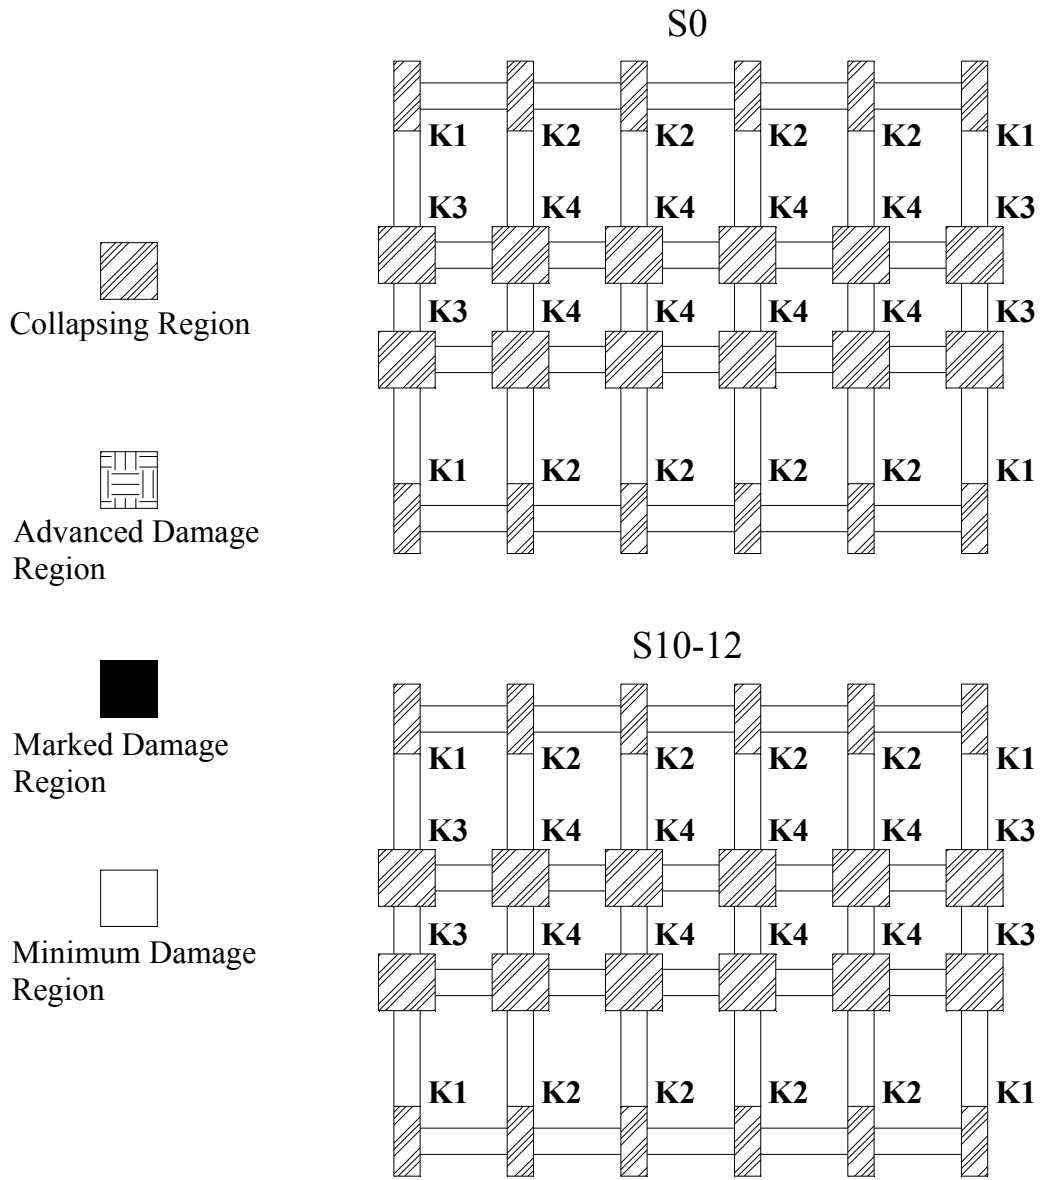
Figure J.2 : The view of damage levels of base columns of S0 ve S10-12 buildings on plan for KOBE, 1995.

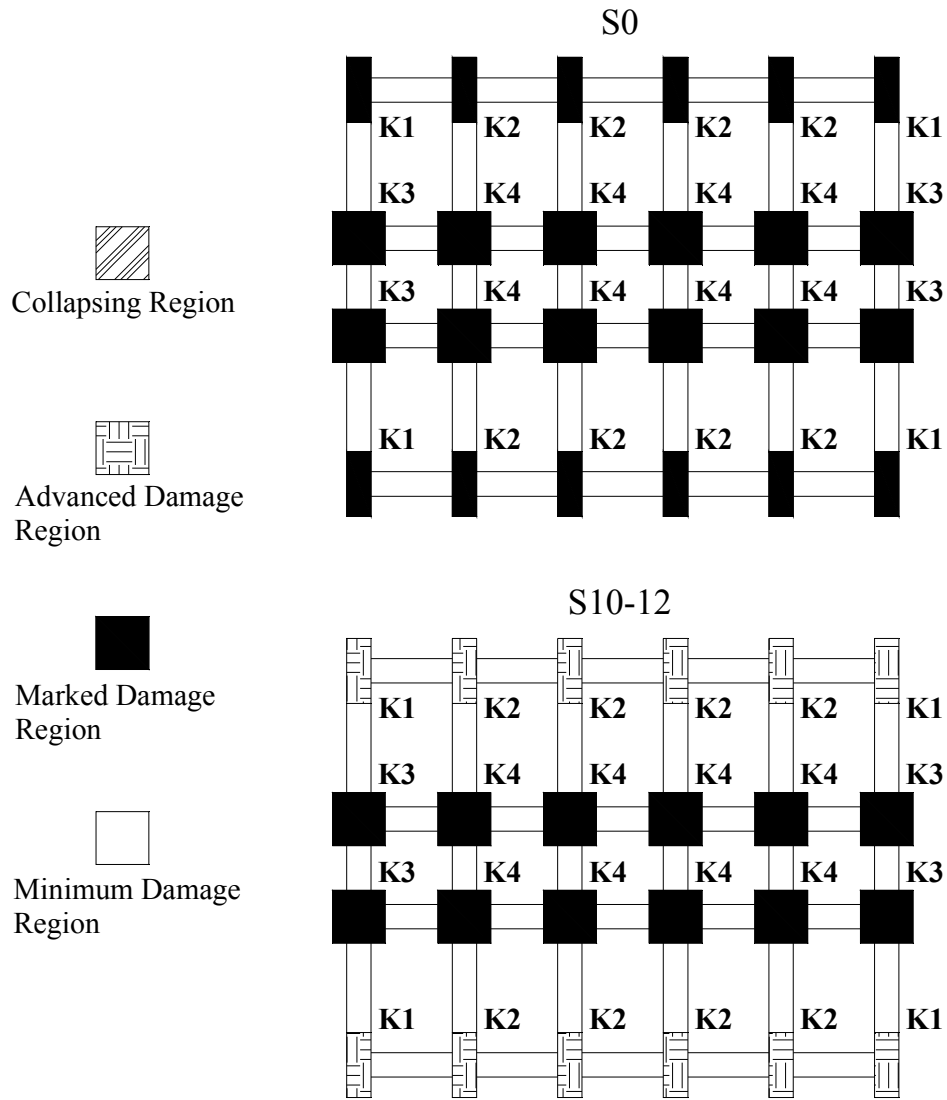
Figure J.3 : The view of damage levels of base columns of S0 ve S10-12 buildings on plan for BİNGÖL, 2003.

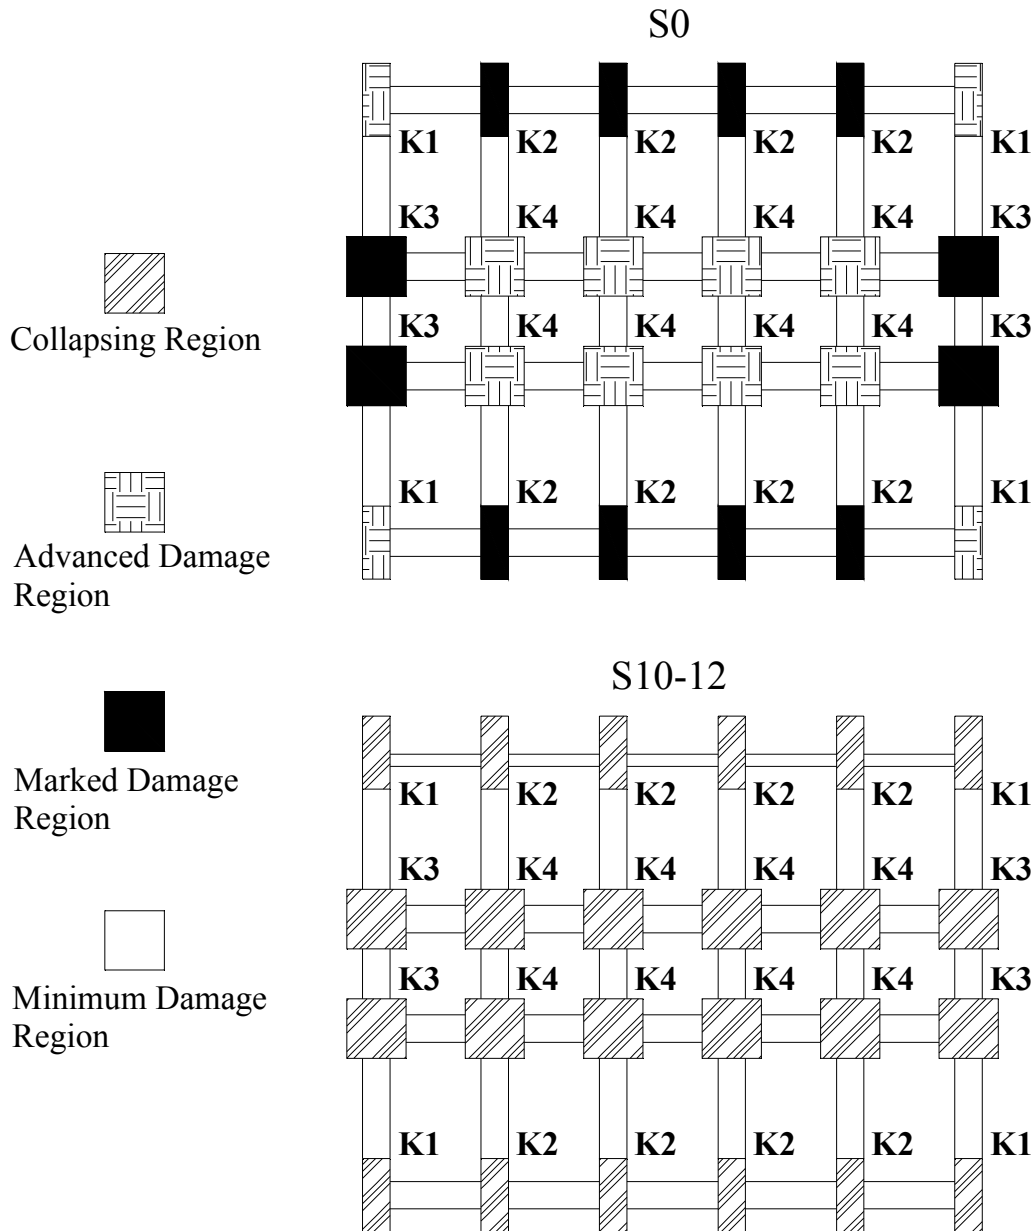
Figure J.4 : The view of damage levels of base columns of S0 ve S10-12 buildings on plan for MEXICO, 1980.
