COMPARING GREEN BUILDING CERTIFICATION SYSTEMS FOR  
EVALUATING ADAPTIVE REUSE OF HERITAGE BUILDINGS: THE CASE  
OF BOĞAZİÇİ UNIVERSITY GÖZLÜKÜLE RESEARCH CENTER

A THESIS SUBMITTED TO  
THE GRADUATE SCHOOL OF NATURAL AND APPLIED SCIENCES  
OF  
MIDDLE EAST TECHNICAL UNIVERSITY

IN PARTIAL FULFILLMENT OF THE REQUIREMENTS  
FOR  
THE DEGREE OF MASTER OF SCIENCE  
IN  
BUILDING SCIENCE IN ARCHITECTURE

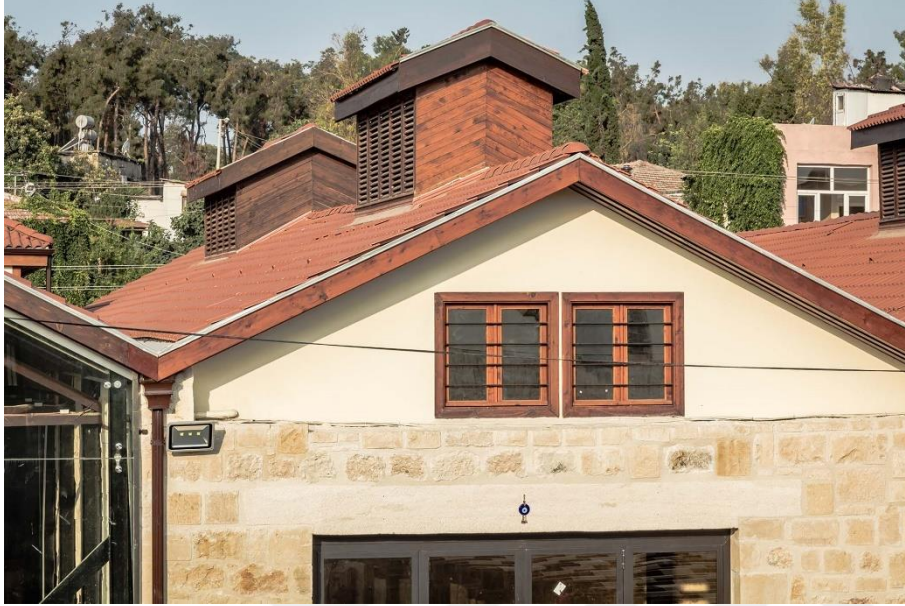
natural ventilation and natural lighting in the upper level have been retained from the original structure to the present day. (SAYKA, 2025)

Figure 19. Roof Lanterns on the roof of Exhibition Hall in Building A (Source: Arkiv, 2025)

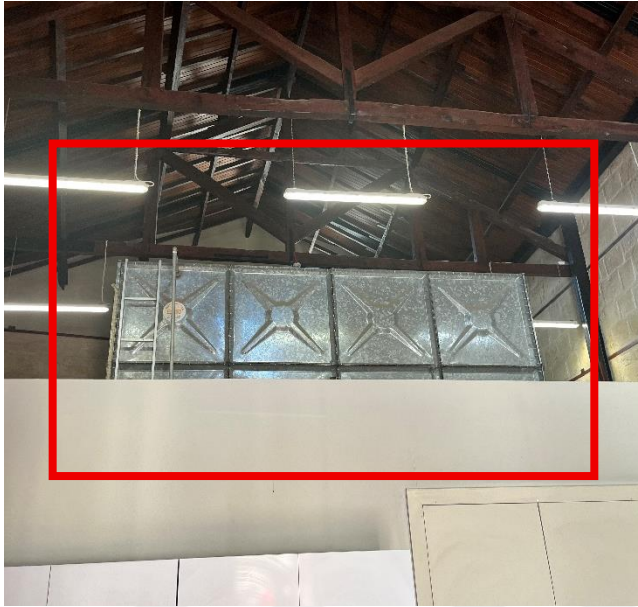
Figure 28. Rainwater Storage Tank in Building C is located in Security room which is the room next to the library

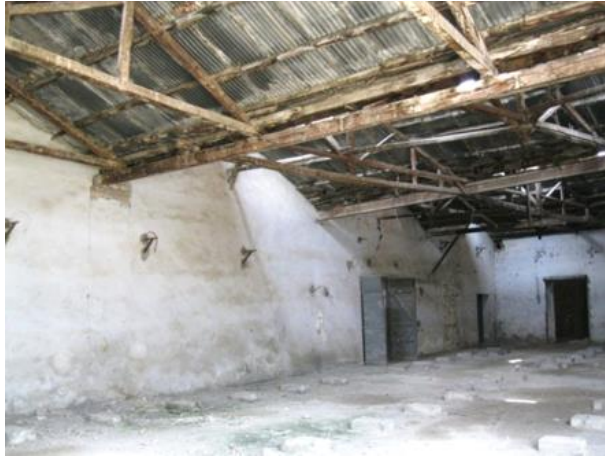
- The cement-added plasters on the wall surfaces were cleaned and the deterioration of the stones was detected.(Figure 33)

Figure 33. Cement-added plaster on the old walls of the building (SAYKA,2025)

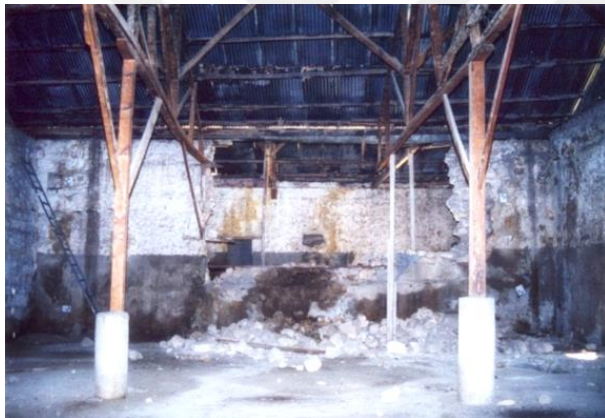
- Local deformations in the walls caused by the use of earth mortar (Figure 34) were eliminated and suspension and reinforcement works were carried out.

Figure 34. Deformations on the existing walls (SAYKA,2025)

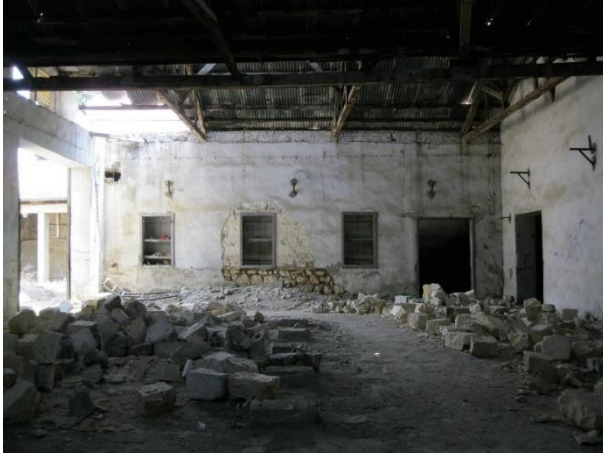
Although the stones in the masonry stone building generally preserved their load-bearing qualities, some of the original stones had lost their load-bearing qualities due to the cement-added plaster(Figure 37), which was estimated to be non-original through old photographs, and the destruction of the structure by external conditions.(SAYKA, 2025) (Soyupak & Cardak, 2024)

Figure 37. Interior Stone walls with the finishing of Cement-Based Plaster (Source: SAYKA,2025)

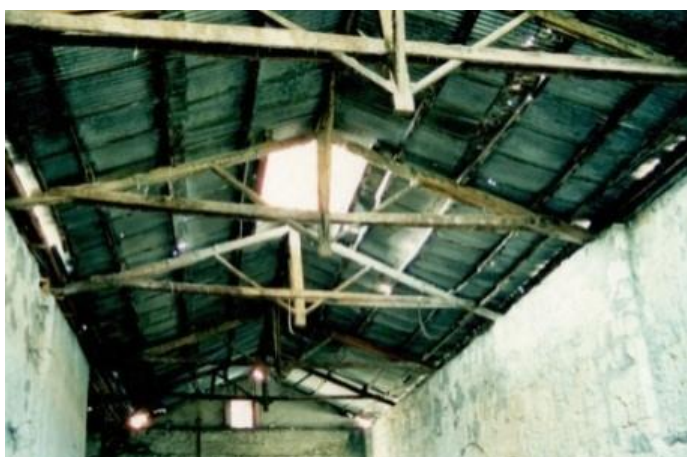
The form of the wooden roof trusses (Figure 40) that form the upper cover, which add value to the building in terms of architecture and carry the roof, and the roof lanterns(Figure 41) which is important for daylighting of the building space on the roof preserved their original quality. However, the wooden trusses, which had lost their load-bearing capacity due to the long years of inactivity of the building and the damages caused by the external conditions, were carried to a recyclable steel system(Figure 42) to carry only their own weight and to carry the load of the roof independently from the stone walls and wooden trusses. This steel system is not coated and is placed inside the building in a way that it is visible from the outside. In this direction, engineering projects were prepared according to the 3D diagram (Figure 43) created for the load-bearing system during the construction process and steel profiles were placed at a distance of 30 cm from the walls. The existing wooden trusses, which had lost their bearing capacity, were cleaned with bristle brushes, reinforced with injection method and restored and additional steel and wooden elements (Figure 44) placed between the steel profiles in their original places.(SAYKA, 2025)

Figure 40. Original Roof Trusses of the Building B (Source, 2025)

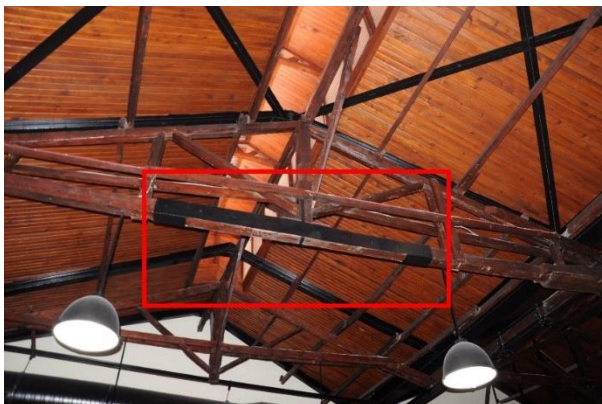
Figure 44. Addition of Steel elements for strengthening to the existing wooden trusses which originally carries the roof in the past

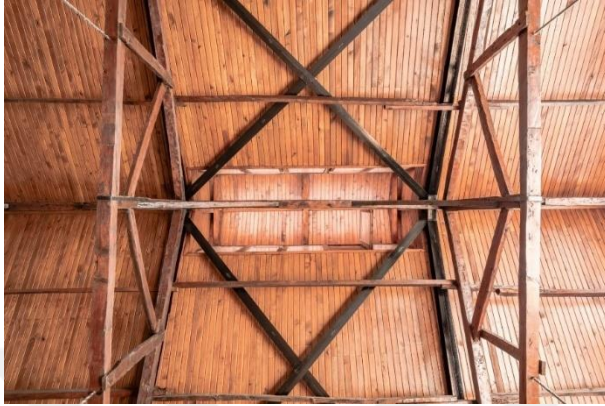
The wooden ceiling coverings (Figure 45), which were not originally in the building, were placed in such a way that they do not refer to the old buildings around and do not damage the structure.(SAYKA, 2025)

Figure 45. Newly added wooden ceiling coverings of the buildings (Source: SAYKA, 2025)

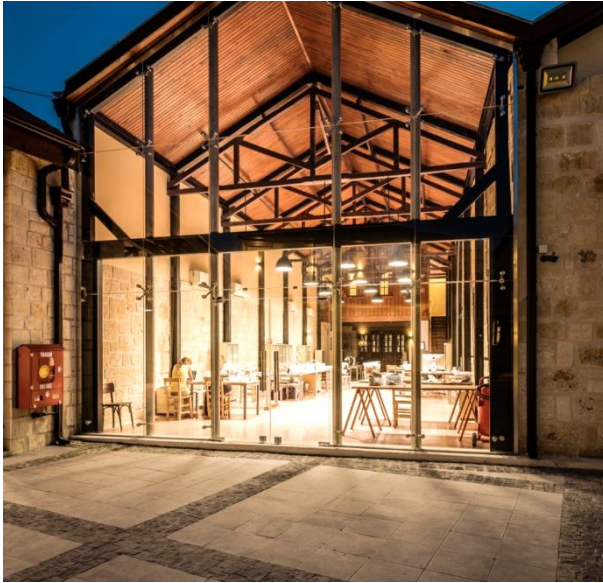
Figure 47. Spider glass cladding facade system of open work area in Building A, view from courtyard. (SAYKA,2025)

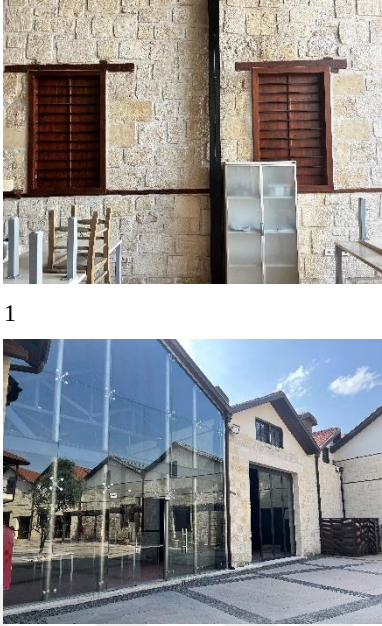
| ARTICLES | PICTURES | EVALUATIONS |
|---|---|---|
| <p>Article 1: The new design should be compatible with its existing surroundings in terms of mass, form, proportion and color.)</p> | <p>1</p> <p>2</p> | <p>New additions after the restoration were found to be compatible with the general design of the building.</p> <p>1: Newly added Windows<br/>2: Newly added glass facade</p> |

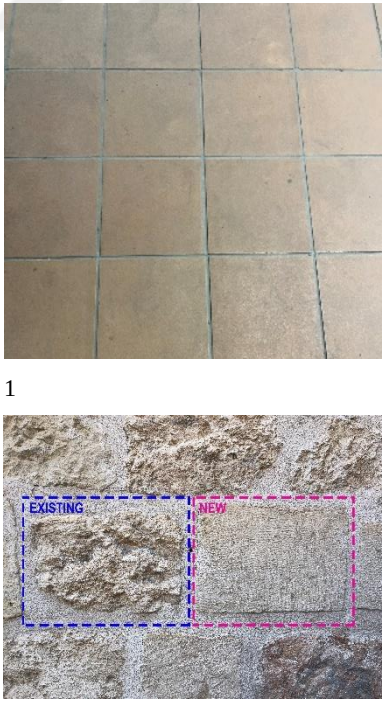
| ARTICLES | PICTURES | EVALUATIONS |
|---|---|---|
| <p>Article 2: The additions or changes in the new design must be clearly recognizable and must not damage the documented character of the historic building in such a way as to mislead future research.</p> | <p>1</p> <p>2</p> | <p>The stones on the walls of the building that preserved their bearing capacity were preserved and the stones that lost their bearing capacity were replaced with the same stones quarried from the same quarry by giving them a different texture. Likewise, the material used as flooring is terracotta or artificial stone, not to be confused with similar historic examples of the region.</p> <p>1: Floors<br/>2: Walls</p> |

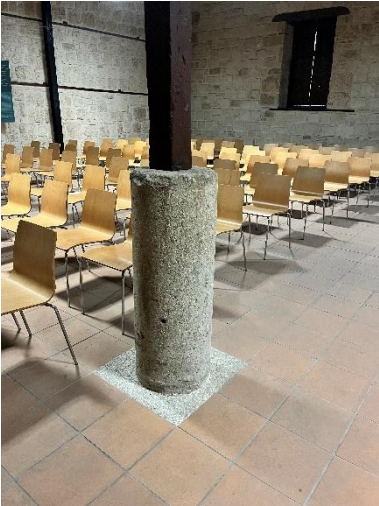
| <p>Article 3: The new design should not devalue the cultural values and traditional character of the existing neighborhood</p> | <p>1</p> | <p>The use of the structural elements of the period in which the building was built in the restoration shows that the building's cultural values are also preserved.</p> <p>1: Original column of the factory building</p> |

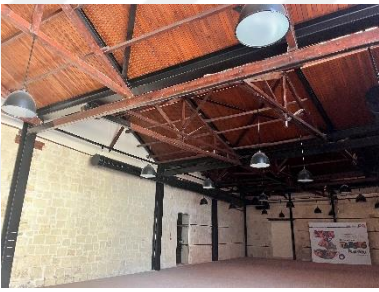
| <p>Article 4: New design and its implementation should utilize current technologies and avoid imitating the styles of the past.</p> | <p>1</p> | <p>While the building was being restored, the addition of a steel bearing frame system to the structure to carry the wooden trusses and roof, which had lost their carrier, and the addition of doors and windows containing today's systems to the structure are indicators of the use of current technologies.</p> <p>1: Steel frame and wooden trusses at Exhibition Hall in Building A</p> |

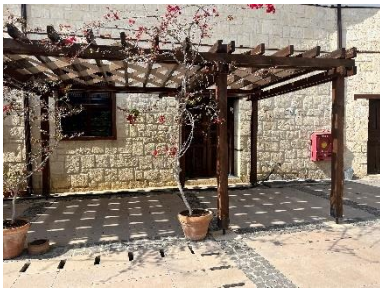
| <p>Article 7: The new design should be compatible with the surrounding historic fabric in terms of height and massing and should not overwhelm it.</p> | <p>1</p> | <p>The pergola structure added to the courtyard of the building is compatible with the fiction of the building and supports the relationship of solid and void by not getting in front of the building with its general mass.</p> <p>1: Pergola in the courtyard<br/>(Located in front of the Building B)</p> |

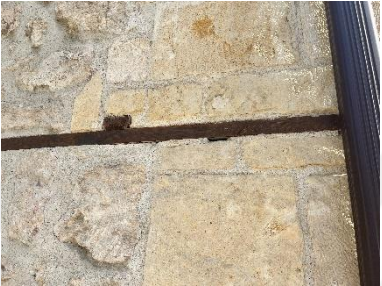
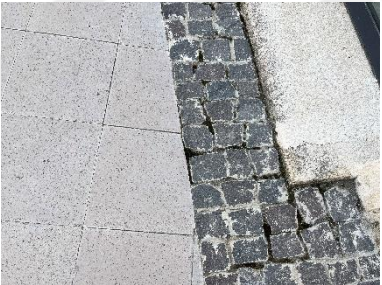
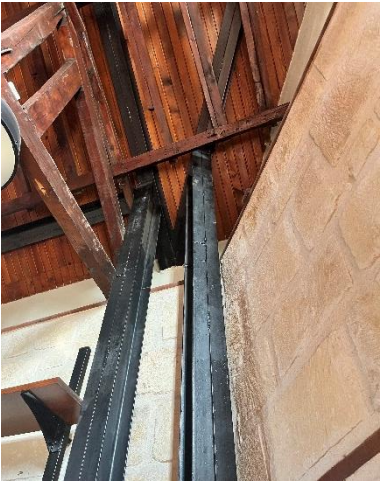
| <p>Article 9: New alterations to the building must be made with materials that are compatible with the overall mass of the building and are not different in appearance and texture.</p> | <p>1</p> <p>2</p> <p>3</p> | <p>The new stones used in the walls of the building, the new flooring materials and the steel structure carrying the roof are designed to be very compatible with the original mass and materials of the building.</p> <p>1: New and Existing stones combination of the wall.<br/>2: Newly added different types of floorings<br/>3: Newly added steel structure</p> |

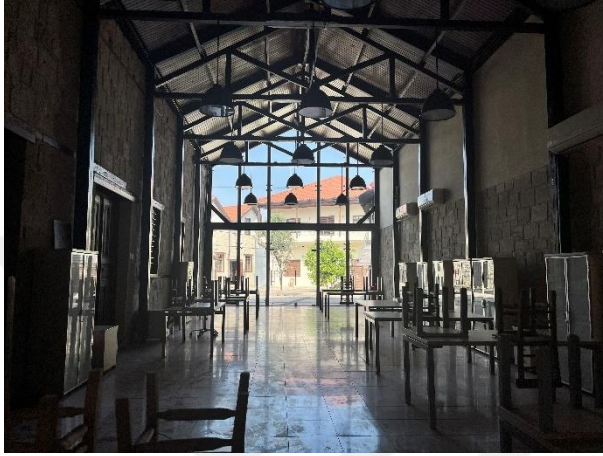
Figure 52. Poor daylighting of open work area from the entrance of Building A from Abdi İpekçi Street.

The utilization of passive and active energy systems is of paramount importance in ensuring the sustainability of the structure. The integration of passive building systems is indicated by the implementation of natural ventilation in the structure through the installation of shutters on the doors and windows. The integration of passive solar systems is further evidenced by the provision of natural sunlight to the roof lanterns and windows. It was determined that the structure in question was not sufficiently illuminated from within, as evidenced by the findings of the site visit. It

has been determined that there is a regular need for illumination devices due to the absence of light during daylight hours. The integration of solar panels and photovoltaic panels into the roof post-restoration has been instrumental in providing hot water and electrical energy to the building, thereby enhancing its sustainability as a model of active energy systems. (Figure 54)

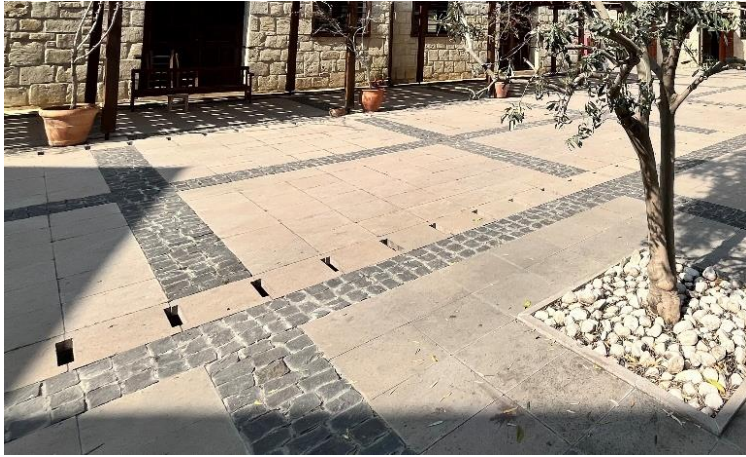
Figure 53. New perforated Floor for rainwater drain of the courtyard

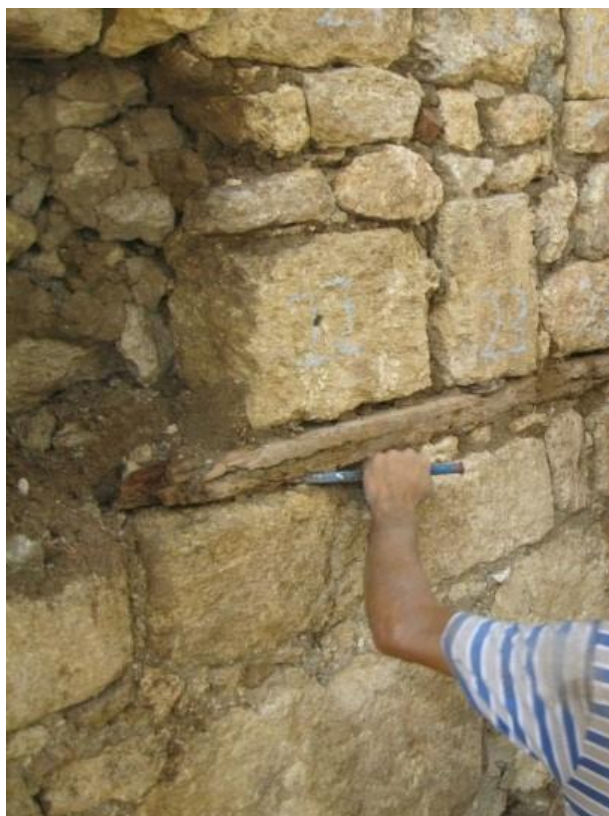
Figure A. 1. Removal of the Stones and Wooden Lintels (Source: SAYKA,2025)

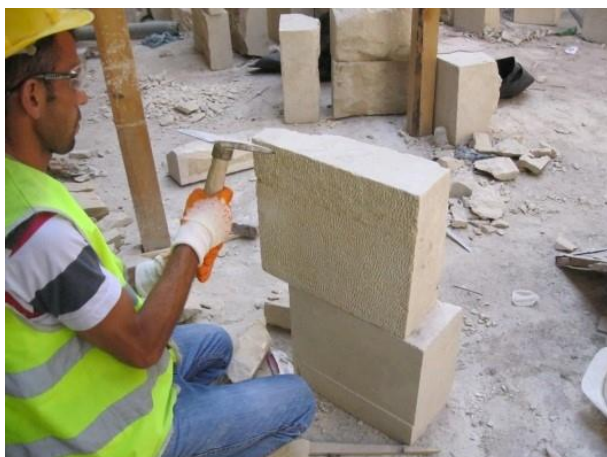
Figure A. 2. The process of crushing the stones brought to the building area in whole form in accordance with their original dimensions (Source: SAYKA, 2025)

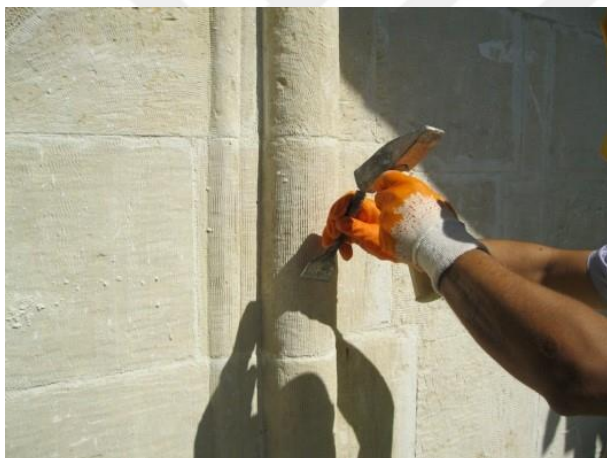
Figure A. 3. Giving different texture to the new stones with hammer (Source:SAYKA,2025)

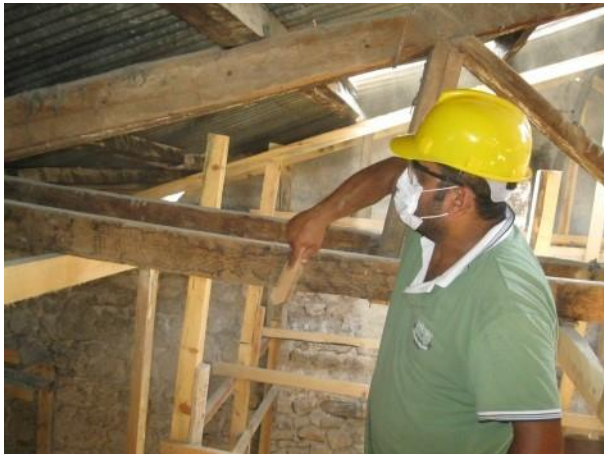
Figure A. 4. Cleaning process of the wooden trusses with bristle brushes (Source: SAYKA, 2025)

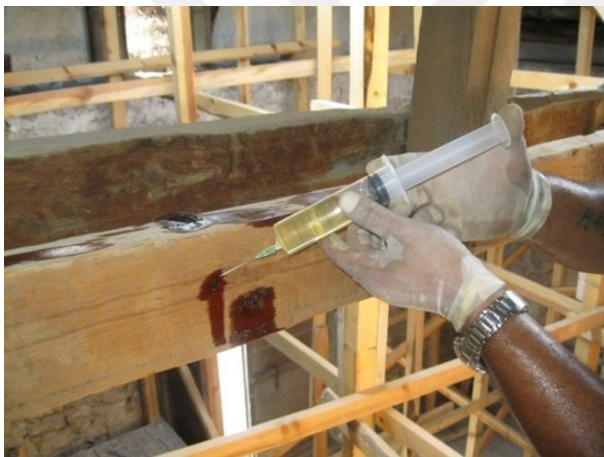
Figure A. 5. Reinforcing the wooden trusses with injection method (Source: SAYKA, 2025)

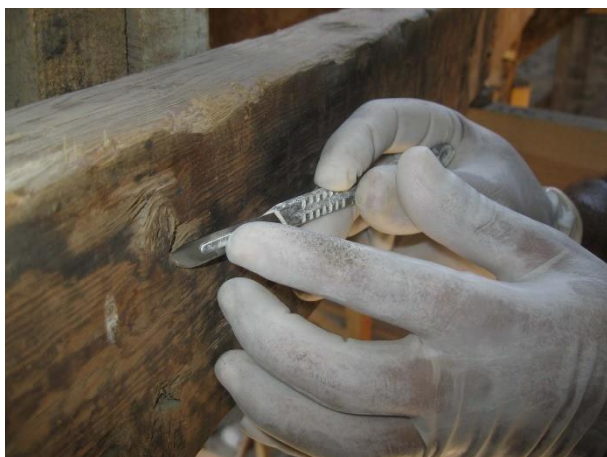
Figure A. 6. Restoring Wooden Trusses (Source: Arkiv,2025)

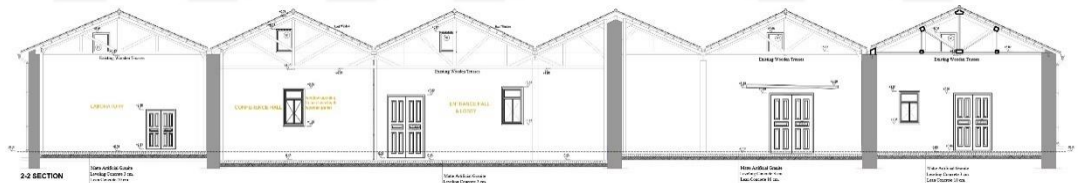
Figure A. 12. Section 2-2 of Gözlükule Excavation Research Center, Tarsus, Mersin (Source: BOUN,2025)

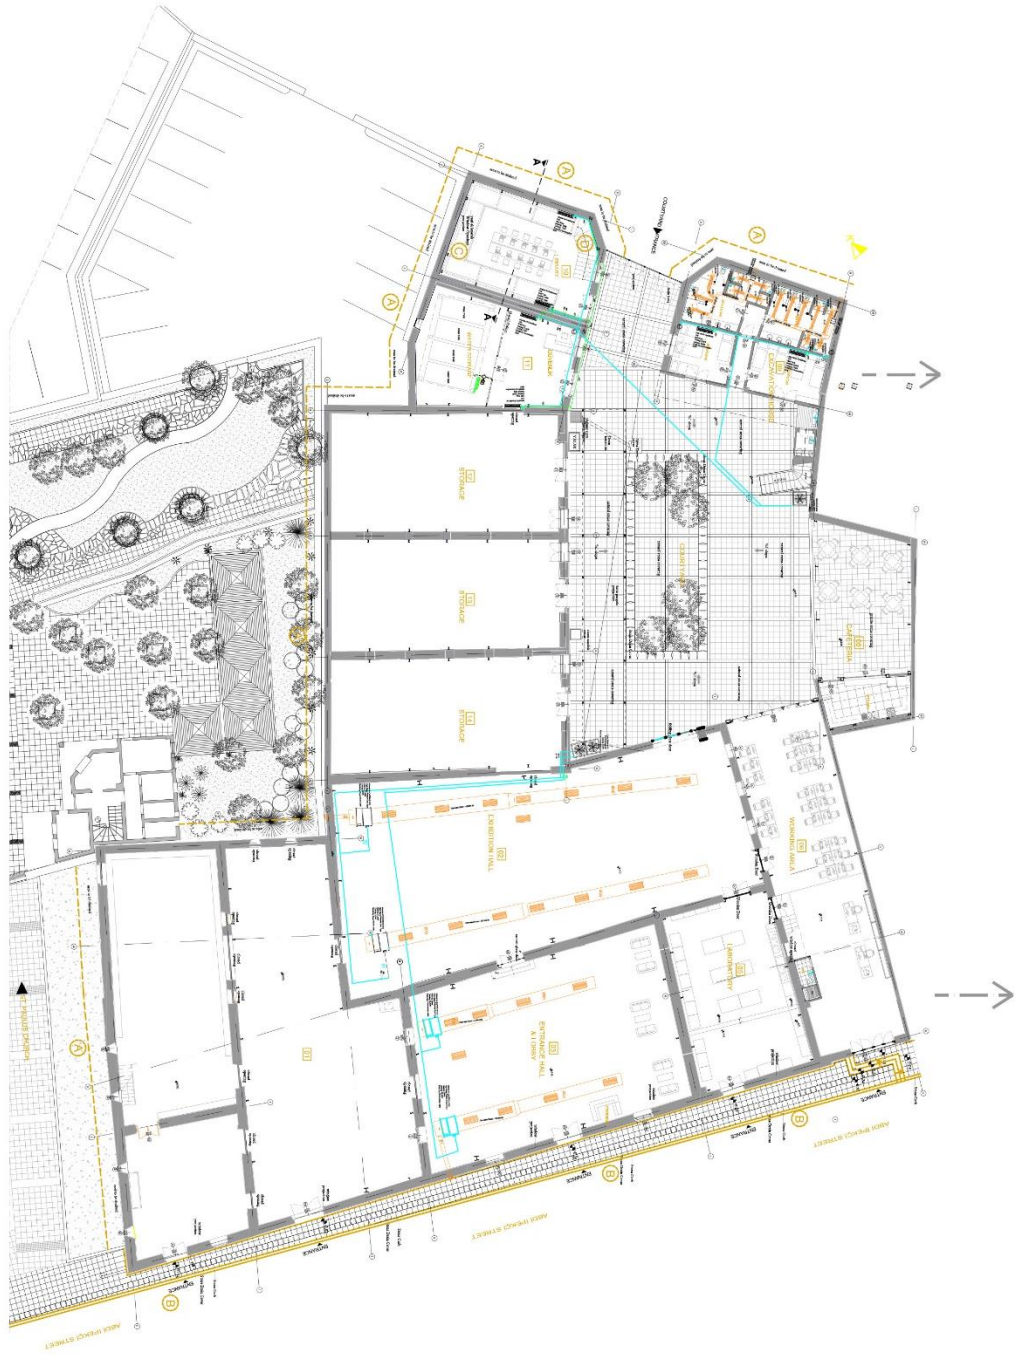
Figure A. 24. Ventilation Ground Floor Plan of Gözlükule Excavation Research Center, Tarsus, Mersin (Source: BOUN,2025)

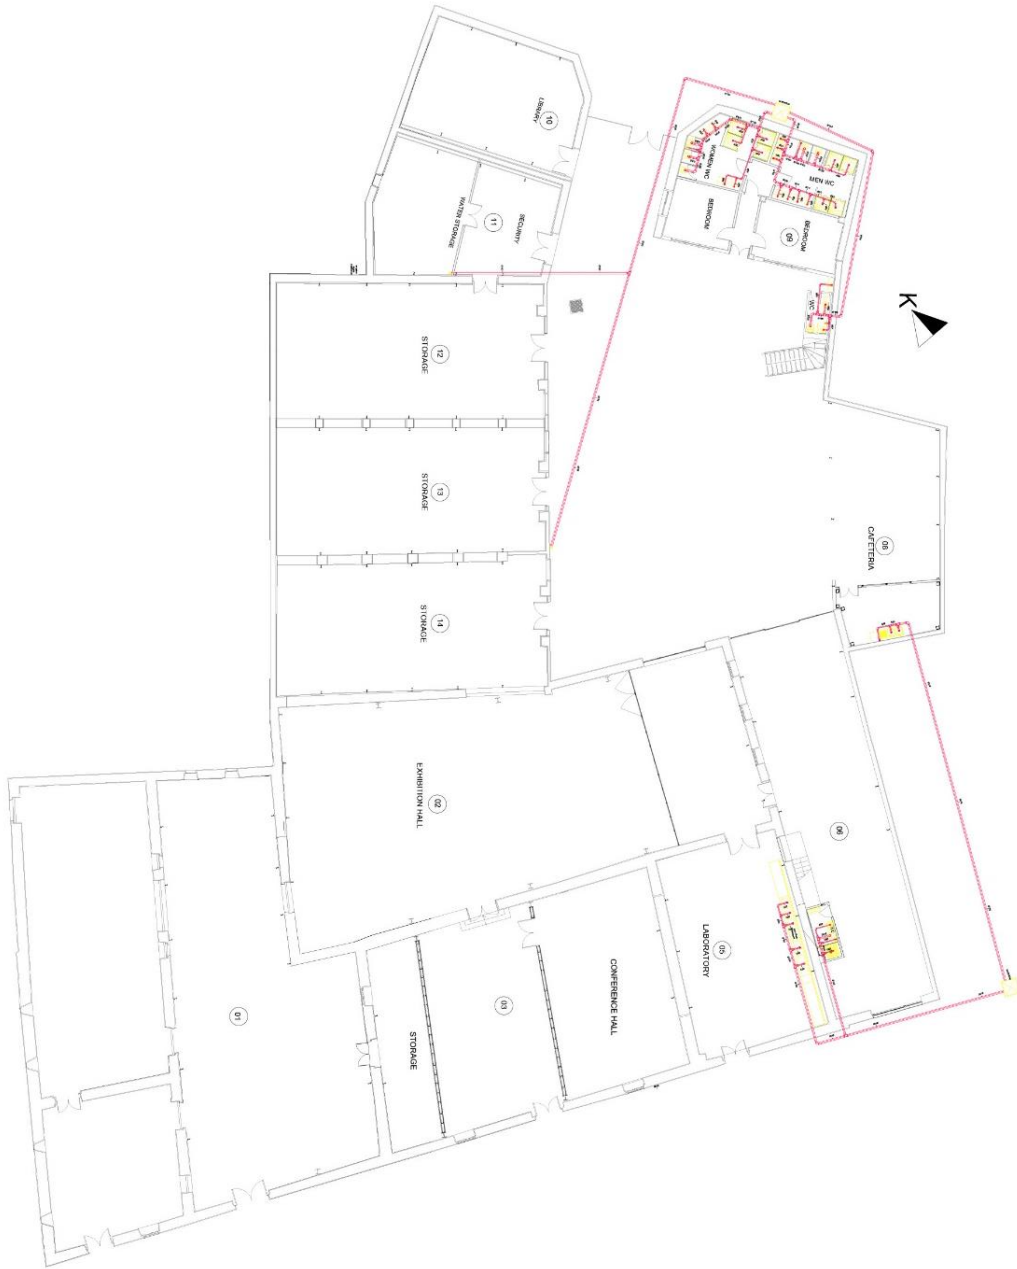
Figure A. 27. Waste Water Plumbing Plan of Gözlükule Excavation Research Center, Tarsus, Mersin (Source: BOUN,2025)

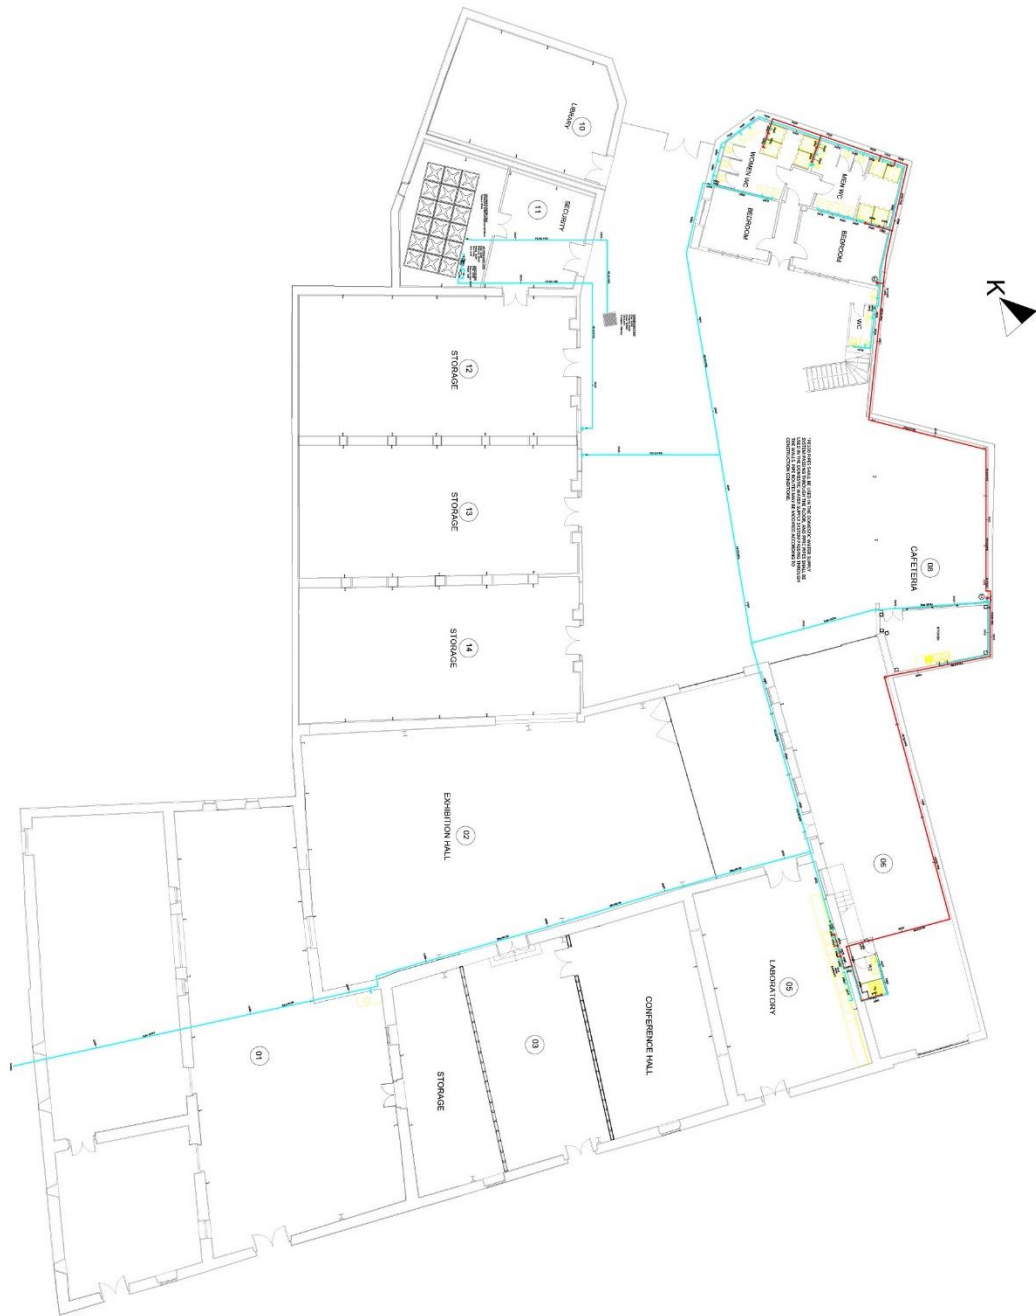
Figure A. 28. Clean Water Plumbing Plan of Gözlükule Excavation Research Center, Tarsus, Mersin (Source: BOUN,2025)

Flow: 5m<sup>3</sup>/h  
Pressure: 3mSS  
Power: 1500W  
One Level  
1 Original, 1 Backup

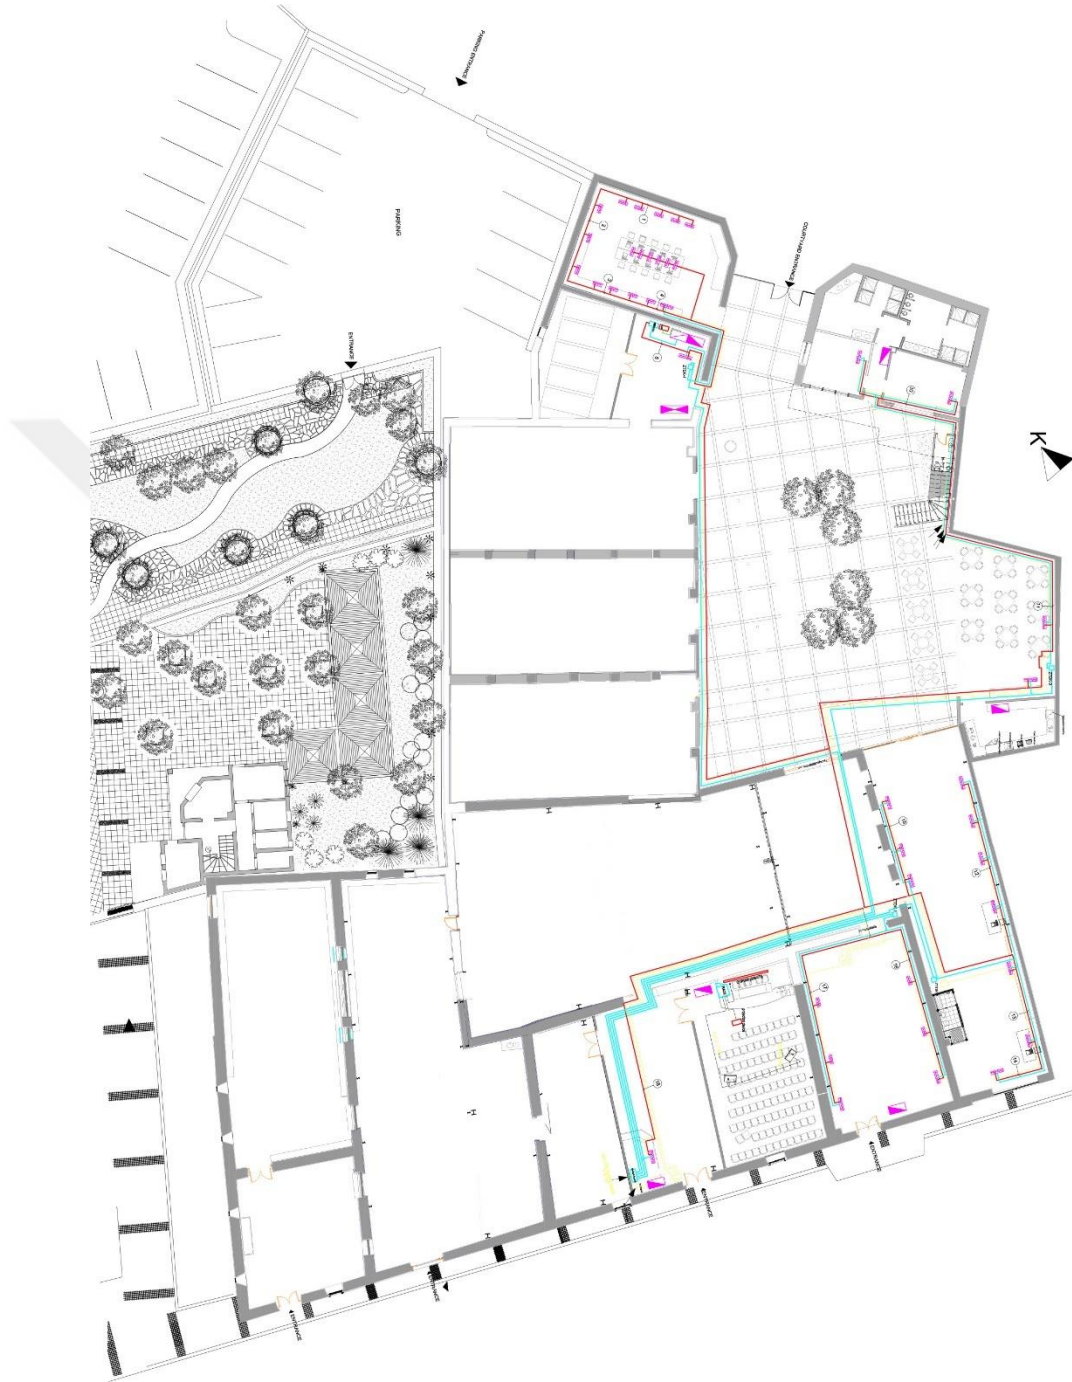
Figure A. 31. Weak Current Ground Floor Plan of Gözlükule Excavation Research Center, Tarsus, Mersin (Source: BOUN,2025)

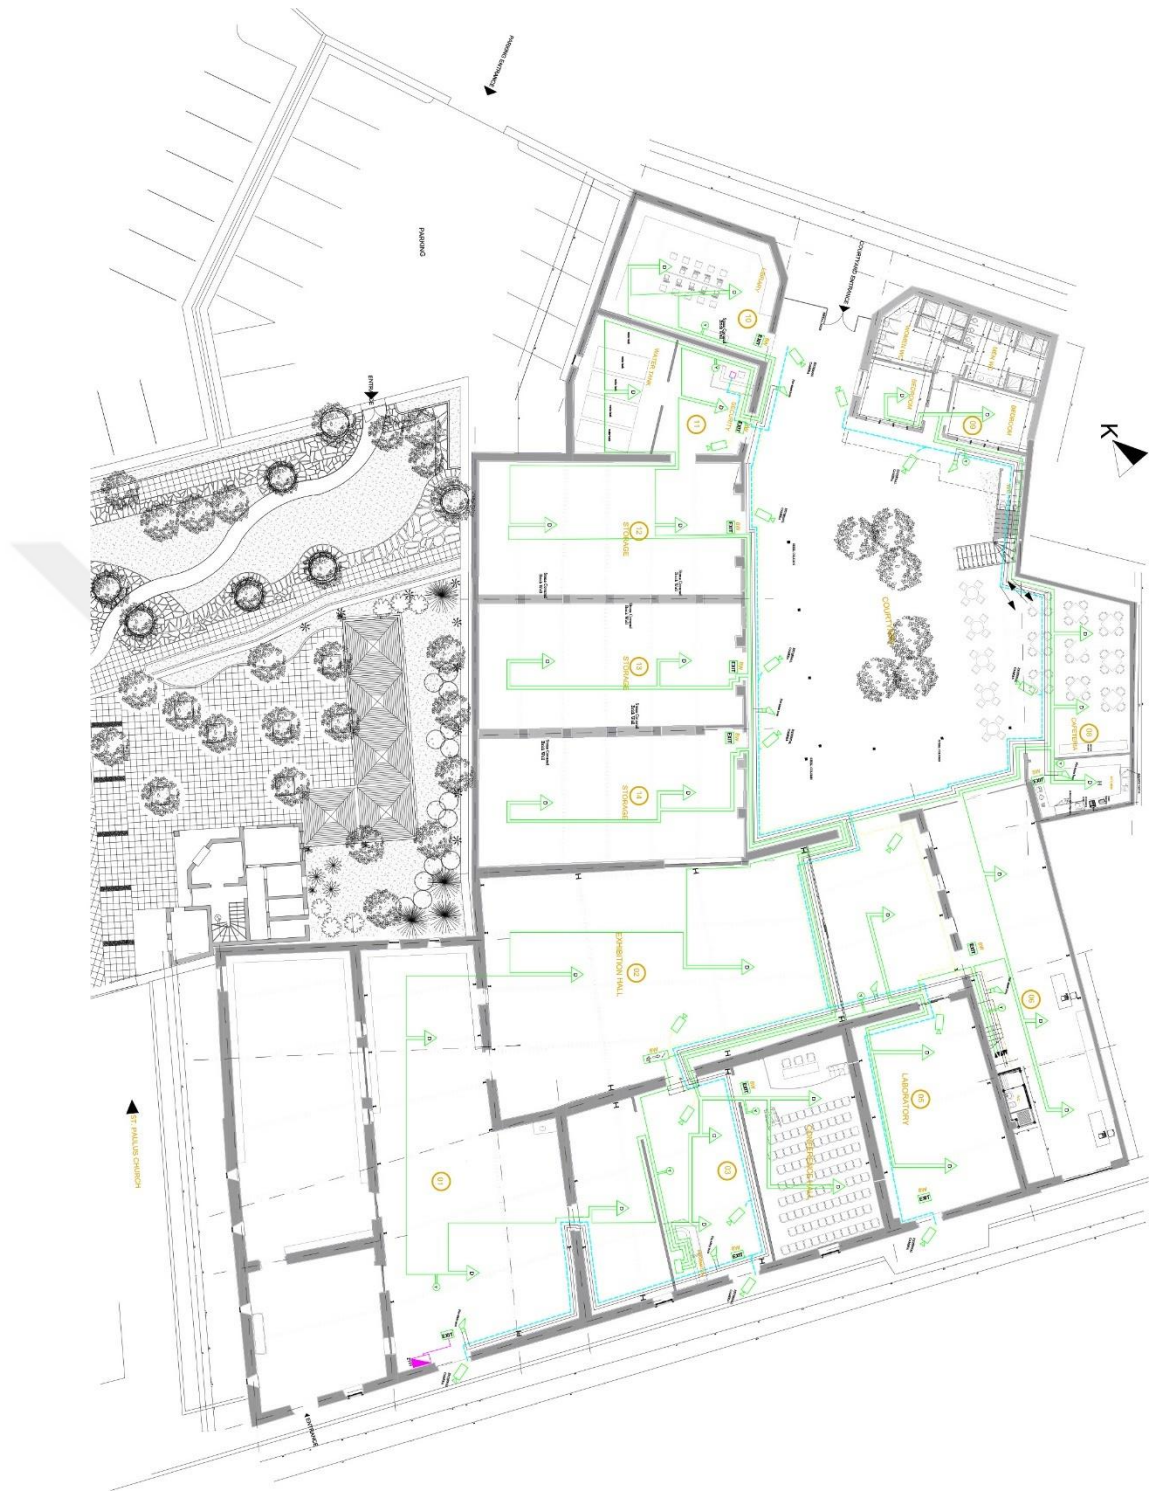
Figure A. 33.Fire Detection and Camera Connection Ground Floor Plan of Gözlükule Excavation Research Center, Tarsus, Mersin (Source: BOUN,2025)

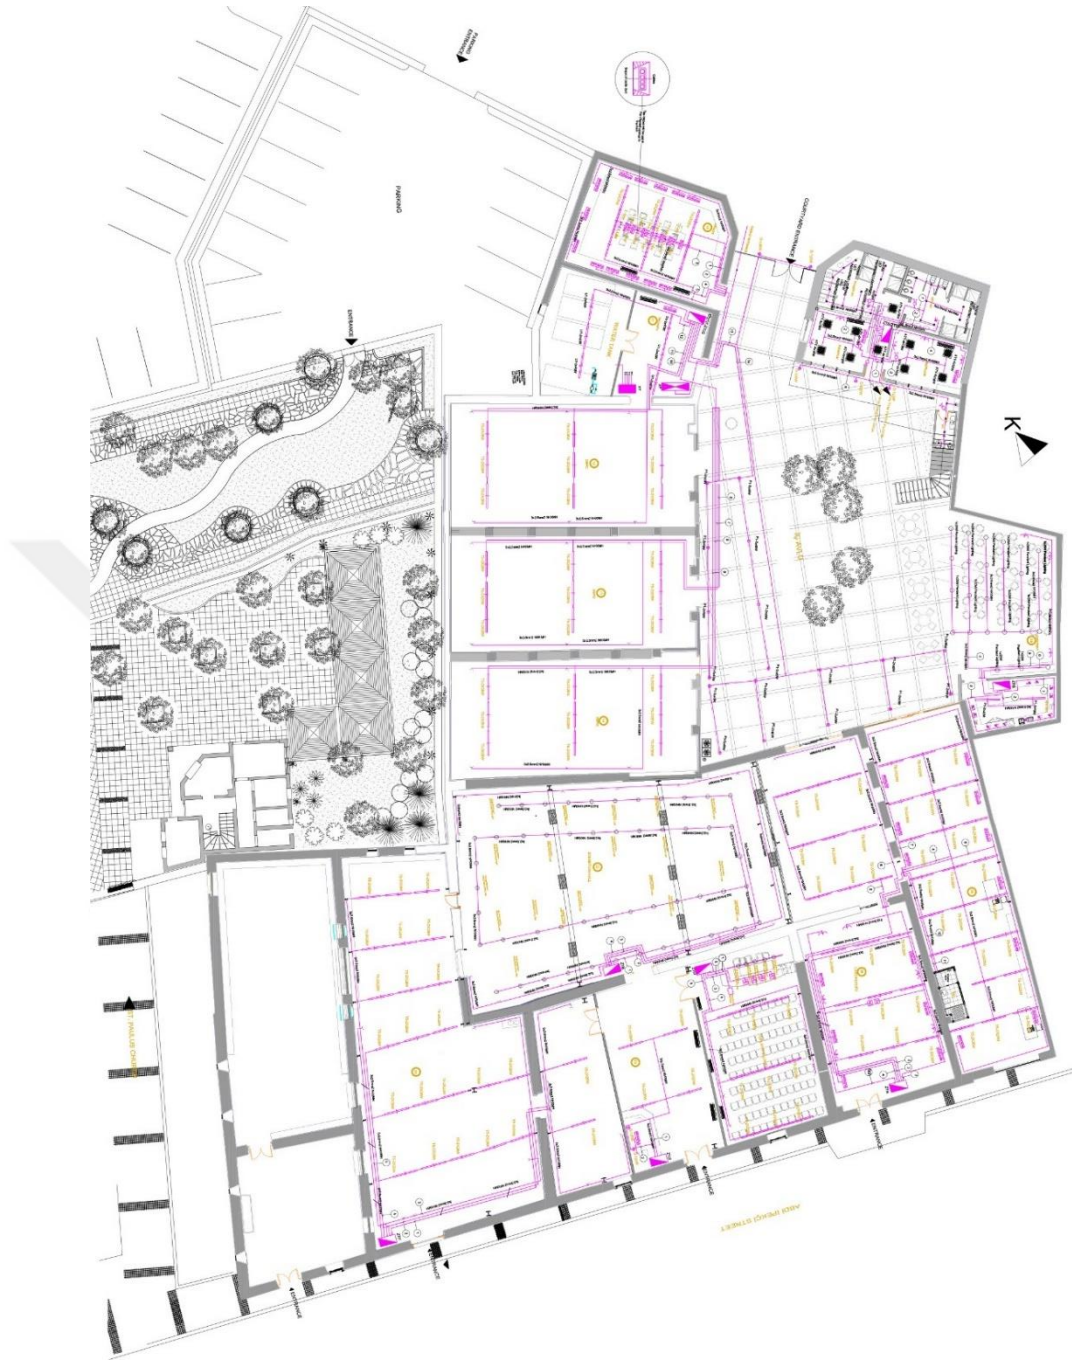
Figure A. 35. Lighting Ground Floor Plan of Gözlükule Excavation Research Center, Tarsus, Mersin (Source: BOUN,2025)
