**UNIVERSITY OF GAZIANTEP
GRADUATE SCHOOL OF
NATURAL & APPLIED SCIENCES**

**REHABILITATION OF THE DAMAGED GLASS-FIBER REINFORCED
CONCRETE CORBELS USING STEEL THREADED RODS**

**M. SC. THESIS
IN
CIVIL ENGINEERING**

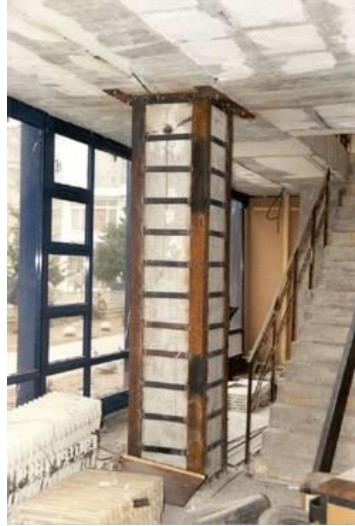
Figure 1.1 Steel-confined column (Source: <http://www.edac.biz>)

Externally confinement using steel has been appointed as one of the most active techniques to rehabilitate concrete structures, the studies showed that stainless steel confining rises the plastic deformation obviously, rises the energy absorbing performance of the structure, and rises the shear strength of the member, as shown in figure (1.1).

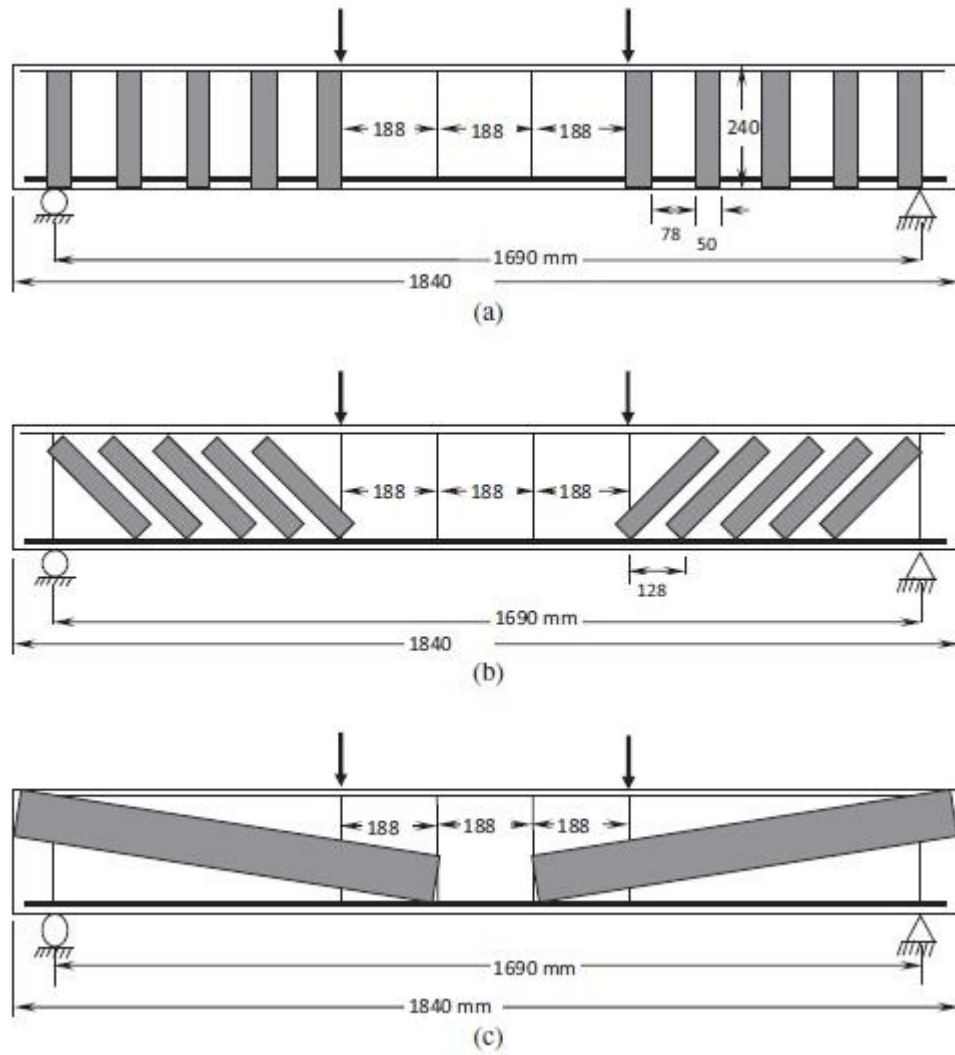
Figure 2.1 Details of three styles of strengthening with aluminum alloys

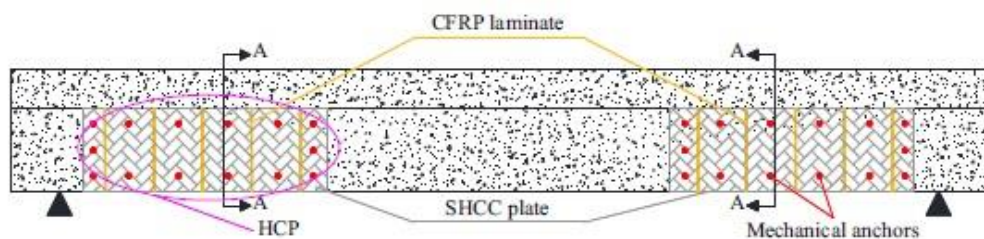
Figure 2.6 Scheme of (HCP) for shear strengthening of RC beams

For the purpose of bonding CFRP laminates and the SHCC plate, openings are made within the surface of the plate and CFRP laminates are fixed into these openings and bonded to the SHCC using a suitable epoxy.

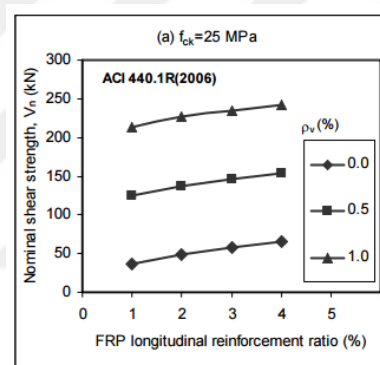
Figure 2.9 Effect of transverse reinforcement on nominal shear strength (ρ_v %) (Ramadass and Thomas, 2010)

(Ramadass and Thomas, 2010) did a theoretical study to discuss the efficiency of the stirrups made of FRP on the shear capacity of concrete beams. Through the study, they noticed that shear capacity of the member reinforced with GFRP becomes enhanced by raising the proportion of vertical reinforcement (ρ_v), the study has showed that longitudinal reinforcement affects secondarily on the shear strength of the member compared to the proportion of the transverse reinforcement. It has been noticed that raising (ρ_v) from 0% to 0.5% enhances the shear strength by 130% of the original strength, while the raising in the proportion from 0% to 1% leads to upgrading the shear strength by 330%, figure (2.9).

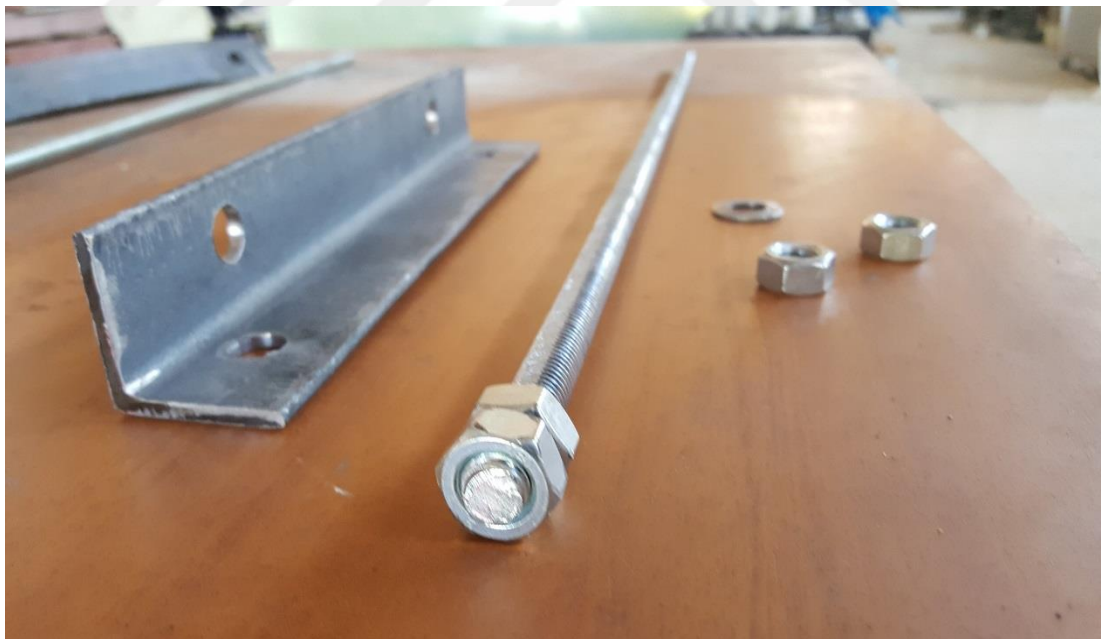
Figure 3.2 Steel Confining Elements

Threaded rods with lengths 0.2 m and 0.6 m were used. While, L40×40×4 sections with length of 27 cm have been used in the experiment, figure (3.2).

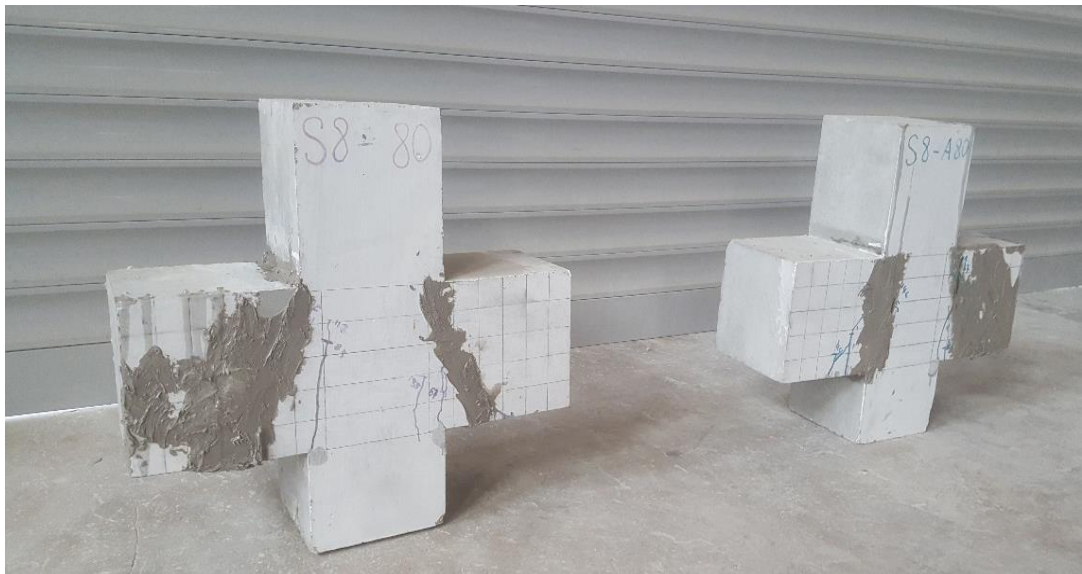
Figure 3.6 High Viscosity Epoxy coated corbels

High viscosity epoxy has been used to coat the cracks exteriorly. After mixing the two parts of epoxy, it was placed to the face of the samples, figure (3.6). After the epoxy was hardened up, deep cracks have been cleared with compressed air. Small cracks (smaller than 6 mm) have been filled with very low viscosity epoxy using (Gravity Feed) method to rehabilitate the small cracks, figure (3.7). Very low viscosity epoxy could cause a leakage because of the low viscosity, and it should be controlled. After leakage controlling, figure (3.8 - a, b), the specimens with leakage have been cured by closing the leakage points exteriorly with High viscosity epoxy. The rest of the cracks (larger than 6 mm) have been cracked with High viscosity epoxy. Finally, another coat of High viscosity epoxy was applied in order to offset the lost mass due to damage. Then, grinding machine have been used to adjust the geometry of the corbels, figure (3.9). It is an important condition to use mask while making the grinding, because of the active dust of the epoxies that can harm the person.

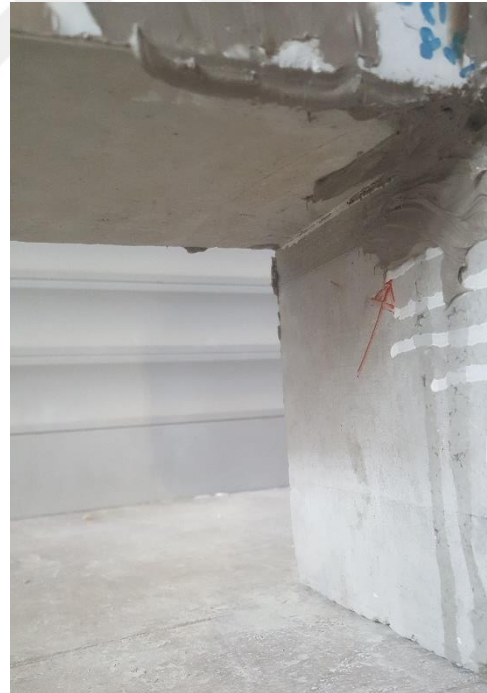
Figure 3.8 Lick controlling: **(a)** Licking of the very low viscosity epoxy, **(b)** Repair of the lick using the high viscosity epoxy.

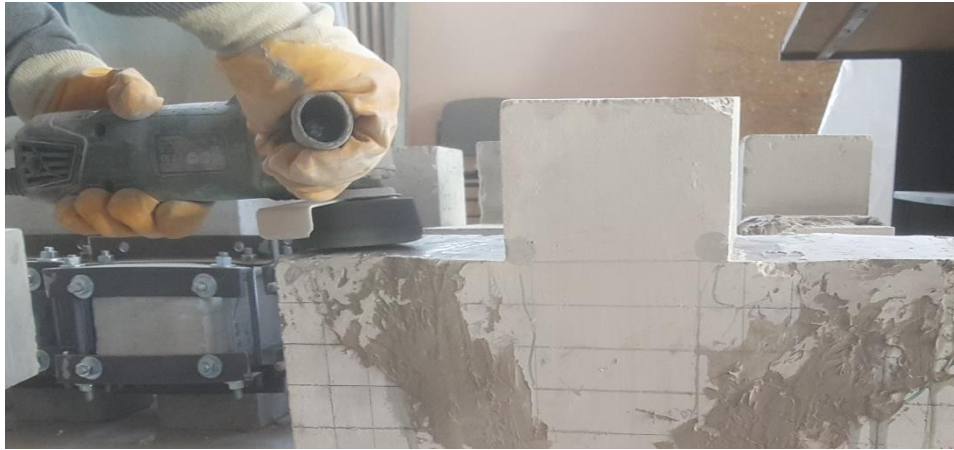
Figure 3.9 Adjusting the faces of the corbel by grinding machine

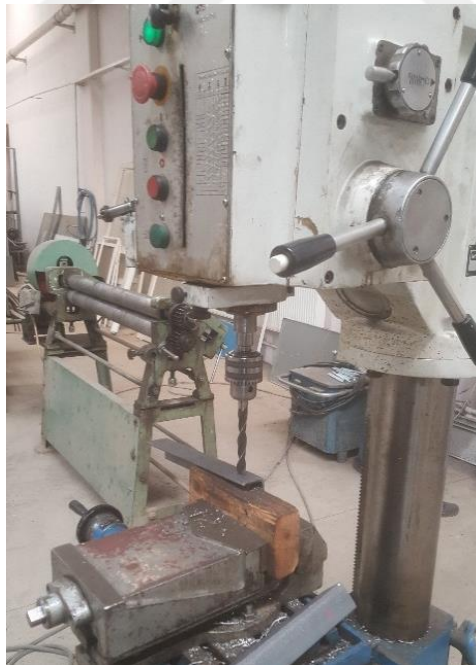
Figure 3.10 Steel punching machine

After cutting the steel L40×40×4 sections into 27 cm pieces, holes have been made in these pieces by steel punching machine, figure (3.10). Threaded rods have been cut into 0.6 m and 0.2 m pieces. All the pieces have been installed and tightened by using nut keys, figure (3.11).

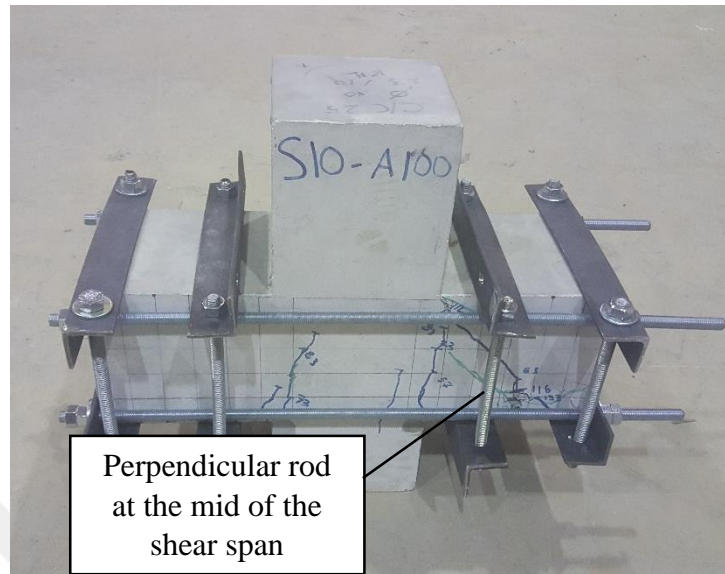
Figure 3.13 middle steel place

mid of the shear span to give the most effective performance against shear cracks, figure (3.13).

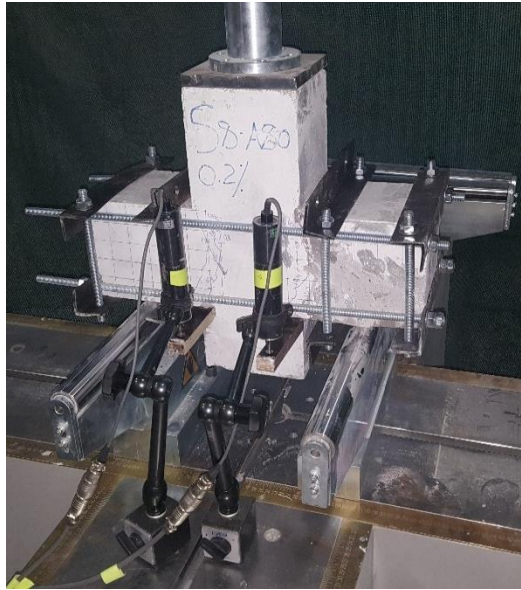
Figure 3.14 A prepared specimen to be tested

Testing machine was used with bearing capacity 500 KN. The load applied from the top face of the emerged column part of the sample. The machine has been set to work in displacement controlled mode with a rate of 0.4 mm/minute, and the reading frequency has been set to 5 readings/sec. After the machine program was configured, the LVDTs has been installed to the under corners between column and corbels. The chosen location of the LVDTs are the most deflected points at the member, figure (3.14).

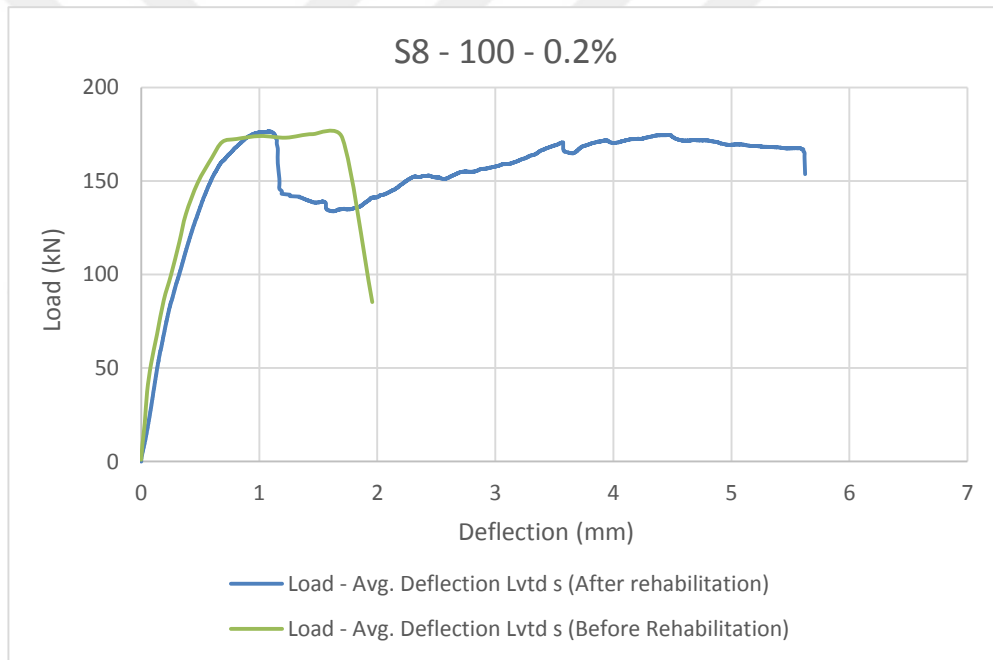
Figure 4.1 Effect of rehabilitation, style-1 (Specimen S8 - 100 - 0.2%)

Specimen (S8-100-0.2%) is a rehabilitated -previously shear failed- RC corbel, and It is a control specimen .The used style of rehabilitation was Style-1. This style consists of confining the corbel using only 4 L-Sections. Figure 4.1 shows the Load-Deflection behavior of the specimen before and after rehabilitation. The first crack propagation have been recorded at 84 kN at the right side –not damaged side-. After this point, both of the old and new cracks started to grow. At 173 kN (Maximum Load), a sudden big crack occurred at the previously cracked side –left -. Then, the specimen failed strongly at the previously damaged –left- side, at deflection of 5.62 mm. The failure mode was diagonally shear failure.

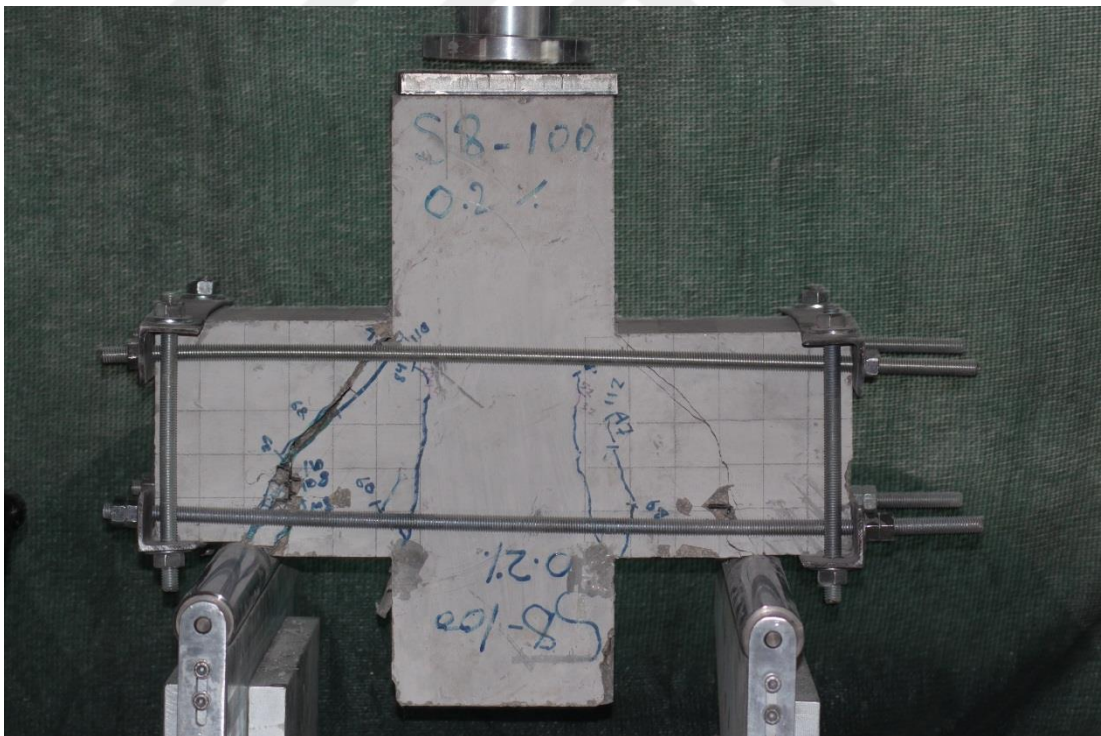
Figure 4.3 (Specimen S8 - 100 - 0.2%) after testing

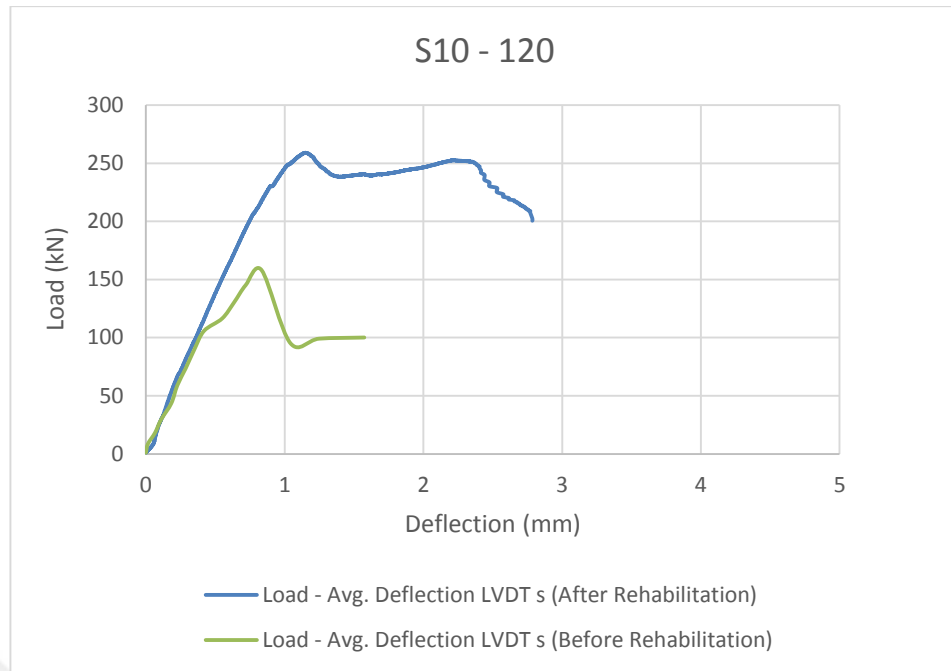
Figure 4.5 Effect of rehabilitation, style-2 (Specimen S10 – 120)

Specimen (S10-120) is a rehabilitated -previously shear failed- RC corbel. The used style of rehabilitation was Style-2. This style consists of repairing the cracks with epoxies, then, confining the corbel using 4 L-Sections. Figure 4.5 shows the Load-Deflection behavior of the specimen before and after rehabilitation. The first crack propagation have been recorded at 74 kN at the left side –previously damaged side-. After this point, the crack started to grow. At 256 kN (Maximum Load), a sudden big crack occurred at the same side. Then, the specimen failed strongly at same side –left-, at deflection of 2.79 mm. The failure mode was diagonally shear failure.

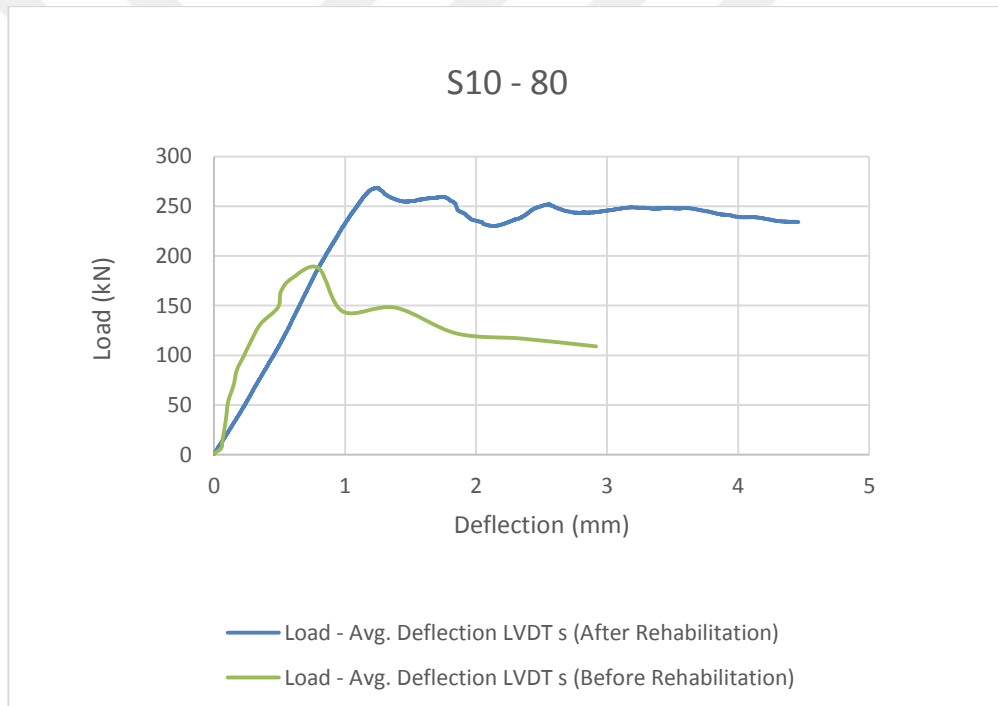
Figure 4.9 Effect of rehabilitation, style-2 (Specimen S10 - 80)

Specimen (S10-80) is a rehabilitated -previously shear failed- RC corbel. The used style of rehabilitation was Style-2. This style consists of repairing the cracks with epoxies, then, confining the corbel using 4 L-Sections. Figure 4.9 shows the Load-Deflection behavior of the specimen before and after rehabilitation. The first crack propagation have been recorded at 98.2 kN at the right side –previously damaged side-. After this point, the crack started to grow. At 265 kN (Maximum Load), a sudden big crack occurred at the same side –right-. Then, the specimen failed strongly at the same side, at deflection of 4.46 mm. The failure mode was diagonally shear failure.

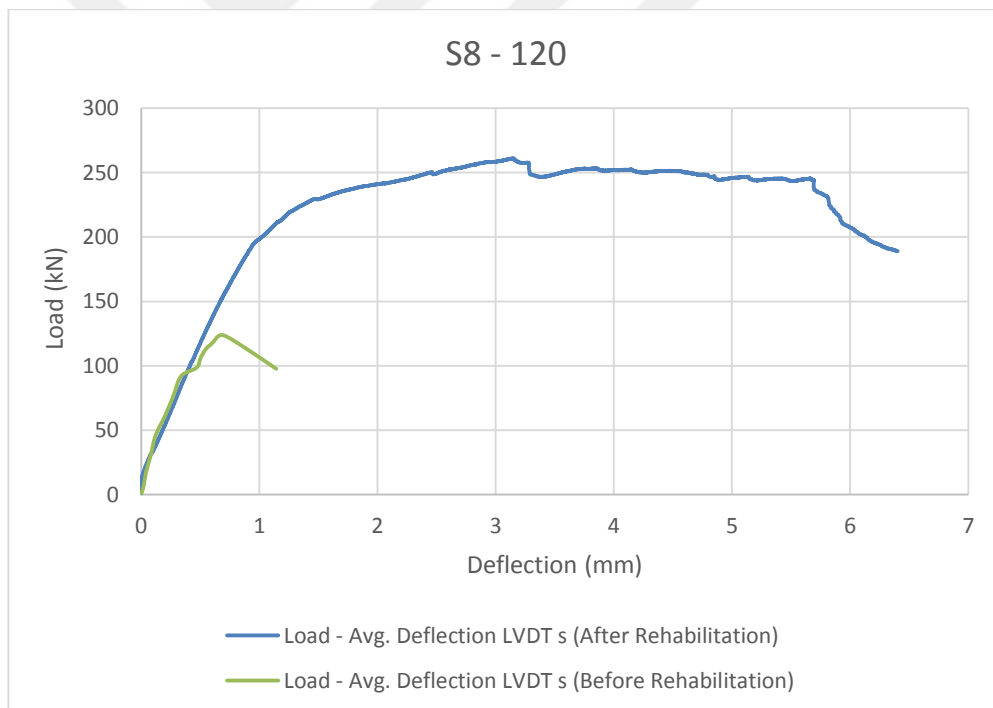
Figure 4.12 Effect of rehabilitation, style-3 (Specimen S8 - 120)

Specimen (S8-120) is a rehabilitated -previously shear failed- RC corbel. The used style of rehabilitation was Style-3. This style consists of confining the corbel using only 8 L-Sections. Figure 4.12 shows the Load-Deflection behavior of the specimen before and after rehabilitation. The first crack propagation have been recorded at 106 kN at the right side –not damaged side-. After this point, both of the old and new cracks started to grow. At 200 kN (Maximum Load), a sudden big crack occurred at the previously cracked side –left -. Then, the specimen failed strongly at the previously damaged –left- side. The deflection at the failure was 6.39 mm. The failure mode was diagonally shear failure.

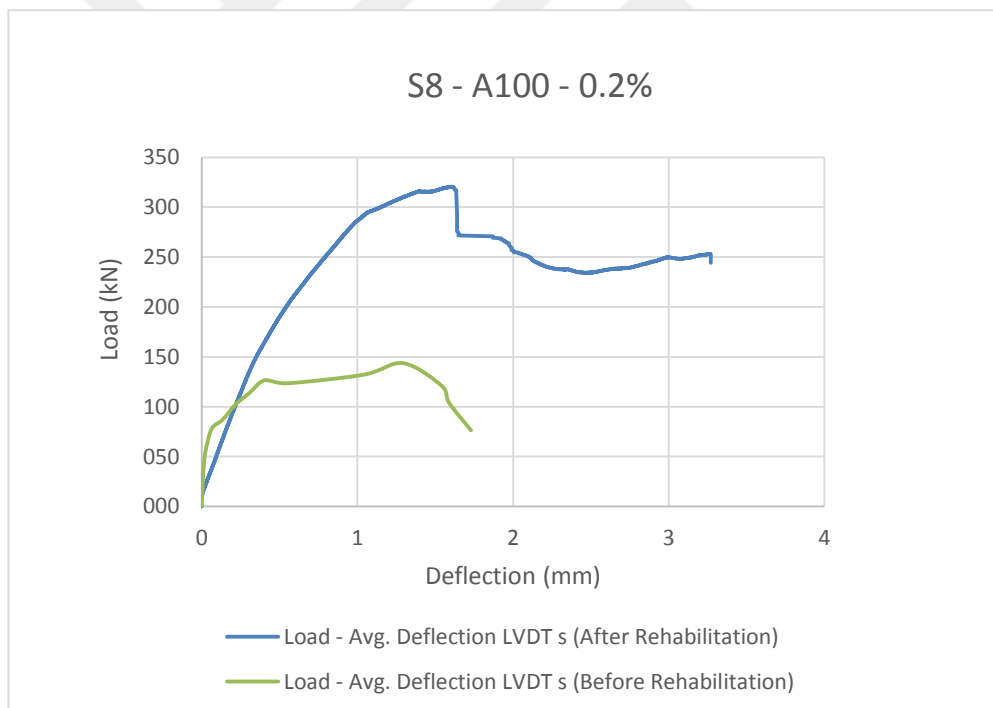
Figure 4.15 Effect of rehabilitation, style-3 (Specimen S8 - A100 - 0.2%)

Specimen (S8-A100-0.2%) is a rehabilitated -previously shear failed- RC corbel. The used style of rehabilitation was Style-3. This style consists of confining the corbel using only 8 L-Sections. Figure 4.15 shows the Load-Deflection behavior of the specimen before and after rehabilitation. The first crack propagation have been recorded at 126.5 kN at the right side –not damaged side-. After this point, both of the old and new cracks started to grow. At 317 kN (Maximum Load), a sudden big crack occurred at the previously cracked side –left -. Then, the specimen failed strongly at the previously damaged –left- side, at deflection of 3.27 mm. The failure mode was diagonally shear failure.

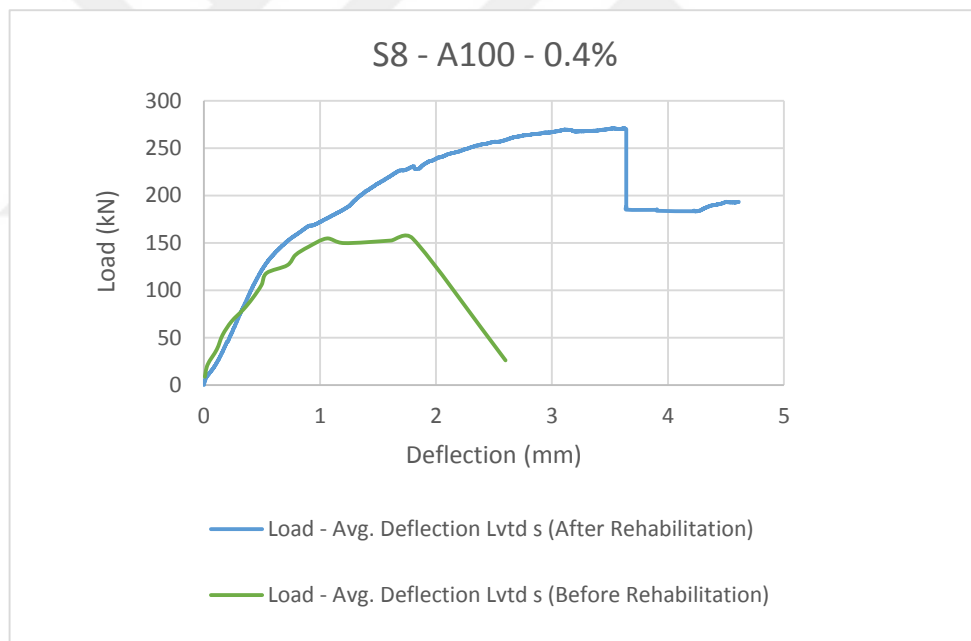
Figure 4.18 Effect of rehabilitation, style-3 (Specimen S8 - 100 - 0.4%)

Specimen (S8-100-0.4%) is a rehabilitated -previously shear failed- RC corbel. The used style of rehabilitation was Style-3. This style consists of confining the corbel using only 4 L-Sections. Figure 4.18 shows the Load-Deflection behavior of the specimen before and after rehabilitation. The first crack propagation have been recorded at 118 kN at the right side –not damaged side-. After this point, both of the old and new cracks started to grow. At 270 kN (Maximum Load), a sudden big crack occurred at the previously cracked side –left -. Then, the specimen failed strongly at the previously damaged –left- side. The deflection at the failure was 6.61 mm. The failure mode was diagonally shear failure.

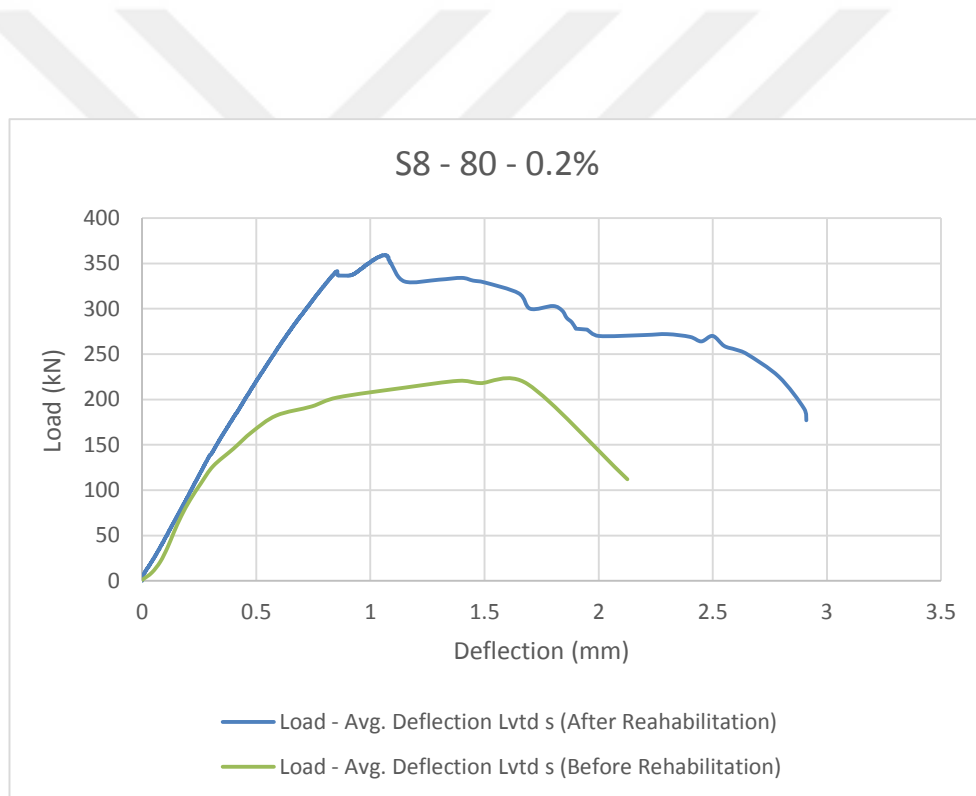
Figure 4.21 Effect of rehabilitation, style-3 (Specimen S8 - 80 - 0.2%)

Specimen (S8-80-0.2%) is a rehabilitated -previously shear failed- RC corbel. The used style of rehabilitation was Style-3. This style consists of confining the corbel using 8 L-Sections. Figure 4.21 shows the Load-Deflection behavior of the specimen before and after rehabilitation. The first crack propagation have been recorded at 142 kN at the right side –previously damaged side-. After this point, both of the old and new cracks started to grow. At 340 kN, a sudden big crack occurred at the right side. At 359 (Maximum Load), the crack began to grow seriously. The deflection at the failure was 2.91 mm. The failure mode was diagonally shear failure.

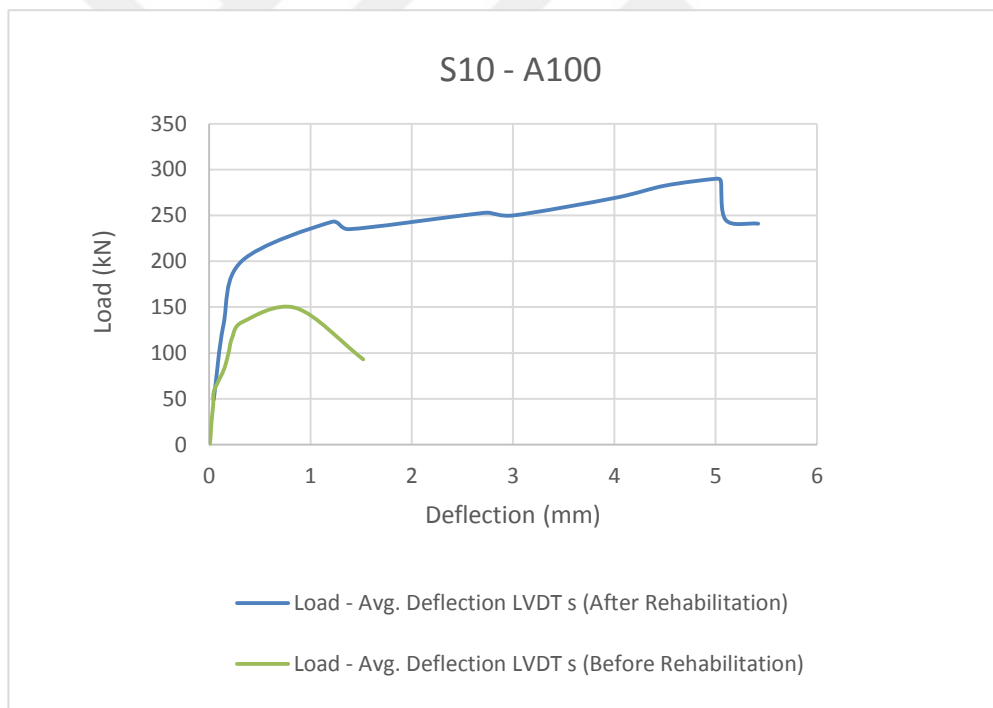
Figure 4.24 Effect of rehabilitation, style-3 (Specimen S10 - A100)

Specimen (S10-A100) is a rehabilitated -previously shear failed- RC corbel. The used style of rehabilitation was Style-3. This style consists of confining the corbel using 8 L-Sections. Figure 4.24 shows the Load-Deflection behavior of the specimen before and after rehabilitation. The first crack propagation have been recorded at 117 kN at the left side –not damaged side-. After this point, both of the old and new cracks started to grow. At 235 kN, a sudden big crack occurred at the right side –previously damaged side-. At 288 (Maximum Load), another sudden crack happened at the left side. The deflection at the failure was 5.42 mm. The failure mode was diagonally shear failure.

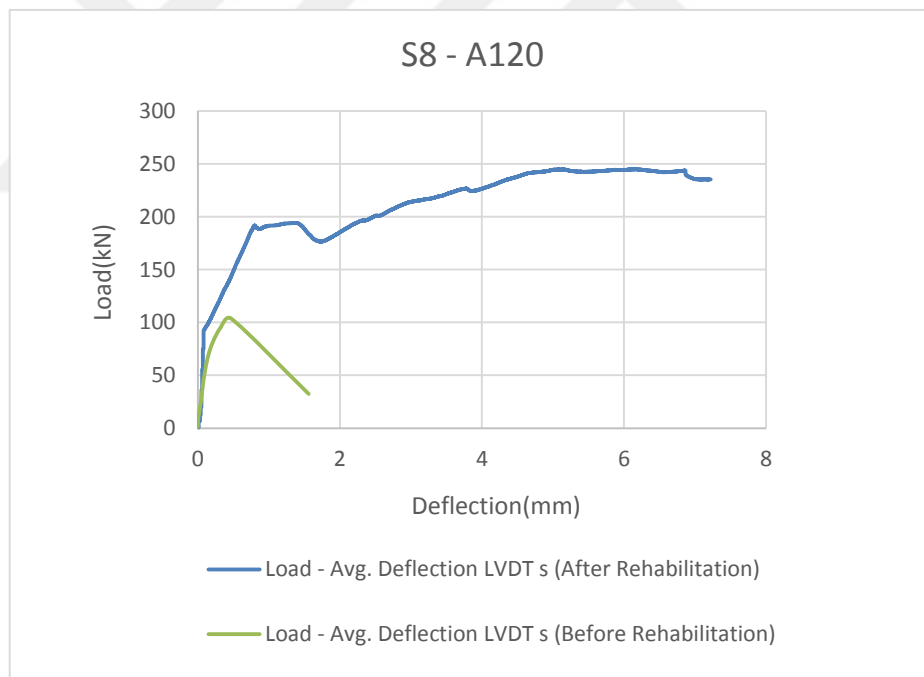
Figure 4.27 Effect of rehabilitation, style-4 (Specimen S8 - A120)

Specimen (S8-A120) is a rehabilitated -previously shear failed- RC corbel. The used style of rehabilitation was Style-4. This style consists of repairing the cracks with epoxies, then, confining the corbel using 8 L-Sections. Figure 4.27 shows the Load-Deflection behavior of the specimen before and after rehabilitation. The first crack propagation have been recorded at 81.5 kN at the right side –previously damaged side-. At 191 kN, a sudden crack occurred at the same side. At 243 (Maximum Load), the crack started to grow seriously. The deflection at the failure was 7.2 mm. The failure mode of the both sides was diagonally shear failure.

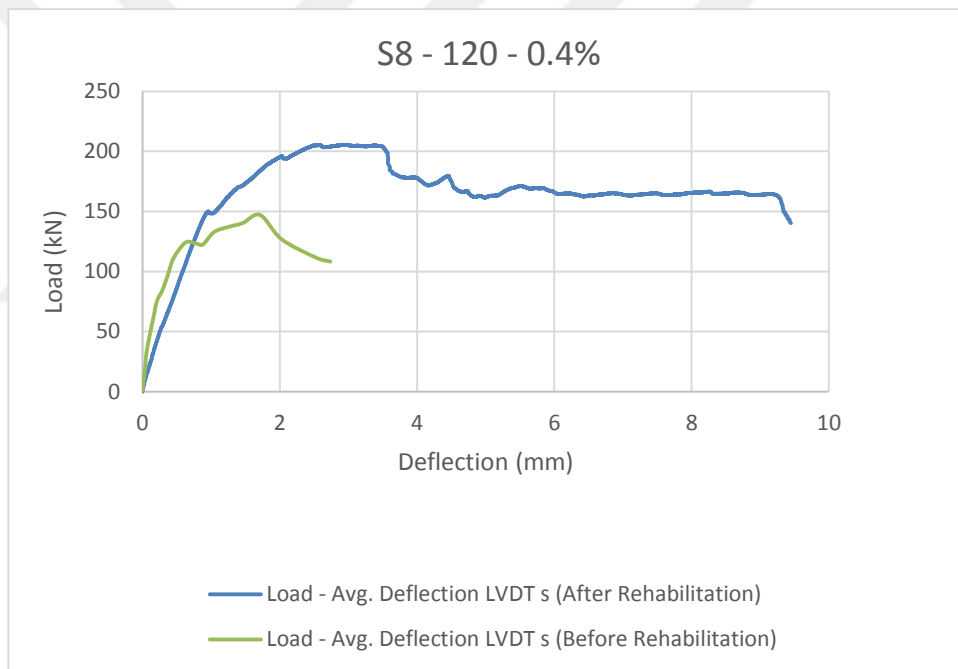
Figure 4.30 Effect of rehabilitation, style-4 (Specimen S8 - 120 - 0.4%)

Specimen (S8-120-0.4%) is a rehabilitated -previously shear failed- RC corbel. The used style of rehabilitation was Style-4. This style consists of repairing the cracks with epoxies, then, confining the corbel using 8 L-Sections. Figure 4.30 shows the Load-Deflection behavior of the specimen before and after rehabilitation. The first crack propagation have been recorded at 75.3 kN at the right and left sides respectively – both were previously damaged -. At 150 kN, a sudden crack occurred at the same side. At 205 (Maximum Load), the crack started to grow seriously until it failed at the right side. The deflection at the failure was 9.45 mm. The failure mode of the both sides was diagonally shear failure.

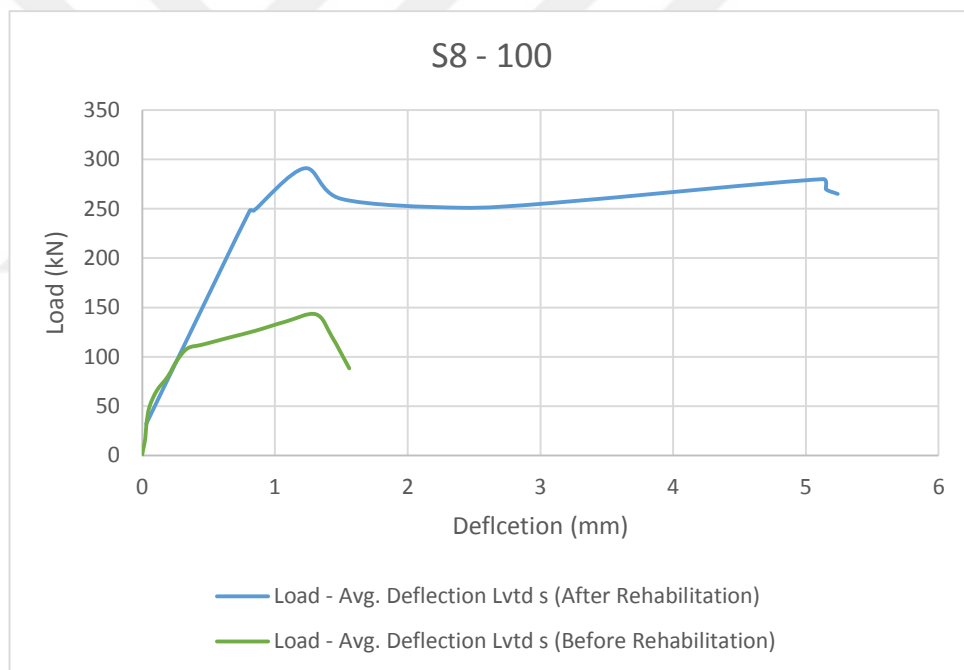
Figure 4.33 Effect of rehabilitation, style-4 (Specimen S8 – 100)

Specimen (S8-100) is a rehabilitated -previously shear failed- RC corbel. The used style of rehabilitation was Style-4. This style consists of repairing the cracks with epoxies, then, confining the corbel using 8 L-Sections. Figure 4.33 shows the Load-Deflection behavior of the specimen before and after rehabilitation. The first crack propagation have been recorded at 60 kN at the right side -previously damaged -. At 248 kN, a sudden crack occurred at the same side. At 291 (Maximum Load), the crack started to grow seriously until it failed at the same side. The deflection at the failure was 5.24 mm. The failure mode was diagonally shear failure.

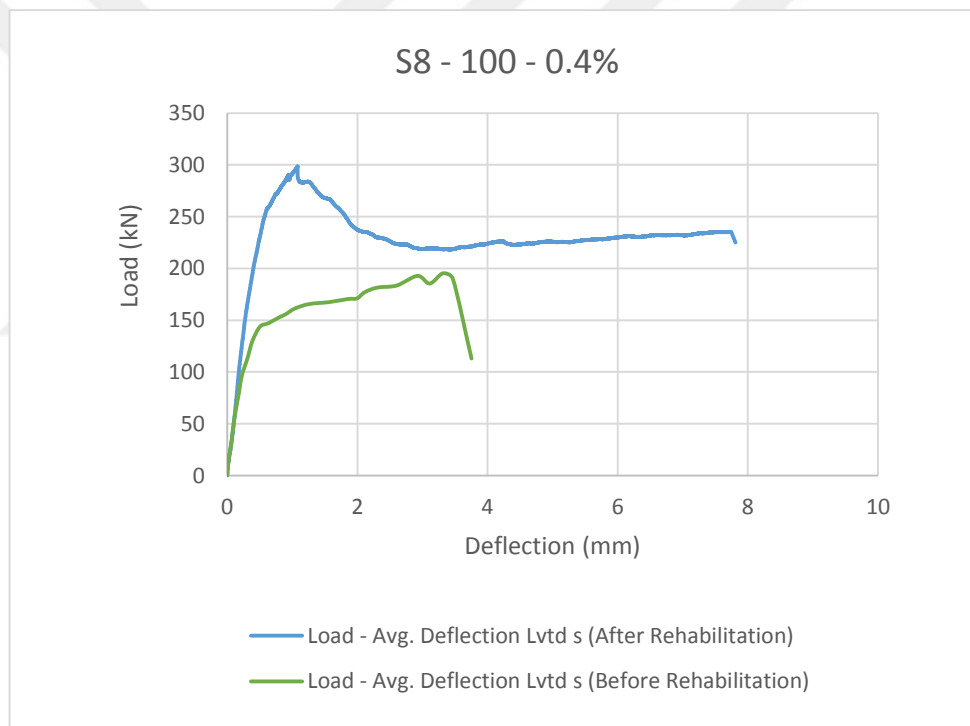
Figure 4.36 Effect of rehabilitation, style-4 (Specimen S8 - 100 - 0.4%)

Specimen (S8-100-0.4%) is a rehabilitated -previously shear failed- RC corbel. The used style of rehabilitation was Style-4. This style consists of repairing the cracks with epoxies, then, confining the corbel using 8 L-Sections. Figure 4.36 shows the Load-Deflection behavior of the specimen before and after rehabilitation. The first crack propagation have been recorded at 100.6 kN at the left side. After this point, the crack started to grow. At 295 kN (Maximum Load), a sudden big crack occurred at the same side –left -. Later, the specimen failed strongly at the same side. The deflection at the failure was 7.81 mm. The failure mode was diagonally shear failure.

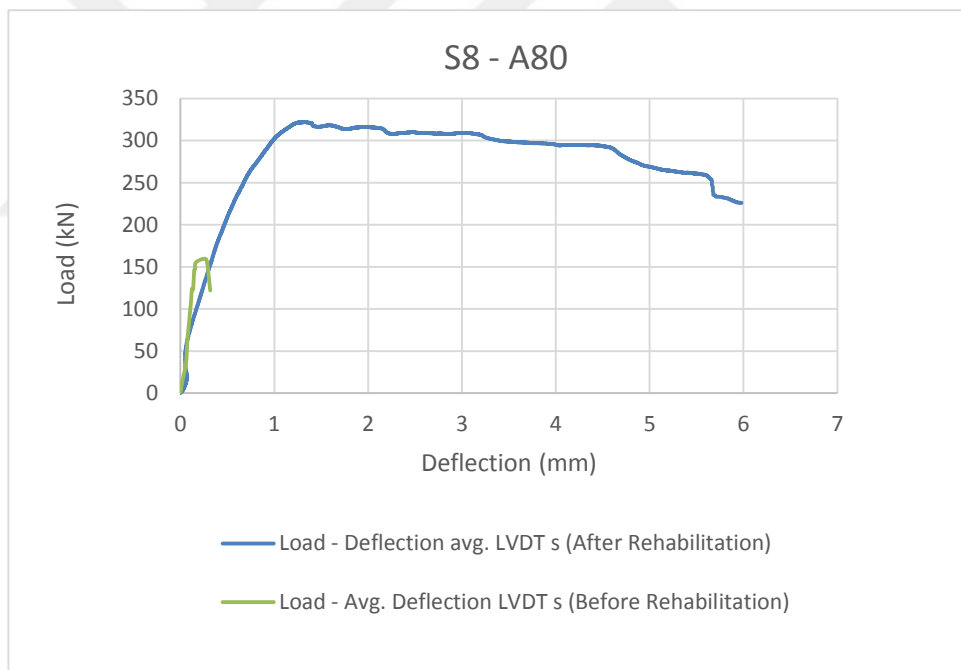
Figure 4.39 Effect of rehabilitation, style-4 (Specimen S8 – A80)

Specimen (S8-A80) is a rehabilitated -previously shear failed- RC corbel. The used style of rehabilitation was Style-4. This style consists of repairing the cracks with epoxies, then, confining the corbel using 8 L-Sections. Figure 4.39 shows the Load-Deflection behavior of the specimen before and after rehabilitation. The first crack propagation have been recorded at 100.6 kN at the right side –previously damaged side-. At 260 kN, another crack started to appear at the left side –not damaged side-. At 318 kN (Maximum Load), a sudden big crack occurred at the right side. Later, the specimen failed strongly at the righ side. The deflection at the failure was 5.96 mm. The failure mode was diagonally shear failure.

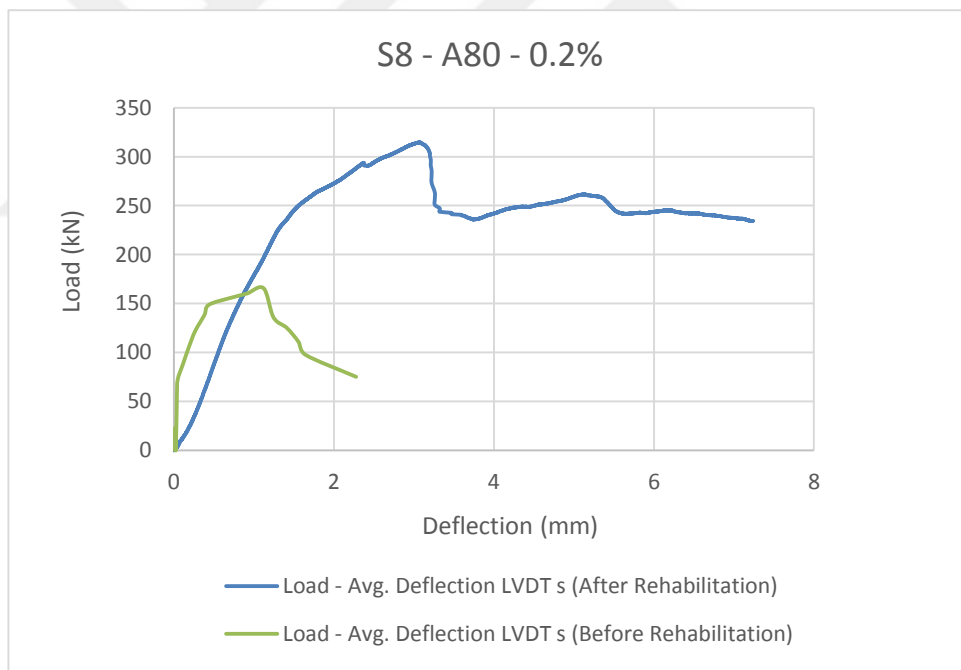
Figure 4.42 Effect of rehabilitation, style-4 (Specimen S8 – A80 – 0.2%)

Specimen (S8-A80-0.2%) is a rehabilitated -previously shear failed- RC corbel. The used style of rehabilitation was Style-4. This style consists of repairing the cracks with epoxies, then, confining the corbel using 8 L-Sections. Figure 4.42 shows the Load-Deflection behavior of the specimen before and after rehabilitation. The first crack propagation have been recorded at 80 kN at the right side –previously damaged side-. At 291 kN, another crack started to appear at the left side –not damaged side-. At 313 kN (Maximum Load), a sudden big crack occurred at the right side. Later, the specimen failed strongly at the right side. The deflection at the failure was 7.23 mm. The failure mode was diagonally shear failure.

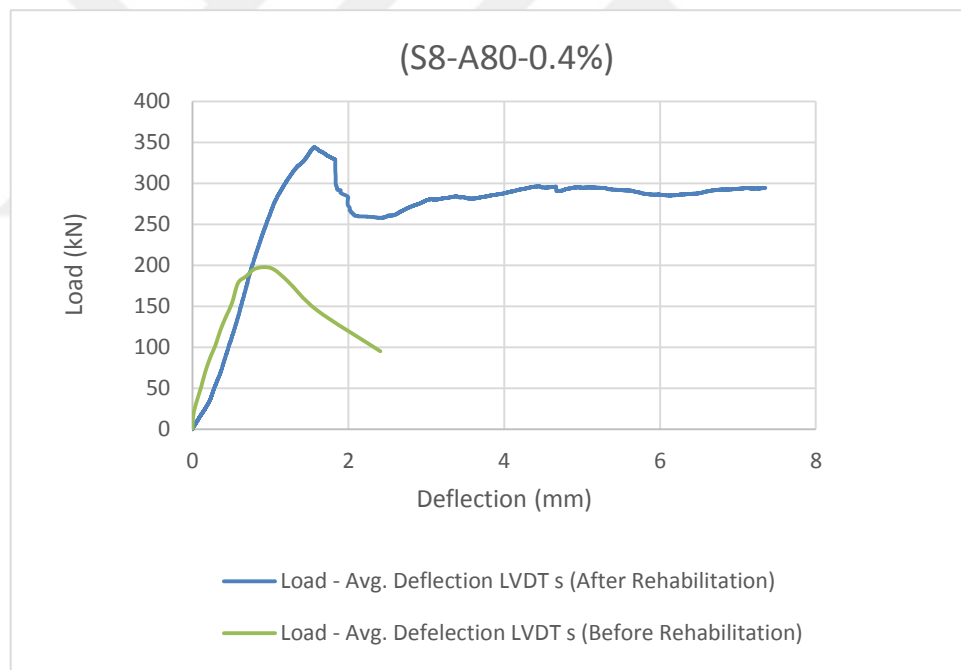
Figure 4.45 Effect of rehabilitation, style-4 (Specimen S8 – A80 – 0.4%)

Specimen (S8-A80-0.4%) is a rehabilitated -previously shear failed- RC corbel. The used style of rehabilitation was Style-4. This style consists of repairing the cracks with epoxies, then, confining the corbel using 8 L-Sections. Figure 4.45 shows the Load-Deflection behavior of the specimen before and after rehabilitation. The first crack propagation have been recorded at 196 kN at the right side (previously damaged side). At 273 kN, another crack started to appear at the left side –not damaged side-. At 314 kN (Maximum Load), a sudden big crack occurred at the right side. Later, the specimen failed strongly at the right side. The deflection at the failure was 7.34 mm. The failure mode was diagonally shear failure.

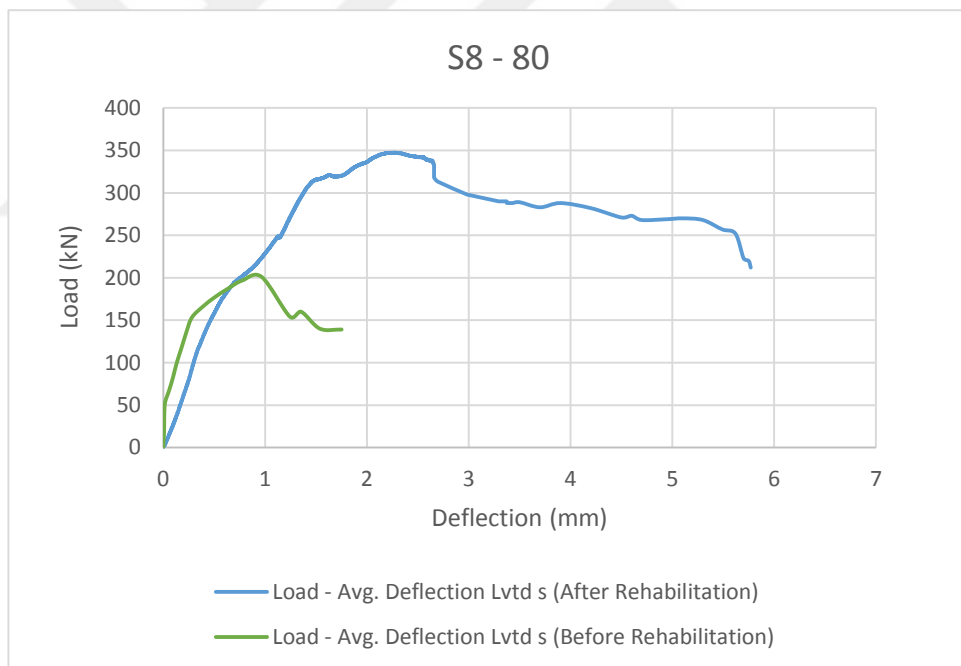
Figure 4.48 Effect of rehabilitation, style-4 (Specimen S8 - 80)

Specimen (S8-80) is a rehabilitated -previously shear failed- RC corbel. The used style of rehabilitation was Style-4. This style consists of repairing the cracks with epoxies, then, confining the corbel using 8 L-Sections. Figure 4.48 shows the Load-Deflection behavior of the specimen before and after rehabilitation. The first crack propagation have been recorded at 122 kN at the left side –previously damaged side-. At 247.2 kN, another crack started to appear at the right side –not damaged side-. At 319 kN a sudden big crack occurred at the left side. Later, the specimen failed strongly at the right side. The deflection at the failure was 5.77 mm and the maximum load was (347.3 kN). The failure mode was diagonally shear failure.

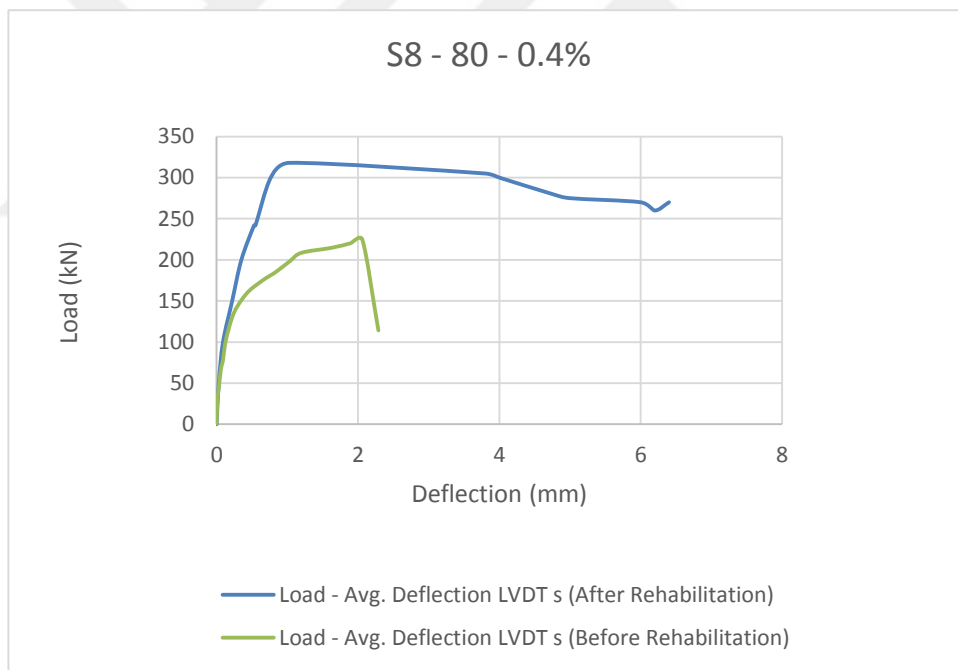
Figure 4.51 Effect of rehabilitation, style-4 (Specimen S8 - 80 - 0.4%)

Specimen (S8-80-0.4%) is a rehabilitated -previously shear failed- RC corbel. The used style of rehabilitation was Style-4. This style consists of repairing the cracks with epoxies, then, confining the corbel using 8 L-Sections. Figure 4.51 shows the Load-Deflection behavior of the specimen before and after rehabilitation. The first crack propagation have been recorded at 113.4 kN at the right side –previously damaged side-. At 242 kN, another crack started to appear at the left side –not damaged side-. At 318 kN (Maximum Load), the crack at the right side began to grow seriously. Later, the specimen failed strongly at the right side. The deflection at the failure was 6.4 mm. The failure mode was diagonally shear failure.

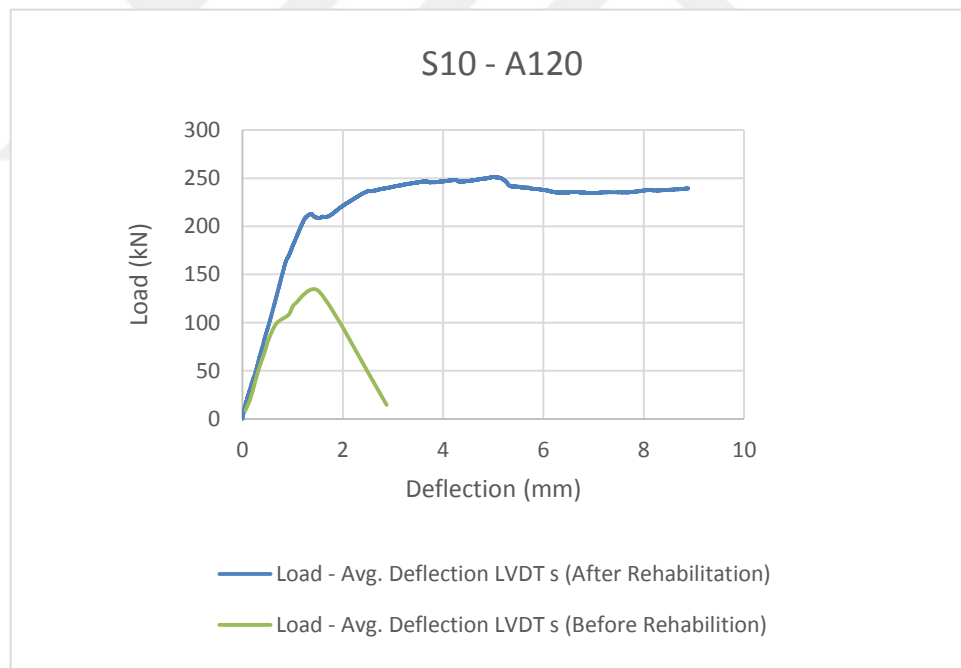
Figure 4.54 Effect of rehabilitation, style-4 (Specimen S10 - A120)

Specimen (S10-A120) is a rehabilitated -previously shear failed- RC corbel. The used style of rehabilitation was Style-4. This style consists of repairing the cracks with epoxies, then, confining the corbel using 8 L-Sections. Figure 4.54 shows the Load-Deflection behavior of the specimen before and after rehabilitation. The first crack propagation have been recorded at 99.4 kN at the left side –previously damaged side-. At 162 kN, another crack started to appear at the right side –not damaged side-. At 210 kN a sudden crack happened at the left side. At 249.7 kN (Maximum Load), the crack at the left side began to grow seriously. Later, the specimen failed strongly at the left side. The deflection at the failure was 8.84 mm. The failure mode was diagonally shear failure.
