**UNIVERSITY OF GAZIANTEP
GRADUATE SCHOOL OF
NATURAL & APPLIED SCIENCES**

**REHABILITATION OF THE DAMAGED GLASS-FIBER REINFORCED
CONCRETE CORBELS USING STEEL THREADED RODS**

**M. SC. THESIS
IN
CIVIL ENGINEERING**

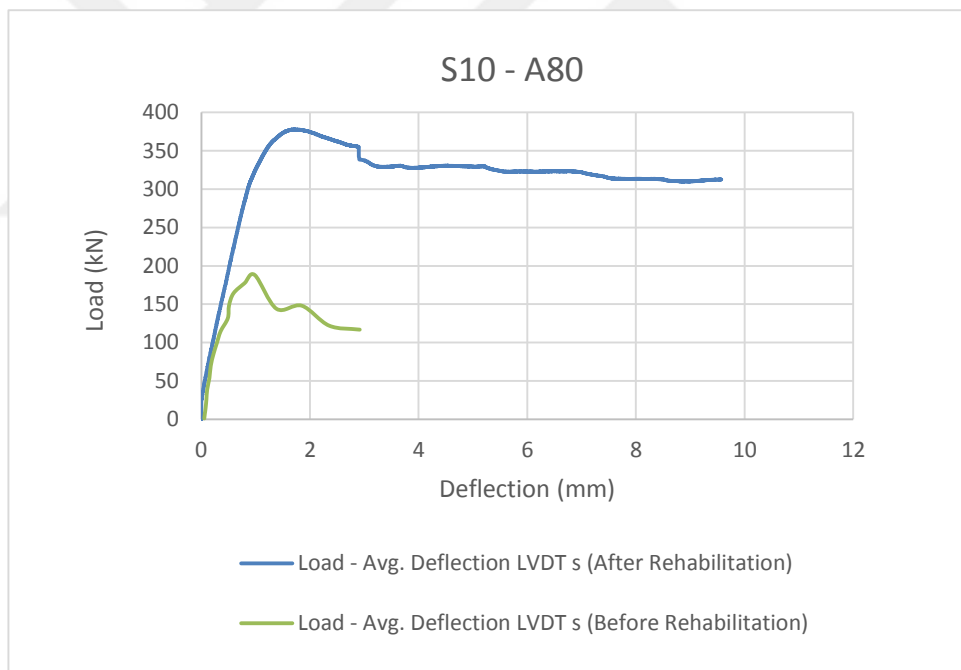
Figure 4.57 Effect of rehabilitation, style-4 (Specimen S10 – A80)

Specimen (S10-A120) is a rehabilitated -previously shear failed- RC corbel. The used style of rehabilitation was Style-4. This style consists of repairing the cracks with epoxies, then, confining the corbel using 8 L-Sections. Figure 4.57 shows the Load-Deflection behavior of the specimen before and after rehabilitation. The first crack propagation have been recorded at 116 kN at the right side –previously damaged side- and the crack began to grow. At 377.6 kN (Maximum Load), the crack at the right side began to grow seriously. Then, a sudden crack happened at the right side at (337.6 kN). Later, the specimen failed strongly at the same side. The deflection at the failure was 9.55 mm. The failure mode was diagonally shear failure.

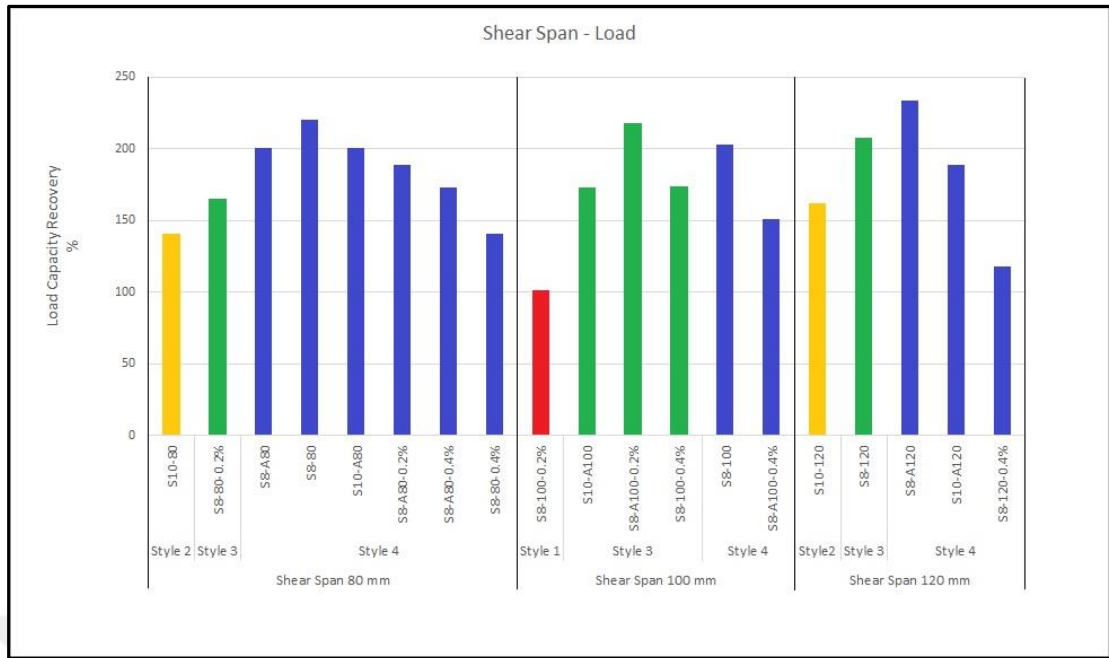
Figure 4.60 Relation between load capacity recovery and shear span according to rehabilitation styles

By examining the results, it was observed that shear span affects the rehabilitation efficiency, figure (4.60). Specimens with larger shear span were recovered better than those with smaller shear spans. This remark was obvious especially in styles-(2, and 3). This may be because of two reasons: first reason, the activity of the steel system starts at earlier time, since the epoxies have no serious effect in large spans and fail early. The second reason, the old performances were different, while, the new performances are more similar because the rehabilitation system forms a new composite material instead of the concrete. The figure (4.61) gives a further explanation about this point.

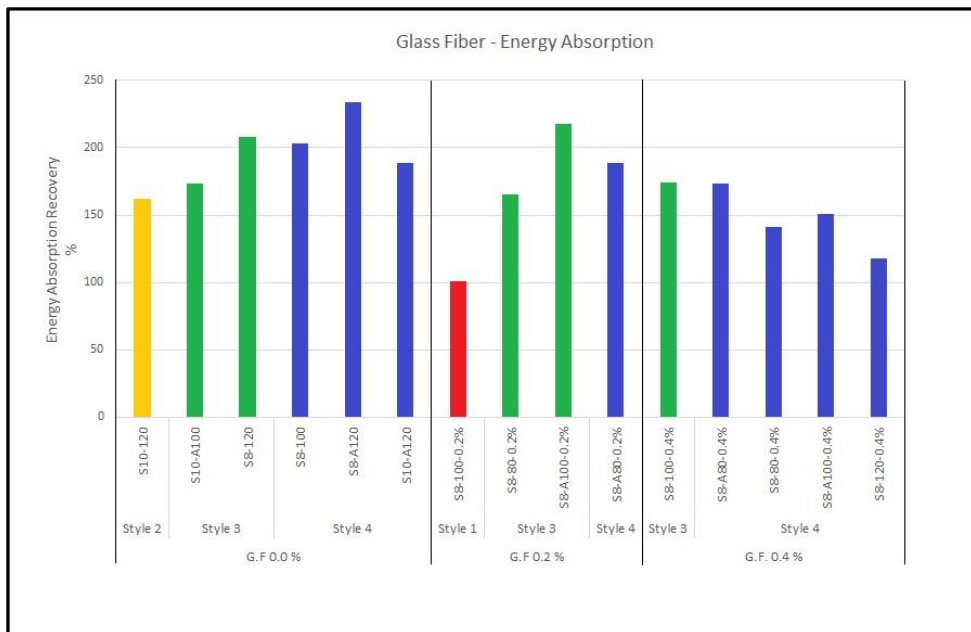
Figure 4.63 Energy absorption recovery according to glass fiber content

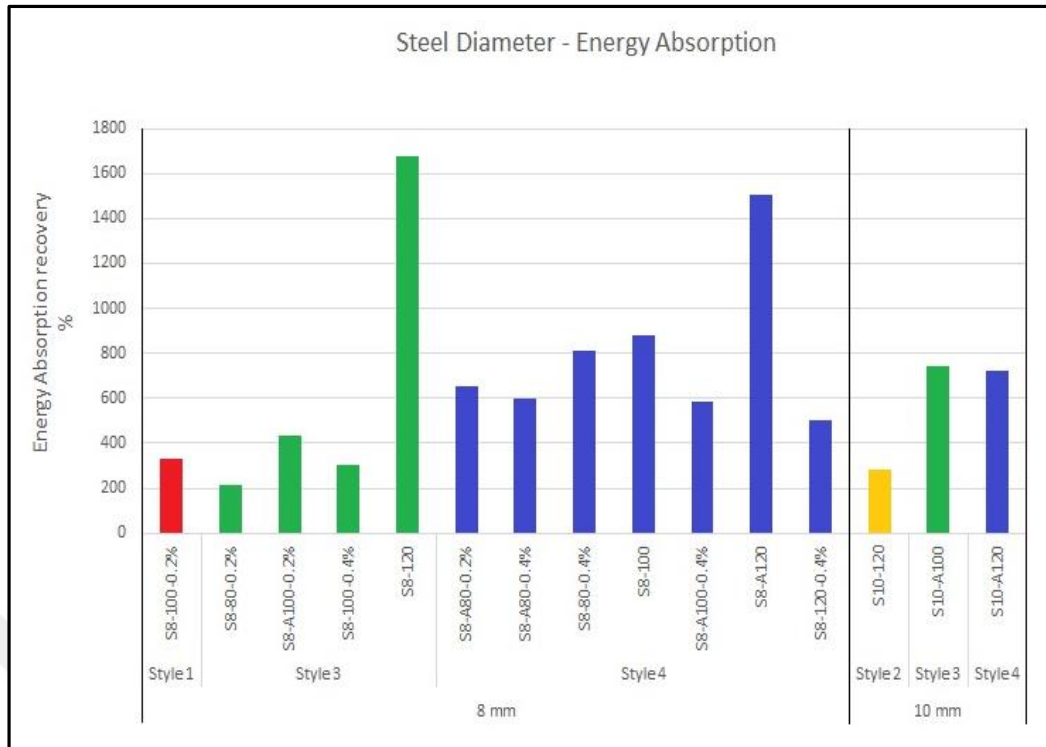
Figure 4.65: Energy absorption recovery according to reinforcement steel diameter

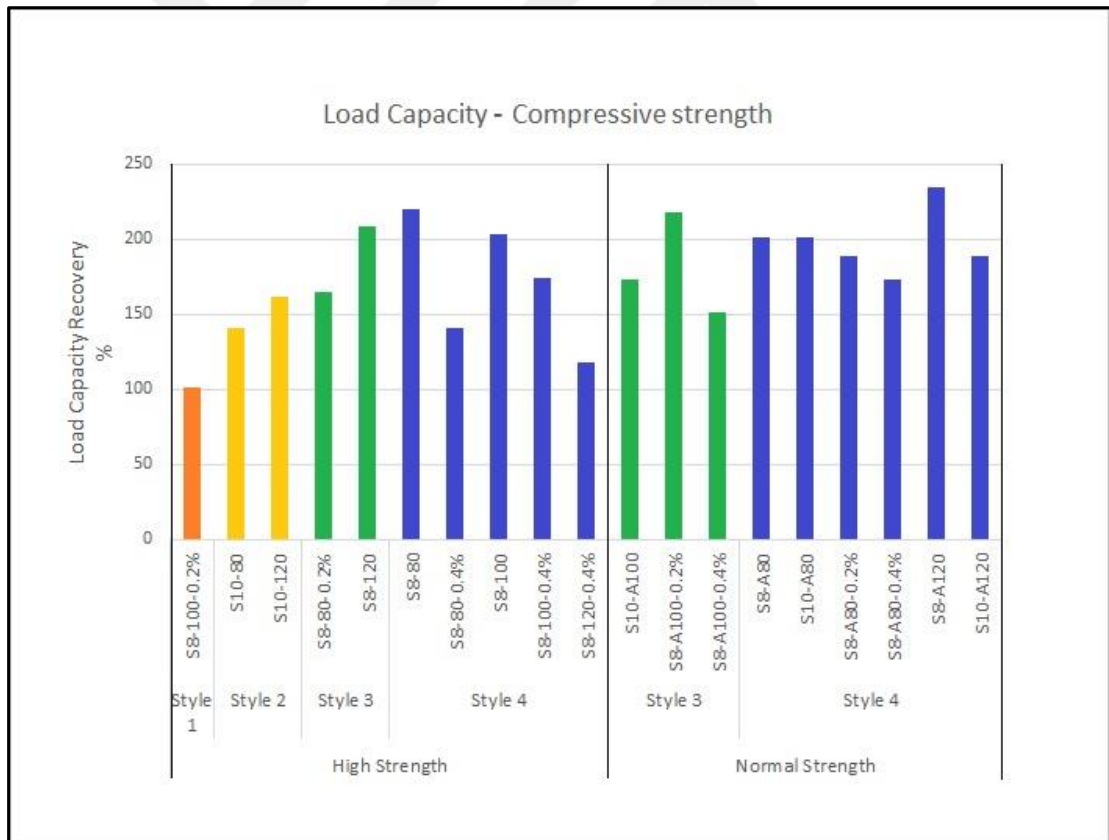
Figure 4.67: Load capacity recovery according to compressive strength
