**DETECTION OF DAMAGES IN CFST COLUMN USING ULTRASONIC  
WAVES**

M.Sc.THESES

PREPARED BY: Nashwan Ibrahim SALEH  
SUPERVISOR: Assoc. Prof. Dr. Murat MUVAFİK  
CO – SUPERVISOR: Prof Dr. Nadom Khalifa MUTLİB

VAN - 2021

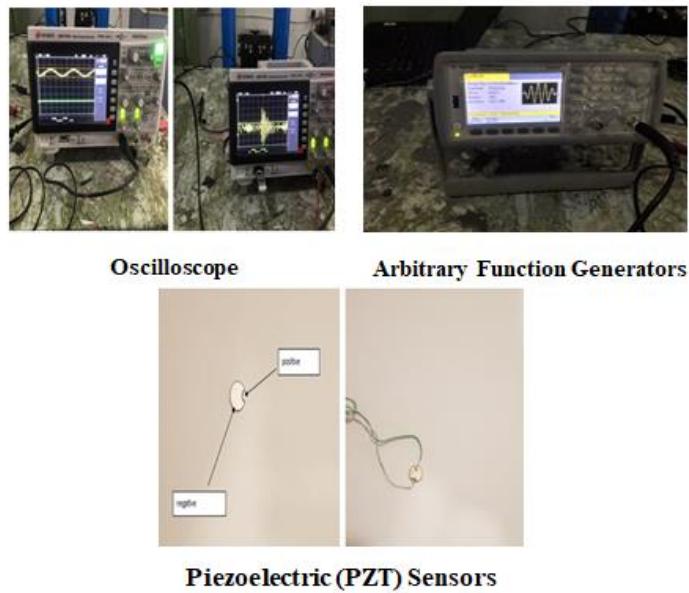
Concrete filled-steel tube samples are prepared using the required materials in the labs. ACI code followed in the casting process. Oscilloscope and function generator shown in (Figure 3.1) below were used in the wave detection process. The wave signal was created and transmitted using the wave generator using an arbitrary wave function. After that, the piezoelectric transmitter sensor transferred the signal into the sample and the receiver sensor convert the wave back into an electrical signal to be captured and saved by the oscilloscope.

Figure 3.1. The Oscilloscope, function generator devices, and piezoelectric transmitter sensor use in study.

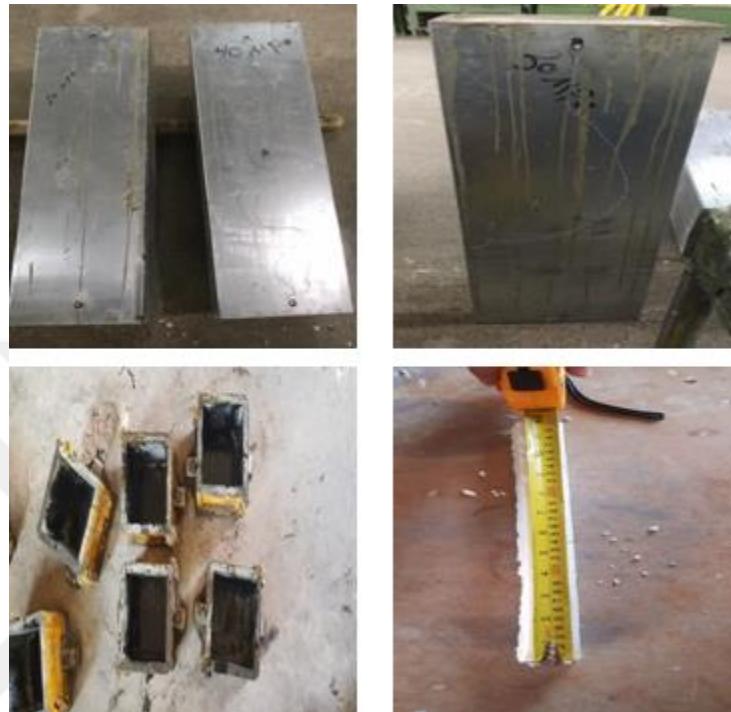
remove the polystyrene material using this liquid leaving the rooms which perform the debonding damage. The concrete-filled steel tube, the dimension of the damage, and cubes are shown in (Figure 3.2).

Figure 3.2. The sampling (20 Mpa, 30 Mpa, 40 Mpa)and the dimensions damages.

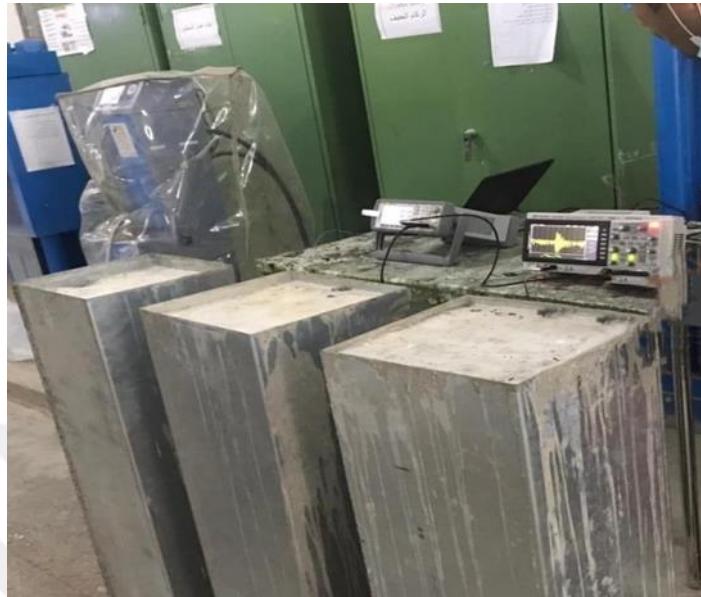
caused by using polystyrene foam material, as each of the three models has different failures. See (Figure 3.3) shows the experimental procedure.

Figure 3.3. Experimental setup.

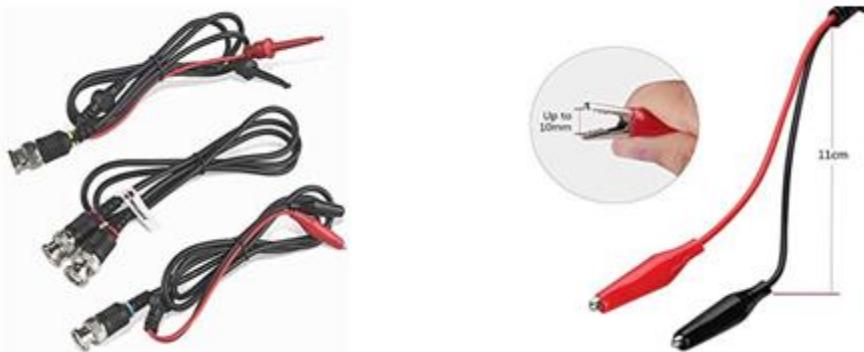
These sensors are connected to two devices (transmitters, receivers), a cable connected to the device's port, and clips on the sensor, as shown in the figure below.

Figure 3.4. Cable connected and clips.

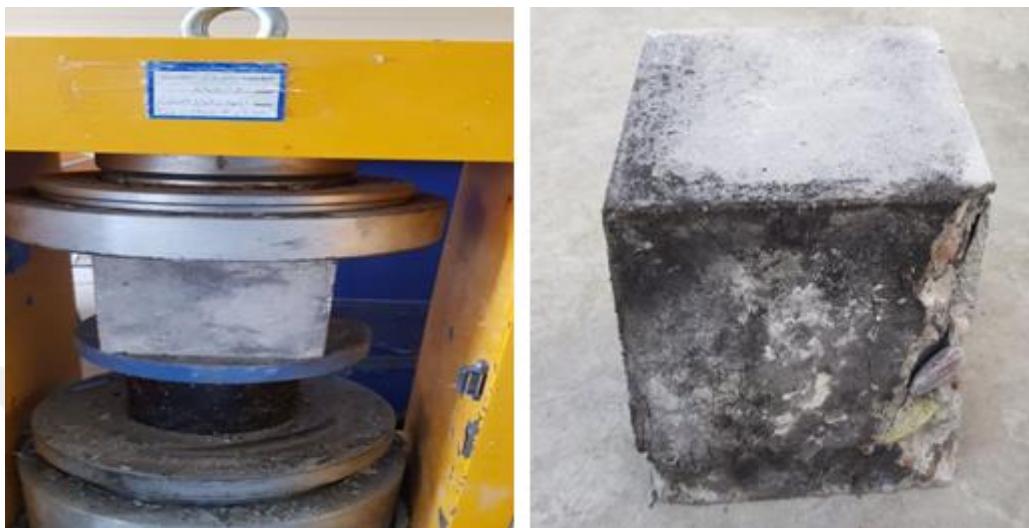
The compressive strength test of the cubes of their dimensions was also performed ( $0.15 \times 0.15$ )m (Figure 3.5) shows the method of examination.

Figure 3.5. Test of Compressive Strength and Cubes Failed.

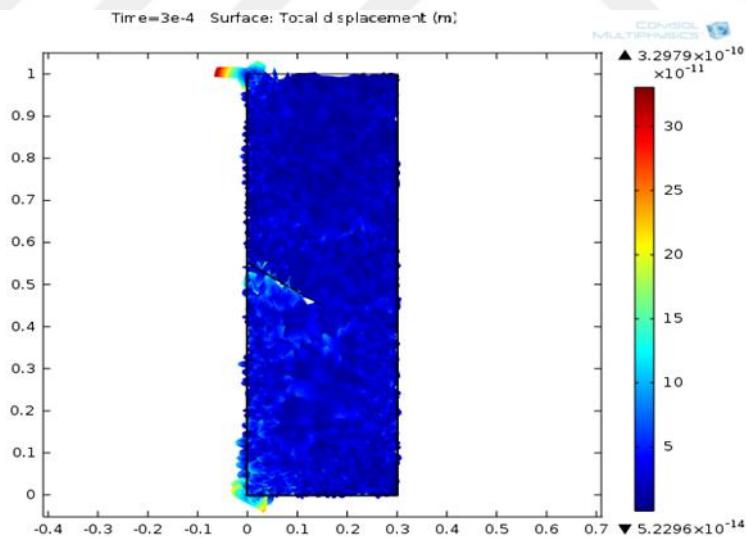
Six models with different cracks were designed by the user software. The waves were plotted with Excel and analyzed by wavelet at the beginning of the cracks that start with (2,4,5,6,8,10 mm). Figure 4.1 shows the heart diagram of the wave propagation in the model (2 mm). Where the wave travels from the transmitter sensor on the surface of the model from one side through the damage that falls in the middle. Also, the figure shows decreasing at a certain angle to draw the crack. It moves to the receiving sensor on the same side of the transmitter sensor and also on the surface. It has been noticed the wave glows at first then it gradually begins to reduce. The wave starts from the lowest displacement which is represented with the blue color to the highest value of the red displacement. The wave loses some of its energy due to the steel, the concrete as well as the distance. The presence of cracks in the path of waves leads to losing some of the energy.

Figure 4.1. Wave transmission and model shape by Comsol Multiphysics for crack (2 mm).

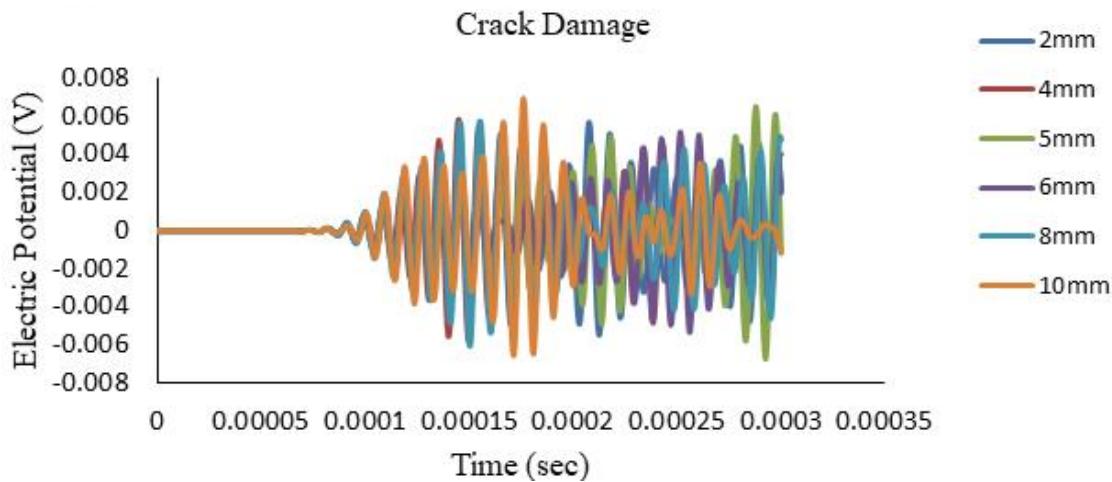
The beginning of the cracks that start with (2,4,5,6,8,10 mm) the data for all models which are taken from (Comsol Multiphysics) program was drawn for each model in (Figure 4.2) that shows the comparison between the waves from these models. The wave amplitude is big when the crack is small and the crack increases when the amplitude of the wave begins to decrease. This affects the wave propagation and therefore when the wave propagation amplitude decreases this gives a high probability of failure. The figure below shows the wave pattern for all styles.

Figure 4.2. Schematic diagram showing time domain of all crack models.

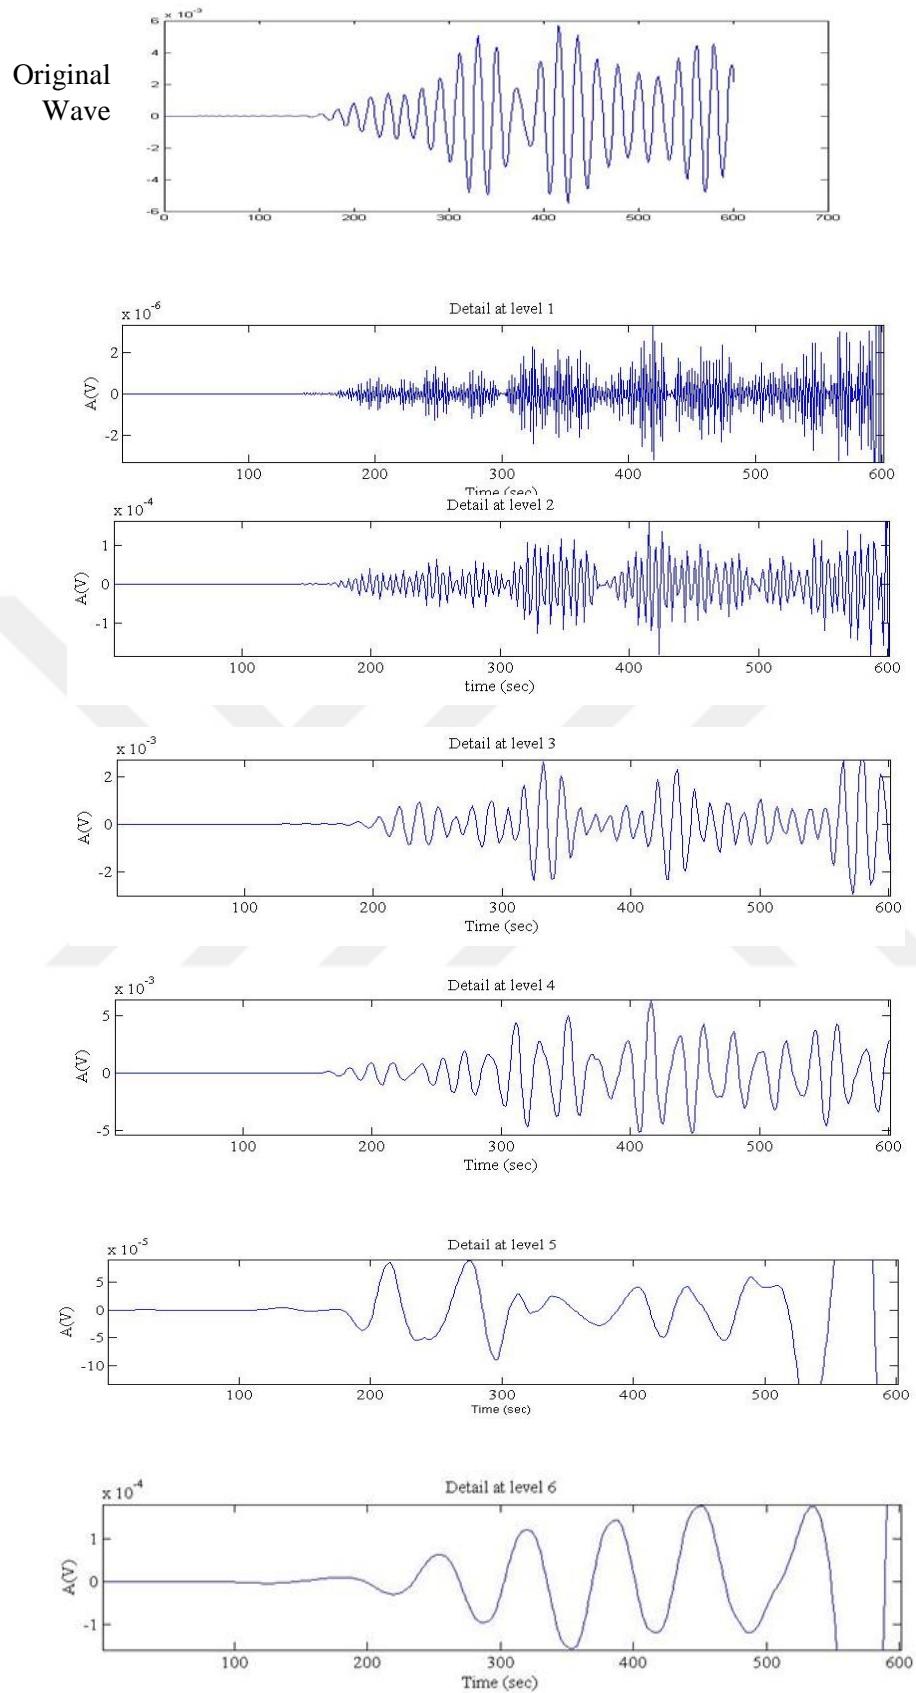
After completing the data transfer to Matlab, the analysis has done by (wavelet - 1D) into six levels to give the greatest accuracy. In (Figure 4.3 ) shows the original wave and the six analyzed levels. It is noted that the first level wave is close to the original wave due to its high frequency that is close to the original wave frequency. Then the waves in the other levels begin to reduce their amplitude because of decreasing the frequency as in the sixth level. Low frequency is better accuracy and less noise than higher frequency.

Figure 4.3. The six levels of crack (2 mm) were extracted by Wavelet Transform.

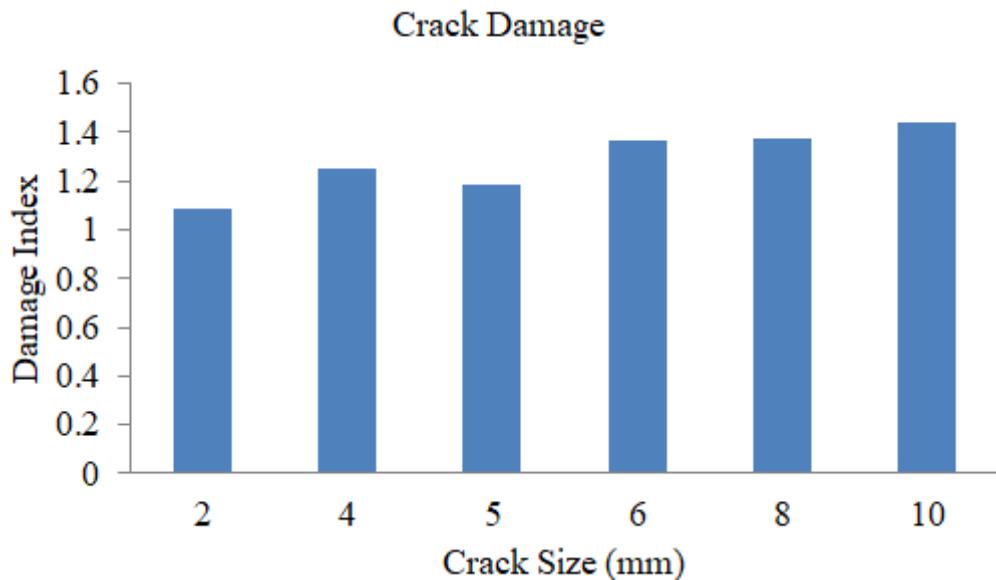
After completion of the wave analysis into six levels, the damage index was extracted for all levels of the six patterns. The third level for all models was chosen because it is the appropriate one. It is noted that the damage index increases with the increase of the cracking. So this gives important information about the detection and presence of cracking. Other levels do not qualify as the wave propagation is irregular between high amplitude and slope. Therefore, the analysis of waves is complicated and unstable. In (Figure 4.4) shows the damage index and how it increases with increasing cracking. As a wave passes through these cracks, it loses some of its energy. When the wave loses some of its energy, this means there is a possibility of damage occurrence.

Figure 4.4. The damage index of all cracks models (Third level).

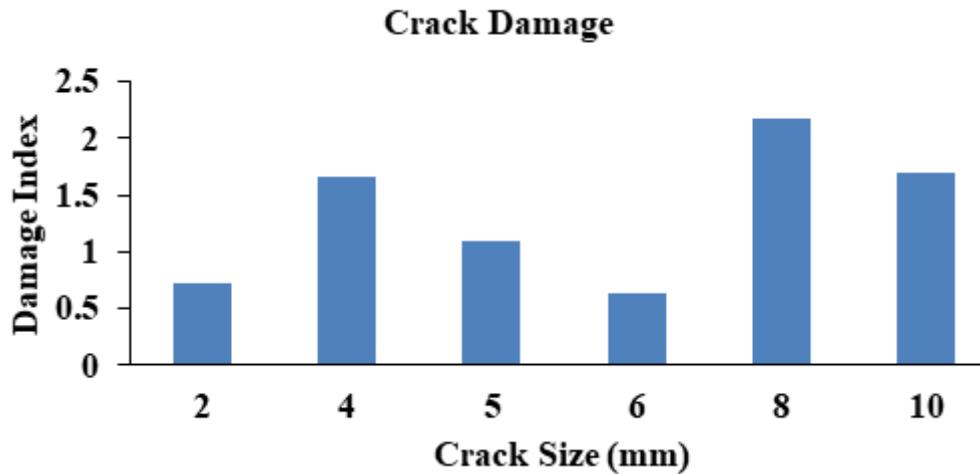
Figure 4.5. The sixth level of Wavelet Transform showing disproportionate relation between the crack damage and DI.

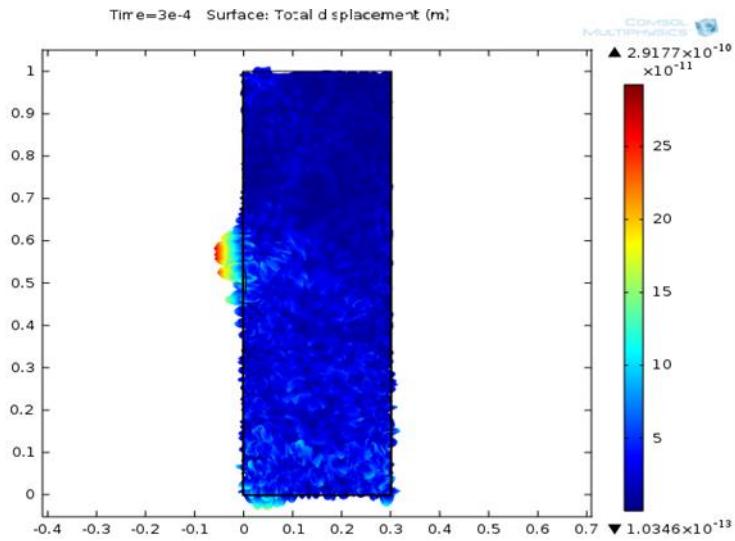
The transmitted sensor is located at the bottom of one side of the model on the surface and the receiver is on top of the model on the same side. It can be noted that the site of the breakdown through the difference in the displacement when it starts with the lowest displacement represented by the blue color down to the highest displacement represented by the red color. This process is done during a time of  $3 \times 10^{-4}$  seconds. This indicates that when the wave reaches the refraction site, it loses some of its energy. Finally, the location of the damage can be determined. In (Figure 4.6) shows the propagation of the wave across the damage.

Figure 4.6. The wave transfer from the sent sensor to the receiving sensor and was done by a program Comsol Multiphysics for debond 5 cm model.

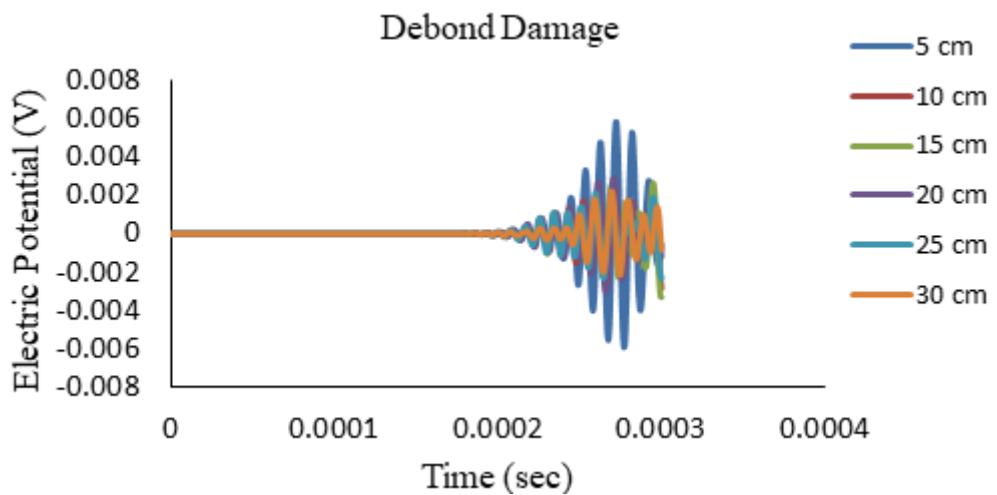
Using the data in Excel, the wave was plotted for all models [(1×5),(1×10),(1×15),(1×20),(1×25) and (1×30)cm].and compared to each other. It can be noted whenever the size of the debonds increases, the wave propagation, and its energy decreases. This is important to detect the damage through the loss of some wave energy. As (Figure 4.7) shows a comparison of these waves by plotting them.

Figure 4.7. Time-domain of all debonds models.

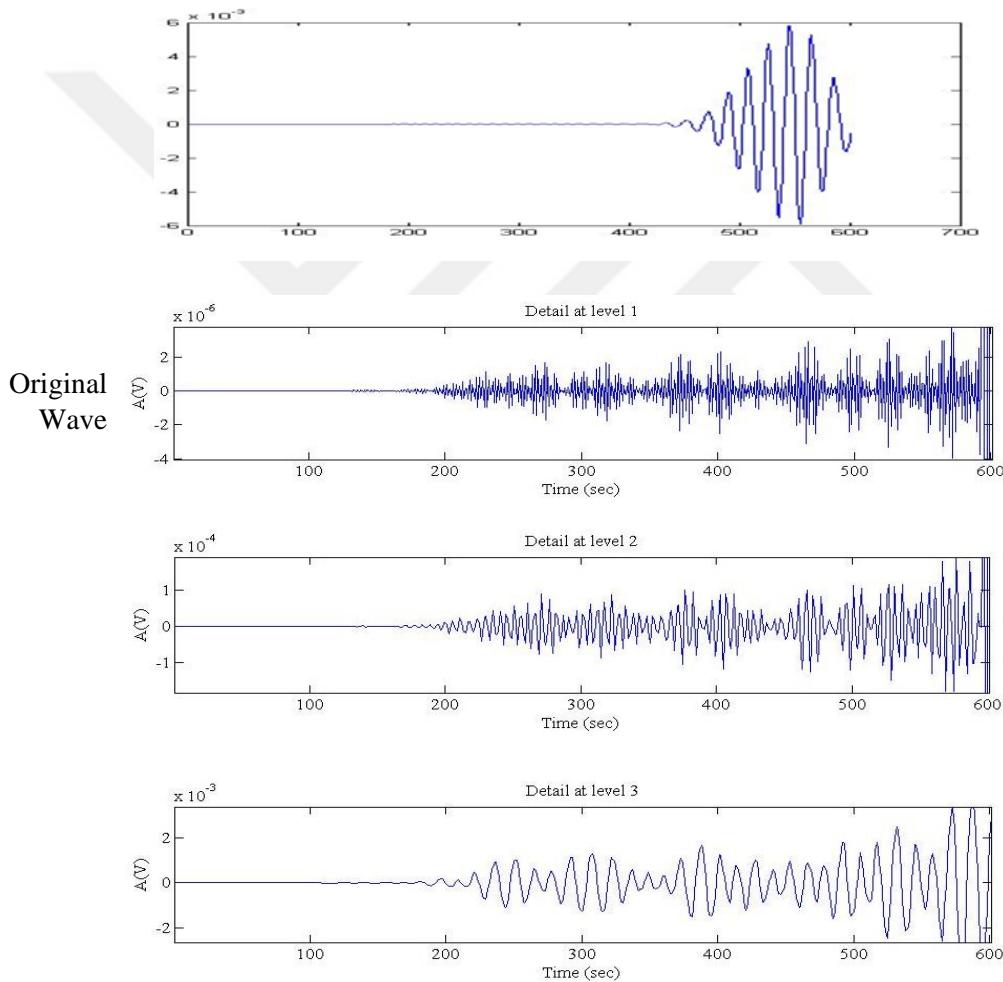
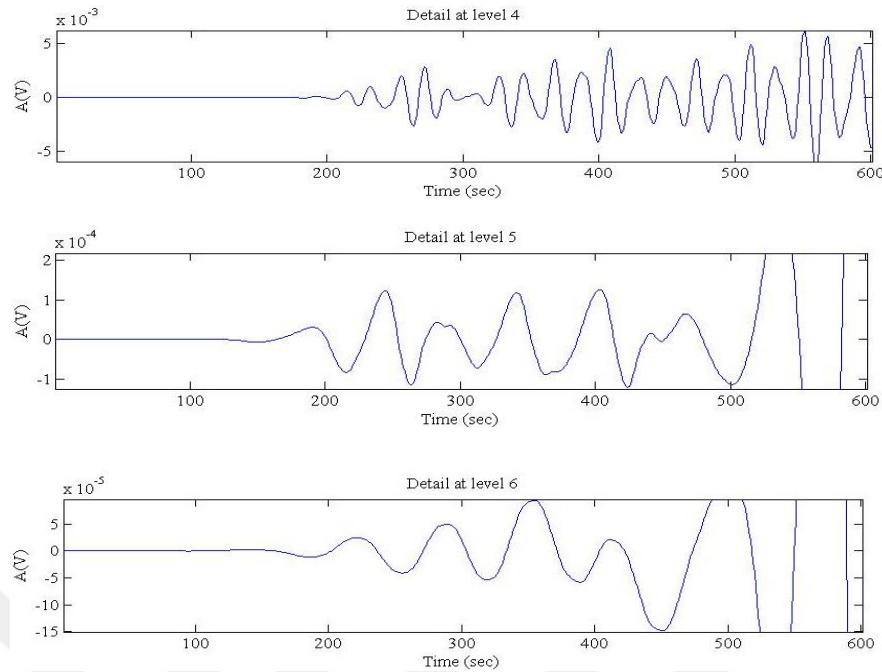
When analyzing the wave from Excel to Matlab using (wavelet - 1D) into six levels, it has been noticed that the wave energy is decreased gradually from the first level, which has the largest frequency and the wave is similar to the original wave, to the sixth level which has the lowest frequency. The wave lost a lot of its energy due to the low frequency. This indicates that the higher frequency at the first level is less accurate and noisier than the lower frequency at the sixth level. Figure 4.8 shows the original wave and the six analyzed levels.

Figure 4.8. The six levels were extracted by Wavelet Transform for 5 cm debonding damage

Figure 4.9. The six levels were extracted by Wavelet Transform for 5 cm debonding damage(Continuine) .

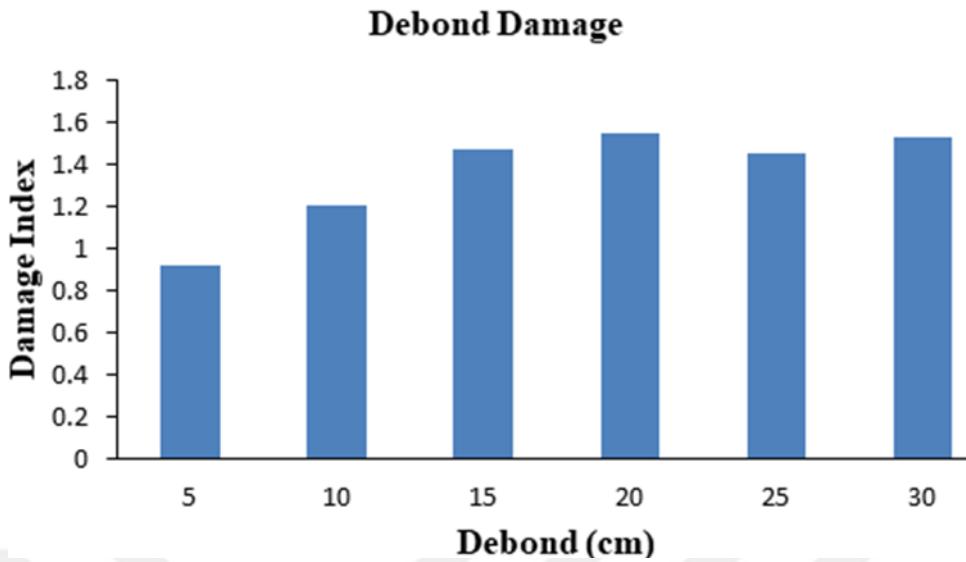
After designing all debond models and plotting their data as a wave, and analyzing these waves into six levels, a damage index of them has been extracted. From the graph in (Figure 4.9), It has been noticed when any increase in debond dimension leads to an increasing in damage index. The second level has been used for each model from the sixth model because the second level gives the appropriate results to get important information to detect the damage. As the wave is transmitted and collides with the debond, it loses some of its energy to detect the location of the damage. The other levels are not appropriate because they are complicated and it is difficult to be analyzed, unlike the second level. The graph below shows the debond with the damage indicator, when the debond increases, the damage index increases also.

Figure 4.10. Damage index for all models of debonding (second level).

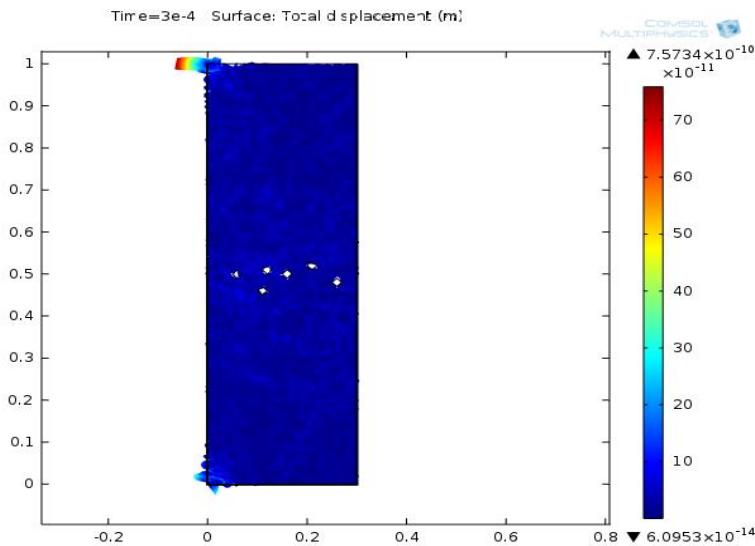
Three models have been designed which containing fabricated voids. One of these models has fewer voids and the second has more voids than the first case and the last one has more voids of the second and the first. The model was drawn by a software designer. See (Figure 4.10) shows the transmission and propagation of the wave. Steel also affects the wave propagation, the frequency and reduces its amplitude.

Figure 4.11. The shape of the wave transmission and the number of voids.

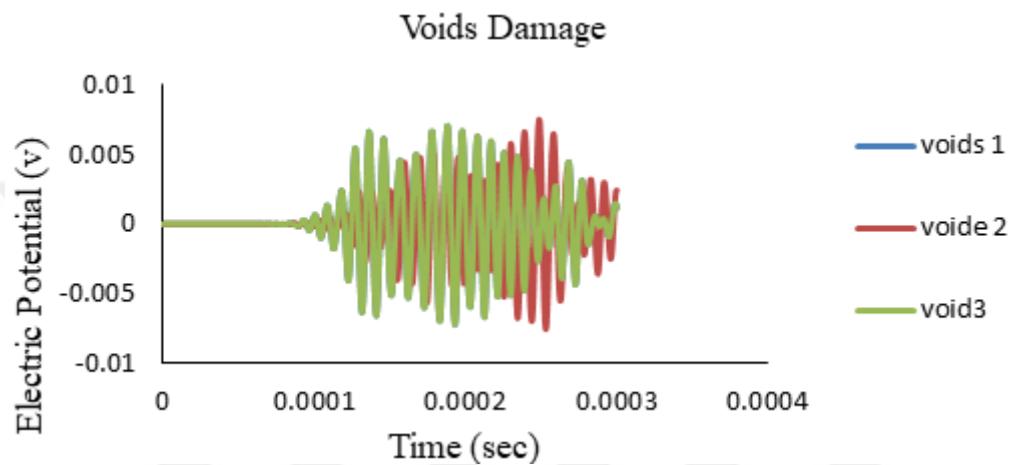
The waves of all the models were compared by drawing them in the Excel program. As shown in (Figure 4.11), It is noticed that with an increase in the number of voids, the wave is dispersed. That means the dispersion of the wave in a specific area of the model leads to the presence of damage in the examined model.

Figure 4.12. The comparison between signals for different voids values.

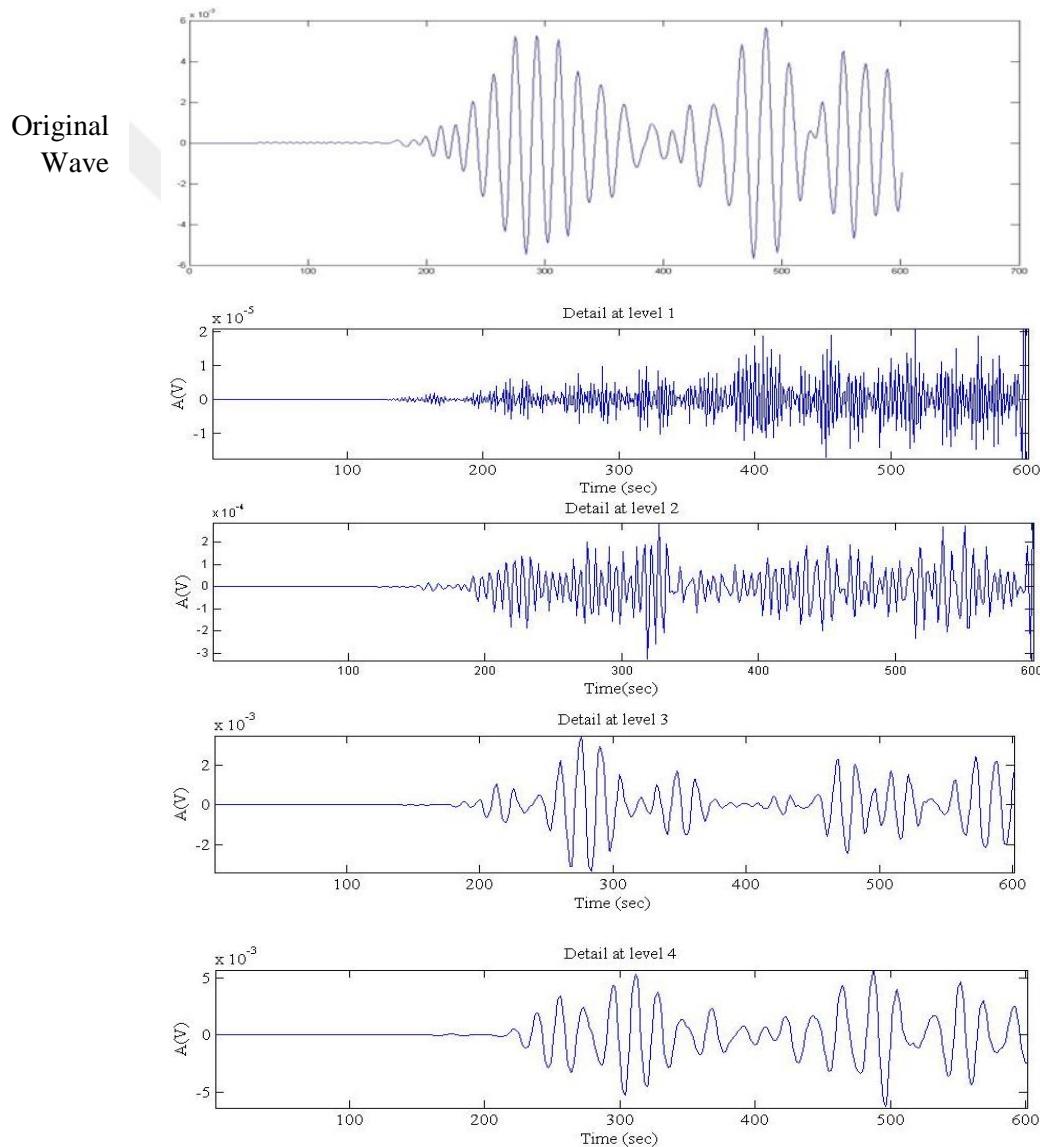
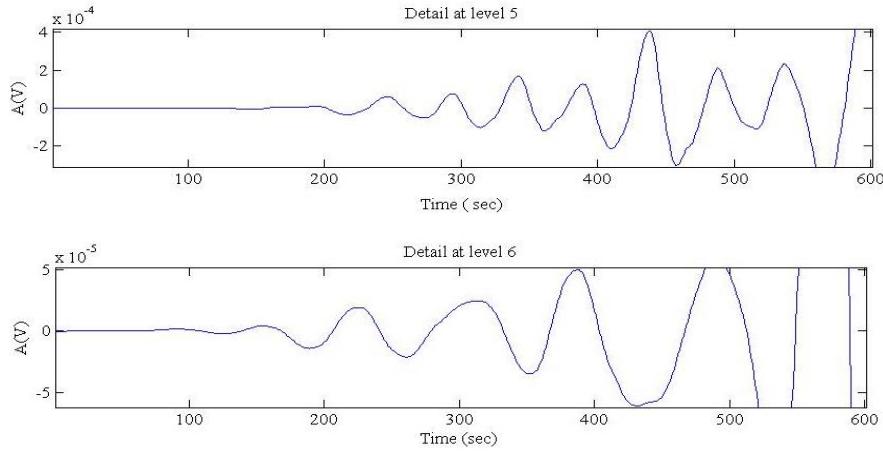
To get an accuracy of the results, it is important to analyze the wave of the model which contains few voids to six levels by (wavelet -1D). In (Figure 4.12), it shows that with increasing frequency, the wave is noisier and less accurate as indicated in the first level which its wave and its frequency are similar to the original wave, unlike the sixth level which is less frequency, more accurate, and less noisy.

Figure 4.13. Wavelet Transform levels for the case of many voids

Figure 4.14. Wavelet Transform levels for the case of many voids (Continuie).

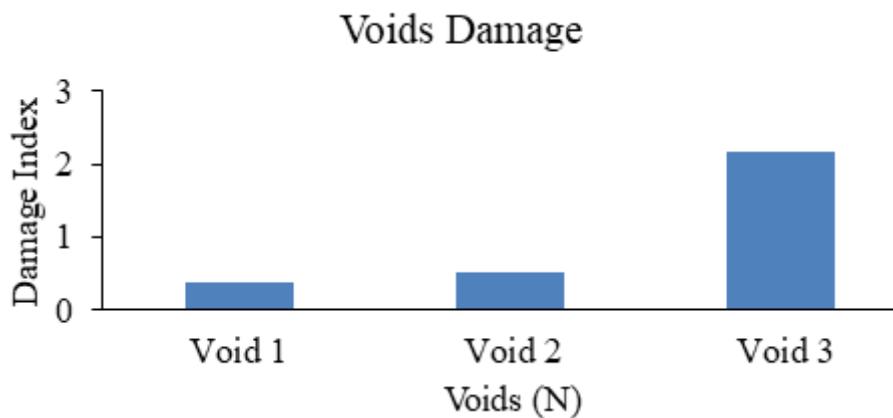
To draw the damage index, it is needed to analyze all the models to six levels. The sixth level was chosen because of its appropriate results which show the relationship between the number of voids and the damage index. It is noticed that increasing the number of voids leads to an increasing the damage index as indicated in (Figure 4.13). For the other levels, the first level was also good and showed that more voids lead to increasing the damage index. The other levels were inappropriate. This may be attributed to the matching between voids size and number from a side and the level of frequency from another side.

Figure 4.15. Damage index for all cases of voids (Sixth level).

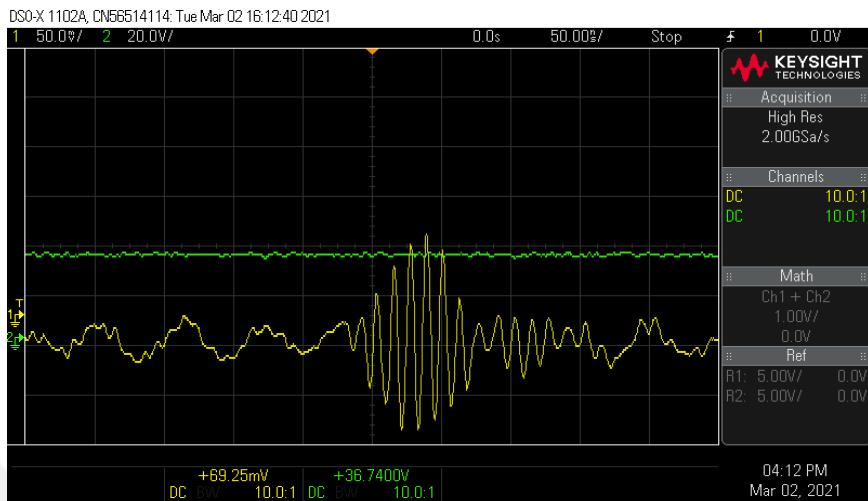
indicates that whenever the strength increases, the mixing ratio increases also that finally affects the propagation of the wave.

Figure 4.16. The raw wave was extracted by oscilloscope for 20 MPa compressive strength.

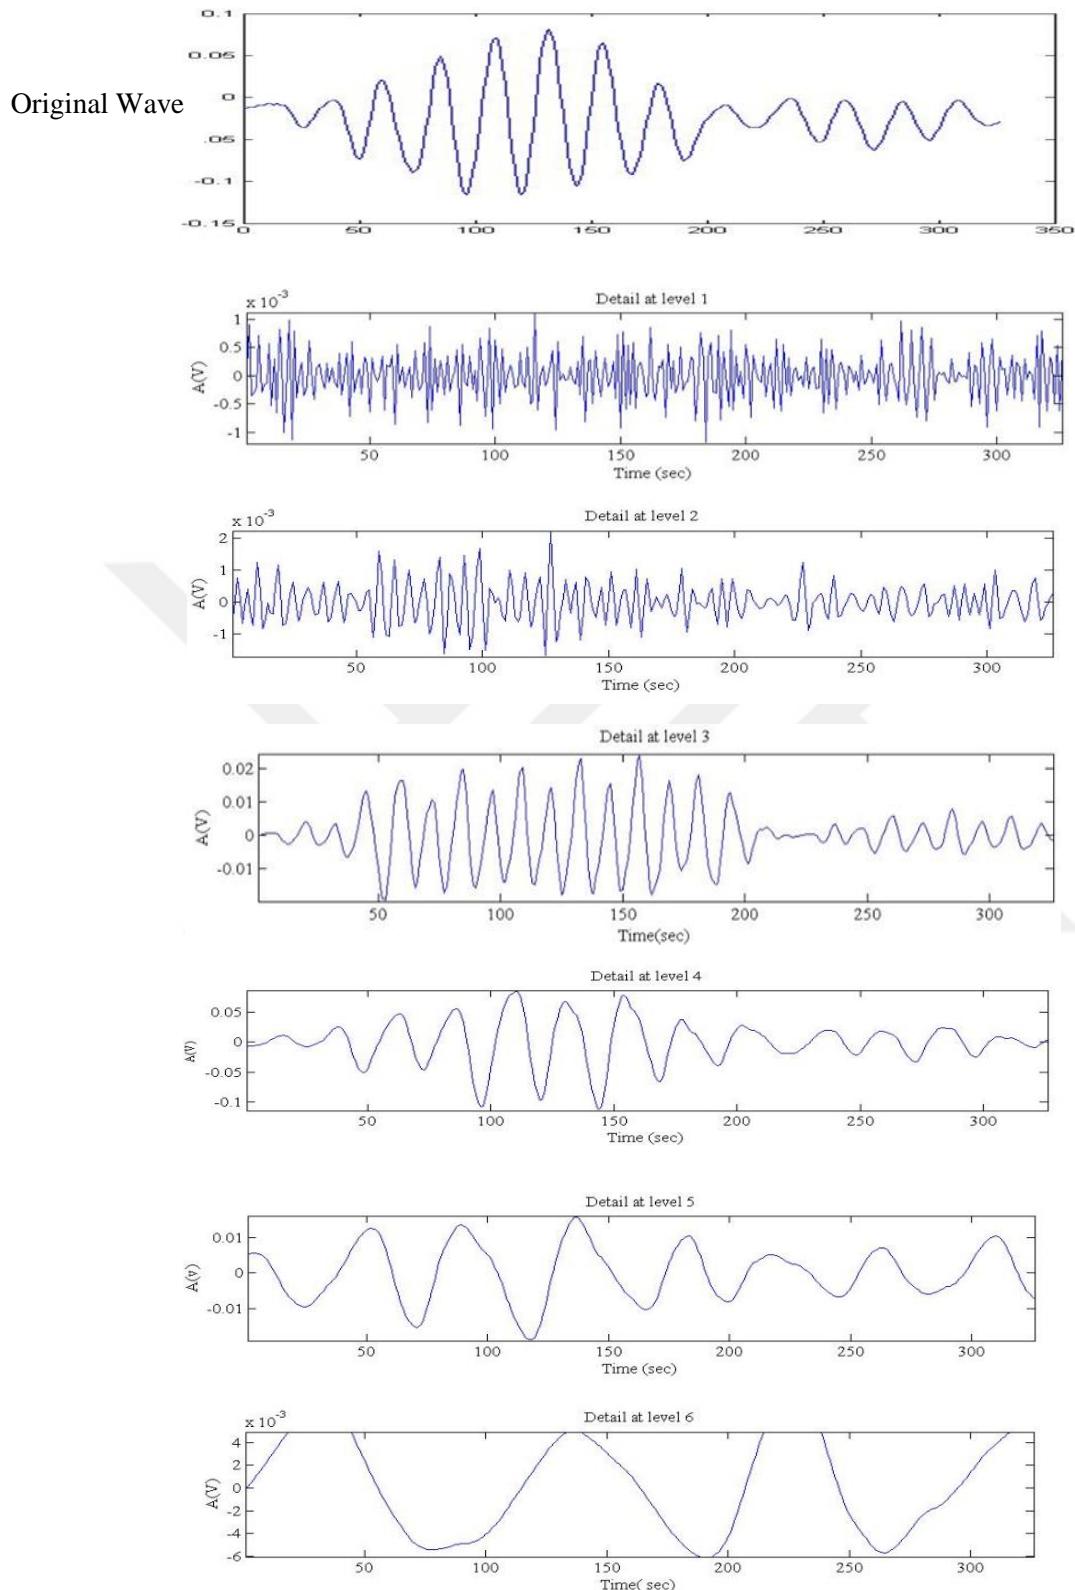
The wave that was drawn by oscilloscope and analyzed by (wavelet - 1D) into six levels, It is noticed that the first level is high-frequency with more noise and less accuracy. Whenever the wave frequency increases, the attenuation of the signal increases. While the level whose frequency is lower, its accuracy is better and its noise is less. It is important to know that the shrinkage of concrete affects the mechanical behavior of the sensors that affect the propagation of the wave. In (Figure 4.15) shows the main wave and its six levels of a (20 Mpa) model examined in the laboratory.

Figure 4.17. The original wave and its six levels of the (20 MPa) model that was examined in the laboratory.

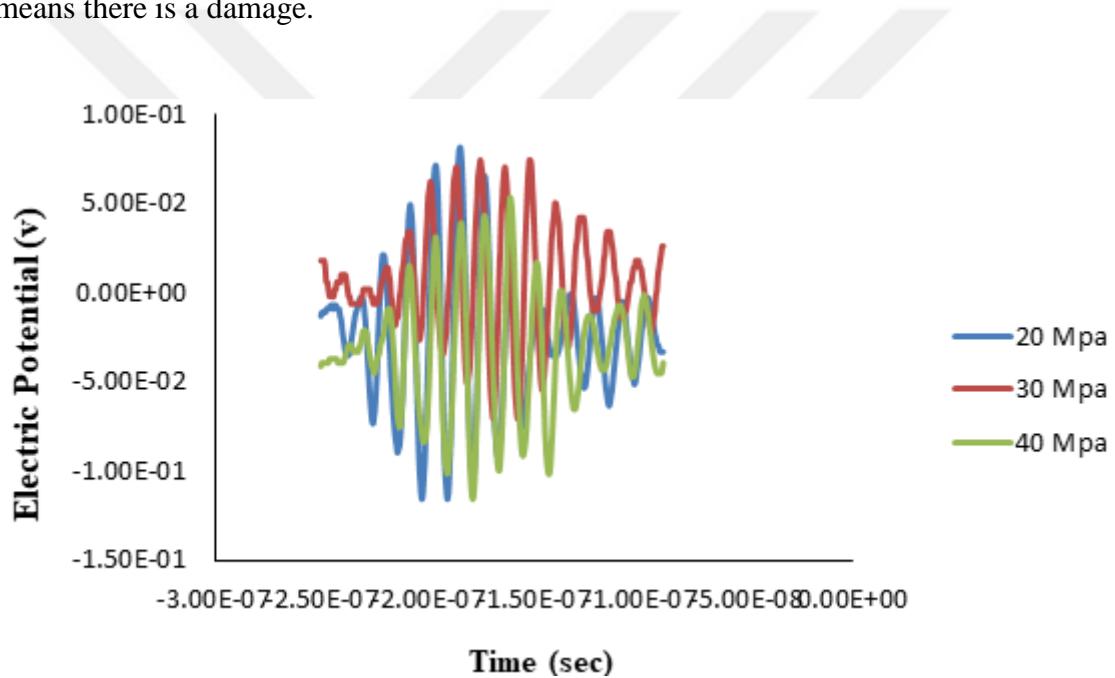
A mix ratio of compressive strength (20 MPa) was (1: 2.68: 1.98) and W / C (0.5). While the mix ratio for obtaining strength (30 MPa) was (1: 1.86: 2.57) W / C (0.48) and the mix ratio for obtaining strength (40 MPa) was (1: 1.68: 2.41) W / C (0.45). Figure (4.16) below shows how the wave is affected by the increase in compressive strength which is affected by the properties of the concrete. This increase in the resistance was happened because of the increase in the mix ratios which affect the spread of the wave. When the wave collides with the failure, the wave loses part of its energy. This is important to give good results in case the wave loses its energy. This means there is a damage.

Figure 4.18. A comparison of the compressive strength of waves (20, 30 & 40 MPa) for laboratory-examined models.

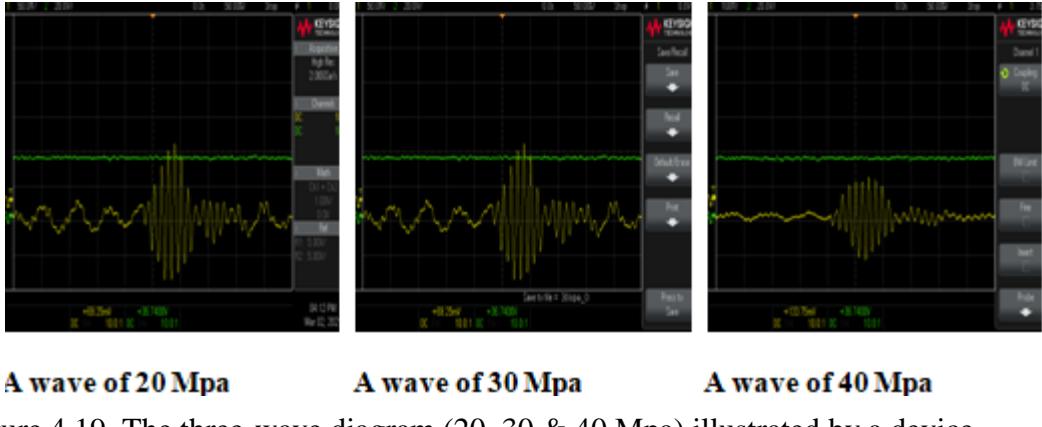
Figure 4.19. The three-wave diagram (20, 30 & 40 Mpa) illustrated by a device oscilloscope.

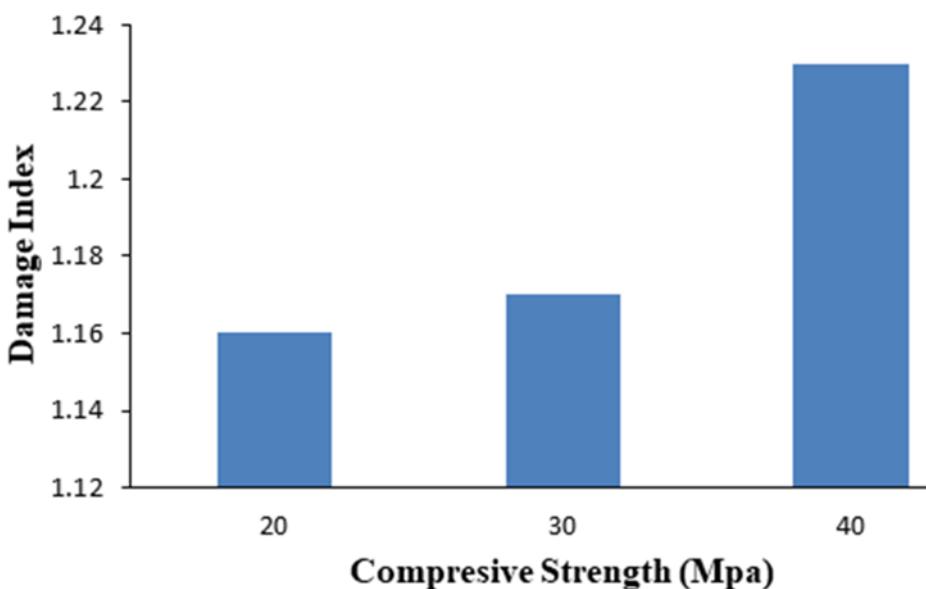
Three models have been used to get a different strength. It is worth mentioning that not no resistance has got in the laboratory is the same that is wanted. For example, in the case of 20 Mpa, it may get less or more resistance than the required resistance because the laboratory results are not accurate like simulation results. After completing the examination of the three models to detect the artificial damage inside them and taking the results and analyzing them by MATLAB, the wave of each model was analyzed into six levels to increase the accuracy of the results. After the completion of the analysis and knowing the six levels, it was found that the second level is the best to give important results. Whereas the increase of compressive strength, the damage index increases and this increases the likelihood of failure and detect it early. Figure 4.18 shows the relationship between the damage index and compressive strength and whenever the compressive strength increases, the damage index increases also.

Figure 4.20. The relationship between damage index and compressive strength for the second level and all models examined in the laboratory.

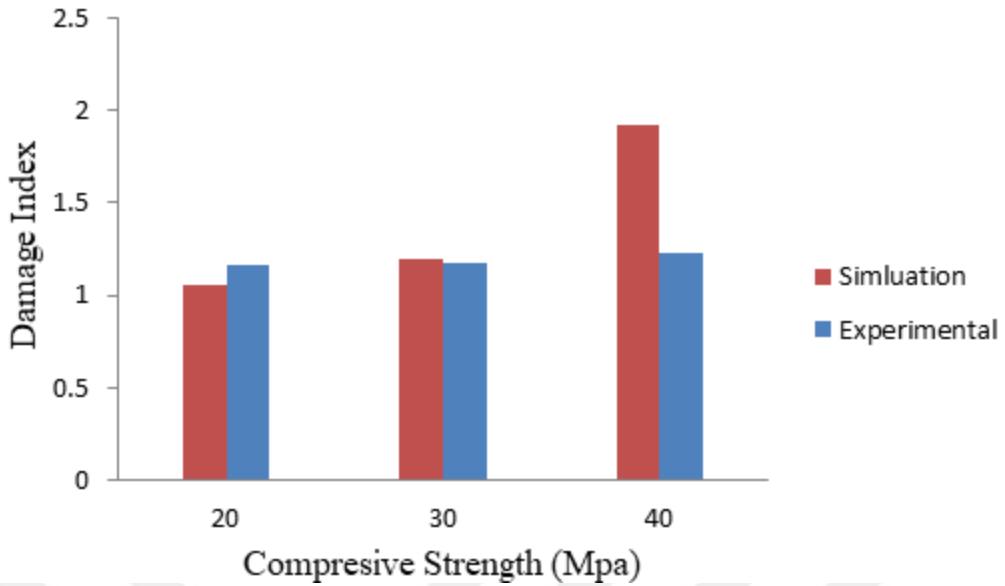
The first level of the wave (20 MPa) that drawn by COMSOL Multiphysics was compared with the second level of the wave (20 MPa) examined in the laboratory with noting that it has the same frequency (100 kHz) as well as the same dimensions of damage (1×5cm). In COMSOL, waves are sent and received through sensors already in the program. While in the laboratory the waves are created by the function generator that sends them to oscilloscope that plots this wave and stores the data.. It has been observed that with the increase in compressive strength, the damage index increases. In (Figure 4.19), the comparison between damage index and compressive strength for the first level in simulations with the second level of all the models that were examined in the laboratory. This is important in giving results of damage detection. The reason for choosing the first level of simulation with the second level of practicality is that they have the same frequency and are close to each other. The simulation case is a typical one that means choosing a compression strength (20 Mpa), the same resistance has been got without increasing or decreasing. In the laboratory, (20 Mpa) has never the same value required.

Figure 4.21. The comparison between damage index and compressive strength for the first level in simulations with the second level of all the models that were examined in the laboratory.

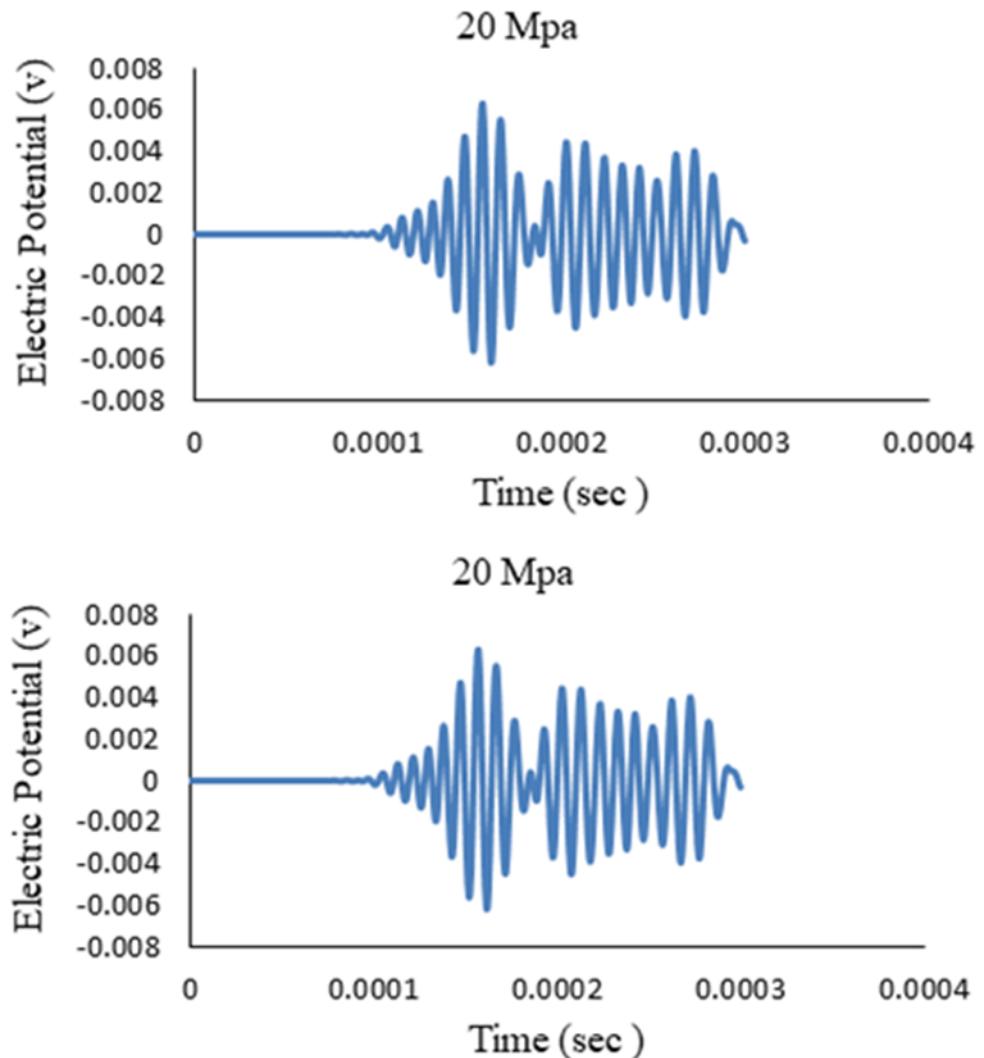
Figure 4. 20 shows the comparison between two waves of two models having the same compressive strength and the same synthetic failure but one of them was designed by the software and the other model was examined in the laboratory with mixed ratios (1: 2.68: 1.98) and W / C (0.5) to obtain it. The results showed that the simulation wave is typical and does not contain deformation unlike the wave of the experimental model. The spreading of laboratory model waves affects the properties of concrete that leads to deforming and loses part of its energy.

Figure 4.22. waveforms of the 20 MPa model, Experimental (upper side) and simulation (lower side).

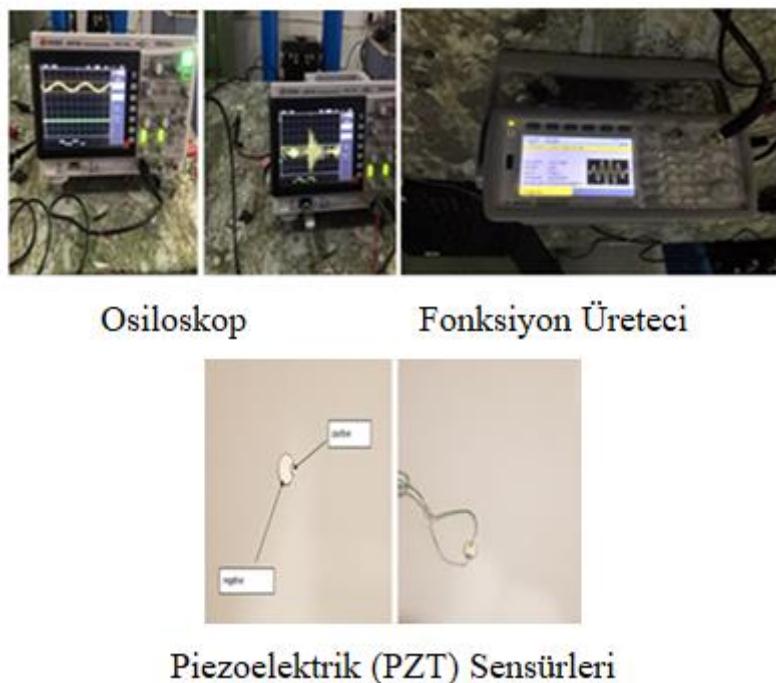
Beton dolgulu çelik kolon numuneler gerekli malzemeler kullanılarak, ACI yönetmeliğinin öngördüğü doğrultusunda hazırlanmıştır. Dalga algılama işleminde Şekil 1'de gösterilen osiloskop ve fonksiyon üretici kullanılmıştır. Dalga sinyali, rastgele bir dalga fonksiyonu kullanılarak dalga üretici kullanılarak oluşturulmuş ve iletilmesi sağlanmıştır. Bundan sonra, piezoelektrik verici sensörü, sinyali numuneye aktarmakta ve alıcı sensör, dalgayı, osiloskop tarafından yakalanacak ve kaydedilecek bir elektrik sinyaline geri dönüştürmektedir.

Şekil 1. Osiloskop, fonksiyon üretici cihazları ve piezoelektrik verici sensörü

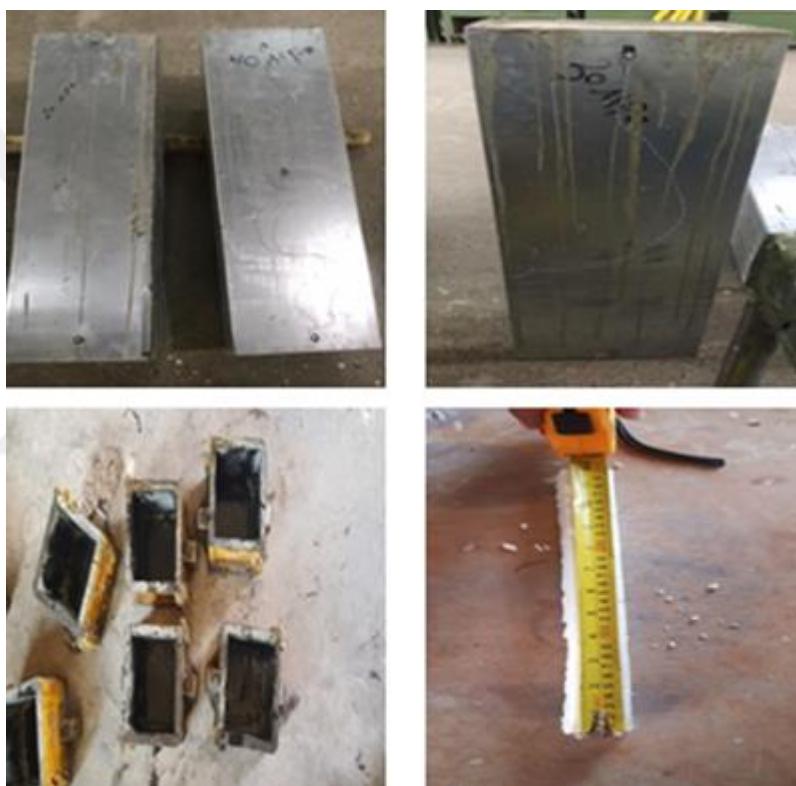
Taban boyutları  $30 \times 30$  cm ve 1 m yüksekliğine sahip olan üç CFST numunesi seçilmiştir. Çelik levhanın kalınlığı 2 mm'dir. Her numune, farklı bir ayırtma hasarı boyutuna ve farklı basınç dayanımı sahiptir. Kare, dikdörtgen ve yuvarlak dahil olmak üzere farklı CFST şekilleri vardır. Bu çalışmada, polistiren köpük, CFST kolonundaki ayırtma hasarını simüle etmek için kullanılmıştır. Numuneler sertlik kazandıktan sonra betonun üst yüzeyini polistiren köpüğün konulduğu yerlere bağlayan daha önce açılan deliklerden akaryakıt bir malzeme dökülür. Akaryakıt dökülmesinden amaç bu sıvayı kullanarak polistiren malzemeyi yok ederek ayırtma hasarı oluşturmaktır.

Şekil 2. Farklı dayanımı sahip örnekler (20 Mpa, 30 Mpa, 40 Mpa).
