**DETECTION OF DAMAGES IN CFST COLUMN USING ULTRASONIC  
WAVES**

M.Sc.THESES

PREPARED BY: Nashwan Ibrahim SALEH  
SUPERVISOR: Assoc. Prof. Dr. Murat MUVAFİK  
CO – SUPERVISOR: Prof Dr. Nadom Khalifa MUTLİB

VAN - 2021

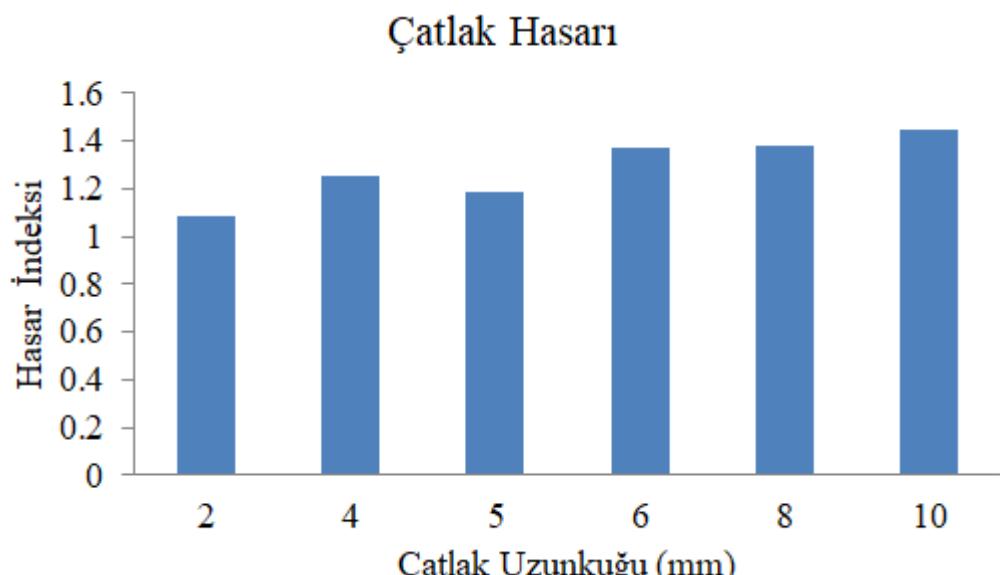
Dalga analizinin altı seviyede tamamlanmasından sonra, altı modelin tüm seviyeleri için hasar indeksi çıkarılmıştır. Dalgacık analizinde 6 seviye arasında, tüm modeller için uygun olduğu için 3. seviye seçilmiştir. Çatlama arttıkça hasar endeksinin de arttığı görülmektedir. Bu da çatlamanın tespiti ve varlığı hakkında önemli bir oluşum sağlamaktadır. Diğer seviyeler, dalga yayılımı yüksek genlik ve eğim arasında düzensiz olduğu için geçerli değildir. Bu nedenle dalgaların analizi karmaşık ve istikrarsız olmaktadır.

Şekil 3. Tüm Çatlak Modelleri İçin Hasar İndeksi (Üçüncü seviye).

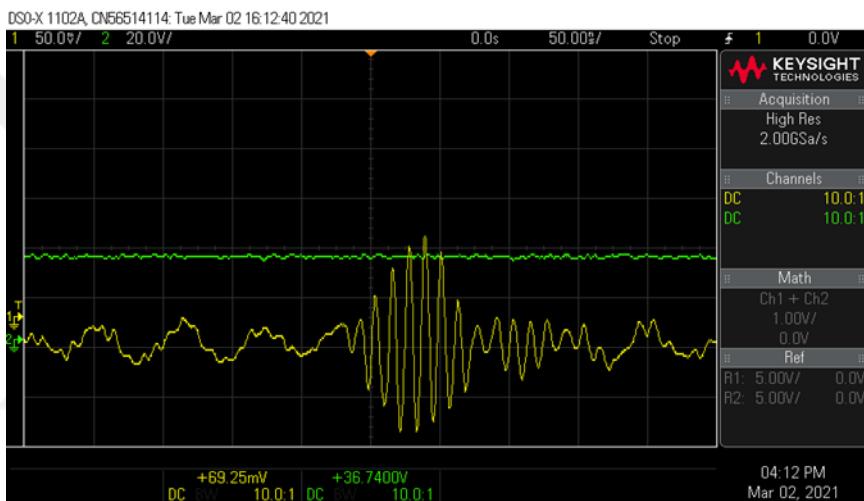
Bu dayanımı elde etmek için model (1:2.68:1.98 Mpa) buyutlarında ve su/çimento: (0.5) oranında beton karışımına göre dökülmüştür. 20Mpa dayanıma sahip numune için osiloskopta elde edilen dalga Şekil 4'te verilmektedir. Bu dalga, model yüzeyinin yan tarafında üstte bulunan cihaz (fonksiyon üreteçleri) sensörleri aracılığıyla gönderilmiştir. Bu dalga modelin içine yerleştirilen yapay hasardan (2×5cm) modelin alt kısmında bulunan alıcı sensöre de yüzeyde geçer. Oluşan hasarların tespiti için bu model incelenerek elde edilen sonuçlar, iletilen dalganın karışım oranlarından etkilendigini göstermiştir.

Şekil 4. 20Mpa Dayanıma Sahip Numune İçin Osiloskopta Elde Edilen Dalga

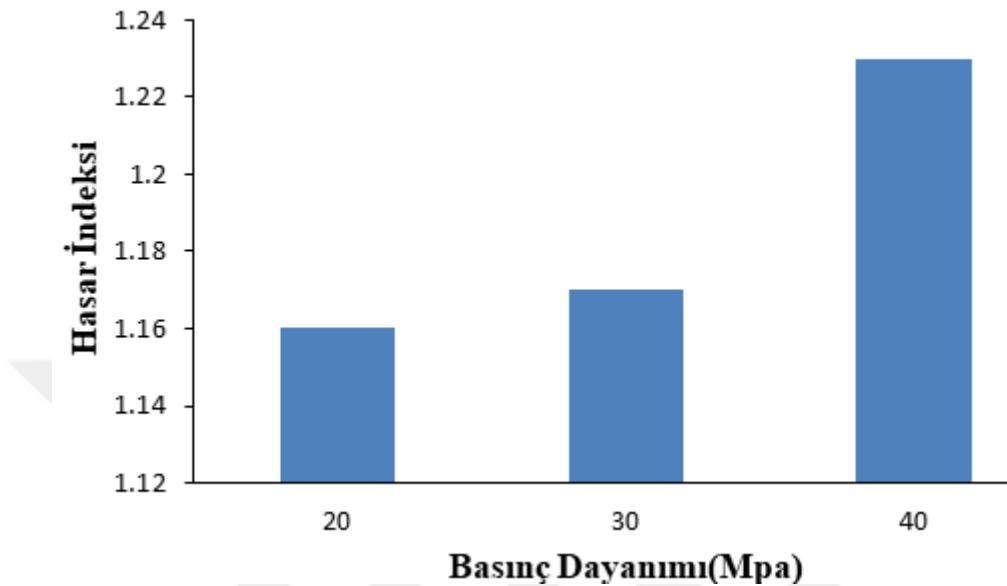
artış anlamına gelmekte ve bu da hasar olasılığını artırır ve hasarın erken tespitini sağlar. Hasar indeksi ile basınç dayanımı arasındaki ilişki Şekil 5’de verilmektedir.

Şekil 5. Laboratuvara incelenen tüm modellerde 2. seviye için hasar indeksi ile basınç dayanımı arasındaki ilişki.
