**ANALYSIS, REPAIR AND STRENGTHENING OF HISTORICAL MASONRY  
STRUCTURES; CASE STUDY: MEHMET AGA MOSQUE**

**M.Sc. Thesis by  
Yaşar Hanifi GEDİK, B.Sc.**

**Department : CIVIL ENGINEERING**

**Programme: EARTHQUAKE ENGINEERING**

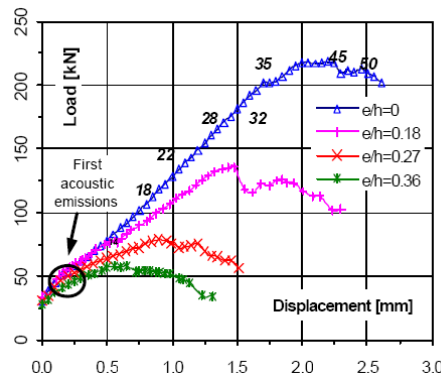
**Figure 2.4:** Load displacement diagram due to different eccentricity ratios (Brancich et al., 2002).

In masonry structures, such as arches, vaults and pillars components are generally exposed to eccentric normal force (Brancich et al., 2002). Load eccentricity affects the compressive strength. Brancich's study shows that, there is an inverse ratio between eccentricity and the compressive strength of component (Brancich et al., 2002) (Figure 2.4).

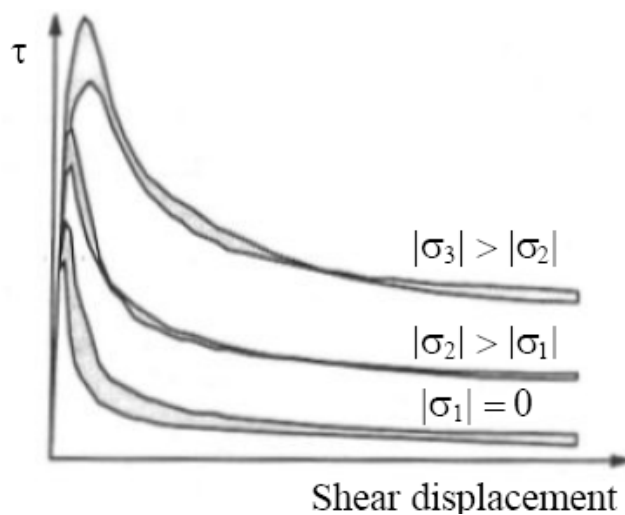
**Figure 2.5:** Typical experimental shear stress-displacement diagrams (Van der Pluijm, 1993).

for determining the shear strength of masonry, where;  $\tau_{em}$  is the shear strength of the masonry wall,  $\tau_0$  is the fracture strength of the wall,  $\mu$  is the friction coefficient which can be taken as 0.5 and  $\sigma$  is the vertical stress of the wall (Ministry of Reconstruction and Resettlement, 2007). Equation 2.4 shows that, if the vertical stress of masonry increases, also the shear strength of masonry increases. Figure 2.5 shows the shear stress-strain diagrams under various vertical stresses (Van der Pluijm, 1993).

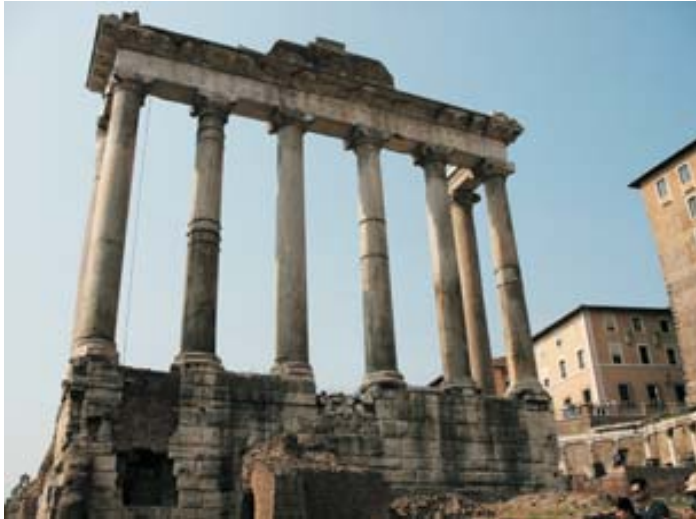
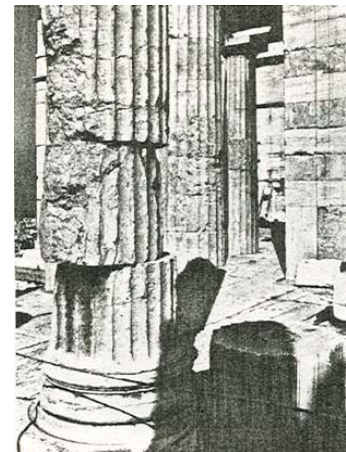
Pillars carry significant compressive stress. They can be composed either one-piece stone or multi-piece stone which is obtained interconnecting the stone parts with pins (Figure 3.4) (Sesigür et al., 2007).

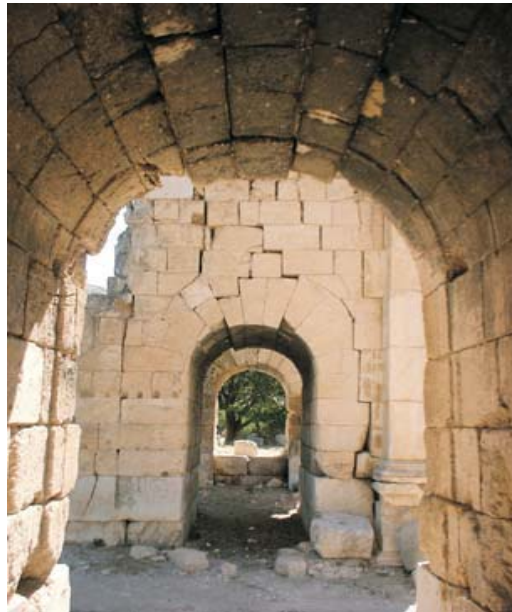
**Figure 4.5:** Pointing separation of the vault (Sesigür et al., 2007).

the flexural strength of abutments and vertices. However, membrane tensile failure at the groins dominated at last. (Theodossopoulos et al., 2004) Pointing separation damage in vaults shown in Figure 4.5.

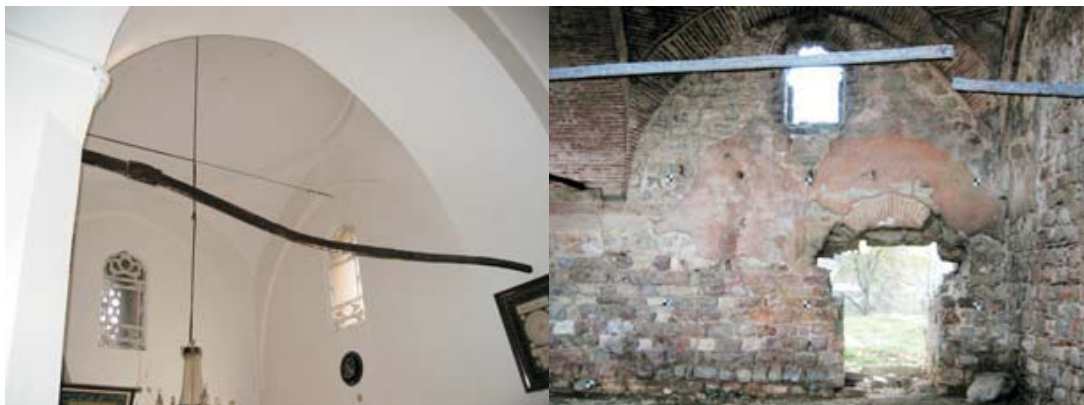
- Tie damages: Extreme corrosion is the most common deterioration type in the iron ties. Most observed damages are the buckling and rupture of the ties due to motions in the structure (Figure 4.6). Putrefaction damage may occur on the wood ties (Sesigür et al., 2007).

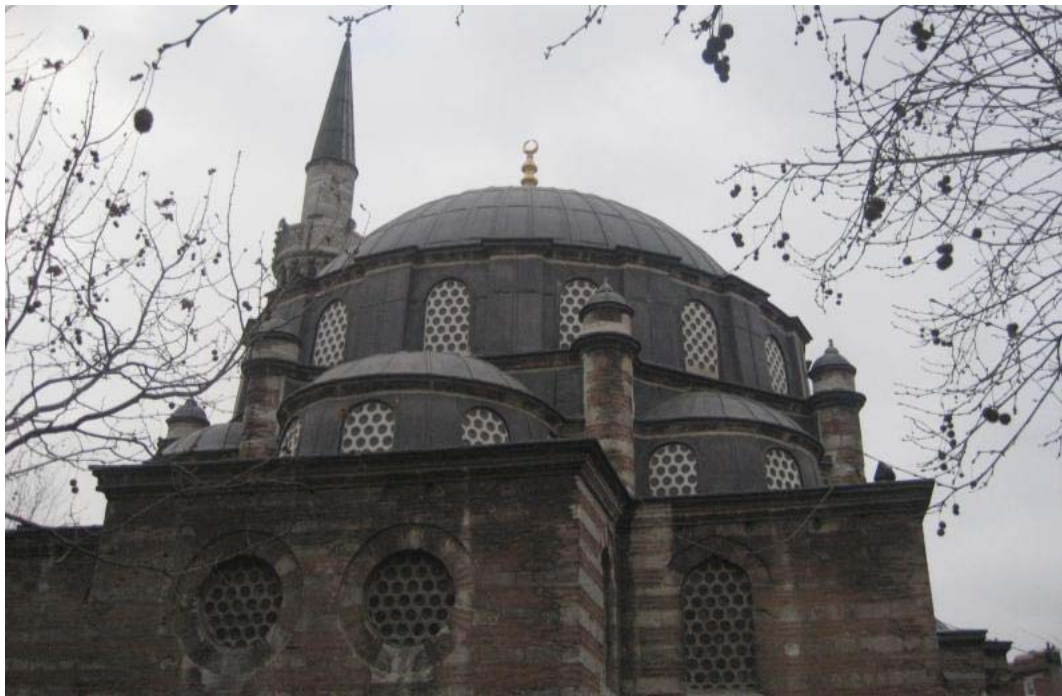
**Figure 5.1:** Mehmet Ağa mosque.

Mehmet Ağa mosque was constructed in 1585 (Okçuoglu, 1994) (Figure 5.1). It has been in service since its construction date. The mosque belongs the Ottoman Empire time. It was commissioned by Mehmet Ağa of Darussade. Architecture of the mosque is Davud Ağa who is a student of great Ottoman Architect Sinan.

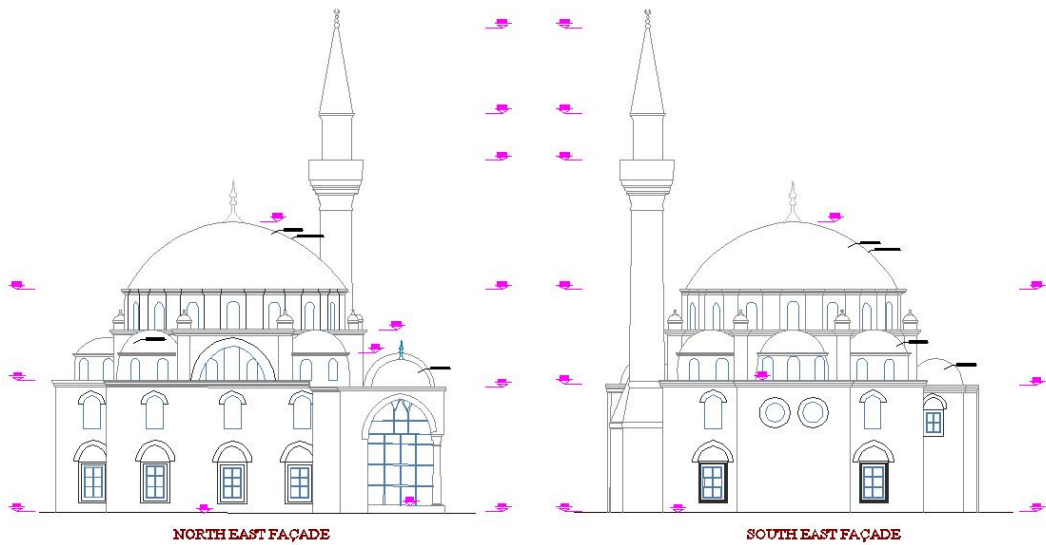
**Figure 5.6:** North-east and south-east façade views

Mehmet Aga Mosque has a square shaped main part called “Harim”. This part is covered with the main dome, which has a height of 17.3m and a diameter of 11.0m, and with five tromps. The pendentives are placed in between the main dome and tromps. The arches that bear the main dome are supported by four pilasters and by the four corners of body walls (Figure 5.2, 5.3, 5.4, 5.5, 5.6 and 5.7)

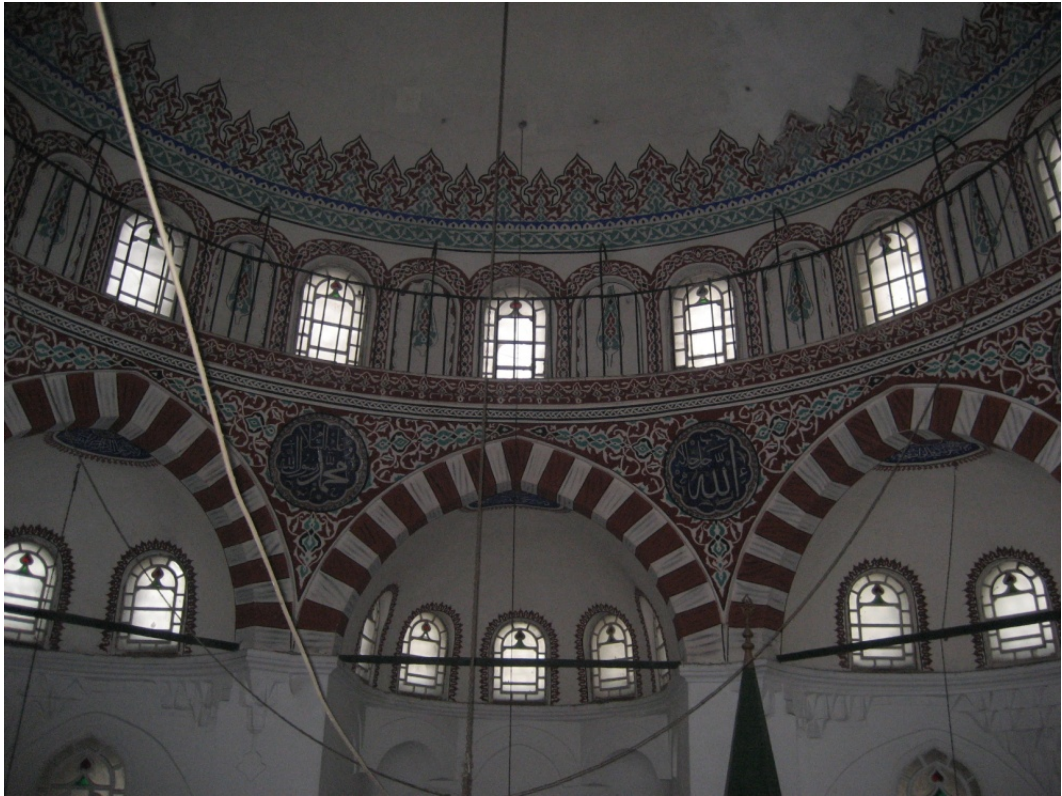
**Figure 5.7:** Mosque interior; arches, tromps, pendentives and arch ties

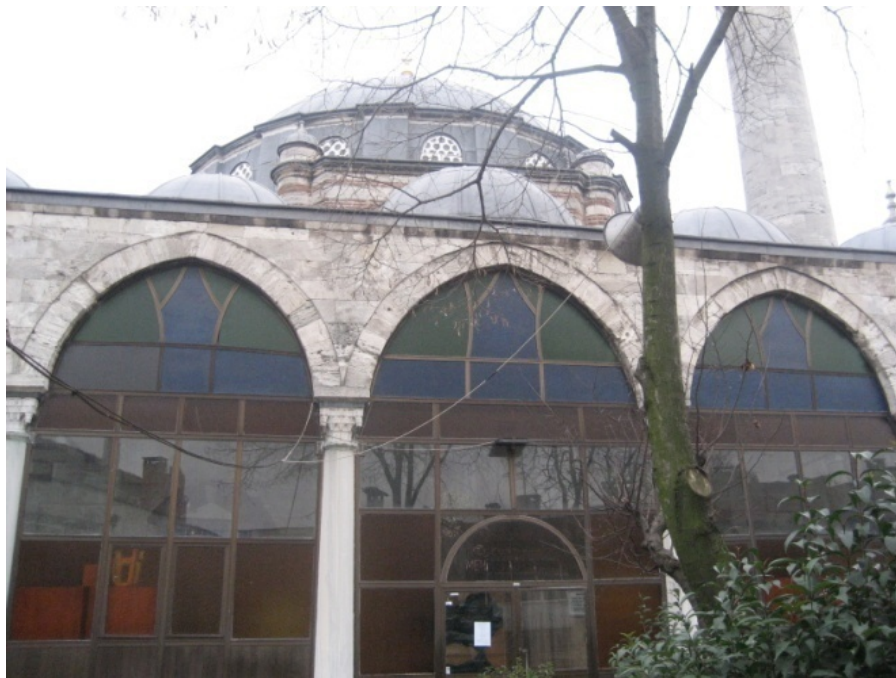
**Figure 5.8:** Front façade- the cloister of the mosque.

The mosque has a wooden interior balcony having a height of 2.8 m. External body walls of the building consist of one stone row alternated with three brick rows, which called “almaşık örgü” and its average thickness is 1.3 m. The main dome is made of brick. The cloister of the mosque consists of five parts covered by five small domes, which are supported by the six marble columns having stone heads through the arches (Figure 5.8). All arches have iron ties. The mosque has a minaret of 29 m height. The minaret is made of ashlar. Although most of them were changed, there

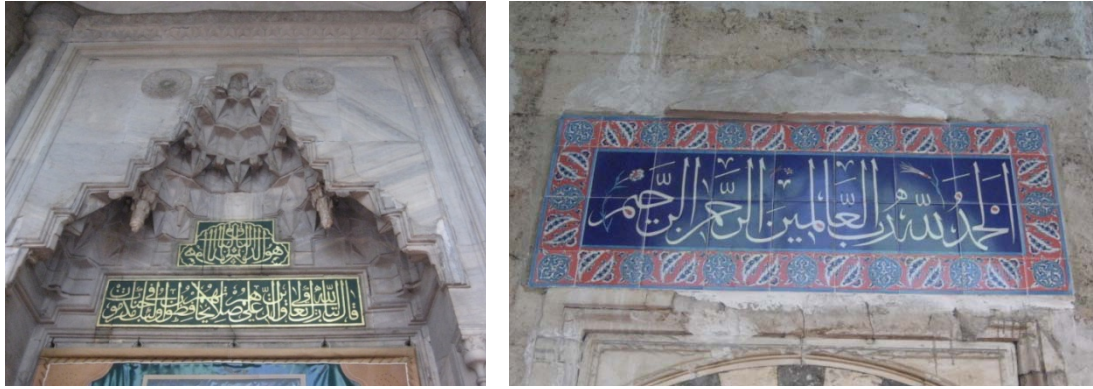
**Figure 5.9:** Calligraphies, handicrafts and ceramics

are still some original nice ceramics, beautiful calligraphies and handicrafts on the walls (Figure 5.9).

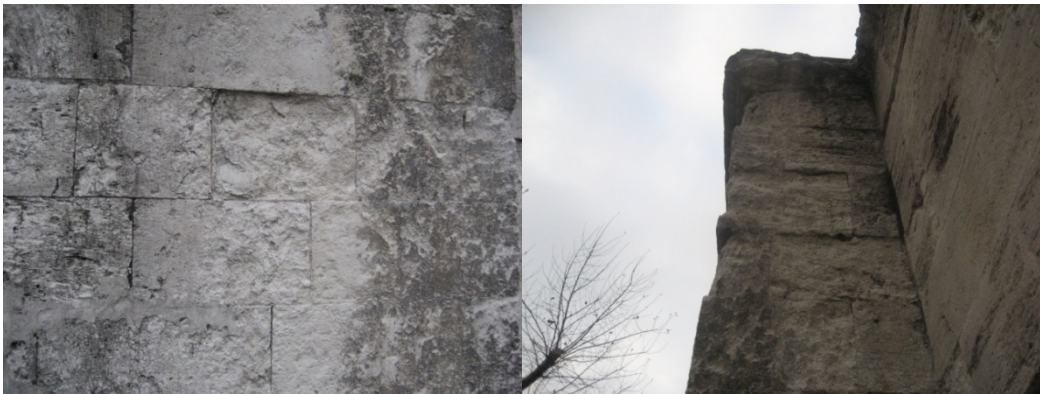
**Figure 5.10:** Stone deterioration on the wall of the cloister.

- Some ashlar are deteriorated in the cloister of the mosque (Figure 5.10).

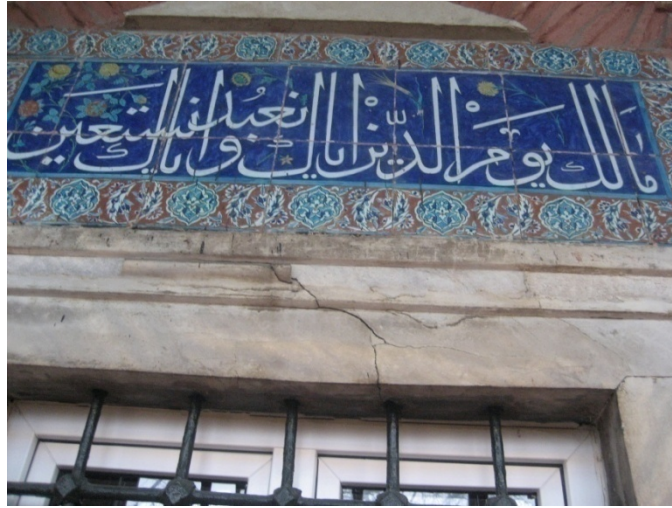
**Figure 5.11:** Cracks of window edges

- Few slight radial cracks are observed on one of the tromps.
- Generally, the edges of windows openings have cracks (Figure 5.11).

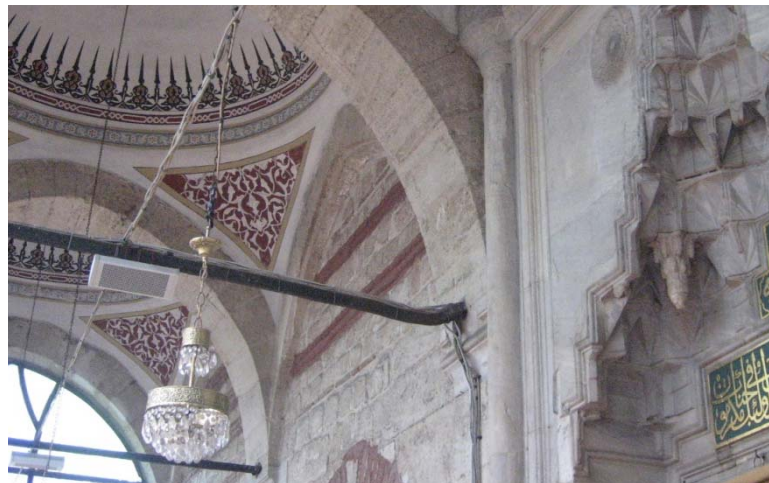
**Figure 5.12:** Buckling damage of iron ties.

- There are buckling damages at connection points of some iron ties (Figure 5.12).
