SOME OBSERVATIONS ON THE SEISMIC BEHAVIOUR OF
TRADITIONAL TIMBER STRUCTURES IN TURKEY

A THESIS SUBMITTED TO
THE GRADUATE SCHOOL OF NATURAL AND APPLIED SCIENCES
OF
MIDDLE EAST TECHNICAL UNIVERSITY

ASLI ER AKAN

JUNE 2004

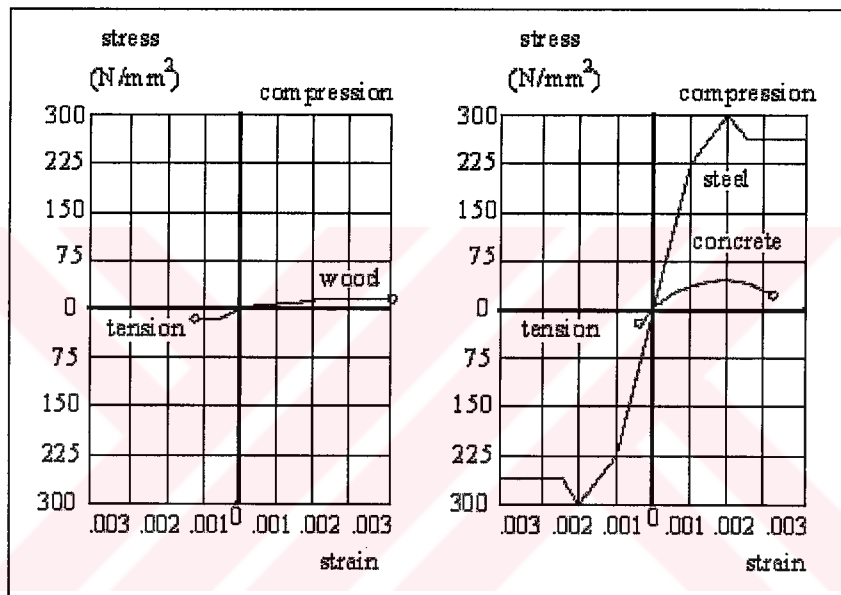
Figure 2.1 Typical Stress-Strain Curves for Wood, Steel and Concrete
<http://people.cornell.edu/pages/jo24/cuhk/courseNotes/timber/timber.html>

A linear relationship between stress and strain is an indicator of elastic behaviour (the return of a material to its original shape after being stressed and then un-stressed). Structures are expected to behave elastically under loads. Typical stress-strain curves for wood, steel and concrete are shown in Figure 2.1.

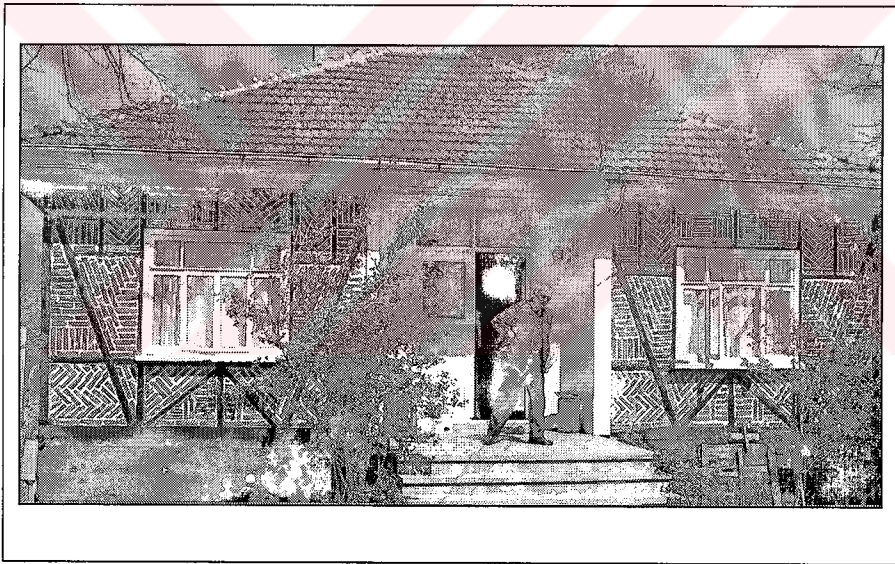
Figure 3.16 An Example of Himiş Structure with Brick Infill from Düzce

Brick Fill: This system was first used in 16th century. Due to the lack of wooden workmanship this traditional system started to disappear after 18th century (Çobancaoğlu, 2001). In this method brick is used for infill material and the thickness of the wall approximately the size of a half brick. In addition, spaces between the posts, which are generally 80-90 cm., are divided with diagonal members. Filling the bricks into wall can be shaped into horizontal, vertical and crosswise. Especially exterior walls that are closed to street were filled different shapes and were not plastered. Surfaces of timber framed houses with brick filled were sometimes left unplastered whereas sometimes plastered except beams and posts. An example of himiş structure with brick infill from Düzce is shown in Figure 3.16.

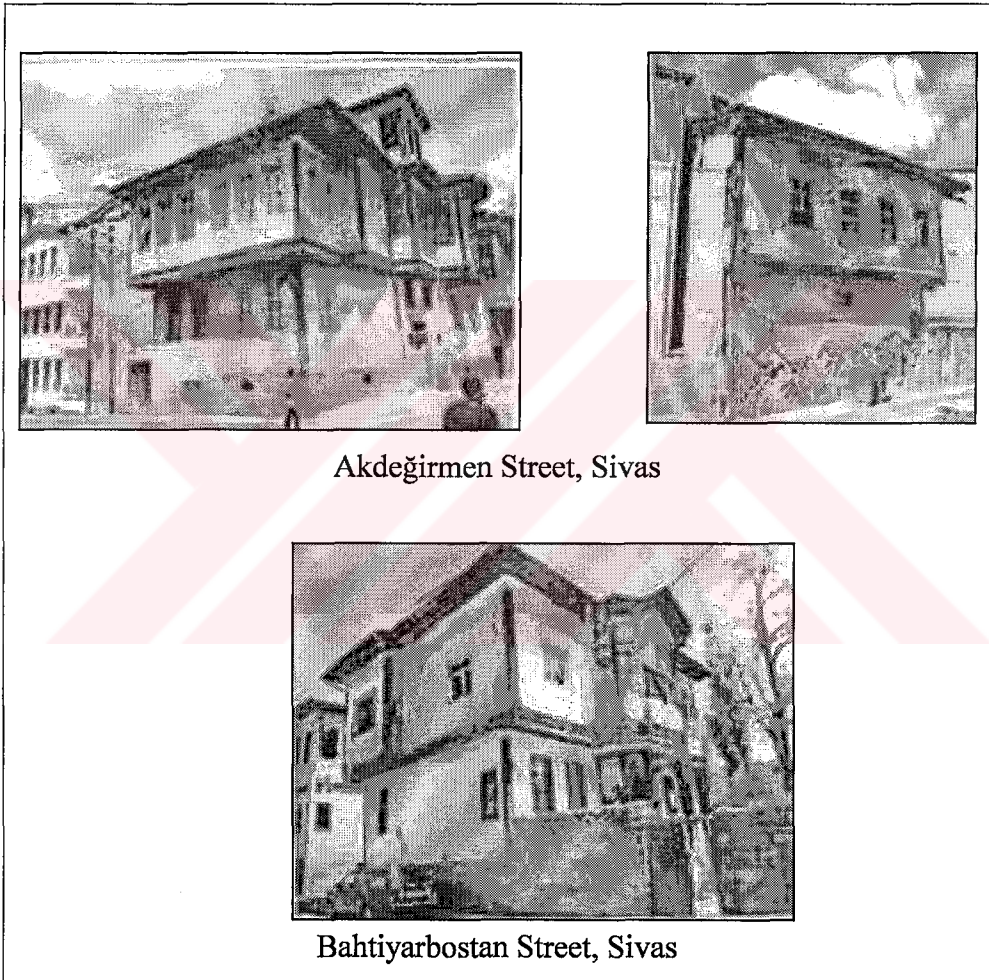
Figure 3.17 Traditional Timber Buildings with Sun-Dried Brick Fill
(<http://www.sivas.gov.tr/tarihivasevleri/k14.htm>)

In frame main posts that placed in every 1-1.5 m, studs with 60-70 cm spaces between main posts and diagonal members carry the fill. Sun-dried brick sizes vary according to region but the most widely used dimensions are 40/40/12 cm. Surfaces of the houses built with this system were plastered with mud except the main posts and beams.

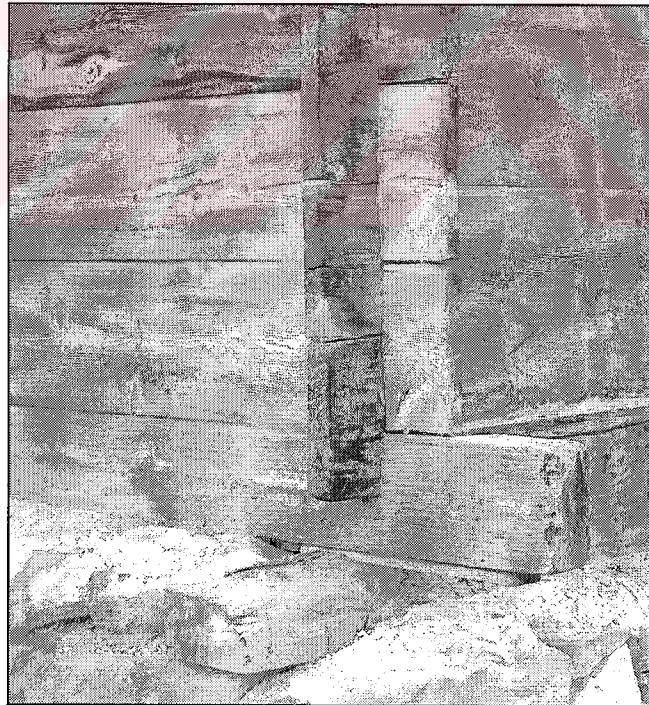
Figure 3.21 Wood Block System with Rafters

This system springs up from simple wood block system with round logs however; it has more sophisticated connection details than the former. It is usually used in the inner parts of the Black Sea Region. The form of logs is generally rectangular. Çakır (2000) points out that this system called as Çantı and it can be examined in two groups such as wooden block system placed on the masonry walls and wooden block system placed on the posts. In horizontal direction logs are inserted on the masonry wall that have 50 cm width in the former type. The load is transferred to the ground logs and masonry walls, respectively (Figure 3.21).

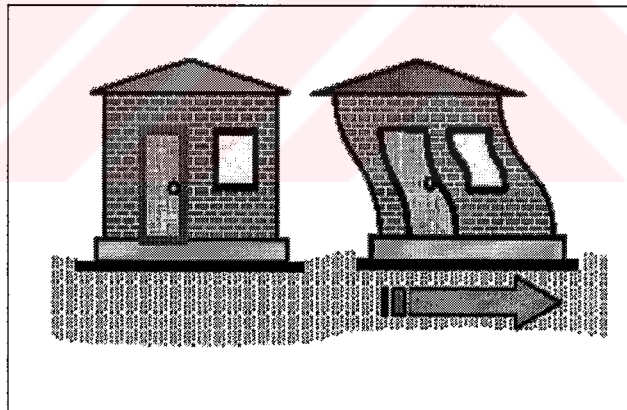
Figure 4.2 Effect of Inertia in a Building When Shaking at its Base

Earthquake causes shaking of the ground on which buildings rest. Therefore, buildings experience motion at their bases. From Newton's First Law of Motion, while the base of the building moves with the ground, the roof has a tendency to stay in its original position. However, since the walls and columns are connected to roof, they haul it along with them (Figure 4.2). As a result, this tendency to continue to remain in the previous position is called inertia. Certainly, the heavier the building the more inertia has to be overcome. Thus, lighter buildings sustain the earthquake shaking better.

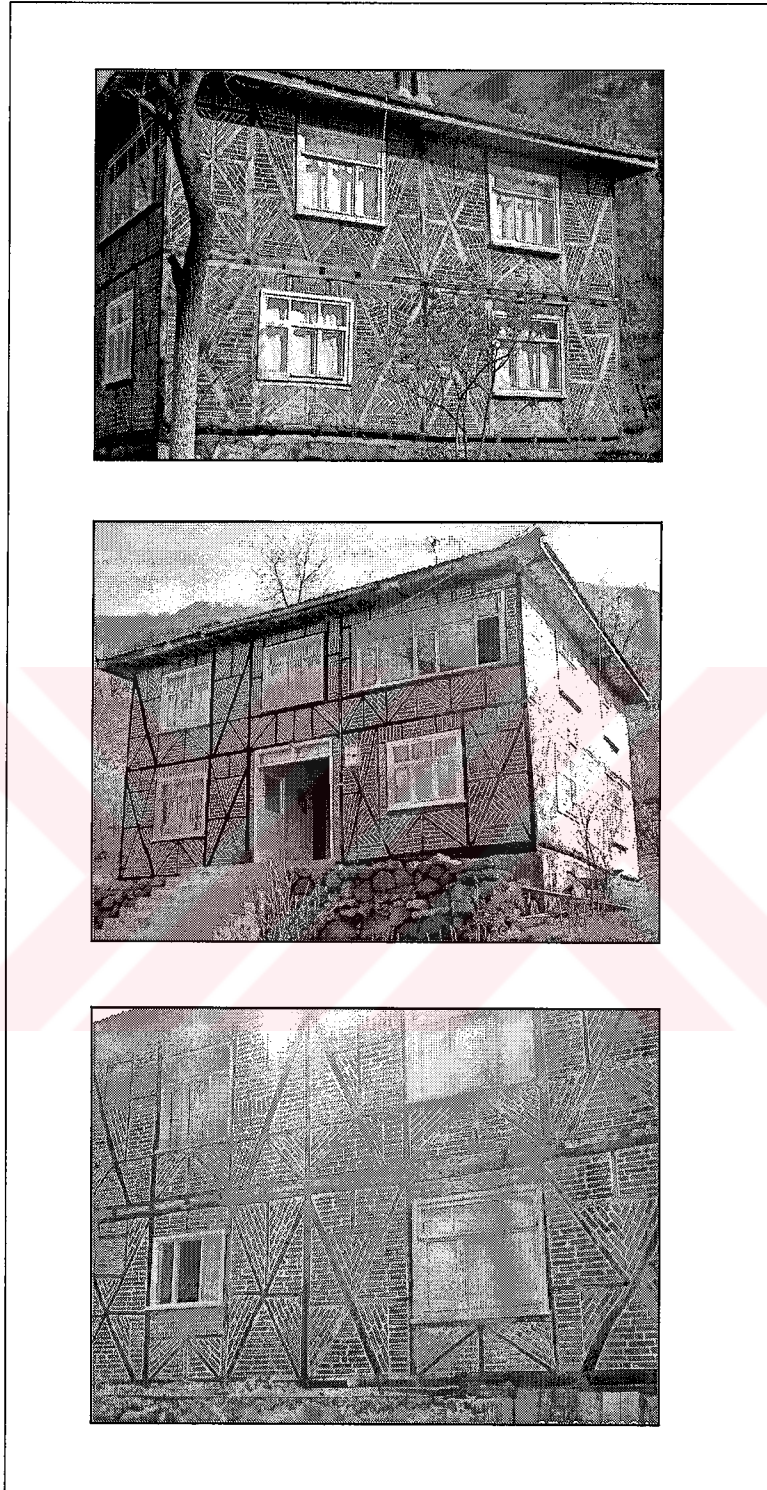
Figure 5.4 The Case Study (Hacı Musalar-Gölyaka)

The case study from Hacı Musalar village of Gölyaka is a hımış structure with brick infill as shown in Figure 5.4. To compare the seismic performance of hımış and bağdadi, the same building is assumed to be made of with bağdadi system. The self-weight of structural elements and infill materials are included into the calculations. Furthermore, the earthquake loads are applied in two directions X and Y.

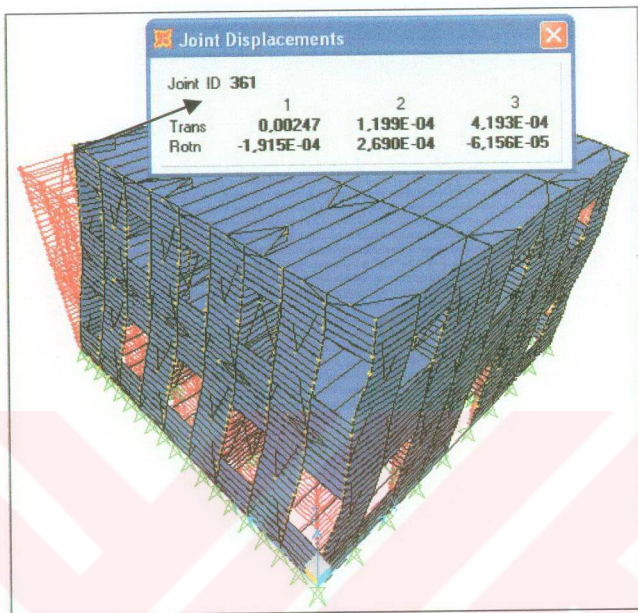
Figure 5.18 Deformed Shaped of Bağdadi Type Building With Infill
