**SAFE PILOT LADDER PROCEDURES**

**M.Sc. THESIS**

**Department of Maritime Transportation Engineering**

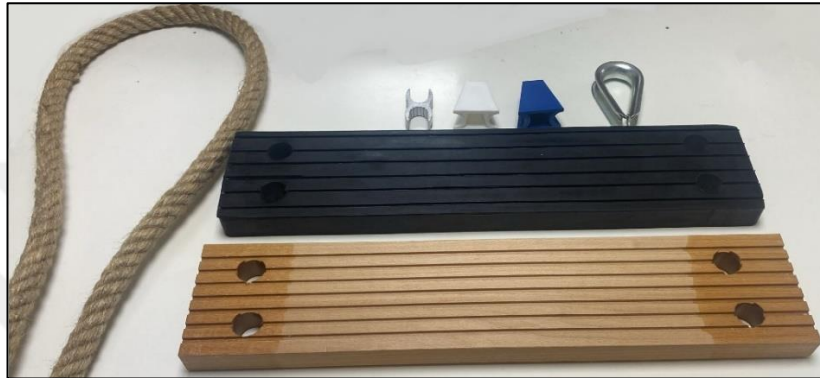
**Figure 1.2 :** Pilot ladder materials

In order to make a pilot ladder, you will need rubber steps, wood steps, spreader, manilla ropes, and step fixing pieces (Figure 1.2, Figure 1.3, Figure 1.4).

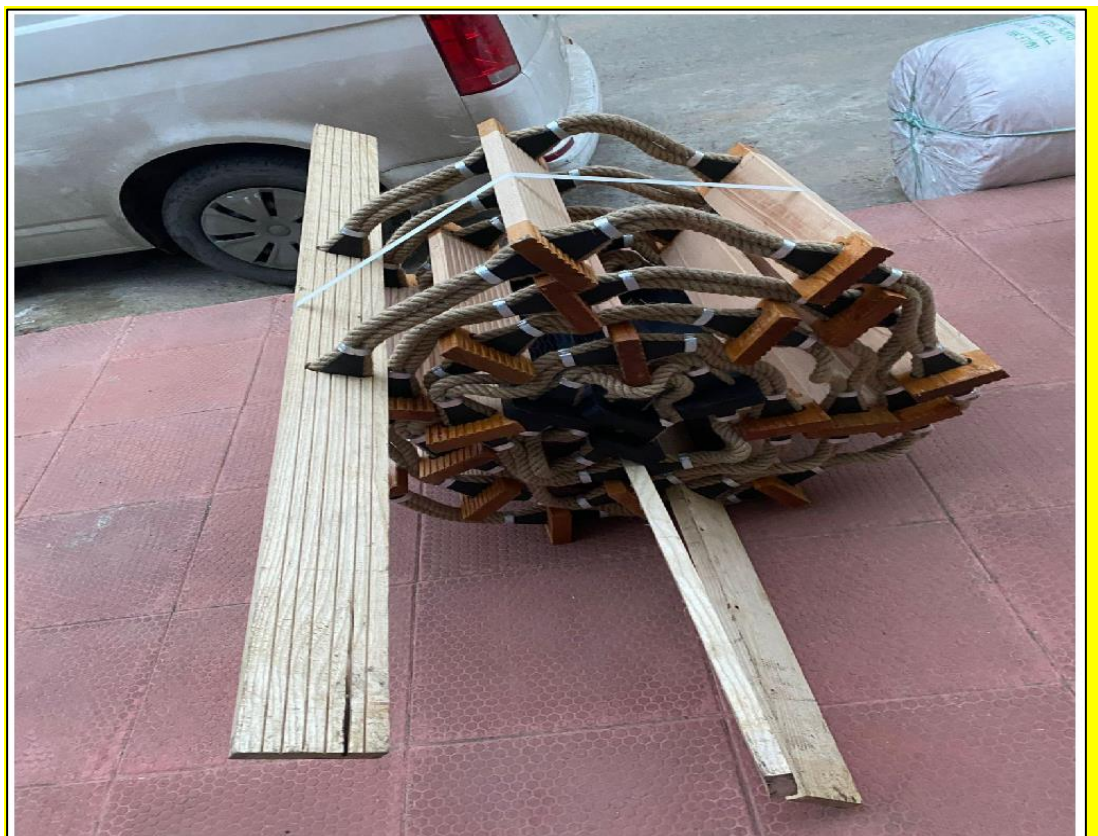
**Figure 3.4 :** New ladder: Non-compliant

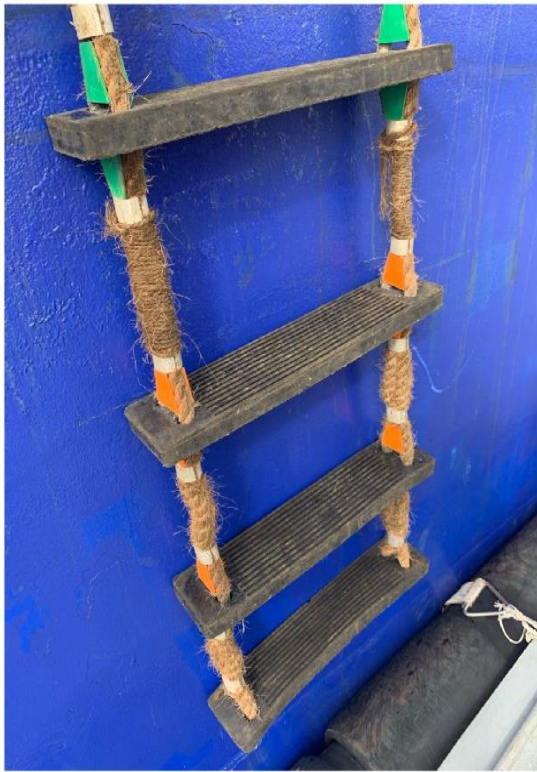
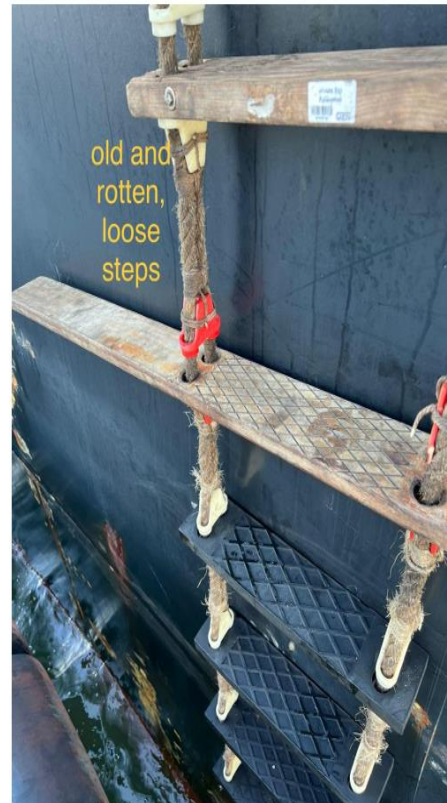
There is another element which affects the certification of the pilot ladder. A pilot ladder could be supplied to a vessel with a proper certificate, it could be in a good condition, a high-standard ladder, though after some time crew could make replacement on the ladder. As per the rules and regulations, if the crew repairs the existing pilot ladder, and the two steps of the repaired ladder is done different than the original construction the pilot ladder, then the ladder should be replaced and not to be used. However, if the replacement of steps done such way that looks like its original, crew could continue using the ladder. Once you remove the steps from the existing ladder, the certificate is no longer belongs to that ladder. Even though the official research show that 13.43 % of pilot ladders are non-compliant because of the crew repairs this percentage is actually around 60-85% (Rattray, 2021). Figure 3.5 shows the ladders which modified by crew. It is obvious that those ladders are not brand new, however different construction is visible, and they are still in use. People have to rely

on seamanship skills of crew while they use the pilot ladders. Unless crew was participated the practical deckhand course, integrity of the repaired pilot ladder is questionable.

**Figure 3.5 : After repairs (Palmers A., 2022)**

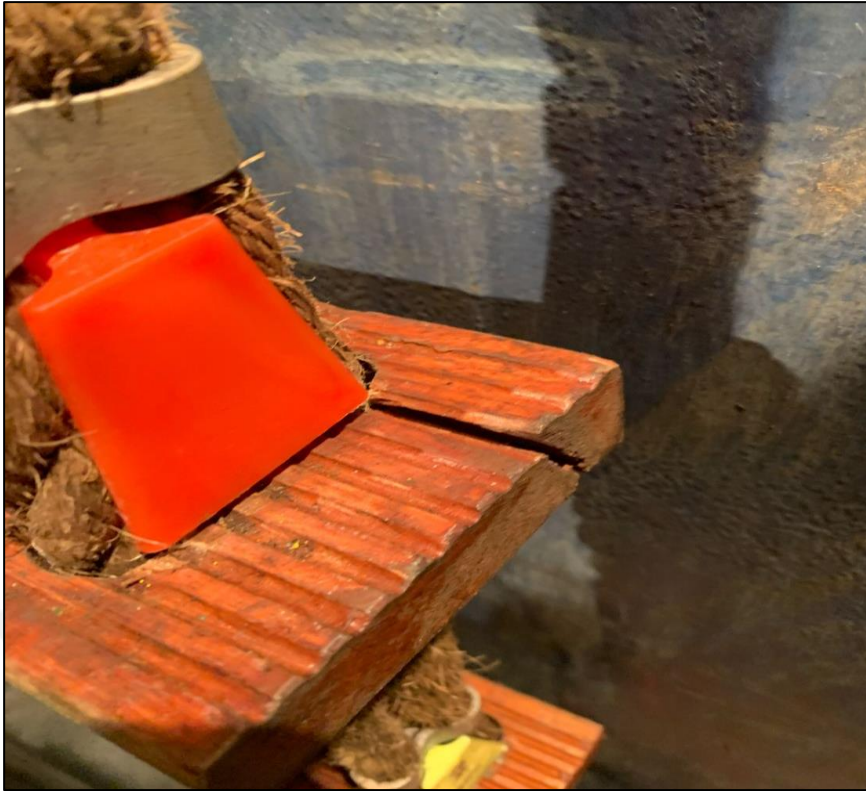
**Figure 3.8 : Cracked step (Palmers A., 2022)**

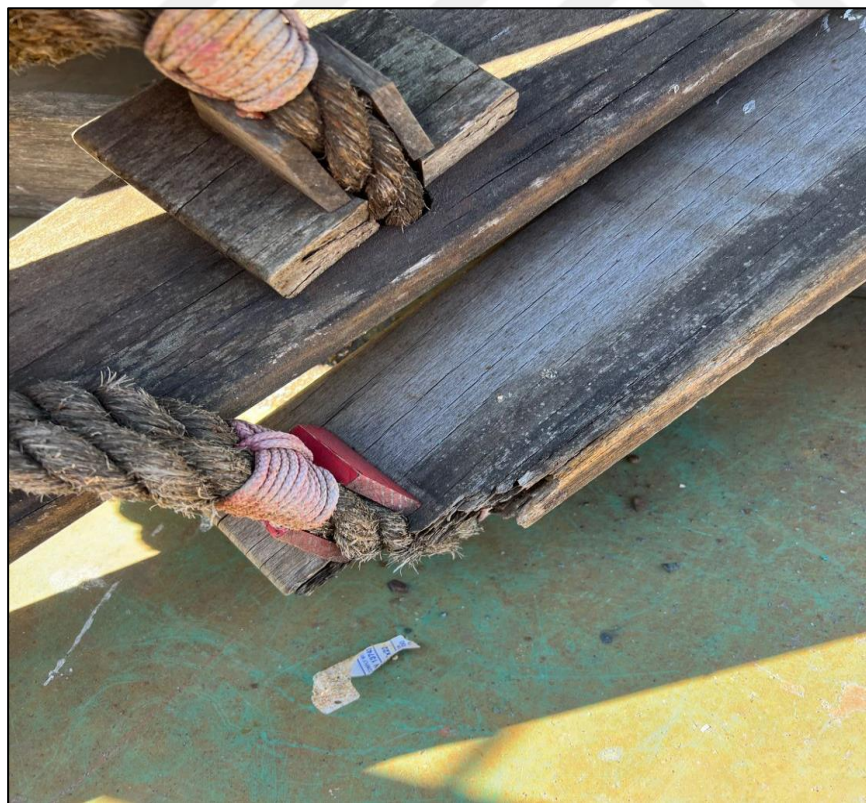
**Figure 3.9 : Broken spreader (Palmers A., 2022)**

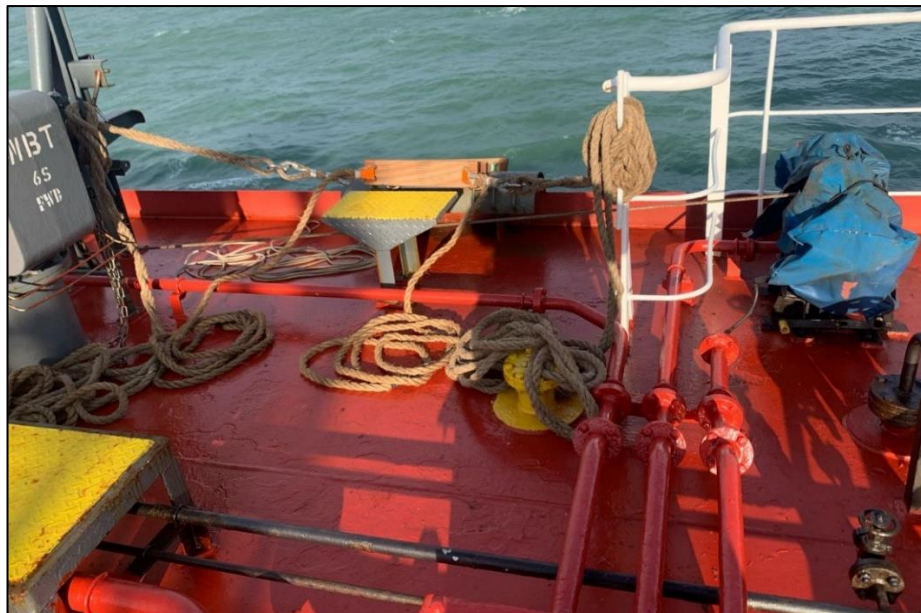
problematic, because regulations do not prescribe how the ladder is to be secured at deck level. According to defective ladder reports shows securing arrangements which are not in line with good seamanship (Figure 3.10). For a proper combination ladder, accommodation ladder shall be sited leading aft, the lower platform shall be secured to ship's side to ensure accommodation ladder held firmly against ship's side within the parallel body length of the ship. Also the lower platform should be minimum of 5m above sea level. If it is secured with magnets; two magnets required instead of one. Stanchions at the lower step / platform of the pilot ladder should be properly secured. In case of an existing trap door, person has to lean back to access to the trap door and the transition through trap doors must be provided with adequate handholds. Accommodation ladder angle (depending on the design) should not be more than 45°. Manropes required to be 28-32mm diameter. When the ladder is in use, the ropes cannot come in contact with the ship's hull. Metals used for clamping and fastening shall be corrosion resistant.

**Figure 3.10 :** Not secured on deck (Palmers A., 2022)
