**T.R.**  
**GEBZE TECHNICAL UNIVERSITY**  
**GRADUATE SCHOOL**

**DEVELOPMENT OF DECISION-MAKING MECHANISMS  
IN RESTORATION PROJECTS THROUGH STRUCTURAL  
HEALTH MONITORING METHODS**

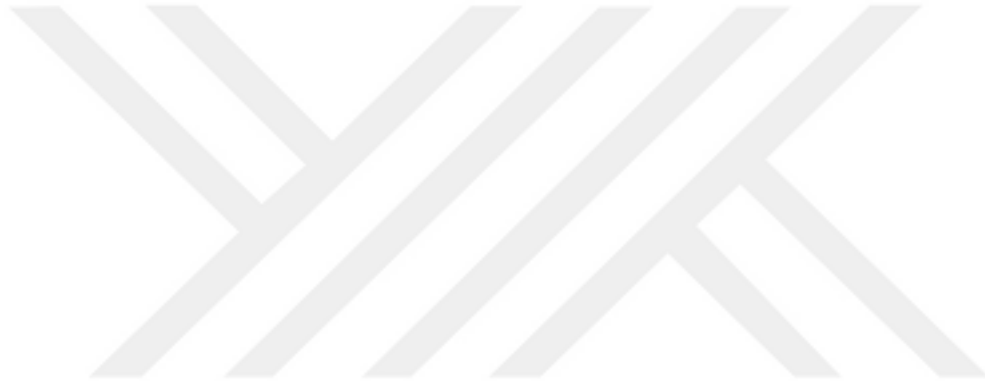
<b>Figure 5.47:</b> Calculated frequency spectrum in Y direction.	76
<b>Figure 5.48:</b> Calculated frequency spectrum in Z direction.	76
<b>Figure 6.1:</b> Injection Mortar Application Detail.	80
<b>Figure 6.2:</b> Reinforcement of Cracks Using Stitching Elements.	81

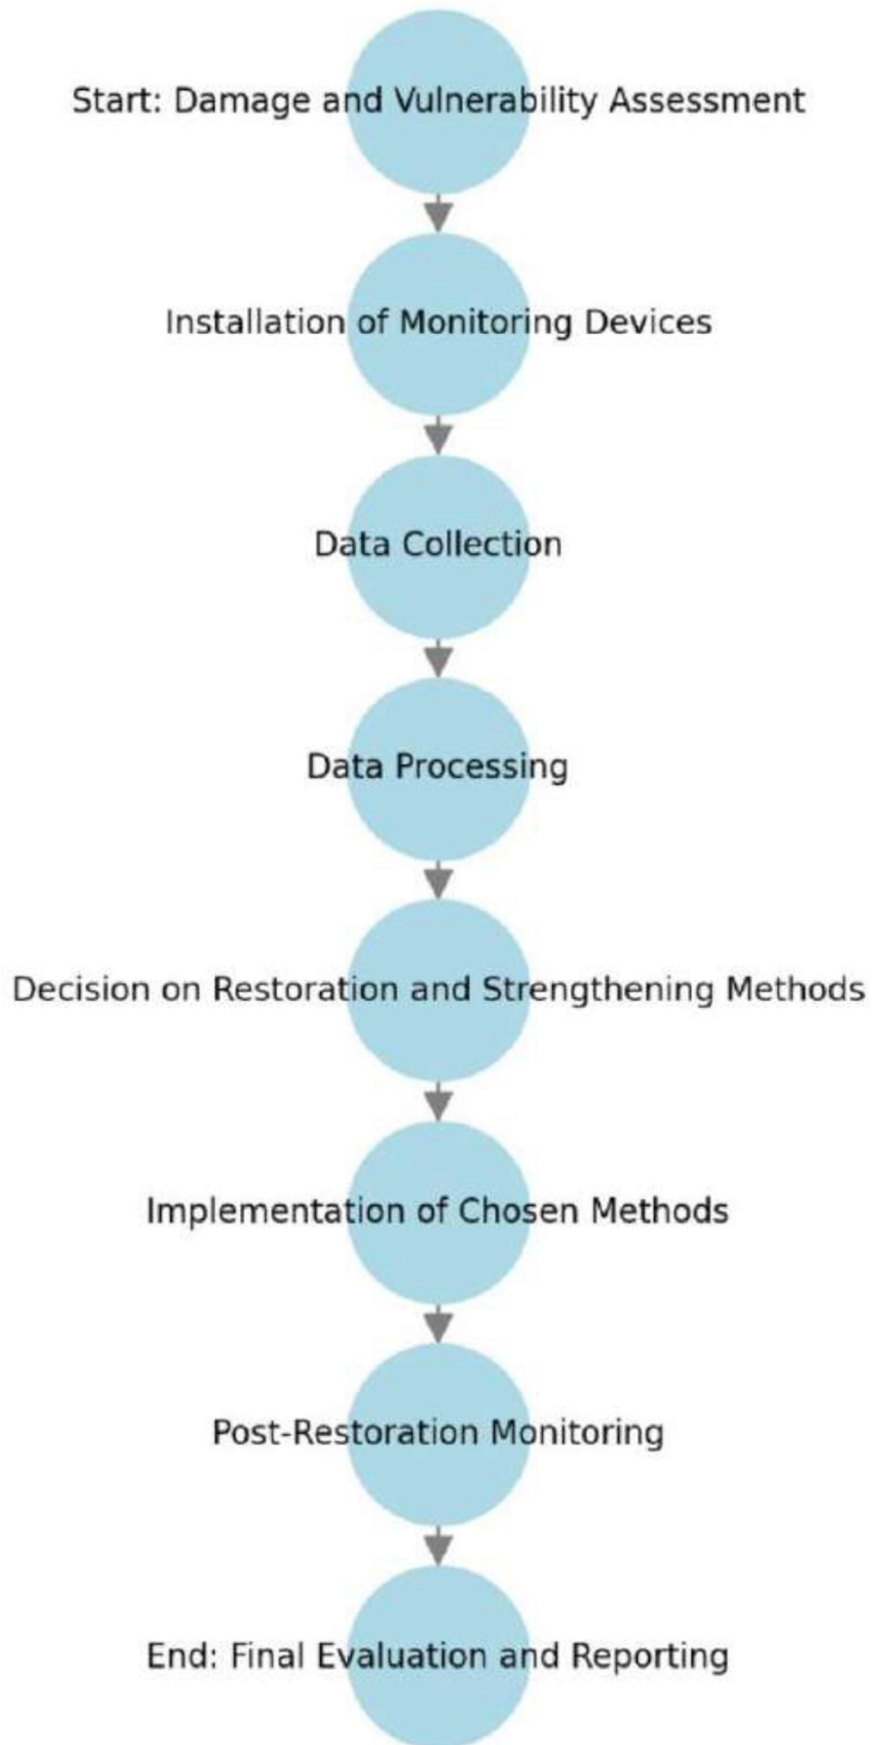
**Figure 3.1:** Flowchart for Restoration Decision-Making Using SHM Equipment.

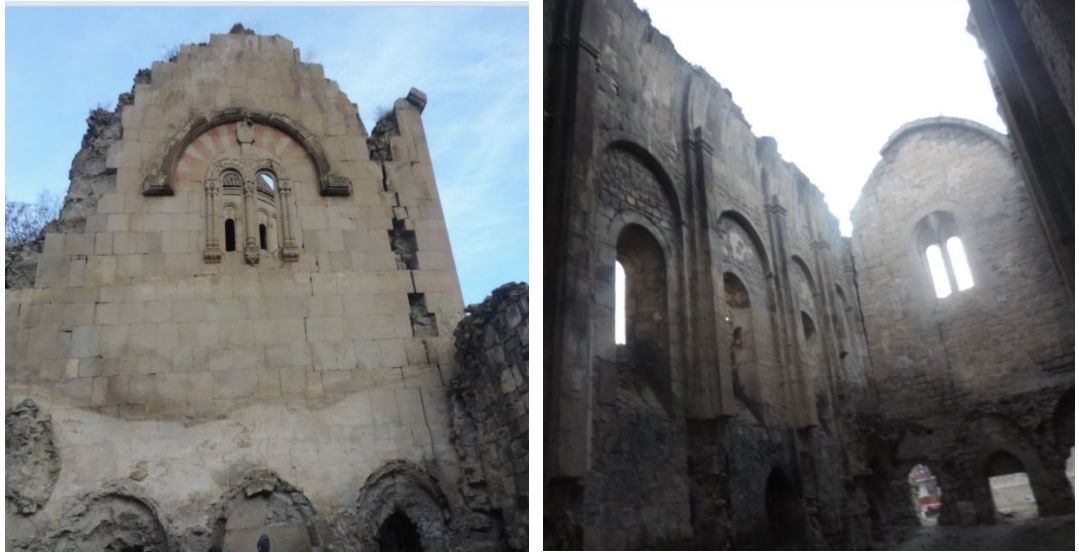
**Figure 4.8:** The Crack on the Western Facade of the Church and the Completely Collapsed Roof Section.

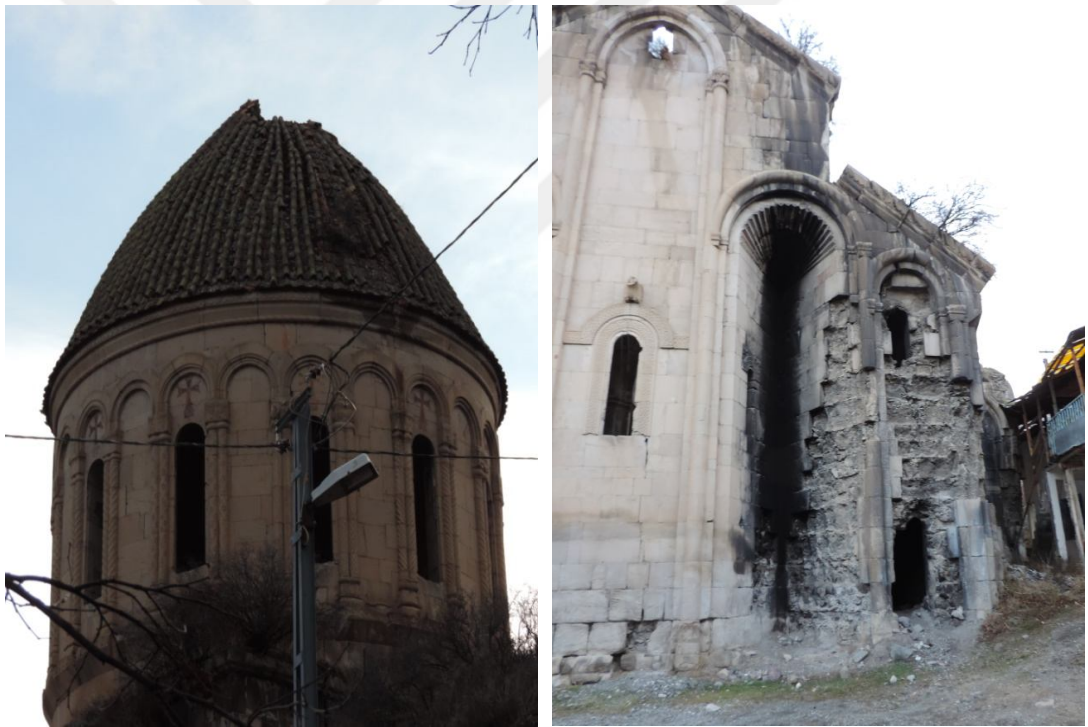
**Figure 4.9:** Damages Observed on the Main Dome and Eastern Facade of the Church.

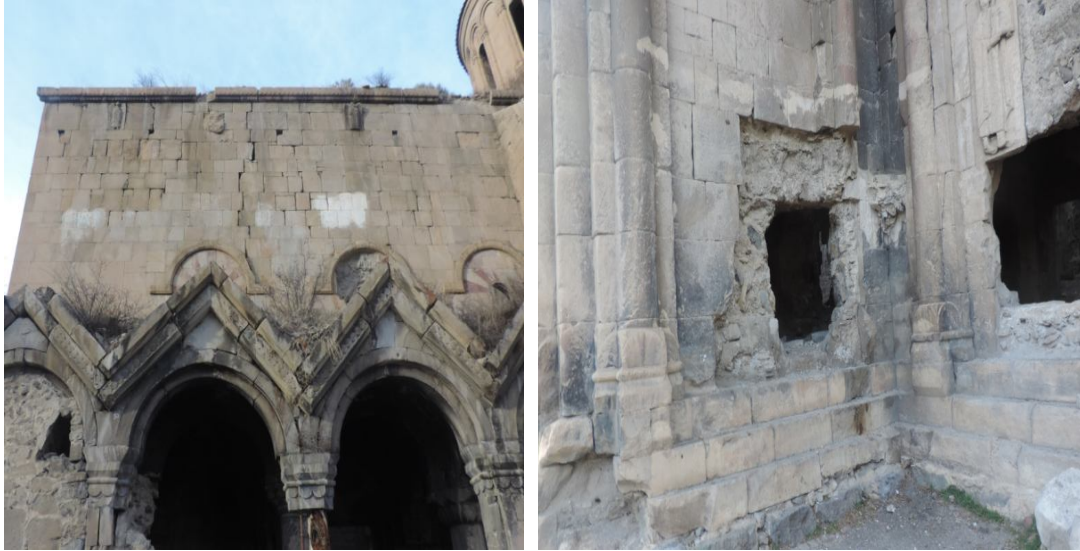
**Figure 4.10:** Some Cracks Observed on the Exterior Facade of the Structure.

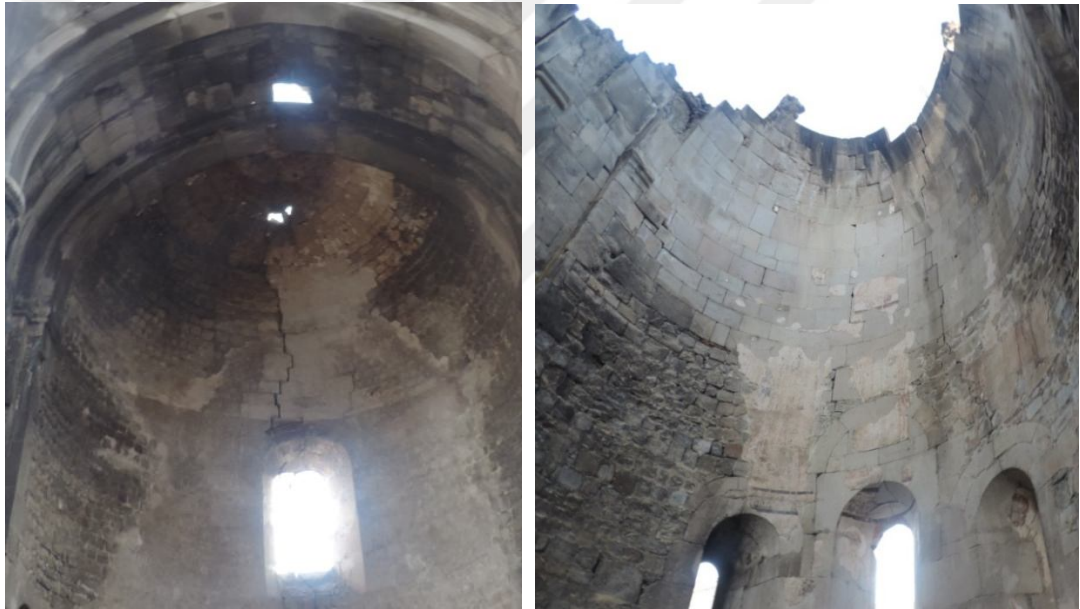
**Figure 4.11:** The Damaged Dome and Apse Section on the Interior Facade of the Structure.

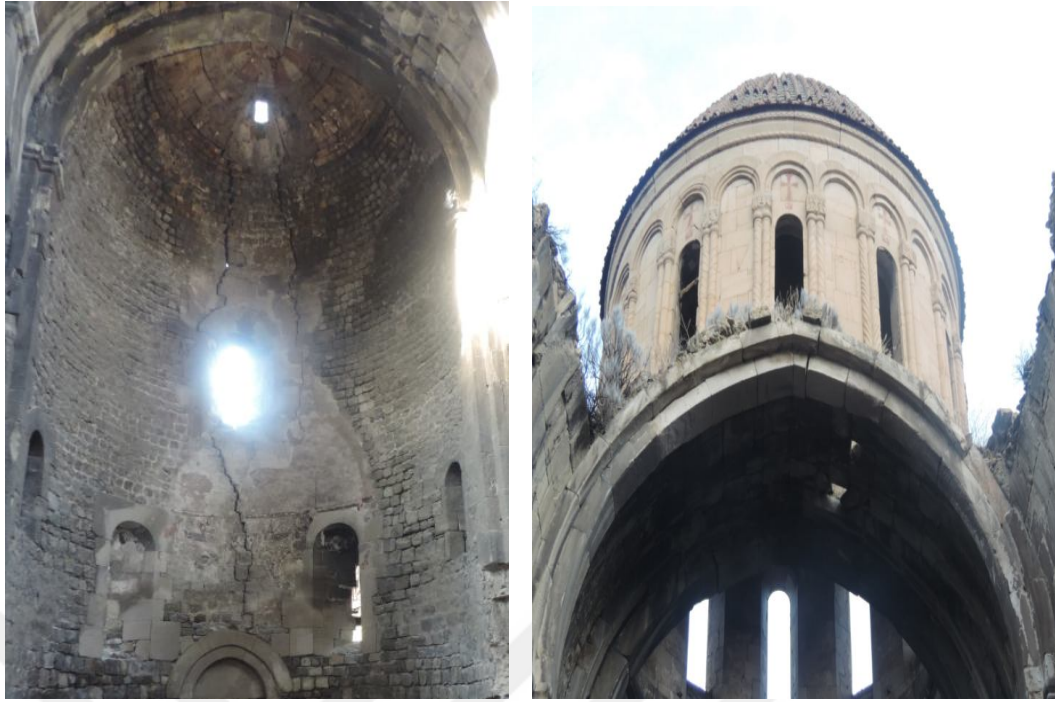
**Figure 4.12:** Some Damages Observed on the Interior Facade of the Structure.

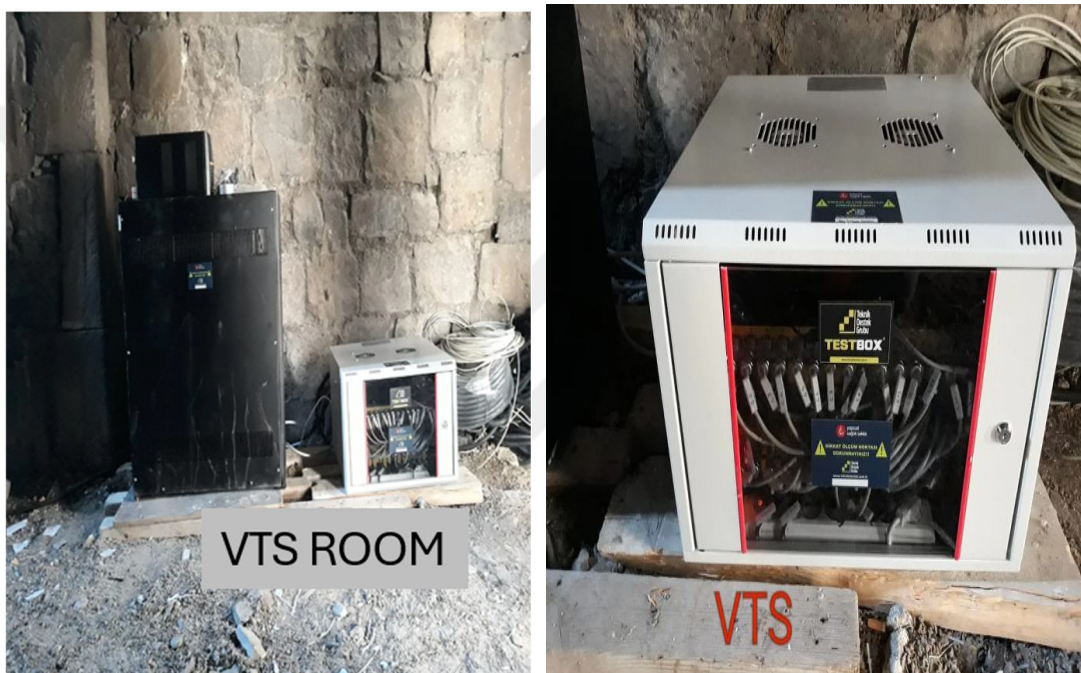
**Figure 4.13:** Some visuals of SHM Equipment .

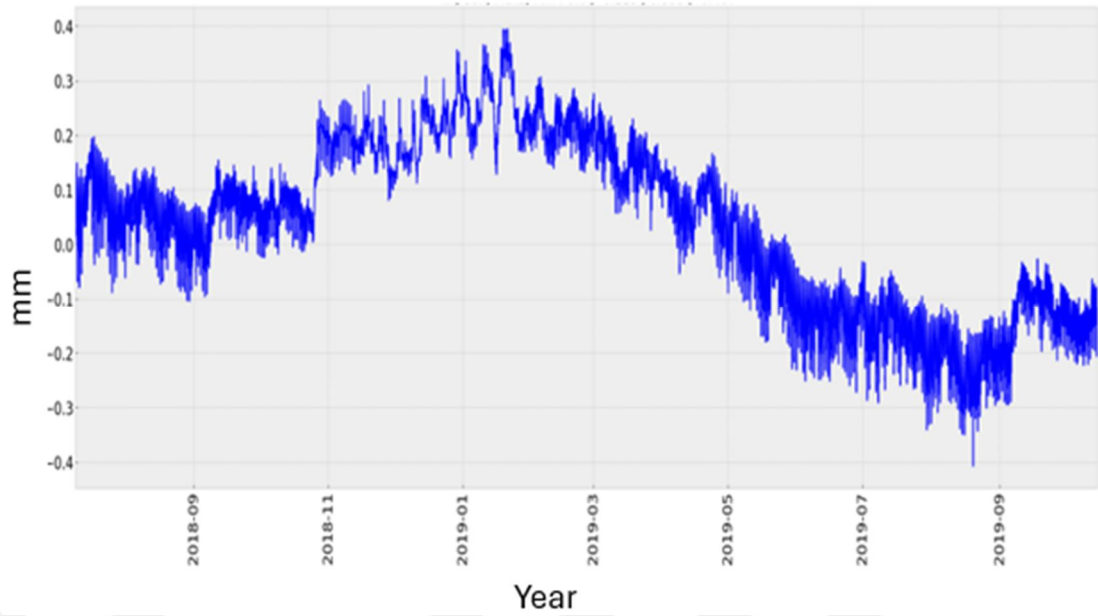
**Figure 5.22:** Crack 7 first &last data time : 2018\_0709-11:20:00&2019\_1015-11:00:00 First , last ,max. ,min. : 0.0 , -0.119 , 0.395 , -0.407

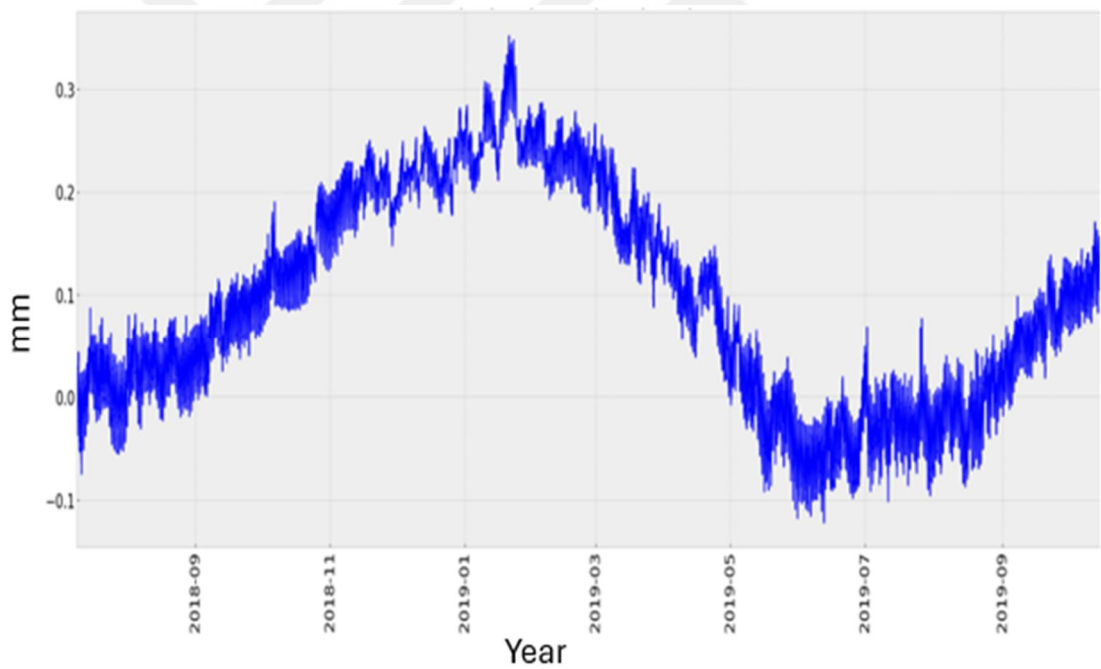
**Figure 5.25:** Crack 10 first &last data time : 2018\_0709-11:20:00&2019\_1015-11:00:00 First , last ,max. ,min. : 0.0 , 0.105 , 0.351 , -0.122

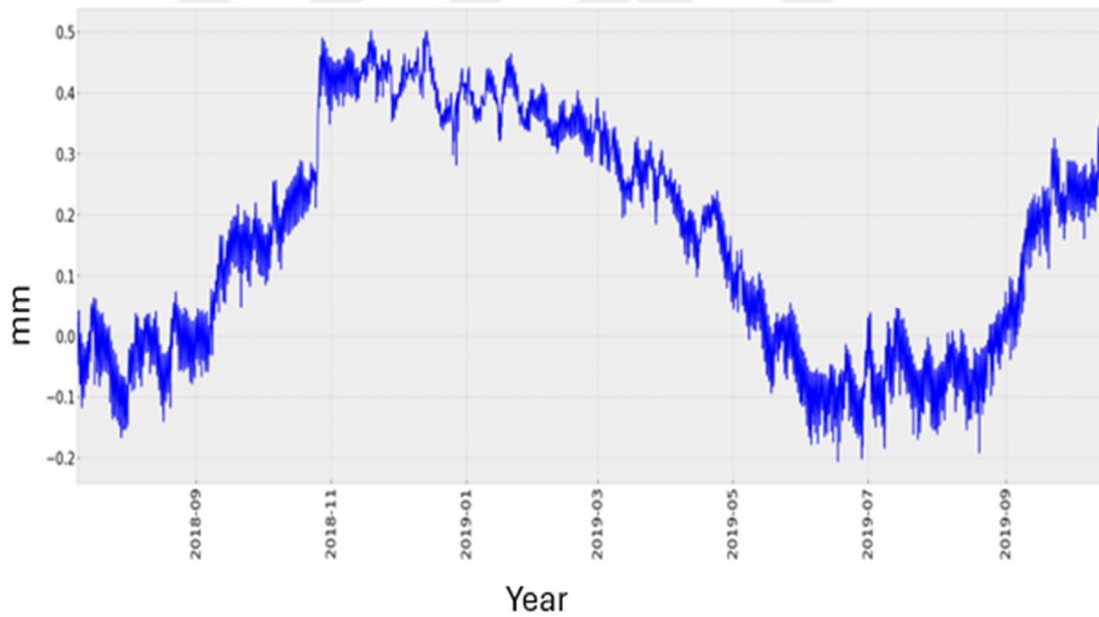
**Figure 5.35:** Crack 20 first &last data time : 2018\_0709-11:20:00&2019\_1015-11:00:00 First , last ,max. ,min. : 0.0 , 0.319 , 0.502 , -0.206

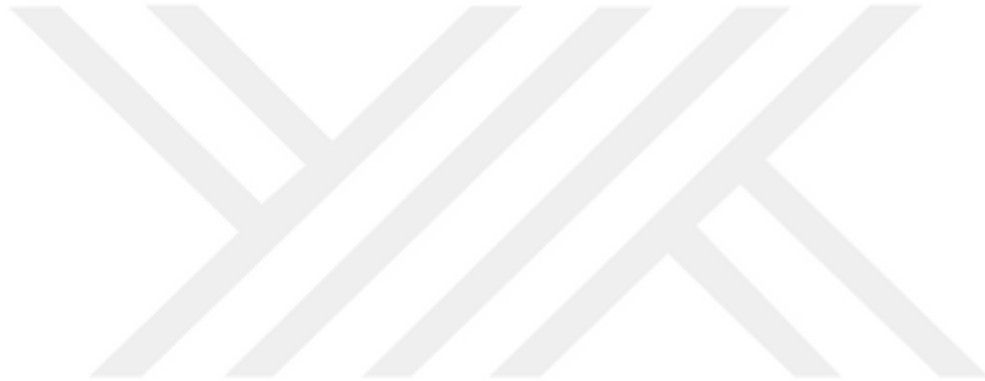
of the structure. These repairs must also be distinguishable from the original state of the structure to prevent misrepresentation of its artistic and historical authenticity. Additionally, during the restoration of section losses, attention should be paid to the vertical load path, ensuring that the thickness of the masonry walls is consistent across all floors and properly aligned.
