**AIR POLLUTION EFFECTS ON THE FAÇADE OF  
THE BOTTER APARTMENT IN ISTANBUL**

**A Thesis Submitted to  
the Graduate School of Engineering and Sciences of  
Izmir Institute of Technology  
in Partial Fulfillment of the Requirements for the Degree of**

**In Architectural Restoration**

**by  
Birsen PARLAK**

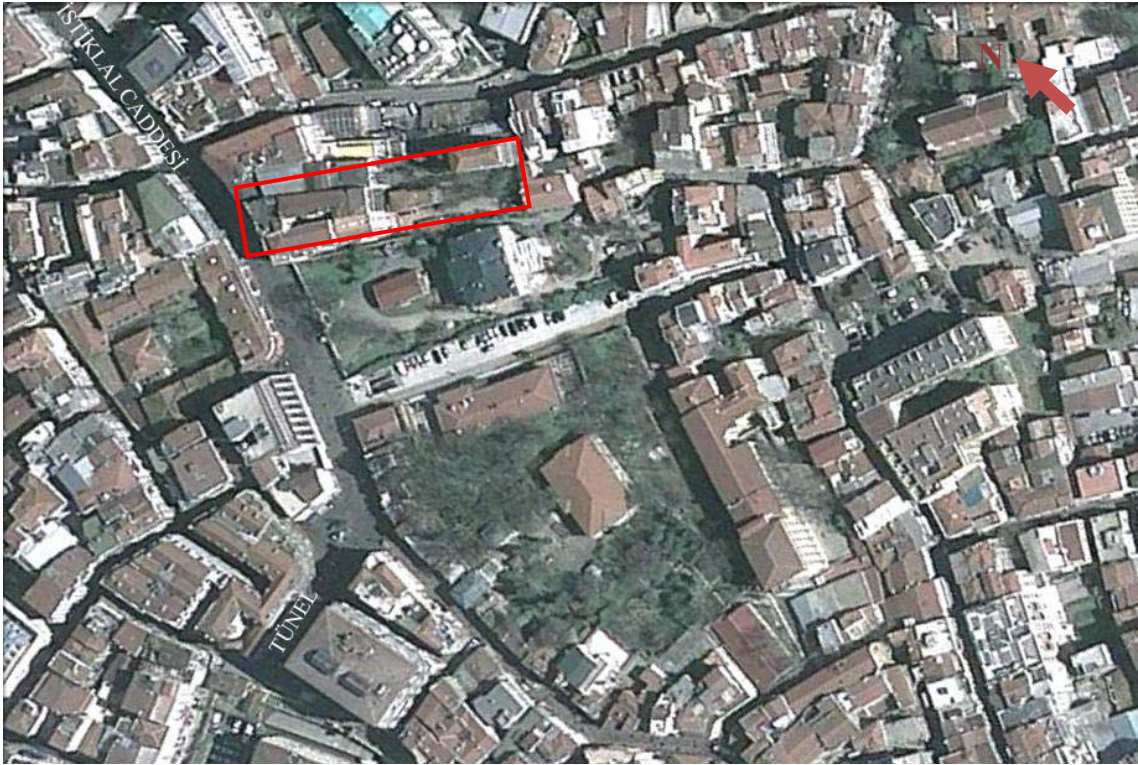
Figure 1. Aerial photo showing the location of the plot of Botter Apartment on İstiklal Avenue (Source: Istanbul Büyükşehir Belediyesi 2010)

Botter Apartment with its original name Maison Botter located on the İstiklal Avenue near to the Tunnel Square in Beyoğlu, Istanbul (Figure 1, Figure 2). The plot on which the monument situated is narrow and deep. The location of the Apartment is on the northwest side of the plot. There is an annex at the southeast side of the plot.

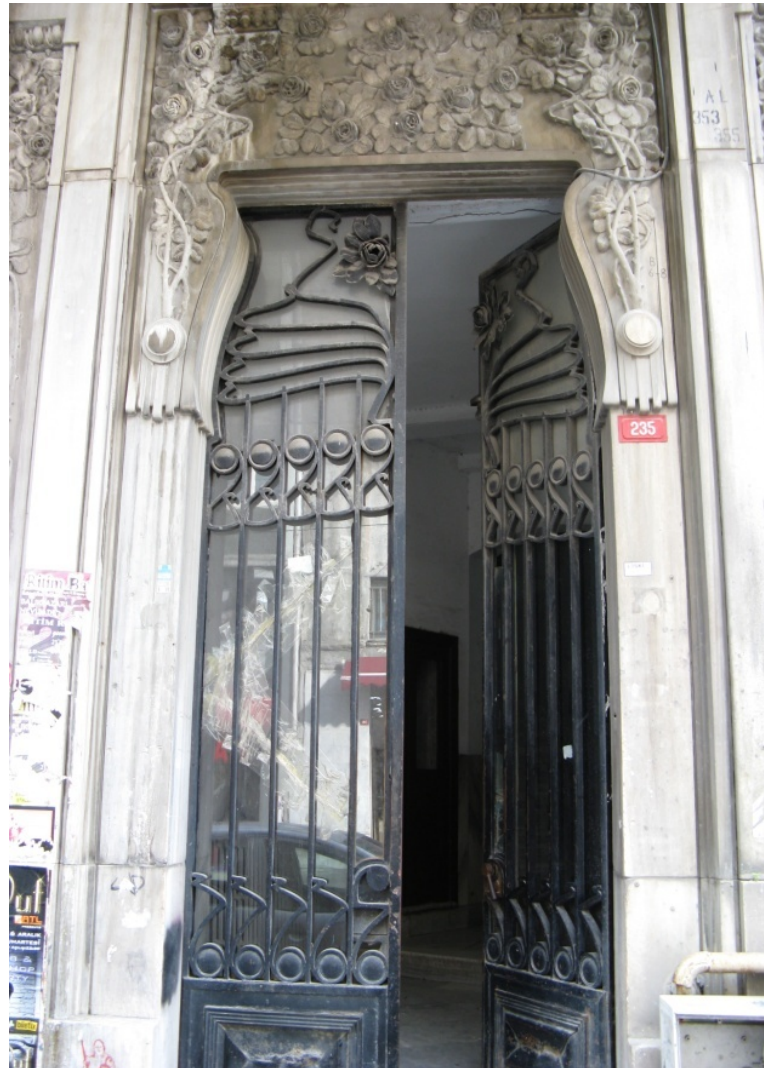
Figure 5. Florally ornamented main entrance door of Botter Apartment

All architectural elements of the building were especially designed by D'Aronco (Batur 1993). Elliptical planed stairs, ornamented balustrades, stained glass windows, main and atelier ornamented entrance doors (Figure 5), the lighting elements and original elevator (Figure 6) make this building an important art object that projects the style of its period.

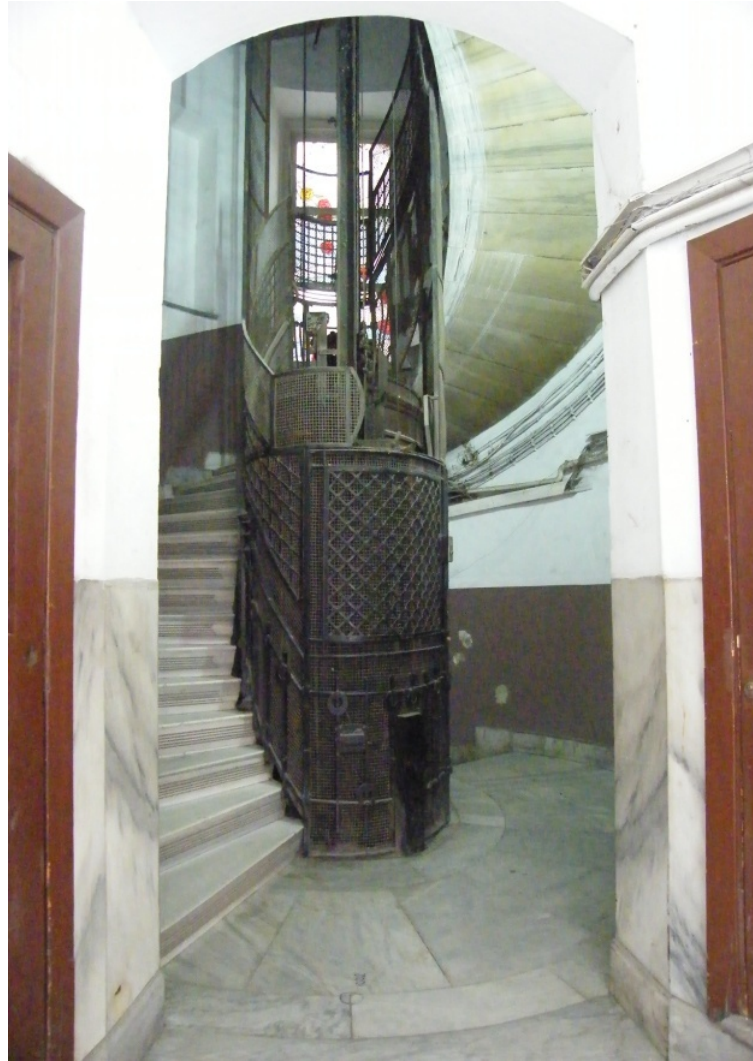
Figure 6. Original elevator of Botter Apartment

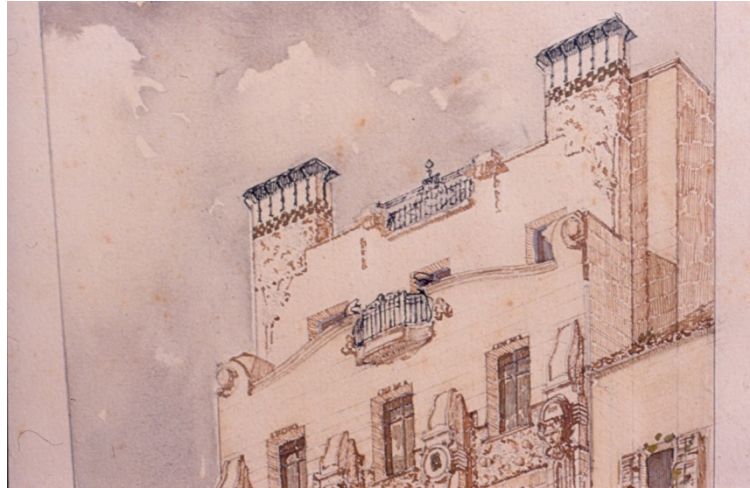
Figure 8. Original watercolor paintings of D’Aronco showing the terrace and fifth floor façade ornamentations (Source: Afife Batur Dia Archieve, Udine Civic Museum of History and Art, Udine-Italy)

Original façade design of D'Aronco has not changed until today except for the ground floor atelier part (Batur 1993). Ornamented atelier entrance door (Figure 7) was changed during the previous interventions. On the façade order the workplace section breaks up with five horizontal bands that have curvilinear ornaments at the edges. The upper floors that were used as a residence are in symmetrical order and also like frame

with ornamentations (Figure 8). Differentiations on the ornamentations are observed at each floor. At the fourth floor dense floral ornamentations and at the two sides of the façade under the circular medallion head of Meduza take attention with its wavy hair and crown. At fifth floor, which was designed as a setback storey, balcony emphasizes with its curvilinear ornamented railings and straight bands at two sides which have circular curves at the edges (Figure 9).

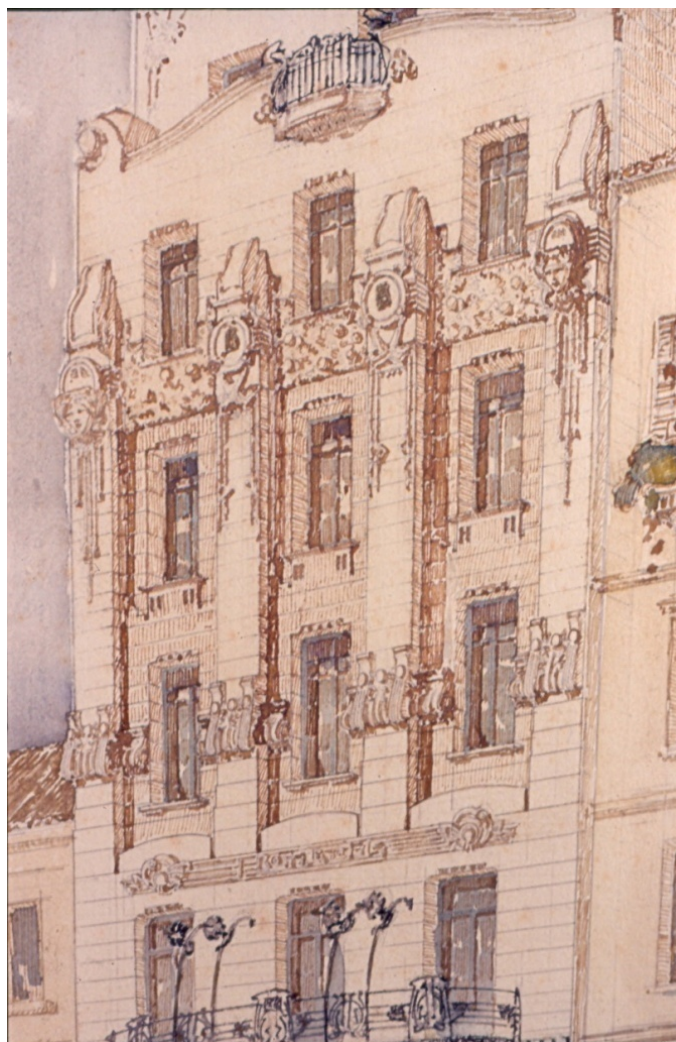
Figure 9. Original watercolor paintings of D’Aronco (Source: Afife Batur Dia Archieve, Udine Civic Museum of History and Art, Udine-Italy)

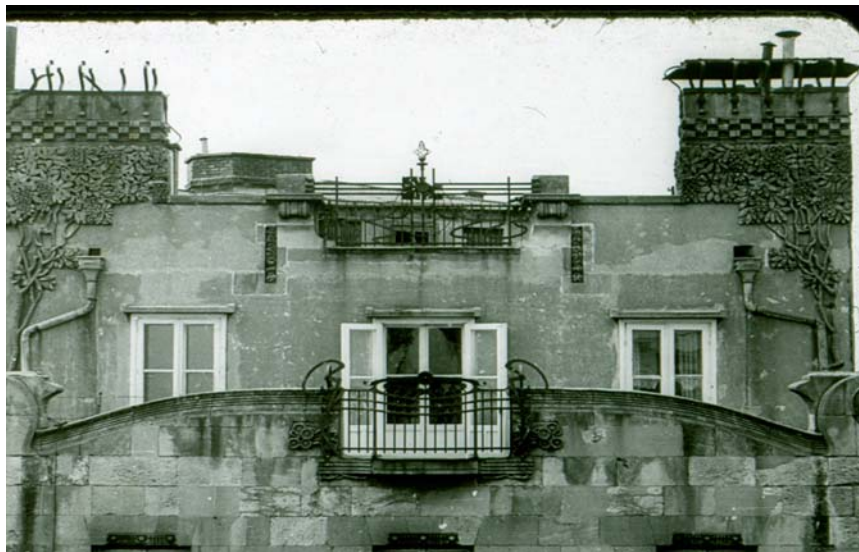
Figure 10. Detail from the terrace floor of the Apartment at 1980s (Source: Afife Batur archive, photograph taken by Erkin Emiroğlu)

At the terrace floor the centre of the parapet wall is decorated with iron railings. The chimneys at the two sides were also decorated with dense florally ornamentations. Details of the chimney above the ornamentations cannot be reached today. This detail is documented with a photograph taken in 1980s (Figure 10). Deterioration on the façade can be easily observed with comparing the two photographs taken thirty years apart (Figure 11).

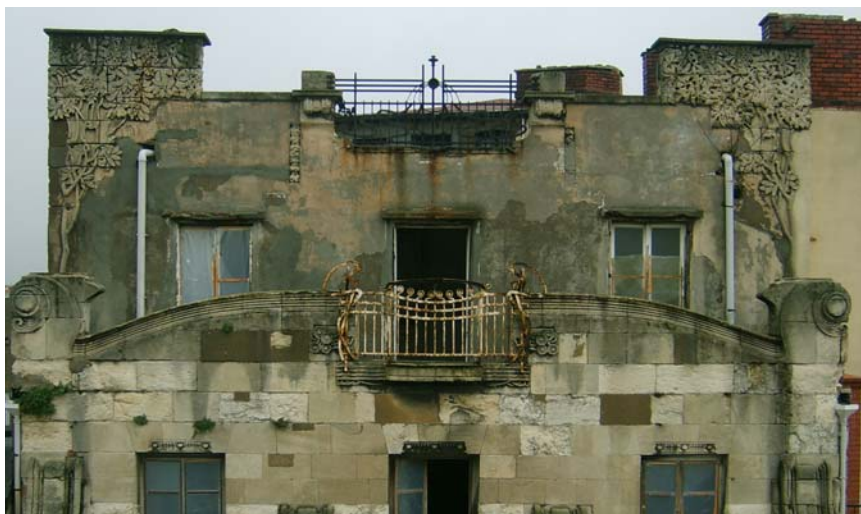
Figure 11. Detail from the terrace floor of the Apartment at 2009

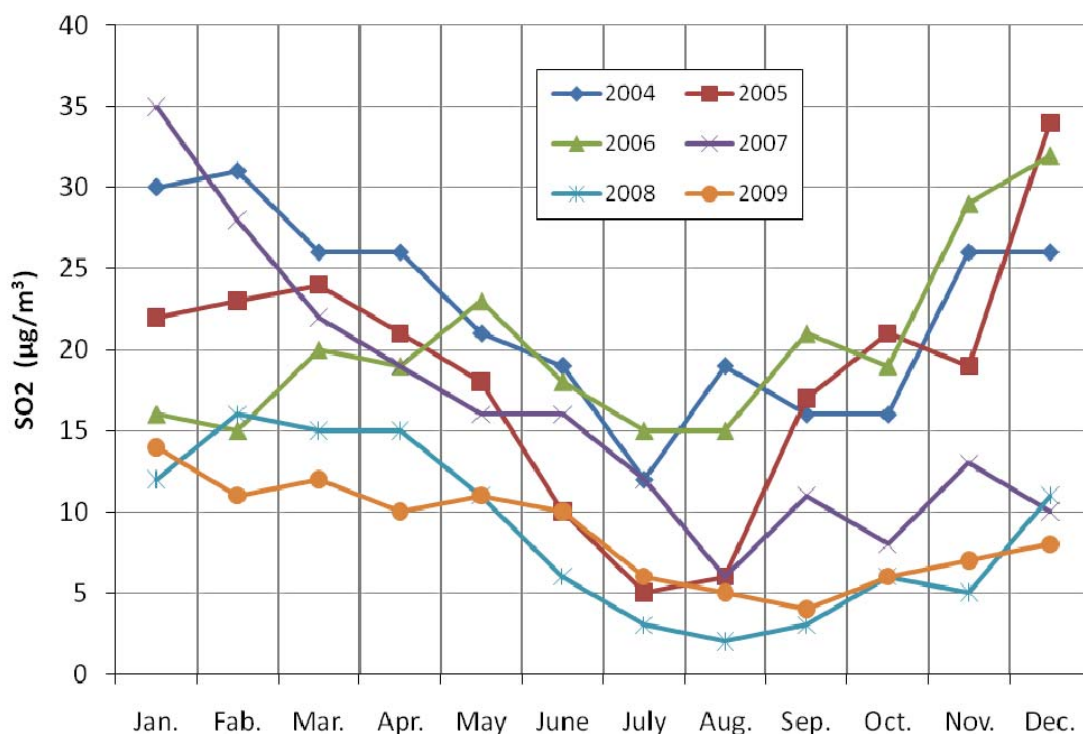
Figure 12. Monthly SO<sub>2</sub> concentrations in Beşiktaş - Istanbul between the years 2004 – 2009 (Source: Air Pollution Forecasting Service 2010)

In this study, the effects of air pollution mainly SO<sub>2</sub> on limestone have been investigated in Istanbul. SO<sub>2</sub> levels and particulate matters (PM) concentrations in Beşiktaş - İstanbul between the years 2004 – 2009 are given in Table 1 and Table 2. A decrease is observed in SO<sub>2</sub> concentrations in the recent years. The highest concentrations of SO<sub>2</sub> are observed between October and April and it decreases in the summer months (Figure 12). This result can be explained by the consumption of more fuel for heating in winter months. Table 2 shows the particulate matters concentrations in Beşiktaş – İstanbul. Similar to the SO<sub>2</sub> concentration PM concentrations also reach its highest level in winter months (Figure 13).

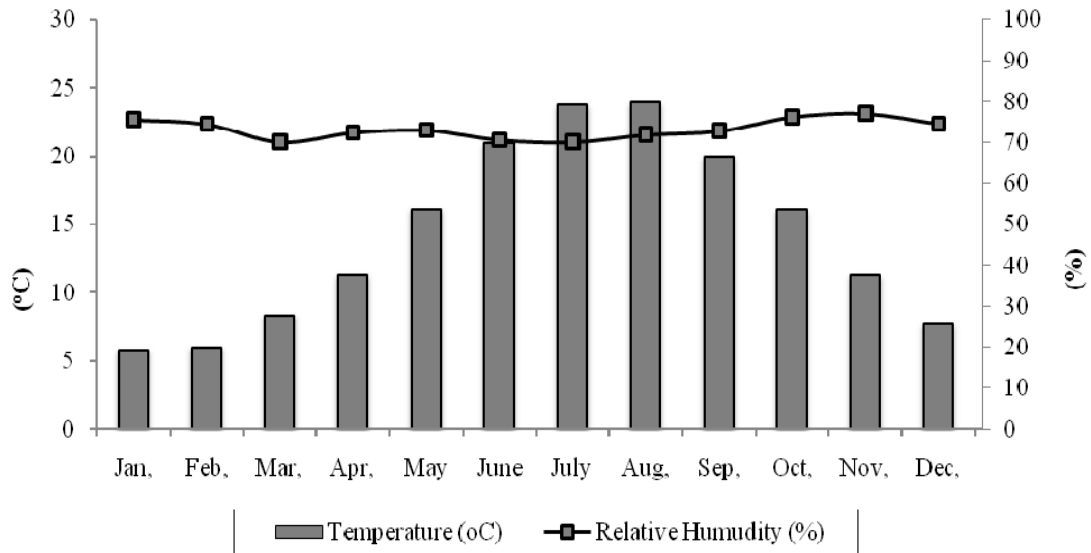
Figure 14. Monthly average values of temperature and relative humidity between the years 2000 and 2009. (Source: General Directorate of State Meteorological Affairs Ankara)

Istanbul is located in a transition zone and has a temperate climate. The humidity is constantly high all year. The average of the annual relative humidity is between 75 – 80 % (Figure 14). Summers are hot and the average temperature is 25 °C between the July and August. Winters are cold and snowy. The average temperature is 5 °C in winter. Spring and autumn seasons are usually moderate but they also show difference from chilly to warm. The average temperature in spring and autumn is about 13 °C.

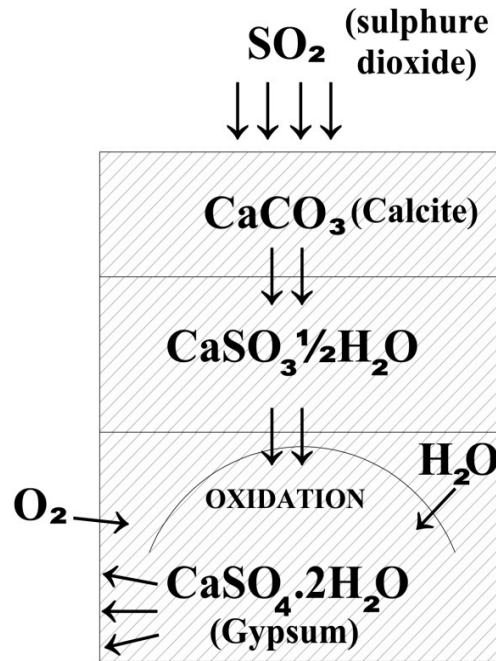
Figure 17. Gypsum formation on the stone surface by dry deposition of  $\text{SO}_2$   
(Source: Fassina 1988)

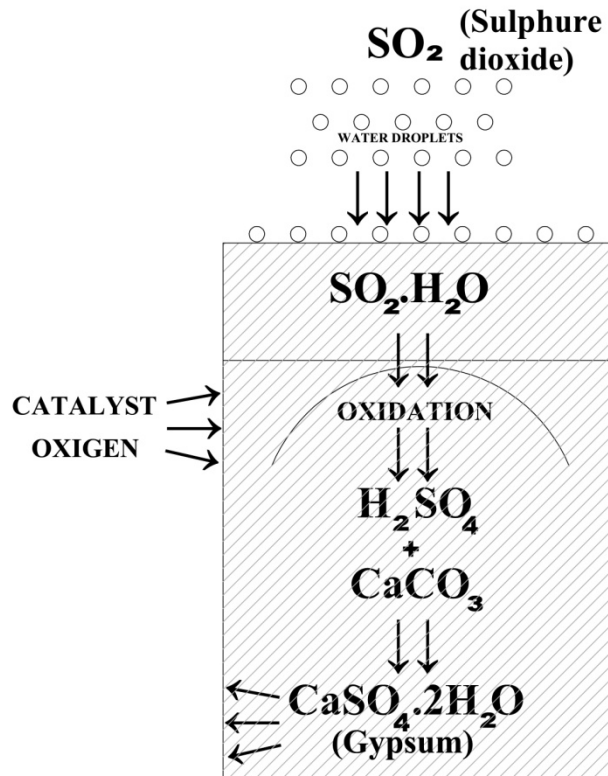
Figure 18. Gypsum formation on the stone surface by wet deposition of  $\text{SO}_2$  (Source: Fassina 1988)

the sulphuric acid ( $\text{H}_2\text{SO}_4$ ) deposited on the stone surfaces reacts with calcium carbonate ( $\text{CaCO}_3$ ) and converts it into gypsum ( $\text{CaSO}_4 \cdot 2\text{H}_2\text{O}$ ) (1.3 and 1.4).

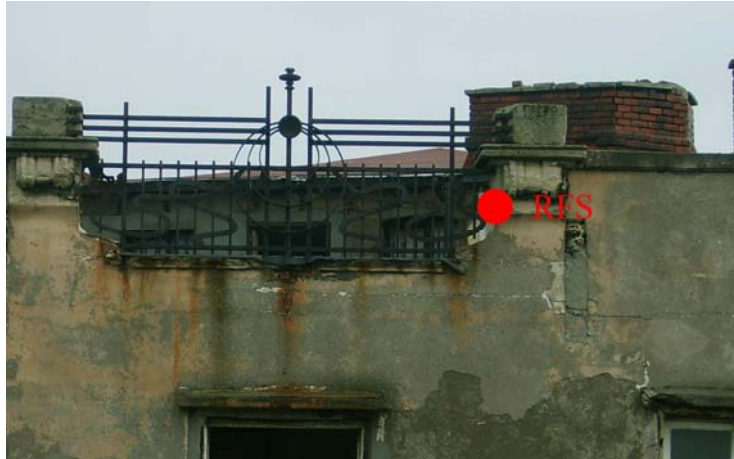
| Sample Name | Sample Layers | Sample Definition |
|---|---|---|
| <b>Roof Floor Sample (RFS)</b><br>(Figure 21) | RFS-W1- Weathered Layer-1 (0-5 mm) | Stone sample from the roof floor which sheltered from the rain on the front facade |

Figure 21. Figure showing the place of Roof Floor Sample (RFS) taken from.

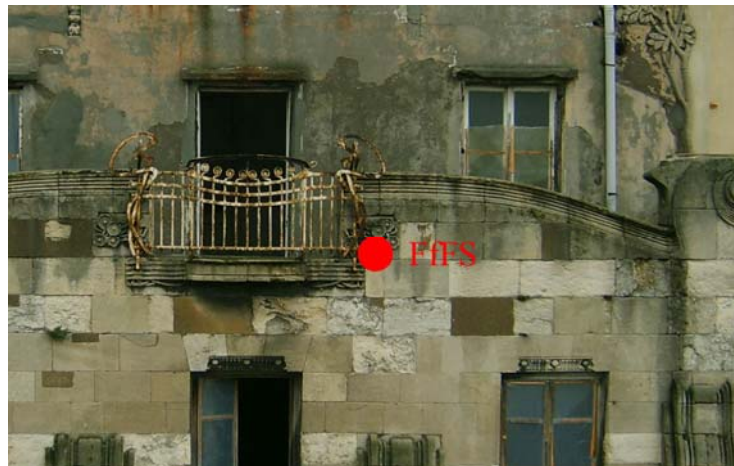
| Sample Name | Sample Layers | Sample Definition |
|---|---|---|
| <b>Fifth Floor Sample (FfFS)</b><br>(Figure 22) | FfFS-W1- Weathered Layer-1 (0-5 mm) | Sill Stone sample from the fifth floor which rain washed place of the front facade |

Figure 22. Figure showing the place of Fifth Floor Sample (FfFS) taken from.

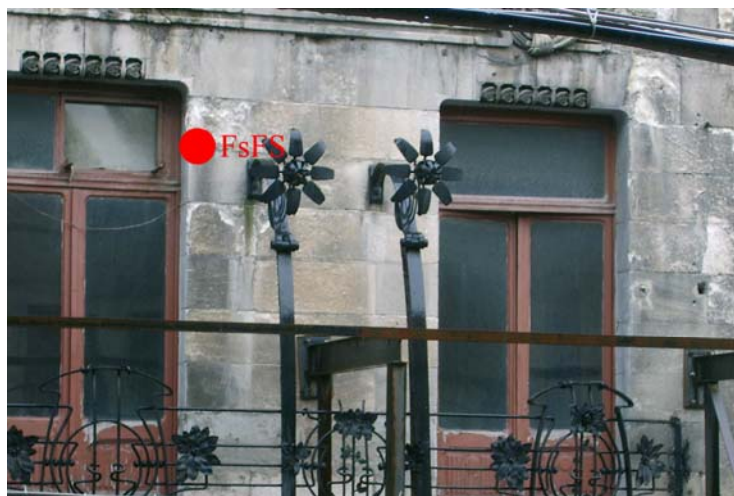
| Sample Name | Sample Layers | Sample Definition |
|---|---|---|
| <b>First Floor Sample (FsFS)</b><br>(Figure 23) | FsFS-W1- Weathered Layer-1 (0-5 mm) | Stone sample from the first floor which sheltered from the rain on the front facade |

Figure 23. Figure showing the place of First Floor Sample (FsFS) taken from.

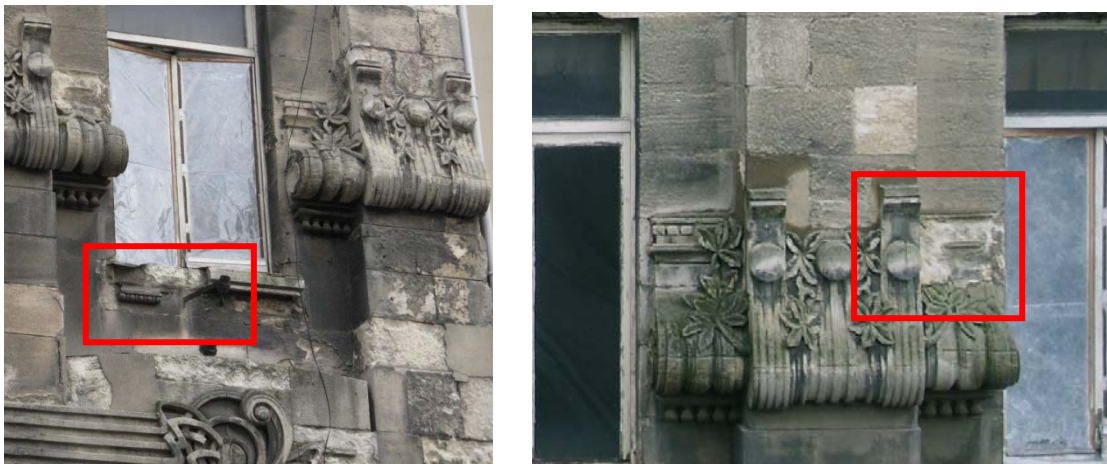
Figure 25. Break out on the façade of the Botter Apartment

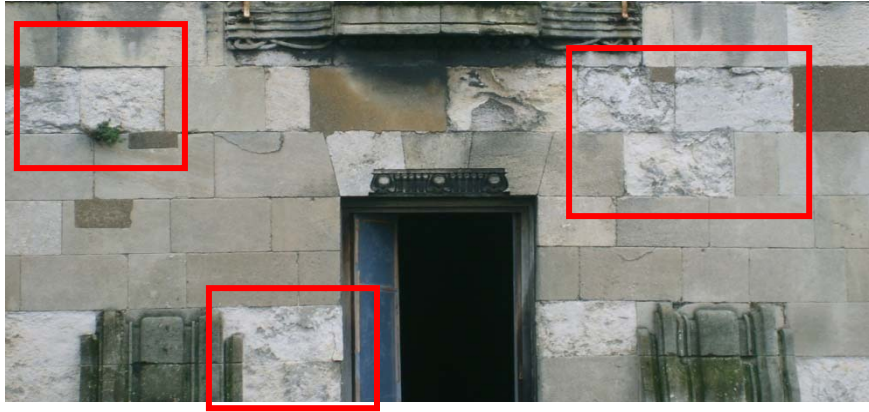
Figure 26. Back weathering due to the loss of black crust

The detachment on the stone is observed in the form of scaling. Scaling is the detachment of the stone pieces parallel to the stone surfaces but is not followed by any stone structure (Fitzner and Heinrichs 2001). Scaling that observed on the Botter apartment is detachment of the black crusts.

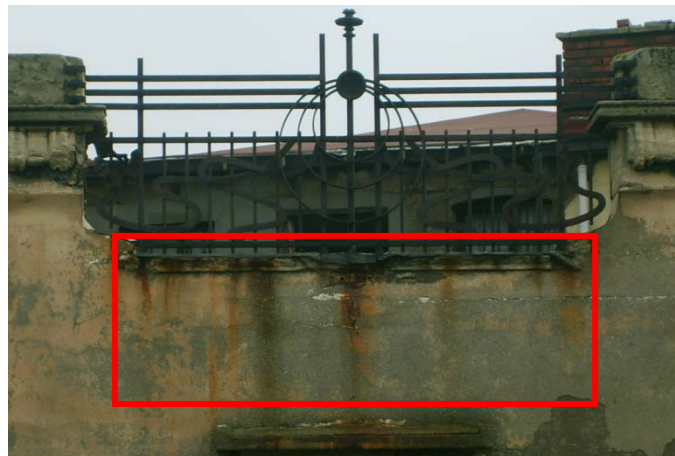
Figure 27. Coloration due to the corrosion products of the metals

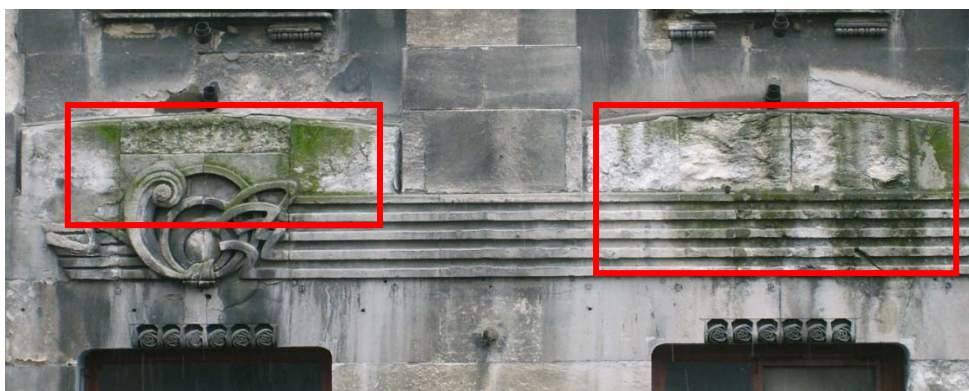
Figure 28. Microbiological Colonization on the façade of the Botter Apartment

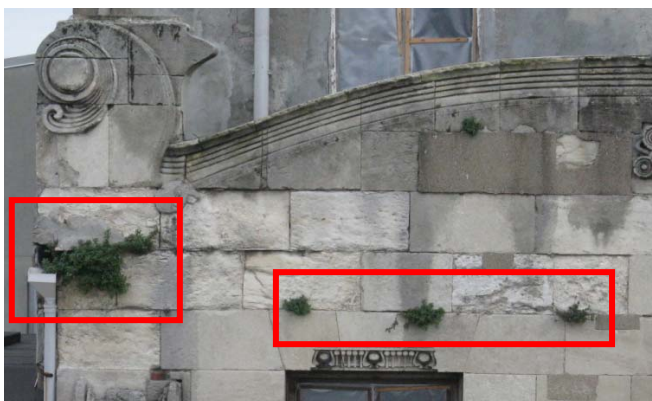
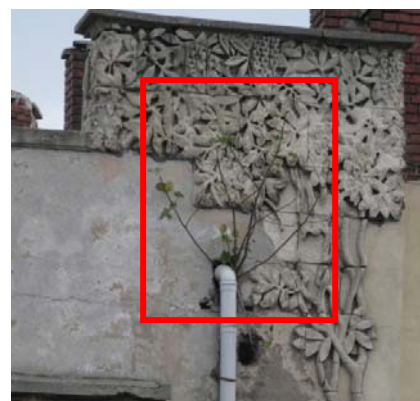
Figure 30. Higher Plants on the façade of the Botter Apartment

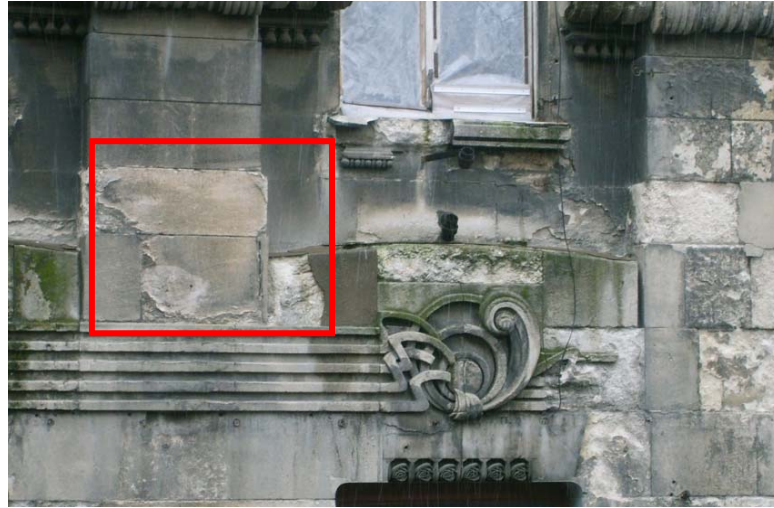
Figure 31. Scaling on the façade of the Botter Apartment

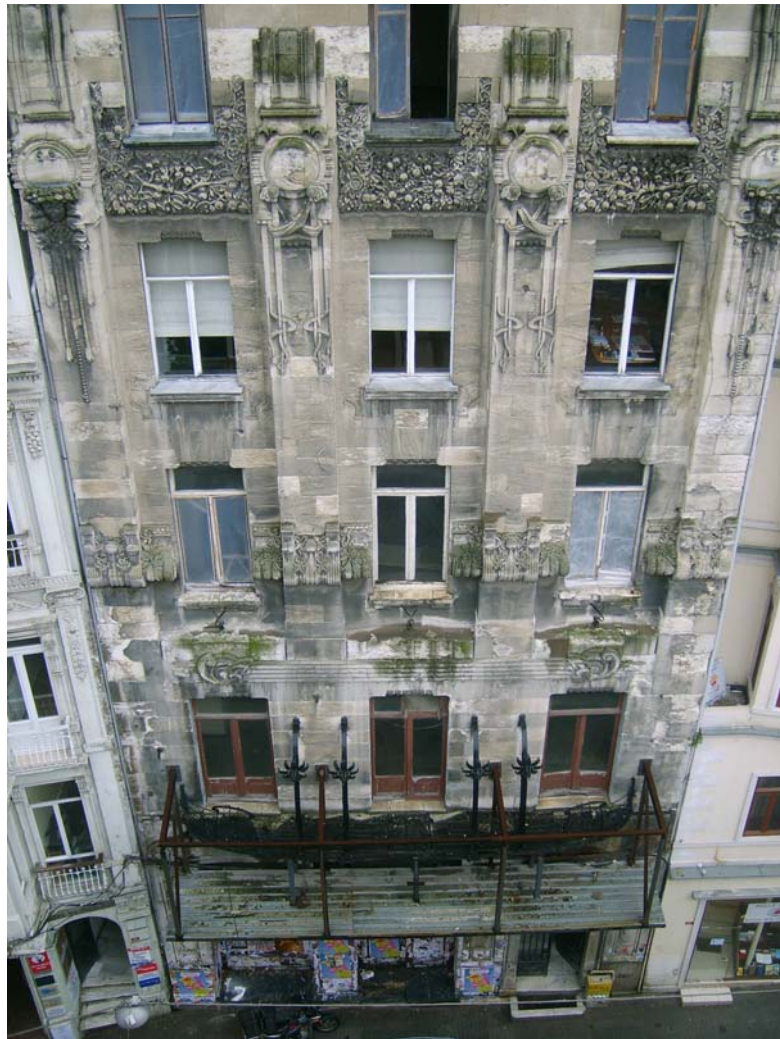
Figure 32. Present condition of the Botter Apartment

The main weathering forms observed on the stone surface were considered in three headings and showed with mapping (Figure 24). First, the loss of stone material in the form of break out (Figure 25) and back weathering due to the loss of black crust (Figure 26), the second discoloration and deposit in the form of coloration (Figure 27), microbiological colonization (Figure 28), black crust (Figure 29) and higher plants (Figure 30) and third, detachment in the form of scaling (Figure 31). The listed weathering forms material deteriorations showed on the drawing of the Botter Apartment façade (Figure 32).

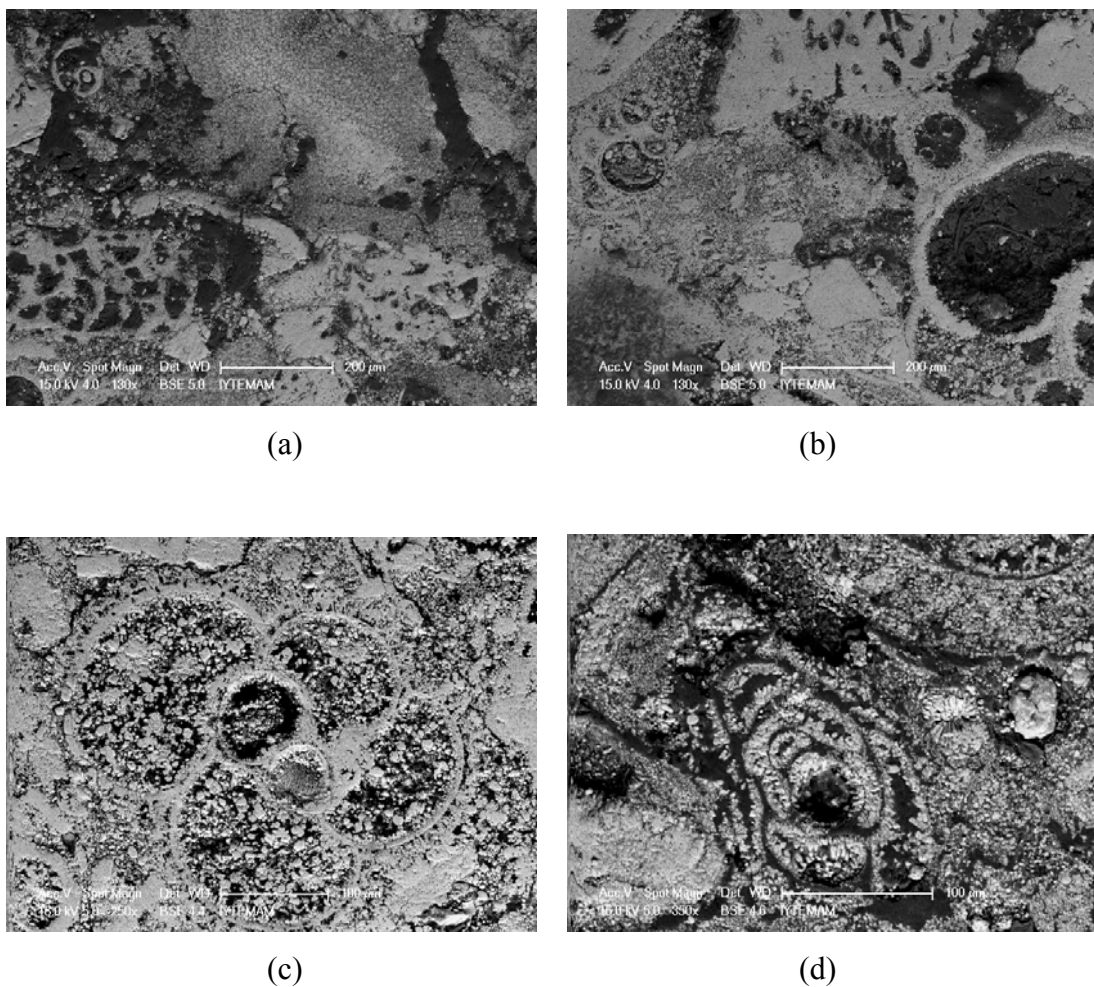
Figure 33. SEM images of limestone showing calcite minerals, the sea shell and corals in composition with a magnification setting of (a) and (b) 130 x, (c) 250 x and (d) 350 x and accelerating voltage 15 kV

Limestone used on the façade of the Botter Apartment is mainly composed of calcite minerals of sea shell and corals (Figure 33). The texture of the limestone used on the façade of the Botter Apartment was analyzed by SEM analyses. SEM analysis indicated that limestone used on the façade of the Botter Apartment is mainly composed of calcite minerals of sea shell and corals (Tuğrul and Zarif 1998).

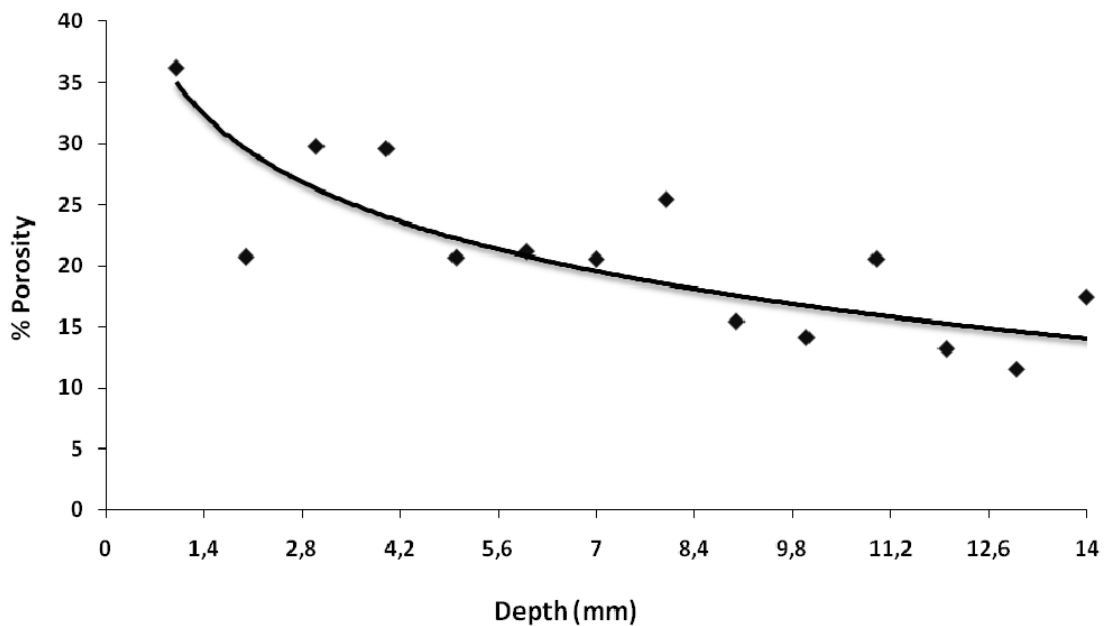
Figure 34. Porosity values of the FsFS from surface to the inner.

At the first floor sample (FsFS) decrease of porosity was observed through inside of the stone (Figure 34). Roof floor sample (RFS) was analyzed approximately 8 mm inside of the stone (Figure 35). High porosity values were observed near the surface of the stone.

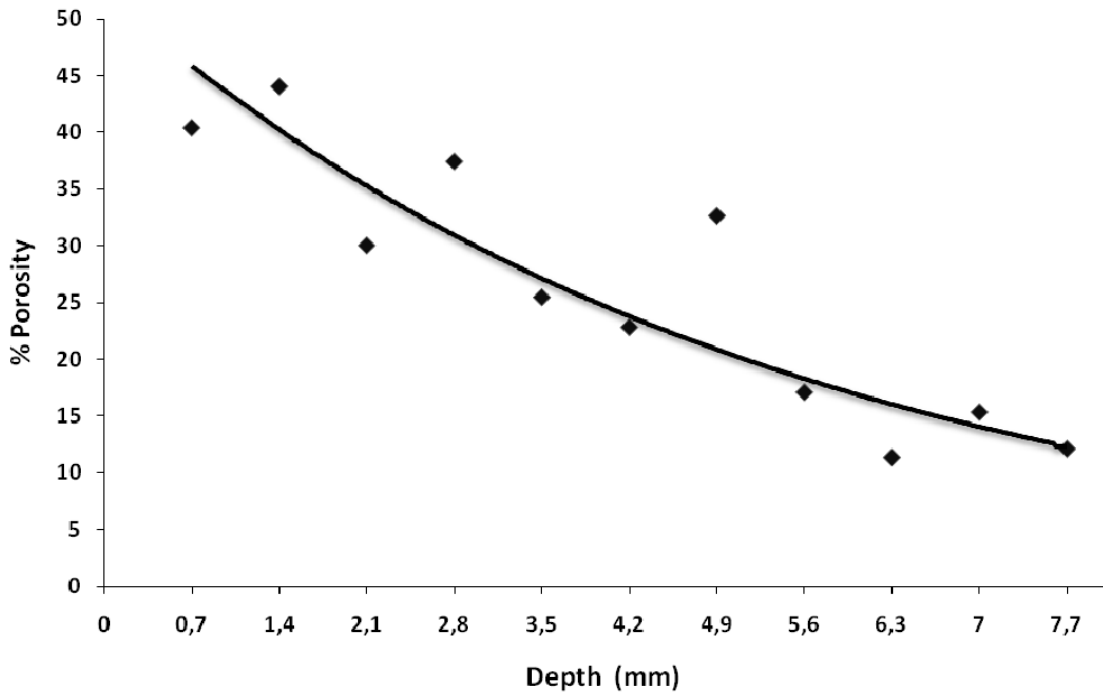
Figure 35. Porosity values of the RFS from surface to the inner

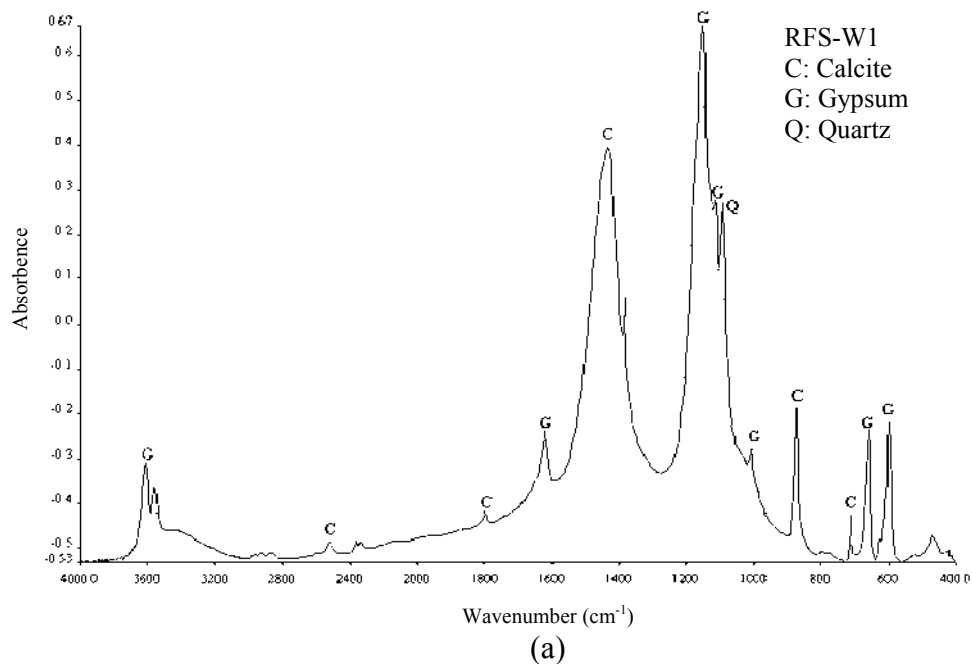
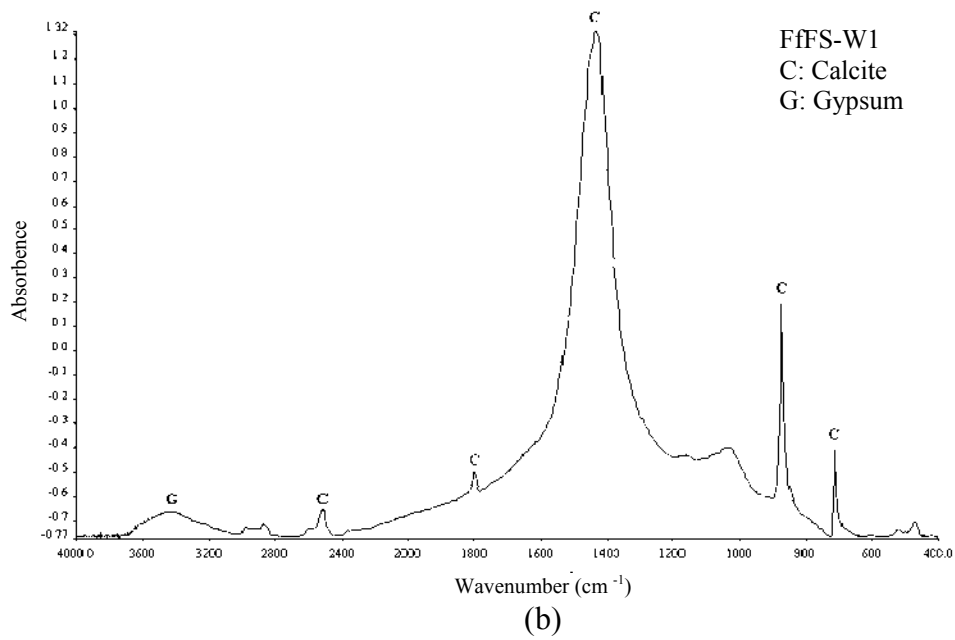
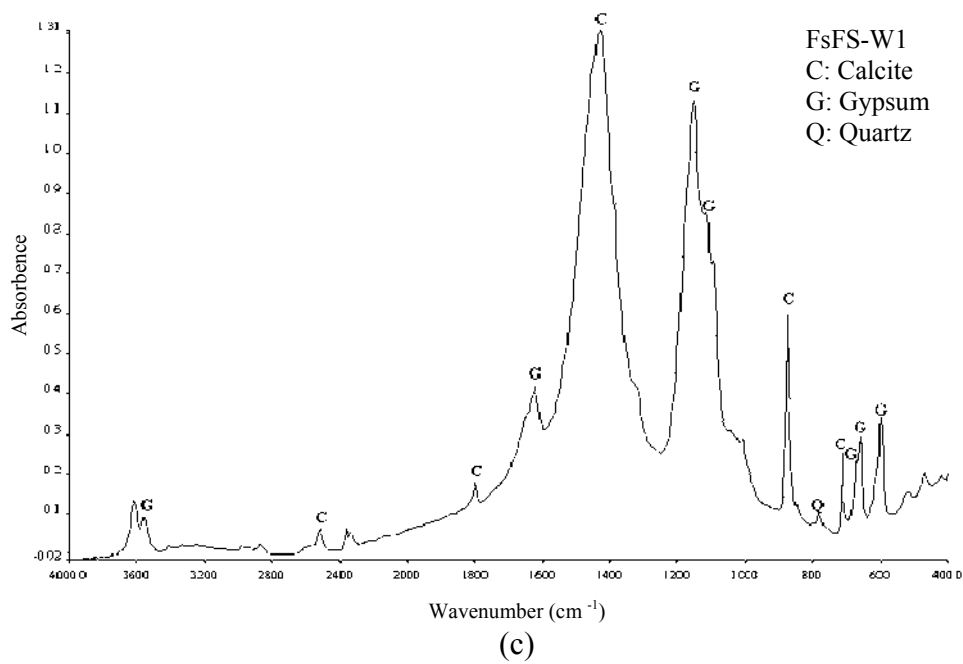
Figure 40. FT-IR graphs of the Weathered Layer-1 of the samples (A): Roof Floor Sample (RFS-W1), (B): Fifth Floor Sample (FfFS-W1), (C): First Floor Sample (FsFS-W1)

Mineralogical compositions of the weathered parts and under weathered parts of the collected samples were analyzed with FT-IR analysis. At the weathered parts, the strong absorption bands of Gypsum at  $3611\text{ cm}^{-1}$ ,  $1620\text{ cm}^{-1}$ ,  $1146\text{ cm}^{-1}$ ,  $1116\text{ cm}^{-1}$ ,  $1008\text{ cm}^{-1}$ ,  $661\text{ cm}^{-1}$  and  $599\text{ cm}^{-1}$  were indicated at the roof floor and first floor samples. Also Quartz was observed in the FT-IR spectrum at  $1094\text{ cm}^{-1}$  and  $781\text{ cm}^{-1}$ . At fifth floor sample that taken from the unsheltered part of the façade quartz was not indicated and gypsum was observed at  $3423\text{ cm}^{-1}$  (Figure 40).

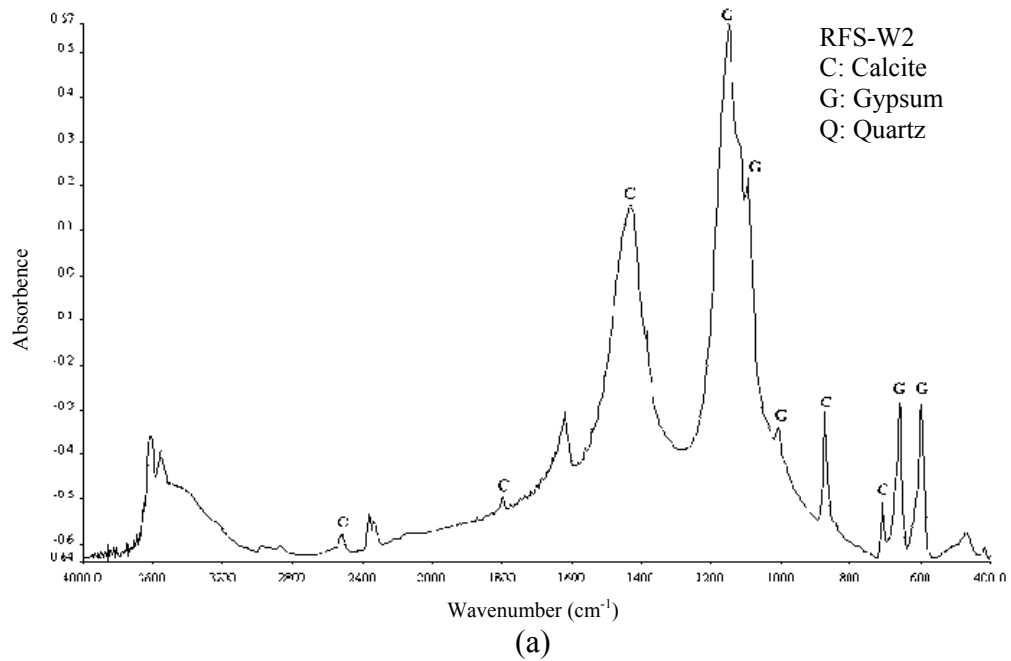
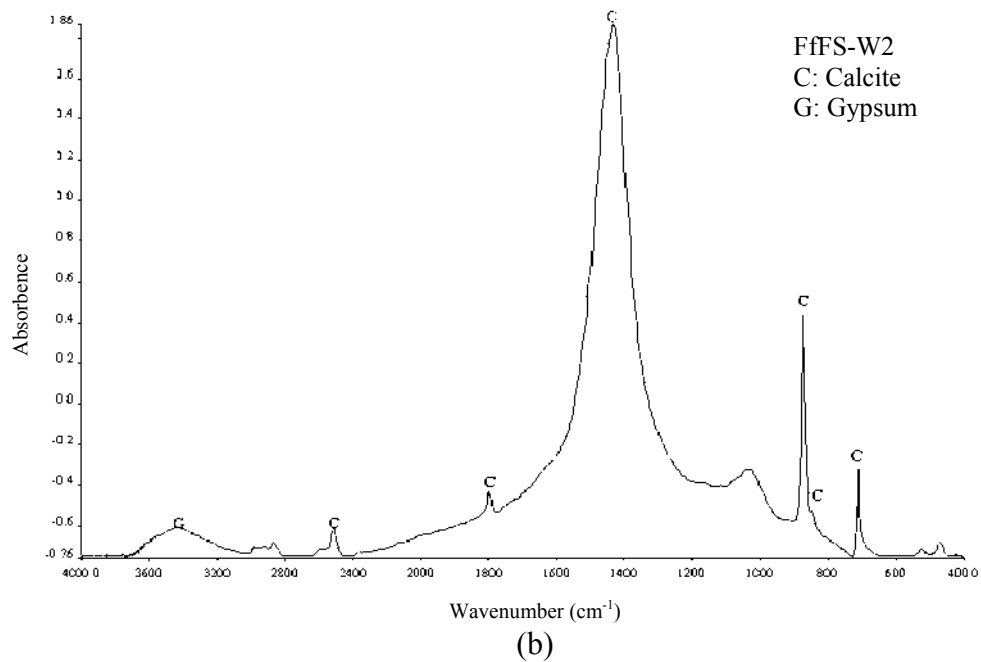
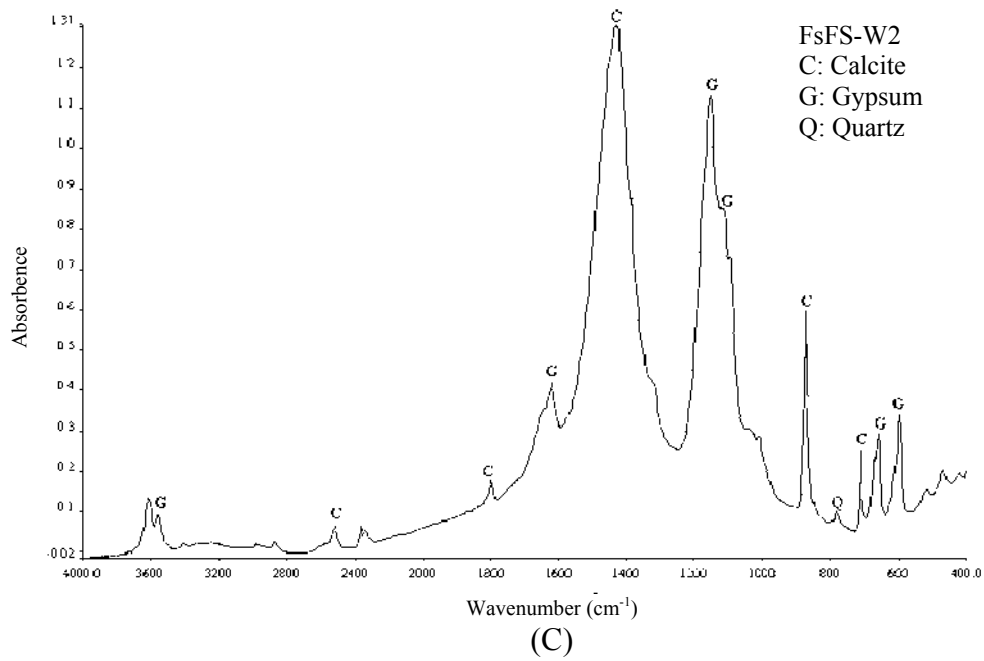
Figure 41. FT-IR graphs of the Weathered Layer-2 (approximately from 5mm to 15 mm inside) of the samples (A): Roof Floor Sample (RFS-W2), (B): Fifth Floor Sample (FfFS-W2), (C): First Floor Sample (FsFS-W2)

taken from the unsheltered part of the façade gypsum was observed at  $3423\text{ cm}^{-1}$  (Figure 41).

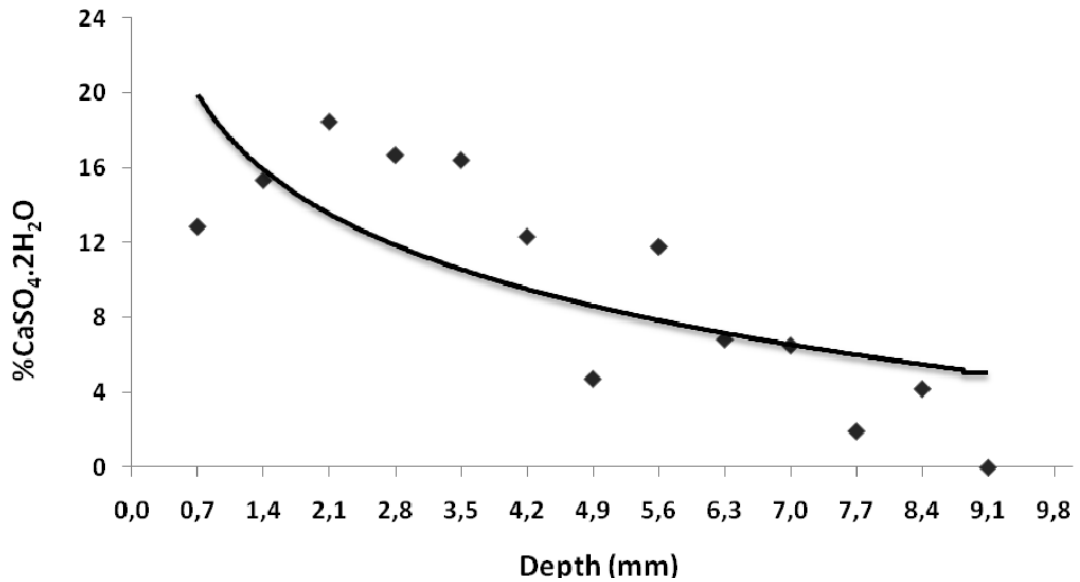
Figure 43. Gypsum rates of the FsFS from surface to the 9,8 mm inside.

The amount of gypsum was also determined on the cross section of the samples. The gypsum was observed from surface to inside the samples (~ 1 cm) (Figure 43).

As it seen in Figure 3.20, high amounts of gypsum are present on the surface and it decreases with dept of the sample. Gypsum that formed inside of the stone deteriorates the physical structure of the limestone (Figure 44).

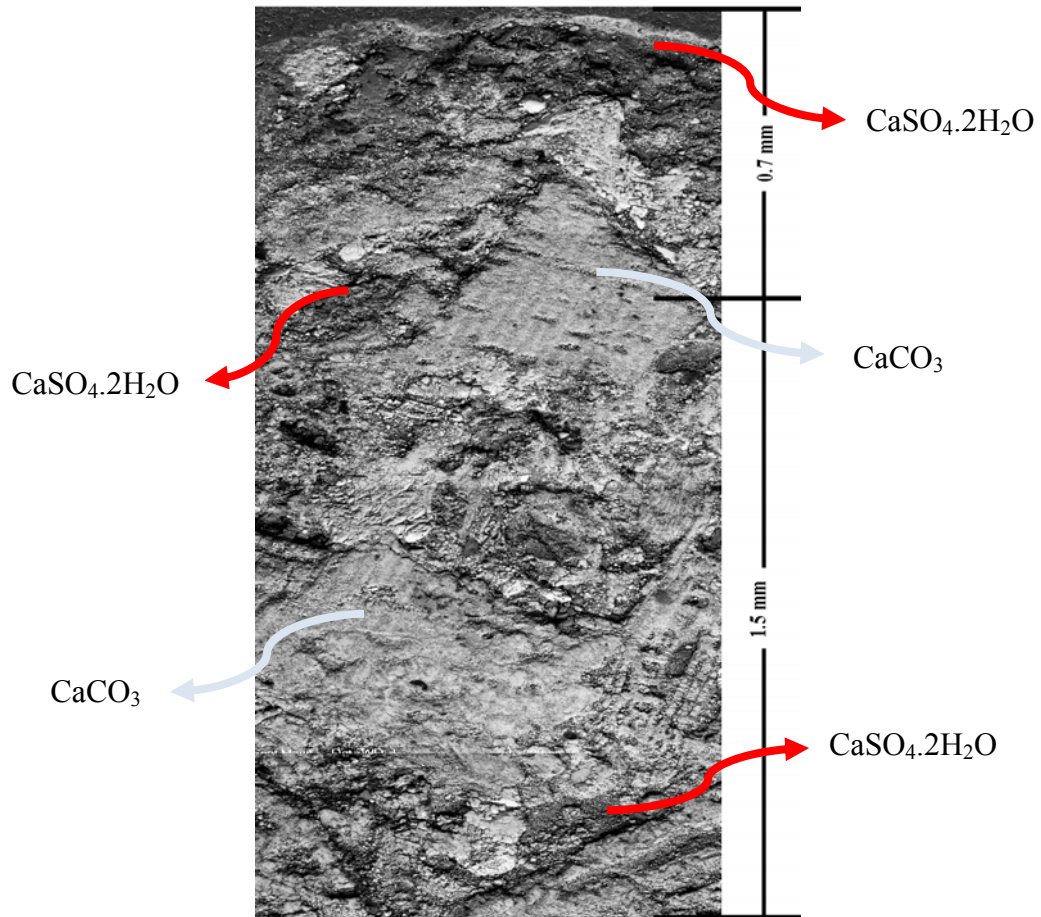
Figure 44. SE image of the FsFS from surface to the 2,2 mm inside showing the gypsum formation.

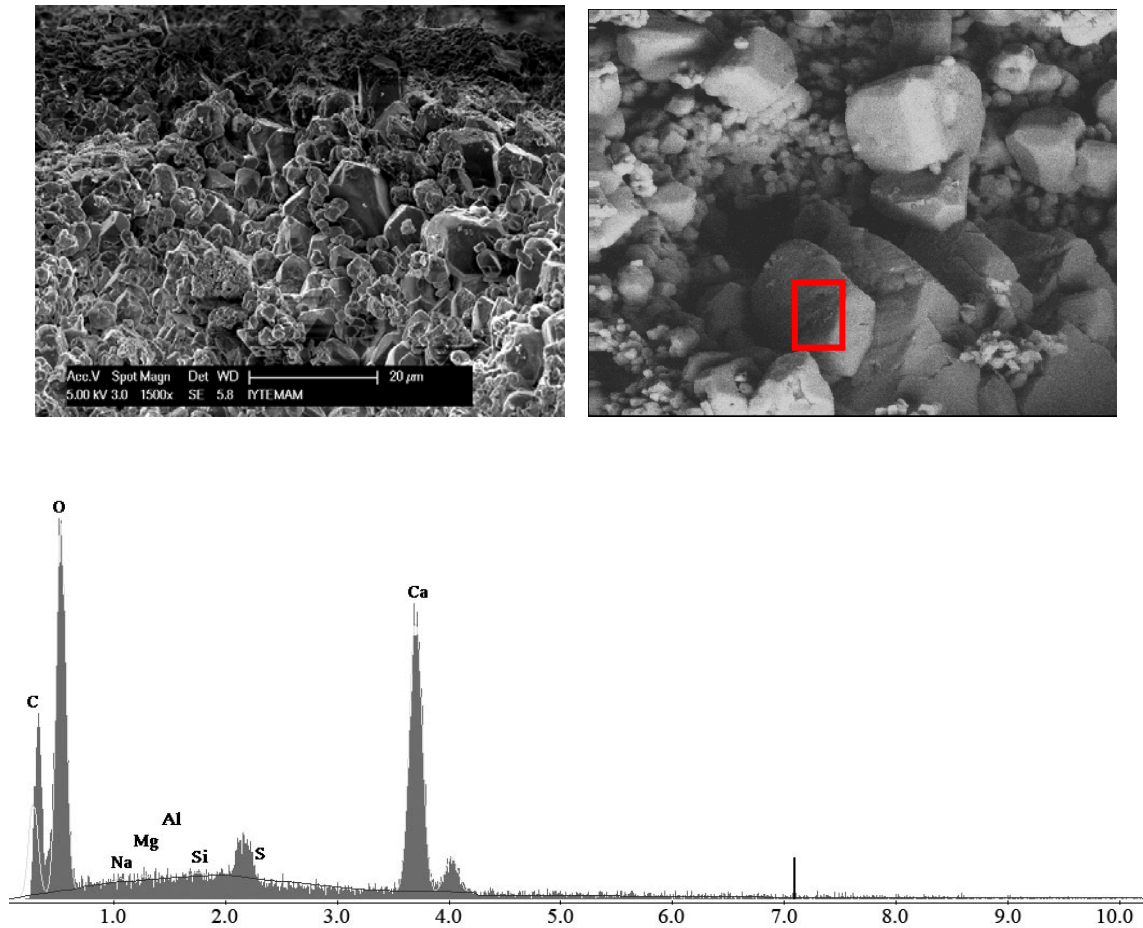
Figure 45. SE image and EDX spectrum of the gypsum crystals on the Roof Floor sample (RFS) with a magnification setting of 1500x and accelerating voltage 5 kV

Gypsum crystal ( $\text{CaSO}_4 \cdot 2\text{H}_2\text{O}$ ) at the Roof Floor sample was indicated by SEM analysis (Figure 45).
