**AIR POLLUTION EFFECTS ON THE FAÇADE OF  
THE BOTTER APARTMENT IN ISTANBUL**

**A Thesis Submitted to  
the Graduate School of Engineering and Sciences of  
Izmir Institute of Technology  
in Partial Fulfillment of the Requirements for the Degree of**

**In Architectural Restoration**

**by  
Birsen PARLAK**

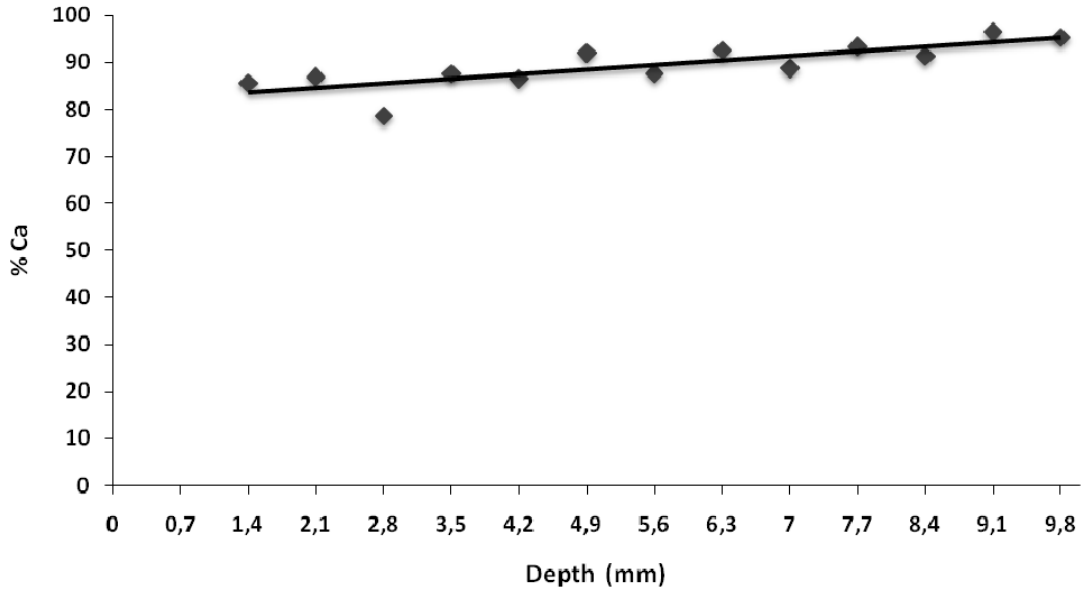
Figure 46. % Ca value from surface to the 9.8 mm inner in the sample of First Floor (FsFS)

In the Figure 46, % Ca in the stone is increased from surface to the inner parts due to the conversion of calcium carbonate ( $\text{CaCO}_3$ ) to gypsum ( $\text{CaSO}_4 \cdot 2\text{H}_2\text{O}$ ). Sulphure dioxide reaches to the stone surface by wet and dry deposition and penetrates to the inside of the stone. As a result, gypsum crystals on surface of the stone (RFS) were observed in SEM-EDS analyses (Figure 47). It is seen in Figure 48 that the sulphur formation advances towards the inner parts of the stone approximately 1cm from the surface. When sulphure dioxide reacts with calcite and this reaction leads to significant structural damage due to the changes in mineral volume associated with gypsum-calcite transition (Lefèvre and Ausset 2002).

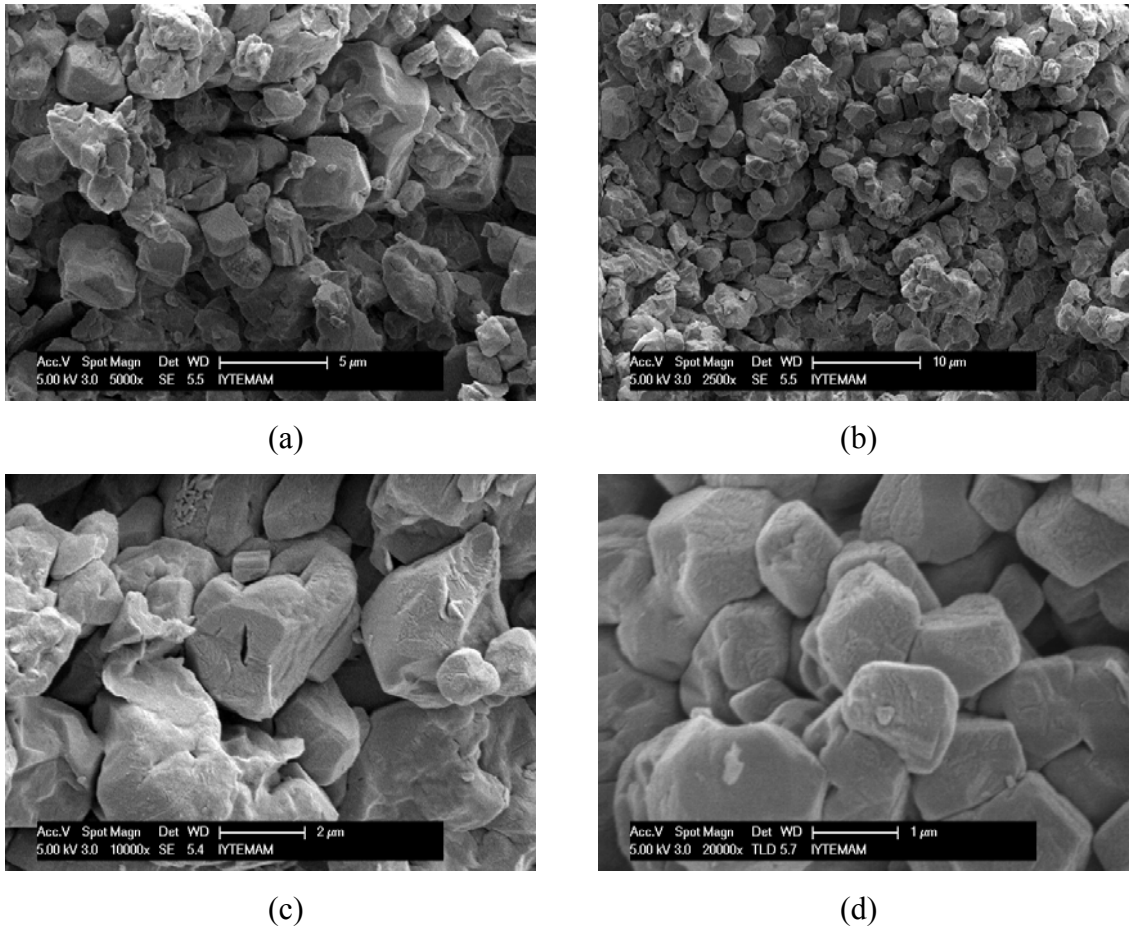
Figure 47. SEM images of gypsum crystals at Roof Floor Sample (RFS) with a magnification setting of (a) 5000 x, (b) 2500 x, (c) 10000 x and (d) 20000 x and accelerating voltage 5 kV

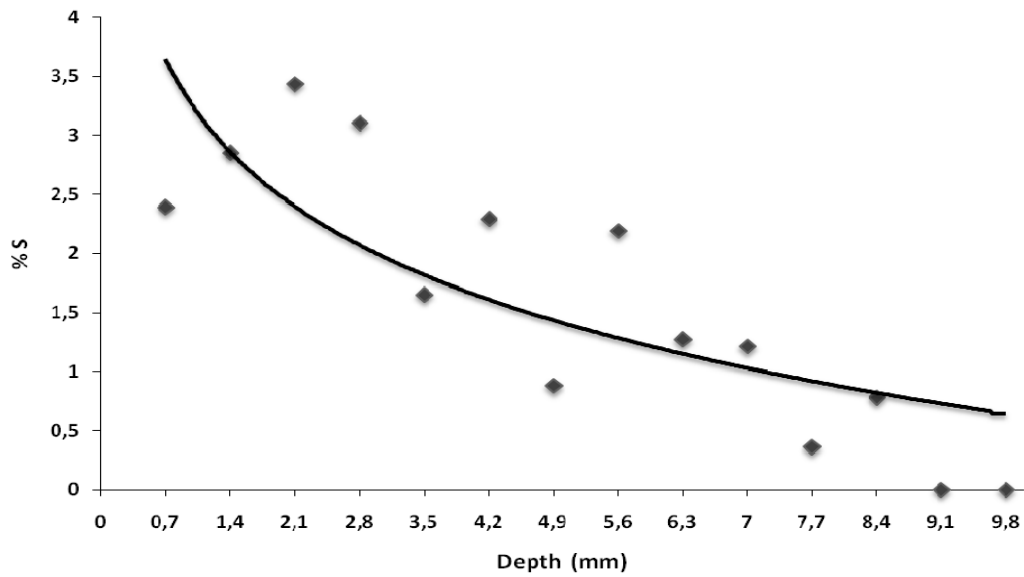
Figure 48. % S value from surface to the 9.8 mm inner in the sample of First Floor (FsFS)

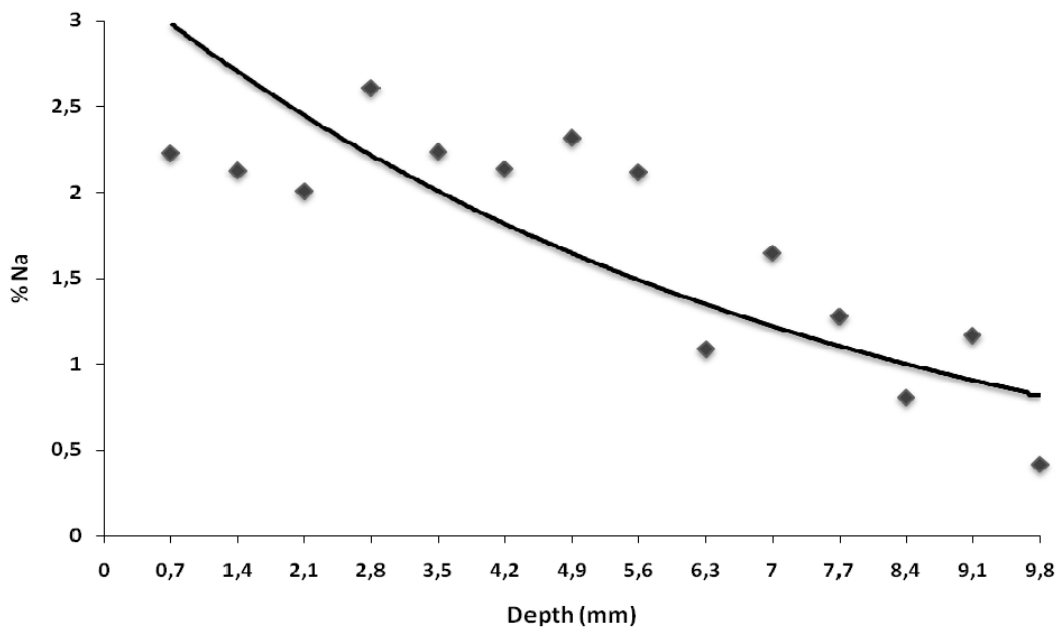
Figure 49. % Na value from surface to the 9.8 mm inner in the sample of First Floor (FsFS)

In the composition of the limestone, chlorides present at the level of 1 % that mainly dependent on the deposition of marine sediments (Fassina et al. 2002). The high level of the Cl (Figure 50) element in the weathered sample can be attributed to the essence of salt that deposited from the sea spray. With the essence of salt the rates of Na (Figure 49) element show similarity with Cl element due to sea spray.

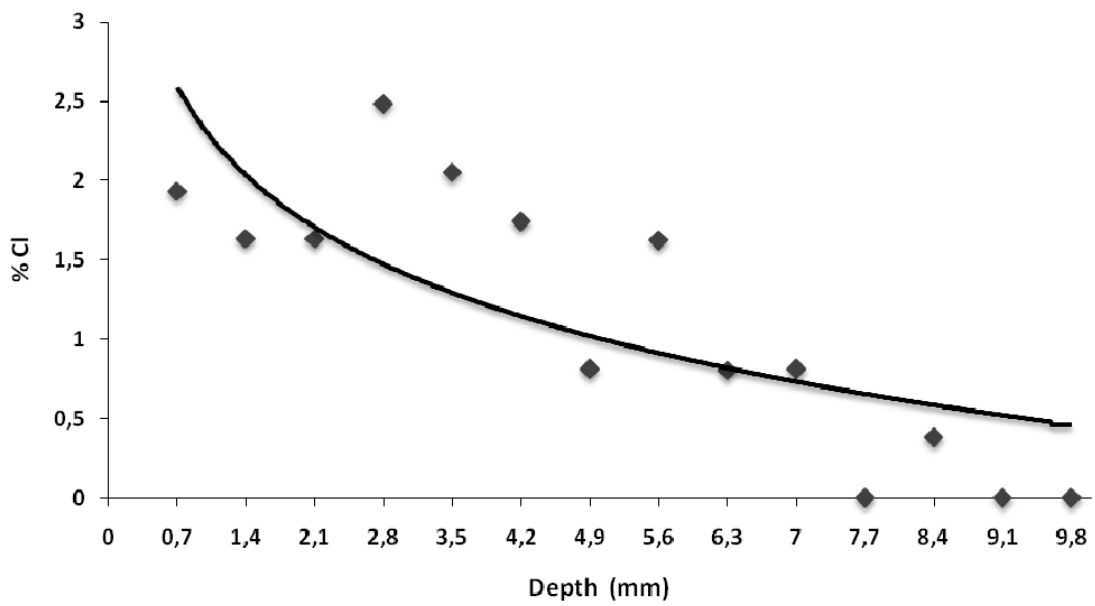
Figure 50. % Cl value from surface to the 9.8 mm inner in the sample of First Floor (FsFS)

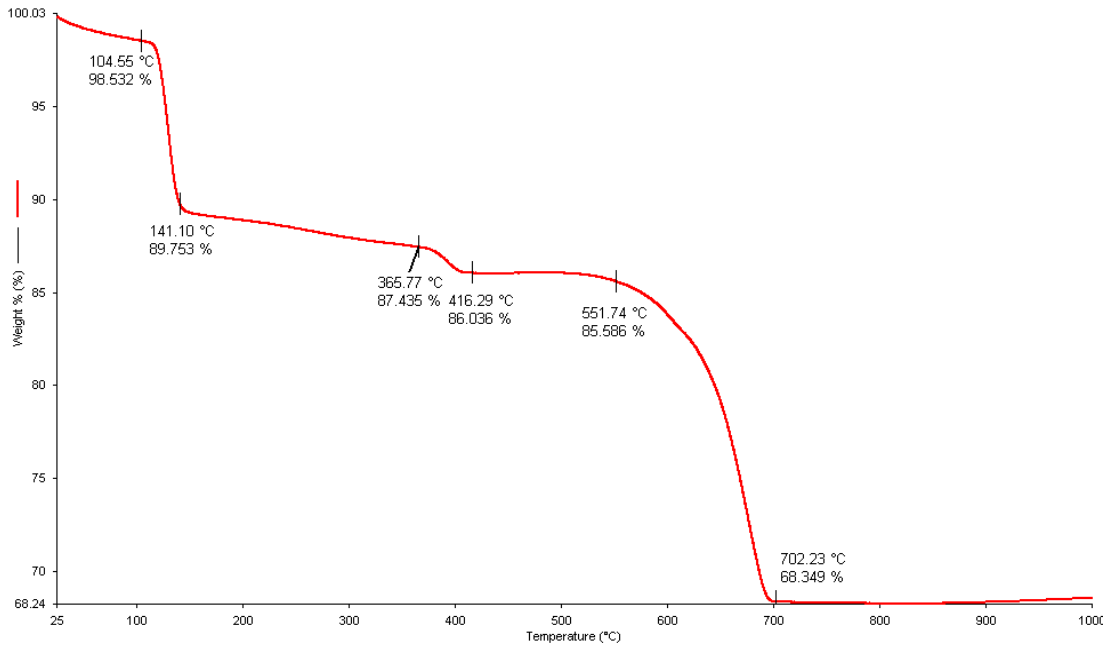
Figure 54. TGA analysis of RFS-Weathered Layer-1

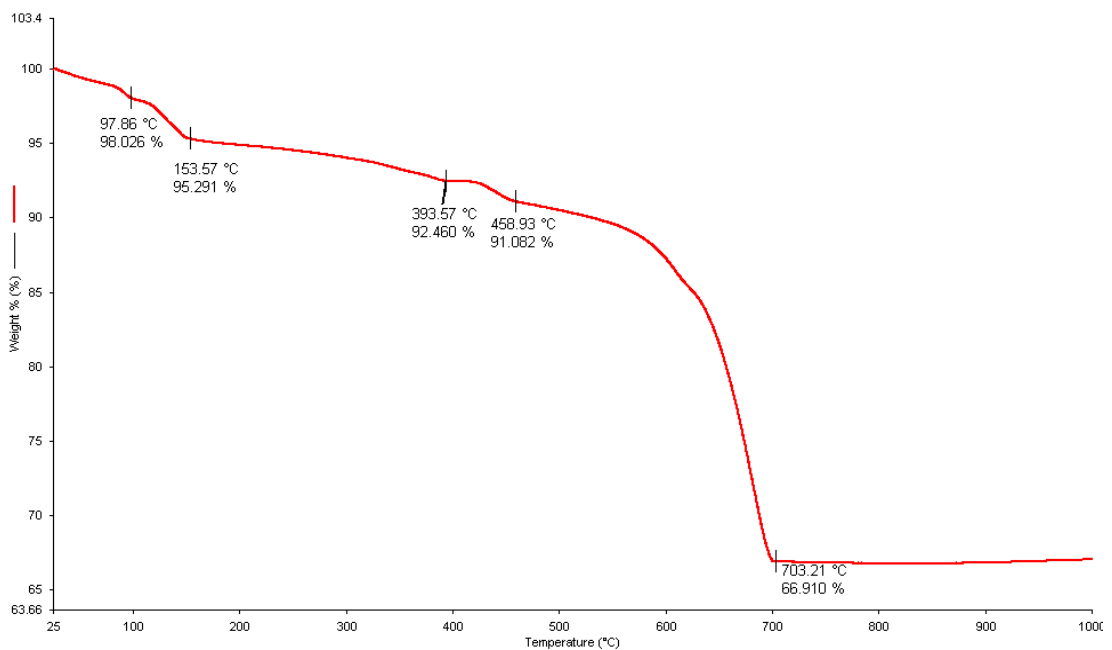
Figure 56. TGA analysis of FsFS- Weathered Layer-1

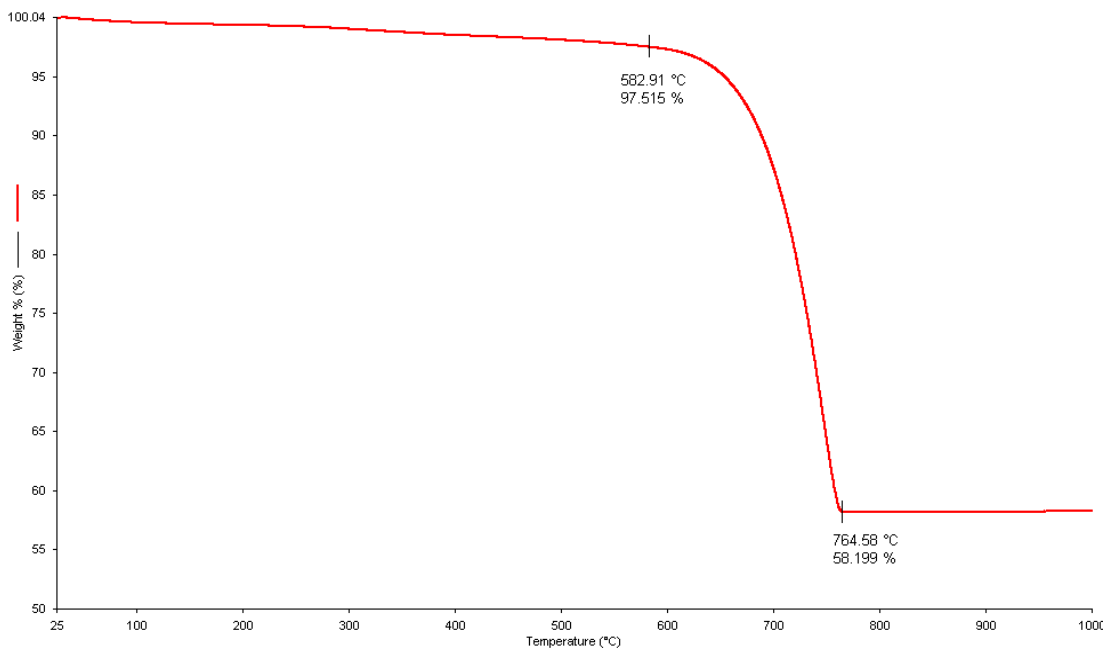
Figure 57. TGA analysis of FfFS- Weathered Layer-1 (the sample which taken from the unsheltered place)
