**QUICK DETERMINATION OF THE PERFORMANCE OF EXISTING BUILDINGS
IN ERBIL CITY IN BRAYATY QUARTER USING STREET-WALK METHOD**

M.Sc. THESIS

Rokhosh KHUDHUR
Supervisor: Assoc. Prof. Dr. Murat MUVAFIK

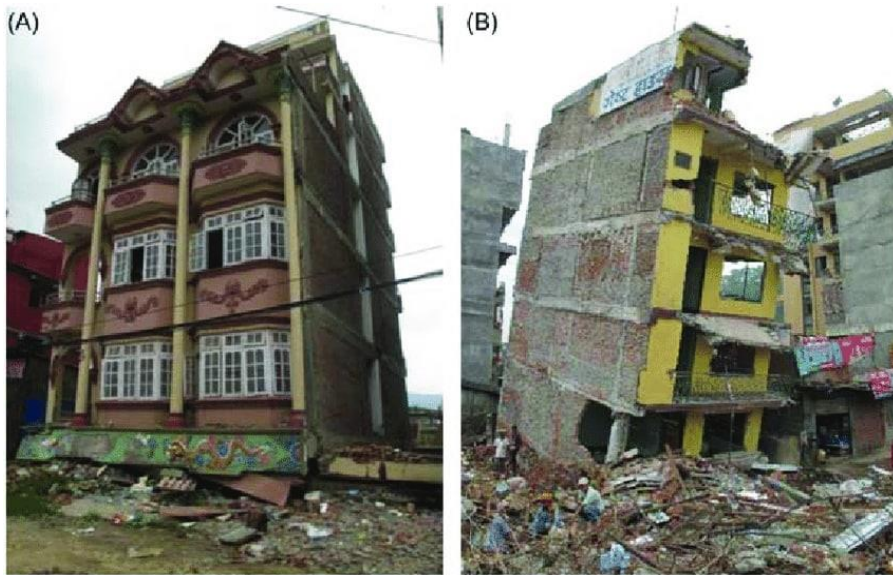
Figure 2.2 Examples of Nepal earthquake-related buildings that experienced soft-story collapse

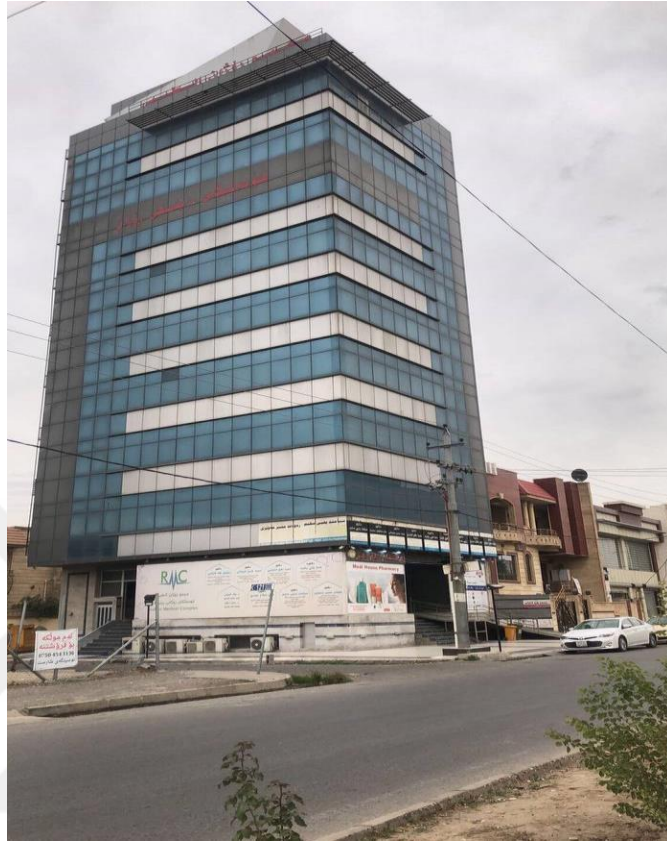
Figure 2.3 Pounding type 1

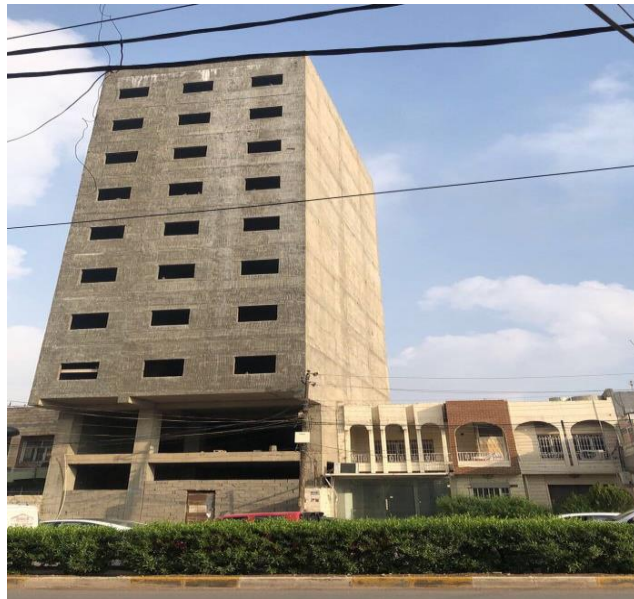
Figure 2.4 Pounding type 2

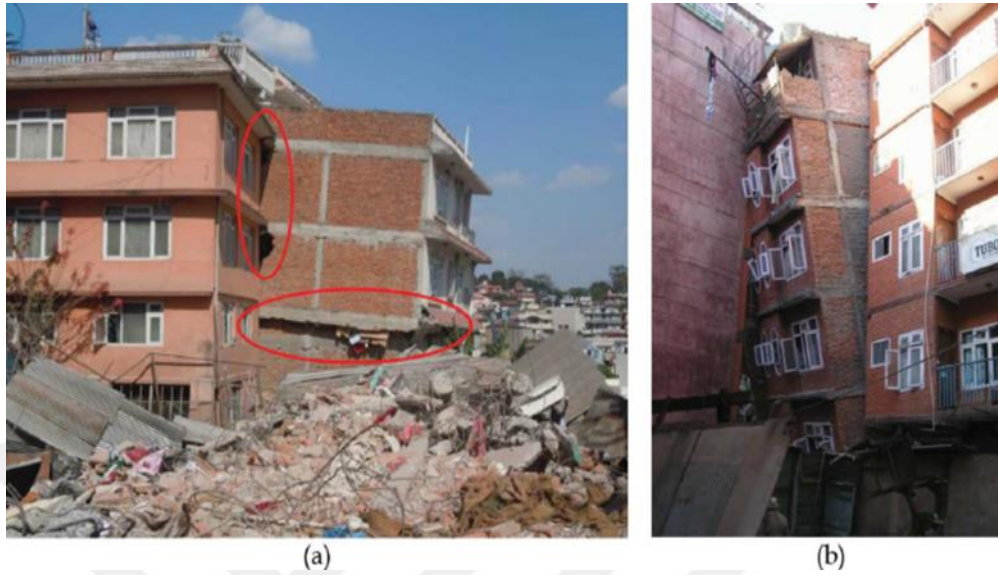
Figure 2.5 (a)The intermediate storey collapsed due to the adjacent building pounded against it, and (b) collapse due to extension of the upper storey plan beyond the column grid lines which created vertical irregularity

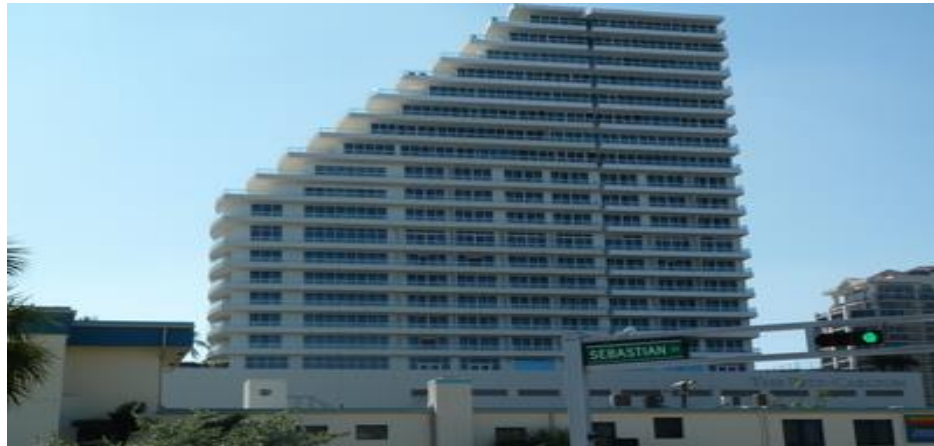
Figure 2.6 Vertical irregularity

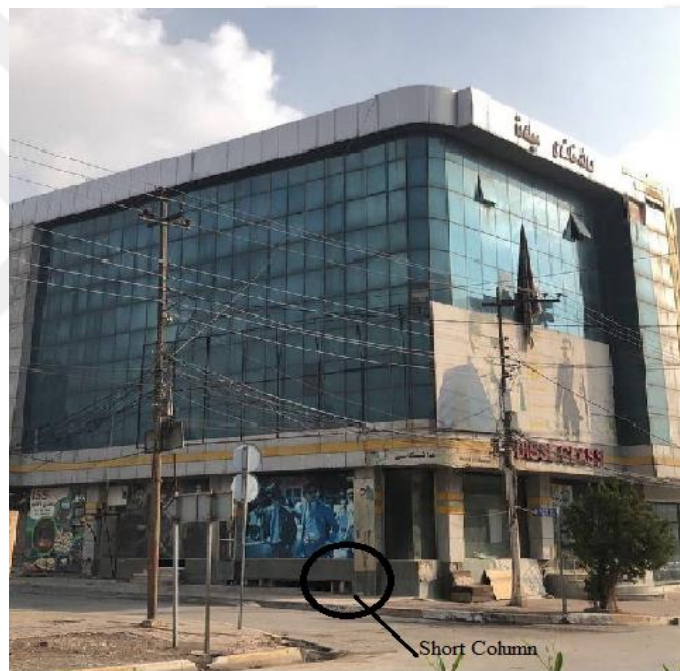
Figure 2.8 Short column

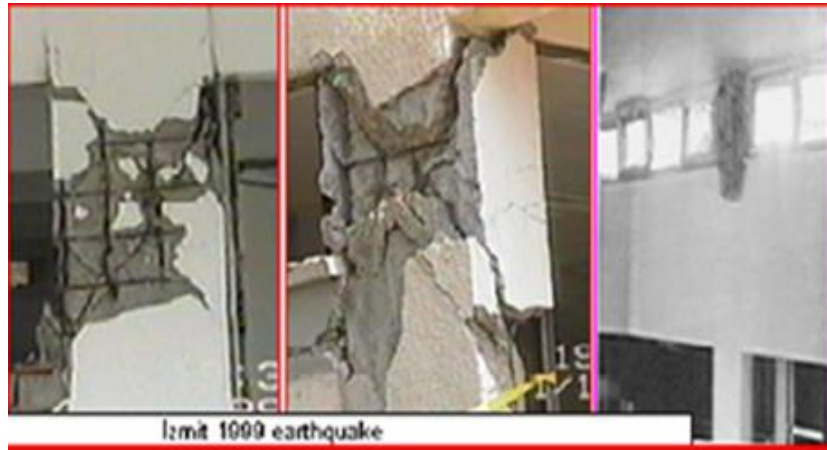
Figure 2.9 Examples of short column failures observed after earthquakes (Isik, 2006)

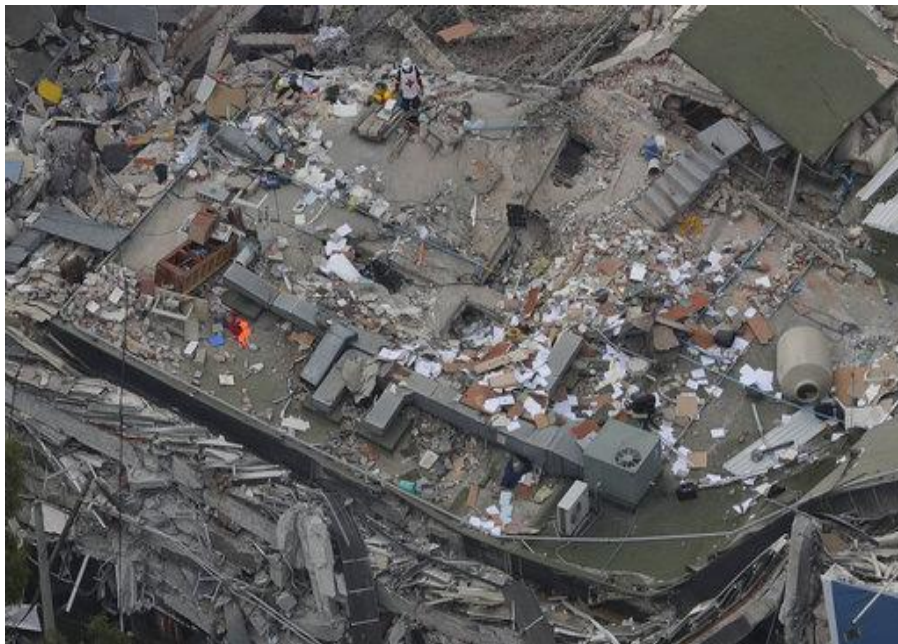
Figure 2.10 Soft soil makes Mexico City shake like it was built on jelly

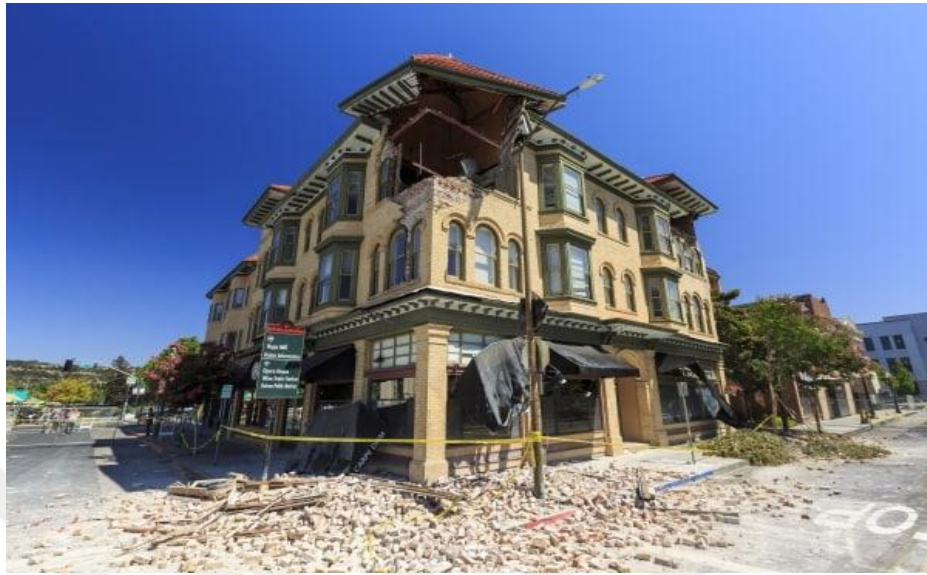
Figure 2.11 The earthquake damage to this building may have been influenced by the type of soil it's sitting on. (Nolan, 2022)

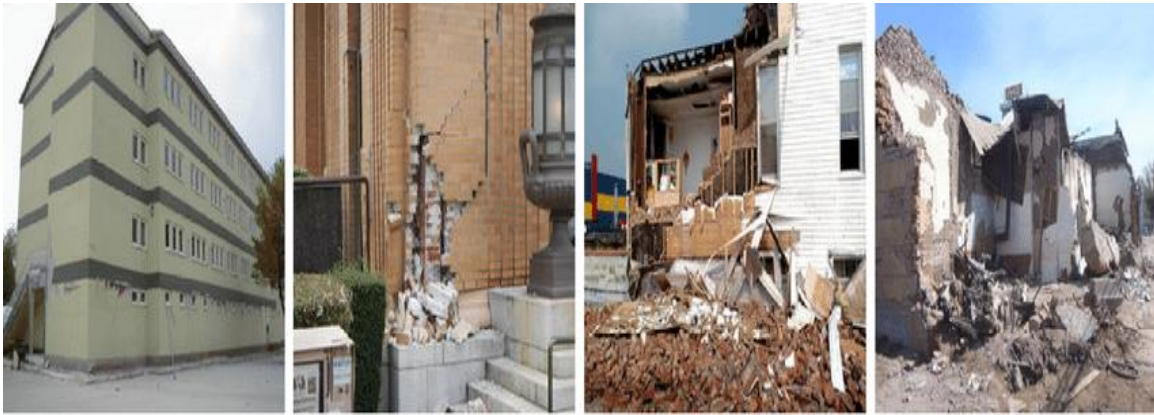
Slight-damage (0.25) Moderate-damage (0.5) Heavy-damage (0.75) Total-destruction (1)

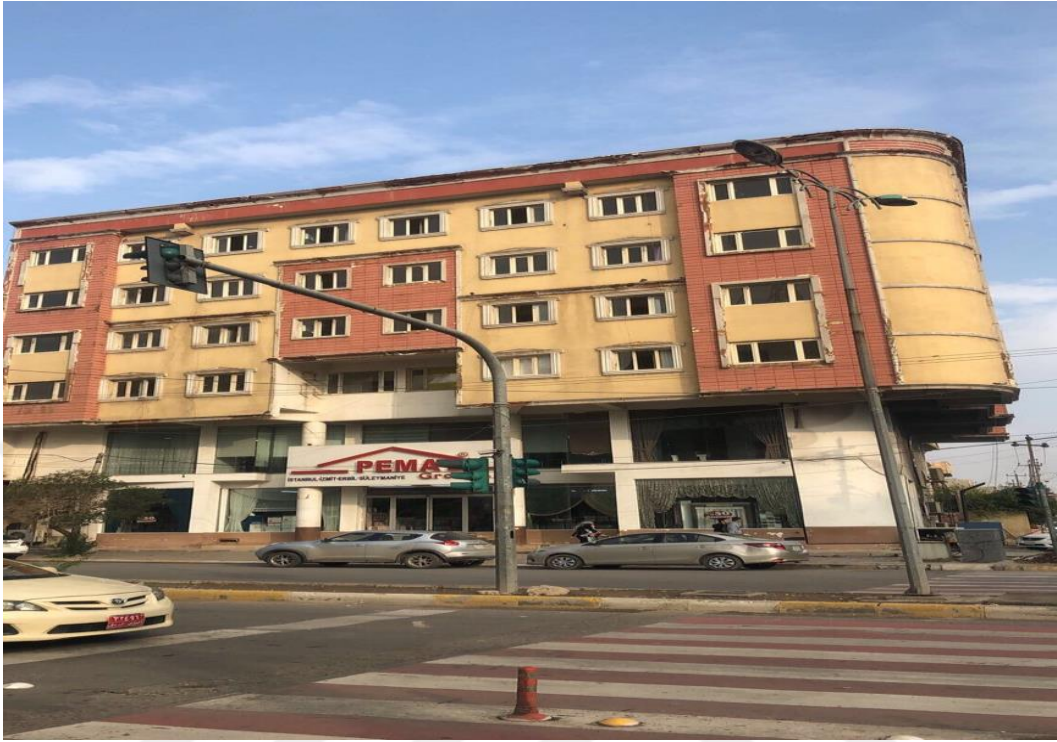
Figure 3.5 Sample of reinforced concrete building in Brayaty Quarter, solving by (Sucoğlu and Yazgan, 2003) method

Vulnerability Score = $70+(-20*1-15*1-5*1-3*1)=27<50$ the building is high risky

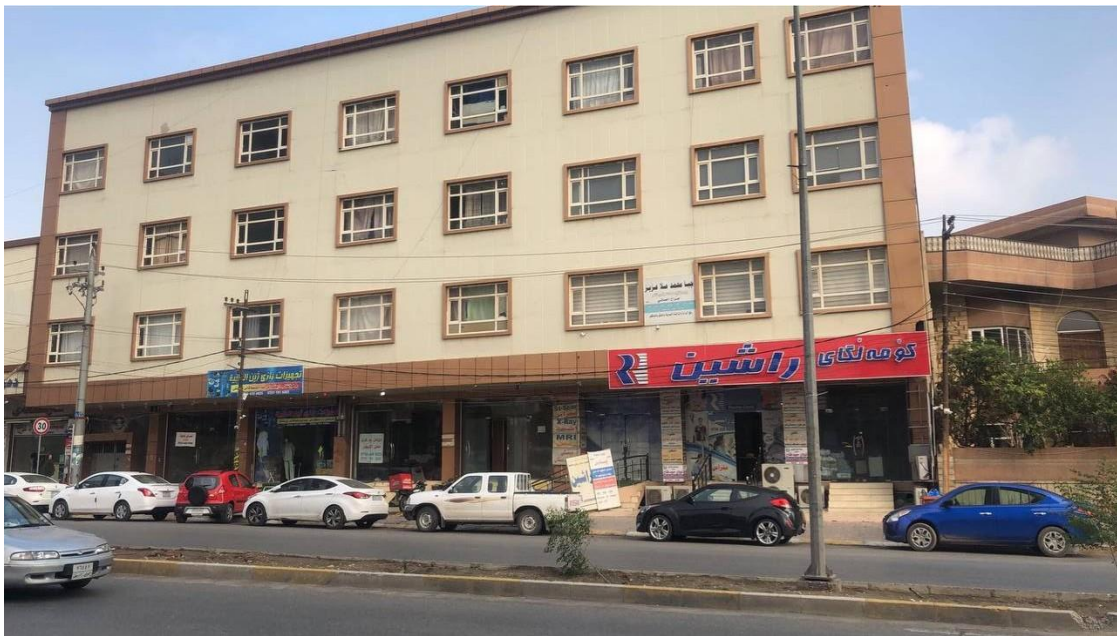
Figure 4.4 Four storey building example in Brayaty Quarter in Erbil City

This criterion deals with measuring number of storeys above and below grades. Above grade indicates that the portion of a building is above the ground, while below grade refers to the portion of a building below the ground. Figure 4-4 is an example the building has four storeys above grade and one storey below grade in Brayaty Quarter in Erbil City.

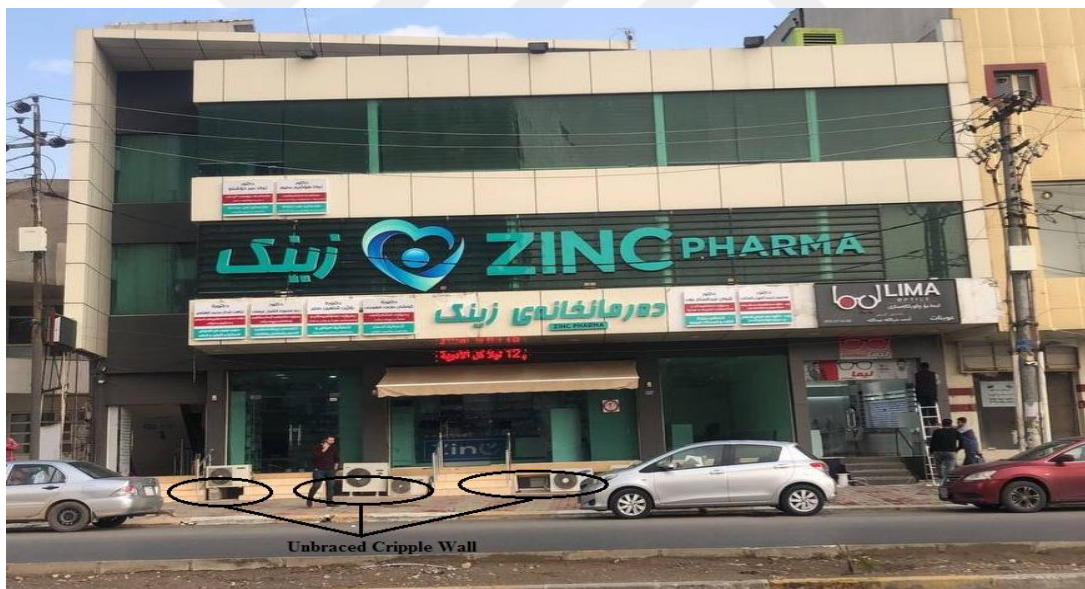
Figure 4.10 Unbraced cripple wall in the building in Brayaty Quarter in Erbil City

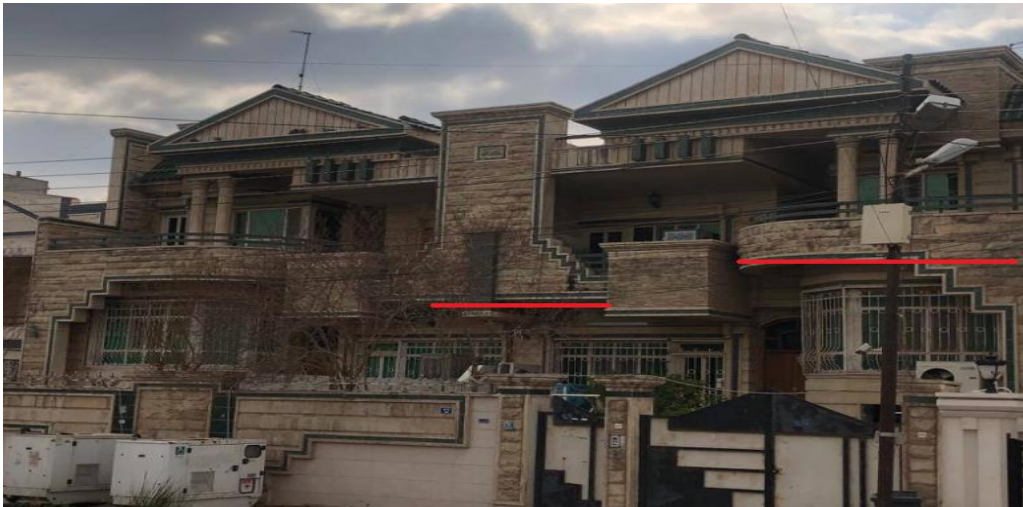
Figure 4.12 The two red lines illustrate split level in a building in Brayaty Quarter in Erbil City

Split levels are buildings where the floors are not parallel or have a step in the roof level. Another definition is that a building has a room or rooms higher than others by less than a whole storey as in Figure 4-12.

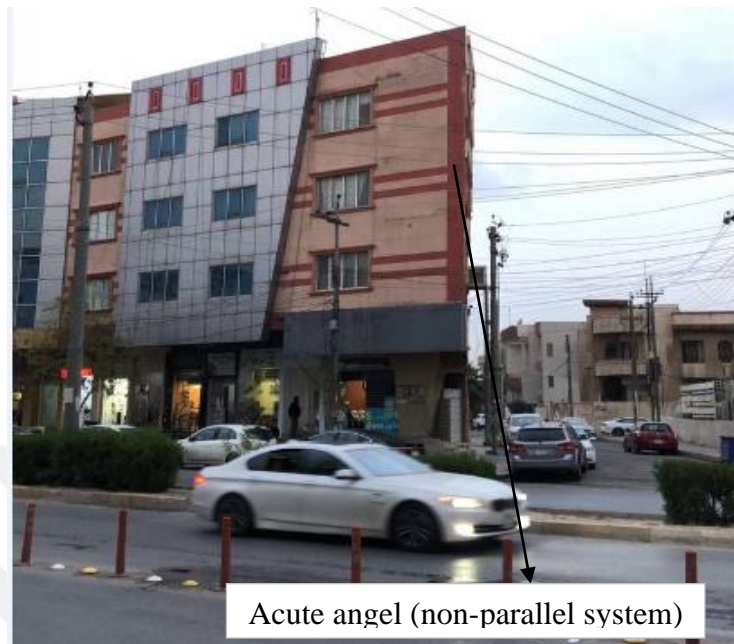
Figure 4.15 The front of the building and the side on the right do not form 90-degree angles in Brayaty Quarter in Erbil City

This criterion can be defined as the building's sides don't meet at 90 degrees as in the figures 4-14. and 4-15.

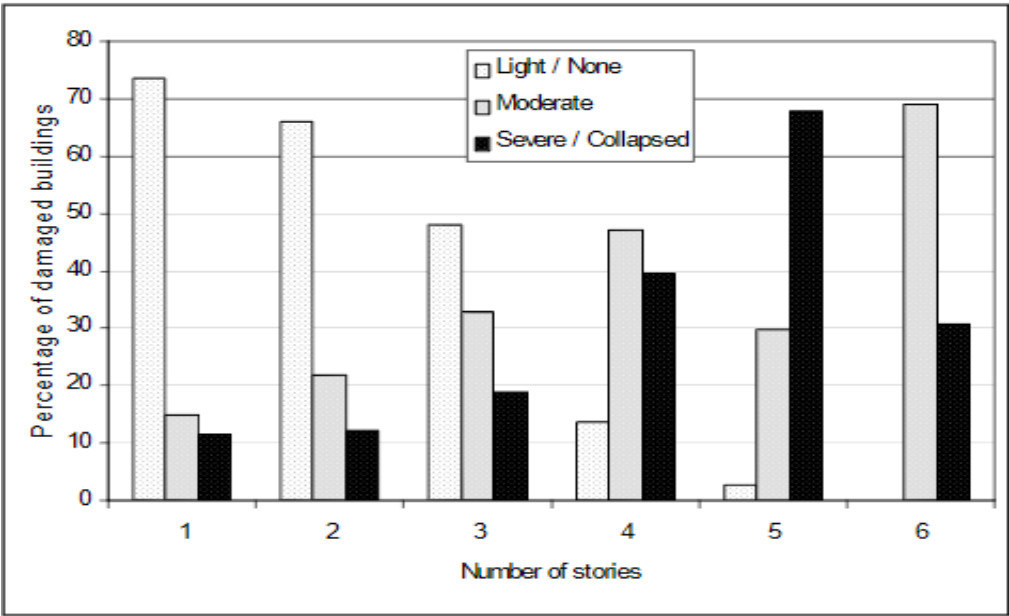
Figure 4.19 Percentage of damaged buildings in Düzce after the 1999 earthquakes, with respect to the number of stories (Sucoğlu and Yazgan, N.D.)

for each of the 9685 buildings in Düzce following the two quakes in 1999 is computed. The results are shown in Figure 4-19 below, which normalizes the number of damaged buildings to the total number of structures at a given story level. Damage grades shift linearly with the number of stories, as in Figure 4-19 The percentage of undamaged and lightly damaged buildings declines continuously as the number of stories rises, but the ratio of moderately and severely damaged structures rises in the opposite direction. This shows clearly that the number of stories is an important factor-possibly the most important one-in determining how seismically vulnerable Turkish multistory concrete buildings are (Sucoğlu and Yazgan, N.D.).

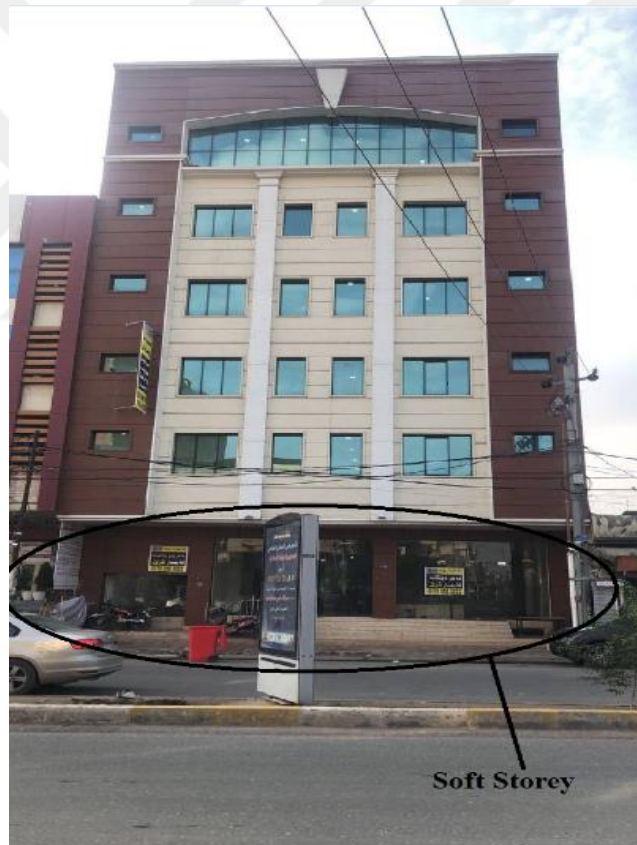
Figure 4.20 Illustrates presence of a soft storey in the building in Brayaty Quarter in Erbil City

commercial space. The commercial space at the bottom is mainly left open between the frame elements, allowing for customer mobility, while these top stories benefit from the increased rigidity and strength that many partition walls provide. Additionally, the ground stories may have irregularity due to taller clearances and a different axis system. From the standpoint of earthquake engineering, the cumulative effect of all these negative parameters is referred to as a soft story. During previous earthquakes around the world, it was observed that many structures with soft stories collapsed as a result of a soft story that had pancaked. (Sucoğlu and Yazgan, N.D.). Figure 4-20 is an example of soft storey:

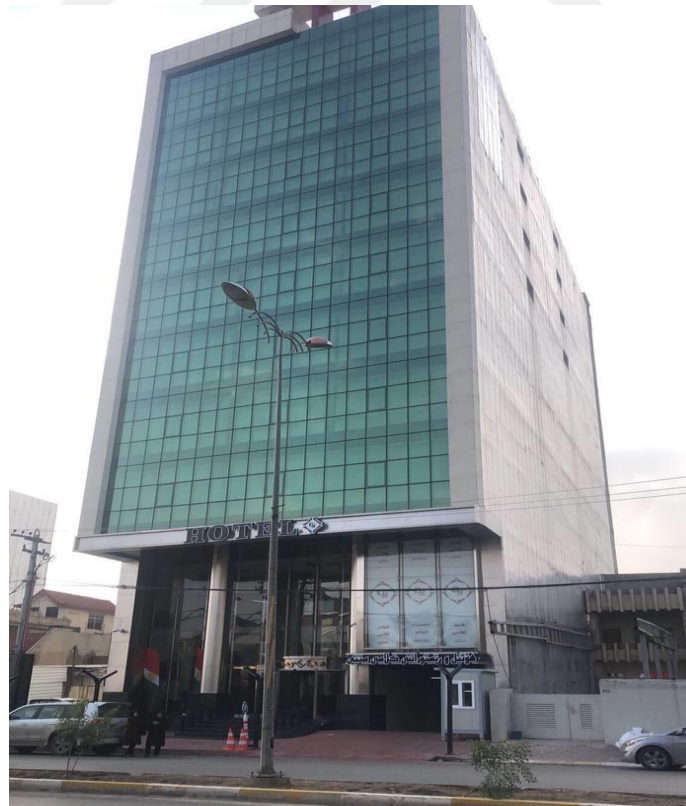
Figure 4.21 Shows presence of heavy overhang

In multistory reinforced concrete buildings, heavy balconies and overhanging levels shift the mass center upward, increasing seismic lateral stresses and overturning moments during earthquakes. In comparison to conventional structures in elevation, buildings with balconies with enormous overhanging cantilever spans encased with massive concrete parapets suffered greater damages during the recent earthquakes in Turkey. This building feature is included in the parameter set because it is simple to see during a walk-down survey. (Sucoğlu and Yazgan, N.D.) Figure 4-21 indicates presence of heavy overhang in a building in Brayaty Quarter in Erbil city.

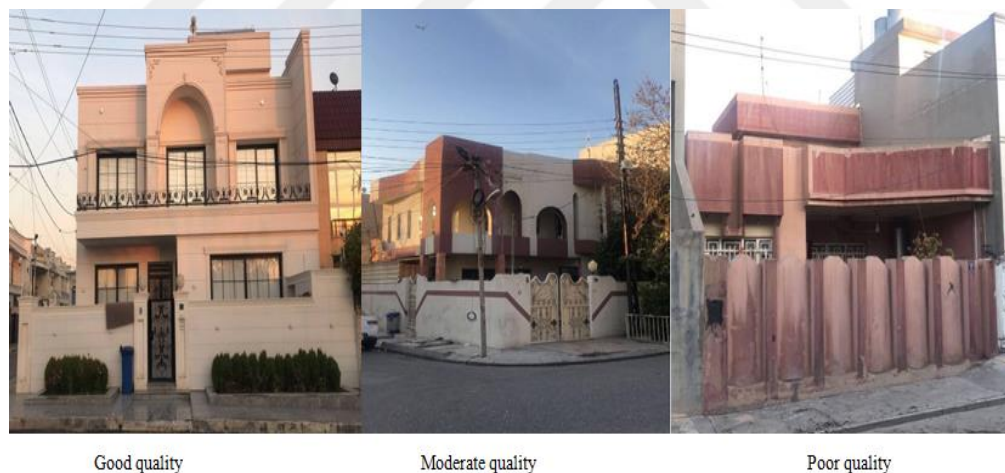
Figure 4.22 Shows three types of apparent building quality in Brayaty Quarter in Erbil City

The apparent quality of a structure is reflected in the quality of the materials and workmanship as well as the attention paid to its maintenance. A well-trained observer can roughly classify a building's apparent quality as good, moderate, or poor. During the recent earthquakes in Turkey, a strong correlation between the visible quality and the actual damage was seen. One can anticipate that a building with poor apparent quality will have weak material strengths and insufficient detailing. (Sucoğlu and Yazgan, N.D.) Figure (4-22) below illustrates three types of apparent building quality.

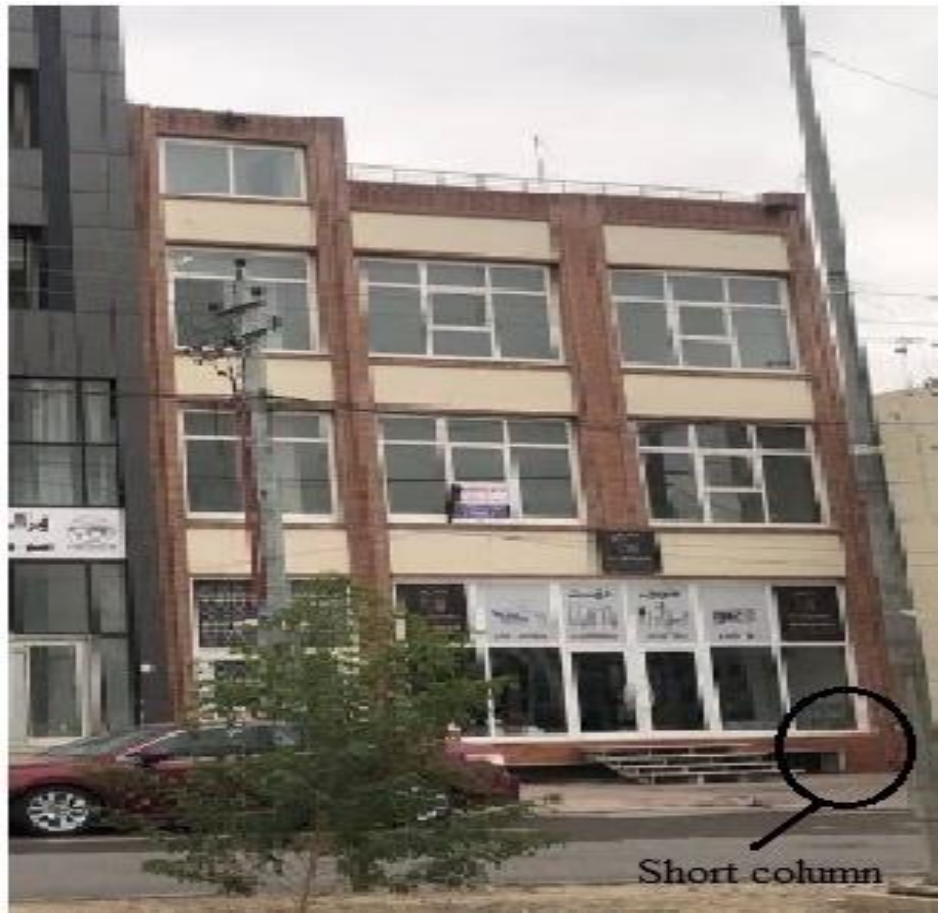
Figure 4.24 Presence of short column in Brayaty Quarter in Erbil City

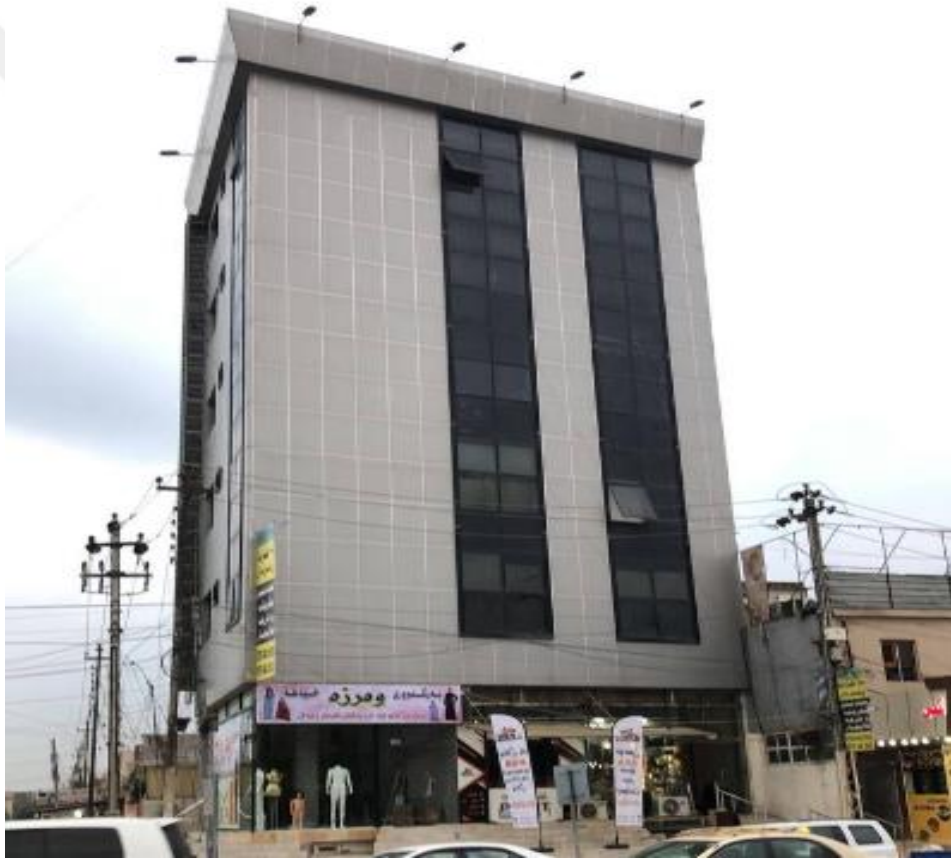
Figure 4.25 Pounding end building

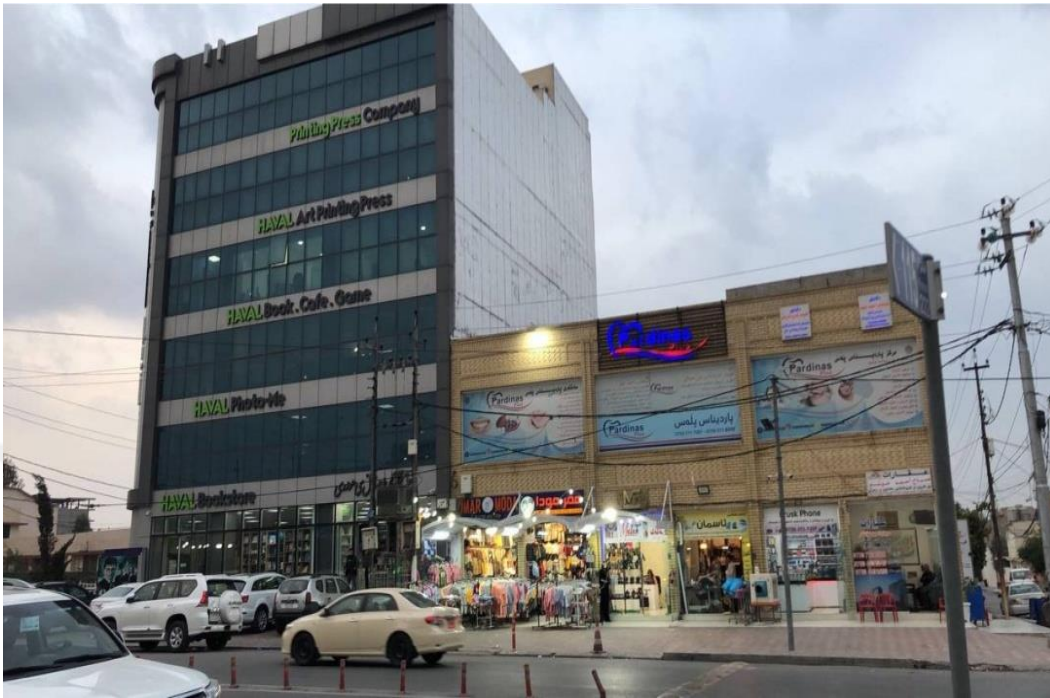
Figure 4.26 Pounding one building is two or more stories taller than the other

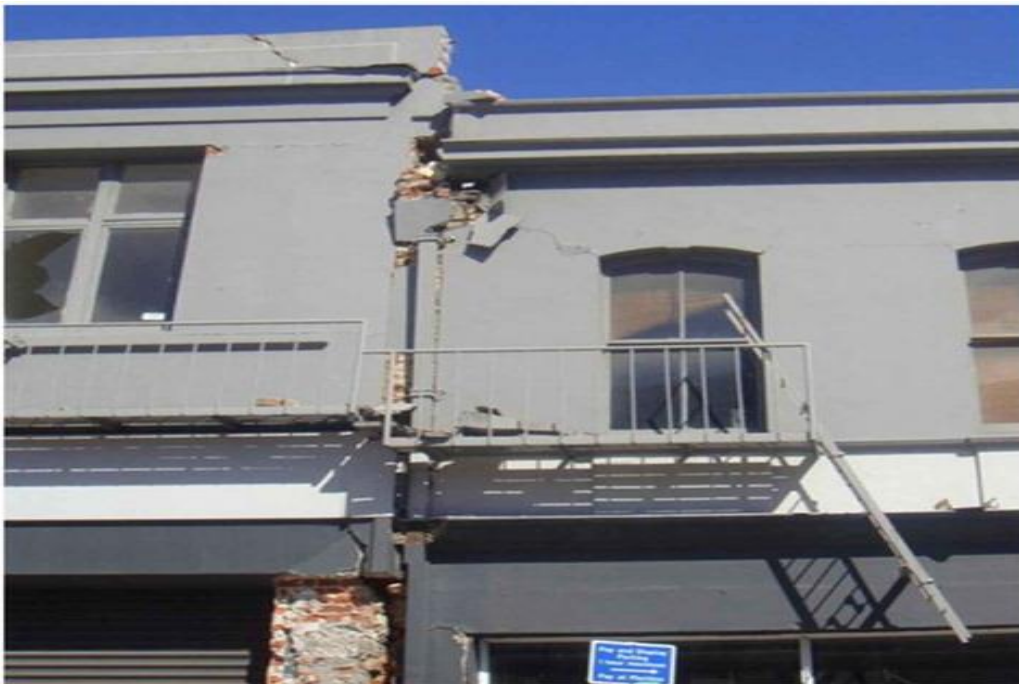
Figure 4.27 Pounding damage observed in Christchurch CBD, 2011 (Noman et al., 2016)

earthquakes, pounding of adjacent buildings can be extremely dangerous. Damage as a result of inadequate energy dissipation systems or gaps that are too small to account for the relative motion of these buildings. (Noman et al., 2016) Figure 4-25 and Figure 4-26 are respectively examples of pounding end building and pounding where one building rises above the other by two or more stories in Brayaty Quarter in Erbil City. Figure 4-27 is an example of pounding damage observed in Christchurch CBD, 2011.

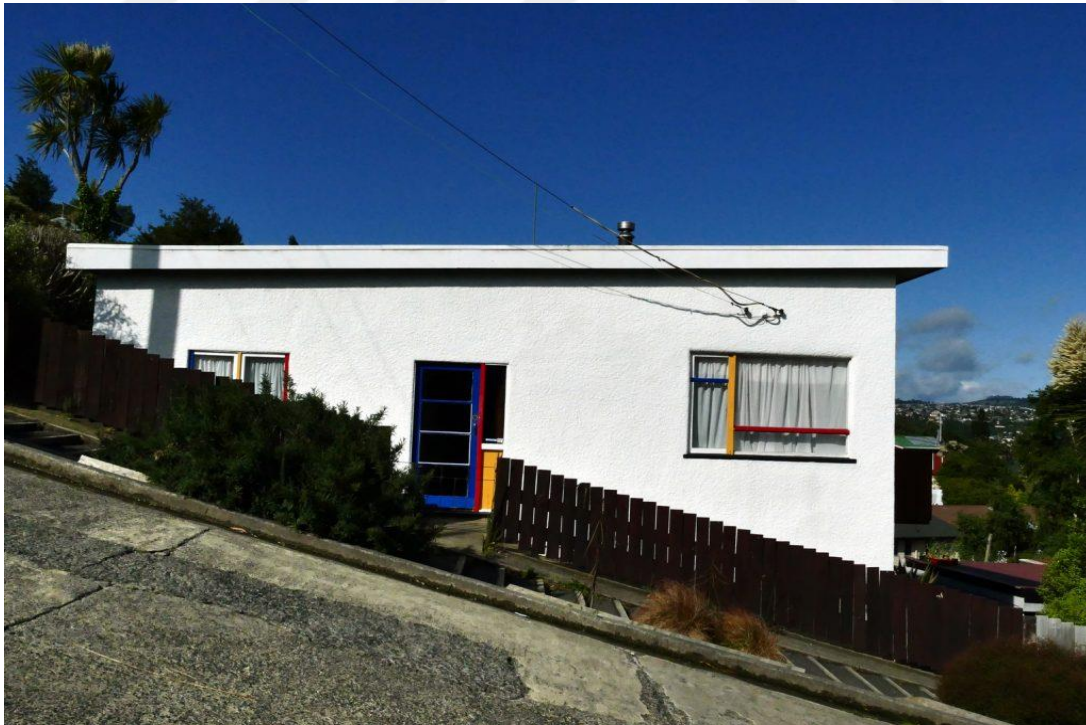
Figure 4.28 Building a house on a sloped land

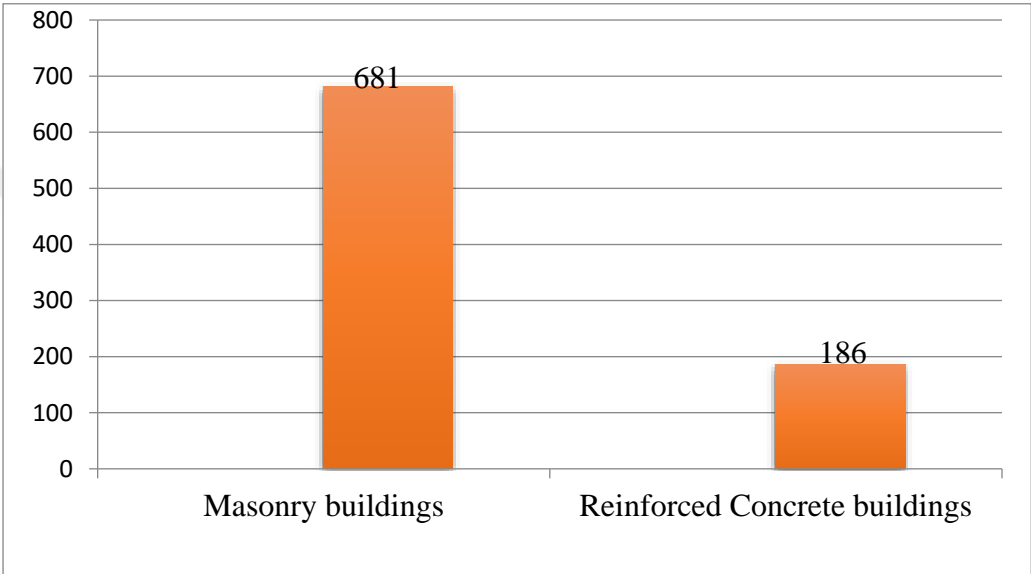
Figure 5.1 Distribution of structural systems of 867 buildings in Brayaty Quarter in Erbil City

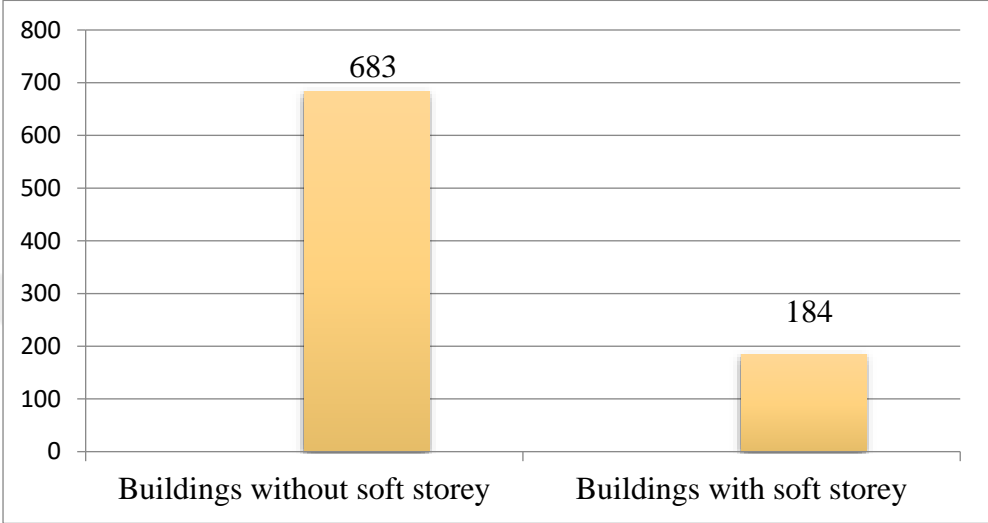
Figure 5.3 Number of buildings with soft storey and buildings without soft storey in the target area

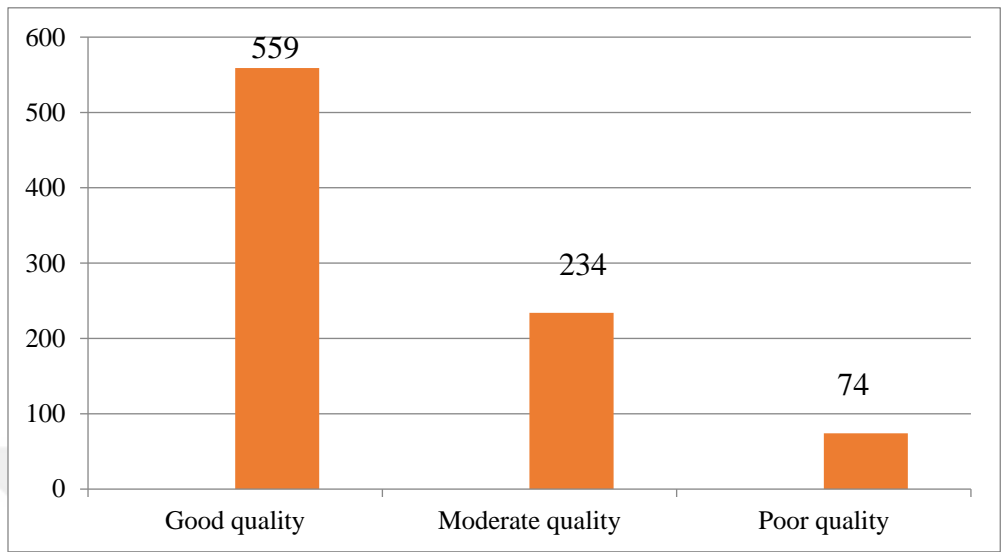
Figure 5.5 Number of buildings in good, moderate and poor quality

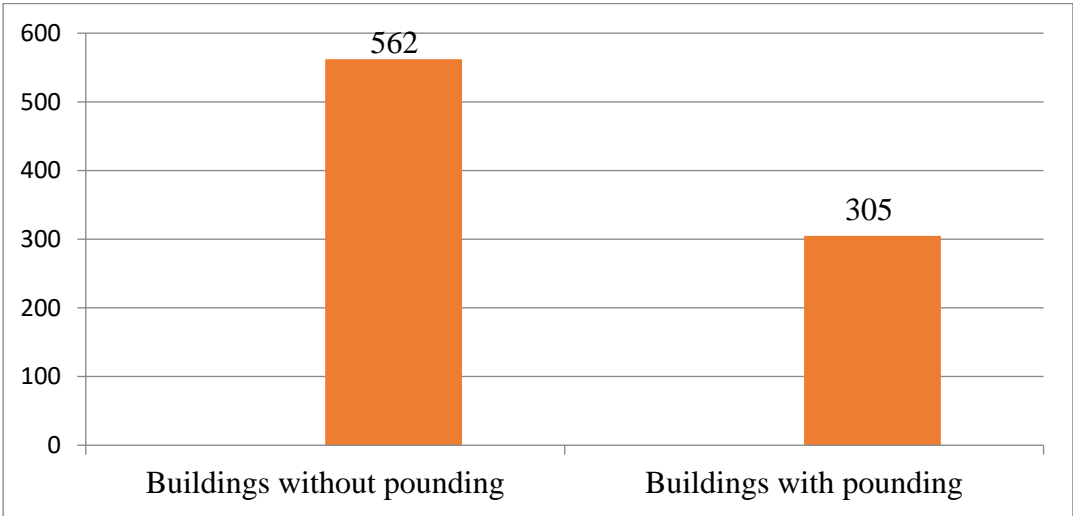
Figure 5.6 Number of buildings with pounding and without pounding

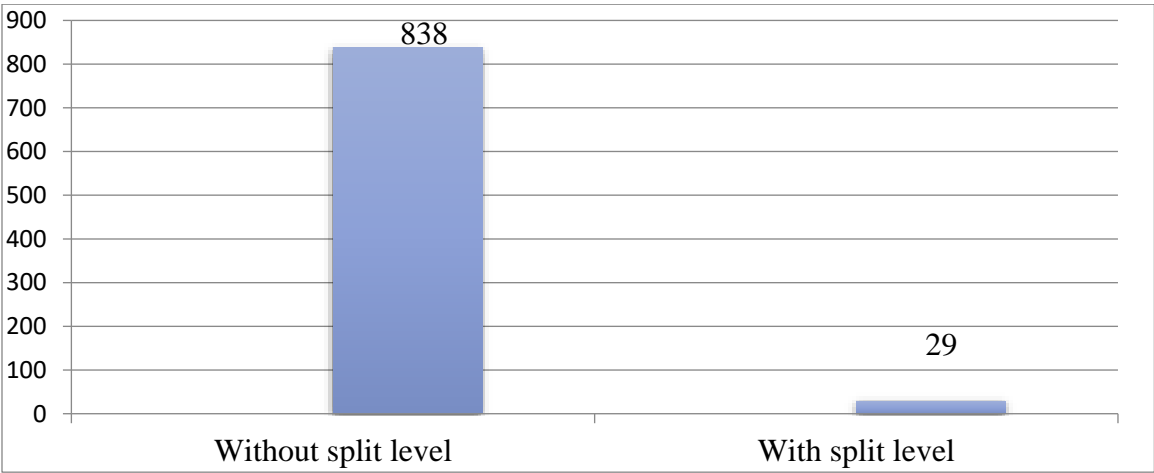
Figure 5.7 Number of buildings with and without split level

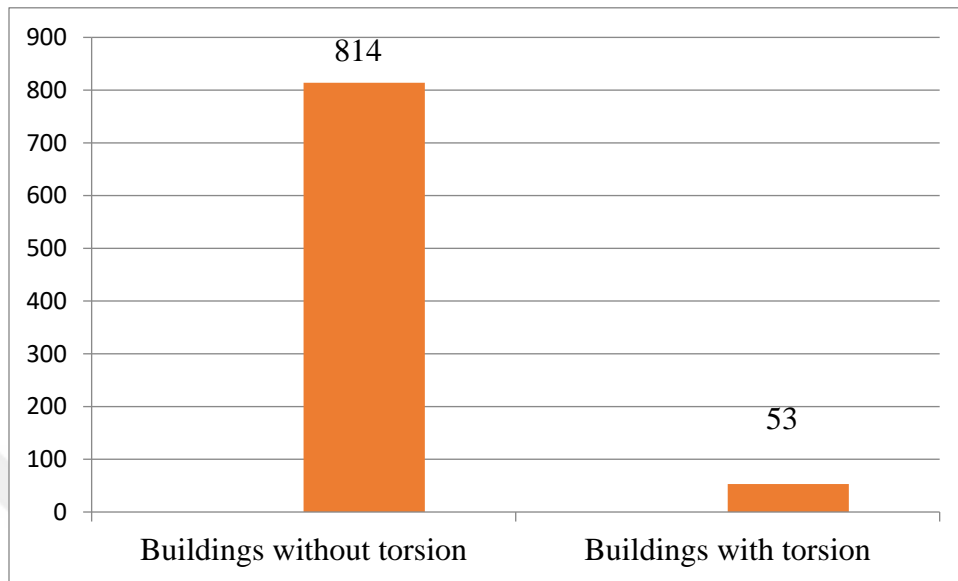
Figure 5.8 Distribution of buildings with and without torsion

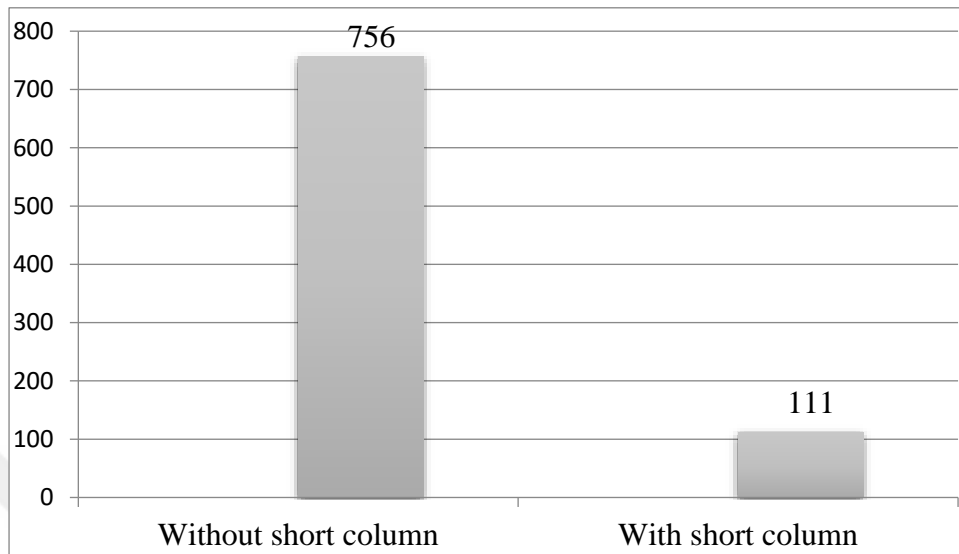
Figure 5.9 Distribution of the number of buildings with short column

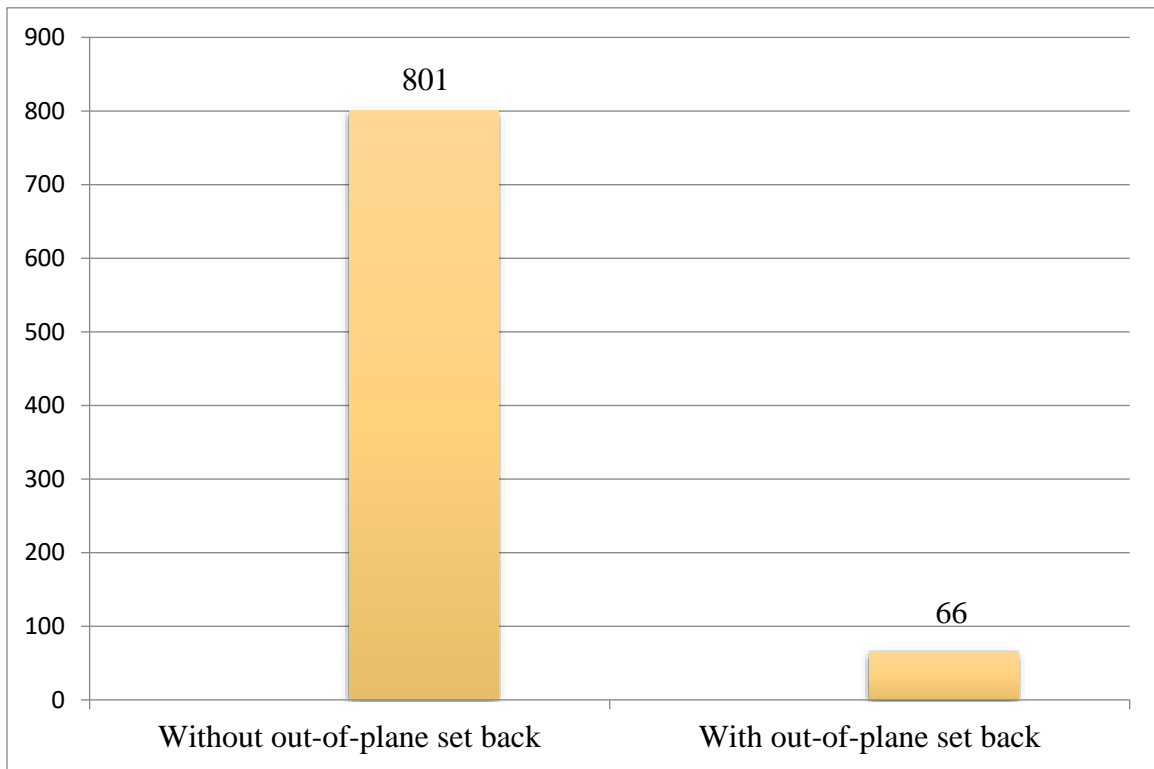
Figure 5.10 Number of buildings with and without out-of-plane set back

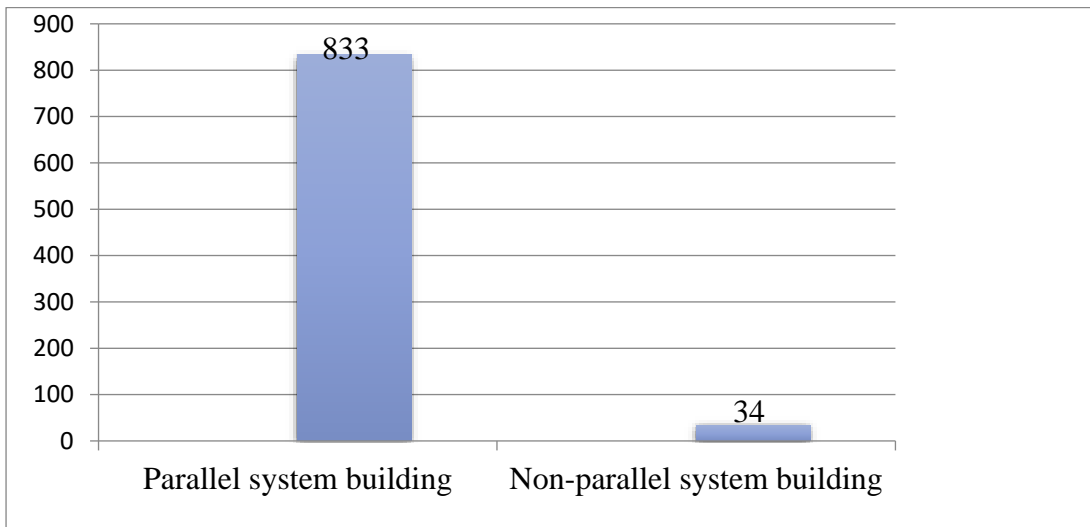
Figure 5.12 Parallel and non-parallel system

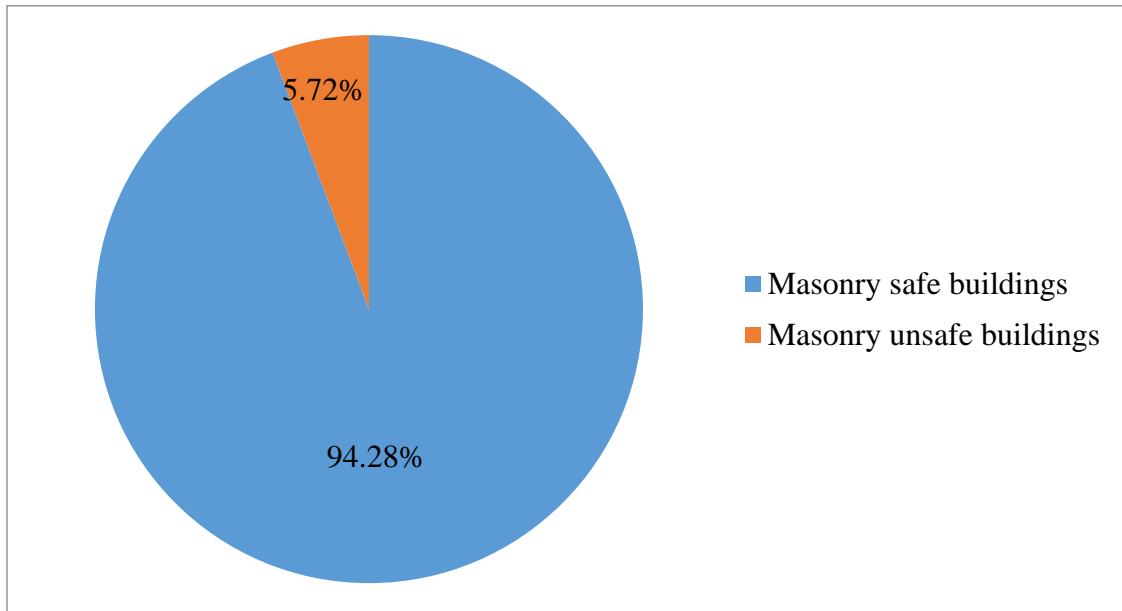
Figure 5.15 Percentage of safe and unsafe masonry buildings for (FEMA P-154, 1988)

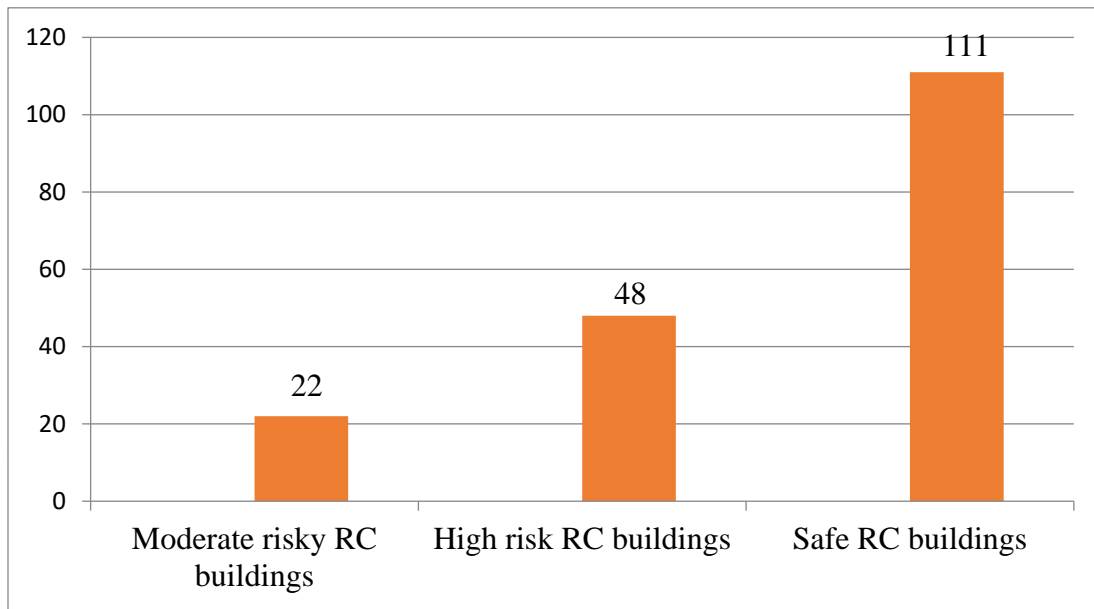
Figure 5.16 Number of moderate, high risky and safe RC buildings
