**QUICK DETERMINATION OF THE PERFORMANCE OF EXISTING BUILDINGS
IN ERBIL CITY IN BRAYATY QUARTER USING STREET-WALK METHOD**

M.Sc. THESIS

Rokhosh KHUDHUR
Supervisor: Assoc. Prof. Dr. Murat MUVAFIK

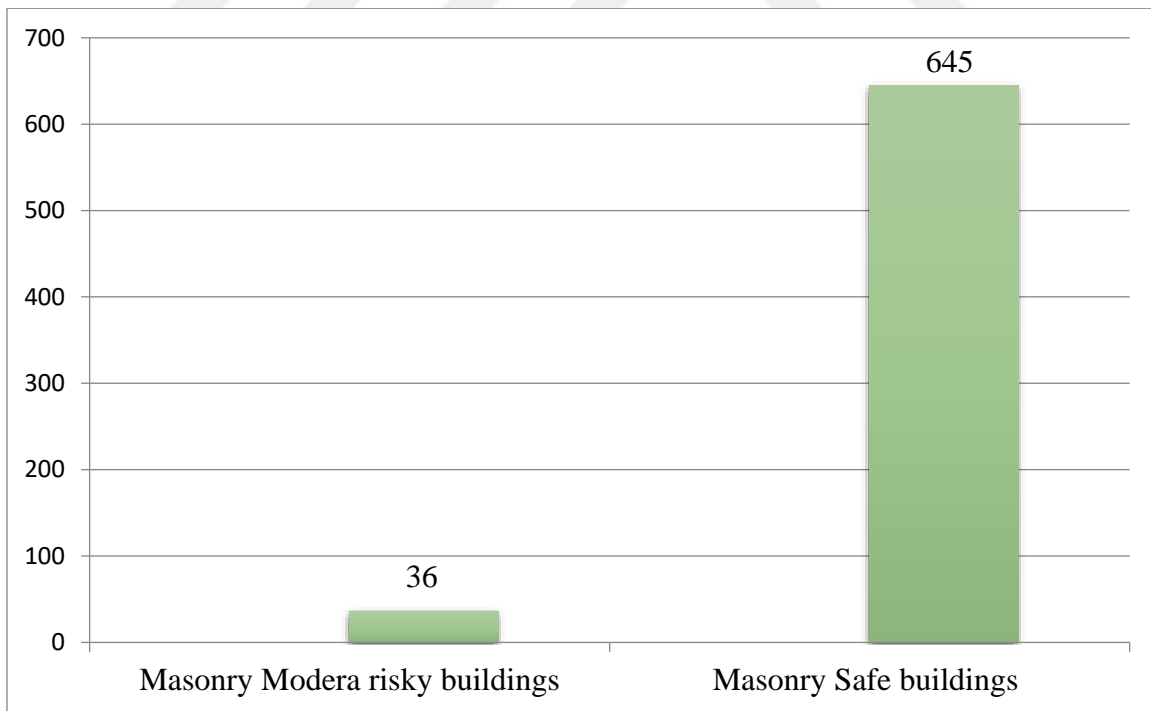
Figure 5.17 Moderately, risky and safe masonry buildings
