REPUBLIC OF TÜRKİYE
GAZİANTEP UNIVERSITY

IMPACT PERFORMANCE OF ENGINEERED CEMENTITIOUS
COMPOSITES AT AMBIENT AND HIGH TEMPERATURES

Ph.D. THESIS
IN
CIVIL ENGINEERING

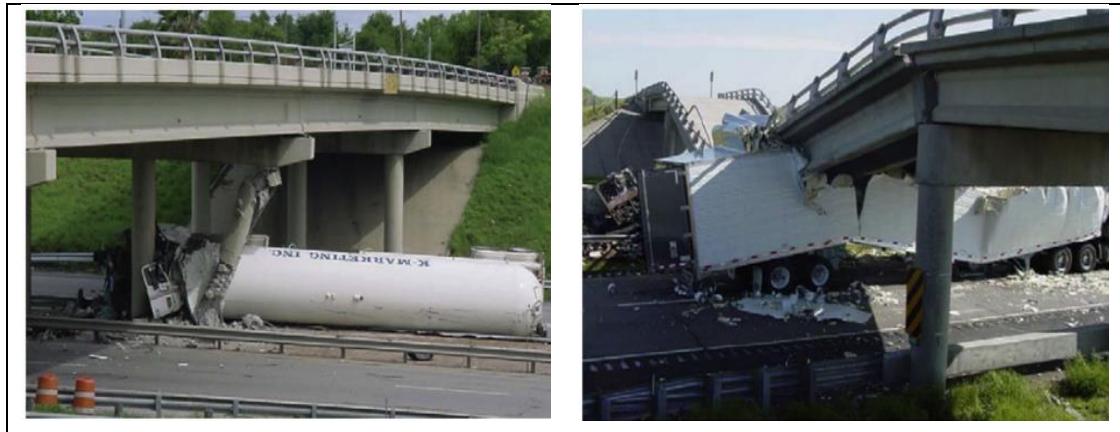
Figure 1.2. Failure of the bridge column as a result of a collision with a truck.

Furthermore, according to research by Wardhana & Hadipriono, (2003) around 3% of 503 bridges in the United States broke due to car collisions during an 11-year period from 1989 to 2000. Figure 1.2 shows two instances of bridge pier and superstructure collapses. Extensive research has been conducted in the academic literature to investigate the impact of various loading-related and structural parameters on the force of the automobile collision as well as the structural responses of the damaged pier.

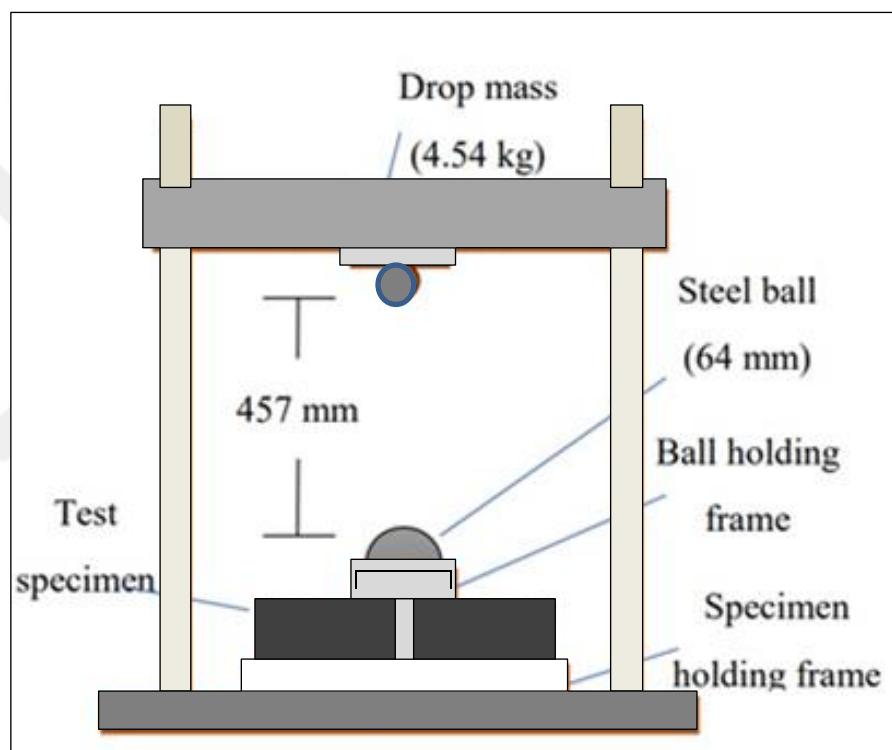
Figure 1.4. The drop-weight impact test.

failure impact numbers, depending on the concrete mixture in question. The standard test specimen design is based on a cylindrical (disk) test specimen with dimensions of approximately 150 mm in diameter and 64 mm in thickness, and a thickness of approximately 64 mm. Under normal circumstances, the drop weight is manually raised to the specified drop height and then released, with the steel ball resting in the center of the specimen's top surface, allowing it to be freely dropped on the specimen's top surface by gravity, as described in the standard test. Following the steel ball acts as a load distribution point and is held in place by a special framing system that also serves to hold the concrete disk specimen in place (see Figure 1.4).

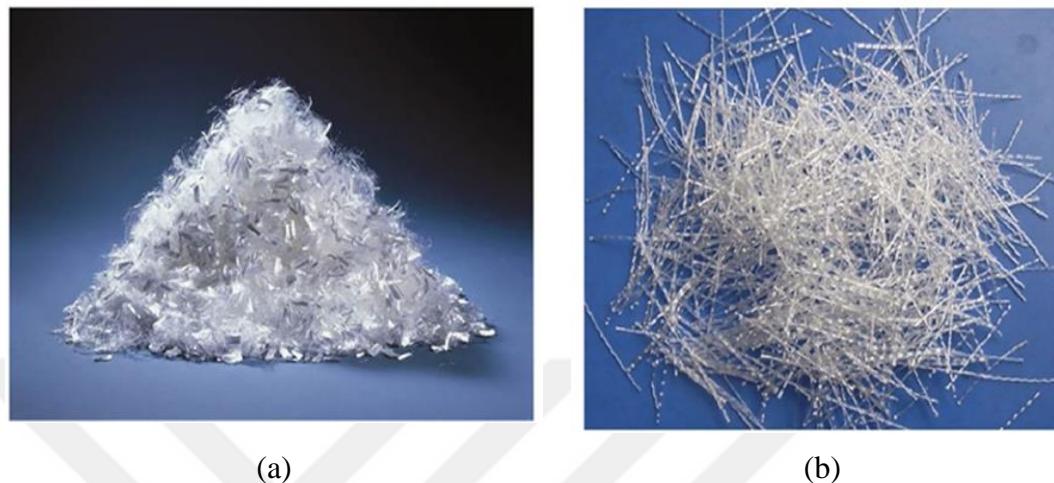
Figure 1.7. PP (a) microfibers and (b) macro-fibers.

Their primary function is to prevent plastic shrinkage from occurring in the concrete and to restrict the production of fractures in the concrete. As a consequence, they improve the durability of the element and extend its useful life as a result. In certain situations, Micro PP fiber may be used as an alternative to crack control meshes.

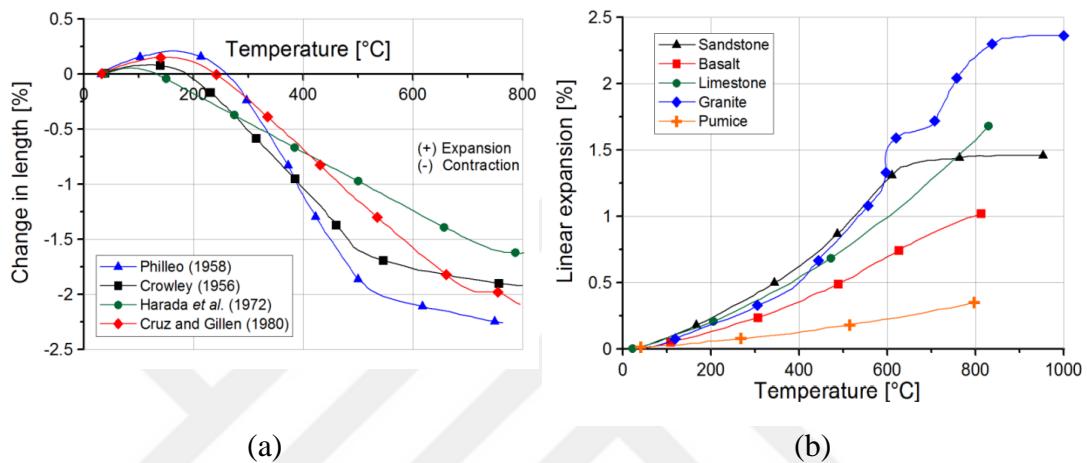
Figure 2.2. Length change of Portland cement paste specimens; (b) linear thermal expansion of various rocks adapted from (Bažant & Kaplan, 1996).

differential stresses are formed as a result of the thermal incompatibility between the two concrete ingredients, resulting in the formation of microcracks. Typically, in a typical concrete mixture, the expansion of the aggregates is greater than the contraction of the cement paste, and the aggregates' combined expansion results in the expansion of the concrete as a whole. There are exceptions to this rule, though. For example, lightweight concrete that is made with pumice particles may shrink when heated to around 300 °C (Bažant & Prat, 1988).

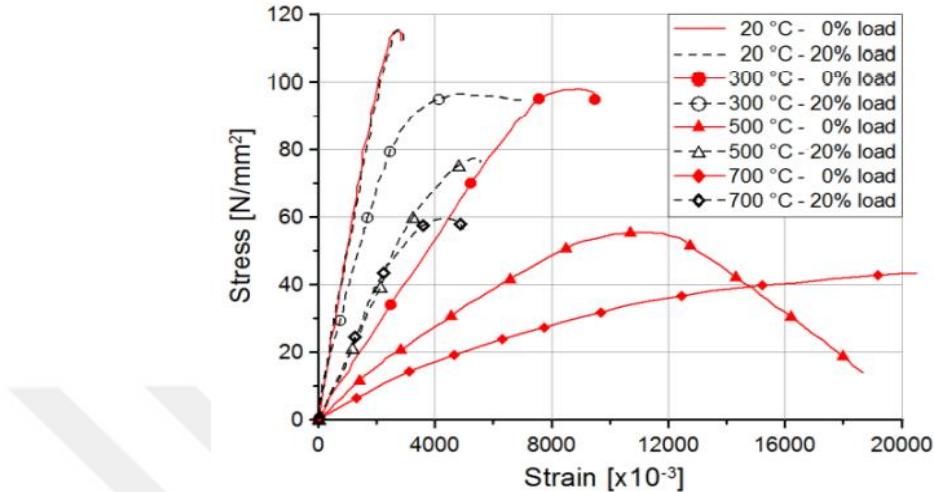
Figure 2.3. Stress-strain curves for different testing (compression) temperature levels; comparison between unloaded (0% applied load) and loaded (20% applied load) tests for Ultra High Strength concrete specimens containing steel fibers (Khoury, 1999).

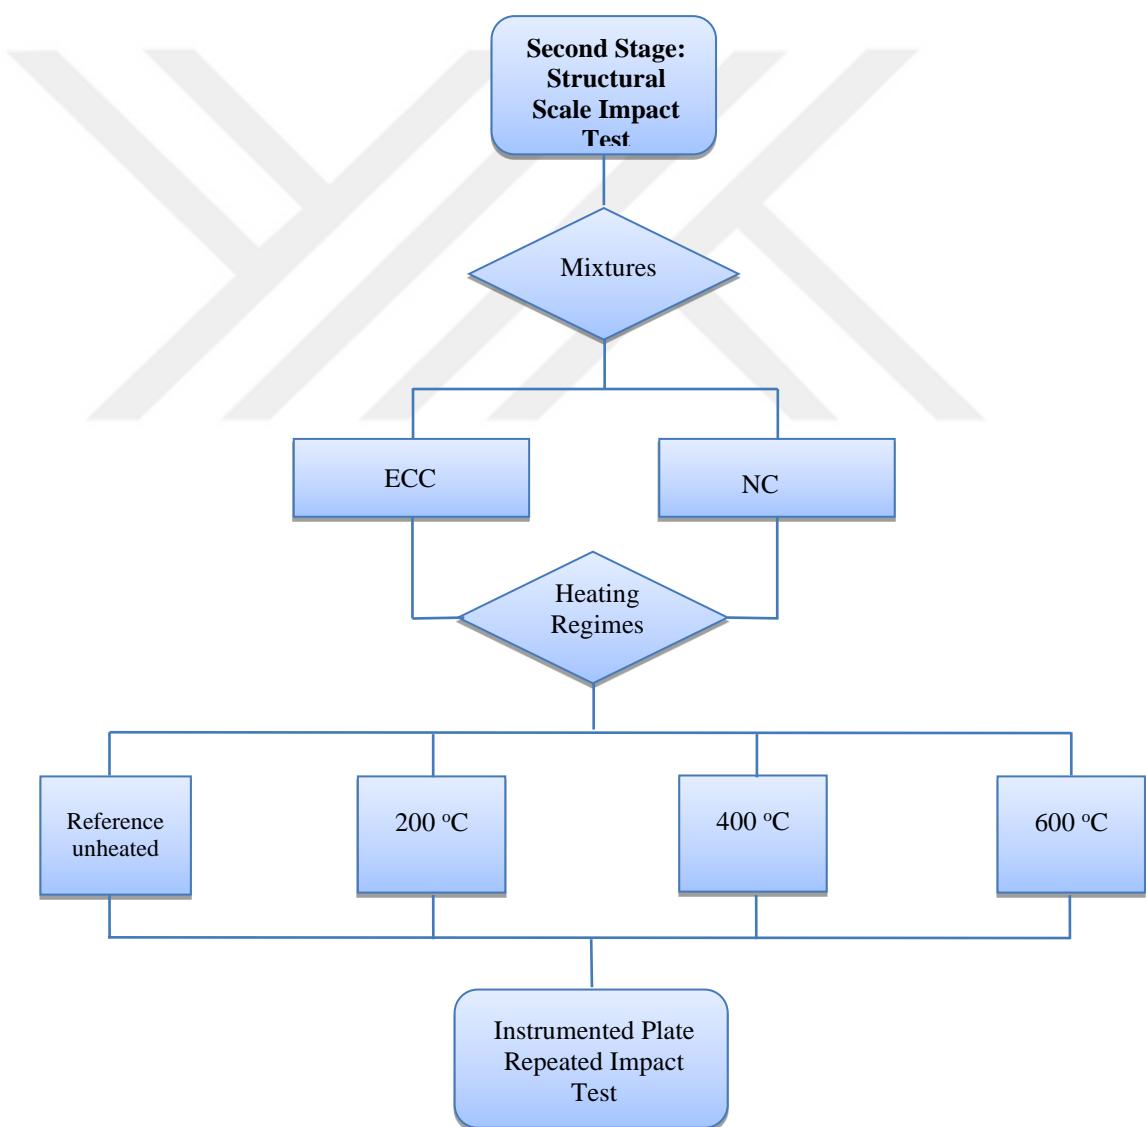
Figure 3.2. Test sequence of the structural-scale stage.

In the second part of the experimental work, reinforced square palate specimens were subjected to elevated temperatures and tested under repeated impact loads. The instrumented drop-weight test was considered to evaluate the residual impact strength of the test specimens. The test included different measurements of force, deflection, and vibration and considered for different structural boundary conditions. Three boundary conditions were considered to simulate the simple support case, two-opposite sides restricted case, and four-sides restricted case.

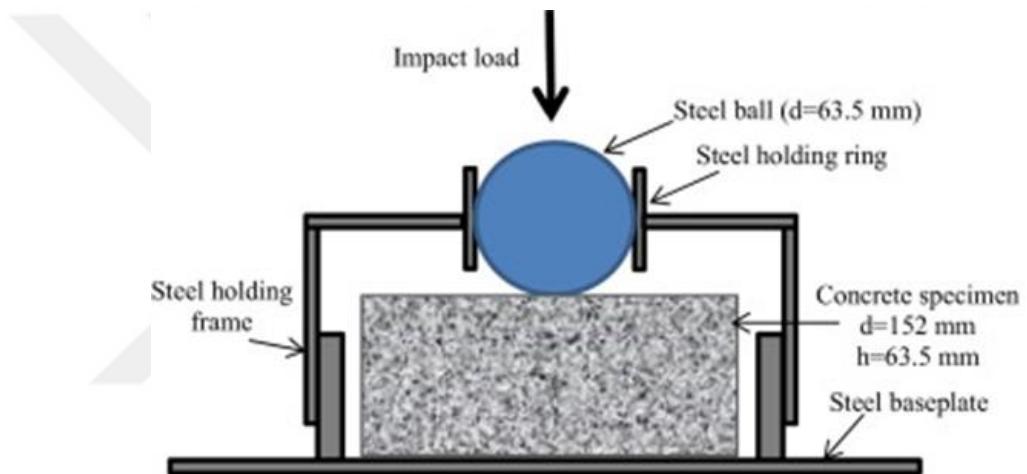
Figure 3.8. The test specimen and the lower portion of the ACI 544-2R RBDWI testing apparatus (Abid, et al., 2020b).

The standard test specimen is cylindrical (disk) with a diameter of approximately 150 mm and a thickness of approximately 64 mm. The standard test is operated manually by hand-lifting the drop weight to the specified drop height and releasing it to be freely dropped by gravity on a steel ball, which rests on the center of the specimen's top surface. The steel ball is used as a load distribution point and is held in place using a special framing system that also holds the concrete disk specimen as illustrated in Figure 3.9. However, it was found in the previous works that the manual operation requires significant effort and is time consuming, especially because at least 6 replication specimens are required to assess the test records due to the high dispersion of this test's results.

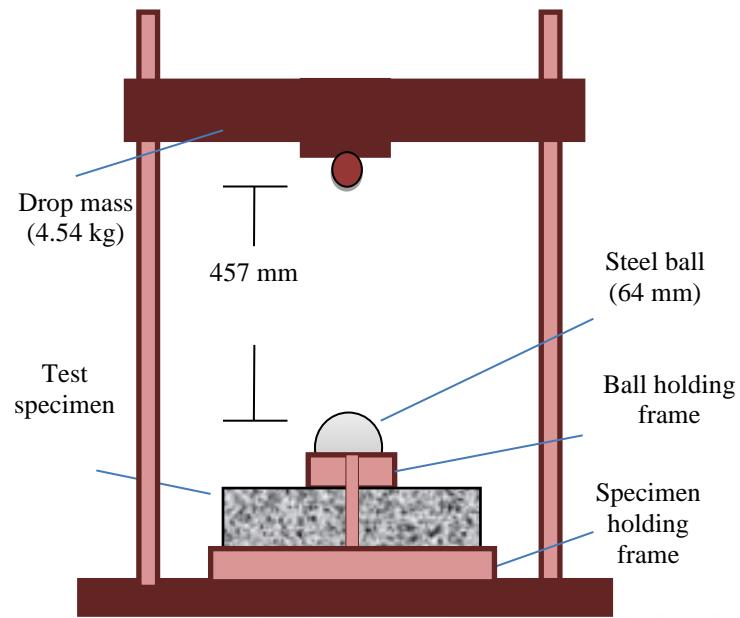
Figure 3.9. Testing apparatus of the ACI 544-2R repeated impact test (Abid, et al., 2020b).

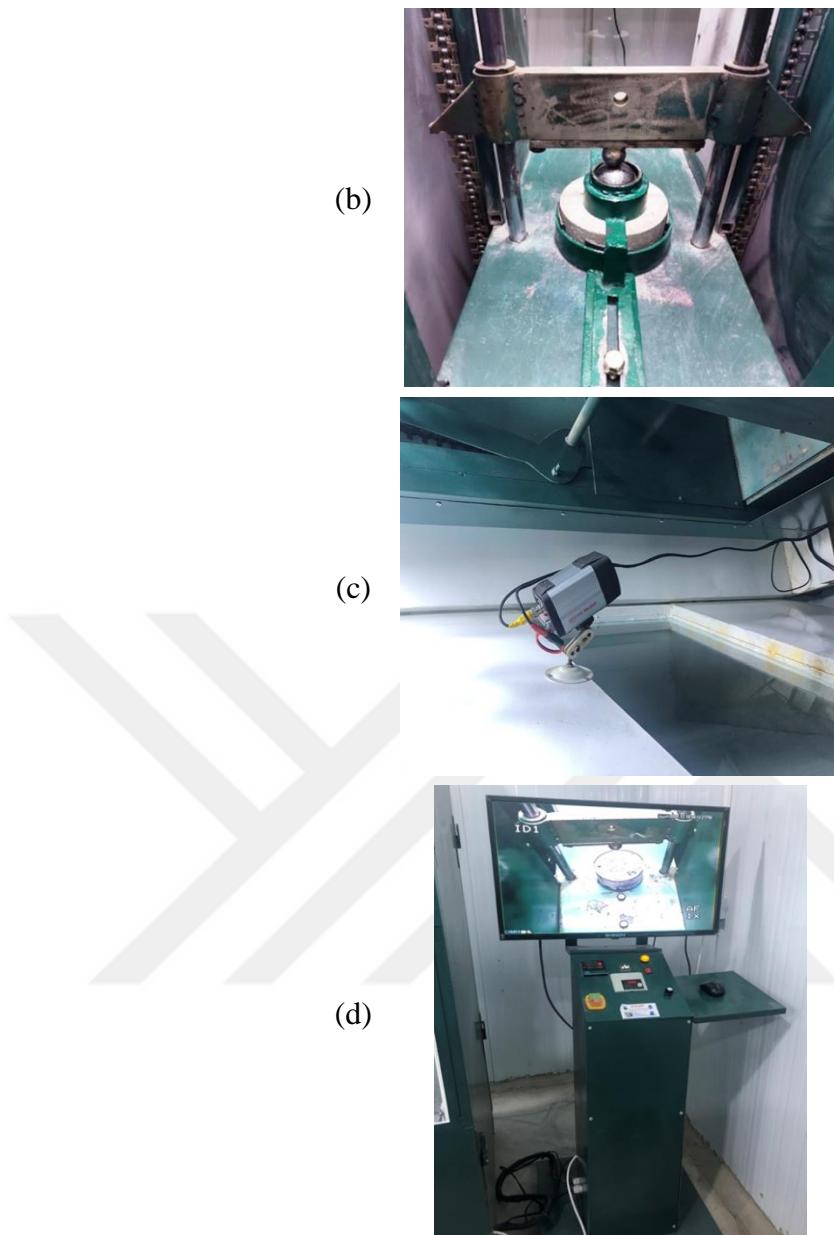
Figure 3.10 The automatic repeated impact testing machine (a) general view (b) test cabinet (c) camera system and (d) test control and monitoring unit.

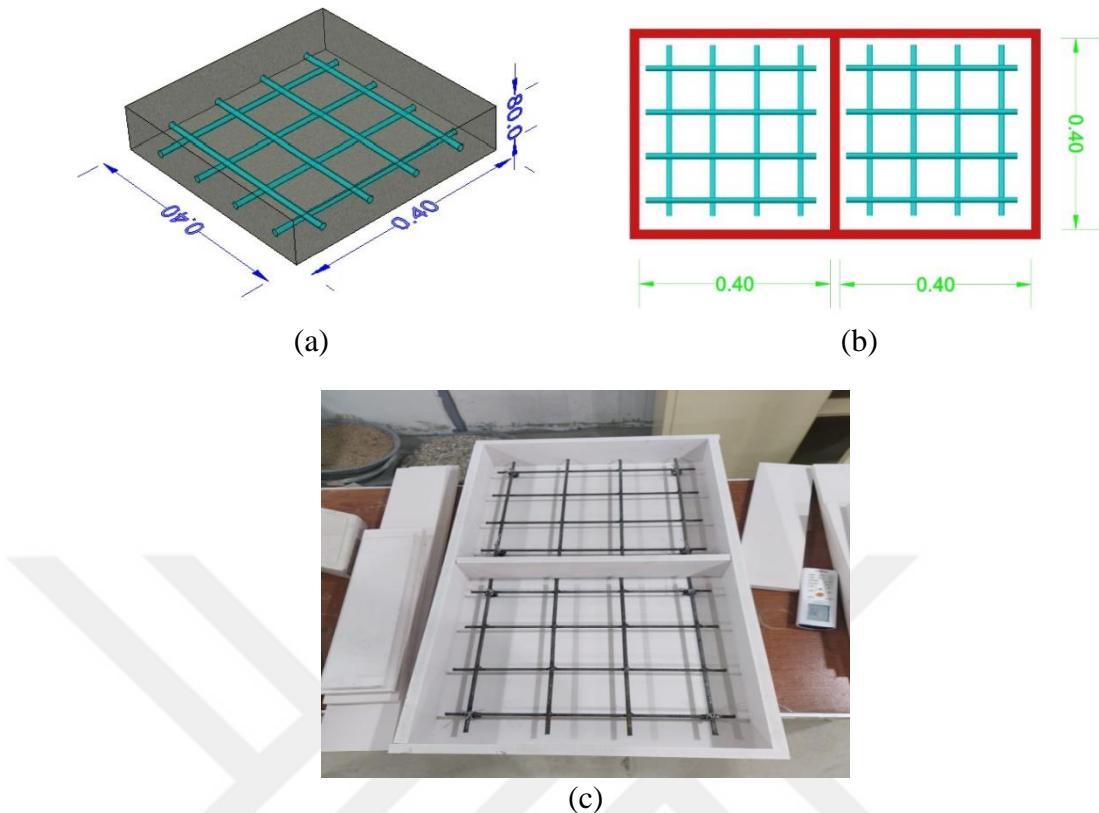
Figure 3.20. The dimensions and reinforcement of the plate specimens.

The plate specimens were designed so that they will be easily inserted in and removed out the electrical furnace. Because of the limited furnace internal dimensions, the size of the plates was reduced to 400×400 mm, while the depth was reduced to 80 mm to be compatible with the length side as depicted in Figure 3.20a. The plates were reinforced with four bars with 6 mm diameter each direction as depicted in Figure 3.20a and 3.20b. The formwork was prepared so that each two plates can cast using one wooden formwork as shown in Figure 3.20c.

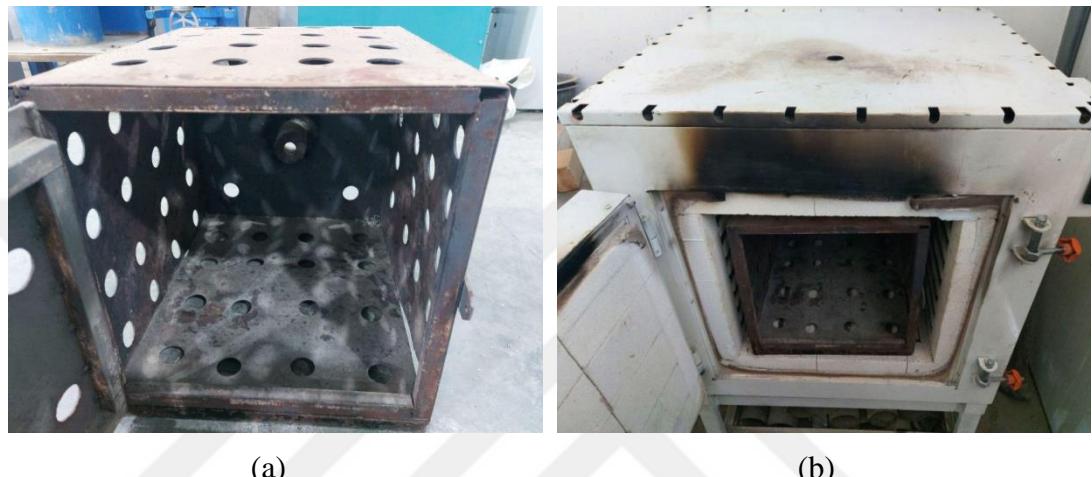
Figure 3.28. Protection of the electrical furnace using a steel cage (a) the steel box-cage (b) the final internal view of the furnace.

On the other hand, the drop-weight plate specimens (structural-scale stage) were heated to three levels of temperatures of 200, 400, and 600 °C in addition to the reference specimens. The steel cage shown in Figure 3.28a was used to reduce the destructive effects of the concrete explosive failure on the internal walls and heaters of the furnace as shown in Figure 3.28b. The specimens were placed in small groups and were placed on special thermal insulation spacers from the base as shown in Figure 3.29 to allow for a uniform and balanced heating for all specimens.

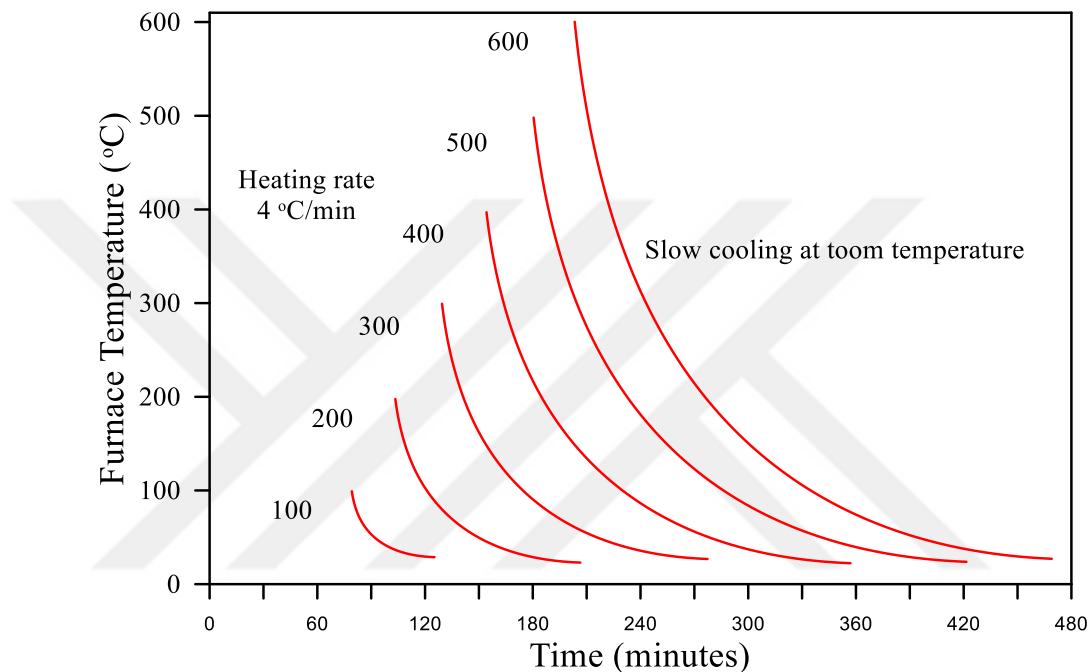
Figure 3.30. Heating and cooling regime of the electrical furnace.

The heating process followed the heating and cooling procedure shown in Figure 3.30, where the specimens were heated steadily at a heating rate of approximately $4\text{ }^{\circ}\text{C}/\text{min}$ till the target temperature. Then after, the specimens were thermally saturated at this temperature for one hour to ensure the thermal steady-state condition (Phan & Carino, 1998; Husem, 2006). Finally, the furnace door was opened to allow for the natural air cooling of the specimens. As their temperature reduced, the specimens were left in the laboratory environment and tested in the next day.

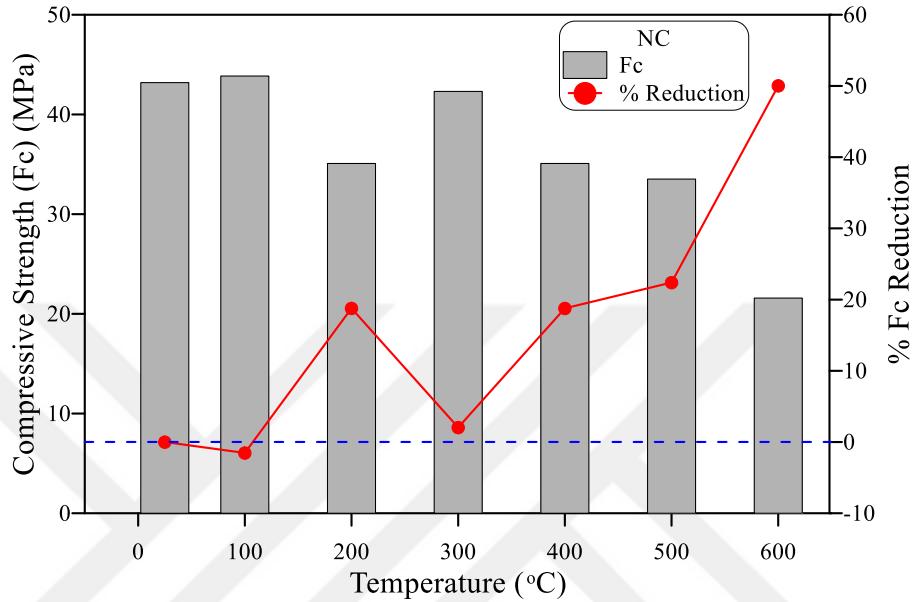
Figure 4.1. Compressive strength-temperature behavior of NC.

Hence, more than 16% strength recovery was gained as the temperature was increased from 200 to 300 °C. As temperature increases beyond 200 °C, the removal of water from the surfaces of the cement gel particles induces higher attraction surface forces (Vander Val's forces), which might increase the ability of the microstructure to absorb higher compression stresses (Arna'ot, et al., 2017).

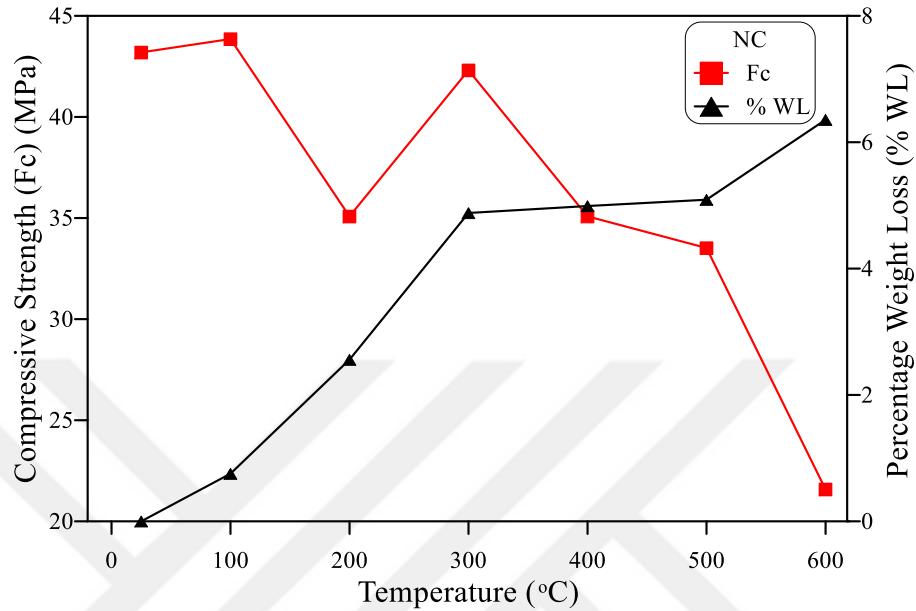
Figure 4.2. Compressive strength-weight loss relation of NC at high temperature.

the slope of the percentage weight loss was high after exposure to the sub-high temperature range (100 to 300 °C), which indicates early high weight loss. This weight loss can be attributed to the evaporation of the free pore water before 200 °C and the absorbed water in the cement gel particles.

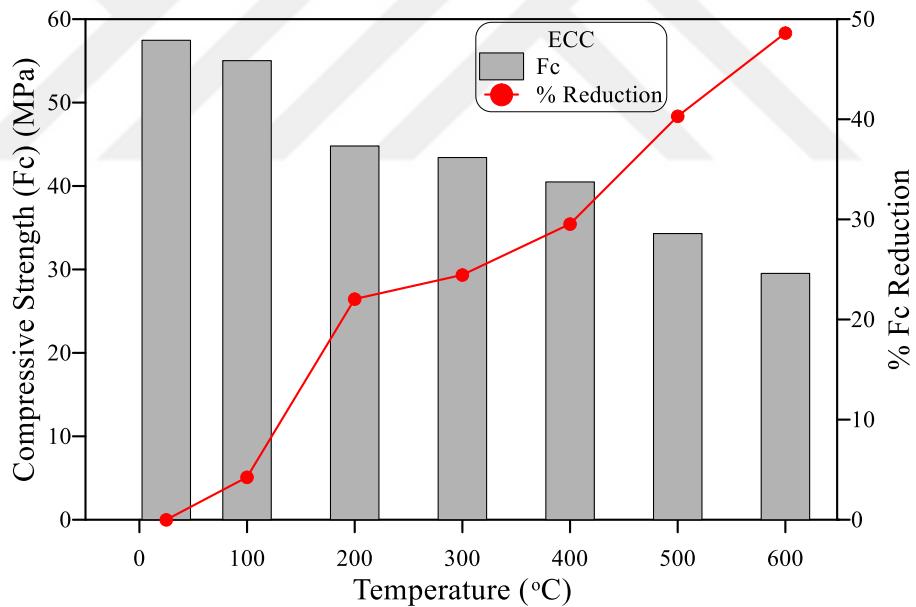
Figure 4.3. Compressive strength-temperature behavior of ECC.

Figure 4.3 illustrates the influence of heating to the adopted various temperature levels on the compressive strength (f'_c) of the ECC specimens. Previous studies showed that the concrete compressive strength (f'_c) of ECC (Shang, & Lu, 2014), increased in some cases after exposure to temperatures in the range of 100 to 300 °C, or exhibited a partial recovery after exposure to 300 °C. Such a behavior did not occur in this study where the compressive strength (f'_c) of ECC exhibited continuous decrease as temperature increased. However, the strength reduction after exposure to 100 °C was limited to approximately 4% as shown in Figure 4.3, where the compressive strength (f'_c) decreased from 57.5 to 55.0 MPa. Another notice is that the strength reduction at 200 °C is comparable to that at 300 °C, where the strength reduced to 44.8 and 44.4 MPa, respectively, exhibiting percentage decreases of 22 and 24.4%, respectively. Similar continuous reduction of compressive strength (f'_c) of ECC with temperature was also reported by previous studies (Sahmaran, et. al., 2010; Sahmaran, et. al., 2011).

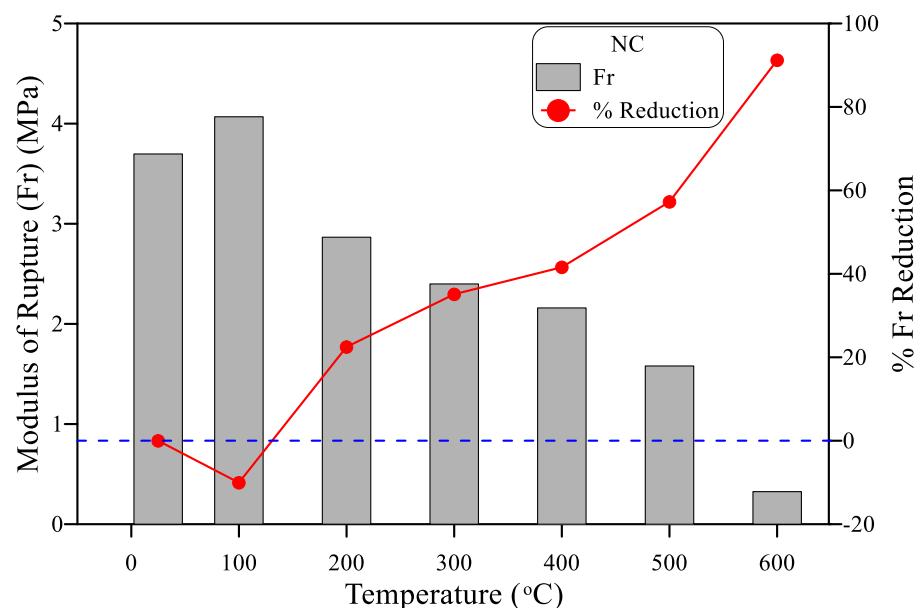
Figure 4.5. Flexural strength-temperature behavior of NC.

Temperature	NC		ECC	
	Flexural strength ($f_{ct,fl}$) (MPa)	Percentage weight loss ($\% W_l$)	Flexural strength ($f_{ct,fl}$) (MPa)	Percentage weight loss ($\% W_l$)
Room	3.70	0.00	6.94	0.00
100	4.07	0.73	7.78	1.11
200	2.87	2.57	5.75	4.76
300	2.40	5.13	5.63	10.07
400	2.16	5.25	4.32	11.32
500	1.58	6.10	2.98	13.61
600	0.32	7.64	2.32	14.73

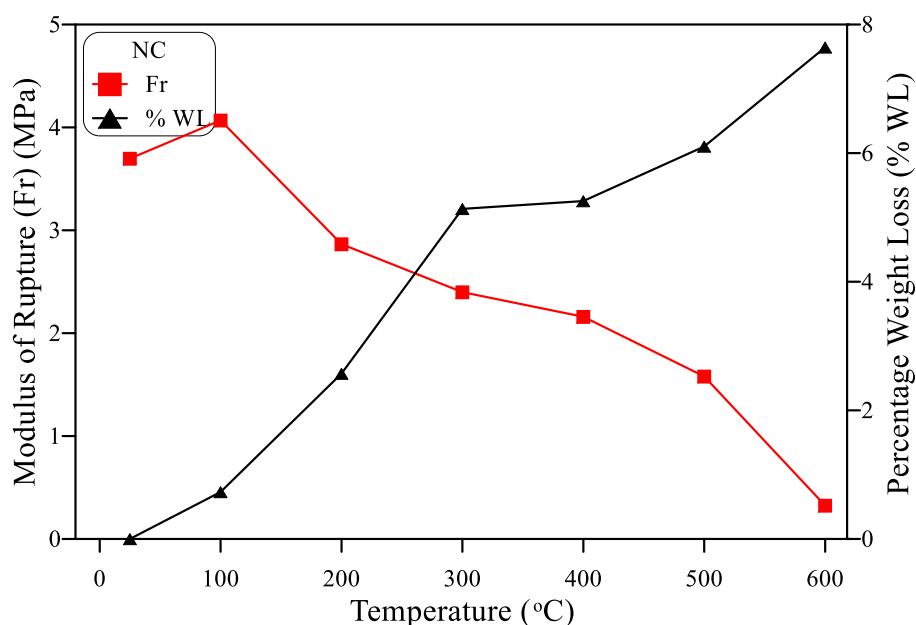
Figure 4.6. Flexural strength-weight loss relation of NC at high temperature.

The weight loss for the same prisms was recorded and from which the percentage weight loss was calculated, which is depicted in Figure 4.6 against the residual modulus of rupture. The Figure 4.6 also shows that a similar three-stage behavior can be recognized for the prism specimens to that recorded for cube specimens, where the slope of the percentage weight loss was higher before 300 °C and beyond 500 °C, while it was lower between them. Similarly, excluding the high residual flexural strength recorded at 100 °C, the strength reduction curve exhibited a similar three-slope behavior to that of weight loss, where the percentage reduction slope was high from 100 to 300 °C and from 500 to 600 °C, while it was semi-stabilized between 300 and 400 °C for both the flexural strength and weight loss as shown in Figure 4.6. The similar trend confirms the strong relation between weight loss and strength reduction after high temperature exposure.

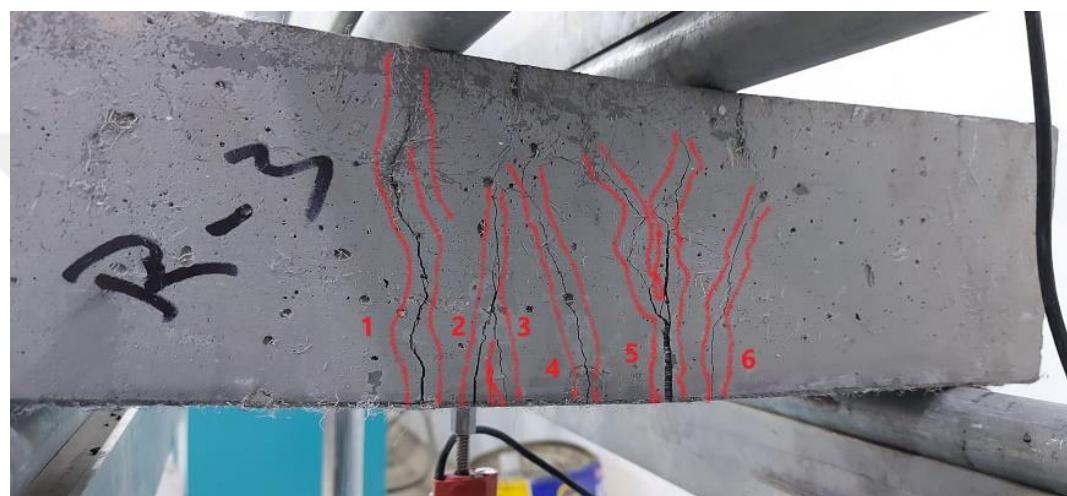
Figure 4.7. multi-cracking failure of tested prisms.

The flexural strength was tested using the four-point bending setup to determine the modulus of rupture (MOR). The unheated ECC specimens exhibited the multi-cracking ductile behavior as shown in Figure 4.7 and Figure 4.8a, where all specimens showed more than five cracks that extended from the bottom surface of the beam specimen vertically towards the top loading points as the load was increased. Finally, one of these cracks was opened wider leading to the failure of the specimen. This cracking behavior assures the ductile performance of the adopted PP-based ECC.

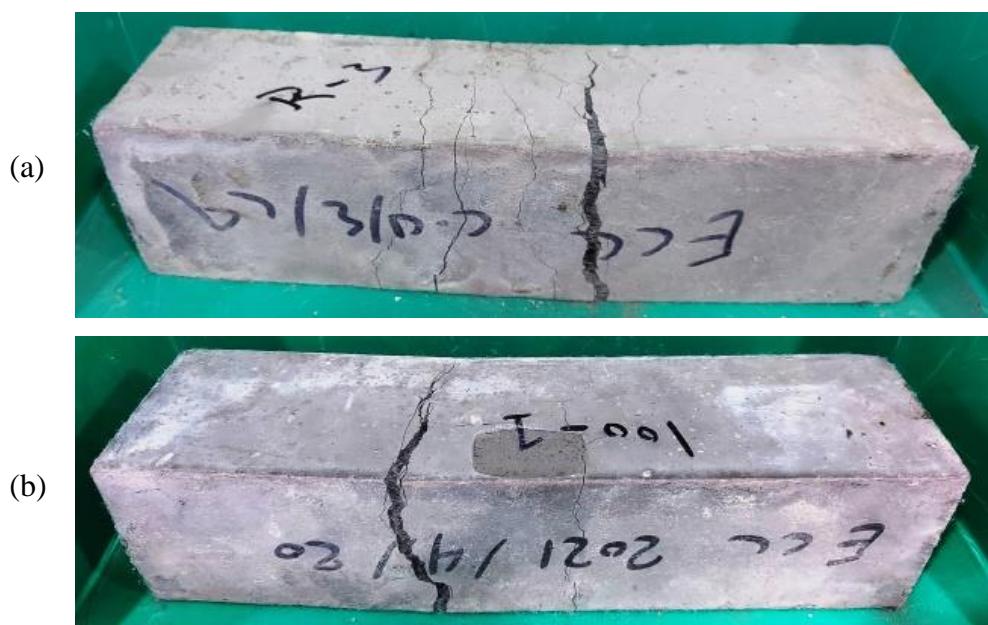
Figure 4.8. Failure of tested prisms (a) unheated specimens (b) heated to 100 °C.

A similar cracking and failure performance was also recorded for the specimens exposed to 100 °C as depicted in Figure 4.8b. However, the number of cracks was lesser than those in the unheated specimens. After exposure to 200 °C, the specimens exhibited a brittle failure with only one crack that widened quickly under loading increase as shown in Figure 4.9a, while the specimens exposed to 300 °C exhibited a clear sudden brittle failure similar to that of NC as shown in Figures 4.9b, which is the same trend of behavior for the higher temperatures of 400, 500, and 600 °C as shown in Figures 4.9c through 4.9e.

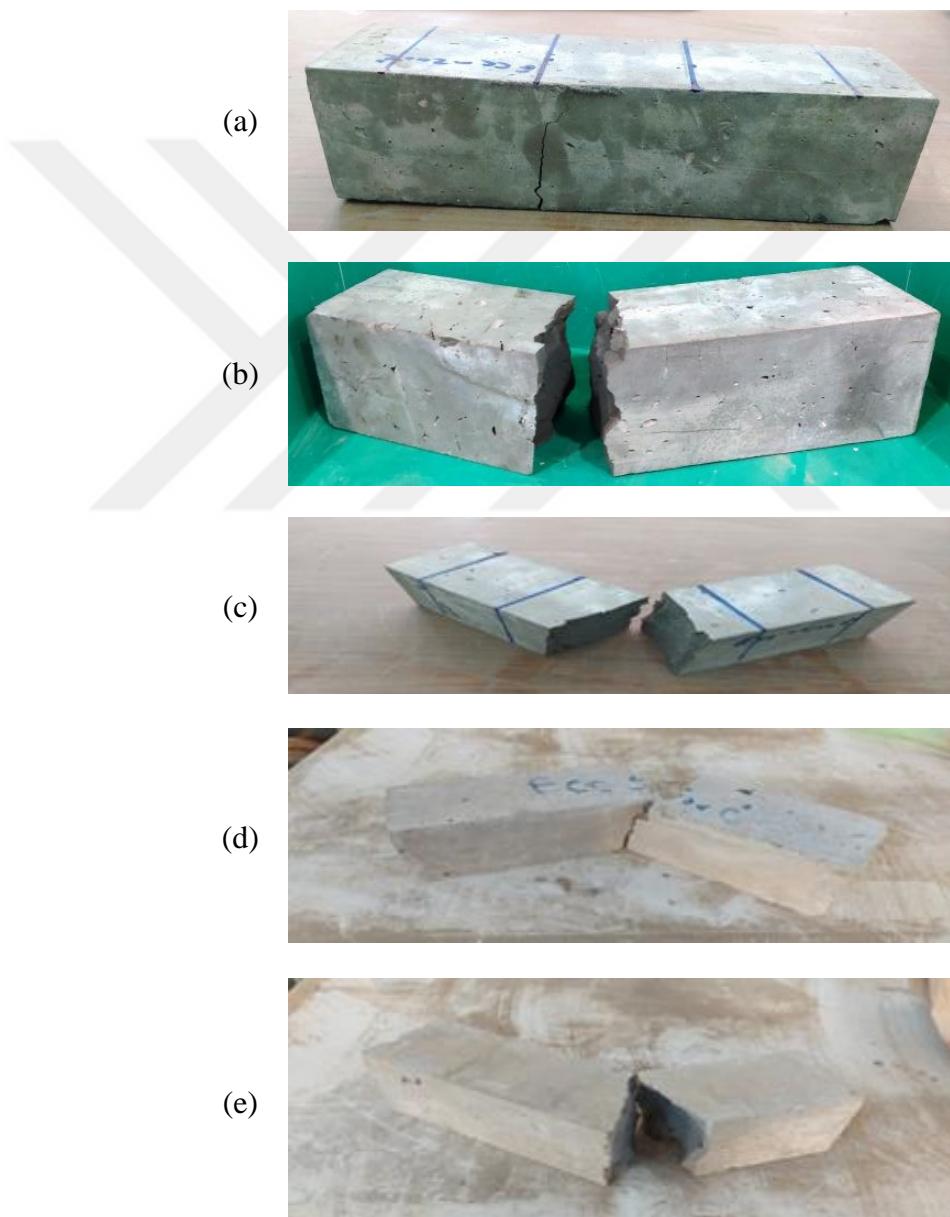
Figure 4.9. Failure of tested prisms exposed to different temperatures (a) 200 °C, (b) 300 °C, (c) 400 °C, (d) 500 °C and (e) 600 °C.

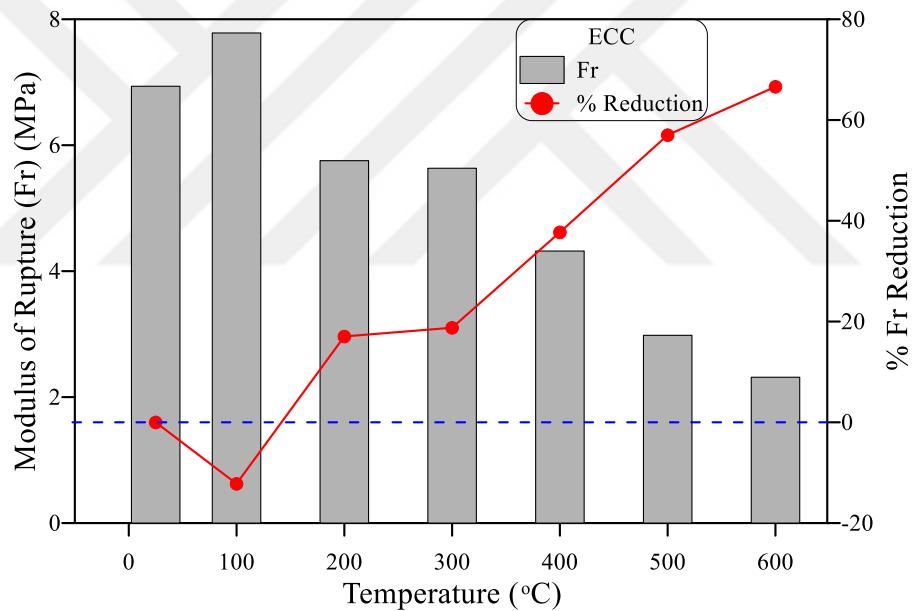
Figure 4.10. Flexural strength-temperature behavior of ECC.

Figure 4.10 shows the flexural strength behavior of with temperature increase. Similarly, the Figure 4.10 also shows the percentage difference in flexural strength compared to the reference unheated record. It can be seen in the Figure 4.10 that the flexural strength of the tested PP-ECC was not significantly affected by heating to temperatures up to 300 °C, while it exhibited a continuous decrease when exposed to higher temperatures up to 600 °C.

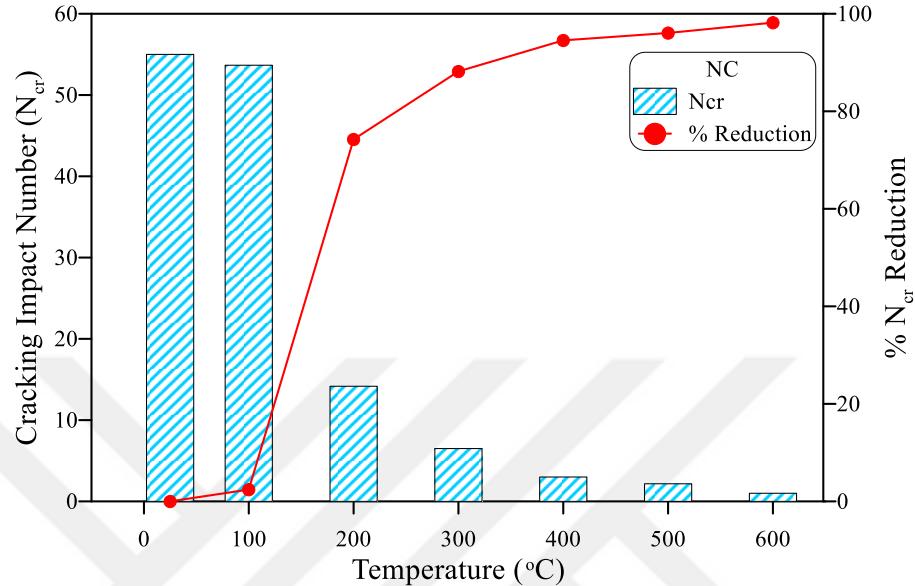
Figure 4.12. Cracking impact number-temperature behavior of NC.

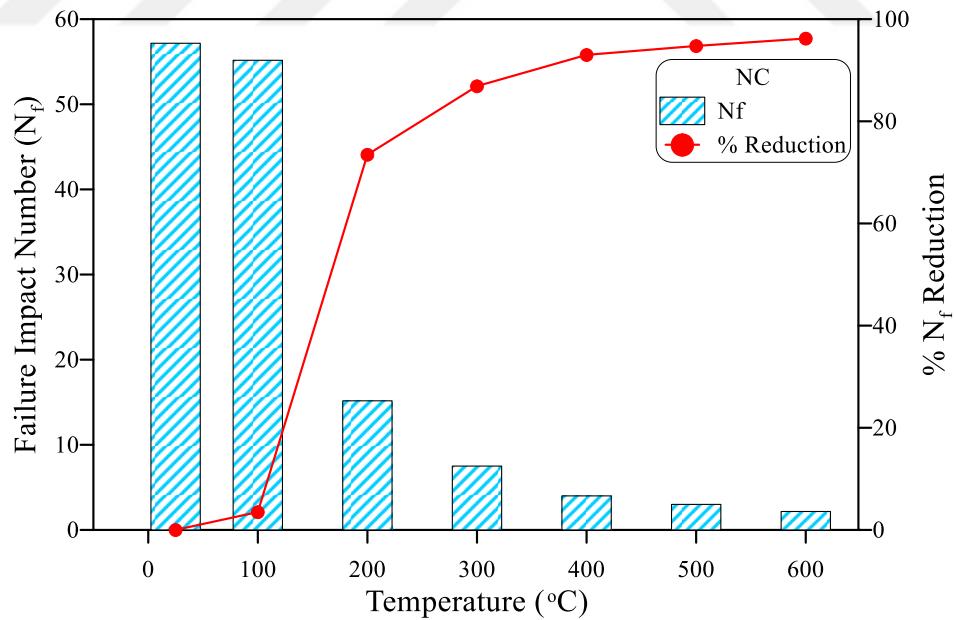
Figure 4.13. Failure impact number-temperature behavior of NC.

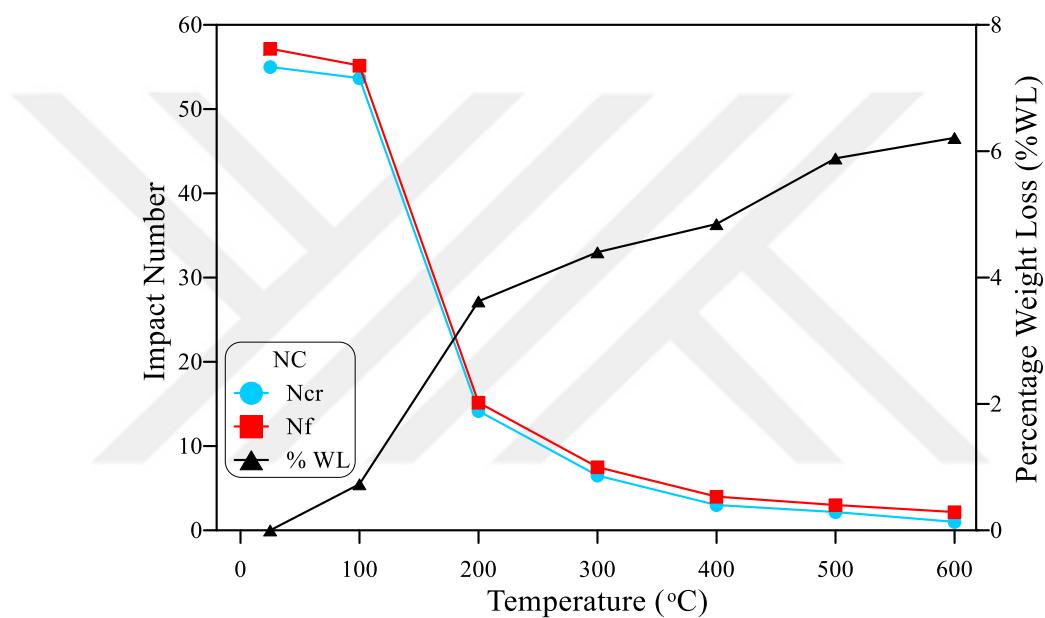
Figure 4.14. Impact number-weight loss relation of NC at high temperature.

Figure 4.14 compares the behaviors of residual impact strength in terms of impact numbers of the disc specimens and the percentage weight loss of the same specimens. It can be said that the trend of impact strength reduction is related to that of the percentage weight loss, where the same minor reduction is clear in the Figure 4.14 after exposure to 100 °C for both the strength and the weight loss, followed by a steep drop from 100 to 200 °C. Then after, a continuous decrease in strength and increase in weight loss are obvious from 300 to 600 °C, the percentage strength is much higher than the percentage weight loss at each temperature, however, the behavior of reduction with temperature increase is quite similar.

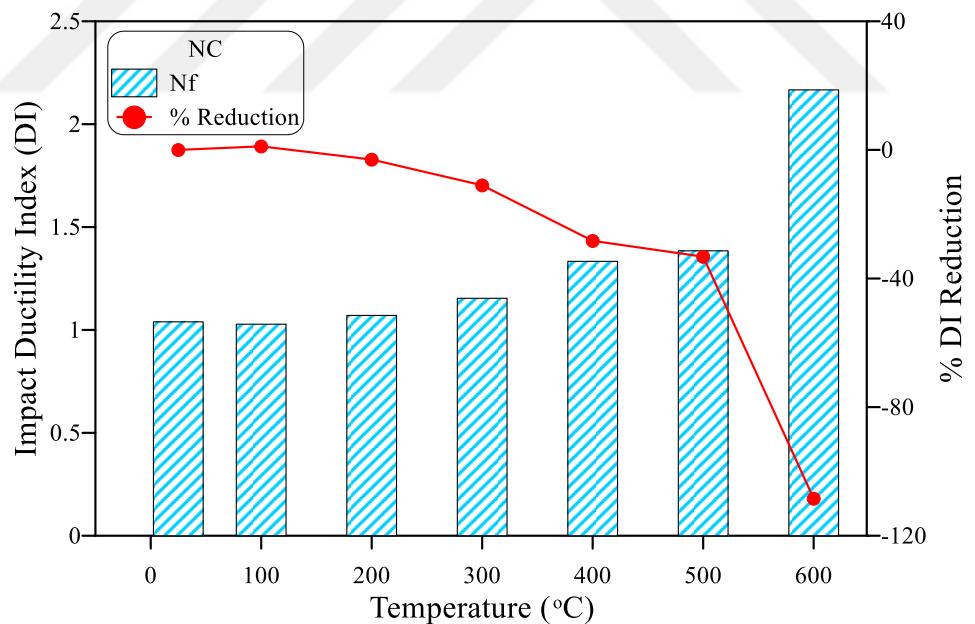
Figure 4.15. Impact ductility index-temperature behavior of NC.

As shown in Figure 4.15, limited ductility index numbers were recorded in general, where DI was approximately 1.0 before heating and after heating to 100 to 300 °C, which was in the range of 1.03 to 1.15, while it was slightly higher than 1.0 after exposure to 400 and 500 °C (1.33 and 1.38, respectively). It should be noted that the lowest possible DI value is 1.0. These low DI values reflect a brittle behavior, where the failure occurred after one or few additional impact blows after cracking, therefore, the value of N_f was very close to that of N_{cr} . The low ductility is expected for NC mixtures that are not reinforced with reinforcing bars or fibers, which is attributed to the very low tensile capacity of concrete. Understanding the evolution of stresses under impact blows would explain this trend. Where the concentrated compressive stresses received at the top surface center from the impactor are transferred through the microstructure along all diagonal directions as tensile stress waves. As soon as the ultimate tensile strength is reached and the crack is formed, the failure becomes imminent by the quick propagation and fracture of the specimens after a very limited number of additional impact blows.

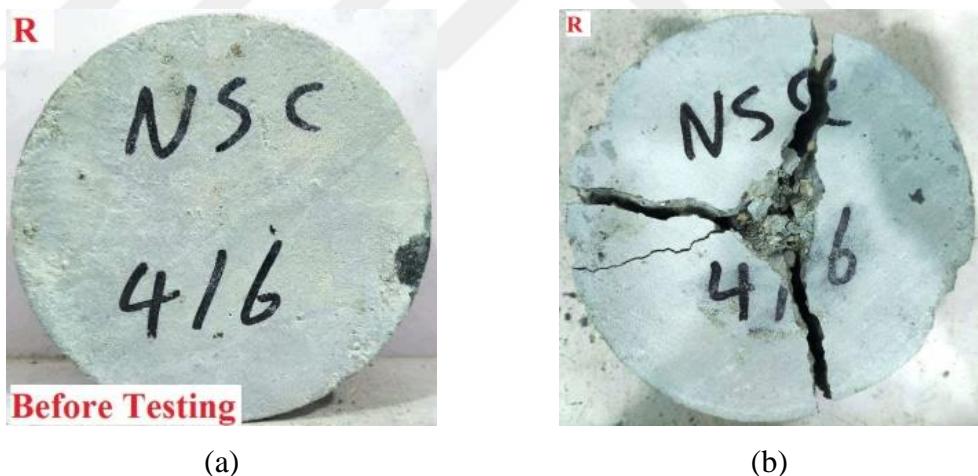
Figure 4.16. Reference unheated NC disk specimens (a) before testing (b) after testing.

Pictures for the disc specimens at room ambient temperature (R) and after exposure to 100, 200, 300, 400, 500, and 600 °C are shown in Figures 4.16 through 4.22 both before and after impact testing. The fracture and failure of the reference unheated specimens align with what was reported in previous studies for plain concrete, where after several repeated blows, a small diameter central fracture zone was created under the concentrated compression impacts via the top surface's steel ball. After a few more blows, the internal cracks propagated to the surface forming a surface cracking of two or three radial cracks from the central fracture zone, which formed the failure shape that occurred after a few additional blows as shown in Figure 4.16.

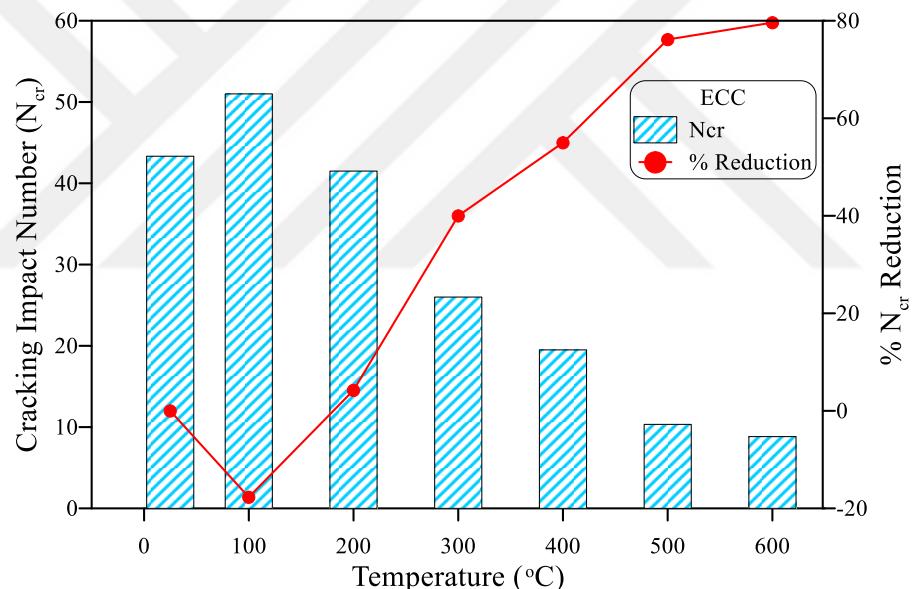
Figure 4.23. Cracking impact number-temperature behavior of ECC.

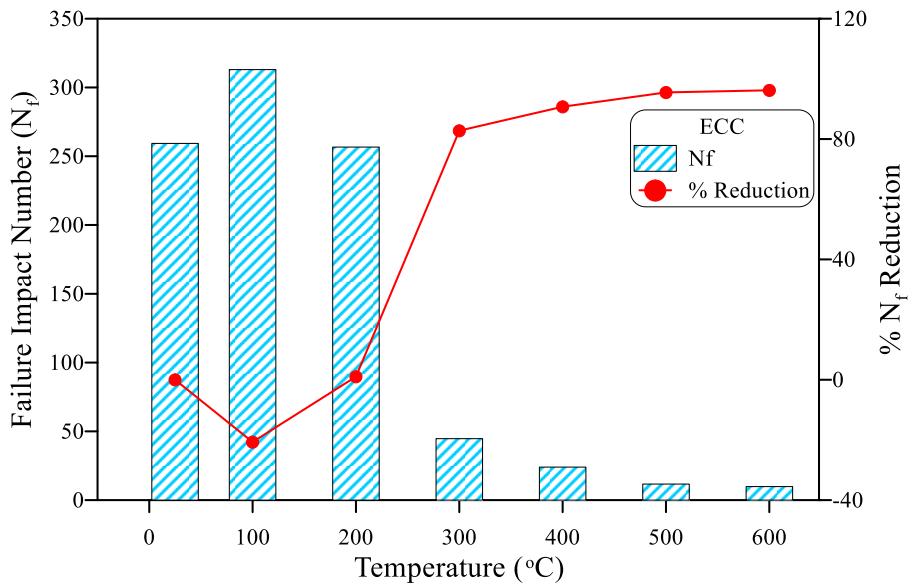
Figure 4.24. Failure impact number-temperature behavior of ECC.

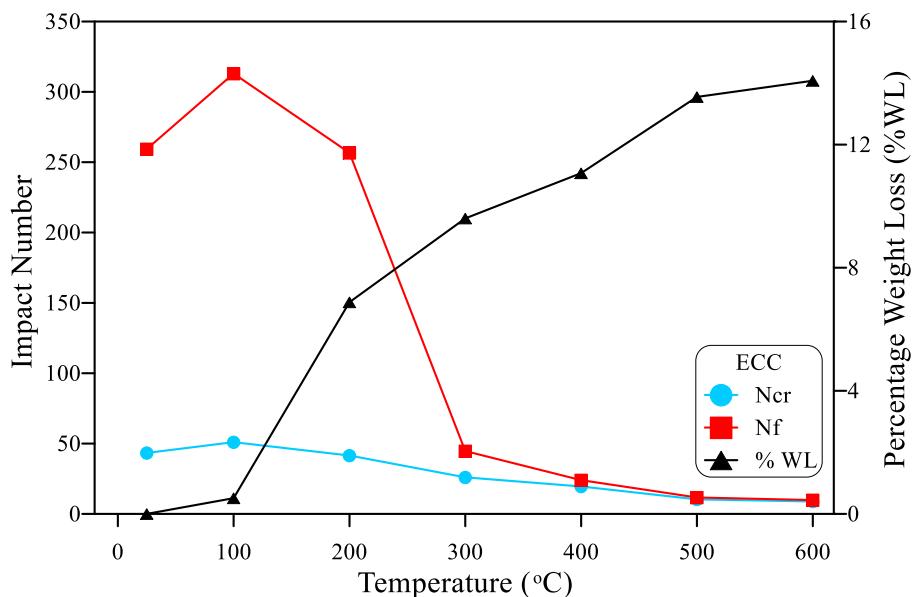
Figure 4.25. Impact number-weight loss relation of ECC at high temperature.

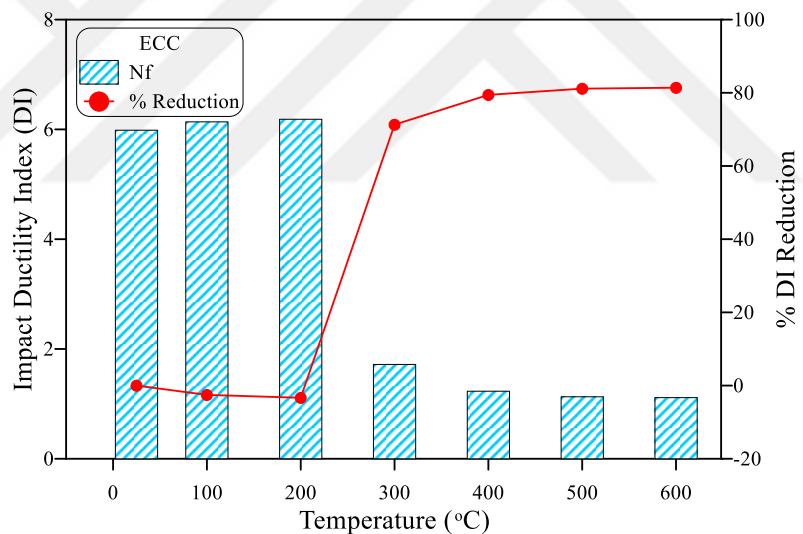
Figure 4.26. Impact ductility index-temperature behavior of ECC.
