REPUBLIC OF TÜRKİYE
GAZİANTEP UNIVERSITY

IMPACT PERFORMANCE OF ENGINEERED CEMENTITIOUS
COMPOSITES AT AMBIENT AND HIGH TEMPERATURES

Ph.D. THESIS
IN
CIVIL ENGINEERING

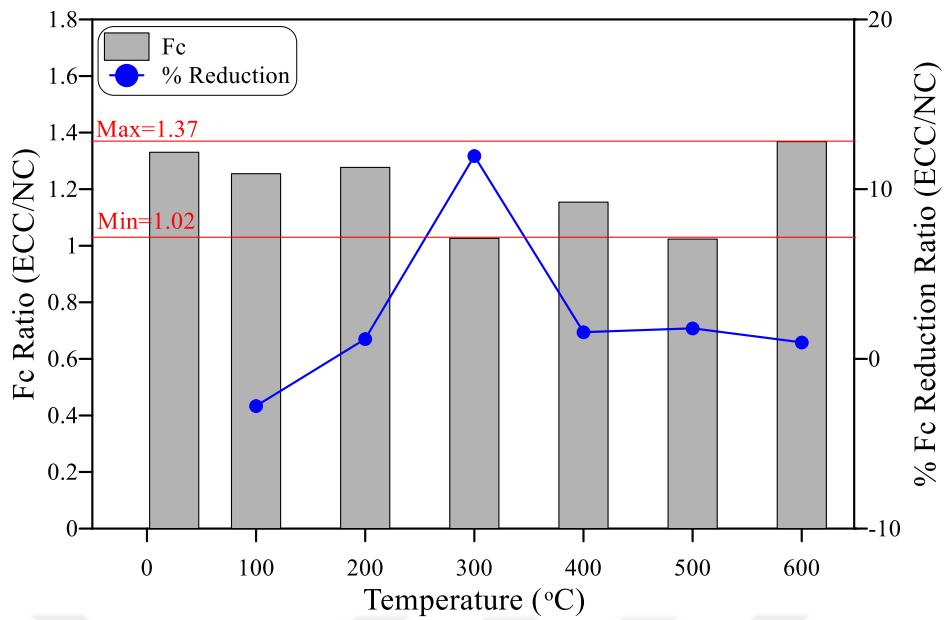
Figure 4.34. Comparison of ECC and NC compressive strengths (f'_c).

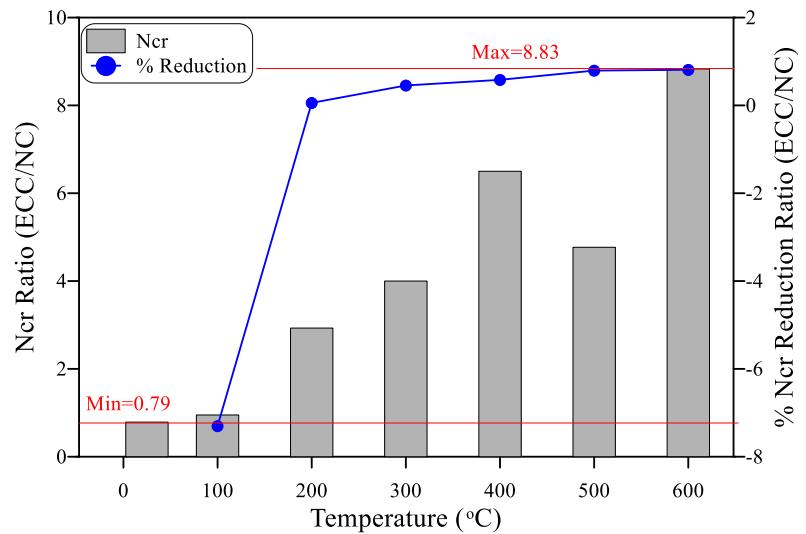
Figure 4.14. Comparison of ECC and NC cracking impact numbers.

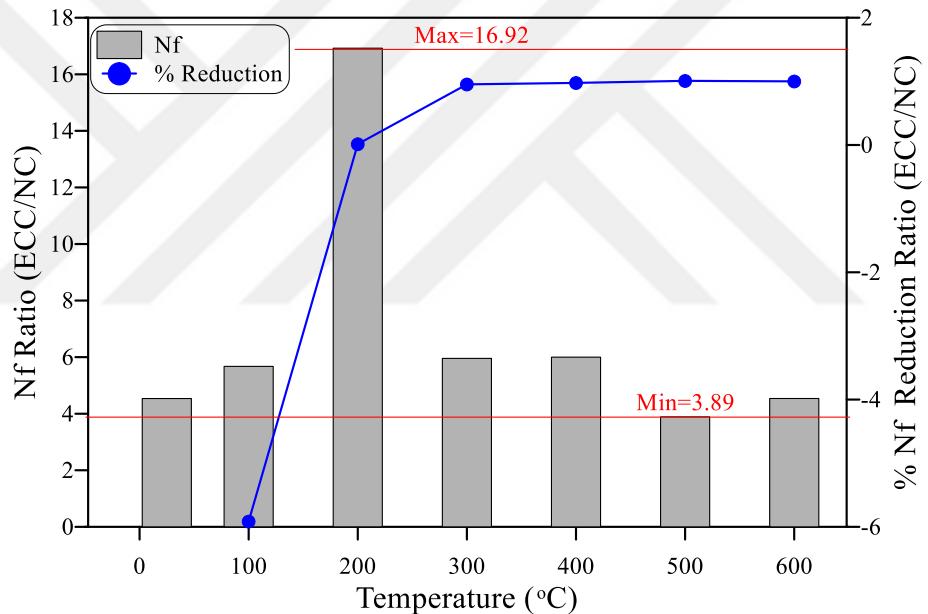
Figure 4.37. Comparison of ECC and NC failure impact numbers.

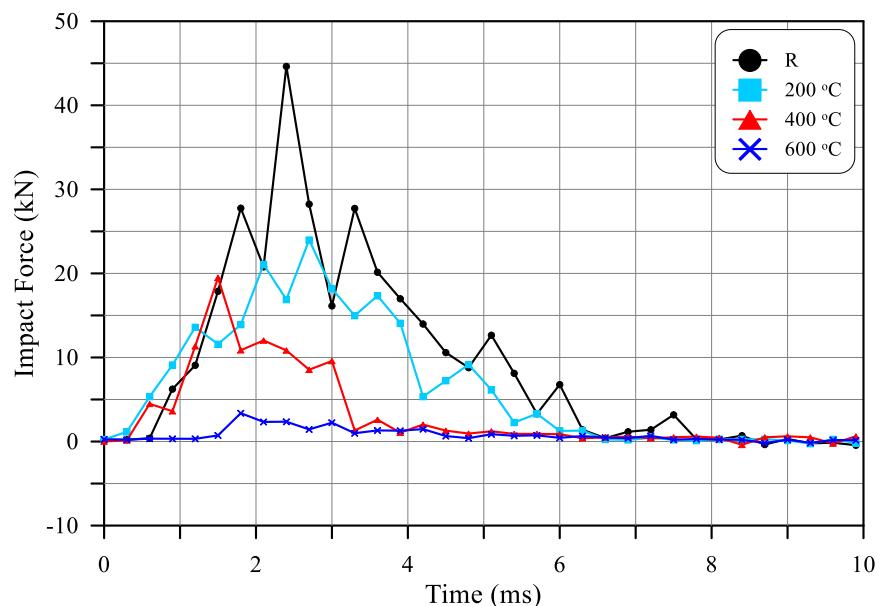
Figure 5.1. Impact force-time variation of NC 4-ends restricted plates of the first impact blow.

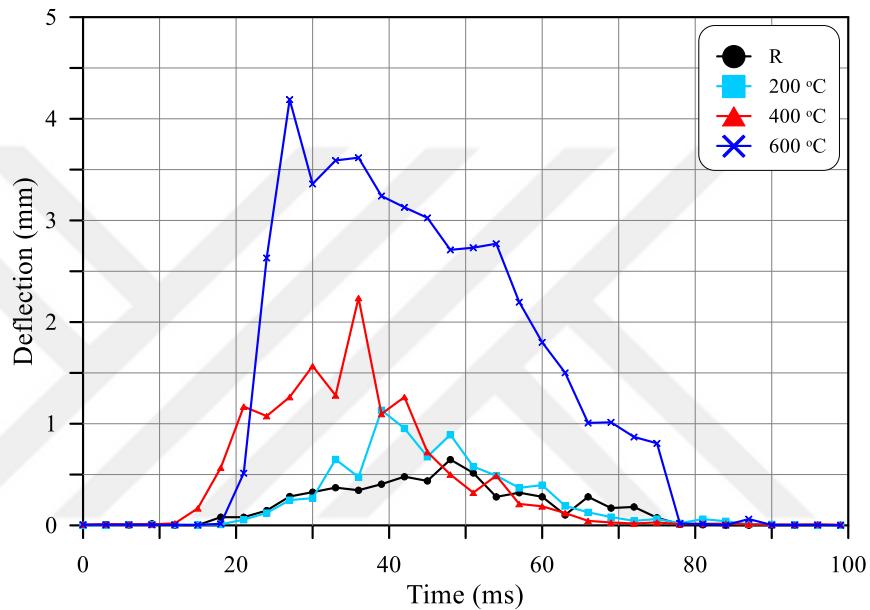
Figure 5.2. Deflection-time variation of NC 4-ends restricted plates of the first impact blow.

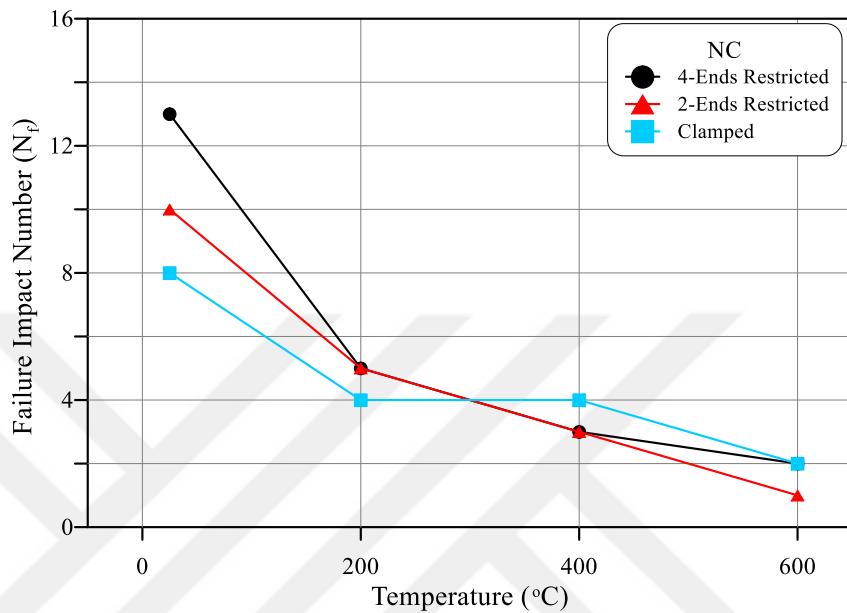
Figure 5.3, Failure impact number-temperature relations of NC plates for different boundary cases.

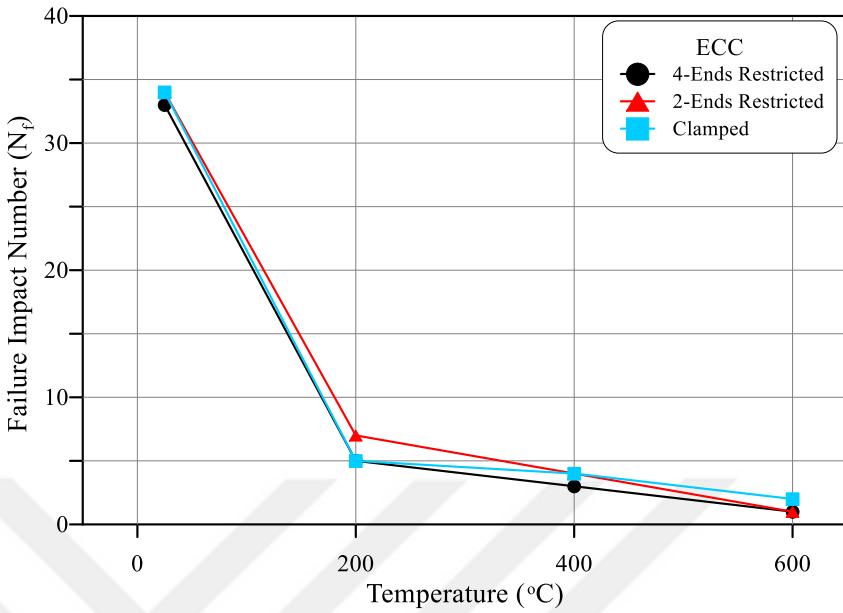
Figure 5.4. Failure impact number-temperature relations of ECC plates for different boundary cases.

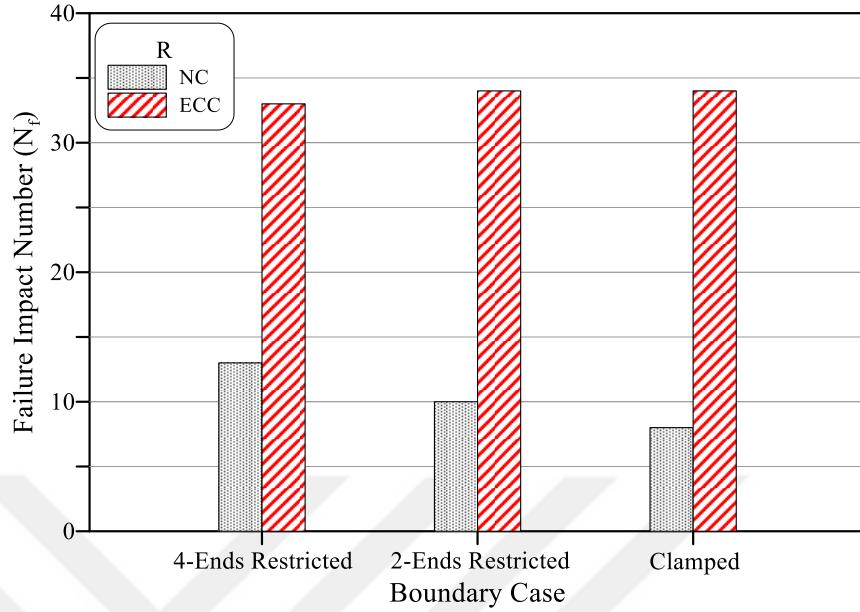
Figure 5.5. NC and ECC failure impact numbers of different boundary cases at room temperature.

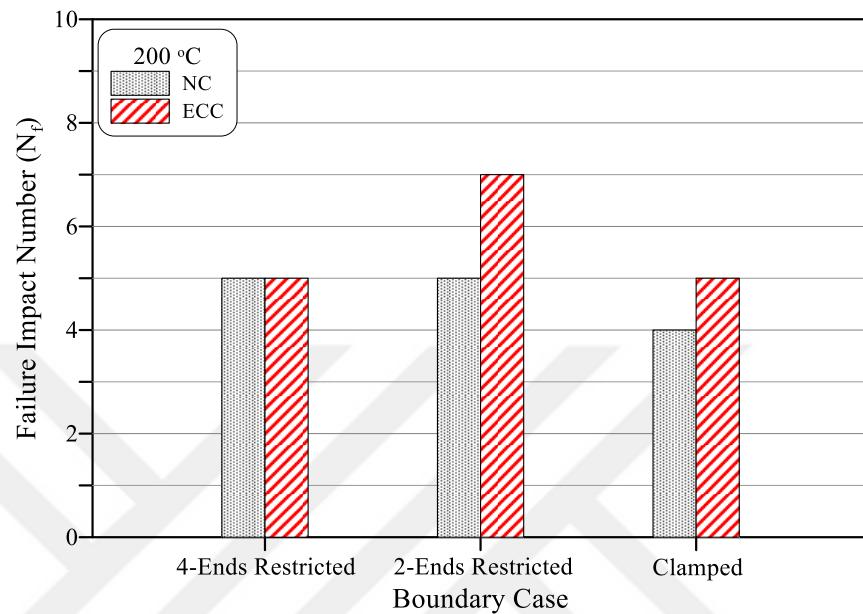
Figure 5.6. NC and ECC failure impact numbers of different boundary cases at 200 °C.

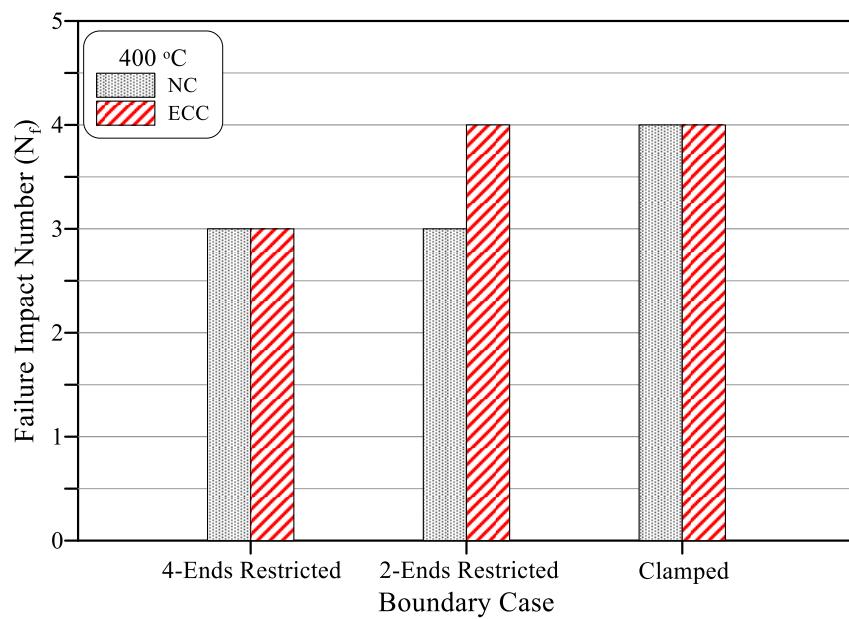
Figure 5.7. NC and ECC failure impact numbers of different boundary cases at 400 °C.

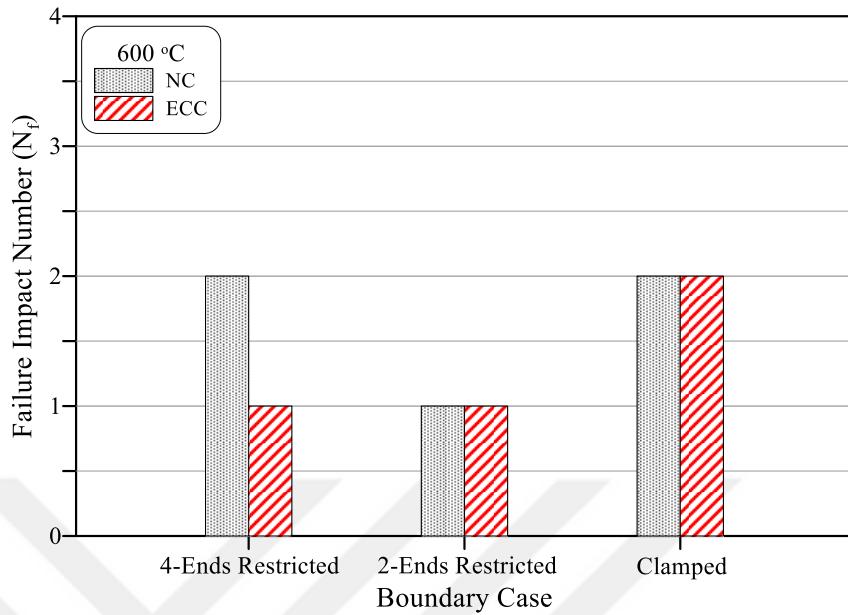
Figure 5.8. NC and ECC failure impact numbers of different boundary cases at 600 °C.

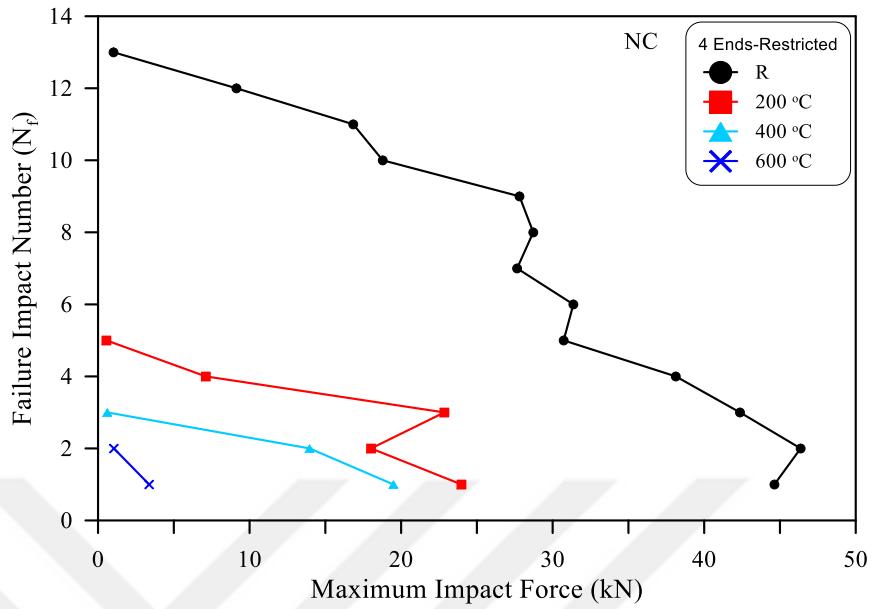
Figure 5.9. NC failure impact number-impact force relations at different temperatures for 4-ends restricted case.

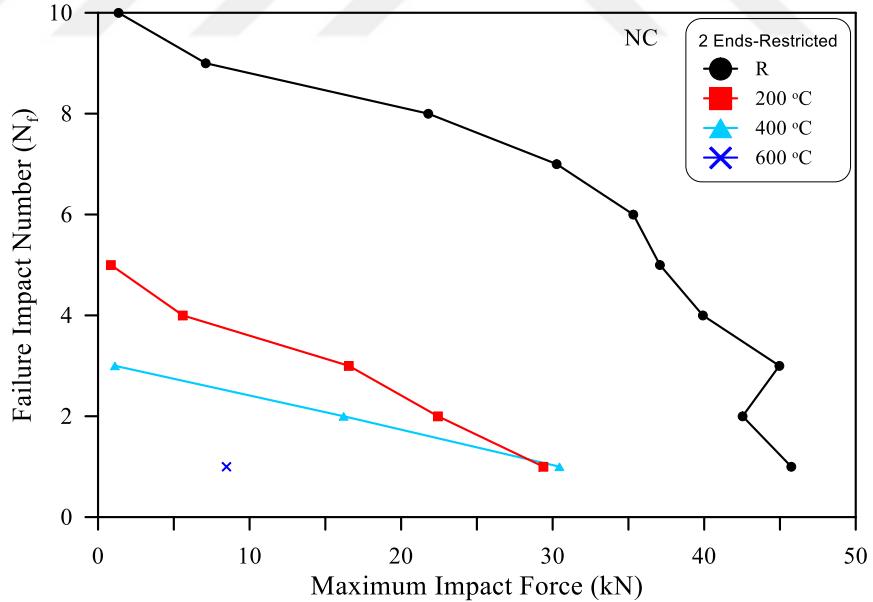
Figure 5.10 NC failure impact number-impact force relations at different temperatures for 2-ends restricted case.

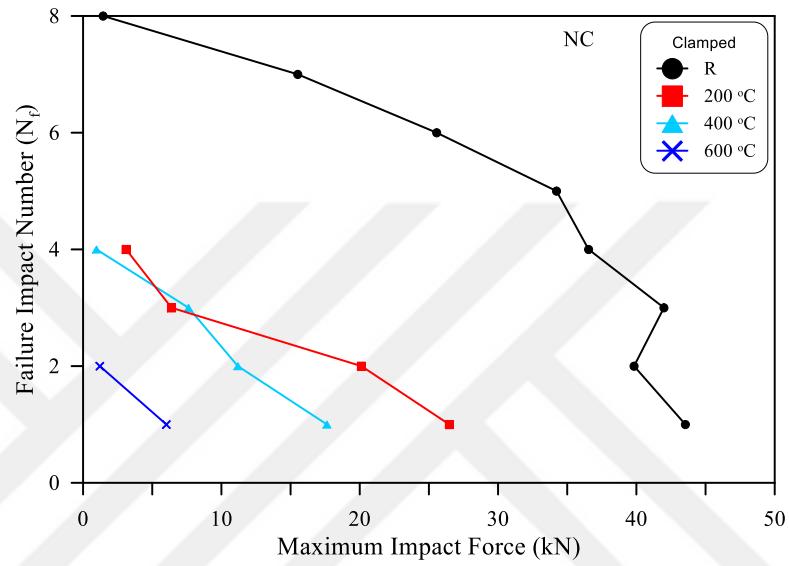
Figure 5.11. NC failure impact number-impact force relations at different temperatures for clamped case.

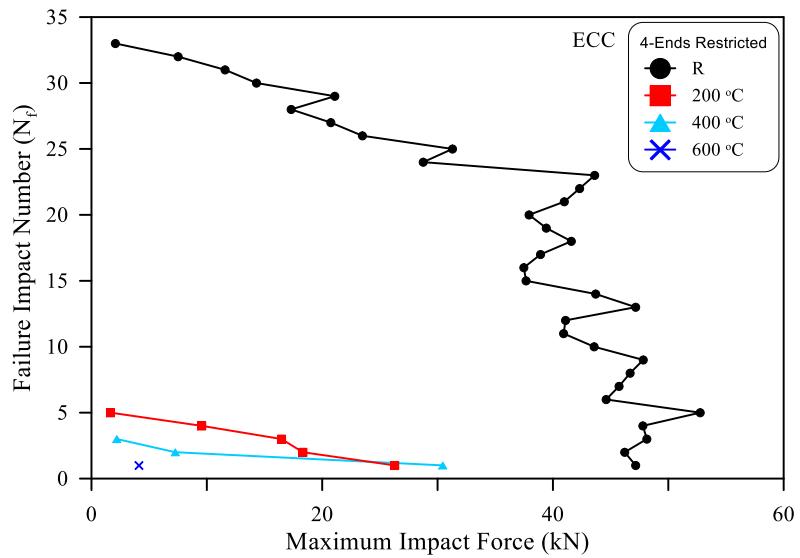
Figure 5.12. ECC failure impact number-impact force relations at different temperatures for 4-ends restricted case.

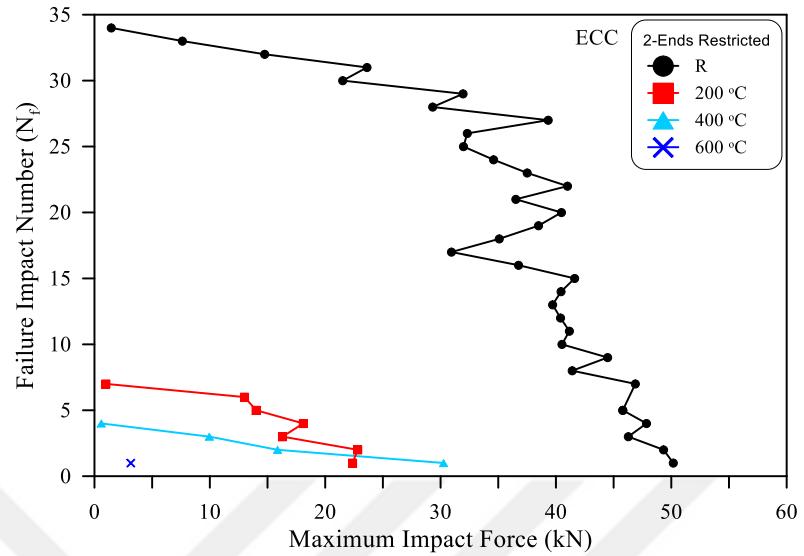
Figure 5.13. ECC failure impact number-impact force relations at different temperatures for 2-ends restricted case.

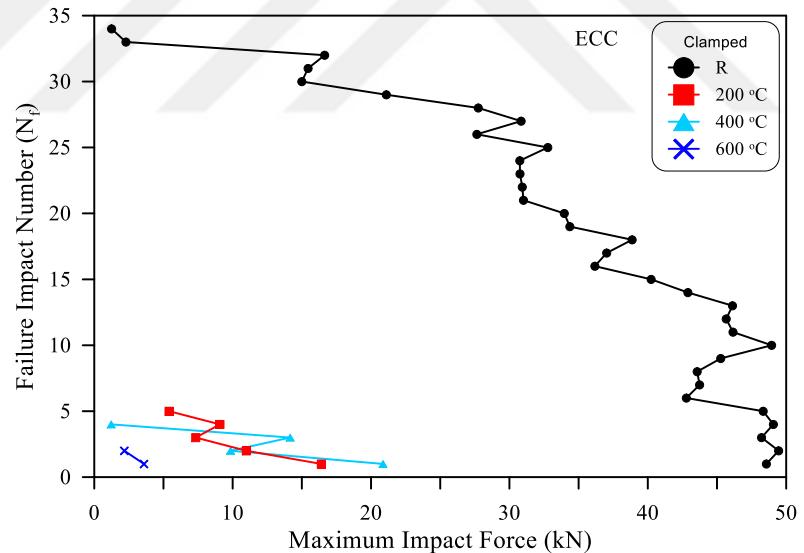
Figure 5.14. ECC failure impact number-impact force relations at different temperatures for clamped case.

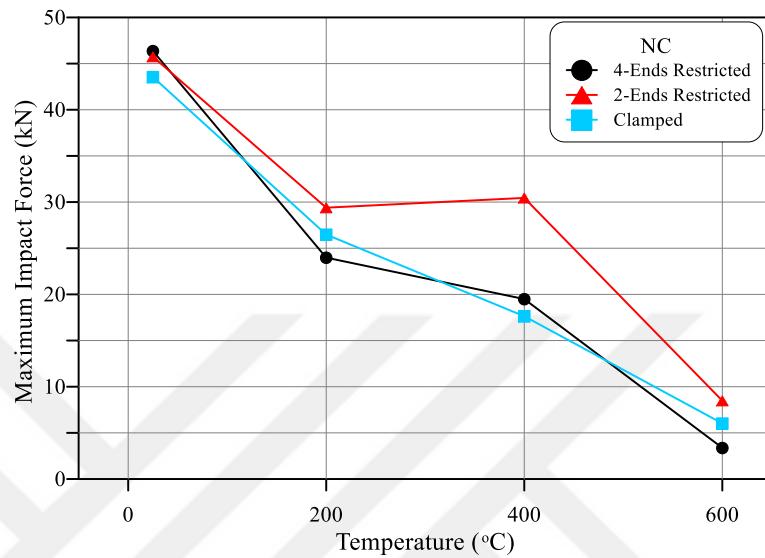
Figure 5.14. Maximum impact force-temperature relations of NC plates for different boundary cases.

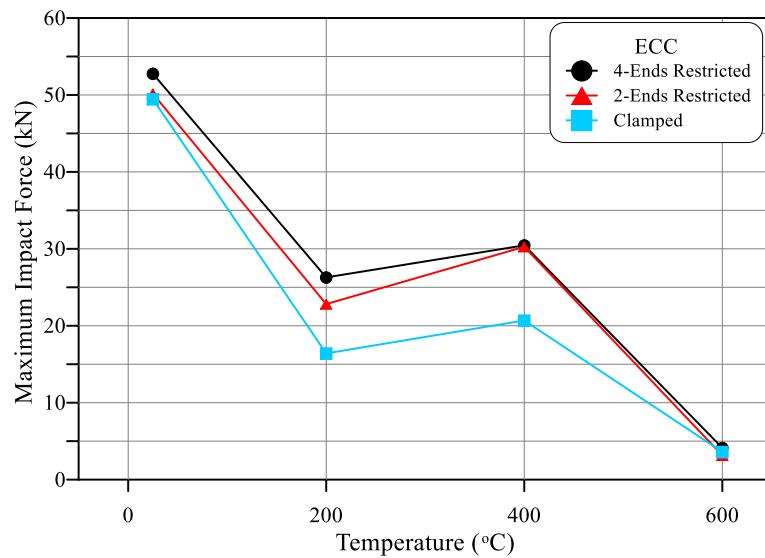
Figure 5.16. Maximum impact load -temperature relations of ECC plates for different boundary cases.

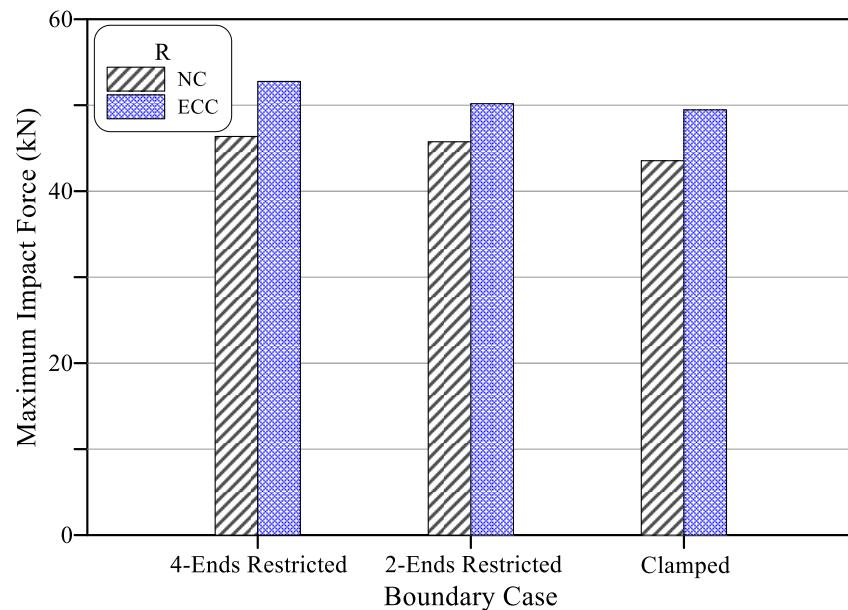
Figure 5.17. NC and ECC maximum impact forces of different boundary cases at room temperature.

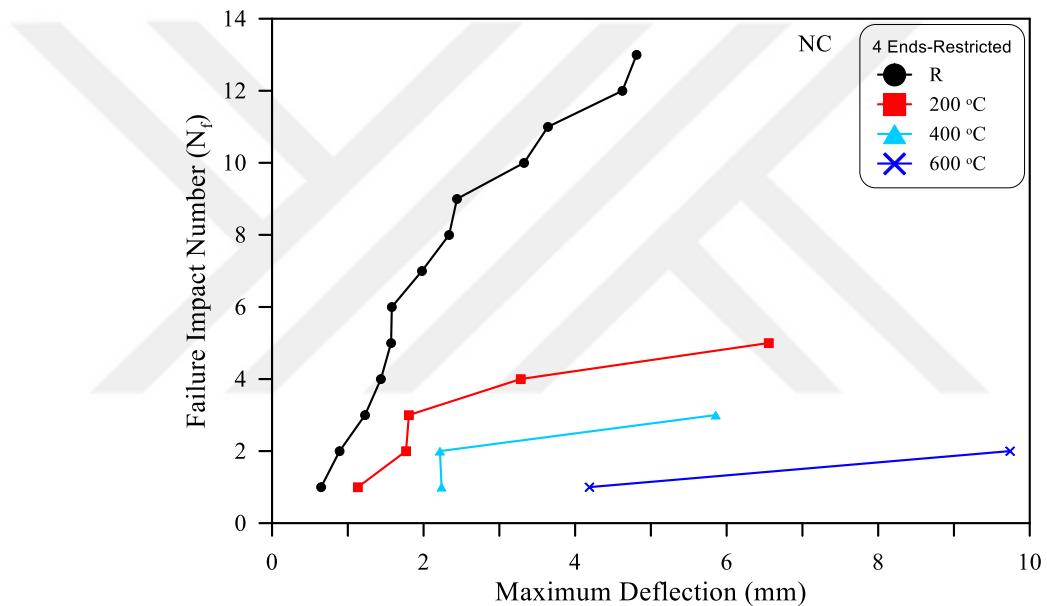
Figure 5.21. NC failure impact number-maximum deflection relations at different temperatures for 4-ends restricted case.

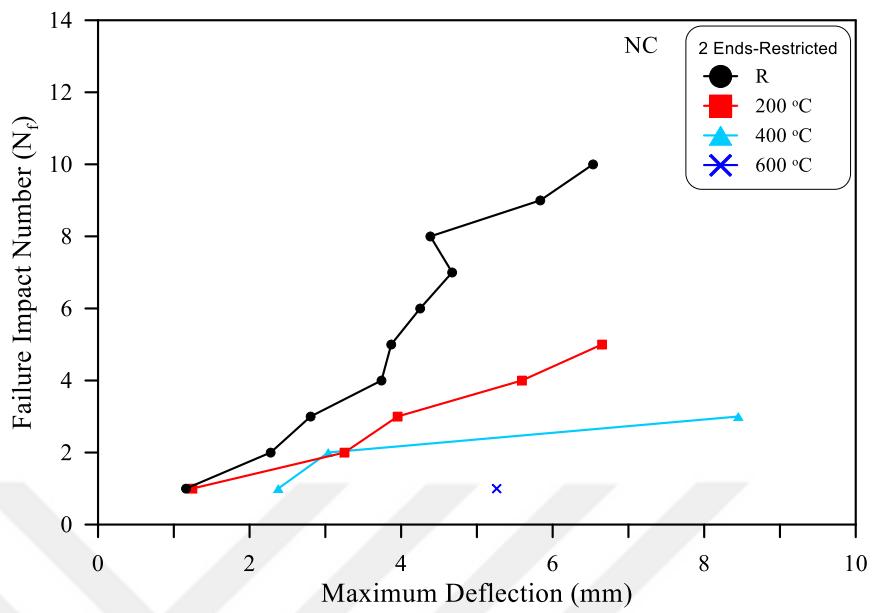
Figure 5.22. NC failure impact number-maximum deflection relations at different temperatures for 2-ends restricted case.

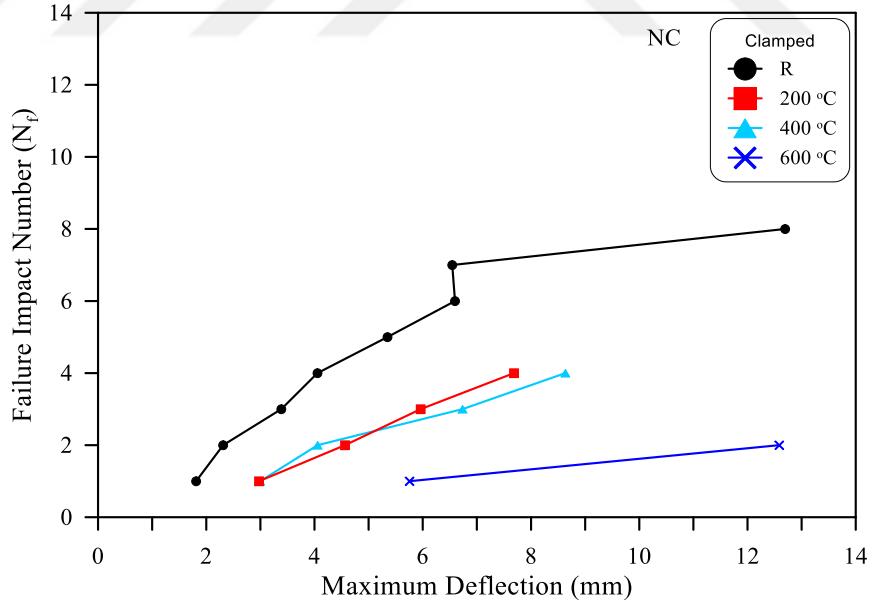
Figure 5.23. NC failure impact number-maximum deflection relations at different temperatures for clamped case.

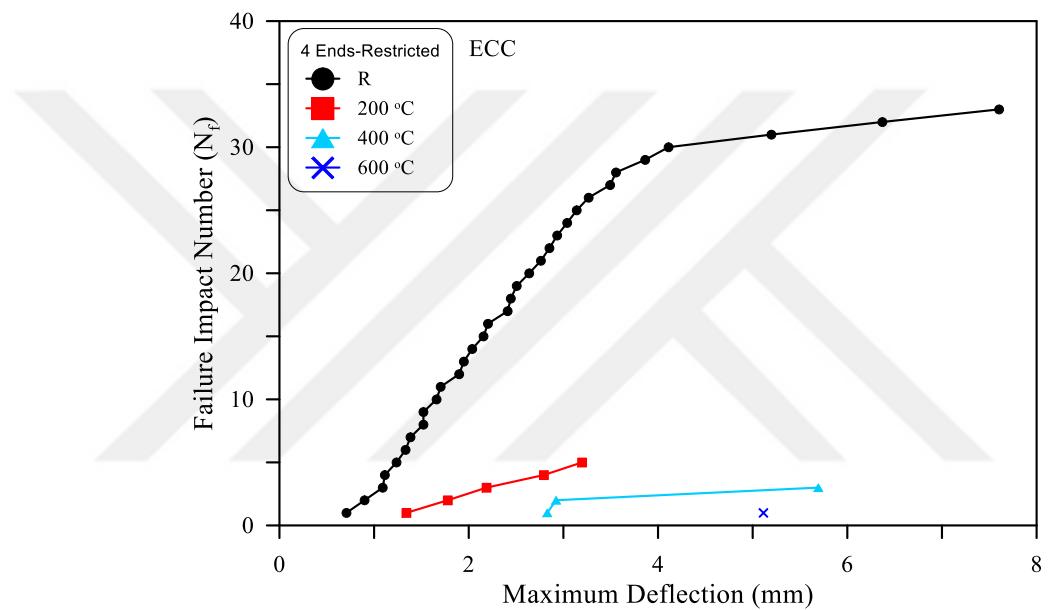
Figure 5.24. ECC failure impact number-maximum deflection relations at different temperatures for 4-ends restricted case.

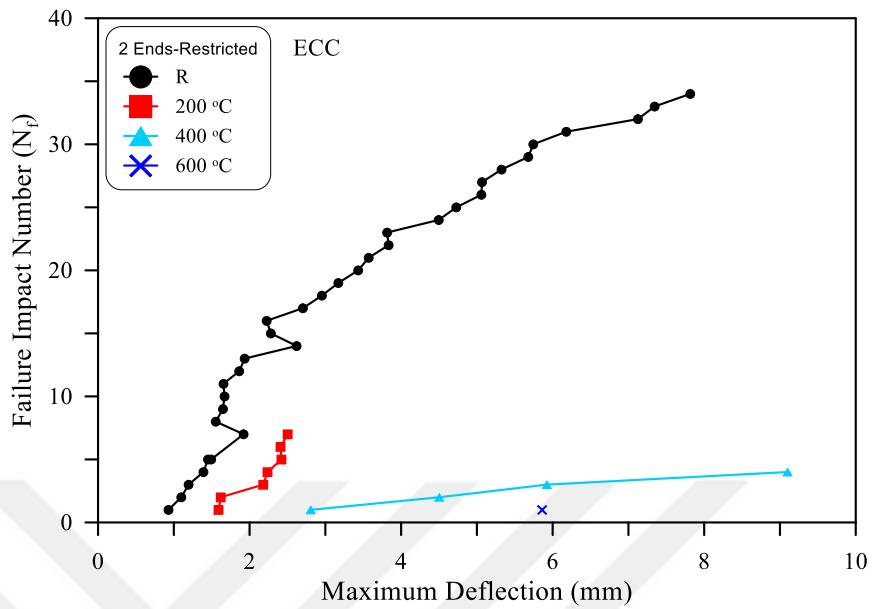
Figure 5.25. ECC failure impact number-maximum deflection relations at different temperatures for 2-ends restricted case.

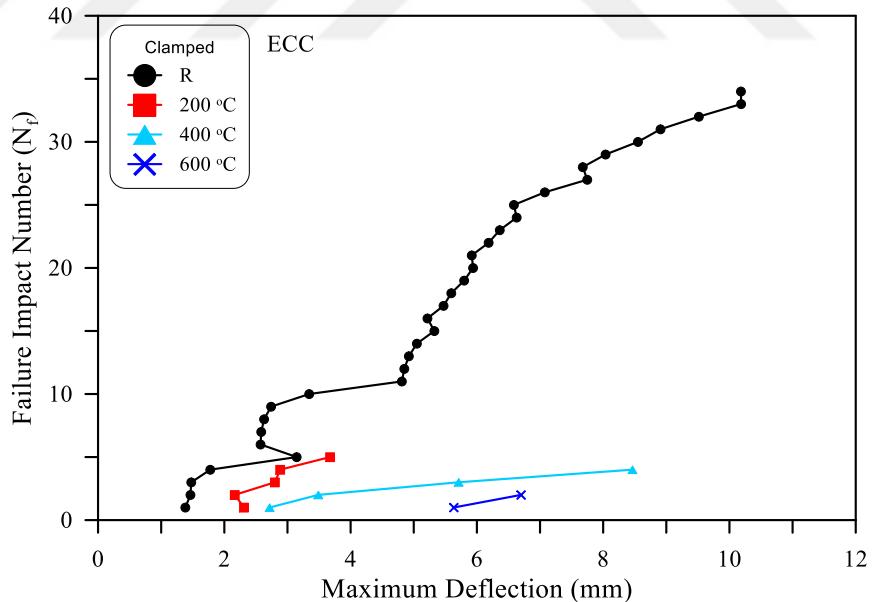
Figure 5.26. ECC failure impact number-maximum deflection relations at different temperatures for clamped case.

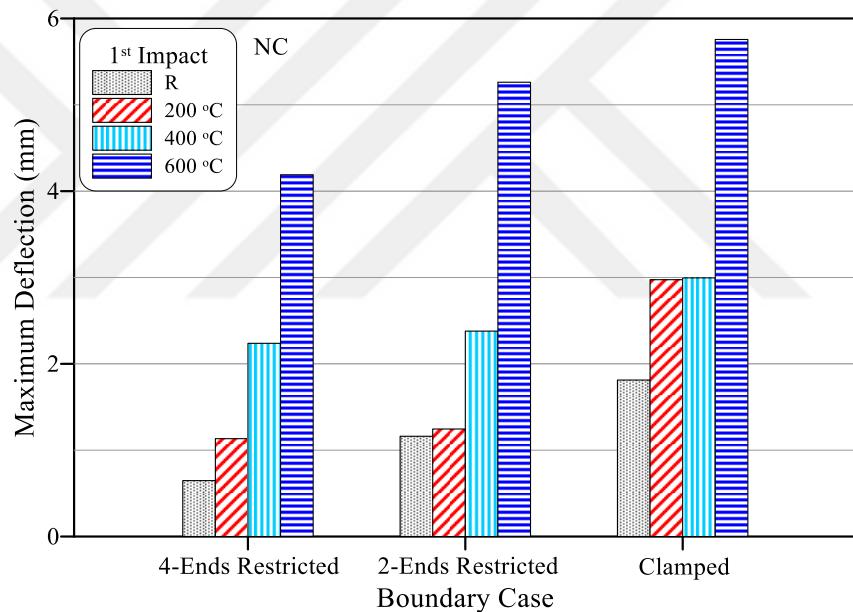
Figure 5.27. NC first impact maximum deflections for different boundary cases at different temperatures.

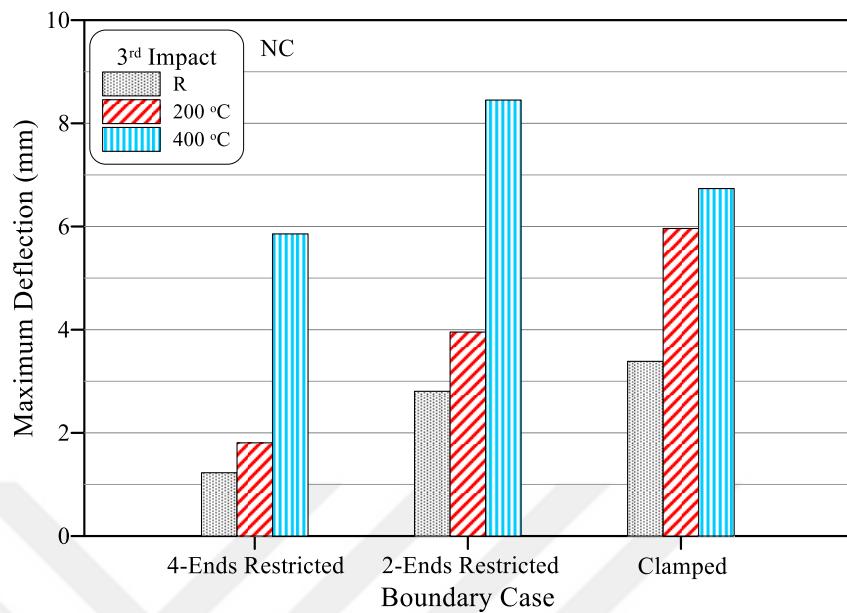
Figure 5.28. NC third impact maximum deflections for different boundary cases at different temperatures.

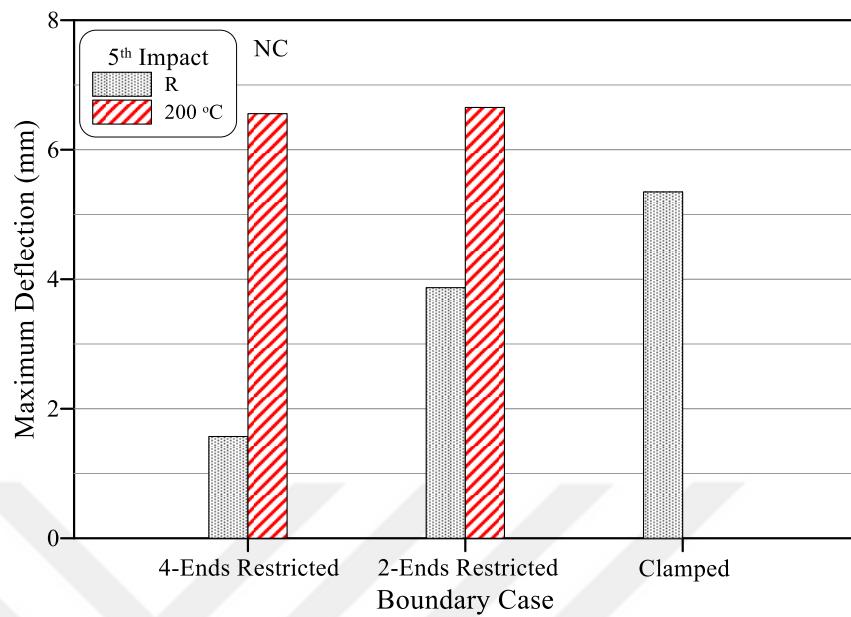
Figure 5.29 NC fifth impact maximum deflections for different boundary cases at different temperatures.

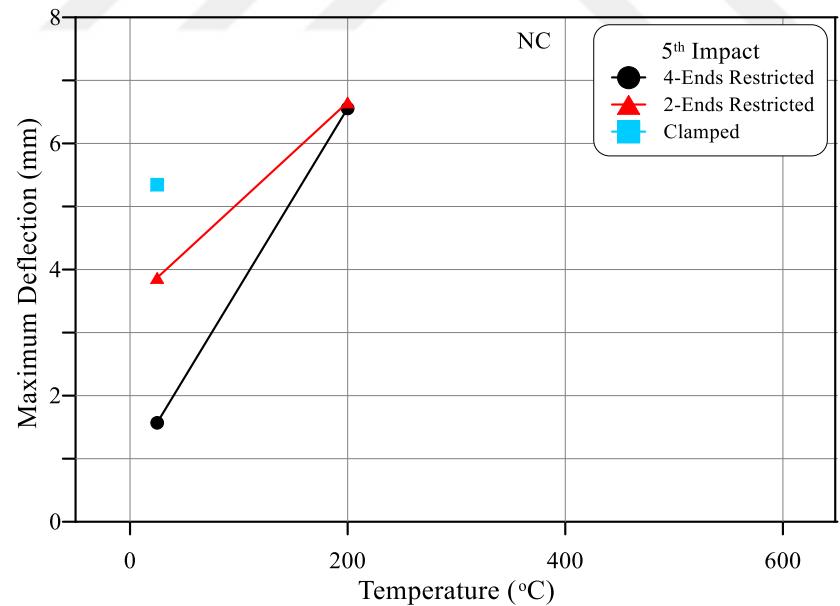
Figure 5.35. NC maximum deflections-temperature relations for different boundary cases at the fifth impact.

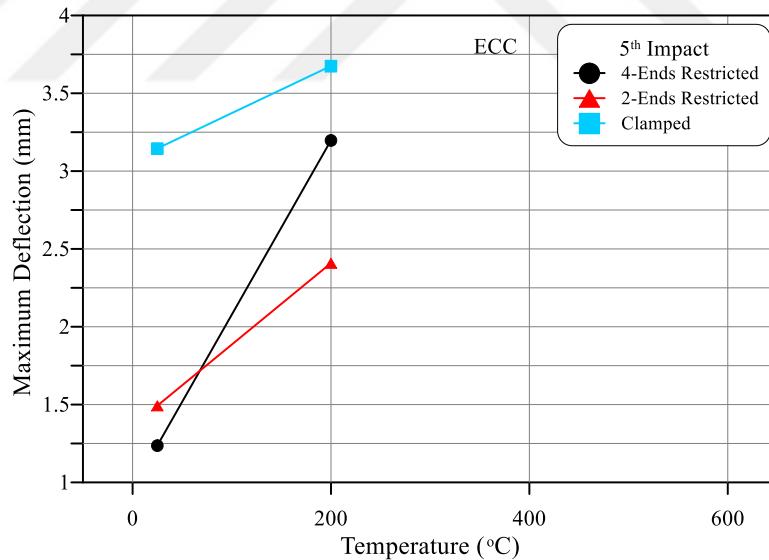
Figure 5.38. ECC maximum deflections-temperature relations for different boundary cases at the fifth impact.

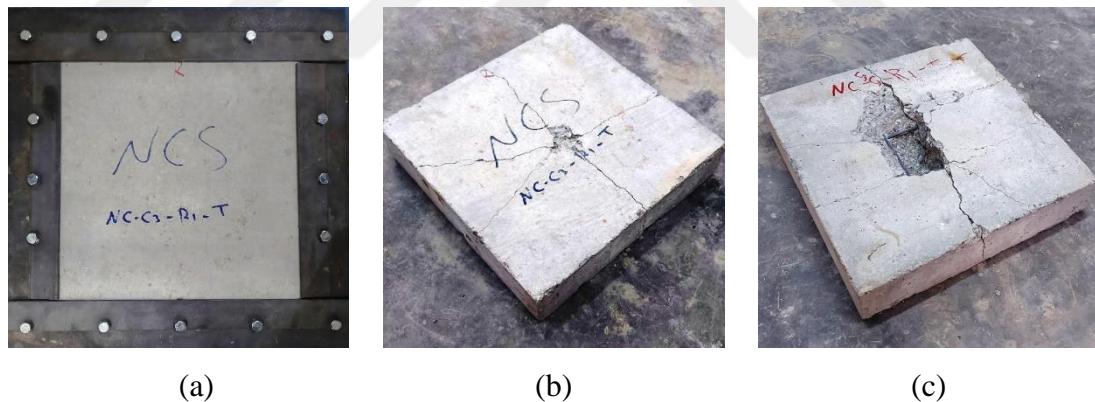
Figure 5.39. Pictures of NC four-ends restricted unheated reference plate (a) before testing (b) top surface after testing (c) bottom surface after testing.

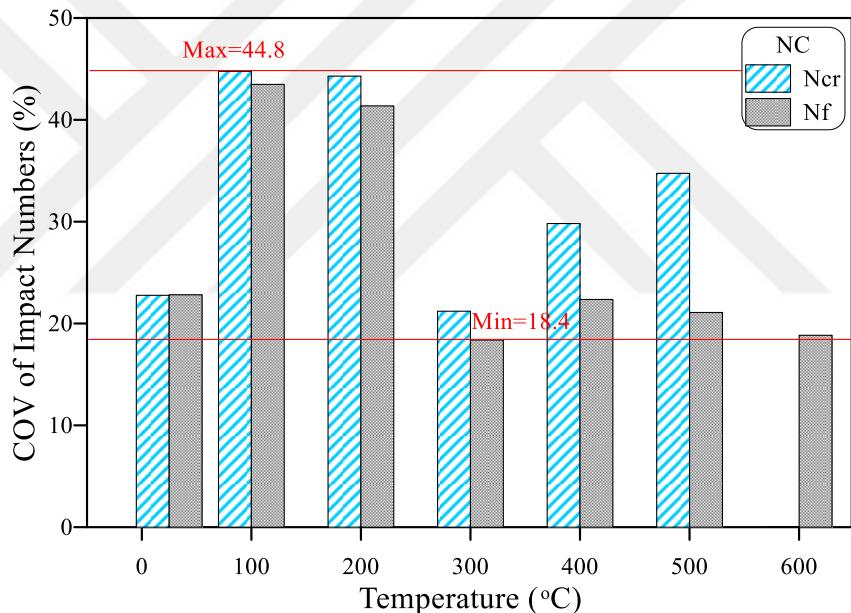
Figure 6.1. COV of cracking and failure impact numbers of NC specimens.

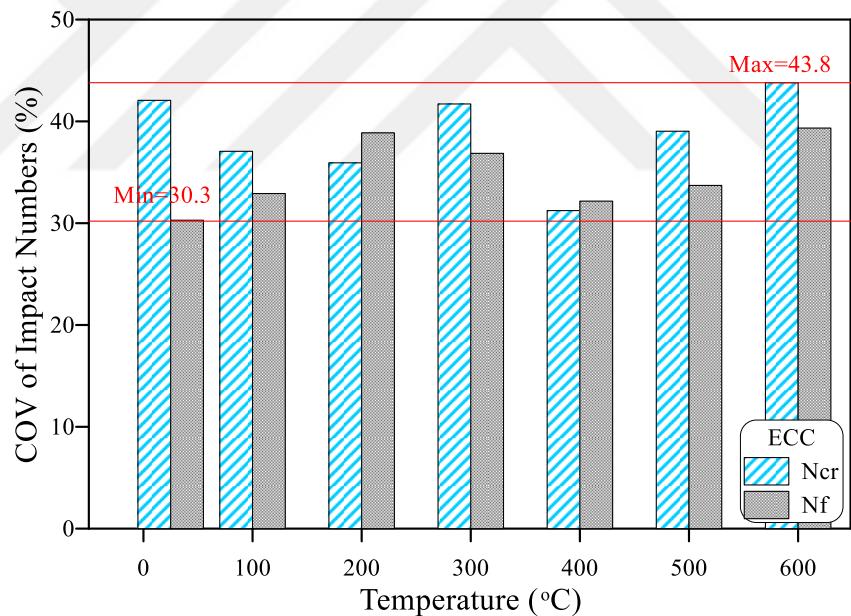
Figure 6.2. COV of cracking and failure impact numbers of ECC specimens.

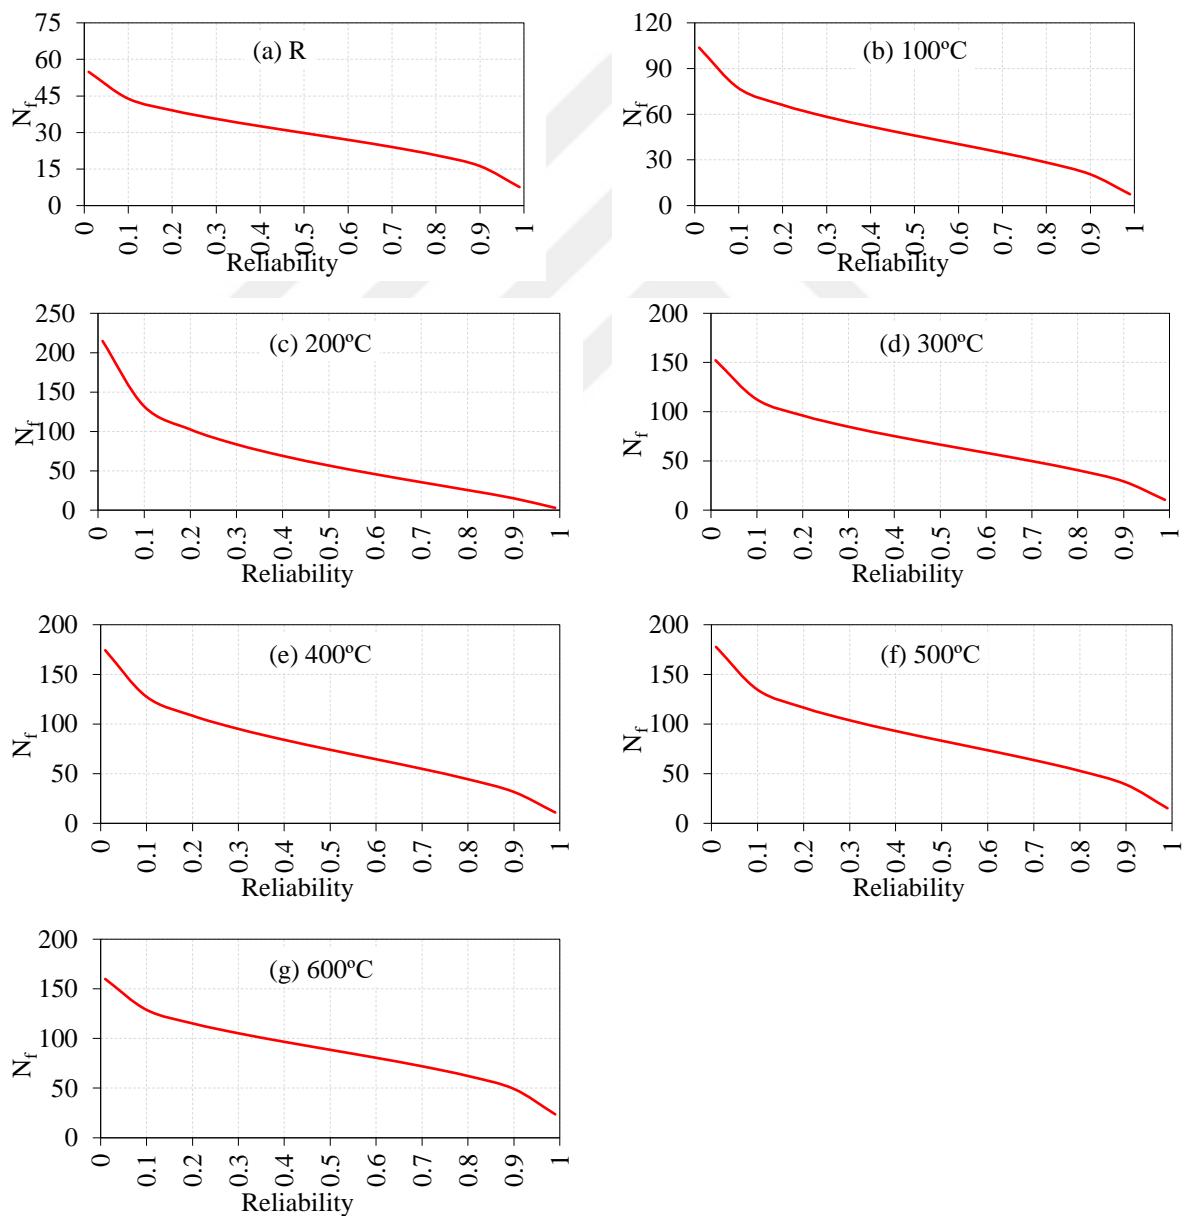
Figure 6.3. Failure impact numbers in terms of reliability of NC.
