TRADITIONAL KARACASU (AYDIN) DWELLINGS:
AN INVESTIGATION INTO THEIR ARCHITECTURAL AND
SOCIAL CHARACTERISTICS

A THESIS SUBMITTED TO
THE GRADUATE SCHOOL OF SOCIAL SCIENCES
OF
MIDDLE EAST TECHNICAL UNIVERSITY

DECEMBER 2006

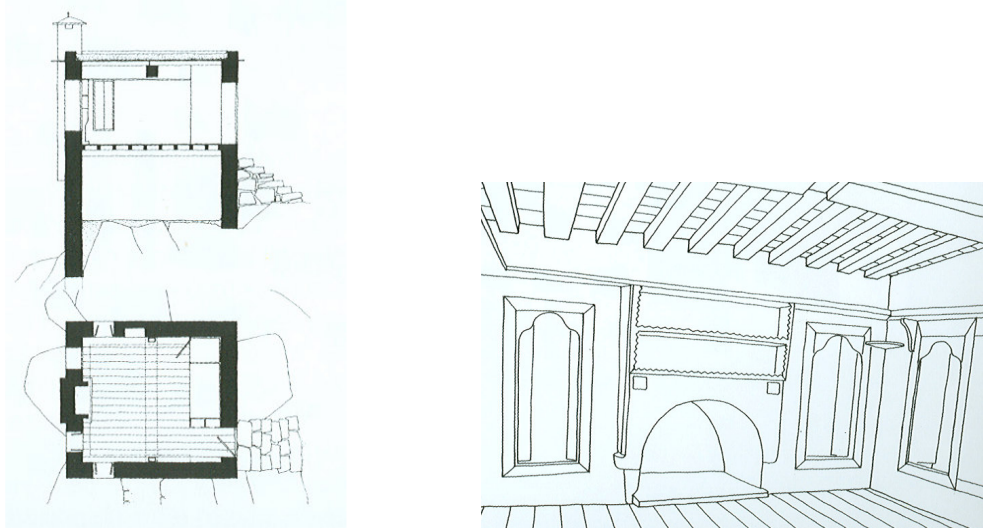
Figure 12, A traditional Milas dwelling; plan, section of the house and interior perspective of a room (Aran, 2000, 140)

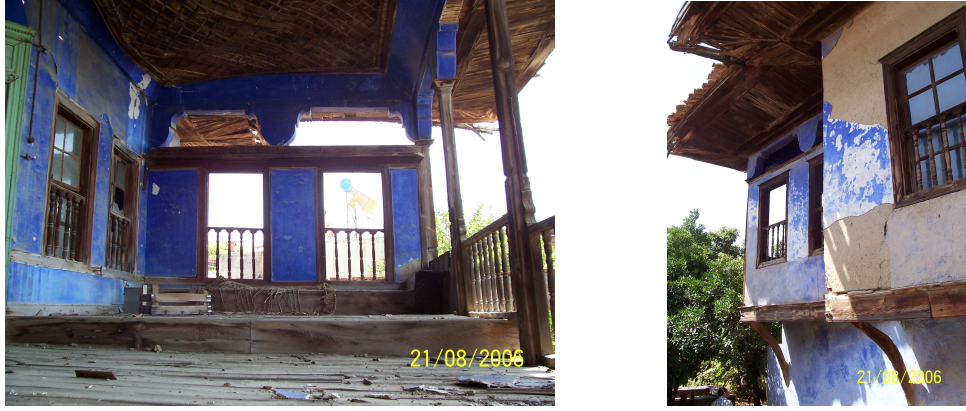
Figure 34, Hulusi Yalçın dwelling (Kuyucak), schematic plans of the house and views from *hayat* and *eliboğründe* (Taşdöğen)

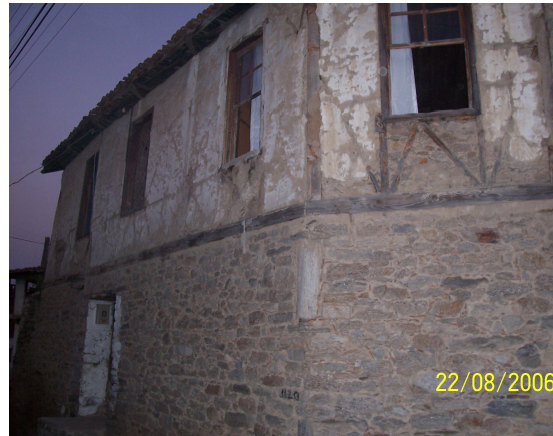
Figure 39, A traditional Bozdoğan dwelling with timber skeleton system (Taşdöğen)

The two dwellings found in *Hıdırlık Mahallesi, Dikilitaş Sokak* are located in front of a valley, and hence there is a level difference between their entrances and the remaining parts which look to the valley. There are also examples built with split wood (*bağdadi*) and timber covering (Figures 38, 39).

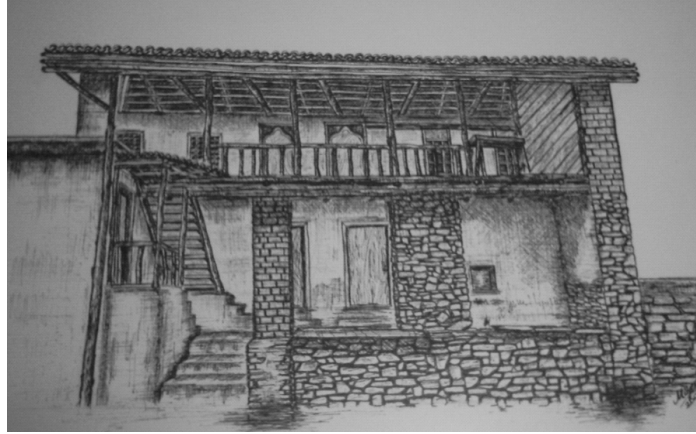
Figure 40, *Yörük Ali Efe Dwelling*, Kavaklı, Aydın, drawn by Müyesser Akın, author’s mother, an architect and expert in the 2nd Conservation Council of İzmir (2001)

The characteristics of the traditional dwellings in Kavaklı are similar to those of traditional dwellings found in nearby settlements. The traditional dwellings here (Figures 40, 41) however are not yet registered by the Ministry of Culture and Tourism. A good example is *Yörüük Ali Efe* dwelling. This is a two-storey dwelling with a courtyard of compressed earth. The courtyard is entered by a two-winged timber door from the street. On the ground floor, there is a shed and a storage space. A timber staircase with a few stone steps leads to the upper floor. The first floor comprises of a *hayat* and two rooms opening to it through doors and windows. The rooms have timber floors and ceilings with cupboards all along the side walls (Taşdöğen, 2001, 14-15). Aydın Governorship, Aydın Municipality, Adnan Menderes University, Chamber of Architects and Directorate for Construction in

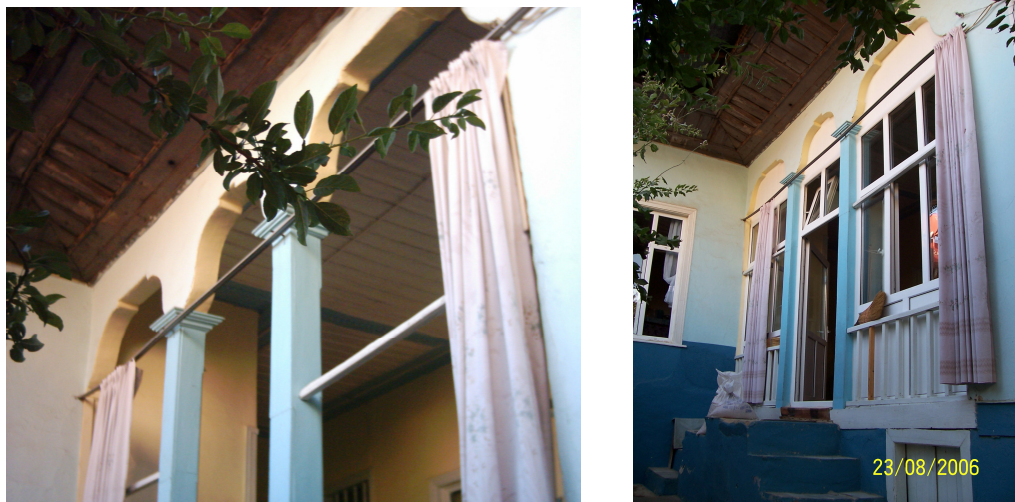
Figure 54, Case 1, *Hayat* before and after closing (Taşdöğen)

Demand for privacy increased in time: it is observed in 2005 that a curtain is hanged in front of the *hayat*; in 2006 *hayat* is closed with PVC windows (Figure 54).

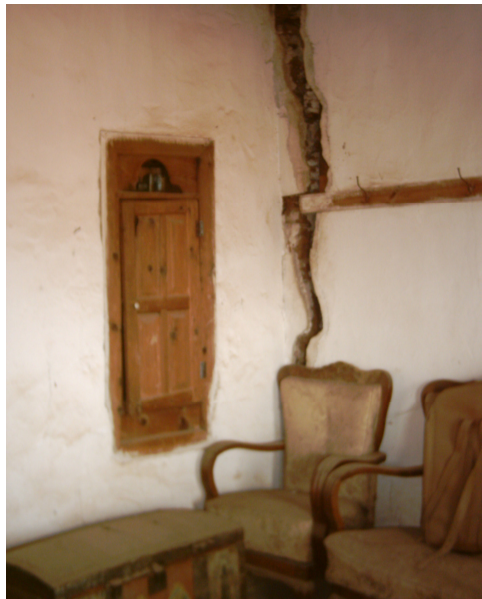
Figure 62, Case 3, Crack on the wall of a room upstairs (Taşdöğen)

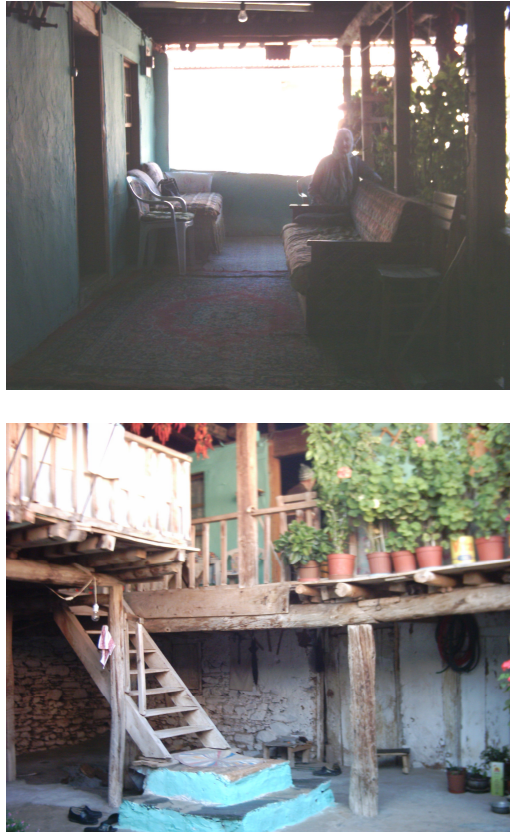
Figure 78, Case 7, *Hayat* and space under the *hayat* (Taşdöğen)

The dwelling is composed of a two-storey high residential unit and single storey service spaces (Figure 78). There are nine spaces in the dwelling: a *hayat*, two rooms, a kitchen and a lavatory on the first floor; two storage units and a kitchen on the ground floor; and an individual lavatory in the courtyard. The courtyard is entered from the street with a two-winged timber door. The space under *hayat* is used for chopping wood. The spaces are partially altered. Some additions were built in the courtyard and on the first floor to be used as a kitchen (G3-F4) and lavatory (G4-F5). *Hayat* is divided for gaining space for these service spaces.

The structural system of the main building is stone masonry in the load bearing walls under a pitched and *alaturka*-tiled roof. Main structural elements are stone and timber. Earth mixed with straw is used as the mortar.

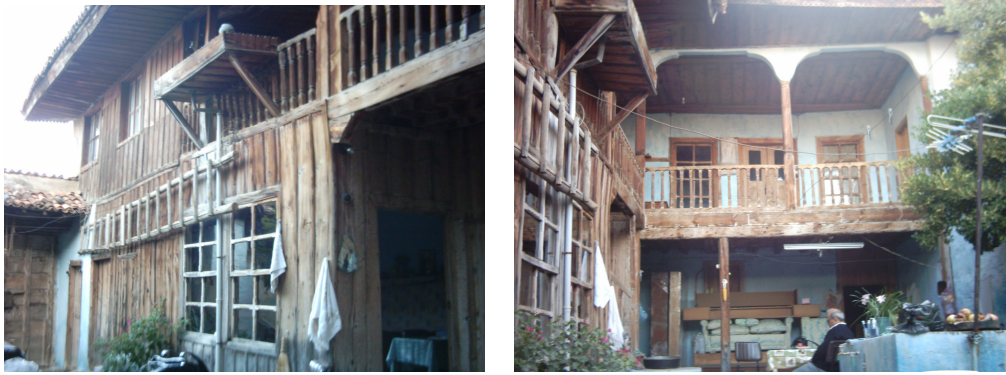
Figure 80, Case 8, View of the residential unit from the courtyard and service spaces on the ground floor (Taşdöğen)

The dwelling is composed of a two-storey high residential unit and a service spaces on the ground floor (Figure 80). There are twelve spaces in the dwelling: a *hayat*, three rooms (Figure 81) and a kitchen on the first floor; two storage units, a minor *hayat*, a space under the *hayat* (opening to the back street), a room, a kitchen and a lavatory on the ground floor. The dried food is stored in the space named as *mağaza*.

The structural system of the main building is timber skeleton with stone masonry up to the 1st floor under a pitched and *alaturka*-tiled roof. Main structural elements are stone and timber. Earth mixed with straw is used as the mortar. The courtyard is entered from the street with a two-winged timber door. There is another entrance opening to the storing space; however it is not used today. It is the unique example of a dwelling faced with timber on the facade looking to the courtyard.

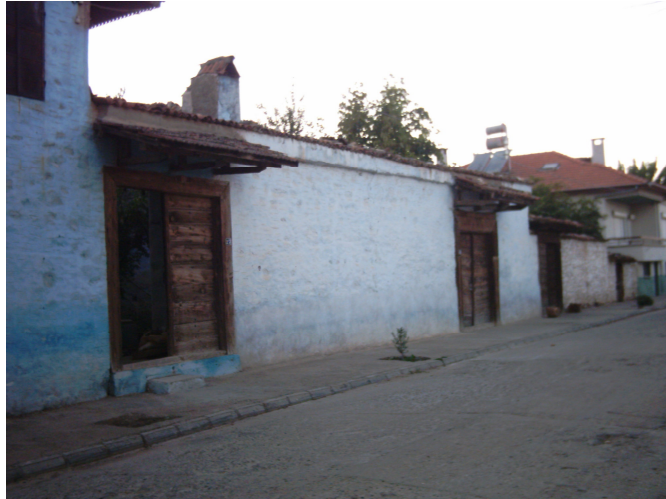
Figure 82, Case 8, Entrances of the two dwellings in the adjacent plots (Taşdöğen)

This dwelling and the one in the adjacent plot were once owned by two brothers; they were built together (Figure 82). The dwellings are combined by a transition between their *hayat* sections. The door between the *hayats* of the two adjacent plots is locked because the inhabitants changed. Today the owner is a family, an old couple living in the dwelling only during holidays; they permanently live in İzmir. The occupation of the family is not mentioned.

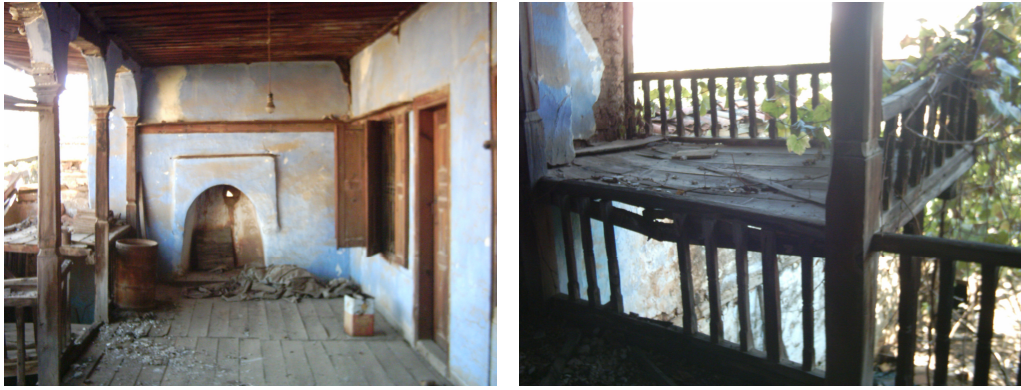
Figure 84, Case 9, *Hayat* and *ayazlık* (Taşdögen)

The dwelling is composed of a two-storey high residential unit, single storey service spaces and a two-storey high unit for sitting in summers. The dwelling is said to be 150 years old; and it is not used for 17 years. There are fourteen spaces in the dwelling: a *hayat* and two rooms on the first floor (Figure 84); two rooms on the ground floor; and a kitchen, a wheat storage, a barley storage, a laundry, a leatherwork place (for machines), a leatherwork storage, a barn, a lavatory and a summer living space in the courtyard. The laundry was also used for making bread. There is an *ayazlık* part in the *hayat*, which is a projection of *hayat* and a cool place for sitting and enjoying the weather. It is also used for drying food and cooling the earthenware jugs.

The structural system of the main building is stone masonry in the load bearing walls under a pitched and *alaturka*-tiled roof. Main structural elements are stone and timber. Earth mixed with straw is used as the mortar. The courtyard is entered from the street with a two-winged timber door. There are olive trees, fig trees, pomegranate trees and grapes cultivated in the courtyard and also a pool for providing watering.

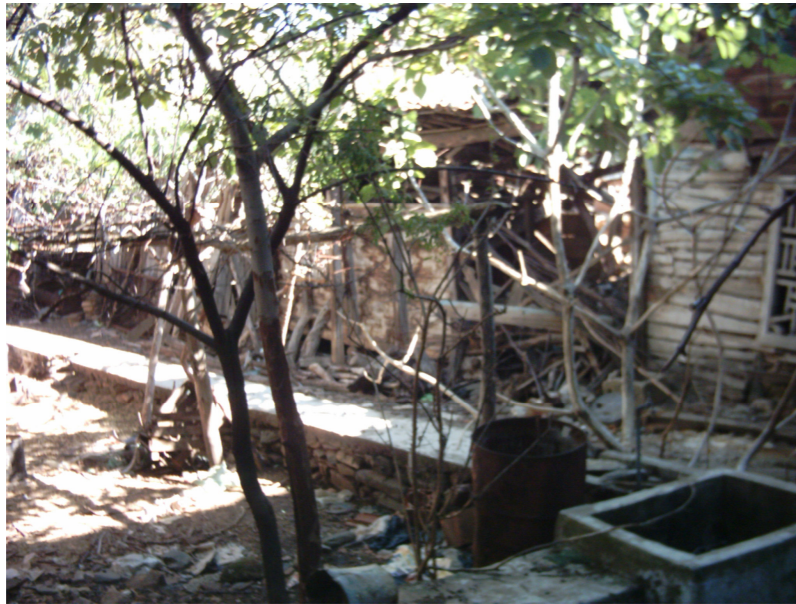
Figure 85, Case9, Footpath in the courtyard (Taşdöğen)

The footpath in the courtyard, which is bordered with a small stone wall, was used for a symbolic ceremony during wedding (Figure 85). Upon her first arrival at the dwelling, the bride used to descend from the horse and take the bride lamp (*gelin lambası*) at the beginning of this footpath. This has a symbolic meaning of brightening the home with happiness. The footpath seems to be a unique feature of Karacasu dwellings.

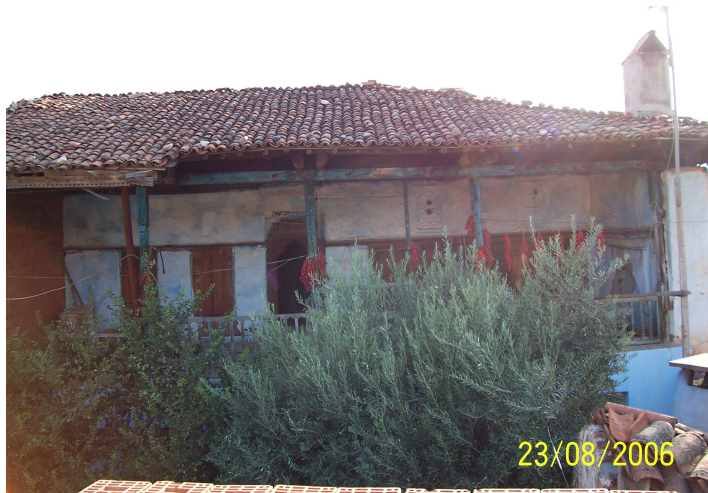
Figure 88, Case 10, Views of the dwelling (Taşdöğen)

The dwelling is composed of a two-storey high residential unit and a single storey new dwelling. There are eight spaces in the traditional dwelling (except for the new dwelling): a *hayat* and two rooms on the first floor; two rooms, a kitchen, a storage unit and a hall on the ground floor (Figures 88, 89). The single storey new dwelling where the present owners live was built with concrete in 2003. Similar to the other examples with new constructions, no traditional material is used in the newly built structures. Under-*hayat* was a semi-open space; it is later closed and became an entrance hall (G3) to the rooms (G1-G2). The adjacent dwelling was demolished in order to widen the street; the entrance to the courtyard was used to be from another street, on a different side. Service spaces changed function; a storage unit became a kitchen (G4).

Load bearing walls of stone masonry and timber skeleton system in the inner walls are used together under a pitched and *alaturka*-tiled roof. Main structural elements are stone and timber. Earth mixed with straw is used as the mortar. The courtyard is entered from the street with a two-winged iron door. This dwelling is a unique example with its upper windows opening to *hayat*.

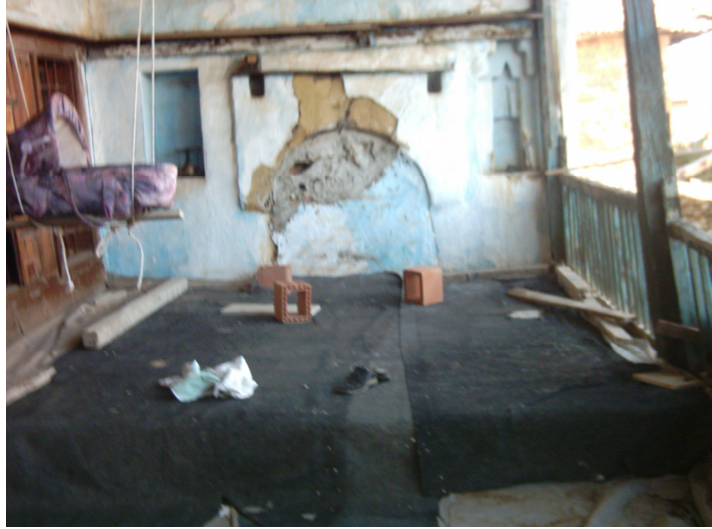
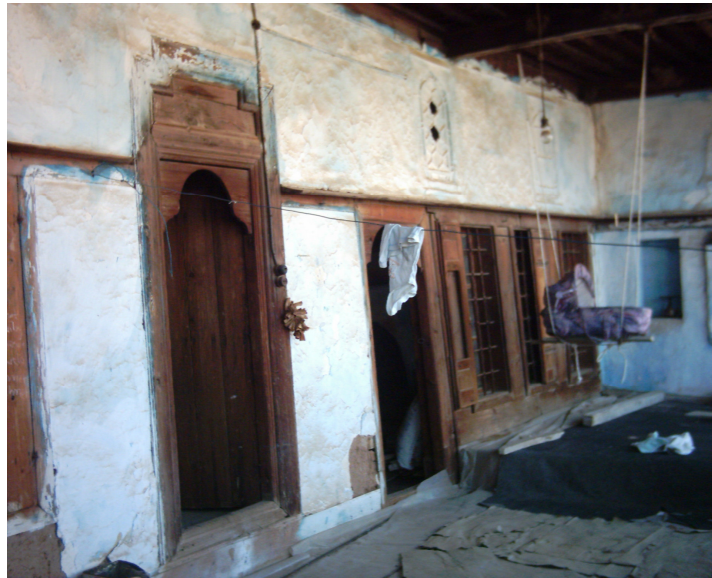
Figure 89, Case 10, *Hayat* and the rooms opening to *hayat* on the first floor (Taşdöğen)

The dwelling is occupied by a family with two children. The father of the family is working in a factory. They use the spaces on the ground floor and the courtyard at the present. The first floor of the main building is in a bad condition. This floor is the playing area of the children (Figure 90).

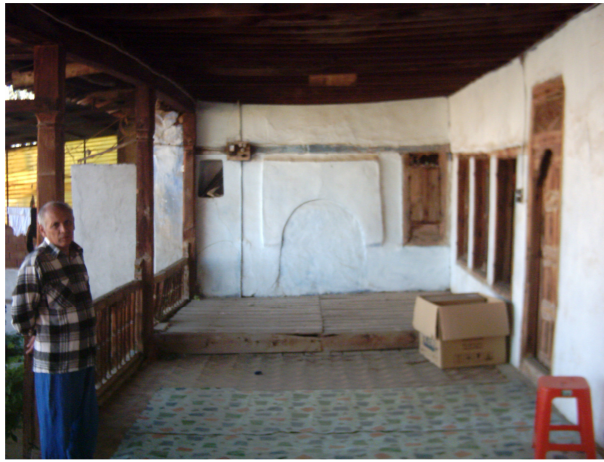
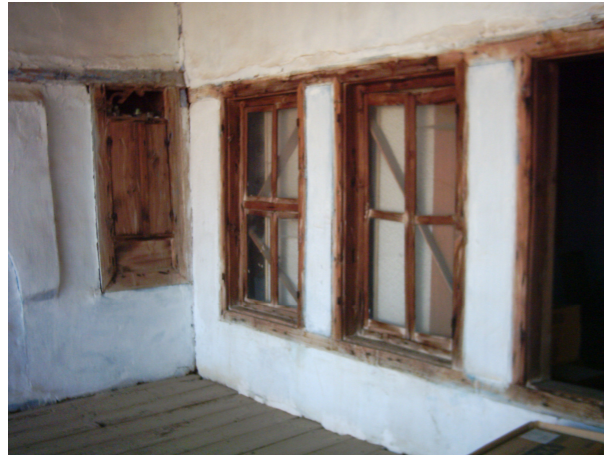
Figure 91, Case 11, *Hayat* with *köşk*, rooms opening to *hayat* (Taşdöğen)

The dwelling is composed of a two-storey high residential unit, single storey service spaces and a single storey new dwelling. There are eight spaces in the dwelling (except for the new dwelling): a *hayat* and two rooms on the first floor (Figures 91, 92); two rooms, a kitchen, a storage unit and a hall on the ground floor. There are two *köşk* sections at the ends, which are differentiated from the *hayat* with a step. These are elevated sections, which are spatially specialized for coming together and sitting in front of a hearth.

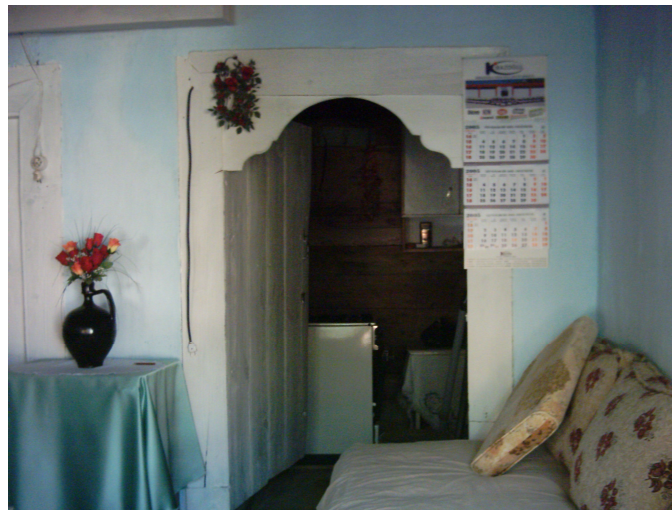
Figure 93, Case11, Kitchen on the ground floor (Taşdöğen)

The main building is in a bad condition. The new single storey structure in the courtyard is built with concrete. The space under the *hayat* is closed and divided to have a hall and two rooms (G3-G4-G5) on the ground floor. The hall is opening to the storage unit (G1) and kitchen (G2) (Figure 93). The present occupants use these spaces and they plan to rent them as an individual residential unit. The place of the timber staircase on the ground floor is changed for this project. The hearth of one room at the first floor was walled with brick because they are not used (Figure 94).

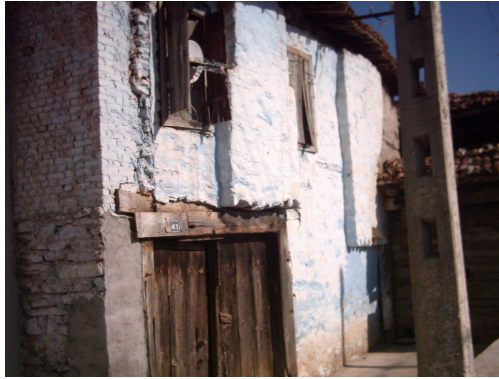
Figure 95, Case 12, View of the dwelling (Taşdöğen)

The dwelling is composed of a two-storey high residential unit and a single storey new dwelling (Fig. 95). There are five spaces in the traditional dwelling: a *hayat* and 2 rooms on the first floor (Figure 96); a *taşlık* and a place for the livestock, named as *tabanaltı* on the ground floor. The main building is in a bad condition. A new dwelling is built in 1990. Brick is used in the walling of the previously destroyed sections. The courtyard is entered from the street with a two-winged timber door through *taşlık*. This is the only example with a *taşlık* observed in Karacasu. *Taşlık* is used for the cooking facilities (G2). There is no individual kitchen in the dwelling.

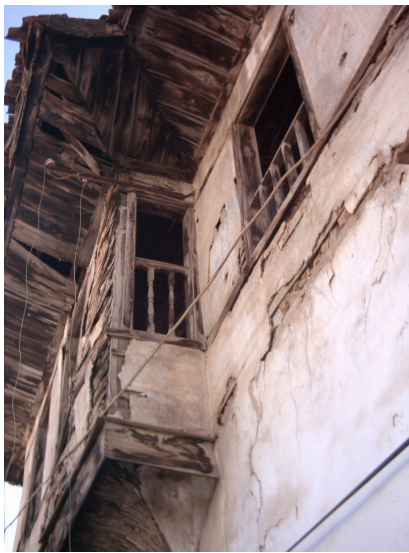
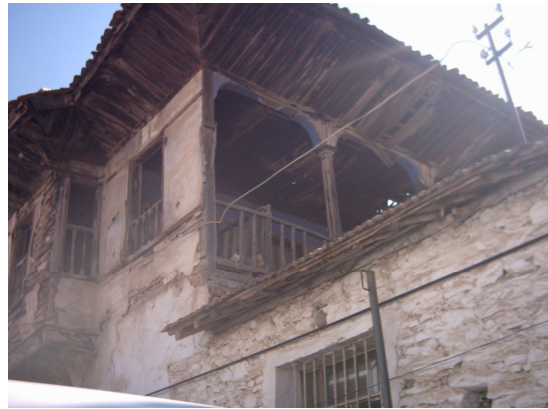
Figure 98, Case 13, Exterior views (Taşdöğen)

The dwelling is near the *arasta* and is composed of a two-storey high residential unit and a courtyard (Figures 98, 99). The residential unit is not used and not restored. There are two entrances: one from the courtyard and one at the back. The structural system of the main building is stone masonry under a pitched and *alaturka*-tiled roof, whereas the service spaces have flat tiles. The stone wall on the ground floor is painted with lime. Plaster and *bağdadi* are deteriorated. Bricks are added in the destroyed parts of the walls.

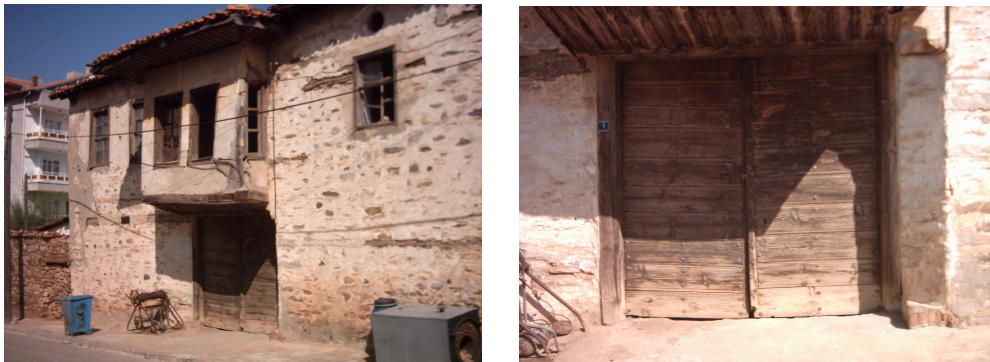
Figure 100, Case 15, Exterior view and the street door (Taşdöğen)

The dwelling is composed of a two-storey high residential unit and a courtyard (Figure 100). The structural system of the main building is timber skeleton with stone masonry up to the first floor, under a pitched and *alaturka*-tiled roof. The owners had migrated to İzmir, so the house is not used at present. The ground floor is blind, it has no windows. The dwelling is not restored. The main entrance is from the street directly to the building. There is a projection on the first floor, which looks to the street. There is a symmetrical organization on the facade. As observed the courtyard is on one side of the residential unit. There might be a *taşlık* in the entrance; because it is not visible from the exterior, it can not be suggested with certainty.

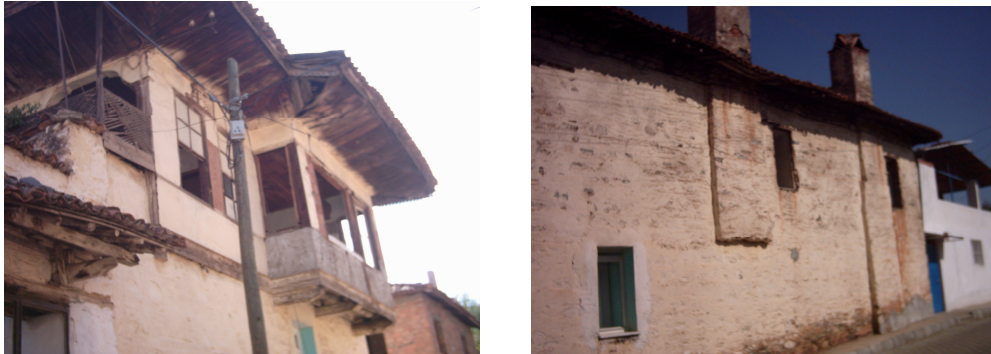
Figure 101, Case 16, Exterior views (Taşdöğen)

The dwelling is composed of a two-storey high residential unit and a courtyard (Figures 101, 102). The structural system of the main building is timber skeleton with stone masonry up to the first floor, under a pitched and *alaturka*-tiled roof. The owners of the dwelling had migrated to İzmir, so the house is not used today; it is locked. There is a projection on the first floor, looking to the street. There is

deterioration on the walls, on which plaster with cement is applied. Some timber elements dropped from the eaves.

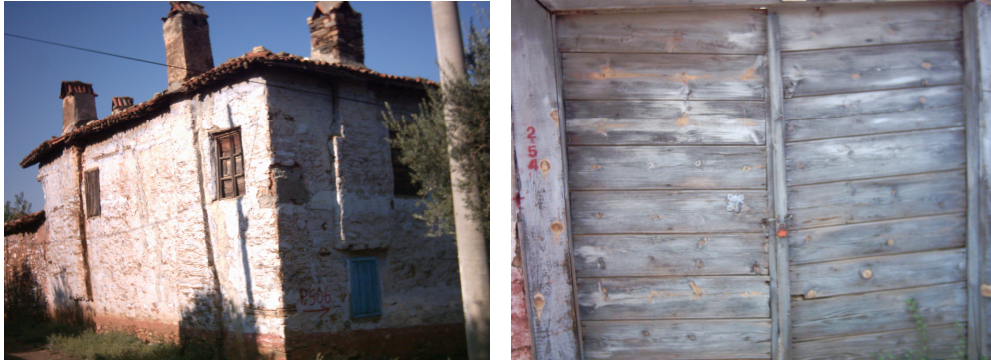
Figure 103, Case 17, Exterior view Figure 104, Case 17, Courtyard door (Taşdögen)

The dwelling is composed of a two-storey high residential unit and a courtyard (Figure 103). The entrance to the house, which is locked, is directly from the courtyard (Figure 104). The structural system of the main building is stone masonry in the load bearing walls, and timber skeleton system in the partition walls under a pitched and *alaturka*-tiled roof. The ground floor is blind. There is deterioration on

the walls; some pieces of tiles and bricks are inserted to the wall.

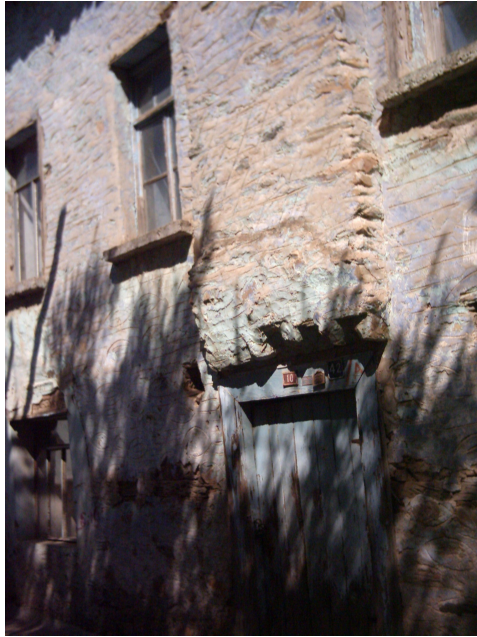
Figure 105, Case 18, Exterior view from back (Taşdöğen)

The dwelling is composed of a two-storey high residential unit and a courtyard (Figure 105). The house is not used and not restored. There are two entrances: one from the courtyard and one at the back. The courtyard door is locked. The structural system of the main building is timber skeleton with stone masonry up to the first floor under a pitched and *alaturka*-tiled roof.

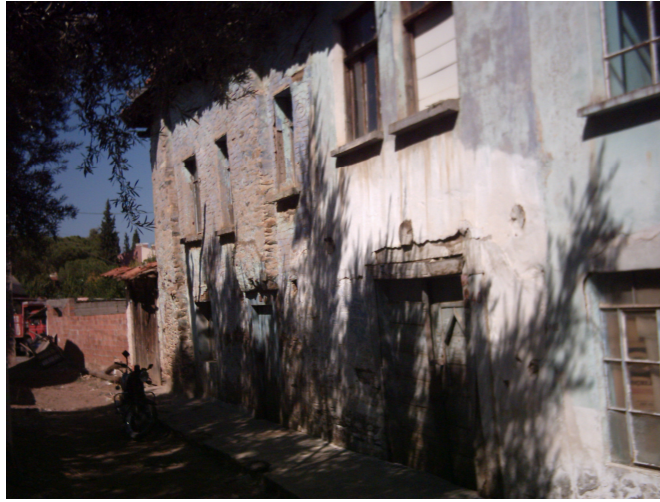
Figure 106, Case 19, Exterior view (Taşdöğen)

The dwelling which is adjacent to Case 18 is composed of a two-storey high residential unit and a courtyard. The house is not used today and is locked. Like in the other examples, there are two entrances: one from the courtyard and one from the back (Figures 106, 107). The structural system of the main building is timber skeleton with stone masonry up to the first floor under a pitched and *alaturka*-tiled roof. This dwelling is also near the *arasta*.

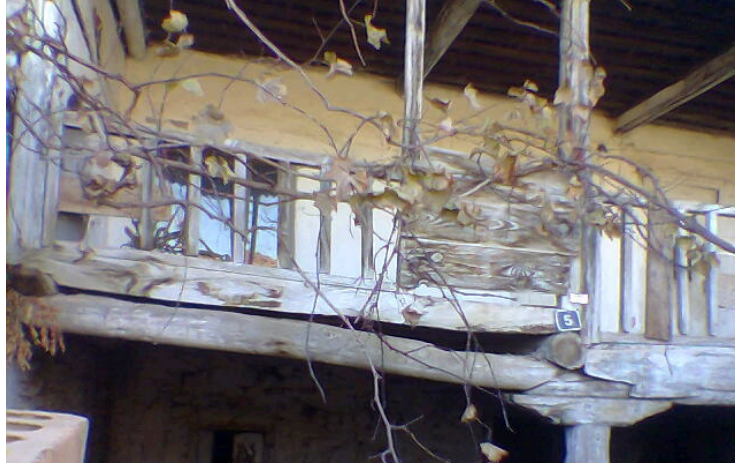
Figure 108, Case 22, *Hayat* (Taşdöğen)

The dwelling is composed of a two storey high main residential unit and a courtyard. The structural system of the main building is stone masonry under a pitched and *alaturka*-tiled roof. The main structural elements are stone and timber with earth mixed with straw mortar. There are two rooms opening to *hayat* (Figure 108). The exterior walls looking to *hayat* are plastered and painted; the stones at the ground

floor are also painted. The colonnade and the ceiling of the *hayat* are timber. The space under the *hayat* opens to storage rooms whose height is less than 2m (Figure 109). The staircase for going upstairs is made of stone.

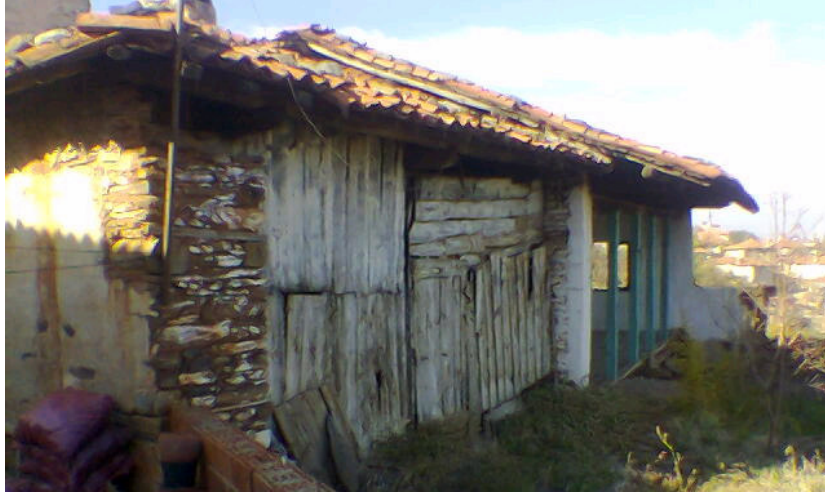
**Figure 110, Case 23, View from courtyard
(Taşdöğen)**

The dwelling is composed of a single storey main residential unit and a wide courtyard (Figure 110). The structural system of the main building is stone

masonry under a pitched and *alaturka*-tiled roof. The main structural elements are stone and timber with earth mixed with straw mortar. There are two rooms opening to *hayat*. The exterior walls are plastered and painted. The main residential unit is heightened in order to isolate the dwelling from the earth. There is an additional space covered with timber panels, which is built as a continuation of the main unit.

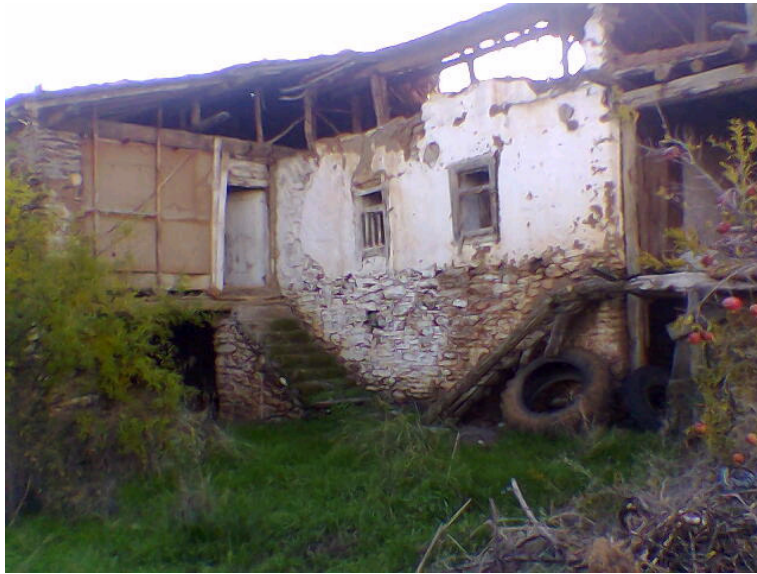
Figure112, Case 25, Courtyard (Taşdöğen)

This dwelling is also composed of a heightened single storey main residential unit and a courtyard. The structural system of the main building is stone masonry under a pitched and *alaturka*-tiled roof. The main structural elements are stone and timber. The exterior walls are without plaster (*kuru duvar*). The L-shaped house opens to the courtyard through a stone staircase. The courtyard is used for storing redundant things (Figure 112).

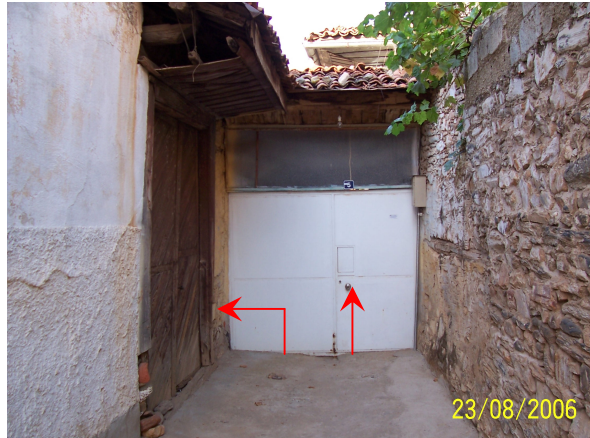
Figure 118, Case 1 and Case 14, Courtyard entrances (Taşdöğen)

Some houses having a west street facade are entered from the street through the *sofa* on the first floor with some steps; since the *hayat* mostly looks to east in order to receive more light. In these dwellings, courtyard is also entered from a secondary door opening to a dead end street (Figures 118, 119).

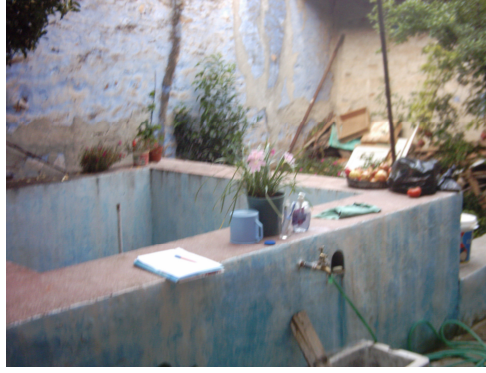
**Figure 122, Case 8, Pool
(Taşdöğen)**

The architectural elements of courtyard are a staircase, a pool, a fountain, a fireplace and a courtyard door (Figure 122). New dwelling units could be built in the courtyards when needed (Case 10, Case 11 and Case 12). In such examples the first floor of the dwellings is not used any more; the courtyard and the ground floor instead are used. In some examples, a kitchen (Case 2) (Figure 123), a lavatory (Case 4) and storage spaces (Case 2 and Case 5) are added as new constructions to the courtyard. Courtyard provides a shelter for the owner's animals in some examples too.

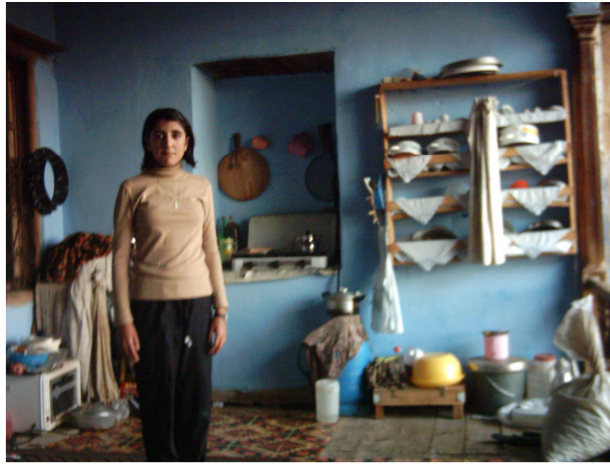
Figure 125, Case 5, *Hayat* being used as a kitchen (Taşdöğen)

Specialized spaces comprise the kitchen, storage unit and lavatory. The kitchen in some dwellings, are located on the ground floor of the main residential unit (Case 1, Case 3 (used to be at the courtyard), Case 4, Case 7, Case 11 and Case 12) or can be found as new constructions in the courtyards (Case 1, Case 2, Case 9). In order to meet the needs of the dwellers, another kitchen can also be placed on the first floor in addition to the one on the ground floor (Case 4 and Case 7). In Case 5, Case 6 and Case 8, *hayat* is also used for food preparation and the rooms for cooking (Figure 125).

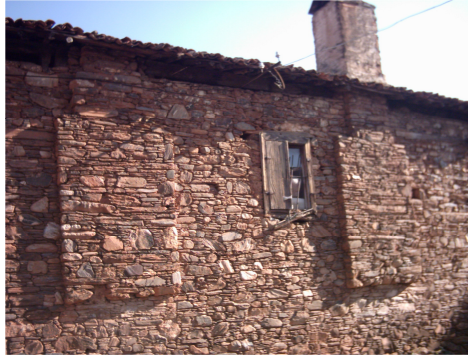
Figure 129, Case 6, Stone masonry (Taşdöğen) Figure 130, Case 10, Timber skeleton sys. (Taşdöğen)

- The use of stone masonry in the entire house (Case 1, Case 7, Case 9, Case 11, Case 12, Case 14, Case 20-25) (Figure 129),
- The use of stone masonry in the load bearing walls only (preferred up to first floor level) and timber frame system with stone infill (Case 2, Case 3 (with *bağdadi*), Case 4, Case 5, Case 8 and Case 17) (Figure 131)
- The use of stone masonry in the exterior walls only and timber skeleton system in the interior walls (Case 10, Case 13, Case 15, Case 16 and Case 19) (Figure 130).

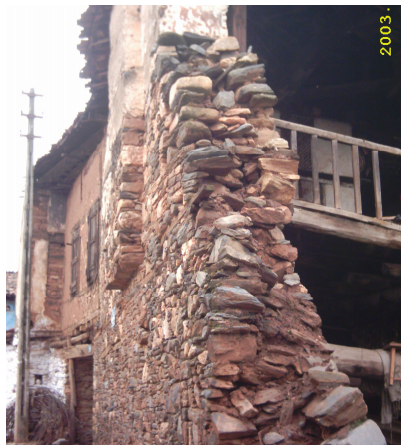
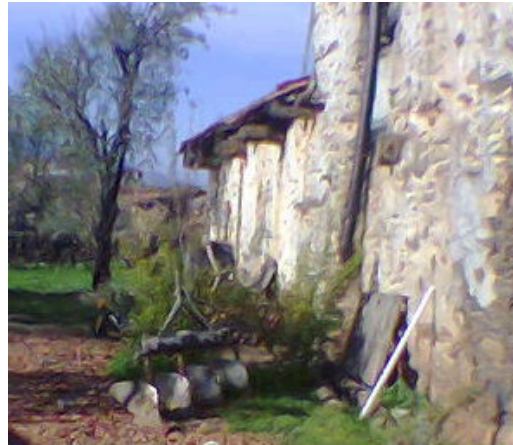
Figure 131, Section of a stone masonry wall and the use of atki in Karşıyaka (Taşdöğen)

Two main construction materials used in Karacasu dwellings therefore are stone and timber chosen according to their structural characteristics and the methods employed in construction (Oliver, 2003, 131). Stone is used as the dominant construction material due to its availability in the region. As Aktuğ (1985, 4) states, stone is a cheap construction material and has been in use for a long time. Stone can be applied without plaster and without mortar (*kuru duvar*) (Case 6) in Karşıyaka district, where there are older traditional dwellings, while it is plastered and wash-painted on timber skeleton system, or plastered and marked with sticks on stone masonry in Çarşıyaka. This plastering is thought to be a later trend. Brick is used only for repairing the demolished walls. Timber is used in a number of outer details and timber beams projected from the exterior walls in a repetitive manner and called *atki*, help to carry the roof. This detail is unique to Karacasu.

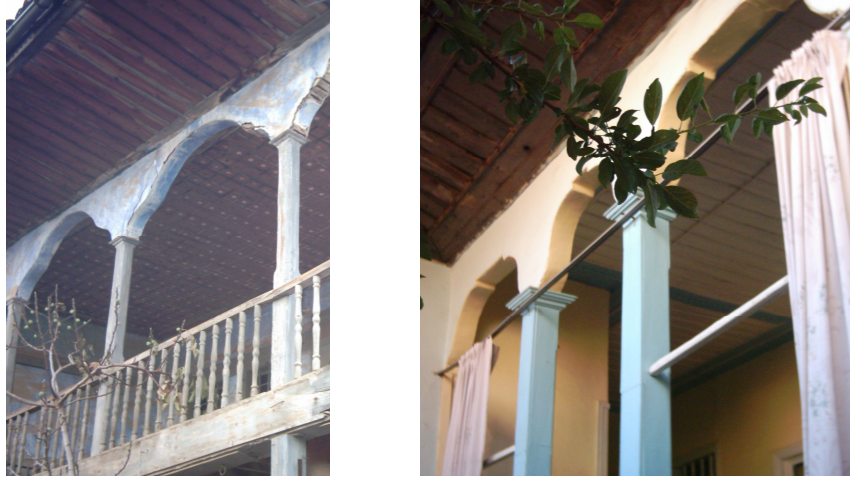
Figure 132, Timber colonnades with Bursa-type arches in *hayats* of a demolished dwelling and Case 1 (Taşdöğen)

Timber can be employed in the colonnade of *hayat* as well, thus also supporting the roof. Common type of a colonnade is the shouldered arch (Figure 132). This type however is common in Çarşıyaka, and not in Karşıyaka. It is therefore can be interpreted as a later-period application. Timber is also used at the floors and the ceilings.

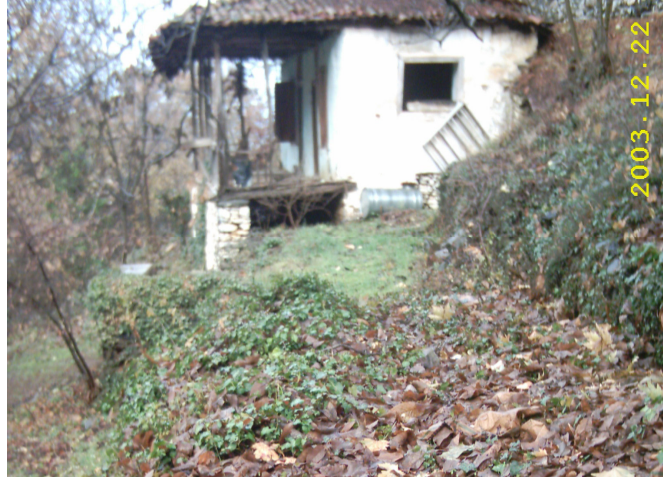
Figure 133, A plateau dwelling (Taşdöğen)

The dwellings in the plateaus are similar to the ones in Karşıyaka in terms of structural system and construction materials. They are mainly stone masonry buildings with or without plastering (Figure 133).

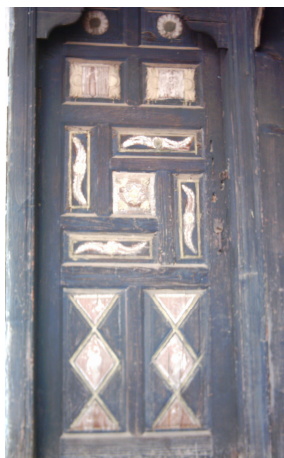
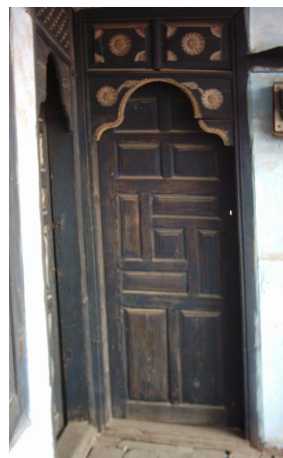
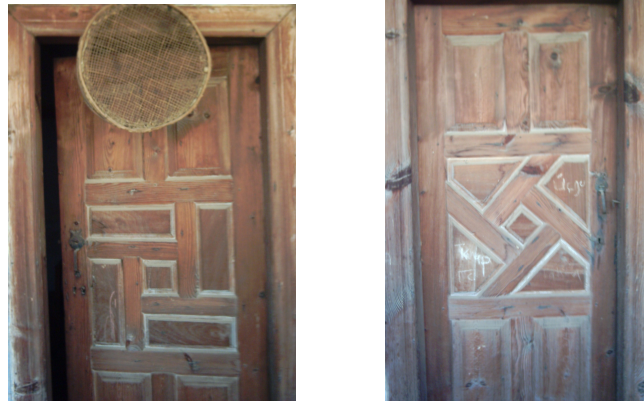
Figure 134, Case 3 and Case 9, Carved timber doors of the first floor (Taşdöğen)

- **Doors:** Doors are made of timber and can be plain or ornamented. Ornamentation is seen mostly on the doors of the first floor of the dwellings. Ornamentation can be applied by means of articulating the door surface in both exterior and interior by carved rectangular or triangular motives (Figures 134). In one example, the door of the room on the first floor is designed as a continuation of the cupboard (Case 8) (See Appendix C).

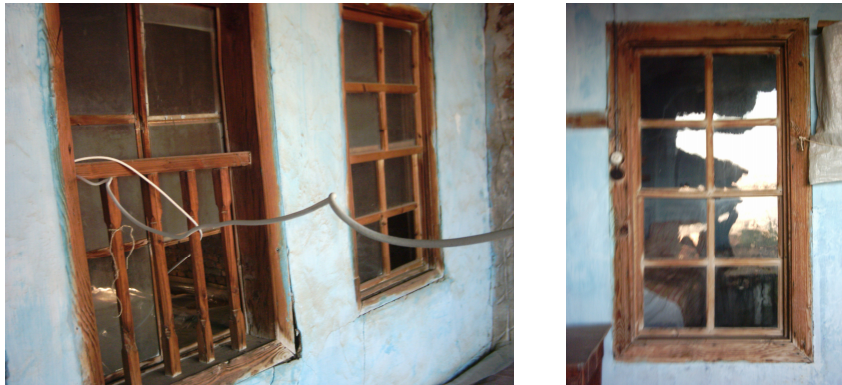
Figure 135, Case 12 and Case 8, Sash windows (Taşdöğen)

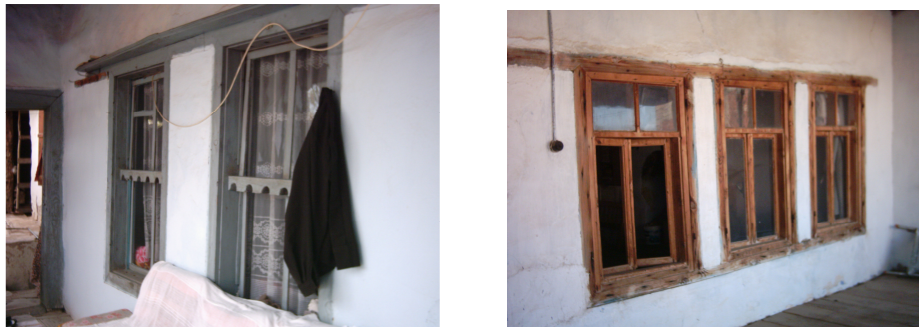
Figure 136, Case 3 and Case 11, Rhythmic order of windows in *hayat* (Taşdöğen)

Windows also determine the character of the inner elevations. They can be found in this respect, on the walls separating the *hayat* from the rooms behind. The windows looking to the *hayat* have a rhythmic order, emphasized with timber lintels (Figure 136). There are also interior windows opening to the inner *sofa* (Case 4). Windows placed close to the ceilings could function to get more light into the room. A single example with ornamented upper windows opening to a *hayat* is Case 10 (Figure 137). In this example, the room is higher than the other dwellings and the second row of windows placed under the upper windows open to the *hayat*, and have shutters. This is a unique case in the sample and thus it is possible that this type of placing two rows of windows was adopted from the dwellings of another region presumably by a master builder who also worked in the construction of this house.

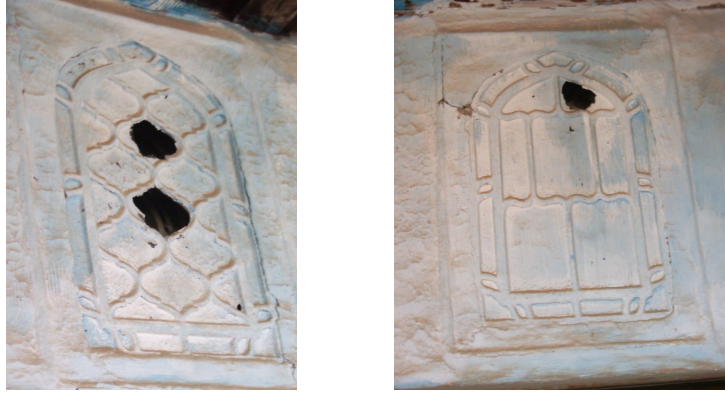
Figure 137, Case 10, Upper windows opening to *hayat* (Taşdöğen)

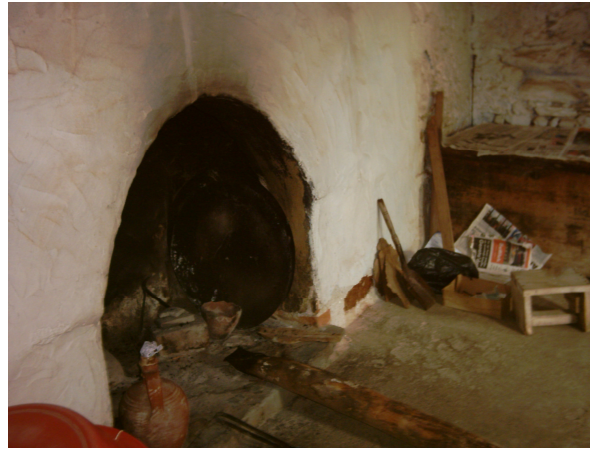
Figure 138, Case 2, Fireplace in the service space (Taşdöğen)

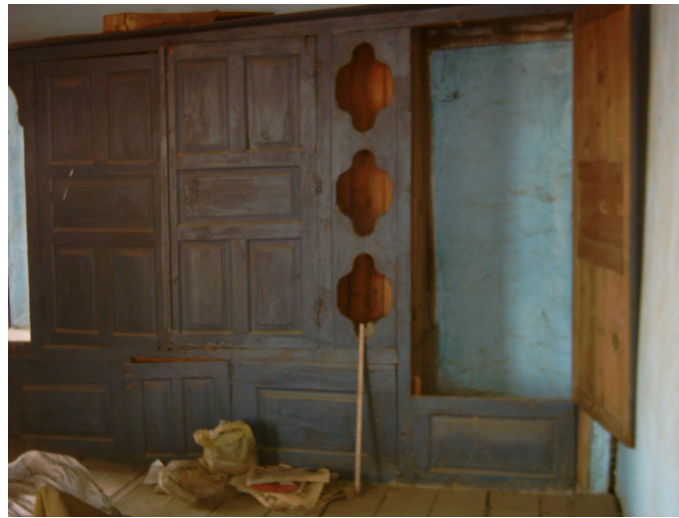
Figure 140, Cupboards in rooms (Taşdöğen)

putting gas lamps) define the functional articulation of the *yüklük* walls (Figure 139, 140).

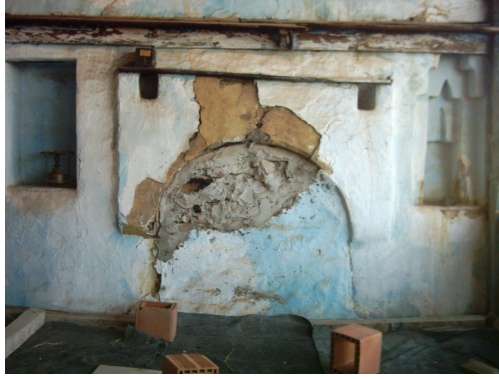
Figure 141, Case 8, Niches in *hayat*
(Taşdöğen)

- **Niches:** Small volumes are pierced from the walls, to be used for a number of functional purposes. These are small cells built into the walls. There are open ones in *hayats* (Figure 141) and closed ones built with timber like small cupboards in the rooms. Niches are mainly placed on one or two sides of the *fireplace* to include gas lamps or to display some ornamental objects (Figure 142).

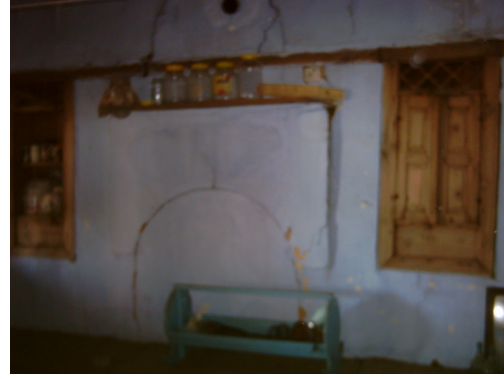
Figure 142 Case 11, Niches in room
(Taşdöğen)

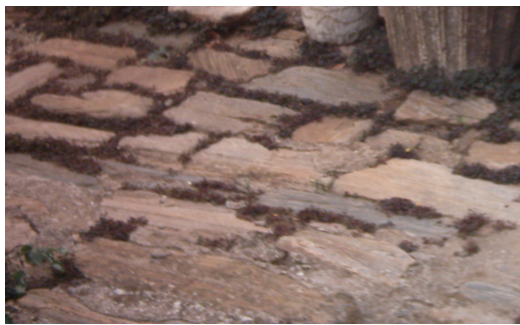
Figure 143, Case 3, *Kaydırak* stone
(Taşdöğen)

- **Floor:** As an outdoor element the courtyards are also defined by horizontal and vertical elements. The surface of the courtyard is covered with local stone called *kaydırak*, which has a large straight surface (Case 3) and marble (Case 1) (Figures 143, 144). *Kaydırak* stones forms an irregular and even surface while marble forms more regular and even surface. Some other stone architectural elements can be placed in the paved courtyard for different purposes. An ancient marble column capital for example is used as a *dibek taşı* in Case 3 and distinguishes that part of the courtyard for a function (Figure 145). It was presumably brought from ancient Aphrodisias in Geyre.

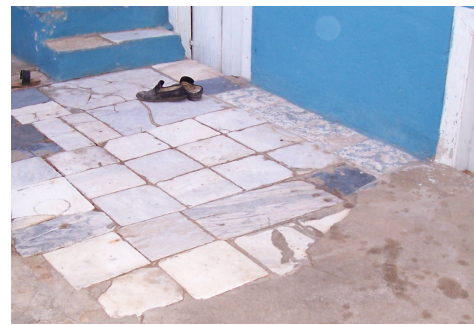
Figure 144, Case 1, Marble pavement
(Taşdöğen)

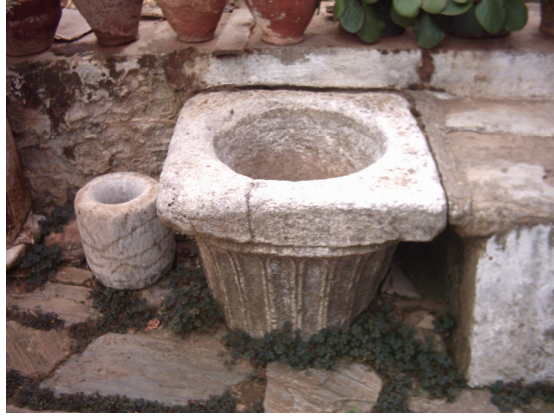
Figure 145, Case 3, Ancient column capital used as an in-situ *dibek taşı* (Taşdöğen)

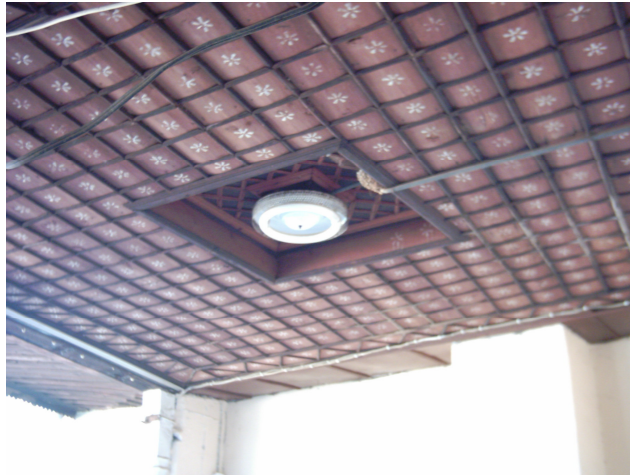
Figure 146, Case 2, Ceiling of *hayat* (Taşdöğen)

- **Ceiling:** The ceiling of a *hayat* is an exterior horizontal feature as it covers a semi-closed space overlooking to the courtyard. It is composed of thin timber laths and fine painted with geometric or flower motives in white, red, pink, yellow and blue, inside the laths. A ceiling is an uninterrupted surface unlike a wall and hence is decorated with *kalemişi* style paintings (Figures 146-148).

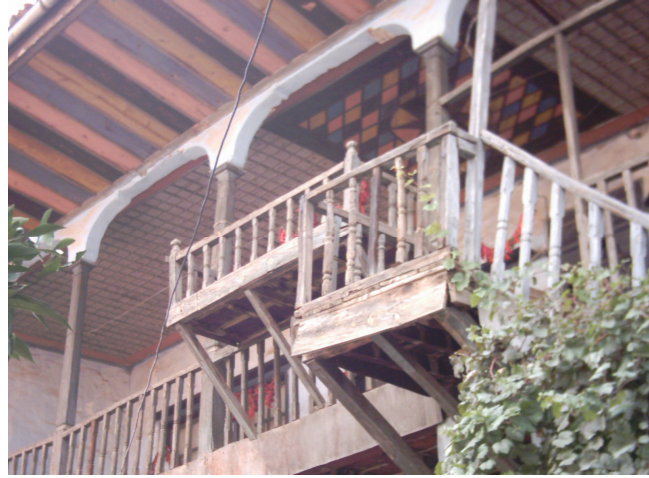
Figure 147, Case 3, Ceiling of *hayat* (Taşdöğen)

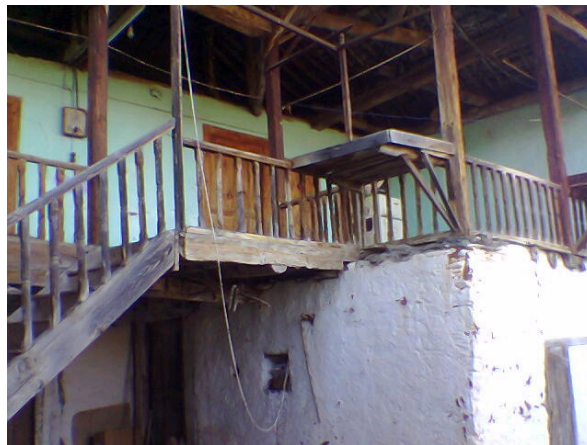
Figure 149, A dwelling in Hacı Arap Street, Karşıyaka; an example without ceiling in *hayat* (Taşdöğen)

In Karşıyaka and in the plateau dwellings however *hayats* could be built without ceilings (Figure 149). In these there is no ceiling to conceal the roof construction above (Figure 150).

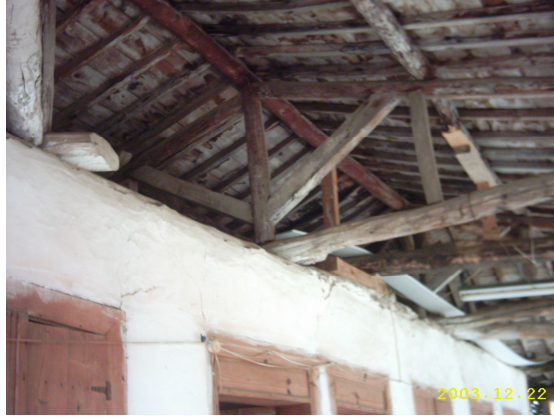
Figure 150, A plateau dwelling without a ceiling in *hayat* (Taşdöğen)
