TRADITIONAL KARACASU (AYDIN) DWELLINGS:
AN INVESTIGATION INTO THEIR ARCHITECTURAL AND
SOCIAL CHARACTERISTICS

A THESIS SUBMITTED TO
THE GRADUATE SCHOOL OF SOCIAL SCIENCES
OF
MIDDLE EAST TECHNICAL UNIVERSITY

DECEMBER 2006

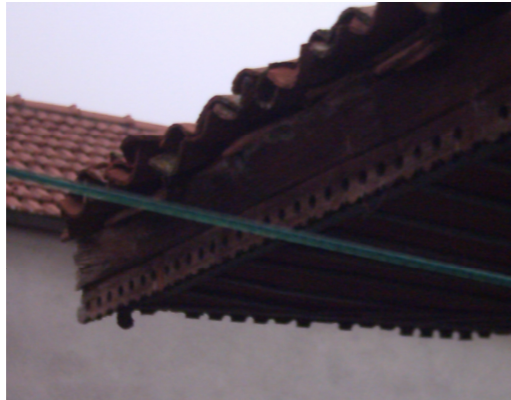
Figure 151, A type of eave (Taşdöğen)

- **Eaves:** Eaves are the most typical elements in Karacasu (Figures 151, 152). Different articulations can be seen in their application. An example is *gaş tavan* which is a kind of eave with geometric motives seen commonly in the traditional dwellings (Figure 153).

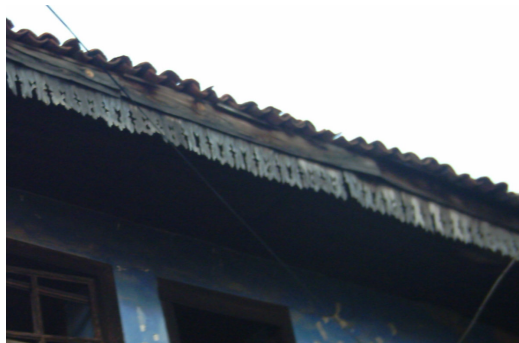
Figure 152, A type of eave (Taşdöğen)

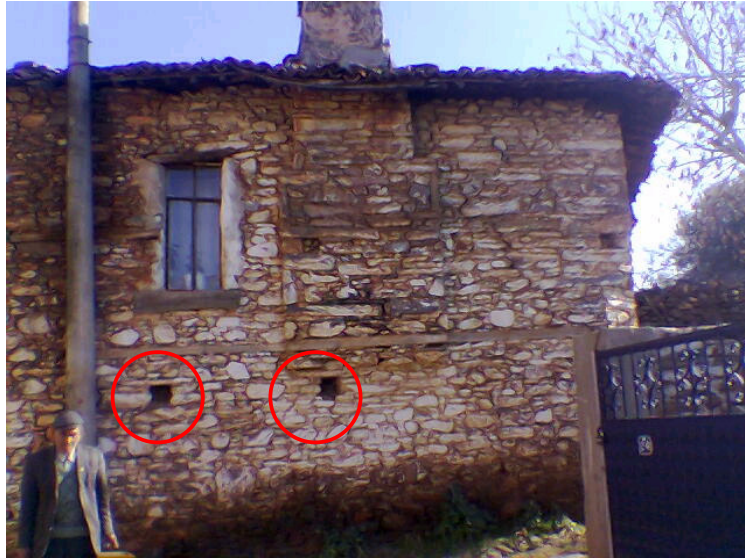
Figure 154, A dwelling in Hacı Arap Street, Karşıyaka, exterior wall with ventilation niches (Taşdöğen)

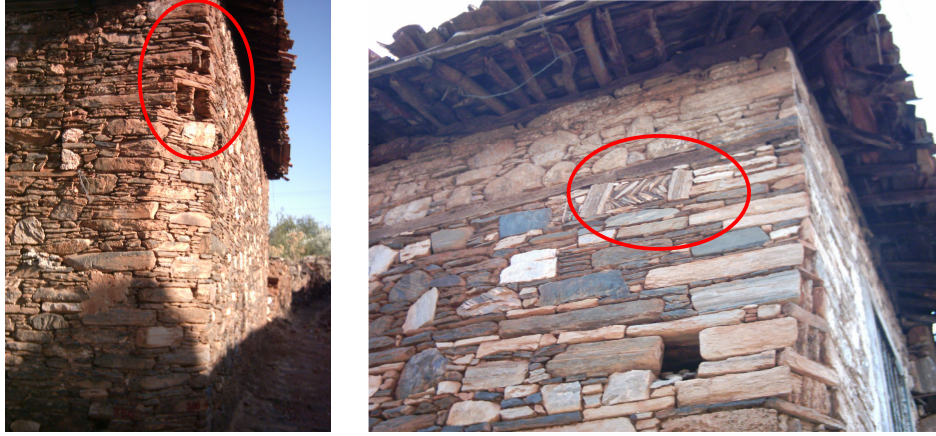
Figure 155, Corner details created with stone in Karşıyaka (Taşdöğen)

- **Walls:** The exterior walls are plastered and wash-painted in different colours on the first floor of the dwellings in Çarşıyaka and in some examples in Karşıyaka. Stone walls are not plastered on the ground floor in these examples. On the other hand, the walls of the dwellings in Karşıyaka are mostly stone masonry without plaster. Small niches can be found at the ground floor level in order to ventilate the storage spaces (Figure 154). Some decorative patterns and functional corners with chamfer can also be created on exterior stone walls (Figures 155, 156).

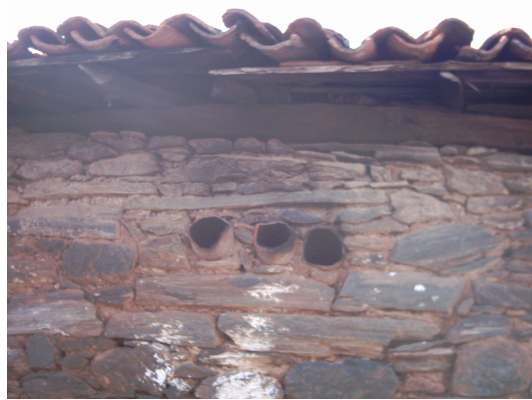
Figure 156, Chimney elements in the facade, an example from Karşıyaka (Taşdöğen)

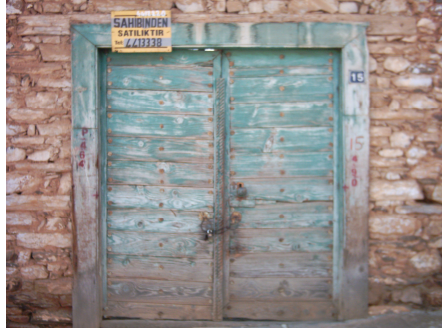
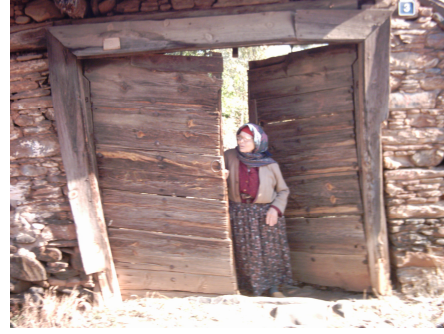
- **Doors:** Two-winged timber doors are used as courtyard doors. The doors to the service spaces in the courtyard could be different in material. The entrance to the courtyard was used to be via a two-winged timber courtyard door (Case 3-5-6-7-8-9-12-13-14-15-17-18-19 and 20) in the 18th century and the beginning of the 19th century (Figure 157). Some of these timber courtyard doors (Case 1-2-4-10-11 and 16) however are now replaced with metal doors for reasons of security.

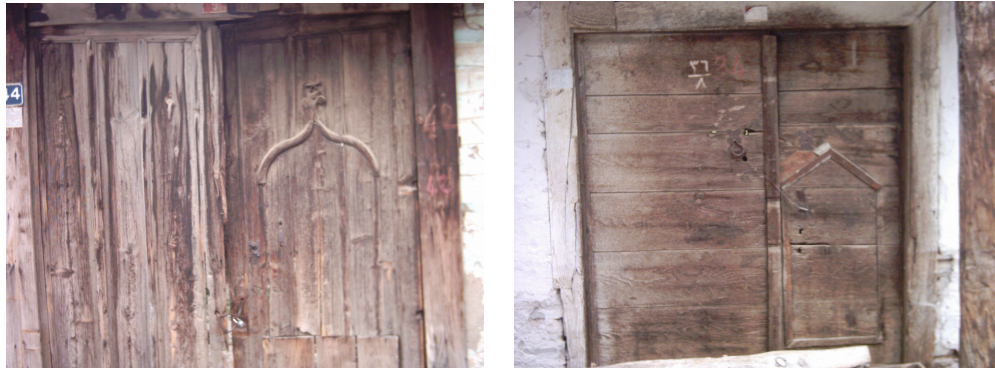
Figure 159, Case 13 and Case 19, *Alkapı* (Taşdöğen)

The courtyard doors of the dwellings looking to the tomb⁶⁸ direction are two-winged with a small opening leaf, named *alkapı*. Kuruüzüm indicated that people had to bow while passing through this small door, which is a symbolic act of showing respect to the tomb (interview, 2005) (Figures 158, 159).
