EXPERIMENTAL STUDY ON THE BEHAVIOR OF A PRESTRESSED  
NINETEEN PARALLEL WIRE STRAND (PWS) IN SUSPENSION BRIDGES  
UNDER HYDROCARBON POOL FIRES

B.S., Civil Engineering, Yeditepe University, 2014

Graduate Program in Civil Engineering

Boğaziçi University

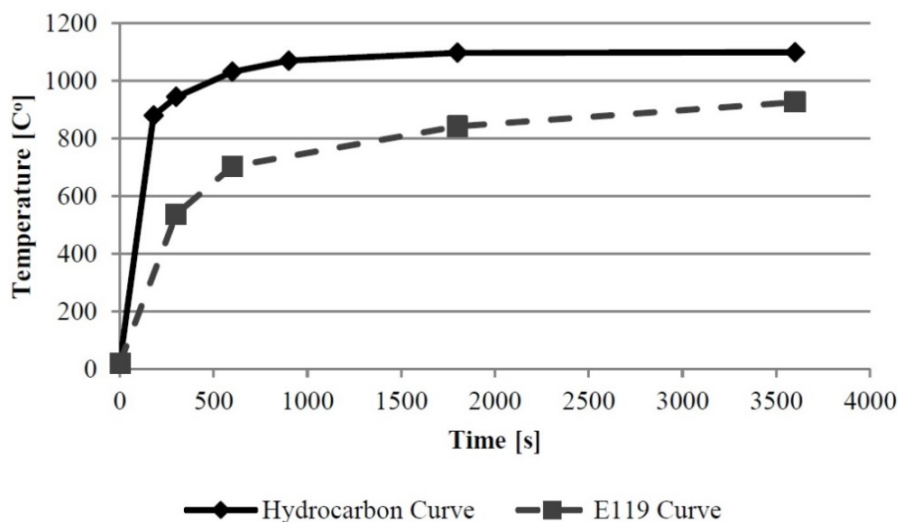
Figure 1.1. Standard fire curve.

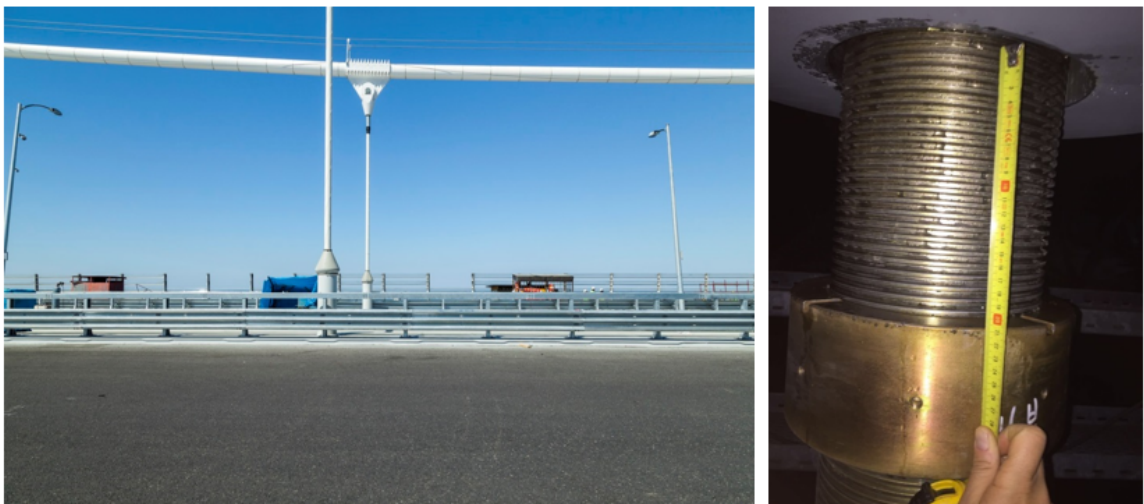
Figure 1.3. Typical suspender system components; main cable, cable band, suspender cable (left-hand side), End Anchor of cable; socket and nut (right-hand side).

The suspender cables and main cables of suspension bridges represent the structures load-bearing element. In recent years, they are typically composed of tens of thousands of parallel high-strength galvanized steel wires. Most generally, a wire with a diameter 5-5.5 mm is used in the main cables whereas wires with a diameter 7 mm are used for parallel wire strands in suspender cables. These cables are terminated with steel sockets, as said cable anchorages and connections, which transfer the tensile force from end-to-end structural components, as shown in Figure 1.3 (Photographs by the author from 3<sup>rd</sup> Bosphorus Bridge, 2015). The socket contains an inner cone, which receives the end of the strand. The cavity between wires and cone is filled either with a hot casting material such as zinc alloy or more newly with a cold casting material which is resin socketing system. When applying the axial load, the wires and casting material drawn into the interior conical recess in the socket. Subsequently, axial load is transmitted between strand and socket by a wedging action, Figure 1.3 illustrates the socket and nut from inside the deck. More detailed information about cable anchorage and connection concept provided in Chapter 2.1.3.

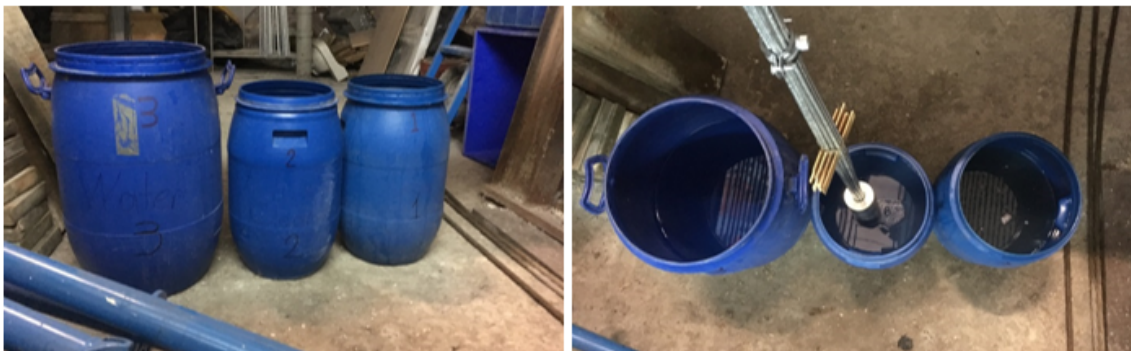
Figure 3.13. Caustic soda (#1), Flux cleaner (#2), Water (#3) and degreasing process for parallel wires.

- (i) Before the socketing, until the opened length of nineteen of parallel wire, the socket material and the array plate were removed dirt, impurities and grease from the surface by degreasing process as shown in below Figure 3.13 (Caustic soda → Flux cleaner → Water).

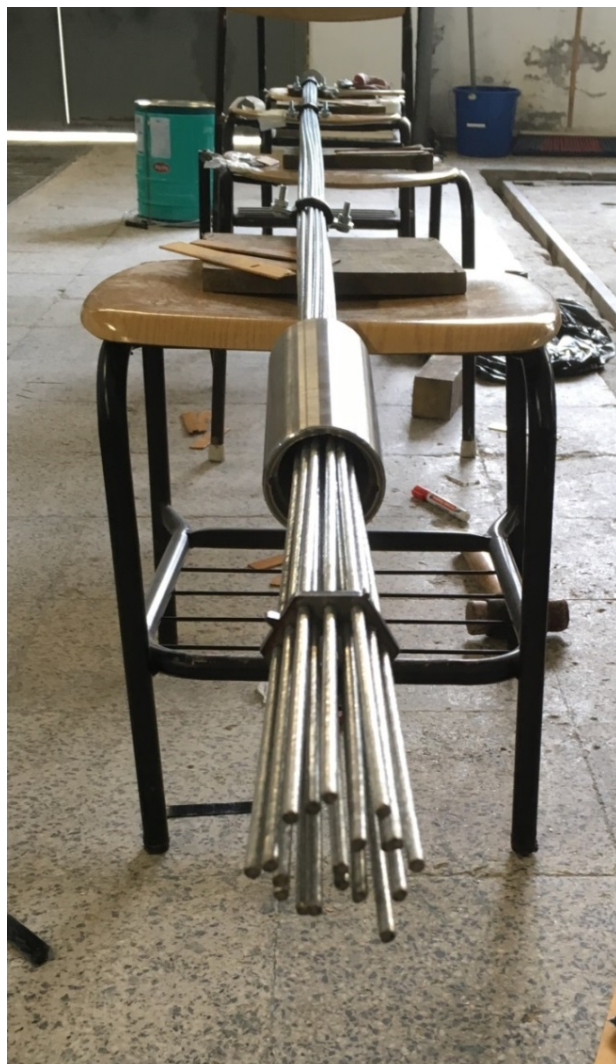
Figure 3.14. Wire position at array plateau.

in position of special made array plate as shown in Figure 3.14. Once wire is positioned at array plate, it doesn't need to measure the tolerance of socket location because the array plate is made optimum size including considered area during the pouring. Hereby, the individual wires are spaced apart uniformly, with the slight twisting of the strand causing the individual wires to open up in a straight line and in a conical pattern, without bending as shown in below Figure 3.14, in a uniform manner over the entire area that will later receive the casting material. As a result, the cast cone inside the socket can be manufactured more accurately in terms of its length and its grip on the individual wires. In this manner, it is also assured that the wires are anchored in the same section, or uniformly, so that relative movement between them is avoided.

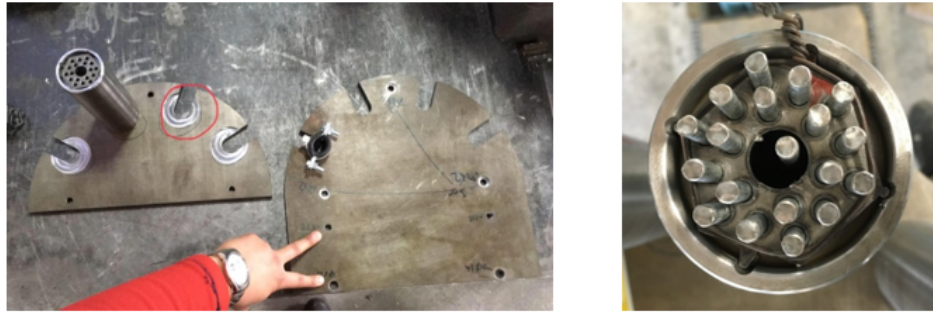
Figure 3.15. The socket holding plates (left-hand side) and the array plate and socket (right hand-side).

- (iv) Advantageously, the socket holding plate (as shown in Figure 3.15) used in the base area of the anchoring socket simultaneously acts as a sealing element for the anchoring socket while the viscous casting material is being introduced.

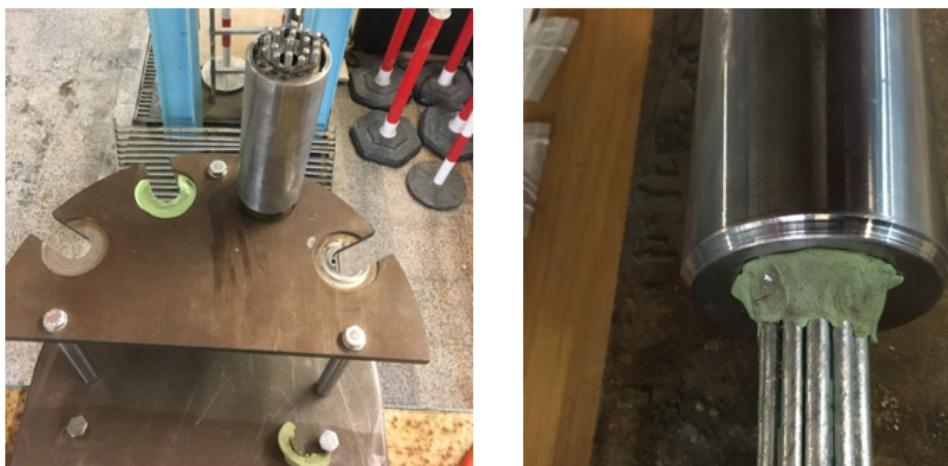
Figure 3.16. Top view of the specimen and socket holding system just before the socketing (left-hand side), sealing the base of the socket with clay for both socketing methods (right-hand side).

- (v) Additionally, the base of the socket was sealed with clay to prevent casting material escaping from the base of the socket as shown below Figure 3.16. Sealing is vital to prevent voids at the bottom of the socket. It is worthy of note that two-thirds of available wedging forces are concentrated in the bottom third of the socket. Therefore, voids must be eliminated as they could cause premature failure of the socket.

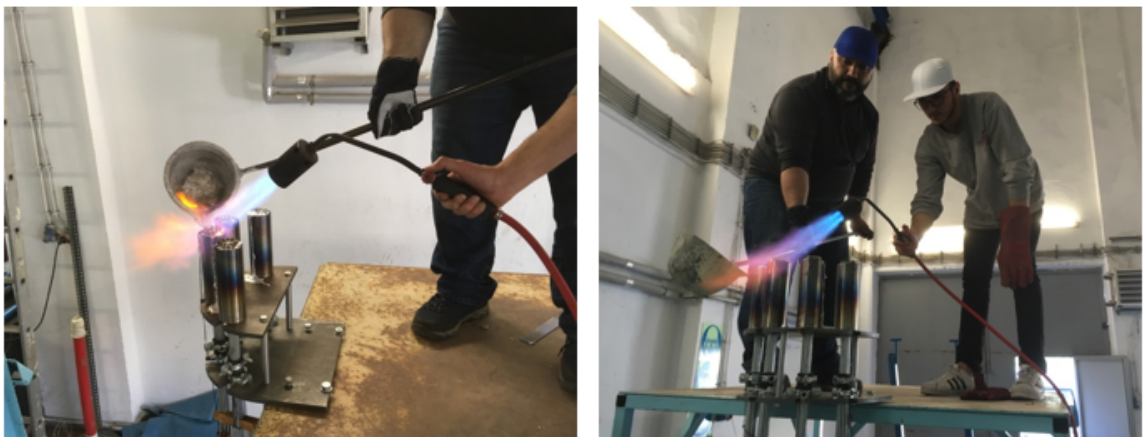
Figure 3.22. Hot casting operation by competent founders.

- (xi) Molten Zn-Cu alloy was then poured into the sockets. The casting was one continuous operation as shown below. Hot casting is a skilled operation that must be performed by competent personnel after casting process was completed; a direct metal-to-metal joint is established between the metallic casting material and the wires or strands of the cable or bundle.

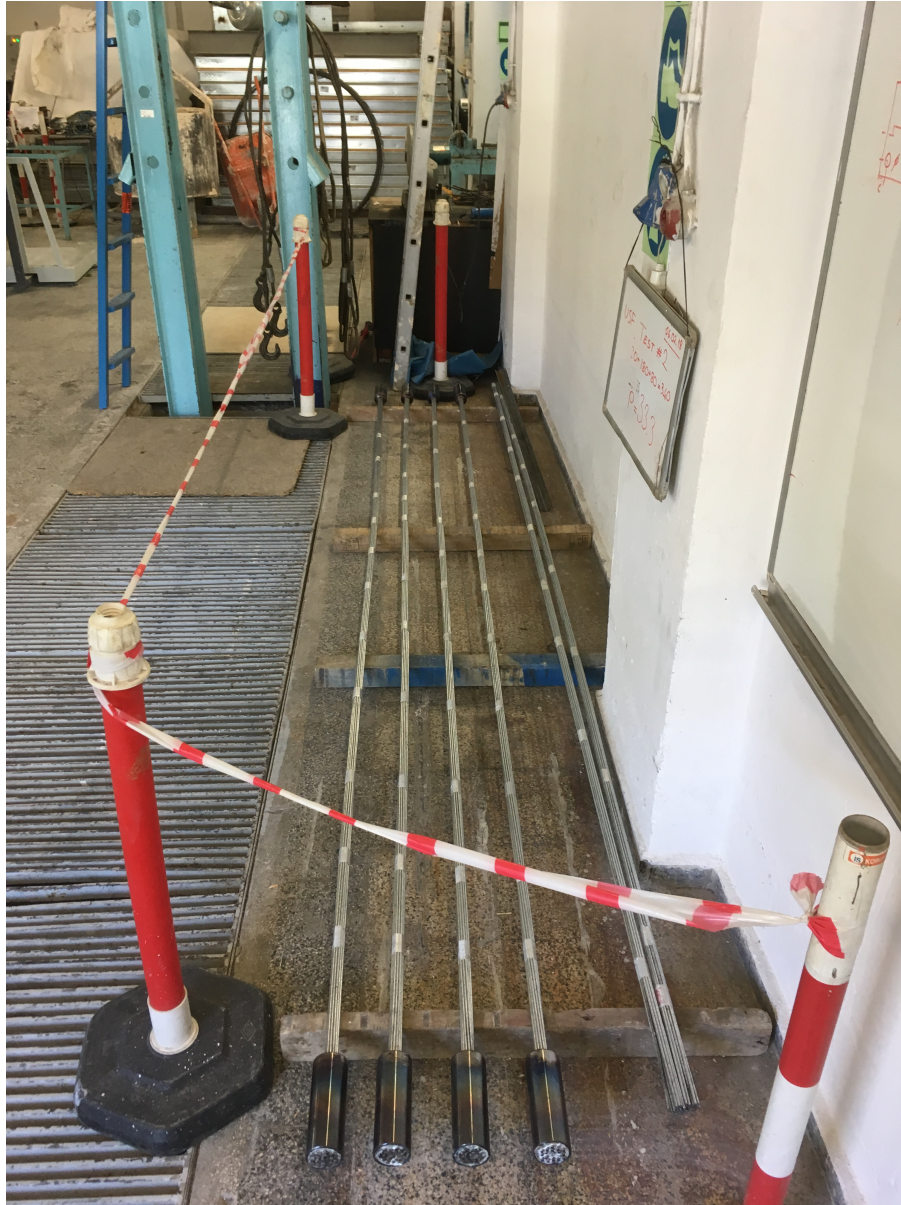
Figure 3.23. Pictures of test specimens assembled by hot casting method.

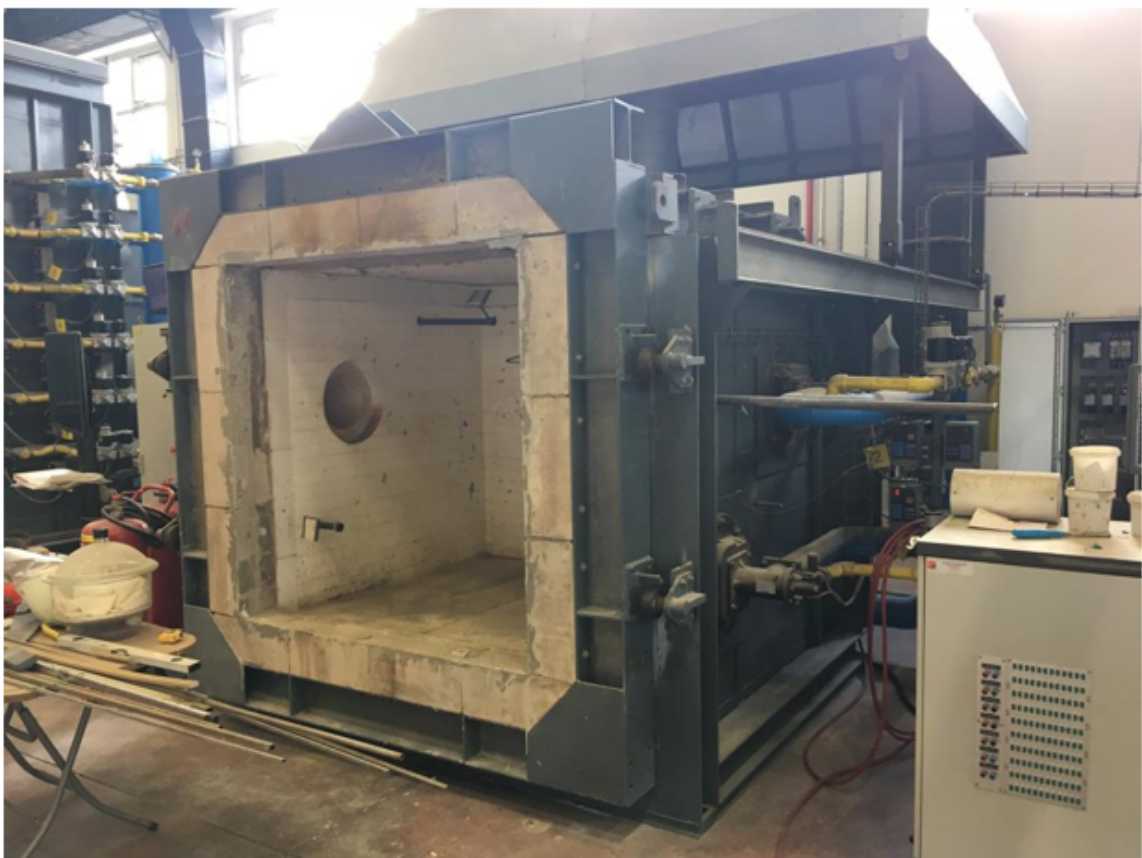
Figure 3.32. Fire Furnace from TSE Laboratories Complex.

by 97 mm by 10 mm thick, density  $(280 \pm 30) \text{ kg/m}^3$ . Thermocouples calibration is being performed and periodically verified with TSE calibration department and with TSE Fire Resistance Laboratory calibrator. After 50-hour thermocouples shall not be used any more as per EN 1363-1 Fire Resistance-Tests -Part 1: General Requirements. Thermocouples temperature values is being controlled by software in order to follow the proposed time-temperature curve and recorded by software per second. The furnace zone has a type K thermocouple mounted to exterior of the heating panels. The furnace control temperature ranges from  $300^\circ\text{C}$  to  $1200^\circ\text{C}$ .

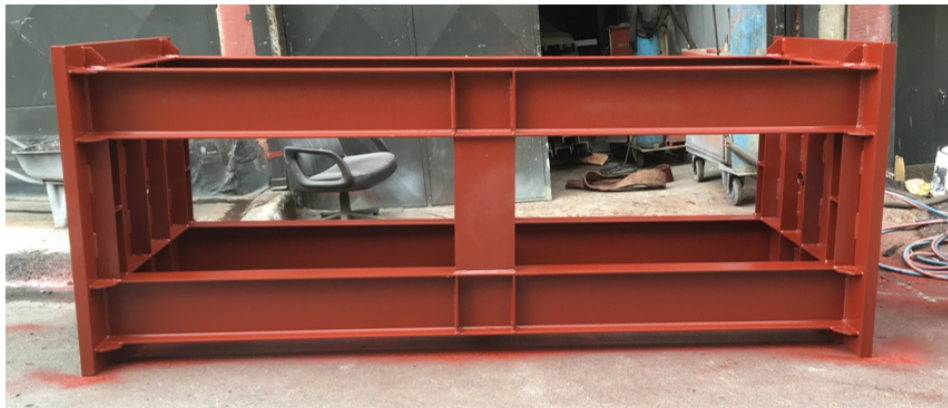
Figure 3.33. Side view of the steel test frame.

The cable specimen was installed and tested in horizontal steel test frame as shown below Figure 3.33 and Figure 3.34. The steel test frame was specifically designed by the author for this project by using structural analyzing program (SAP2000) which presented in Figure C.3. Test frame plan (Autocad) and part list are presented in Figure C.1 and Table C.1, respectively. Even though the steel members were insulated from fire, the steel profiles and plates were oversized on purpose due to the undesirable creep condition for steel members under both compression load and elevated temperature. If creep strains occur on the steel elements of test frame, then the measurement of elastic modulus and heat transfer rates on the wires will not be accurate.

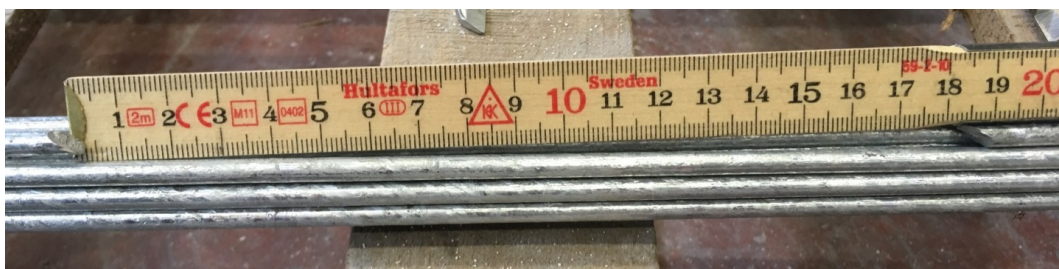
Figure 4.2. The wire fracture for S1.

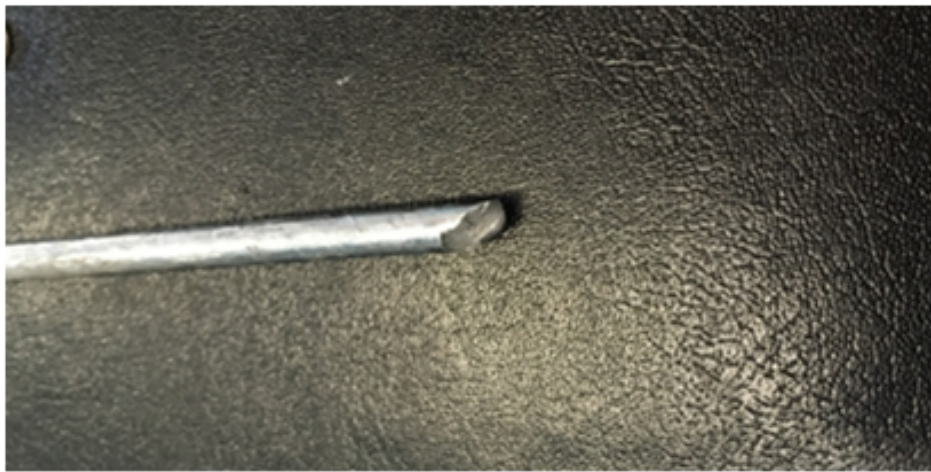
Figure 4.4. Typical shear wire fracture for S1.

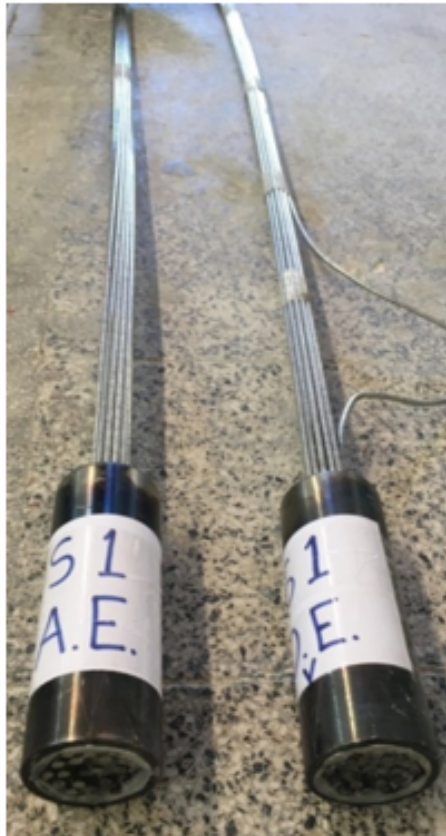
Figure 4.5. Condition both ends of the specimen S1.

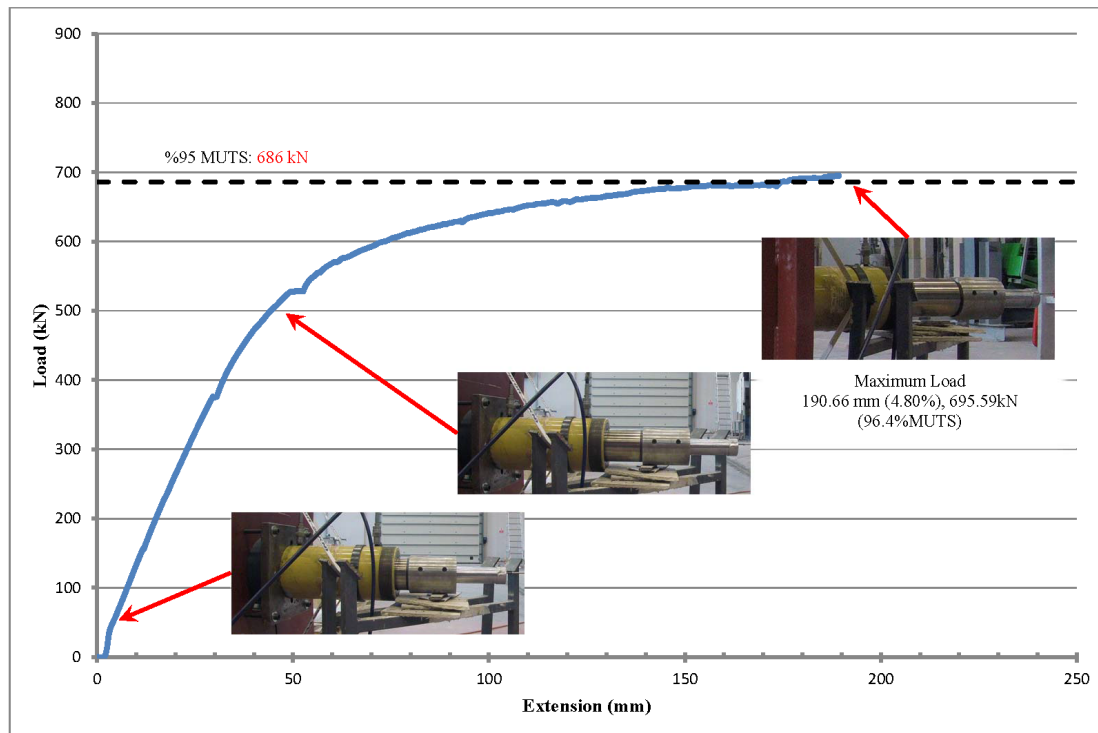
Figure 4.6. Force-extension relation for the tensile Test 2 including the view of the hydraulic cylinder piston ram opening at 50 kN, 500 kN and 695 kN.

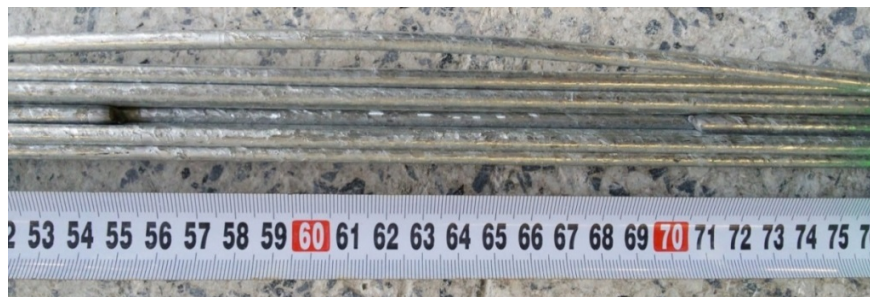
Figure 4.7. The ruptured wire position for S2.

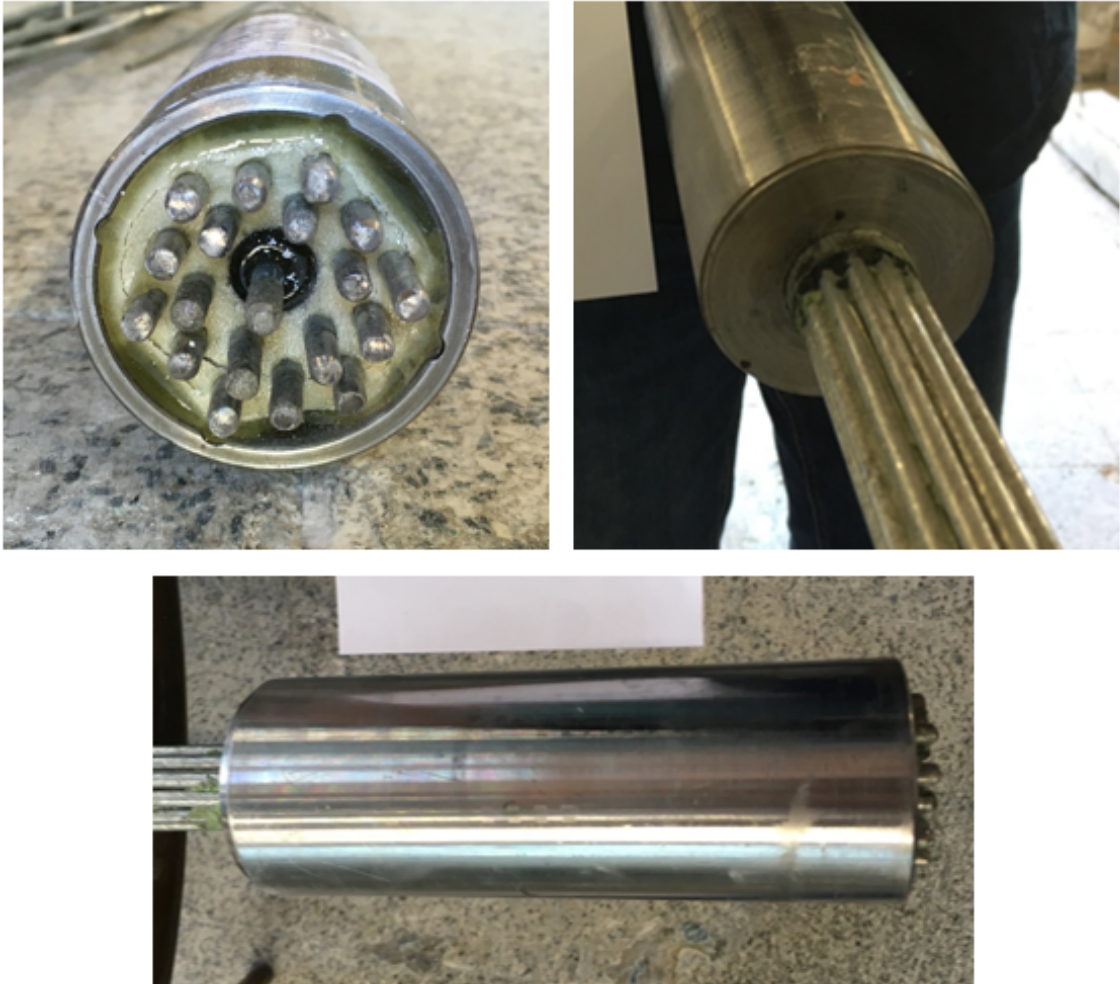
Figure 4.8. Condition of sockets after static test.

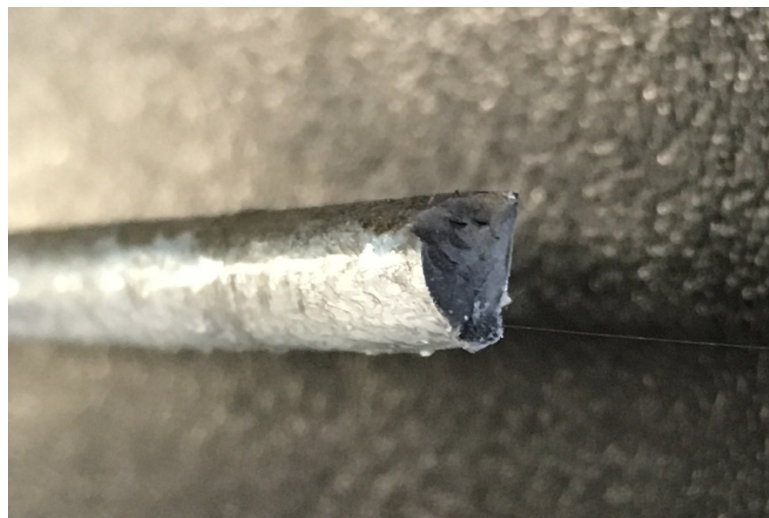
Figure 4.9. A wire fracture for S2.

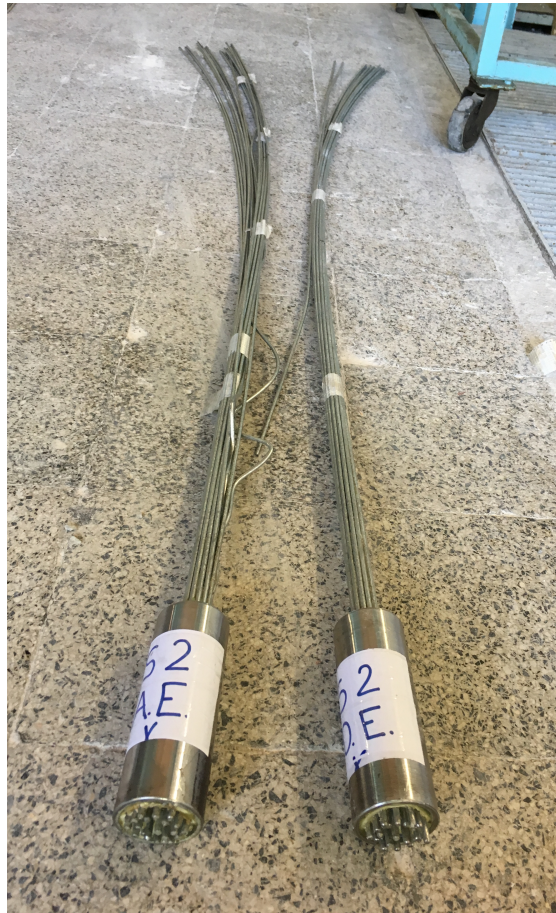
Figure 4.10. Condition both ends of the specimen S2.

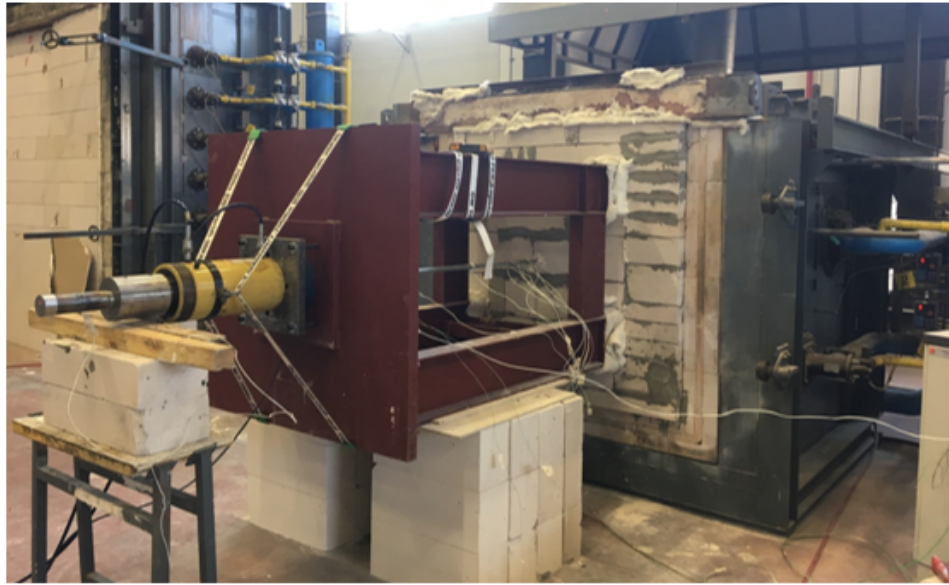
Figure 4.11. The view of the Test 3 setup.

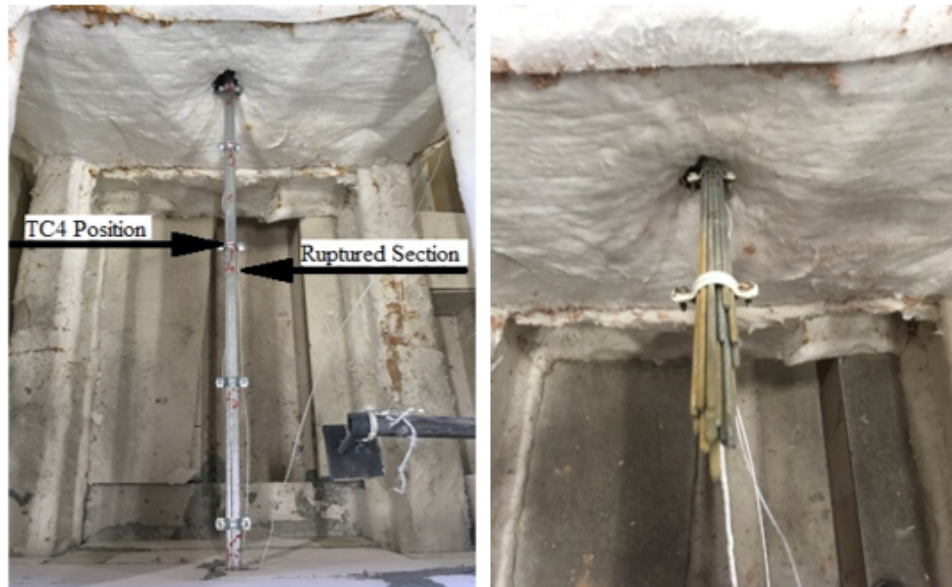
Figure 4.16. Ruptured section and TC4 position (left-hand side) and front view of rupture section (right-hand side).

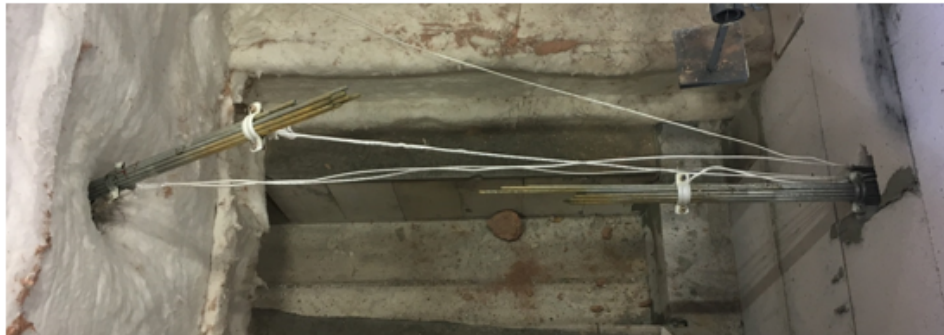
Figure 4.17. Failure view of S3 after fire Test 3.

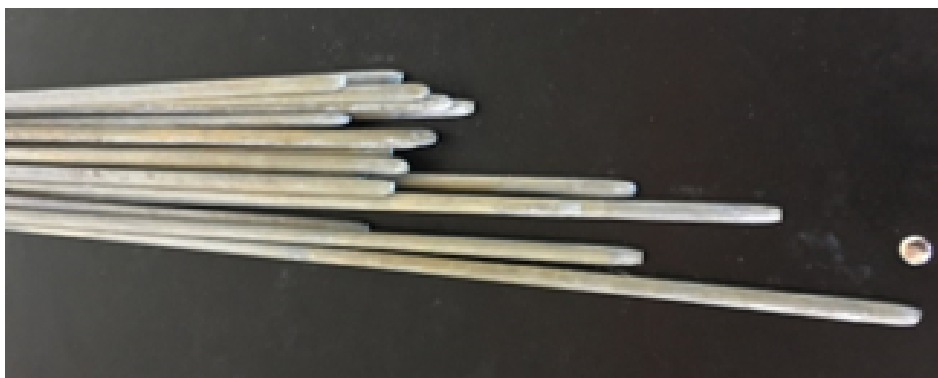
Figure 4.18. Discoloration of ruptured wires after fire Test 3.

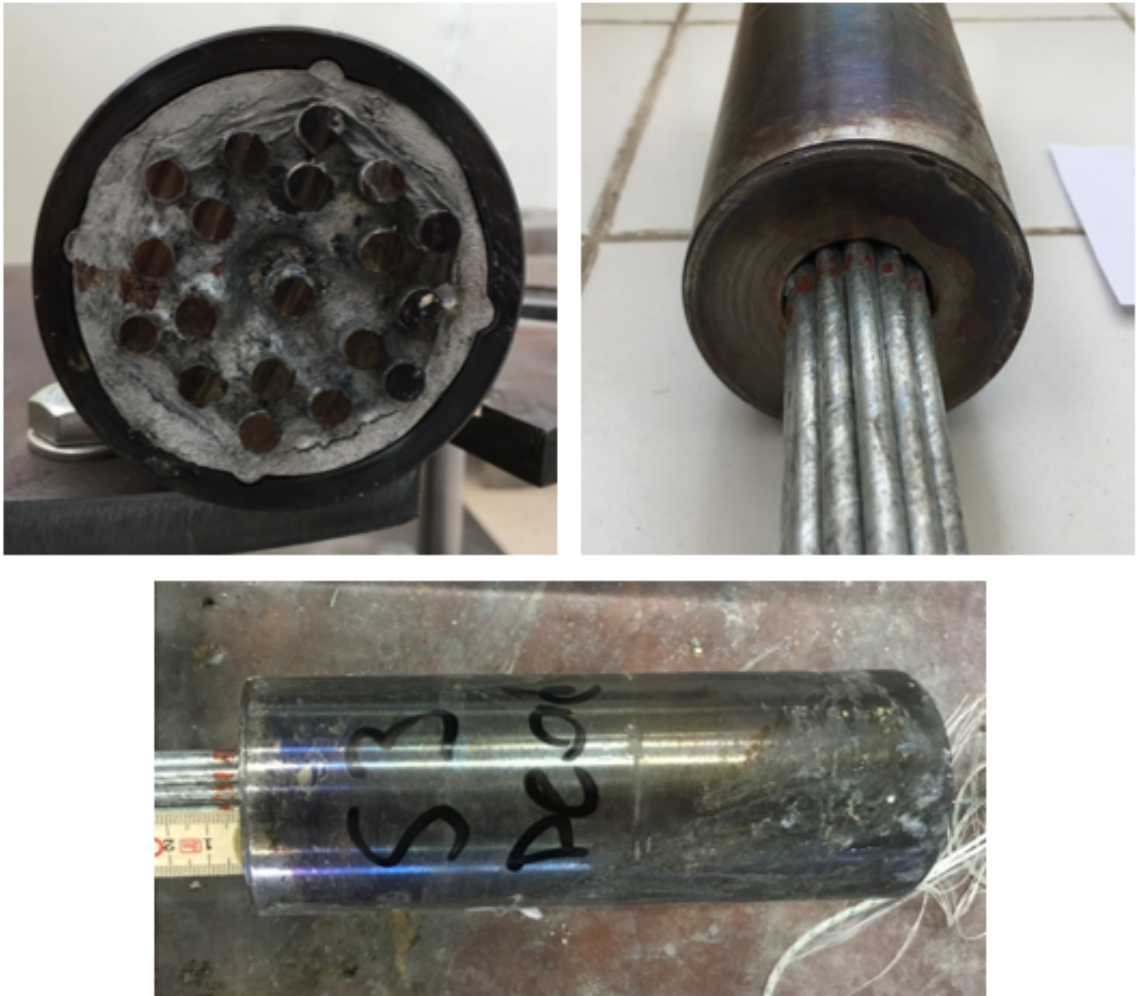
Figure 4.19. Condition of dead end socket after fire Test 3.

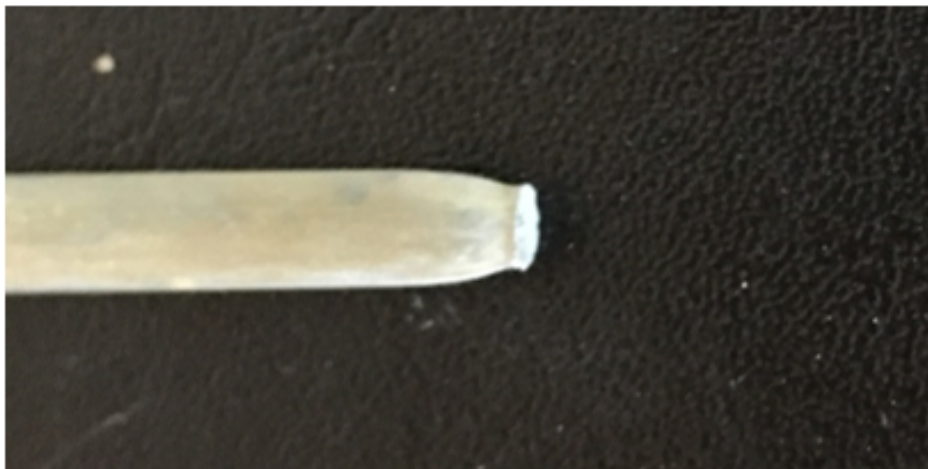
Figure 4.20. A typical cup and cone wire rupture for S3.

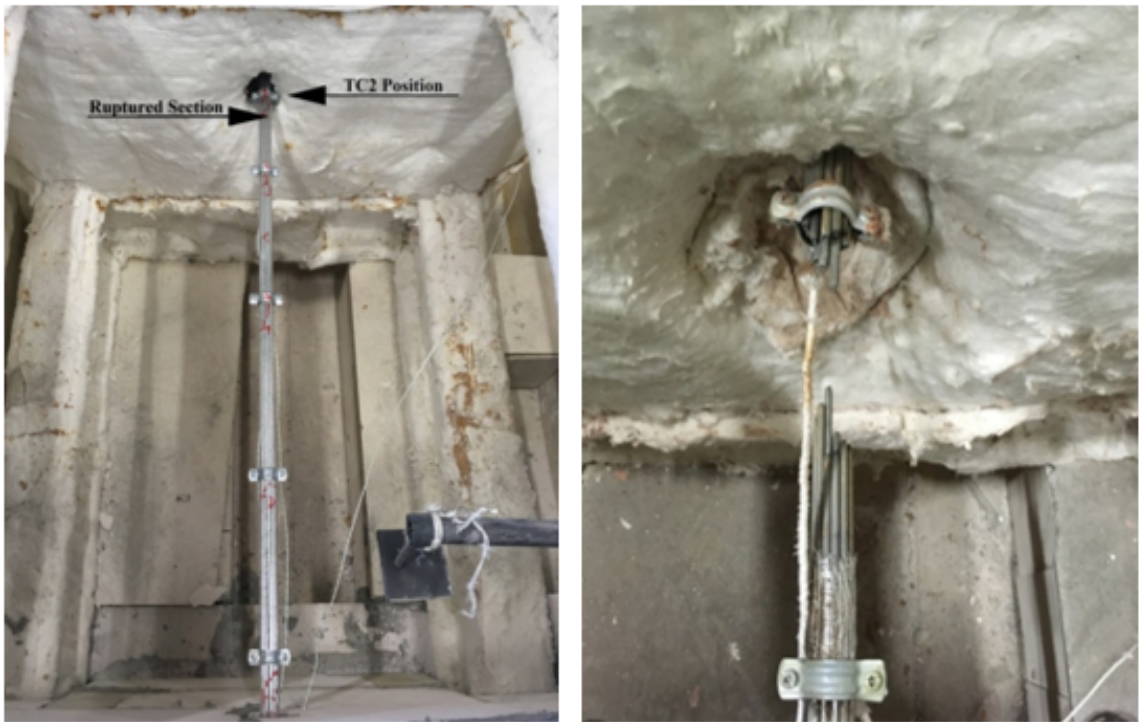
Figure 4.21. TC2 position prior to Test 4 and front view of ruptured section.

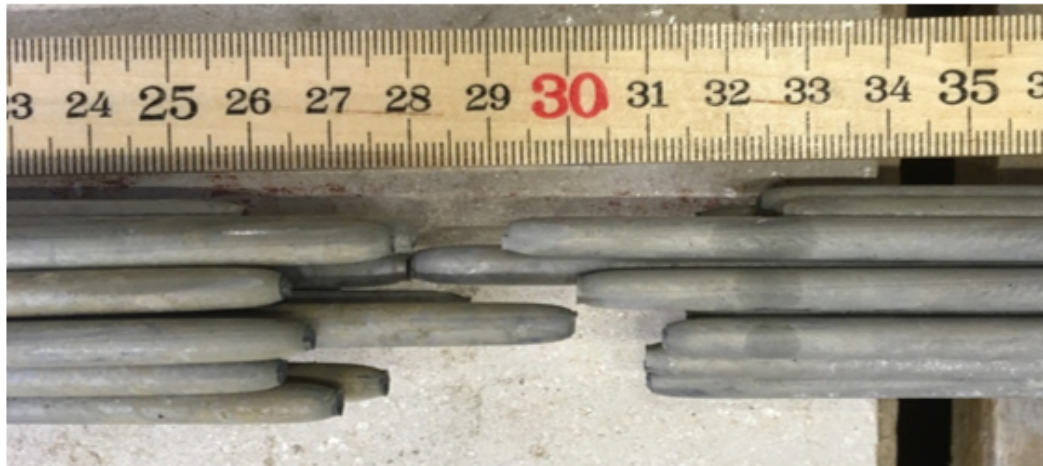
Figure 4.22. Ruptured section.

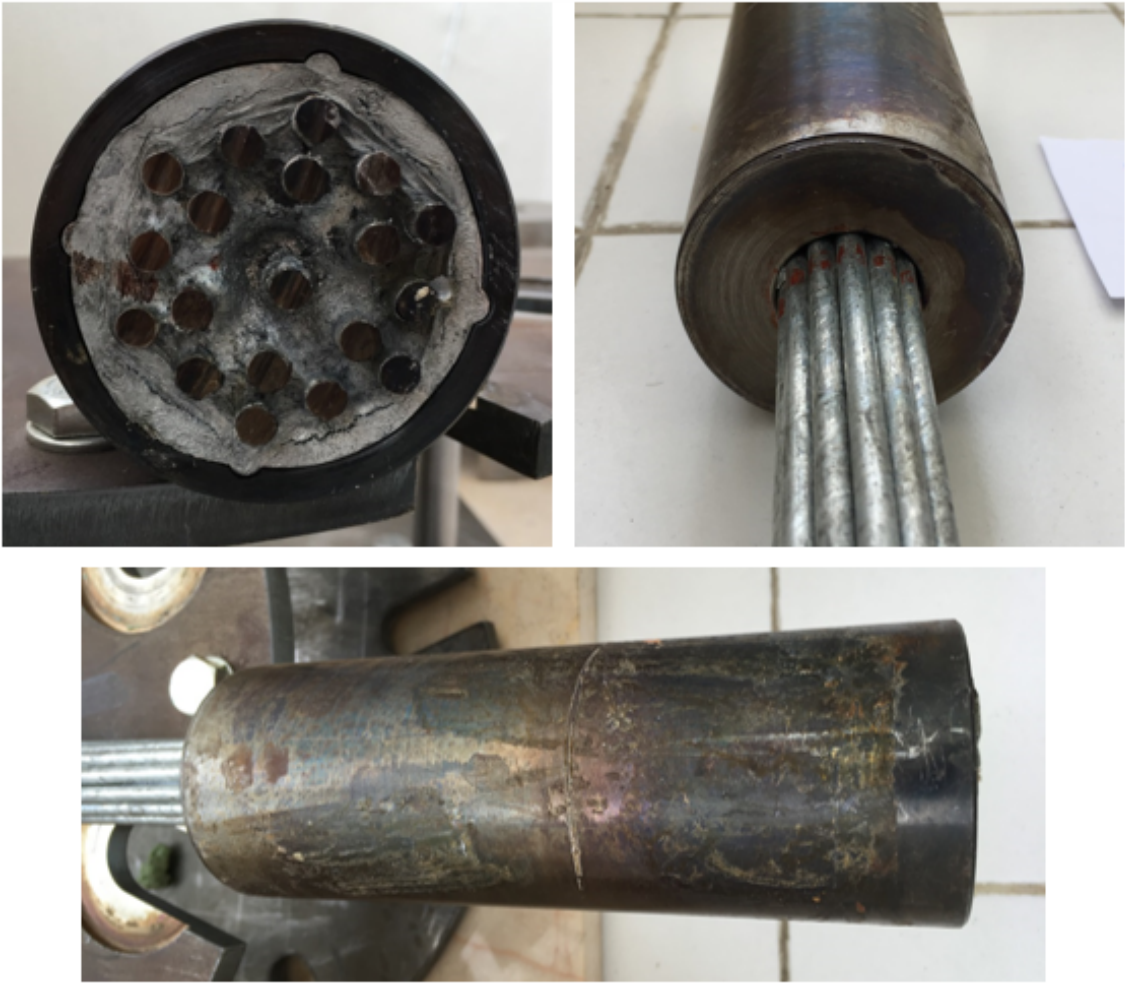
Figure 4.23. Condition of dead end socket after fire test.

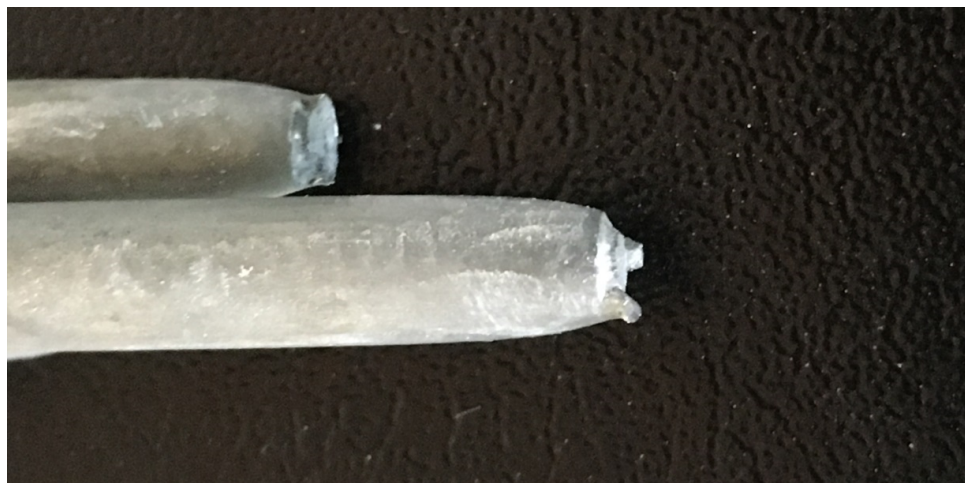
Figure 4.24. Typical cup and cone two wire break fracture for S4.

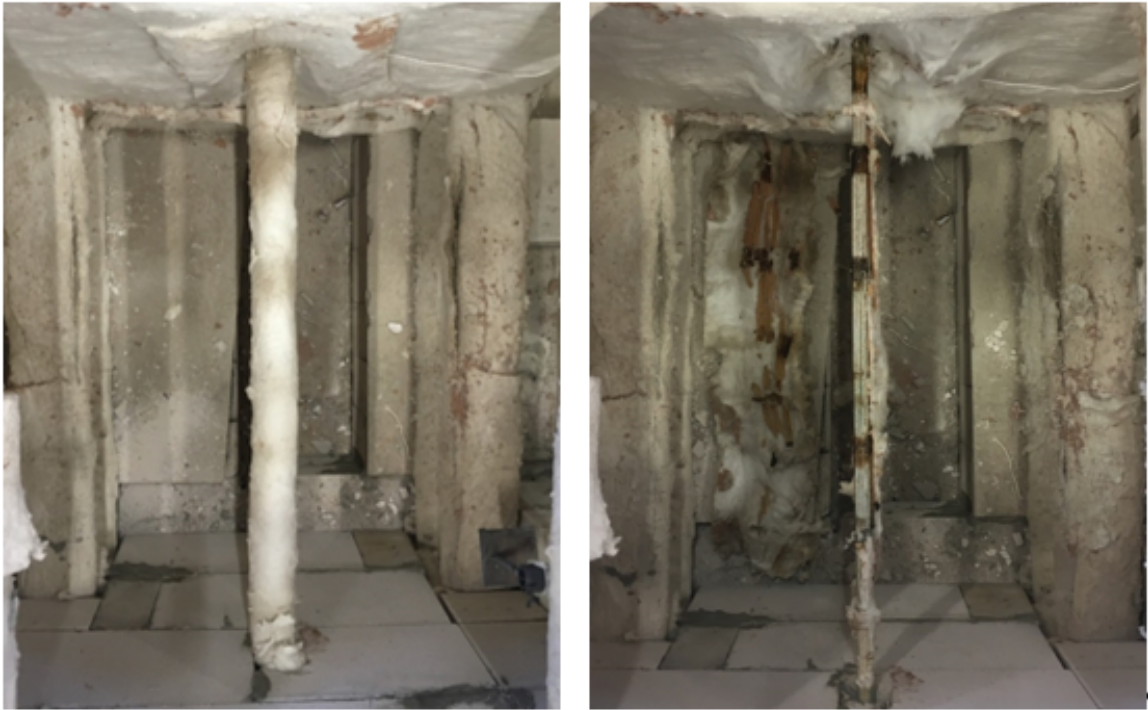
Figure 4.29. S5 strand protection prior to fire test (left-hand side) and S5 condition after fire test 5 (right-hand side).

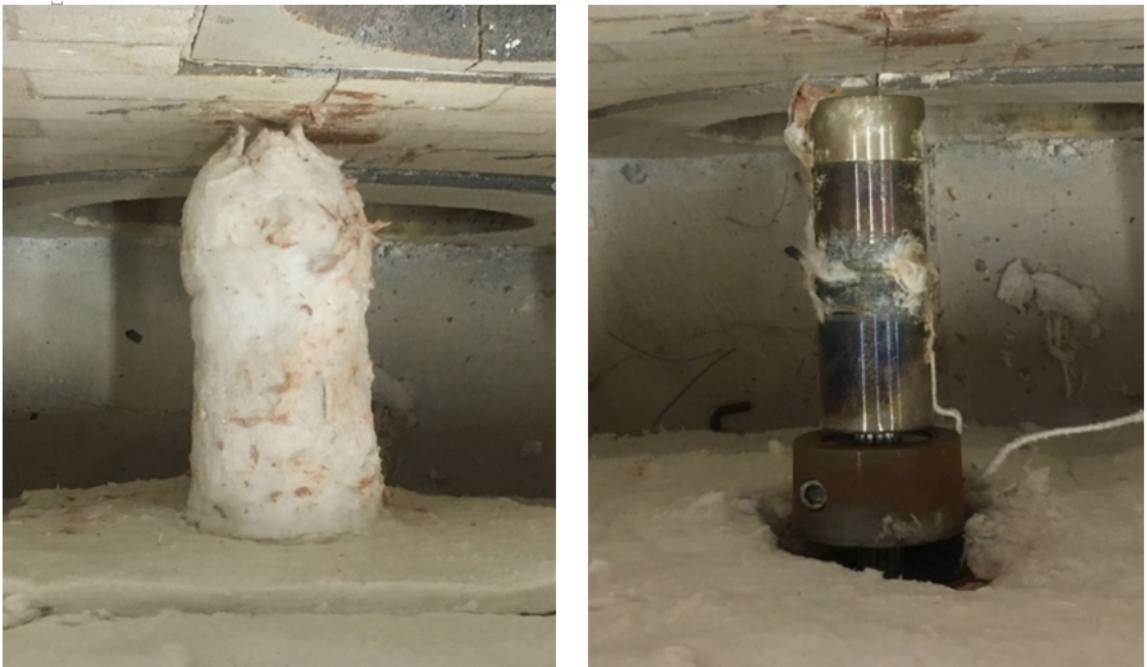
Figure 4.30. S5 socket protection prior to fire test and S5 socket condition after fire test 5.

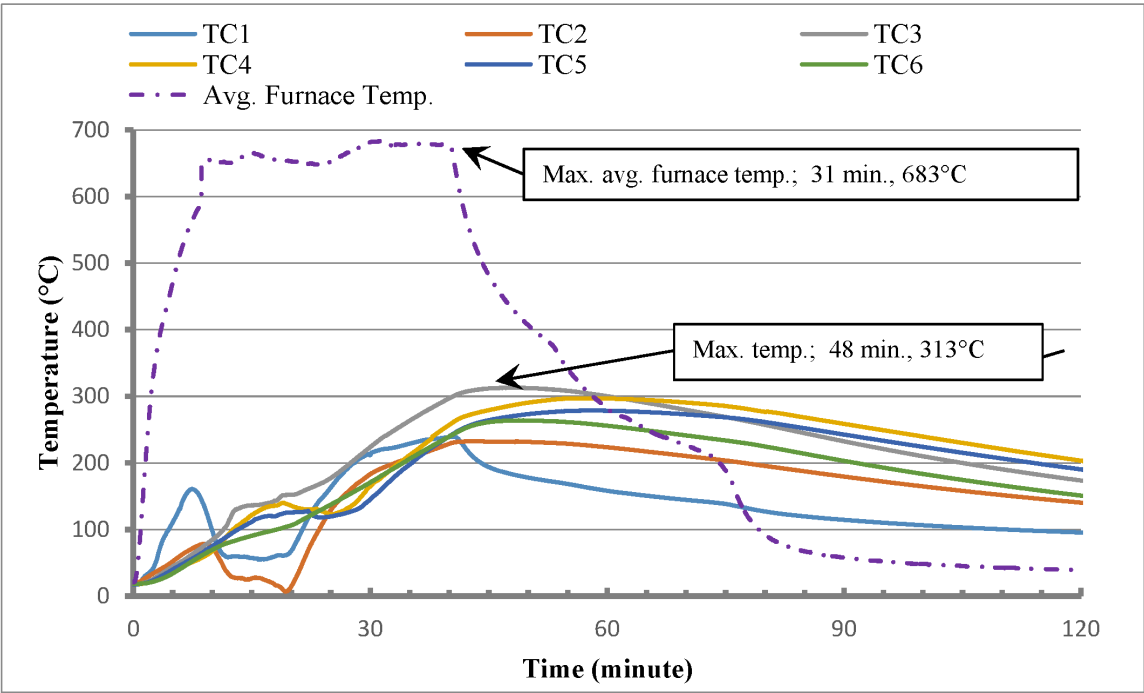
Figure 4.31. Inside furnace thermocouples for S5.

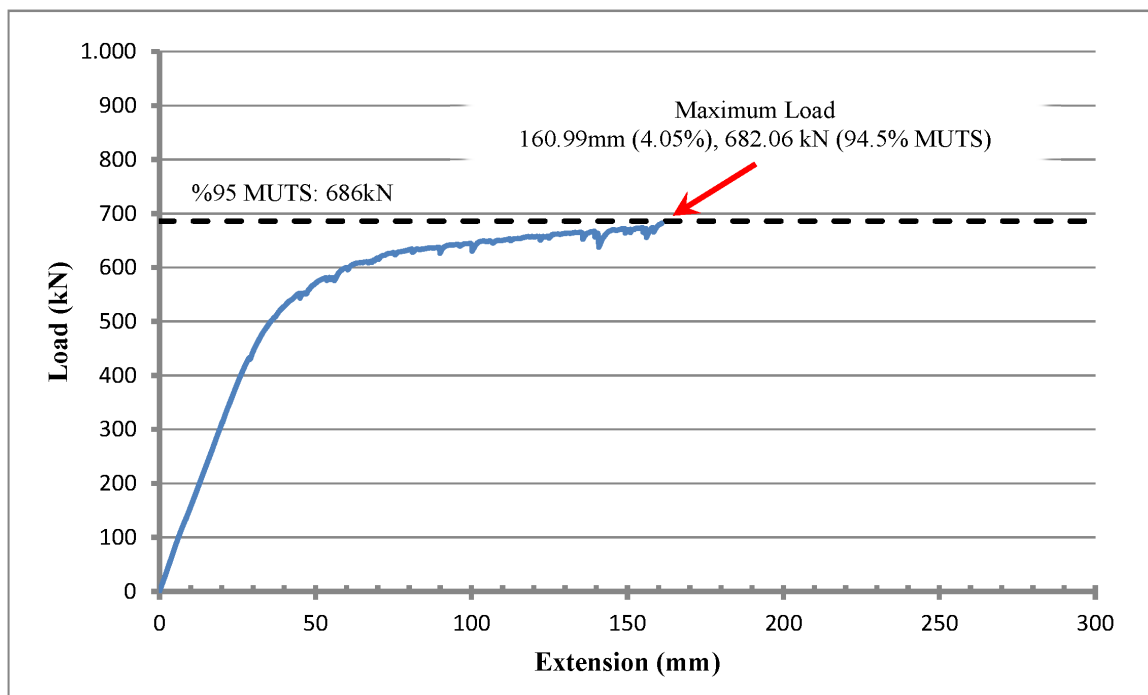
Figure 4.35. Force-extension relation in the tensile test (S5).

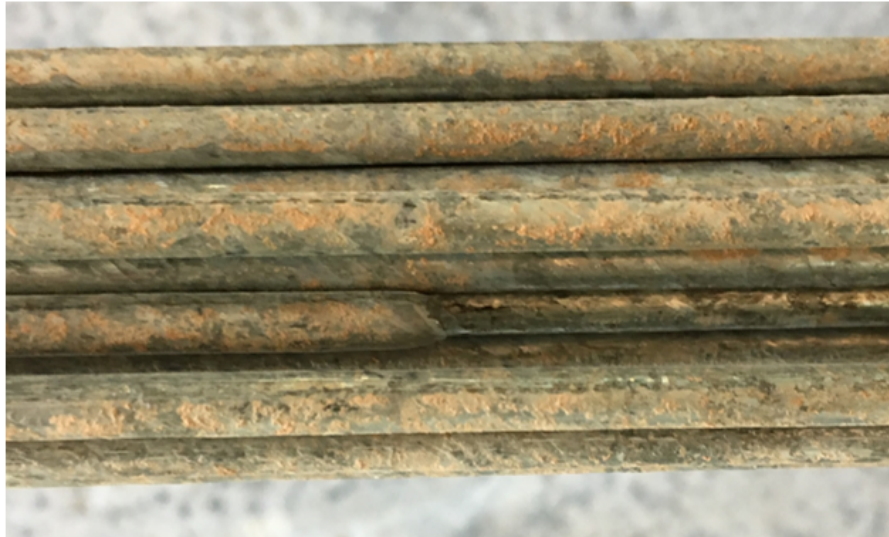
Figure 4.36. S5 discoloration and internal ruptured wire.

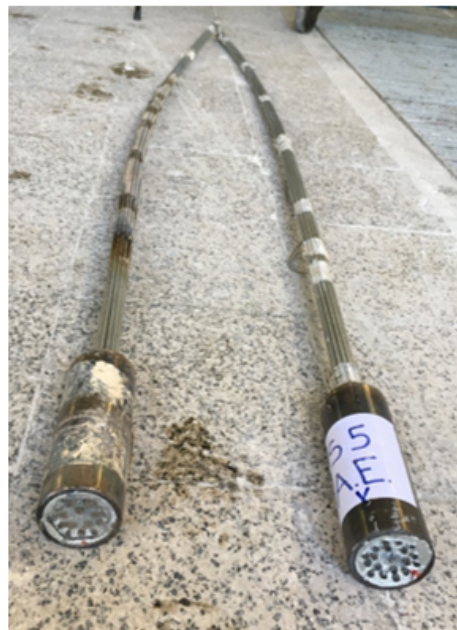
Figure 4.37. Condition both ends of the specimen S5.
