EXPERIMENTAL STUDY ON THE BEHAVIOR OF A PRESTRESSED  
NINETEEN PARALLEL WIRE STRAND (PWS) IN SUSPENSION BRIDGES  
UNDER HYDROCARBON POOL FIRES

B.S., Civil Engineering, Yeditepe University, 2014

Graduate Program in Civil Engineering

Boğaziçi University

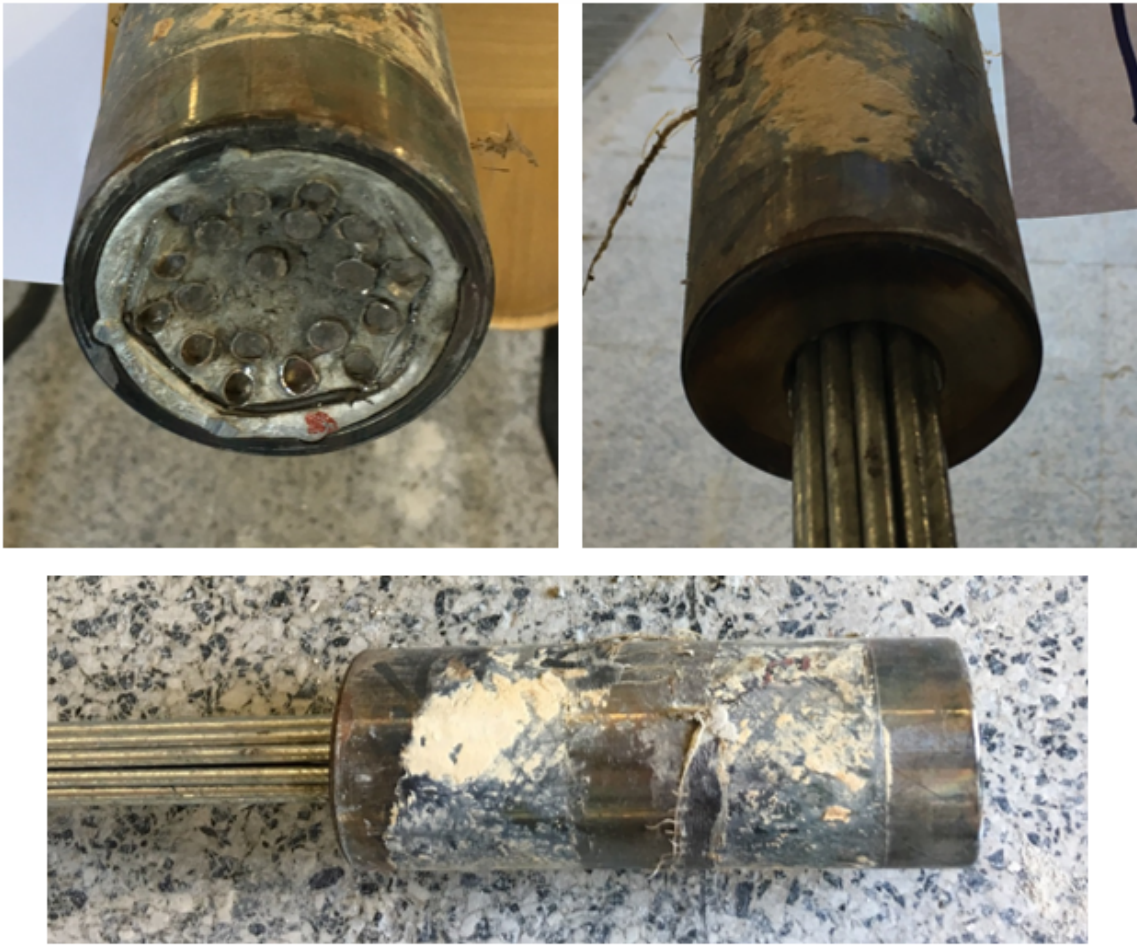
Figure 4.38. Condition of dead end socket after fire Test 5.

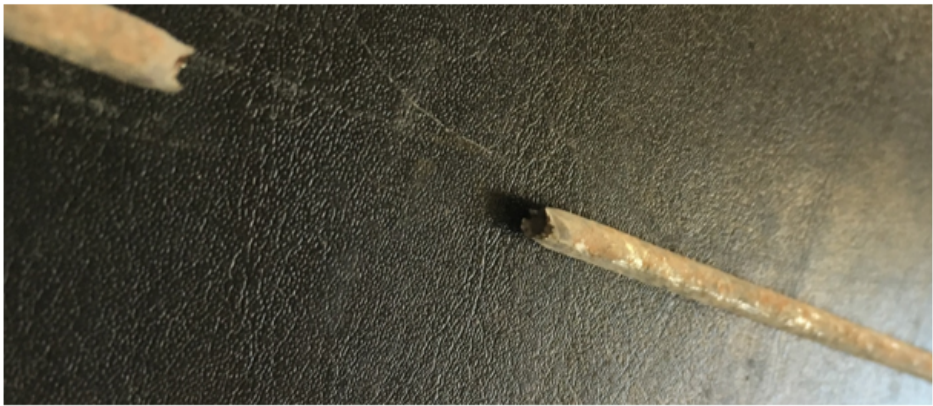
Figure 4.39. A wire fracture for S5.

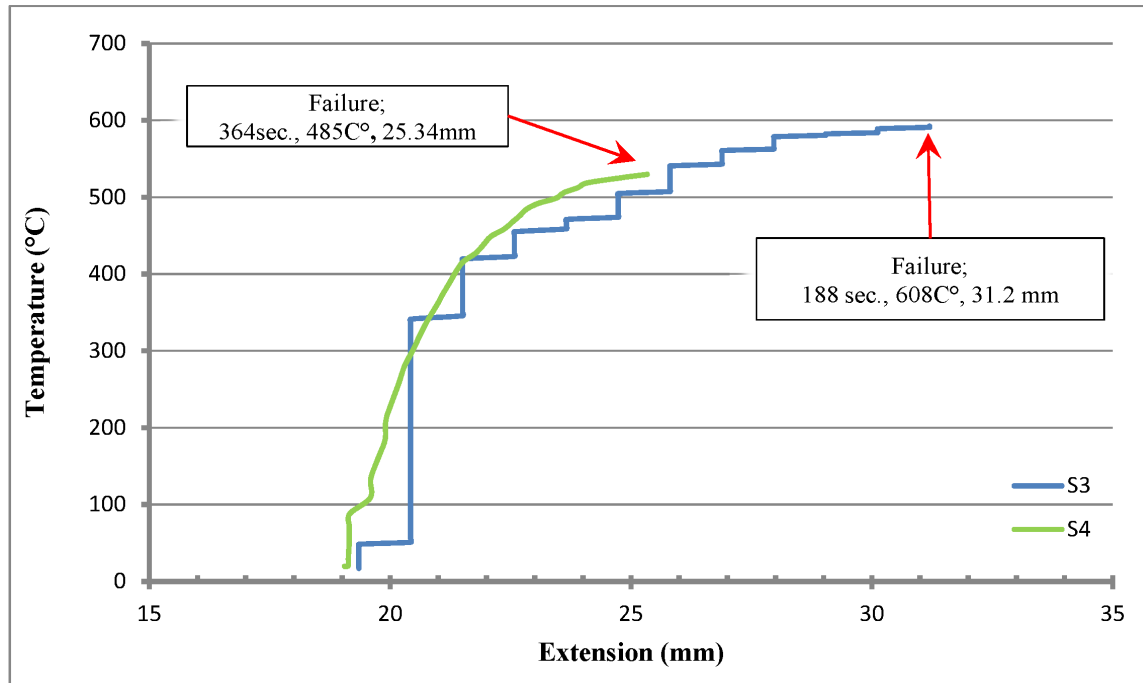
Figure 5.2. Extension-temperature comparison for S3 and S4.
