**TOWARDS INCLUSIVE URBAN DESIGN:  
PROMOTING DESIGN FOR ALL IN SYRIA**

**M.Sc. Thesis by**

**Department of Post-Disaster and Post-War Reconstruction and  
Rehabilitation**

**January 2023**

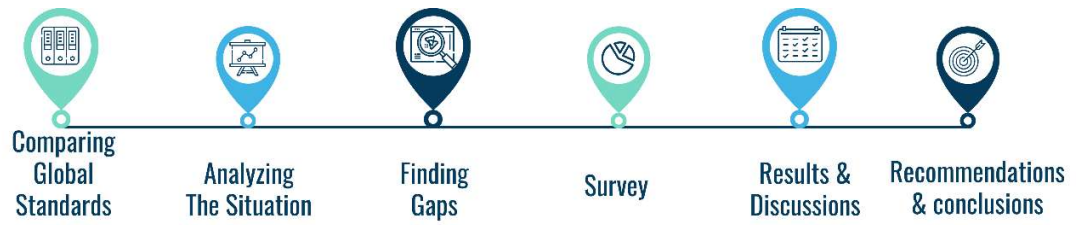
**Figure 1.1** Methodology

regular design process, in order to design the streets without exceptions. Figure 1.1 Shows the method plan.

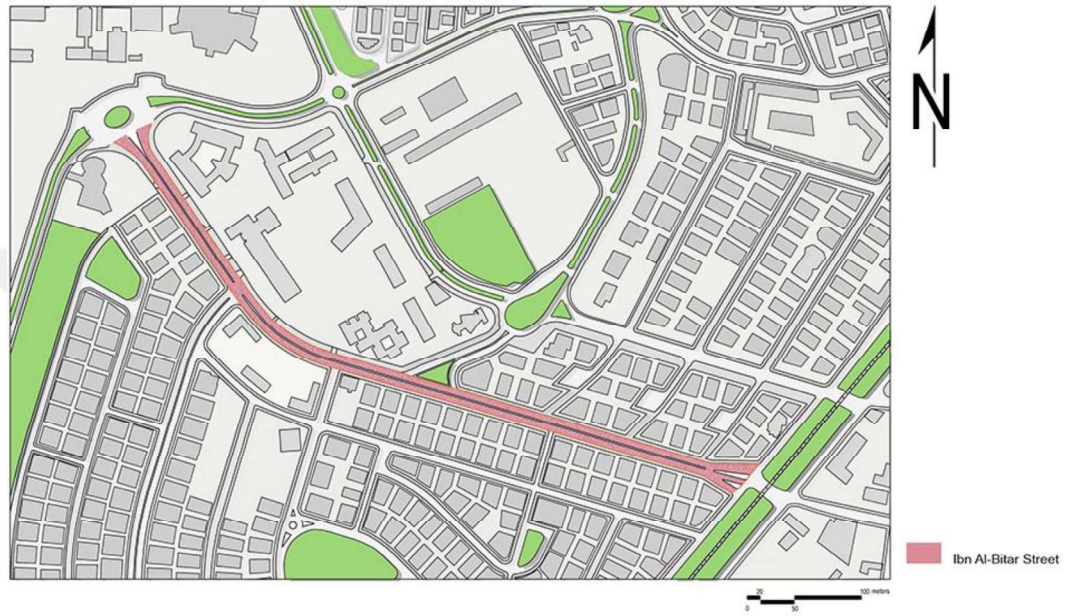
**Figure 3.5.**Ibn Al-Bitar Street.

The land of Ibn AL-Bitar Street has light inclinations, the lowest point of the street is in the east with a height of 379 m above sea level, and the highest point of the street is in the west from the University side at a height of 409 m above sea level. Figure 3.5. shows the street in the neighborhood.

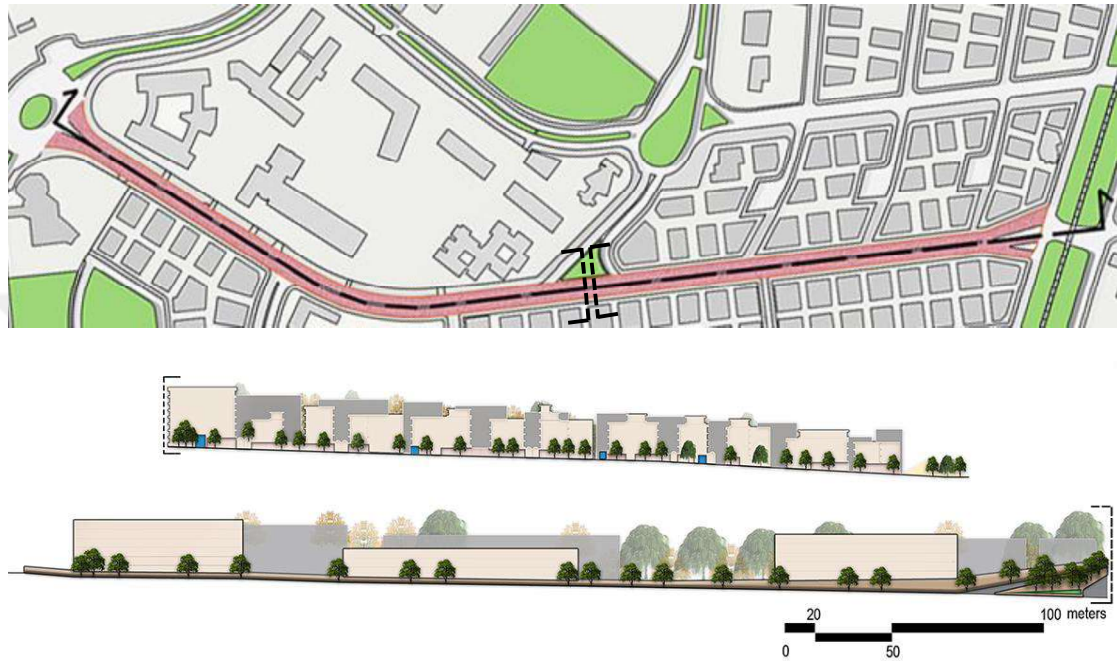
**Figure 3.6.** AA Cross-Section.

AA section in figure 3.6 crosses the street and shows the resident from the right side until the university on the left side and shows the stores and the electricity generators, also the difference between the street height.

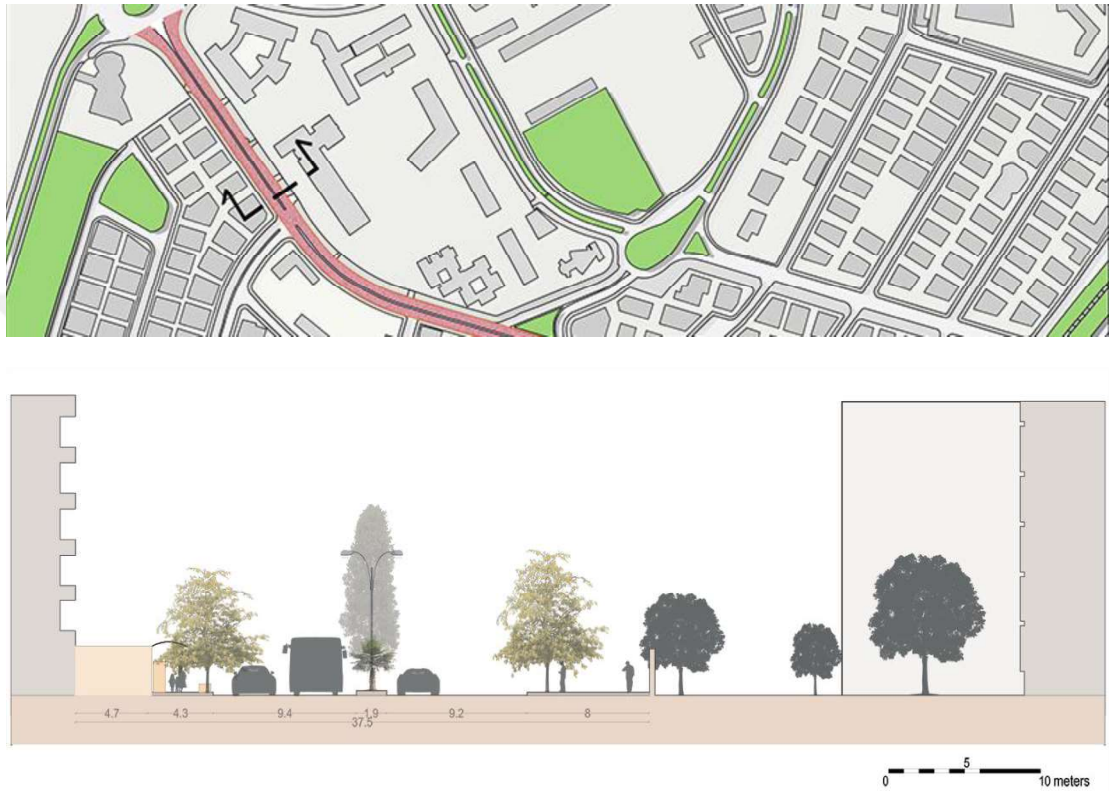
**Figure 3.7.** BB Cross-Section.

figure 3.7 is the BB section, It crosses the street in the university from the right side and the resident from the left side and shows the street measures and the stores' furniture on the walkway.

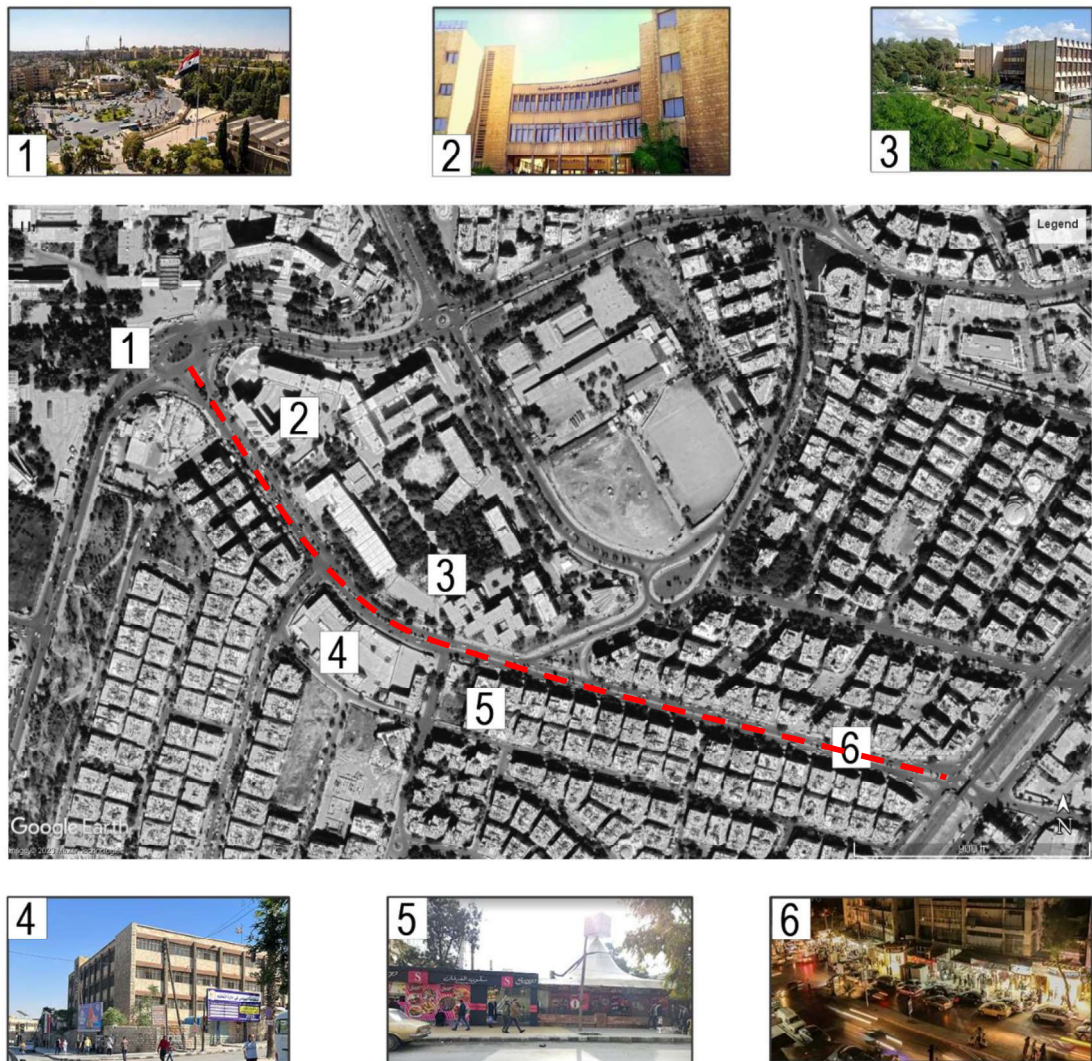
**Figure 3.9.** Photos along Ibn-Albitar street.

The street is one of the crowded streets, surrounded by many residential buildings that were inhabited by their owners, and some of these houses are rented by university students. It has many libraries, clothes stores, cafeterias, food shops, and schools. After the war, and some people started to move there, many food shops and clothes stores opened, which constituted an additional incentive for attracting more internally displaced people. Figure 3.9. shows photos of some buildings along Ibn-Albitar street taken at different times.

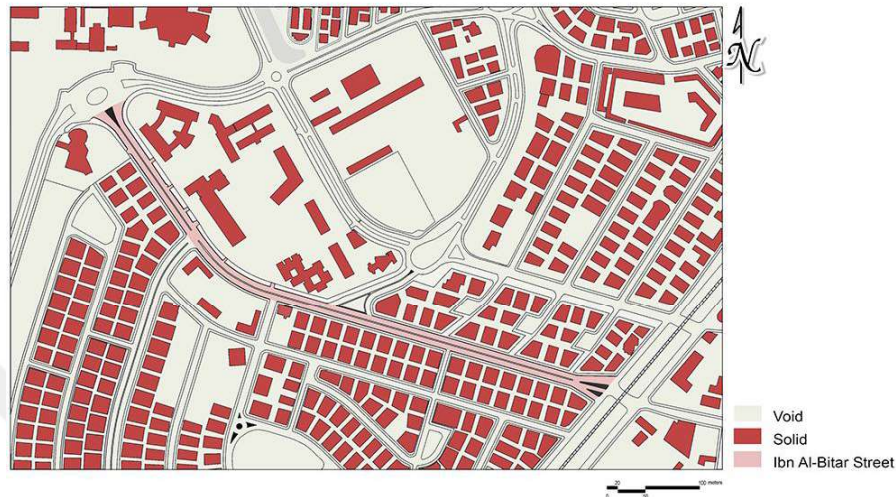
**Figure 3.11.** Mass and Vacuum.

Figure 3.11. presents a space and mass analysis of the street structure, examining the relationship between solid and void areas. it shows how the street service others to emphasize how much it is crowded and important.

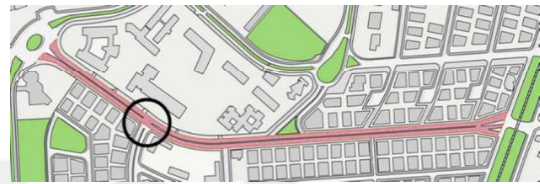
**Figure 3.18** A location

The following figures highlight the problematic situations that exist at Location A in figure 3.18. an area surrounded by residents, a school, and a university. Figure 3.15, figure 3.16 and figure 3.17, shows The analysis reveals that the crosswalk lacks ramps for PRM, the street signs are not at an accessible height, and the columns are placed in the middle of the walkway, hindering movement. Additionally, the traffic sign side lacks ramps and the drainage is not properly maintained, causing water to accumulate. On the opposite side of the street, there are obstacles such as trash containers and a lack of ramps and level surfaces for pedestrians to safely cross the street.

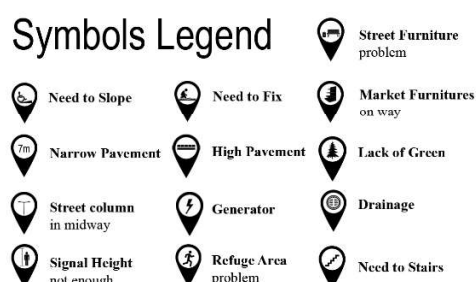
**Figure 3.19. B Location**

The following figures highlight the issues at Location B in figure 3.19, an area located in front of a high school and across from a university. Figure 3.20, figure 3.21 and figure 3.22, shows the walkway is wide, but lacks from trees shade . On the university side, there is a bus station without seating or ramps for easy movement. Additionally, the pavement at this location is in need of repair, with areas that are uneven and make the walkway narrow in certain spots. The drainage system is also impeded by a tree whose roots have damaged the pavement and blocked the flow of water.

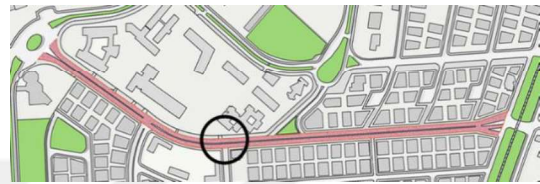
**Figure 3.26 C Location**

The following figures highlight the problematic situations at Location C in figure 3.26, which is located at a street intersection near a cafeteria, a school, and a university. Figure 3.23, figure 3.24 and figure 3.25, presents several accessibility challenges, including electrical columns and market stands placed in the middle of the pavement, and a lack of ramps for PRM. The street crossing is also too narrow, and the pavement height is uneven, making it difficult to navigate. Additionally, the street sign at this location is inadequate, as it is not placed in an optimal location.

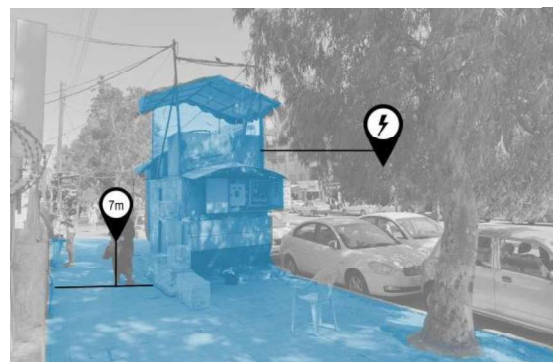
The following figures highlight the problematic situations at Location D in figure 3.30, The area located on a street crossroad which leads to Duwar Al-Ukhuwa and is surrounded by residential areas and a university. Figure 3.27, figure 3.28 and figure 3.29, displays the area characterized by a difference in elevation levels, which requires the installation of ramps to allow for easy pedestrian access. The presence of trash containers obstructs movement, and the pavement width is too narrow to accommodate PRM. Additionally, the area needs trees to provide shade and cover the empty space. The placement of billboards in the middle of the pavement, as well as the presence of chipped surface layers and stones, further contribute to the difficulty of navigating the area.

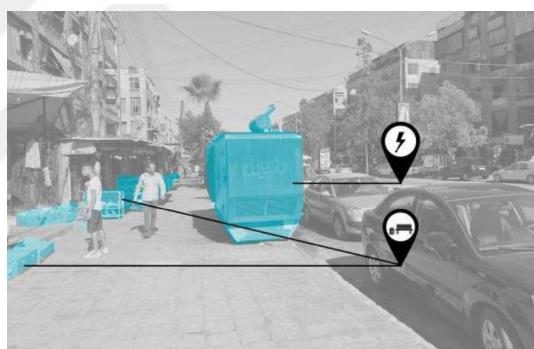
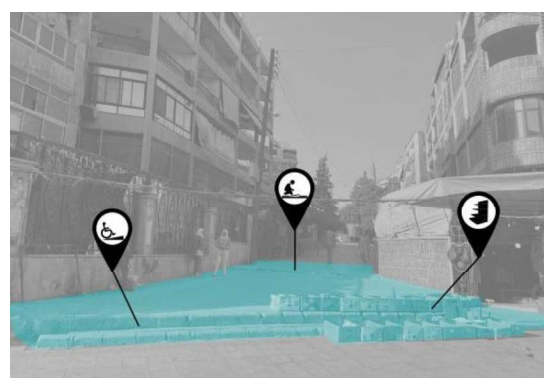
The following figures highlight the problematic situations at Location E in figure 3.32. Figure 3.31, figure 3.33 and figure 3.34 display the corridor has stairs but with no ramps, making it difficult for PRM to access. Additionally, the area is cluttered with market goods, blocking the path and creating obstacles for pedestrians. The surface of the pavement is uneven and cracked, and there is a lack of seating or shading options for those waiting at the bus station. Furthermore, the presence of electrical generators in the area adds to the congestion and lack of accessibility for all individuals. Overall, these corridors present a number of challenges for PRM.

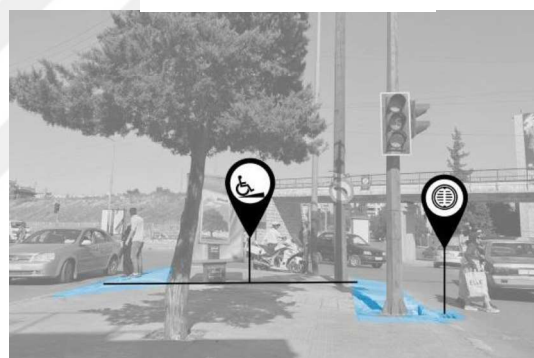
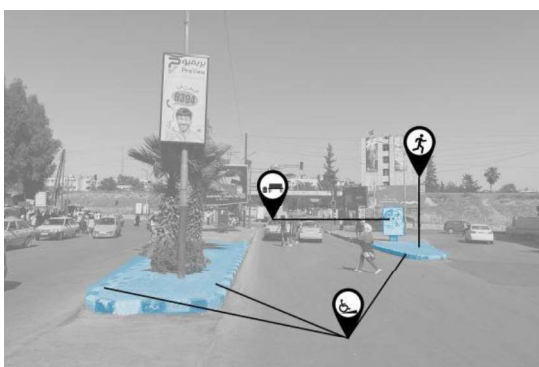
The following figures highlight the problematic situations at Location F in figure 3.35, The area located in the end of Ibn Al-Bitar Street. Figure 3.36, figure 3.37 and figure 3.38, shows the pavement in this area also in poor condition with chipped and cracked surfaces, making it difficult for PRM to navigate.

Additionally, there is a lack of proper street signage and traffic signals, making it difficult to safely cross the street. The area also lacks proper drainage, which can cause water to pool on the pavement and further impede accessibility.
