**MONITORING AND EXPLORING NATURAL  
HAZARD RISK IN TEOS ANCIENT CITY USING  
REMOTE SENSING AND GIS**

**Fatih YILDIZ**

**A Thesis Submitted to the  
Graduate School of Natural and Applied Sciences of Dokuz Eylül University  
In Partial Fulfillment of the Requirements for the degree of Master of  
Science in Geographical Information Systems Program**

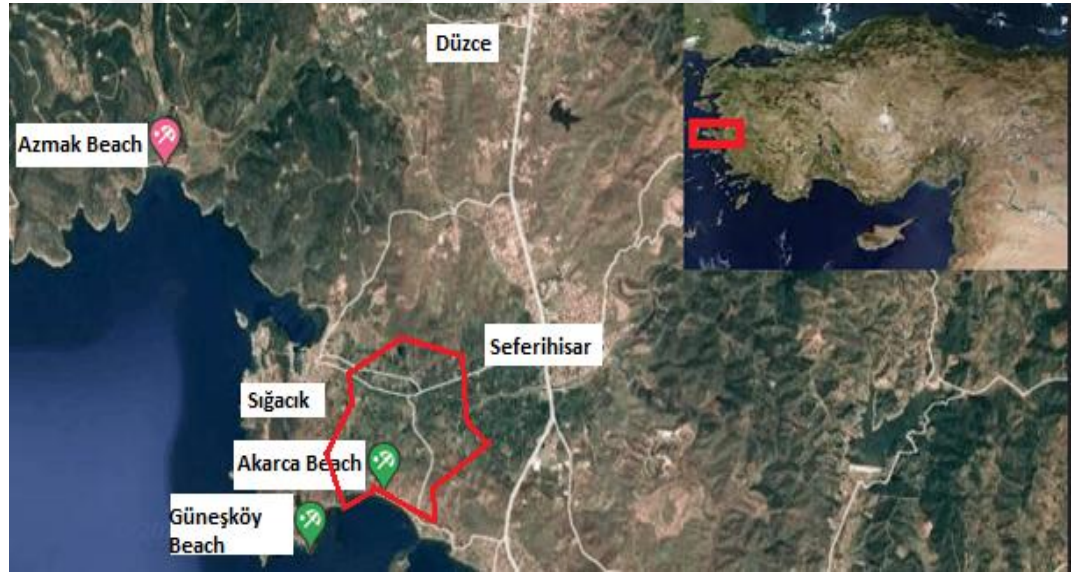
Figure 1.1 Location of Teos Ancient City (Red Outline) (Source: ©Google Maps, 2021)

The borders of Teos Ancient City are marked with a red outline and its position relative to Seferihisar and Sığacık appears in Figure 1.1

coastal town called Sığacık, which is connected to the district of Seferihisar in İzmir. (“Teos,” 2022) (Fig 1.1).

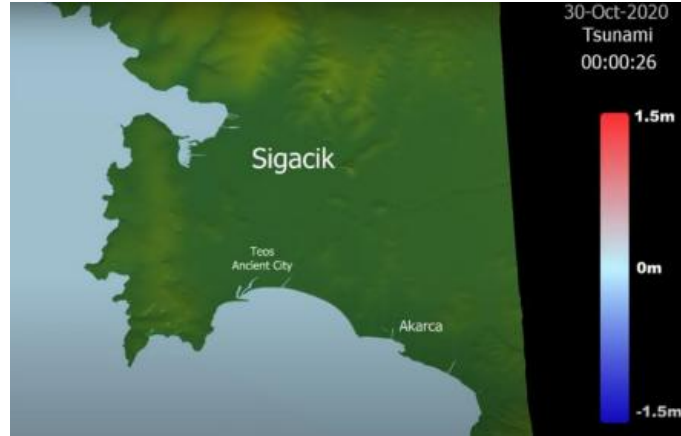
Figure 2.6 Before the beginning of tsunami (Özacar et al., 2020, p.16)

According to the studies of Özacar et al. (2020, p.16) carried out in the field and the statements of the people who were in the region at the time of the incident, it was concluded that the places that were most heavily affected after the earthquake were Sığacık Marina, Sığacık Bay and Akarca region. The distance of these places to the epicenter was seen as 30 km. Tsunami generation zone, distribution of the tsunami wave and wave run-up were seen spatio-temporally in the study of Özacar et al. (2020, p.16) (Fig. 2.6, Fig. 2.7 & Fig. 2.8).

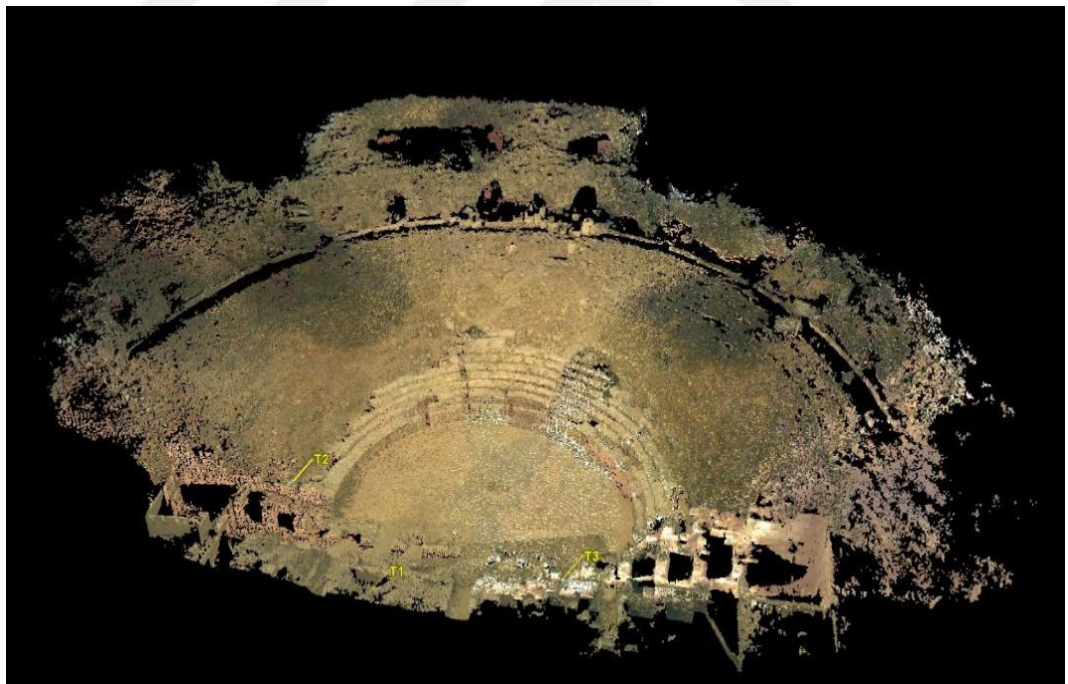
Terrestrial LiDAR scanner was planned to be used in order to detect millimetric changes in the structures between two different dates. However, because of the pandemic conditions and the lack of economic funding, second measurements could not be realized.

LiDAR outputs obtained as a result of the first measurement are 2 pieces (Fig. 3.25 & Fig. 3.26). In the 2nd output image (Fig. 3.26), vegetation has been removed for more accurate LiDAR studies.

The first measurements made with terrestrial LiDAR could not be completed due to Covid-19 and adverse weather conditions. No conclusion could be reached with the output images obtained (Fig. 3.25 & Fig. 3.26).

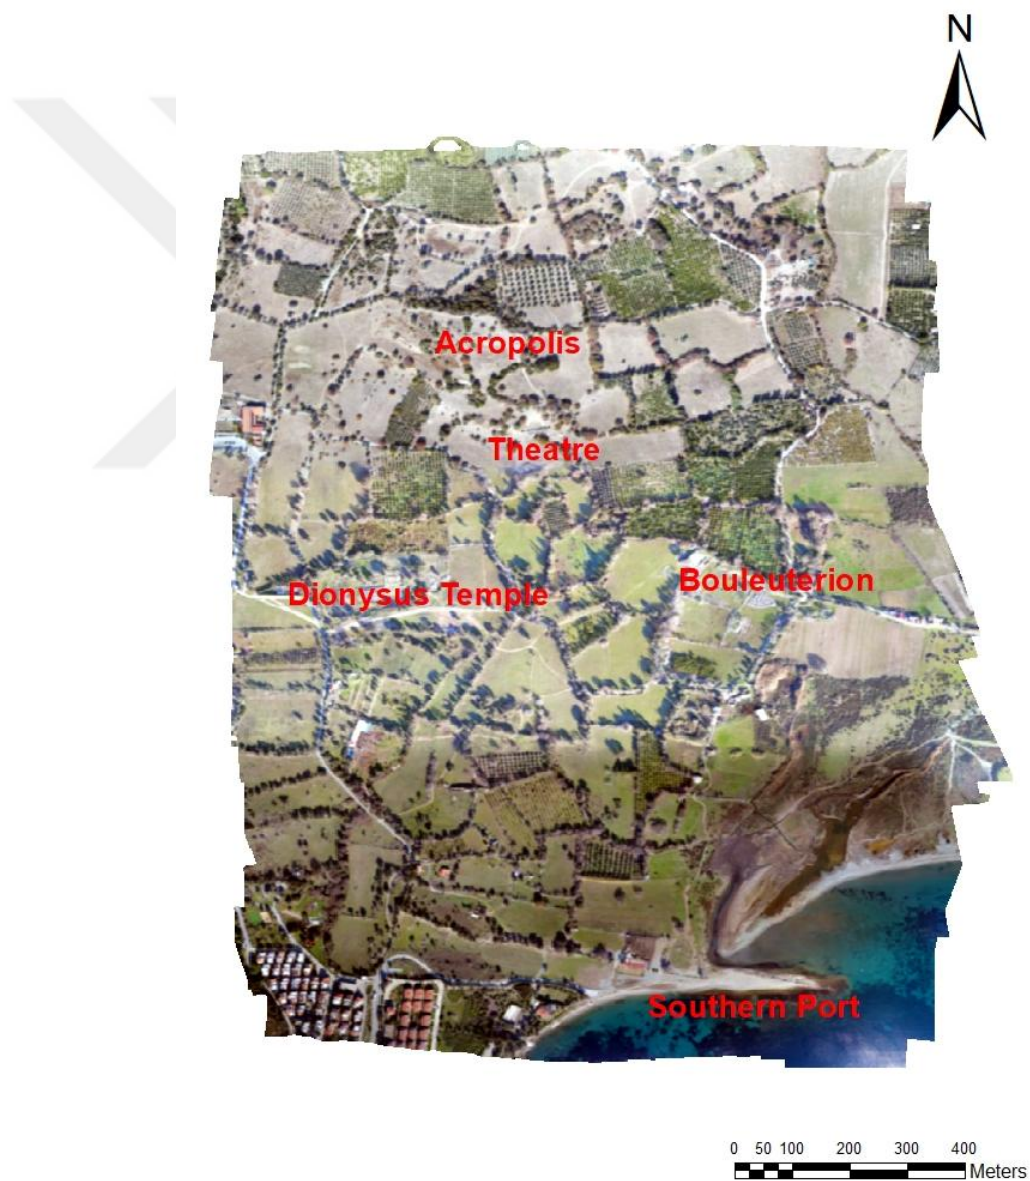
Figure 3.27 UAV image of Teos made with UAV flight outputs in 2021

The UAV images were used to produce the most up-to-date map of the study area (Fig. 3.27).

The UAV flights included oblique picture acquisition and were pre-planned using modern UAV systems' waypoint capability.

A map covering the ancient city of Teos and its surroundings, which was created with the data obtained after the UAV flights, was revealed (Fig. 3.27).

- As a result of the UAV images obtained by UAV flights (Fig. 3.28, Fig. 3.29, Fig. 3.30, Fig. 3.31 & Fig. 3.32) and the map created with these images (Fig. 3.27), the most up-to-date images of the ruins in Teos were obtained in high resolution. According to the images, it was observed that vegetation surrounds the Acropolis, Theater and Dionysus Temple. Southern Port, on the other hand, is notable for its obvious proximity to residences and restaurants used by people. The illegal construction around Teos was not reflected in the orthophoto images, but this situation was revealed in in-situ observations.

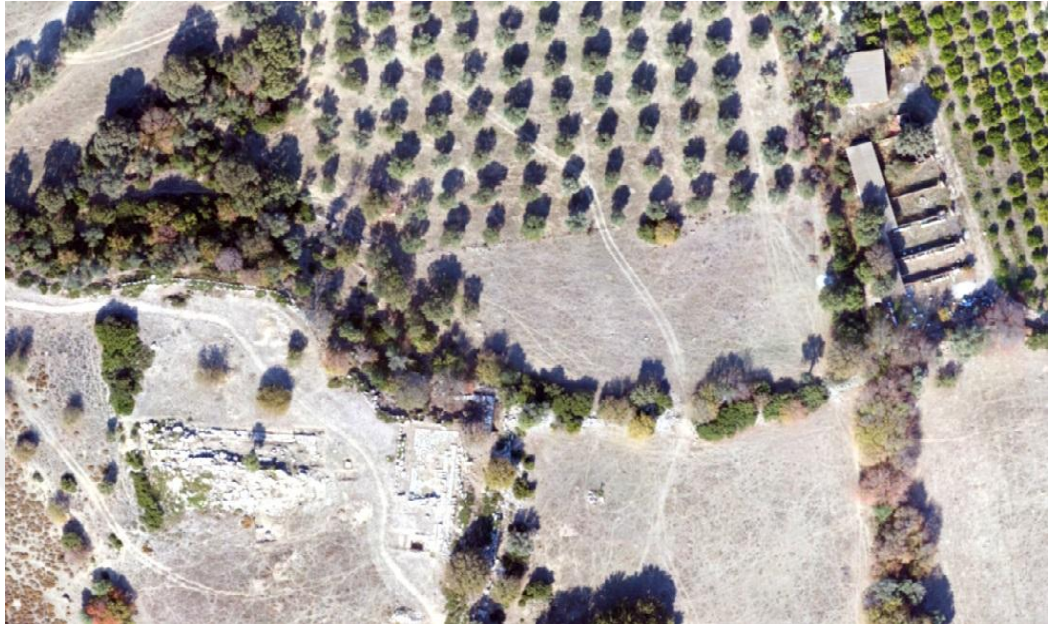
Figure 3.28 UAV image taken in 2021 that shows Acropolis

In addition, the most up-to-date UAV images of the important ruins in Teos were obtained during the UAV flights (Fig. 3.28, Fig. 3.29, Fig. 3.30, Fig.3.31 & Fig. 3.32)

High resolution UAV images of all important ruins in Teos were obtained after UAV flights (Fig. 3.28, Fig. 3.29, Fig. 3.30, Fig. 3.31 & Fig. 3.32).
