**EXPERIMENTAL AND NUMERICAL  
INVESTIGATION OF PIPING IN UNIFORM  
EMBANKMENT DAM WITH WEAK LAYER AT  
THE UPPER REGION**

**A Thesis Submitted to  
the Graduate School of Engineering and Sciences of  
İzmir Institute of Technology  
in Partial Fulfillment of the Requirements for the Degree of**

**in Civil Engineering**

**by  
Merve OKAN**

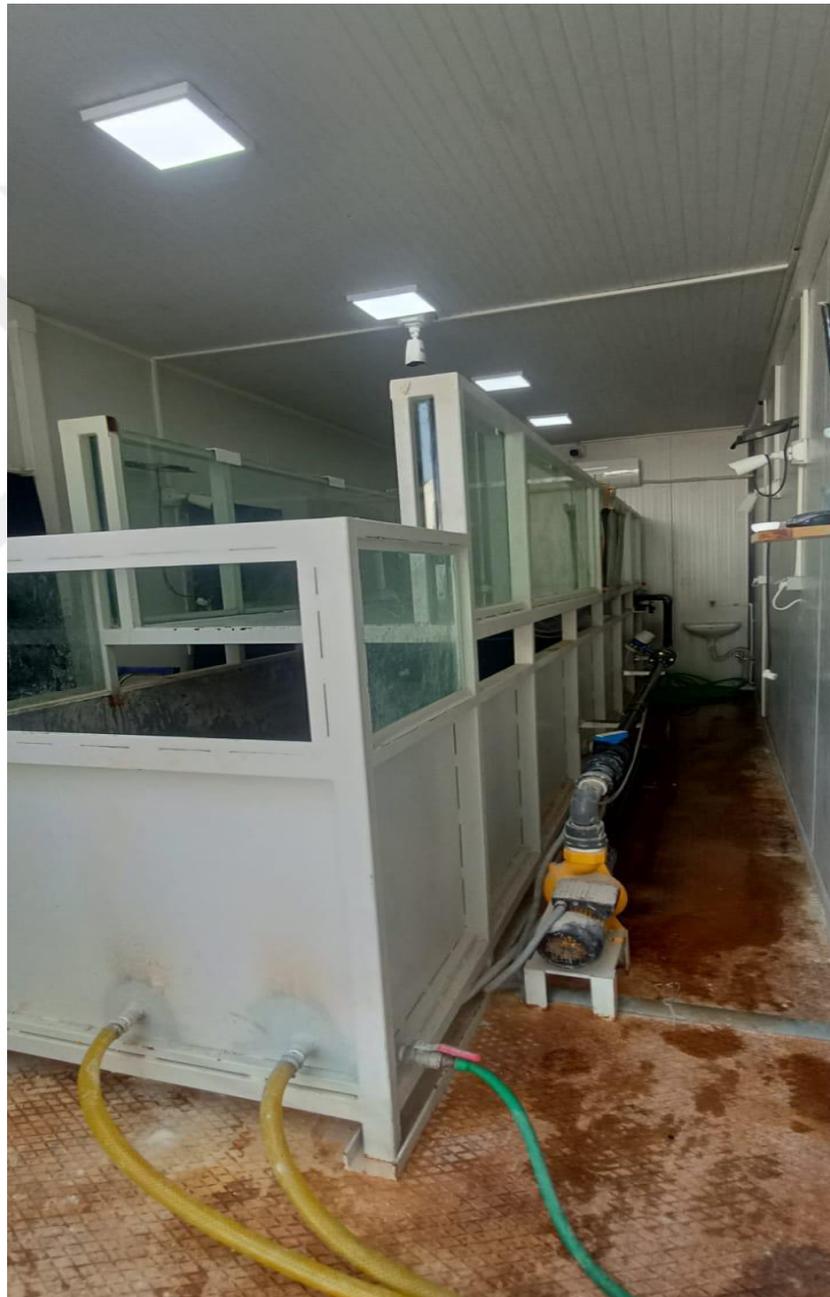
Figure 4.2. Experimental Flume

To adjust the flow from the pump to the flume, a control valve is used. A flow straightener was assembled during the production of the flume on the upstream side to make a smooth flow and decrease turbulence. The flowrate was measured by a magnetic flowmeter. To adjust the water level, an electromagnetic sensor was attached which starts and stops the pump when water depths in the channel were 0.540 m and 0.555 m, respectively. Grid lines were arranged on the side glasses with 1-cm grid interval.

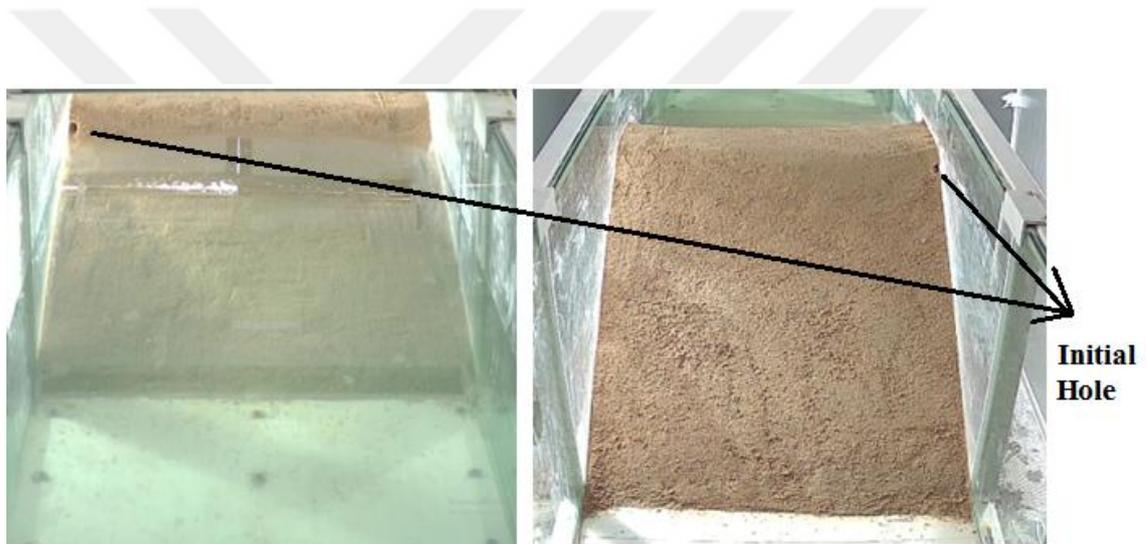
Figure 5.4. Initial hole place for the first scenario

- In the first scenario, a 2-cm circular hole at 54 cm level and the right side of the dam was created (Figure 5.4). The pump was adjusted to maintain 3.82 m<sup>3</sup>/h continuous flow.
