**BEHAVIOR OF BOLTED TENSION SPLICE CONNECTIONS IN STEEL  
LATTICE OVERHEAD TRANSMISSION LINE TOWERS**

**A MASTER'S THESIS**

**Civil Engineering**

**Atilim University**

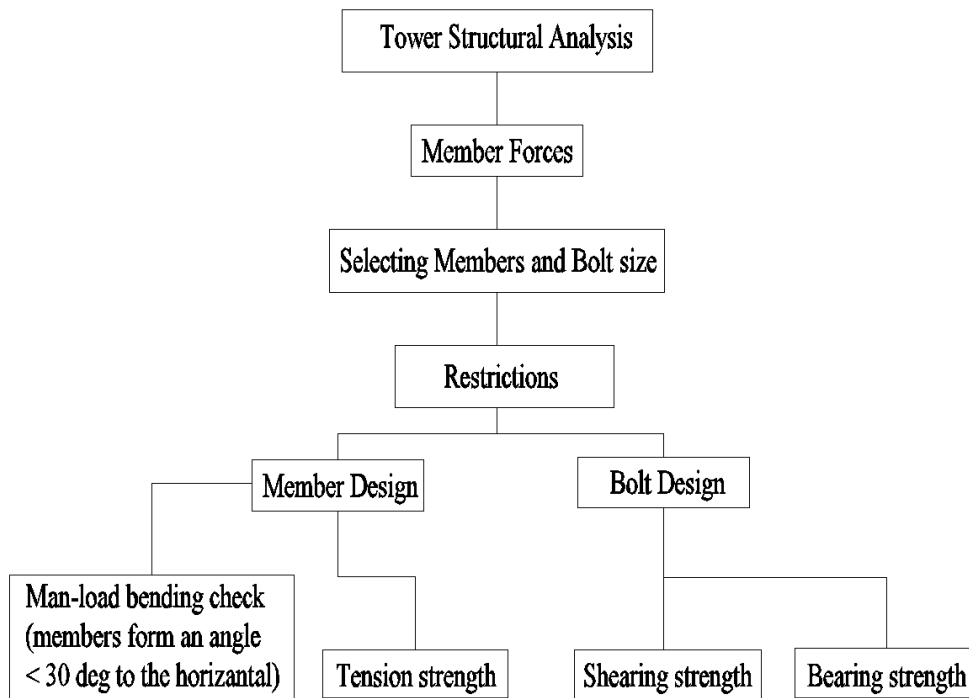
**Figure 1.2.** Tower design flow chart for tension

Figure 1.2. Loads to be applied to the structure are determined based on several factors, such as the location and type of the tower. Finite element model of the tower is generated and the structural analysis is performed using a software called PLS-Tower. Afterwards, member forces are computed and then member and bolt sizes are chosen not only to satisfy the code requirements and resist the external forces but also to achieve an optimal design. In addition, special for the transmission towers, members have to resist man-load during the maintenance and repair period if the angle of member is smaller than 30 degree to the horizontal.

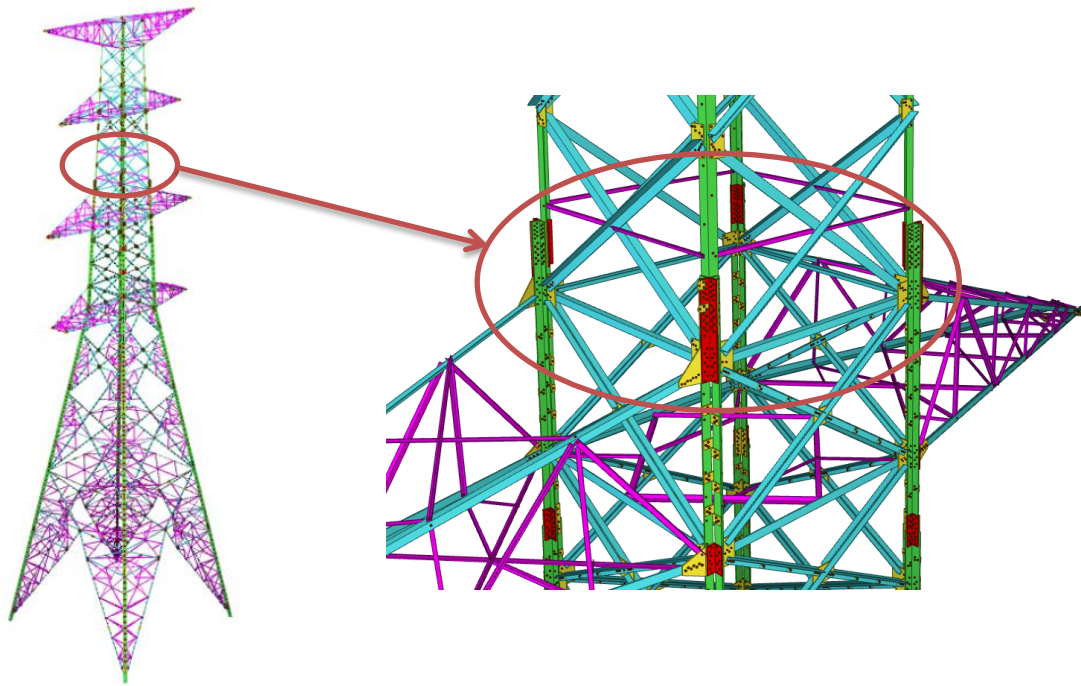
**Figure 2.1.** 3D tower model and connection part of structure

A prototype latticed transmission tower was designed and the splice connection at main legs of this prototype structure was used as a basis for the test specimens. The prototype tower has a height of 75 m and a capacity of 500 kV. Loads used for the design included wind and ice loads, installation and repair loads, equipment and conductor loads, earthquake load, and broken wire load. A commercial computer program (PLS-Tower) was used to create the tower geometry, to apply the loads on the tower, to analyze the tower under loads, and to specify the member sizes. A view of the prototype tower is given in Figure 2.1. The main leg splice connection indicated on the figure was investigated in this study. Design of the tower is based on S355 grade steel angles and 8.8 grade bearing type bolts.

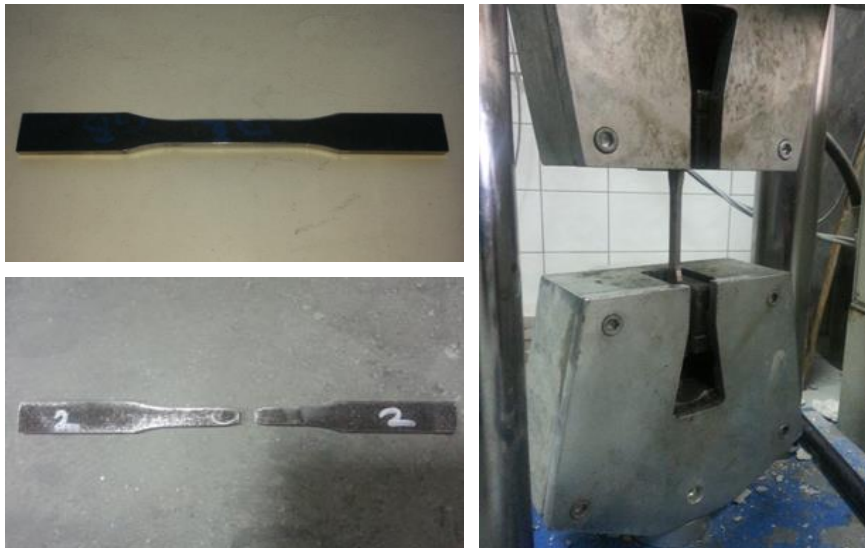
Tension tests were performed on coupon samples that were cut from upper main member in Specimens 1, 2, 4, 5, and 6. Pictures of coupon samples and testing procedure are shown in Figure 2.9. By this way, yield and ultimate strength values were determined, and are given in Table 2.2.

**Figure 2.9.** Tension test coupons and testing procedure

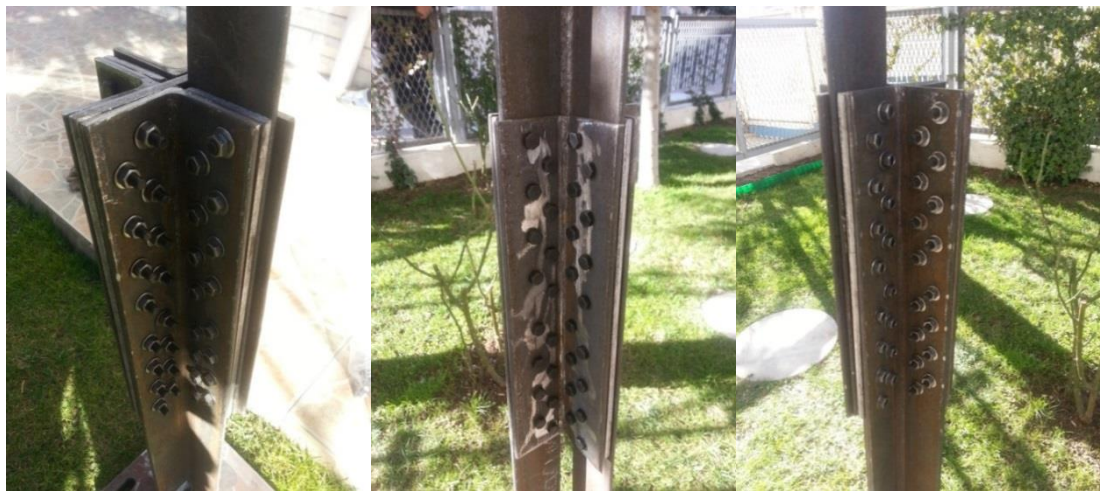
General views and geometric details of the connection region in Specimen-1 are given in Figures 2.13 and 2.14, respectively. Different from the other specimens, 7 mm diameter (M7) bolts are used in this specimen. This detail represents the connection that is currently being used in the industry for splice of main member angle sections in steel latticed transmission towers. Both interior and exterior reinforcement angles were used in the connection. The connection also included two pieces of short and one piece of long filler plates, and sixty-four bolts in total.

Figure 2.13. Members and connection detail of Specimen-1

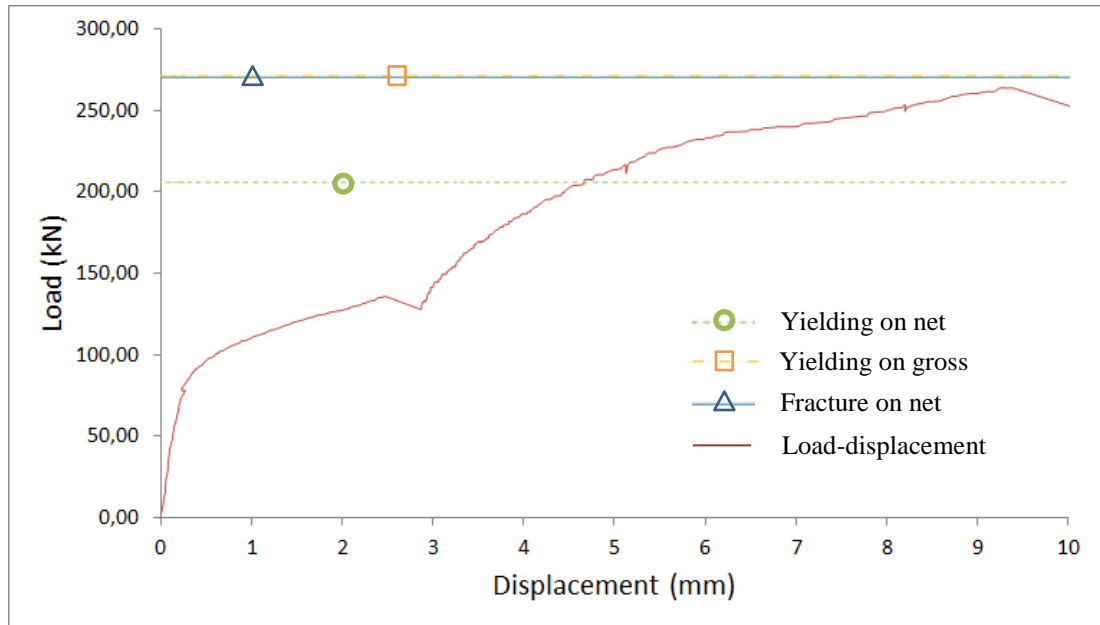
**Figure 2.21.** Load-displacement behavior for Specimen-1

Measured load-displacement response of Specimen-1 is given in Figure 2.21. Load values shown on the plot indicate the load applied by the actuator at the top end of the upper main member, while the displacement values represent the relative displacement between points A and B shown in Figure 2.12. Calculated capacities corresponding to yielding on gross cross section, yielding on net cross section, and fracture on net cross section of the upper main member are also shown on the same plot. It should be noted that these calculated values are based on the assumption of pure axial force in the main members. Therefore, presence of bending in these members would violate this assumption and result in capacities different than these predicted ones.

As mentioned previously, load testing of this specimen was terminated when some of the bolts in the connection region were fractured. For this reason, a direct comparison between the measured load capacity and the predicted load capacity corresponding to fracture on net cross section of the upper main member is not possible. On the other hand, measured and predicted load capacities in terms of yielding can be compared. The load at which the initial slope of the load-displacement curve started to change

can be taken as the load causing initiation of yielding. Value of this load is approximately 88.3 kN for Specimen-1, and it is significantly lower than the predicted load level corresponding to yielding on net cross section.

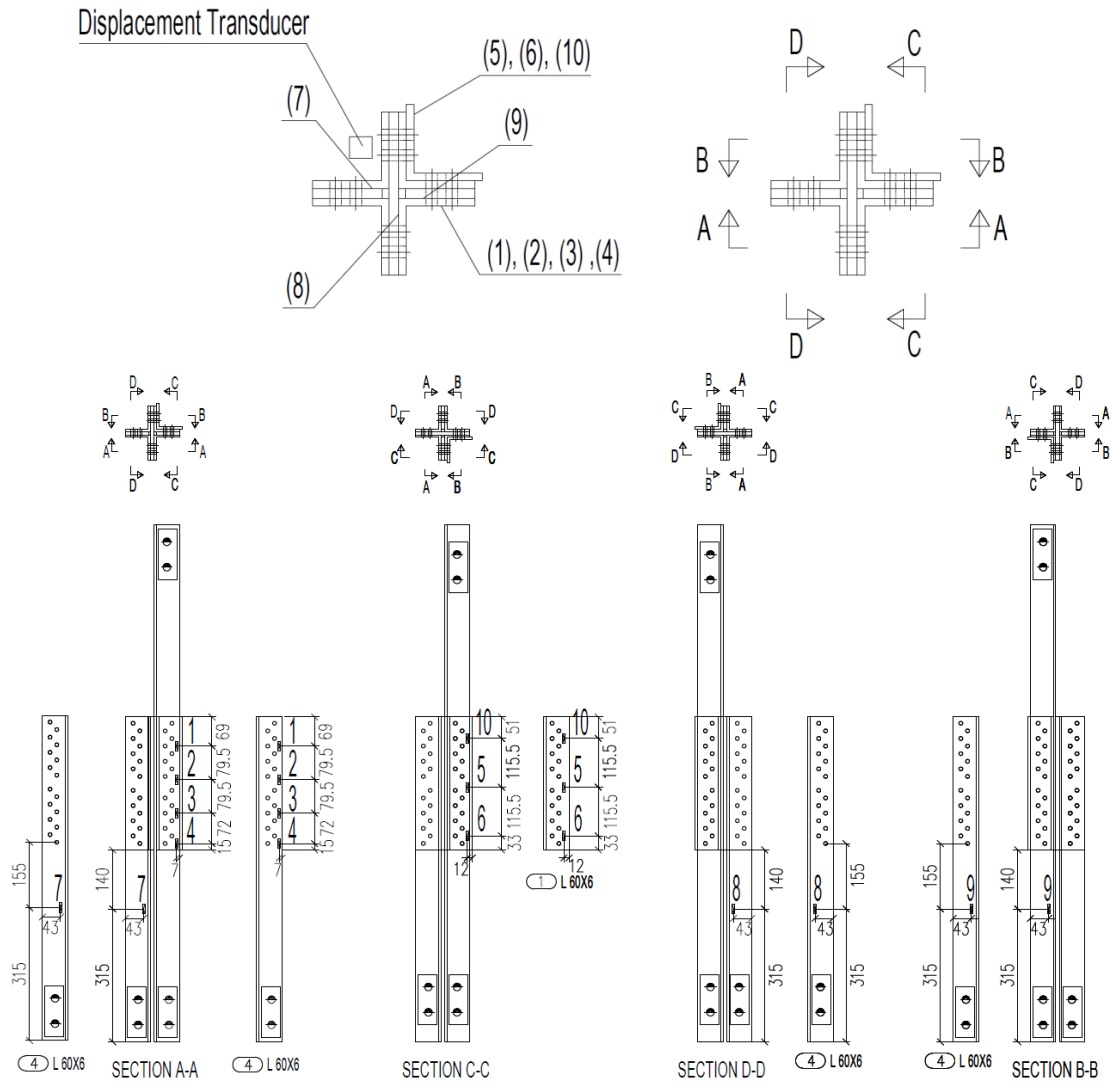
**Figure 2.22.** Strain gage and displacement transducer locations in side and cross-sectional view of Specimen-1 (dimensions in mm unit)

The main members and interior reinforcement angle in Specimen-1 was instrumented with totally ten strain gages, as shown in Figure 2.22. Readings from these gages were used to determine the strain distribution at different parts of the specimen.

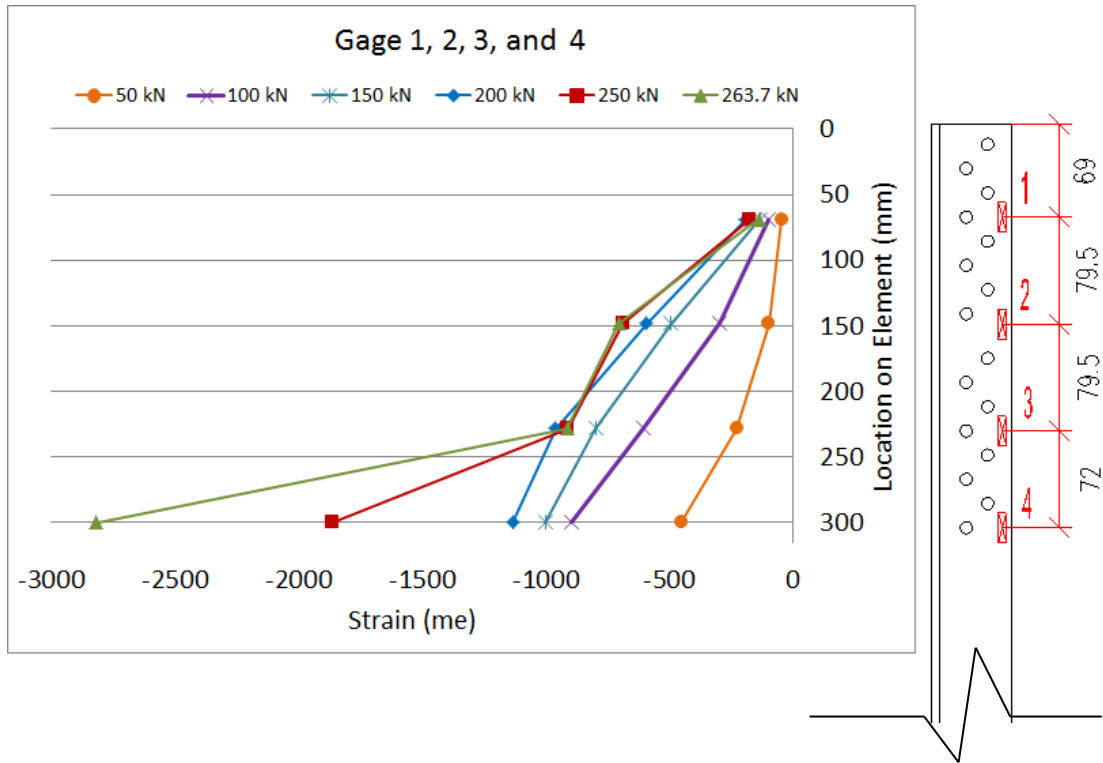
**Figure 2.24.** Variation of strain profile in lower main member of Specimen-1 (dimensions in mm unit)

Readings from Gages 1-4 were also used to extract the strain profile on one of the lower main member at different load levels. These profiles are given in Figure 2.24. The plots indicate that the strain profile remained almost linear up to a load level of 220 kN, and after this level the rate of change of strain at the most critical section (indicated by Gage 4) started to increase. It should again be noted that the load values shown on these plots are the total load applied by the actuator. Load in each lower main member would be expected to be half of the total actuator load.

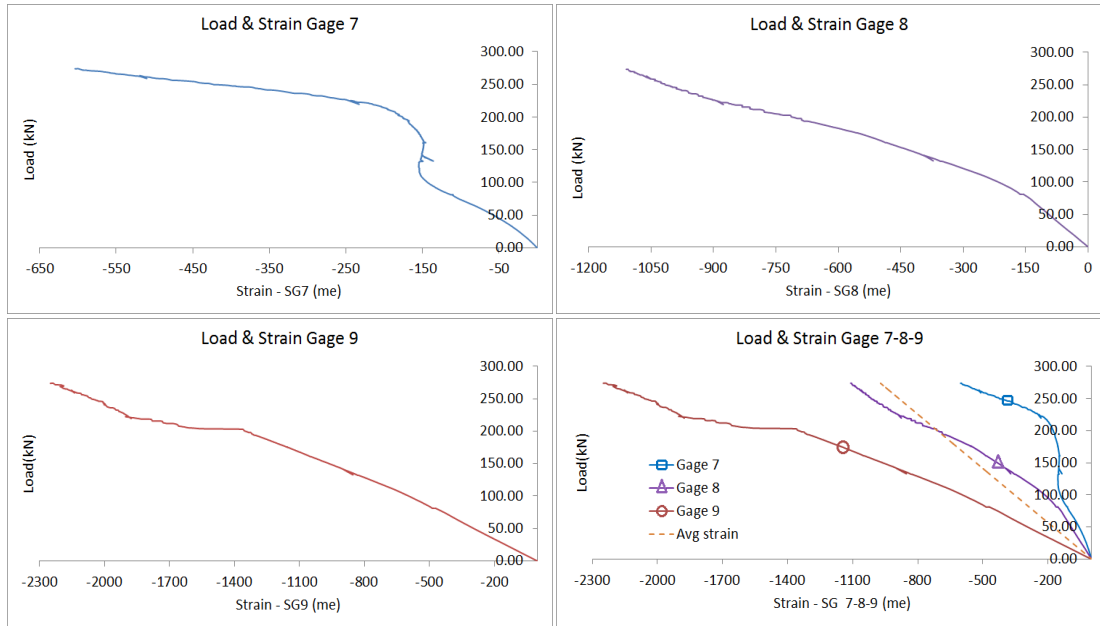
**Figure 2.25.** Comparison of strains in lower main members of Specimen-1

Gages 8 and 9 were located on two legs of one of the lower main member, while Gage 7 was located on one leg of the other lower main member. These three gages were located at cross section away from the connection region. Location of all of these three gages on the leg of the angle section as well as the distance from the end of the member was the same. Readings from these gages are shown in Figure 2.25. The fact that the strain readings from these three gages are different from each other is another indication that the lower main members are not under pure axial tension loading. Another reason that the strain readings from Gages 8 and 9 are different from each other is related with the shear lag effect in the lower main members. Only one leg of each lower main member is connected to the upper main member. Therefore, near the connection region, the strain in the leg that was connected to the upper main member would be expected to be larger than the strain in the other leg, which had no direct connection. This is justified by the condition that Gage 9 indicated larger strains than Gage 8.

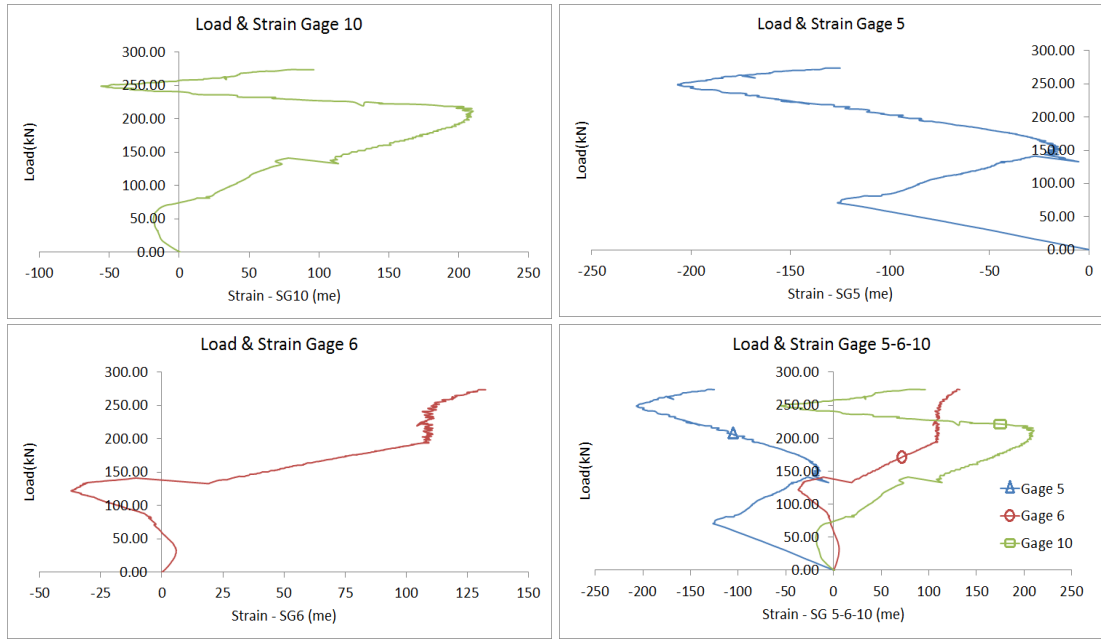
**Figure 2.26.** Strain distribution in interior reinforcement angle of Specimen-1

The interior reinforcement angle was instrumented with three strain gages (Gages 5, 6, and 10). Readings from these gages are shown in Figure 2.26. Assuming that the member itself will be subjected to tensile load, the strain gages would be expected to indicate only tensile strain. The plots, on the other hand, indicate that Gages 6 and 10, which were located at two ends of the interior reinforcement angle recorded both tensile and compressive strains. The reason for this is believed to be bending of the interior reinforcement angle together with the upper and lower main members. Such bending deformation was evident in the upper and lower main members following the load test. The main reason for this additional bending deformation was the eccentricity of the load acting on the angle members with respect to the centroidal axis of each member.

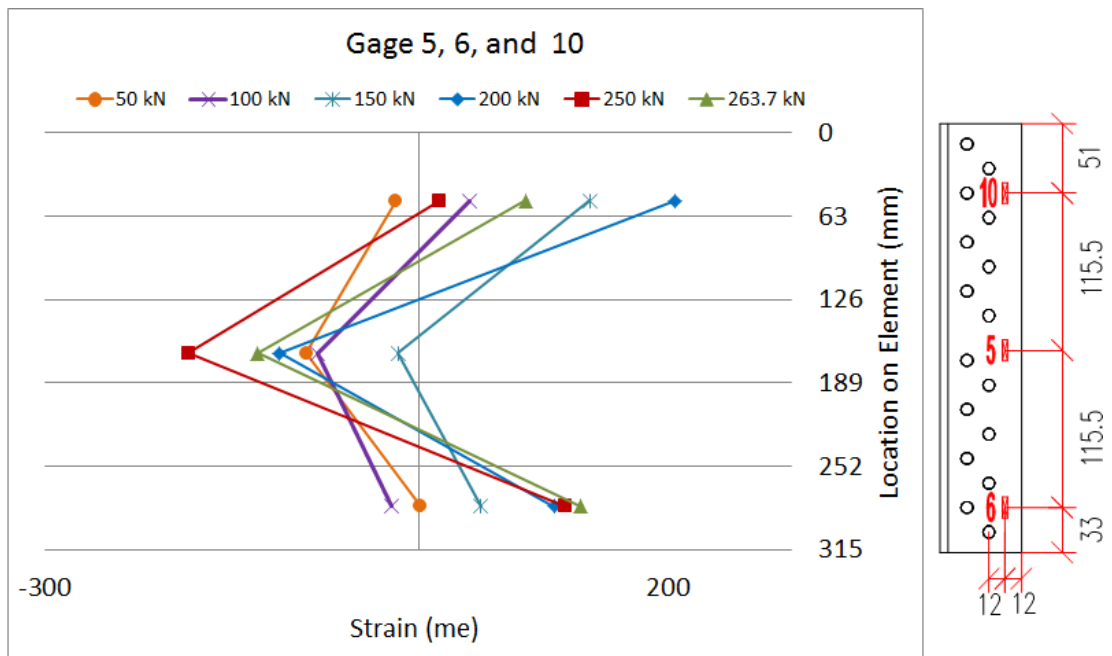
**Figure 2.27.** Variation of strain profile in interior reinforcement angle of Specimen-1 (dimensions in mm unit)

The unexpected distribution of strains in the interior reinforcement angle as a result of additional bending deformations can also be seen clearly on the strain profiles shown in Figure 2.27.

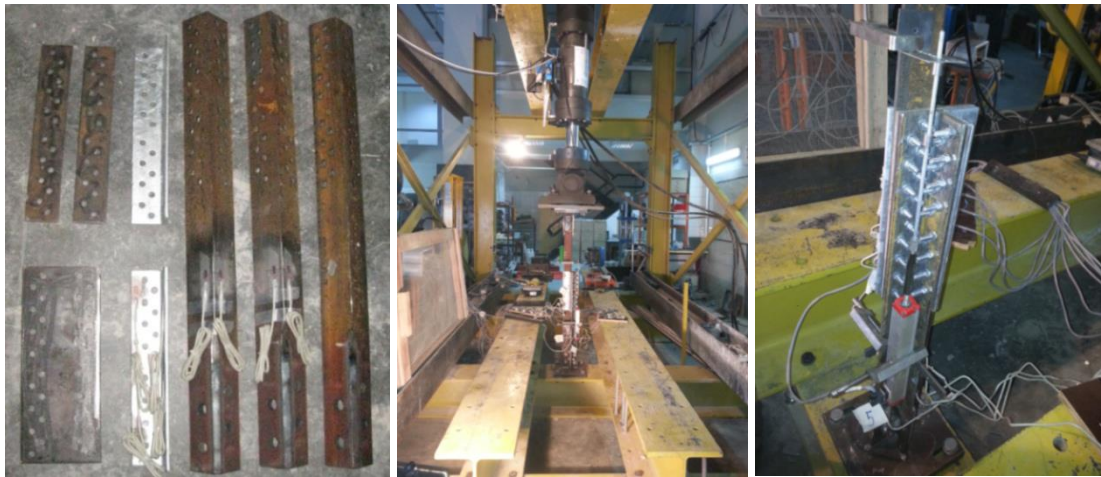
**Figure 2.28.** Cross-sectional view of Specimen-2

**Figure 2.29.** General views of Specimen-2

In order to prevent the bolt failure occurred on Specimen-1, M7 bolts were replaced by M8 bolts with threads excluded from the shear plane. Other than this difference in the bolts, the connection details used in Specimen-2 was the same as those in Specimen-1. The connection included sixty-four bolts in total. General views and geometric details of the connection region in Specimen-2 are given in Figures 2.28 and 2.29.

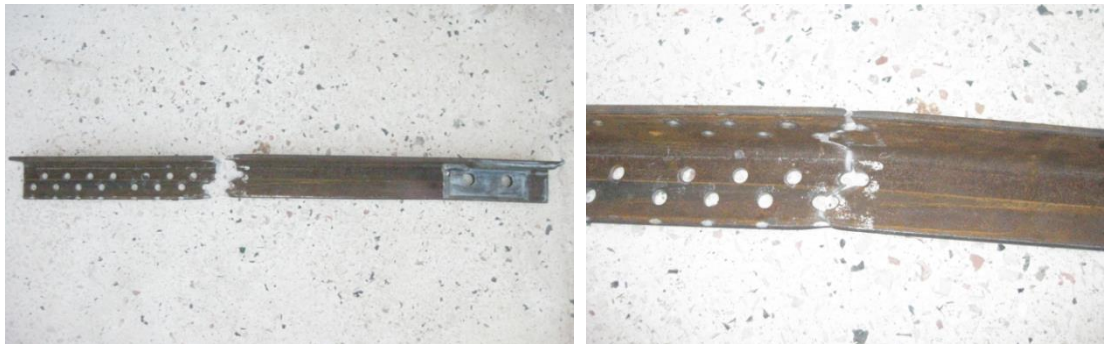
**Figure 2.31.** Deformations on ruptured angle member of Specimen-2

According to the hand calculations, upper main member was expected to rupture on critical path in 264.1 kN of loading. During load testing the member underwent net section fracture along the first line of bolts at a load of 254.4 kN (see Figure 2.30). Analysis of the upper main member after the load test indicated bearing on bolt

holes, necking on the artificial cross section, and overall bending deformation of the member, as seen on the pictures given in Figure 2.31.

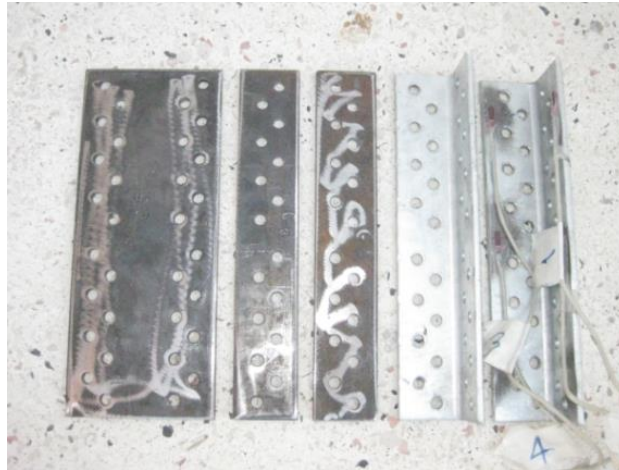
**Figure 2.32.** Reinforcement angle members and filler plates of Specimen-2, after testing

Reinforcement angle members and filler plates were analysed and as shown in Figure 2.32, and no deformation was observed on these elements.

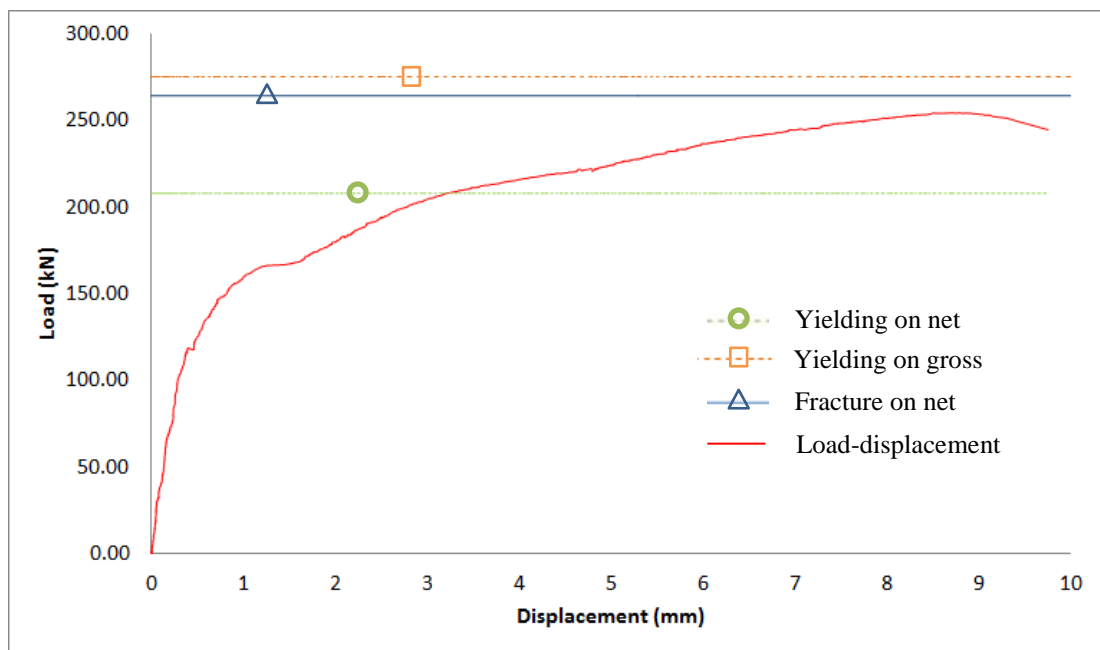
**Figure 2.38.** Load-displacement behavior for Specimen-2

Measured load-deformation behavior of Specimen-2 is shown in Figure 2.38. The relation between the predicted load capacities corresponding to yielding on net section, yielding on gross section and fracture on net section, and the measured response of the specimen can also be seen on this plot. The increase in measured displacement with almost no change in load is believed to correspond to relative slip between the upper and lower main members. The measured load capacity of the specimen corresponding to net section fracture of the upper main member was 3.7% smaller than the capacity predicted based on the AISC procedure.

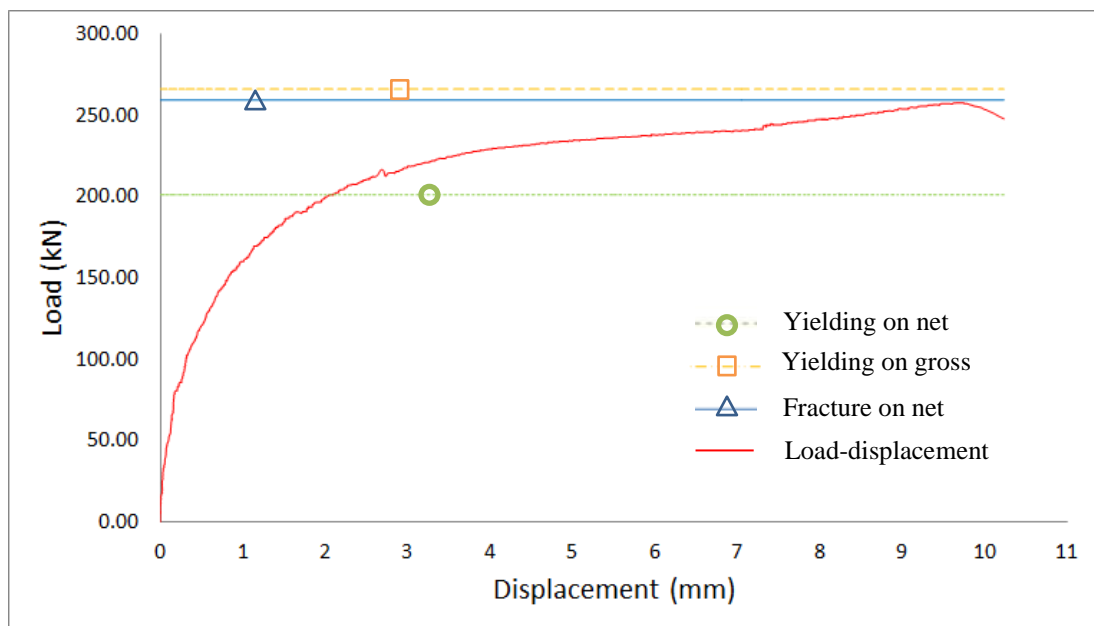
**Figure 2.48.** Load-displacement behavior for Specimen-3

Predicted capacity corresponding to yielding on net section, fracture on net section, and yielding on gross section are calculated with average strength values of five specimens which were exposed to coupon tension test. Based on calculations, load capacity of the specimen corresponding to the failure mode of net section fracture was expected to be 259.3 kN. Failure of the specimen was actually the net section fracture of the upper main member at the first line of bolt with a maximum load of 257.6 kN. Therefore, the measured load capacity was 99.3% of the predicted capacity. The calculated capacity corresponding to yielding of the net section in the upper main member was 201 kN. The measured load-deflection response of the specimen together with the predicted capacities are shown in Figure 2.48.

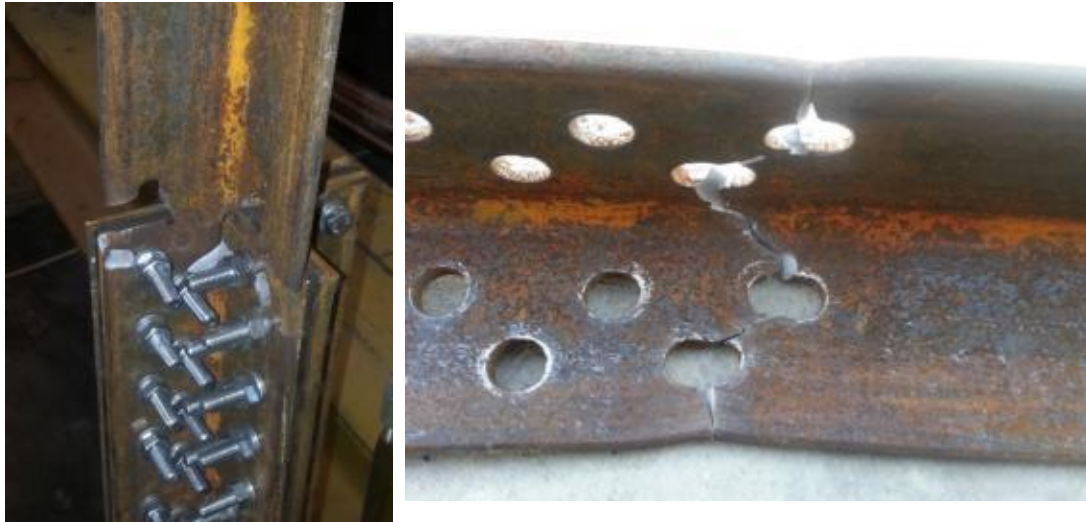
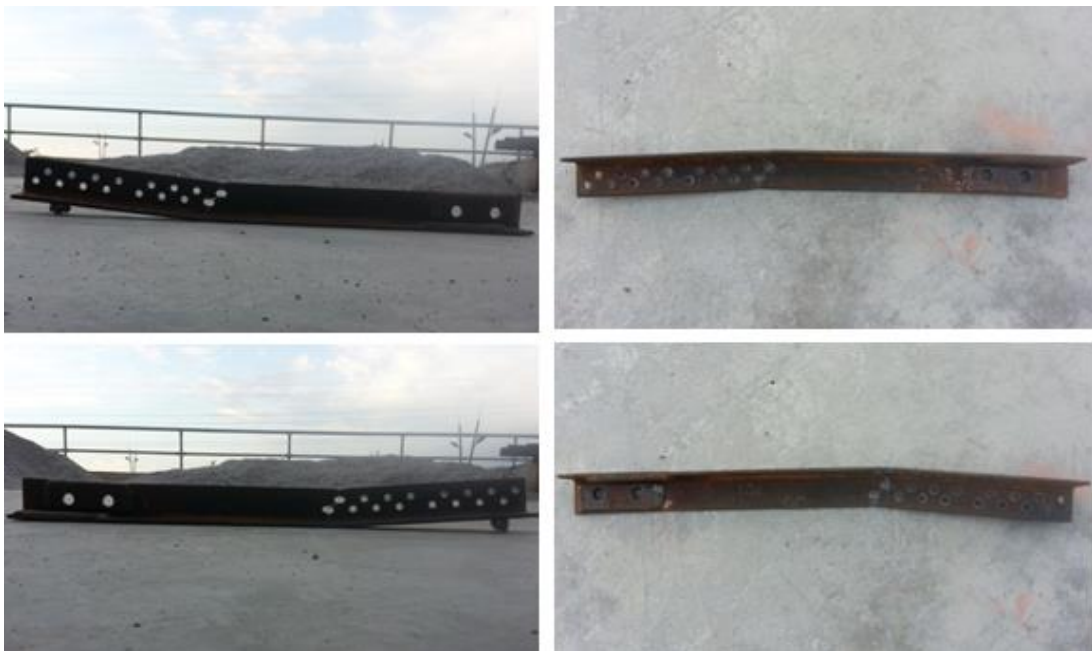
**Figure 2.49.** Rupture on critical path of Specimen-3

**Figure 2.50.** Bending of ruptured angle member of Specimen-3

Photographs of the fractured upper main member can be seen in Figures 2.49 and 2.50. Analysis of this member after the load test revealed necking of the member at the fracture section and bearing on the bolt holes, as seen on the photographs. Overall bending deformation of the member is also evident.

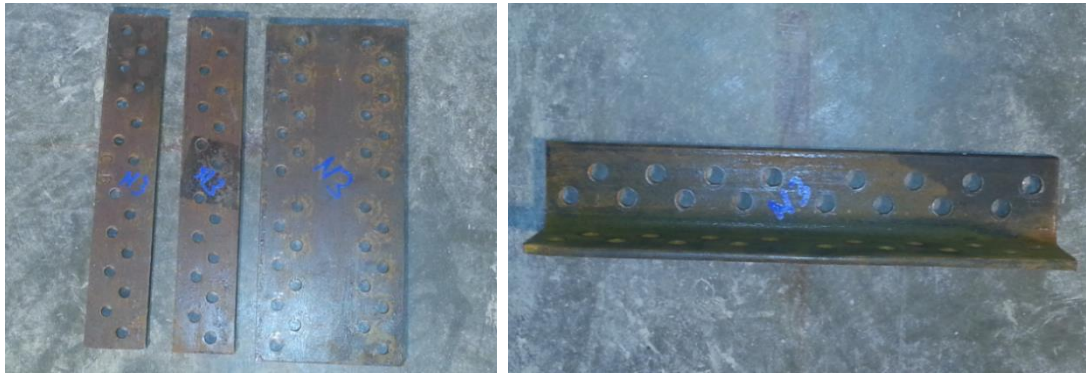
Interior reinforcement angle member and filler plates were analysed and as shown in Figure 2.51, and no deformation was observed on these elements.

**Figure 2.51.** Reinforcement angle member and filler plates of Specimen-3, after testing

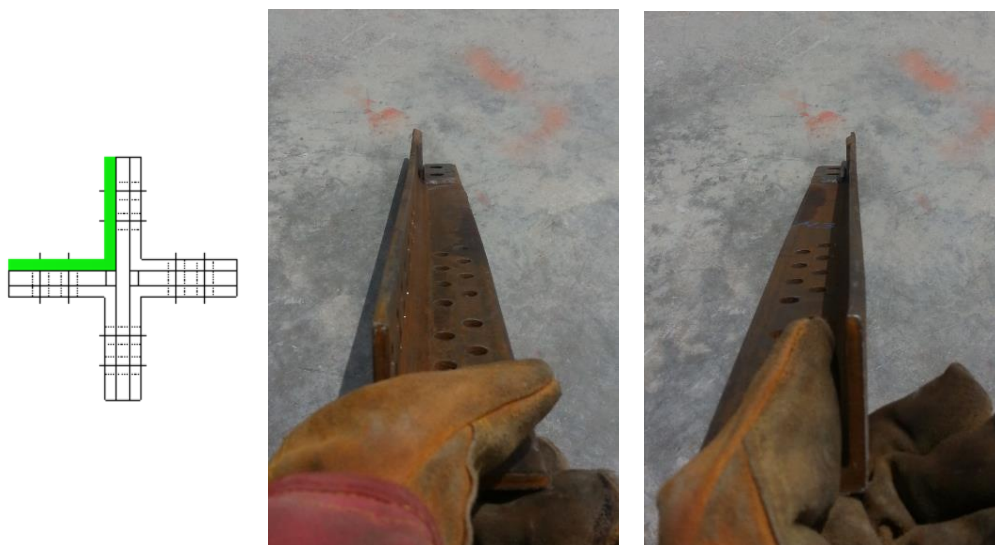
Bending on two lower main members together with a slight bearing deformation at bolt holes was also detected as in the previous specimens. These deformations are shown in Figures 2.52-2.53. In addition, bearing on critical path bolt holes can be seen in Figure 2.54.

**Figure 2.52.** Bending on lower main member 1 (Specimen-3)

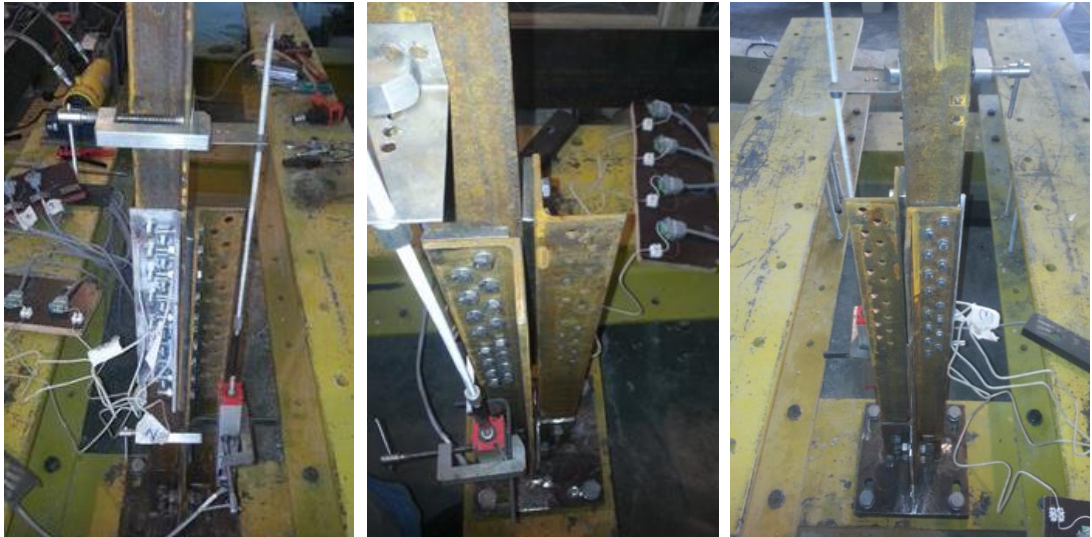
In the connection detail used in Specimen-4, no exterior reinforcement angle was used. The long filler plate between the lower main members was also eliminated, and a short piece of filler plate was provided between the upper main member and each of the lower main members. As a result of these modifications, the total number of bolts was reduced from sixty-four to thirty-two. Used members, geometric details of the connection region in Specimen-4 and general views are given in Figures 2.55 and 2.56.

Figure 2.56. General view of Specimen-4

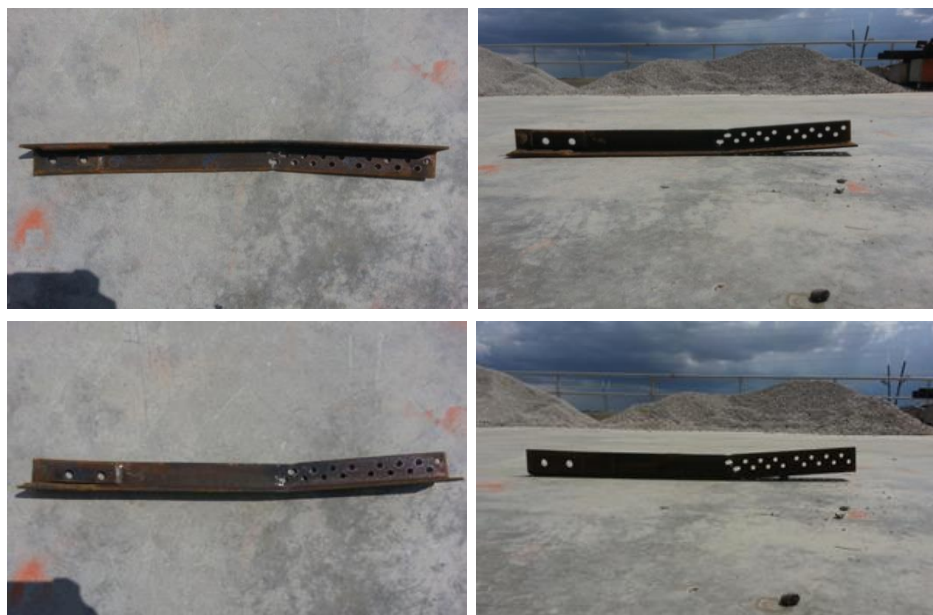
**Figure 2.59.** Bending of ruptured angle member of Specimen-4

Ruptured angle arm was analysed. Necking, bearing on bolt holes and bending can be seen in Figure 2.59. Bending on this arm was higher than the previous four specimens. Reinforcement angle members and filler plates were analysed and as shown in Figure 2.60, there was no deformation on those elements.

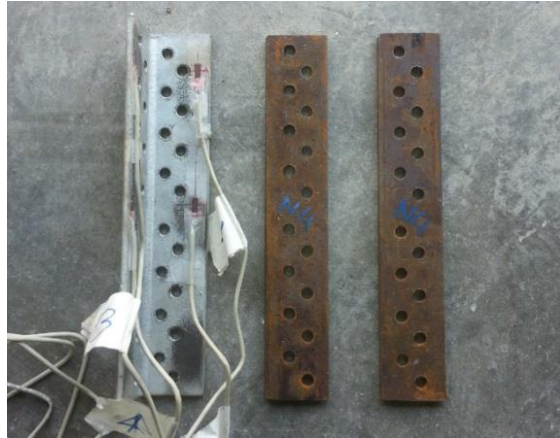
**Figure 2.60.** Reinforcement angle members and filler plates of Specimen-4, after testing

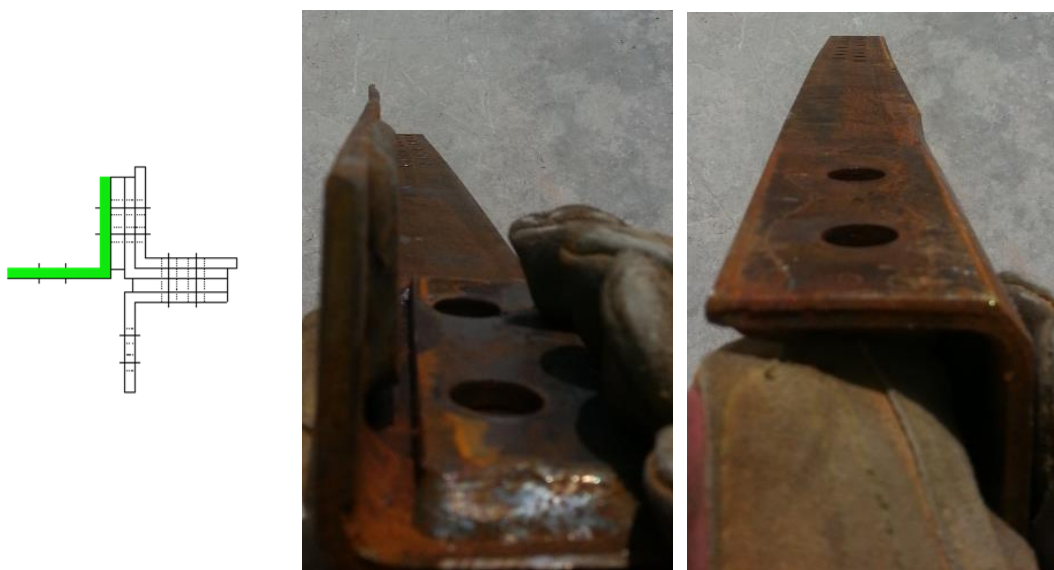
Behavior of lower main members was same as previous specimens in a sense that additional bending deformations occurred. Bending deformations were more significant for this specimen than the previously tested specimens, and this was attributed to the lack of long filler plate. In the previous specimens, the two main members were connected together by a long filler plate, and this was not the case with Specimen-4. This condition introduced additional “flexibility” and resulted in more significant bending deformation especially in the lower main members (Figures 2.61 and 2.62). Bearing deformations on the lower main members were observed to be somewhat less than the previous specimens (Figure 2.63).

**Figure 2.61.** Bending on lower main member 1 (Specimen-4)

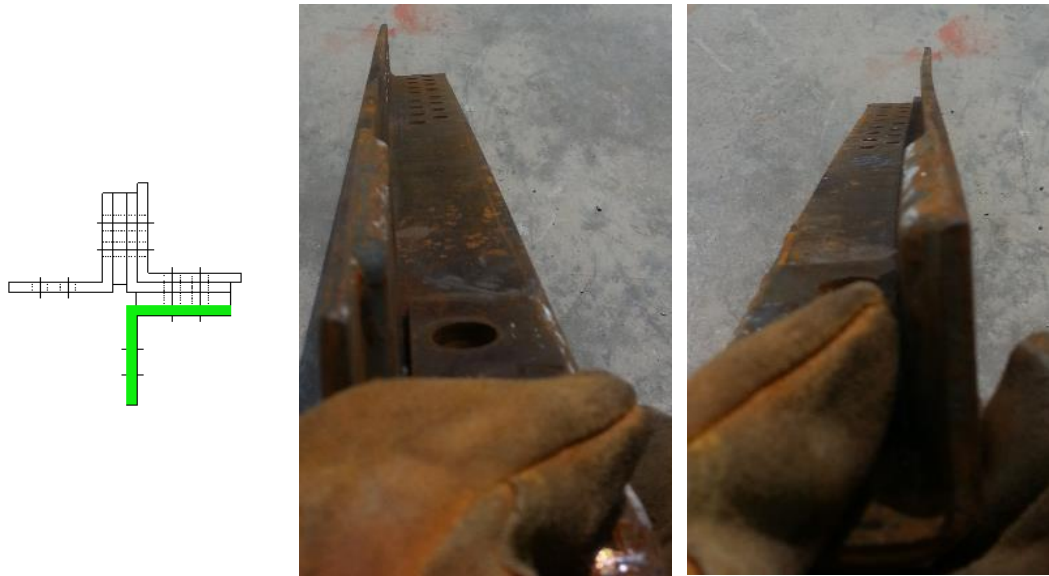
**Figure 2.62.** Bending on lower main member 2 (Specimen-4)

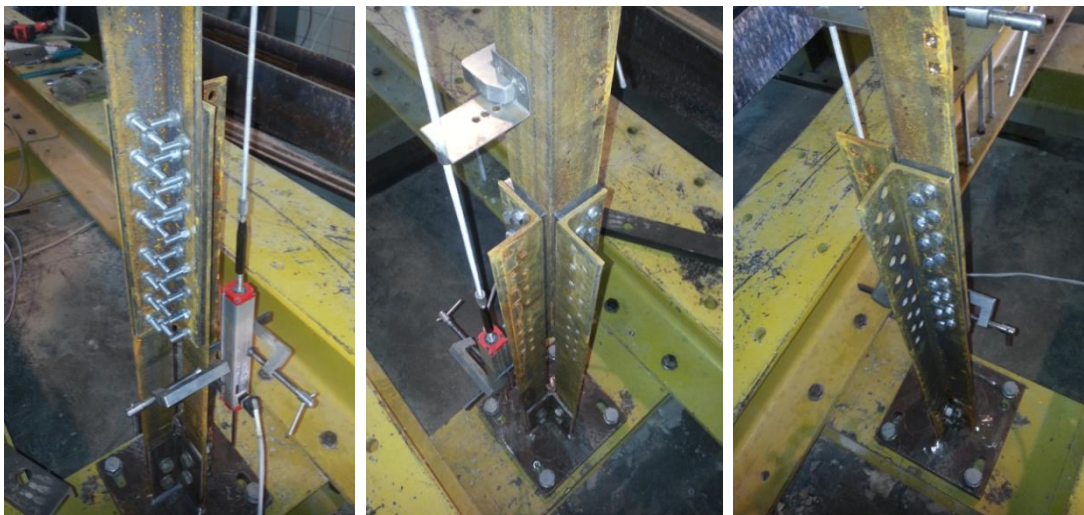
The connection detail used in Specimen-5 was similar to the one in Specimen-4. The only difference between these two details was that the interior reinforcement angle was eliminated in Specimen-5. Therefore this detail did not include the interior and exterior reinforcement angles, and represents the simplest connection geometry tested in the study. The total number of bolts used in the connection was still thirty-two. Used members, geometric details of the connection region in Specimen-5 and general views are given in Figures 2.69 and 2.70.

**Figure 2.70.** General view of Specimen-5

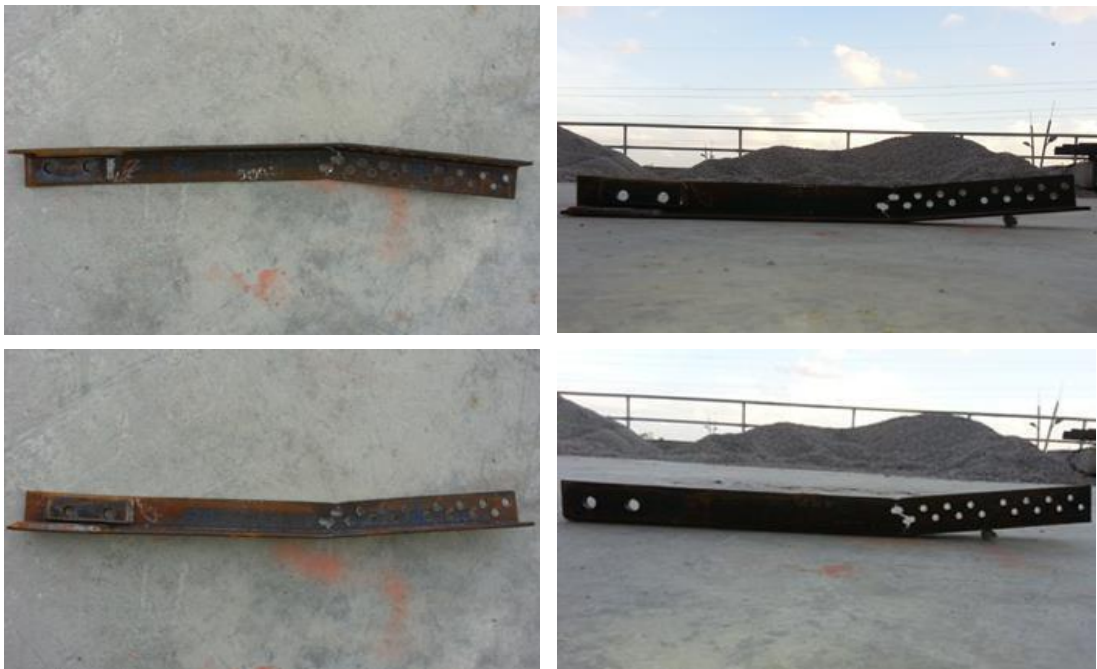
**Figure 2.73.** Bending of ruptured angle member of Specimen-5

Ruptured upper main member was analysed. Necking, bearing on bolt holes and bending can be seen easily in Figure 2.73. Upper main member in this specimen was observed to undergo bending deformation much more than the previously tested specimens. The reason for such behavior is attributed to the loss of “stiffness” as a result of the lack of reinforcement angles. Filler plates were analysed and as shown in Figure 2.74, there was no deformation on those elements. Minimal bending deformation was observed on the lower main members (Figures 2.75 and 2.76). No bearing deformation was visible on the lower main members (Figure 2.77). Different from the previous specimens, bearing deformations were observed in the upper main member at bolt holes located near the fracture path (Figure 2.78).

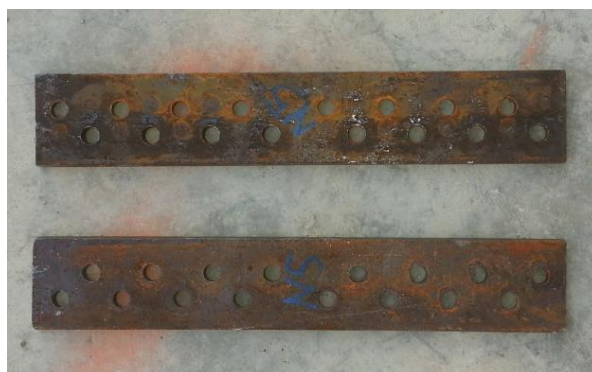
**Figure 2.74.** Filler plates of Specimen-5, after testing

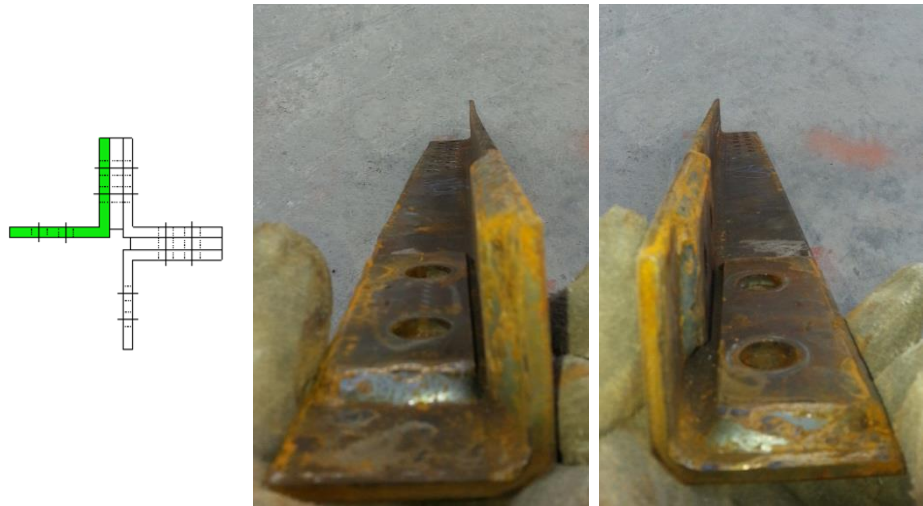
**Figure 2.75.** Bending on lower main member 1 (Specimen-5)

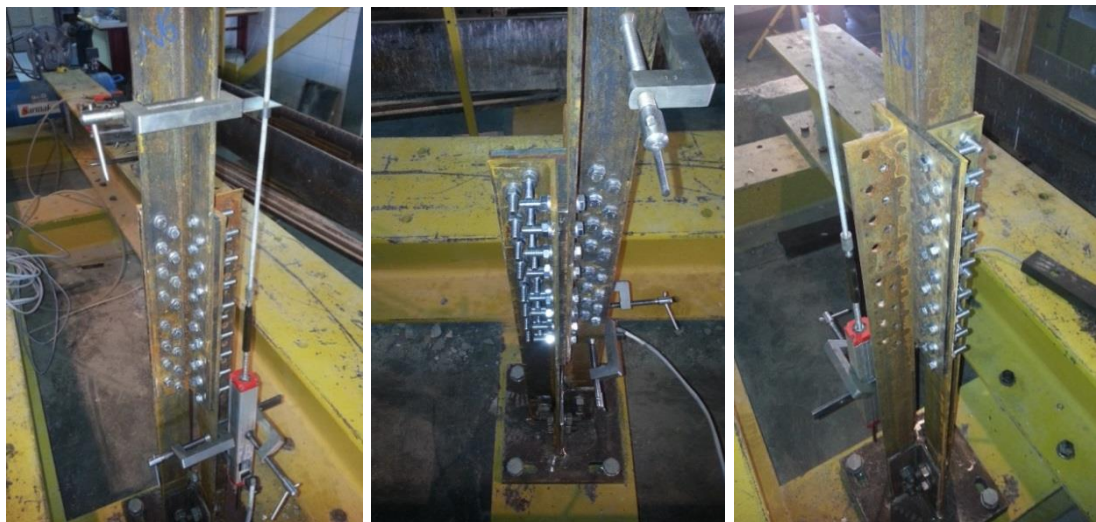
One of the short filler plates in Specimen-5 was replaced by a long plate to connect the two lower main members together in Specimen-6 (Figures 2.79 and 2.80). This specimen did not have interior and exterior reinforcement angles, either, and included thirty-two bolts in total. Other than the absence of exterior reinforcement angle, this detail was also similar to the one used in Specimen-3.

Figure 2.80. General view of Specimen-6

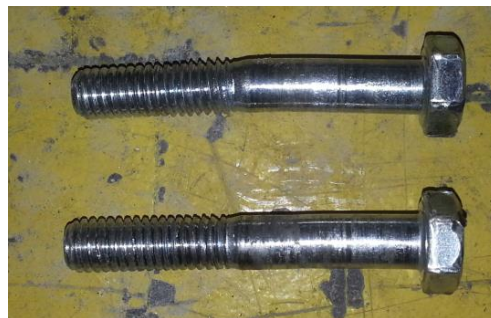
**Figure 2.82.** Bending deformation on bolts (Specimen-6)

that were located on the critical path. Bending deformation of these bolts can be seen in Figure 2.82.

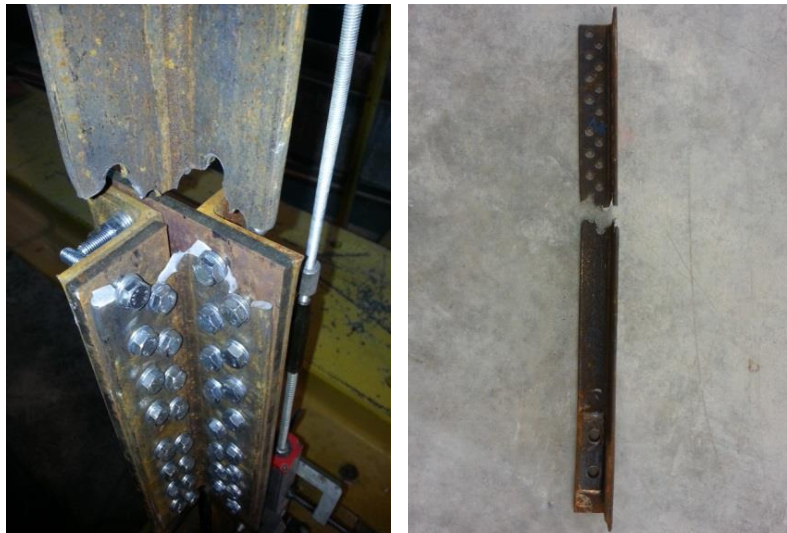
**Figure 2.83.** Rupture on critical path of Specimen-6

Fracture occurred on the upper main member (Figure 2.83) and the maximum load was 262 kN. The predicted load capacity corresponding to net section fracture of the upper main member was 245.3 kN. The measured load capacity corresponds to 106.8% of the predicted capacity. The measured load-deflection response of the specimen is given in Figure 2.84. A sudden relative slip between the upper and lower main members occurred under a load of approximately 130 kN.
