**BEHAVIOR OF BOLTED TENSION SPLICE CONNECTIONS IN STEEL  
LATTICE OVERHEAD TRANSMISSION LINE TOWERS**

**A MASTER'S THESIS**

**Civil Engineering**

**Atilim University**

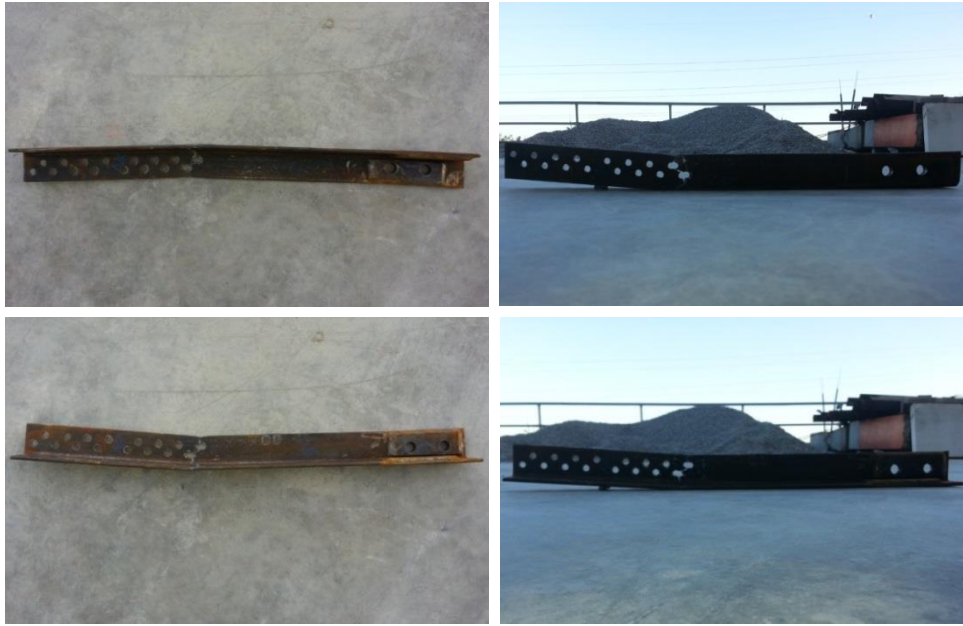
**Figure 2.85.** Bending of ruptured main member of Specimen-6

Bending of the fractured upper main member is evident in the pictures given in Figure 2.85. Filler plates were analysed and as shown in Figure 2.86, there was no deformation on those elements. Bending deformations of lower main members can be seen in Figures 2.87 and 2.88. As shown in Figure 2.89, no bearing deformation was observed on the bolt holes at critical path. On the other hand, bearing deformations occurred in the upper main member at bolt holes located near the fracture path (Figure 2.90).

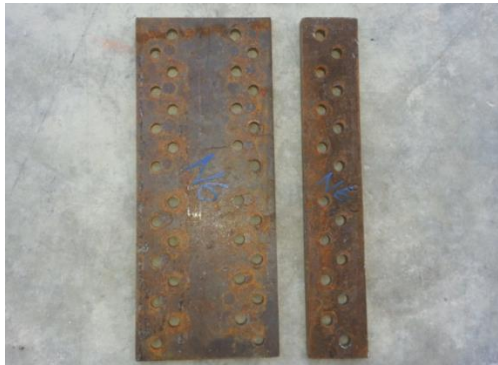
**Figure 2.86.** Filler plates of Specimen-6, after testing

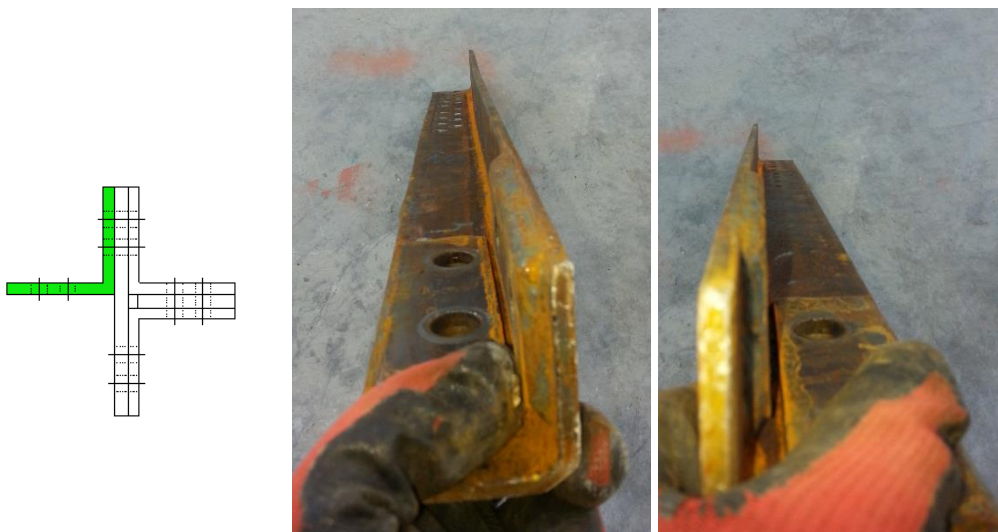
**Figure 2.87.** Bending on lower main member 1 (Specimen-6)

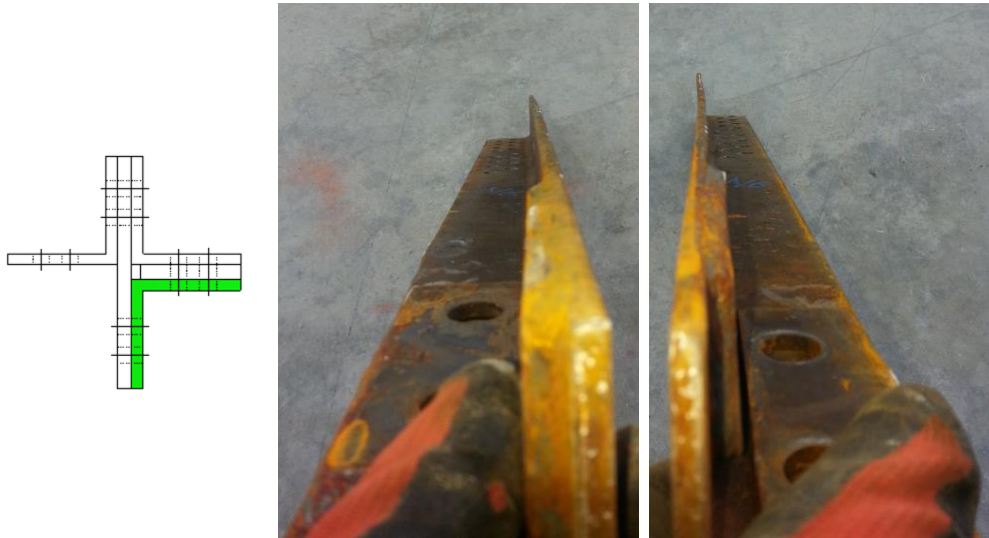
**Figure 2.88.** Bending on lower main member 2 (Specimen-6)

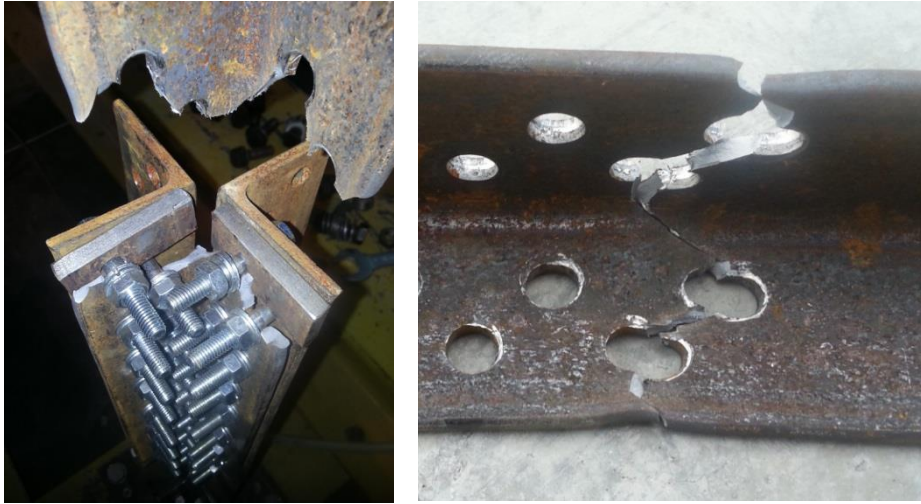
Specimen-7 behaved almost the same as Specimen-5, as expected. Different from Specimen-5, the bolts were observed to undergo significant amount of rotation during the load test, as shown in Figure 2.94. The measured load capacity of the specimen was 272.5 kN, which correspond to 105.1% of the predicted capacity of 259.3 kN. Yielding on net section, fracture on net section, and yielding on gross section are calculated with average strain values as Specimen-3. Net section fracture occurred on the upper main member (Figure 2.95). The measured load-deflection response of the specimen is given in Figure 2.96.

**Figure 2.95.** Rupture on critical path of Specimen-7

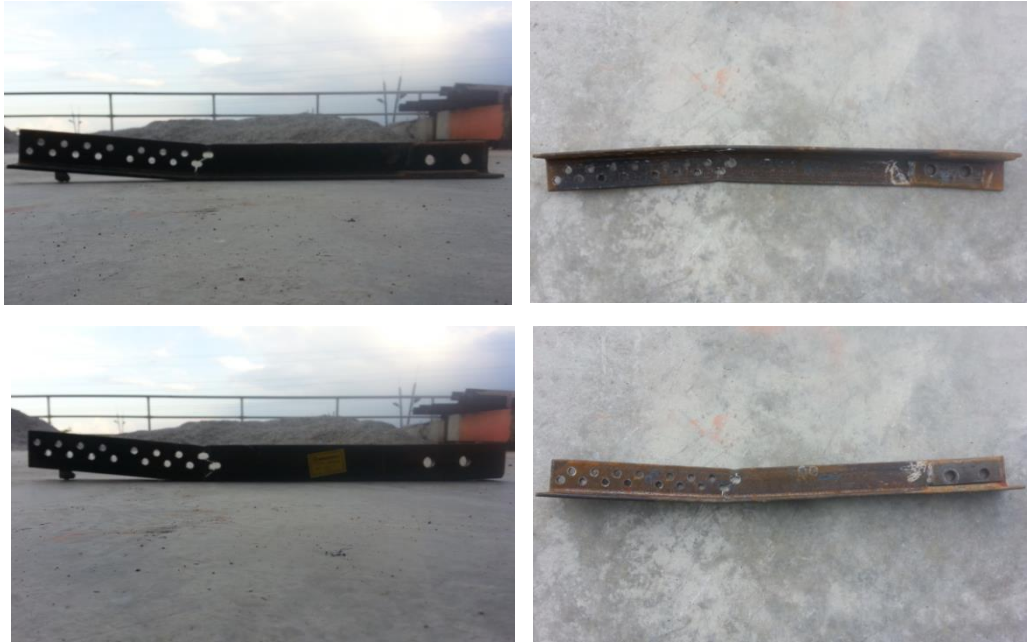
**Figure 2.97.** Bending of ruptured main member of Specimen-7

Figure 2.97 shows the type and extent of deformations occurred on the upper main member. Similar to Specimen 5, significant amount of bending deformation occurred on the upper main member. The washer plates were analysed and as shown in Figure 2.98, there was no deformation on these elements. Bending deformation occurred on one of the lower main member is shown in Figure 2.99. Minor amount of bearing deformation was also observed around bolt holes at one leg of both of the lower main members (Figure 2.100).

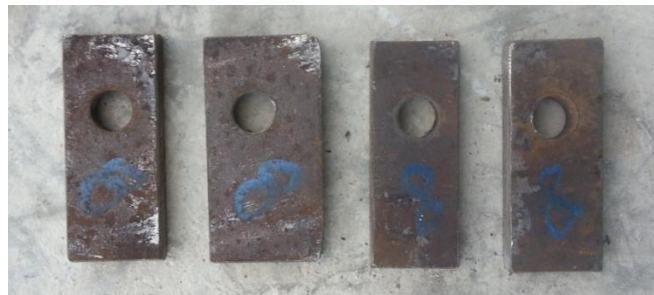
**Figure 2.98.** Filler plates of Specimen-7, after testing

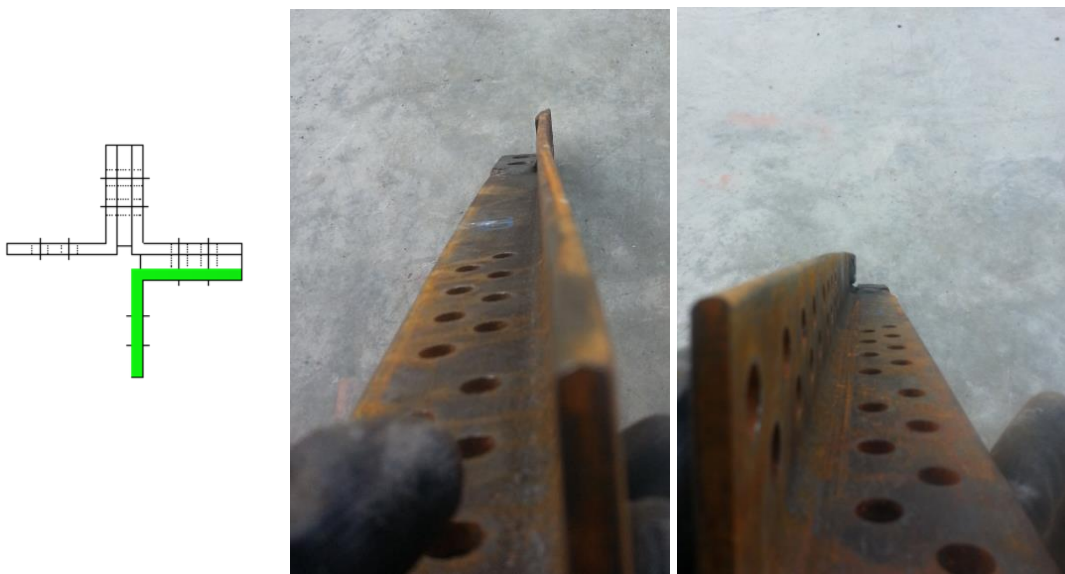
**Figure 2.99.** Bending on lower main member 2 (Specimen-7)

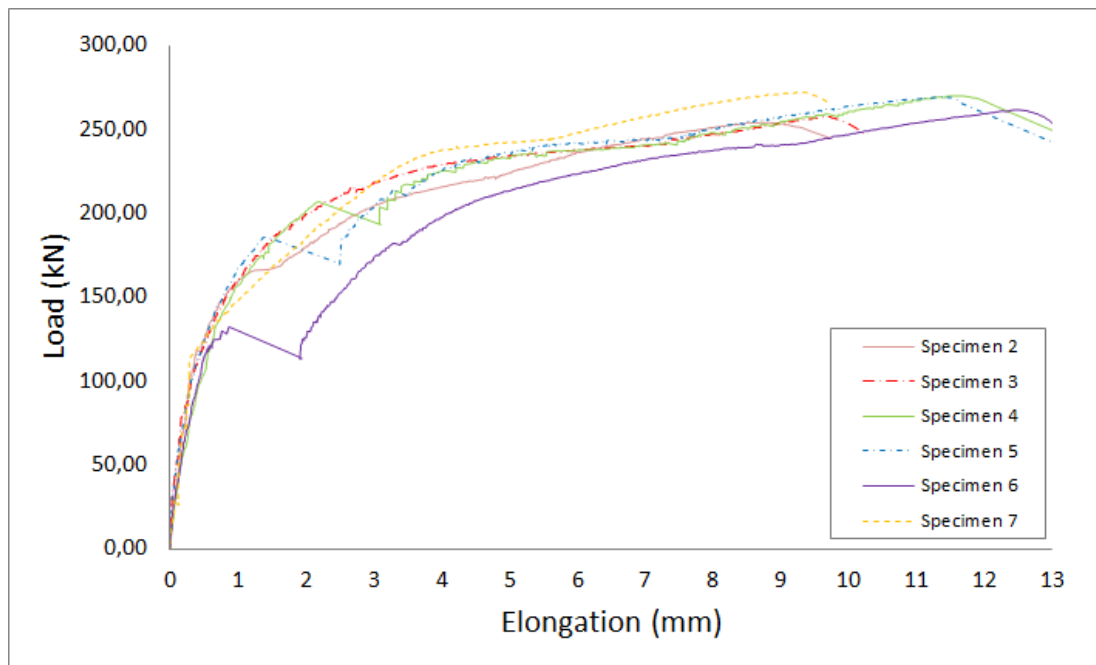
**Figure 2.101.** Load-displacement behavior comparison of all specimens
