ASSESSMENT OF SOUND TRANSMISSION CHARACTERISTICS OF  
TRADITIONAL TIMBER FRAMED DWELLINGS IN ANKARA, TURKEY

A THESIS SUBMITTED TO  
THE GRADUATE SCHOOL OF NATURAL AND APPLIED SCIENCES  
OF  
MIDDLE EAST TECHNICAL UNIVERSITY

MELTEM ERDİL

FEBRUARY 2015

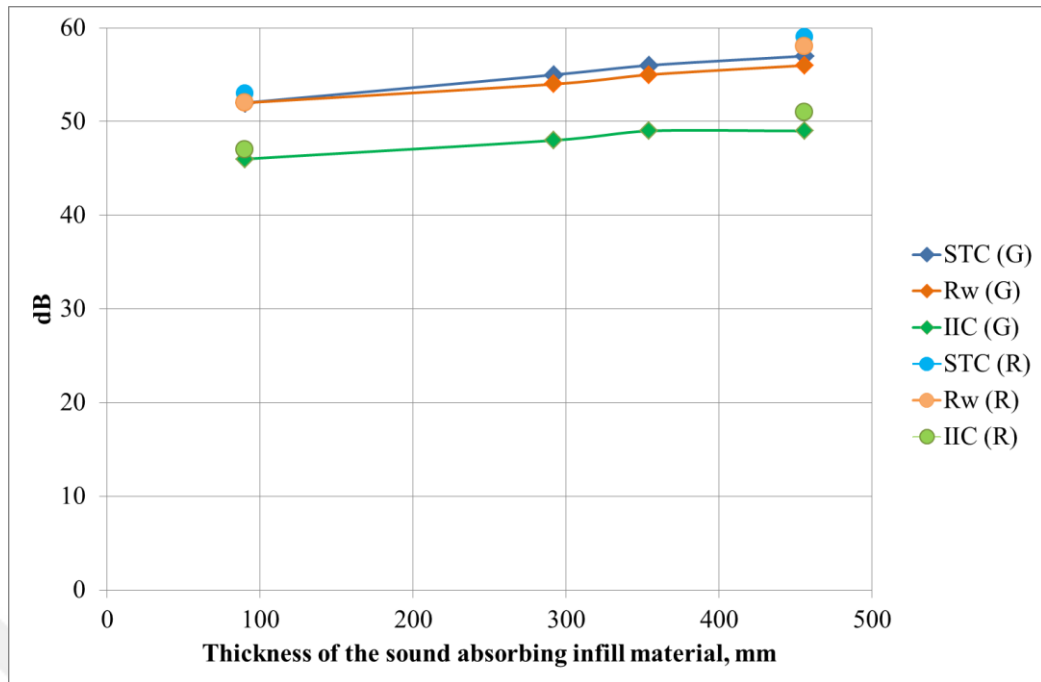
Figure 2.11 The values of STC,  $R_w$  and IIC Reference B timber frame floor including various thicknesses sound absorbing infill materials; glass wool (G) and rock wool (R) within the section (Warnock & Birta 2000).

Type of the sound absorbing material	Changes at thickness of the sound absorbing infill material within Reference B floor (mm)	The improvement at values of single number rating			
		STC (dB)	Rw (dB)	IIC (dB)	Lnw (dB)
Glass wool	From 90mm to 152mm	+1	-	+1	+1
	From 90mm to 456mm	+5	+4	+3	+2
Rock wool	From 90mm to 456mm	+6	+6	+4	+5

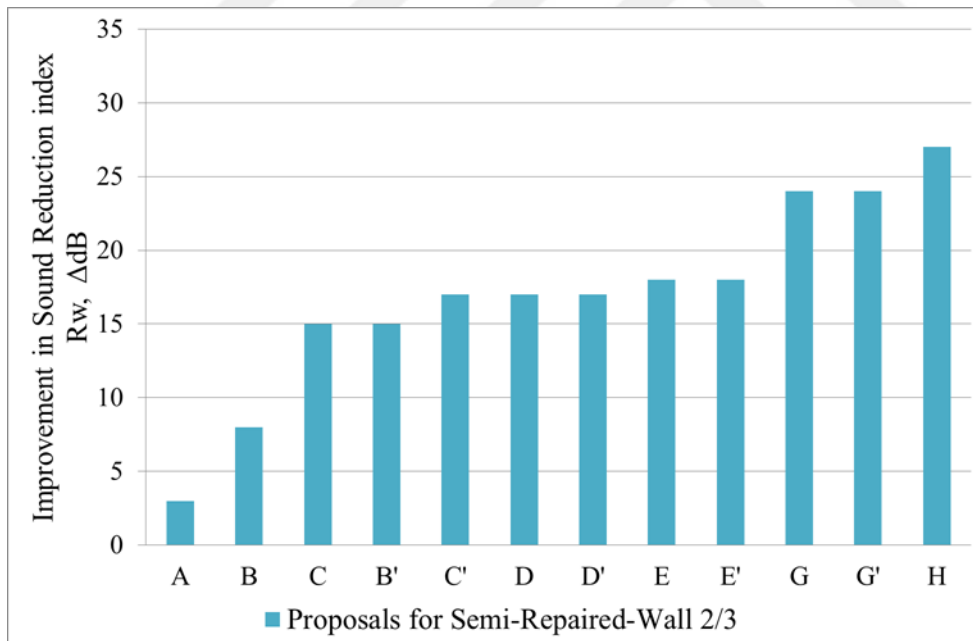
Figure 4.9 Improvement in sound reduction index of the proposals for Semi-Repaired Wall 2/3.

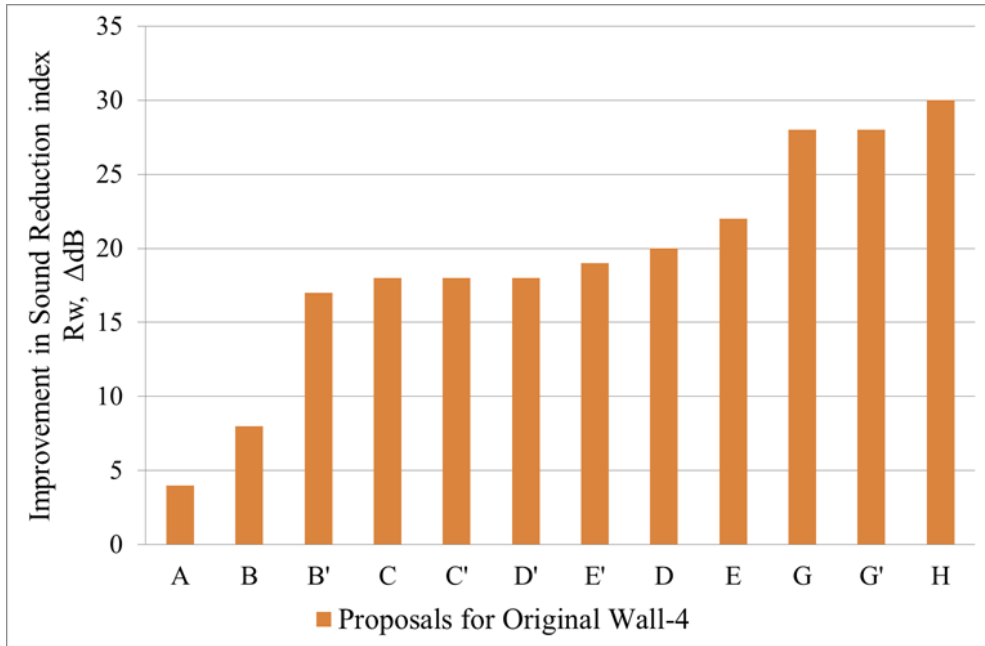
Figure 4.10 Improvement in sound reduction index of the proposals for Original-Wall 4.

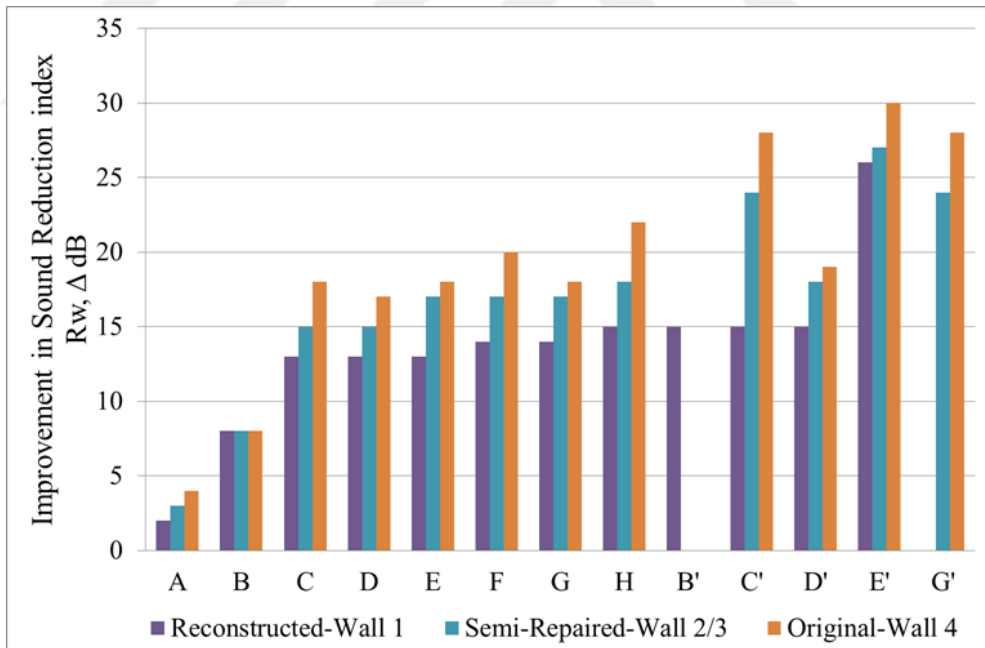
Figure 4.11 Improvement in sound reduction index of the proposals for Reconstructed-Wall 1, Semi-Repaired Wall 2/3 and Original-Wall 4.

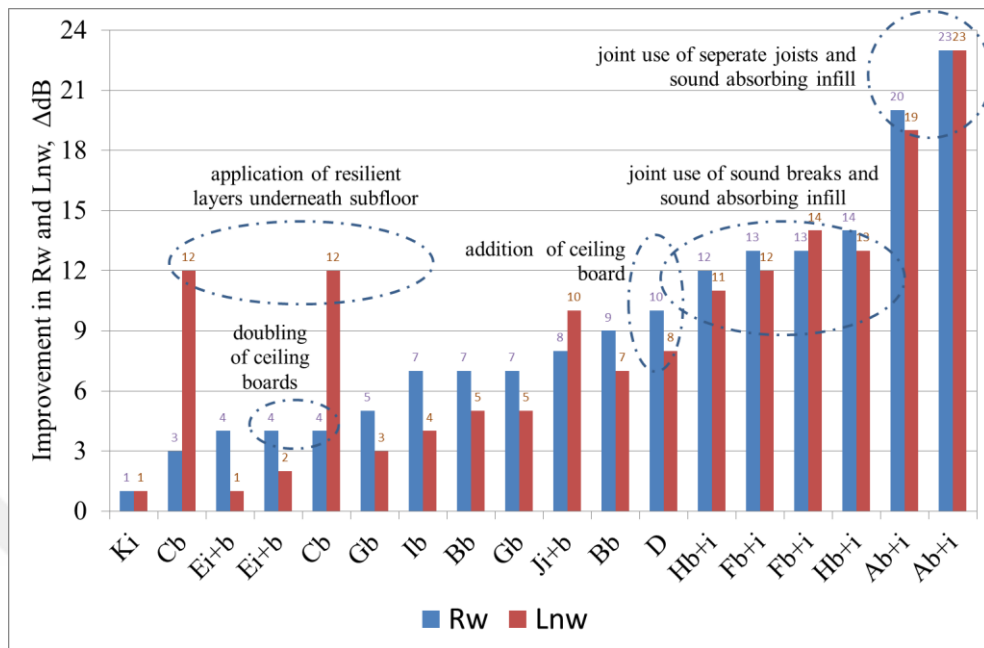
Figure 4.17 Improvement in Rw and Lnw values of the proposals for Reconstructed-Floor 1, Semi-Repaired-Floor 2/3 and Original-Floor 4.

Improvement Scale in dB	1-3	4-6	7-9	11-12	13-15	16-18	19-21	22-24
-------------------------	-----	-----	-----	-------	-------	-------	-------	-------

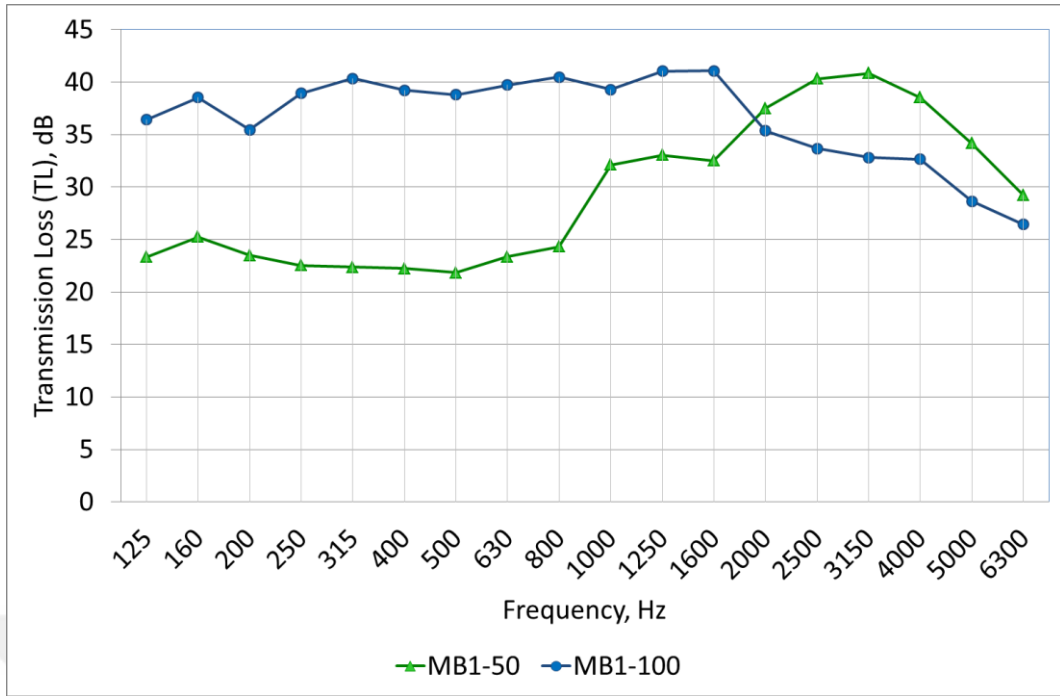
Figure 4.19 TL values of MB1-50 and MB1-100.

Samples	MB1-50	MB1-100
Mass law frequency range	NA	125 – 250 Hz

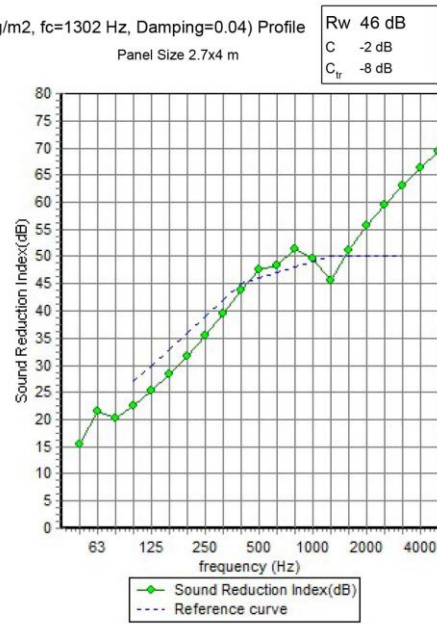
Figure F.9 Estimated data of II<sub>F</sub>-A proposal of Semi-Repaired-Floor 2/3.

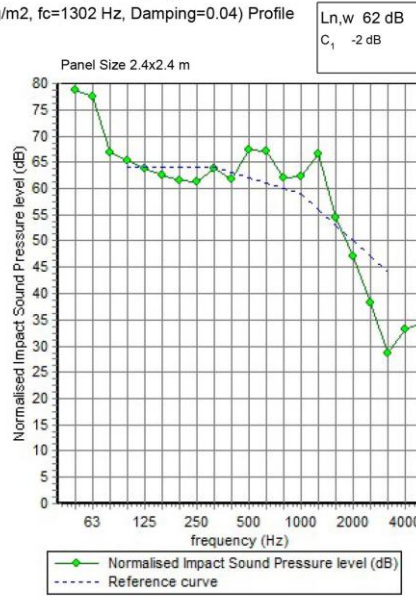
Figure F.11 Estimated data of II<sub>F</sub>-B proposal of Semi-Repaired-Floor 2/3.

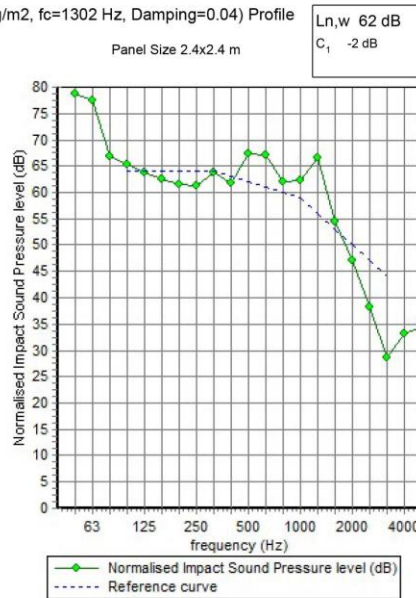
Figure F.12 Estimated data of II<sub>F</sub>-B proposal of Semi-Repaired-Floor 2/3.

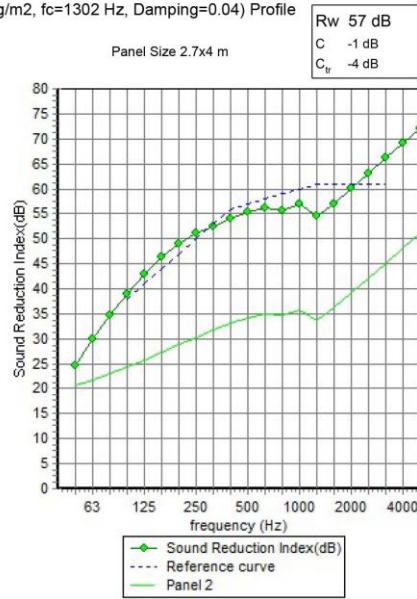
Figure F.15 Estimated data of II<sub>F</sub>-D proposal of Semi-Repaired-Floor 2/3.

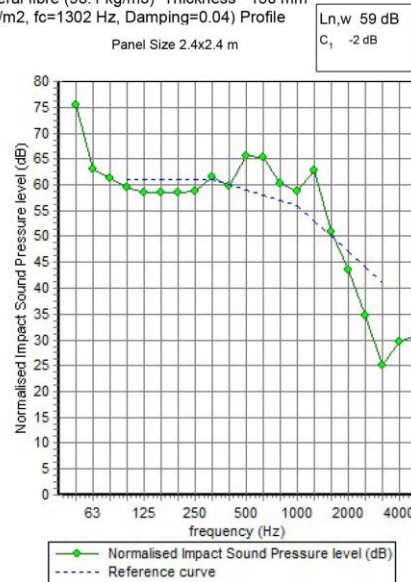
Figure F.16 Estimated data of II<sub>F</sub>-D proposal of Semi-Repaired-Floor 2/3.

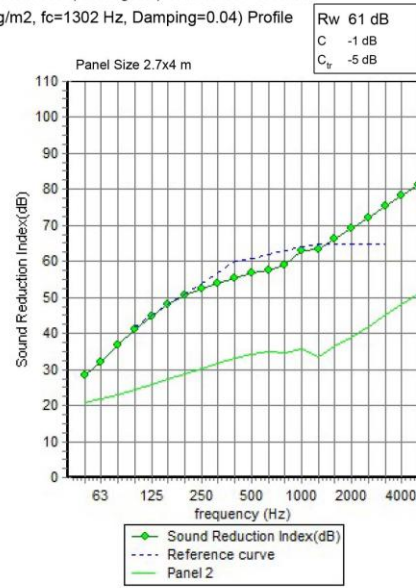
Figure F.17 Estimated data of II<sub>F</sub>-E proposal of Semi-Repaired-Floor 2/3.
