**TRADITIONAL RURAL ARCHITECTURE IN GEDİZ  
VALLEY : STUDY AND DOCUMENTATION OF VINEYARD  
HOUSES AND FARM BUILDINGS**

A Thesis Presented to the  
Graduate School of Natural and Applied Sciences  
Dokuz Eylül University

In Partial Fulfillment of the Requirements for  
the Master Degree In Architecture

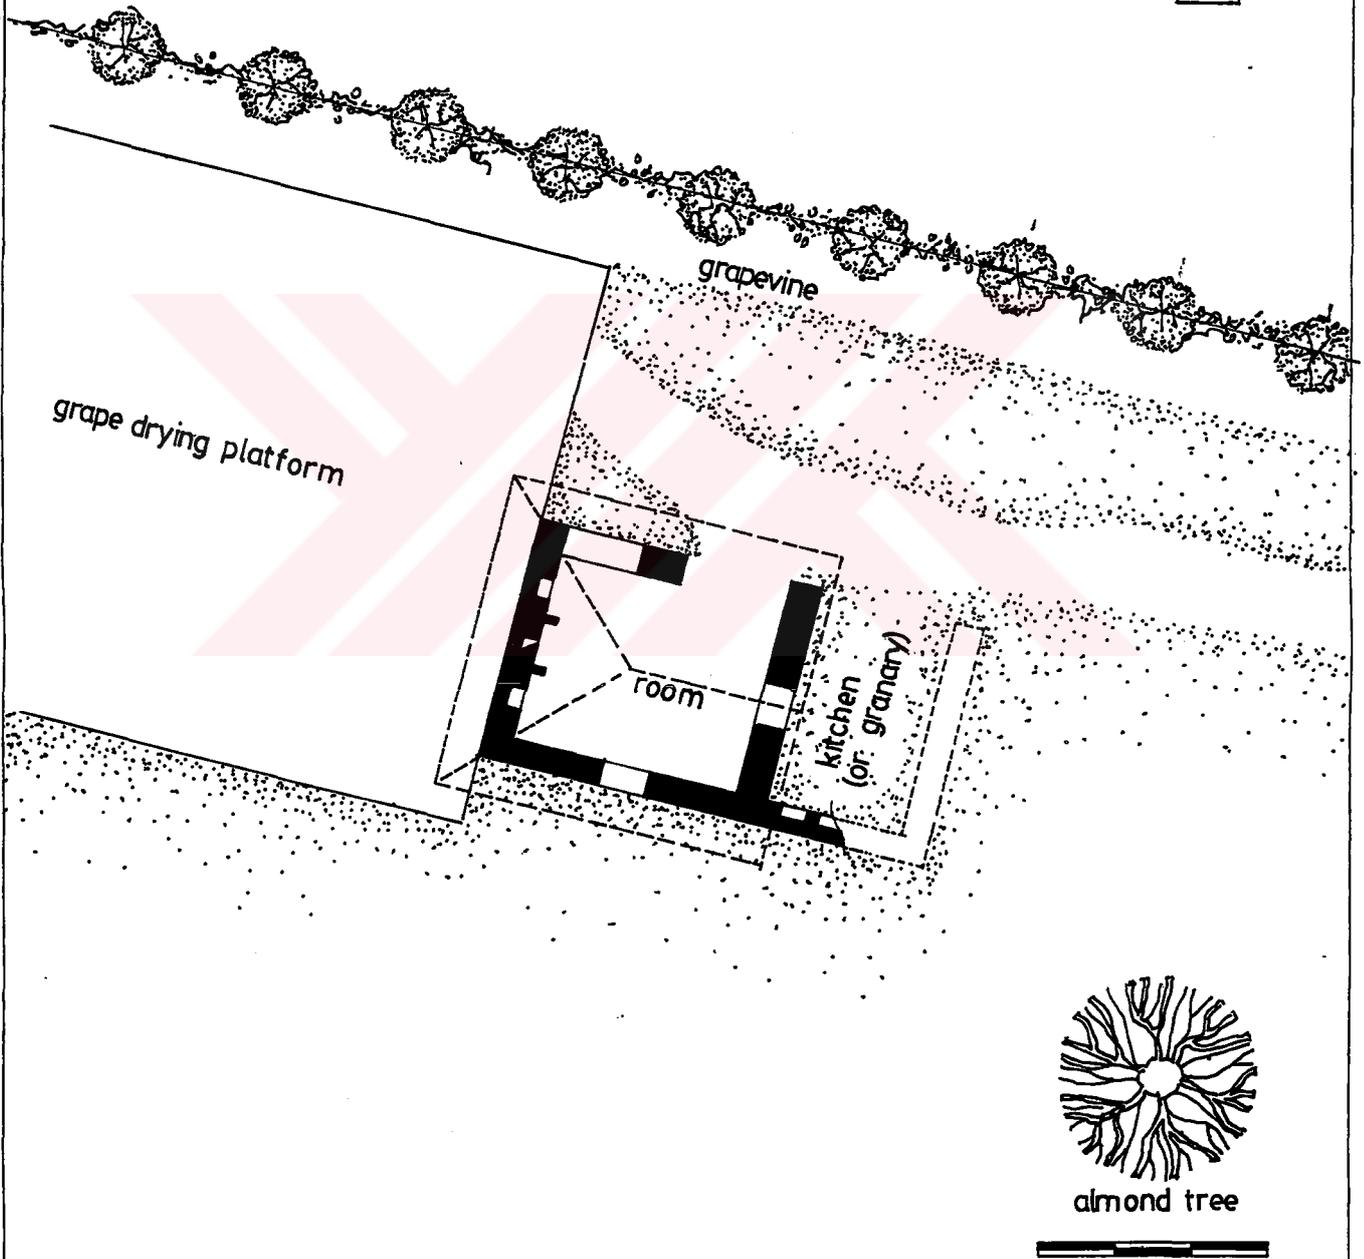
**Figure: 5**

**Example 4**  
**Fahri usta 's House**  
**The House is seven kilometres far away from AHMETLI**  
**Single room type**

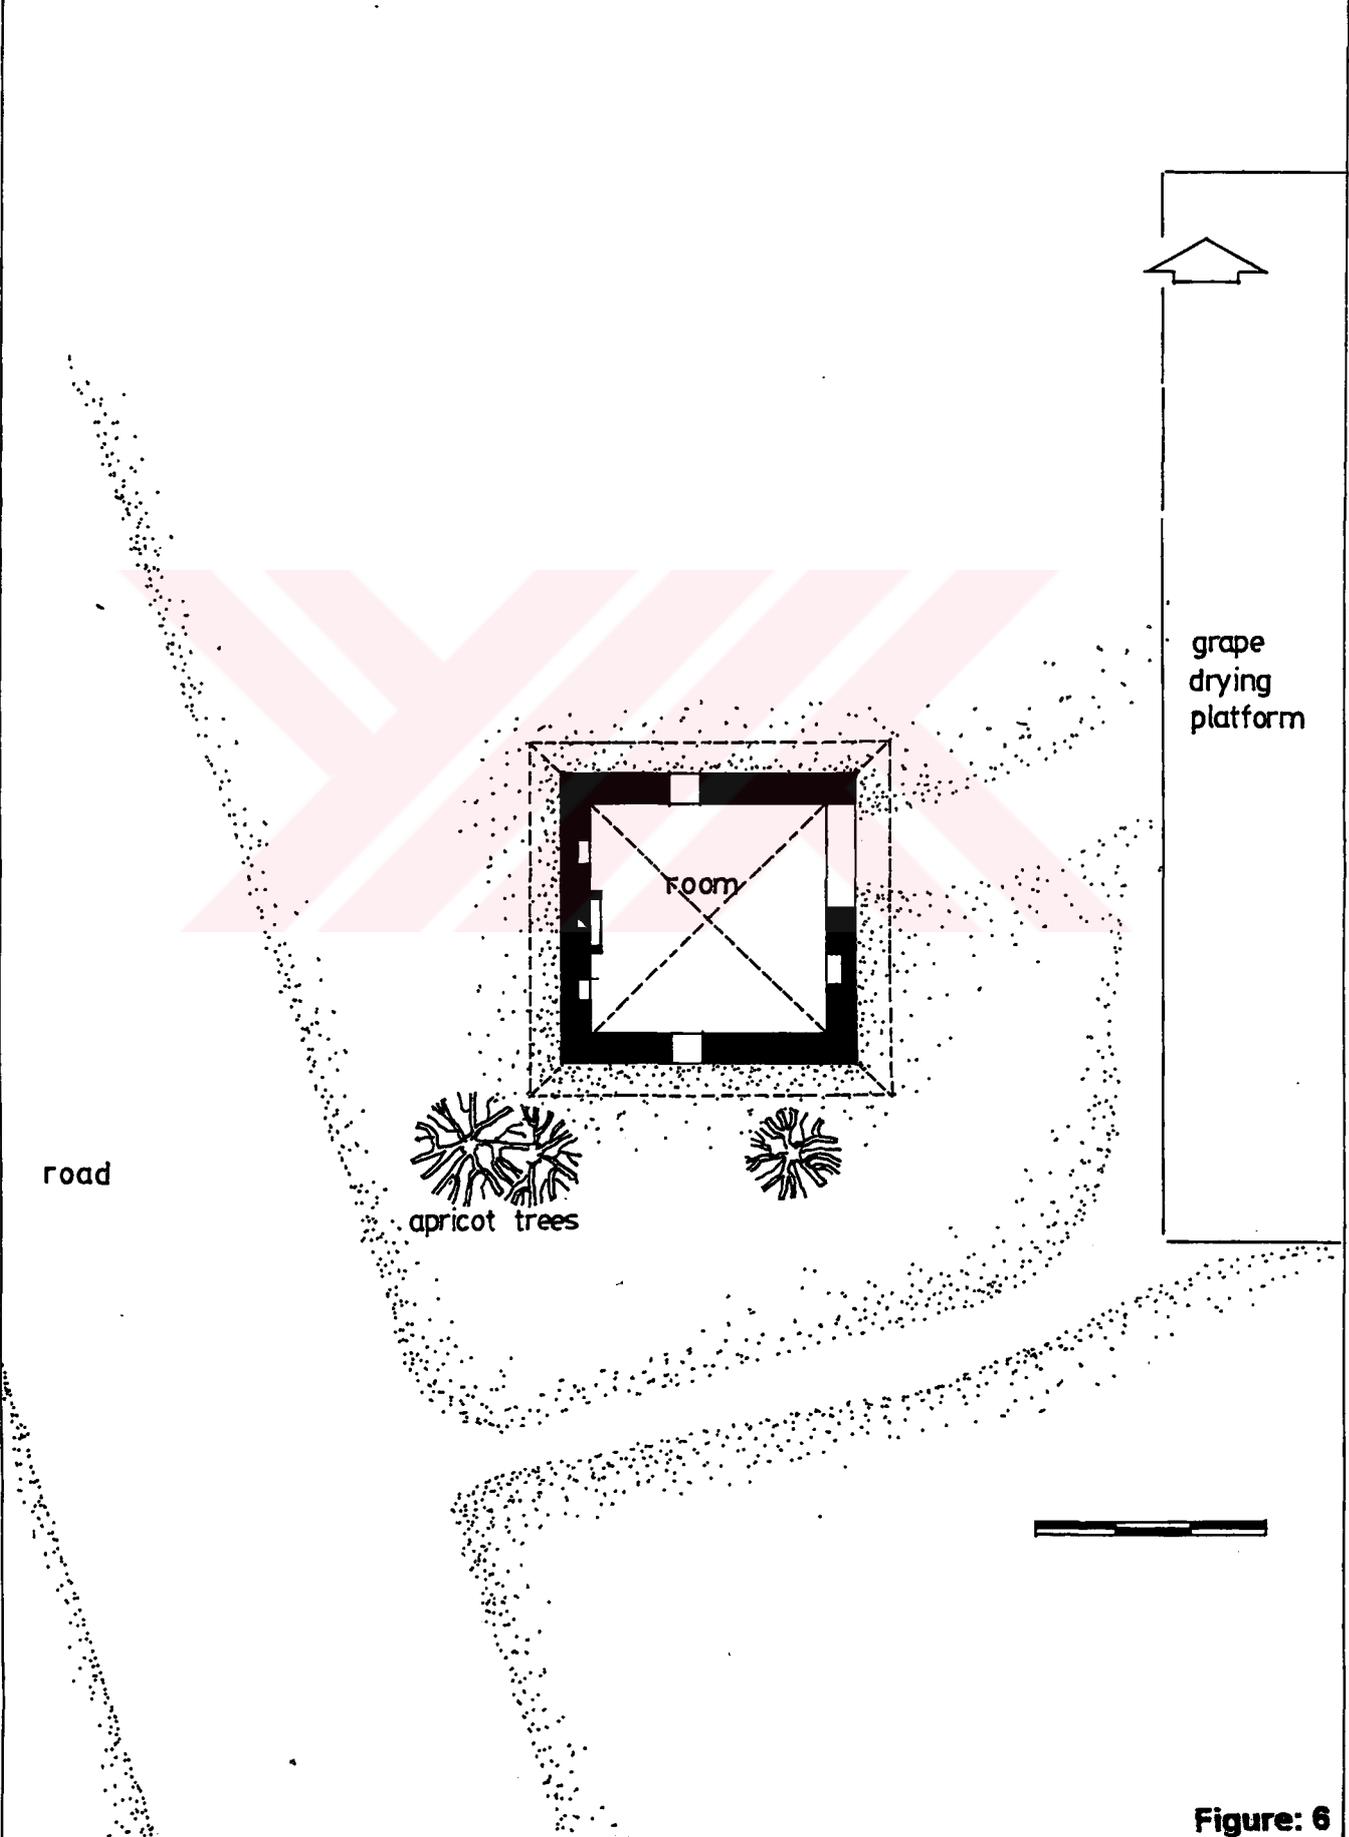
**Figure: 6**

grape drying platform

room

**Example 5**  
**Talip Bey's house**  
The House is eight kilometres far away from AHMETLI  
Single room type.

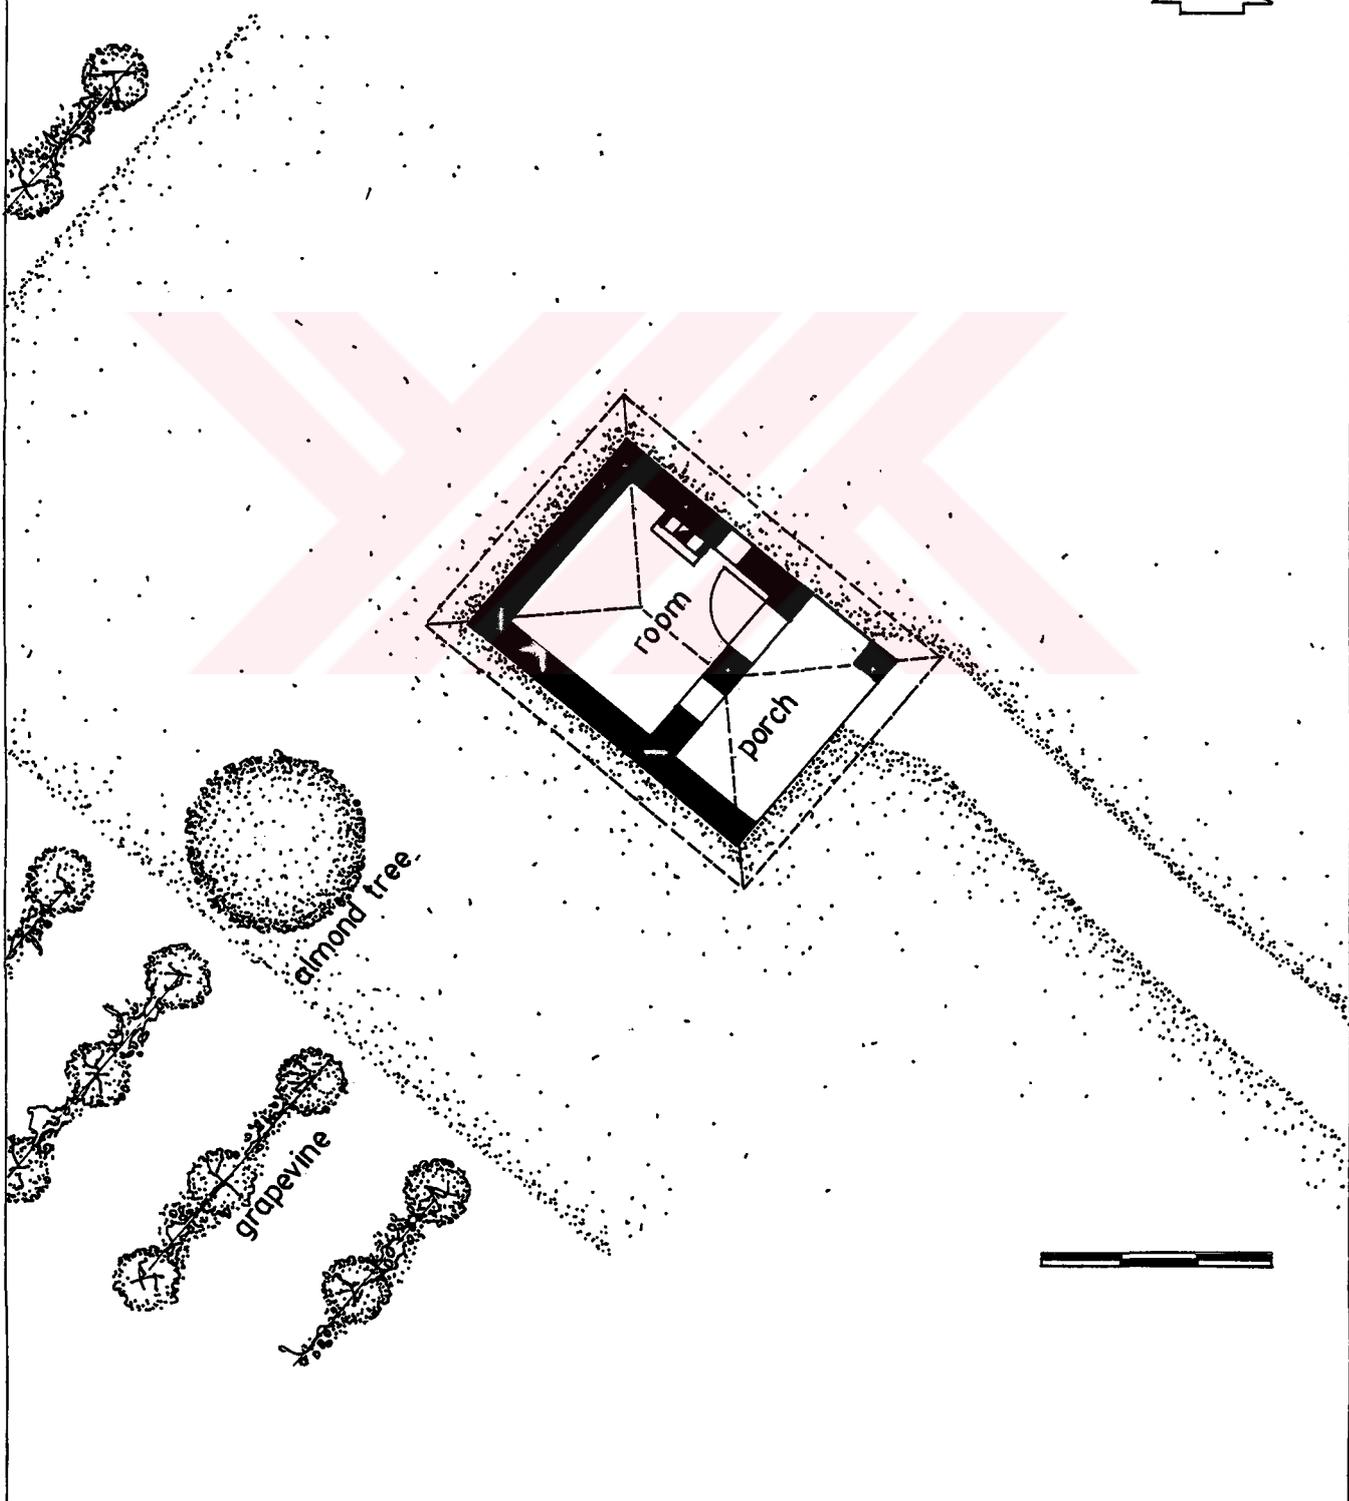
**Figure: 8**

**Example 13**  
The House is near ÖRNEKKÖY  
Asymmetric megaron type

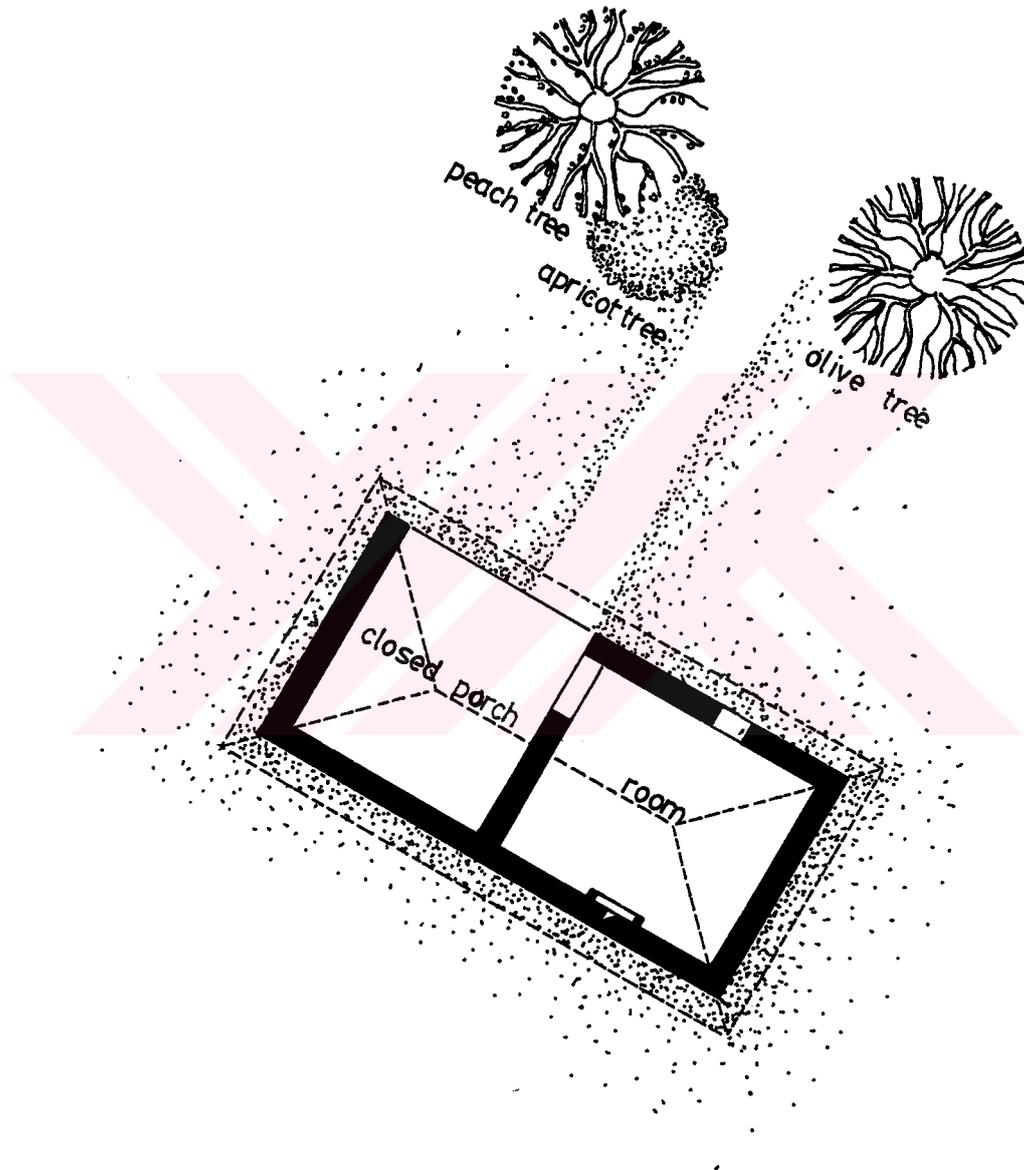
**Figure: 9**

**Example 20**  
**Ismail YALVAÇ's House**  
The House is two kilometres far away from MANISA  
The house is in the other group

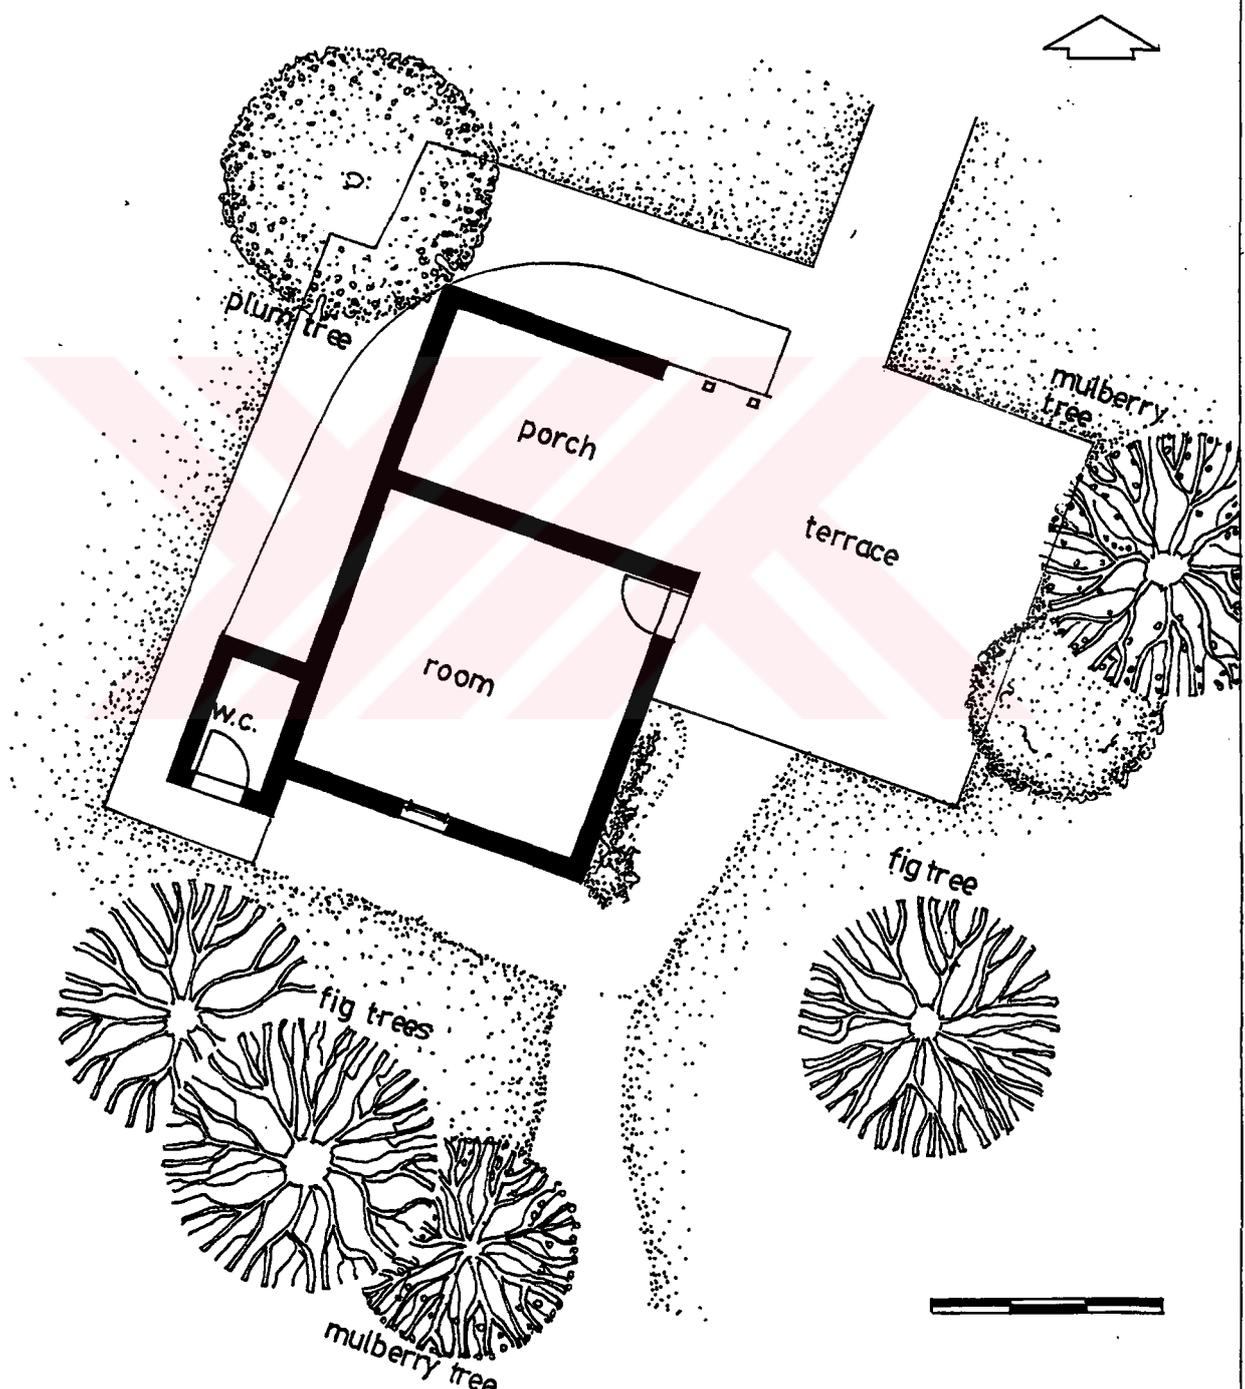
**Figure: 10**

**Example 17**  
**Sertaç KAPĞLAN's House**  
The House is one kilometre far away from MANİSA  
Pure megaron type

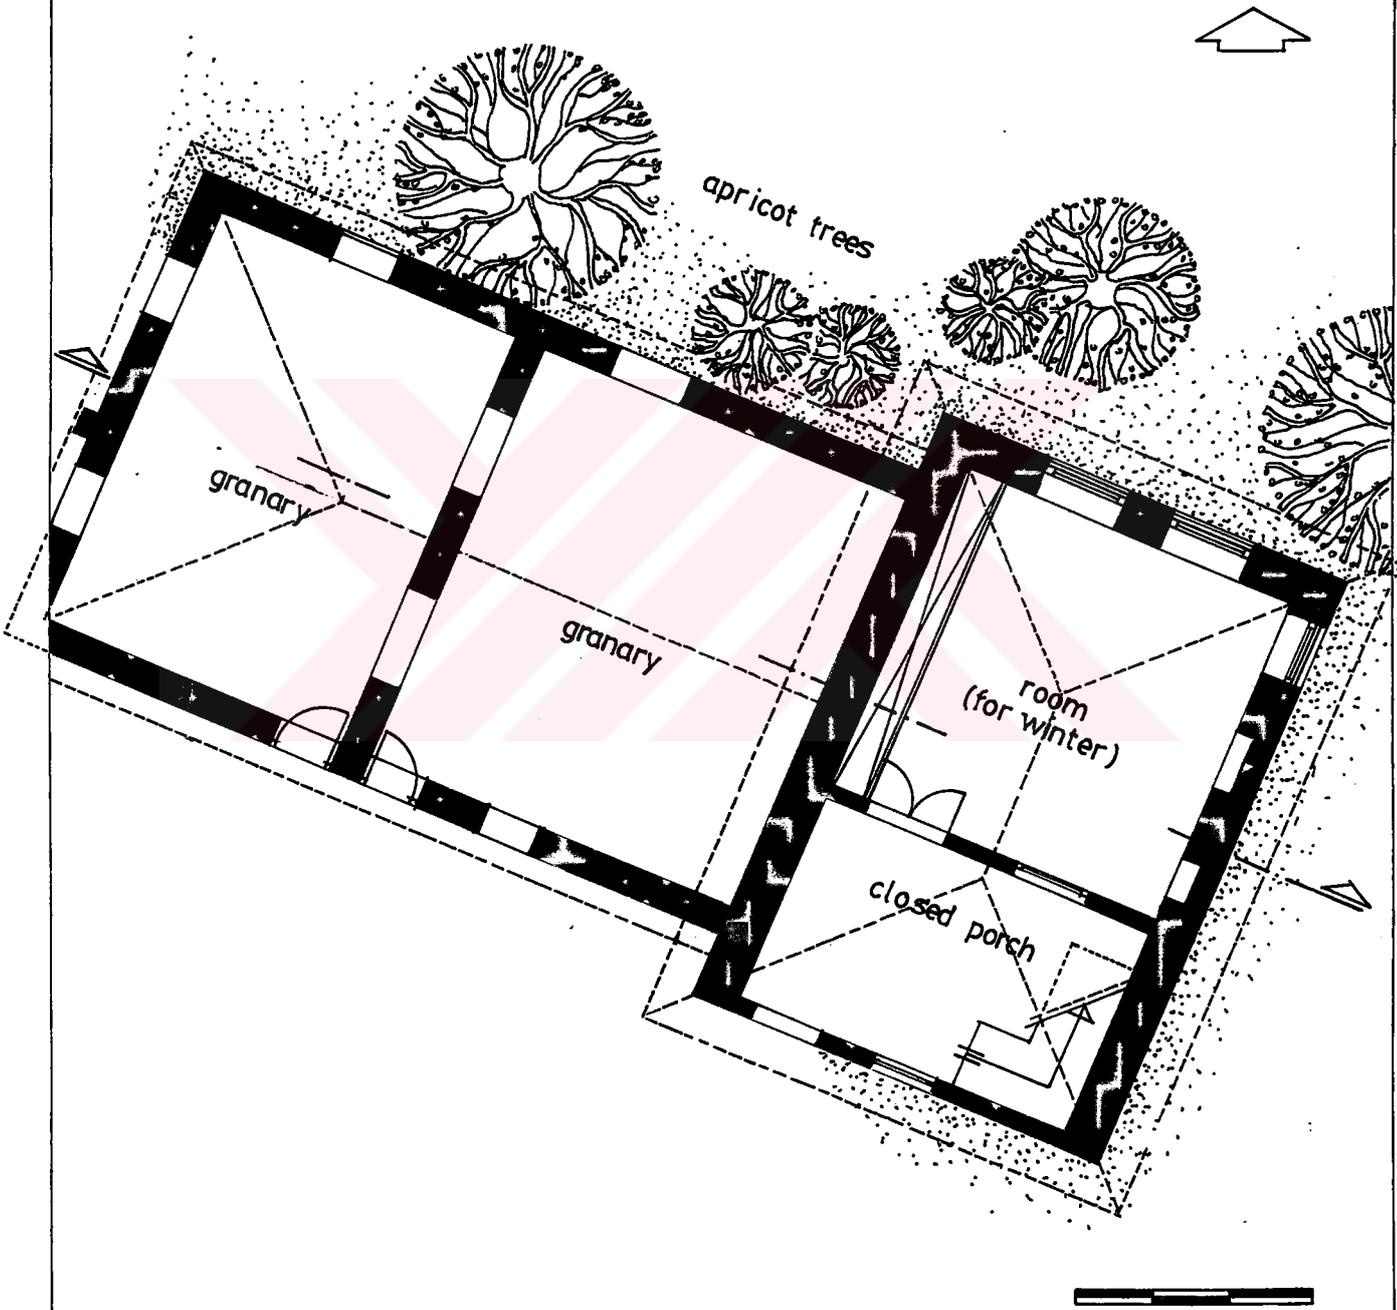
**Figure: 16**

**Example 28**  
**Hacı Teyze's House**  
The House is a kilometre far away from ÜÇPINAR  
Tower type house

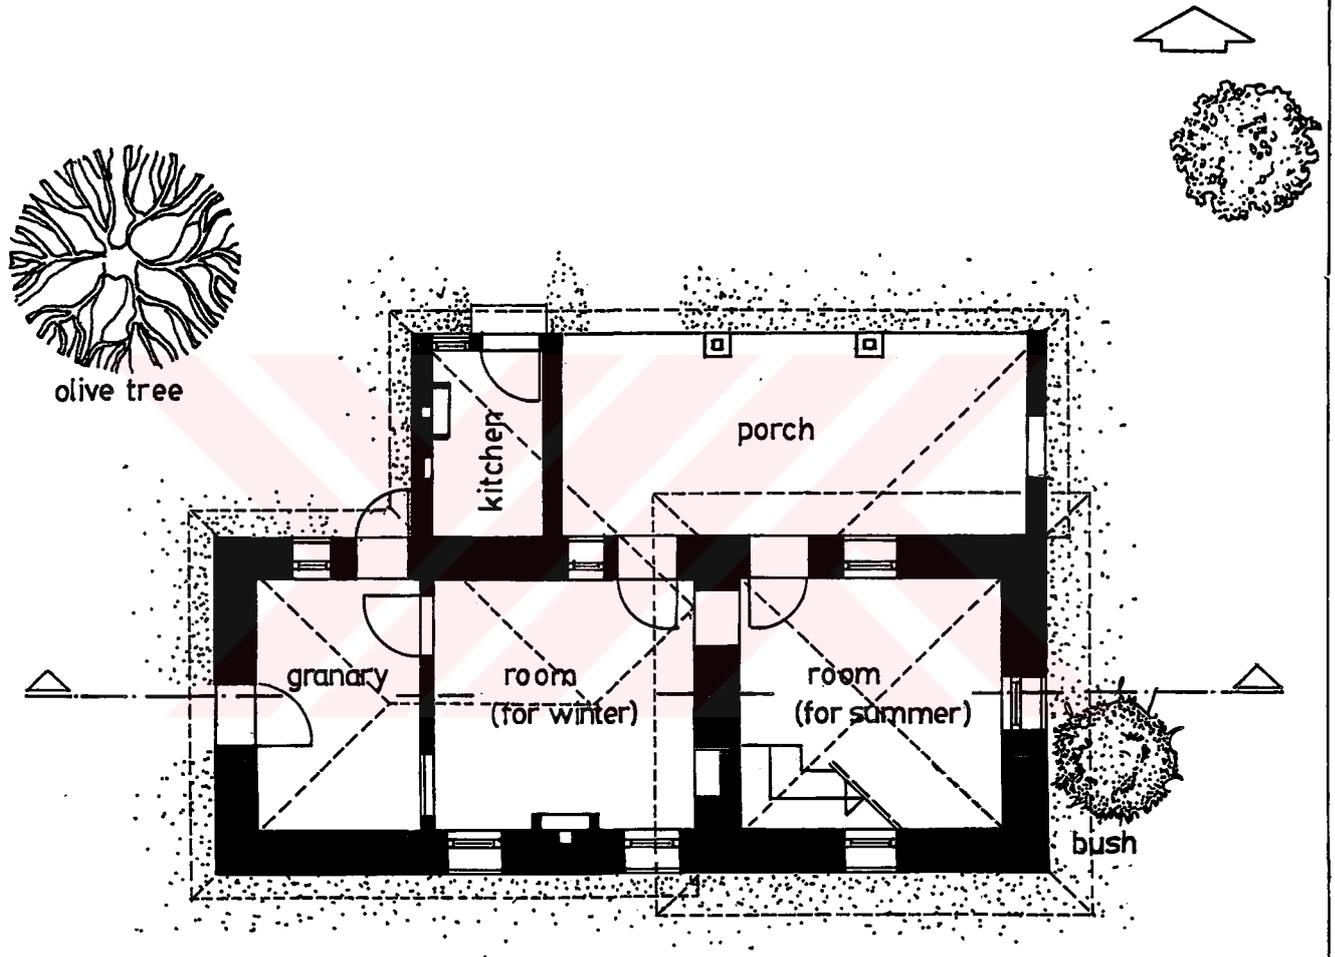
**Figure: 19**

**Example 29**  
**Ruhi BAYDAR's House**  
The House is two kilometres far away from MURADIYE  
Tower type house
