**IN-DEPTH ACCIDENT ANALYSIS AND CASE STUDY IN  
NIGERIAN ROAD AND TRAFFIC CONDITION**

**A THESIS SUBMITTED TO  
THE GRADUATE SCHOOL OF NATURAL AND APPLIED  
SCIENCE  
OF  
ATILIM UNIVERSITY**

**BY  
ABUBAKAR DAYYABU**

**MARCH 2014**

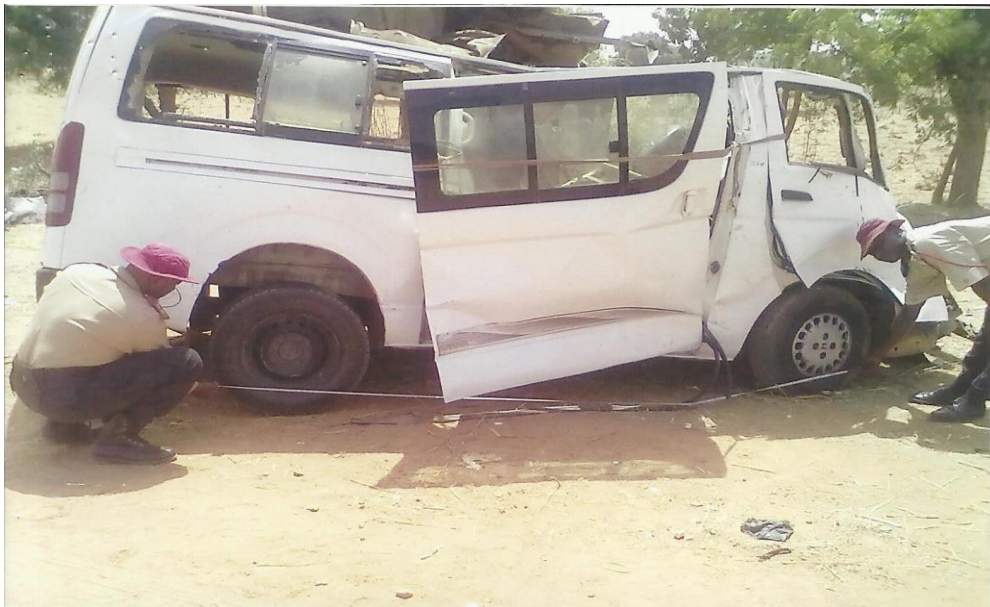
Side View of the Involved Bus

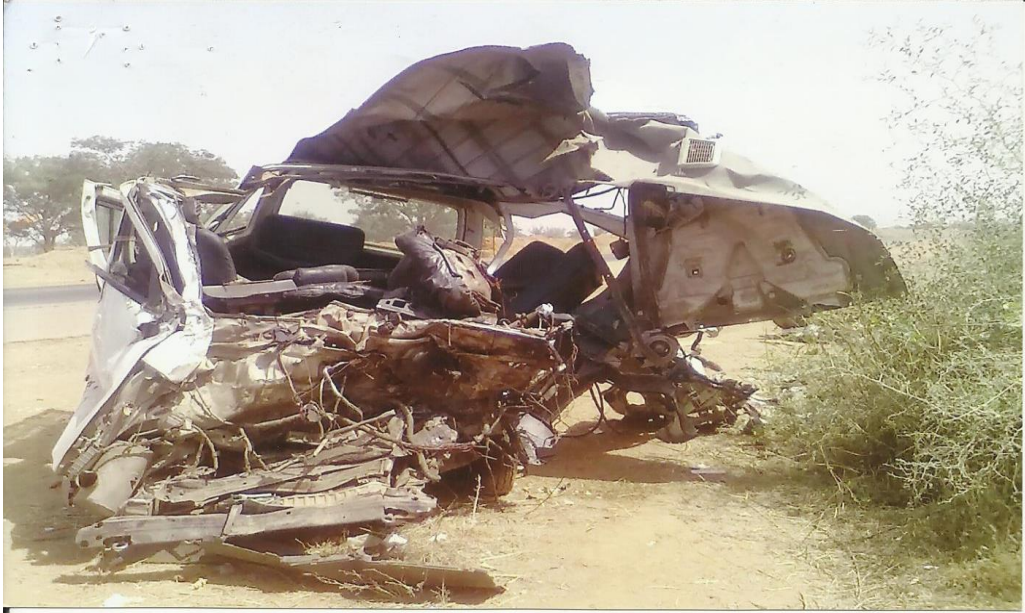
Front View of the Involved Bus

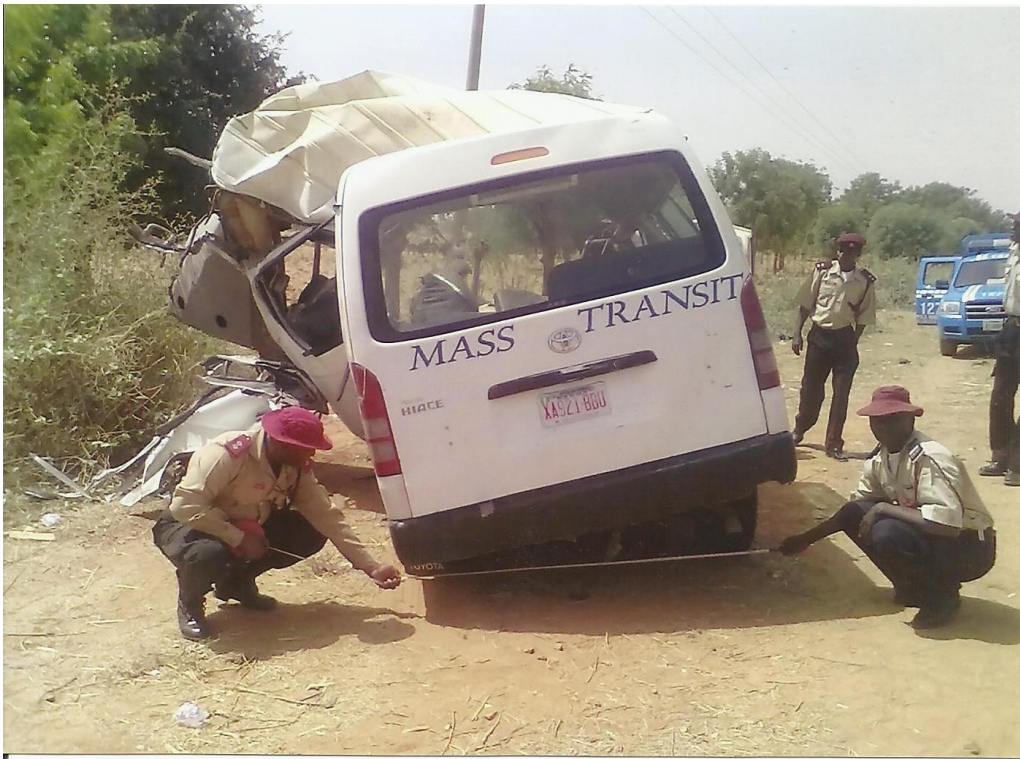
Rear View of the Involved Bus

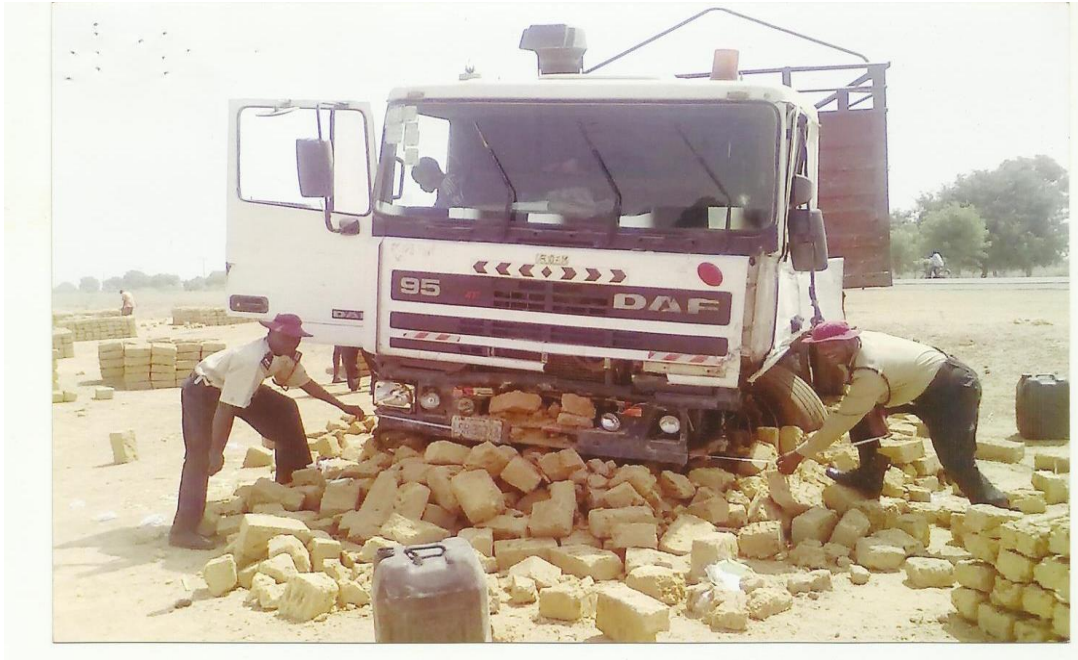
Front View of the Involved Truck in the Rest Position

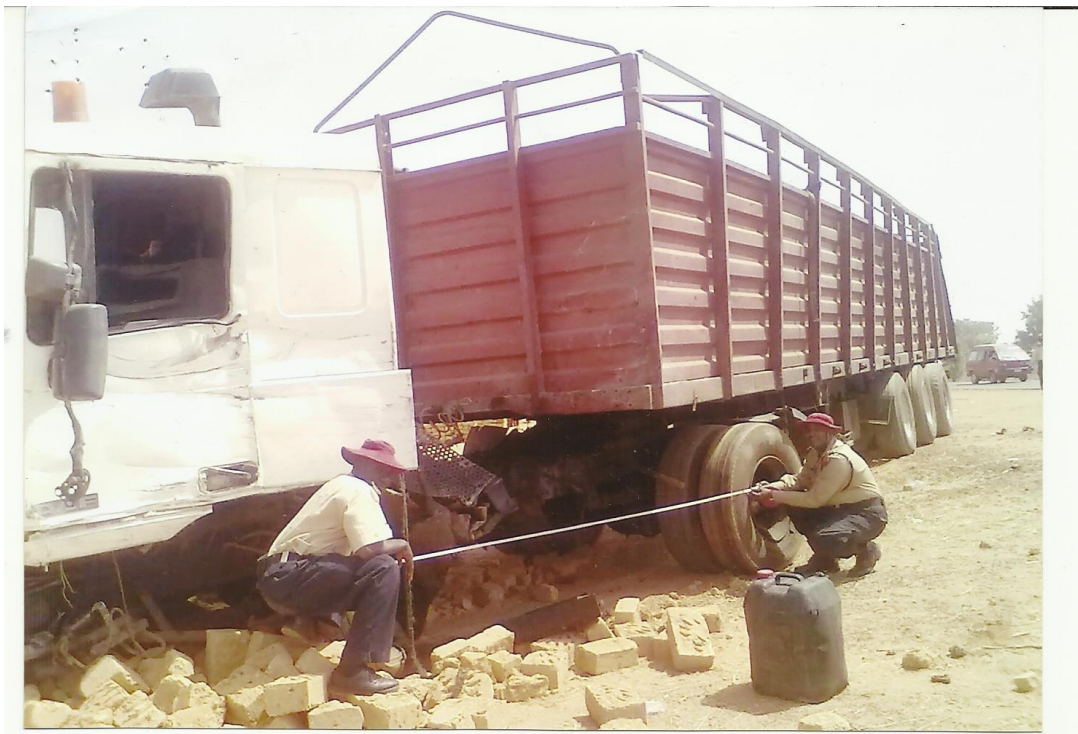
Side View of the Involved Truck in Its Rest Position

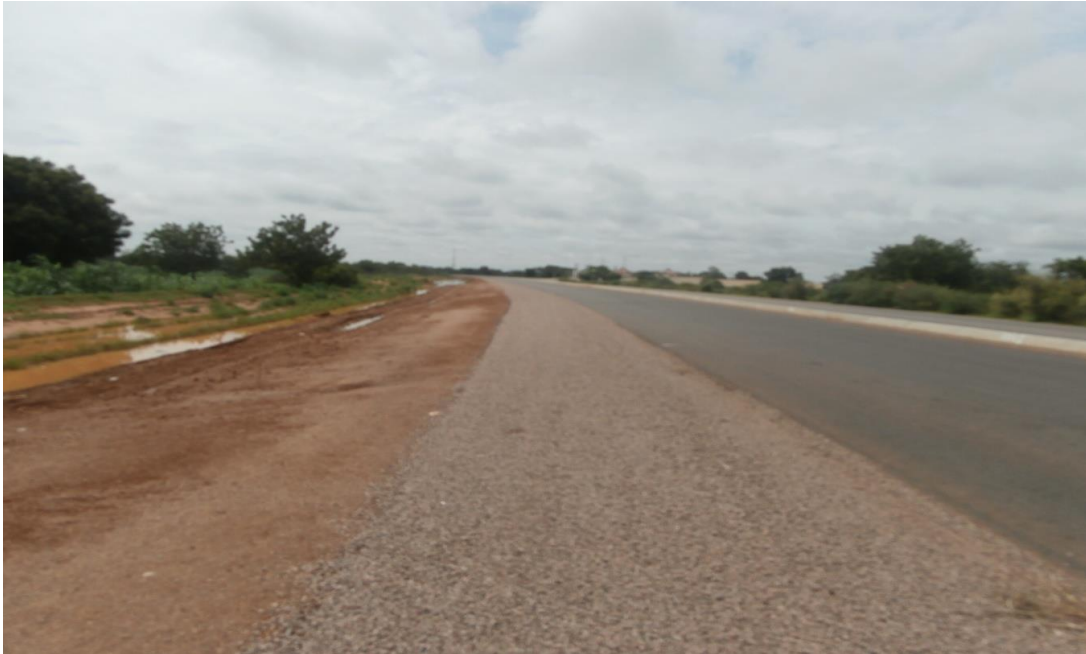
Road Cross-Section Showing Various Road Elements

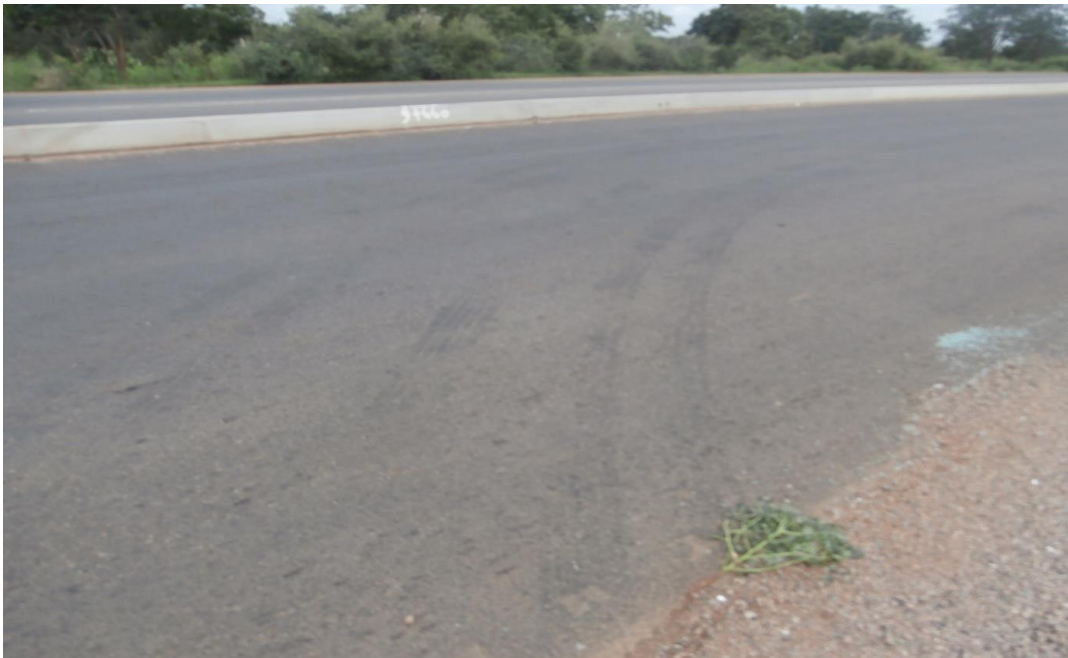
PICTURE SHOWING SKID MARKING PRODUCE BY THE INVOLVED BUS

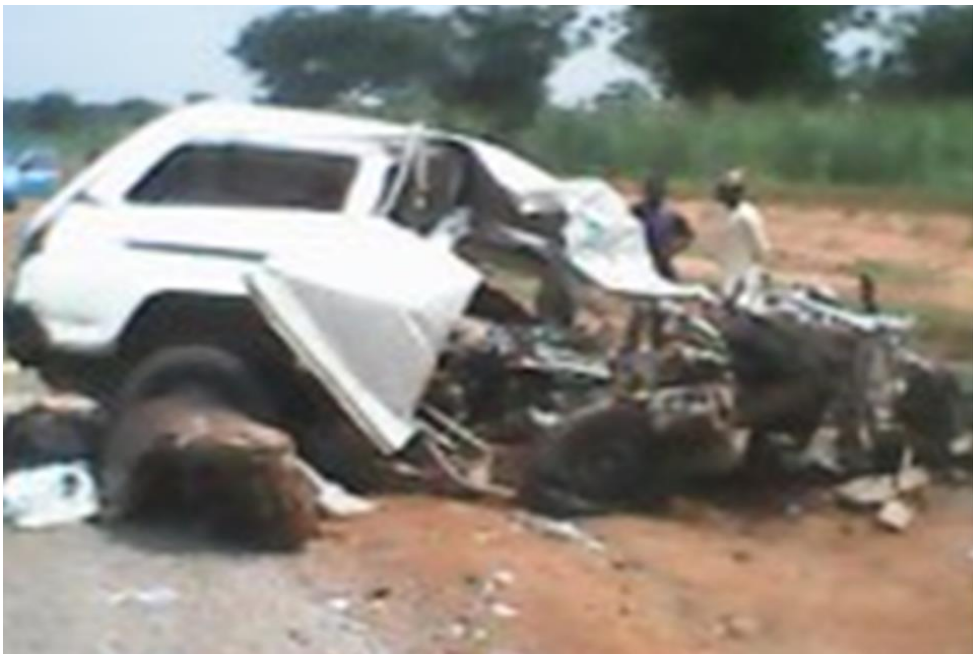
Front View of the Involved Bus

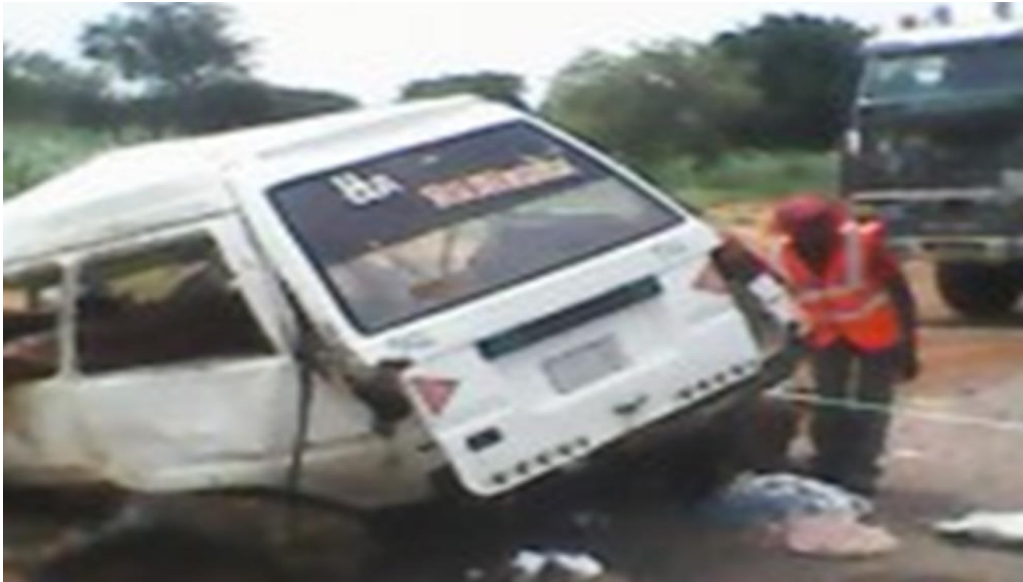
Rear View of the Involved Bus

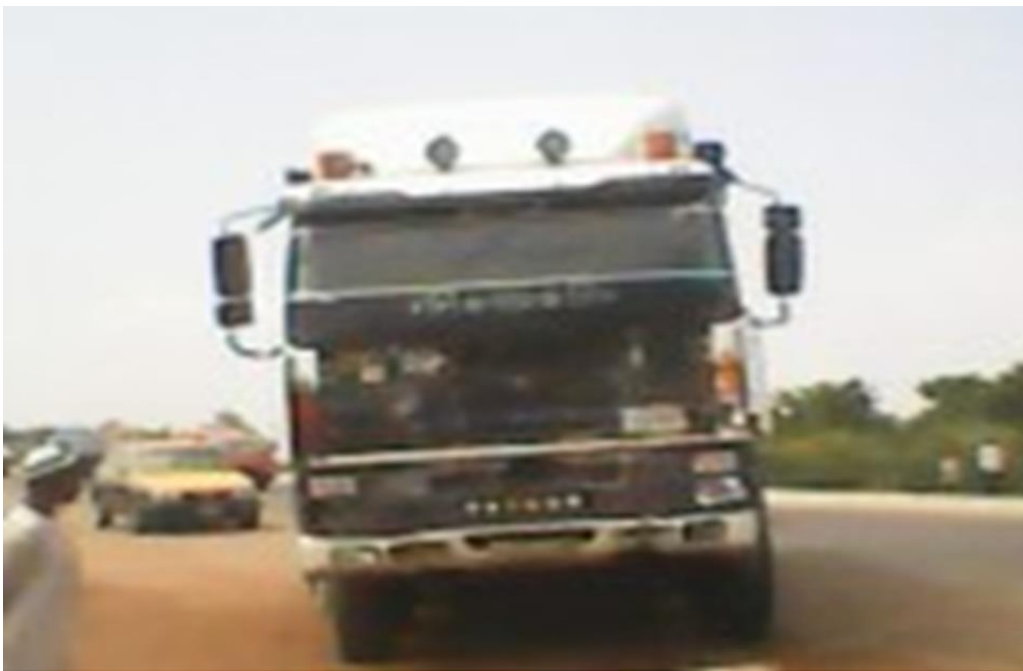
FRONT VIEW OF THE INVOLVED TRUCK

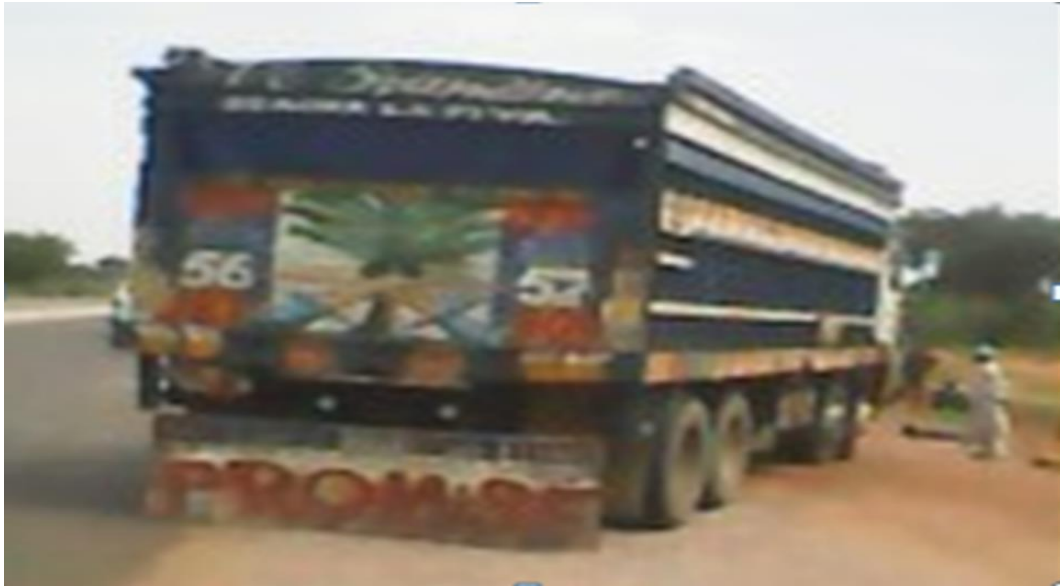
REAR VIEW OF THE INVOLVED TRUCK

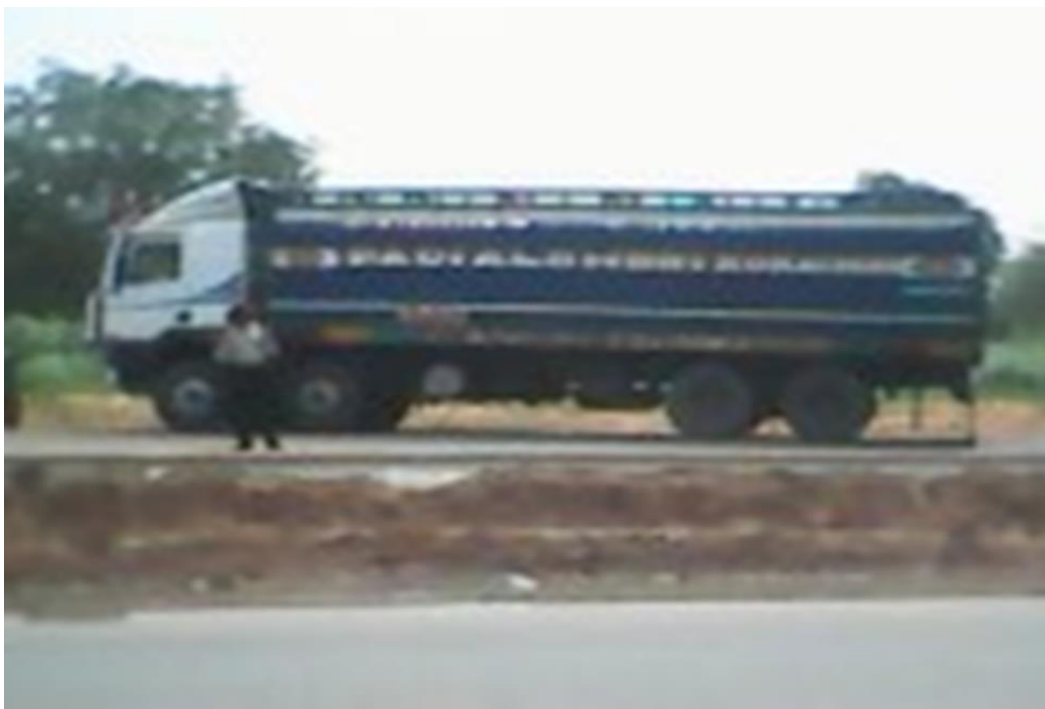
SIDE VIEW OF THE INVOLVED TRUCK

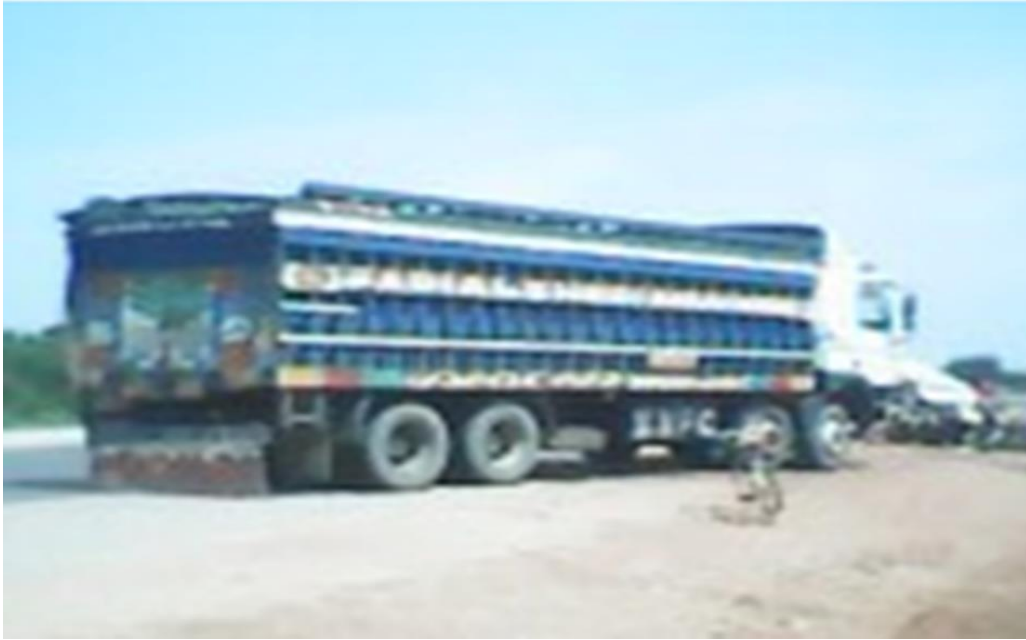
SIDE VIEW OF THE INVOLVED TRUCK
