**SAFETY AUDITING ON URBAN ROADS WITH SPECIAL EMPHASIS TO  
INTERSECTIONS  
IN A CASE STUDY IN KANO, NIGERIA.**

**A MASTER'S THESIS**

**Civil Engineering**

**Atilim University**

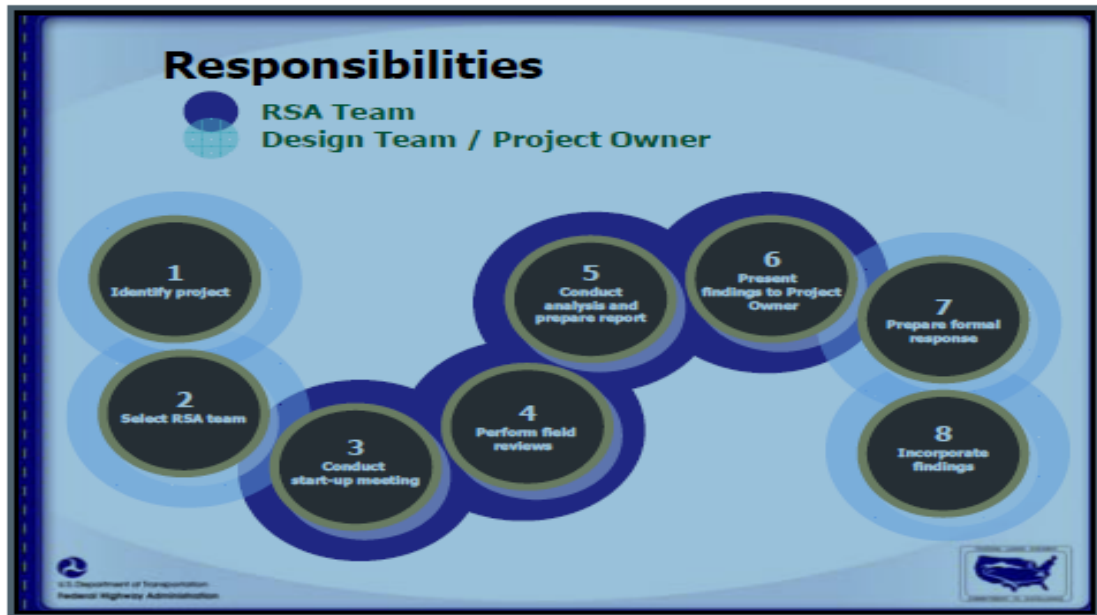
**Figure 2.2 Road Safety Audits/Inspections Process [21]**

The formal response is for the project owner and the design team to review the audit report and jointly prepare a written response to its findings, the response should outline what actions the project owner or design team will take related to each safety concern listed in the audit report. Once the response report is sent to the RSA team, the project owner and design team will need to ensure that the agreements described in the response report are completed as described and in the time-frame documented. [21]

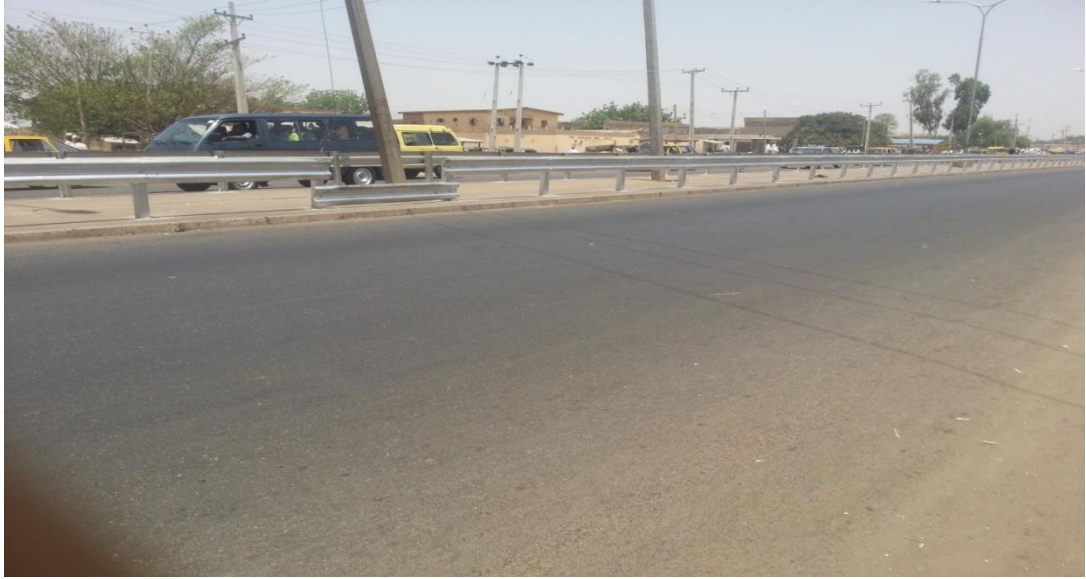
Absence of lane marking caused vehicle drivers to leave a particular travelled lane that creates confusion among motorists and cause a serious accident. Throughout the route section been observed, there was a complete absence of lane marking.

**Figure 4.2 Absence of lane markings (Throughout the road section)**

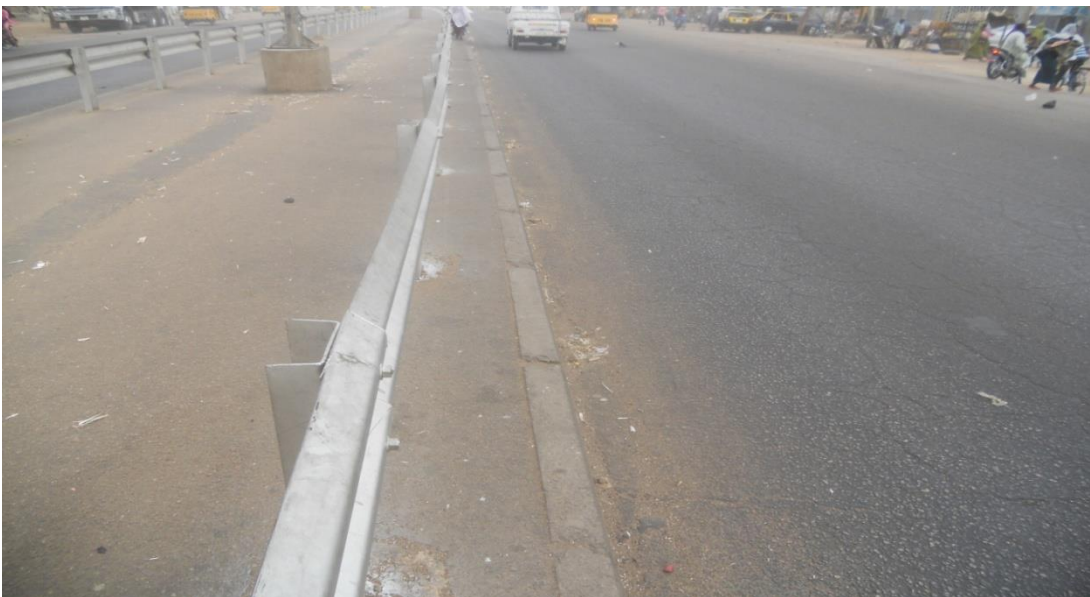
Absence of edge markings might create serious misunderstanding issues with the drivers of the vehicles using the inner and outer lanes. Drivers using inner lane might mistakenly hit the median edge due to the edge line missing and create accidents. There were completely absences of route edge line markings throughout the observed route section.

**Figure 4.3 Absence of edge line markings (Throughout the road section)**

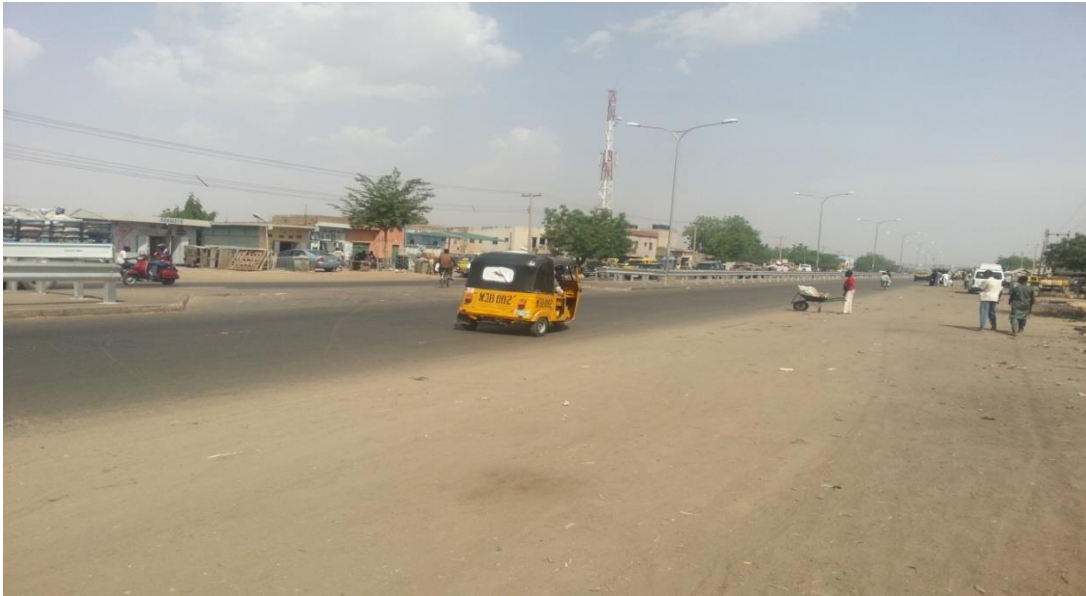
There was complete absence of transverse markings of the route, especially at the junction areas that help in alerting drivers to stop or yield. This circumstance could lead to serious intersection accidents, especially at un-signalized junctions.

**Figure 4.4 Absence of transverse marking (throughout the road section)**

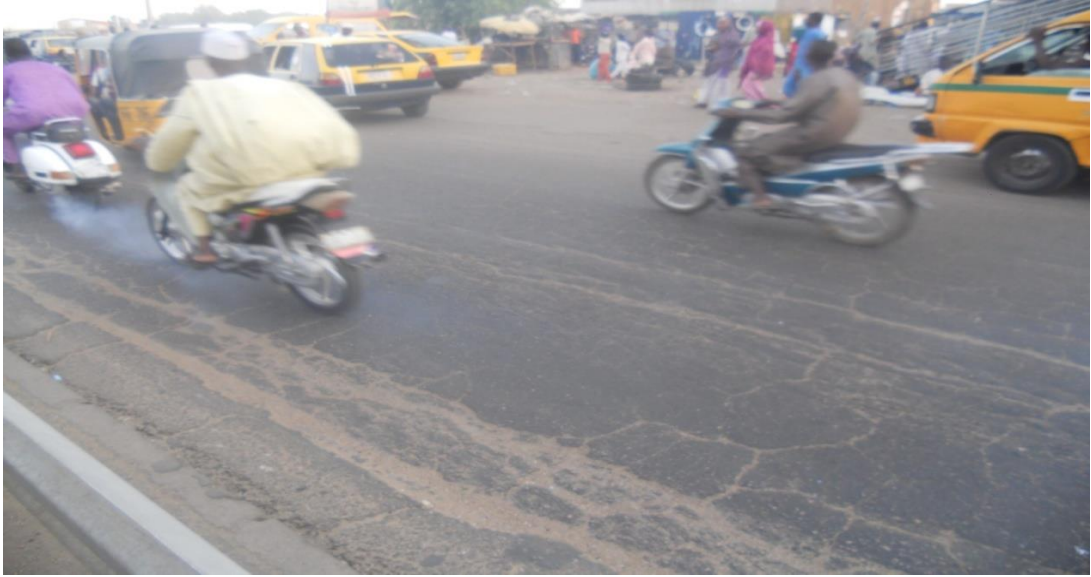
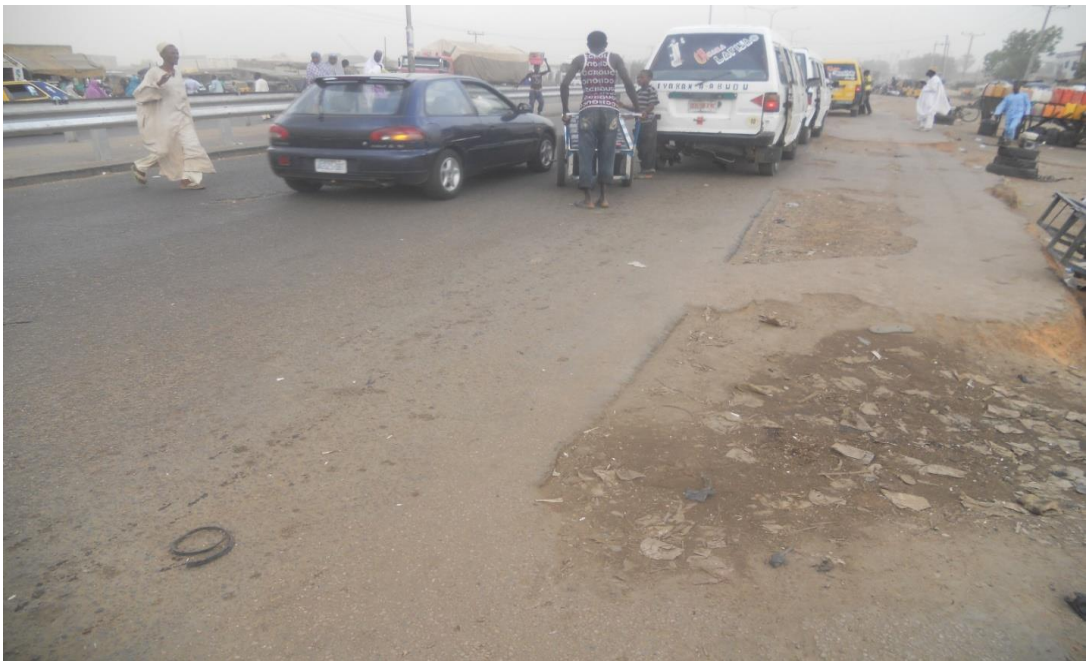
Absence of proper routine maintenance has been observed along the overall road section particularly at outer travelled lane edges, some sections of the route had been routed and deformed, which caused vehicles to have sudden break or parked on the outer travelled lane which could lead to serious accidents.

**Figure 4.5 Lack of maintenance (Km 04+900) Bachirawa Junction-Airport Roundabout**

**Figure 4.6 Lack of maintenance (Km 02+500) Bachirawa Junction-Airport Roundabout**

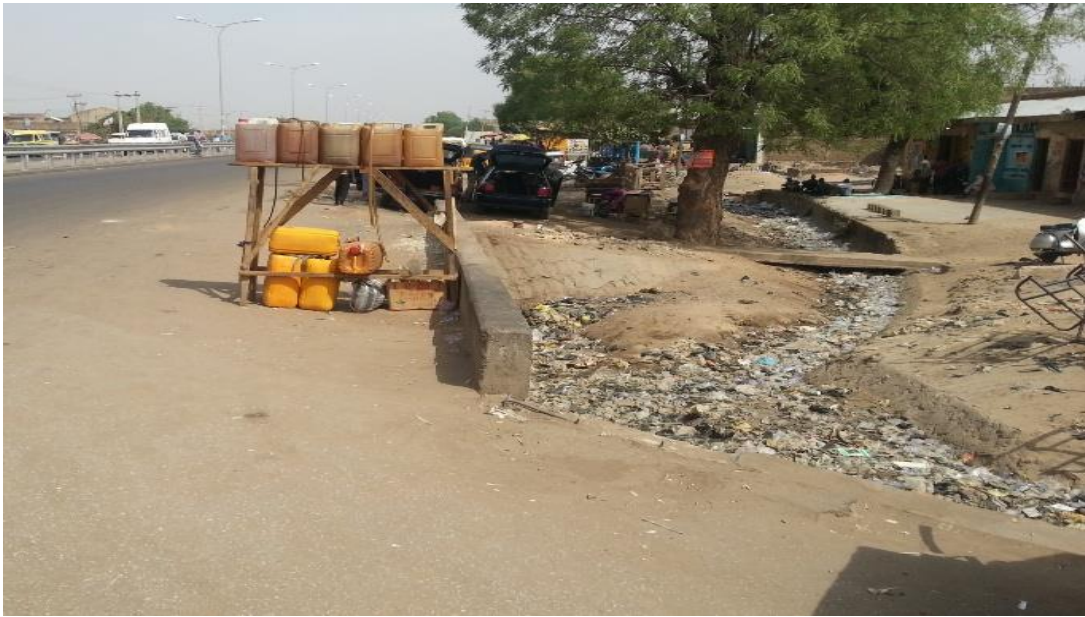
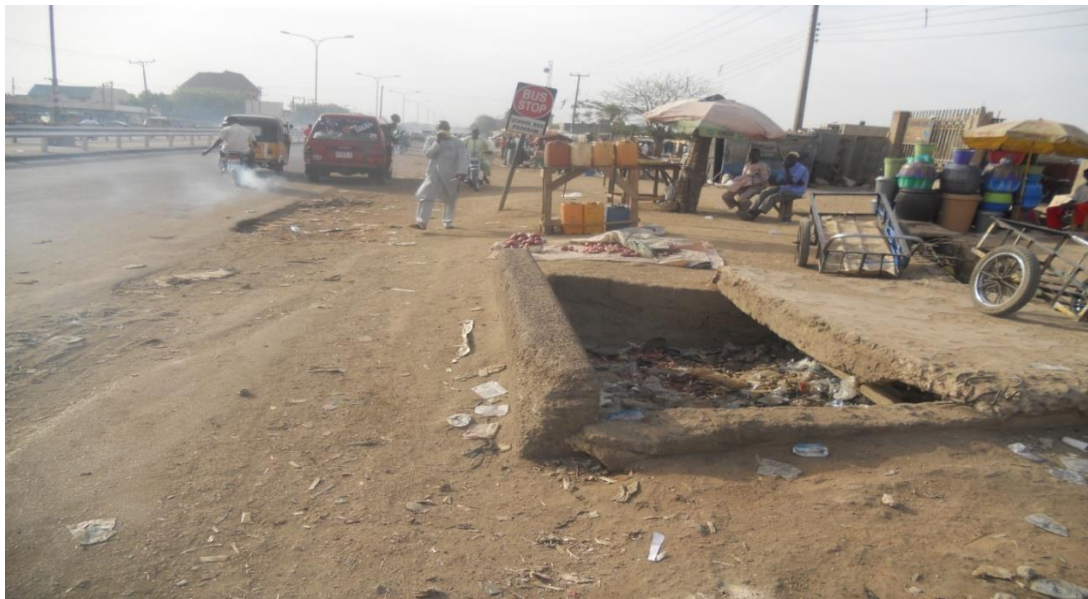
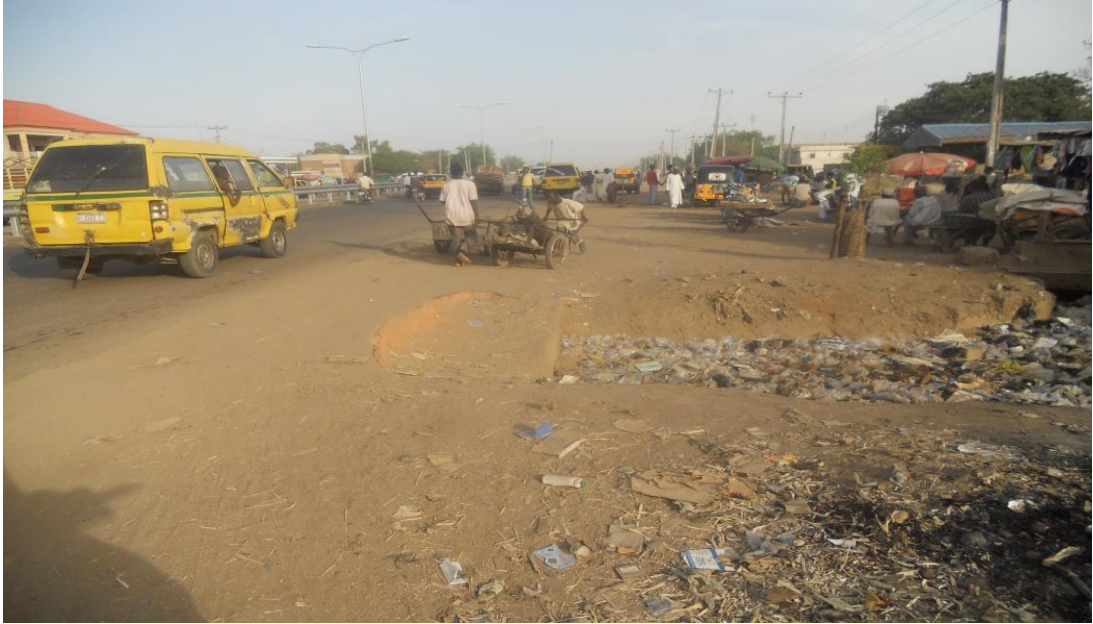
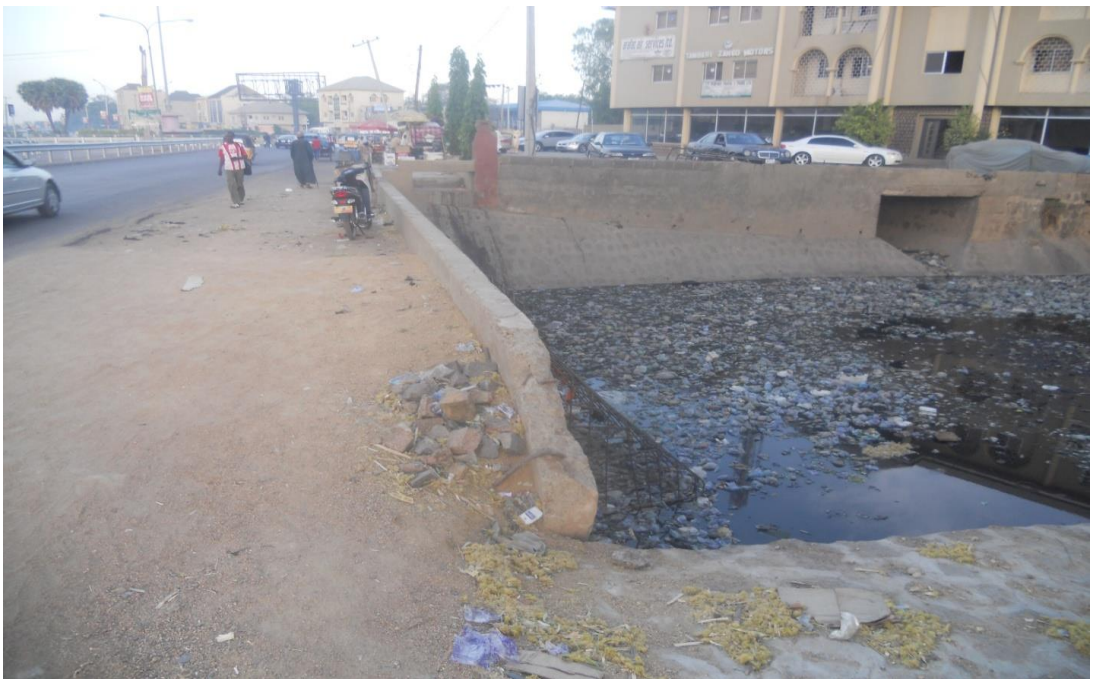
Poor drainage systems and open channels culverts have been observed along the entire route section, These situations could contribute a lot in destroying the surface pavement and create high potential safety problems to vehicle drivers and vulnerable road users.

**Figure 4.7 Improper drainages (km 04+250) Bachirawa Junction-Airport Roundabout**

**Figure 4.8 Improper drainages (Km 05+300) Airport Roundabout-Bachirawa Junction**

**Figure 4.9 Improper drainages (Km 00+5) Bachirawa Junction-Airport Roundabout**

**Figure 4.10 Improper channels (Km 07+700) Bachirawa Junction-Airport Roundabout**

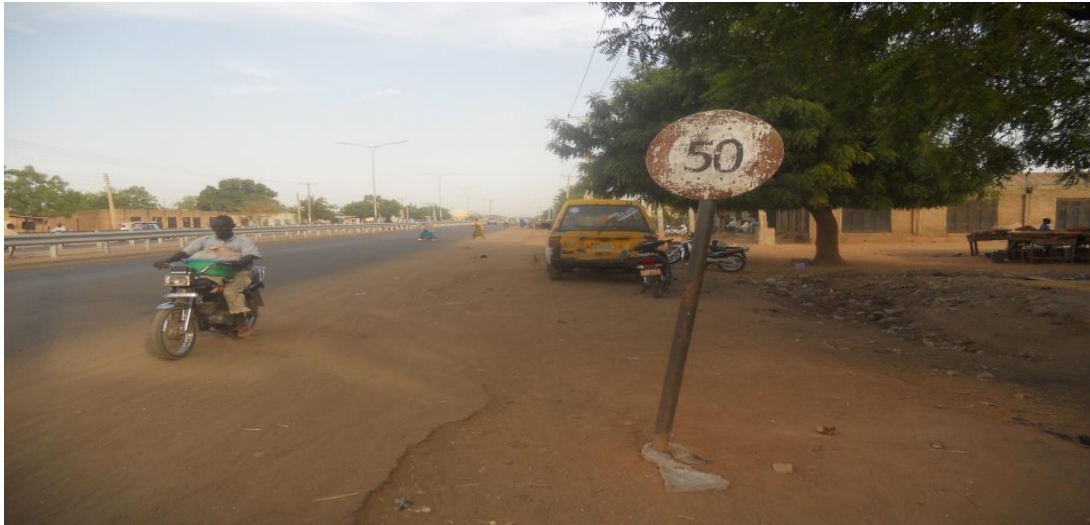
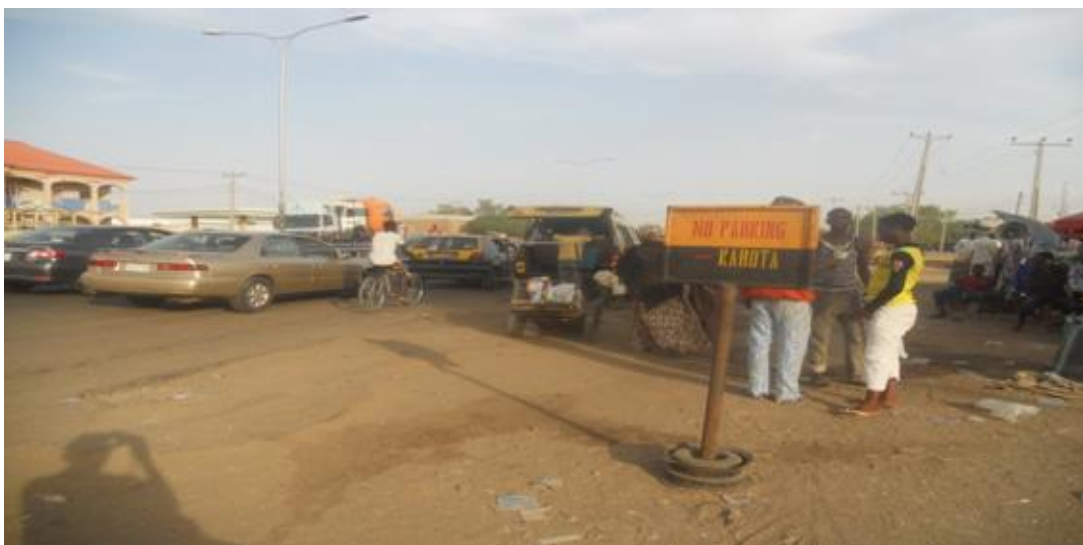
Several improper and worn out regulatory signs have been observed along the audited route section, some observed signs were not clear enough at some relative distance while others were inappropriately being placed close to an outer travelled lane which can create potential problems to the road users.

**Figure 4.11 Worn out speed limit sign (Km 06+10) Bachirawa Junction-Airport Roundabout**

**Figure 4.12 Improper parking control sign (Km 0+20) Bachirawa Junction-Airport Roundabout**

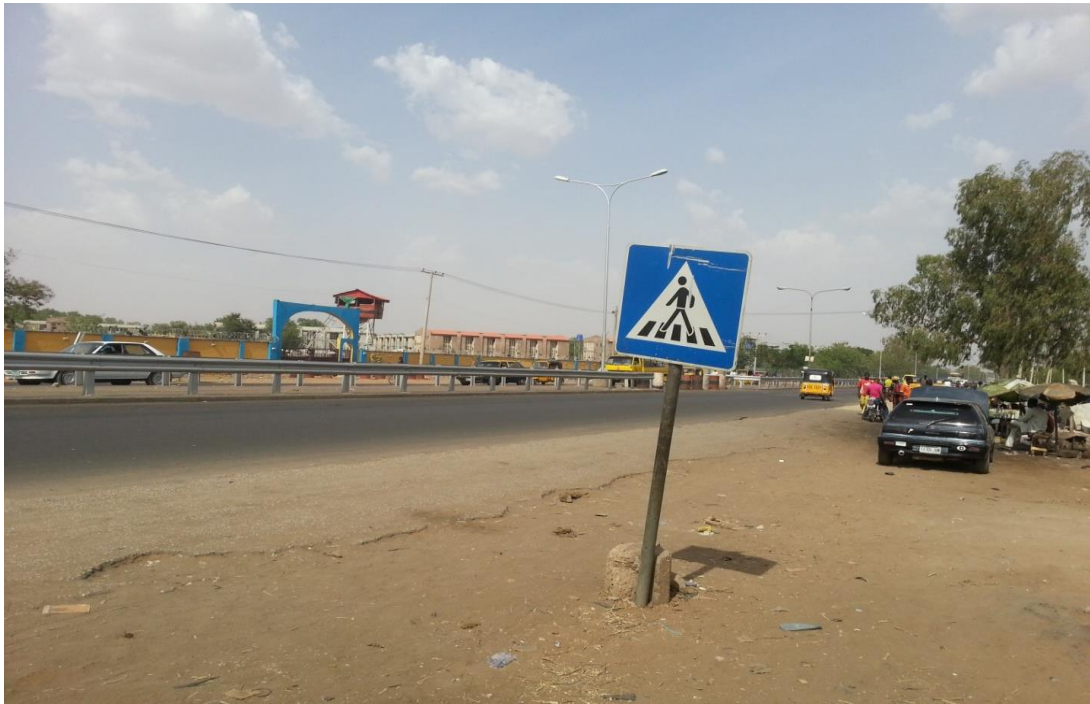
Many inappropriate pedestrian crossing signs have been observed along the audited route section in which guardrails have been mounted completely on the median in order to block pedestrians from crossing the road, There were completely absence of warning ahead sign on the overall route section.

**Figure 4.13 Improper pedestrian crossings (Km 06+550) Bachirawa Junction-Airport Roundabout**

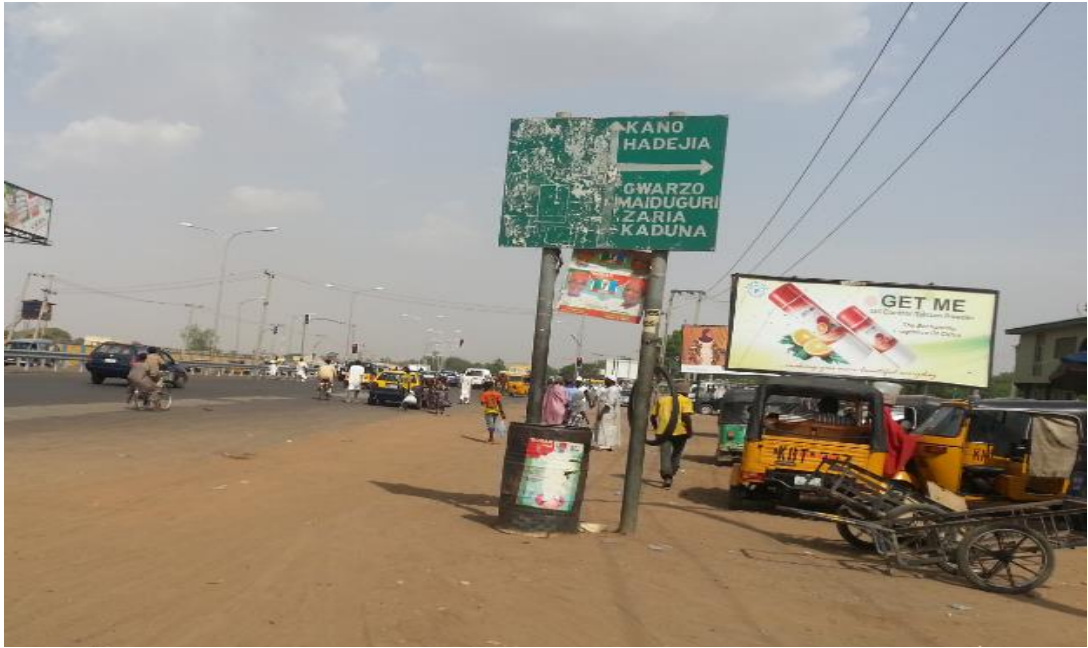
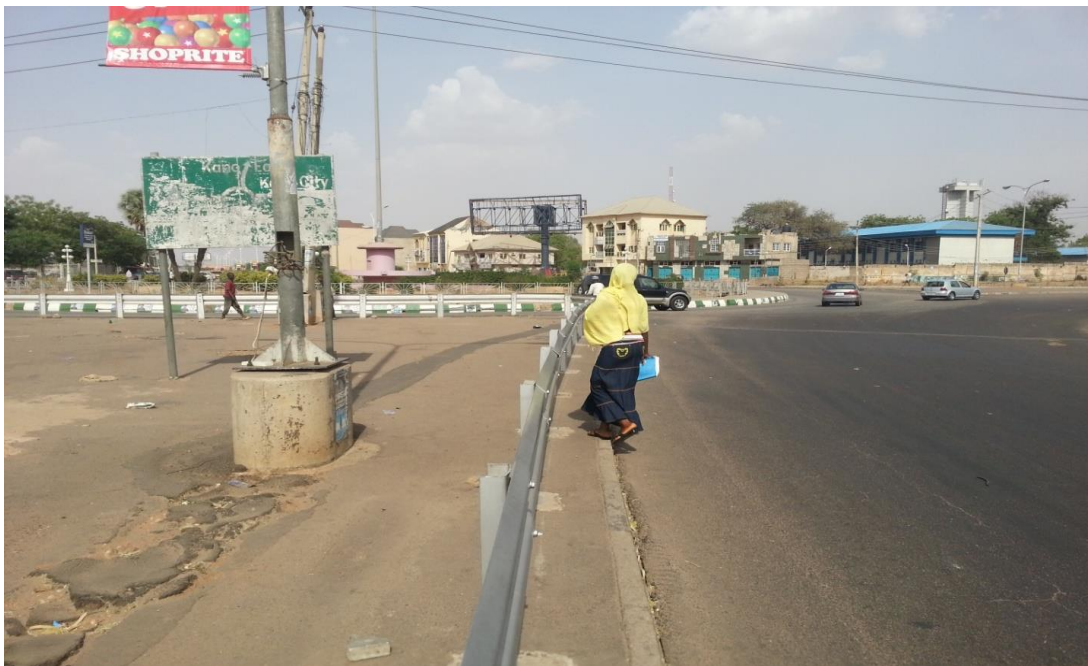
Several numbers of worn out directional and informational signs have been observed along the audited route section that helped in guiding and informing drivers about intended destination. Such circumstances could contribute a lot in creating accident as drivers would be busy trying to read and identify the intended direction.

**Figure 4.14 Worn out directional sign (Km 05+700) Bachirawa Junction-Airport Roundabout**

**Figure 4.15 Worn out directional sign (Km 07+790) Bachirawa Junction-Airport Roundabout**

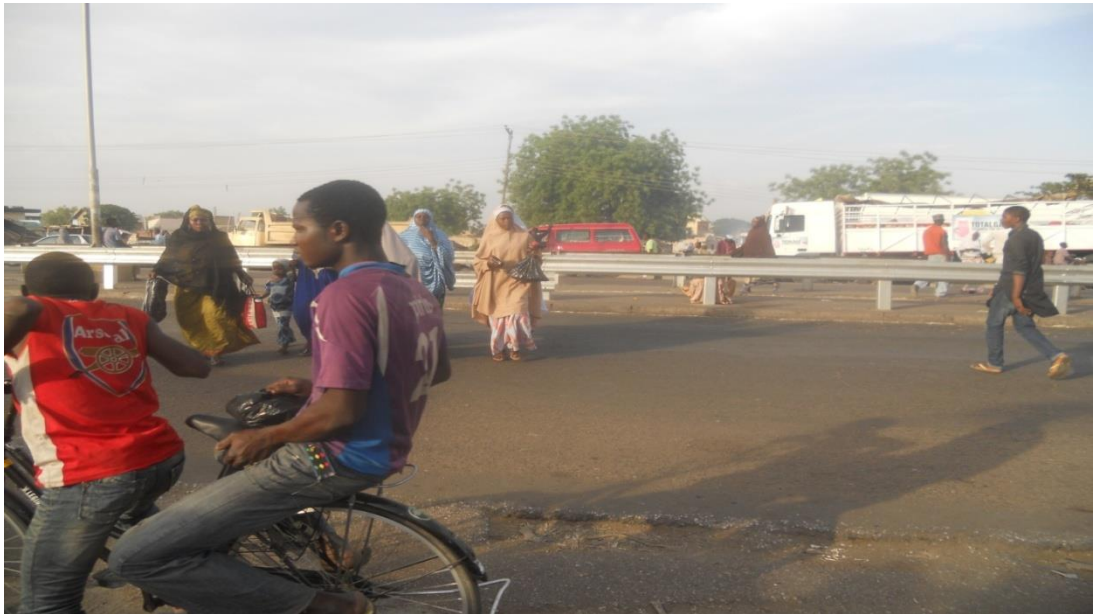
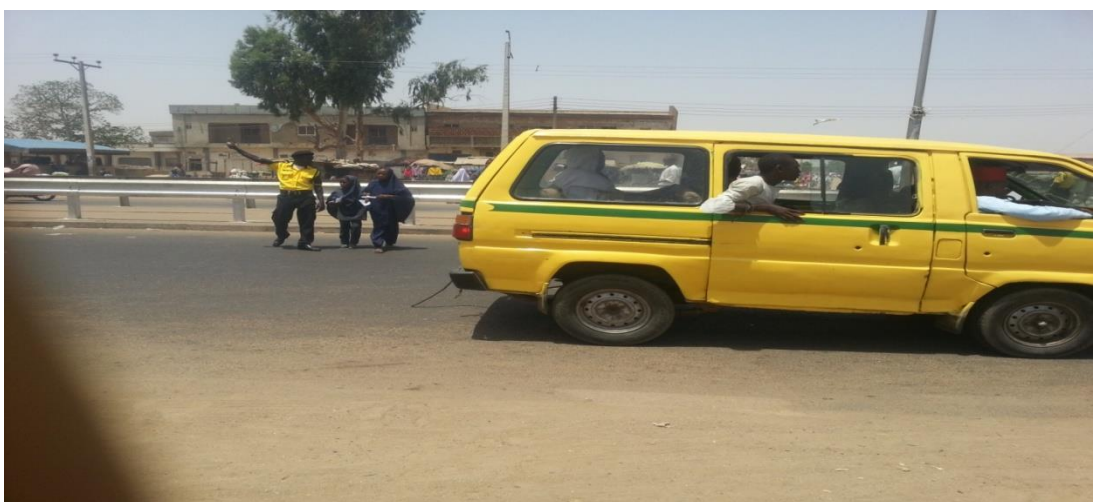
Throughout the audited route section only two pedestrian crossing bridges were observed which were located at Kurna Asabe Main Line and Gobirawa Special primary School 2.9 km and 3.9 km respectively along the route section. Moreover, guardrails have been mounted in almost all the urban route section being audited. This situation exposed pedestrians to great dangers while crossing.

**Figure 4.16 Lack of pedestrian crossing (almost throughout the road section)**

**Figure 4.17 Lack of pedestrian crossing (almost throughout the road section)**

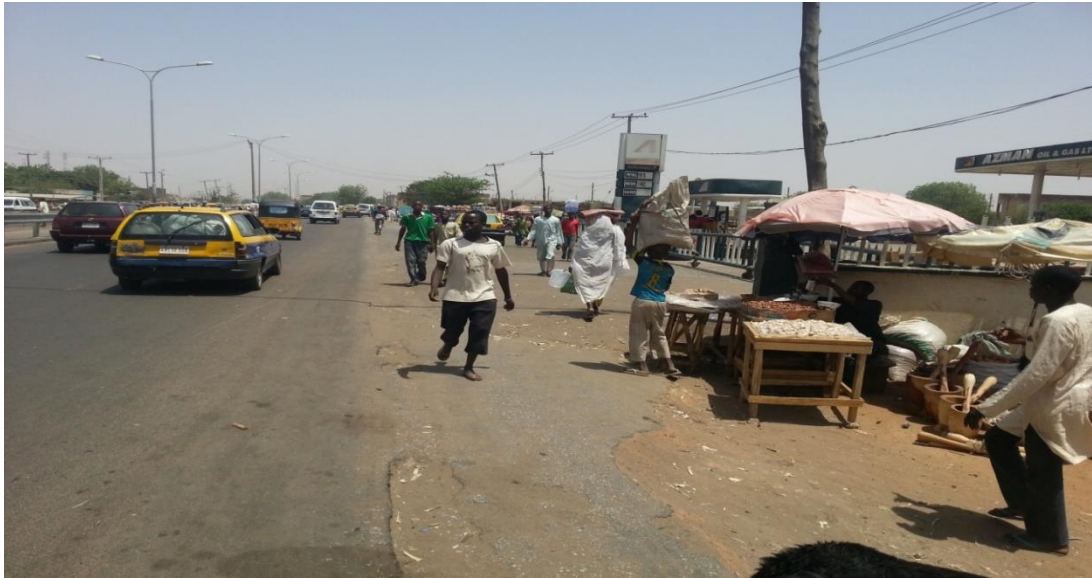
As observed along the audited route section, there was a complete absence of proper pedestrian footpaths whereby pedestrians were walking on an outer travelled lane which exposed them to serious potential accident risks.

**Figure 4.18 Lack of pedestrian footpath (throughout the road section)**

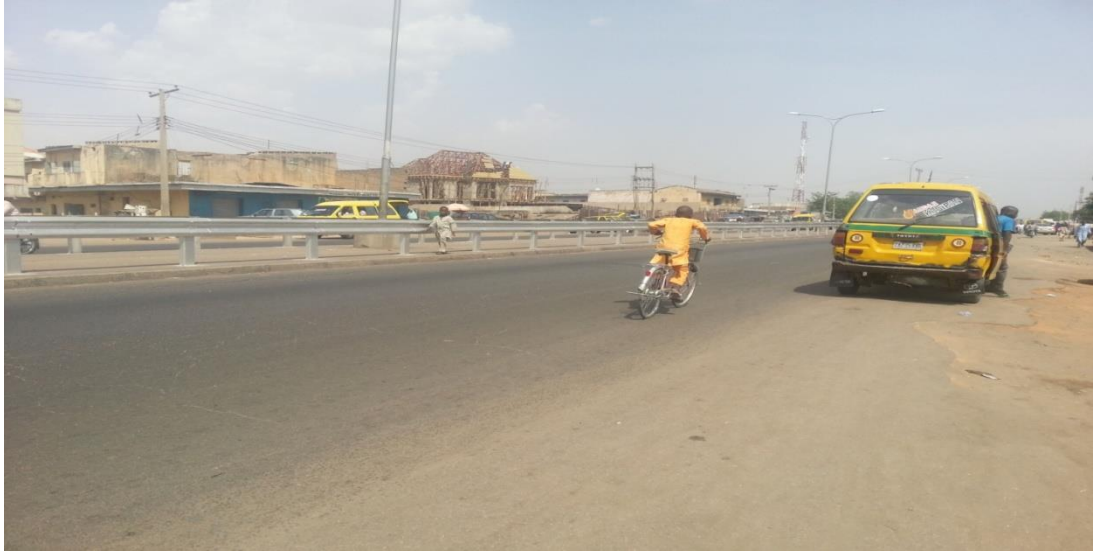
Along the inspected section of the urban route being audited on both directions, there were completely lacking of cyclists' facilities which forced them to travel on an outer travelled lane that has 3.5m width which exposed them to high potential accidents and according to AASTHO the outer travelled lane should be 4.2m if no shoulder exists.

**Figure 4.19 Lack of cyclist facilities (throughout the road section)**

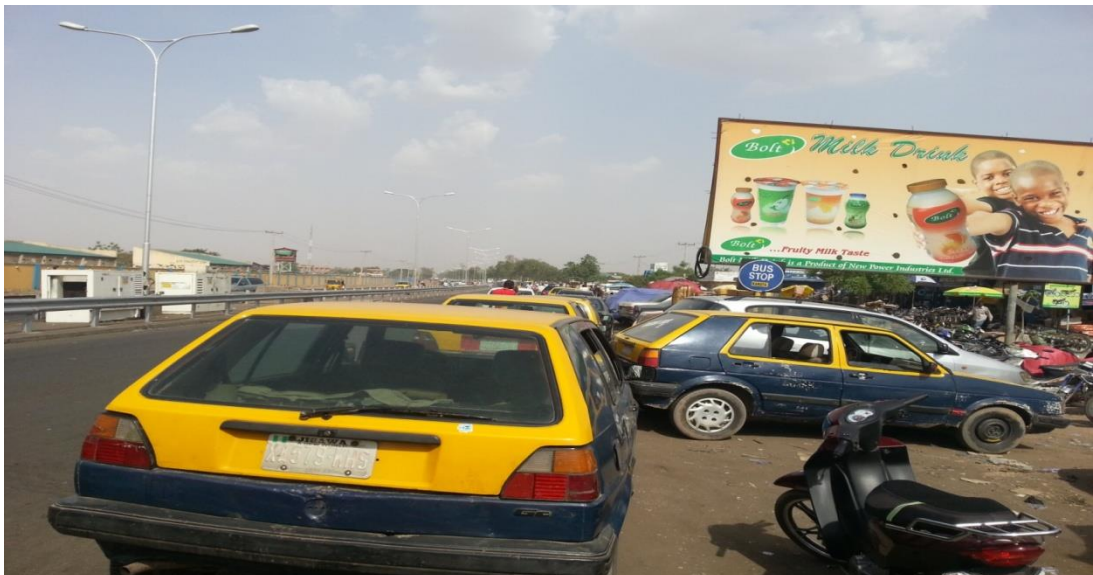
Parking maneuvers were totally missing along the audited route section, where stopped vehicles could safely park outside the travelled lane without disturbing continues traffic movement which creates serious problems for drivers and vulnerable road users.

**Figure 4.20 Lack of parking maneuver (Km 06+00) Bachirawa Junction- Airport Roundabout**

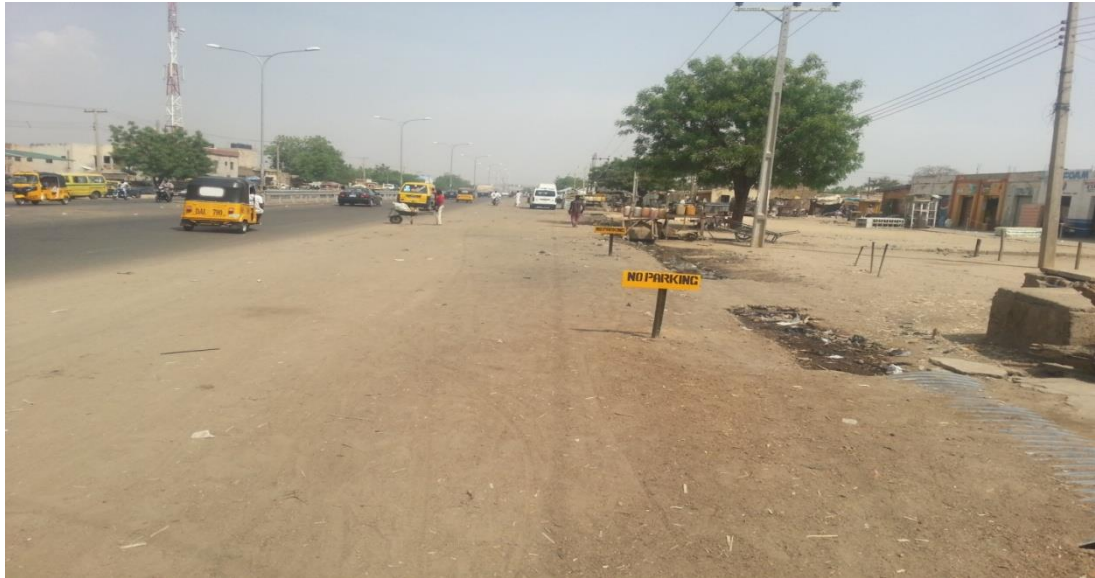
Along the audited route section, there have been many improperly placed parking control signs which were not designed based on standard and might not even exact serious warning impacts to vehicle drivers using the route.

**Figure 4.21 Improper parking controls (Km 03+500) Bachirawa Junction-Airport Roundabout**

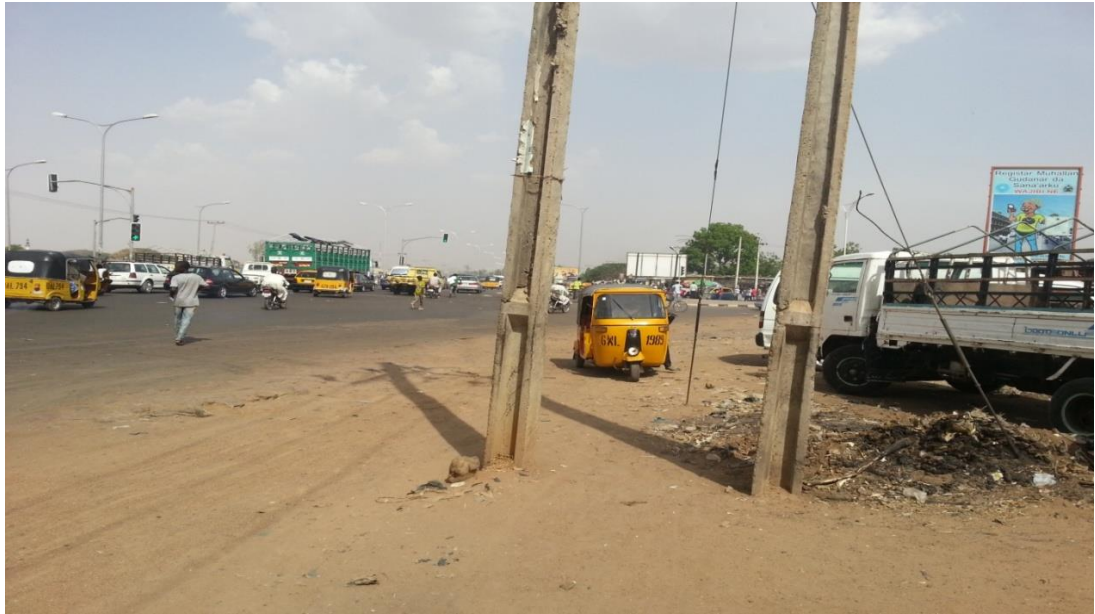
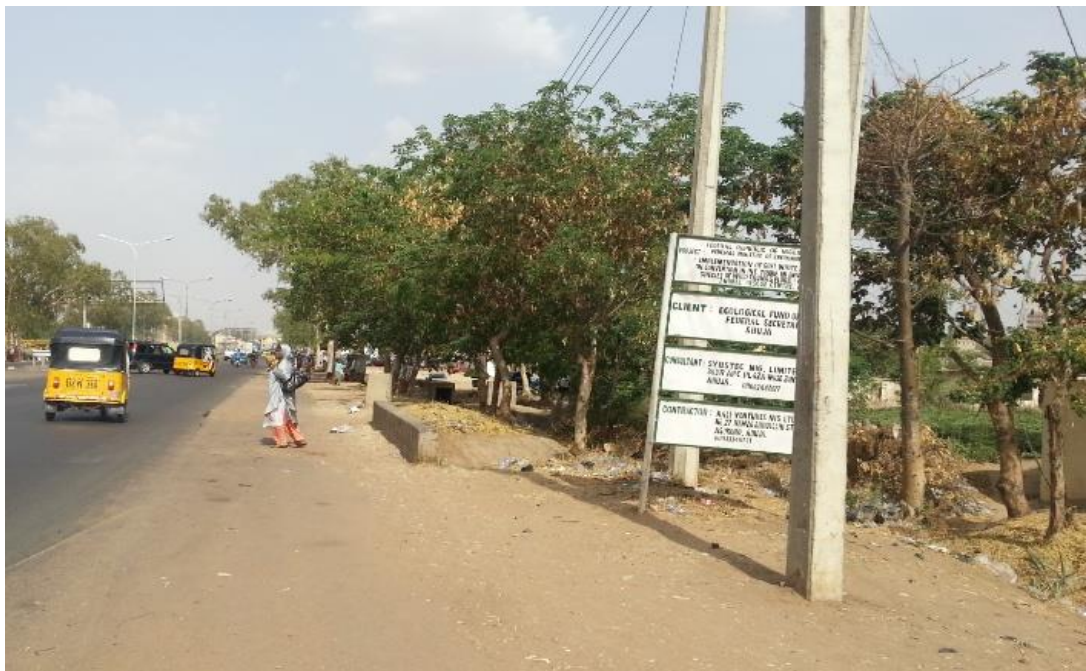
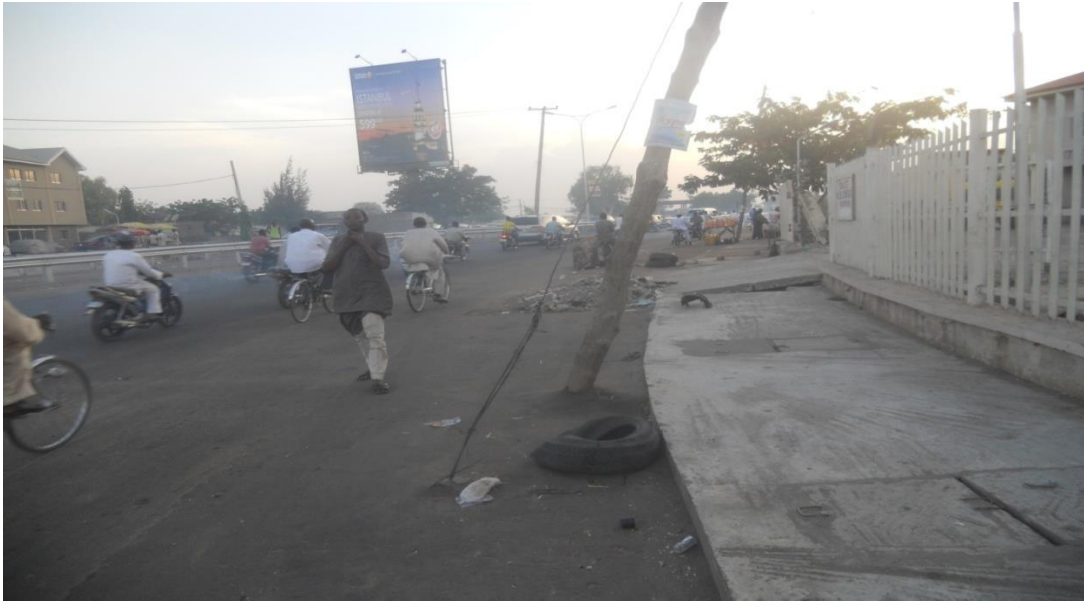
Utility poles can cause severe roadside crashes. Along the inspected route section there have been many concrete and wooden electric poles, which were located close to the outer travelled lanes on both sides of the road that could create higher potential safety problems to the road users.

**Figure 4.22 Improper poles location (Km 05+750) Bachirawa Junction-Airport Roundabout**

**Figure 4.23 Improper pole locations (Km 07+200) Bachirawa Junction-Airport Roundabout Junction**

**Figure 4.24 Improper pole locations (Km 00+40) Airport Roundabout-Bachirawa Junction**

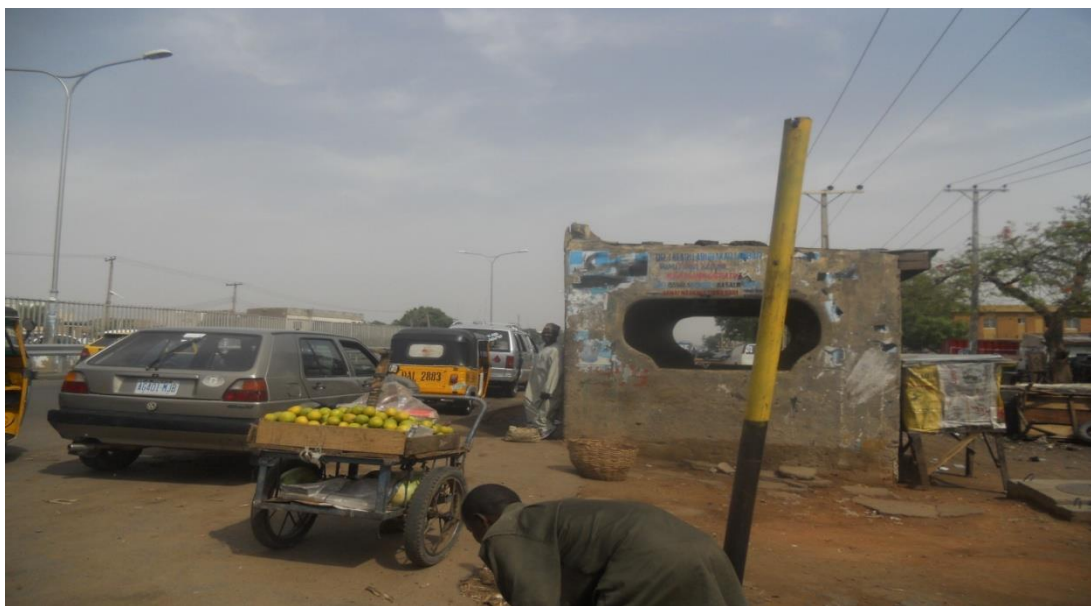
Improperly designed and located bus stop shelter can contribute a lot in creating severe risk of potential accident to the road users, along the audited section observed, there has been improperly located bus stop shelter closed to the outer travelled lane.

**Figure 4.25 Improper bus stop shelter (Km 03+00) Airport Roundabout-Bachirawa Junction**

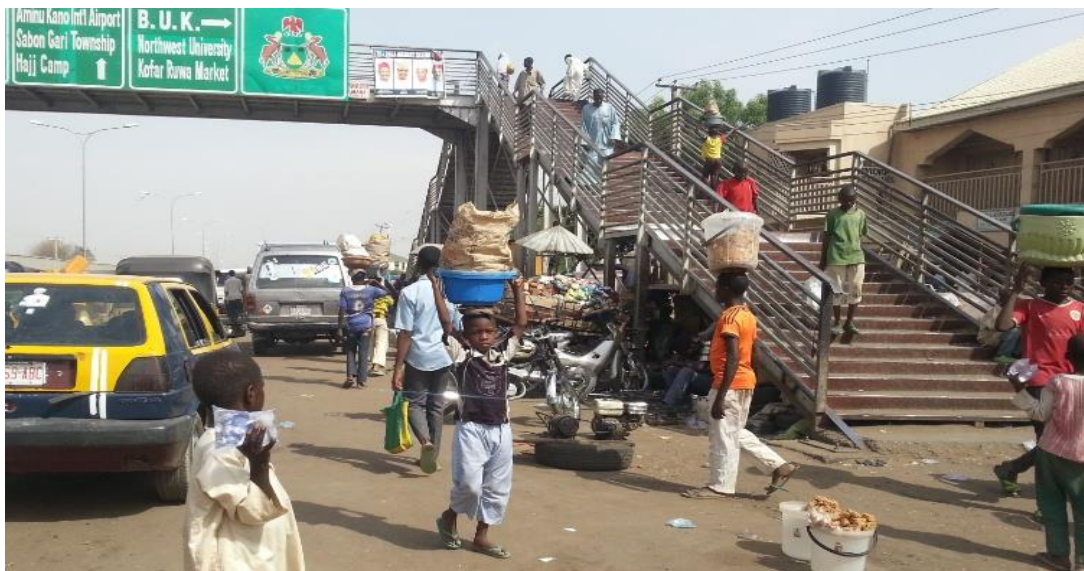
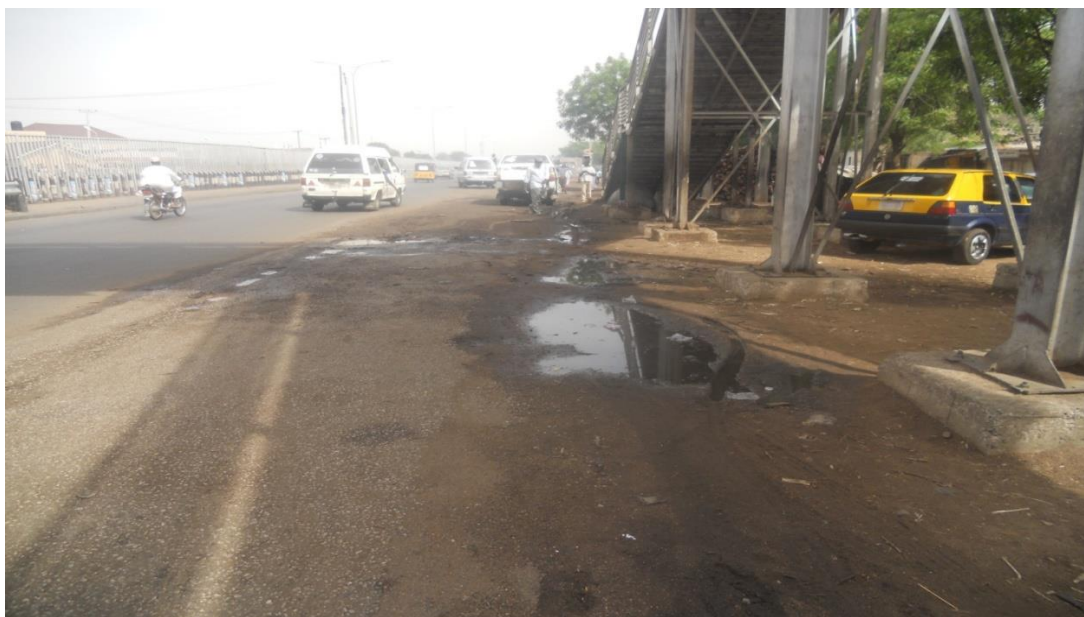
Along the audited route section on both sides of the road, there have been two pedestrian crossing bridges which their pillars were located close to the outer travelled lanes at Kurna Asabe main line and Gobirawa Special Primary School 2.9km and 3.9km respectively that can create a serious potential accident situation.

**Figure 4.26 Improper pillar location (Km 04+900) Bachirawa Junction-Airport Roundabout**

**Figure 4.27 Improper pillar location (Km 03+900) Airport Roundabout-Bachirawa Junction**

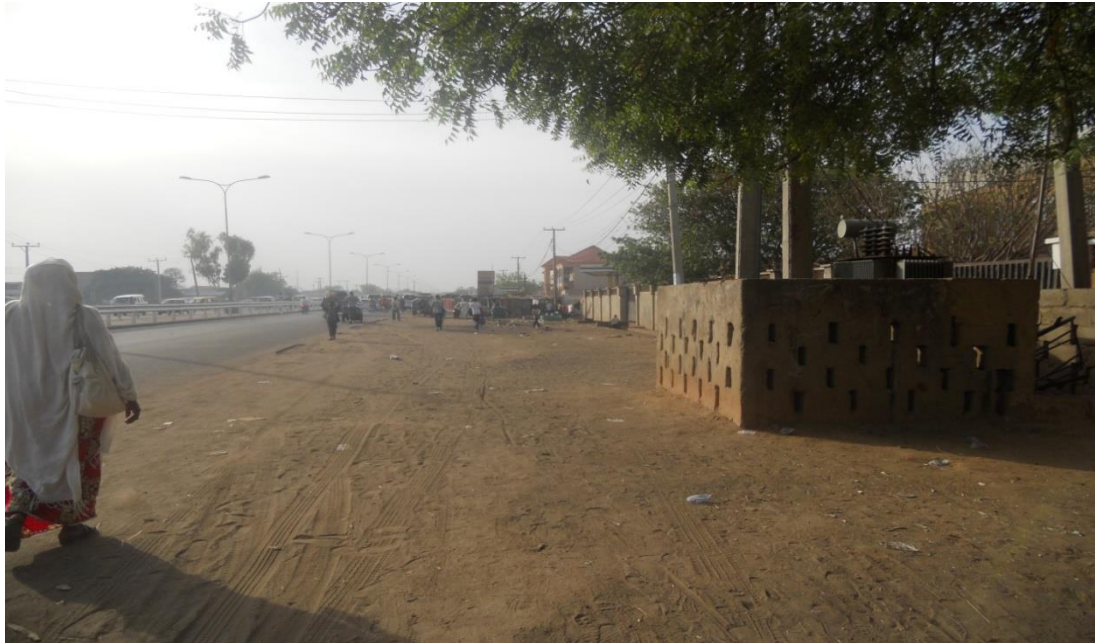
Along the route section been observed, there was transformer shelter positioned close to the outer travelled lane that can cause serious safety problems to the road users.

**Figure 4.28 Improper transformer location (Km 07+700) Airport Roundabout-Bachirawa Junction**

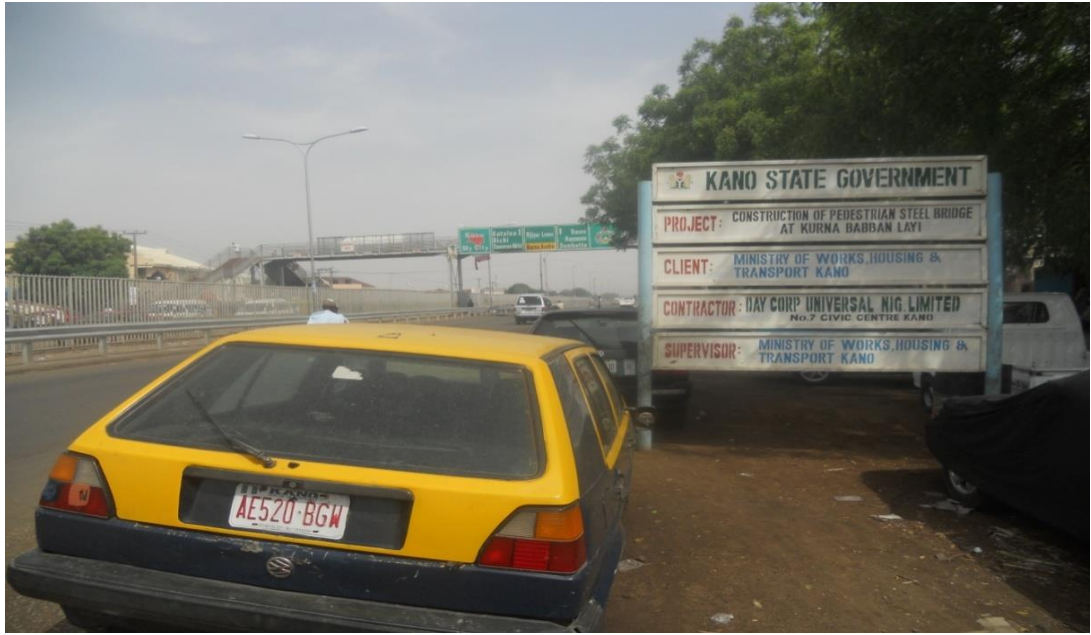
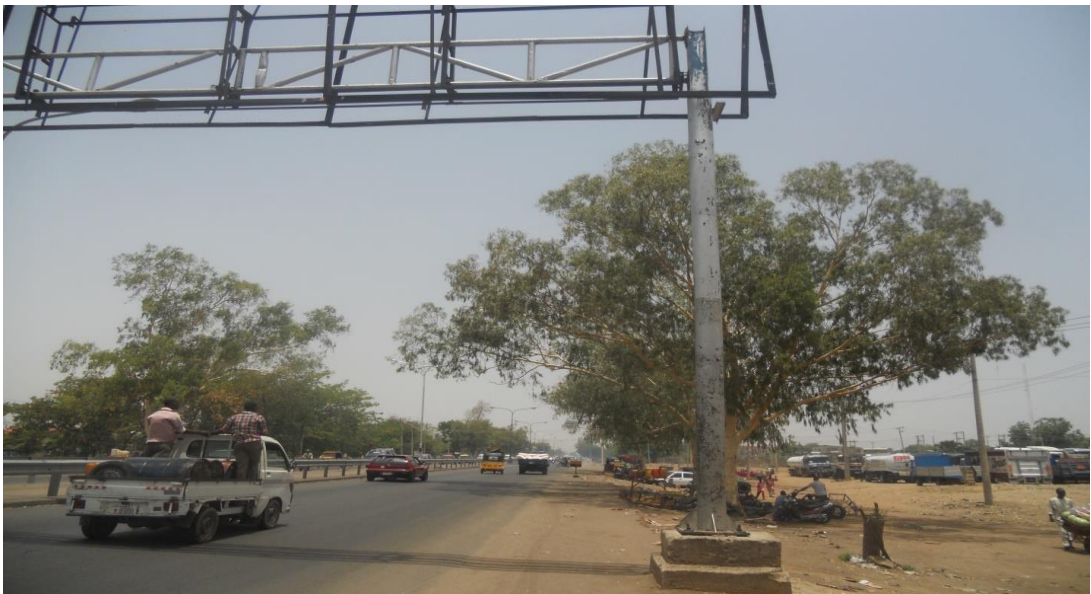
Inappropriate positioning of signboards at the road side contribute massively to serious accidents causation, along the audited route section there have been many located signboards and advertising boards mounted close to the outer travelled lane that can contribute a lot to accident occurrences.

**Figure 4.29 Improper signboard locations (Km 2+800) Airport Roundabout-Bachirawa Junction**

**Figure 4.30 Improper location of advertising board (Km 00+550) Airport-Bachirawa Junction**
