**SAFETY AUDITING ON URBAN ROADS WITH SPECIAL EMPHASIS TO  
INTERSECTIONS  
IN A CASE STUDY IN KANO, NIGERIA.**

**A MASTER'S THESIS**

**Civil Engineering**

**Atilim University**

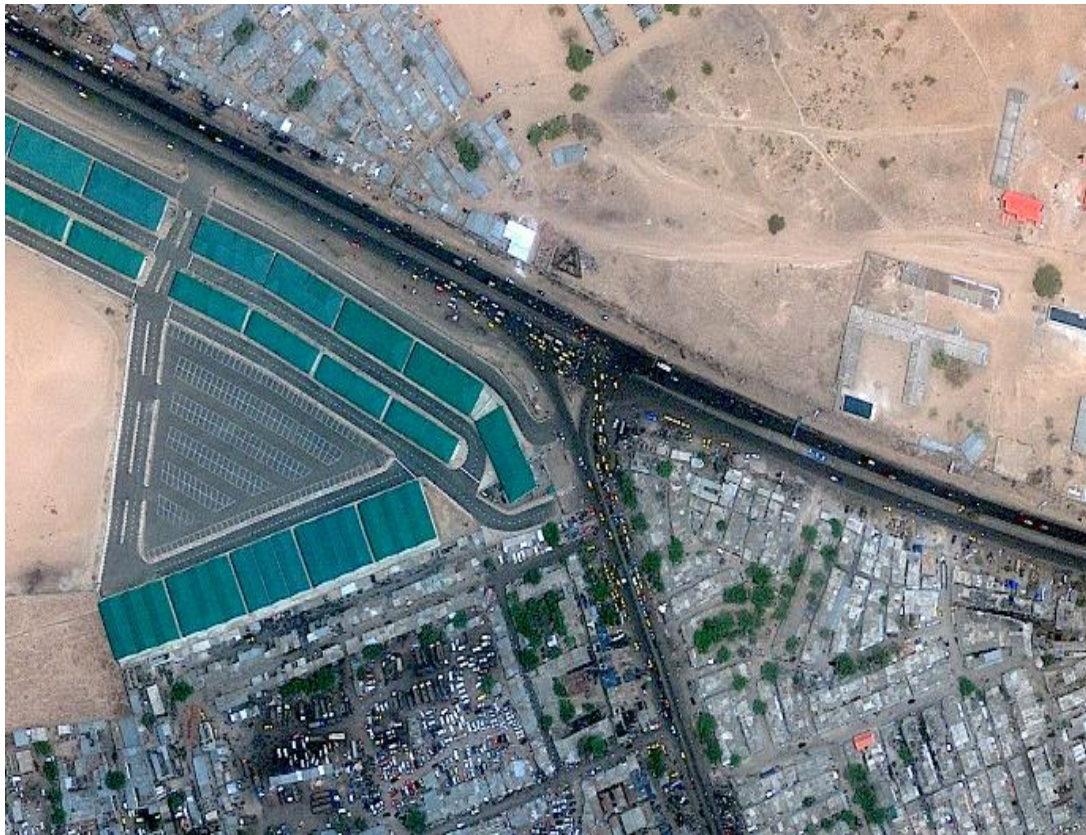
The subject inspected signalized intersection is located at Kofar Ruwa, 1.92km from the audit starting point (Airport Roundabout) and has 7.0m width of carriageway on west bound approach, 7.4m on the eastbound approach with right turning lane having 3.6m and 3.4m width for left and right turning travelled lane on northbound approach. It has been located close to Kofar Ruwa market, Bukavu Military Barrack and many schools. It was an at grade signalized intersection that has three signalized approaches connected to Katsina Road and Aminu Kano Way and has a Y-junction layout. The subject signalized intersection has high number of traffic personnel that also oversee its operational conditions despite the installed signal controls due to the complexity and congestion. In relation to that, adequate and proper intersection control and management system could adversely increase safety and better operational performance of the junction.

**Figure 4.31 Intersection surroundings and layout**

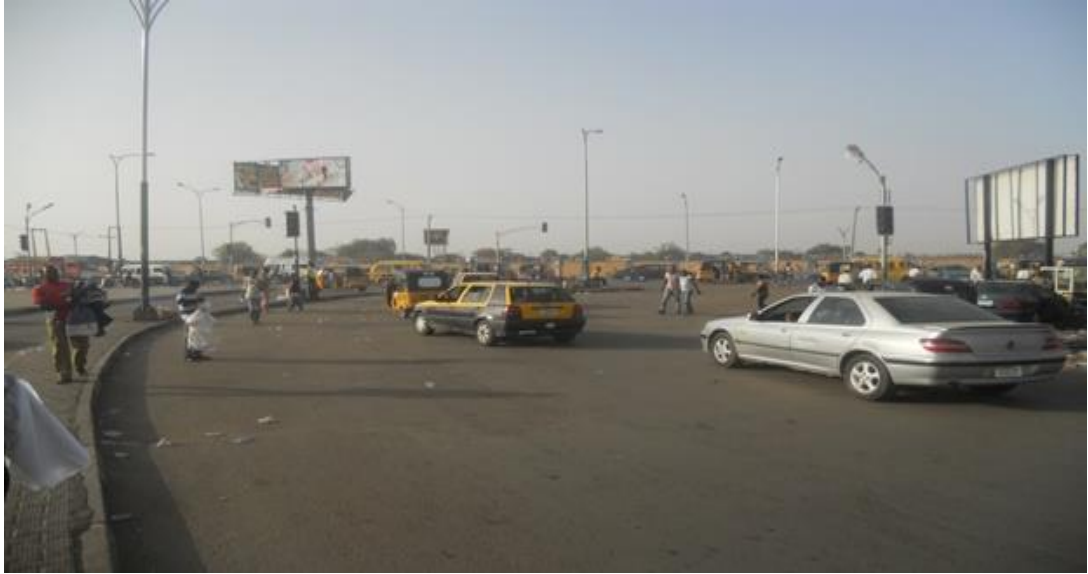
As observed during inspection, the horizontal curvature of Aminu Kano Way has limited visibility to the drivers using the subject intersection, vehicles that joined a queue often extended beyond clear visibility of the signal head indications which might contribute to rear-end crash and long trucks obscured the view of head indication.

**Figure 4.33 Limited sight distance at the northbound approach**

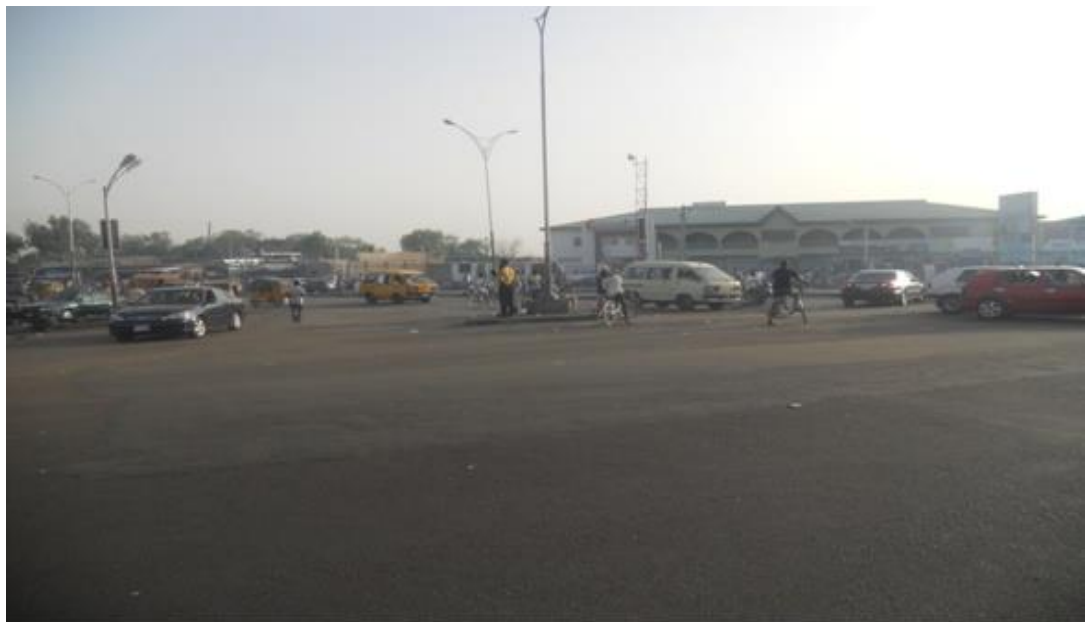
There were the absences of designated lanes at the subject intersection in all three approaches. Absence of pavement markings might create difficulty to drivers and increases sideswipe collisions.

**Figure 4.34 Lack of pavement markings at the intersection**

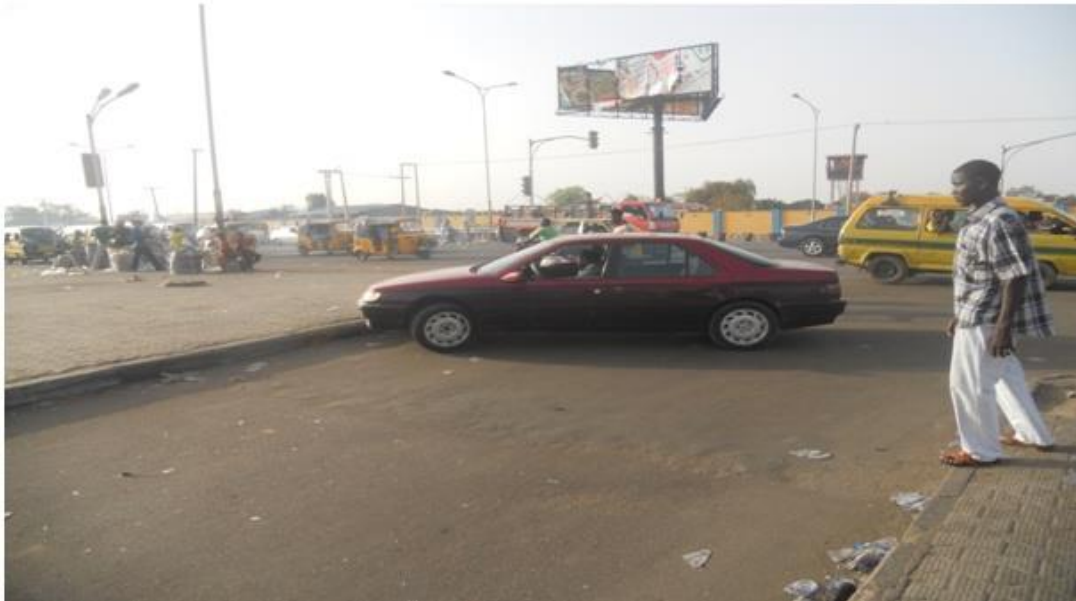
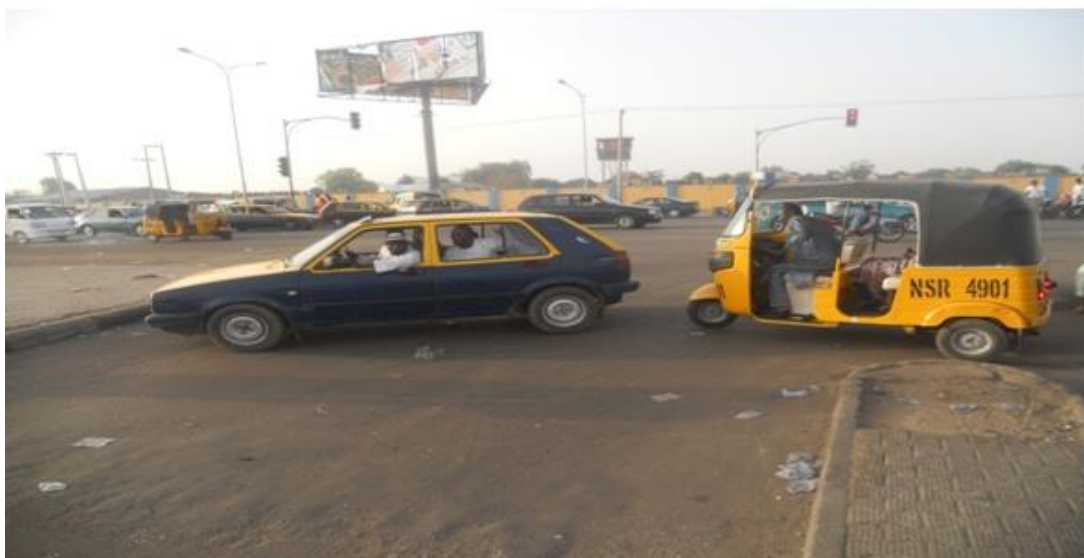
It has been observed that, there was an inadequate turning radius at northbound approach for vehicles trying to make U turn and left turn movement from the westbound approach. The turning radius could not even be enough to comfortably accommodate smaller vehicles rather than the large ones which can cause loss of control and accident causation.

**Figure 4.35 Inadequate turning radius at northbound approach**

**Figure 4.36 Inadequate turning radius at northbound approach**

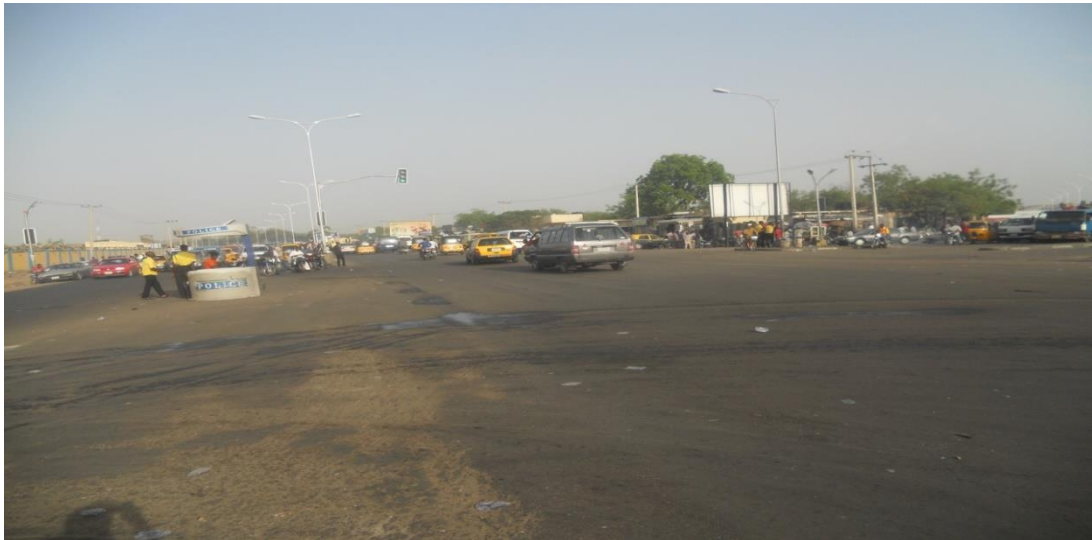
It has been observed that, vehicles that approached and passed through the intersection did not have definite and specific paths to be followed due to the large area of the intersection without channelization, this situation might create confusion among drivers on deciding a particular path to be followed and lead to the accident causation.

**Figure 4.37 Lack of channelization**

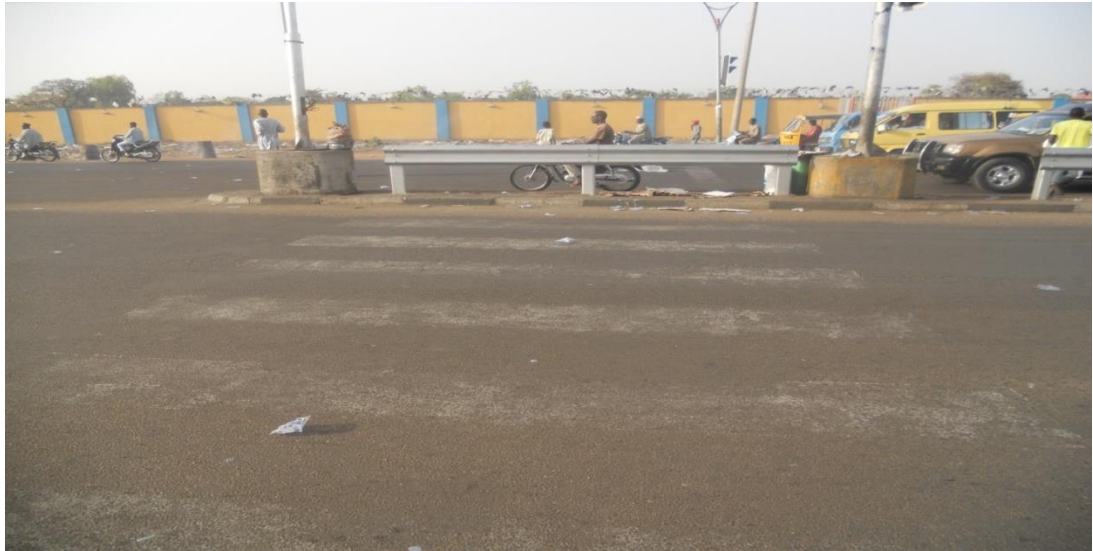
There have been completely less consideration given regarding pedestrian facilities at the subject intersection, pedestrian crossing lines have faded out almost completely at all approaches, absence of pedestrian countdown signal head that give the right of way for them to cross. In the median also, guardrails have been mounted directly facing the pedestrian crossing location which could create potential safety problems while crossing.

**Figure 4.38 Faded and blocked pedestrian crossing**

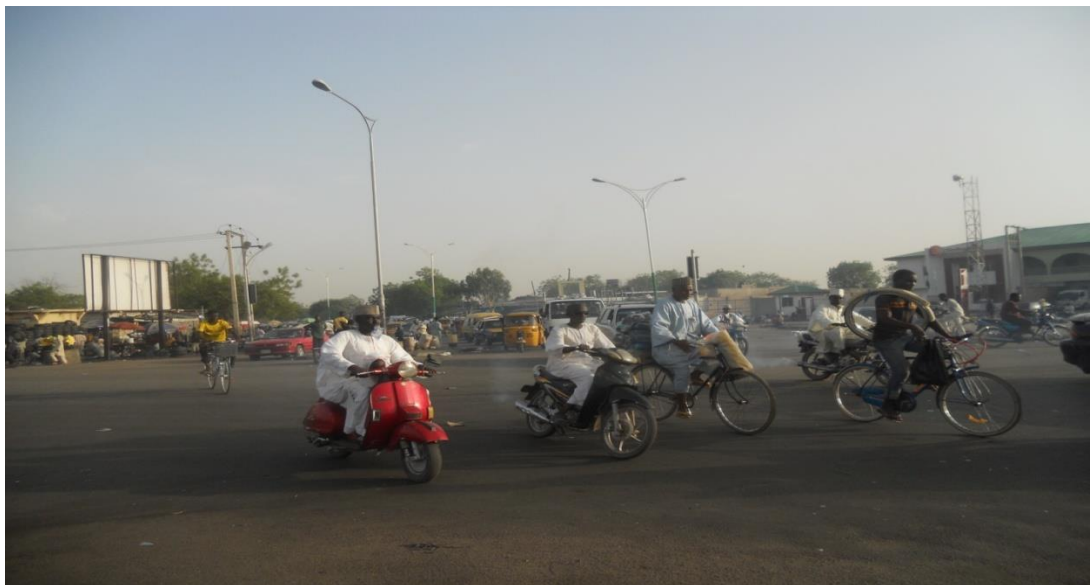
There were absence of proper considerations given to the cyclists at the subject intersection; they shared and interacted together with other road users like motorists and motorcyclists. This subject intersection was a crossing location of nearby residents and students of the Kofar Ruwa Secondary School and Army Day Secondary School, Bukavu. This current situation could lead to serious safety problems to the bike riders as they were exposed to dangers.

**Figure 4.39 Absence of cyclists' facilities**

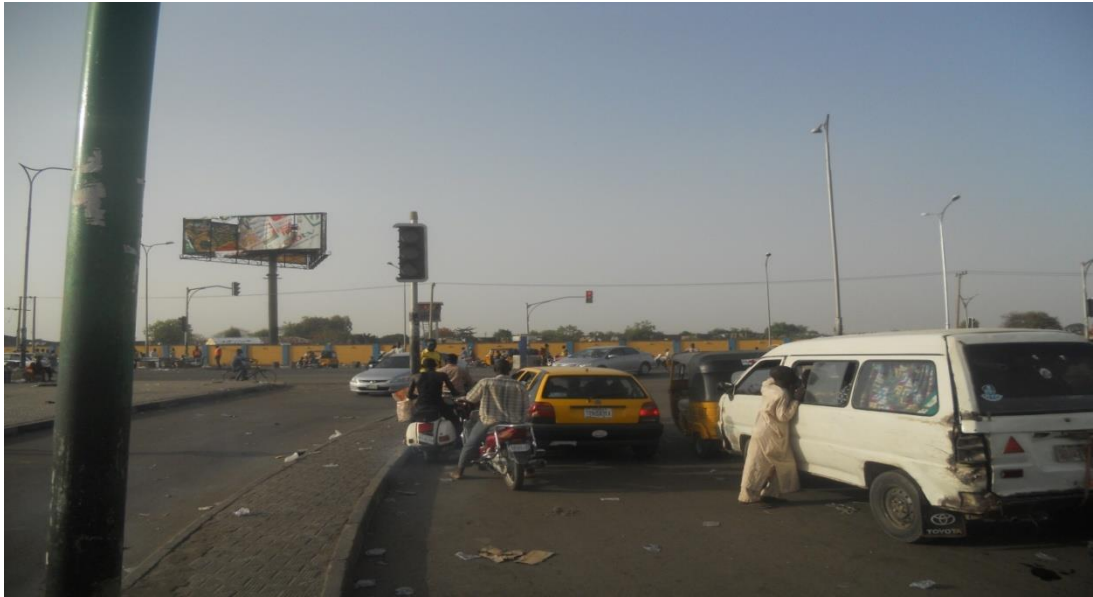
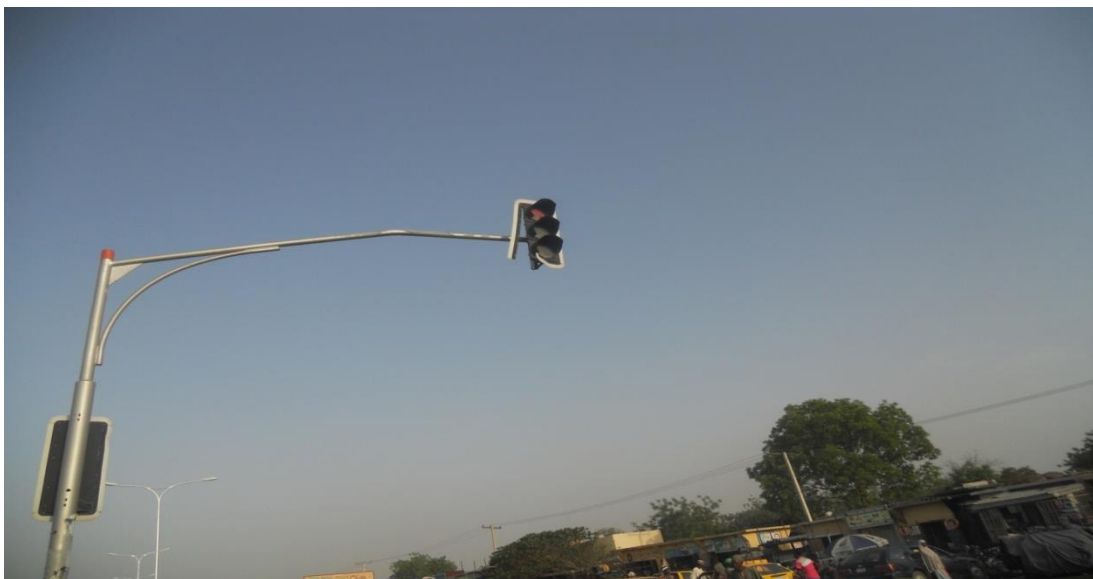
It has been observed that, there was an absence of routine maintenance of damaged traffic signals which limits visibility of the traffic heads at the subject intersection. Vehicles that had long queues often extended beyond clear visibility of the signal head indications could only understand green indication by proceeding forward of the front vehicles which might contribute to rear-end crash accident type.

**Figure 4.40 Lack of signal routine maintenance**

**Figure 4.41 Damage and poor traffic signal head visibility**

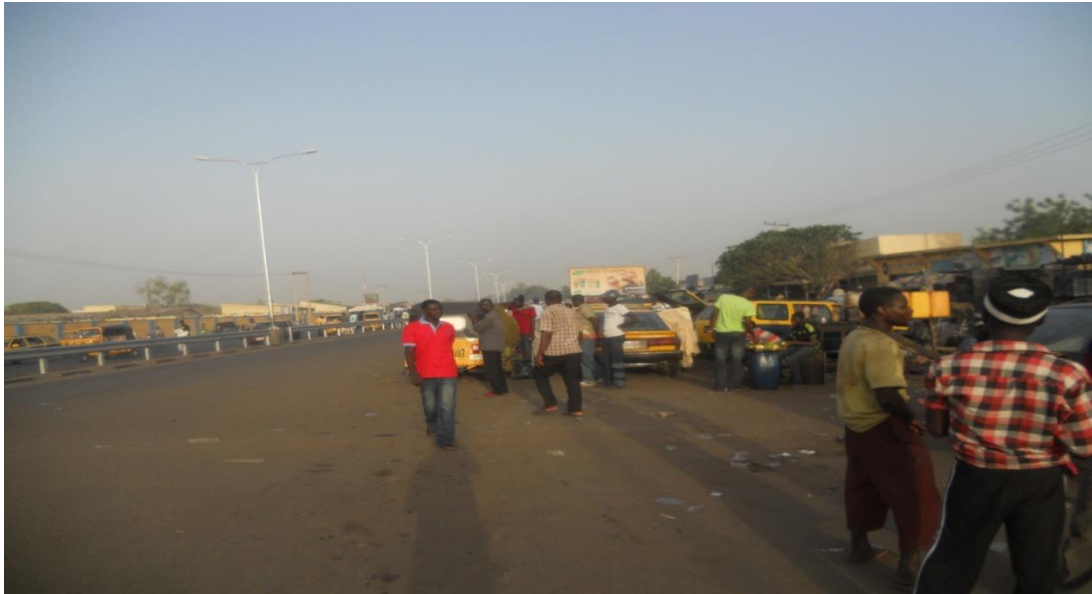
Bus stop location has been observed at 10m just ahead of the subject intersection through eastbound approach, whereby most of stopped vehicles parked on the outer travelled lane which decreased the rate of traffic flow and contributes to potential safety problems.

**Figure 4.42 Improper bus stop locations**
