**REPUBLIC OF TURKEY  
GAZIANTEP UNIVERSITY  
GRADUATE SCHOOL OF NATURAL & APPLIED SCIENCES**

**EXPERIMENTAL INVESTIGATION OF IMPACT BEHAVIOUR  
OF TIMBER FORMWORK BEAMS STRENGTHENED WITH  
CFRP STRIPS**

**M. Sc. THESIS  
IN  
CIVIL ENGINEERING**

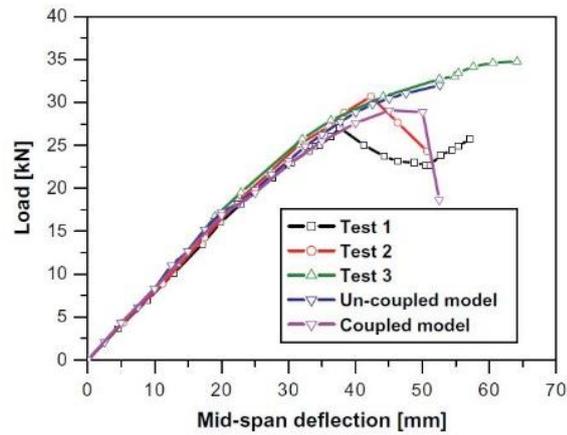
**Figure 2.1** Load versus mid-span deflection for un-strengthened control beams [2]

Figure 2.1 and 2.2 shows comparison between simulation and experiment results.

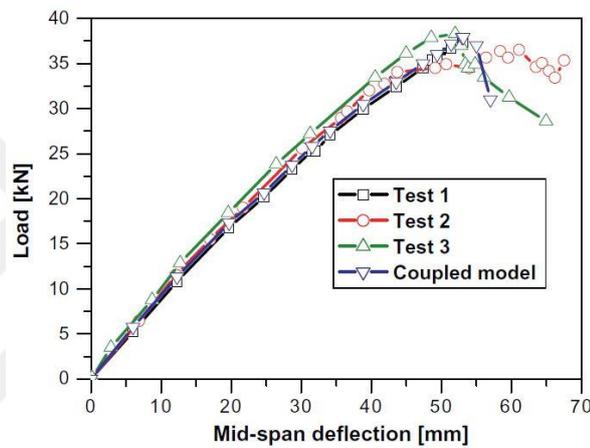
**Figure 2.2** Load versus mid-span deflection for strengthened control beams [2]

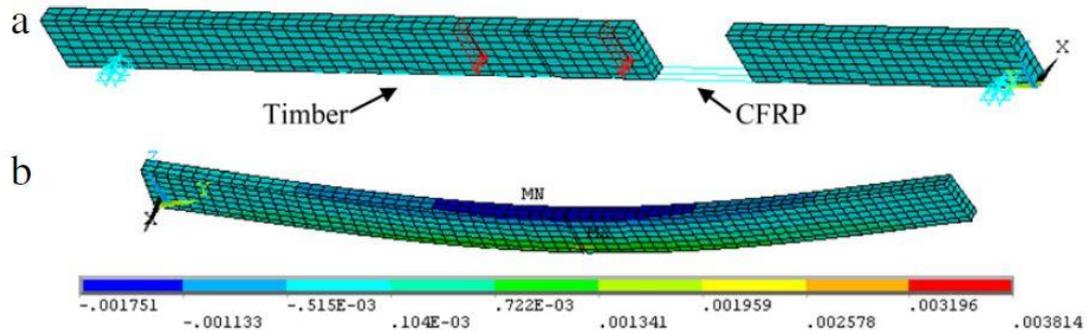
**Figure 2.3** Model: (a) Meshed beam with boundary condition (b) Strain contour [7]

Kim and Harries present a numerical three-dimensional finite element analysis (FEA) model to examining the behavior of timber beams strengthened with CFRP strips based on the orthotropic characteristics of timber. In this study, it was observed that strengthening with CFRP strips increased the carrying capacity for all Northern White Cedar, Douglas Fir, Sitka Spruce, Yellow Birch and Yellow Poplar species using the mechanical properties of those timber beams [7].

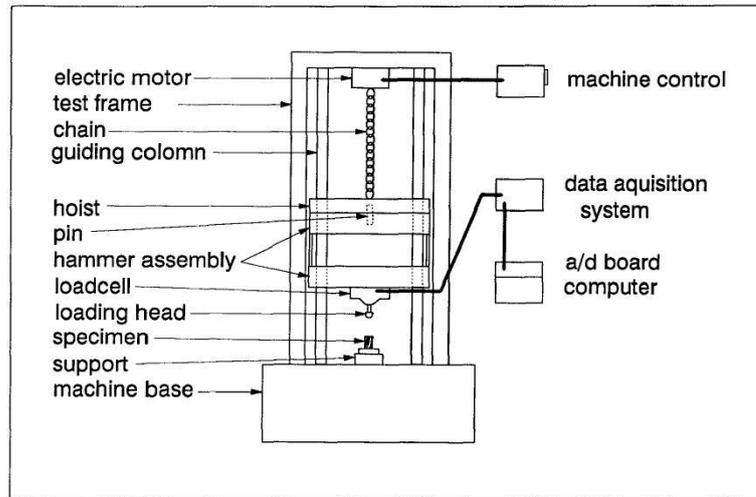
**Figure 2.4** Schematic drawing of impact test set-up [9]

One of the earliest study on impact loading of timber beams is Bength Jansson's master thesis work in 1982 [9]. The test setup is given in Figure 2.4 and the results are given in Figure 2.5 in his thesis work.

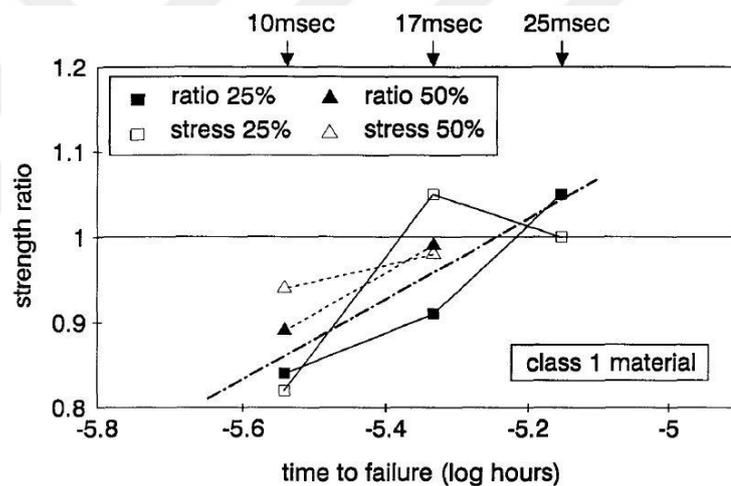
**Figure 2.5** Results of Impact Loading Tests of Timber Beams by Jansson [9]

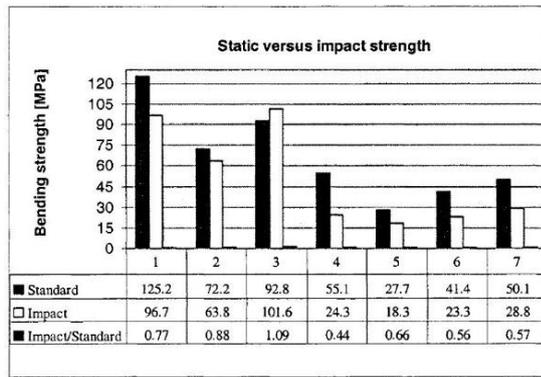
**Figure 2.6** Static versus Impact Strength Results [10]

In addition, static and impact test results were compared according to 7 different types of tree in this study by Leijten and shown in the figure 2.6.

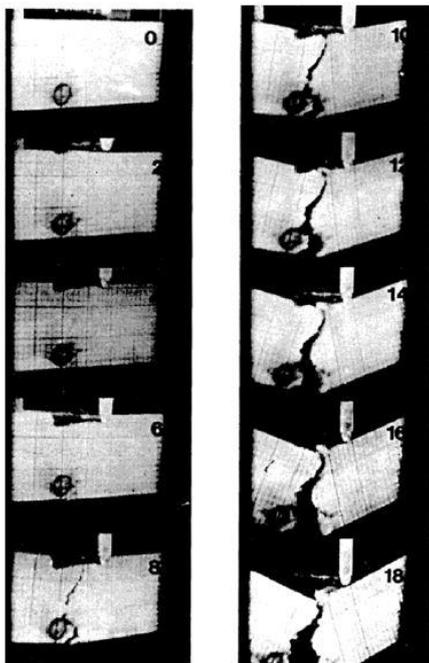
**Figure 2.7** Impact Fracture of Wood [11]

Mindess and Madsen observed the fracture of wood under impact loading. High speed motion picture photography was used to study the fracture, under impact loading, of wood beams. Photographs were taken at the rate of 500 frames per second, which permitted the crack development during the fracture event to be monitored. Load vs. time data during the test were also recorded. This work presents a photographic record of the crack patterns which developed when the beams were tested in an instrumented impact machine [11].

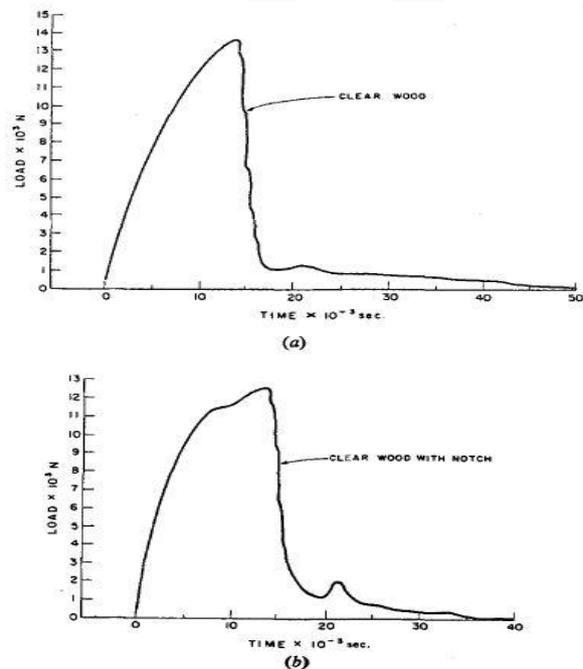
**Figure 2.8** Load vs. Time Curve [11]

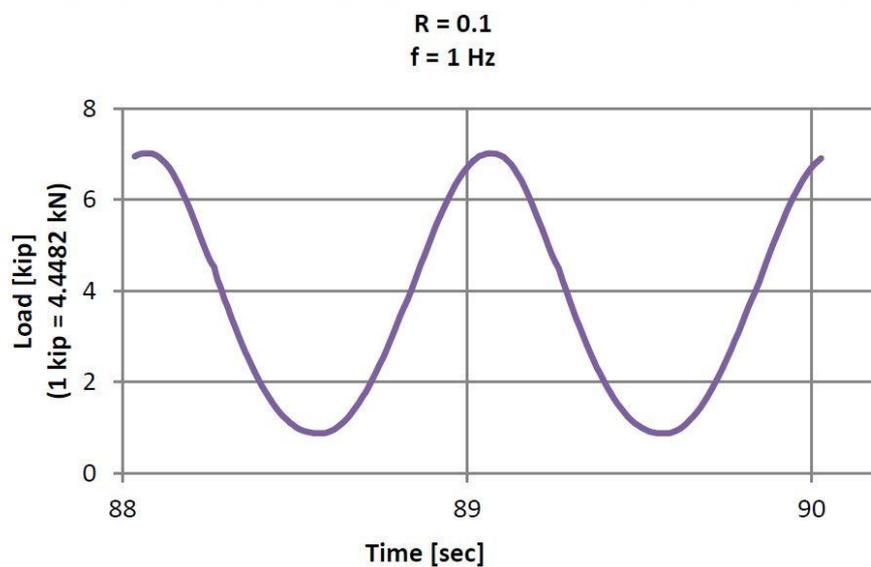
**Figure 2.9** Oscillatory Load [16]

American researchers Balogh and Atadero made an experimental study of fatigue testing of Wood-Concrete composite beams. They worked on wooden concrete composite elements and embedded the anchor with. Also, an example of the oscillation graph is given in Figure 2.9 and behavior of a load cycle given in figure 2.10 [18].

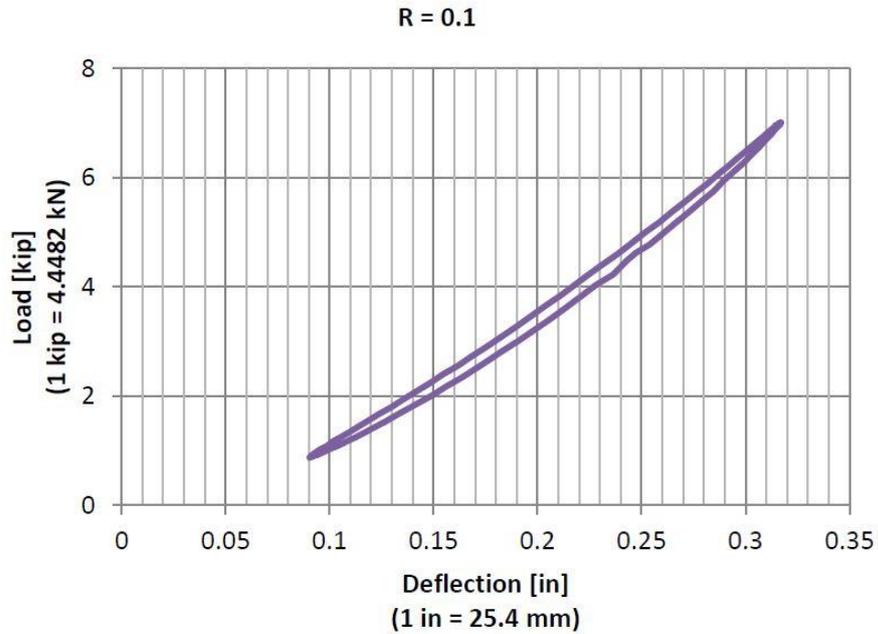
**Figure 2.10** Behaviour for a Load Cycle [16]

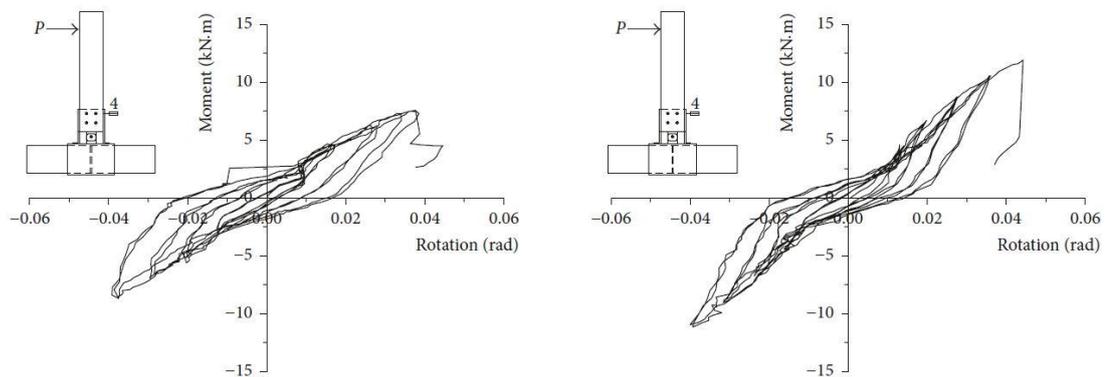
**Figure 2.11** Moment-rotation hysteretic curve of the specimen CJ1 and CJ3 [17]

Zhou, Huang, Ni, Shen and Zhao made an experiment on bamboo (Timber) frame structure under fatigue loading. The specimens were loaded under displacement control with a rate of 10 mm per minute until the specimens reach failure. In this study, failures of 3 test specimens were caused by the buckling of flanges in the compression and that the steel of connections does not yield. Also, curves related this topic given in figure 2.11, 2.12 and 2.13 [17].

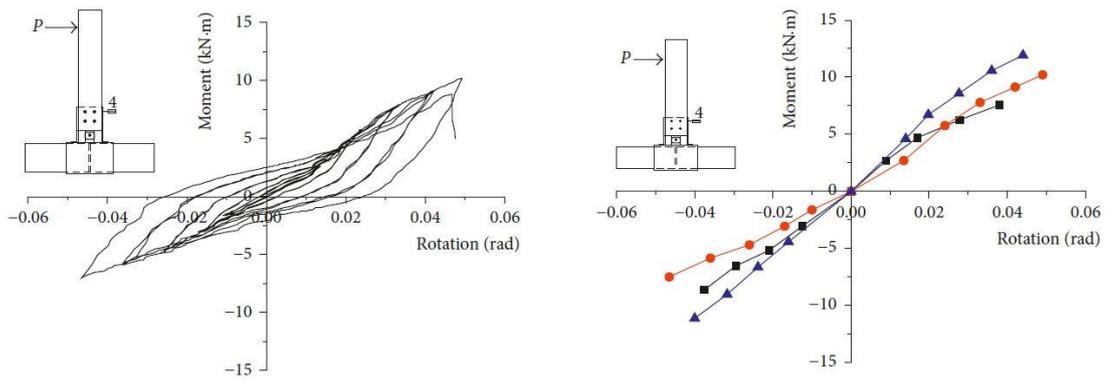
**Figure 2.12:** Envelope curve of the specimen under cyclic loading (Right Side) [17]

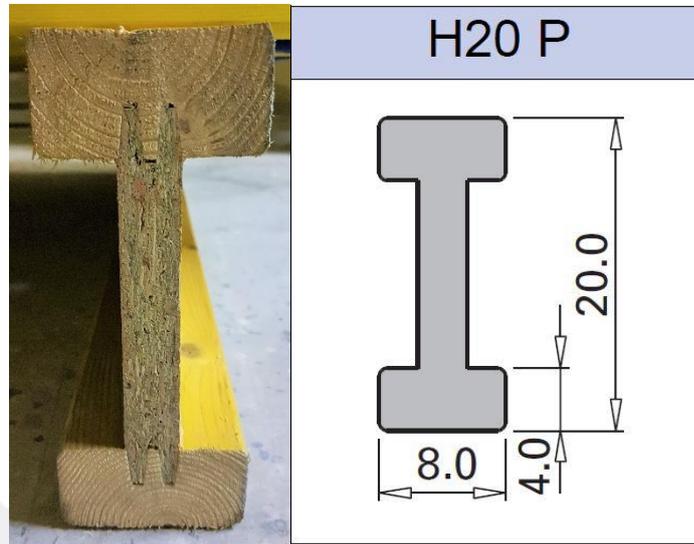
**Figure 3.2** Dimensions of H20 P Beam and Cross-section

\* Web part made of wood and wood-based materials. It is special flat compressed particle board. Thickness of web is 22.0 mm. Section of web is given in figure 3.2.

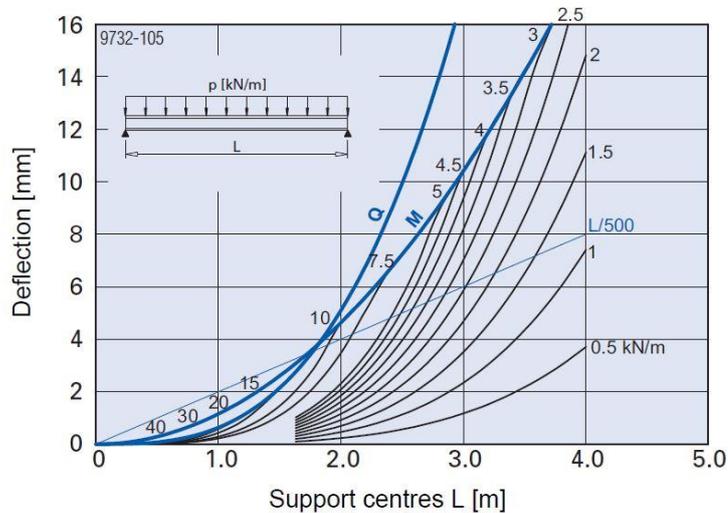
**Figure 3.3** Deflection Diagram of the H20 P Beam [21]

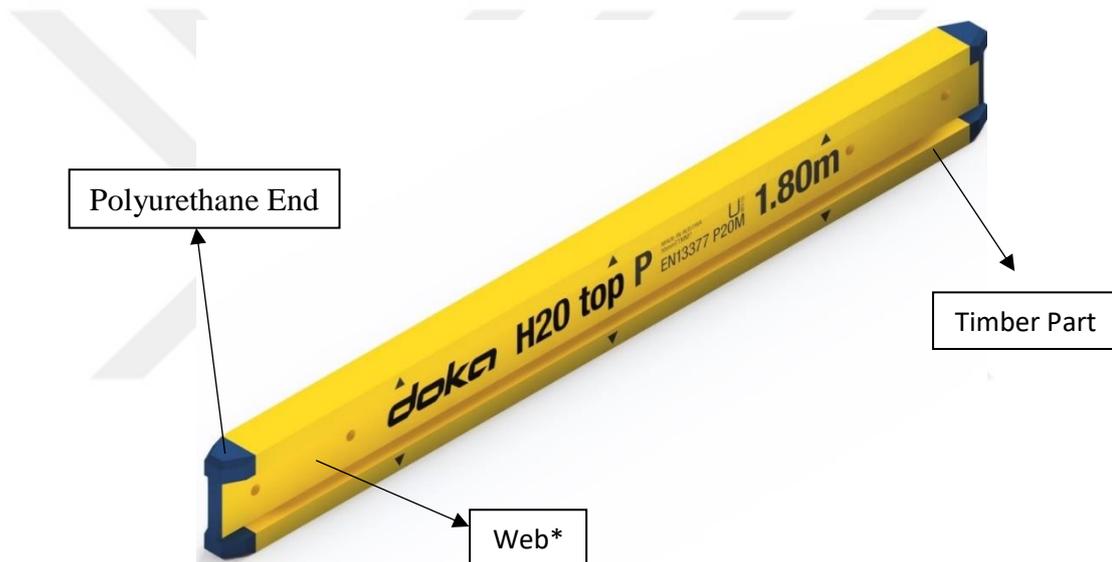
**Figure 3.4** DOKA H20 top P Timber Formwork Beam

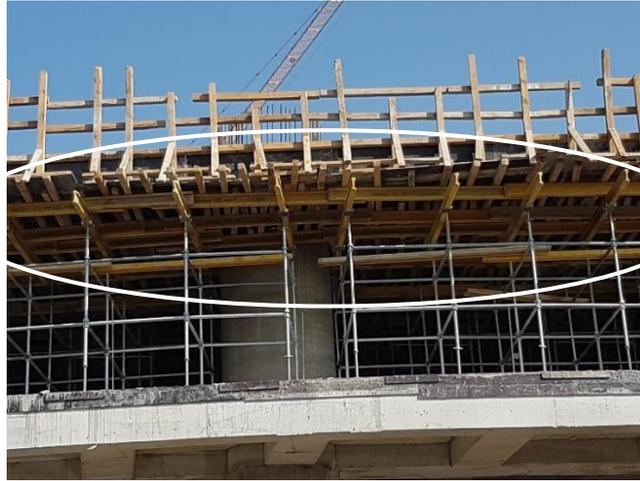
**Figure 3.5** Constructional Use of DOKA Beams

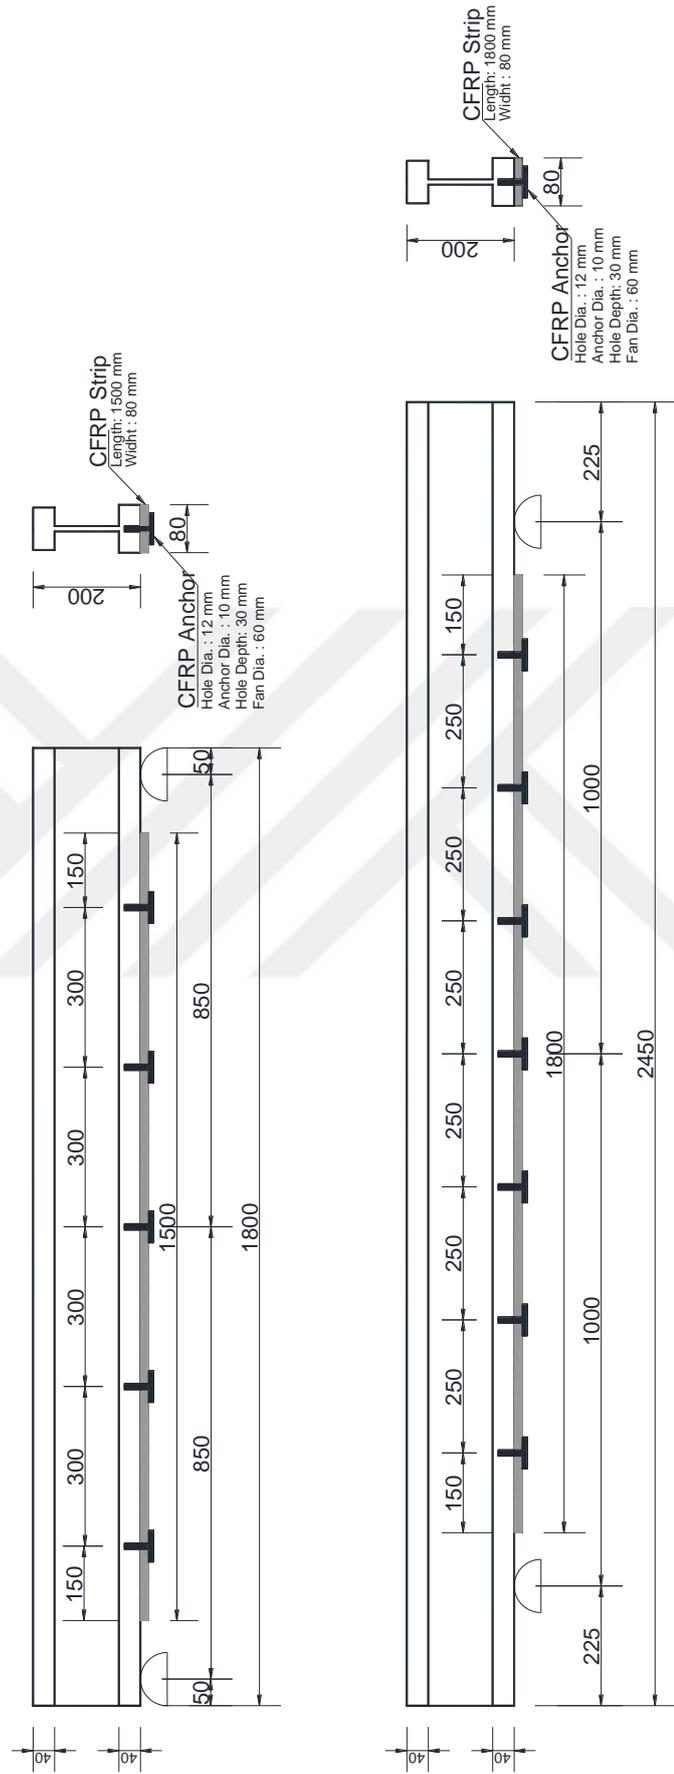
**Figure 3.6** Dimensions and Retrofitting Details of Test Specimens

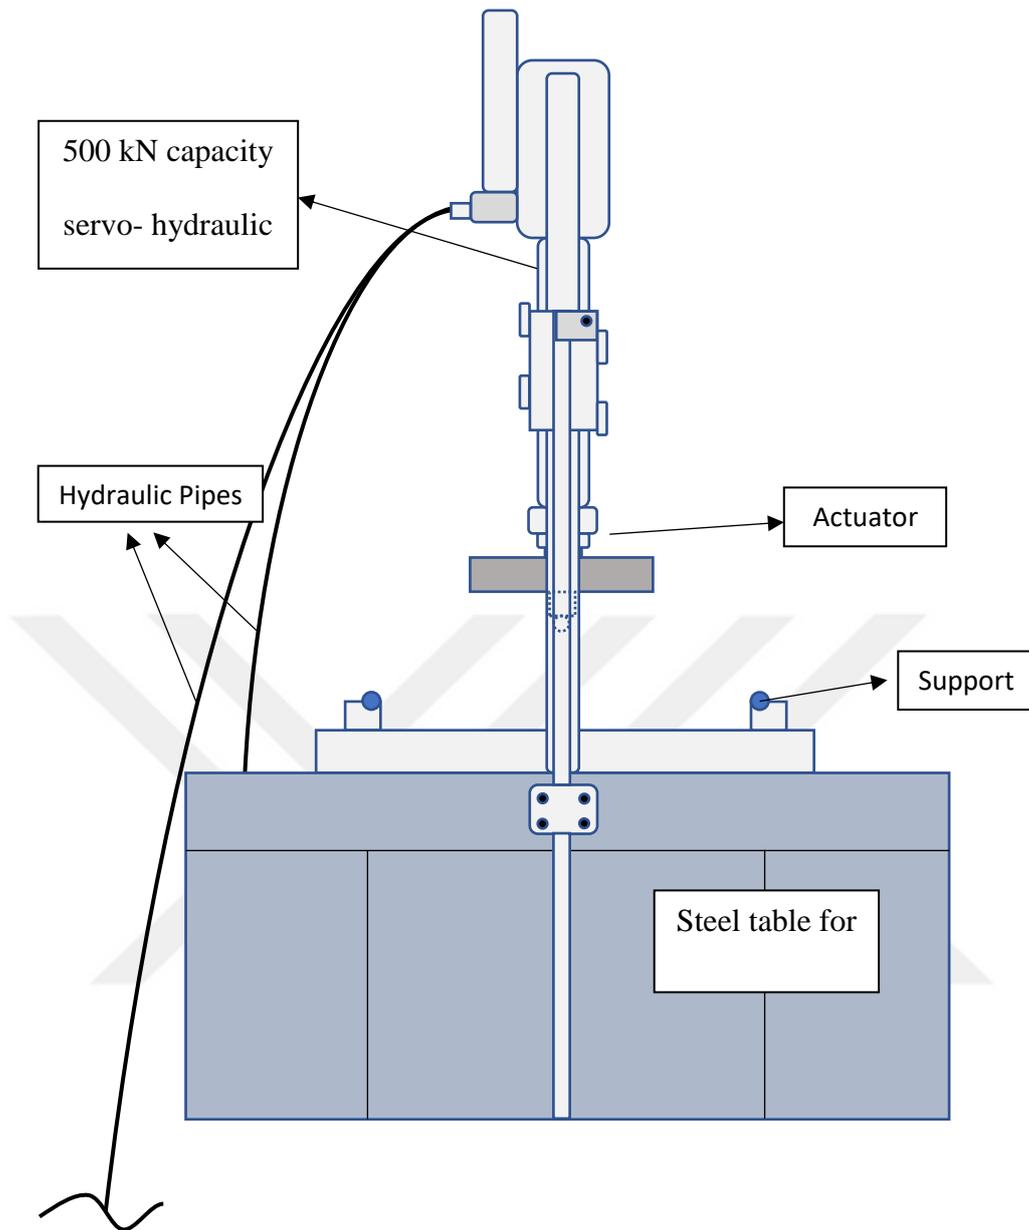
The 3-point bending load is applied to the experimental specimens in all three loading types to the full center opening of the timber beams with the axis of symmetry. In the experimental study, monotonically increased static loading and high load level fatigue loading tests were performed in the MTS 322 model, a 500 kN servo-hydraulic loading system. The speed of the monotonically increased static load applied to the test specimens was applied to the timber beam test specimens of both lengths to be equal to 0.5 mm/sec. Experiments were carried out by drawing the load-displacement graphs during the tests by measuring the beam displacement at the center of the beam where the loading is applied from the test specimens and measuring the applied load and strain values measured from 6 points on the CFRP strip glued to the beam tension surface for repair. The loading was applied by using the servo-hydraulic actuator of the 500 kN capacity test device, which can be adjusted according to the displacement. MTS, which is used in static loading tests, is given in Figure 3.7. As a result of the static loading, the general load-displacement behaviors and maximum carrying-capacity values of the two different length timber formwork test specimens were determined and this information was used to create the loading profile of the high load level fatigue test which is the second loading type to be examined in the experimental study. The fatigue loading profile, which varies between 85% and 10% of the maximum bearing capacity values, is applied to the test specimens with a frequency of 4 hZ. The ratios of maximum fatigue load and minimum fatigue load values are 8.5 for the beam test specimens of both lengths and the minimum fatigue load is at a level of 12% of the maximum fatigue load. This fatigue loading cycle was applied to the test specimens four times per second. The fatigue loading applied to the test specimens is identical to the static loading applied as a 3-point bending loading and the displacement values of the mid-span of the beam, changes of the applied load and strain values measured from 6 points on the CFRP strip glued to the beam tension surface for repair are measured.

**Figure 3.7** Test setup for monotonous static and high load level fatigue load

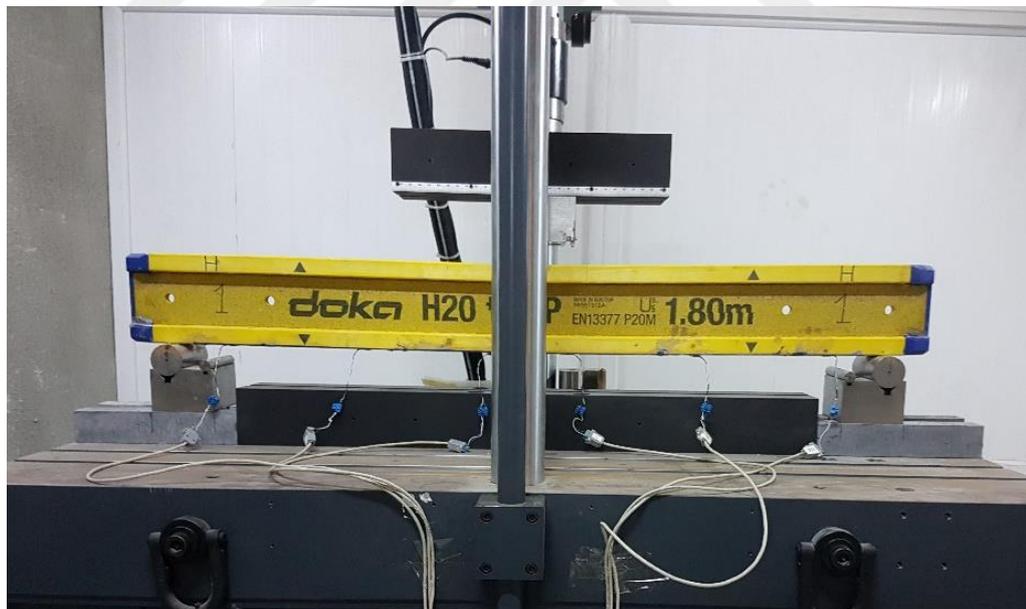
**Figure 3.8** During the Static Loading of Retrofitted Beam (Specimen 1)

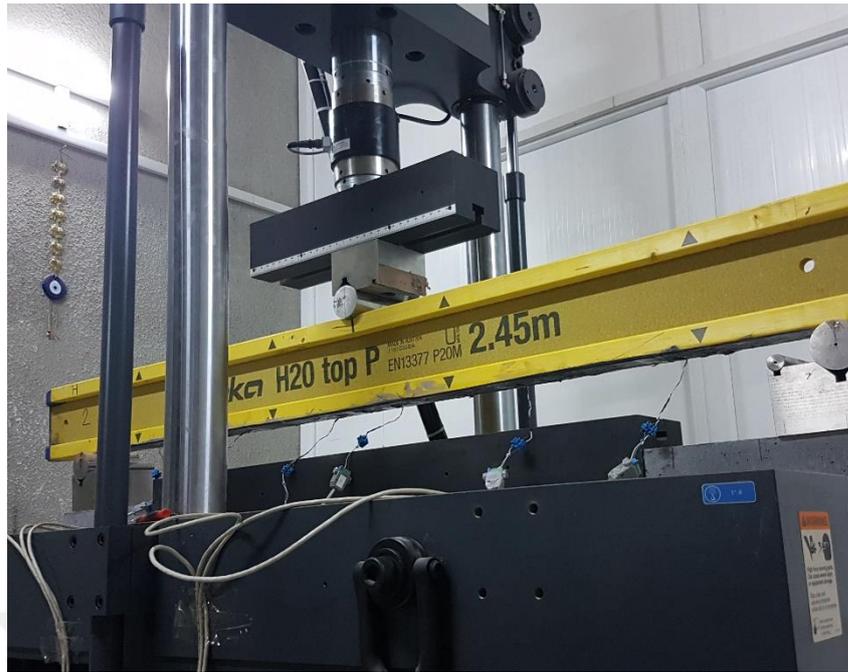
**Figure 3.9** During the Fatigue Loading of Retrofitted Beam (Specimen 7)

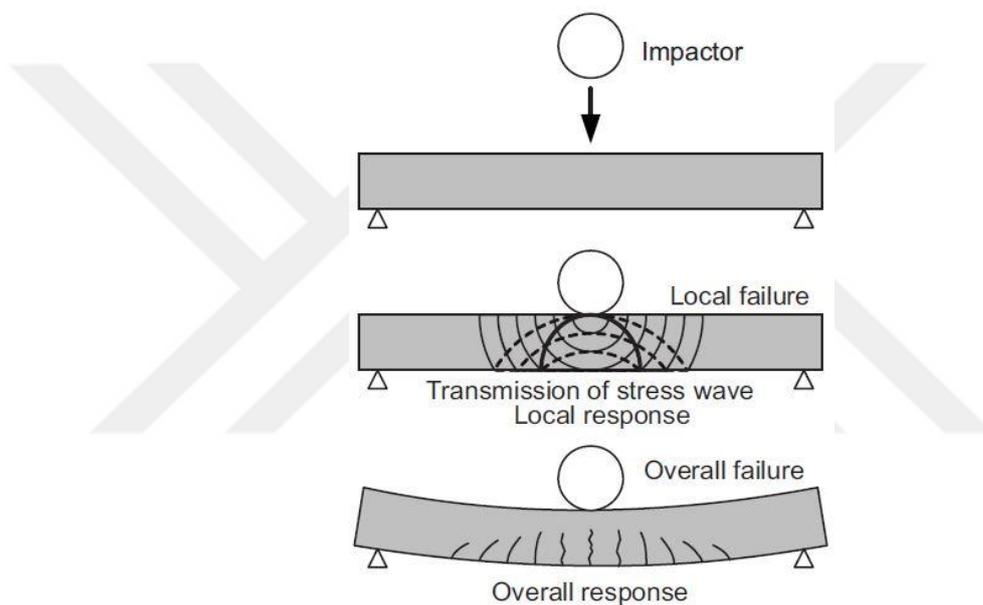
**Figure 3.10** Impact responses of a RC member [22]

Impact loading tests have been carried out many times on reinforced concrete structural elements, but they have never been done on timber structural elements. For example, the reaction of the reinforced concrete beam to sudden loading is as seen in figure 3.10. While reinforced concrete structure elements tends to deflect more at the end of impact loading, timber structural elements exhibit a more elastic behavior.

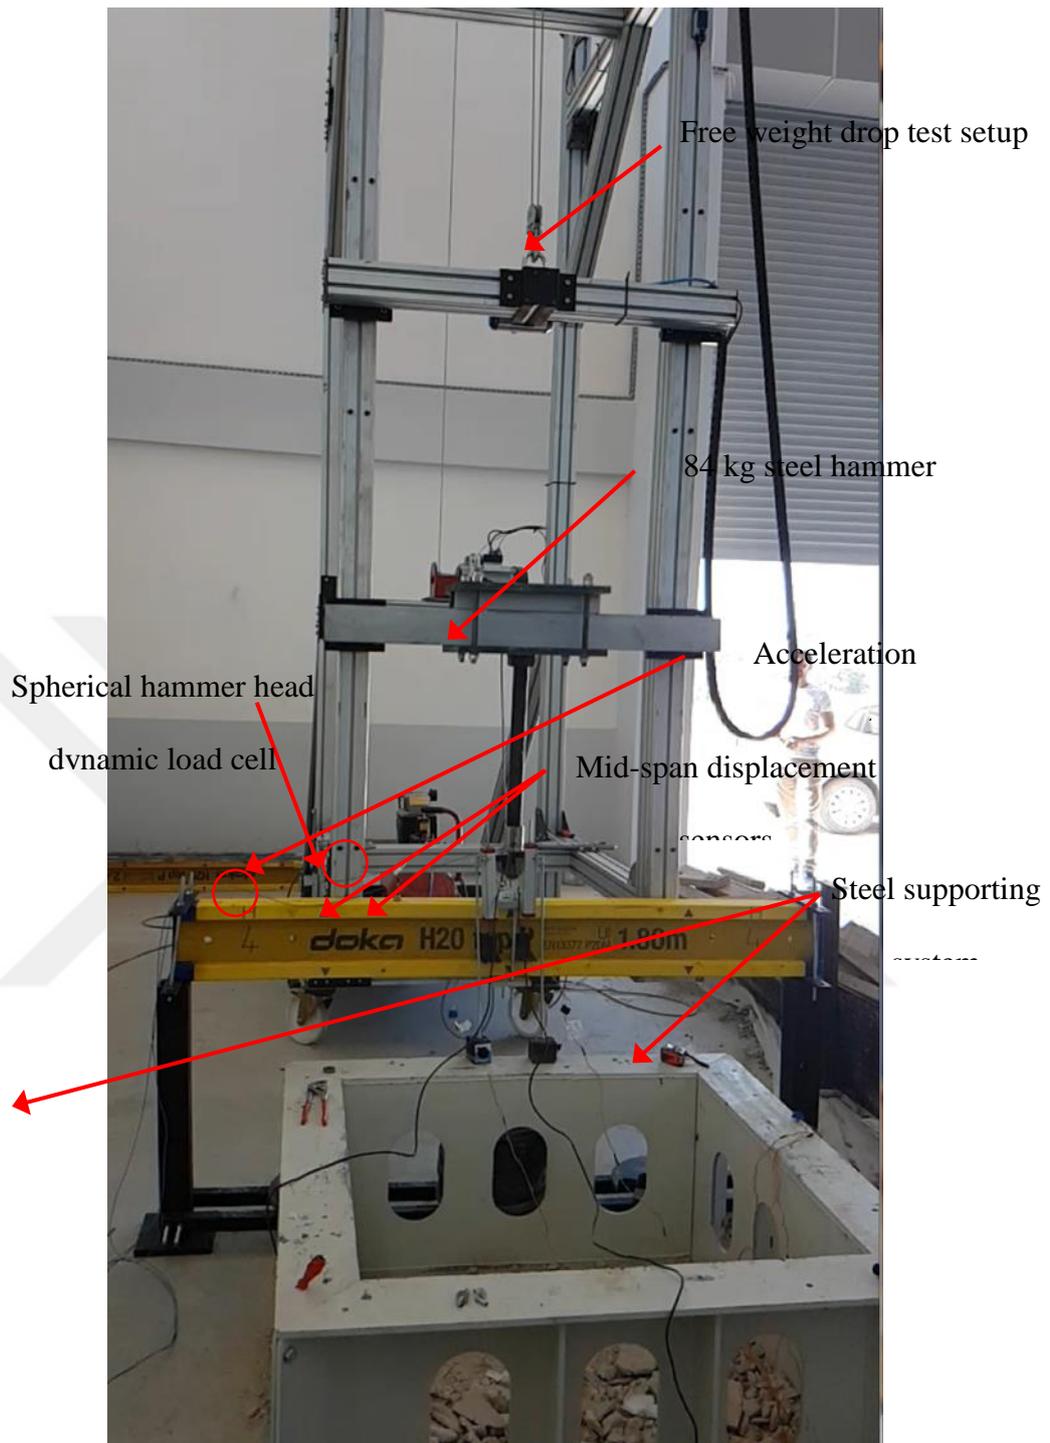
**Figure 3.11** Free weight drop test setup for impact load

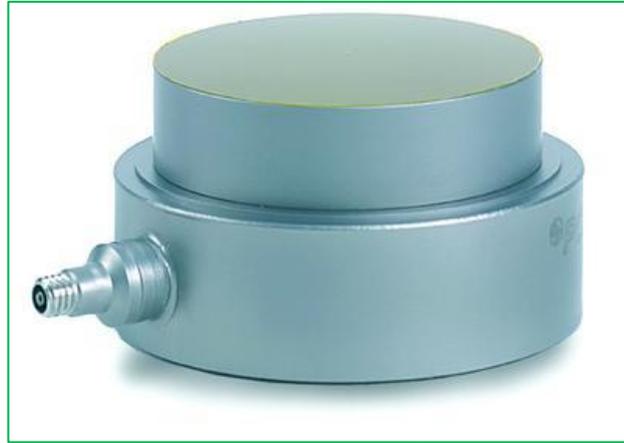
**Figure 3.12** Load cell with model number 200C50 produced by PCB Group

a high hardness material to make this connection durable and healthy. Location and image of the load cell with model number 200C50 produced by PCB Group presented in Figure 3.13.

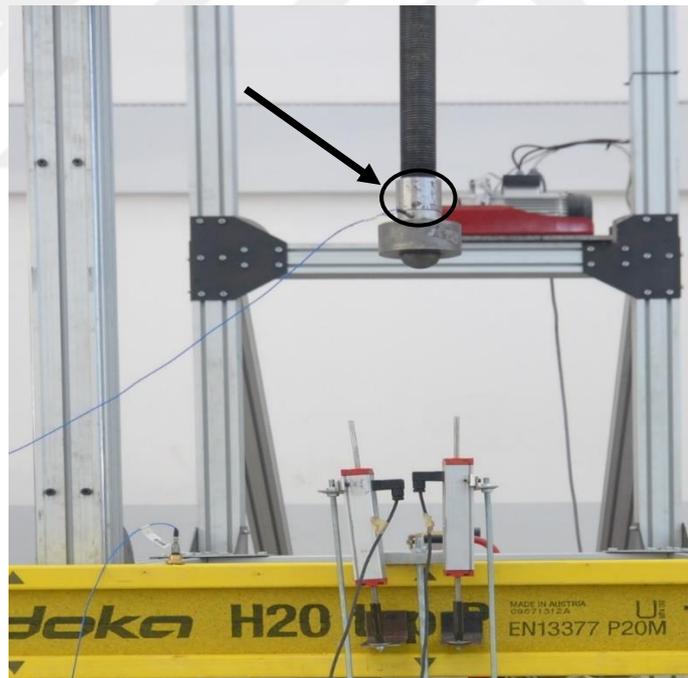
**Figure 3.13** Mounting of the load cell on the impact test

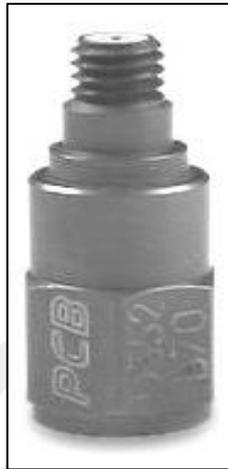
**Figure 3.14** Piezoelectric Accelerometer PCB Group ICP 352B70 Model

In this study, one ICP 352B70 model piezoelectric accelerometers produced by PCB Group were used. The piezoelectric accelerometer produced by the PCB company with the model number ICP 352B70 on impact test is given in Figure 3.14. Piezoelectric accelerometers must be mounted correctly on the test specimen in order to obtain

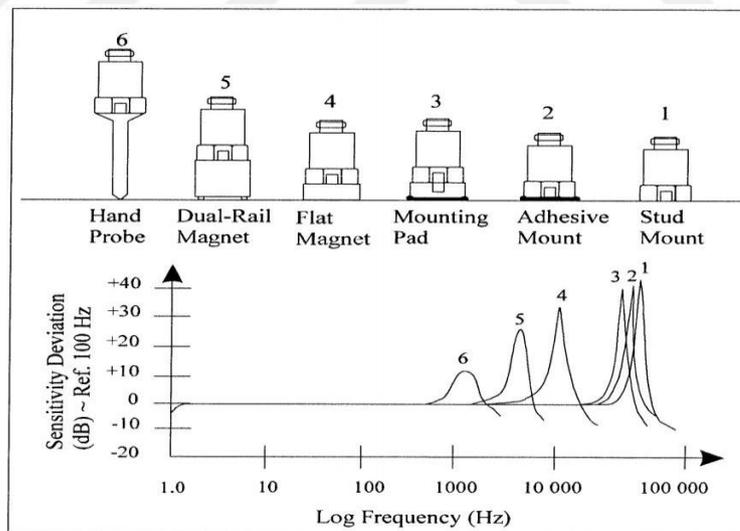
**Figure 3.15** Correct mount methods of piezoelectric accelerometers [23]

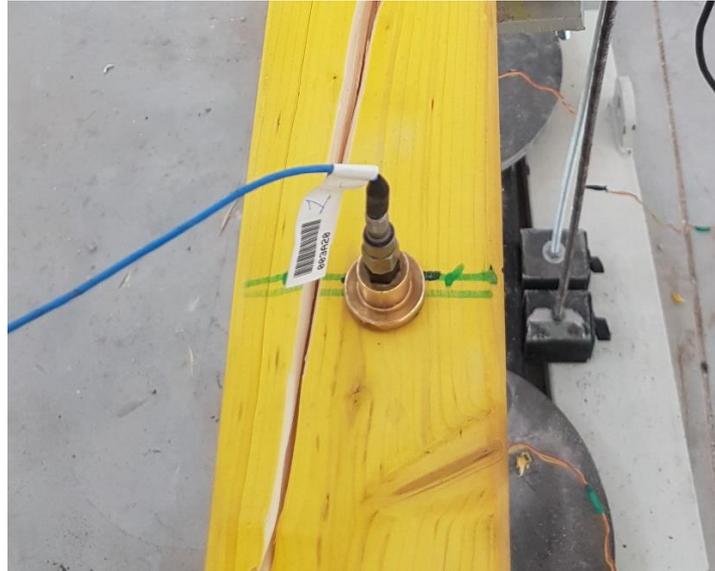
**Figure 3.16** Mounting of piezoelectric accelerometer on test specimens

In order to obtain the highest sensitivity at the highest frequencies, the specified mounting style was applied to the specimens and the mounting form is shown in Figure 3.16.

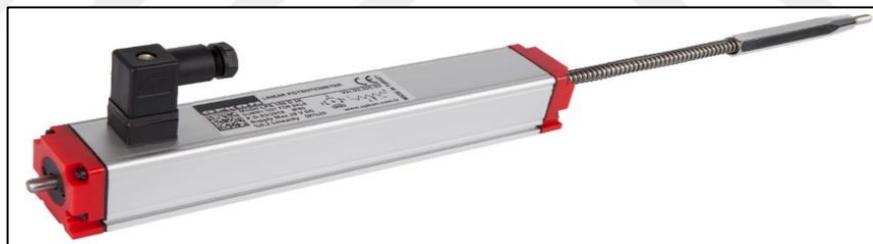
**Figure 3.17** The LPS100 Model Linear Potentiometer of Opkon Company (LVDT)

LPS100 Model Linear Potentiometer (LVDT) produced by Opkon company was used to measure the displacements of the test specimens subjected to impact loading and shown in Figure 3.17.

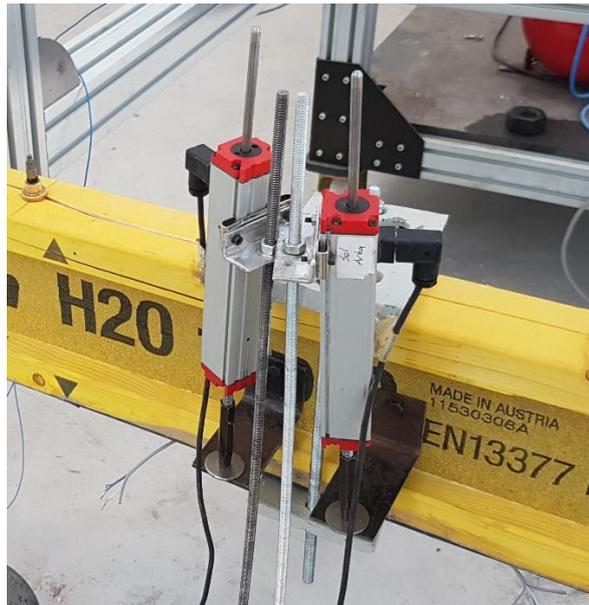
**Figure 3.18** Installation of Linear Potentiometer (LVDT)

The LVDT which are very sensitive about the displacement measurement is screwed into the body of the timber beams to be tested. Two LVDT are mounted to the central part of the beam on the left and right sides of the body where the hammer is applied in order to measure the largest displacement and fixed on the steel apparatus which is independent of the impact. The details of LVDT which is mounted on the test setup are presented in Figure 3.18.

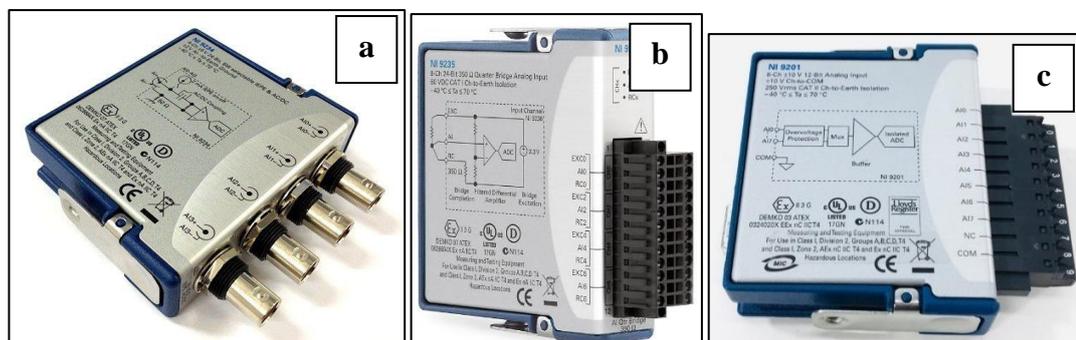
**Figure 3.19** (a) NI 9234 (b) NI 9235 (c) NI 9201

Data logger devices NI 9234, NI 9235 and NI 9201 which were produced by National Instruments company were used in this study to make the values taken from the load cell, piezoelectric accelerometer, strain gauges and LVDT to be discarded to the computer via connecting cables. The NI 9234 data logger was used to transfer data from load cell and accelerometers to computer while the NI 9235 data logger was used to transfer data from strain gauge to the computer. Also, the NI 9201 data logger was used to collect the displacement values measured from the LVDT. Data loggers figures given in figure 3.19-a, 3.19-b and 3.19-c, respectively. The technical specifications for the NI 9234 model numbered data logger are presented in Table 3.8 as well.

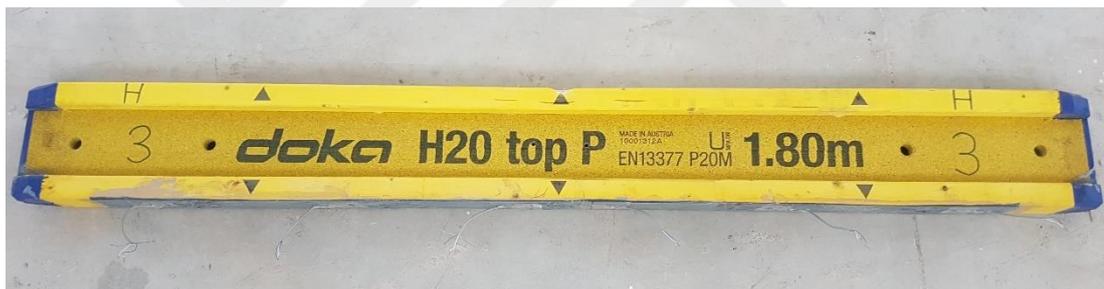
**Figure 3.20** Failure Mode of Specimen 3

Specimen 3, Specimen 4 and Specimen 5 with 1.80 m length were less damage after the impact test and and post-experiment photographs are shown in Figure 3.20, Figure 3.21 and Figure 3.22, respectively. Beside, damage and fractures on the timber beams for Specimen 8, Specimen 9 and Specimen 10 with 2.45 m length after the impact test are shown in Fig. 3.23, Fig. 3.24 and Fig. 3.25, respectively.

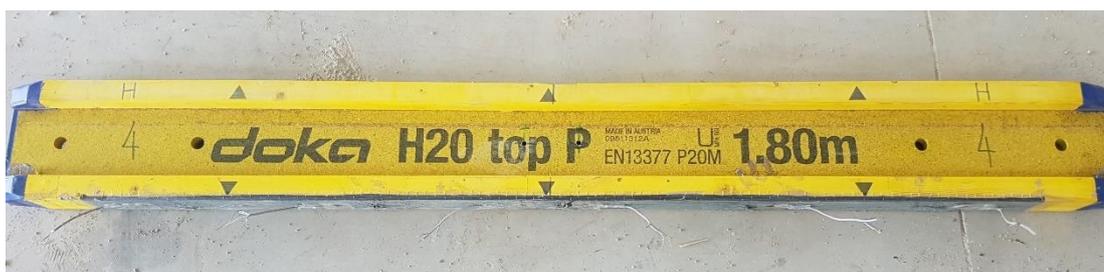
**Figure 3.21** Failure Mode of Specimen 4

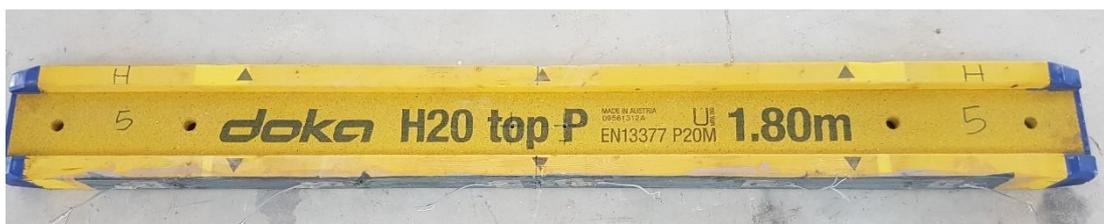
**Figure 3.22** Failure Mode of Specimen 5

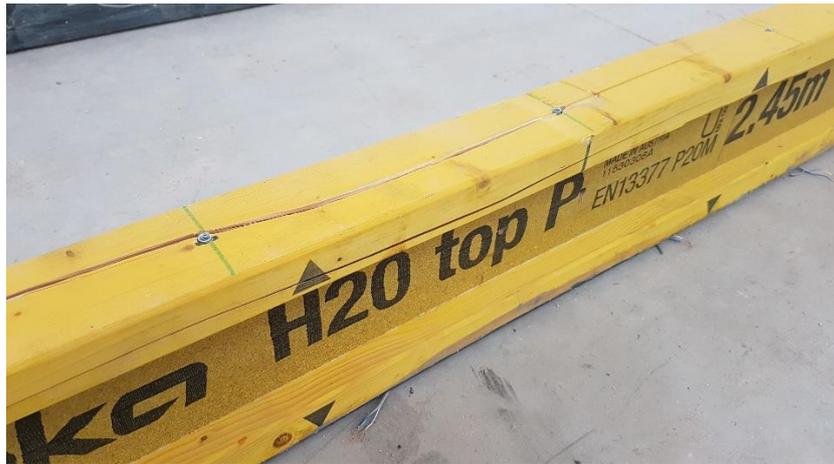
**Figure 3.23** Failure Mode of Specimen 8

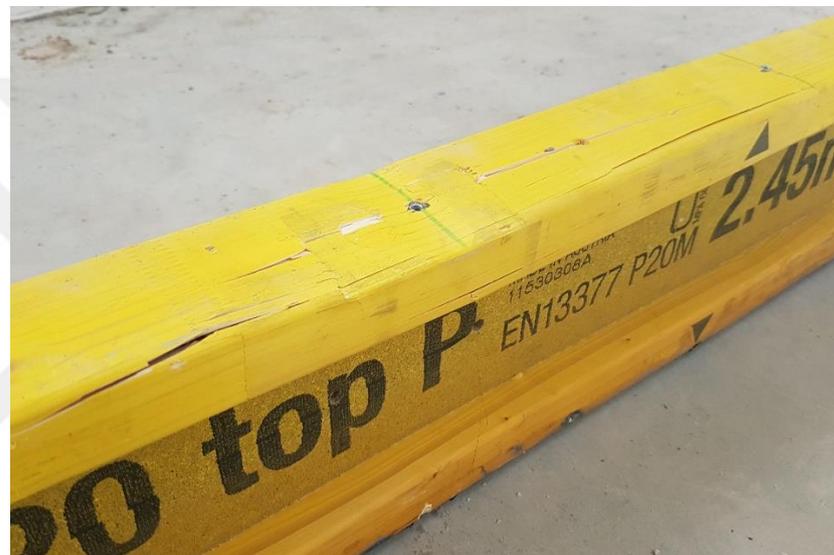
**Figure 3.24** Failure Mode of Specimen 9

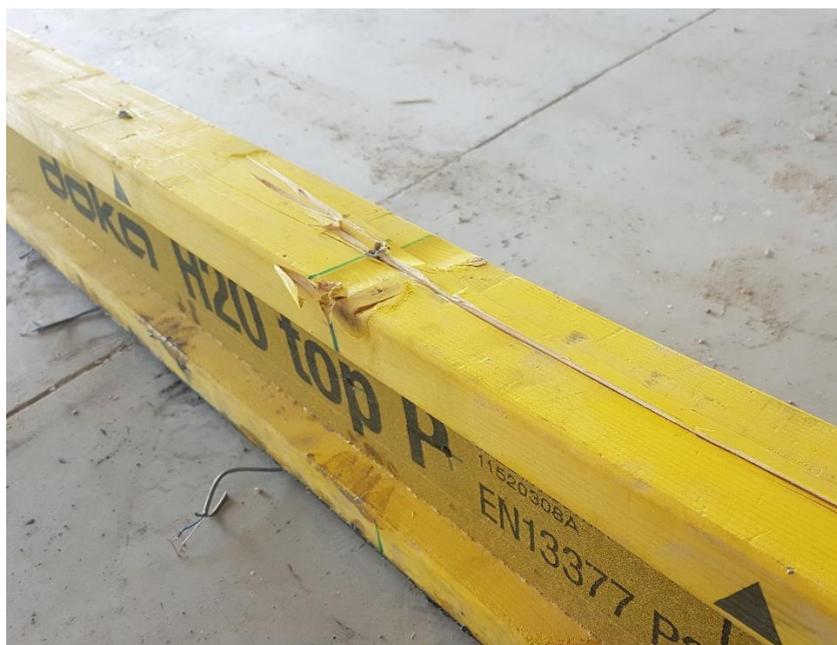
**Figure 3.25** Failure Mode of Specimen 10

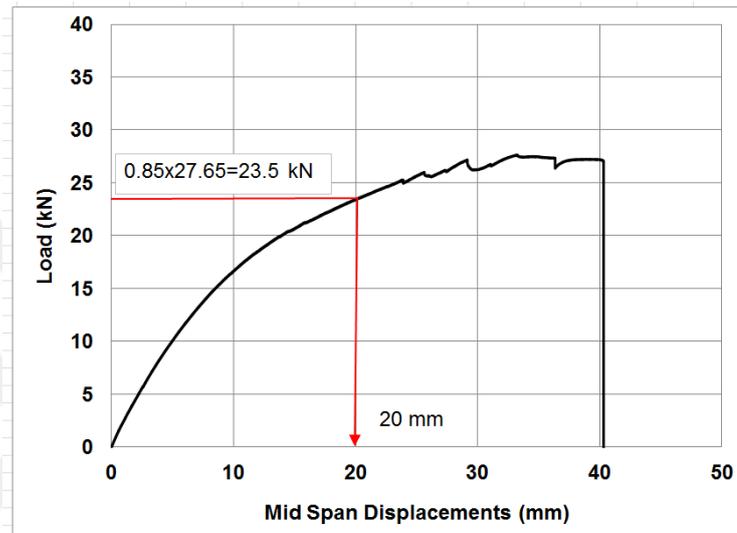
Figure 3.26 Damage Limit of 1.80 m Timber Beam

In this thesis study, there are test specimens that are damaged and then retrofitted with CFRP anchor and CFRP strip. Damage and retrofitting operations mentioned in this section. The damage process graphs of the 1.80 and 2.45 m length beams are shown in Figure 3.26 and 3.27, respectively.

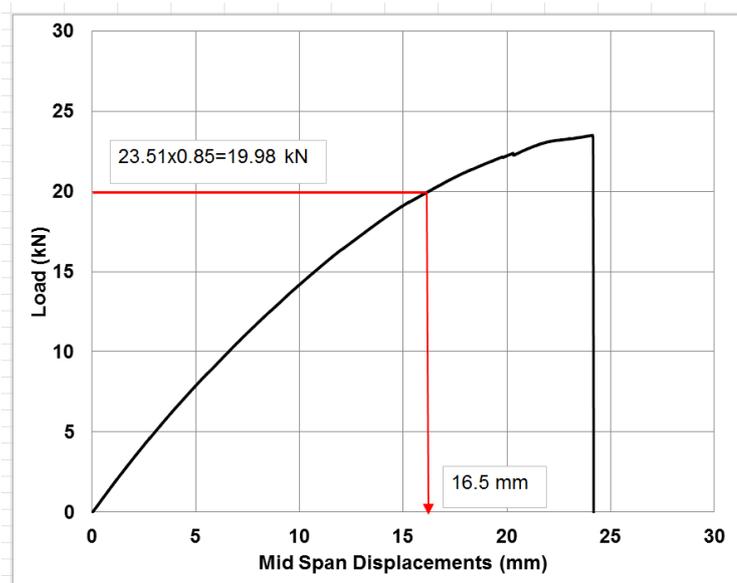
Figure 3.27 Damage Limit of 2.45 m Timber Beam

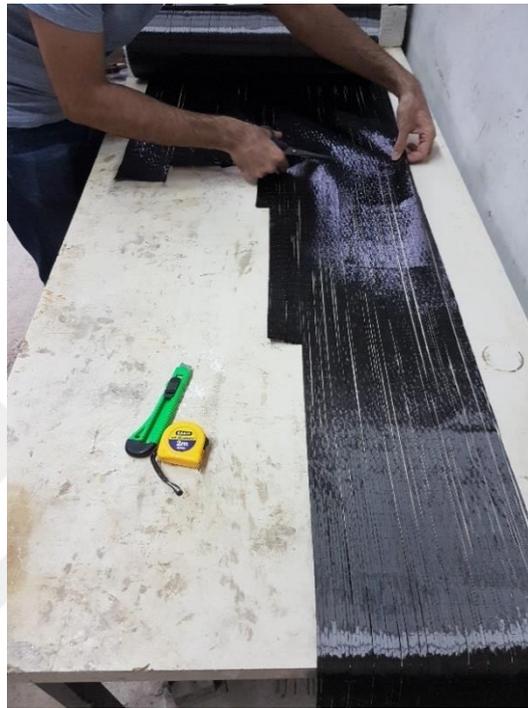
**Figure 3.28** Cutting of CFRP Strips

After the damage process, CFRP was cut according to the strip size as shown in figure 3.28. CFRP anchors are also prepared as shown in figures 3.29.

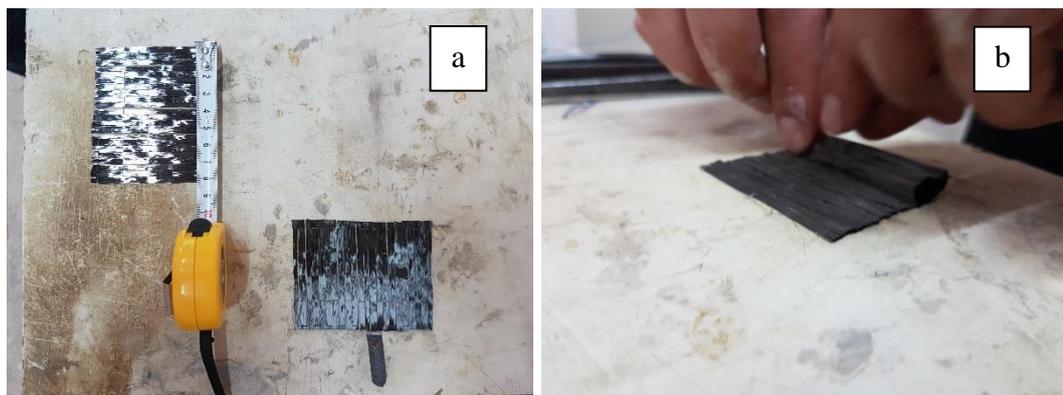
**Figure 3.29** (a) CFRP Anchor Diameters (b) CFRP Wrap on Iron Piece ( $\phi 8$ )

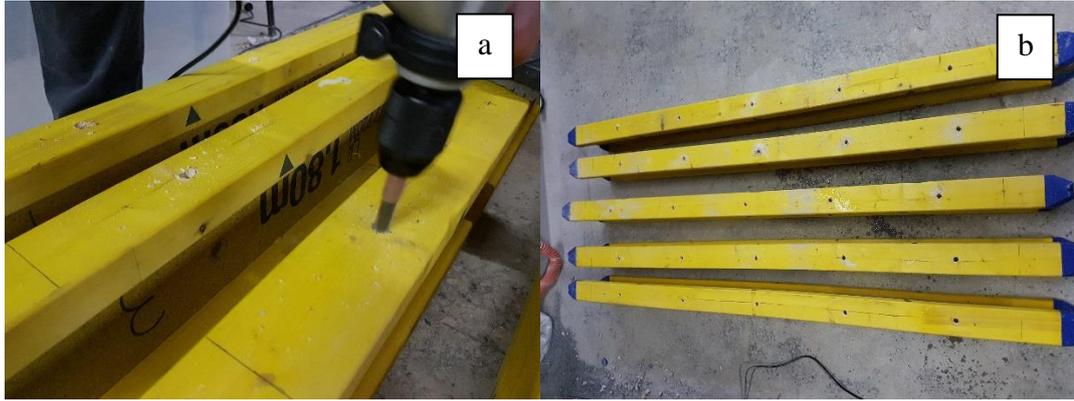
**Figure 3.30** (a) Making a Hole in Timber (b) Drilled Timber Beams

After the CFRP strips and anchors were prepared, holes were opened on the timber beams as shown in figures 3.30.

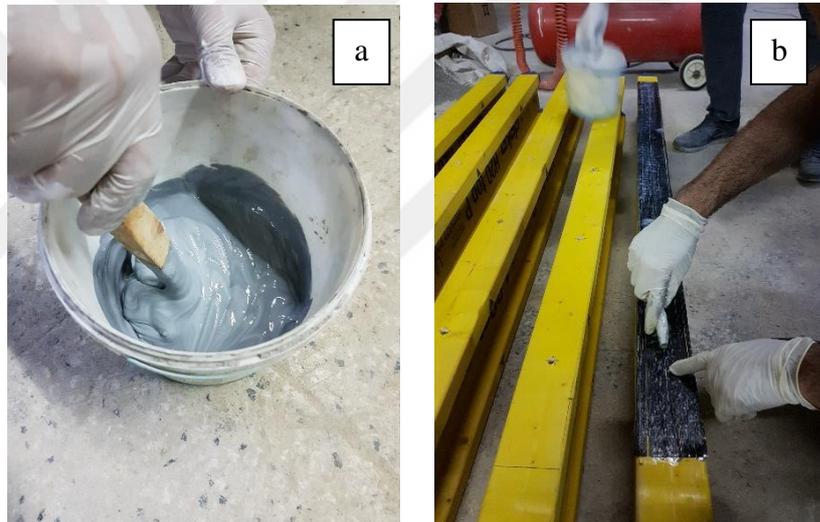
**Figure 3.31** (a) Preparation of Epoxy (b) CFRP Bonding

After the drilled beams were cleaned with a wet cloth, the epoxy was prepared as in figure 3.31(a) and the CFRP strips were glued as in figure 3.31(b).

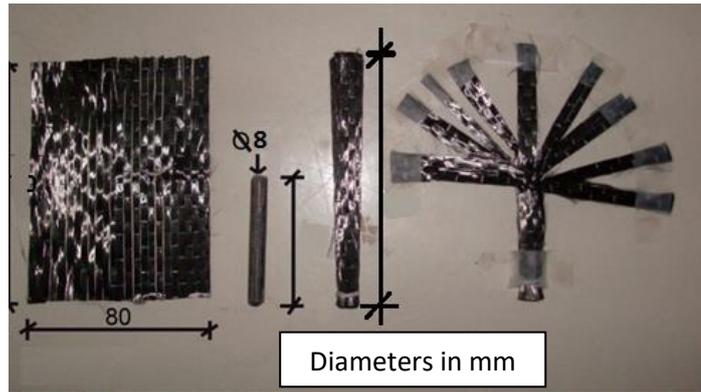
**Figure 3.32** Details of CFRP Fan Type Anchor

After the CFRP is bonded, the anchorage holes are opened as shown in Figure 3.33 and the anchors are nailed on timber by injecting epoxy into the anchorage holes. After the CFRP Anchors nailed as show in figure 3.34, it is bonded as fan type on CFRP. Fan type anchor details given in the figure 3.32.

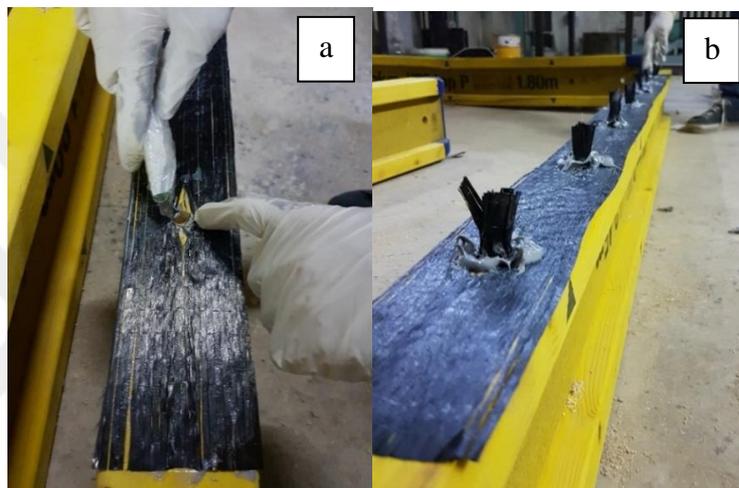
**Figure 3.33** (a) Finding the Drill Hole (b) CFRP Anchors
