**REPUBLIC OF TURKEY  
GAZIANTEP UNIVERSITY  
GRADUATE SCHOOL OF NATURAL & APPLIED SCIENCES**

**EXPERIMENTAL INVESTIGATION OF IMPACT BEHAVIOUR  
OF TIMBER FORMWORK BEAMS STRENGTHENED WITH  
CFRP STRIPS**

**M. Sc. THESIS  
IN  
CIVIL ENGINEERING**

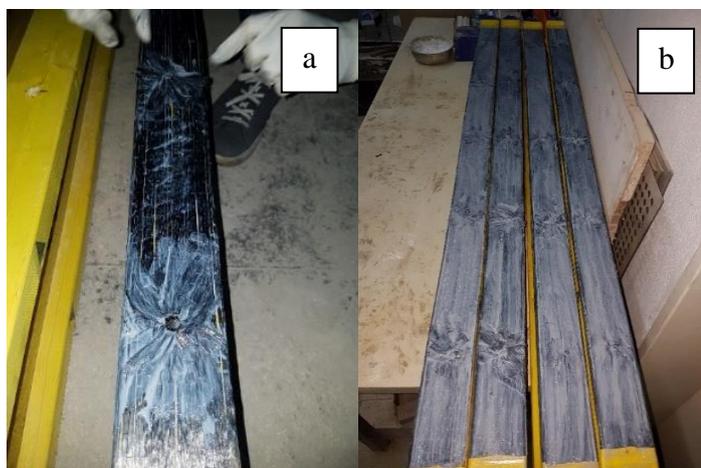
**Figure 3.34** (a) Fan Type CFRP Application (b) Retrofitting with CFRP

Fan type anchor application is given in figure 3.34(a) and the timber beams which retrofitted with CFRP image is shown in figure 3.34(b).

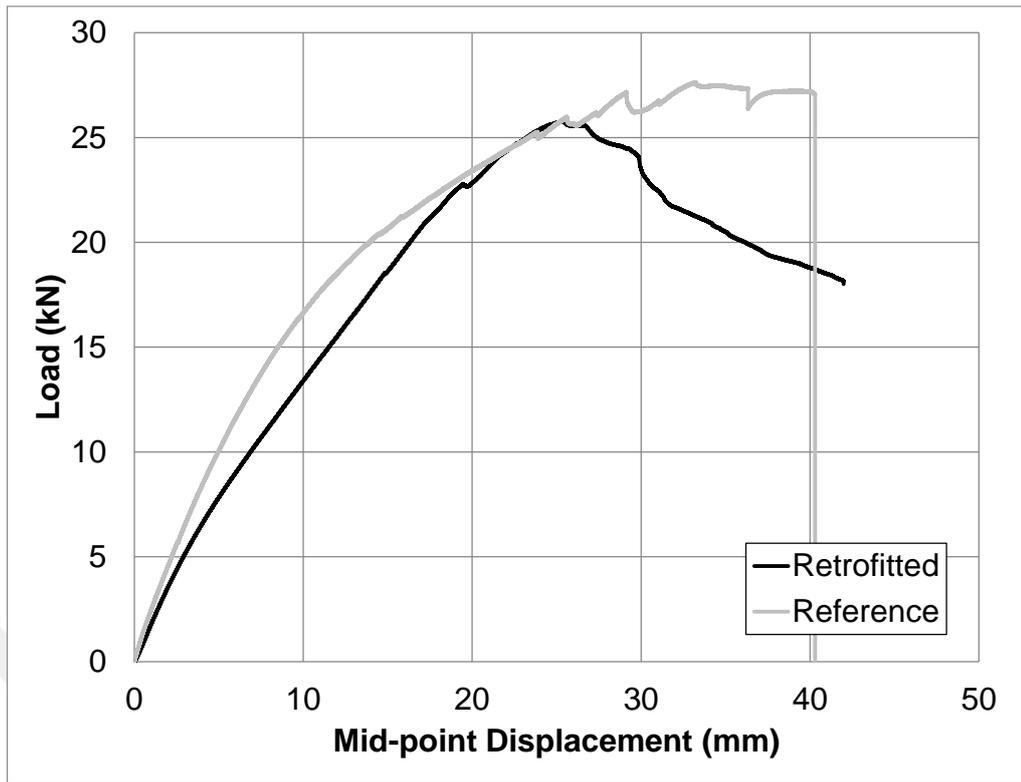
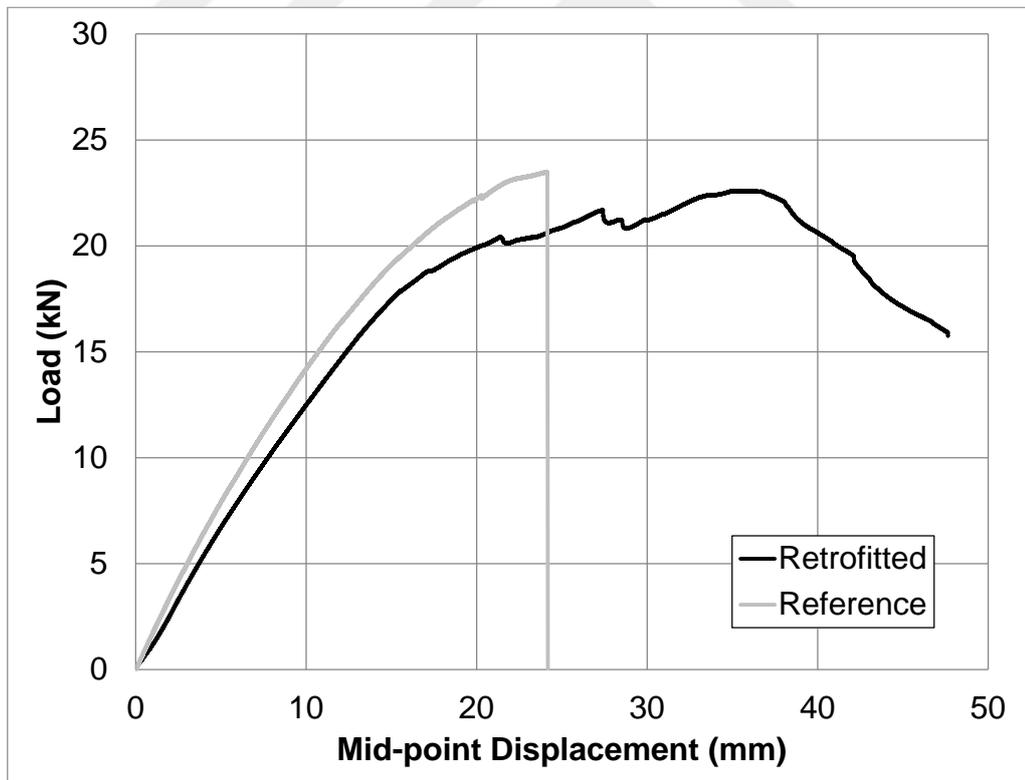
a) Specimen-1 monotonous static load-displacement graph

b) Specimen-6 monotonous static load-displacement graph

**Figure 4.1** Static Load-Displacement Graphs of Specimens

In the experimental study, first of all the tests of damaged retrofitted timber formwork beams under monotonic increased static loading effect were performed and the load-displacement behaviors of the beams were obtained. The load-displacement graphs obtained as a result of the tests of the Specimen 1 with 1800 mm length and Specimen 6 with a length of 2450 mm are given in Figure 4.1 and the results are given in Table 4.1. In addition, for the maximum load level, the distribution of the strain values measured on the CFRP fan type anchored CFRP strips bonded to the tension surface of the damaged beams for repair purposes is given in Figure 4.2. By using the load-displacement graphs obtained as a result of the experiments, the maximum carrying capacity values, initial stiffness, displacement ductility ratios and energy dissipation capacities of the experimental elements were calculated and determined. Displacement ductility ratio values were defined as the point where the maximum carrying capacity of the test specimens decreased by 15% to at a level of 85% and the displacement value of this point is calculated by proportioning the maximum carrying capacity to the displacement value. The energy dissipation capacity values of the test specimens was obtained by calculating the area of the load-displacement graphs below the parts up to the collapse point. The point of displacement is identical to the point of collapse and used for displacement ductility rates. The methods used to determine the calculated values for the test specimens are presented in Figure 4.3.

When the test results were examined, it was observed that the Specimen 1 with 1800 mm span had a maximum carrying capacity of 14% more than the Specimen 6 with 2450 mm span and reached 40% more displacement to this load level. Specimen 1 achieves maximum carrying capacity with less displacement and more ductile

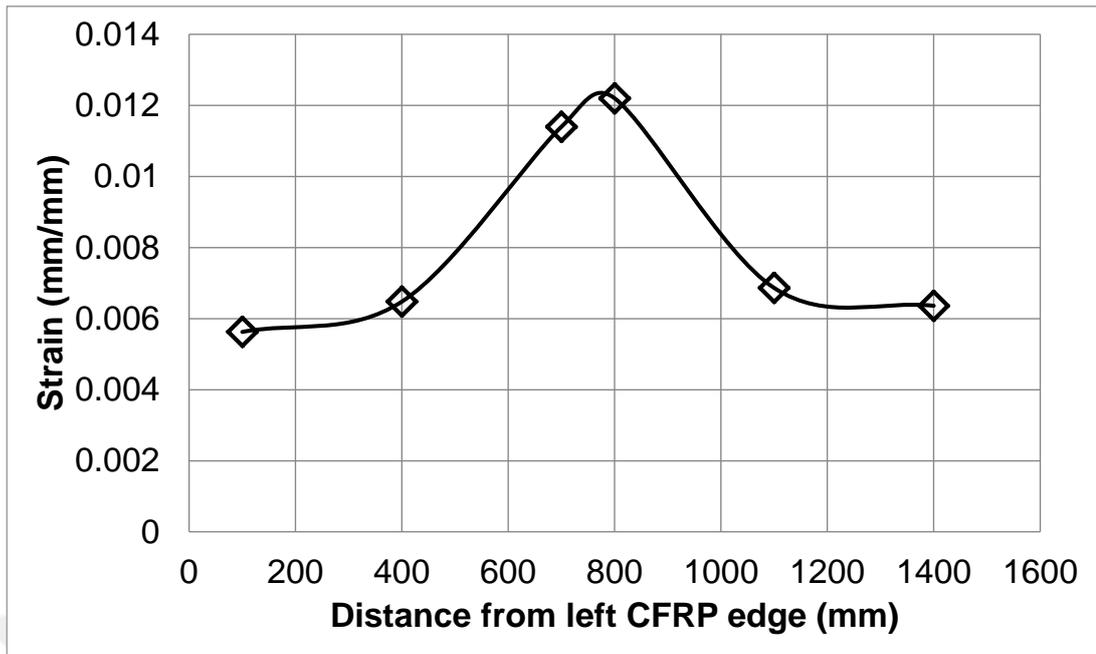
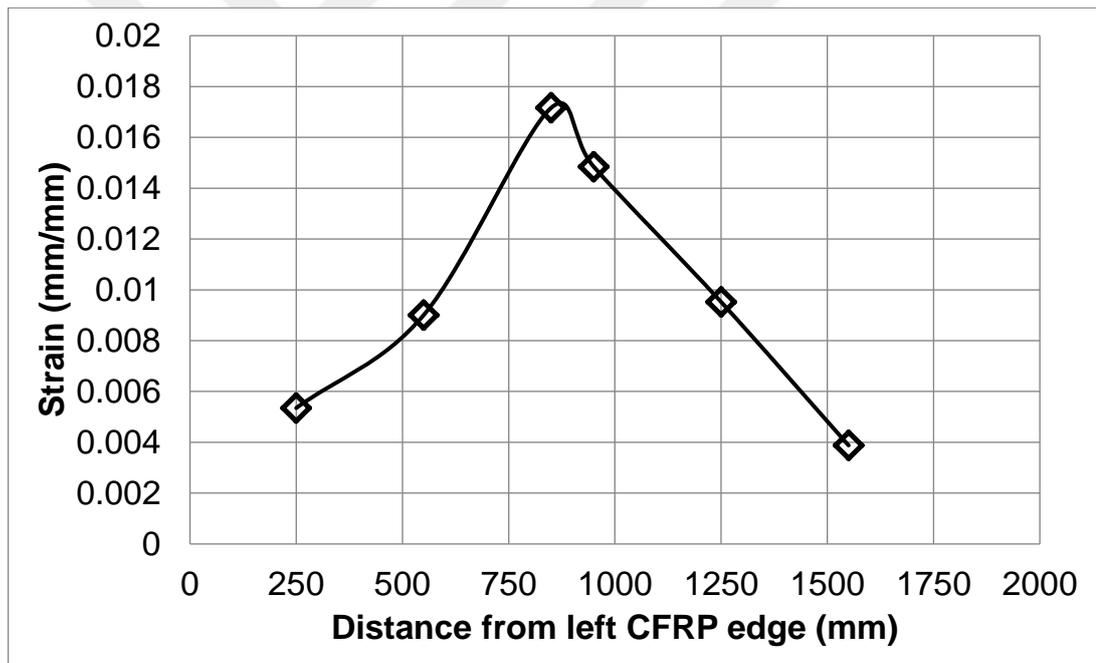
a) Specimen-1 strain distribution along to CFRP strip

b) Specimen-6 strain distribution along to CFRP strip

behavior, as well as 23% more initial stiffness than the Specimen 6. The displacement ductility rate of the Specimen 1 is 8% greater than the Specimen 6. Since the Specimen 6 reached a maximum displacement value with a much higher displacement, the energy dissipation capacity was calculated as a small percentage of 7% from the Specimen 1. In general, it was observed that the behavior of the damaged retrofitted Specimen 1 was better than the Specimen 6 under static loading, and showed a load-displacement behavior with high strength and rigidity as well as a more ductile behavior than the Specimen 6. Specimen 1 showed even a little higher energy consumption capacity than the experimental element due to the fact that Specimen 6 reaches maximum carrying capacity by far more displacement as well. The load-displacement graphs which described as a reference in Figure 4.1 belong to undamaged timber beam. When the load-displacement behaviors of damaged retrofitted Specimen 1 and Specimen 6 compared with undamaged reference test specimens it was observed that the repair technique applied to the test specimens of two different lengths gives very successful results. Both of the test specimens were obtained with a rigidity similar to the approximate maximum carrying capacity with the undamaged reference test specimens, and the damaged retrofitted Specimen 6 exhibited a much more ductile behavior and exhibited greater energy dissipation capacity than the undamaged reference test specimen. When the strain distributions taken on the CFRP strips bonded to the tensile surfaces given in Figure 4.2 for retrofitted Specimen 1 and Specimen 6 are examined, it is seen that the strain values in both test elements reach the maximum value in the axis of symmetry where the loading is applied at the mid point of the beam. The maximum strain value measured at the mid-point of the Specimen 6 was 41% higher than the Specimen 1. This result showed that more load is carried by the anchored CFRP strip used for repair in the Specimen 6. The use of anchors prevented the slipping of the CFRP strips from the surface and increased the maximum strain values measured from the CFRP strips by increasing the 0.005 mm / mm limit value given as the slipping limit value for the CFRP material in the ACI 440 R1-17, 2017 committee report. Maximum strain values measured under the effect of static loading from the damaged test specimens retrofitted with anchored CFRP strips were obtained on average 194% larger than the slipping strain value for CFRP strips given in ACI 440 R1-17 committee report.

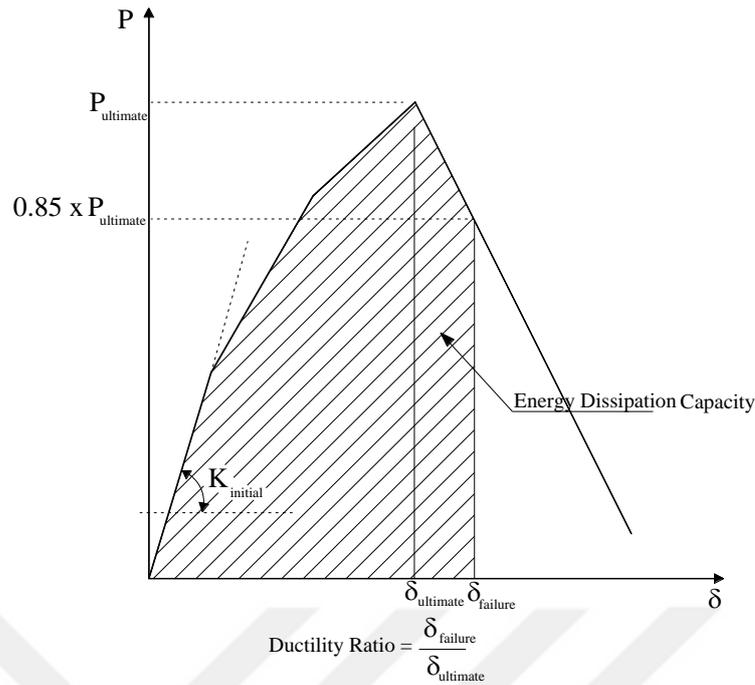
**Figure 4.3** Calculation Approach of Ultimate Load Capacity, Initial Stiffness, Displacement Ductility Ratios and Energy Dissipation Capacity

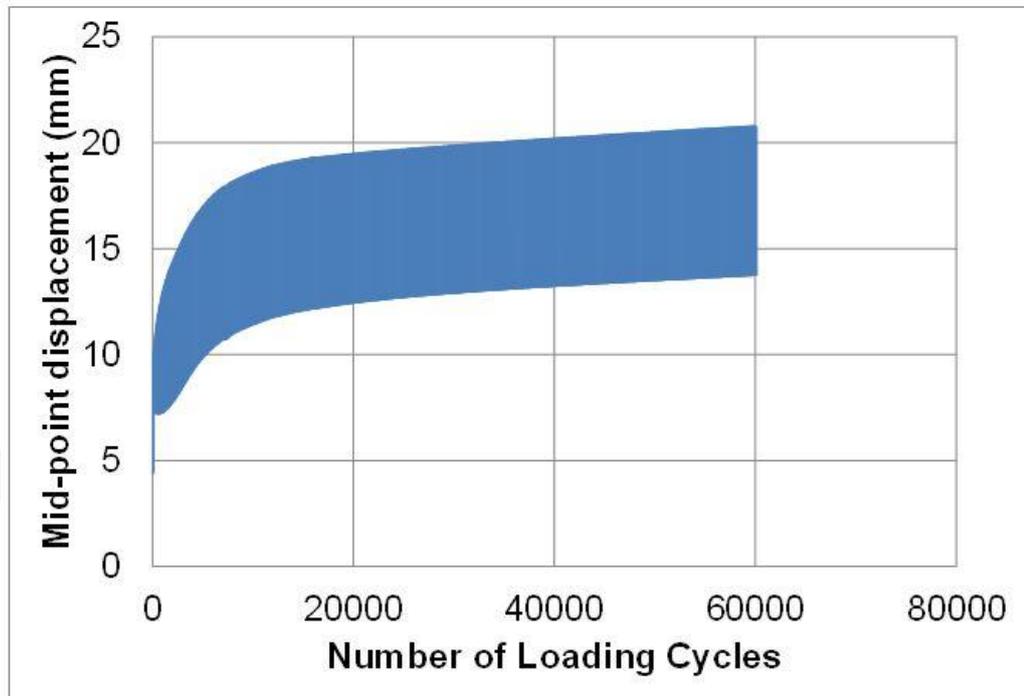
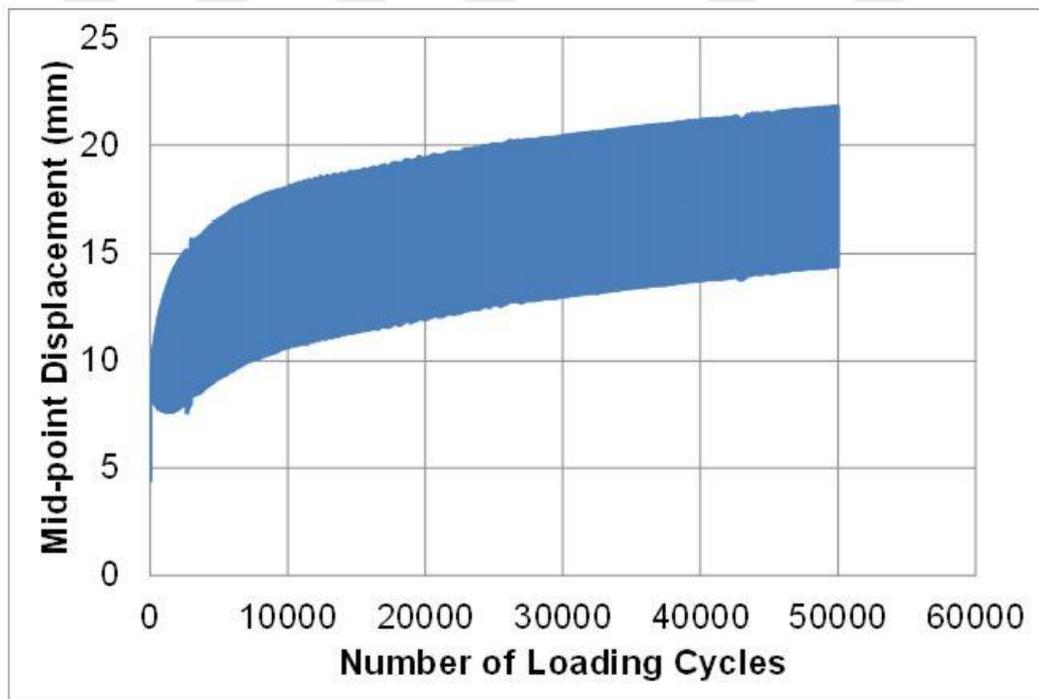
a) Specimen-2 displacement-number of loading cycles graph for fatigue load

b) Specimen-7 displacement-number of loading cycles graph for fatigue load

The second type of installation examined in the study is a high load low cycle fatigue loading. The profile of fatigue loading applied to the Specimen 2 damaged repaired timber beam of 1800 mm length was determined using the results obtained from the Specimen 1. The maximum and minimum load levels in the fatigue loading profile applied to the Specimen 2 were determined as 10% and 85% of the maximum carrying capacity of Specimen 1, respectively. As a result of the 60000 loading cycle applied to the specimen 2, the specimen has failed and the test has been completed. While the mid-point displacement of the beam is 4.45 mm when the fatigue load is applied to the Specimen 2, mid-point displacement increased up to 20.71 mm just before failing. While damaged retrofitted Specimen 1 with the same properties displace 17.6 mm at 21.94 kN load level under the effect of static loading, displacement at the same load level under the effect of fatigue loading was 18% more as a result of the 60000 loading cycle. The amount of change in beam mid-point displacement increased up to 5.81 mm at the end of the test when loading value varies between maximum and minimum values under the effect of fatigue loading profile applied to Specimen 2. The damaged

retrofitted Specimen 7 tested by fatigue loading is identical to the Specimen 6 tested under static loading. The maximum and minimum values of the fatigue loading applied to the Specimen 7 were determined similar to the beam test specimen with a length of 1800 mm as 85% and 10%, respectively, of the maximum carrying capacity of the Specimen 6. The fatigue loading applied to the Specimen 7 failed after the 50000 loading cycles and the test has been terminated. At the beginning of the experiment, when the mid-point displacement value of the Specimen 7 was 4.42 mm, after the 50000 loading cycle the mid-point displacement of the beam increased to 21.81 mm just before failing at the test result. The mid-point displacement of the beam increased to 20% more just before the failing on the Specimen 7 tested under the influence of fatigue loading at the end of the test, the beam mid-point displacement value of the same 19.22 kN load level is 18.19 mm in the Specimen 6 tested with static loading effect on identical properties. The difference between the maximum and minimum load levels of the beam mid-point displacement values increased up to 7.31 mm before failing under the influence of fatigue loading applied to the Specimen 7 at the end of the test. The displacement graphs obtained as a result of the fatigue tests applied to the Specimen 2 and Specimen 7 are given in Figure 4.4 and the test results are given in Table 4.2. Undamaged 1800 and 2450 mm long timber beam test specimens under high load level fatigue loading has achieved much more displacement in the number of low cycles than retrofitted with damaged anchored CFRP strips test specimens. Undamaged timber beams of 1800 mm and 2450 mm length have failed through the loading cycle of 3372 and 4339 respectively, and the beam mid-point displacement values have reached 46.58 mm and 31.92 mm, respectively. Damaged, retrofitted with anchored CFRP strips 1800 and 2450 mm long timber beam test specimens, on the other hand, resist on a much longer time fatigue loading as a result of 17.8 times and 11.5 times more loading cycles, respectively. Undamaged 1800 mm and 2450 mm long beams have more displacement of 125% and 46% than the damaged retrofitted beams, respectively. The retrofit technique applied with anchored CFRP strips has reduced the mid-point displacement of the beam due to fatigue loading much more successfully and has significantly reduced. In addition, the distribution of the strain values measured on CFRP fan-type anchored CFRP strips bonded to the tension surface of damaged beams for repair purposes is given in Figure 4.5 at the end of the test. When the strain distributions measured along CFRP strips bonded to the beam tension surface for

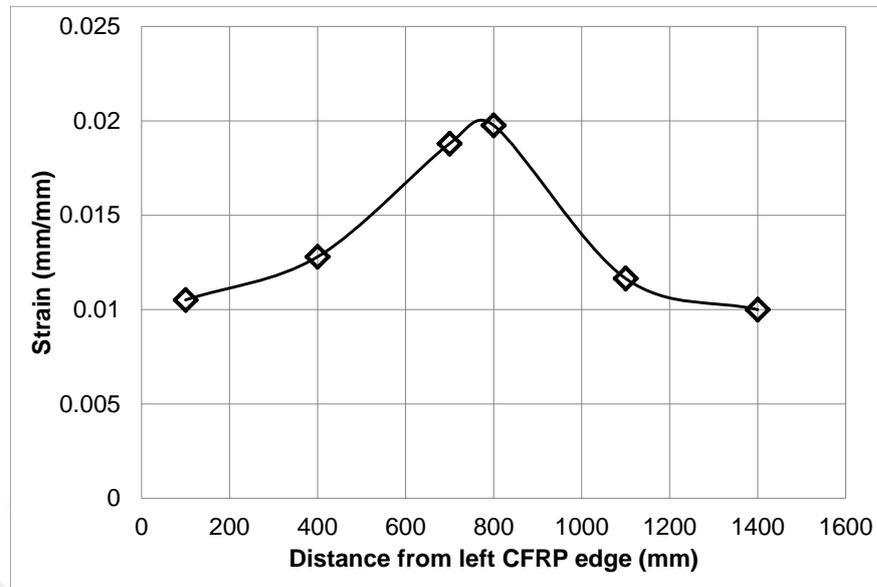
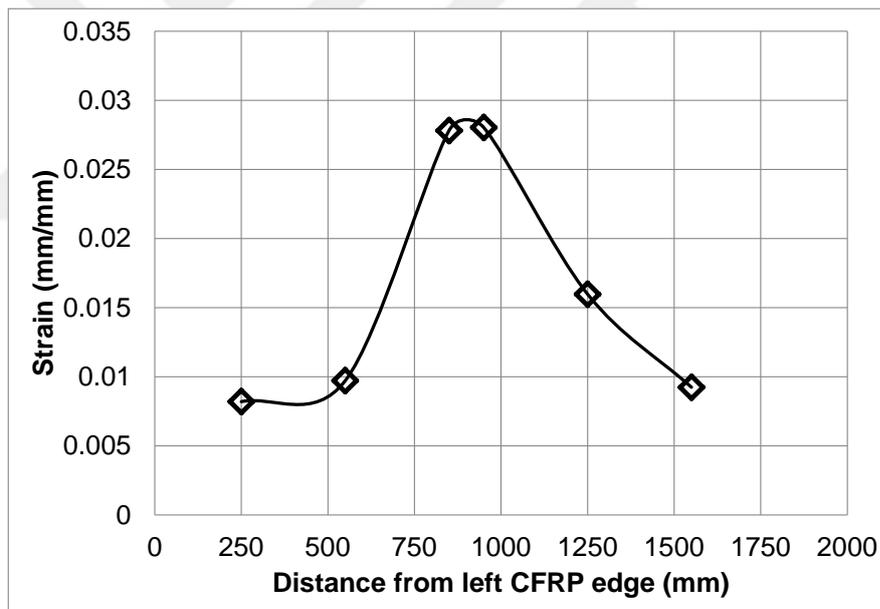
a) Specimen-2 strain distribution along to CFRP strip

b) Specimen-7 strain distribution along to CFRP strip

repair are examined, it is seen that the maximum strain values occur at the mid point of the beam where fatigue load is applied.

Maximum strain values measured from damaged retrofitted timber beams tested under the effect of fatigue loading are obtained as 378% greater than 0.005 mm / mm surface slipping strain limit value given for CFRP strips in ACI 440 R1-17 committee report. The result showed that CFRP strips which are used for retrofitting are able to take significant axial tensile stresses with the effect of fatigue loading and they were able to reach much larger strain values without being slipped off the surface by the effect of anchors. The retrofit technique applied with anchored CFRP strips effectively limited the deformations of the damaged timber beams under fatigue loading and the CFRP strips carry an axial tension force without slipping off the surface, allowing more carrying load cycle than undamaged reference beams. When the behavior of the Specimen 2 with 1800 mm length and Specimen 7 with 2450 mm length tested under the effect of fatigue loading, it has been seen that the Specimen 2 has a more successful performance. Specimen 2 has 5% less displacement than the Specimen 7 and 20% more fatigue loading has carried the load up to the number of cycles without failing at the end of the test. Moreover, the Specimen 2 withstand more loading cycles by making less displacement while the maximum strain value measured from the CFRP strip remained at a lower level than the Specimen 7. The maximum strain value measured from the CFRP strip of Specimen 7 is 41% greater than the Specimen 2. These results showed that the applied retrofit technique performed in the Specimen 2 which was tested under the effect of fatigue loading with 1800 mm length showed a more successful performance than the Specimen 7 with a length of 2450 mm. Also, the maximum strain values measured from CFRP strips in Specimen 2 and Specimen 7 were measured an average of 63% more compared with Specimen 1 and Specimen 6 tested under static loading. Obtained this result showed that CFRP strips had more

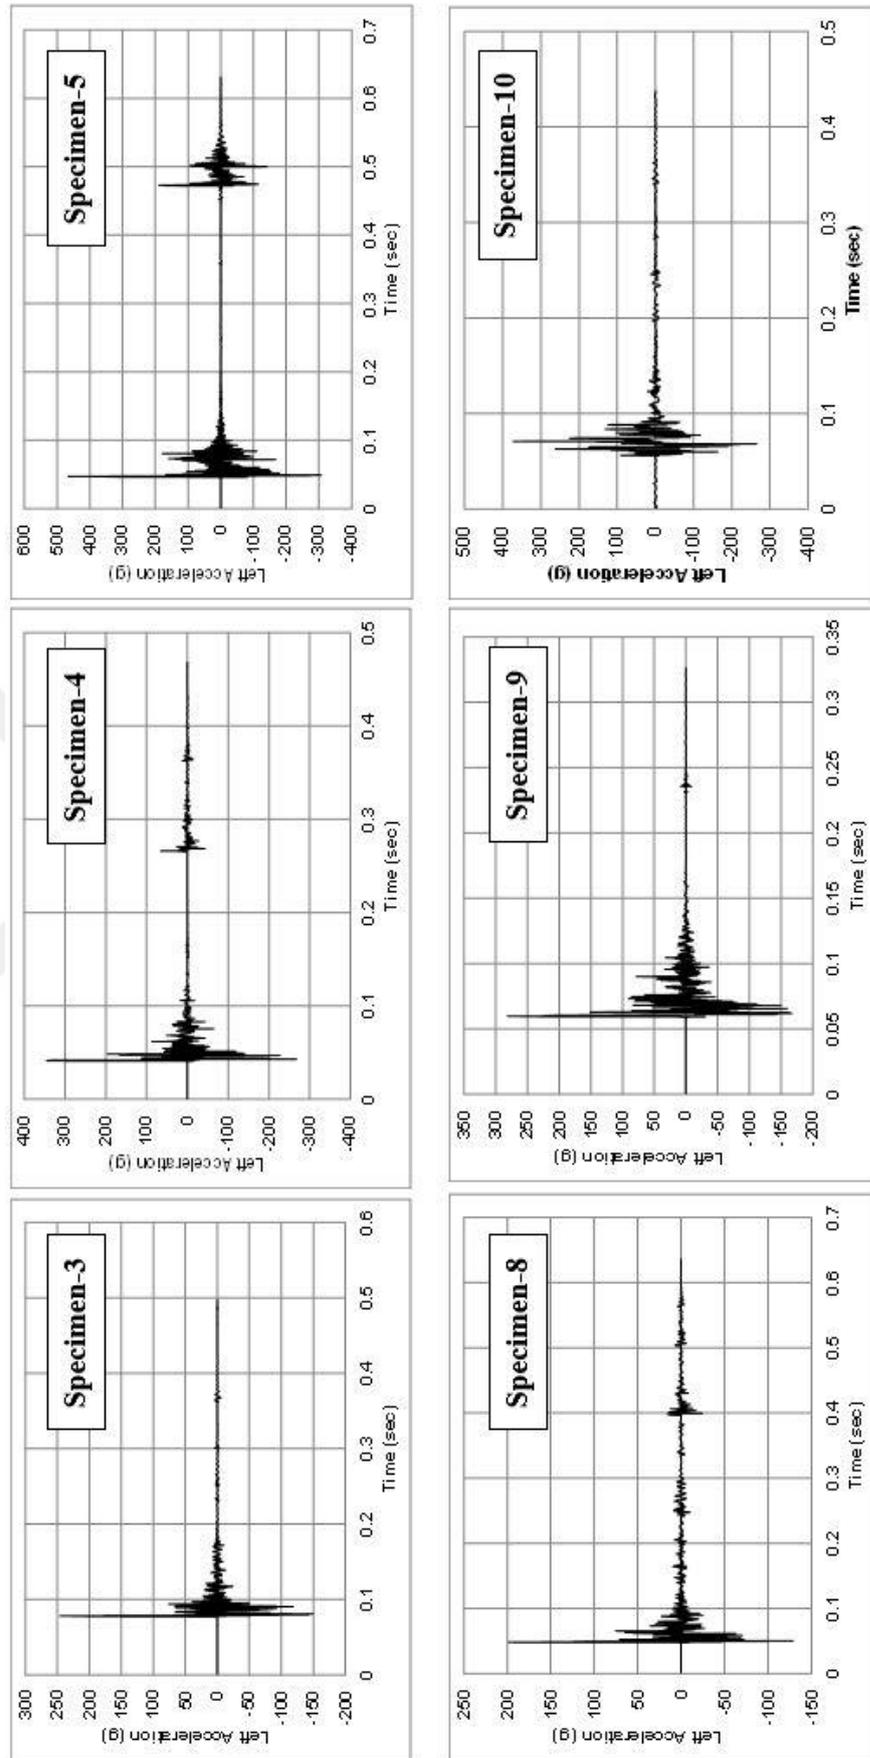
**Figure 4.6** Left Acceleration-Time Graphs of Specimens under Impact Load

The maximum acceleration, maximum left and right displacements, and maximum strain values measured from the beam test specimens, all decreased when the span of damaged retrofitted timber beam test specimens increased under the effect of impact loading. The maximum acceleration, maximum left and right displacement and maximum strain values of the test specimens having 1800 mm span were obtained more an average of 24%, 20%, 17%, and 18%, respectively than the test specimens having 2450 mm span. When the graphs of strain distributions along the CFRP strip are analysed in Figure 4.10, maximum strain values have been observed at the mid-point of the beam where the impact loading is applied on damaged retrofitted timber beams. When the maximum strain values measured by the effect of impact loading were examined the resulting values were found to be greater than the average of 0.005 mm / mm from the slipping limit value given in the ACI 440 R1-17 committee report. This obtained result shows that CFRP strips carry effective axial tensile stress without slipping from the surface by the effect of impact loading in the applied retrofit technique. In this result, the CFRP fan-type anchors used on CFRP strips have played an active role and they allowed CFRP strips to carry much more axial tensile forces as they prevent slipping from the surface. When the behavior of undamaged timber beams and damaged retrofitted timber beams under impact loading is examined, they perform close to each other and the retrofit technique applied on damaged beams increases their performances of the beams under the impact loading and brings them closer to the undamaged beams. The maximum left acceleration values measured from undamaged timber beams measured as small as 10% than damaged beams and maximum left and right displacement values measured from damaged wooden beams were obtained greater 8% and 11%, respectively than the undamaged beams. Damaged beams exhibited a very close performance to the undamaged beams under the effect of impact loading.

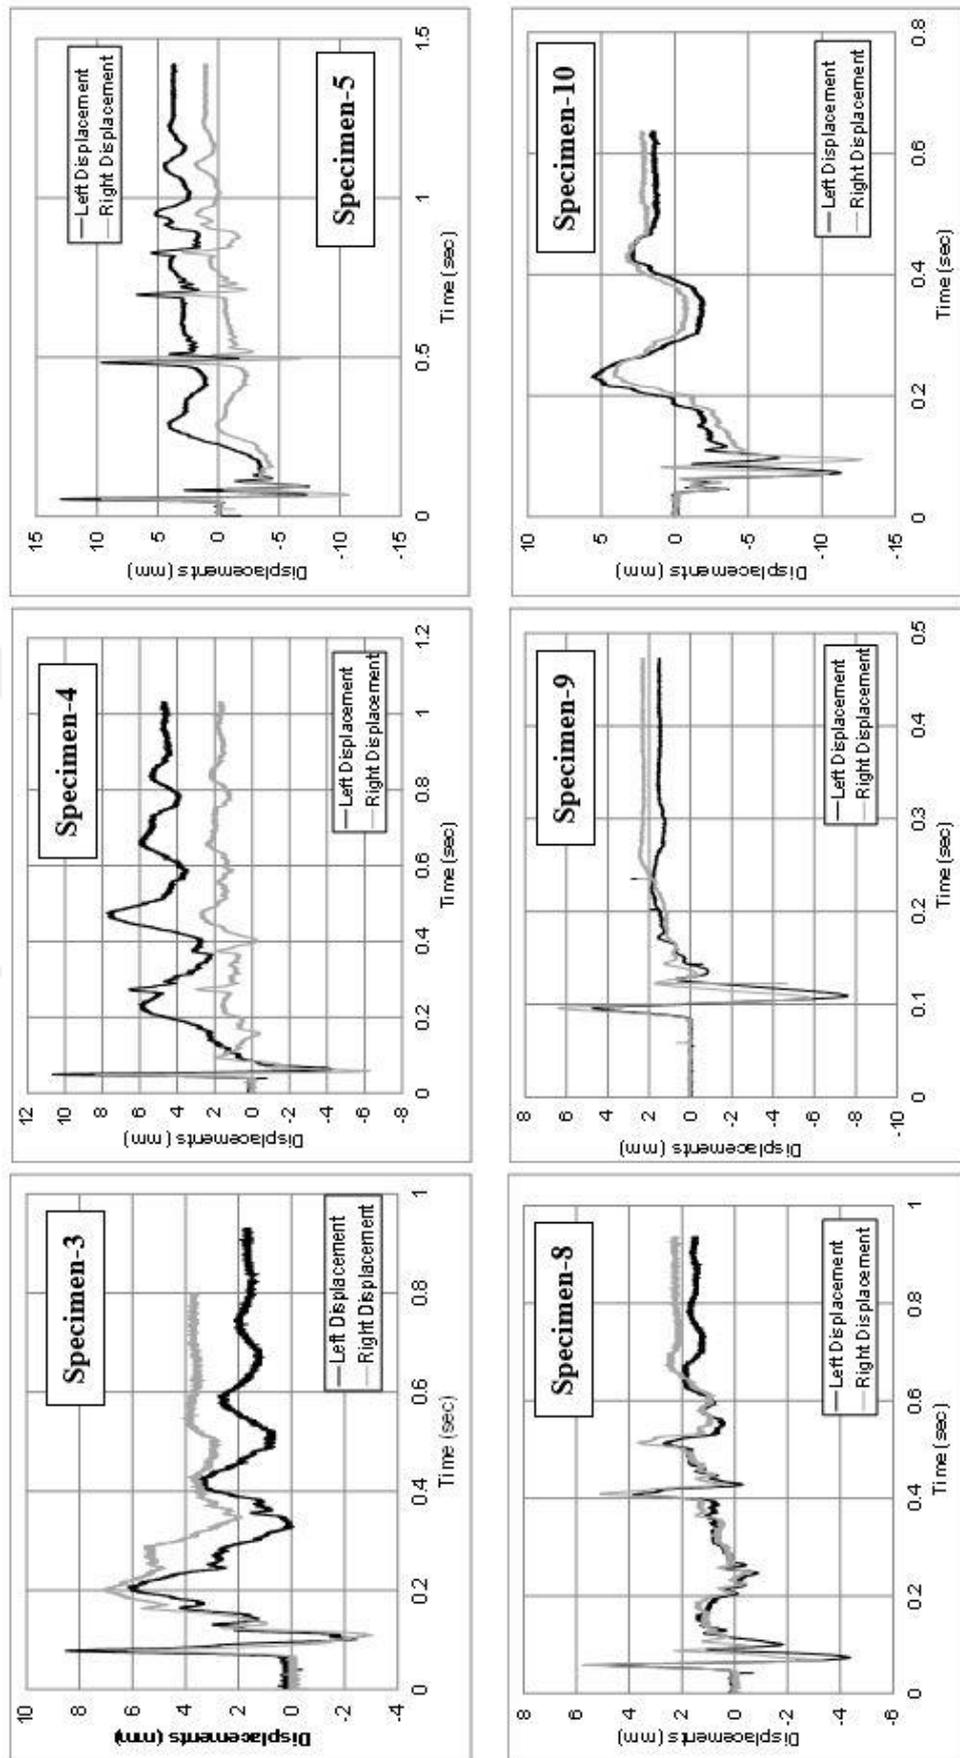
**Figure 4.7** Displacement-Time Graphs of Specimens under Impact Load

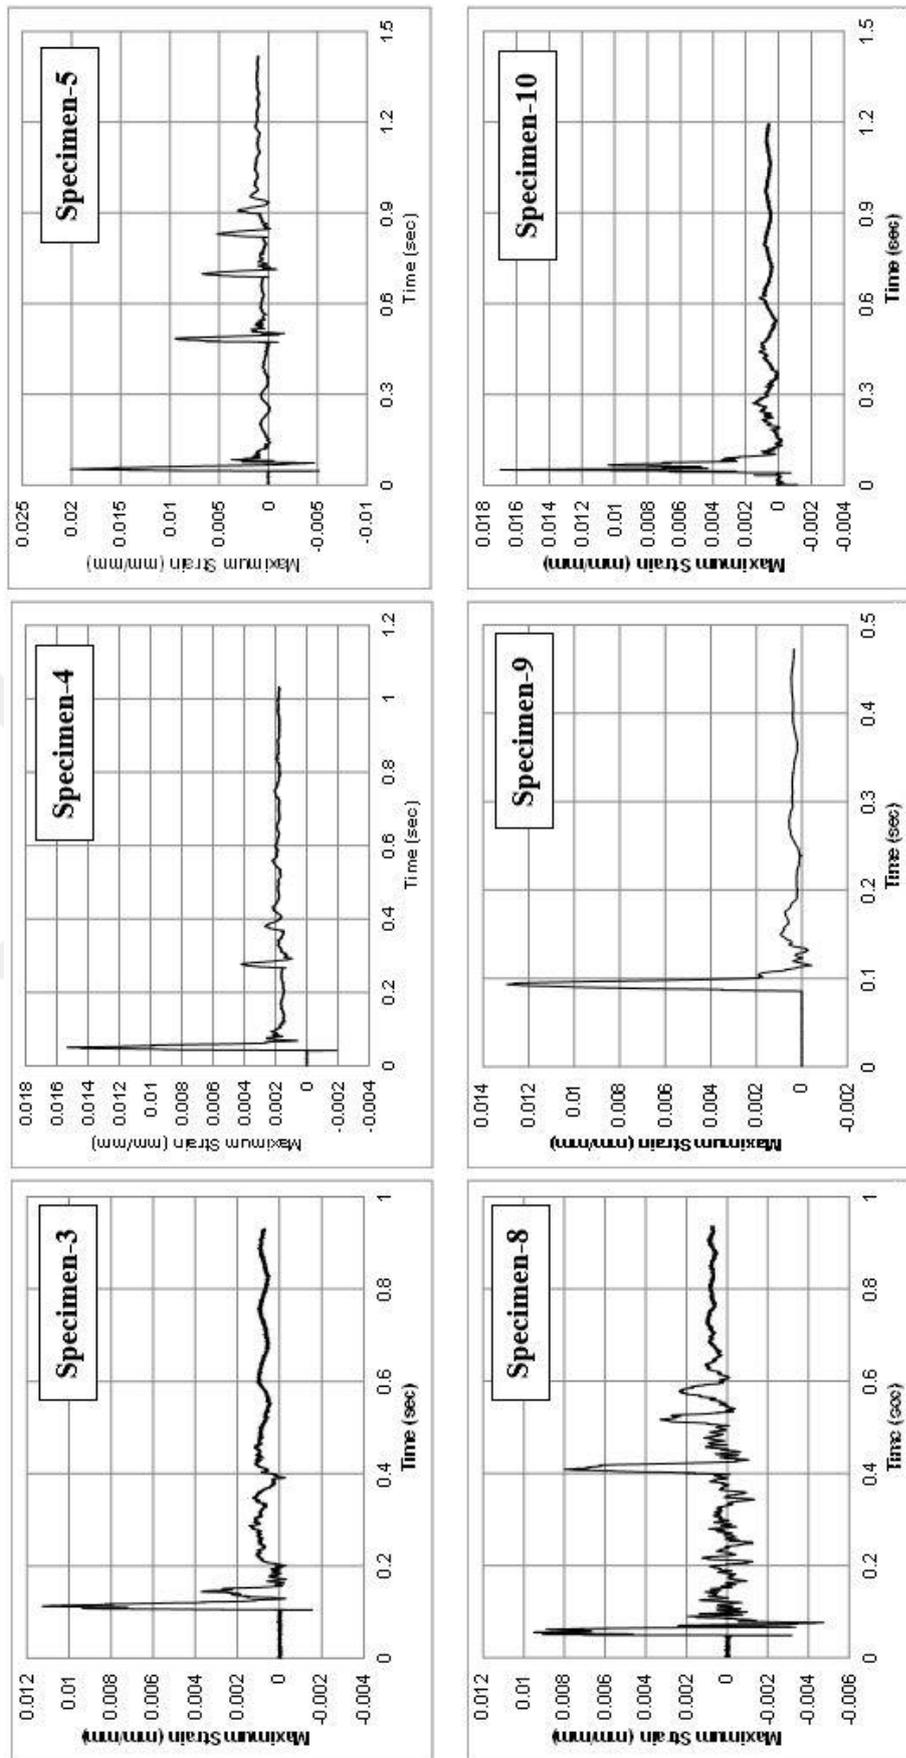
**Figure 4.8** Maximum Strain-Time Graphs of Specimens under Impact Load

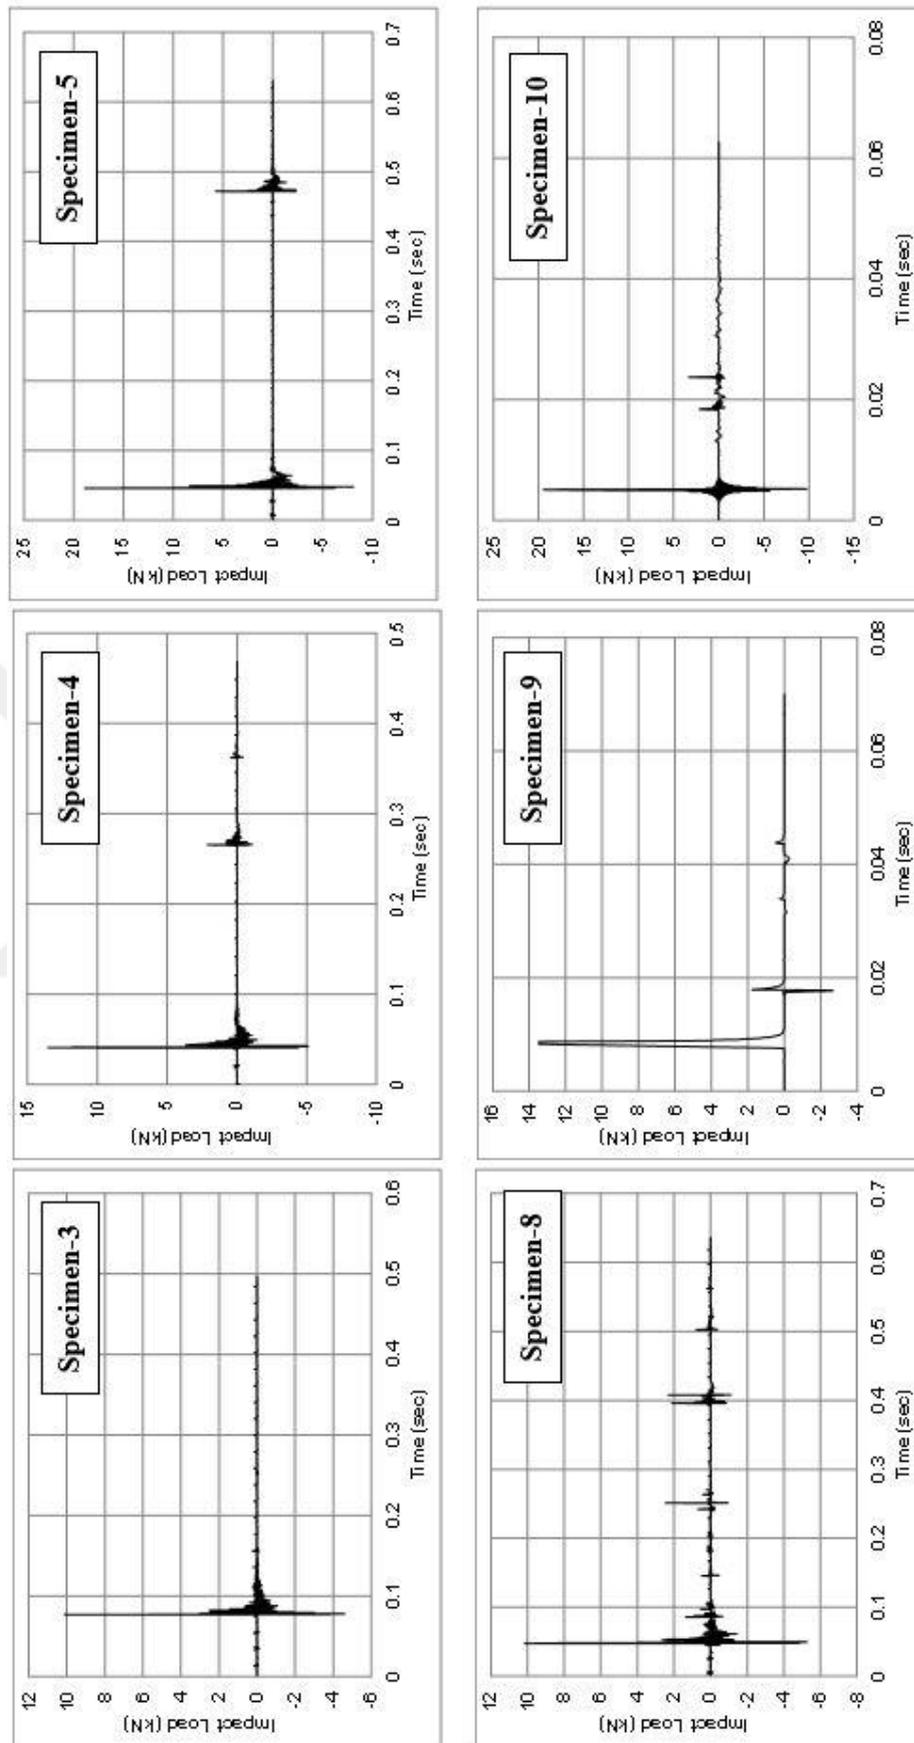
**Figure 4.9** Impact Load-Time Graphs of Specimens

When the test results of Specimen 3, 4 and 5 with 1800 mm span are examined, as a result of the increase in the impact energy and load applied to the test specimens with the increased drop height, the maximum acceleration values measured from the test specimens, the mid-point displacement values of the beam, and the maximum change of the strain values of the beam-tension surface all increased. Specimen 5 tested by applying a drop from a height of 1000 mm exhibited more maximum acceleration, maximum left displacement, maximum right displacement and maximum strain values of 35%, 38%, 39%, and 31%, respectively than the Specimen 4 tested with a height of 750 mm. The impact load applied to the Specimen 5 is 40% greater than the Specimen 4. Specimen 4 tested with a 750 mm drop height had more maximum acceleration, maximum left and right displacement and maximum strain values of 41%, 36%, 44%, and 36%, respectively than the Specimen 3 tested with a height of 500 mm. Similar behavior trend was observed in Specimen 8, 9 and 10 test specimens with 2450 mm span as well. The maximum acceleration, maximum displacement, maximum strain values measured from the test specimens all increased significantly as a result of the increase of the impact height and the increase of the impact energy applied. Specimen 10 tested with a 1000 mm drop height displayed more maximum acceleration, maximum left displacement, maximum right displacement and maximum strain values of 34%, 37%, 37%, and 31%, respectively than the Specimen 9 tested with a height of 750 mm. The impact load applied to the Specimen 10 is 41% greater than the Specimen 9. Specimen 9 tested with a 750 mm drop height had more maximum acceleration, maximum left and right displacement and maximum strain values of 41%, 34%, 34%, and 36%, respectively than the Specimen 8 tested with a height of 500 mm.

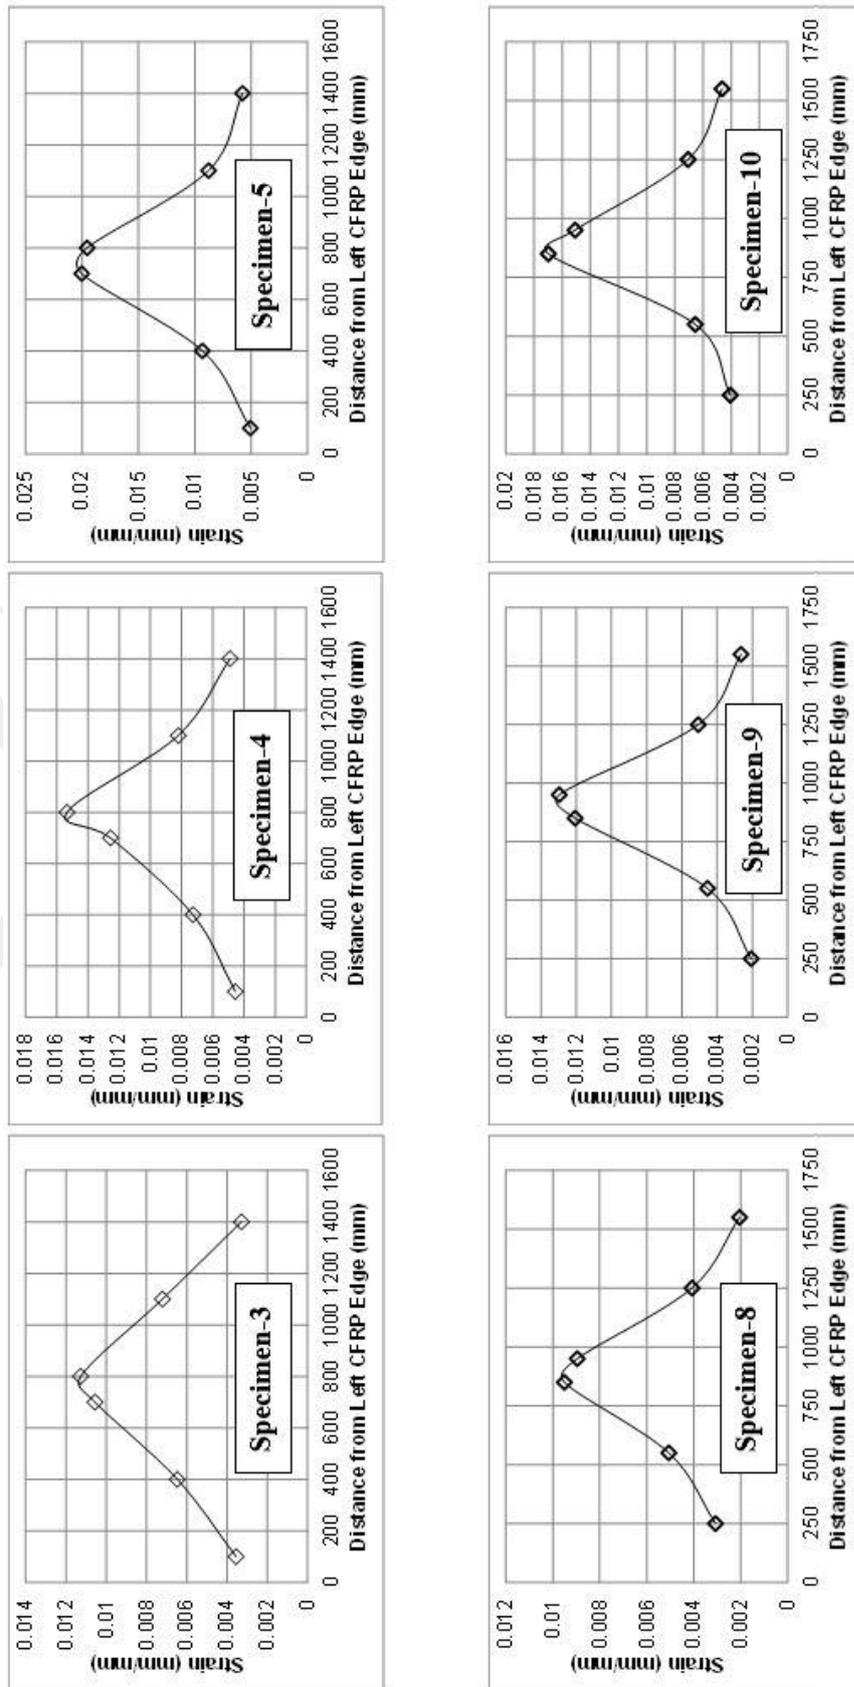
**Figure 4.10** CFRP Strain Distribution Graphs of Specimens at Ultimate Load Level under Impact Load

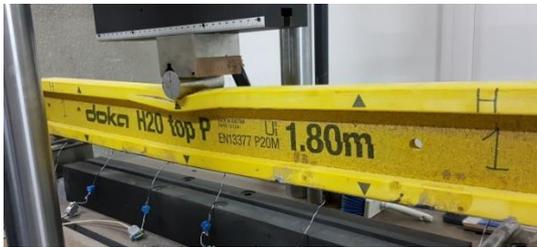
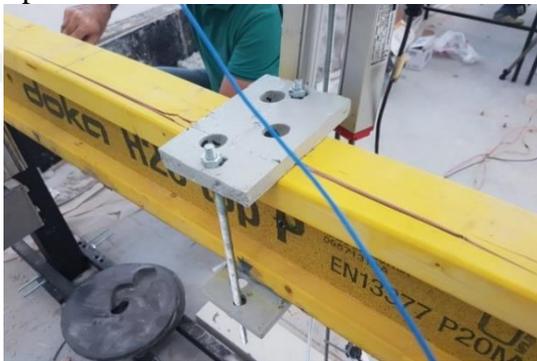
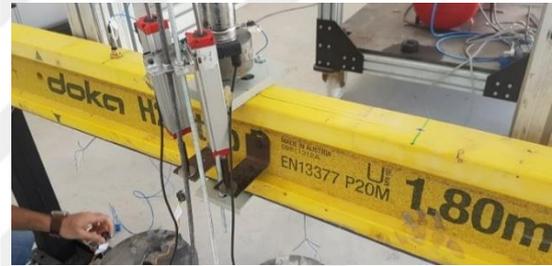
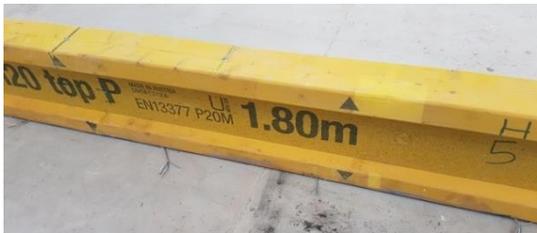
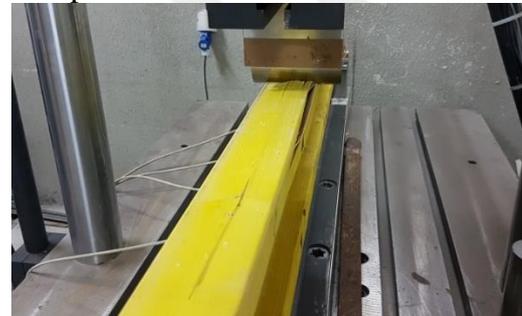
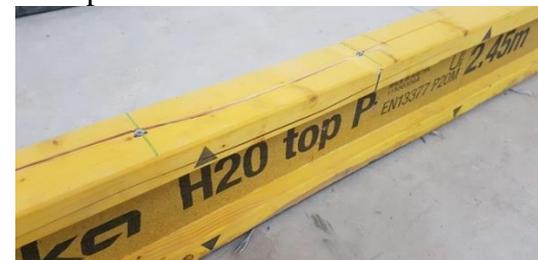
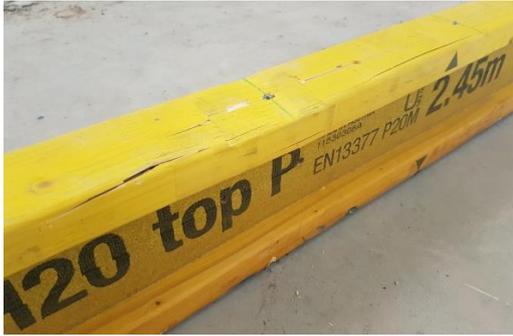
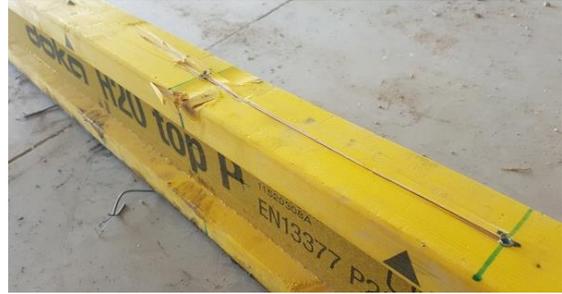
**Figure 4.11** Failure Modes of All Specimens

Damage and fracture distribution after testing depending on the type of loading applied to the test specimens showed a significant change and failure mechanisms are given in Figure 4.11 by selecting the photos. When the failure mechanisms occurring in the Specimen 1 and Specimen 6 test elements tested in the static loading effect were examined, in the cross-section where the loading at the mid-point of the beam is applied, the upper pressure surface of the timber beam has crushed at the point where the load is applied at the mid-point of the beam and the crush zone has expanded with

increasing loading. As a result of the expansion of the crush zone, beams were failed by occurring cracks in the direction of parallel to the axis of the beam on the top header part of the beam. Anchored CFRP strips bonded to the tensile surfaces of Specimen 1 and Specimen 6 have not been slipped or ruptured from the surface. Anchors prevented the slipping of CFRP strips from the surface. When the failure mechanisms of Specimen 2 and Specimen 7, where fatigue loading is applied, the damage and fracture distribution in the test specimens has been shown to occur in a very similar way to the Specimen 1 and the specimen 6 tested under the static loading effect. In the first cycles where fatigue loading is applied to the test elements, a crush zone has been formed in the region where the number of loading cycles is increased and the fatigue load is applied in the top header part of the beams. Then, as the result of increased loading cycle number and mid-point displacement occurring in the beams, bending cracks were formed in the bottom tension heads of the beams close to the point where the load was fully applied and the CFRP strips bonded to the tension surface were ruptured by tearing in both test specimens at a point very close to the mid-point of the beam. When the failure mechanisms of the test specimens where the impact loading is applied were examined, the increase was seen in damage and fracture distribution occurred on the test specimens as the impact energy applied to the test specimens increased. It has been seen that crushes occur at the point where the loading is applied at the top header of beam at the mid-point of the beam, except for the fractures occurring along the beam axis and at the sections of the beams with the effect of impact loading applied. In the Specimen 5 and Specimen 10 tested by dropping from a height of 1000 mm, CFRP strips were not slipped off from any surface, but the CFRP strip was ruptured by tearing at the center of the beam where the impact loading was applied while CFRP strips do not slip or rupture from the surface in Specimen 3, 4, 8 and 9 tested with 500 mm and 750 mm height drop.
