CONSERVATION AND PRESENTATION OF GRECO-ROMAN TEMPLE REMAINS IN WESTERN ANATOLIA: A CRITICAL ASSESSMENT ON SELECTED EXAMPLES THROUGH THE CONCEPT OF ANASTELOSIS

in Architectural Restoration

by
Özge Deniz TOKÖZ

June 2018
İZMİR

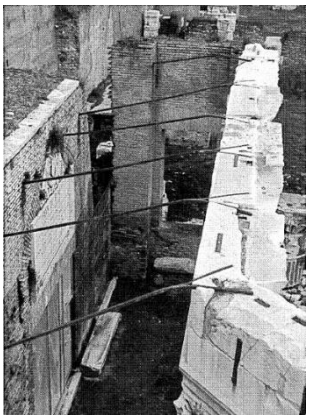
Figure 2.32. Iron tension rods in the Deorum Consentis Portico, Rome, Italy (Source: Starosta, 1999).

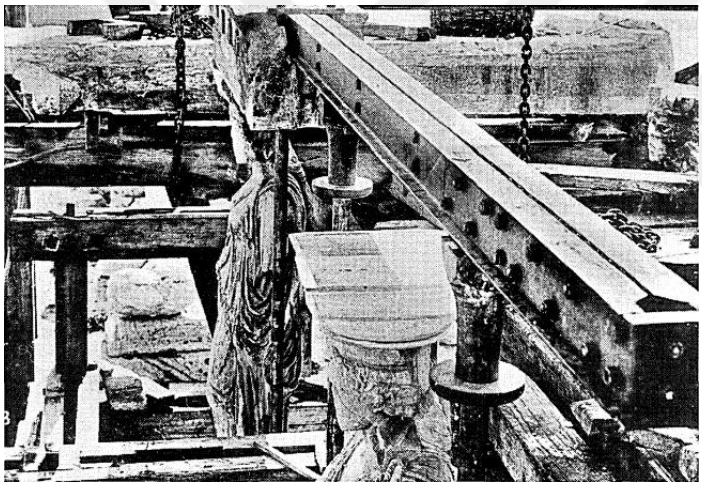
Figure 2.33. Iron I-beams in architrave of the Caryatid's Portico in Erechtheion, the Acropolis of Athens, Greece (Source: Starosta, 1999).

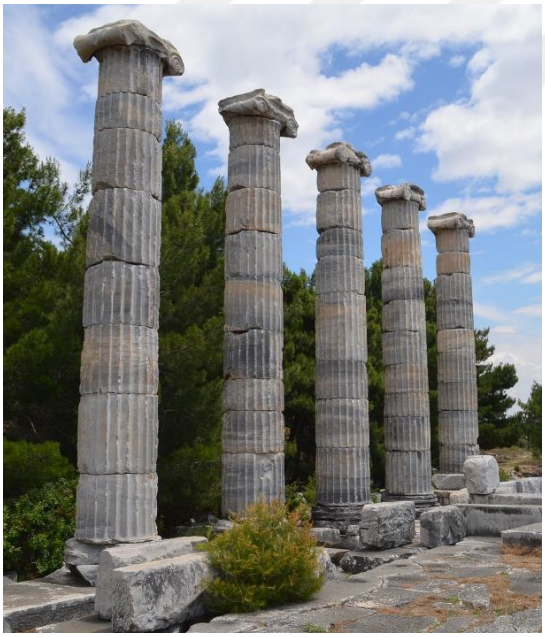
Figure 3.79. Unorganized site as uninformative (May 19, 2017).

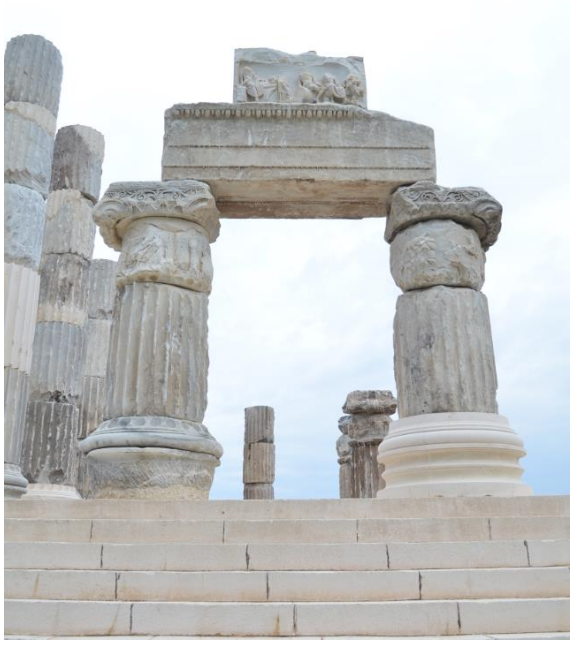
Figure 3.130. Organization of two column rows on southeast side (June 17, 2017).

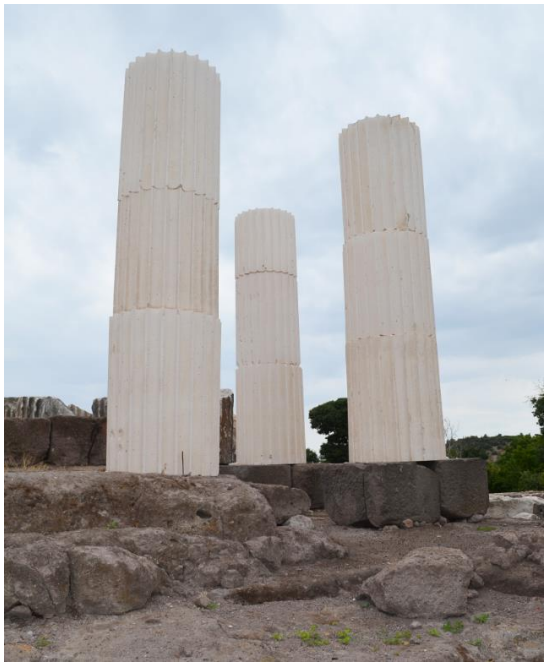
Figure 3.131. New drums on northeast corner (June 17, 2017).

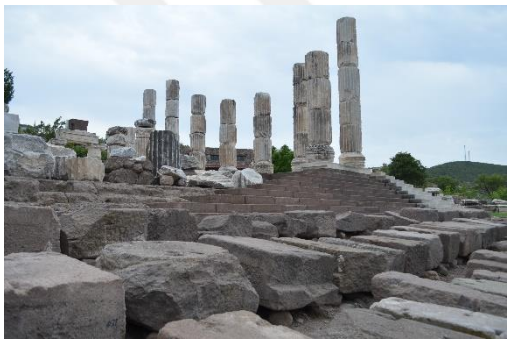
The marble blocks belonging to the crepis, that constitutes the lower structure of the temple, were completely lost, most of the andesite blocks were not found and the tuff steps were exposed to weather conditions and scattered. Some columns and bases belonging to the upper structure were used for re-erection work, and architrave, frieze and cella blocks were exhibited on the northwest of the temple on the ground and in the museum (Figure 3.134). The reconstruction done in the crepis of the temple creates visual contrast with the re-erection of the original columns and the worn-out state of the original foundation in the southwest due to the use of new materials. The difference in colour between the steps, as reconstructed in different periods of crepis, distorts the visual integrity of crepis. (Figure 3.135, Figure 3.136). With a different understanding than the re-erection of the other columns; the structural integrity of the two columns in the southeast side, where the original height is not provided, which is believed to be done as partial display with missing drums, could not be provided due to the lack of drums.

Figure 3.134. Architectural members of the temple on the ground (June 17, 2017).

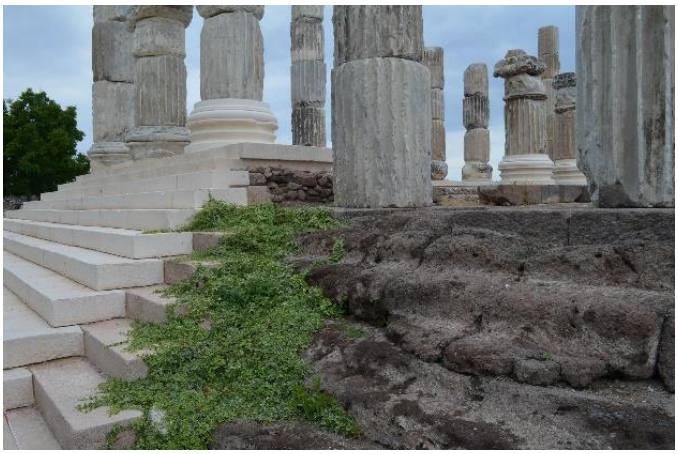
Even though the original crepis steps have survived to present day in a small amount, they have provided the right information about the foundation system. The reconstructed crepis was created by placing andesite and marble imitation blocks on the tuff foundation as it was originally. These blocks, copied from the original material, can be seen as a misleading application because they are reinforced concrete and given the appearance of marble and andesite with paint. Drums that were assembled together are not the ones that belong to each other but were less damaged ones and chosen to provide

Figure 3.135. Disharmonious transition between new and original blocks of crepis (June 17, 2017).

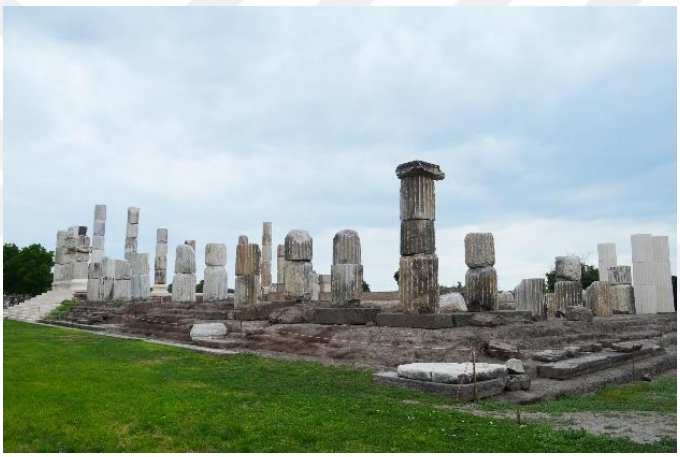
Figure 3.136. Original foundation with new columns in background (June 17, 2017).

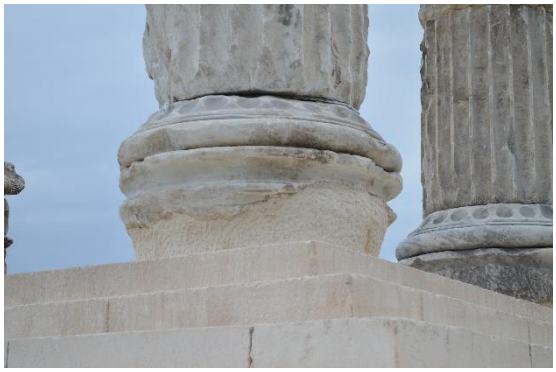
Figure 3.137. Completion of missing parts with new material (June 17, 2017).

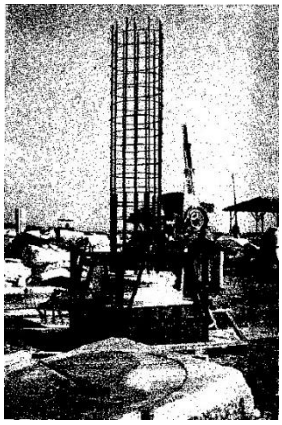
Figure 3.152. Reproduction of missing part of a column with reinforcing iron bars (Source: İnan, 1985).

belonging to the foundation were removed and numbered. Reinforced concrete foundation was built by pouring lean concrete 1.5 m below the stylobate. A mixture of marble dust, marble chips, sand and white cement was poured into the moulding made of sheet metal in order to complete the missing parts of the columns. Moulding made of plaster was prepared for the bases. In order to re-erect corner column in the southwest corner; the missing stylobate block, base and the bottom 4.25 m part of the column were poured from the concrete with the help of sheet metal and plaster mouldings on top of the iron connecting rods on the foundation (Figure 3.152). Holes were left on the reinforced concrete part of the column in order to mount it on its original section. The original column's broken section was flattened by adding concrete material in order to place the capital; the two members were attached to each other by steel rods and araldite mixed with marble dust. The original column piece and the reinforced concrete column piece were also assembled by the same method. The fluting of the reinforced concrete column sections was done after the joining was completed (İnan, 1985).

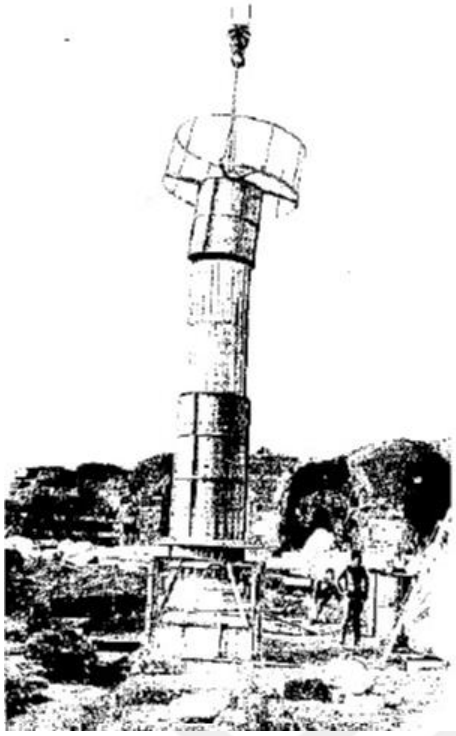
Figure 3.153. Moulding of a column.
(Source: İnan, 1986)

It was planned to re-erect the fourth column of the west façade as the second column in 1984. Since the lower parts of the stylobate, base and the bottom 4 m part of the column were missing, these parts were reproduced from the concrete (Figure 3.153). Unlike the previous year, a polyester moulding was used for the base, not plaster, and it was observed that it was easier to work with this moulding. The cracks of the column were reinforced with stainless steel clamps, reinforced concrete and original column parts were joined together with stainless steel bars, the assembled parts were fitted with steel bars to reinforced concrete foundation (Figure 3.154). The columns were re-erected without flutings, and the fluting was done according to the original sections after the assembly process was completed (İnan, 1986).

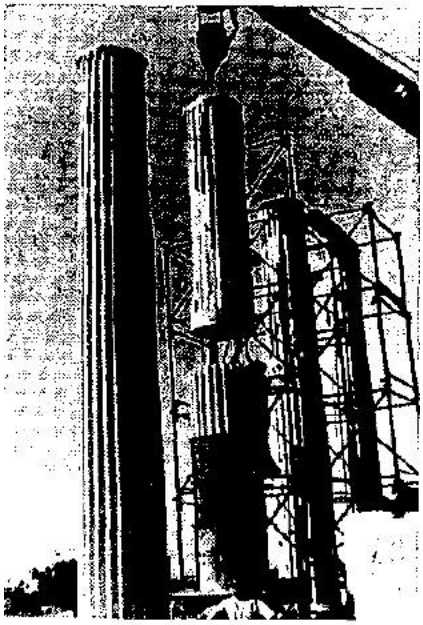
Figure 3.155. Re-erection of a column.
(Source: İnan, 1988)

The fourth column of the west façade was re-erected in 1986. The incomplete bottom part of the column and base, with its stylobate present, were poured from concrete. The cracks of the surviving original capital were consolidated with steel clamps and araldite, and the missing corner parts were completed with reinforced concrete. Small pieces of other capitals were also completed with reinforced concrete material. The original pieces of the capitals were put into the mouldings and the appropriate reinforcement was prepared and concrete was poured in this way (İnan, 1988) (Figure 3.155).

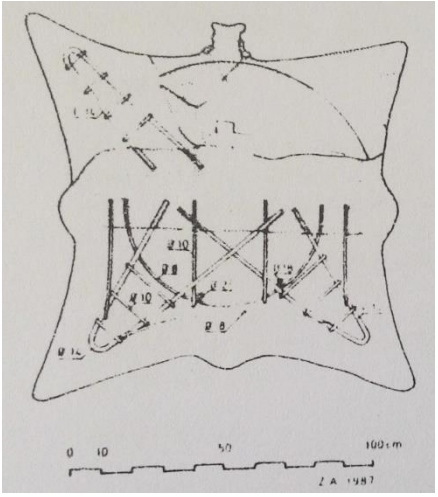
Figure 3.157. Reinforcement of capital. (Source: Yorulmaz, Çili & Ahunbay, 1989)

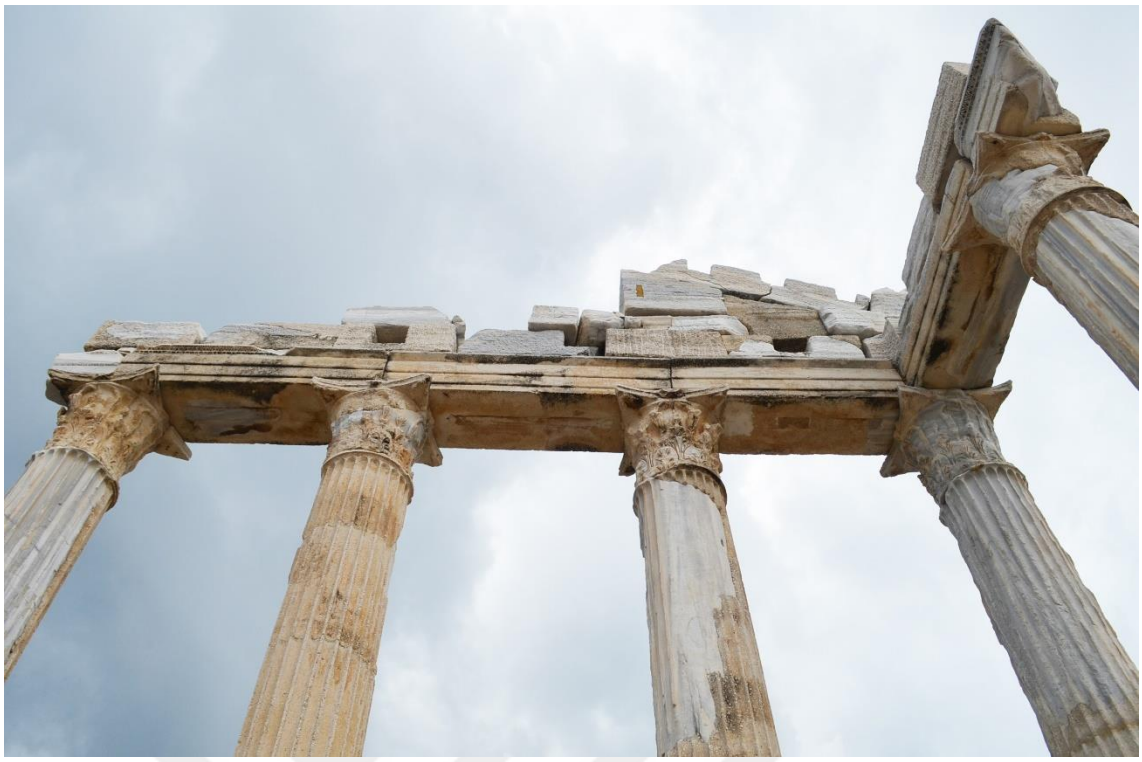
Figure 3.162. Decay of the new material in architraves (October 29, 2017).

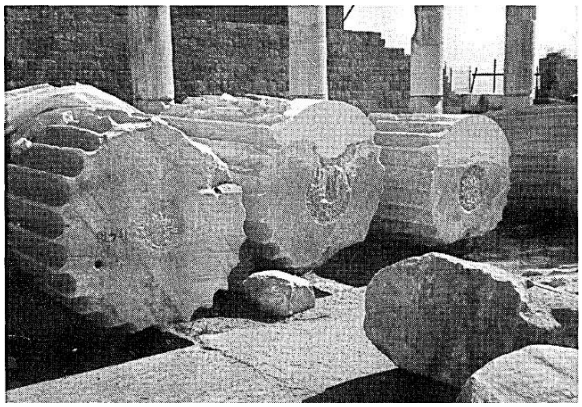
Figure 3.177. Completion of drums with new material (Source: Nohlen, 1999).

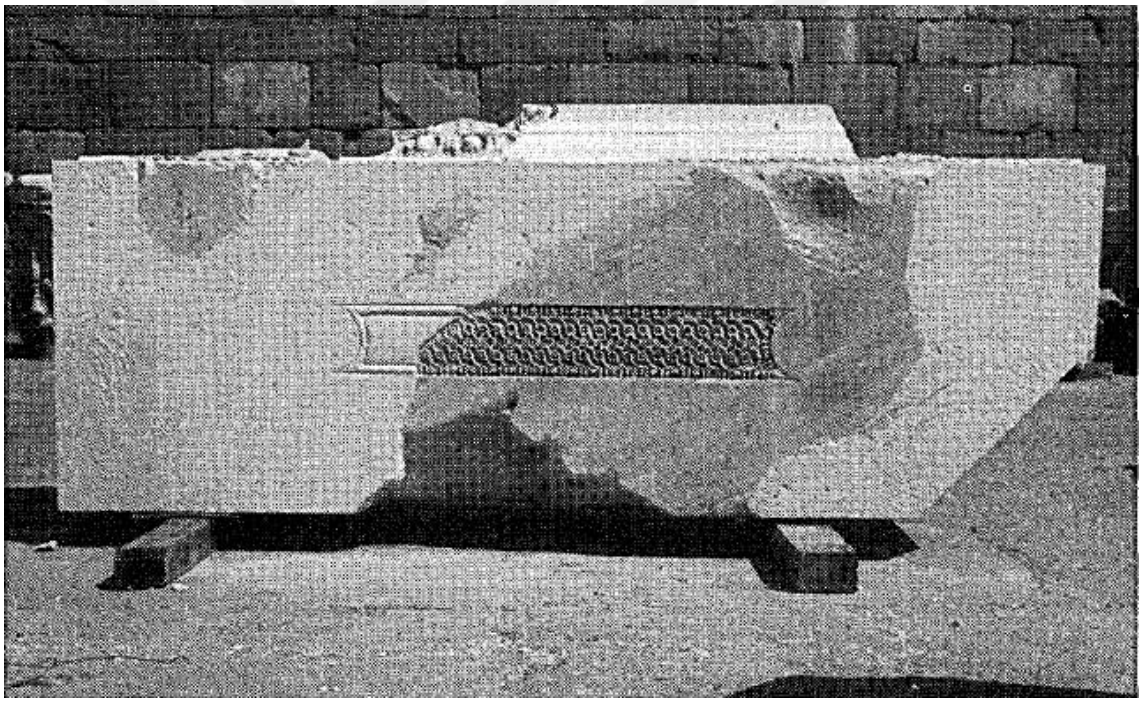
Figure 3.178. Completion of missing parts of an architrave without ornamentation. (Source: Nohlen, 1999)

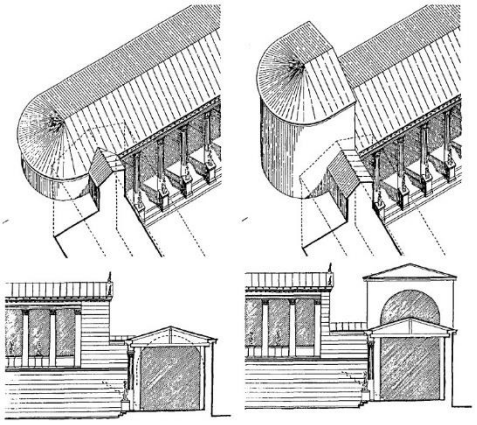
were avoided (Nohlen, 1999) (Figure 3.188, Figure 3.189). Possibilities related to the original situation were transferred through publications or information panels.

Figure 3.188. Two hypothetical restitution of point of junction of east and north galleries (Source: Drawing of Peter Feichtner. Retrieved from Nohlen, 1999).

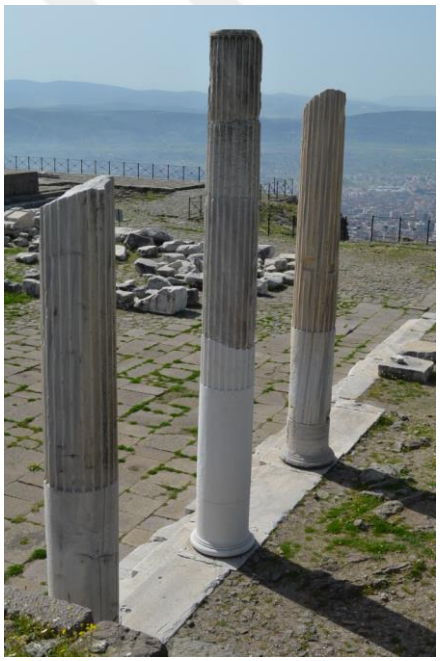
Figure 3.192. Changing damage part of the column with new marble (April 1, 2018).

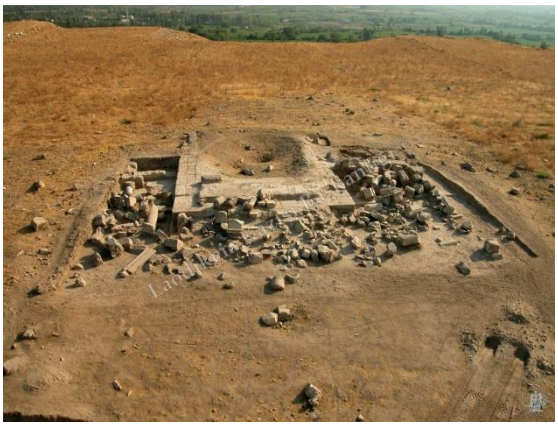
Figure 3.200. Temple A after excavation in 2004.
(Source: http://laodikeia.pau.edu.tr Retrieved at March 28, 2018)

it was determined that some elements such as columns, friezes, architraves of the temple were unearthed with illegal excavations earlier. At the end of the excavations in cella, a vaulted space was discovered under the temple (Şimşek, 2006) (Figure 3.200).

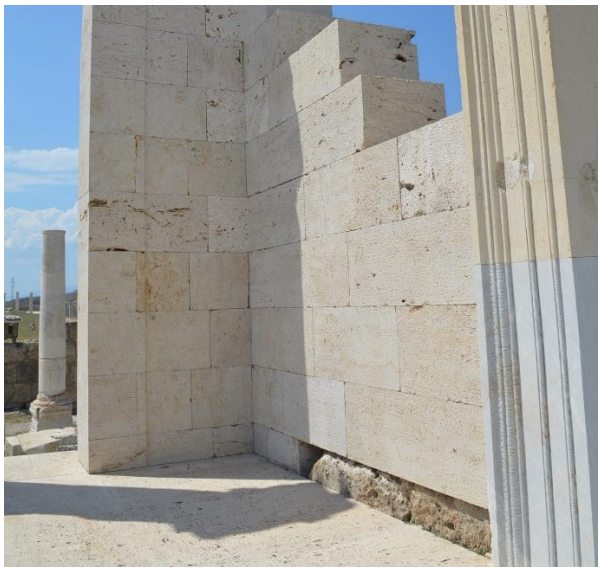
The ratio of architectural elements that survived in Temple A is around 10% (Şimşek, 2007a; Şimşek, 2009). However, in the temple, the re-erection was carried out with these few existing elements. The missing parts were completed with marble-white cement mixture, completely missing blocks were reproduced from travertine and marble. In the reconstruction application, it was planned to remove the front façade of the temple re-erect. This led to the use of new travertine blocks on the whole façade of the cella (Figure 3.221). For these reasons, the ratio of the application is low. When the blocks were brought together, they were combined with lead covered iron clamps as originally. Thus the construction technique authenticity was partially maintained might be thought.

Figure 3.221. Few amount of original cella blocks (July 1, 2018).

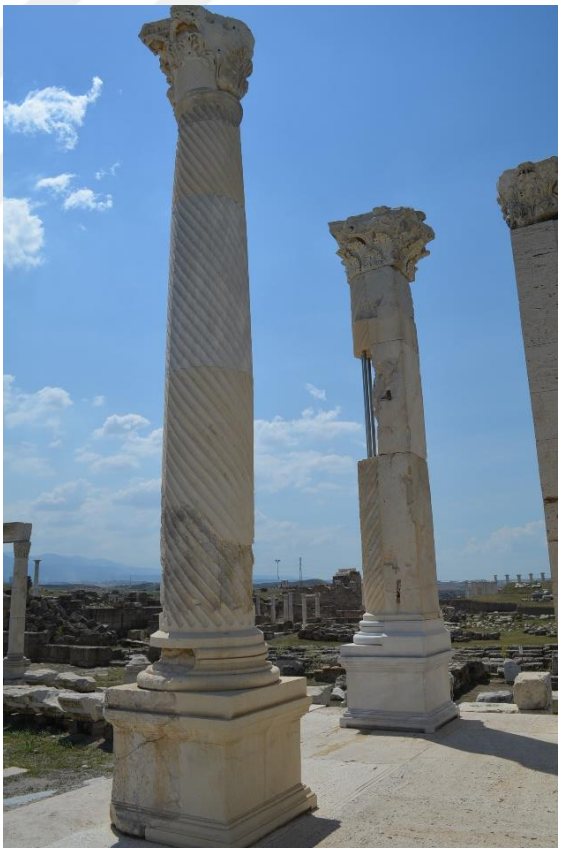
Figure 3.223. New production marble postament and base in back. Completion drum, base and postament with white cement in front (July 1, 2018).
