SEISMIC ASSESSMENT OF A TRADITIONAL RESIDENTIAL BUILDING IN  
ANTAKYA AFTER 2023 TÜRKİYE EARTHQUAKE SEQUENCE

A THESIS SUBMITTED TO  
THE GRADUATE SCHOOL OF NATURAL AND APPLIED SCIENCES  
OF  
MIDDLE EAST TECHNICAL UNIVERSITY

BY  
HASİP ATICI

DECEMBER 2024

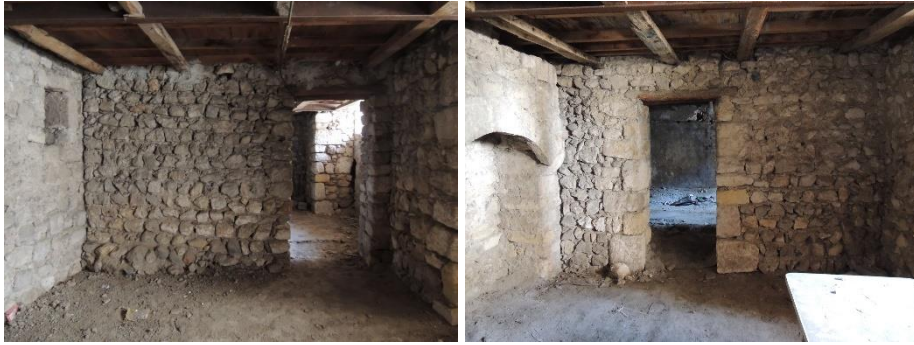
The basement partition walls are made of stone masonry with mud mortar. Cut stones are used on the edges of openings such as doors, windows, and niches. Partition walls are addition walls having different type of mesh and different sizes of stones from the main walls and without a proper connection (Figure 2.30). There are also masonry masses on the southern facade of the basement (Figure 2.31).s

Figure 2.30 Partition walls in the basement (Şahin Güçhan, 2019)

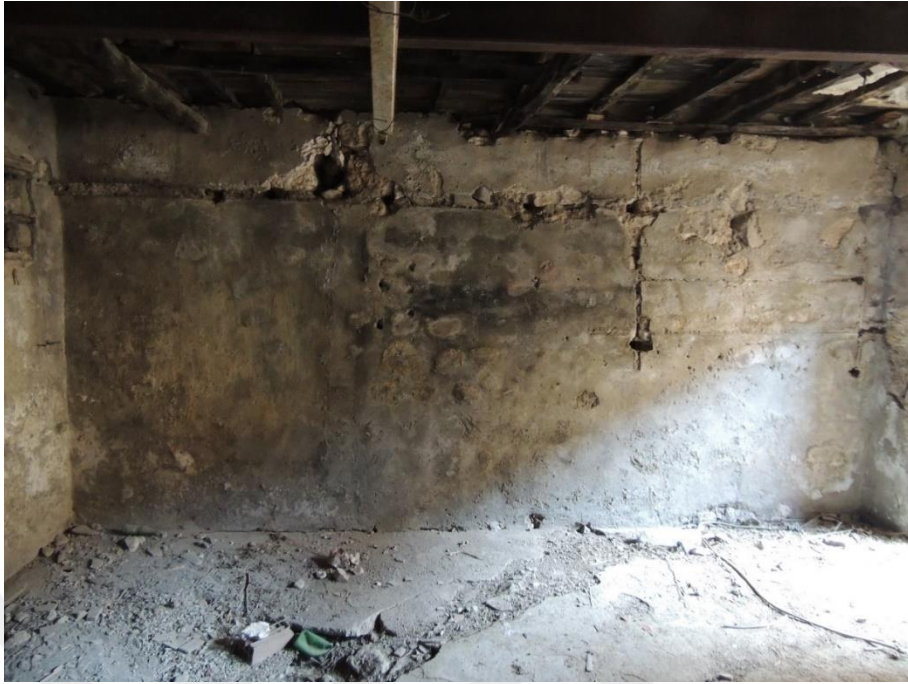
Figure 2.32 Traces of intervention in the east wall of the B01 Room (Şahin Güçhan, 2019)

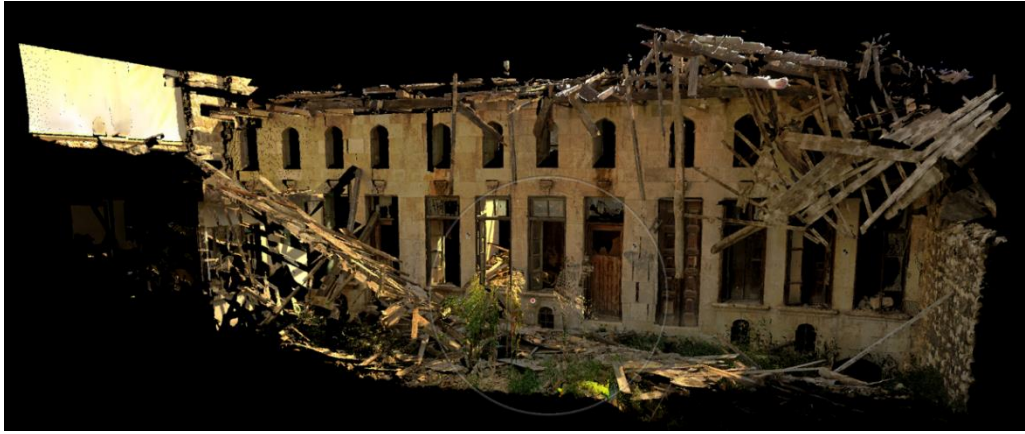
Figure 2.47 Point cloud created by 3D laser scanning (METU TAÇDAM, 2023)

After the earthquake sequence, field visits were carried out by METU TAÇDAM to Antakya in March 2023 and June 2023. According to field observations, the roof of the building, the timber-frame construction of the first floor, and the walls of the first floor collapsed (Figure 2.47-Figure 2.48). The first floor and ground floor slabs partially collapsed (Figure 2.49- Figure 2.50). The ground floor walls remained standing with various cracks due to in-plane and out-of-plane movements within the walls (Figure 2.49-Figure 2.52). Basement floor damage could not be observed and detected in detail due to safety concerns (Figure 2.50). According to the EMS-98 Damage classification, the building can be classified as Grade-4 which stands for “very heavy damage” by definition (Figure 2.53).

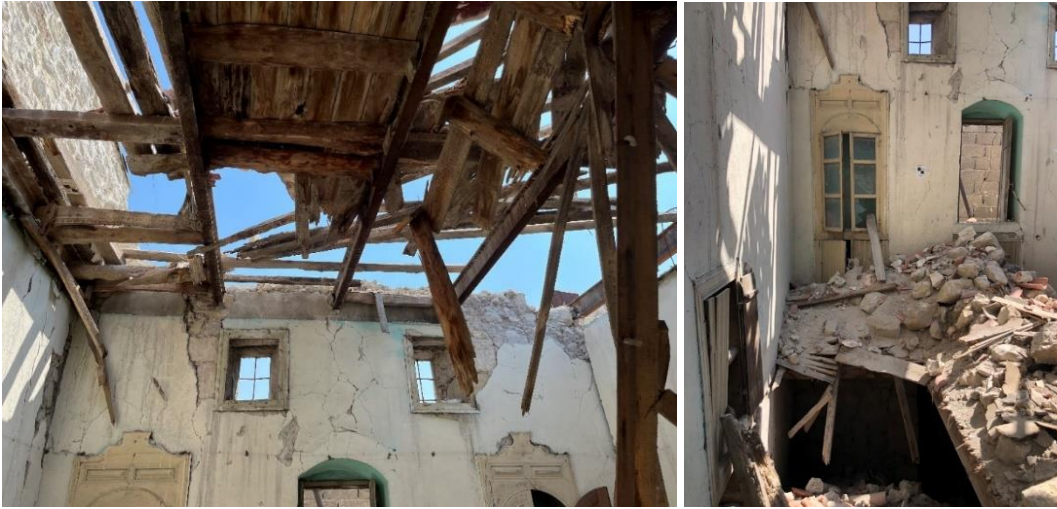
Figure 2.49 First and ground floor slabs (METU TAÇDAM, 2023)

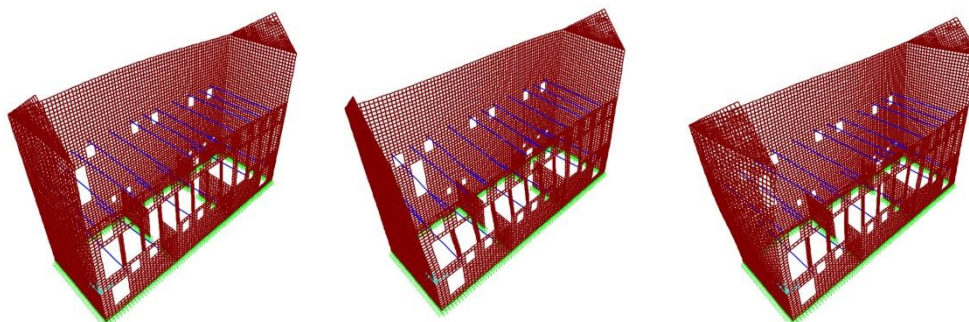
The mode shapes of the 1<sup>st</sup>, 2<sup>nd</sup> and 9<sup>th</sup> modes of the structure are shown below in Figure 3.6. In the first mode, the buildings behavior is in the Y direction. In this mode, north wall of the first floor shows significant out of plane behavior. In the second mode, there is horizontal translation in the X direction, and in the 9th mode,

it is seen that torsional behavior is also effective in addition to translation in the X direction. In the 2nd and 9th modes, out-of-plane movement of the east and west walls of the first floor is observed.

Figure 3.6 Mode shapes of the structural model (Mode 1 & Mode 2 & Mode 9)

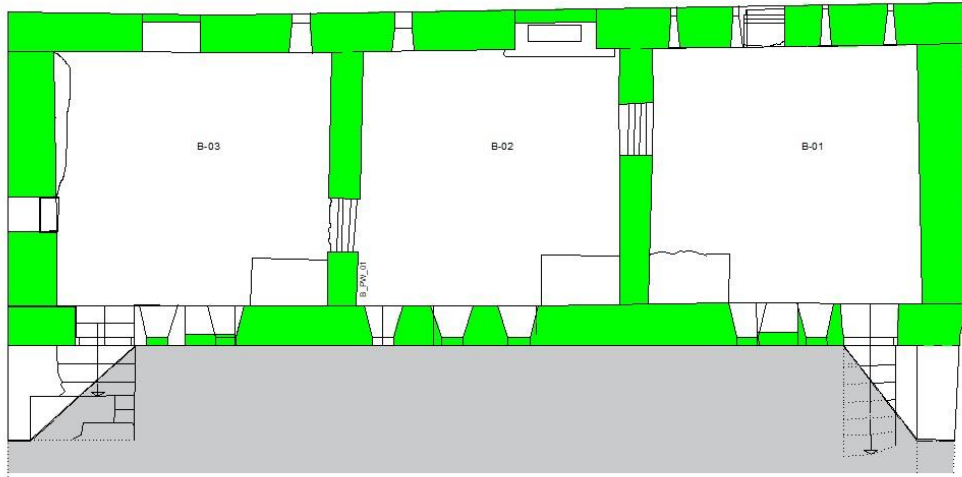
Figure 3.7 Drift control for basement walls

Figure 3.7-Figure 3.9 demonstrate the performance state of the walls at each floor in plan view. In addition to previous colors used for the exceedance of specified limit states, green color stands for the safe walls which satisfy all drift limit. It should be noted that for both ground and first floor, walls in the long direction are critical for drift. The inferior performance of the north wall in the first storey is not an

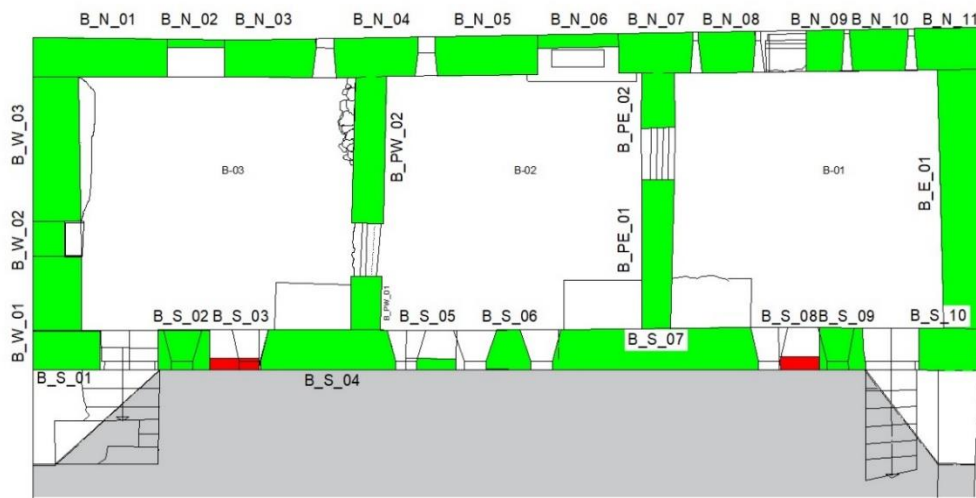
Figure 3.10 Vertical strength control shown in the basement floor

where  $\lambda$  is the strength reduction factor due to slenderness,  $A$  is the horizontal cross-sectional area of the wall,  $f_d$  is the design compressive strength of the masonry wall,  $f_k$  is the characteristic compressive strength of the masonry wall and  $\gamma_m$  strength reduction factor for masonry material. Strength reduction factor  $\lambda$  is assumed as 0.51, the minimum value in the TSC (2007), for slenderness ratio values greater than 15. The parameter  $f_k$  has been taken as the minimum value in the study by Bozyigit *et al.* (2024), which is 3.4 MPa. The parameter  $f_d$  is calculated as 1.7 MPa by considering  $\gamma_m=2$ . The comparison of the vertical design loads with the vertical load demands acting on the walls is presented in Table 3.5. The same information is visualized in Figures 3.10-3.12 in colored format on the floor plans. The green and red colors stand for the safe and unsafe walls under vertical loads, respectively according to the vertical load check by the TBSC (2018). The critical walls under vertical load analysis are observed to be the ones with reduced thickness due to the placement of niches and also the column-like masonry walls between openings of the south facade in the ground floor of the building.

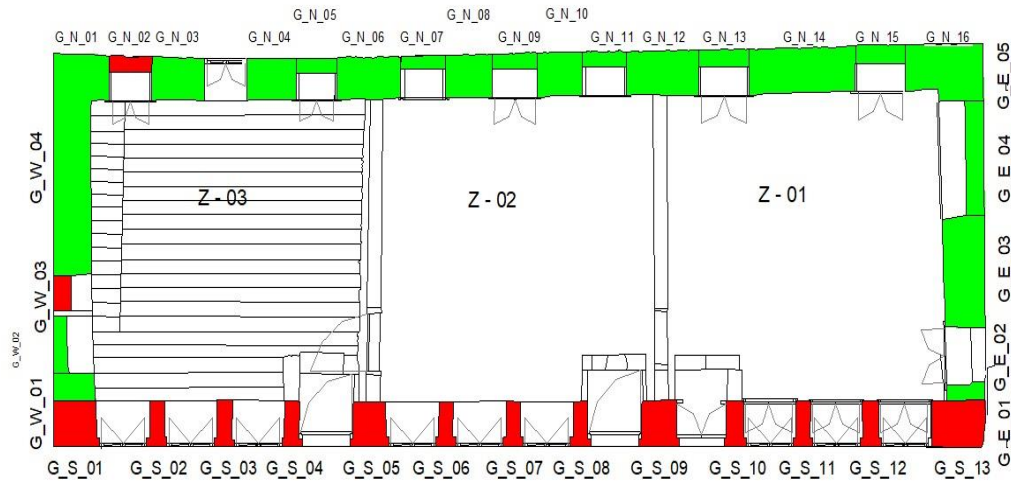
Figure 3.11 Vertical strength control shown in the ground floor

Compression Check						
No	Floor	Elevation	Wall No	NRd	Ned	$ Ned  < NRd$
				kN	kN	
30	Ground Floor	North Wall	G-N-01	506	-218	CHECK
31			G-N-02	121	-138	FAIL
32			G-N-03	726	-312	CHECK
33			G-N-04	685	-254	CHECK
34			G-N-05	114	-112	CHECK
35			G-N-06	873	-170	CHECK
36			G-N-07	128	-96	CHECK
37			G-N-08	636	-166	CHECK
38			G-N-09	129	-112	CHECK
39			G-N-10	604	-166	CHECK
40			G-N-11	128	-100	CHECK
41			G-N-12	987	-134	CHECK
42			G-N-13	145	-92	CHECK
43			G-N-14	1444	-168	CHECK
44			G-N-15	145	-144	CHECK
45			G-N-16	832	-240	CHECK
46		West Wall	G_W_01	608	-394	CHECK
47			G_W_02	136	-130	CHECK
48			G_W_03	179	-230	FAIL
49			G_W_04	2493	-188	CHECK
50		South Wall	G_S_01	305	-960	FAIL
51			G_S_02	218	-1120	FAIL
52			G_S_03	218	-1220	FAIL
53			G_S_04	218	-1130	FAIL
54			G_S_05	261	-1150	FAIL
55			G_S_06	218	-1170	FAIL
56			G_S_07	218	-1150	FAIL
57			G_S_08	218	-1180	FAIL
58			G_S_09	505	-1980	FAIL
59			G_S_10	218	-1160	FAIL
60			G_S_11	218	-1180	FAIL

61			G_S_12	218	-1170	FAIL
62	G_S_13		418	-1210	FAIL	
63	East Wall	G_E_01	477	-416	CHECK	
64		G_E_02	138	-208	FAIL	
65		G_E_03	1353	-228	CHECK	
66		G_E_04	563	-176	CHECK	
67		G_E_05	424	-240	CHECK

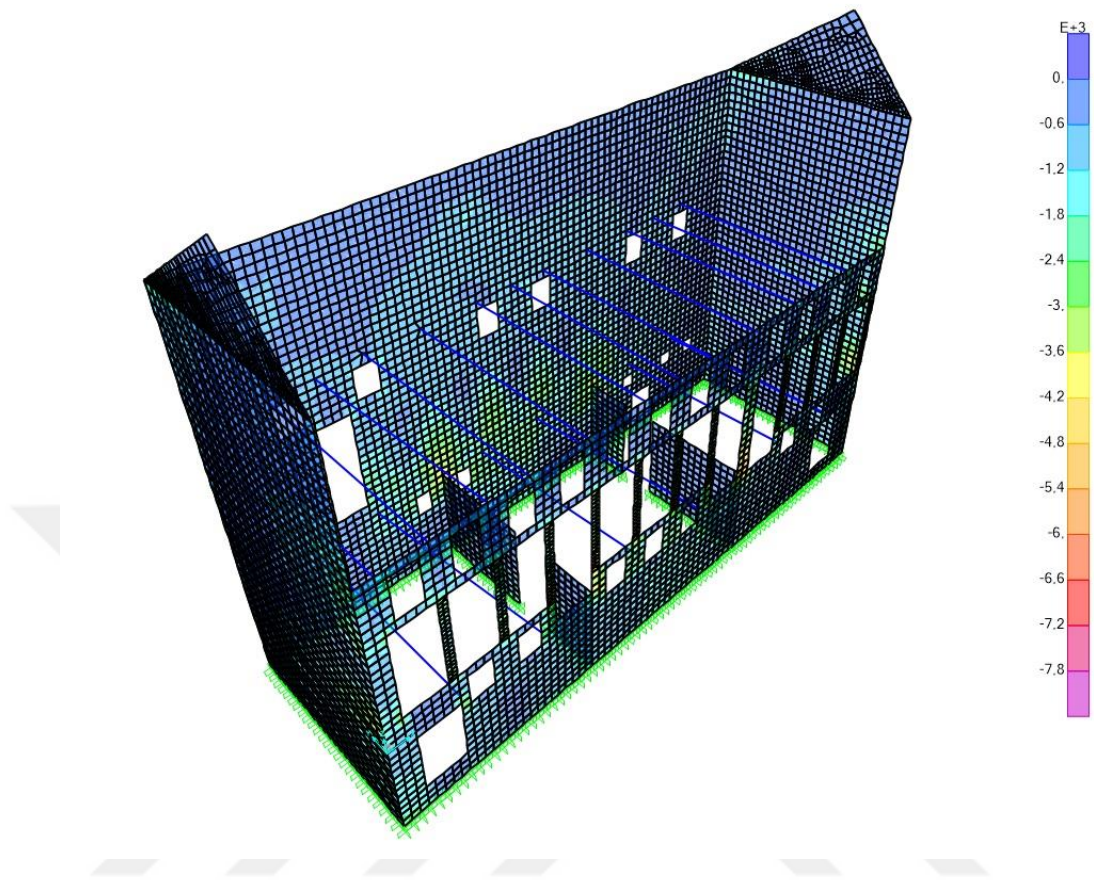
In addition, the spatial distribution of vertical (compressive) stress contours within the mesh of the building under critical loading conditions is shown in Figure 3.13. The distribution of the compressive stresses within the building mesh seems to be in accordance with the vertical force check results.

Figure 3.13 Maximum compression stress distribution within the building model under critical loading condition

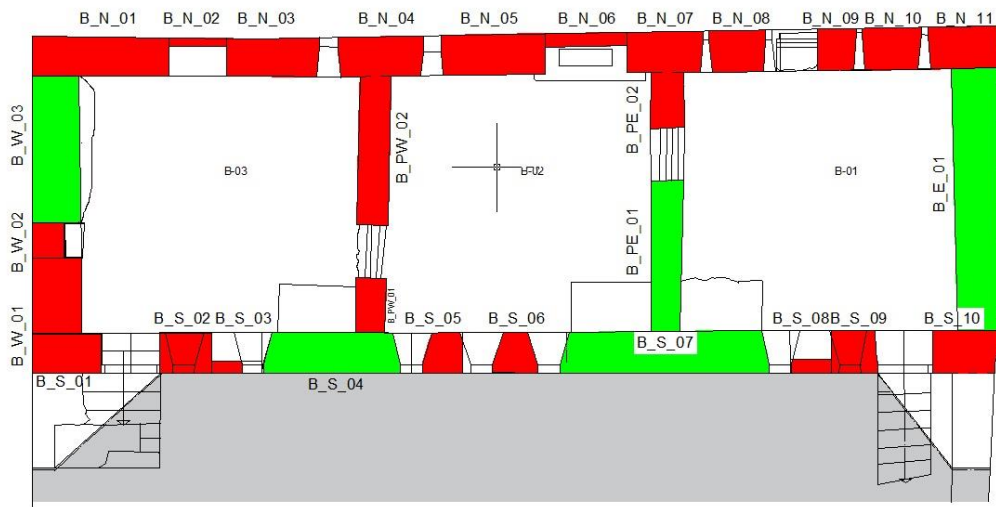
Figure 3.14 Shear force control shown in the basement floor

SHEAR CHECK									
No	Floor	Elevation	Wall No	VRd (1)	VRd (2)	VRd	VEd	SHEAR CHECK (VEd < VRd)	FAIL PATTERN
				kN	kN	kN	kN		
1	Basement	North Wall	B_N_01	175	100	100	110	FAIL	Diagonal Tension
2			B_N_02	24	14	14	99	FAIL	Diagonal Tension
3			B_N_03	194	60	60	124	FAIL	Diagonal Tension
4			B_N_04	192	55	55	128	FAIL	Diagonal Tension
5			B_N_05	204	54	54	136	FAIL	Diagonal Tension
6			B_N_06	51	13	13	104	FAIL	Diagonal Tension
7			B_N_07	150	41	41	122	FAIL	Diagonal Tension
8			B_N_08	105	30	30	123	FAIL	Diagonal Tension
9			B_N_09	63	28	28	110	FAIL	Diagonal Tension
10			B_N_10	83	47	47	118	FAIL	Diagonal Tension
11			B_N_11	68	57	57	112	FAIL	Diagonal Tension
12		West Wall	B_W_01	229	153	153	158	FAIL	Diagonal Tension
13			B_W_02	66	54	54	206	FAIL	Diagonal Tension
14			B_W_03	225	253	225	162	CHECK	-
15		South Wall	B_S_01	99	81	81	72	CHECK	-
16			B_S_02	121	93	93	227	FAIL	Diagonal Tension
17			B_S_03	14	22	14	94	FAIL	Sliding Shear

18			B_S_04	293	150	150	104	CHECK	-
19			B_S_05	16	19	16	40	FAIL	Sliding Shear
20			B_S_06	61	41	41	56	FAIL	Diagonal Tension
21			B_S_07	532	259	259	134	CHECK	-
22			B_S_08	16	22	16	82	FAIL	Sliding Shear
23			B_S_09	76	74	74	130	FAIL	Diagonal Tension
24			B_S_10	115	82	82	84	FAIL	Diagonal Tension
25		East Wall	B_E_01	996	541	541	140	CHECK	-
26		Partition Wes	B_PW_01	76	75	75	136	FAIL	Diagonal Tension
27			B_PW_02	219	196	196	196	FAIL	Diagonal Tension
28		Partition East	B_PE_01	203	182	182	136	CHECK	-
29			B_PE_02	122	89	89	218	FAIL	Diagonal Tension

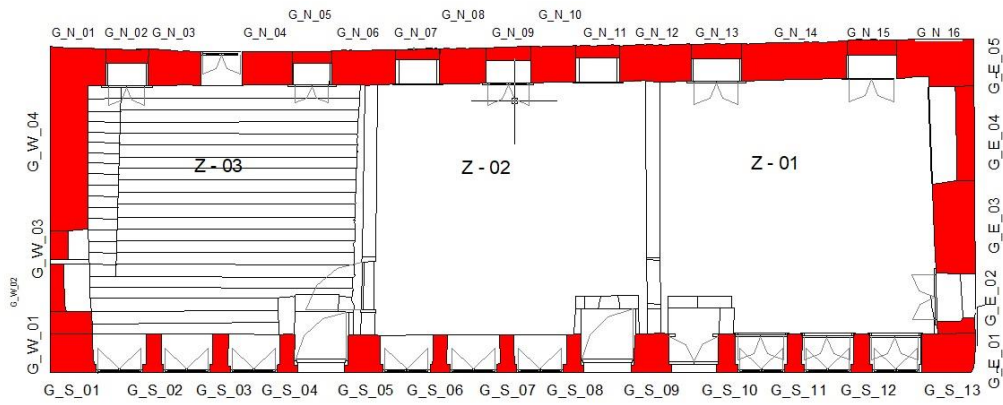
Figure 3.15 Shear force control shown in the ground floor

where  $f_{vd}$  is the wall design shear strength,  $f_{vdo}$  is the design shear strength at zero vertical stress,  $\ell$  is the wall length,  $\ell_c$  is the wall length under compression,  $t$  is the wall thickness and  $b$  is the stress distribution shape coefficient. Accordingly, the shear force checks for all the walls under design-basis (DD2) earthquake spectrum are presented in Table 3.6. The spatial distribution of wall shear stresses in plan for all the floors are provided in Figures Figure 3.14-Figure 3.16. Again, the green and red colors stand for the approval and failure of the shear force check for the walls, respectively. The results reveal that most of the walls in basement floor and all the walls in ground floor do not qualify the shear stress check dictated by the equations in TBSC (2018). On the first floor, the walls with reduced thickness seem to be critical.

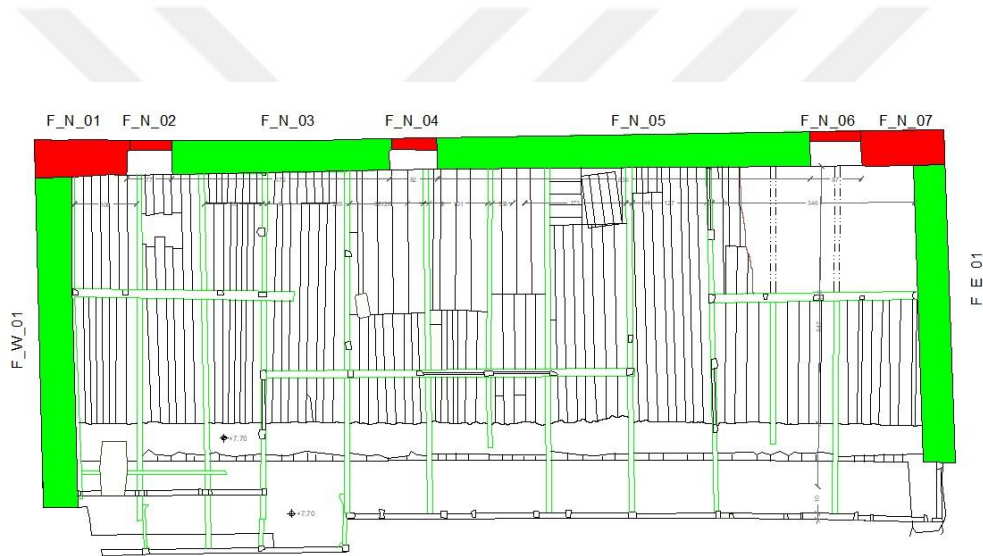
Figure 3.16 Shear force control shown in the first floor

SHEAR CHECK									
No	Floor	Elevation	Wall No	VRd (1)	VRd (2)	VRd	VEd	SHEAR CHECK (VEd < VRd)	FAIL PATTERN
				kN	kN	kN	kN		
68	First Floor	North Wall	F_N_01	101	57	57	78	FAIL	Diagonal Tension
69			F_N_02	22	13	13	66	FAIL	Diagonal Tension
70			F_N_03	313	179	179	28	CHECK	-
71			F_N_04	31	10	10	12	FAIL	Diagonal Tension
72			F_N_05	531	295	295	32	CHECK	-
73			F_N_06	29	15	15	64	FAIL	Diagonal Tension
74			F_N_07	88	53	53	88	FAIL	Diagonal Tension
75		West Wall	F_W_01	619	287	287	90	CHECK	-
76		East Wall	F_E_01	162	248	162	88	CHECK	-
77		Gable West	F_G_W_01	135	204	135	14	CHECK	-
78		Gable East	F_G_E_01	153	236	153	16	CHECK	-

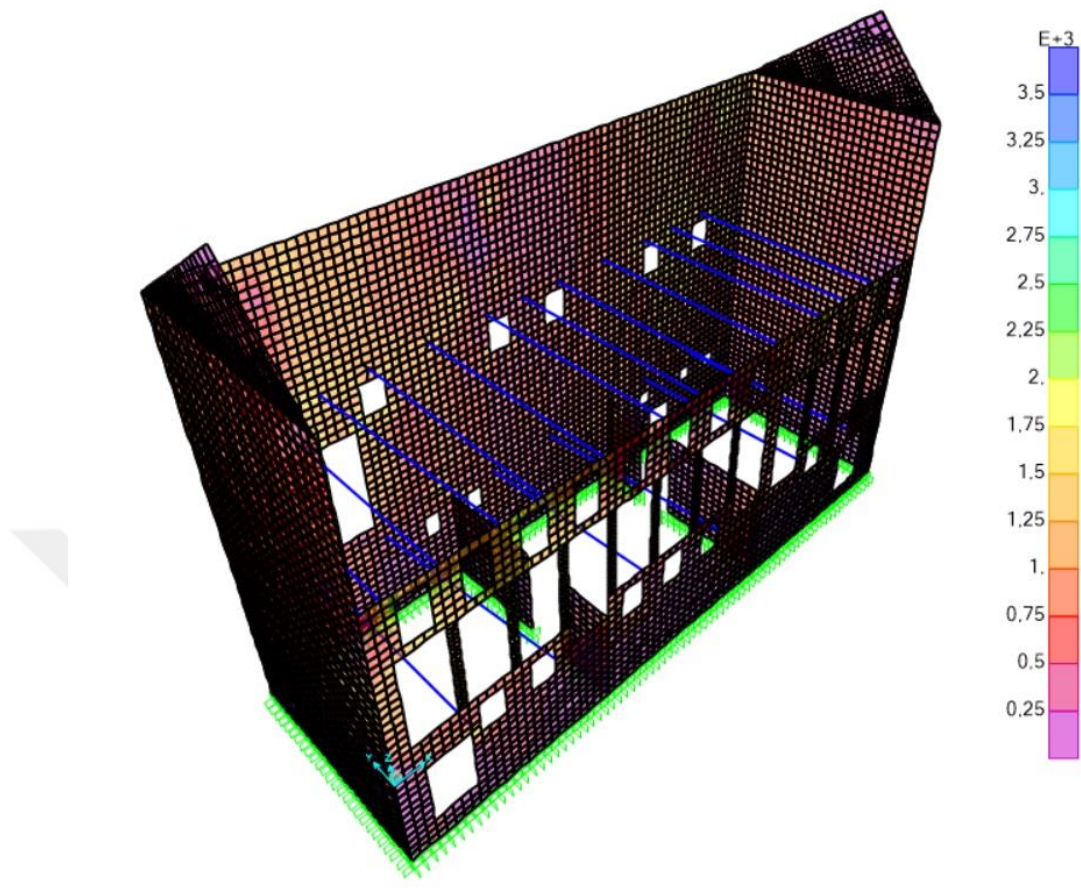
Figure 3.17 Maximum shear stress distribution within the building model under critical loading condition

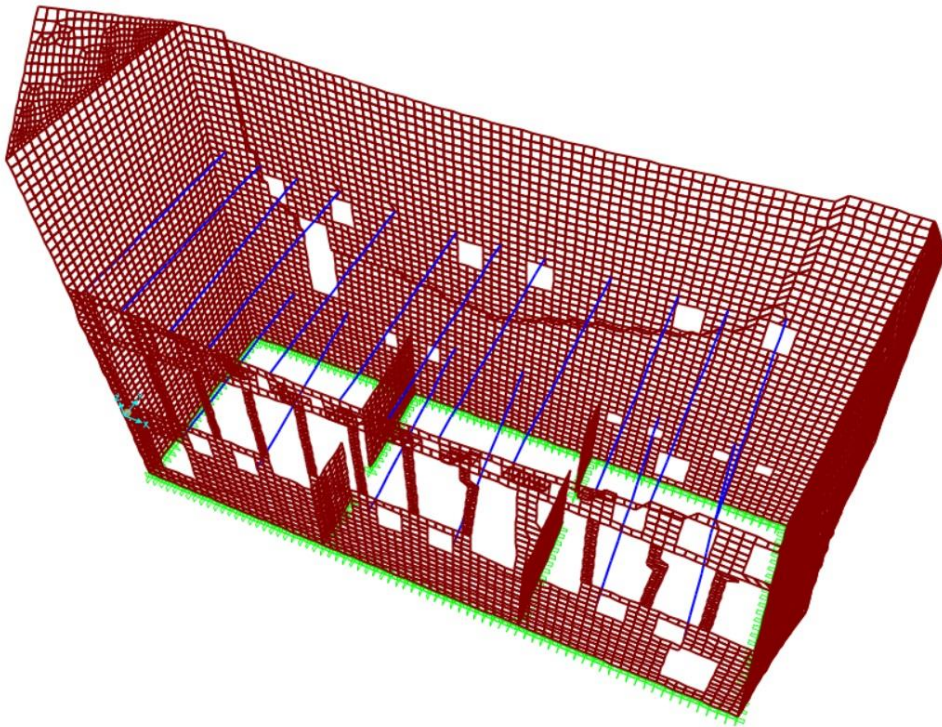
Keeping these assumptions and simplifications in mind, it can be stated that the wall collapse observed in the first floor of the building (Figure 4.1) is consistent with the analysis results. The drift ratio of the north wall of the first floor is calculated beyond the limits given in the GERMHS (2017). More importantly, this wall seems to be critical in the out-of-plane direction as shown in the mechanism calculation explained in Section 3.3.3. The east and west walls of the first floor that collapsed with the earthquake are in a limited damage state according to the drift analysis results. The difference real and simulated behavior of the east and west walls may be due to the fact that in actual case the building cannot move in the east-west direction due to adjacent structures whereas the numerical model simulates a stand-alone dynamic behavior. This may cause a significant difference in the in-plane behavior of the east and west perimeter walls, which are constrained in their out-of-plane direction but free to move in the in-plane direction. In addition, the assessment of shear strength capacity of the walls reveals that shear damage may occur in the corner wall elements where east and west walls intersect with the north wall. These walls may have collapsed because of the collapse of the north wall or they may have collapsed due to the hammering effect of the adjacent buildings with different dynamic characteristics.

Both the finite element analysis and the kinematic mechanism analysis results indicate that the north wall is vulnerable to out-of-plane action and has a high potential to collapse. This is one of the analysis results which has complete match with the observed damage as it can also be seen in Figure 4.1-Figure 4.3.

Figure 4.2 Deformed shape in the finite element model under critical loading condition

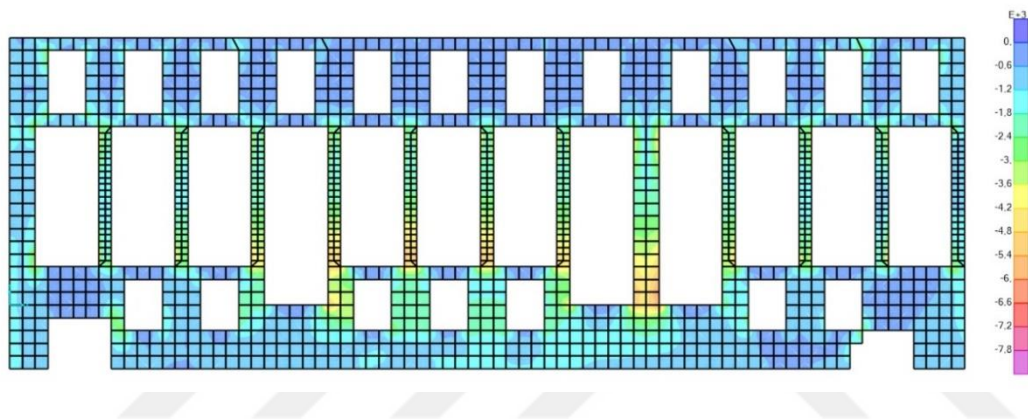
The ground floor walls have remained standing despite in-plane and out-of-plane damage. On the other hand, in the structural analysis, none of the ground floor walls seem to satisfy the shear strength criterion. When the drift analysis results of the north and south walls are examined, these walls are on the verge of collapse with a drift ratio of 0.95%. When these two analyses are evaluated together, it is expected that significant damage leading to collapse would occur in the ground floor walls. However, the actual damage is relatively lower compared to the analysis results. The main reason of this difference may be attributed to the existence of the adjacent buildings. These adjacent buildings limit the horizontal drift and change the damage state of the walls in both directions. As shown in Figure 4.4-Figure 4.5, in-plane wall damages are expected due to stress concentrations at the corners of the openings on the south facade of the ground floor, which has many openings. As shown in Figure 3.11 and Figure 3.15, the walls in this facade seem to violate the compression and shear strength checks under the effect of combined vertical and horizontal loads. In the post-earthquake damage, it is observed that the expected damage occurred at the corners of the doors of the rooms G01 and G02 opening to the courtyard (Figure 4.6). However, it is also necessary to mention the effect of the briquette wall separating

these two rooms. Although it is only taken into account as loads in the analysis, it is thought that this wall has considerable rigidity and forces the south facade out of plane. It is thought that the damage observed in Figure 4.6 is the result of a joint effect governed by in-plane and out-of-plane effects mentioned above. Another expected damage in the corners of upper window opening in the south wall of the ground floor was observed to have occurred after the earthquake (Figure 4.7-Figure 4.8).

Figure 4.4 Compression stress distribution for the south wall in the ground floor

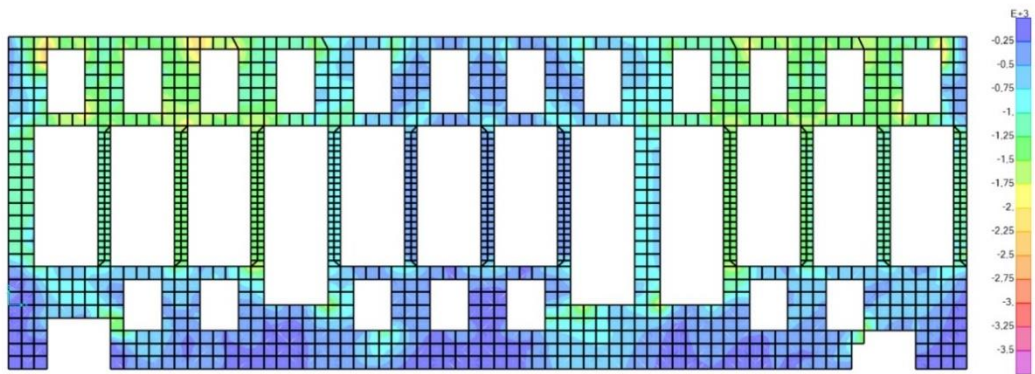
Figure 4.5 Shear stress distribution for the south wall of the ground floor

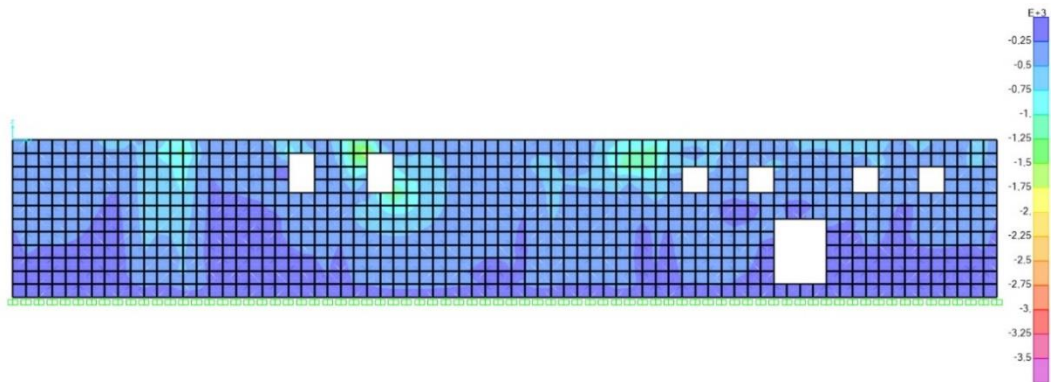
The damage state of the basement floor could not be observed in detail after the earthquake due to security reasons (Figure 2.50). However, considering the member connections at the floor level adjacent to the basement, it is observed that there is no significant out-of-plane damage in the load-bearing walls. According to the results concerning the shear strength checks, it is expected from the north wall of the basement to suffer significant damage (Figure 4.9). This difference can be explained by the fact that the floor is partially under the ground in reality and therefore it is exposed to lower earthquake forces than assumed in the free-standing numerical model. The constraining effect of the adjacent buildings is valid also on this floor as well as in the entire building.

Figure 4.9 Shear stress distribution for the north wall of the basement floor

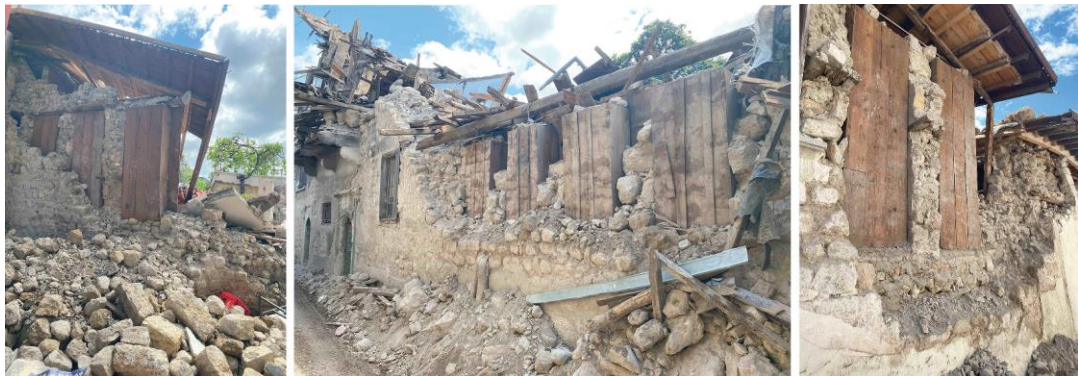
A recent study regarding the performance of traditional Antakya houses after the 2023 earthquake sequence (Rifaioğlu *et al.* 2024) states that the presence of niches and timber frames embedded into masonry walls enhanced the seismic behavior of these buildings and stood intact even if the surrounding wall was heavily damaged or collapsed (Figure 4.10).

Figure 4.10 The superior performance of niches and timber frames embedded into masonry walls during the 2023 earthquakes (Rifaioğlu *et al.* 2024)

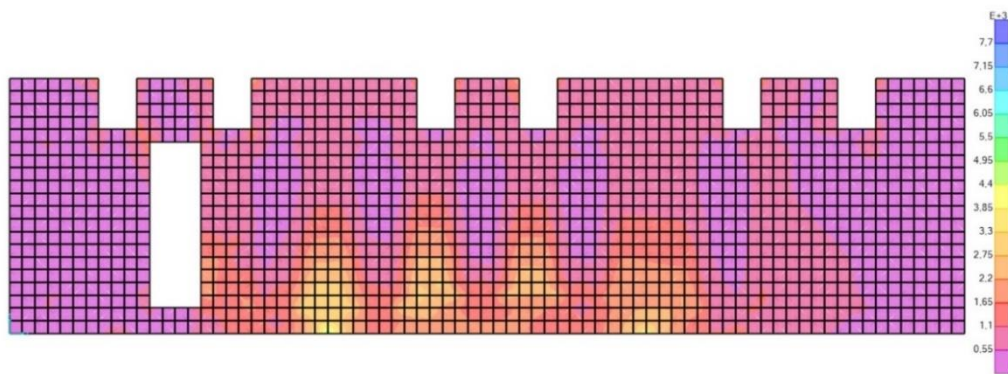
On the other hand, the analysis results show that the regions of niches where the wall section is reduced exhibit inferior performance in the case of both vertical and

horizontal load analysis (Figure 4.11). It is not easy to make definite statements regarding the actual performance of these regions after the earthquake since the real damage had been concentrated in some other regions with more critical deficiencies. However, Rifaioğlu *et al.* (2024) are right in the sense that if these timber prisms embedded in the niches on the wall are connected to each other by timber tie beams at the lintel and plinth level and form a framed structure for additional resistance to horizontal forces, then they can contribute to overall strength of the structure in addition to the load-bearing walls just like a confined masonry structure.

Figure 4.11 Stress concentration in the niches in the north wall of the ground floor

Since Antakya has been a multicultural settlement region since ancient times, it possesses a highly specialized and traditional building construction experience. The Beştetek House is a typical example of this traditional construction practice with its unique characteristics. The structural deficiencies of the Beştetek House that have been explained in the previous sections can be handled by taking proper countermeasures. The primary aim of intervention strategies for historical structures is to protect them from harmful environmental conditions, impacts, and destructive earthquakes while adhering to the principles of conservation. In this context, structural safety of the Beştetek House against seismic action focuses on two major goals: ensuring that the structure satisfies the specified performance level for its intended use and preserving its historical significance, including its original materials and character. Accordingly, the seismic performance of the Beştetek House (and similar timber framed stone masonry buildings in the region) can be improved by focusing on the interventions to overcome the inherent deficiencies of the structure. For instance, the rigid floor diaphragm action can be maintained by improving the timber floors with additional timber elements that allows the load transfer to walls in both orthogonal directions. In addition to this, wall-to-floor connections can be improved by specific connection details in order to ensure the integrity of horizontal and vertical structural members. Another intervention alternative for this structural typology can be to improve the out-of-plane capacity of stone masonry walls by improving the existing wall-to-wall connections and placing additional walls in normal direction in order to reduce the unsupported length of the wall. Timber roof structures should also be improved by replacing the degraded timber members due to moisture and termite action and also improving the joints of the roof truss system. Finally, it should be mentioned that traditional timber prisms used as niches should be connected to each other by timber frame members at the lintel and plinth level in order to construct a timber frame within the stone masonry wall. This timber frame can assist the walls in carrying the lateral loads and also to keep the integrity of the structure just like in

the case of confined masonry buildings. The timber frames used for framing between the prisms should be checked regularly and replaced in the case of material deterioration.
