NON-DESTRUCTIVE EXAMINATION OF STONE MASONRY HISTORIC
STRUCTURES – QUANTITATIVE IR THERMOGRAPHY AND
ULTRASONIC TESTING

A THESIS SUBMITTED TO
THE GRADUATE SCHOOL OF NATURAL AND APPLIED SCIENCES
OF
MIDDLE EAST TECHNICAL UNIVERSITY

FEBRUARY 2010

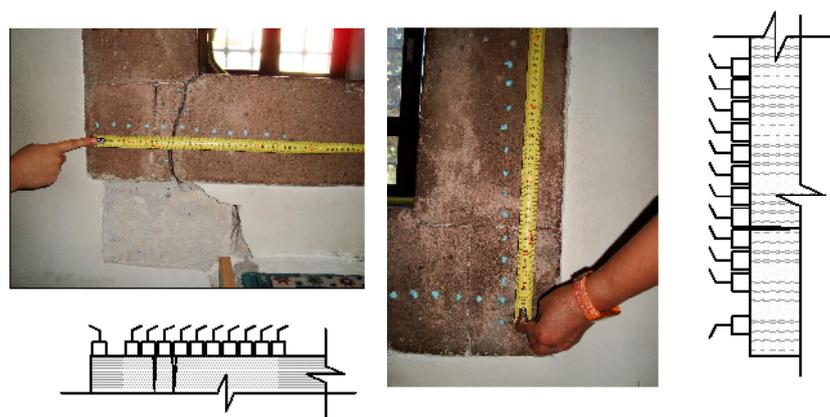
When there were successive cracks on the route of receiver, several measurements were taken from the same route for two cases: At the first case, the transmitter was located at the left side of the cracks and the receiver was moved from left to right (left-to-right direction). At the second case, the transmitter was located at the right side of the cracks and the receiver was moved from right to left (right-to-left direction). The fracture at jointing was the first crack on the route of left-to-right

measurement while the deep crack was the first crack on the route of right-to-left measurement.

Figure 3.7 The arrangement of transducers on red tuff surfaces when placed at the opposite sides of a deep crack (at the left) and at the opposite sides of jointing between two red tuff blocks (at the right).

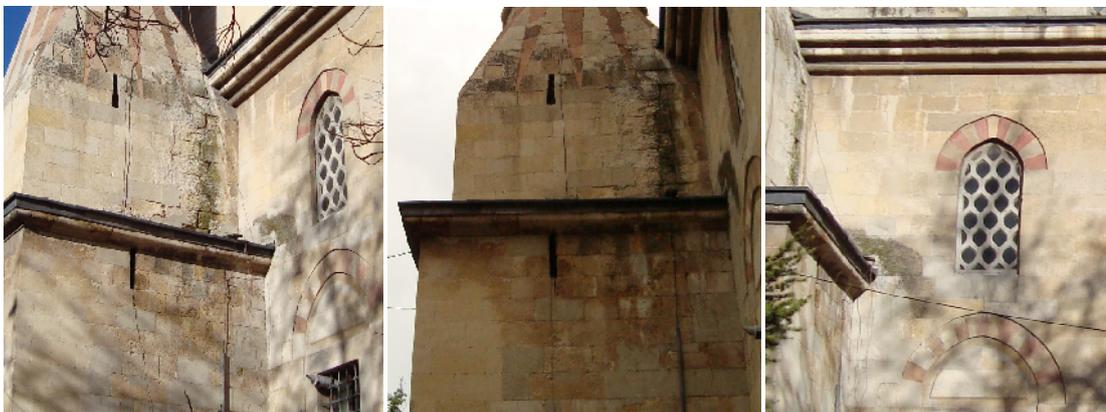
Figure 4.2 Partial view of exterior wall surfaces; south elevation of minaret wall and west elevation of building wall; taken from different directions.

Material loss of the structure was categorized in three types; slight, moderate and severe material loss. Lack of roof drainage system caused material loss in different damage categories both on the south elevation of minaret and west elevation of the building, as it was shown in Figures 4.2 and 4.3. Severe material loss, on the route of water coming from the dome at south side of minaret, was surrounded with moderate material loss and cement based repair coats. Slight material loss was observed on the first layer of minaret wall surface under the eave. Additionally, cement based repairs on the west wall of building was seen mostly around the moderate material loss.

The same wall surfaces were also mapped from the discoloration and deposit positioning at the locations of biological growths, yellow and black staining (Figure 4.3). Biological growths were encountered on the minaret wall surface and on the west wall surface of building where severe and moderate material losses were occurred on the route of water. Yellow staining was common under the eaves and location of slight material loss on south side of minaret wall was overlapped with the yellow and black staining.

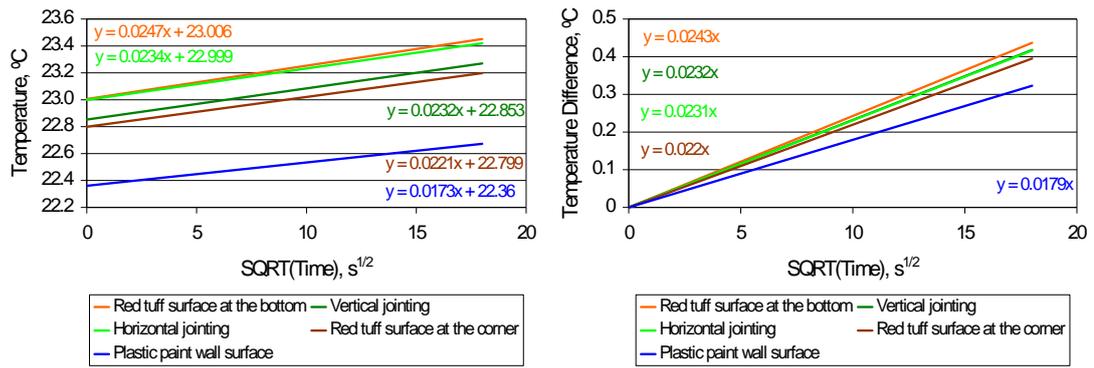
- The results of thermal monitoring for visually-sound masonry surfaces, such as fair faced red tuff blocks, vertical and horizontal jointings in between those blocks and wall surface coated with cement-lime based plaster and plastic paint, during the heating and cooling periods were summarized in Figures 4.8-4.10. IR sequences were taken at the ambient conditions of 23.7°C and 46%RH during the heating period of 856s when the wall surface was uniformly heated with halogen lamp and then during the cooling period of 342s after the halogen lamp was turned off. The linear fitting of surface temperatures versus square root of time and temperature differences versus square root of time during the first 360s of heating period and during the first 324s of cooling period were given in Figures 4.9 and 4.10. The results showed that the red tuff surfaces at the bottom, vertical jointing mortar surfaces, horizontal jointing mortar surfaces and red tuff surfaces at the corner exhibited similar thermal response to the warming up conditions with the rates of 0.0243, 0.0232, 0.0231 and 0.022, respectively. They also exhibited similar thermal response to the cooling down conditions with the rates of -0.025, -0.0241, -0.0235 and -0.0234, respectively. These results signalled that tuff and its jointing mortar had similar thermo-physical properties establishing similar thermal inertia characteristics. The wall surfaces coated with cement-lime based plaster and plastic paint had the coldest surfaces with the slowest rates of warming up and cooling down among fair-faced red tuff and jointing mortar surfaces. These plaster surfaces were colder than the fair faced tuff surface with a temperature difference of -0.64°C and had the warming up and cooling down rates of 0.0179 and -0.0193, respectively.

Figure 4.9 The linear fitting of surface temperatures and temperature differences versus square root of time during the heating period for the case defined in Figure 4.8: The visually-sound red tuff and jointing mortar surfaces exhibited similar warming up rates while the plastered masonry wall coated with plastic paint had the coldest surface temperature with the lowest rate of warming up.

The quantitative analyses of thermal monitoring for visually sound masonry and joint mortar surfaces exhibited that red tuff and jointing mortar surfaces had similar rates of warming up and cooling down during the heating period of 856s and cooling period of 342s, respectively (Figures 4.8-4.10). That signalled that tuff and its jointing mortar had similar thermo-physical properties establishing similar thermal inertia characteristics. The wall surfaces coated with cement-lime based plaster and plastic paint had the coldest surfaces with the slowest rates of warming up and cooling down. The reason(s) of that different thermal inertia characteristic were

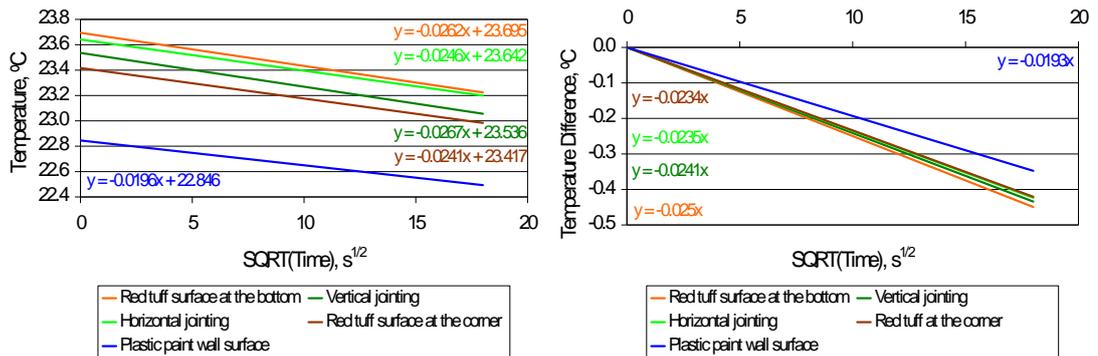
Figure 4.10 The linear fitting of surface temperatures and temperature differences versus square root of time during the cooling period for the case defined in Figure 4.8: The visually-sound red tuff and jointing mortar surfaces exhibited similar cooling down rates while the plastered masonry wall coated with plastic paint had the coldest surface temperature with the lowest rate of cooling down.

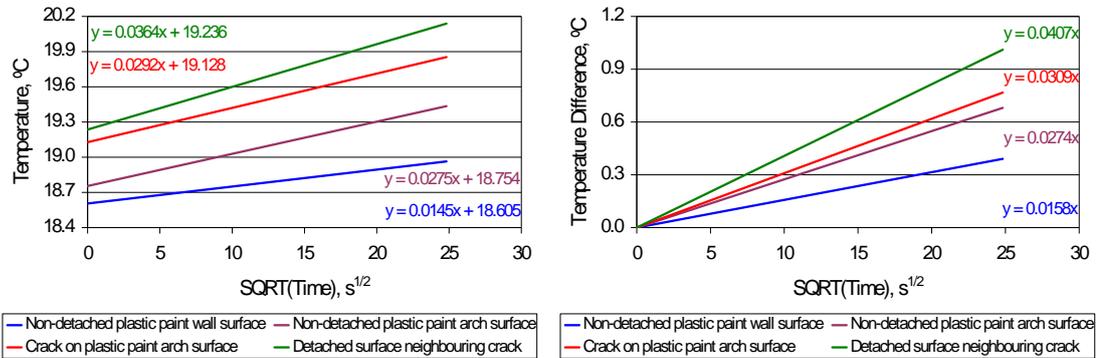
Figure 4.12 The linear fitting of surface temperatures and temperature difference versus square root of time during the heating period for the case defined in Figure 4.11: The detached surfaces warmed up the fastest while the non-detached wall surface coated with plastic paint had the coldest surface temperature with the lowest rate of warming up.

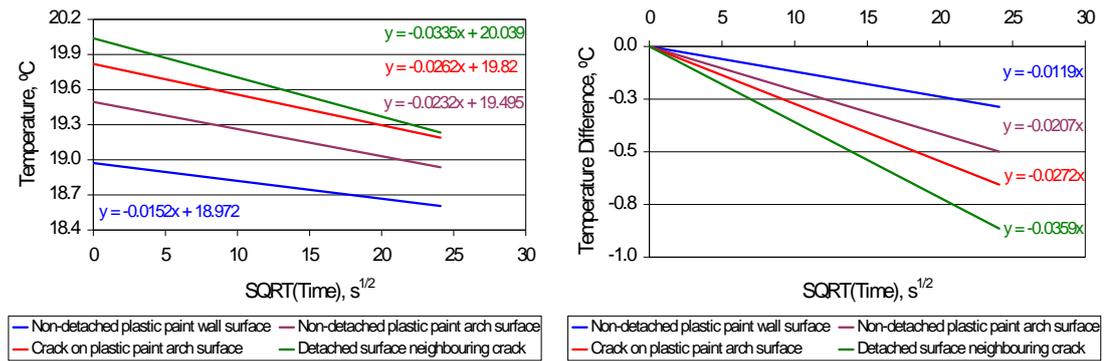
Figure 4.13 The linear fitting of surface temperatures and temperature difference versus square root of time during the cooling period for the case defined in Figure 4.11: The detached surfaces cooled down the fastest while the non-detached wall surface coated with plastic paint had the coldest surface temperature with the lowest rate of cooling down.

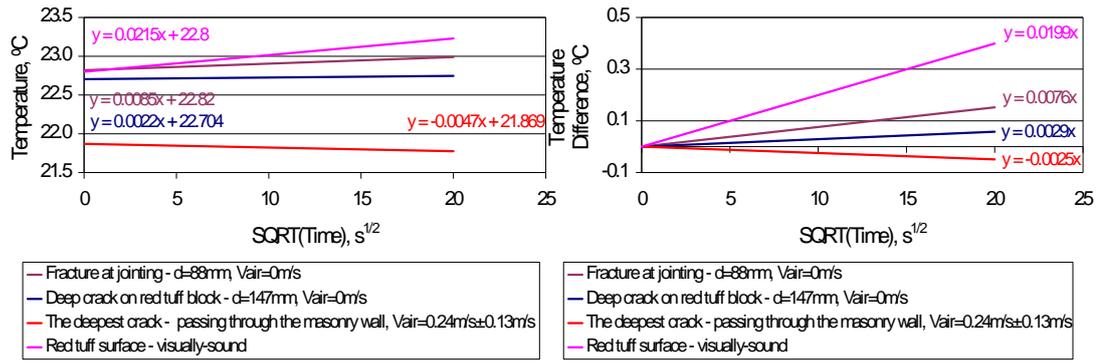
- The deepest crack, deep cracks, visually sound red tuff surfaces, detached and non-detached surfaces were monitored during the heating and cooling conditions. IR sequences were taken at the ambient conditions of 23.7°C and 46%RH during the heating period of 886s when the wall surface was uniformly heated with halogen lamp and then during the cooling period of 430s after the halogen lamp was turned off. The linear fitting of surface temperatures versus square root of time and temperature differences versus square root of time during the first 400s and 282s of heating period, and during the first 120s of cooling period were given in Figures 4.15-4.18. The results showed that the deep cracks at masonry wall with the depths of 147mm and 88mm, presented noticeably slower warming up and cooling down rates than the sound surfaces (Figures 4.14-4.16). The deeper crack had also warmed up and cooled slower than the less deep one. The warming up rates of deep crack in 147mm depth, deep crack in 88mm depth and visually-sound tuff surfaces were 0.0029, 0.0076 and 0.0199, respectively while the cooling down rates of deep crack in 147mm depth, deep crack in 88mm depth and visually-sound tuff surfaces were -0.0109, -0.0119 and -0.0314, respectively. The deepest crack had the coldest surface temperature, being colder than the visually-sound tuff surface with a temperature difference of -0.93°C and cooled down during the heating period with the rates of -0.0025 and -0.0035 for the cases defined in Figures 4.15 and 4.17, respectively. That signalled the presence

of entrapped moisture in the masonry and air flow through its gap/cavity, both encouraging evaporative cooling there. The deepest crack also presented the slowest rate of cooling down during the cooling period with the rate of -0.008 (Figures 4.14, 4.16 and 4.18). The deepest crack, even neighbouring detachments, had noticeably colder surface temperature than the deep cracks and sound surfaces.

Figure 4.15 The linear fitting of surface temperatures and temperature difference versus square root of time during the heating period for the case defined in Figure 4.14: The deep cracks had noticeably slower rate of warming up than the sound red tuff while the deepest crack allowing air leakage through its cavity had the coldest surface temperature and cooled down under the exposure of heating up process.

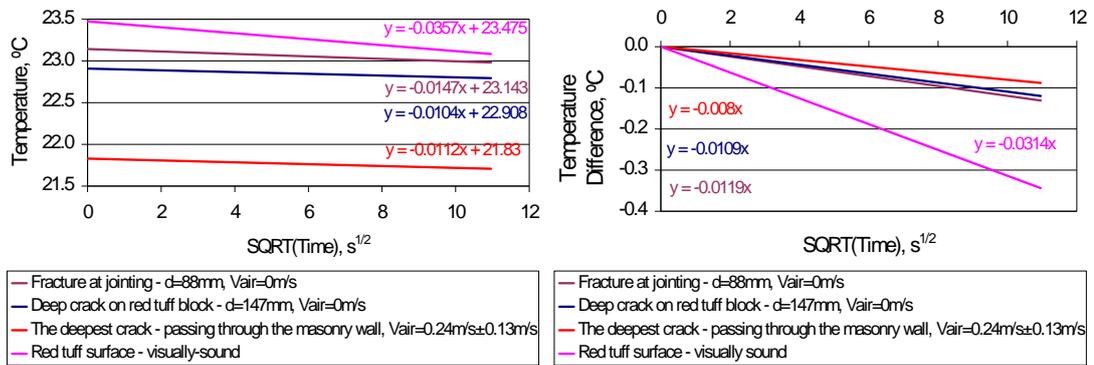
Figure 4.16 The linear fitting of surface temperatures and temperature difference versus square root of time during the cooling period for the case defined in Figure 4.14: The deep cracks had noticeably slower rate of cooling down than the sound red tuff while the deepest crack allowing air leakage through its cavity had the coldest surface temperature and the slowest rate of cooling down.

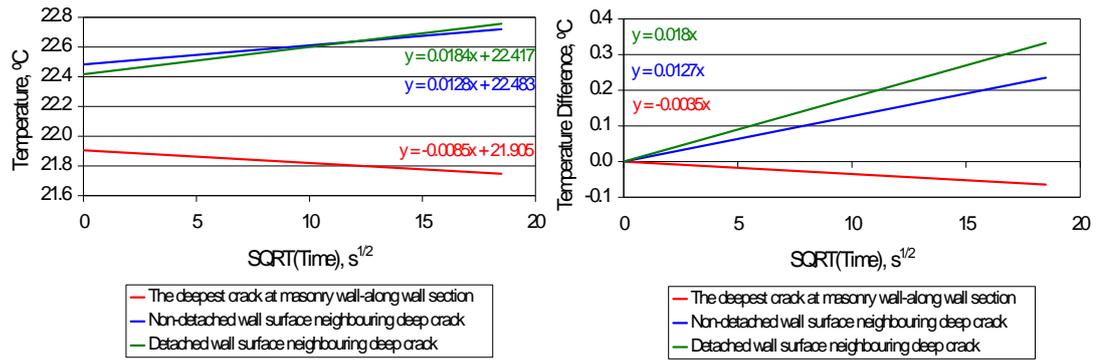
Figure 4.17 The linear fitting of surface temperatures and temperature difference versus square root of time during the heating period for the case defined in Figure 4.14: The thermal behaviour of the deepest crack at the masonry neighbouring detachments was in contrast to the superficial cracks neighbouring detachments (compare with Figure 4.12). The deepest crack had the coldest surface temperature and slightly cooled down under the exposure of heating.

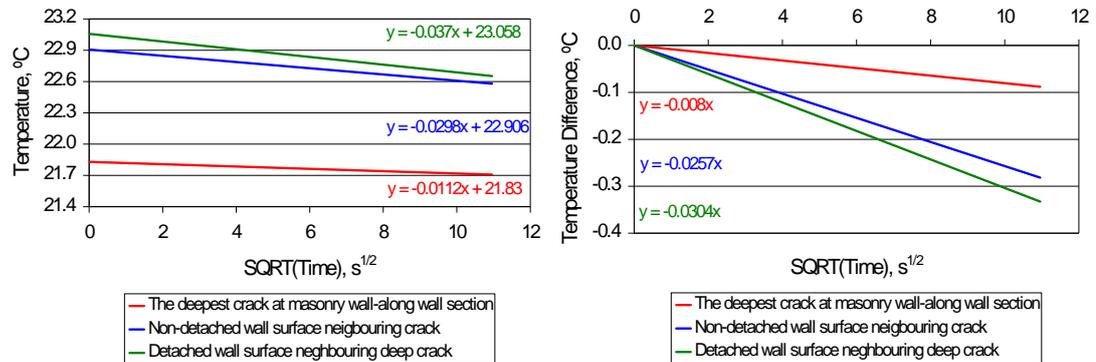
Figure 4.18 The linear fitting of surface temperatures and temperature difference versus square root of time during the cooling period for the case defined in Figure 4.14: The thermal behaviour of the deepest crack at the masonry neighbouring detachments was in contrast to the superficial cracks neighbouring detachments (compare with Figure 4.12). The deepest crack had the coldest surface temperature with the slowest rate of cooling down among neighbouring all wall surfaces.

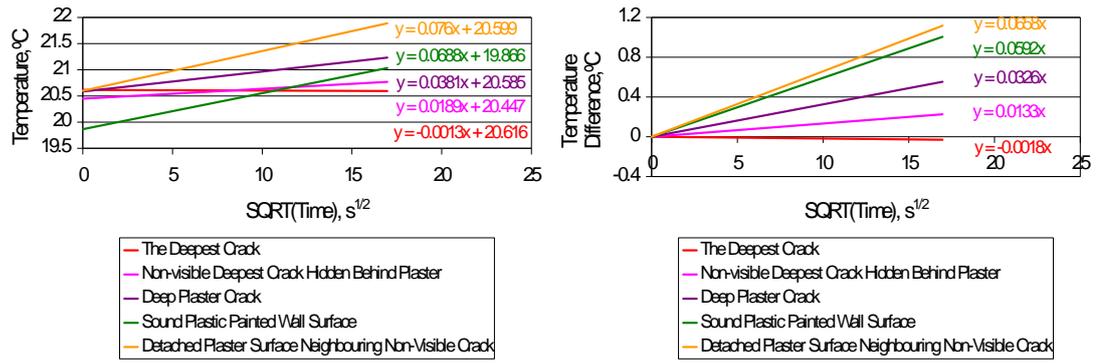
The area between the arch of first layer window and the decoratively painted wall surface above the first layer window was seen visually-sound although thermal analysis signalled the crack on the examined surface due to the similar thermal behaviours of the deepest crack and this examined surface under the exposure of warming up and cooling down conditions. This non-visible deepest crack behind plaster had slightly faster warming up and cooling down rates than those of the deepest crack. Non-visible deepest crack had the warming up and cooling down rates of 0.0133 and -0.0149, respectively (Figures 4.20 and 4.21).

Figure 4.20 The linear fitting of surface temperatures and temperature difference versus square root of time during the heating period for the case defined in Figure 4.19: The detached surfaces warmed up the fastest while the warming rates of cracks were slower than the visually-sound surface. Deep plaster crack warmed up faster than the deepest cracks and the deepest crack slightly-cooled down under the exposure of heating up process.

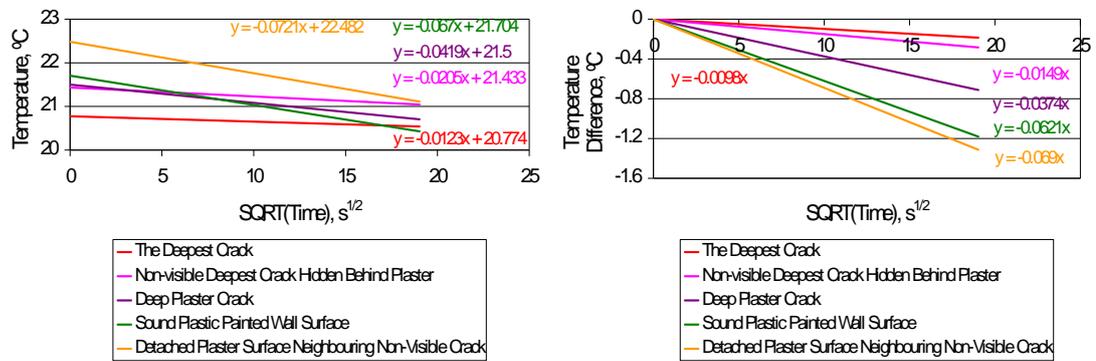
Figure 4.21 The linear fitting of surface temperatures and temperature difference versus square root of time during the cooling period for the case defined in Figure 4.19: The detached surfaces cooled down the fastest while the cooling down rates of cracks were slower than the visually-sound surface. Deep plaster crack cooled down faster than the deepest cracks while the deepest crack had the slowest cooled down rate.

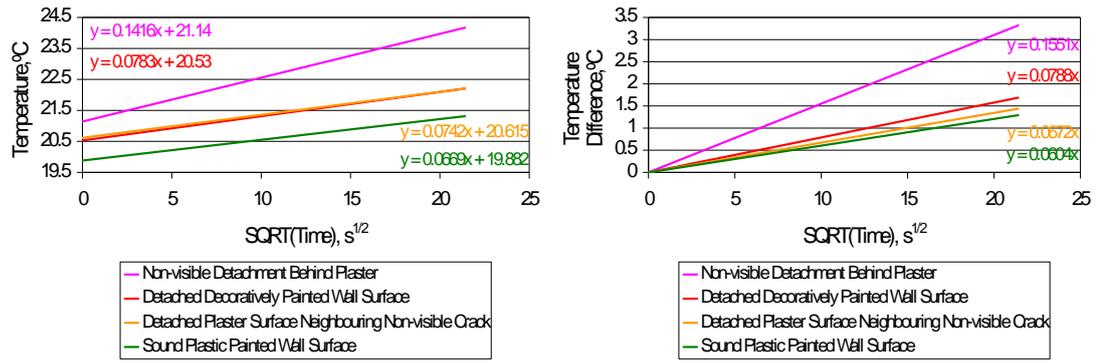
The detached surfaces could be differentiated from each other as well (Figures 4.22 and 4.23). All detachments were warmer than the visually-sound plastic painted wall surface and had the faster warming up and cooling down rates than the visually-sound surface. Detached decoratively painted wall surface and detached plaster surface neighbouring non-visible crack exhibited similar thermal response to the warming up conditions with the rates of 0.0788 and 0.0672, respectively. They also exhibited similar thermal response to the cooling down

Figure 4.22 The linear fitting of surface temperatures and temperature difference versus square root of time during the heating period for the case defined in Figure 4.19: The initial temperatures and warming up rates of detached surfaces were higher than the visually-sound plastic painted wall surface. Non-visible detachment was the warmest surface with the fastest warming up rate.

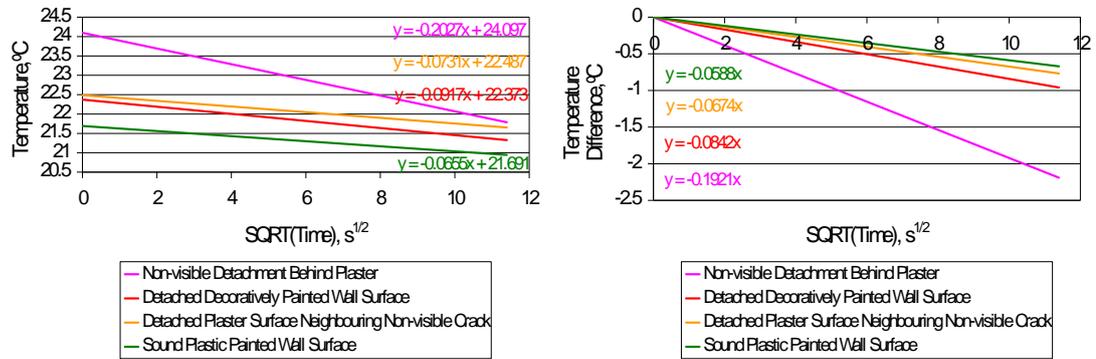
conditions with the rates of -0.0842 and -0.0674 , respectively. Non-visible detachment behind the plaster, on the other hand, was the warmest surface with the fastest rates of warming up and cooling down. This non-visible detachment was warmer than the visually-sound plastic painted wall surface with a temperature difference of 1.26°C and had the warming up and cooling down rates of 0.1551 and -0.1921 , respectively.

Figure 4.23 The linear fitting of surface temperatures and temperature difference versus square root of time during the cooling period for the case defined in Figure 4.19: The initial temperatures and cooling down rates of detached surfaces were higher than the visually-sound plastic painted wall surface. Non-visible detachment was the warmest surface with the fastest cooling down rate.

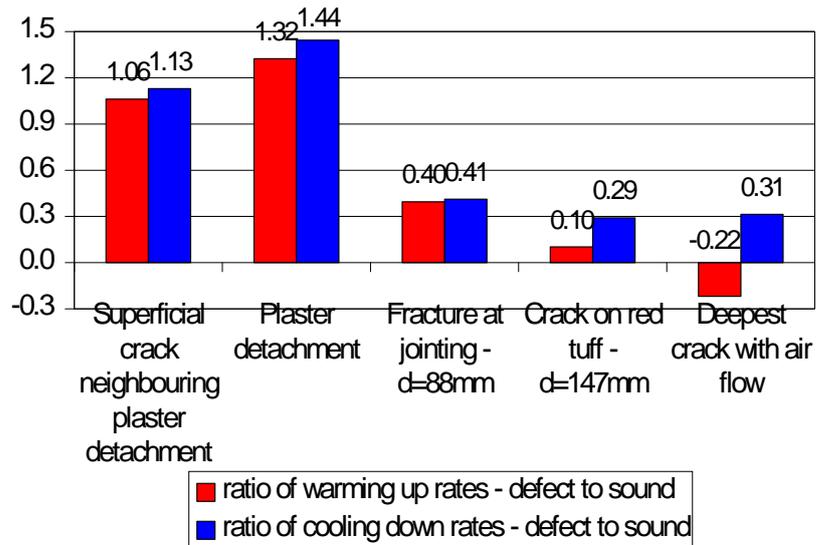
- The data on the warming up (R_w) and cooling down rates (R_c) for each crack/defect were summarized in Table 4.1, Figure 4.24 and 4.25. When the rates of defects were compared with the rates of visually-sound surfaces, it was found that plaster detachment had the highest ratio for warming up and cooling down conditions. The cracks, on the other hand, had the slowest ratios (Figure 4.24). Non-visible deepest crack hidden behind the plaster layer and the deepest crack presented exactly the same thermal responses under the exposure of cooling

Figure 4.24 The ratios between the R_w (or R_c) of crack/defect to the R_w (or R_c) of sound surface: Superficial and deep cracks had different thermal responses to exposed conditions which made them distinguishable by QIRT analyses.

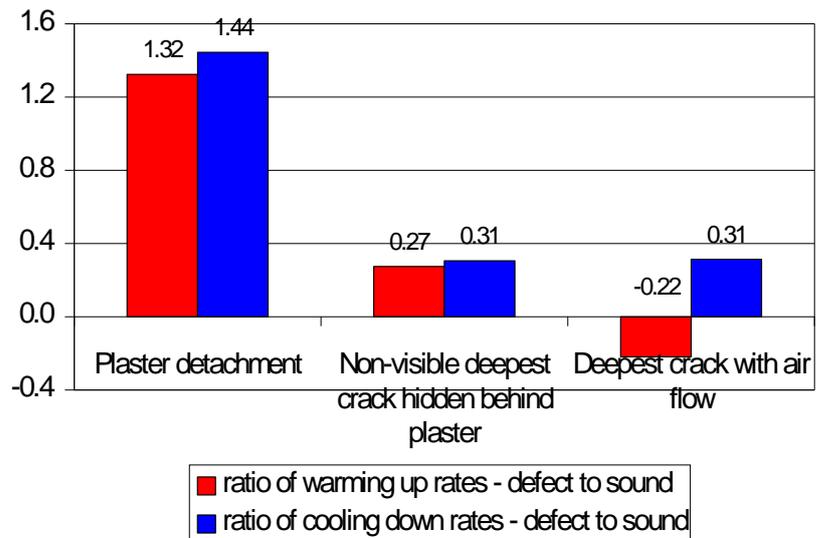
condition and the ratio between the R_W of non-visible deepest crack hidden behind the plaster layer and the deepest crack to the R_W of sound surface were similar while the ratio between the R_W (or R_C) of plaster detachment to the R_W (or R_C) of sound surface was noticeably higher (Figure 4.25).

Figure 4.25 The ratios between the R_w (or R_c) of crack/defect to the R_w (or R_c) of sound surface: Non-visible deepest crack had similar thermal responses with the deepest one especially in cooling period, while thermal behaviour of superficial crack and deepest cracks were totally different.

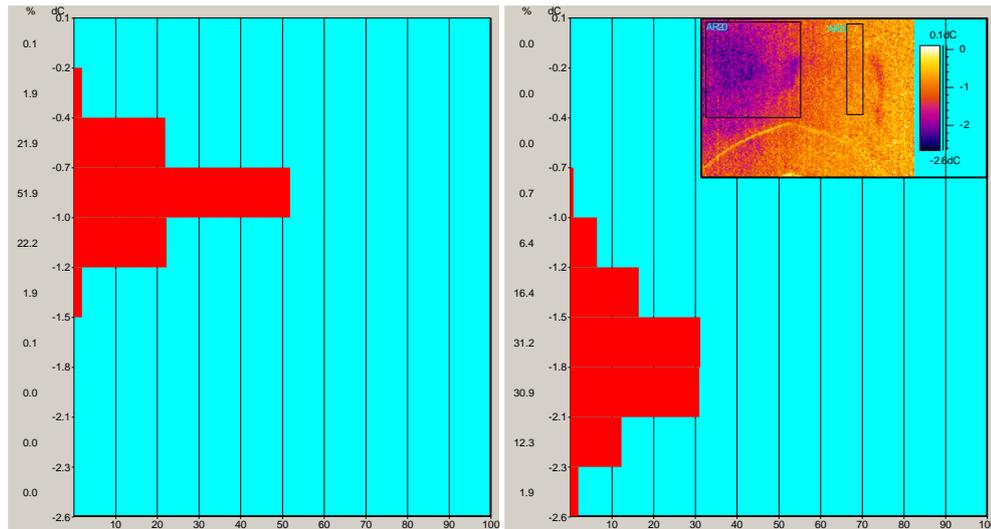
- The wall surface of second floor at the north side painted with recent plaster repairs was analysed during the heating and cooling conditions (Figure 4.27). IR sequences were taken at the ambient conditions of 20.6°C and 55%RH during the heating period of 735s when the wall surface was uniformly heated with halogen lamp and then during the cooling period of 456s after the halogen lamp was turned off. The results showed that heterogeneous temperature distribution of wall surfaces coated with plastic painting was noticed easily in IR images. That signalled the incompatibility of recent repairs. Superficial cracks and the detached plaster surfaces were detected easily in IR image as warmer patches while it was not possible to notice all detaching parts clearly by eye. Temperature distributions of visually-sound and deteriorated wall surfaces coated with plastic paint were presented with the histograms which were taken from the differential IR image taken at 456. second of the cooling period (Figure 4.28). Histograms showed that deteriorated surfaces cooled down faster than the visually-sound wall surfaces.

Figure 4.28 Histogram views of visually-sound wall surface (at the left) and deteriorated surface (at the right) taken from the differential IR image of cooling period for the case defined in Figure 4.27: Heterogeneous temperature distribution of deteriorated surface was easily observed in IR images. Deteriorated wall surfaces cooled down faster than the visually-sound wall surfaces.

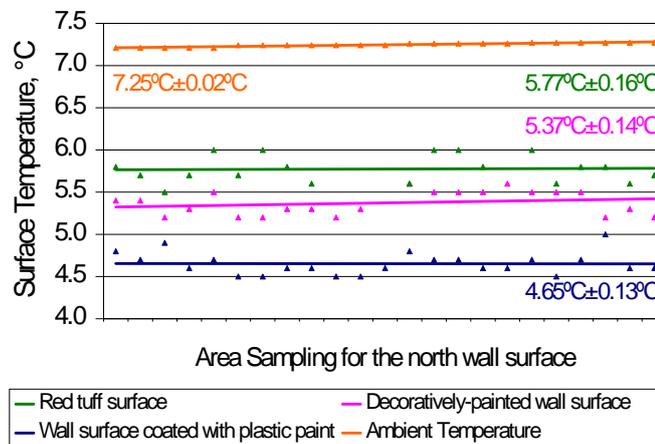
- Single IR images were taken from the decoratively painted wall surfaces above the first layer windows at north wall at the interior climatic conditions of 7.2°C and 51%RH and outside climatic conditions of 2.5°C and 62.5%RH (Figures 4.29 and 4.30). It was found that decoratively painted wall surfaces were warmer than the surfaces coated with plastic paint with +0.6°C temperature difference. In Figure 4.30, the surface temperature data for the fair-faced red tuff, decoratively-painted and plastic paint wall surfaces together with the inside air temperature close to the surface were extracted from several IR images scanning the north wall entirely. According to the results of that scanning, all north wall was colder than the ambient temperature. Wall surfaces coated with plastic paint were the coldest surfaces, having -2.6°C temperature difference with the ambient temperature close to wall surface. Red tuff surfaces, on the other hand, were the warmest areas, with a temperature difference of -1.5°C.

Figure 4.30 The surface temperature plot of north wall showing that the overall wall surfaces were colder than the inside ambient temperature while the ones coated with plastic paint were the coldest areas while the red tuff surfaces were the warmest areas.

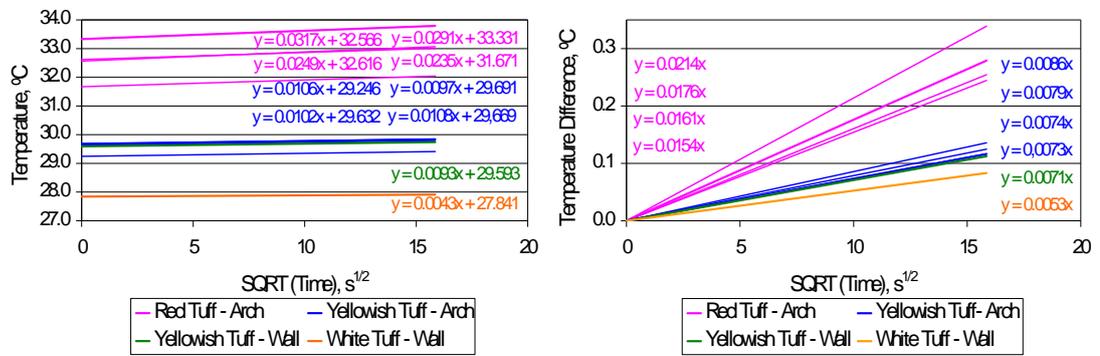
- Thermal behaviours of yellowish, white and red tuff blocks used at exterior wall and arch surfaces were determined by the sequential IR imaging under exposure of solar radiation in damp condition (Figures 4.32 and 4.34). Sequential IR images were taken at the ambient conditions of 28.6 °C and 28%RH during the heating period of 271s when the wall surface was uniformly heated by solar radiation for the case defined in Figure 4.32. Sequential IR images for the case defined in Figure 4.34, on the other hand, were taken at the ambient conditions of 29.4 °C and 27%RH during the heating period of 291s when the wall surface was uniformly heated by solar radiation. The results exhibited that the red tuff blocks at arches had the warmest surface temperatures and they were determined to warm up faster than the yellowish and white tuffs. The yellowish tuff of masonry wall had similar warming up rates with the ones on arches (Figures 4.33 and 4.35). White tuffs, on the other hand, had the coldest surface temperatures. They

Figure 4.33 The linear fitting of surface temperatures and temperature differences versus square root of time during the heating period for the case defined in Figure 4.32: The red tuffs had the warmest surfaces with the fastest warming up rates. The white tuff had coldest surface with the slowest heating up rate. Yellowish tuffs used on wall surfaces and on arches exhibited similar warming up rates.

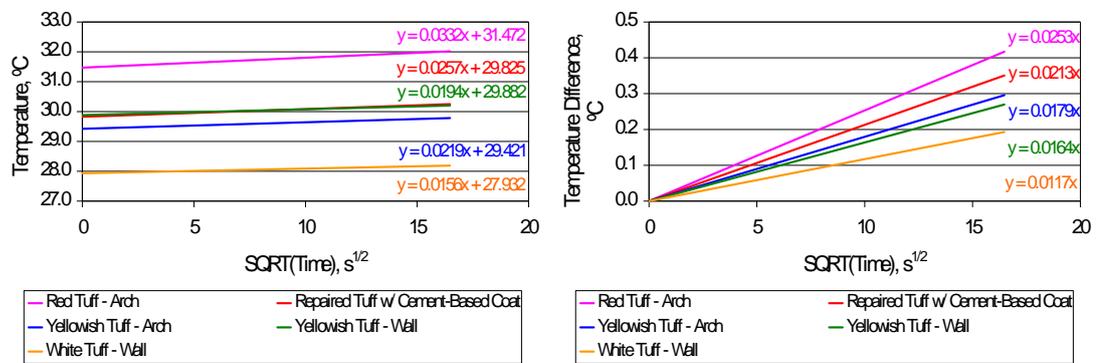
were colder than the ambient temperature with the warming up rate being slower than those of yellowish and red tuffs. That might be due to the presence of moisture in tuffs in different ranges. The repaired tuff with cement-based coat presented different thermal response to the warming up condition than the tuffs. Although the initial real surface temperatures of repaired tuff and yellowish one were similar, the repaired tuff with cement-based coat warmed up faster than the yellowish tuff (Figure 4.35).

Figure 4.35 The linear fitting of surface temperatures and temperature differences versus square root of time during the heating period for the case defined in Figure 4.32: The red tuff had the warmest surface with the fastest warming up rate. The white tuff had coldest surface with the slowest heating up rate. Repaired tuff with cement-based coat had faster warming up rate than the yellowish and white tuffs.

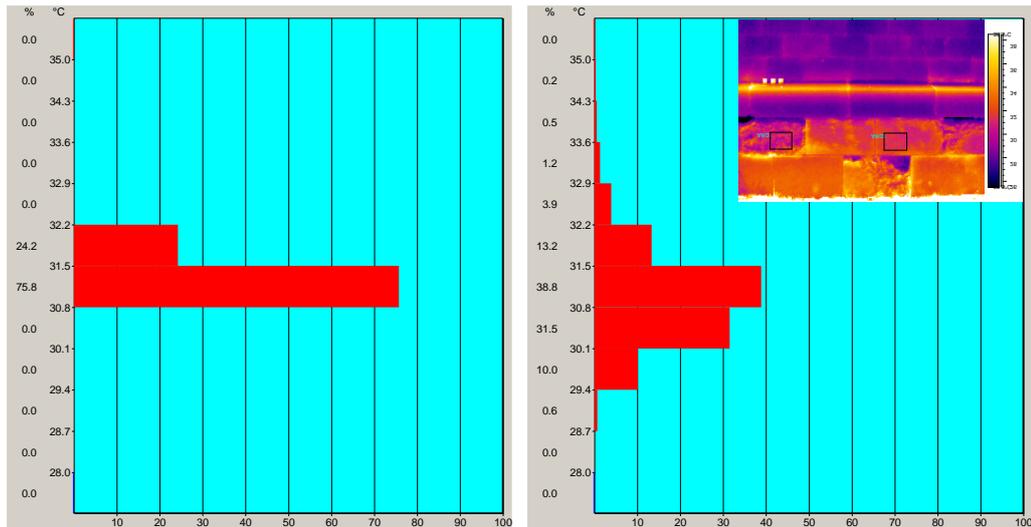
- Visually sound and deteriorated andesite stones at the basement of structure were examined under exposure of solar radiation when the ambient conditions were 28.9 °C and 28%RH. The results were given in the form of histogram views, showing the visually sound and deteriorated andesite stones in the first and second courses above ground level (Figure 4.36 and 4.37). For the first course above the ground level, an even distribution of surface temperatures was observed on the visually-sound andesite, having the surface temperature in the range of 30.9°C and 32.0°C with an average of 31.3°C±0.2°C. On the other hand, andesite which was deteriorated in the forms of material loss and detachments in the first course above ground level showed heterogeneous temperature distribution with the surface temperature in the range of 29.0°C and 34.7°C with an average of 30.9°C±0.7°C (Figure 4.36). For the second course above the ground level, an even distribution of surface temperatures was observed on the visually-sound andesite, having the surface temperature in the range of 31.8°C and 33.4°C with an average of 32.6°C±0.2°C. On the other hand, andesite which was deteriorated in the forms of material loss and detachments in the second course above ground level showed heterogeneous temperature distribution with the surface temperature in the range of 30.5°C and 38.5°C with an average of 33.5°C±1.3°C (Figure 4.37). the results showed that andesite stone which was deteriorated in the form of material loss and detachment had heterogeneous temperature distribution. Additionally, visually-sound and deteriorated andesites in the second course were warmer than the andesite stones in the first course above ground level.

Figure 4.36 Histogram views of visually-sound andesite masonry located in the first course above ground level (at the left) and deteriorated surface in the first course (at the right): Deteriorated surface had heterogeneous temperature distribution.

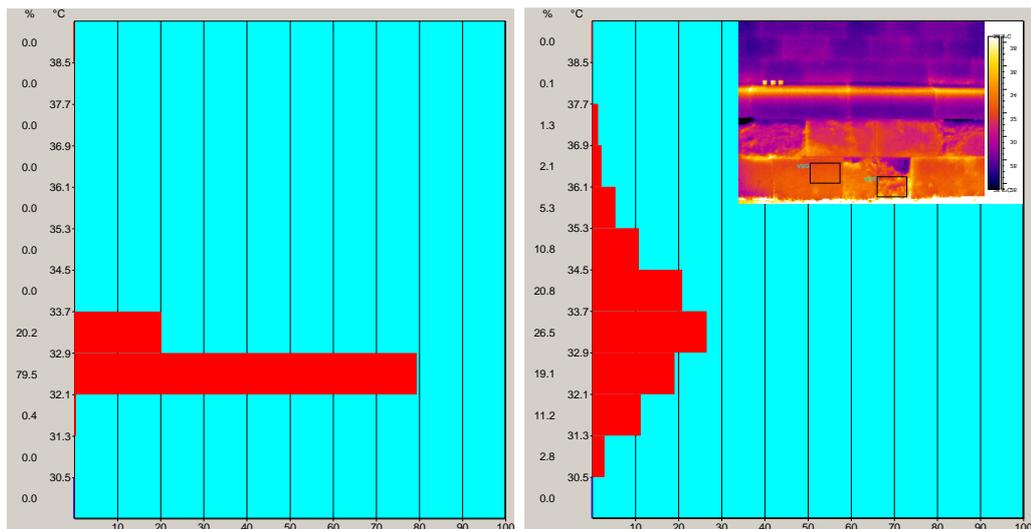
Figure 4.37 Histogram views of visually-sound andesite masonry located in the second course above ground level (at the left) and deteriorated surface in the second course (at the right): Deteriorated surface had heterogeneous temperature distribution.

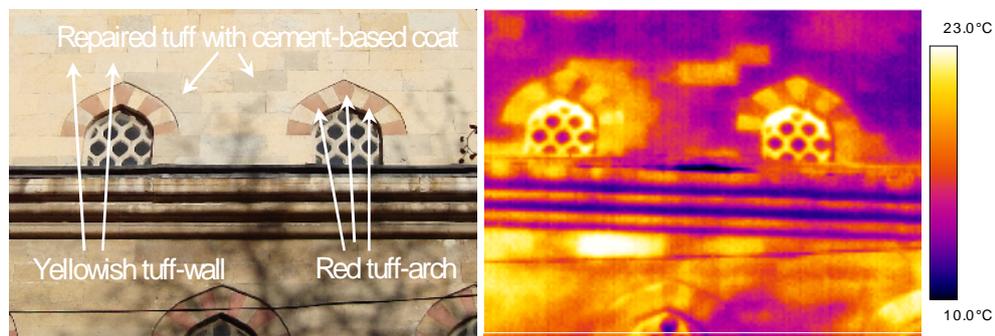
- Surface temperatures of yellowish tuff on wall, red tuff at the arch and repaired tuff with cement-based coat were examined in individual IR images taken during the warming period of daytime at the ambient conditions of 12.4 °C and 48%RH (Figure 4.38). It was found that repaired tuffs with cement-based coat were

warmer than the ambient temperature and visually-sound yellowish tuff wall surfaces with temperature differences of $+6.65^{\circ}\text{C}$ and $+2.5^{\circ}\text{C}$, respectively, that made the detached surfaces clearly visible in IR images although it was not easy to differentiate the repaired tuff surfaces visually by eye. Yellowish and red tuffs could also be distinguished easily due to their different thermal behaviours. Red tuff surface was warmer than ambient temperature with $+7.6^{\circ}\text{C}$ temperature difference while yellowish tuff on wall was $+4.15^{\circ}\text{C}$ warmer than the ambient temperature.

Figure 4.38 Partial view of exterior wall surfaces at west side (at the left) and its IR image (at left bottom): Different stone types were easily detected in IR images. Red tuff at the arch and repaired tuff with cement-based coat were warmer than the yellowish tuff used on wall surfaces when all surface temperatures were above the ambient temperature.

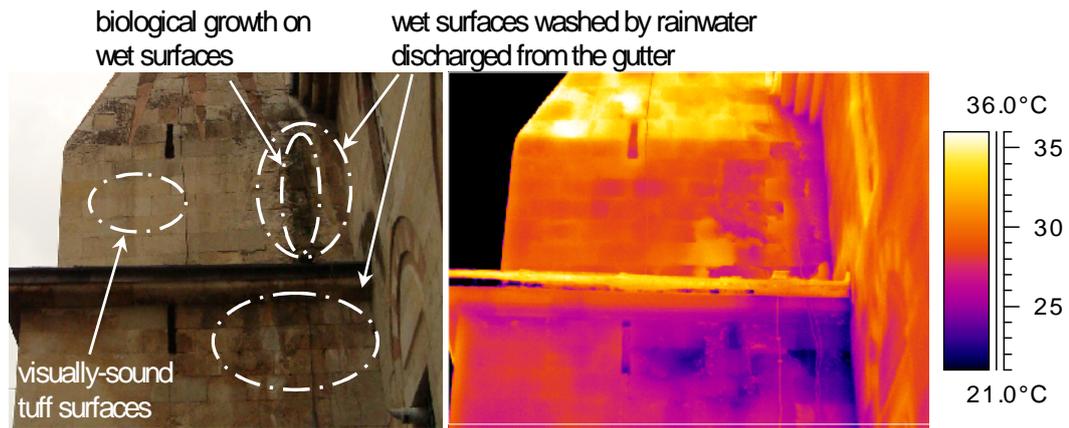
- Thermal responses of minaret wall surface on south façade were detected in IR image after the preliminary wetting by light summer rainfall (Figure 4.39). IR image was taken at the exterior boundary conditions of 30°C and 21%RH. It was found that the visually sound yellowish tuff wall surfaces were $-1.18^{\circ}\text{C}\pm 0.34^{\circ}\text{C}$ colder than the ambient temperature due to the slightly damp tuff surfaces. The wall surfaces washed by the rainwater discharged directly from the gutters were the coldest surfaces in the IR images, being colder than the ambient temperature with a temperature difference of $-6.75^{\circ}\text{C}\pm 2.04^{\circ}\text{C}$ while these damp surfaces covered with biological growth were observed to be warmer than visually-sound tuff surfaces with a temperature difference of $+0.7^{\circ}\text{C}$ while being still colder than the ambient temperature.

Figure 4.39 Partial view of exterior wall surface at the south facade of minaret (at the left) and its IR image (at the right): The visually-sound tuff surfaces were colder than the ambient temperature. The damp surfaces washed by rainwater were the coldest areas while biological growths on these damp zones were warmer than visually-sound tuff surfaces.

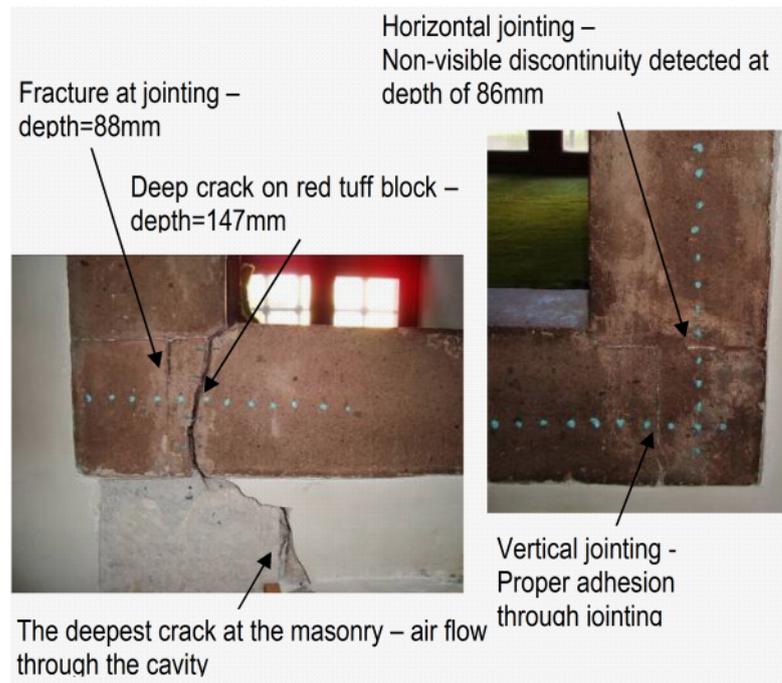
The results of ultrasonic testing were summarized in Table 4.2 and Figure 4.40, together with the close views of cracks/jointings examined. For the visually-sound red tuffs, the indirect ultrasonic velocity (UPV_{IND-T}) was determined to be in the range of 826m/s and 1026m/s with an average of $944m/s \pm 83m/s$ and slope of the regression line (S_T) was determined to be in the range 0.98 and 1.23 with an average of 1.08 ± 0.13 (Table 4.2). The jointing detail between the red tuff blocks decreased the indirect ultrasonic velocity (UPV_{IND-TM}) to $374m/s \pm 23m/s$ and increased the slope of regression line (S_{TM}) to 3.38 ± 0.23 (Table 4.2). Those values were accepted as the reference UPV data in indirect transmission mode for the sound red tuff individually and together with jointing mortar.

According to the spot readings by vernier calliper, the depths of fracture at jointing and deep crack on red tuff were measured in the range of 25.8mm-42.6mm and 32.5mm-75.7mm, respectively. However, the depths were calculated to be 88mm for fracture at jointing and 147mm for deep crack on red tuff by using UPV data (Table 4.2). Those results exhibited that cracks were deeper than depth measurements taken

by the vernier calliper and the UPV measurements in indirect mode were more accurate for depth assessment of cracks.

Figure 4.40 The close views of structural cracks and jointings on red tuff blocks at the left and right bottom corners of window niche examined *in-situ* by using QIRT and ultrasonic testing.

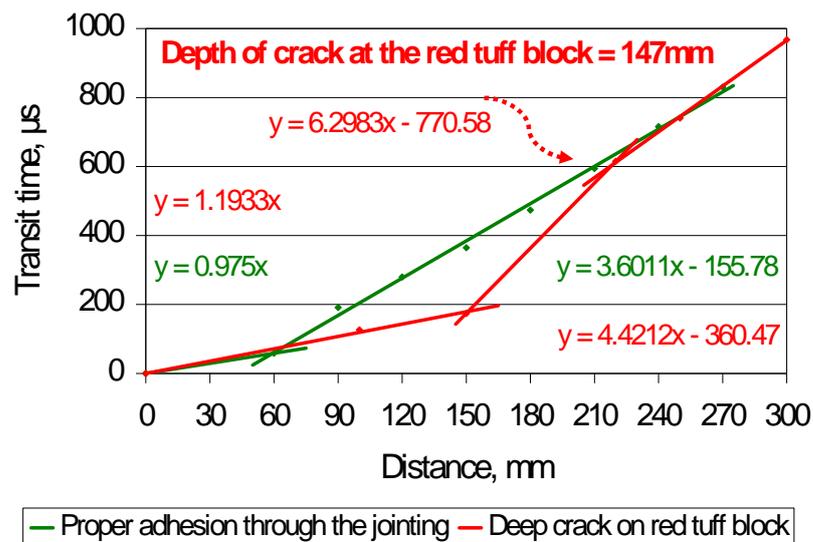
The transit time readings taken on the route of deeper crack and vertical jointing between the red tuff blocks were presented in Figure 4.41. For the case of deeper crack on red tuff block, cavity depth was found 147mm with the correlation coefficients (R^2) in the range of 0.995-1.00. 147mm depth meant that it extended along the cross section of red tuff block, having the dimensions of 15cmx94cmx20cm (width x length x height). The crack having almost 15cm depth showed that the block was separated entirely into two. It was not expected to achieve transit time readings in such a case when transmitter and receiver were placed at both sides of the crack. However, a reliable UPV data was obtained when the transducers placed at the opposite sides of crack, presenting a constant slope of 4.42 and indirect UPV value of 335m/s \pm 24m/s (Figure 4.41). It meant that broken tuff block was still well-fastened on the backing masonry with a proper adhesion.

Figure 4.41 The slope of regression lines for the tuff followed by proper jointing (line in green) and the change in the regression slope corresponding to the depth of crack which had separated the red tuff block into two (line in red).

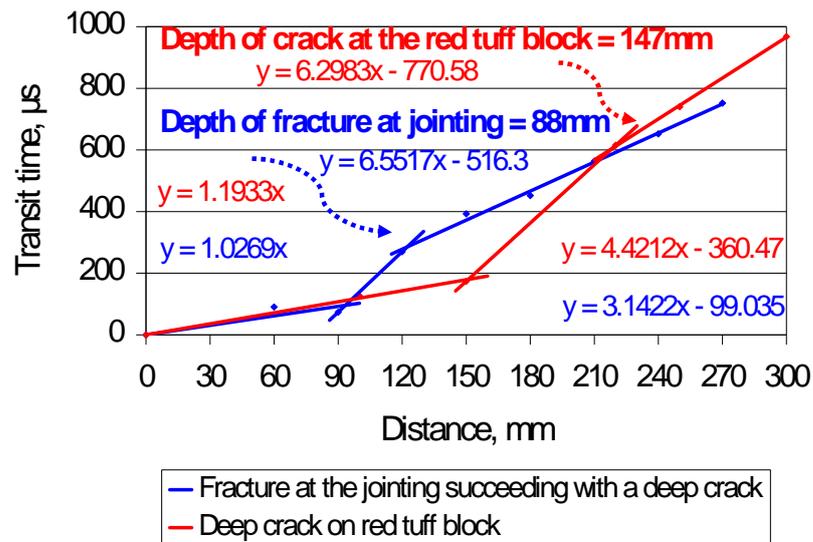
The results of indirect transit time readings taken on the route where there were two succeeding cracks being close to each other were summarized in Figure 4.42. Those cracks were “the fracture at jointing” followed by “the deep crack” on the red tuff

blocks surrounding the left bottom of window niche, as shown in Figure 4.40. The line in blue presented the UPV data taken on left-to-right direction when the fracture at jointing was the first crack on the route of measurement. The line in red presented the data taken at the opposite direction when the deep crack was the first crack on the route of measurement. When there were two successive cracks on the route of receiver, the displacement of regression line belonging to the first crack (fracture at jointing) seemed to dominate and conceal the signals for the following crack. The blue line in Figure 4.42 showed the sharp displacement of regression line for the fracture at jointing with the correlation coefficients (R^2) in the range of 0.75-1.00. (being the first crack on the route of transit time readings) while the red line in Figure 4.42 presented the displacement of regression line for the deep crack with the R^2 of 1.00 (being the first crack on the route of transit time readings).

Figure 4.42 The changes in the slope of regression lines for the tuff corresponding to the depth of crack (line in red) and the depth of fracture at jointing (line in blue).

When there were succeeding cracks/vertical discontinuities being close to each other on the same route of indirect UPV measurements, a special care should be given to the location of transmitter and the arrangement of the route for indirect UPV measurements, especially in the presence of successive defects. This meant that the direction of transit time readings became important for such cases. The sharp displacement of regression line, belonging to the first crack/discontinuity, seemed to hide the signs for the second/following crack(s), as shown in Figure 4.42. In order to improve the accuracy of the UPV analyses, the transit time readings should be taken by starting from both sides of cracks and repeating the measurements for several times.

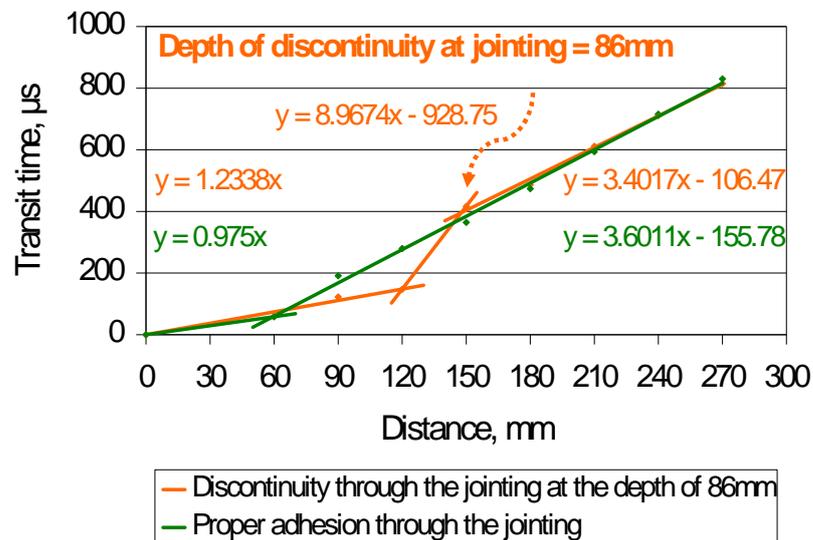
The results obtained from the transit time readings taken for the analyses of vertical and horizontal jointings between the red tuff blocks surrounding the right bottom of window niche were presented in the graph, as shown in Figure 4.43. Here, the red tuff presented a constant slope of regression line while the increase in the slope of

following regression line was due to the presence of jointing detail between neighbouring red tuff blocks (follow the line in green in Figure 4.43). The constant slope of 3.60 with the UPV value of 387m/s without any displacement in transit time readings demonstrated the sound/proper adhesion between the mortar and red tuff at the vertical jointing. On the other hand, the displacement in transit time measured immediately after the jointing with the correlation coefficients (R^2) in the range of 0.97-1.00 signalled the presence of a discontinuity/detachment which could not be observed visually (follow the line in orange in Figure 4.43). Here, the horizontal jointing at the right bottom of red tuff blocks was calculated to have a discontinuity at the depth of 86mm.

Figure 4.43 The slope of regression lines for the tuff followed by proper jointing (line in green) and the change in the regression slope corresponding to the depth of discontinuity at jointing (line in orange).

the UPV value of 387m/s without any displacement in transit time readings (follow the line in green in Figure 4.43). On the other hand, the displacement in transit time measured immediately after the horizontal jointing signalled the presence of a discontinuity at the depth of 86mm which could not be observed visually (follow the line in orange in Figure 4.43). Those jointings, both vertical and horizontal ones, where no visual defect/failure noticed on their surfaces, were found to be sound as well up to a certain depth according to the QIRT analyses. Similar thermal inertia characteristics were determined for the visually-sound jointing mortar and red tuff blocks according to their similar thermal response during the heating period of 15 minutes by halogen lamp (Table 4.1). Considering all, the defect at horizontal jointing should be a local detachment at depth about 86mm, behind which proper adhesion was again achieved.

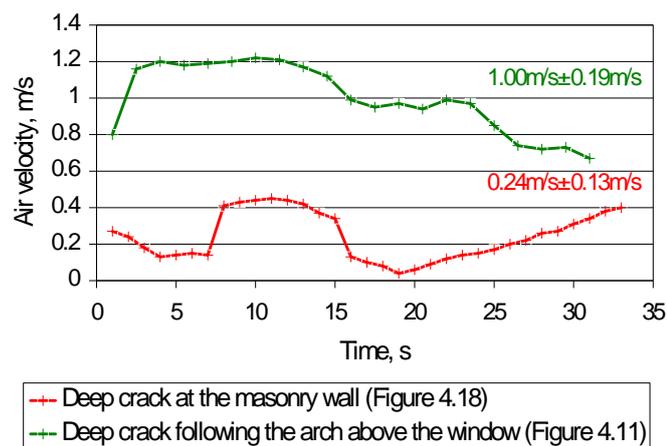
The presence of air flow through the cavity of cracks was measured by using anemometer “VELOCICALC 8364”. Recorded V_{AIR} values for a period of 30seconds were given in Figure B.1. The V_{AIR} values were found to be in the range of 0.04m/s and 0.45m/s for the crack at the masonry wall located at the left bottom of window niche. Air flow passing through the cavity of the same crack was measured to be $0.04l/s \pm 0.04l/s$ for a period of 30 seconds when the sizes of airflow were accepted to be 1cmx6.5cm in width and length. The V_{AIR} values for the crack following the arch above the window were found varying in the range of 0.67m/s and 1.22m/s. Air flow passing through the cavity of the same crack was measured to be $0.41l/s \pm 0.17l/s$ for a period of 30 seconds when the sizes of airflow were accepted to be 1cmx5cm in width and length. No airflow was measured for the other cracks.

Figure B.1 The V_{AIR} values measured at the cavities of deep cracks at the east side of the structure for a period of 30 seconds, proving the presence of air flow between outside and inside through the cracks.
