ASSESSMENT OF SLOPE STABILITY FOR A SEGMENT
(Km: 25+600-26+000) OF ANTALYA-KORKUTELİ HIGHWAY

A THESIS SUBMITTED TO
THE GRADUATE SCHOOL OF NATURAL AND APPLIED SCIENCES
OF
MIDDLE EAST TECHNICAL UNIVERSITY

JUNE 2010

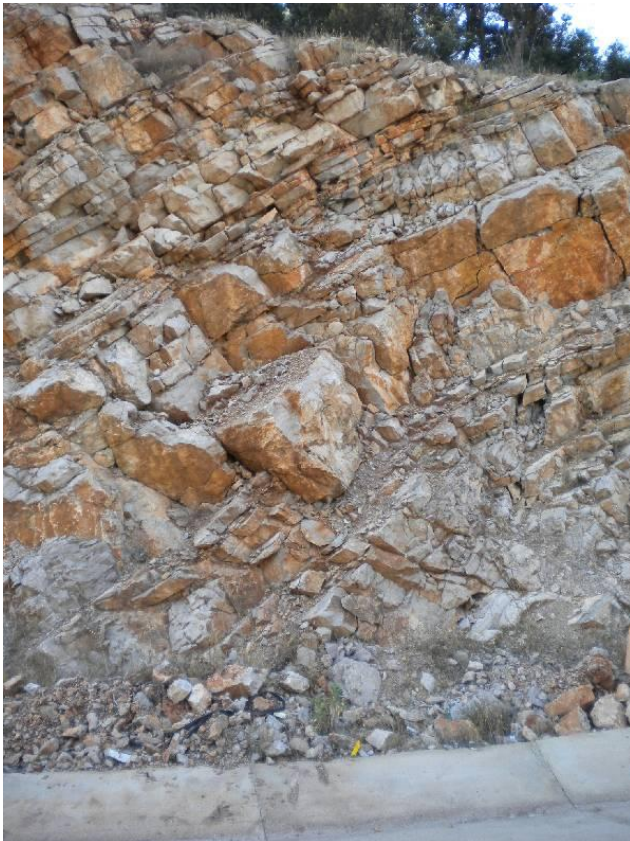
Figure 3.7. A view from the limestone facing north at Km: 25+600.

The limestone at this locality is beige to gray, fine grained (micritic), fossiliferous, and highly jointed (Figure 3.7). Fifty six discontinuity measurements were taken during the scan-line survey carried out for a length of nearly 30 meters. The joints and bedding plane constitute the major discontinuities at this location.

The discontinuities generally have close to wide (60 mm-1000 mm) spacing, tight to partly open (0.1 mm-0.5 mm) aperture, planar rough to undulating rough discontinuity surfaces, slightly weathered mainly in

the form of discoloration along discontinuity surfaces although some karstic cavities exists near the surface, medium strong and strong. The discontinuities have practically no infill material except upper 1 m. On the other hand, the discontinuities are locally filled by secondary calcite. Most of the discontinuities (bedding planes and joints) have high persistence mainly greater than 10 m, but one of the joint set is bed confined. No groundwater seepage was encountered at this location.

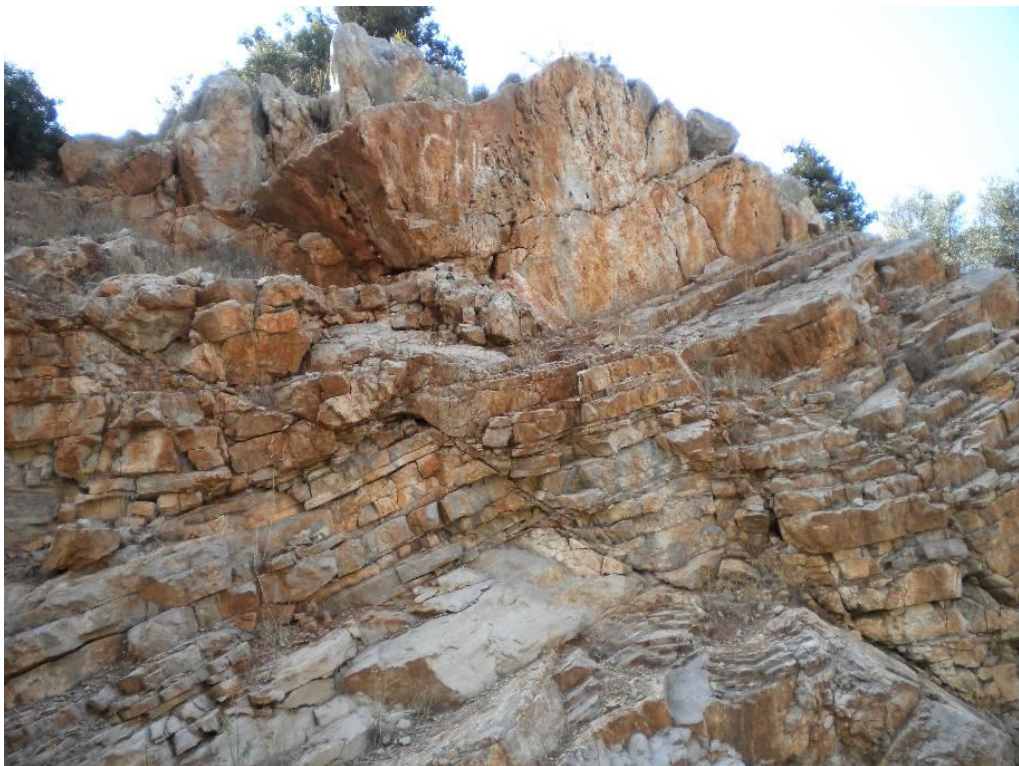
Figure 3.11. A view from the limestone facing north at Km: 25+600.

Based on the discontinuity analysis, there are two dominant joint sets and one bedding plane (Figure 3.11). The orientation data of the discontinuities are presented in Table 3.1. The joint sets (J1 and J2) have dip amount/dip direction of poles of 35/191 and 60/141. On the other hand, dip amount/dip direction of the bedding plane (BP) is 70/214.

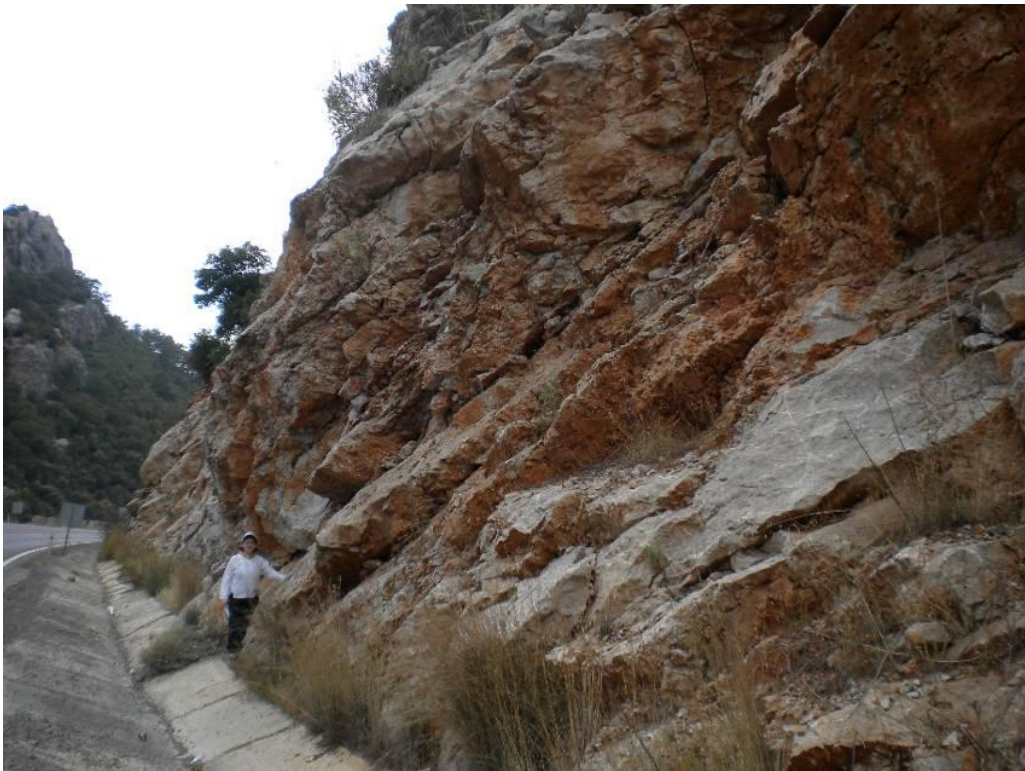
Figure 3.12. A view from the limestone facing north at Km: 25+900.

The limestone at this locality is very similar to the one observed at Km:25+600. The rock is beige to gray, fine grained, and highly jointed (Figure 3.12). One hundred forty eight discontinuity measurements were taken during the scan-line survey carried out for a length of nearly 30 meters. The joints and bedding plane constitute the major discontinuities at this location.

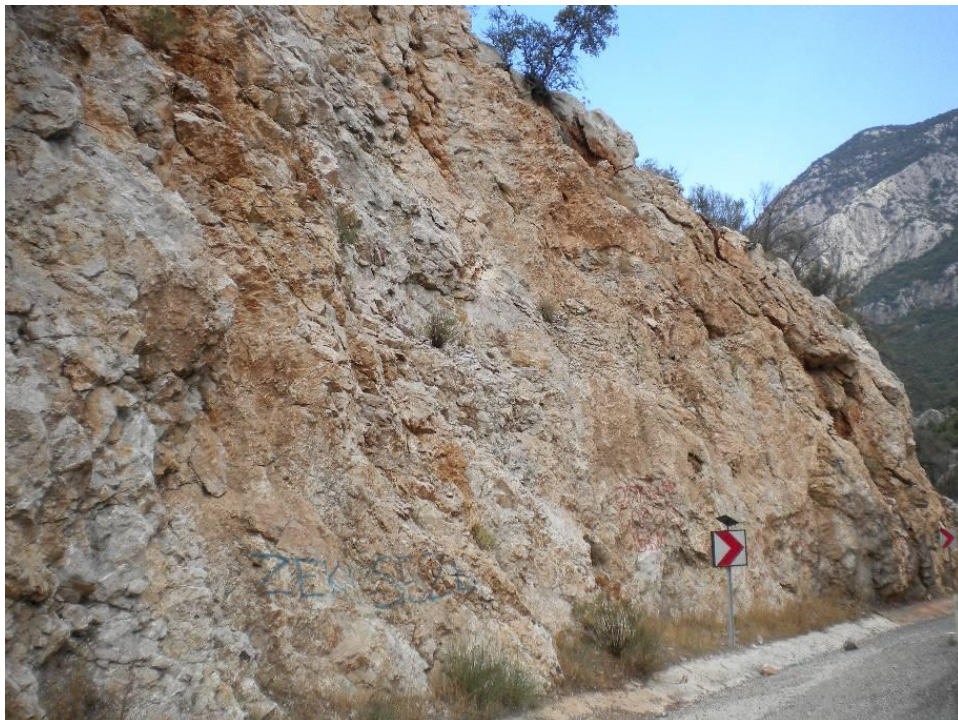
Figure 3.16. A view from the limestone at Km: 25+900.

Based on the discontinuity analysis, there are two joint sets and one bedding plane at this location (Figures 3.15 and 3.16). The orientation data of the discontinuities are presented in Table 3.2. The joint sets have dip amount/dip direction of 25/135 and 57/256. On the other hand, dip amount/dip direction of the bedding plane is 55/345.

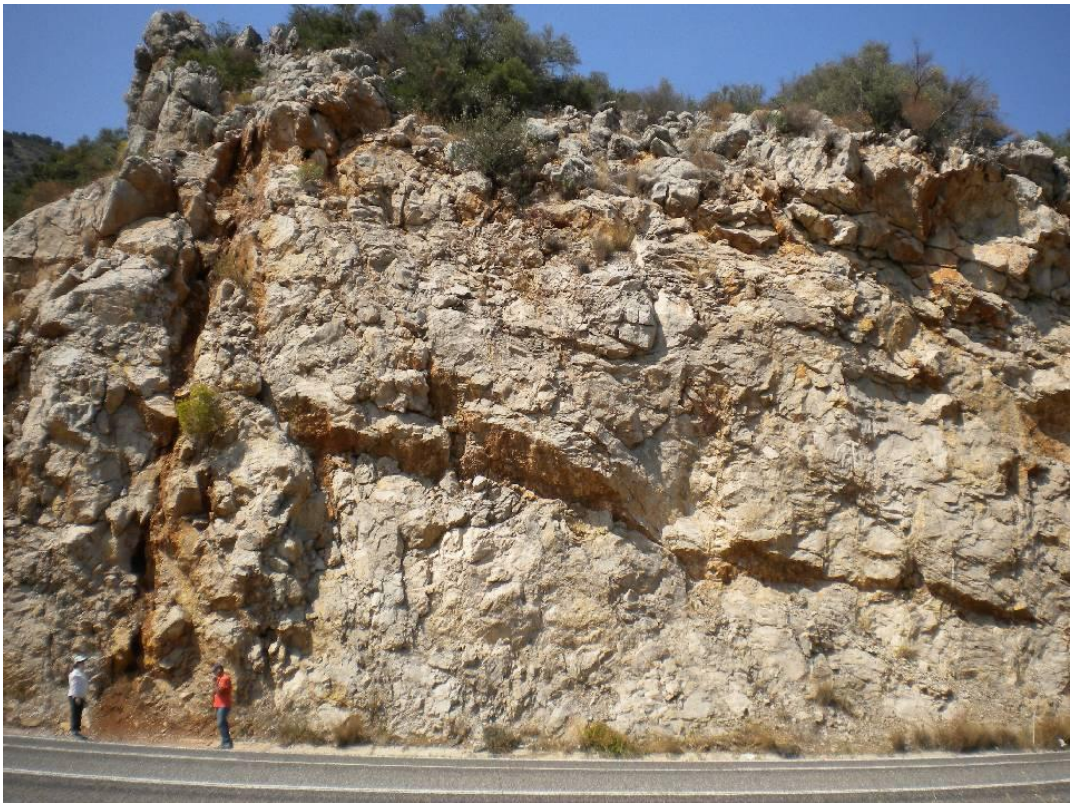
Figure 3.17. A view from the limestone facing north at Km: 26+000.

The limestone at this locality is also very similar to the one observed at Km:25+600 and 25+900. The rock is beige to gray, fine grained, and highly jointed (Figure 3.17). Seventy six discontinuity measurements were taken during the scan-line survey carried out for a length of nearly 30 meters. Similar to other two locations, the joints and bedding plane constitute the major discontinuities at this location.

The discontinuities have close to wide (60 mm-1000 mm) spacing, tight to partly open (0.1 mm-0.5 mm) aperture, planar rough to undulating rough discontinuity surfaces. The weathering is dominant only near the

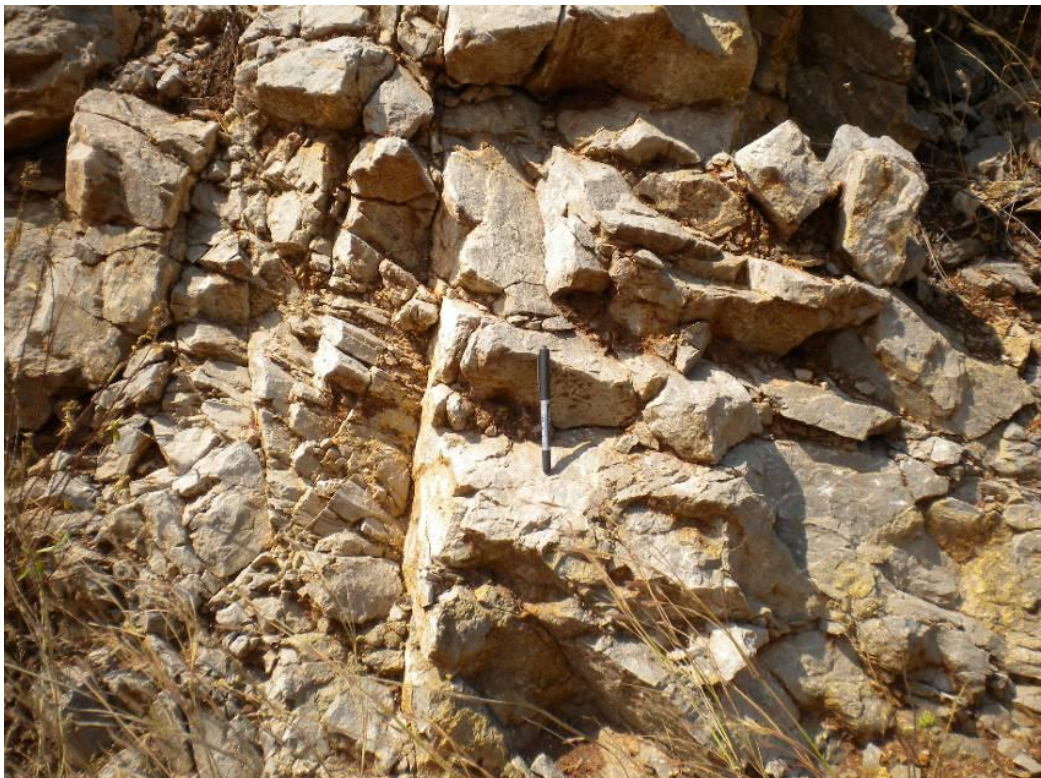
Figure 3.21. Discontinuities developed in the limestone at Km: 26+000.

Based on the discontinuity analysis, it is found that two dominant joint sets and one bedding plane exist at this location (Figures 3.20 and 3.21). The orientation data of the discontinuities are presented in Table 3.3. The joint sets have dip amount/dip direction of 40/335 and 84/268. On the other hand, dip amount/dip direction of the bedding plane is 45/175.

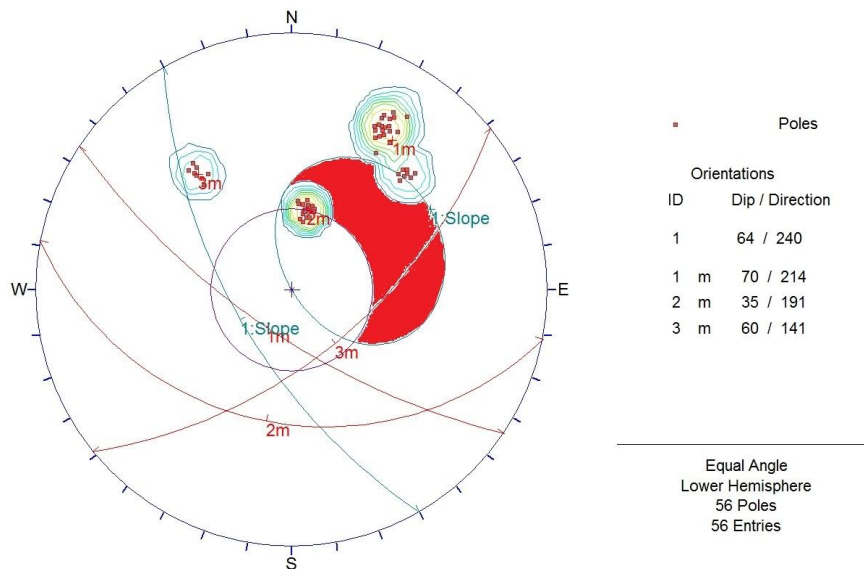
Figure 4.2. Kinematic analysis of the cut slope for planar failure at Km: 25+600.

At this location, two joint sets and a bedding plane form the main discontinuities (Figure 4.1). The kinematic analysis for planar failure performed at Km: 25+600 shows that except one joint set, no plane failure is expected. Nevertheless, the poles of this problematic joint set partly fall within the daylight envelope. Since the difference of the strikes between the slope (64/240) and the discontinuity (35/191) is more than 20° , no planar failure is expected at this location (Figure 4.2). According to the kinematic analysis for wedge and toppling failures (Figures 4.3 and 4.4), the cut slope is stable for both cases.

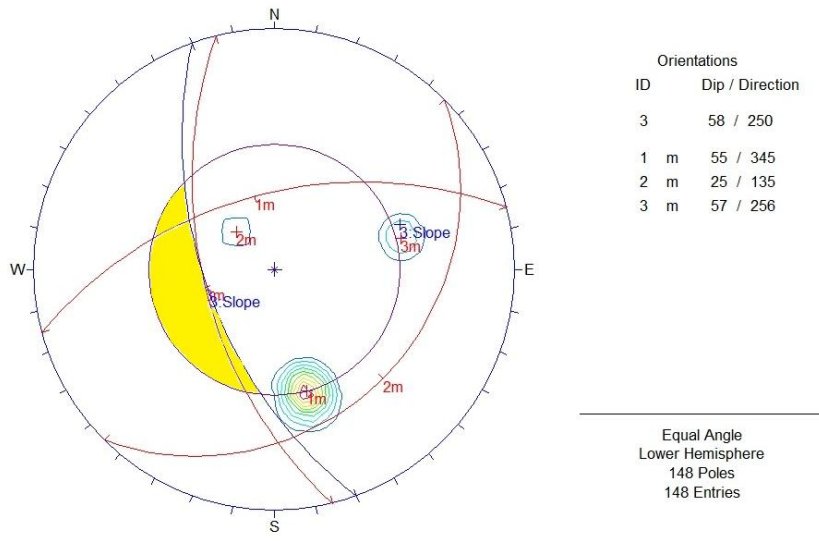
Figure 4.9. Elimination of the wedge failure kinematically by flattening of the slope at Km: 25+900.

The kinematic analysis for wedge failure performed at Km: 25+900 shows that the intersection of the bedding plane (55/345) and joint set 2 (25/135) falls within the danger zone. Therefore, wedge failure is likely to occur at this location (Figure 4.8). In order to eliminate this problem, a slope flattening of 8° is suggested (Figure 4.9). The kinematic analysis for toppling failure reveals that no toppling failure is likely at this cut slope (Figure 4.10).

As a summary, according to the kinematic analysis carried out at Km:25+900, the cut slope does not have any toppling failures, but the planar and wedge failures are likely to occur. 10° of slope flattening will eliminate both risks. Therefore, only kinematic analysis is performed for this part of the study area.

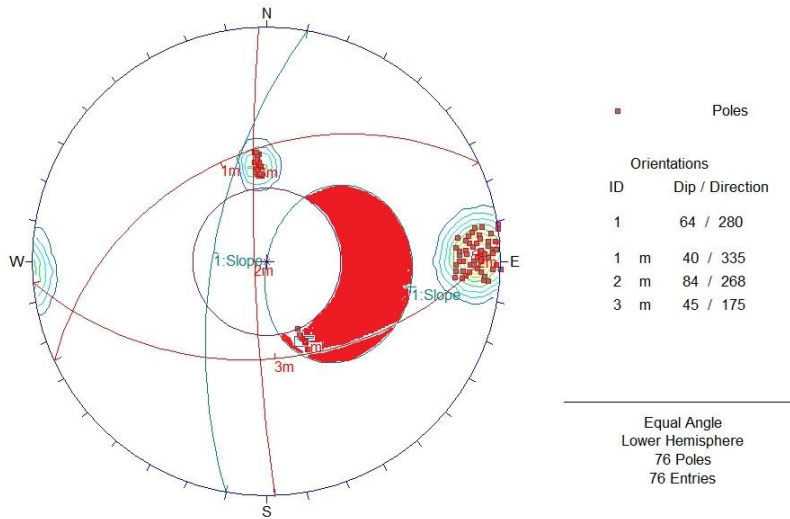
Figure 4.12. Kinematic analysis of the cut slope for planar failure at Km: 26+000.

Similar to the other two cut slopes, two joint sets and a bedding plane also form the main discontinuities at Km: 25+900 (Figure 4.11). The kinematic analysis for plane failure performed at Km: 26+000 shows that although poles of the joint (J2) partly fall within the daylight envelope, its dip amount is steeper than the slope angle (Figure 4.12). Thus, this discontinuity is not daylighting. So, no planar failure is expected at this location.

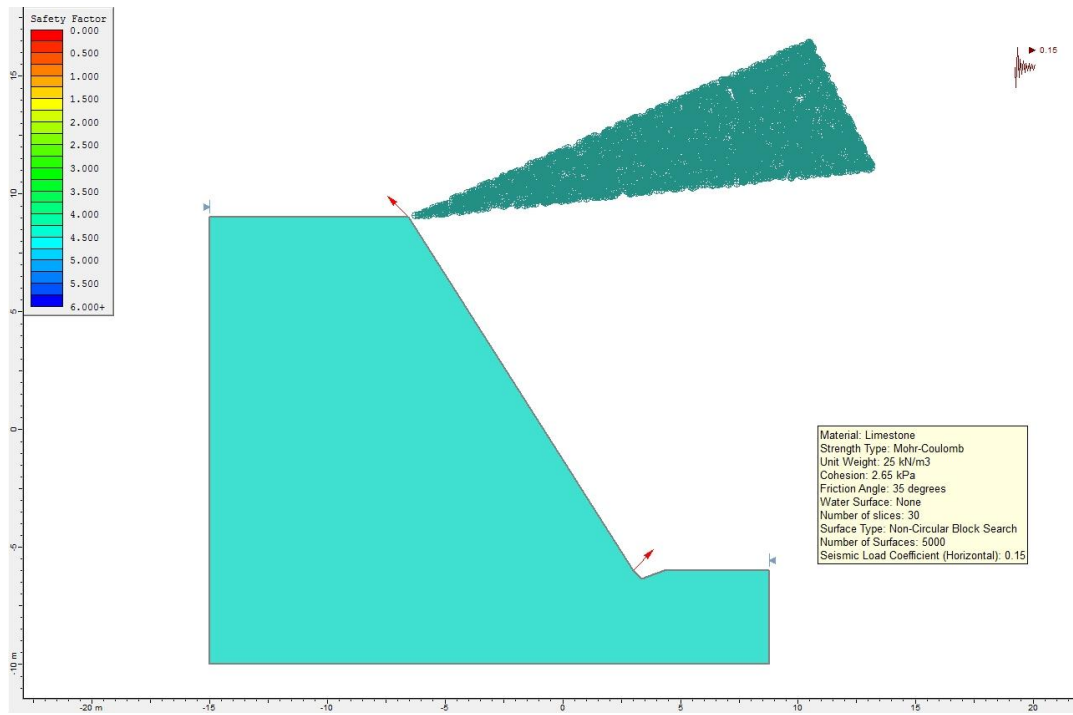
Figure 5.4. Limit equilibrium analysis of the flattened cut slope by 7°.

According to the analysis carried out, this part is found to be the most problematic part of the highway. It is not safe in the current situation due to a very low factor of safety of 0.50 with seismic coefficient (Figures 5.1-5.3).

As a remedial solution slope flattening has been utilized. The slope angle of this part is 64° . Based on the analysis (Figure 5.4), the desired factor of safety is achieved in case the cut slope is flattened by 7° , thus forming a new slope with 57° .

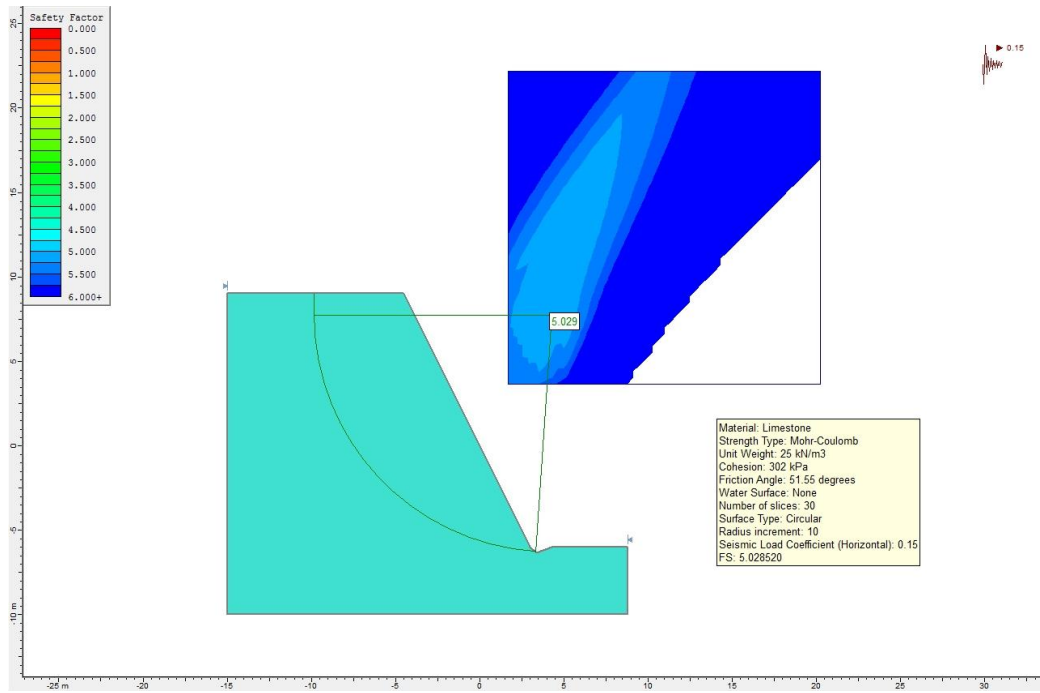
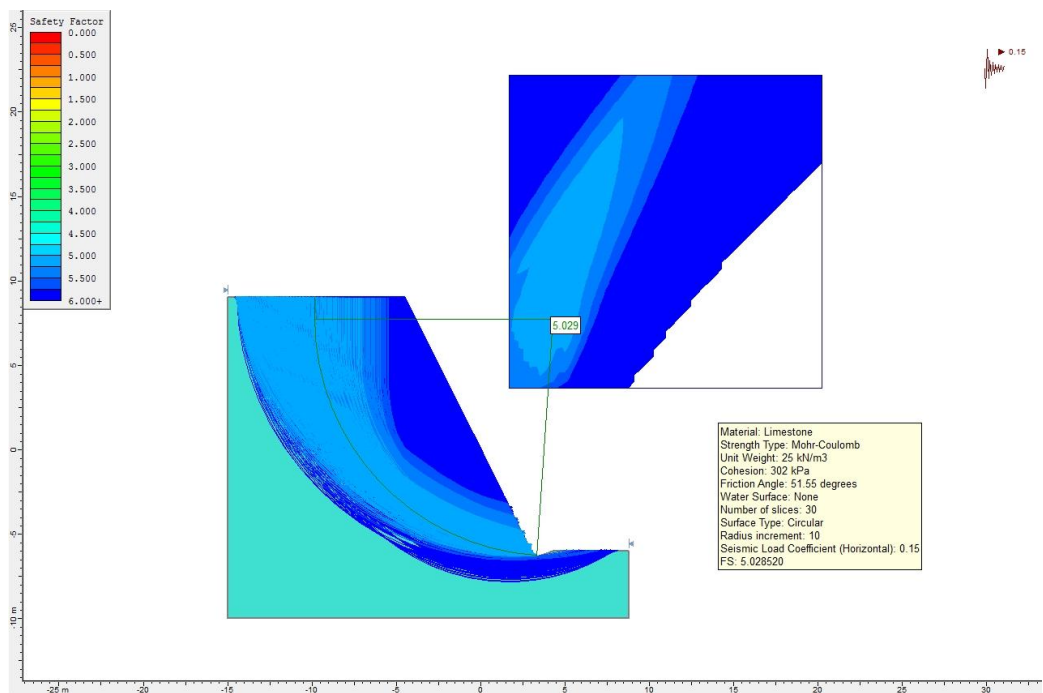
After obtaining the instantaneous cohesion (c) and the internal friction angle (ϕ) values from the RocLab software program, SLIDE software was run again in order to analyze the mass failure risk. The seismicity coefficient is also taken as 0.15 and the slope is analyzed for dry case only. According to the analysis carried out, this part is completely safe in current situation having a factor safety of 5.03 (Figures 5.10-11).

Figure 5.10. Limit equilibrium analysis of the cut slope for mass failure with current slope geometry.

Figure 5.11. Limit equilibrium analysis of the cut slope for mass failure with all possible failure surfaces

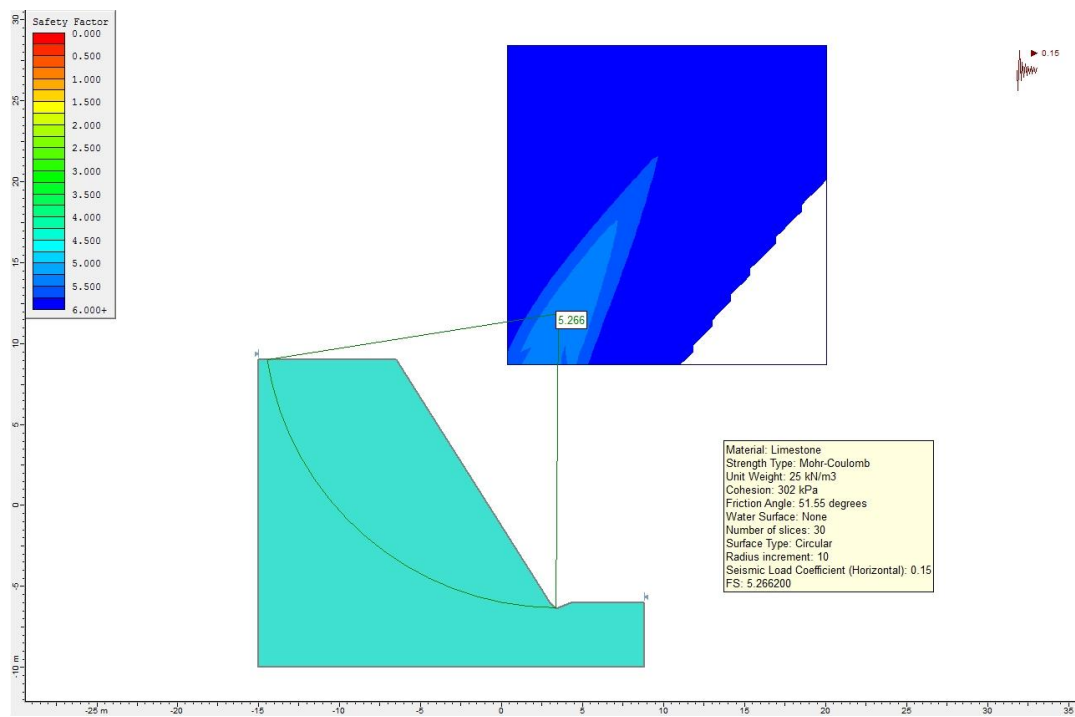
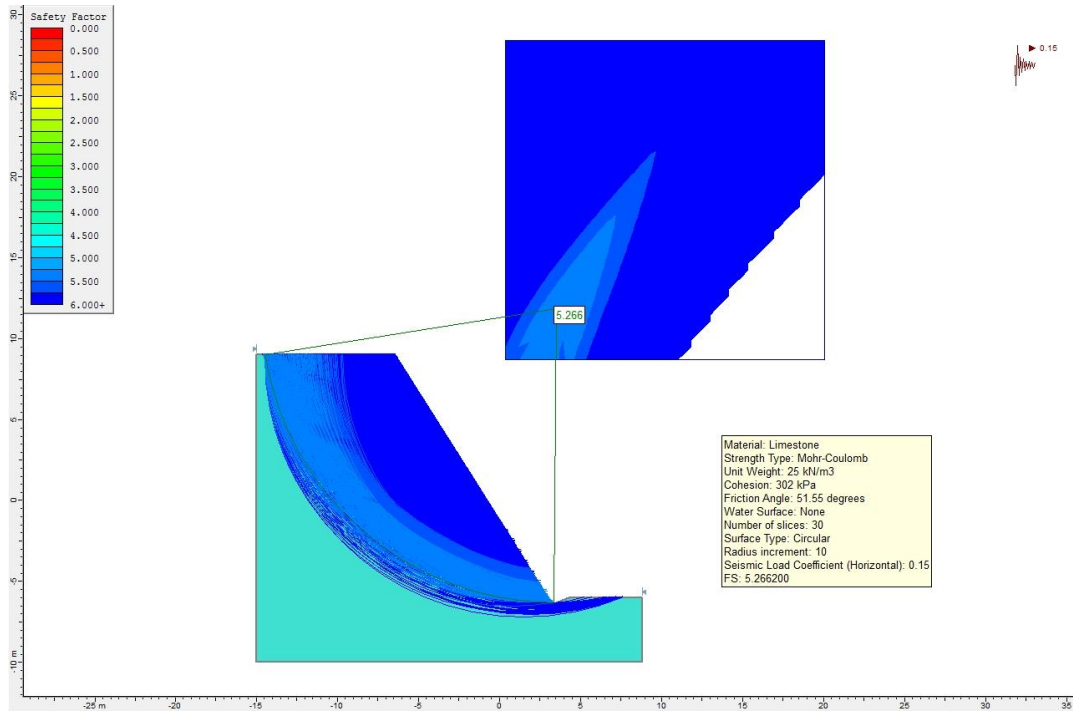
Figure 5.12. Limit equilibrium analysis of the cut slope for mass failure after slope flattening.

Figure 5.13. Limit equilibrium analysis of the cut slope for mass failure after slope flattening with all possible failure surfaces.

As a remedial solution for Km: 25+900, slope flattening has been suggested. In order to see the effects of this remedial solution for the mass failure, limit equilibrium analysis is done. The slope angle of this part was 64° but for the slope flattening solution of Km:25+900, it was changed as 57°. The resultant factor of safety is found to be 5.27 (Figures 5.12 and 5.13).

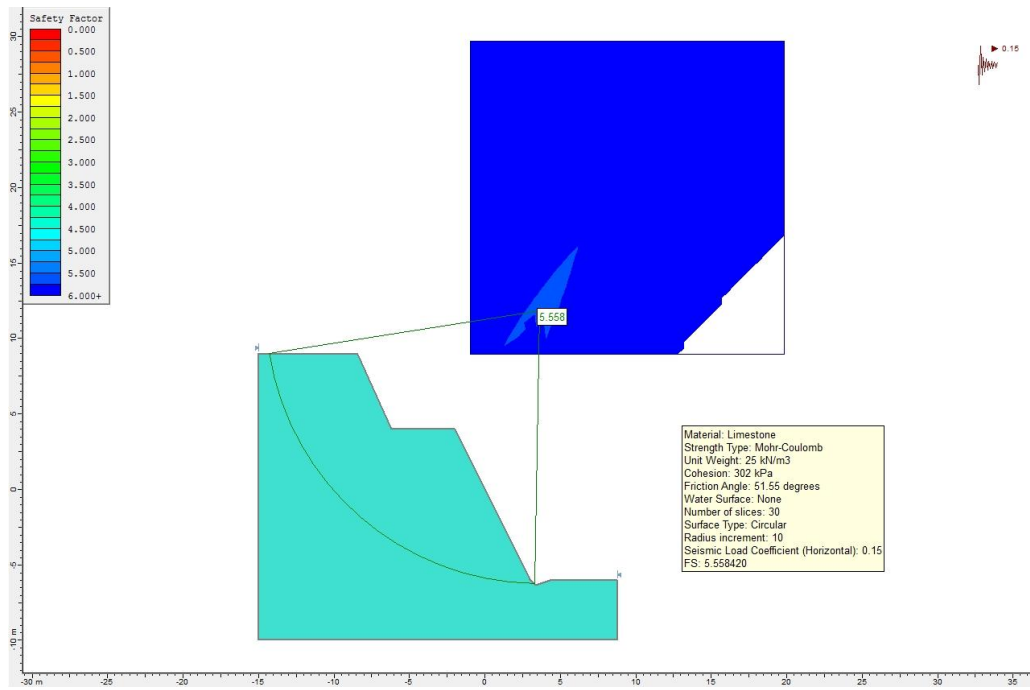
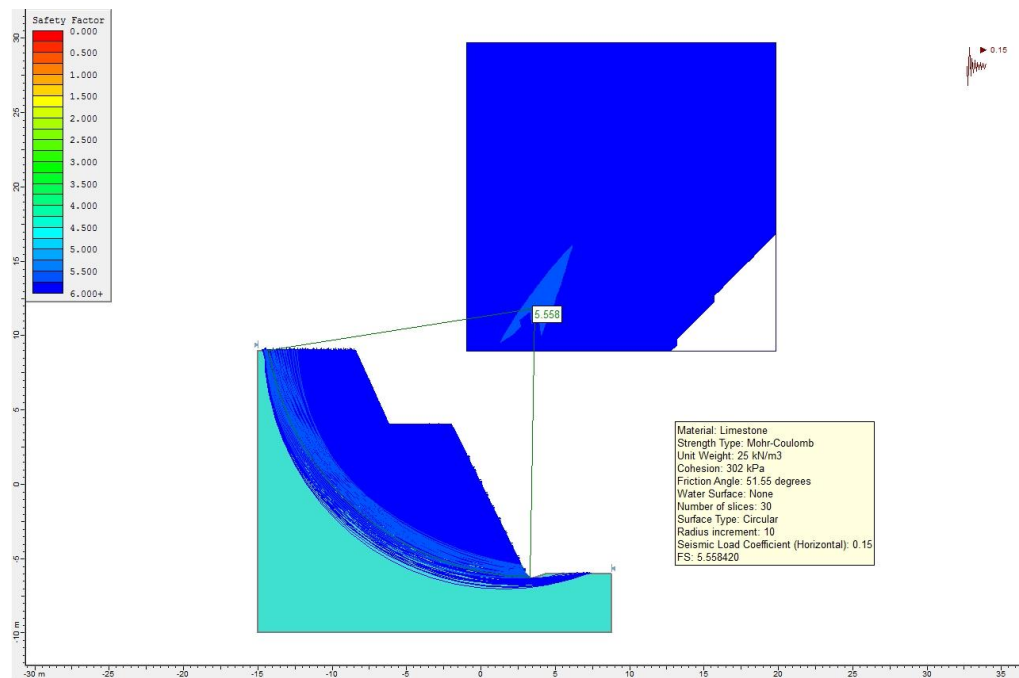
Figure 5.14. Limit equilibrium analysis of the cut slope with bench for mass failure.

Figure 5.15. Limit equilibrium analysis of the cut slope with bench and all possible failure surfaces for mass failure.

As another remedial solution for Km: 25+900, bench has been suggested. In order to see the effects of this remedial solution for the mass failure, limit equilibrium analysis is also done. Another reason to run the limit equilibrium analysis for mass failure in bench solution is that according to the General Directorate of Highway, the slopes cannot be higher than 10 meters without benches. The height of the bench is planned as 10 meters from the road elevation. The horizontal length of the bench is suggested as 5 meter, as indicated before. The resultant factor of safety is found to be 5.56 (Figures 5.14 and 5.15).

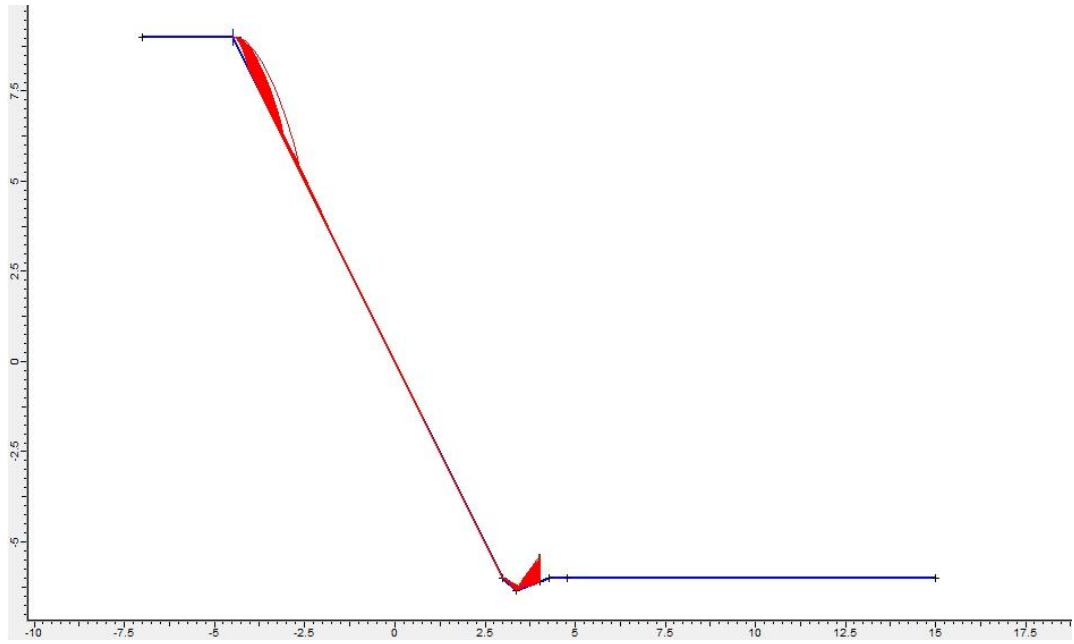
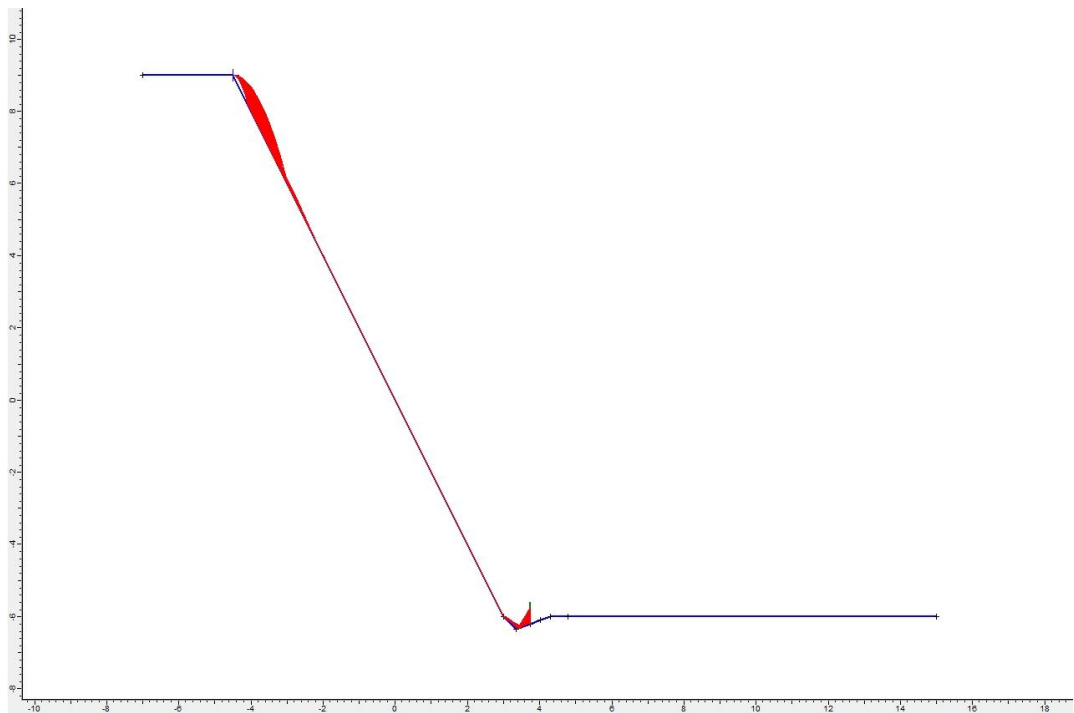
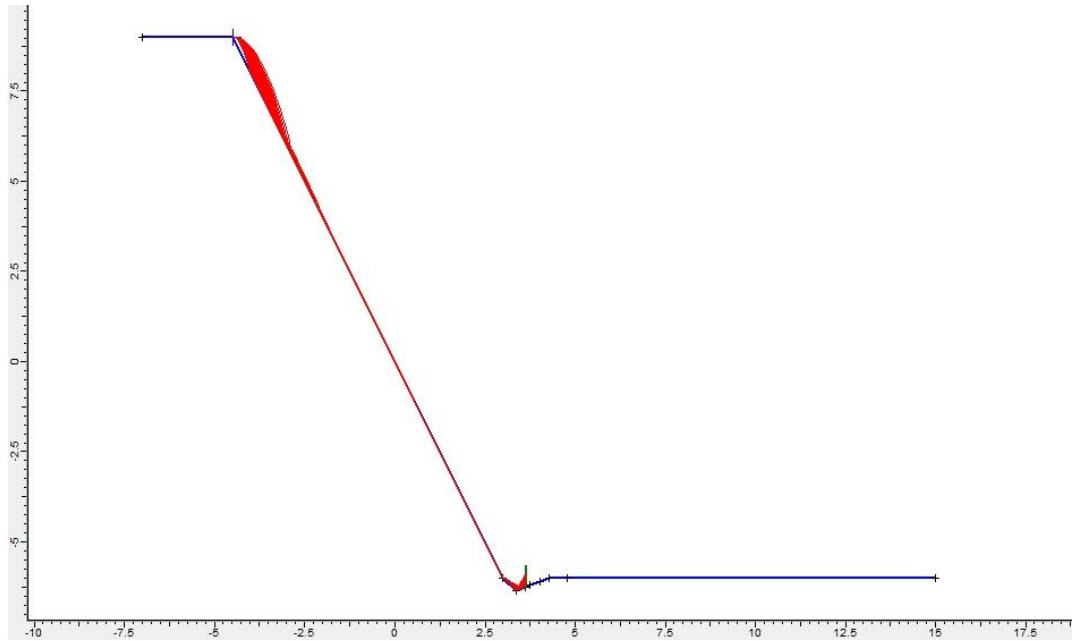
Figure 5.19. Rockfall analysis with 10 kg block and barrier solution for current slope condition.

Figure 5.20. Rockfall analysis with 60 kg block and barrier solution for current slope condition.

Figure 5.21. Rockfall analysis with 150 kg block and barrier solution for current slope condition.

As a solution, catch barrier can be implemented if the slope geometry is not modified. In order to see the behavior of the limestone blocks, the rockfall analysis is also done with the barrier (Figures 5.19-21). As can be seen from the figures, the barrier works well, but it should be installed very close to the road which is not desired in engineering practice.

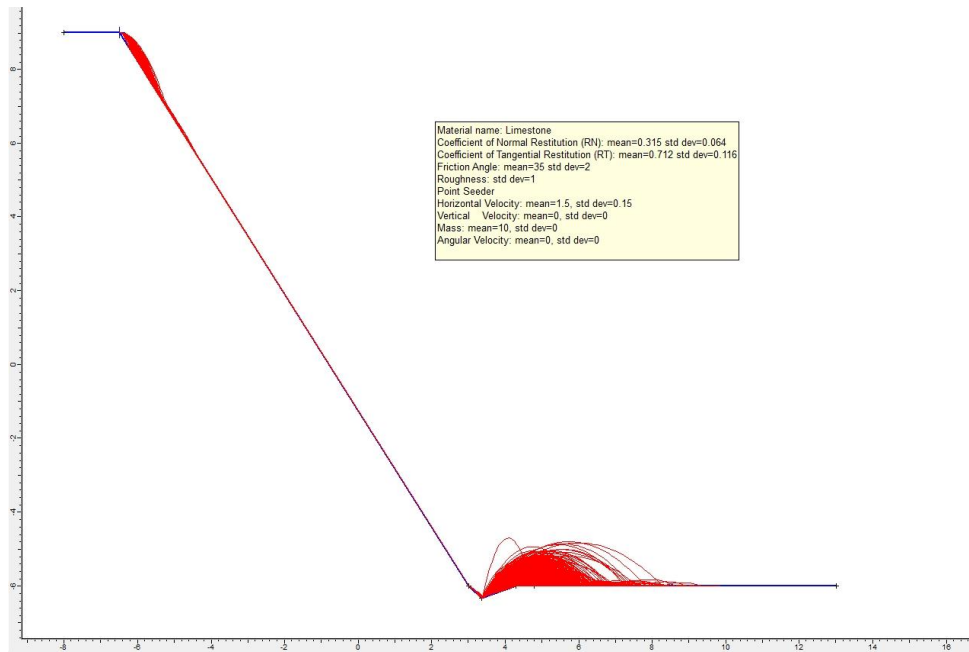
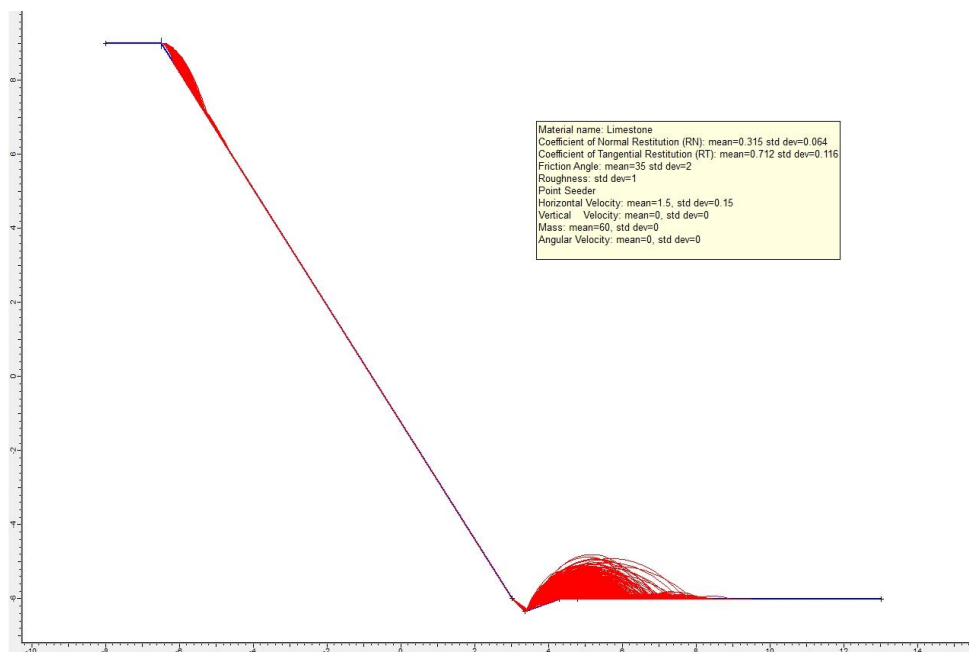
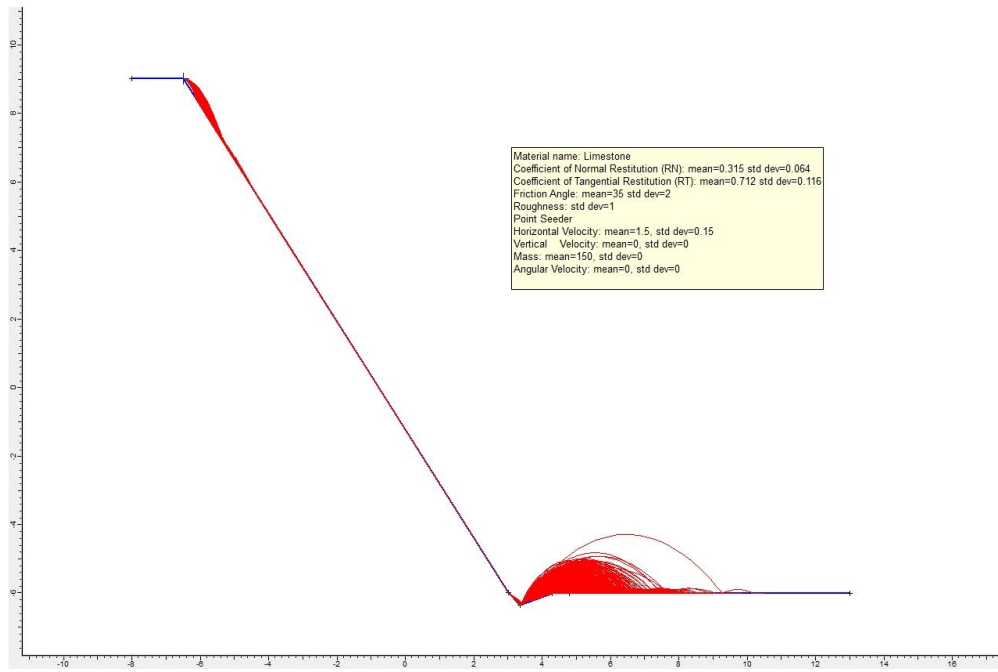
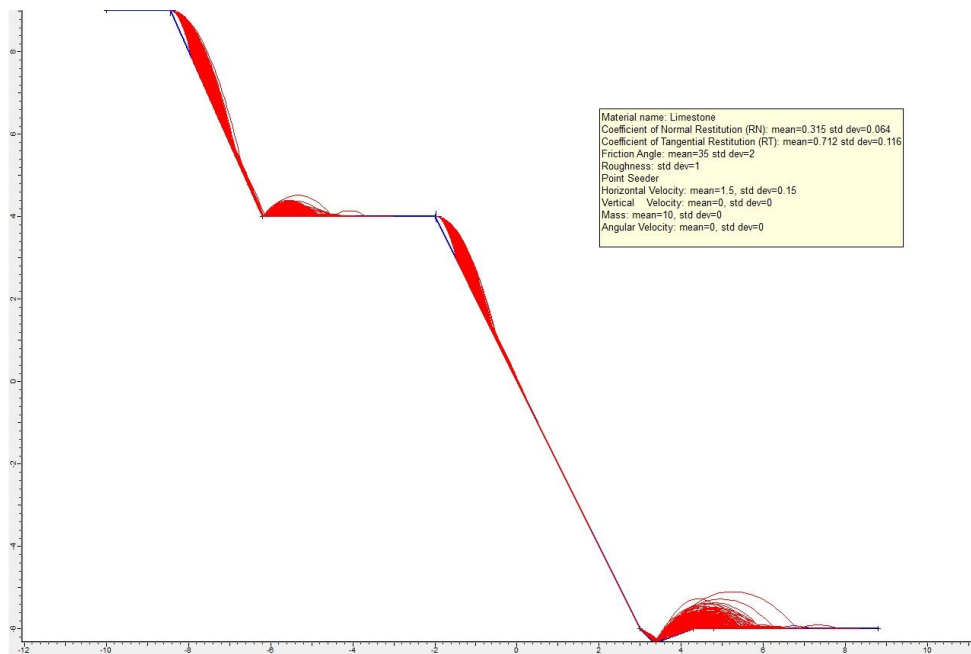
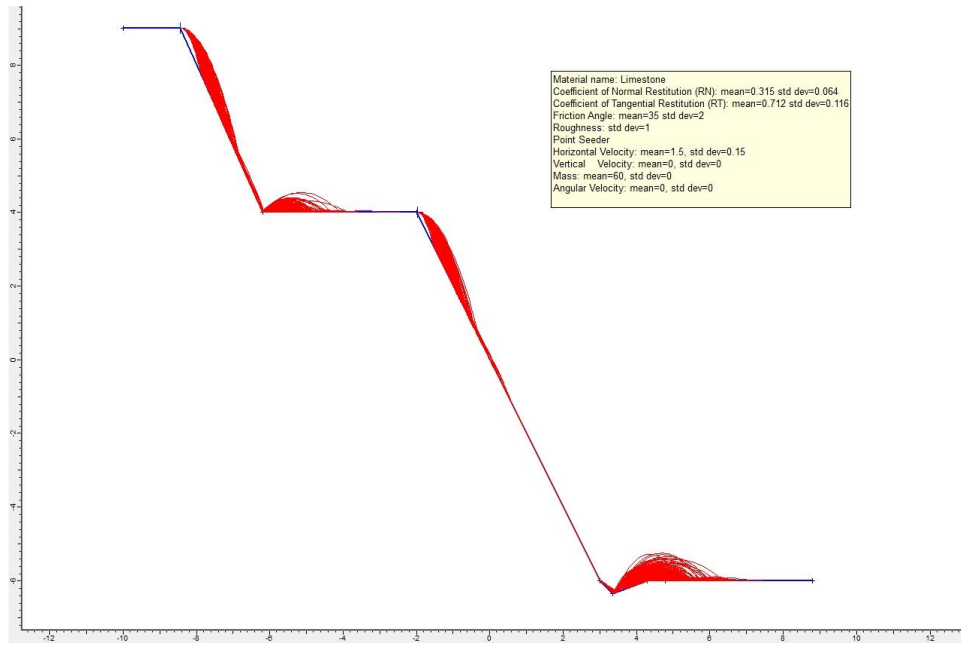
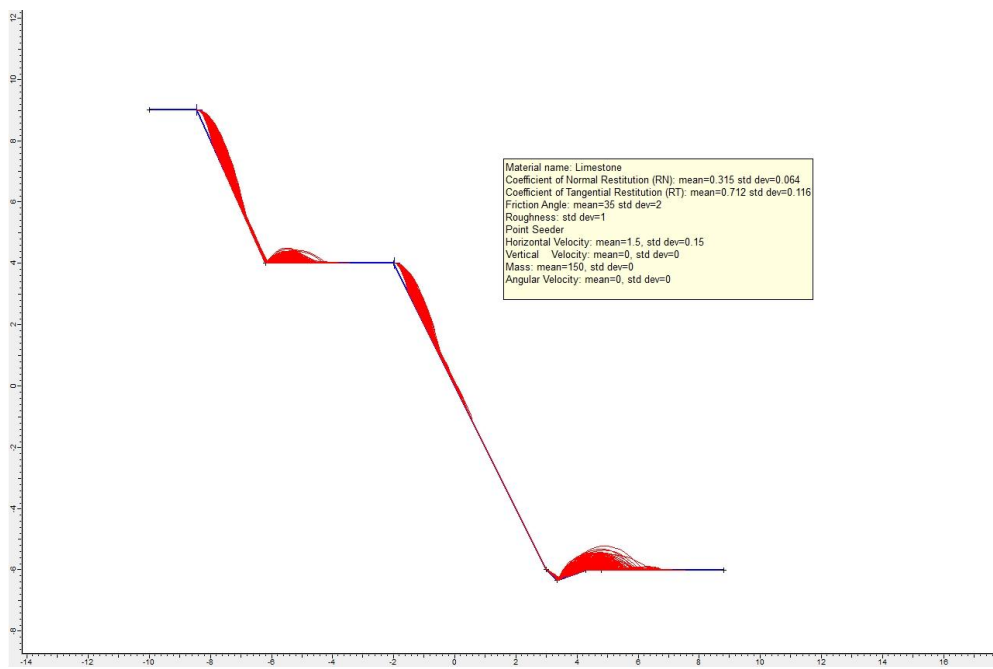
The calculation was done for 10 kg, 60 kg and 150 kg, for both slope flattening (Figures 5.22-5.24) and bench solutions (Figures 5.25-5.27). The slope angle is changed from 64° to 57° . The height of the bench is 10 m and the width is 5 m. As a result, the rocks always ended up in the road.

Figure 5.22. Rockfall analysis with 10 kg block and slope flattening solution at Km: 25+600.

Figure 5.23. Rockfall analysis with 60 kg block and slope flattening solution at Km: 25+600.

Figure 5.24. Rockfall analysis with 150 kg block and slope flattening solution at Km: 25+600.

Figure 5.25. Rockfall analysis with 10 kg block and bench solution at Km: 25+600.

Figure 5.26. Rockfall analysis with 60 kg block and bench solution at Km: 25+600.

Figure 5.27. Rockfall analysis with 150 kg block and bench solution at Km: 25+600.
