ASSESSMENT OF SLOPE STABILITY FOR A SEGMENT
(Km: 25+600-26+000) OF ANTALYA-KORKUTELİ HIGHWAY

A THESIS SUBMITTED TO
THE GRADUATE SCHOOL OF NATURAL AND APPLIED SCIENCES
OF
MIDDLE EAST TECHNICAL UNIVERSITY

JUNE 2010

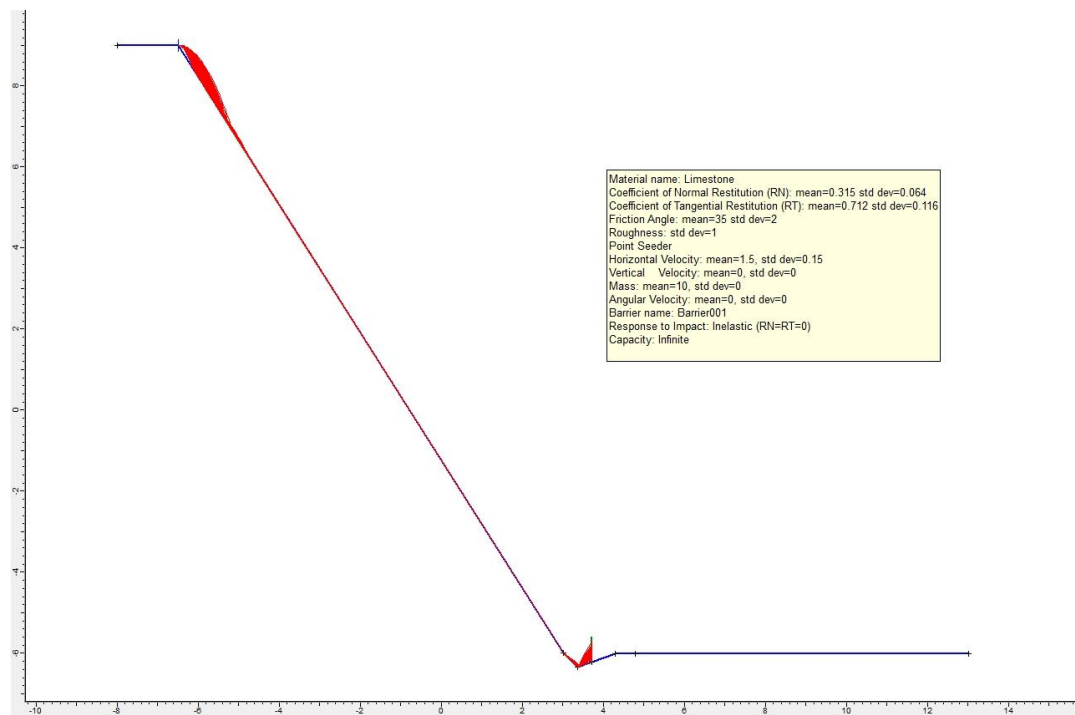
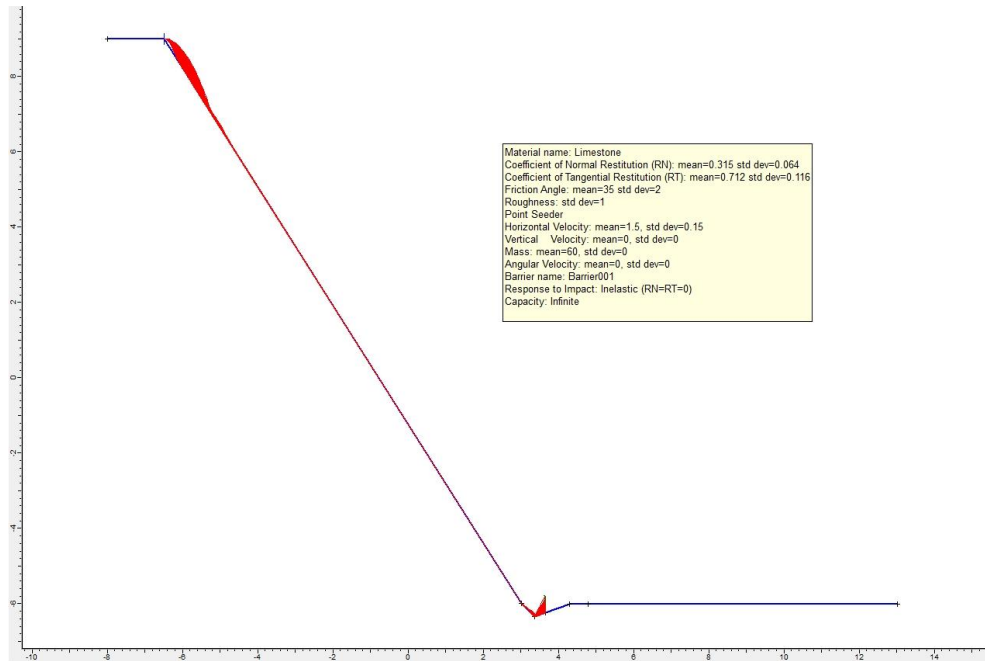
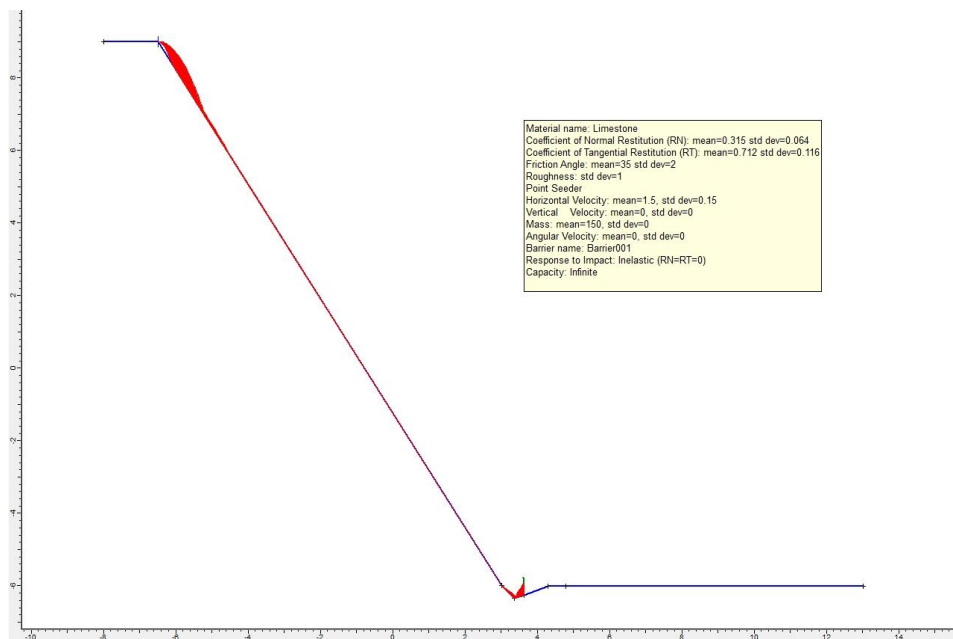
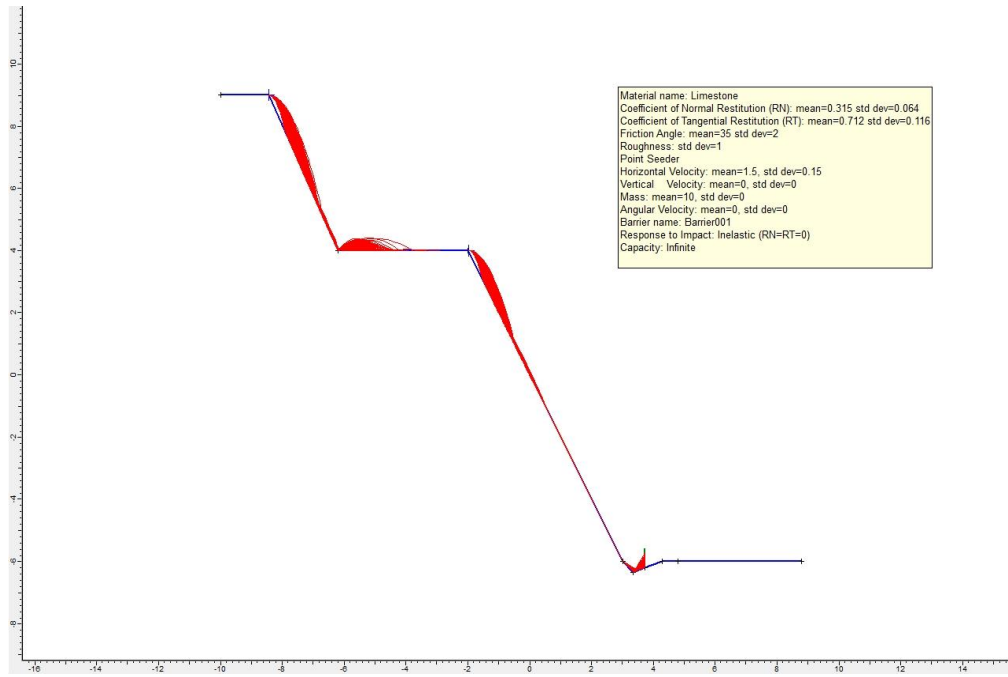
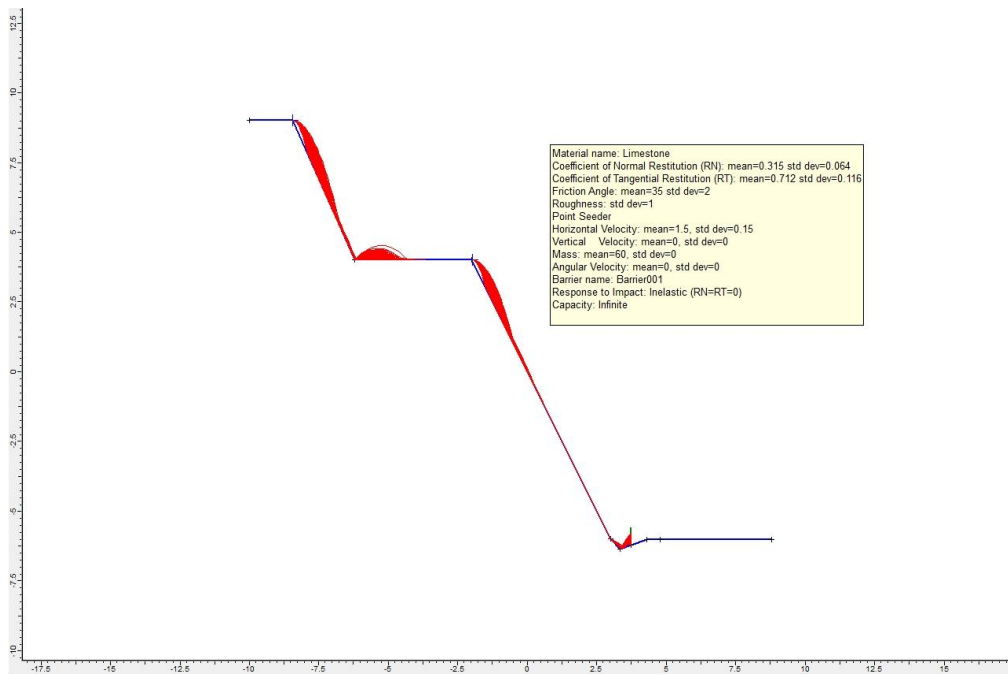
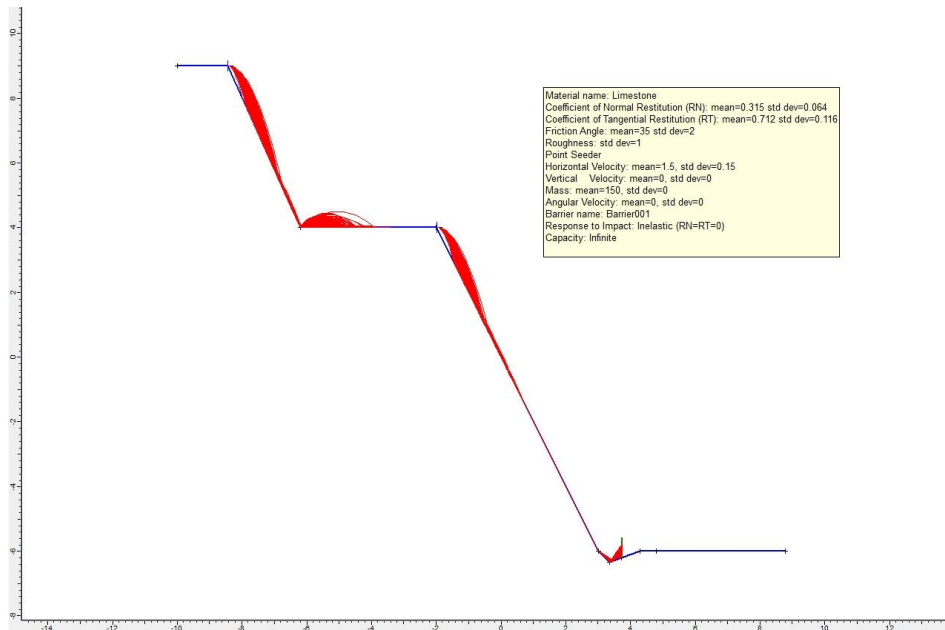
Figure 5.28. Rockfall analysis (10 kg block) with slope flattening and barrier solution at Km: 25+600.

Figure 5.29. Rockfall analysis (60 kg block) with slope flattening and barrier solution at Km: 25+600.

Figure 5.30. Rockfall analysis (150 kg block) with slope flattening and barrier solution at Km: 25+600.

Figure 5.31. Rockfall analysis (10 kg block) with bench and barrier solution at Km: 25+600.

Figure 5.32. Rockfall analysis (60 kg block) with bench and barrier solution at Km: 25+600.

Figure 5.33. Rockfall analysis (150 kg block) with bench and barrier solution at Km: 25+600.

As a solution, catch barrier can also be thought here. In order to see the behavior of the individual rocks, the rockfall analysis is also done with slope flattening and the barrier (Figures 5.28-5.30), as well as bench and the barrier (Figure 5.31-5.33). Still, the barrier works well. However, it should be installed very close to the road.

Based on the rockfall analyses, one can say that the rocks falling from the upper part of the slope do not fall to the road. The bench holds all the rocks. Therefore, benching may be suggested at Km: 25+600 for the upper part of the slope from rockfall point of view.

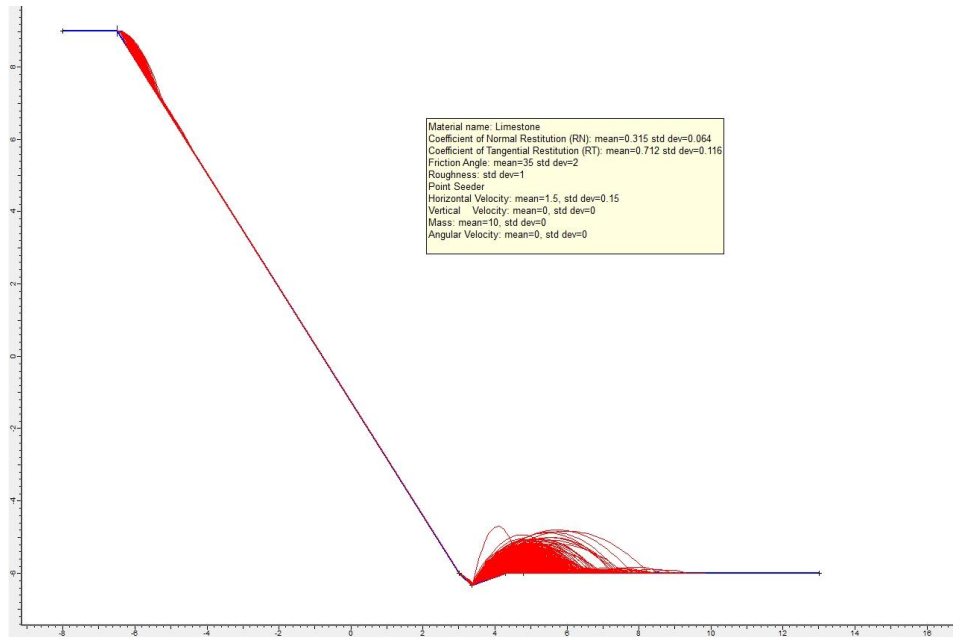
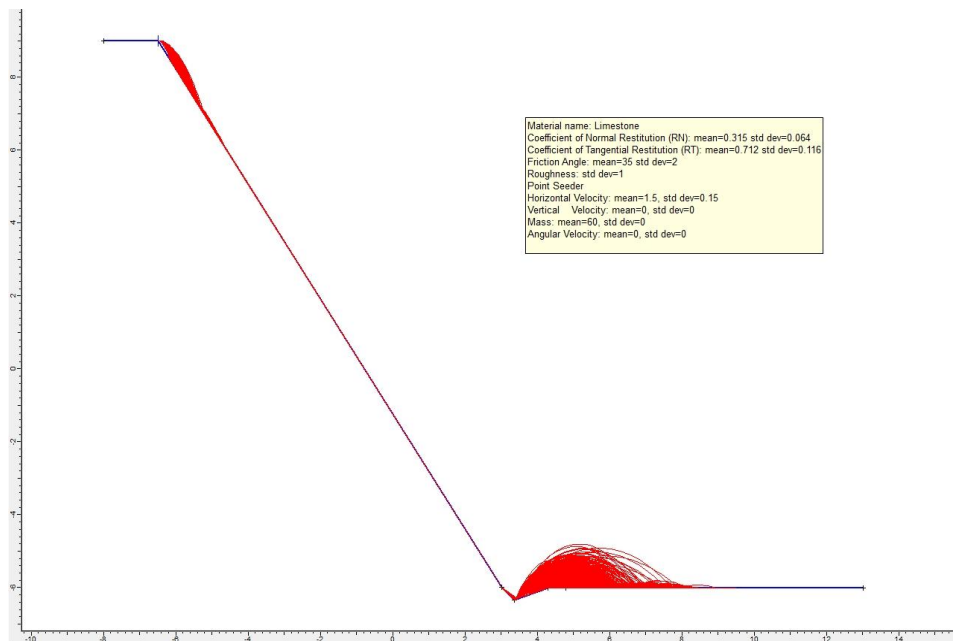
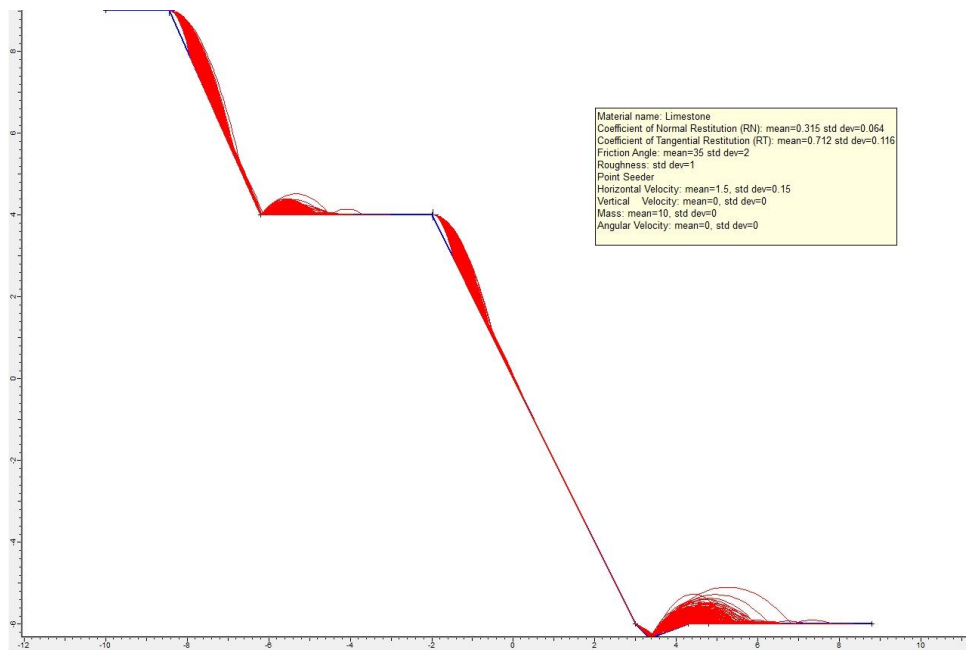
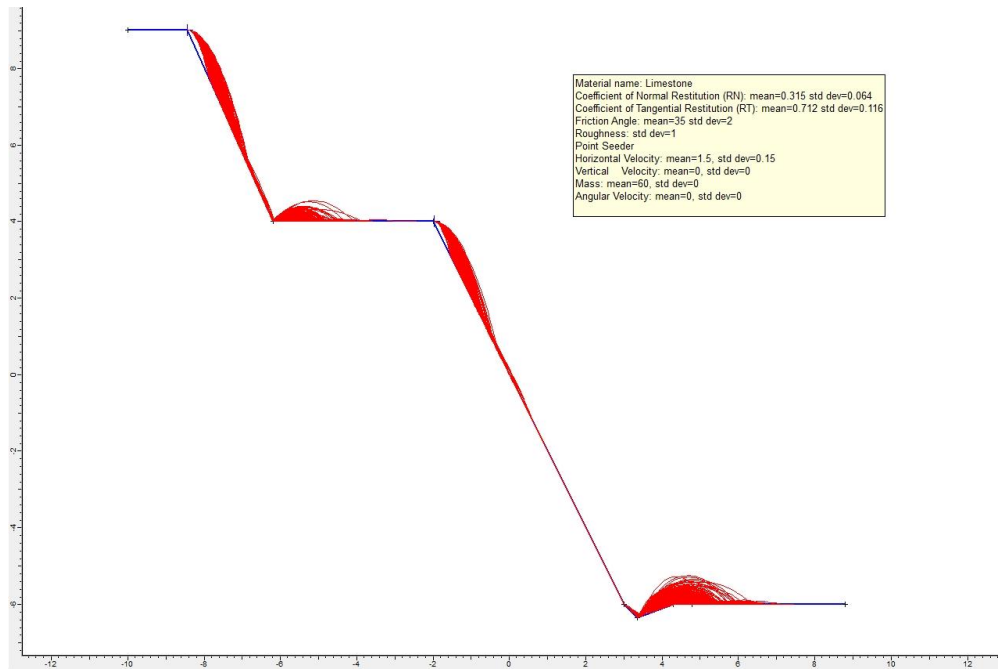
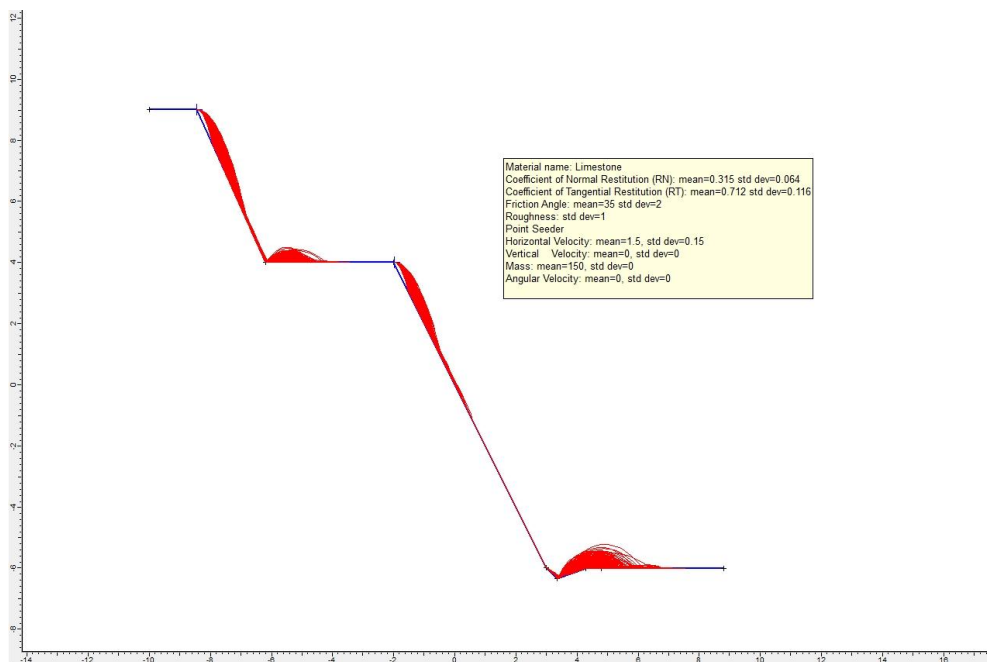
This part of the highway was found to be problematic according to the limit equilibrium analysis. In order to be consistent with those calculations and see the results of the solutions suggested for those slopes, the rockfall analyses were performed again. The calculation was done for 10 kg, 60 kg and 150 kg, for both slope flattening (Figures 5.34-5.36) and bench solutions (Figures 5.37-5.39). The slope angle was changed from 64° to 57°. The height of the bench is 10 m and the width is 5 m. The analyses reveal that the rocks always ended up in the road.

Figure 5.34. Rockfall analysis (10 kg block) with slope flattening solution at Km: 25+900.

Figure 5.35. Rockfall analysis (60 kg block) with slope flattening solution at Km: 25+900.

Figure 5.37. Rockfall analysis (10 kg block) with bench solution at Km: 25+900.

Figure 5.38. Rockfall analysis (60 kg block) with bench solution at Km: 25+900.

Figure 5.39. Rockfall analysis (150 kg block) with bench solution at Km: 25+900.

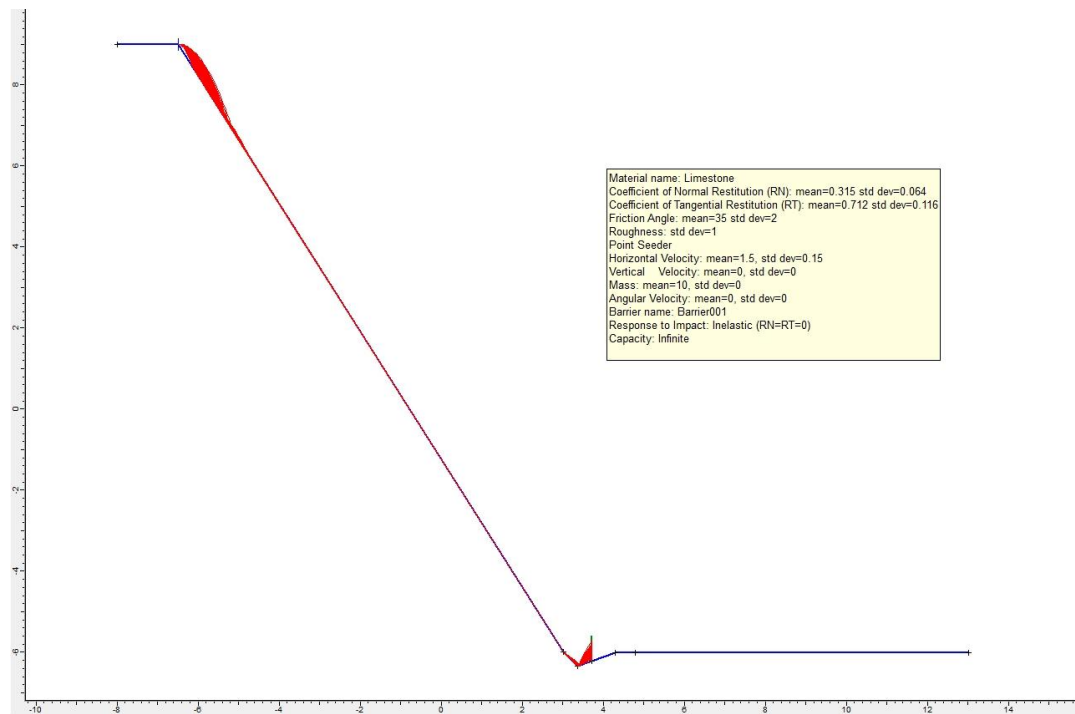
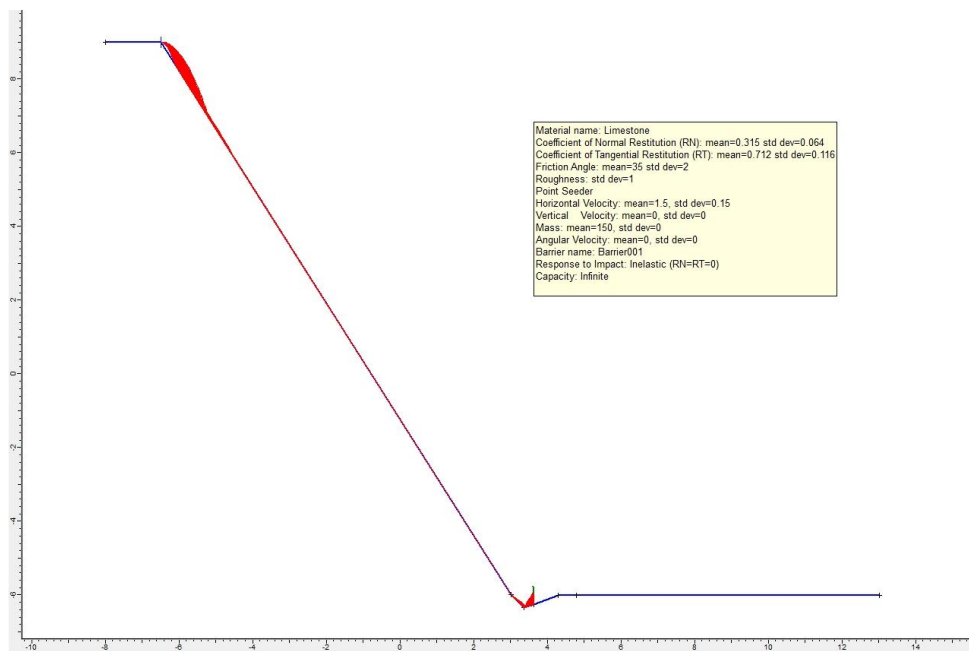
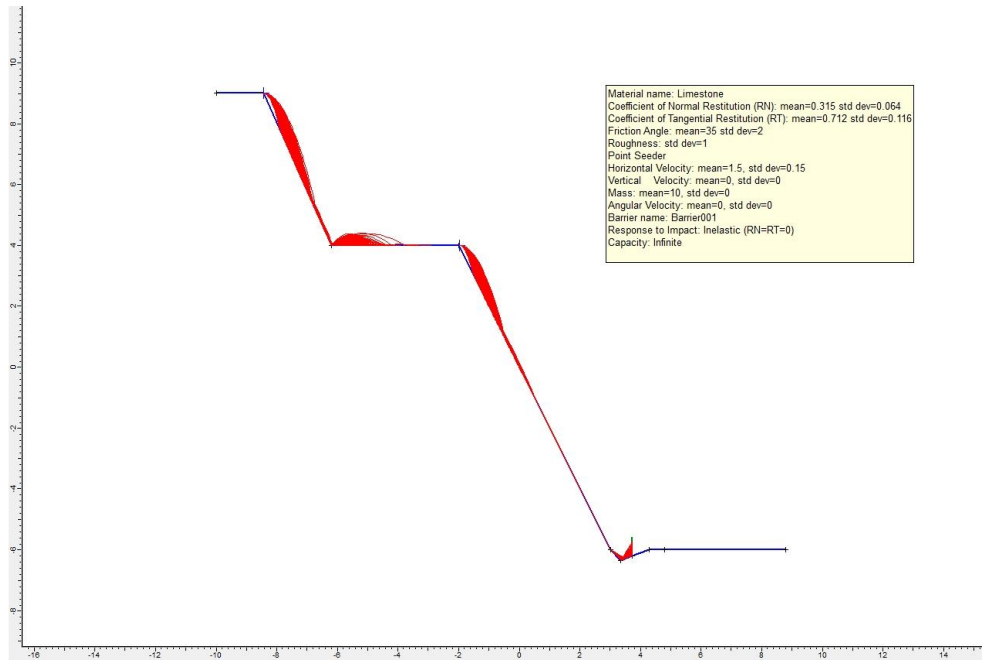
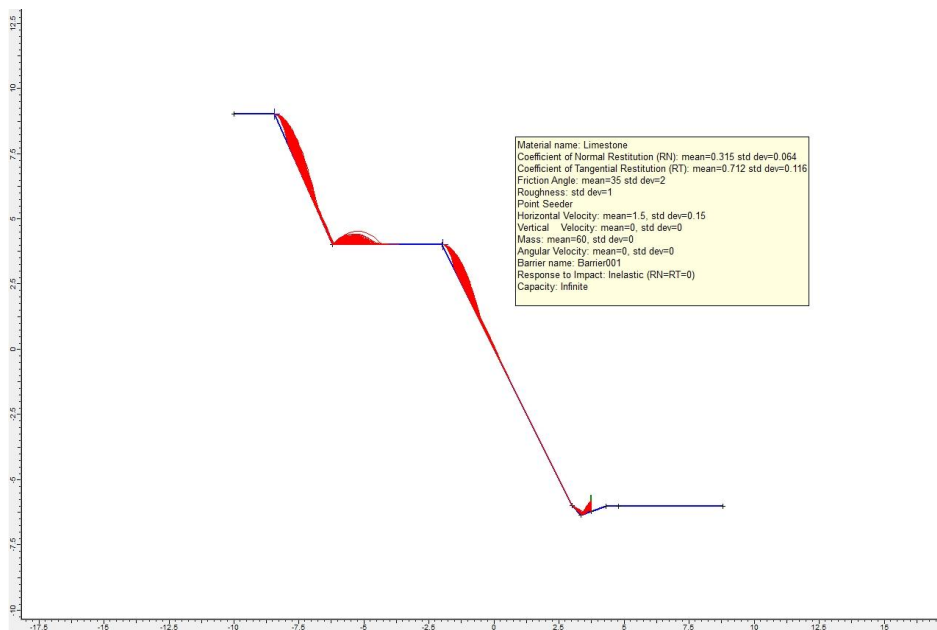
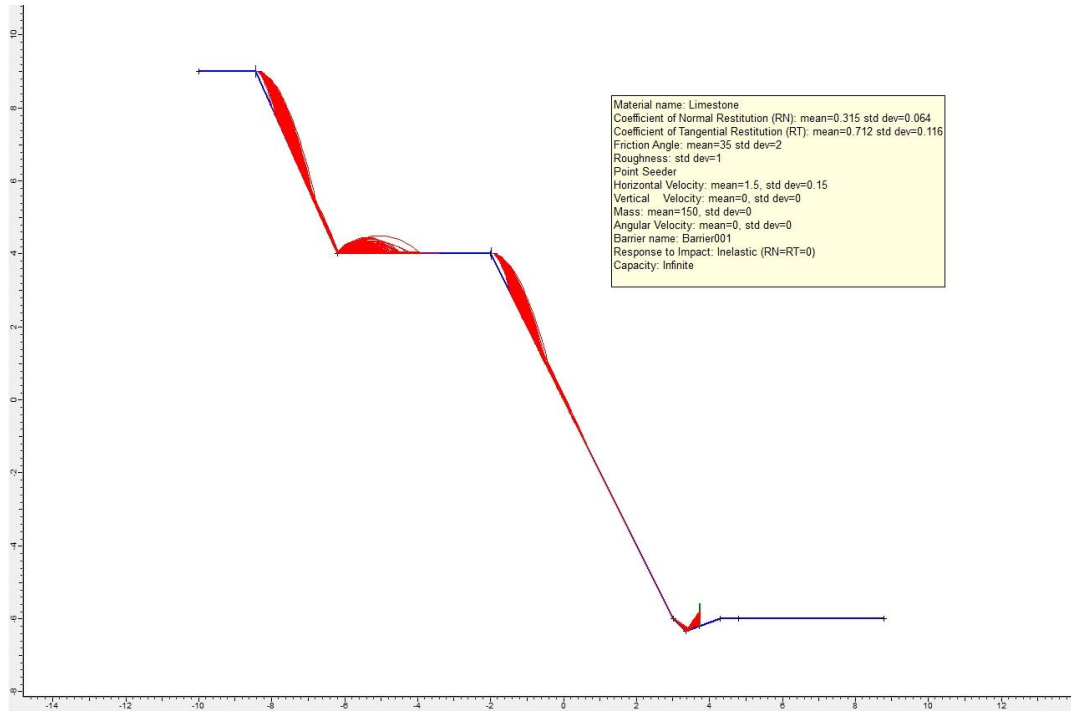
Figure 5.40. Rockfall analysis (10 kg block) with slope flattening and barrier solution at Km: 25+900.

Figure 5.42. Rockfall analysis (150 kg block) with slope flattening and barrier solution at Km: 25+900.

Figure 5.43. Rockfall analysis (10 kg block) with bench and barrier solution at Km: 25+900.

Figure 5.44. Rockfall analysis (60 kg block) with bench and barrier solution at Km: 25+900.

Figure 5.45. Rockfall analysis (150 kg block) with bench and barrier solution at Km: 25+900.

As a solution, catch barrier can be considered here. In order to see the behavior of the individual rocks, the rockfall analysis is also done with slope flattening and the barrier (Figures 5.40-5.42), as well as bench and the barrier (Figure 5.43-5.45). The only problem is that the barrier is very close to the road.

The rocks falling from the upper part of the slope do not fall again to the road. The bench holds all the rocks. As for the rockfall point of view, benching is suggested at Km: 25+900 for the upper part of the slope.

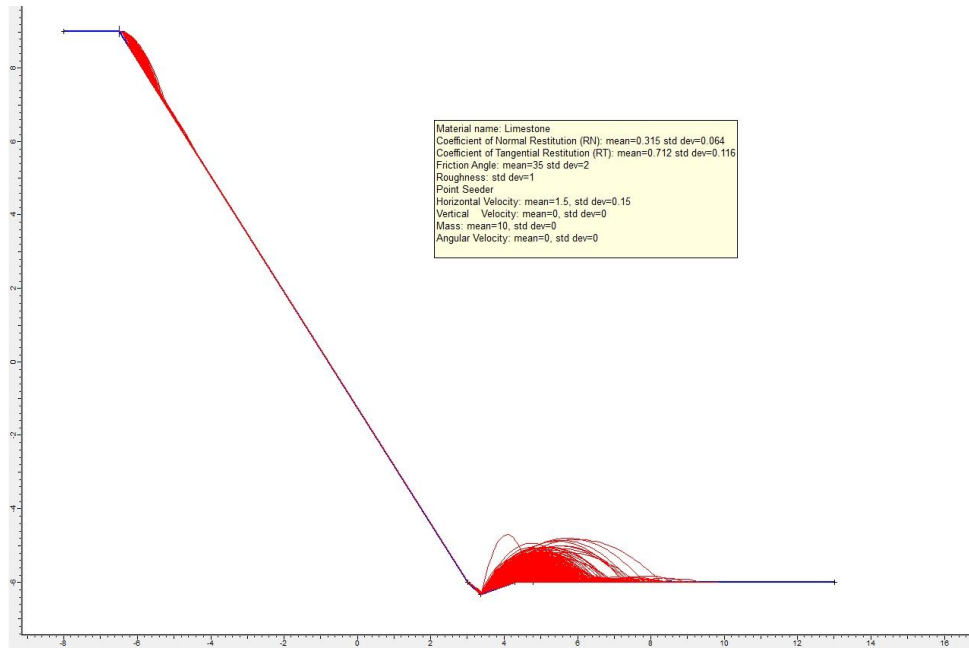
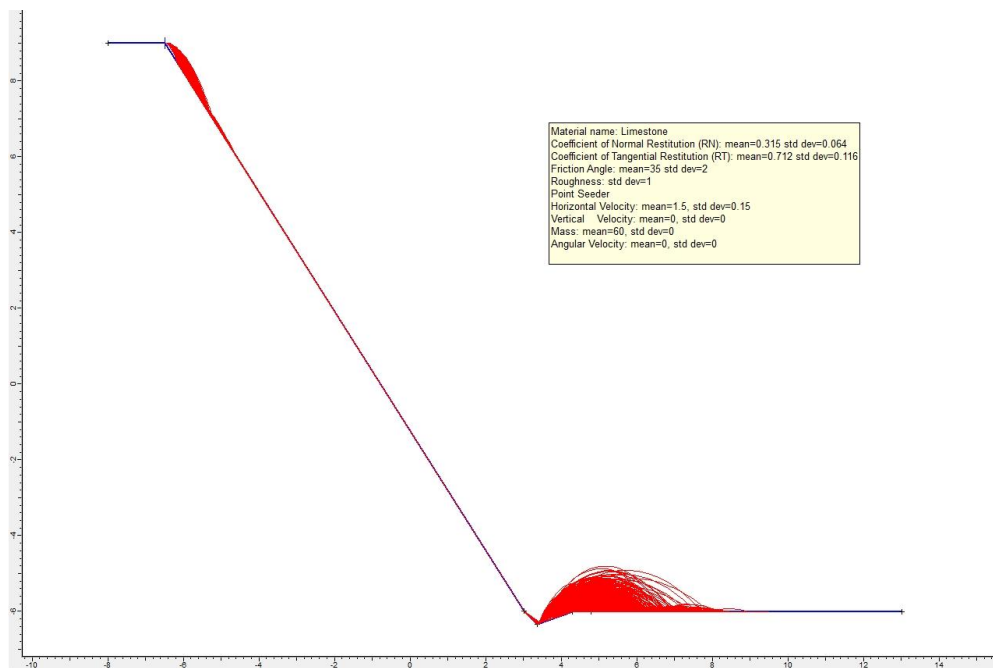
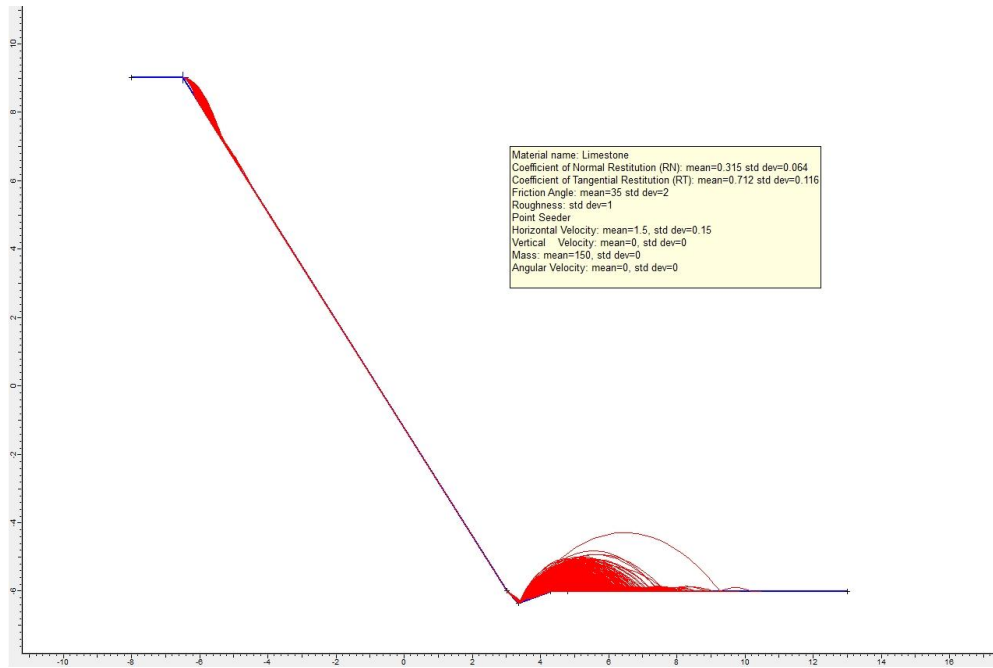
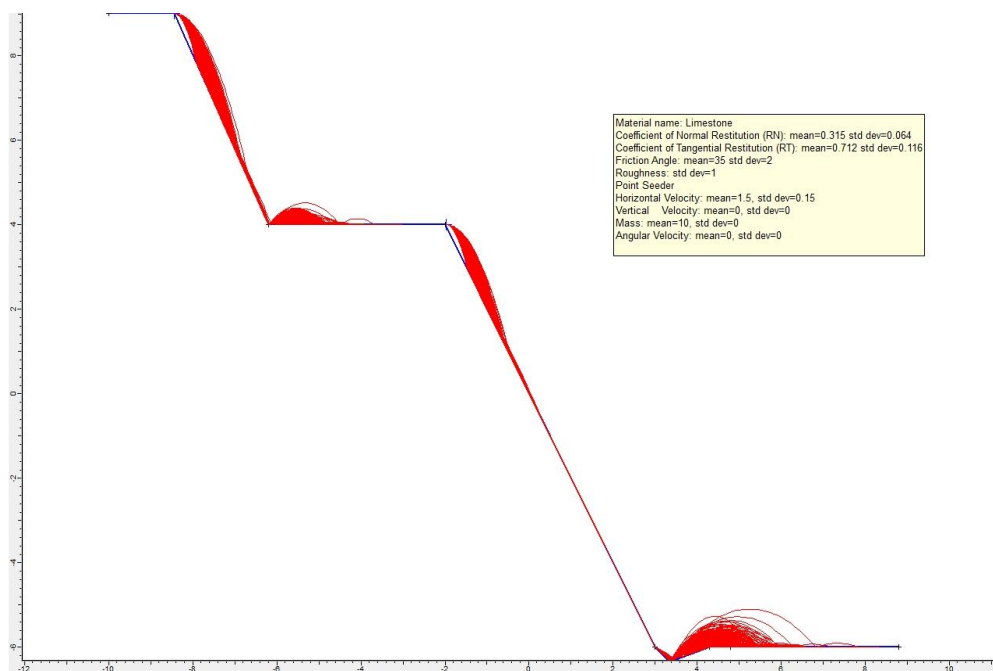
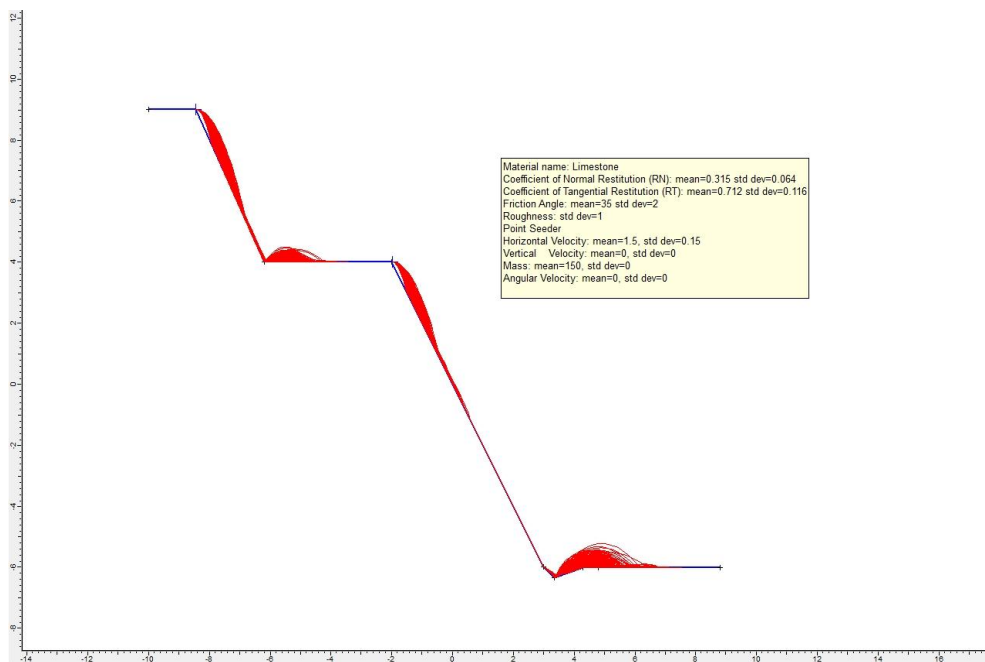
For this part, two remedial solutions, namely slope flattening and bench are considered during the rockfall analysis. The analysis was done for both slope flattening (Figures 5.46-5.48) and bench (Figures 5.49-5.51) solutions with the same block weights. The slope angle was changed from 64° to 57°. The height of the bench is 10 m and the width is 5 m. The rockfall analyses show that the falling rocks mainly reach the road.

Figure 5.46. Rockfall analysis (10 kg block) with slope flattening solution at Km: 26+000.

Figure 5.47. Rockfall analysis (60 kg block) with slope flattening solution at Km: 26+000.

Figure 5.48. Rockfall analysis (150 kg block) with slope flattening solution at Km: 26+000.

Figure 5.49. Rockfall analysis (10 kg block) with bench solution at Km: 26+000.

Figure 5.51. Rockfall analysis (150 kg block) with bench solution at Km: 26+000.

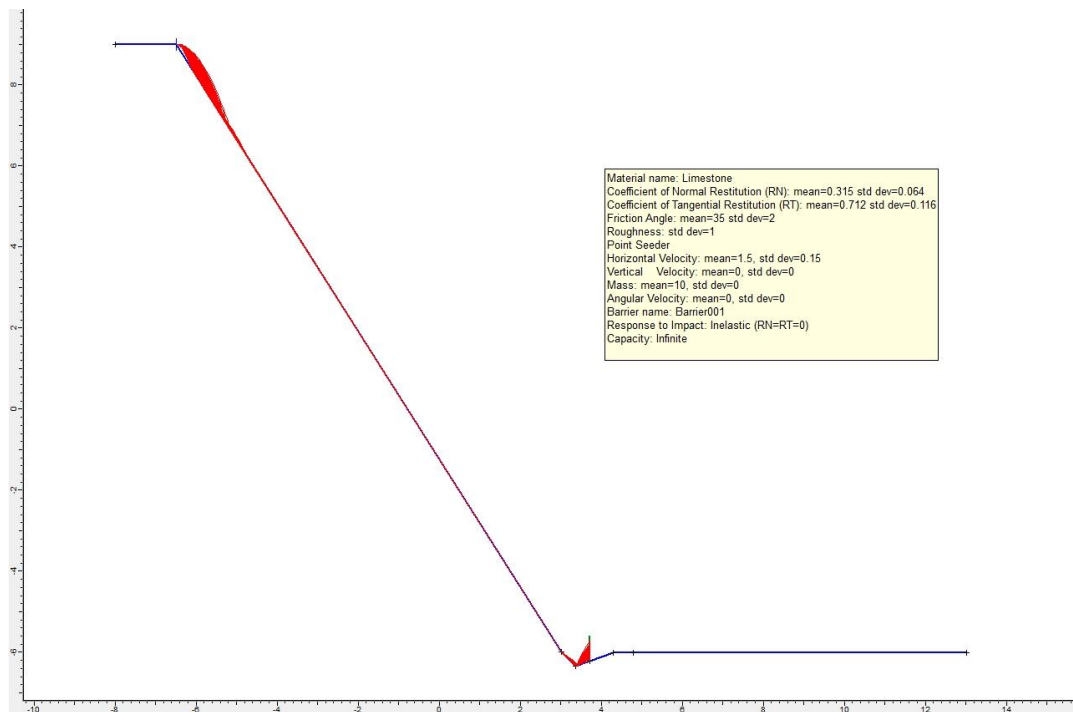
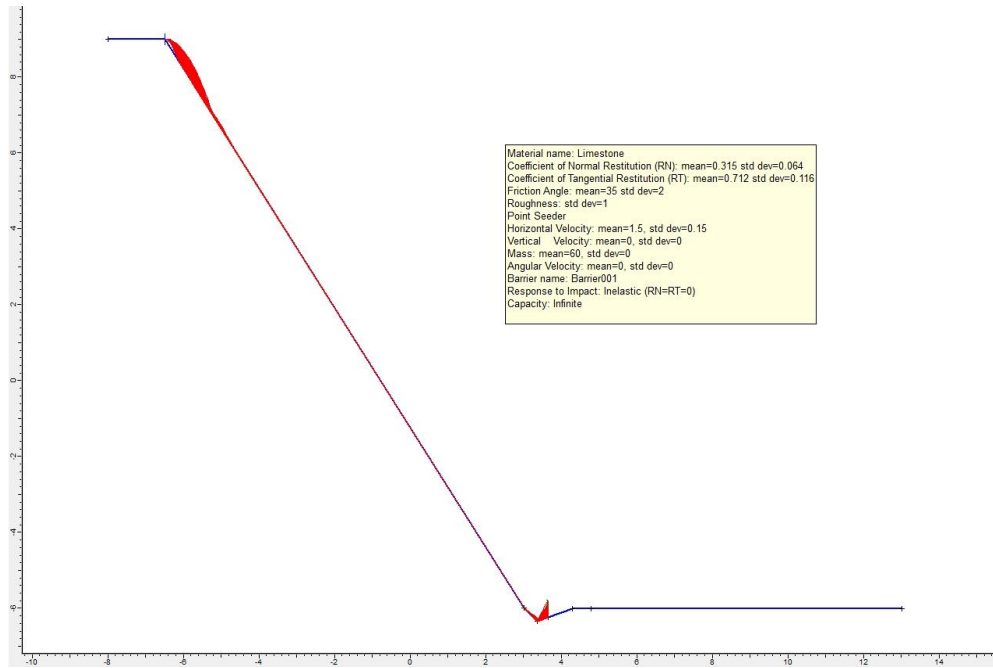
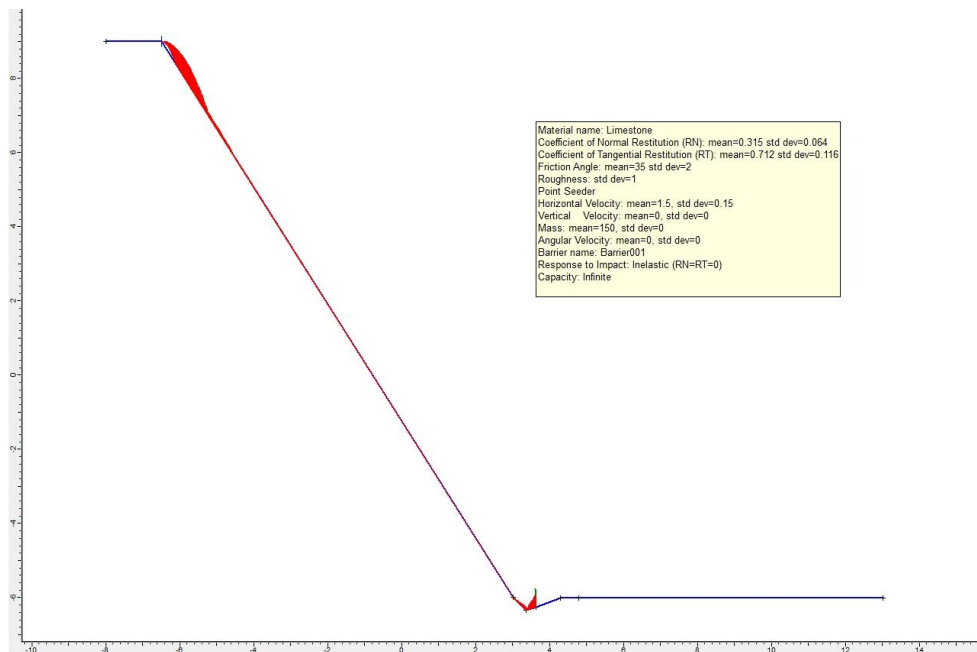
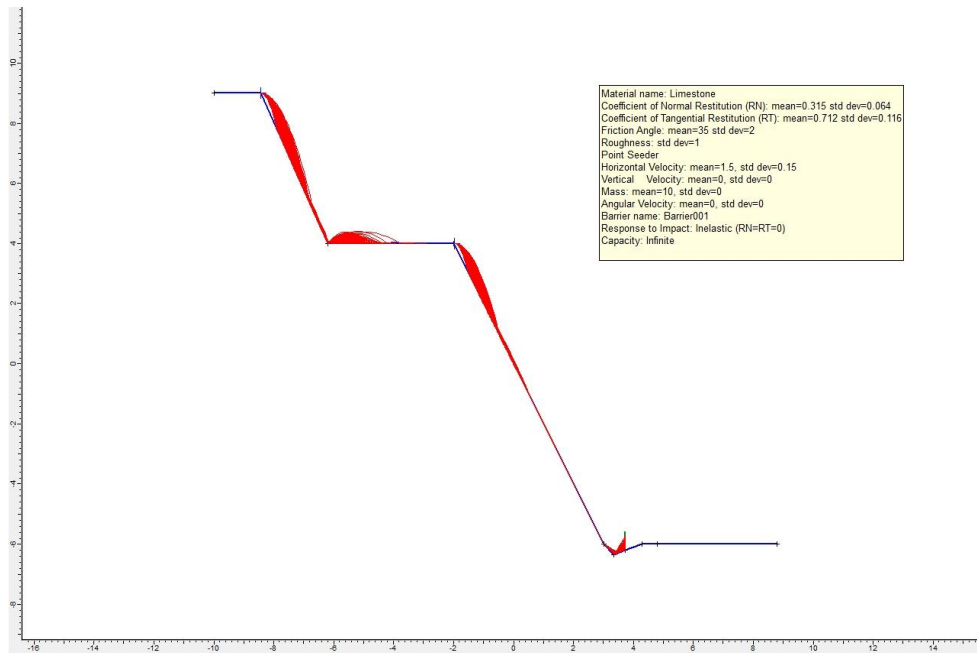
Figure 5.52. Rockfall analysis (10 kg block) with slope flattening and barrier solution at Km: 26+000.

Figure 5.53. Rockfall analysis (60 kg block) with slope flattening and barrier solution at Km: 26+000.

Figure 5.54. Rockfall analysis (150 kg block) with slope flattening and barrier solution at Km: 26+000.

Figure 5.55. Rockfall analysis (10 kg block) with bench and barrier solution at Km: 26+000.

As a solution, catch barrier can be considered here. The rockfall analyses done with slope flattening and the barrier (Figures 5.52-5.54), and bench and the barrier (Figure 5.55-5.57) show that although the barriers solve the problem, they are very close to the road. Therefore, it is preferable to consider other alternatives if the ditch details do not change.
