STRUCTURAL ANALYSIS, EVALUATION AND RECOMMENDATIONS  
FOR CONSERVATION OF THE LAHORE MUSEUM

A THESIS SUBMITTED TO  
THE GRADUATE SCHOOL OF NATURAL AND APPLIED SCIENCES  
OF  
THE MIDDLE EAST TECHNICAL UNIVERSITY

JULY 2018

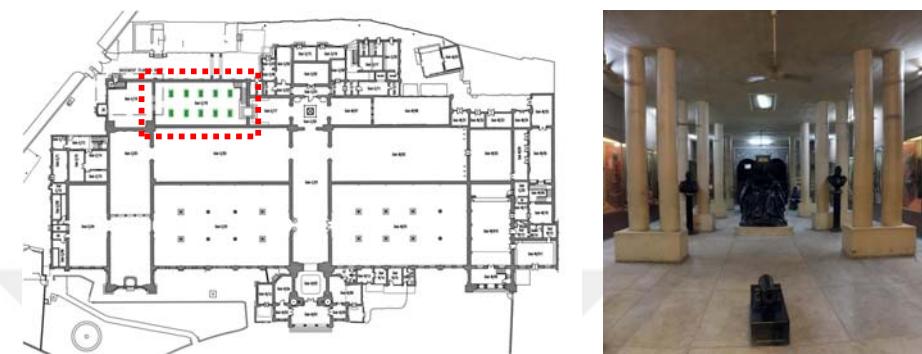
Another gallery where the dual system has been used is Gnd-E/18, constructed in 1972 (Figure 2.42). There are twenty reinforced concrete (RC) columns, each with a dia. of 381 mm (15 in.) and 4 m (13 ft. 3 in.) in height. Every two columns stands on a RC base of 1295 mm x 609 mm x 609 mm (4 ft. 3 in. x 2 ft. x 2 ft.) forming two rows and dividing the space in six bays and three aisles. These columns were added after the first floor was constructed in 1974 and it was noticed that the roof was starting to sag because of the additional load and were propped from the floor of the gallery (Dar, 2016). In the absence of any footing vertical resistance provided by these columns is

only equal to the bearing capacity of the floor on which they rest. Also as these columns have not been tied together they exhibit tying force only through friction, generated by the compressive forces at each end.

Figure 2.42: Lahore Museum key plan showing location of Reinforced Concrete Columns In Space Gnd-E/18 (left) Looking East rows of RC columns in space Gnd-E/18 (right)

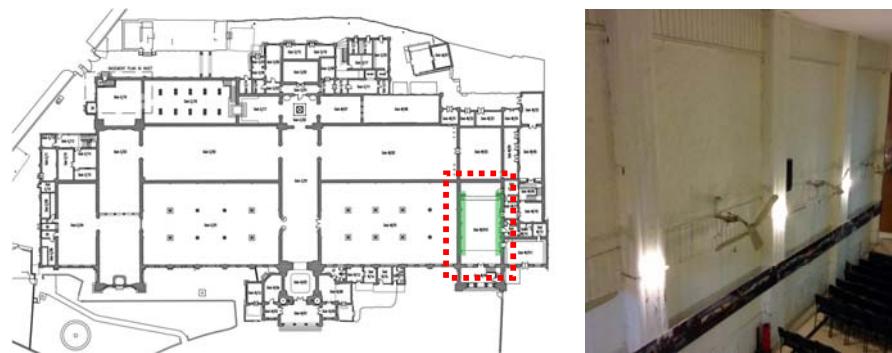
The only other space in the building that employs the dual system is Gnd-W/10. An additional floor was added to the space that was originally 12.19 m (40 ft.) high in 1969. The additional space Snd-W/03 created above houses the Museum library. Five frames were built at regular intervals along the N-S axis of the space Gnd-W/10 using the brick masonry columns and RC beams to support the RC slab and the weight of the additional floor. The columns were tied with the wall to make both masonries monolithic, by removing alternate bricks from the existing wall to form a tongue and groove joint in the vertical direction. The columns seem to have been propped up from the floor hence they provide vertical resistance that is only equal to the bearing capacity of the floor.

Figure 2.43: Lahore Museum key plan showing location of Brick Masonry Columns In Space Gnd-W/10 (left) Looking East Brick Columns in Space Gnd-W/10 (right)

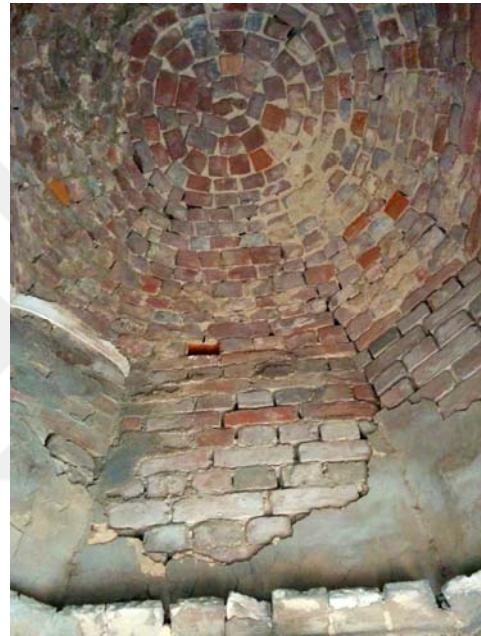
The domes over spaces Fst-N/04 and Fst-N/05 are most probably double-domes, constructed in brick masonry with the cavity in between<sup>24</sup> (Figure 2.37). The dome over the space Fst-N/04 is covered in plaster but the plaster in the space Fst-N/05 has been lost and shows that brick has been used for the construction of the dome (Figure 2.45). They use drums, 1.31 m (4 ft. 3 in.) in height, as the transition element and have a radius of 762 mm (2.5 ft.) while the soffit of the center of the lower dome is 3.5 m (11ft. 6in.) high, from the floor of the spaces. The lower dome, with its center at +9.43 m (31 ft.) above the plinth, has a single-centered segmental-profile. While the upper dome has a four-cross-centered profile and the center of the extrados is +12.5 m (41 ft.) above the plinth.

Figure 2.45: Loss of plaster in space Fst-N/05  
Showing use of brick in the construction of the dome

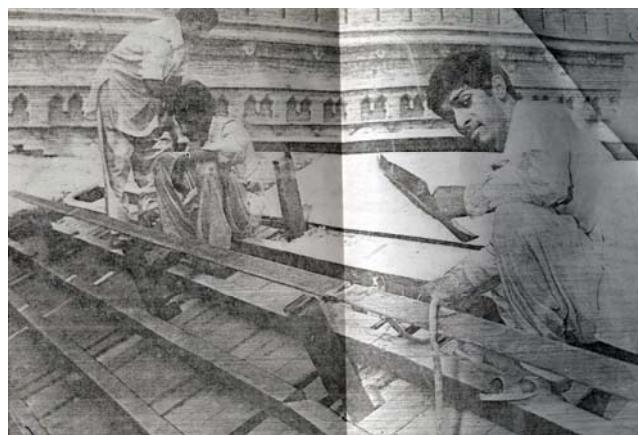
On the exterior the space between the two sections of a truss was used to provide a 610 mm (24 in.) wide gutter. In 1980 the roof detail of space Gnd-W/01 was modified. The wooden boards and wooden battens 64 mm x 102 mm (2.5 in. x 4 in.) from the original detail were maintained while the other layers were removed. These then were topped by GI corrugated sheets which were secured to the steel trusses through iron hoops (Figure 2.48) (Butt, 1980, p. 50).

Figure 2.48: The roof of General Gallery being replaced in 1980  
 Source: Butt, Q. U. H., Executive Engineer, 4<sup>th</sup> Provincial: Building Division, Lahore. (1980). Estimate for: Re-construction of corrugated sheet roofing & drains over existing trusses of Islamic & General gallery in Lahore Museum Lahore. To: Director Lahore Museum. Letter No. E-50-0/50-LM-5915 dated. 10.9.1980. p. 32

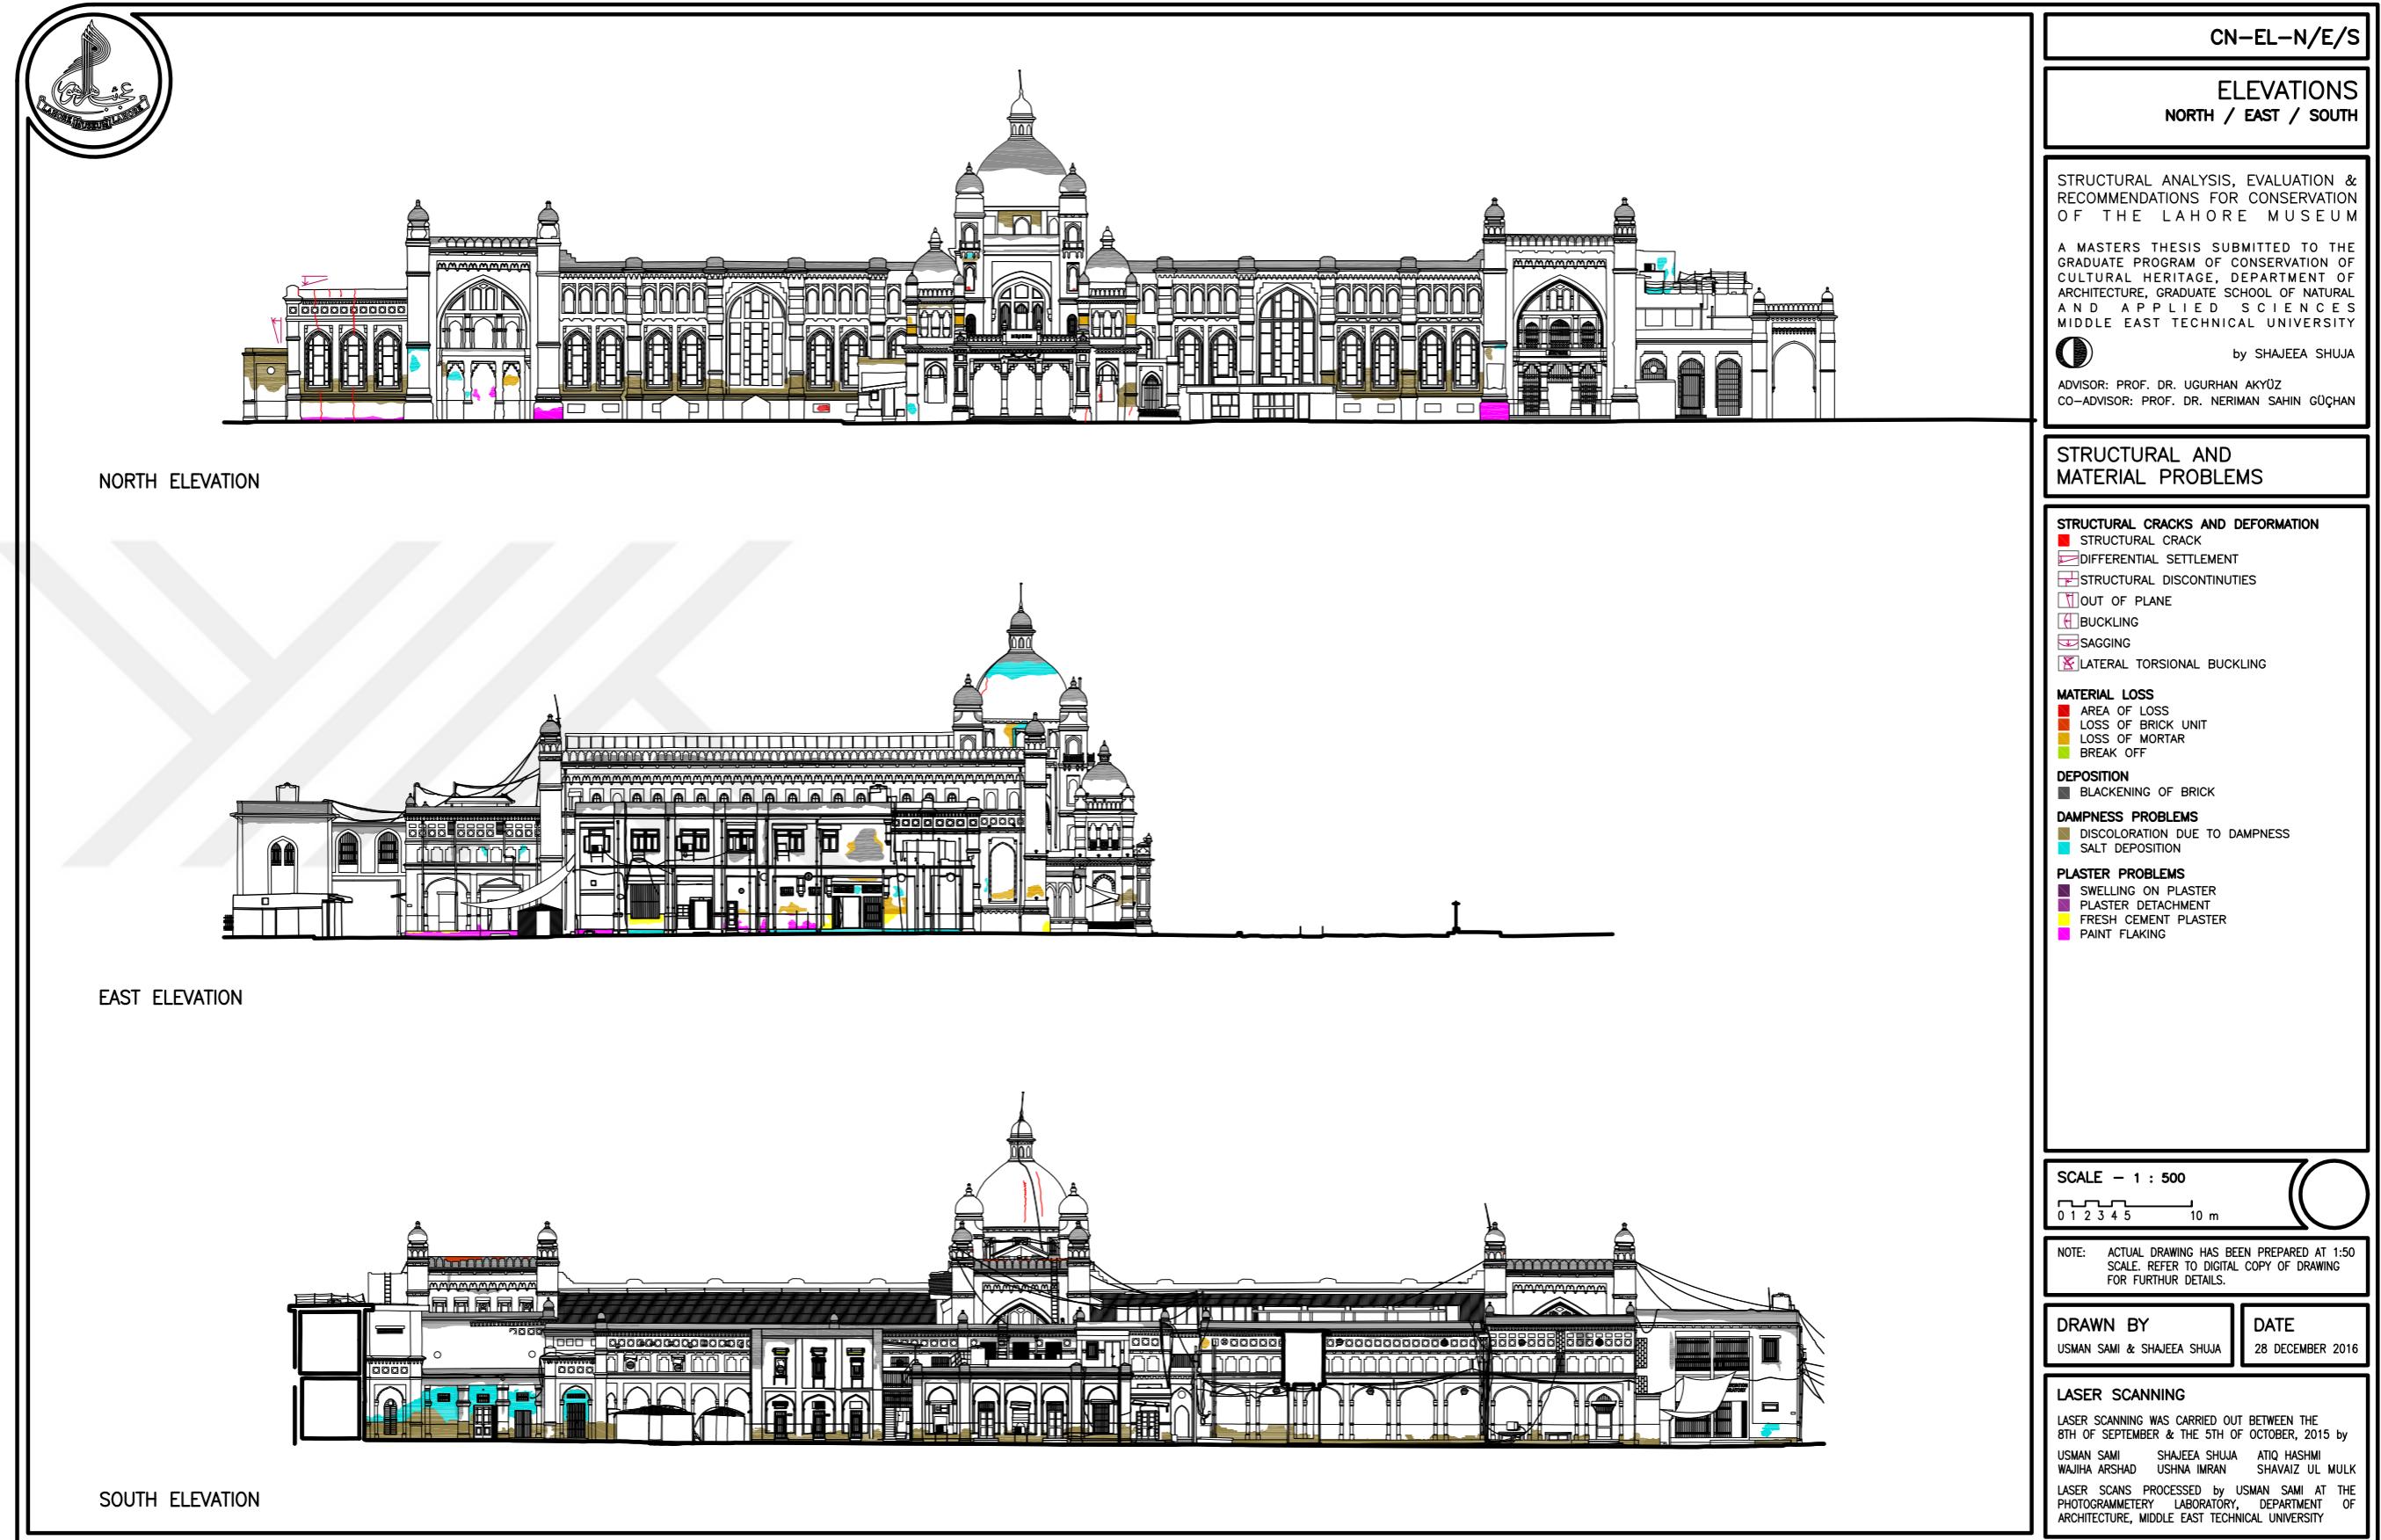
Figure 2.66: CN-EL-N/E/S – Structural and Material Problems – Elevations – North / East / South (2016)

Most critical of the structural damages are observed in Zone 01 where the wall Gnd-E/04-N-W is host to a myriad of problems. Two Vertical Cracks (S1) are observed on the wall, one passing through the central arch and the other passing through the eastern arch (Figure 2.66). These cracks starting at the parapet do not follow the mortar line but have broken brick units and travel all the way to the ground (Figure 2.71). Both cracks are greater in width at the top of the wall as compared to the bottom.

The crack seems to be expanding and in 2017 the second crack passing through the eastern arch was observed for the first time. Also in 2017, a Vertical Separation Crack (S1) was observed at the junction of the wall and the pier at the eastern end of the wall (Figure 2.66). The pier also exhibits out of plane behavior (S5) and is displaced in the North-eastern direction (Figure 2.73). The wall Gnd-E/04-N-W is also showing signs of Lateral Buckling (S6) coupled with out of plane behavior (S5) (Figure 2.73) besides being approximately 50 mm (2 in.) lower at the eastern end in comparison to its western end, which points towards Differential Settlement (S3).

Two meridional cracks are observed on the exterior of the main dome (Thd-N/05) at the southern end (Figure 2.66). The cracks generally follow the mortar line but in places have broken brick units (Figure 2.77). The starting point of the cracks could not

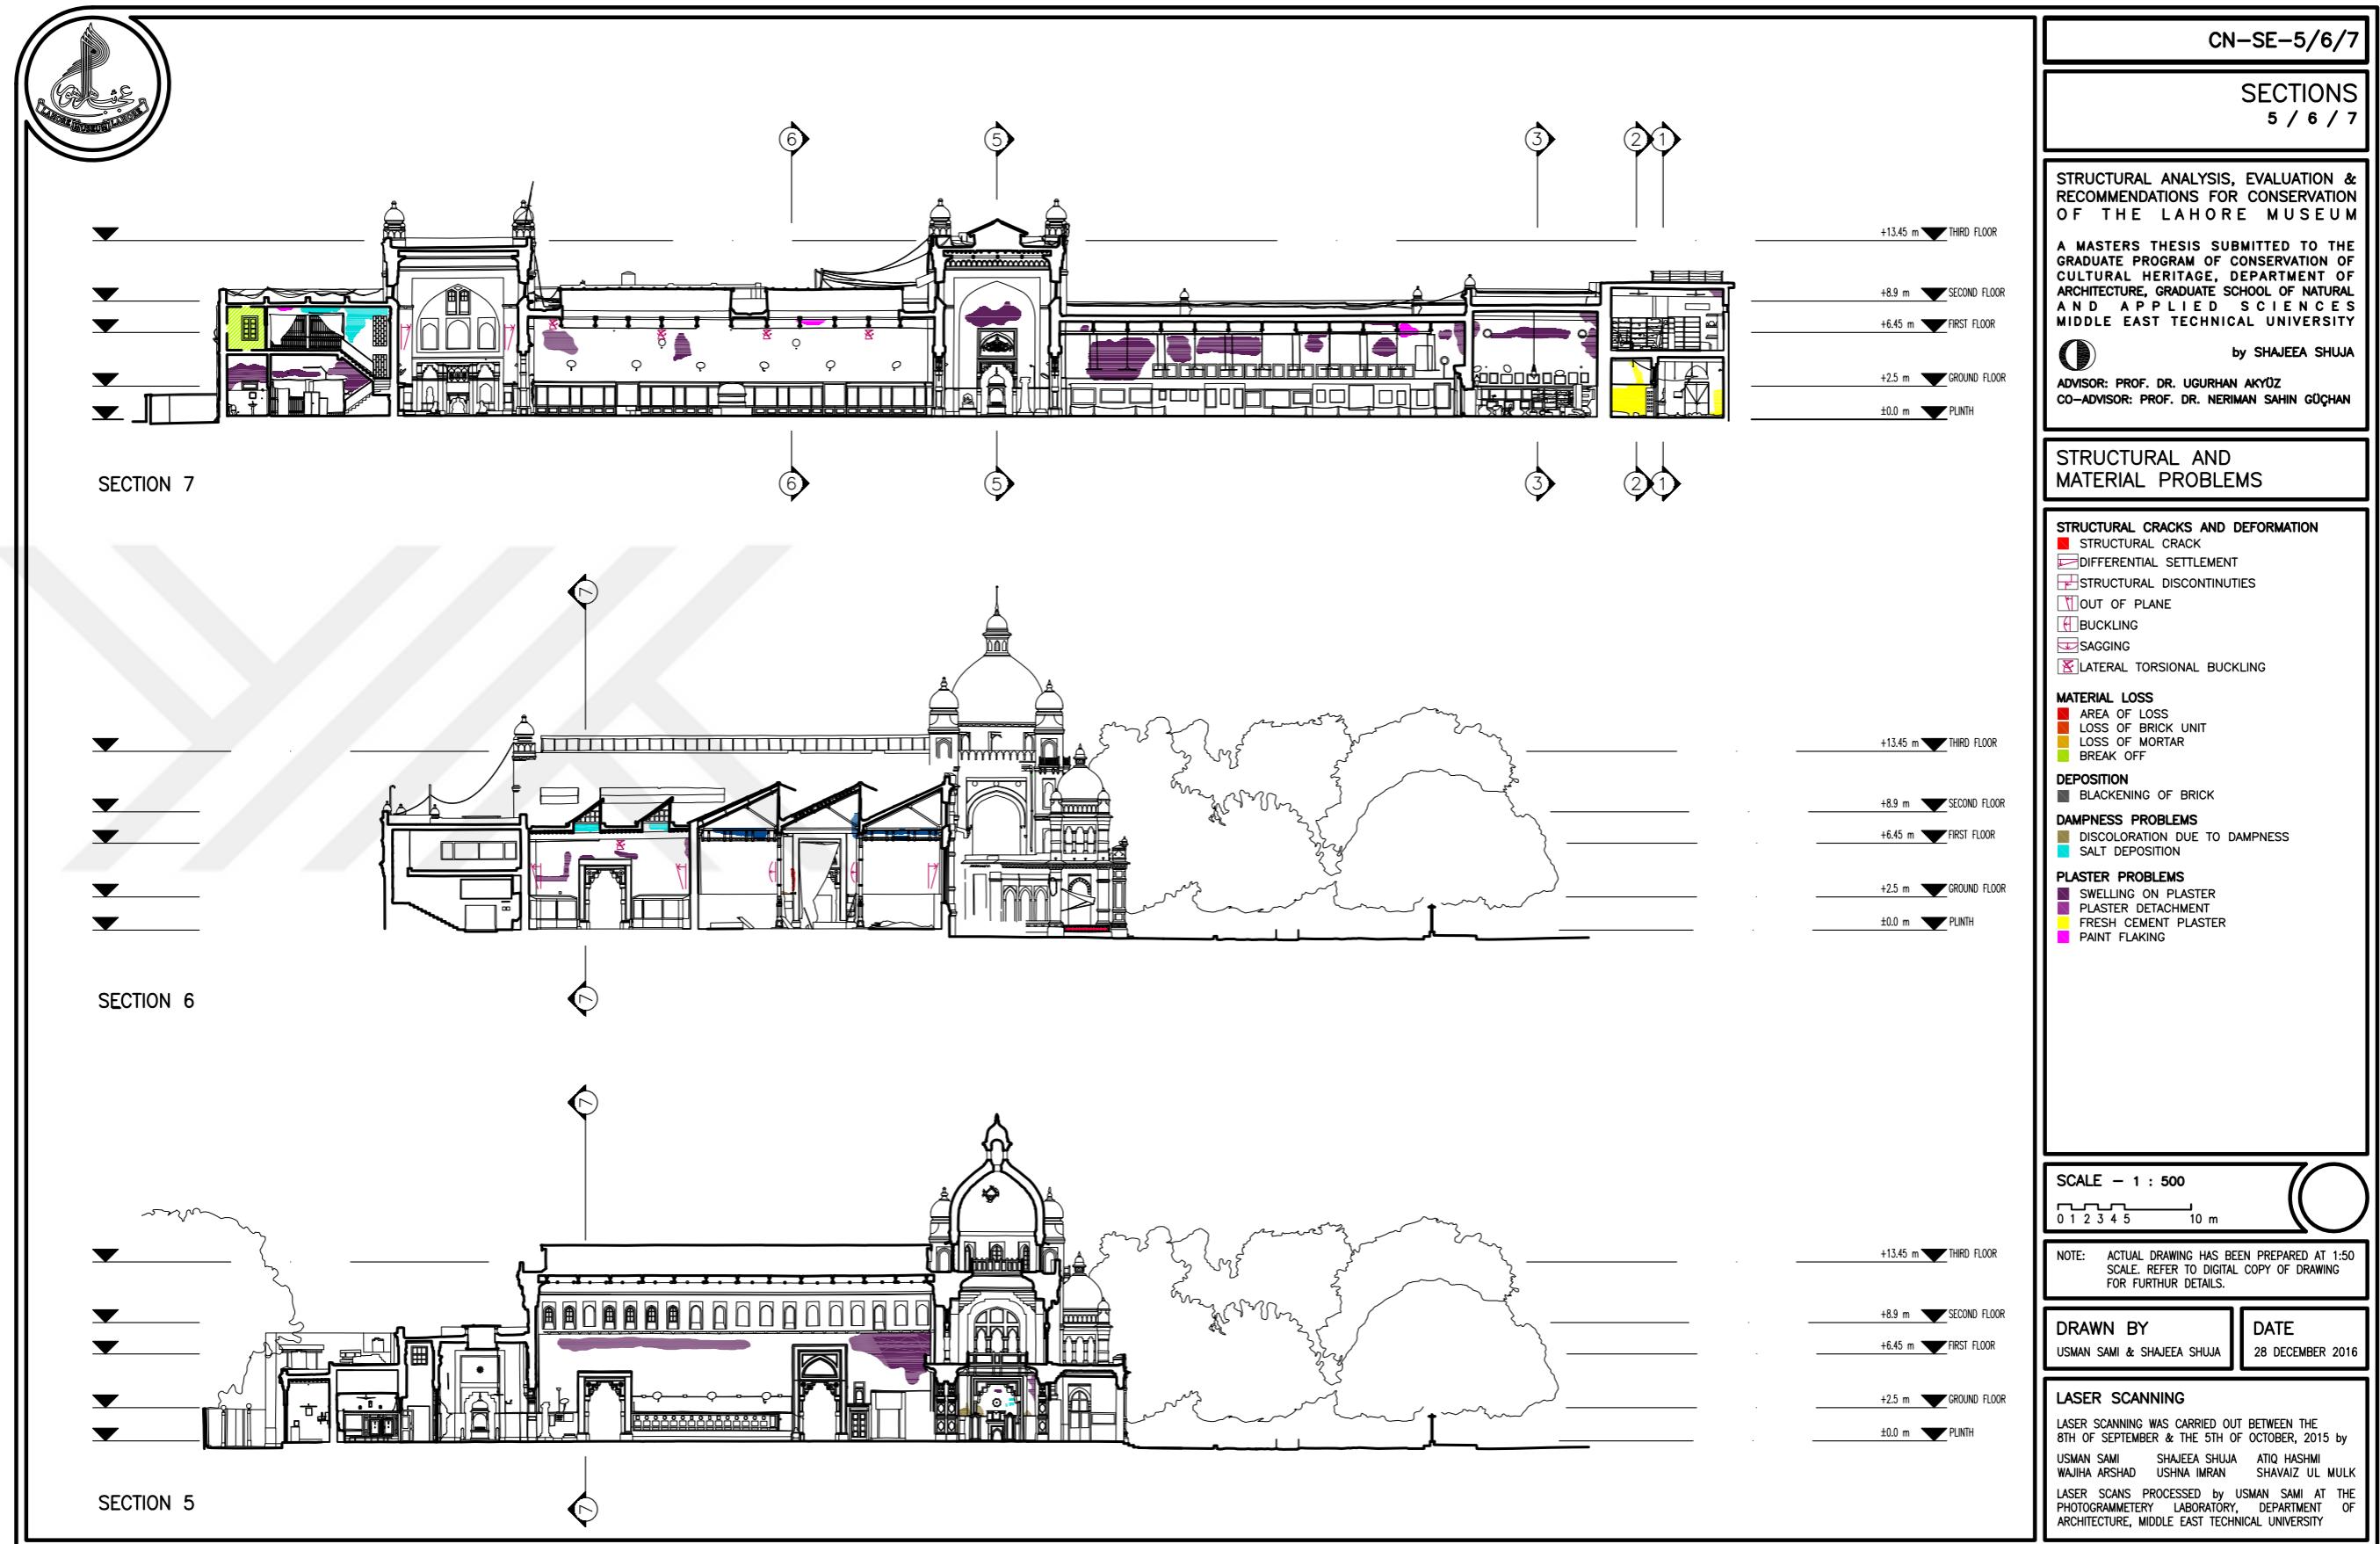
Figure 2.68: CN-SE-5/6/7 – Structural and Material Problems – Sections – 5 / 6 / 7 (2016)

base in the Northern direction. Similarly the wall Gnd-E/01-S-W is also seen to exhibit Out of Plane behavior (S5) and is tilting away from the base in the Southern direction. Lastly, the CI columns are showing signs of slight deformation of shape i.e. Local Buckling (S6) (Figure 2.68).

In case of the wall Gnd-E/02-S-W it was observed that the wall tilted from its base in the southern direction. This was cross checked with the help of a plumb line and was also confirmed through the documentation drawings (Figure 2.68). This behavior can be attributed to the construction of the adjacent space Gnd-E/18, south of space Gnd-E/02 in 1972, and later in 1974 the addition of gallery spaces above Gnd-E/18. Additionally, the roofing system of space Gnd-E/02 was frequently changed due to the persisting roof leakage. Thus the increased gravity load due to the new constructions and the addition of slab approximately at mid-height of the wall Gnd-E/02-S-W coupled with recurring changes in the loading pattern due to roof changes could have resulted in the Out of Plane Behavior (S5) observed in wall Gnd-E/02-S-W .

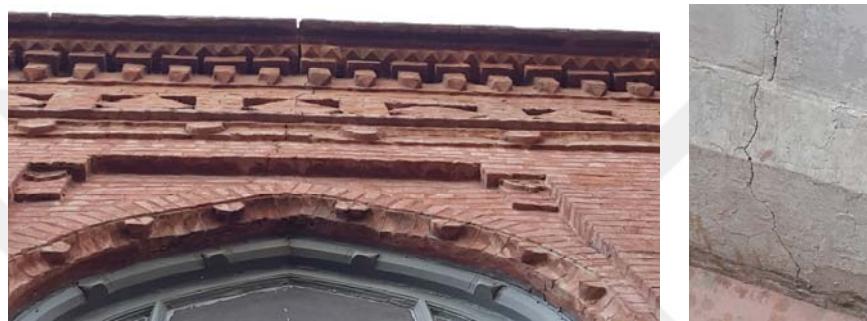
Figure 2.71: Vertical Crack going through Central Arch of Gnd-E/04-N-W (2015)  
Crack starts from the parapet (left) and reaches till the base of the wall (right)

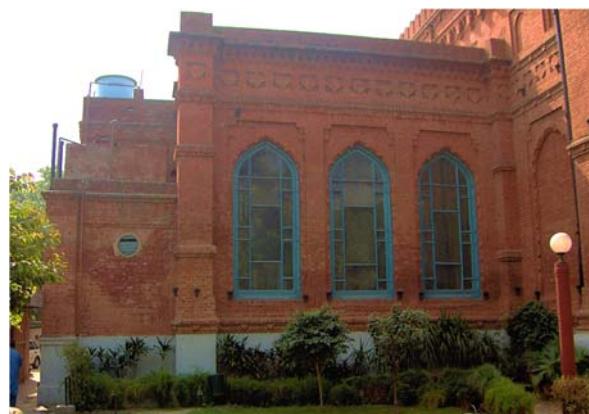
The crack through the central arch, near the top of the wall, is visible both in the interior as well as the exterior. This crack was first observed by the Author in 2013 and close inspection of a photograph from the year 2007 confirms the presence of the crack from an earlier date (Figure 2.72). However no prior documentation of the crack could be found.

Figure 2.72: Slight crack is observed in the wall Gnd-E/04-N-W (2007)  
Source: Fawad Raza

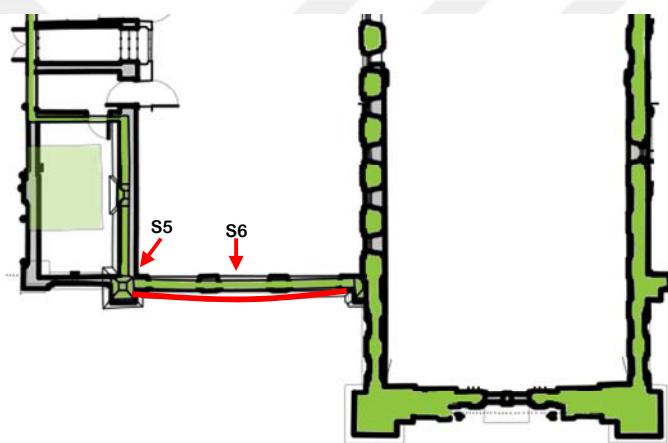
Figure 2.73: Out of Plane behavior (S5) and Buckling (S6) in Zone 01  
 Seen through the overlapping of Plans  
 Plan at +2.5m

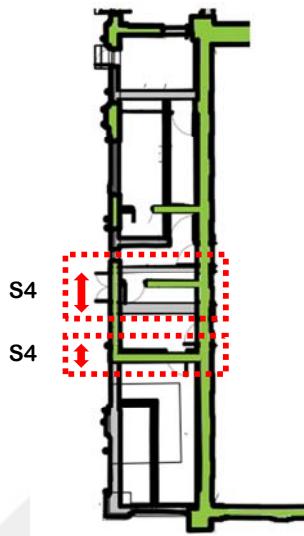
Slight out of plane behavior (S5) was detected in Gnd-E/05-N-W and Gnd-E/07-N-W during the documentation survey in Zone 06. This observation was cross checked with the help of a plumb line and it was observed that the walls were tilting away from the base in the southern direction. As no cracks or settlement of the floor was seen the only plausible reason seemed to be the construction over these spaces. This argument gained more credence when the historical survey revealed that spaces Gnd-E/05 and Gnd-E/07 were carved out of the Eastern Verandah in 1965 while the spaces Fst-E/08 and Fst-E/09 were built in 1978 (Figure 2.58 and Figure 2.59). Overlaying of the plan drawn at +2.5 m (8 ft. 3in.) with the plan drawn at +6.45 m (21 ft. 2 in.) further revealed vertical structural discontinuities (S4) (Figure 2.78). Additionally as the walls Gnd-E/05-N-W and Gnd-E/07-N-W were built as partition walls only there is a high possibility that they were built on-grade. The combination of these two actions could have caused the tilt observed in the walls in Zone 06.

Figure 2.78: Structural Discontinuities in Zone 06 seen through the overlapping of Plans  
 Plan at +2.5m Plan at +6.45m

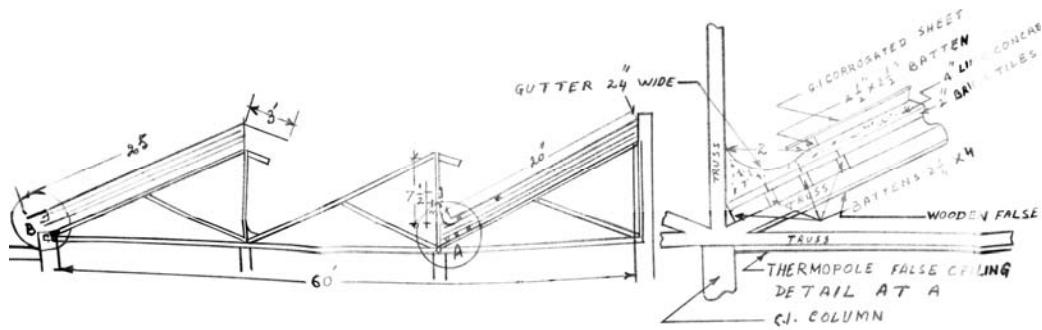
This problem is best exemplified in the case of the two galleries with trusses i.e. Gnd-E/01 (Islamic Arts Gallery and Gnd-W/01 (General Gallery). The design of the roof in these spaces is inherently flawed as the trusses, oriented in the east-west direction, abut much higher building blocks on either side. Catchment channels in the middle of the roof collect rainwater from the two drainage valleys (Figure 2.80) and evacuates it into drain pipes. The pipes then drop below the soffit into the gallery spaces from there they run along the eastern wall of Gnd-W/01 and western wall of Gnd-E/01 concealed behind the plaster of Paris cornices that slope towards the north. The water is finally channeled out of the building through spouts on the upper levels of the northern façade of the building.

Figure 2.80: Section through the General Gallery Roof – Existing (1980)

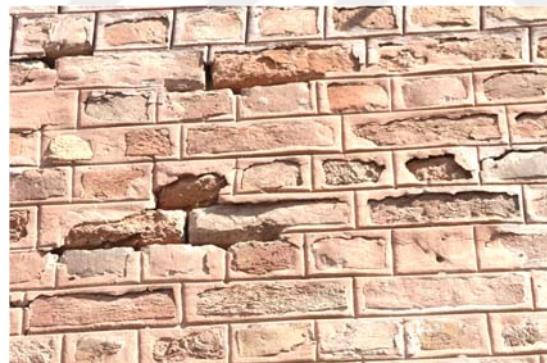
Another problem the museum building faces is the continuous reintroduction of salts to the brickwork. As Portland cement became readily available, the building initially built with brick masonry laid in lime mortar saw a steady shift to cement based construction. Currently, PWD unreservedly uses Portland cement for the construction of additions as well as repair and maintenance of the earlier structures. As the building in parts and at times is completely repointed with red tinted Portland cement mortar, the salts carried by the cement are repeatedly introduced to the brickwork. The moisture from rainwater or leaking sewage pipes may carry other types of salt, which are introduced to the brickwork through rainwater penetration and rising damp. The presence of salt in the brickwork is causing powdering of the brick edges which are then pointed with thicker layers of mortar in an unending cycle.

Figure 2.81: Powdering of Brick / Detachment of Pointing on the exterior wall of Fst-W/01 (2017)

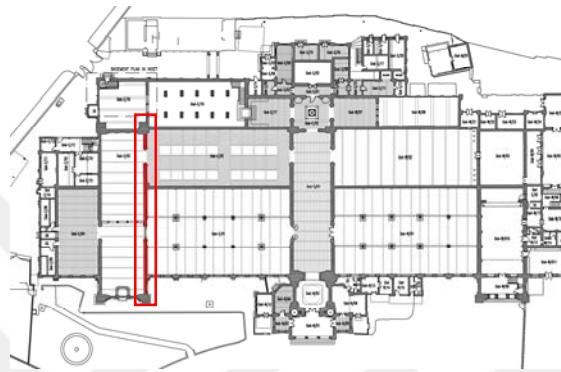
Figure 3.28: Key Plan showing wall Gnd-E/03-W-W

Two critical locations were observed in wall Gnd-E/03-W-W. One of the observed segment is located near the top of the wall close to the junction with wall Gnd-E/01-N-W at the northern end of the wall. The other is located near the top of the wall towards the southern end of the wall.

For the area element at the northern end, S11 results for Stage 1 exhibit very high magnitude of stress values. The nature of stresses is different on the opposite faces with the west (top) face exhibiting tension while the east (bottom) face is in compression. This points to out of plane bending with the tilt towards east. With each subsequent stage magnitude of the stresses reduce although the nature of stresses remains the same. Similar behavior is observed in the entire northern part of the wall. The S22 results, of the same area element, for Stage 1 also show that the west (top) face is in tension while the east (bottom) face is in compression, thus depicting out of plane bending (Figure 3.21-c). In Stage 2, magnitude of stress values reduce while the nature of stresses on opposite faces remains the same. However, in Stage 3 a reversal of stresses is observed, with both faces now experiencing compression, this behavior is retained in Stage 4. These results dictate that addition of galleries, such as Gnd-E/02 (south-west) in Stage 2 and Gnd-E/19 (south) and Gnd-E/11-16 (south-east) in Stage 3, around space Gnd-E/03 have been favorable in redistributing and relieving stresses.

The behavior of the wall observed, at the southern end, in the analytical model corresponds with the behavior observed for the actual wall in the documentation stage of the building (Figure 2.68). Although it is unclear if the behavior observed at the northern end of the wall reflects the on-site condition; as it was not checked during the visual inspection and no section has been cut through this part of the building.

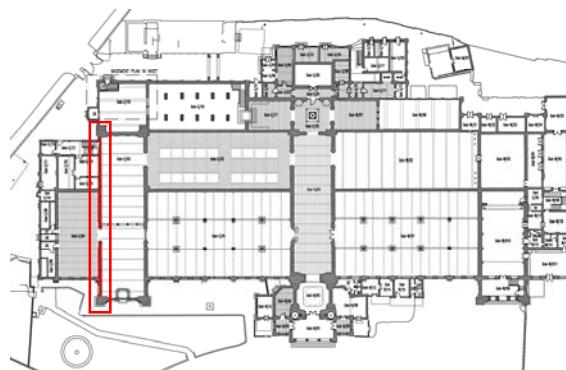
Figure 3.29: Key Plan showing wall Gnd-E/03-E-W

Two critical locations were observed in wall Gnd-E/03-W-W. One of the observed segment is located near the top of the wall close to the junction with wall Gnd-E/04-N-W at the northern end of the wall. The other is located near the top of the wall, above the opening leading to space Gnd-E/04, towards the middle of the wall.

The results for both the area element are very similar. The S11 results, of both area elements, for Stage 1 exhibit compression on the west (top) face while the east (bottom) face is in tension indicating out of plane bending with the tilt in the western direction. In case of the entire wall in Stage 1, the wall from the northern end till the transverse wall Gnd-E/04-S-W exhibits compression on the west (top) face and tension on the east (bottom) face. While in the remaining wall stress reversal is observed with the west (top) face in tension and east (bottom) face in compression. In the subsequent stages for the area element and the entire wall, nature of stresses remain the same while the magnitudes gradually reduce. This could be attributed to the construction of space Gnd-E/02 (south-west) in Stage 2 and spaces Gnd-E/19 (south) and Gnd-E/11-16 (south-east) in Stage 3, which help relieve and redistribute the stresses.

For both area element the S22 results of Stage 1 show that the west (top) face is in compression while the east (bottom) face is in tension depicting out of plane bending (Figure 3.21-c). In the subsequent stages the nature of stresses remains the same while the magnitude gradually reduces. In context of the entire wall, in Stage 1 bending deformations are observed in the top zone which could be caused by the roof of space Gnd-E/03 pulling the wall towards west. While in the mid-section of the wall a reversal of stress is observed which could be due to the roof of space Gnd-E/04, located east of the wall, pulling the wall eastwards. Whereas in the bottom zone the tensile stresses are being eliminated by compression due to the self-weight of the overlying wall matrix. This behavior is sustained in Stage 2 but in Stage 3, an increase in tension is observed in the top zone which could be the result of roof change of space Gnd-E/03 in this stage. The tensile stresses are relieved in the mid-section of the wall which could be due to redistribution of loads due to the addition of spaces Gnd-E/19 (south) and Gnd-E/11-16 (south-east).

The behavior of the wall observed, close to the junction of wall Gnd-E/04 and the discussed wall, in the analytical model corresponds with the behavior observed for the actual wall in the documentation stage of the building (Figure 2.68). Although it is unclear if the behavior observed at the northern end of the wall reflects the on-site condition; as it was not checked during the visual inspection and no section has been cut through this part of the building.

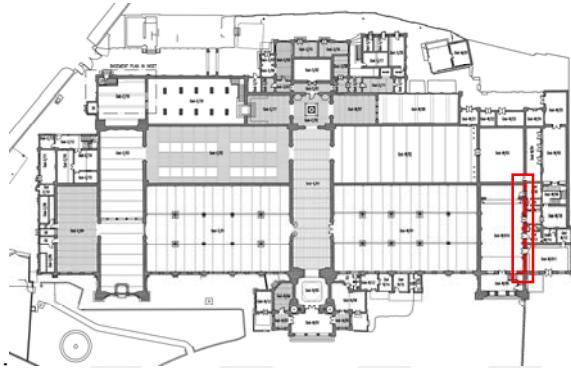
Figure 3.30: Key Plan showing wall Gnd-W/10-W-W

The critical location in the wall Gnd-W/01-S-W is observed approximately mid-wall, near the junction with wall Gnd-W/11-S-W.

In Stage 1, the S11 results for the selected location exhibits stress reversal, with the west (top) face in tension while the east (bottom) face is in compression. Similar behavior is observed for the entire wall which points to out of plane bending (Figure 3.20-d). For both area element and the entire wall, a reduction in the magnitude of stress is observed in the subsequent stages especially in Stage 3. This change can be ascribed to the addition of a floor slab in space Gnd-W/10, supported through column and beam frames inserted into the discussed wall. Also the addition of spaces on the ground floor at the western end of the wall might have helped relieve the stresses. Furthermore, in Stage 4 a further decrease in stress is observed which could be due to the construction of spaces, with multiple partition walls, over those built in Stage 3. These additions besides resulting in the increased vertical loads also provide lateral stiffening elements which tend to reduce lateral deformations and stresses.

In case of the S22 results for Stage 1, the wall segment exhibits tension on west (top) face while the east (bottom) face is in compression pointing to bending in the vertical plane (Figure 3.21-c). In Stage 2 a reduction in the magnitude of stress is observed but in Stage 3 the stresses increase; this change can be ascribed to the addition of a floor slab in space Gnd-W/10. The tensile stresses breach the threshold in all stages although the stress values decrease in Stage 4. In the context of the entire wall, in Stage 1 bending deformations are observed in the top zone which could be caused by the roof

of space Gnd-W/10 pulling the wall towards east. While in the mid-section of the wall a reversal of stress is observed which could be due to the roof of space Gnd-E/26, located west of the wall, pulling the wall westwards. Whereas in the bottom zone the tensile stresses are being eliminated by compression due to the self-weight of the overlying wall matrix. In Stage 2 the stresses are relieved but in Stage 3 the tensile stresses increase in the mid-section of the wall with both faces exhibiting tension. This behavior is sustained in Stage 4 and could be the result of the addition of floor slab in space Gnd-W/10 at this wall height in Stage 3.

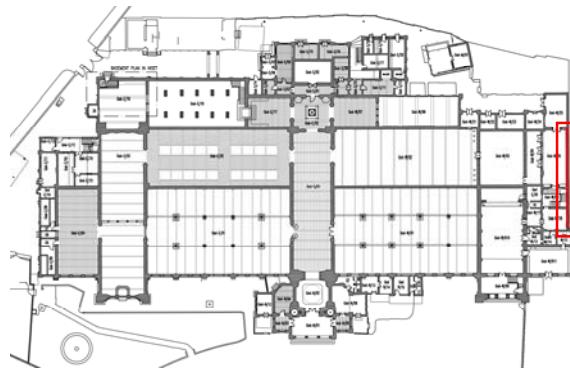
Figure 3.31: Key Plan showing wall Gnd-W/05-W-W

The critical location in the wall Gnd-W/05-W-W, constructed in Stage 3, is observed mid height of the wall near the southern end.

In Stage 3, the S11 results for the selected location exhibits that the nature of the stresses on either face is different; similar behavior is observed in the entire wall as well pointing to out of plane bending with the wall titling in the westward direction (Figure 3.20-d). In Stage 4 for the area element an increase in the magnitude of stresses is observed along with stress reversal, with both faces now in tension. The increase in lateral bending can be the result of construction of space Fst-W/07 over space Gnd-

W/05 in Stage 4; as the wall is an edge wall with a potential to bend laterally under increased load. In case of the entire wall it is observed that the bottom zone (Stage 3 construction) is in tension while the top zone (Stage 4 construction) is in compression pointing to in-plane bending (Figure 3.20-b). This too could be ascribed to the Stage 4 construction of space Fst-W/07 which functions as the reserve storage for the museum.

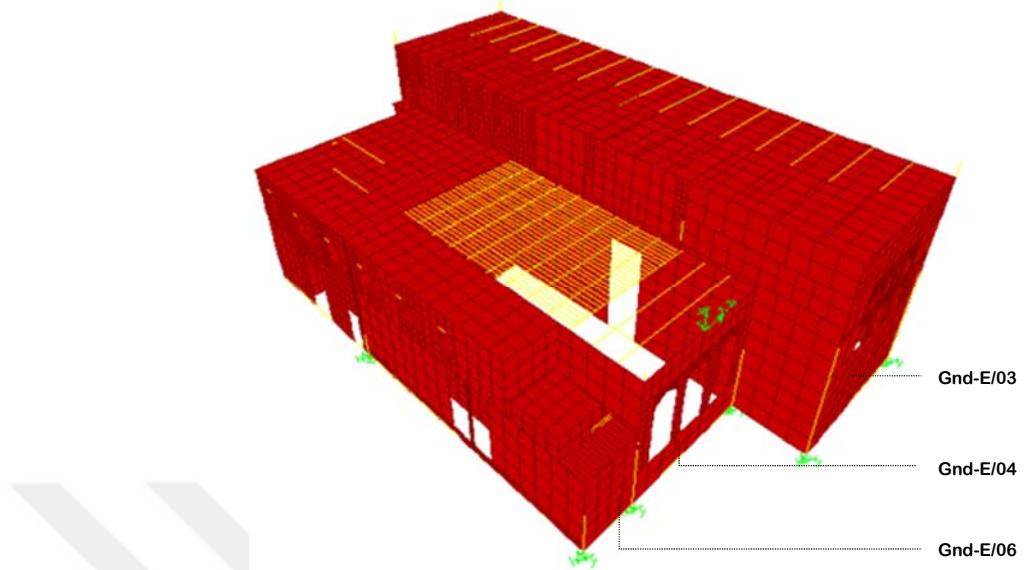
Figure 3.33: Part-Model of Space Gnd-E/04  
For testing out probable causes of damage observed in wall Gnd-E/04-N-W

In order to simulate the hypothesis that localized sub-strata performance might be poor, due to rupturing of water pipes in the adjacent space Gnd-E/06, the subgrade values applied in the form of line springs under the walls Gnd-E/04-N-W and Gnd-E/04-E-W were reduced by 30%. The second hypothesis that the structural alteration triggered by the temporary removal of roof structure of space Gnd-E/04, may have caused the wall to lose its top tie action was simulated through the removal of the roof. Furthermore, the hoisting equipment mounted at the top of the wall during the reworking of the roof was simulated through the application of point load in the part model.

The results for maximum principal stresses, under the simulated conditions, show that on the north (exterior) face, the western half of the wall is in tension while the eastern half is in compression. This behavior is reversed on the south (interior) face with the eastern half now in tension while the western half is in compression which points to lateral buckling. Additionally, tension threshold exceeds in the top spandrel above the arch openings (Figure 3.34). The lateral buckling couple coupled with significant tension observed in the top zone could have initiated the crack in the upper part of the wall which would have travelled downward, as the structure is relieved and stresses are redistributed.

Furthermore, the deformed shape also shows that with worsened local soil conditions the wall exhibits signs of differential settlement; the eastern end of the wall is observed to be lower than the western end.

Hence, the behavior of the wall observed in the analytical model corresponds with the behavior observed for the actual wall in the documentation stage of the building. This suggests that the hypotheses formed are correct and due attention needs to be paid to the local soil condition.

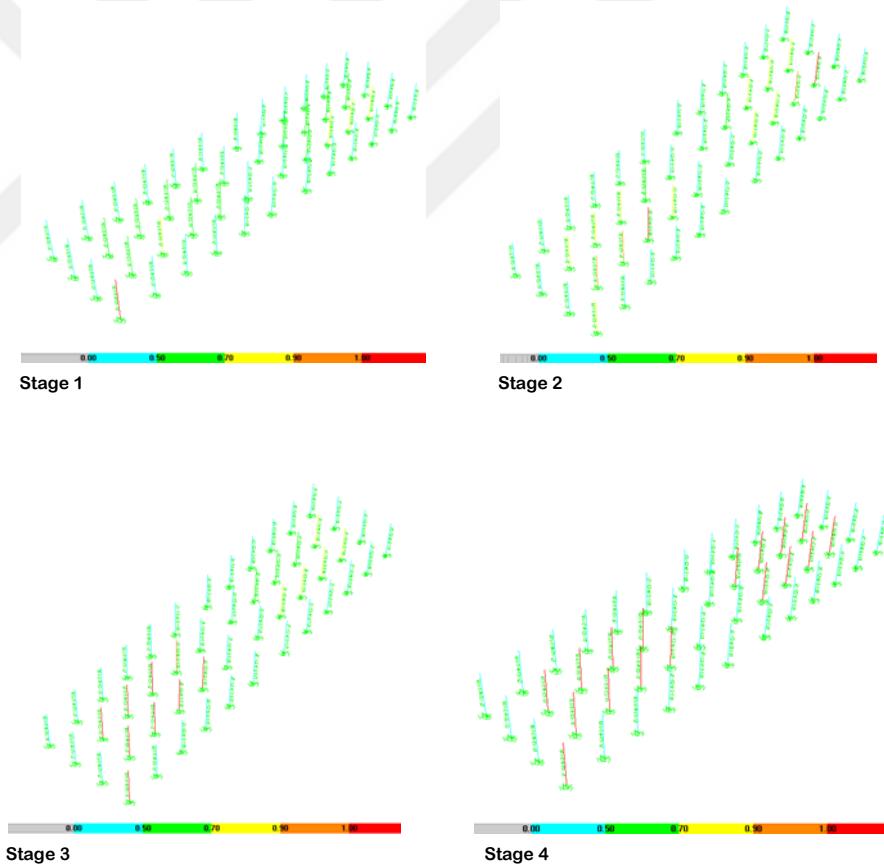
Figure 3.36: Evaluation Results of Cast Iron columns for all four stages.  
Stage 1 (Top Left), Stage 2 (Top Right), Stage 3 (Bottom Left) and Stage 4 (Bottom Right)

The CI columns were also evaluated as per UBC code. It was observed that although the utilization ratio remain under 1.0 for the gravity load combinations but the ratio exceeds 1.0 for seismic load combinations (Figure 3.36).

Although, deformations in the CI columns have also been observed during the documentation stage of the study. But bearing in mind that the material aging and degradation of CI is based on the simplified approach of reduction of MoE of material it cannot be definitively stated whether the problem originates due to inaccuracies of casting or because the material is fatigued. Hence, for any conclusive safety evaluation apropos the structural performance of the CI columns detailed material testing is required.

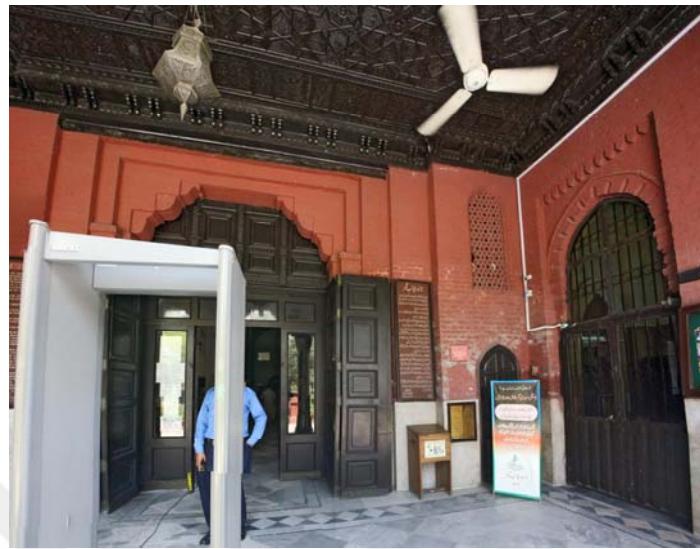
Figure B.1: Gnd-N/01 – Entrance Portico (2017)  
Looking south the image shows the main entrance door to the Museum and the carved wooden ceiling. Also the walls built in exposed bricks can be observed.

The walls built in exposed brick have been repointed in cement mortar. Cement has been used to even out the surface of the bricks as well. The paint and the cement is flaking in numerous places to expose powdering brick.

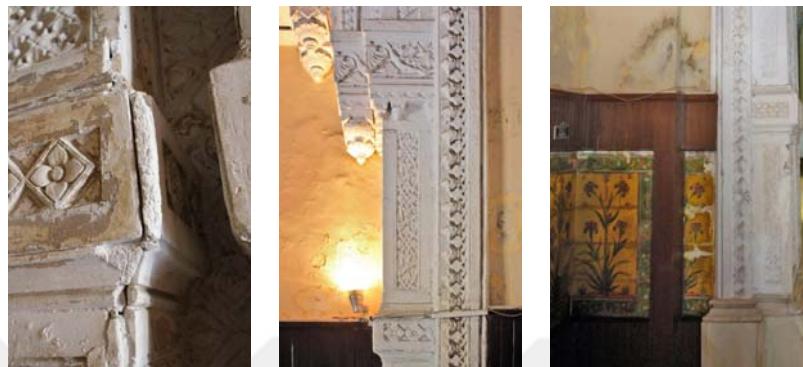
Discoloration of paint due to dampness can be seen above the dado level on both the eastern and the western wall. Additionally the paint has swelled and is flaking off at

various places. The dampness is also affecting the glazed tiles used in the dado as efflorescence is seen where the glazing of the tiles has flaked off.

Figure B.4: Gnd-N/02 – Entrance Vestibule – Deterioration (2016)  
From left to right: Flaking of paint and detachment of molded Plaster of Paris; Flaking of paint on the Eastern Wall; and Flaking of paint and efflorescence on glazed tiles on Southern Wall.

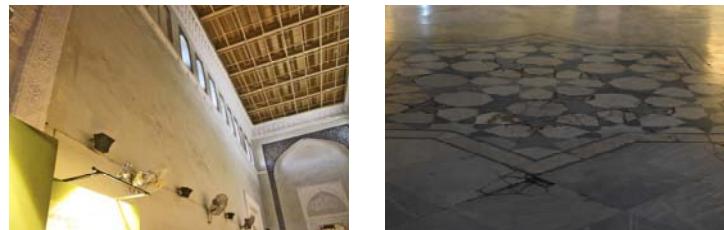
Swelling of plaster is observed midway up the eastern and the western wall. Discoloration of paint is also observed on the cornice of the western and the northern

wall. There are drip marks near the ventilators on the southern end of the western wall. The marble floor is uneven and the marble has cracked in multiple points.

Figure B.6: Gnd-C/01 – Miniature Painting Gallery – Deterioration (2017)  
Swelling of Plaster on the Eastern Wall (left) Marble floor pattern cracked (right)

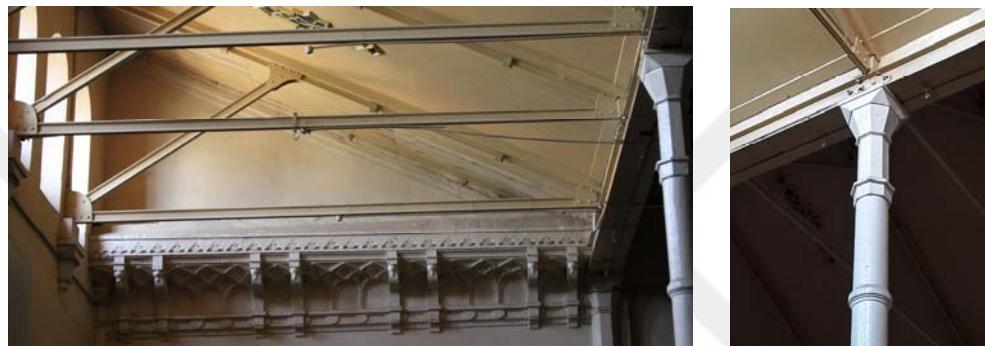
Figure B.9: Gnd-E/01 – Islamic Arts Gallery – Structural Components (2016)  
Saw Tooth Trusses built with railway girders (left) Cast Iron Columns supporting compound girders which in turn support the trusses (right)

Discoloration of paint due to dampness is observed on the upper portion of the western wall as well as the lower half of the northern wall. The calligraphic paintings fitted into the windows on the northern wall are also being damaged due to dampness. A crack is also observed on the floor, in the northern aisle of the space running in the East-West direction.

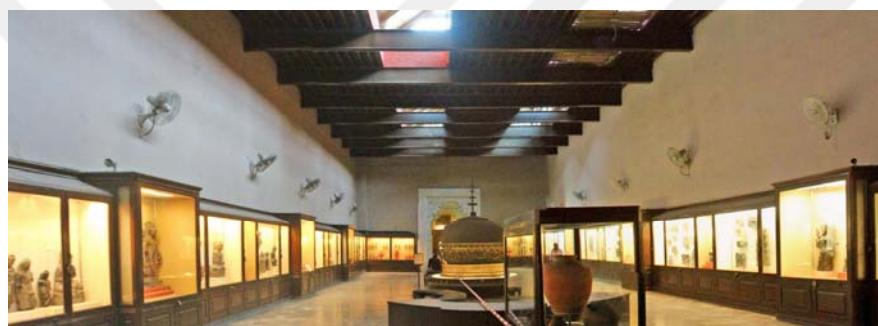
Figure B.11: Gnd-E/02 – Gandhara Gallery (2015)  
Looking West

The roofing system consists of I-Beams, running along the shorter span of the space in the N-S axis, supporting wooden battens and boarding. The roof has four rectangular skylights running in the E-W axis and resting on brick masonry. The skylights are in two rows of two and have pitched roofs that slope towards south and are fitted with glazing on the other three sides. Efflorescence is observed on the bricks masonry supporting the skylights.

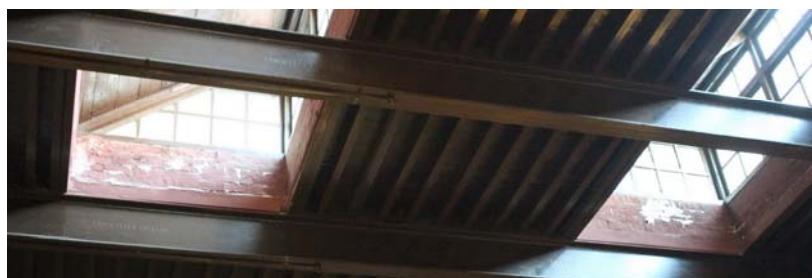
Figure B.12: Gnd-E/02 – Gandhara Gallery – Deterioration (2016)  
Efflorescence on brick masonry supporting skylight

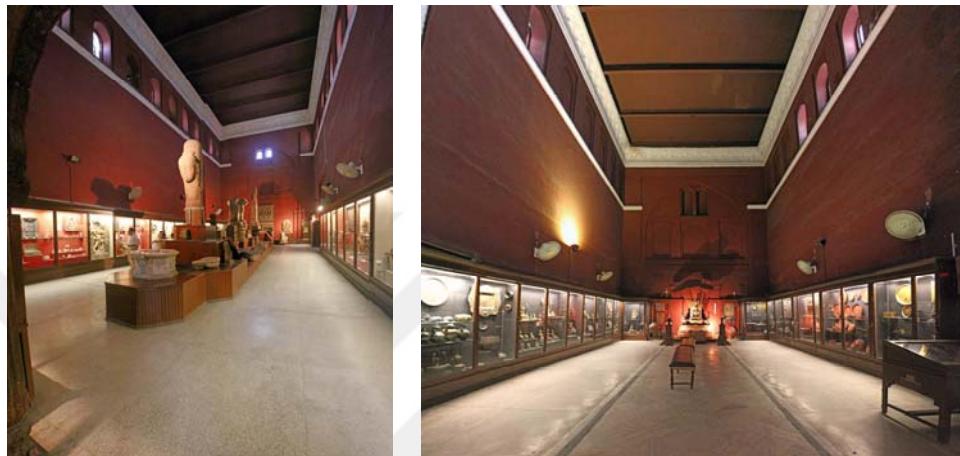
Figure B.13: Gnd –E/03 – Hindu and Buddhist Gallery (2016)  
Looking South (left) Looking North (right)

There is swelling of plaster on both eastern and western walls at mid-level. Also paint discoloration due to dampness is observed in the roof.

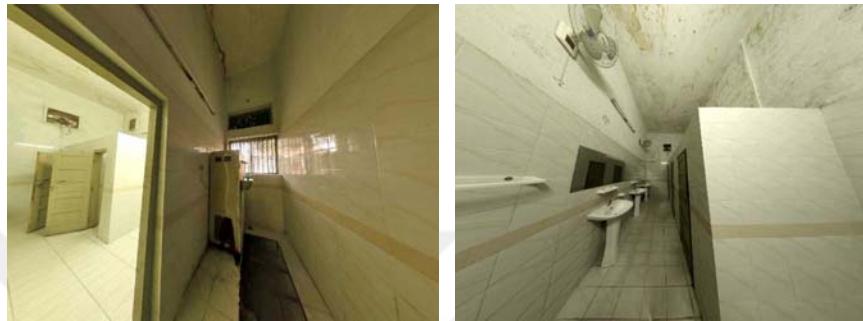
Figure B.17: Gnd-E/05 (left) & Gnd-E/06 (right) – Men's Toilet (2015)

Slight out of plane behavior is observed in the northern wall of Space Gnd-E/05. Also discoloration of paint due to dampness is observed on the ceiling of both the spaces.

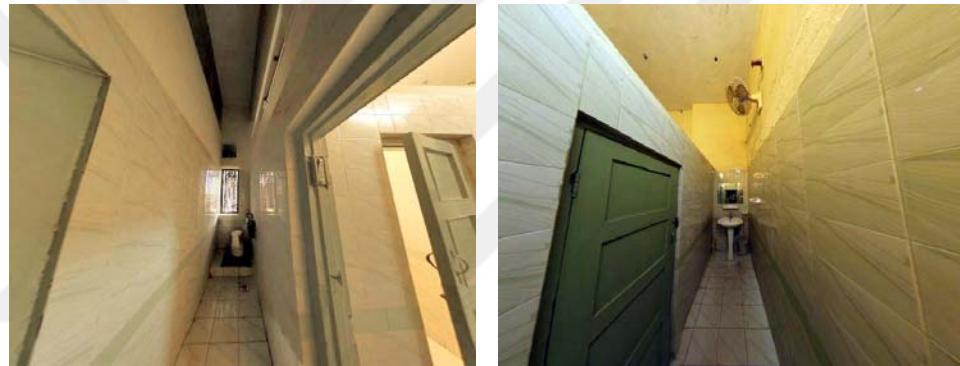
Figure B.19: Gnd-E/07 (left) & Gnd-E/08 (right) – Ladies Toilets (2015)

Slight out of plane behavior is observed in the northern wall of Space Gnd-E/07 while in space Gnd-E/08 flaking of paint due to dampness is observed in the upper part of its western wall.

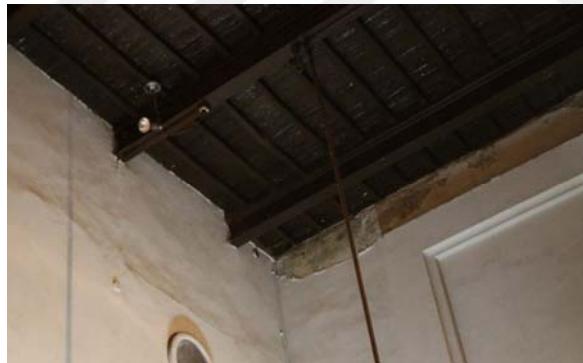
Swelling of plaster is observed on the south wall while paint is flaking at the upper level of the western wall.

Figure B.21: Gnd-E/17 – Jain Gallery (II) – Deterioration (2016)  
Swelling of plaster on the South wall while flaking of paint on the Western wall
