STRUCTURAL ANALYSIS, EVALUATION AND RECOMMENDATIONS  
FOR CONSERVATION OF THE LAHORE MUSEUM

A THESIS SUBMITTED TO  
THE GRADUATE SCHOOL OF NATURAL AND APPLIED SCIENCES  
OF  
THE MIDDLE EAST TECHNICAL UNIVERSITY

JULY 2018

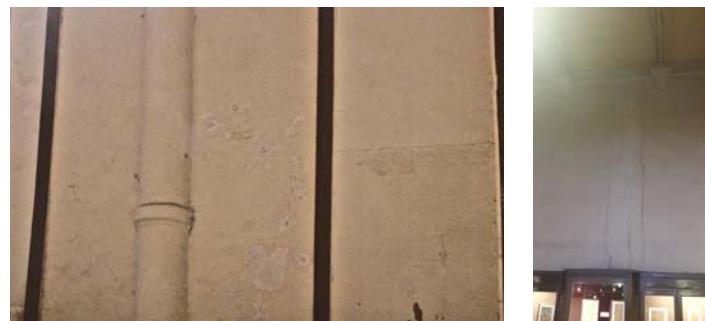
Flaking as well as discoloration of paint due to dampness is observed on the lower half of the northern wall in this space. Drip marks flowing down from the ceiling observed on the Southern wall show the lack of water tightness.

Figure B.25: Gnd-W/01 – General Gallery (2016)  
Flaking of paint and discoloration due to dampness on the Northern wall (left) Drip marks flowing down from the ceiling on the Southern Wall (right)

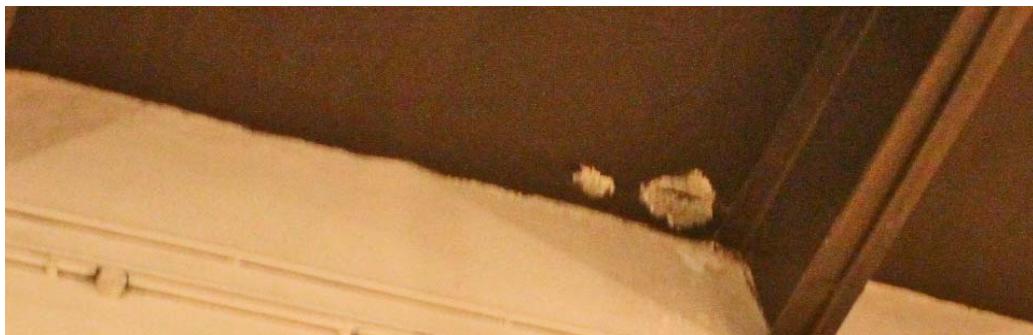
The space is accessed through an ornamented plasterwork doorway in the eastern wall. The southern wall at its western end has a wooden screen fitted into an opening, behind which is space Gnd-W/21. There is a carved wooden doorway in the western wall which leads to space Gnd-W/03. The northern wall has no architectural features of importance. The roof is an RC slab supported on I-Beams running along the shorter span, in the N-S axis. A chunk of concrete has detached from the roof exposing the steel rebars near the southern wall.

Figure B.27: Gnd-W/02 – Contemporary Painting Gallery (2016)  
Detached chunk of concrete near the Southern wall

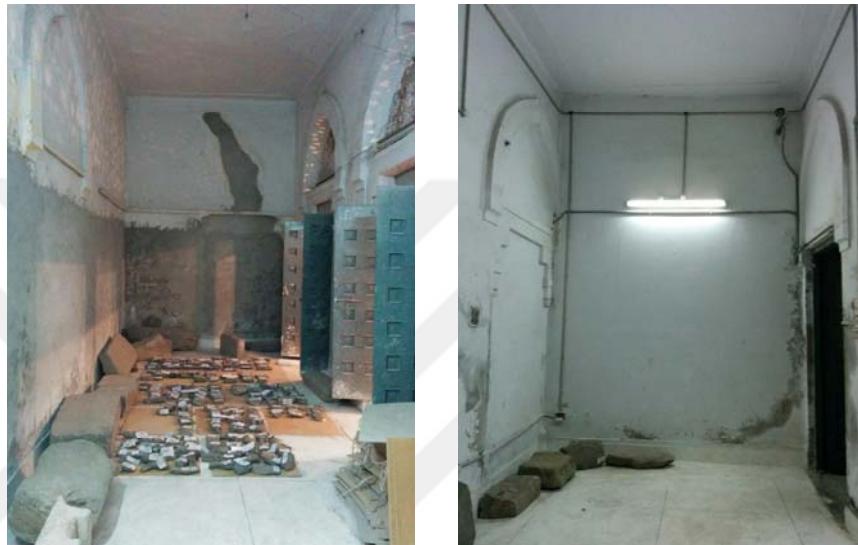
Figure B.29: Gnd-W/04 – Reserves Storage (2015)  
Looking South (left) Looking North (right)

Sagging of roof and out of plane behavior of the northern wall is observed. Also the southern and the eastern walls have been re-plastered with cement mortar. Flaking of paint is observed on the northern and the western walls.

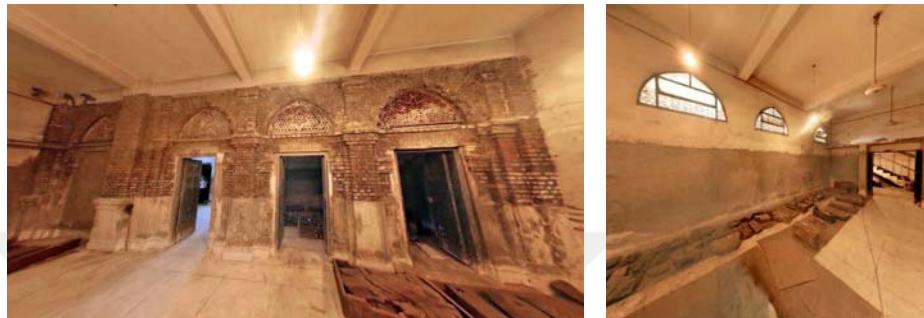
Figure B.30: Gnd-W/05 – Reserves Storage (2015)  
Looking East (left) Looking West (right)

Slight sagging of roof is observed. Also the western wall has been re-plastered and the terracotta *jalis* fixed in the arches on the eastern wall are powdering in some places. Additionally Flaking of paint is also seen on the eastern wall.

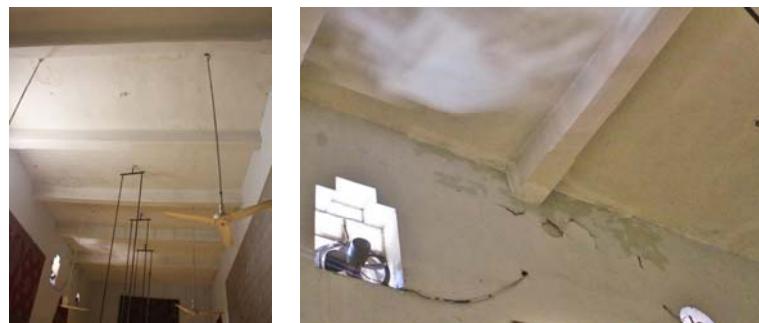
Figure B.34: Gnd-W/08 – Swat Gallery (II) – Deterioration (2016)  
Discoloration due to dampness on the ceiling around the electric points (left) Flaking of paint on the  
Southern wall close to the ceiling

Drip marks and discoloration is observed around every electric point on the ceiling which suggests lack of water tightness around the electric conduits. Flaking of paint due to dampness is also observed on the southern wall and the ceiling.

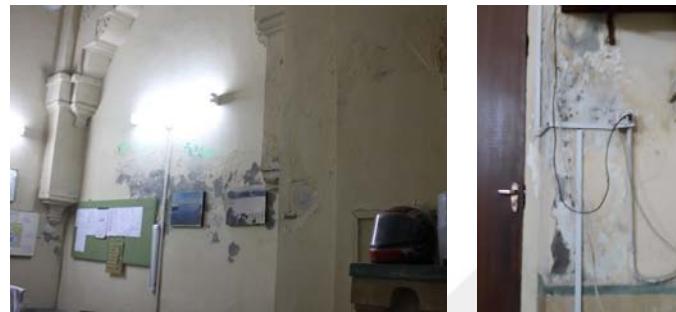
The roof was modified in 1965 and has brick tiles supported on T-iron strips resting on I-Beams laid in the E-W direction. There is discoloration and flaking of paint on both the northern and the western walls due to dampness.

Figure B.37: Gnd-N/04 – Office of Chief Security Officer – Deterioration (2015)  
Flaking of paint on the Western wall (left) Flaking of paint and discoloration Northern wall (right)

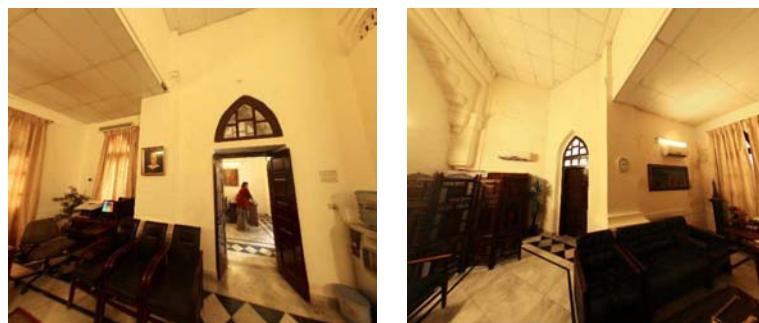
Figure B.39: Office for the Public Relations Officer (2015)  
Looking North (left) Looking South (right)

As the room had been recently painted the only deterioration observed was discolouration and flaking of paint on the south western corner of the space due to dampness (Figure B.39).

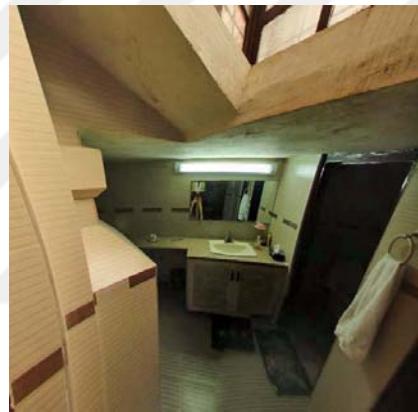
Figure B.40: Gnd-N/07 – Kitchenette (2015)  
Looking South

The space has a RC roof which due to dampness shows discolouration and the paint is also flaking in some patches (Figure B.40 & Figure B.41).

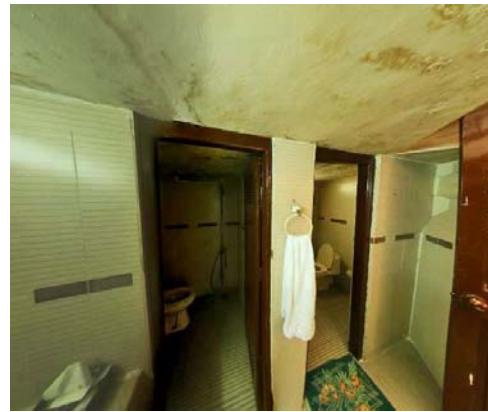
Figure B.41: Gnd-N/08 & Gnd-N/09 – Toilet Stalls (2015)  
Looking West

These spaces also have an RC roof which due to dampness shows discoloration and the paint is also flaking in some patches.

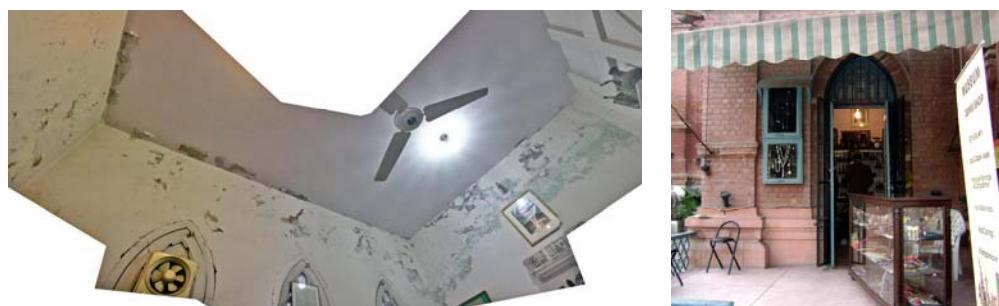
Figure B.43: Gnd-N/12 – Curio Shop (2015)  
Interior looking East (left) Exterior looking South (right)

The paint is flaking due to dampness at the upper edges of the walls and the connecting ceiling edges (Figure B.43).

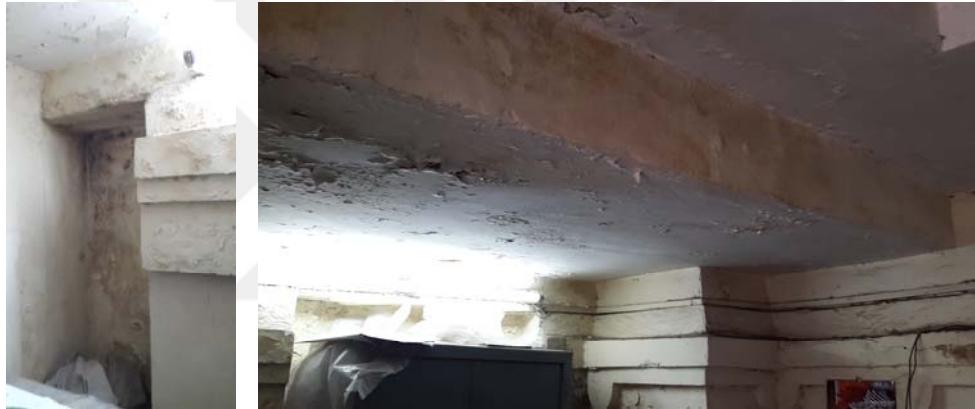
Figure B.44: Gnd-N/13 – Office for Security Staff (2016)  
Looking South (Left) Looking South- East close to the top end of the wall near the ceiling (right)

It is observed that paint as well as plaster is flaking due to dampness on the western and the southern wall as well as the ceiling (Figure B.44).

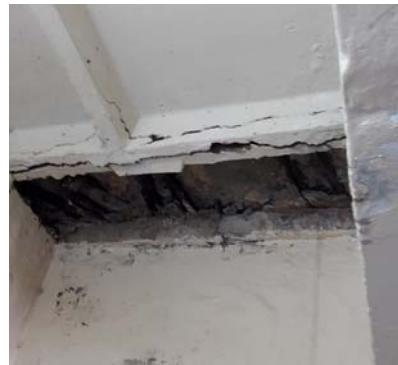
Figure B.45: Gnd-N/14 – Ticketing Booth – Deterioration (2016)  
Discoloration of paint on the western wall and the ceiling (left) Concrete chunk fallen off near the southern wall (right)

Flaking and discoloration of paint due to dampness is observed on the southern and western wall. On the ceiling not only is the paint flaking and discoloration is seen but concrete has fallen off in large chunks exposing the steel rebars in a couple of places due to dampness (Figure B.45).

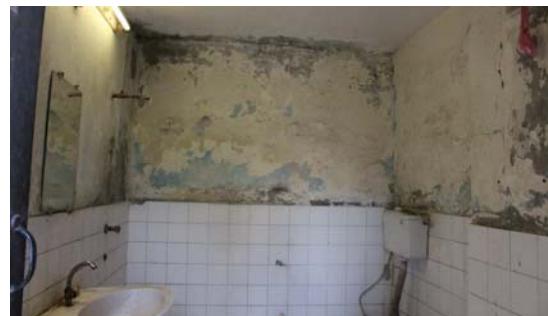
Figure B.47: Gnd-E/10 – Toilet for staff (2016)  
Looking West

The space is accessed through the door in the eastern wall. All other walls of the space have no architectural features of importance. The roof is an RC slab. Paint is flaking off on all the walls and where the paint has completely fallen off there are visible signs of dampness.

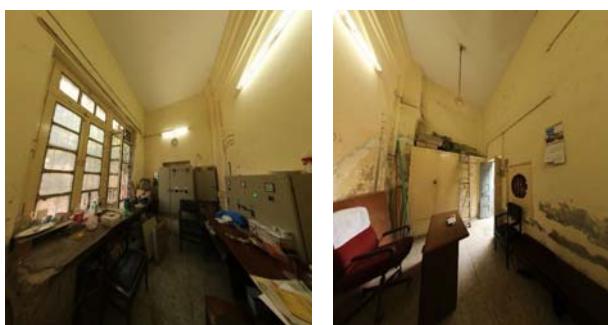
Figure B.48: Gnd-E/11 – Restroom for staff (2016)  
Looking South (left) Looking North (right)

Flaking of paint due to dampness is observed in the lower part of the eastern and the western walls. There are visible signs of dampness where paint has completely fallen off (Figure B.48).

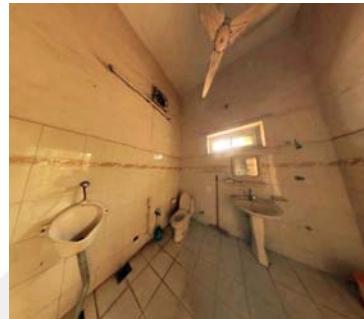
Figure B.50: Gnd-E/13 – Toilet (2015)  
Looking South-East

Swelling of plaster is observed on all the walls above the dado height.

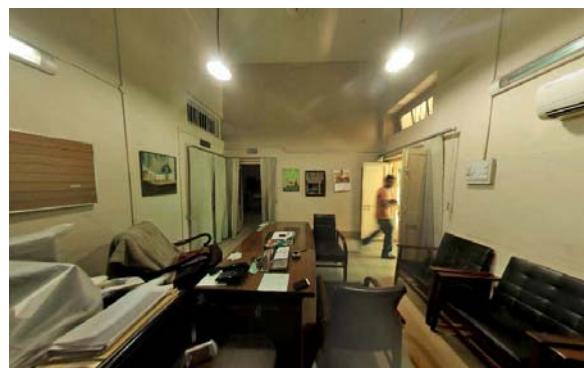
Figure B.51: Gnd-E/14 – Office for the Chief Conservator (2015)  
Looking East

Flaking of paint is observed in the upper part of the western wall.

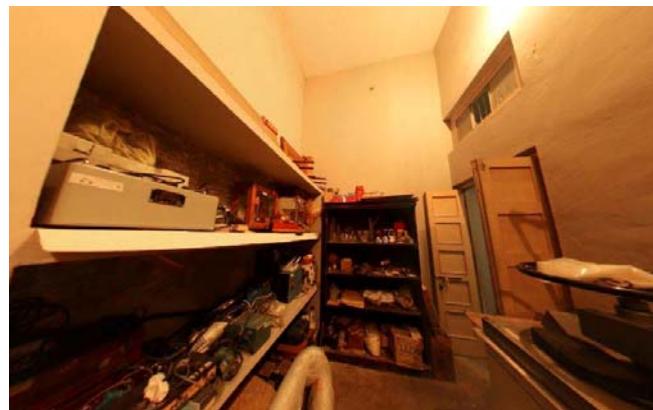
Figure B.52: Gnd-E/15 – Storage Room for Conservation Laboratory (2015)  
Looking East

Flaking of paint is observed in the upper part of the western wall.

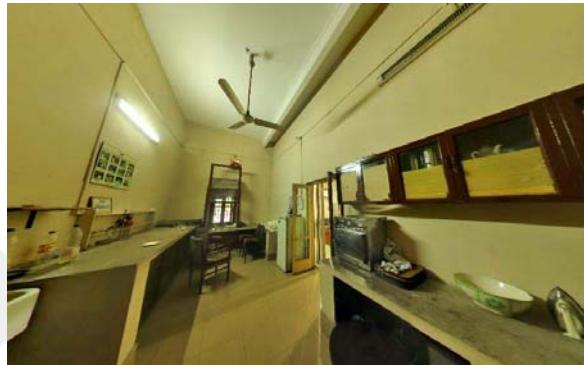
Figure B.53: Gnd-E/16 – Conservation Laboratory (2015)  
Looking South

Flaking of paint is observed on the eastern and northern walls while visible signs of dampness are seen where the paint has completely fallen off.

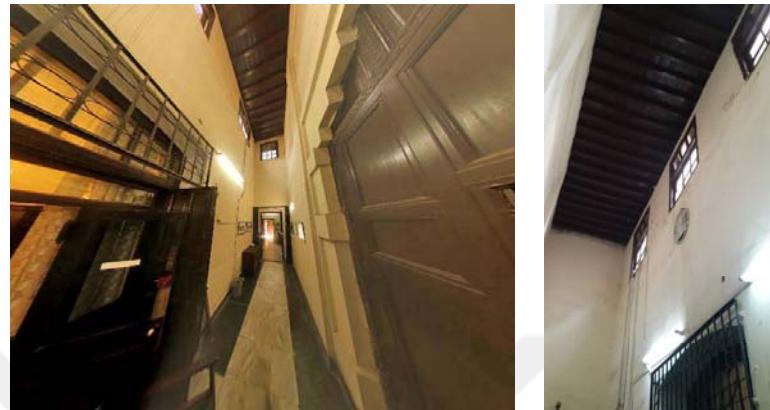
Figure B.55: Gnd-C/03 – Corridor connecting administrative areas to display areas (2015)  
Looking West (left) Looking East (Right)

Drip marks flowing down the ventilators are observed on both the southern and the eastern walls (Figure B.55).

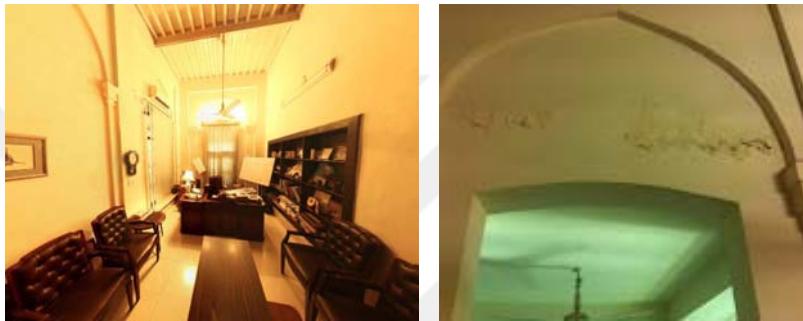
Figure B.59: Gnd-S/04 – Office for Director of the Museum (2015)  
Looking South (left) Flaking of Paint on the eastern wall (right)

Flaking of paint is observed over the doorway in the eastern wall (Figure B.59).

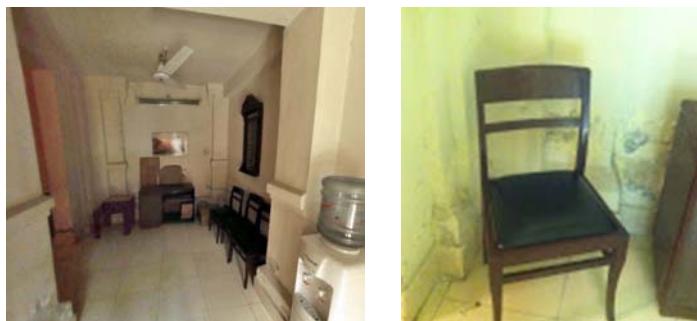
Figure B.60: Gnd-S/05 – Waiting Area for Director's Office (2015)  
Looking North (left) Flaking of paint on the Northern wall (right)

The space is accessed through an opening in the southern wall. The western wall has a doorway set into an in-filled archway leading onto space Gnd-S/04. The northern wall has traces of a closed off archway while the eastern wall is without any significant architectural features. The space has an RC slab roof. Flaking of paint is observed on the lower half of the northern wall (Figure B.60).

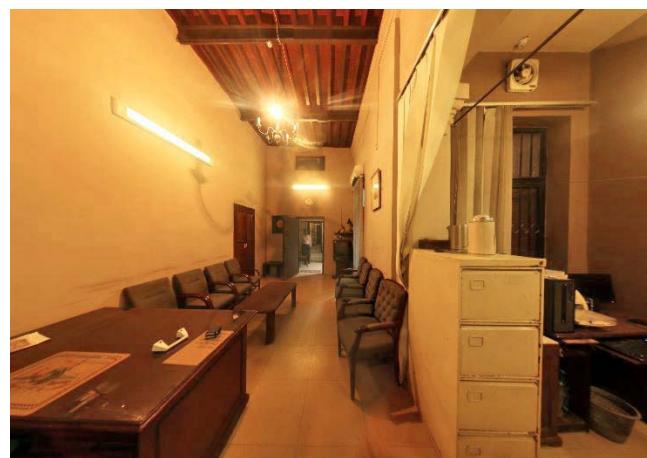
Figure B.63: Gnd-S/10 – Office (2015)  
Looking East

The space is accessed through a door set into an in-filled archway in its eastern wall. There are no architectural features of significance on the northern wall. There is a door in the western wall that opens onto space Gnd-S/12. The southern wall at its western end has an opening leading onto space Gnd-S/11; east of the opening on the same wall is a window. The roofing system consists of I-Beams, running along the N-S axis, supporting wooden battens and boarding. Discoloration and flaking of paint due to dampness is observed on the western wall.

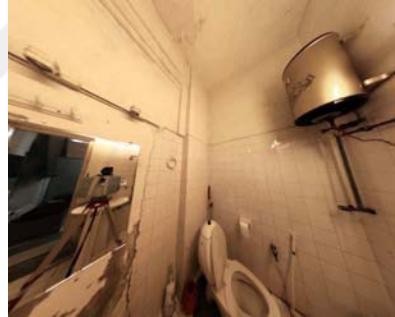
Figure B.64: Gnd-S/12 – Toilet (2015)  
Looking North-West

Flaking of paint due to dampness is observed on the ceiling. The space has partial re-plastering on the western wall.

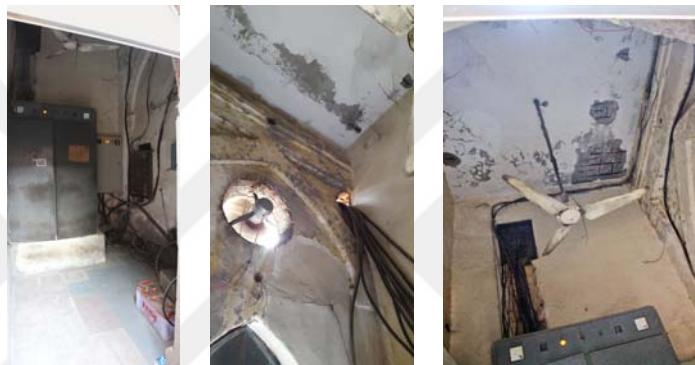
Figure B.65: Gnd-S/13 – Electric Control Room (2016)

Looking North (left) Flaking of paint observed on the Southern wall and on the ceiling (center)  
 Looking North-East flaking of paint observed on the Eastern wall as well as detachment of concrete from ceiling (right)

Chunks of concrete have detached from the ceiling in three places, exposing steel rebars. Flaking of paint due to dampness is observed on the southern wall, the eastern wall as well as the ceiling (Figure B.65).

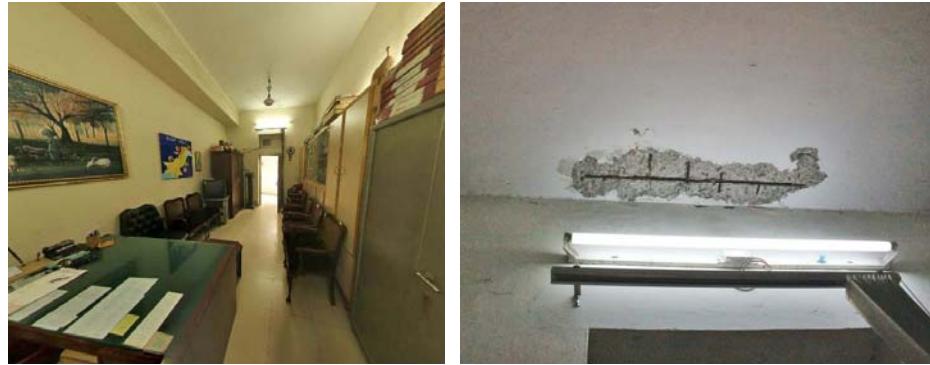
Figure B.70: Gnd-S/19 – Office (2015)  
Looking South (left) Detachment of concrete from ceiling at the Southern end of the room (right)

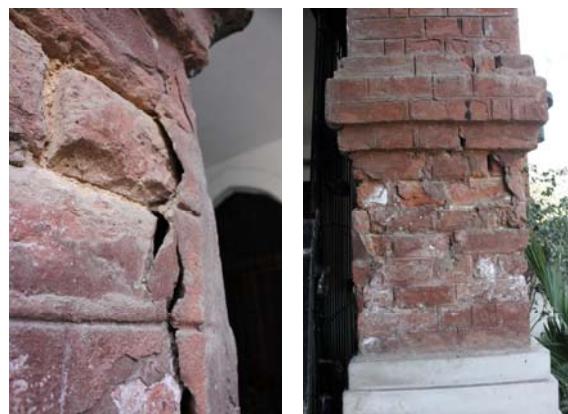
Parts of brick have detached from the columns between the northern openings.

Efflorescence is observed on the northern brick columns also cement repointing has detached from the brick surfaces.

Figure B.72: Gnd-W/09 – Entrance Lobby to the Auditorium and Library – Deteriorations (2016)  
Efflorescence as well as a powdering and detachment of bricks

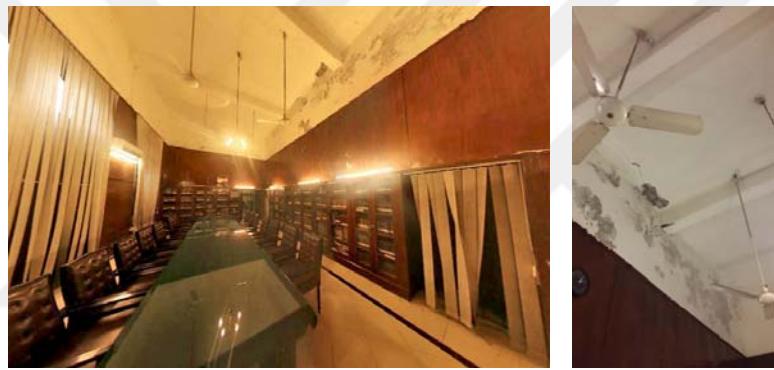
Flaking of paint due to dampness is observed at the upper parts of the southern wall. Close to the southern wall a chunk of concrete has also detached from the ceiling exposing the steel rebars.

Figure B.74: Gnd-W/11 – Conference Room (2015)  
Looking East (left) Flaking of paint on the southern wall & detachment of concrete (right)

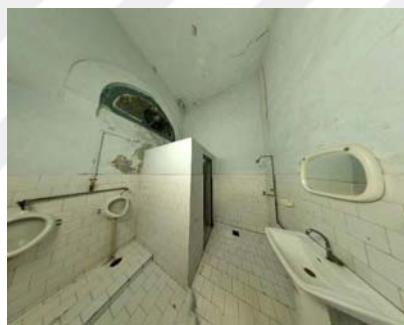
Figure B.77: Gnd-W/14 – Men's Toilet for Auditorium (2015)  
Looking West

The space is accessed through a door in the eastern wall. On the southern wall there is an exhaust fan fitted into a pre-existing window above a blocked archway. There are no architectural features of any importance on the western or the northern walls. In the south west corner of the space is a toilet cubicle accessible through a door on its northern side. The space has an RC slab roof. Flaking of paint due to dampness is observed on the southern wall and parts of the ceiling.

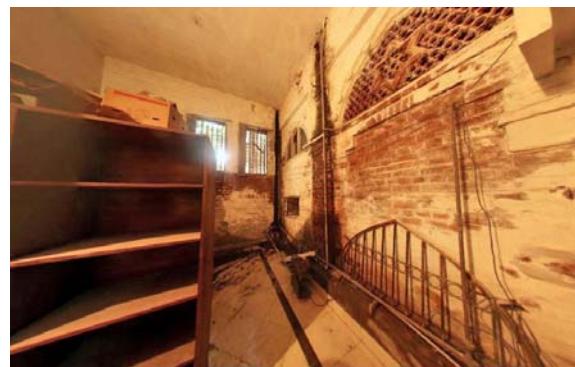
Figure B.80: Gnd-W/18 – Store (2015)  
Looking West

The paint has powdered and flaked off both from the northern and the western wall. At the north-western corner of the space there is a storm drainage downpipe. The water from the pipe empties onto the floor from where it flows into the floor drain located in the corner.

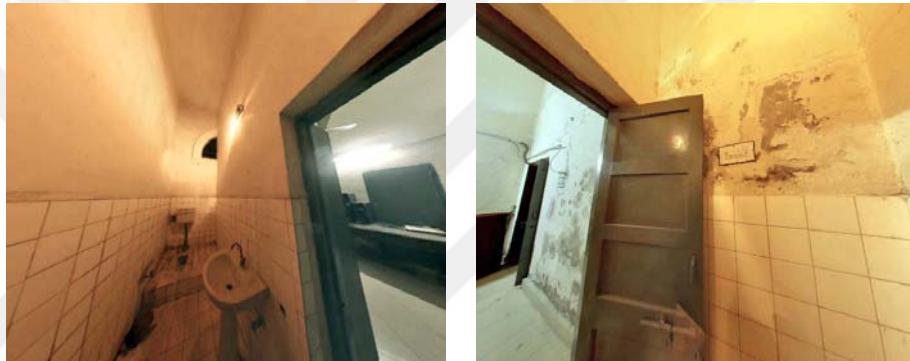
Figure B.81: Gnd-W/19 – Toilet (2015)  
Looking West (left) Looking East (right)

Sagging of roof is detected along with the Out of Plane behavior of the northern wall. Also powdering and flaking off paint due to dampness can be seen on the eastern wall. Additionally some efflorescence can also be observed where the paint has completely fallen off.

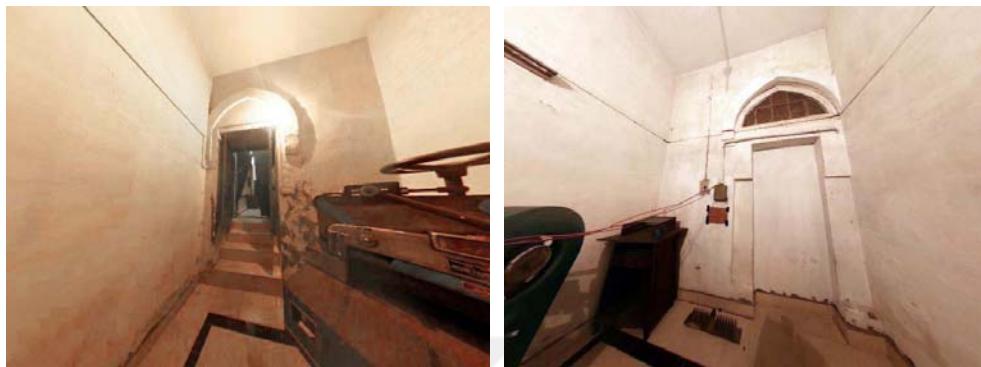
Figure B.82: Gnd-W/20 – Backstage Area for Auditorium (2015)  
Looking East (left) Looking West (right)

Sagging of roof is observed along with out of plane behavior of the northern wall. There is also flaking and powdering of paint due to dampness on the eastern wall.

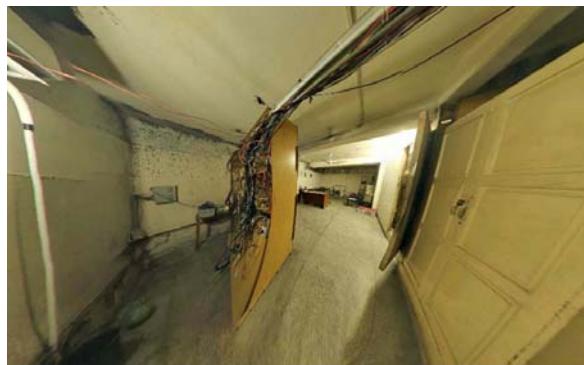
Figure B.83: Bas-E/01 – Surveillance Room (2015)  
Looking North East

32cm (12in.) drop from the soffit running along the shorter span in the N-S axis. No visible signs of deterioration are observed in the space.

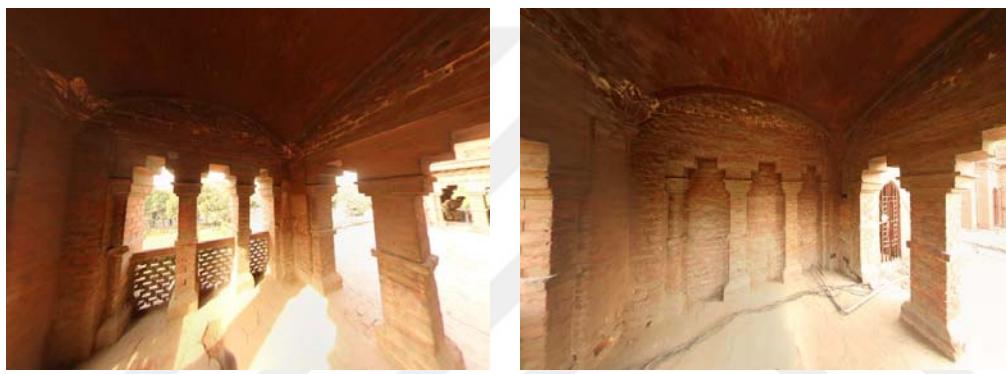
Figure B.87: Fst-N/04 (left) & Fst-N/05 (right) – Western & Eastern Turret respectively (2015)  
Looking North in the image on the left; Looking South in the image on the right

In space Fst-N/04 electric conduits have been installed by carving grooves in the walls which have been grouted with cement. Some of the brick tiles used on the floor are starting to powder and disintegrate. While in space Fst-N/05 the bricks around the edge of the inner dome as well some brick tiles on the floor are starting to powder and disintegrate.

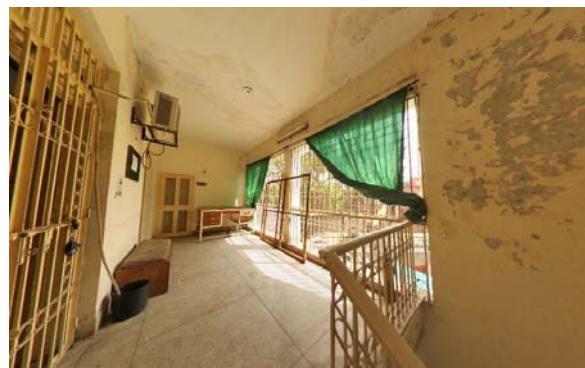
Figure B.90: Fst-E/01 – Verandah/ Stair Hall for Conservation Laboratory (2015)  
Looking East

Drip marks and discolouration of paint is observed around every electric point on the ceiling. Flaking of paint is also observed on the southern wall.

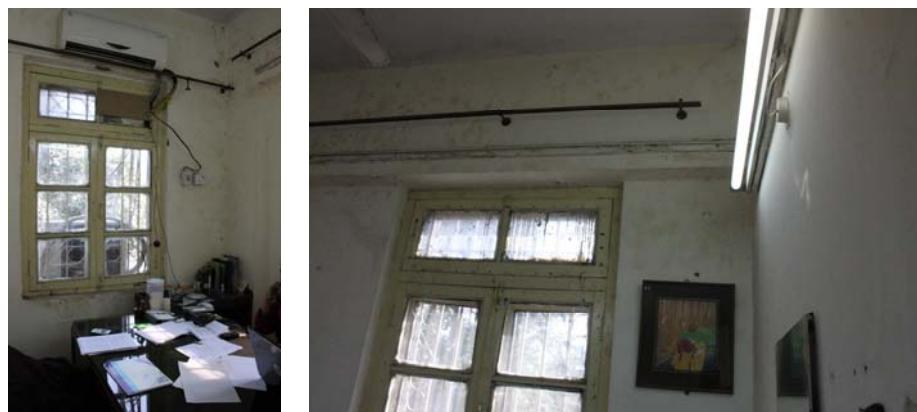
Figure B.91: Fst-E/02 – Office (2016)  
Looking East (left) Looking South (right)

Flaking and discolouration of paint due to dampness is observed on ceiling as well as the eastern and the southern walls.

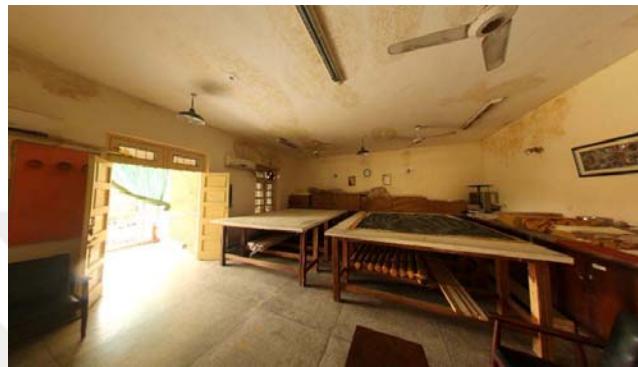
Figure B.92: Fst-E/03 – Conservation Workshop (2015)  
Looking West

Drip marks and discoloration of paint is observed around every electric point on the ceiling. Discoloration of paint is also observed on the northern and the southern walls.

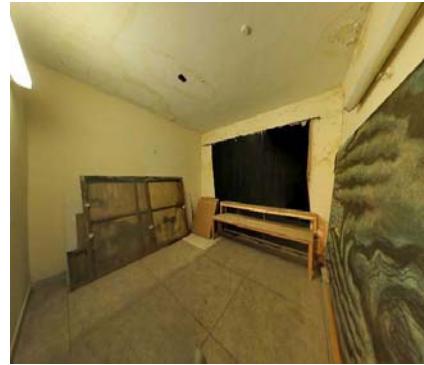
Figure B.93: Fst-E/04 – Photography Room for Conservation Workshop (2015)  
Looking East

Drip marks and discoloration of paint is observed around every electric point on the ceiling. Flaking of paint due to dampness is observed on the eastern wall.

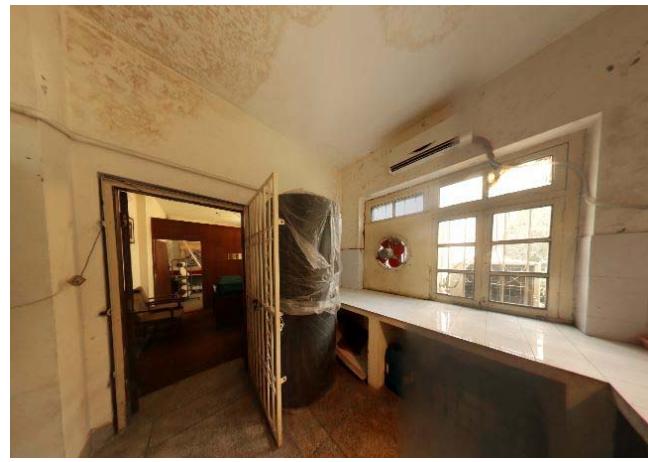
Figure B.94: Transition Space – Extension of Conservation Workshop (2015)  
Looking North-East

The space is accessed from its western side. On the northern wall there is a door that leads onto space Fst-E/06. The eastern wall has a window under which is a built-in concrete shelf. There are no architectural features of importance on the southern wall. The space has an RC slab roof. Drip marks and discolouration of paint is observed around every electric point on the ceiling. Discolouration of paint is also observed on the northern and the eastern walls.

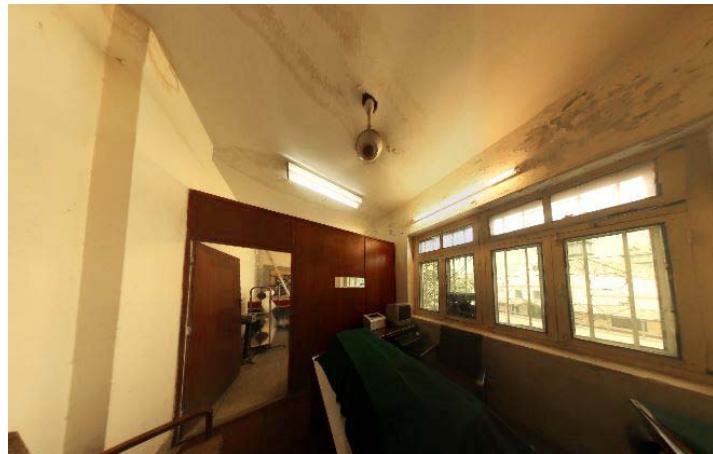
Figure B.95: Fst-E06 – Conservation Workshop (2015)  
Looking North

The space is accessed through the door in the southern wall. There is a window in the eastern wall. The northern wall constructed with plywood panels fixed onto a wooden frame has a door leading onto space Fst-E/07. There are no architectural features of importance on the western wall. The space has an RC slab roof. Drip marks and discolouration of paint is observed around every electric point on the ceiling. Flaking of paint due to dampness is also observed on the eastern wall.

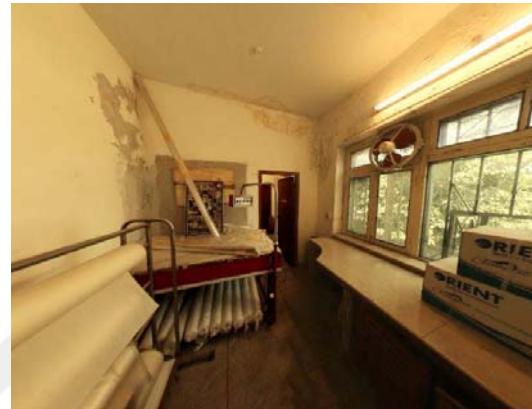
Figure B.96: Fst-E/07 – Conservation Workshop (2015)  
Looking North

Drip marks and discolouration of paint is observed around every electric point on the ceiling. Discolouration of paint continues onto the northern and eastern walls. Slight flaking of paint is observed on the western wall.

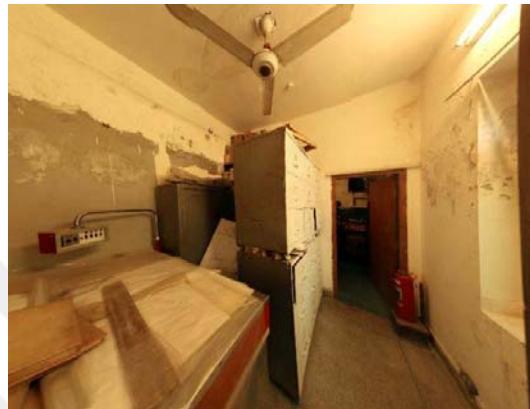
Figure B.97: Fst-E/08 – Conservation Workshop (2015)  
Looking North

roof. Drip marks and discolouration of paint is observed around every electric point on the ceiling. Discolouration of paint continues onto the northern wall. Slight flaking of paint is observed on the eastern wall while the western wall has recently been re-plastered with cement mortar.

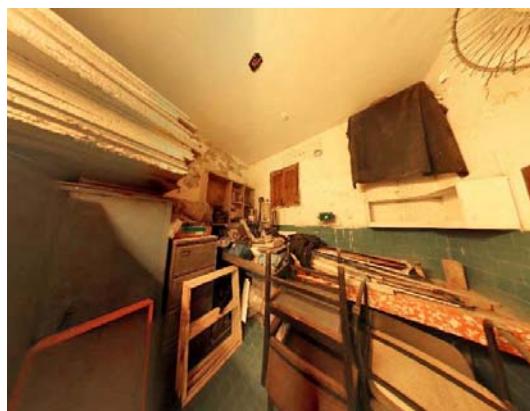
Figure B.98: Fst-E/09 – Storage Room for Conservation Workshop (2015)  
Looking North

The space is accessed through the door in the southern wall. An exhaust fan has been fitted in the northern wall. There are no architectural features of importance on the eastern and the western walls. The space has an RC slab roof. Flaking of paint due to dampness is observed on the eastern, western and the northern walls.

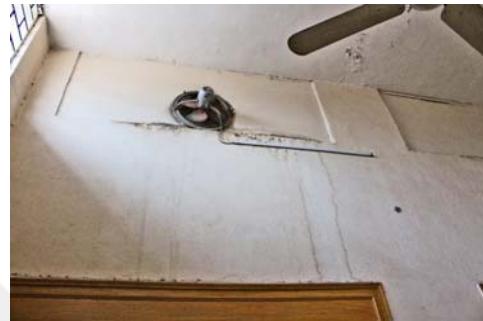
All the spaces have an RS slab roof. No visible signs of deterioration are observed in spaces Fst-E/10, Fst-E/11, Fst-E/12 & Fst-E/14. In space Fst-E/13 drip marks are observed flowing from the ventilators on the northern and the southern walls. Slight flaking of paint due to dampness is observed on the ceiling of the space as well.

Figure B.104: Fst-E/13 – Freedom Movement Gallery – Deterioration (2015)  
Drip marks on the northern wall

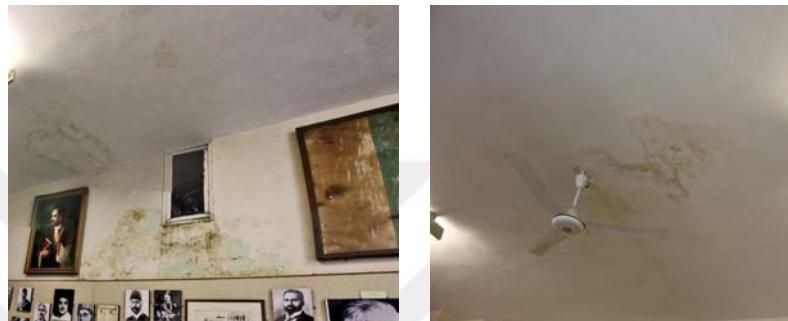
Drip marks and discolouration of paint is observed around every electric point on the ceiling. Slight flaking of paint and drip marks under the ventilators are observed on the eastern wall.

Figure B.106: Fst-E/15 – Freedom Movement Gallery (II) – Deterioration (2016)  
Flaking of paint and drip marks on the Eastern wall (left)  
Drip marks and discolouration of paint on the ceiling (right)

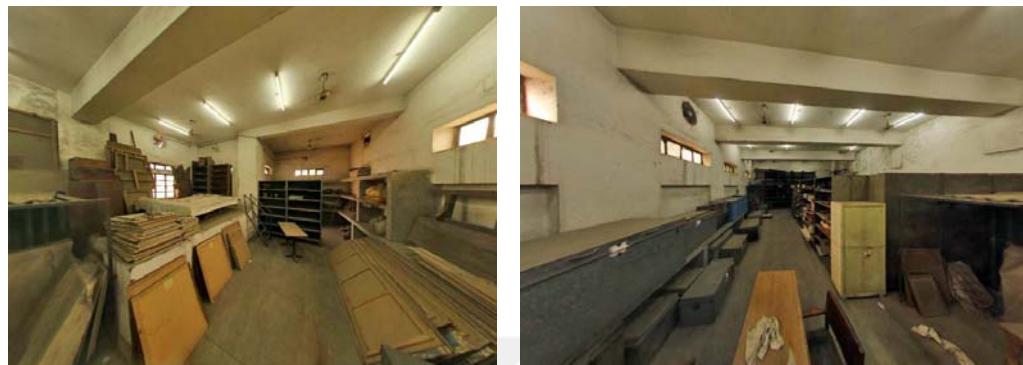
Drip marks are observed flowing from the ventilators on the western wall. Swelling of plaster along with powdering and flaking of paint is observed on the eastern wall.

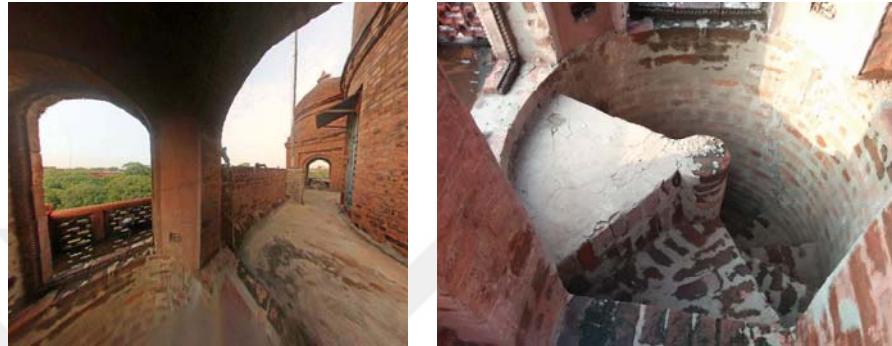
balconies on three sides have sandstone balustrades which are fitted with terracotta *jalis*. The roofing system comprises of a dome constructed in brick masonry. Repair work in cement plaster has been carried out also some of the steps have lost their pointing.

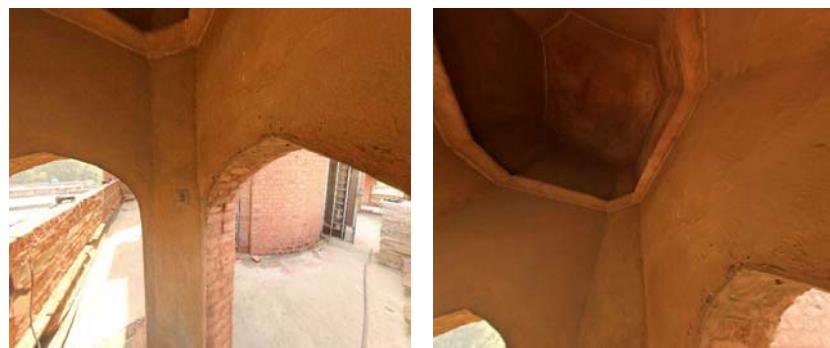
The space built in 1893 and repaired in 1993, is a *Domed Canopy* and is part of Gnd-N/10 (Spiral Stairwell) rising from the ground level and built within the north-eastern pier of the Gnd-N/02 (Entrance Vestibule). It is a mirrored space of Thd-N/01 described above. Repair work in cement plaster has been carried out. No visible signs of deterioration are observed.

Figure B.120: Thd-N/02 – Domed Canopy – North-Eastern (2015)  
Looking South-West (left) Looking upwards at the domical ceiling (right)

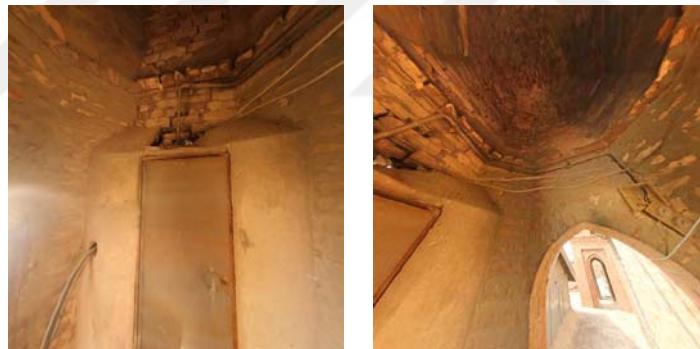
The space has four corner columns and identical arched openings on all four sides. The space can be accessed through the arched opening on the northern side as well as the arched opening on the western side. On the southern side the arched opening has been blocked off by a brick masonry wall which has been fitted with an electric box. The arched openings at the eastern side extends onto a small balcony supported on four brackets. The balcony on three sides has a sandstone balustrade which is fitted with terracotta *jalis*. The roofing system comprises of a dome constructed in brick masonry. The dome has lost most of its lime plaster. Parts of the canopy's interior have been repointed with cement mortar.

Figure B.121: Thd-N/03 – Domed Canopy – South-Eastern (2015)  
Looking South (left) Looking West (right)

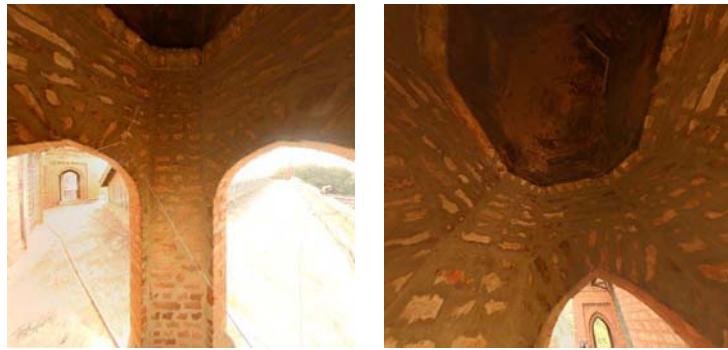
Figure B.122: Thd-N/04 – Domed Canopy – South-Western (2015)  
Looking East (left), Looking upwards at the domical ceiling (right)

The dome has partially lost its lime plaster. Repointed with cement plaster has been carried out in parts of the interior of the canopy.

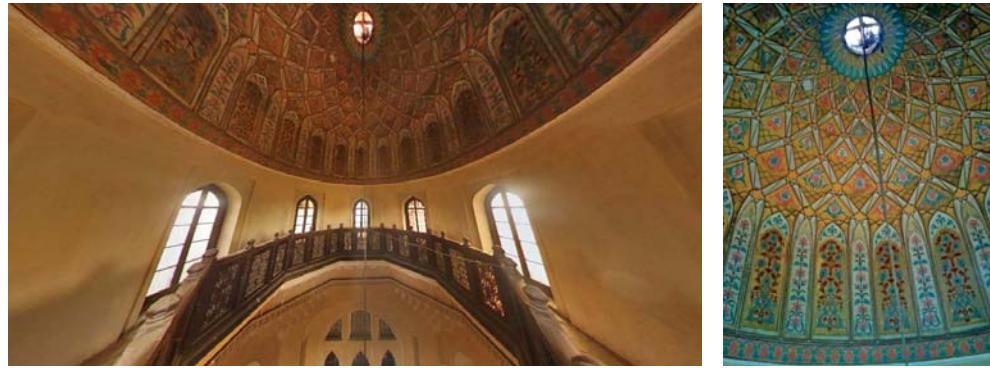
Figure B.123: Thd-N/05 – Main Dome (2015)  
Looking South (left) Close-up of the dome showing the fresco details (right)

Slight cracks are observed in the fresco that adorns the interior surface of the dome.
