RESTORATION OF A HISTORIC OLIVE OIL MILL IN DİKİLİ

**A Thesis Submitted to the Graduate School of Engineering and Science
of İzmir Institute of Technology in Partial Fulfillment of the
Requirements for Degree of**

in Architectural Restoration

December 2014

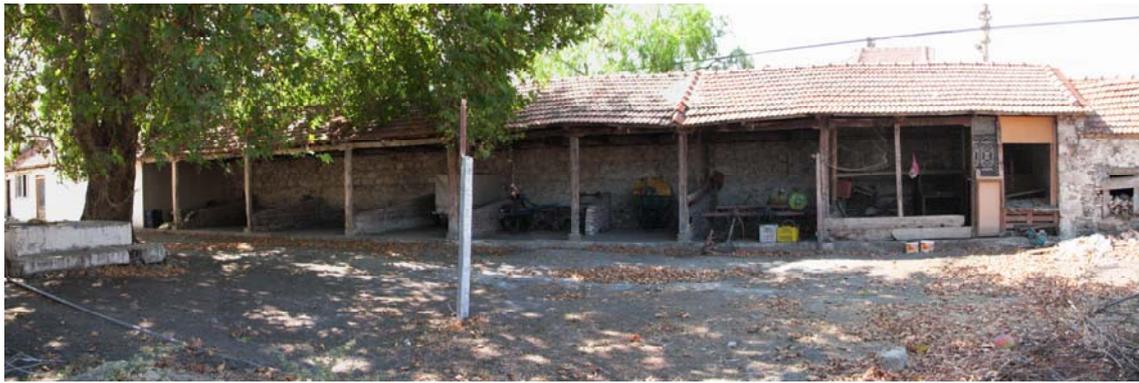
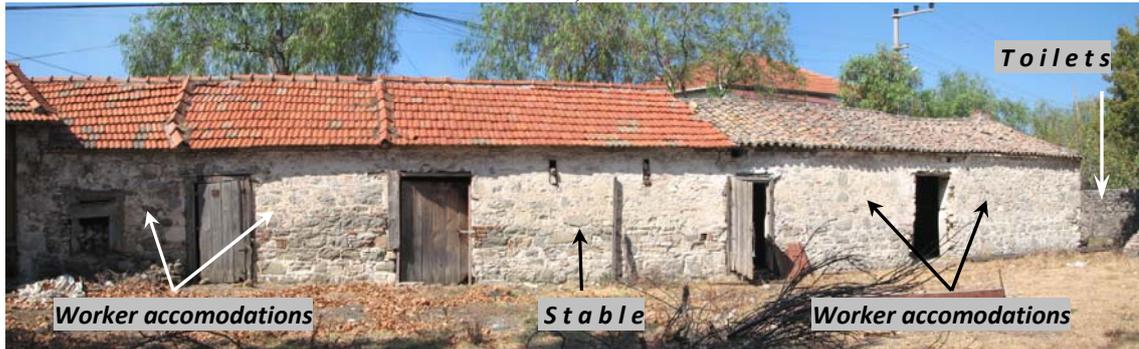
Figure 4.5. a) Semi-open olive storage units, b) accommodations for workers and stable

There are semi-open storage spaces, totally 136 m², adjacent to these accommodation units in a clockwise direction. It is composed of eight units and surmounted with timber gable roof supported with seven timber posts which hold the timber frames. This semi-open space is used for storing olive sacks. Separation of the units is provided by brick walls, the heights of which are not more than 1.00 m, slightly incline towards the courtyard (Figure 4.5 a).

The stone masonry accommodation buildings and a stable are on the western side of the courtyard and they cover an area of 169 m² in total. Except for the worker accommodations at the eastern end, all roofs of are composed of timber frames and covered with interlocking (*Marseilles*) type of roof tile. The roof of at the eastern end is covered with round (Turkish, or *a'la Turca*) tiles. Toilets, the roof of which is missing at present, are placed at the western end of these buildings (Figure 4.5 a, b).

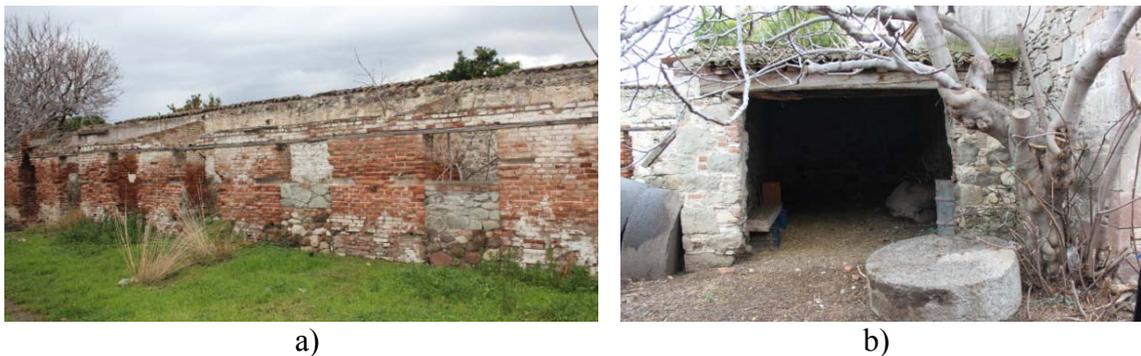
Figure 4.8. a) Accommodations for workers in the northeast, b) a semi-open olive storage space

Opposite the storage space in the north, five accommodation units (135 m² in total) used as accommodation for seasonal workers, are leaned to the northeast ‘stone masonry-periphery wall’ across the storage space. Front and partition walls are built of brick. The roof, inclined towards the courtyard, is missing at present (Figure 4.8 a). A semi-open stone masonry olive storage space, which is surmounted with a timber roof with interlocking tiles, is located adjacent to the accommodation unit covers an area of 27 m². It is used as hen coop at present (Figure 4.8 b).

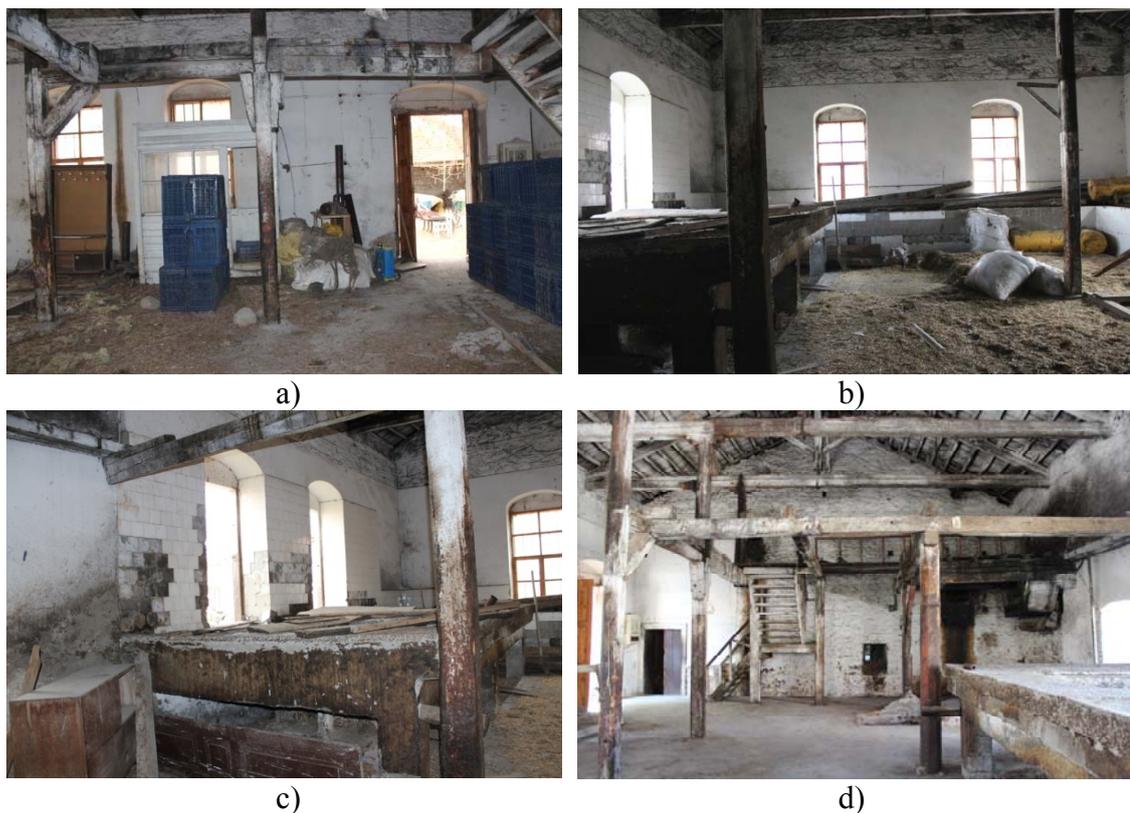
Figure 4.11. a) Southern, b) eastern, c) northern, and d) western sides of the production unit G-01

With approximate dimensions, there are three wood-framed window openings, of 1.00 / 2.00 m on the southern wall (Figure 4.11, Appendix A.6), two, of 1.00 / 2.00 m on the eastern wall (Figure 4.11 b, Appendix A.7) and another two, of 1.00 / 1.93 m on the northern wall (Figure 4.11 c, Appendix A.6). All these openings are spanned by brick segmental arches.

At the northwestern corner of G-01, there are brick masonry platforms, of 0.95 m in diameter and approximately 3.13 / 0.97 m for grinder. It is covered with screed. In front of this platform, there is rectangular basin (*havza*) to collect olive-paste coming from grinder during grinding process, approximately 0.97 / 1.39 m in dimension. The floor covering is covered with screed.

The surmounting system of G-01 is timber roof composed of five timber frames, battens and planks on which roof tiles are placed. The entire roof structure is supported by four timber posts and the beams of frames (Figure 4.11 d, Appendix A.4).

These windows are slightly trapezoidal in their plan. Their heights (from sill up to the wooden lintels; 1.97 ~ 2.00 m) and their widths (at the order of exterior and interior dimensions; 1.00 ~ 1.13 – 1.19 ~ 1.20 m) are close for the windows located in the east, north and southern walls of production unit and boiler unit (G-01, G-08). However, the dimensions of the one located in the western wall of boiler unit to the north is relatively smaller than the others, 0.73 – 0.90 m in exterior and interior width and 1.25 m in height, although it has the same layout (Figure 4.36 c). The wings of the windows located in the northern wall of production unit are missing as can be seen in Figure 4.11 c (Appendix B.2).

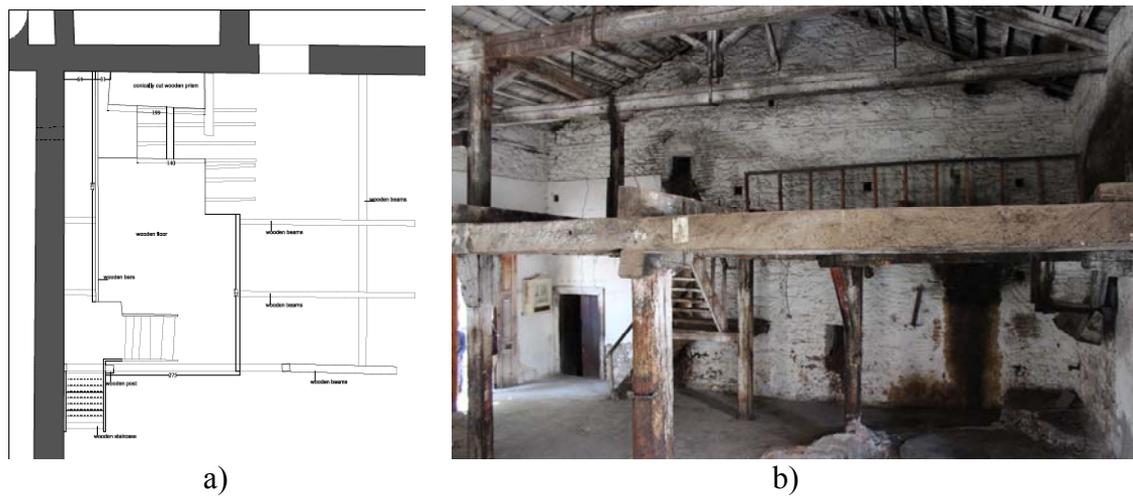
Figure 4.12. a) plan, and b) a view of mezzanine floor

A timber-frame **mezzanine floor**, designed for pouring olives into the crusher (grinder) through a conically cut-wooden prism (called *ambar*), is reached through a wooden staircase which is adjacent to the western wall in front of the entrance. It is supported by five wooden posts 0.17 x 0.17 m, and the beams approximately 0.17 x 0.20 m in their cross sections. Covered with a layer of stain, only a small portion of the planks on this floor remain (Figure 4.12 a, b, Appendix A.3).

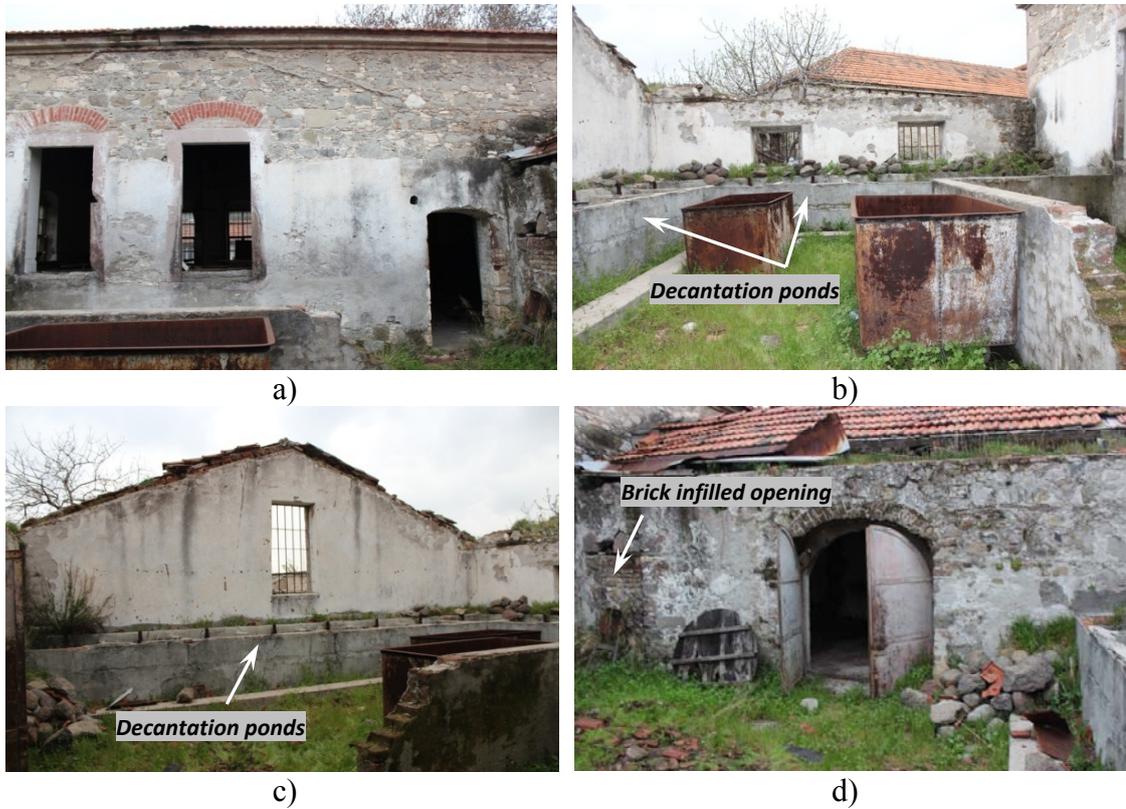
Figure 4.13. a) South, b) east, c) north, and d) western walls of office space G-02

The roof of decantation unit (G-02) totally collapsed. On the northern side of the hall, there is a gable wall which gives information about the type of the roof (Figure 4.13 c).

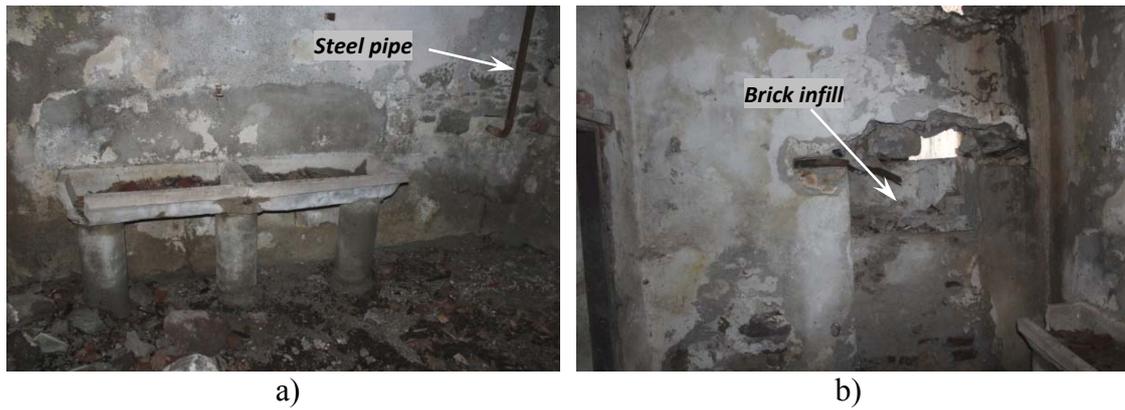
Figure 4.16. a) Concrete basin on the southern wall of G05, b) infilled door on eastern wall of G05

A cast-in concrete basin, which rested on brick supports, and a steel pipe are on the southern wall (Figure 4.16 a). Eastern wall contains an infilled door opening, that provided access to decantation unit G-02 in the past. It measures 0.90 / 2.14 m (Figure 4.16 b).

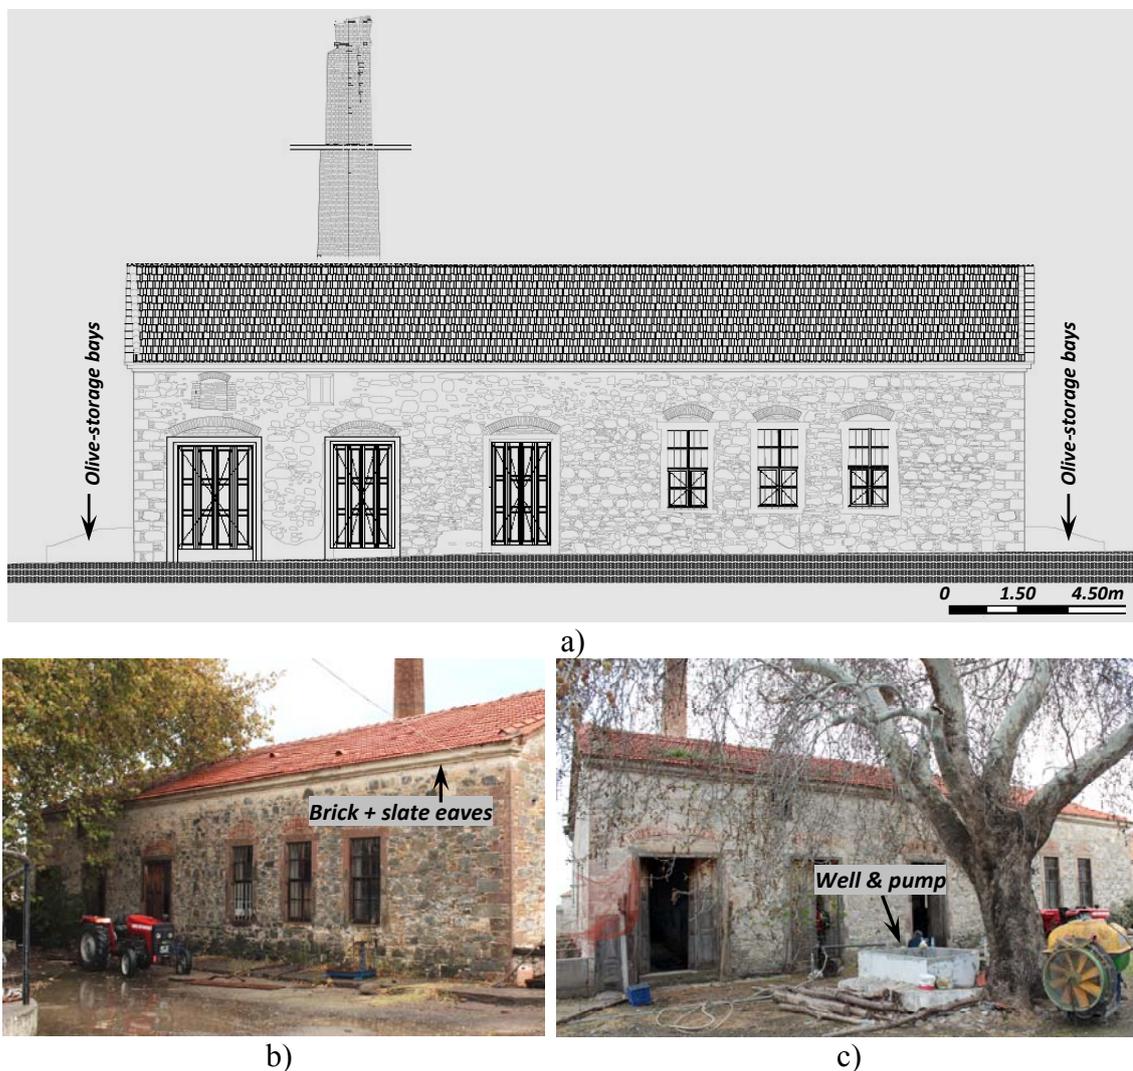
Figure 4.21. a) Southern elevation of the production unit, b) view from the northeast, and c) northwestern corners of the mill

Southern façade, 22.44 m long and 4.60 m high to the level of the eave, which makes three-stepped protrusion, composed of two rows of solid brick units and a slate (*kayrak*) row in between. Although detachments are observed in some parts, the eaves are plastered in general (Figure 4.21 a, b, c, Appendix A.9).

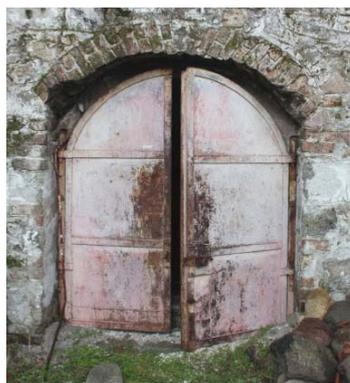
Figure 4.34. The outer view of double-wing iron door with segmental arch

Access from decantation ponds (G-02) to the administration unit (G-04) is provided by double-wing iron door in an opening, which is framed with a brick segmental arch measuring 1.40 m in width and 1.98 m in height from interior floor level to the highest point at the intrados of the arch. It is fixed to the edges by means of two iron posts anchored to stone masonry (Figure 4.34, Appendix B.3).

The problem of **rusting** is seen at the iron frame which enclose the chimney base (Figure 4.28 a), iron entrance door of administration unit (Figure 4.34), water tank (Figure 4.51) and iron grills in the window openings (Appendixes E.4 and E.7).

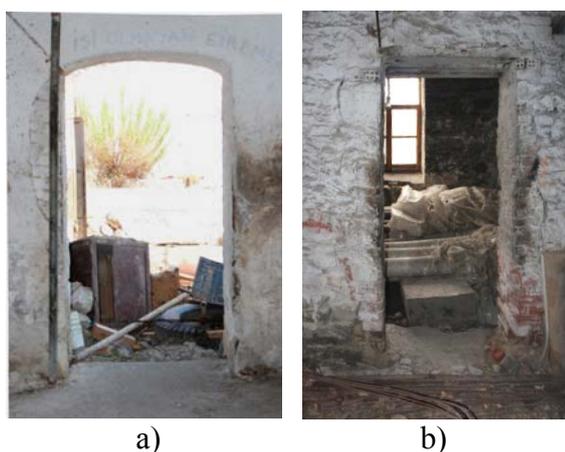
Figure. 4.35. a) Passage spanned with segmental arch, b) passage with wooden lintel

Passages: There are two types of passage-openings in the mill: the opening spanned with brick segmental arch and the other one spanned with timber lintels set within the thickness of the masonry wall. The first one is placed on the northern wall of the production unit and provides access to decantation ponds area G-02. The width of the passage is 1.00 m. The height at the highest at the intrados of the arch is 1.95 m. (Figure 4.35 a, Appendix B.2). The second passage spanned with timber lintel(s) is located in the western wall of machinery unit (G-07). It provides connection between machinery unit and boiler unit (G-08). This passage is 95 cm wide and 1.96 m high (Figure 4.35 b).

One of the two passageways was opened in the northern wall of production unit to access decantation ponds area (G-02) (Appendixes D.1 and D.3). The second passage was opened between machinery unit (G-07) and boiler unit (G-08) (Figure 4.35 a, b, Appendix D.1).

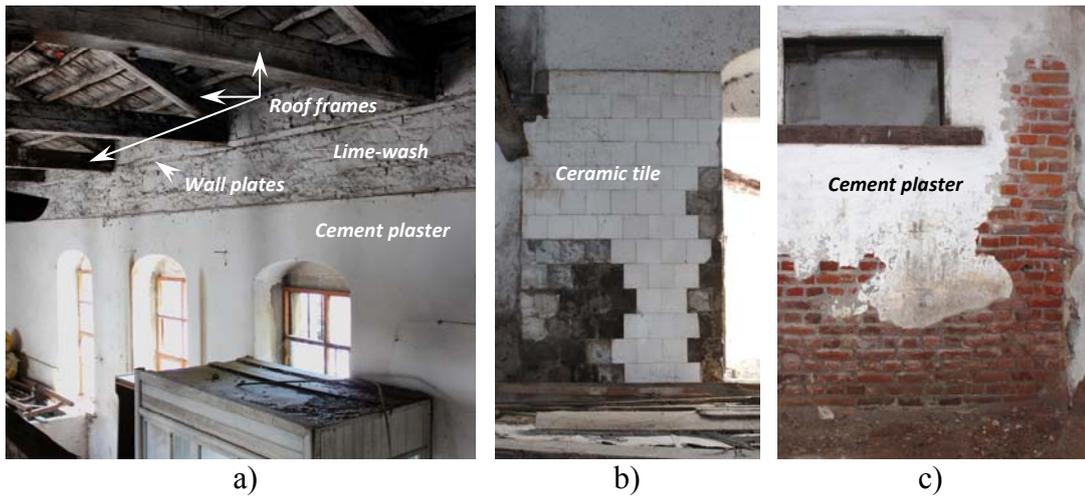
Figure 4.47. a) Plastered surfaces of the production unit (G0-1), b) ceramic-tile cover on the walls behind decantation ponds, c) Plastered brick-wall surface of an administration office (G-04)

As finishing material, cement plaster was applied on all interior faces of the walls of production unit (except for its northwestern corner) and decantation ponds area unit until the level 0.50-0.60 m below the wall plates on which roof frames are rested (Figure 4.47 a, Appendixes C.3 and C.4). The rest above this level and other walls without plaster are lime-washed directly applied on the surfaces in the production,

Material additions: As partially noted in the above analyses, of spaces and elements, mostly applied material is the cement plaster and screed in the mill other than those included in the additional masses and elements. Ceramic tiles are used to cover decantation ponds and a certain parts of the walls behind them (Figure 4.47 a, b, Appendixes D.3, D.4 and D.5).

Detachments of plasters observed on the walls of; administration unit (G-04) and decantation ponds unit (G-02) (Figures; 4.47 c, 4.54 a, b, c, Appendixes E.4 and E.5). It is due to that the plaster is of cement base. Some losses in the courses of ceramic tiles are also observed on exterior and interior faces of decantation ponds and on the walls behind them in the main production unit (G-01) are considered as detached materials (Figure 4.48. b, Appendixes E.3 and E.4).

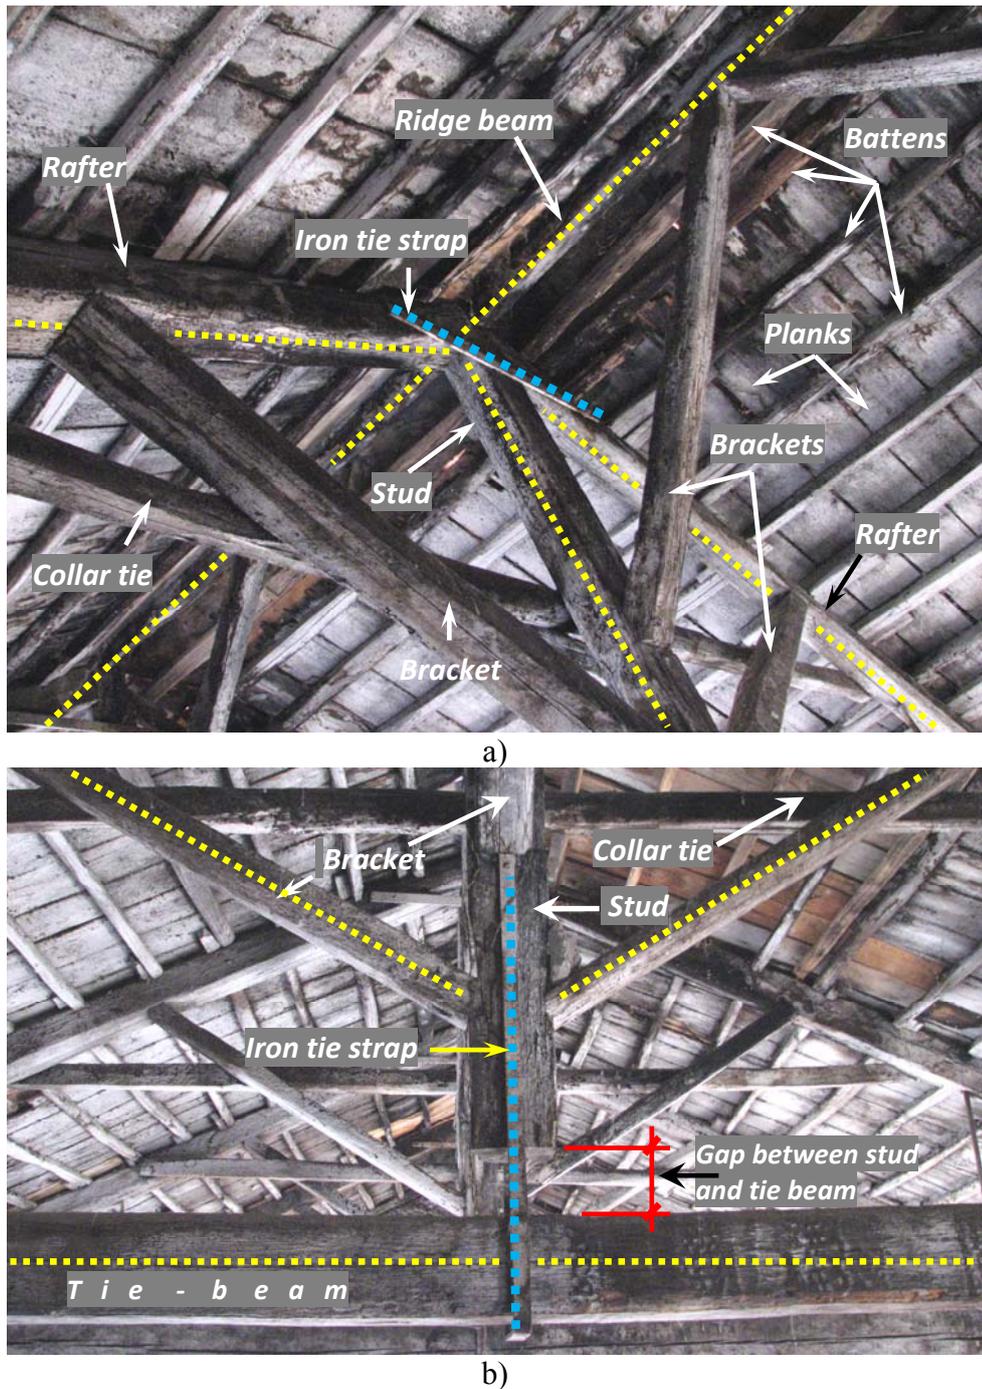
Figure 4.48. a) An axonometric view of the upper part of a roof frame and its components, b) front view of the components of lower part

Besides timber elements, iron tension-straps (5 cm wide, 0.5 cm thick) are also used as tension members stretched between two rafters (17 cm x 20 cm) of the frame (Figure 4.48 a). Another iron strap is used to connect the stud and tie beam, 17 cm in width and 20 cm height in its cross section with a gap around 10 cm in between (Figure 4.48 b, Appendixes C.3 and C.4).

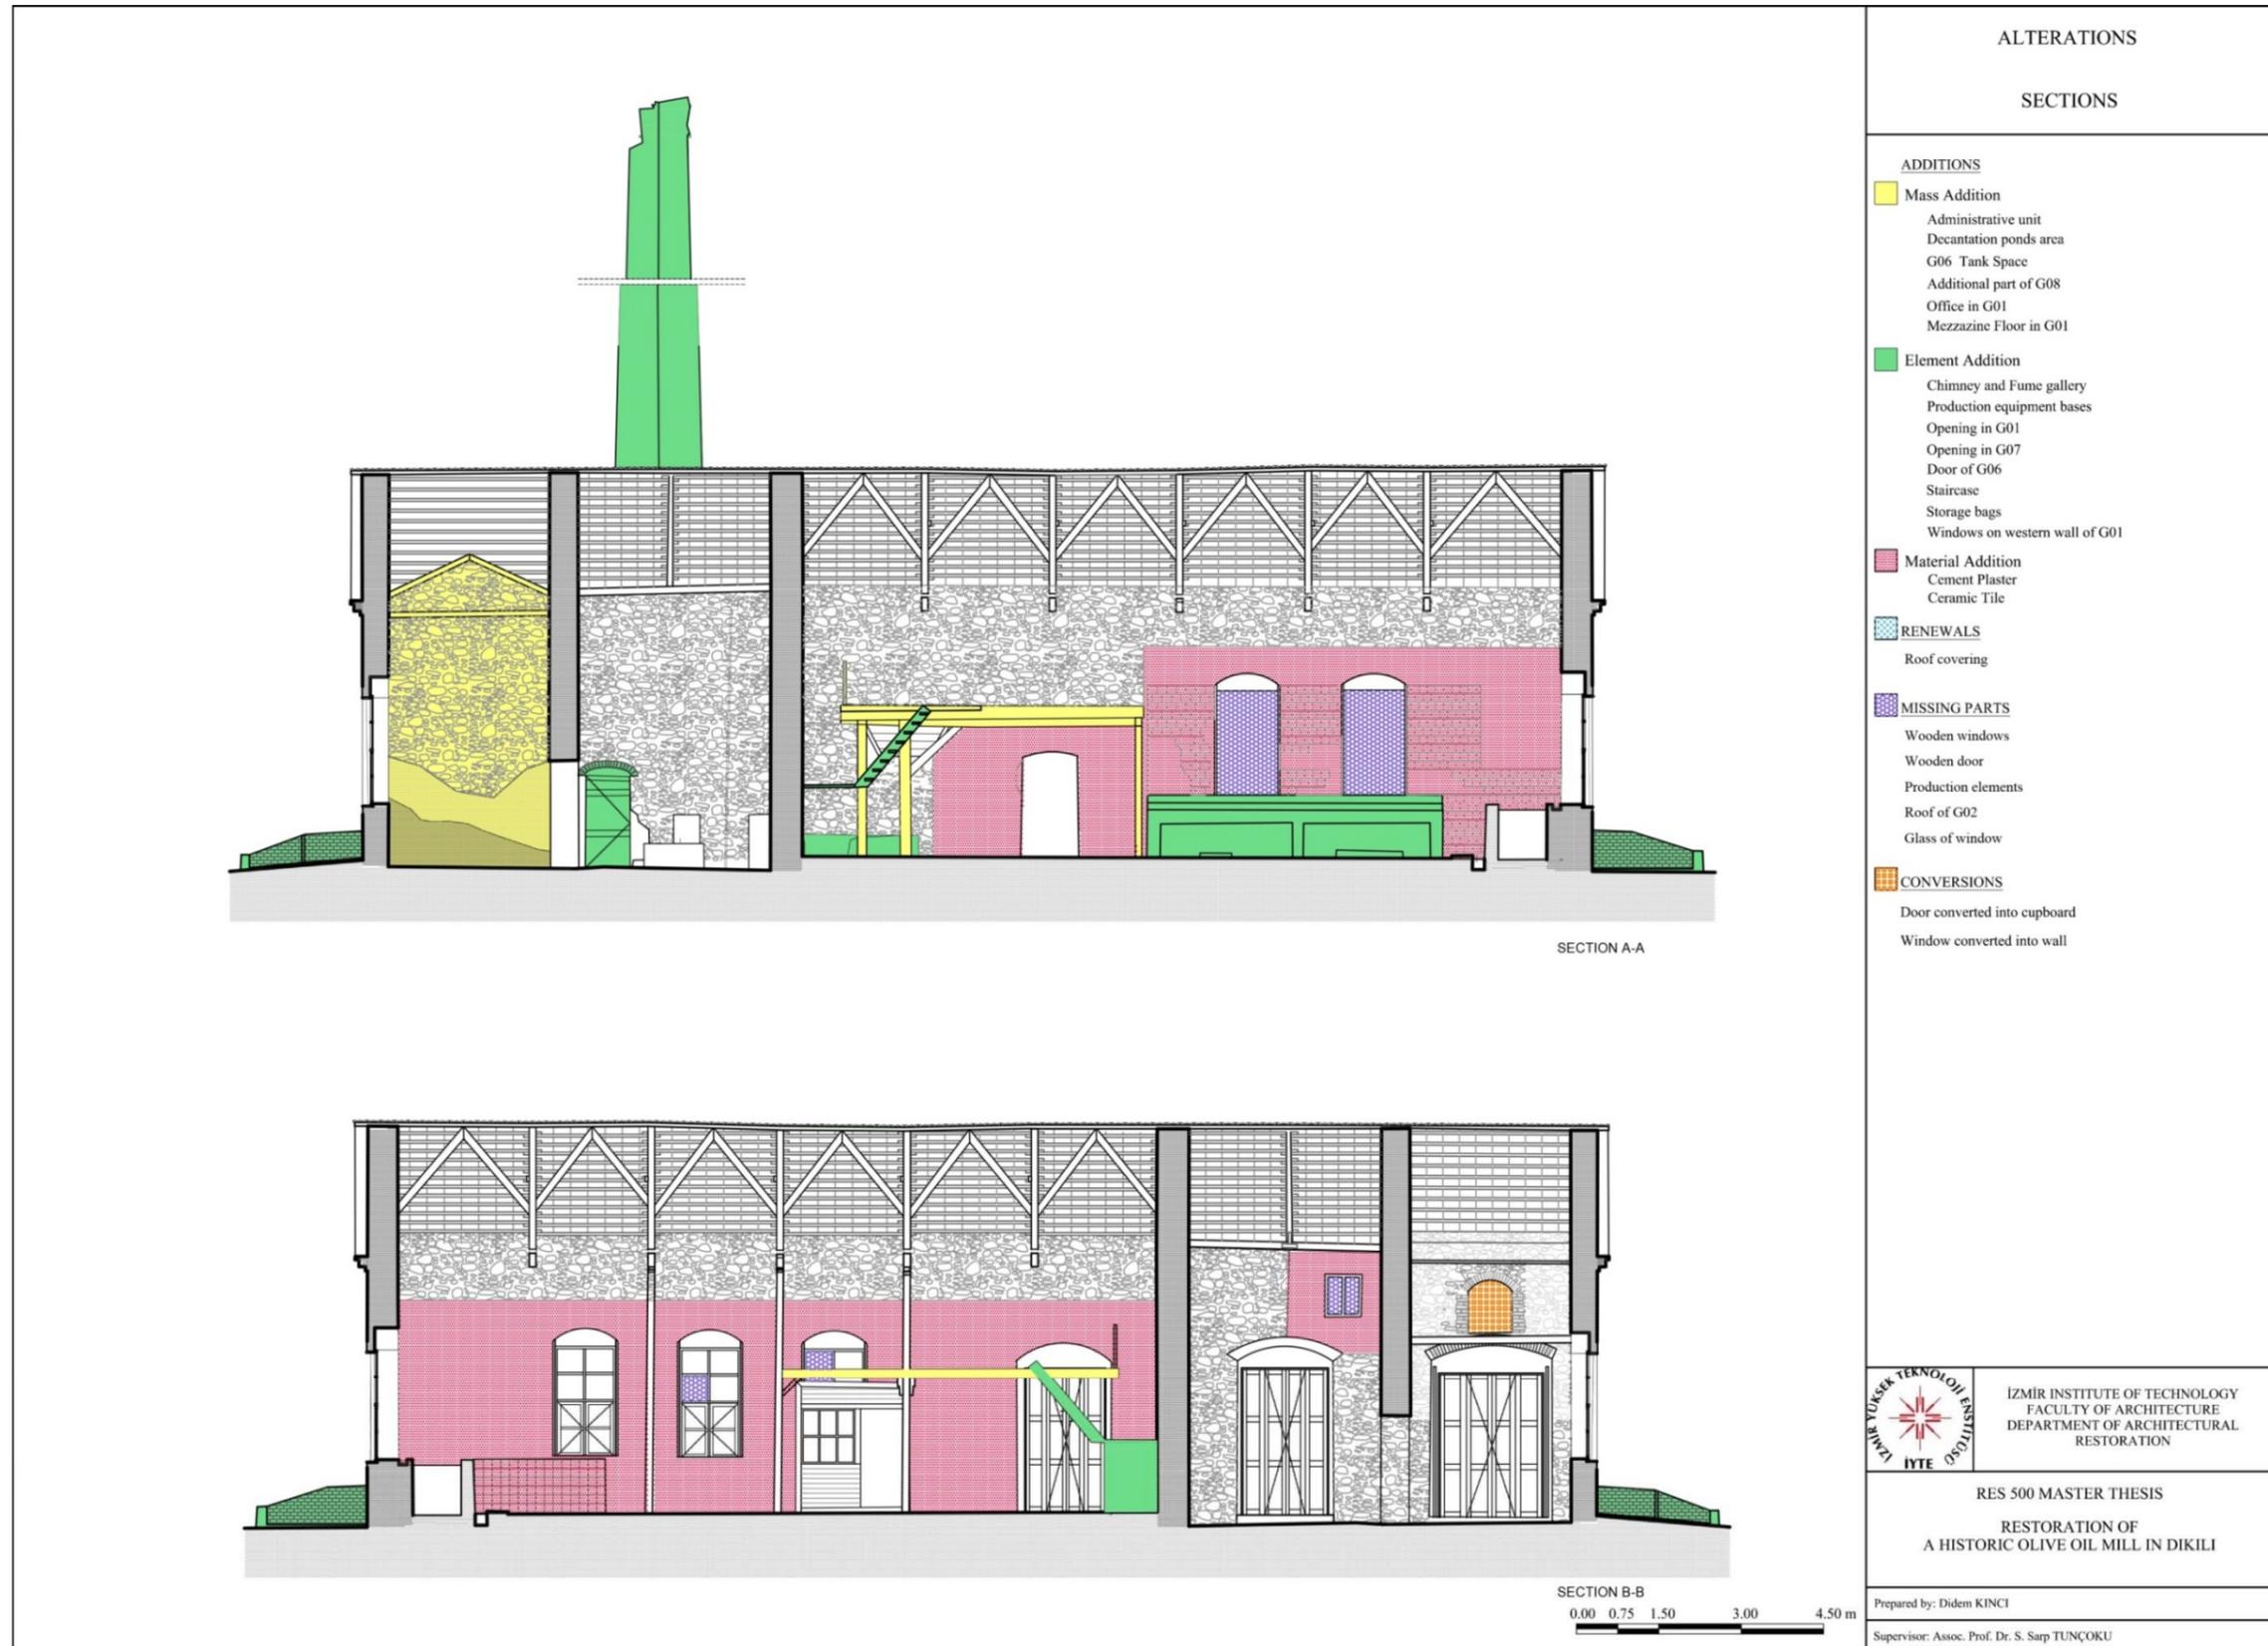
D.3. Analysis of alterations- Sections A-A and B-B

The roof of decantation ponds unit (G-02) is the most prominent constructional loss in the mill building (Appendixes D.4 and D.7.). Wooden windows in the northern wall of the production unit (G01) (Appendix D.3), the wooden door of the office (G05) in the administrative unit, and glasses of some window panes can be considered as other elemental losses. Although not constructional, but production equipment, such as; steam engine, grinder, boiler, hydraulic pump and hydraulic presses are considered as missing elements which have importance in terms of industrial hardware of the mill.

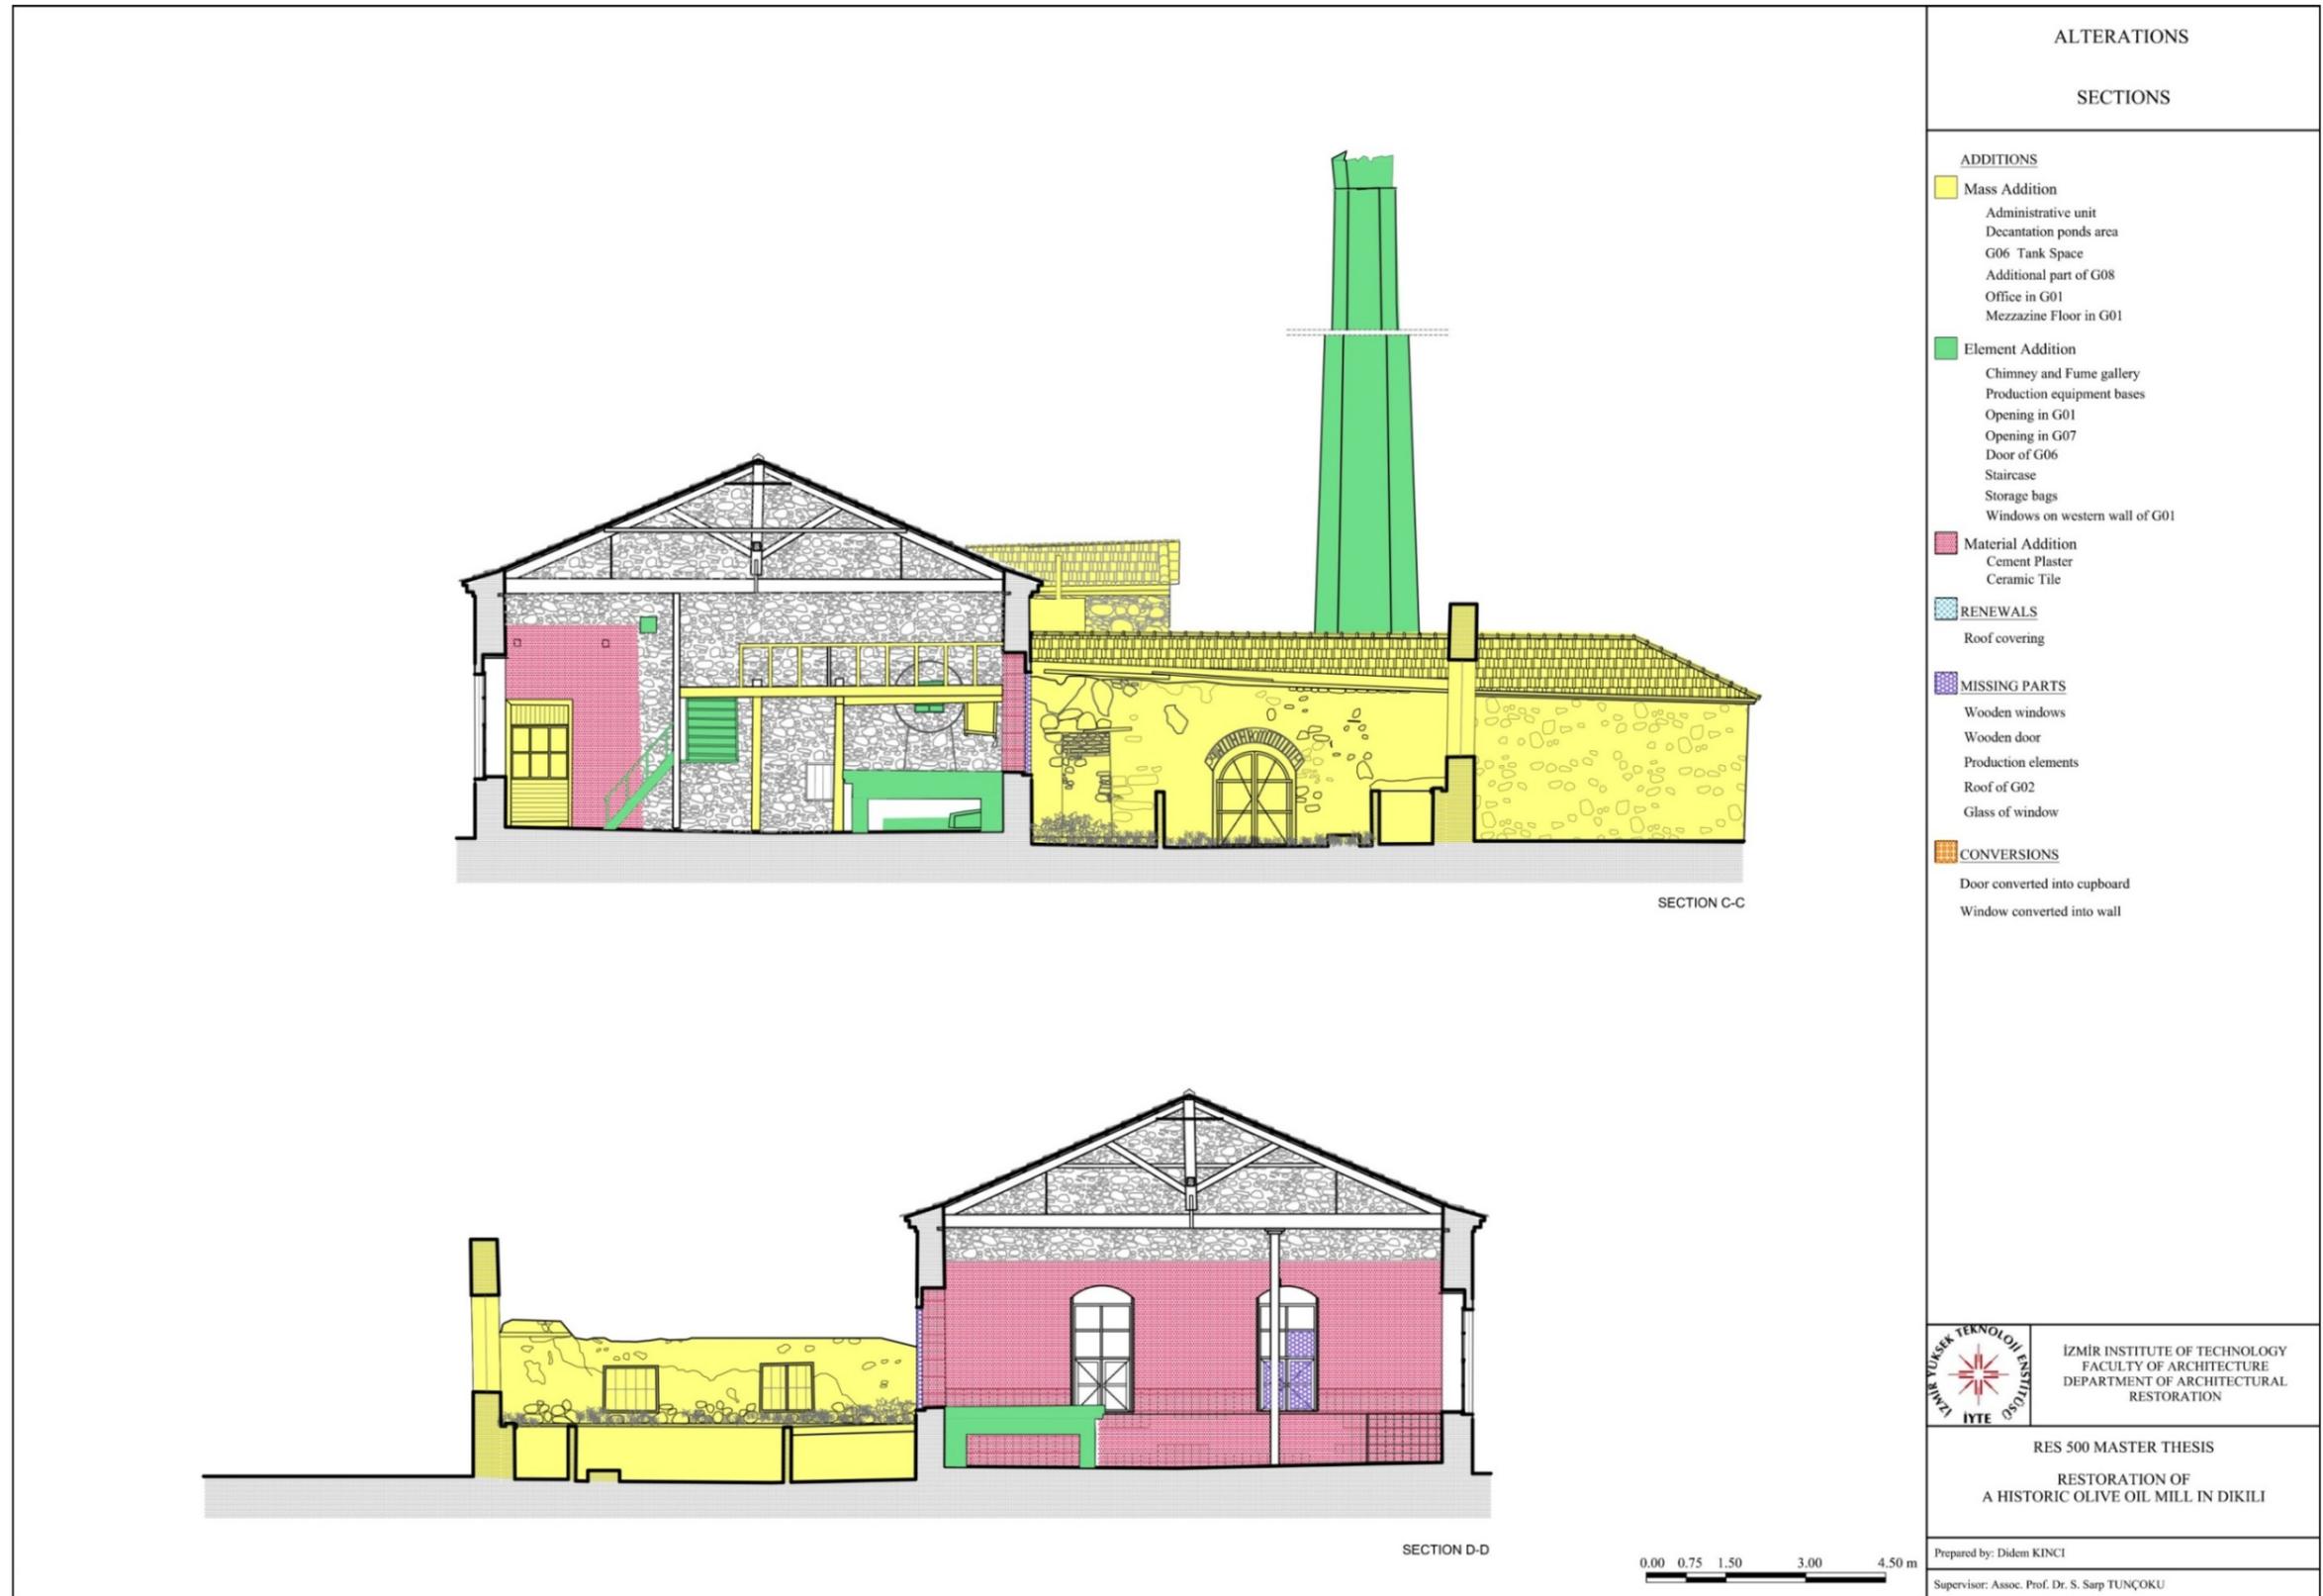
D.4. Analysis of alterations- Section C-C and D-D

Structural problems: Based on observation, there are three problems having potential to cause further hazards in the structure (Appendix E). The first apparent problem is the missing roof of decantation unit (G-02). It seemed that following its collapse, all fallen material of the roof have been taken away likely to be used in another construction since there are no remains on the ground. As well as the ground, which is filled with water in rainy seasons – being a source of raising damp, all walls of the decantation unit are open to the natural conditions at present (Figure 4.52, Appendixes E.1 and E.2.).

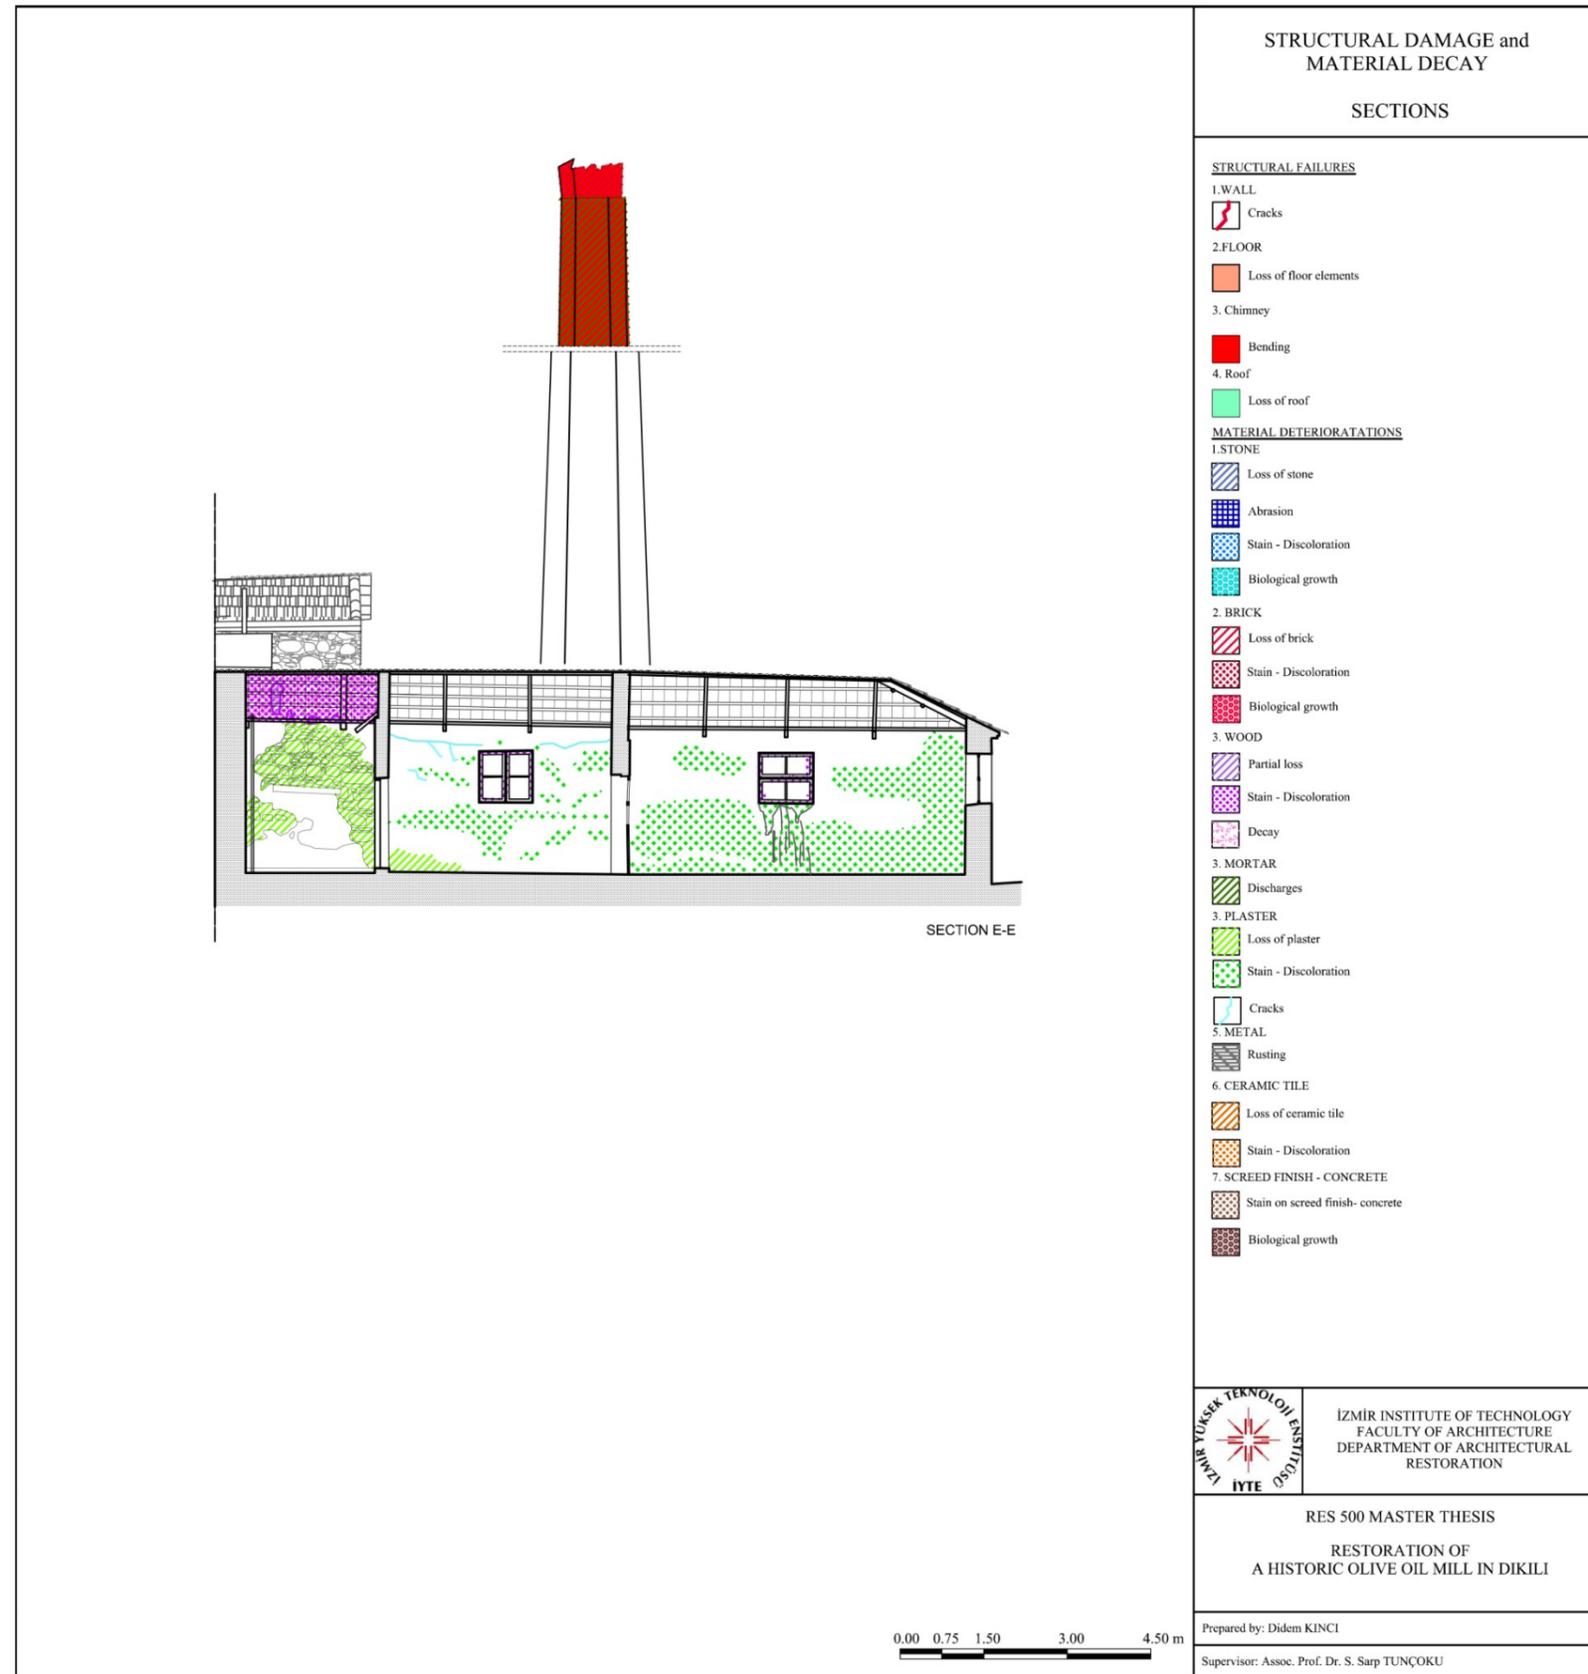
E.5. Analysis of structural damages and material decay- Section E-E

- STRUCTURAL FAILURES**
1. WALL
 Cracks
2. FLOOR
 Loss of floor elements
3. Chimney
 Bending
4. Roof
 Loss of roof
- MATERIAL DETERIORATIONS**
1. STONE
 Loss of stone
 Abrasion
 Stain - Discoloration
 Biological growth
2. BRICK
 Loss of brick
 Stain - Discoloration
 Biological growth
3. WOOD
 Partial loss
 Stain - Discoloration
 Decay
3. MORTAR
 Discharges
3. PLASTER
 Loss of plaster
 Stain - Discoloration
 Cracks
5. METAL
 Rusting
6. CERAMIC TILE
 Loss of ceramic tile
 Stain - Discoloration
7. SCREED FINISH - CONCRETE
 Stain on screed finish- concrete
 Biological growth
